Weston-super-Mare, North Somerset: Great Weston Heritage Action Zone, Aerial Investigation and Mapping Project

Research Report Series no. 50-2018

Great Weston Heritage Action Zone
Aerial Investigation and Mapping Project

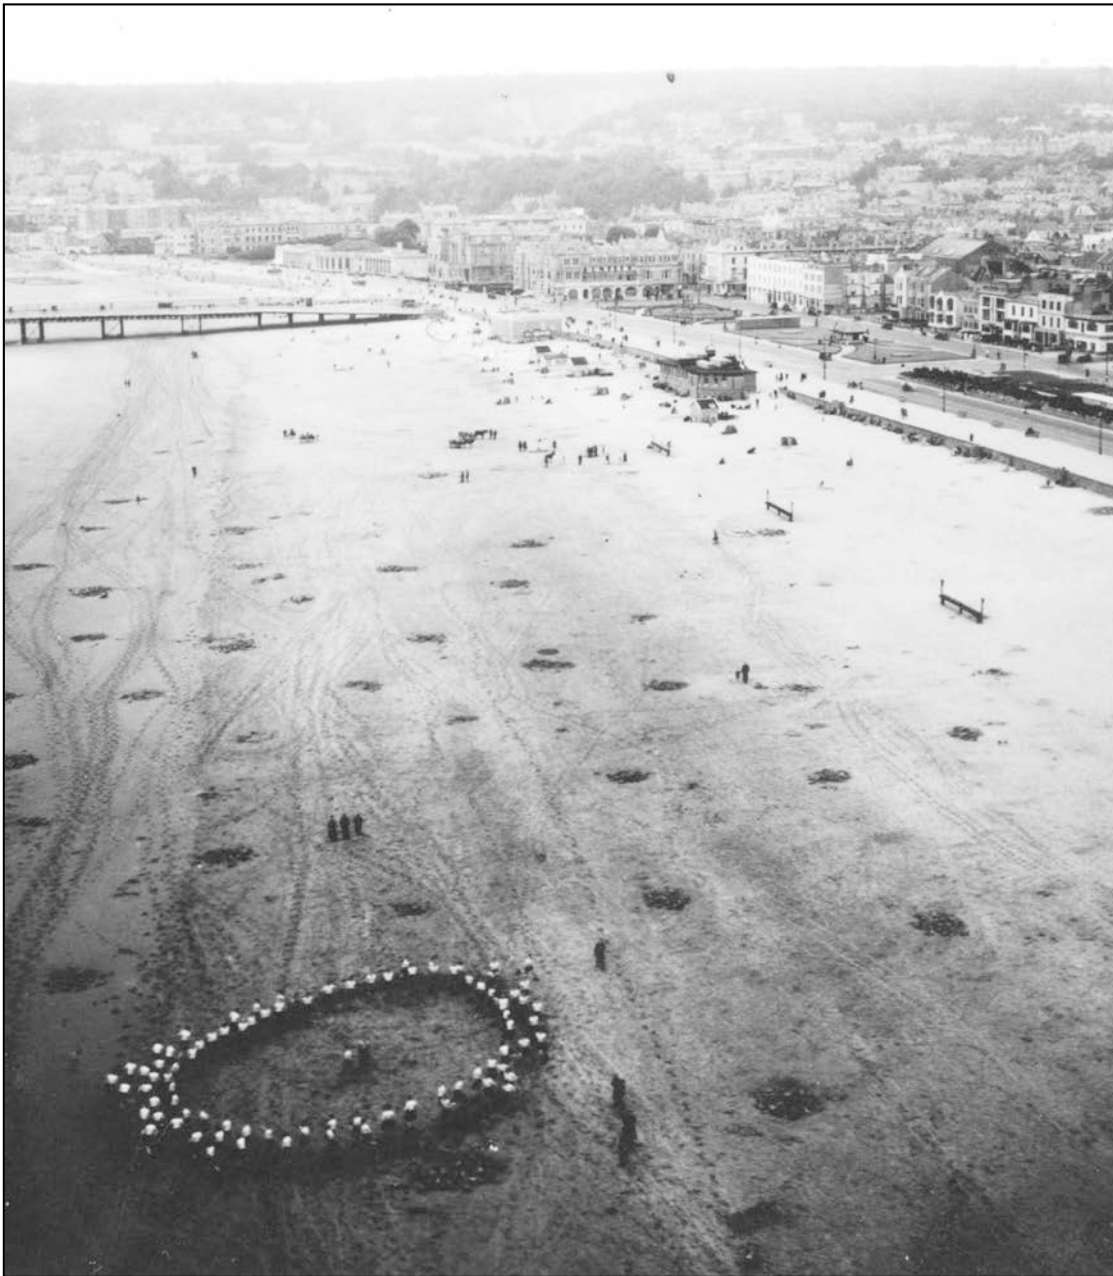
Figure 61 Weston-super-Mare beach September 1941. Detail of RAF/1416/S512184/PO-060 19-SEP-1941 Historic England (RAF Photography)

At first glance, the effects of the war are not immediately apparent. The pier is intact and people are on the beach - some enjoying donkey rides. However, this photo tells another story. The people in the foreground appear to be troops undergoing physical training. The beach is dotted with low piles of stones, positioned to act as aircraft obstructions to prevent the enemy using it as an airstrip. Just off the sand on Beach Lawn three air raid shelters can be seen.

A familiar image of seaside towns during the Second World War consists of resorts with few people, the beaches closed-off by barbed wire, lines of anti-tank defences along the promenade and sections removed from piers isolating them from the seafront (Walvin 1978, 127; Hassan 2003, 134). This can be contrasted with an aerial photograph taken of Weston-super-Mare in 1941 that shows a very different view of the seaside in wartime (Fig 61).

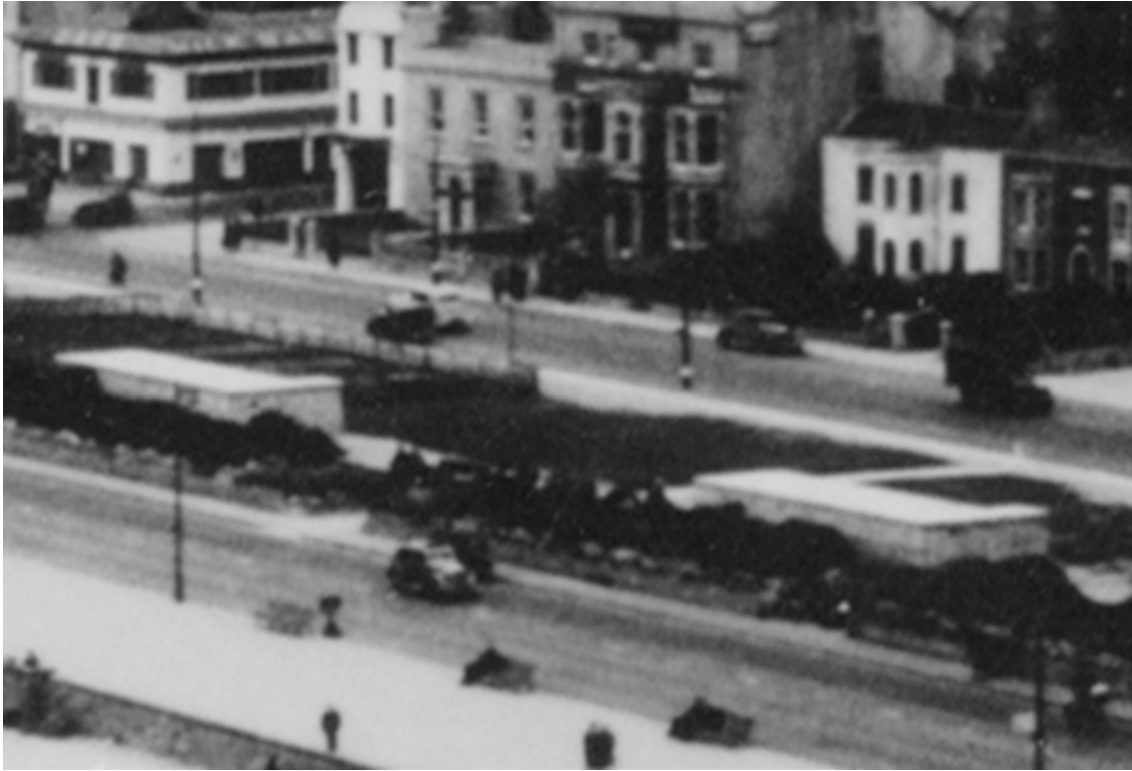
Figure 62 Public surface shelters on Beach Lawn in 1941. Detail of RAF/1416/S512184/PO-060 19-SEP-1941 Historic England (RAF Photography)

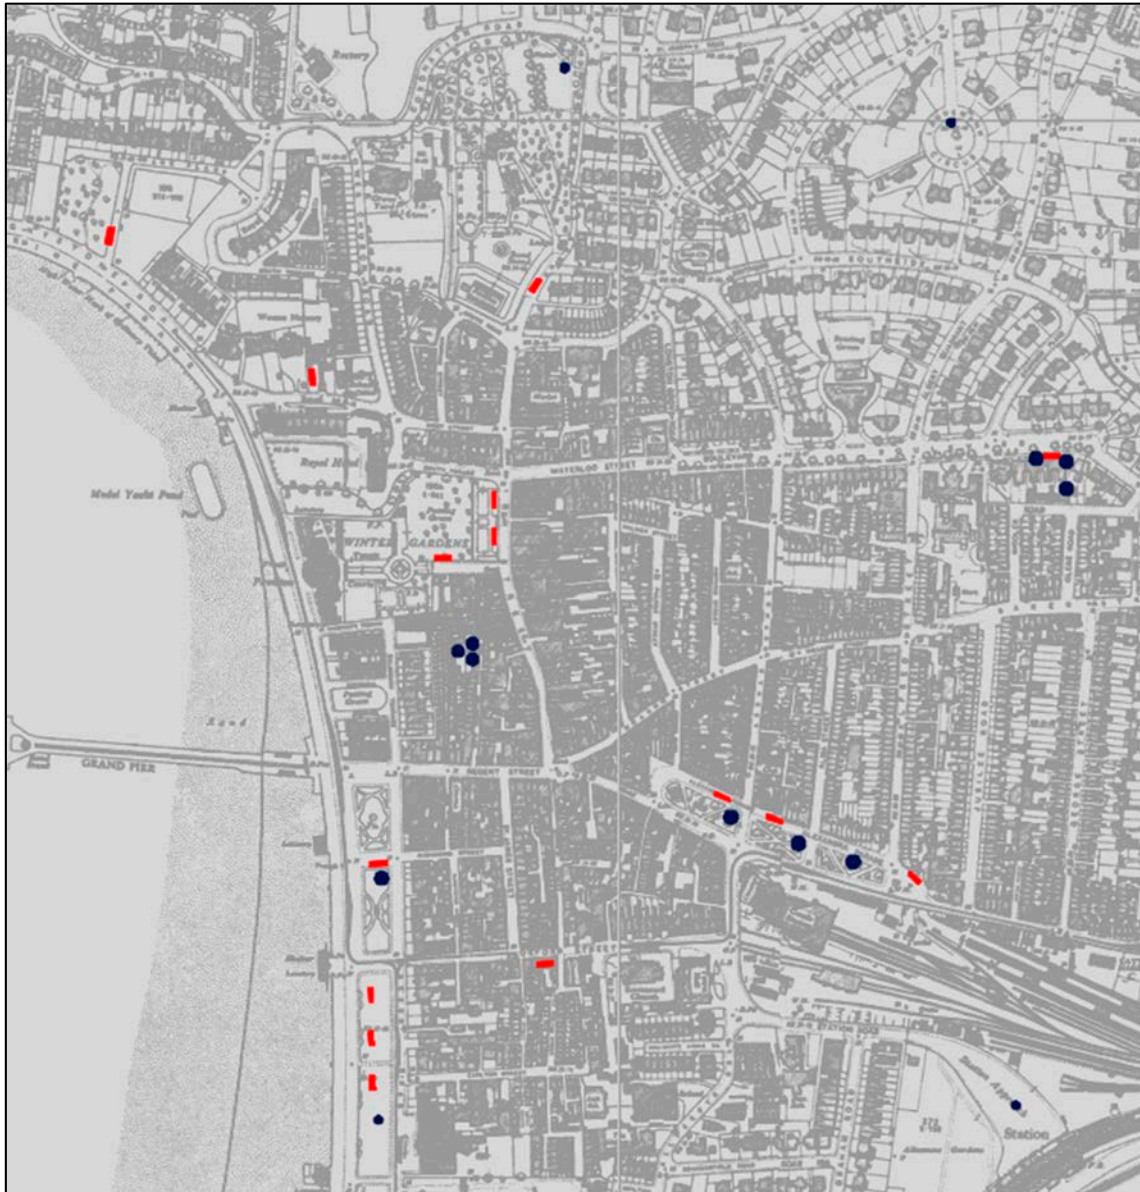
Figure 63 The distribution of public surface shelters (in red) and Emergency Water Supply (EWS) reservoirs (in blue) across the northern part of town. Ordnance Survey 1:2,500 published 1931 © and database right Crown Copyright and Landmark Information Group Ltd (All rights reserved 2081) Licence numbers 000394 and TP0024

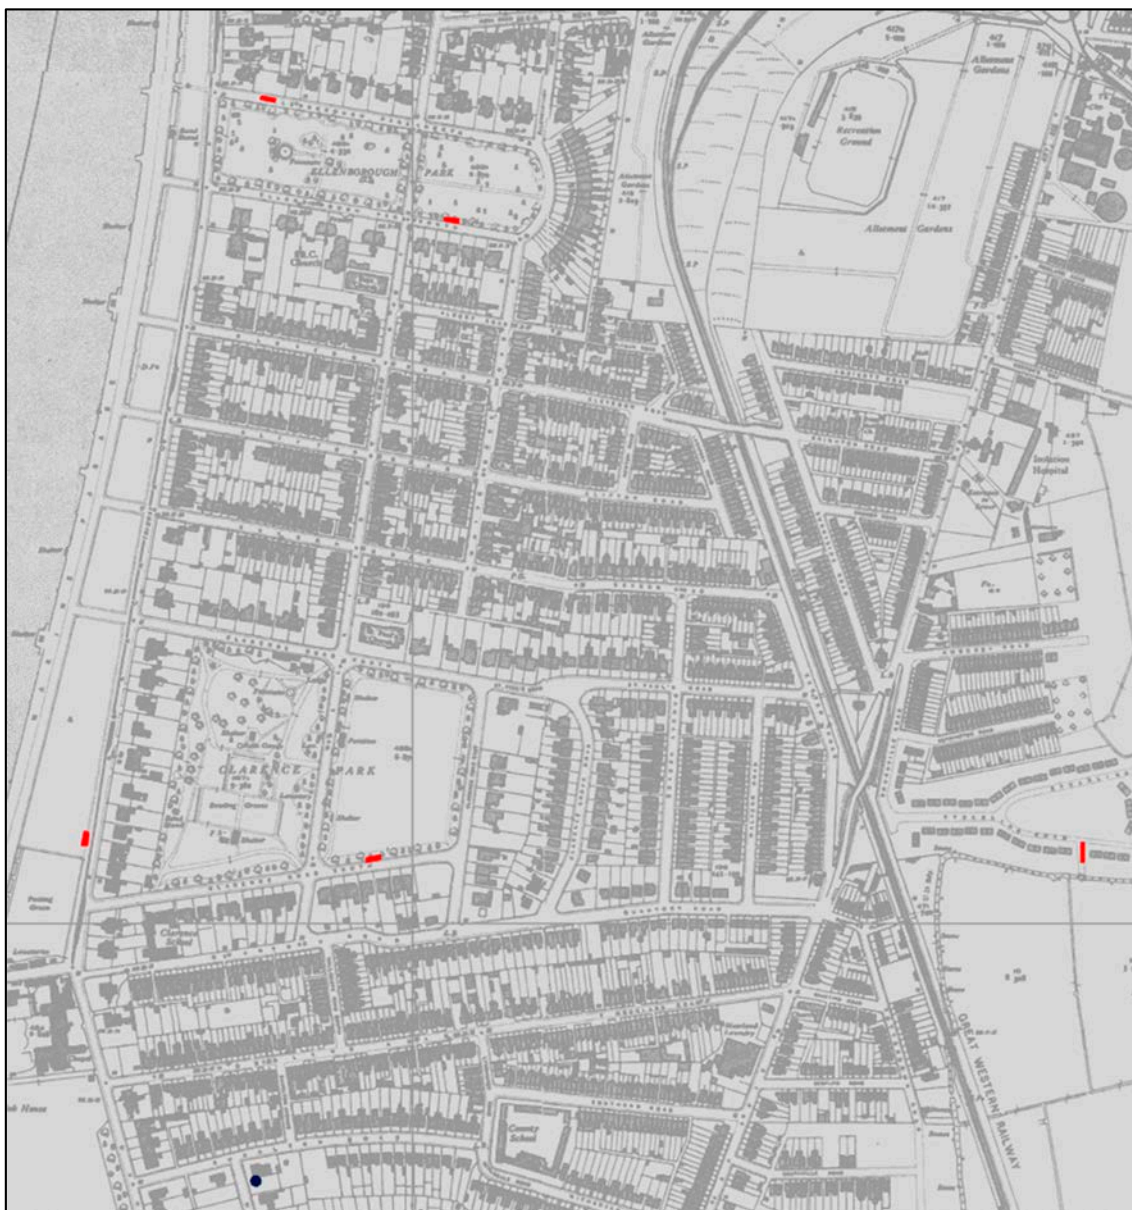
Figure 64 The distribution of public surface shelters (in red) and EWS (in blue) across the southern part of town. Ordnance Survey 1:2,500 published 1931 © and database right Crown Copyright and Landmark Information Group Ltd (All rights reserved 2081) Licence numbers 000394 and TP0024

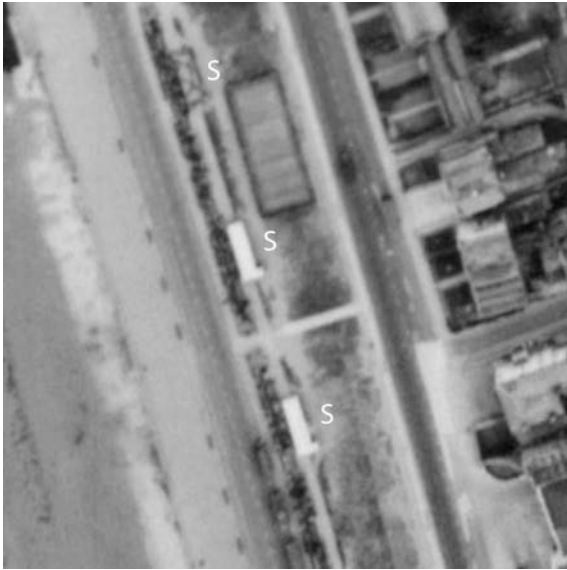
Figure 65 Three shelters (marked S) on paths on Beach Lawn 1941. The top shelter appears to be camouflaged. Detail of RAF/GHQ/105 V 47 14-MAY-1941 Historic England Archive (RAF Photography)

The shelters were located across the town (Fig 63-64) and although some were built on open land, most of these appear to have been built on paths rather than grassed areas. The three shelters on the north of Beach Lawn were erected on the broad pathways or pavements that fringe and cut across the lawns (Fig 65). The shelters built for those using the public parks were not built in the parks but instead on the roads alongside them (Fig 66). Only one air raid shelter was built in a park. This was situated in the park (now playground) between Albert Buildings and Victoria Buildings. A third category were shelters built on bombsites, one on Oxford Street, the other on the Boulevard.

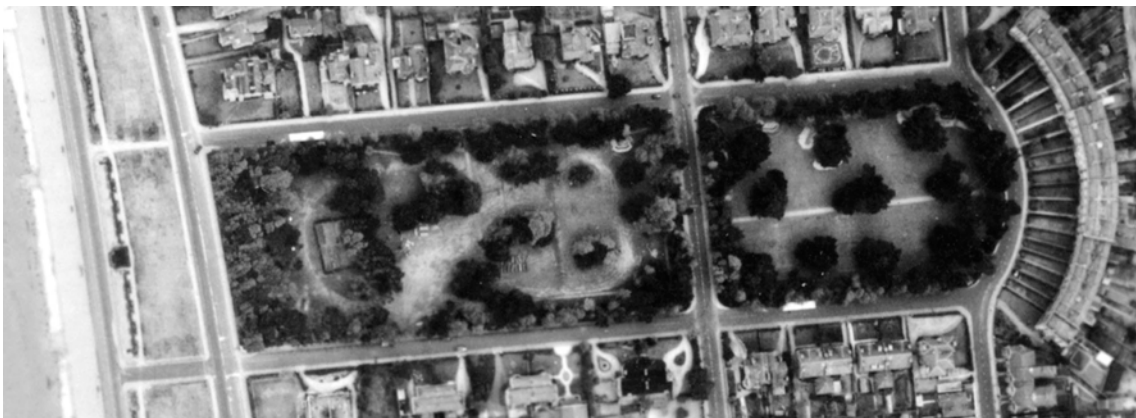
Figure 66 Ellenborough Park 1941. Two white rectangular shelters on the roads by the park, top left and bottom right. Detail of RAF/GHQ/105 V 50 14-MAY-1941 Historic England (RAF Photography)

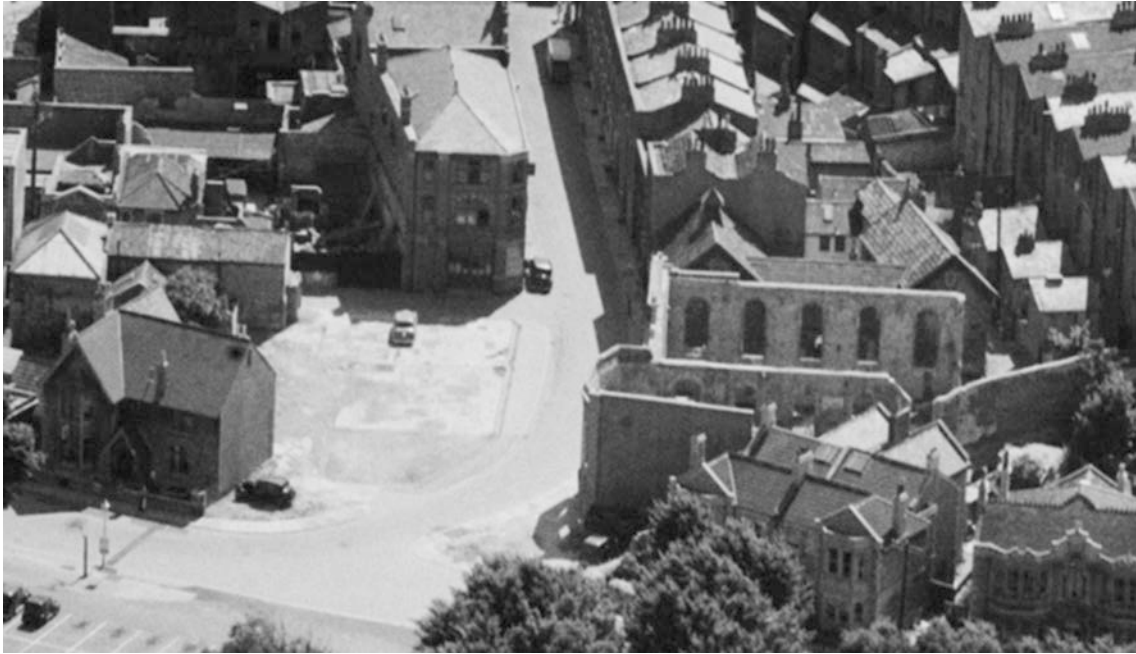
Figure 70 Bomb damage on Wadham Street 1949. The shell of the Baptist Chapel is on the right, opposite is a cleared bomb site. AFL 61877/EAW025151 25-Jul-1949 © Historic England (Aerofilms Collection)

The first bombs fell on Weston in September 1940 and in total the town suffered ten air raids (*Western Daily Press* 11 Nov 1948, 1 Col G), including the heaviest on the night of 28th/29th June 1942. The RAF photography provides a range of evidence of the air raids on Weston-super-Mare. This includes bomb craters, damaged or demolished buildings and cleared bombsites. Aerial photographs taken in July 1942 show the effects of the air raid of the previous month with evidence of the destruction to a number of buildings including the Congregational Chapel and Sunday School in Waterloo Street and the Tivoli Cinema (the former Victoria Hall) in the Boulevard. Lance and Lance's department store was also destroyed in the raid and the site had been cleared by that date. The effects of the raid were still clearly seen in 1946 (Fig 69) and in more detail in 1949 (Fig 70).

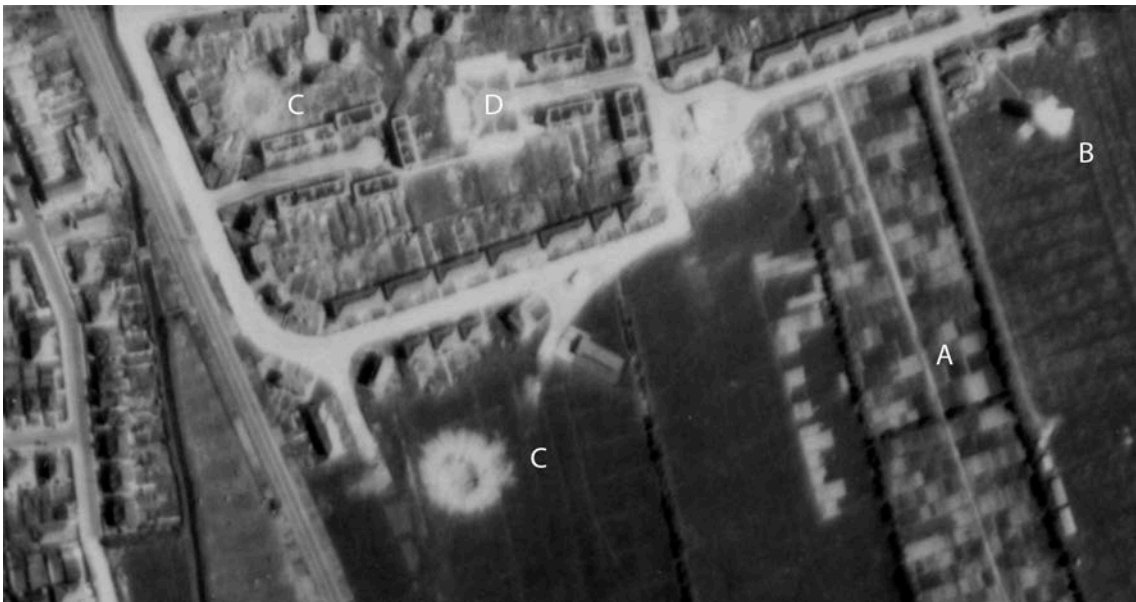
Figure 71 Part of Bournville after an air raid in 1942. Detail of RAF/FNO/37V 5078 11-JUL-1942 Historic England Archive (RAF Photography)

Figure 71 shows the aftereffects of a raid on the Bournville area of the town. Two definite bomb craters are marked C. Bomb damage is not always apparent on aerial photographs, but D is at the centre of the three buildings that were demolished after the raid, their outlines seen in white. B is a barrage balloon, although the image is blurred. A is an area of wartime allotments.

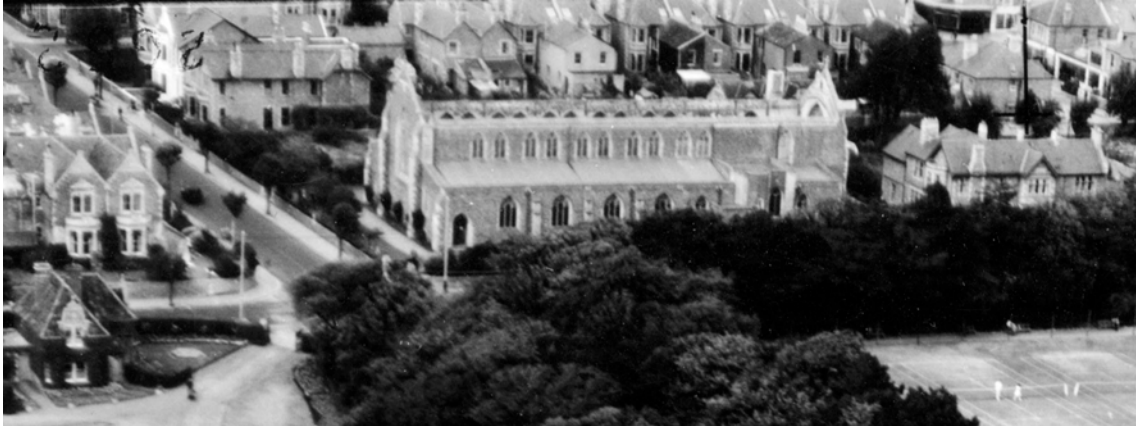
Figure 72 The shell of St Paul's Church, Clarence Road North in 1948. Detail of RAF/541/99/PSFO-0055 16-JUL-1948 Historic England Archive (RAF Photography)

Cleared bombsites and the shells of damaged buildings can be seen on immediate post-war photographs taken in 1946 and 1948. Some damaged buildings were eventually rebuilt, such as St Paul's Church that was gutted by fire during a raid (Fig 72). Other buildings were demolished. Figure 73 show the rubble remains of the former Rossholme School.

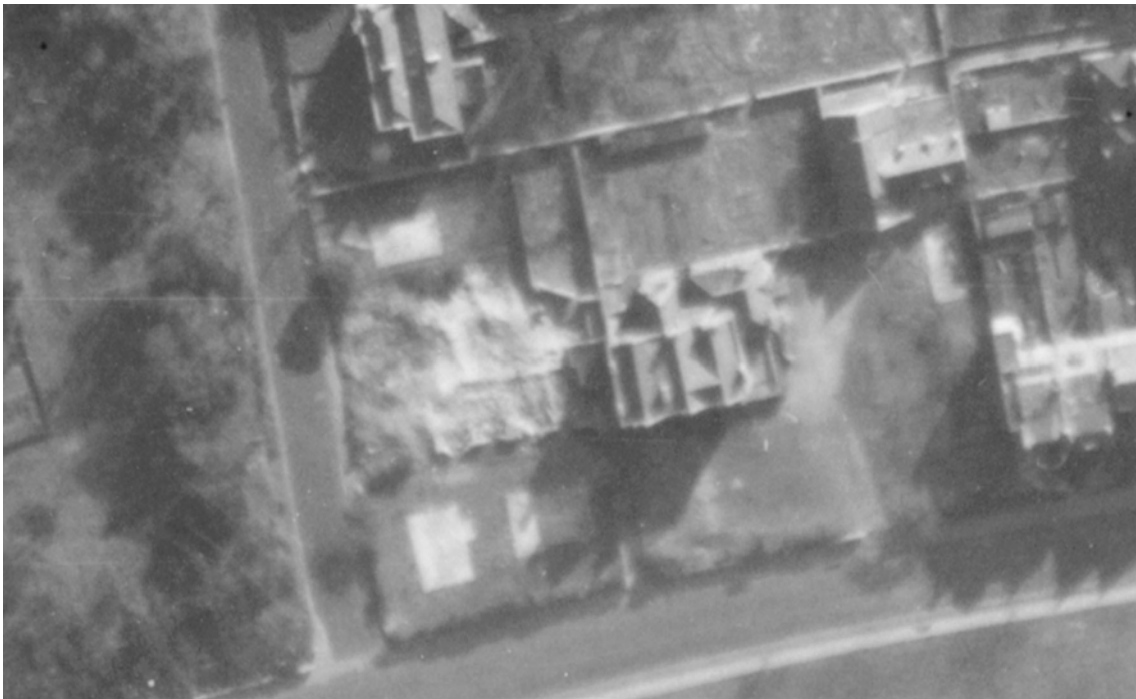
Figure 73 The rubble remains of Rossholme School on the seafront at the corner of Beach Road and Ellenborough Park South, demolished after bomb damage. Detail of RAF/CPE/UK/2489 V5049 11-MAR-1948 Historic England Archive (RAF Photography)

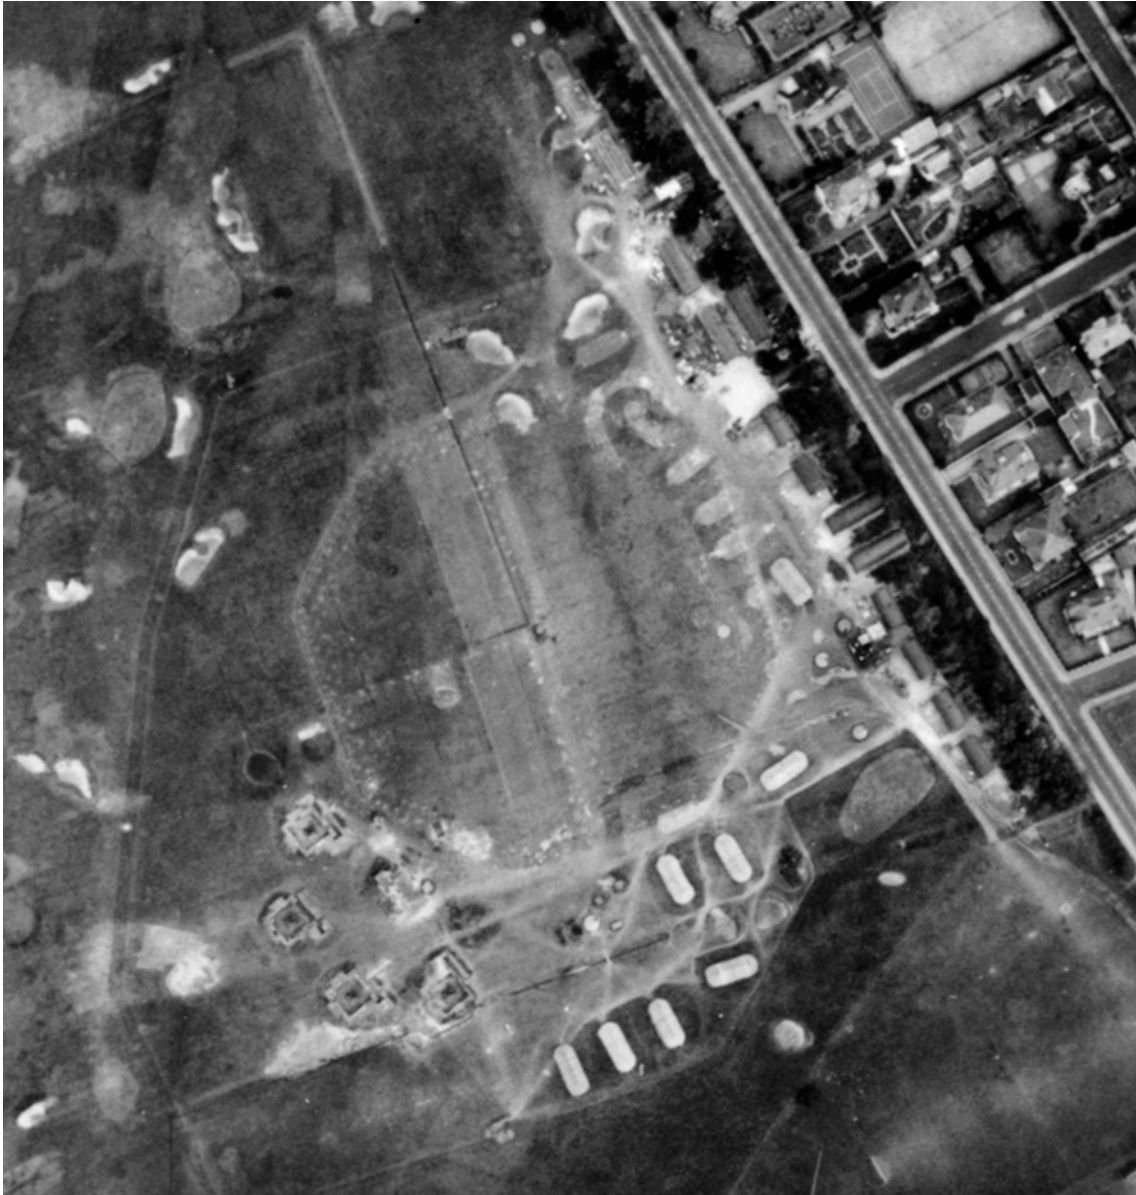
Figure 75 Uphill HAA battery in 1941. Detail of RAF/GHQ/105 V 14-MAY-1941 Historic England Archive (RAF Photography)

The battery follows the standard arrangement of four emplacements, each with a gun, arranged in an arc in front of a command post. Uphill battery is clearly in a period of transition at this date. On the landward side of the battery alongside Uphill Road North are a series of huts forming the accommodation for the troops. Two of these are still under construction and at least one hut seen on later photographs remained to be built. The battery also had eight large tents that provided accommodation for the troops while the huts were built. Some of the tents had been removed by 14 May 1941, but they had been in place long enough to leave a mark on the ground and the outlines of six tents can be picked out in the grass (Fig 76).

Six days before the first mention of Uphill Battery in official documents, a RAF reconnaissance aircraft photographed the coastline on 14 May 1941. The coverage does not extend far enough inland to include the Coronation Estate area, but does cover the golf course and offers a detailed view of the HAA battery located there. The entire site is illustrated in Fig 75 and detailed views of different parts of the site in Figs 76-79.

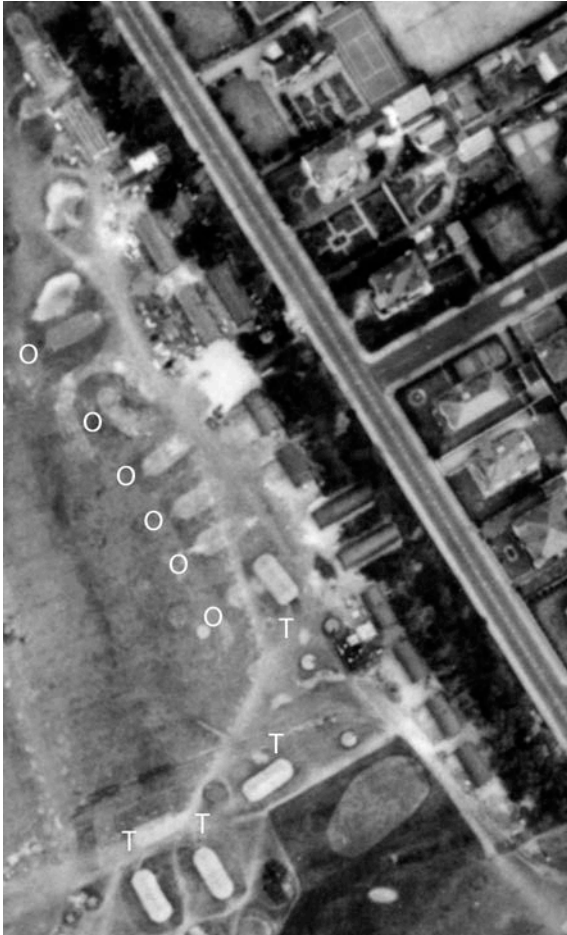
Figure 76 Uphill HAA in 1941. Tents are marked T, the outline of recently moved tents marked O. Accommodation huts can be seen alongside the road running diagonally across the image. Those at the top are still under construction. Detail of RAF/GHQ/105 V 14-MAY-1941 Historic England Archive (RAF Photography)

Although the removal of some of the tents does suggest that by May 1941 the huts were beginning to be occupied, this is not the whole story. All but one of the tents that had been removed were in the way of a large GL mat that formed part of the GL radar system. At least one tent was repositioned rather than removed to make room for the GL mat.

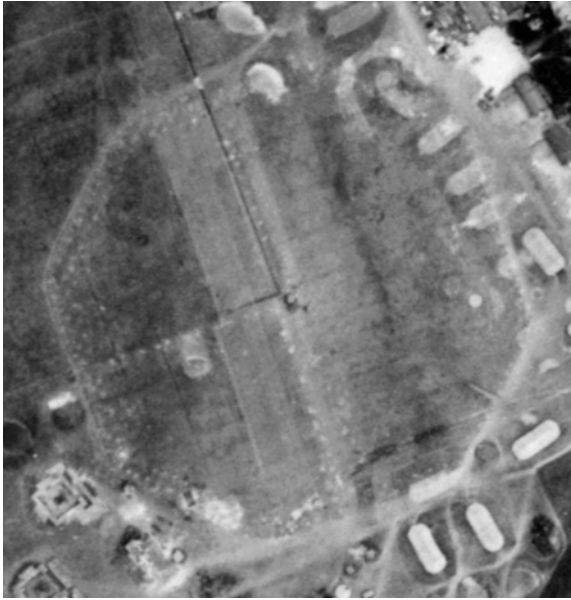
Figure 77 The outline of Uphill HAA's octagonal GL mat. Detail of RAF/GHQ/105 V 14-MAY-1941 Historic England Archive (RAF Photography)

The development of radar to provide range and bearing information of enemy aircraft to the gun battery was undertaken from the late 1930s and is outlined in detail in Dobinson 1996, 128. The first set was the GL Mk I. This came into service in September 1939 and consisted of separate trailer mounted transmitter and receiver units. The accuracy of this radar was improved when the receiving unit was situated in the middle of an area of uniform electrical properties at least 119m across. This was achieved by the construction of an octagonal wire lattice within which the receiver was positioned (Fig 77). These wire lattices were known as GL mats and came into service in December 1940. Radar improvements led to the development of the GL Mk II. This was introduced in January 1941 but still required a GL mat.

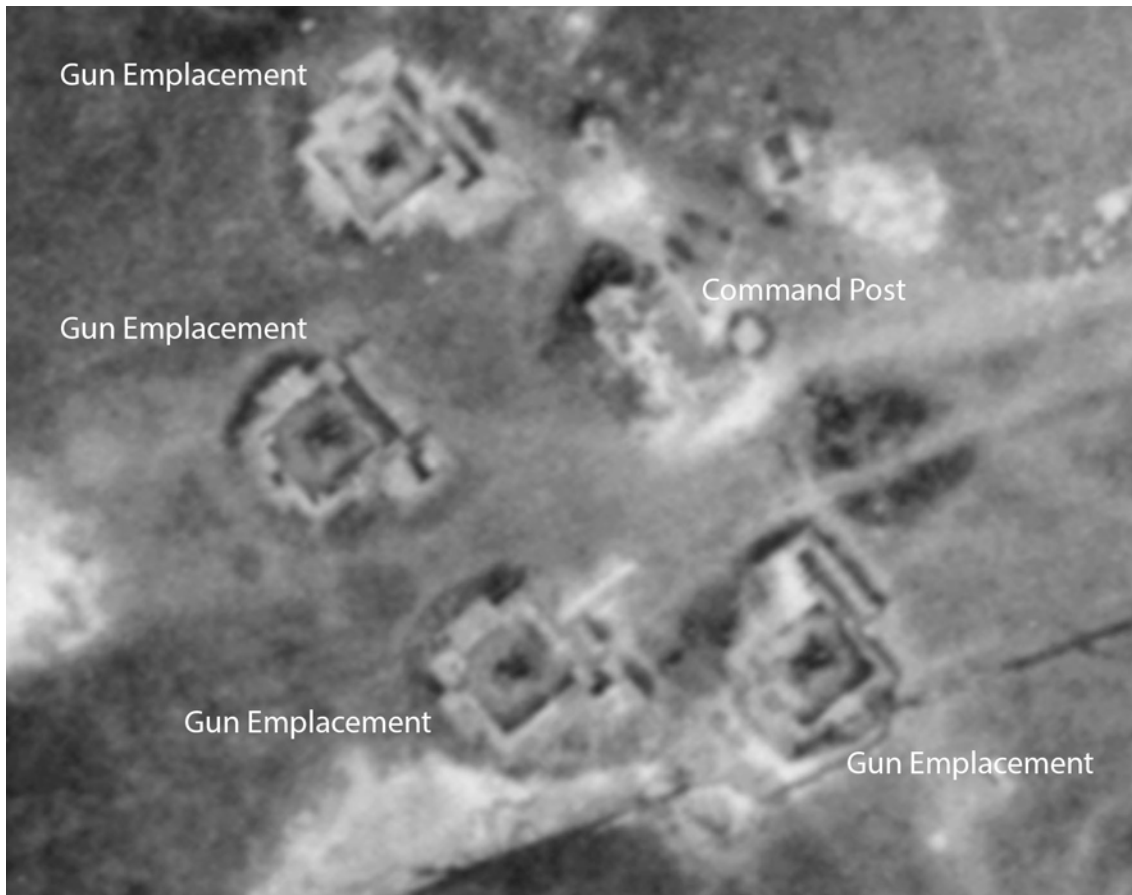
Figure 78 Uphill HAA, four emplacements and a command post in 1941. Detail of RAF/GHQ/105 V 14-MAY-1941 Historic England Archive (RAF Photography)

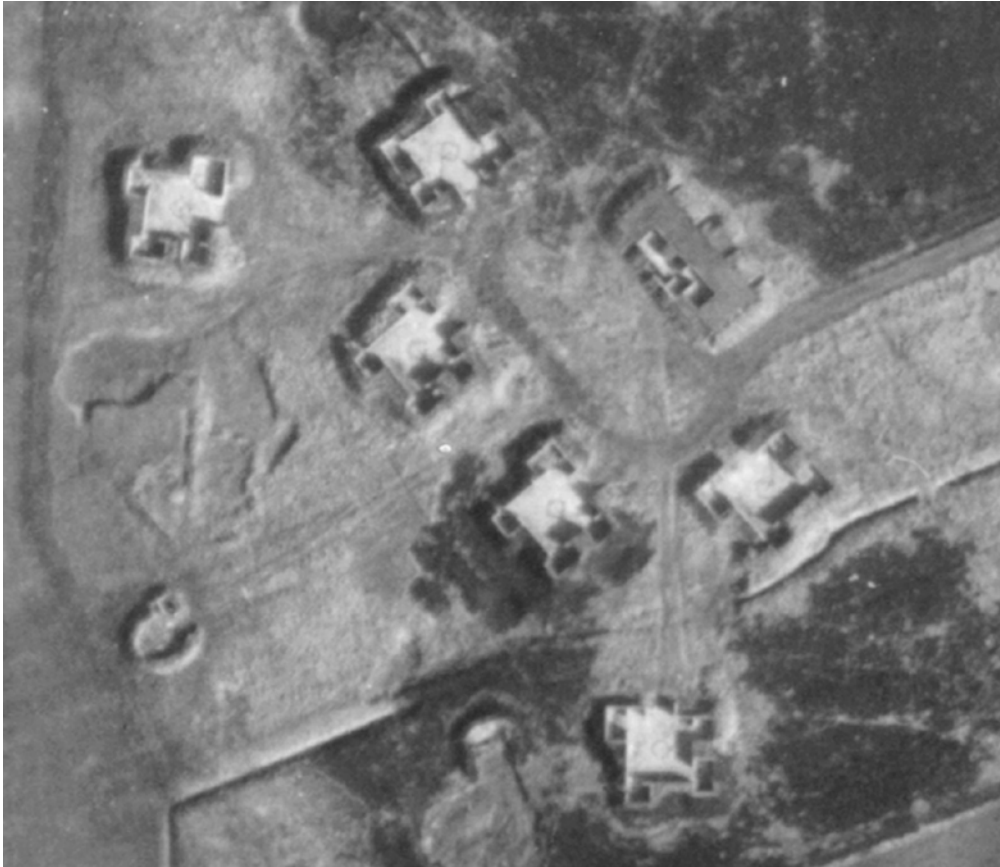
*Figure 79 Uphill HAA emplacements and command post seen in 1948.
RAF/CPE/UK/2489 V5053 11-MAR-1948 Historic England Archive (RAF
Photography)*

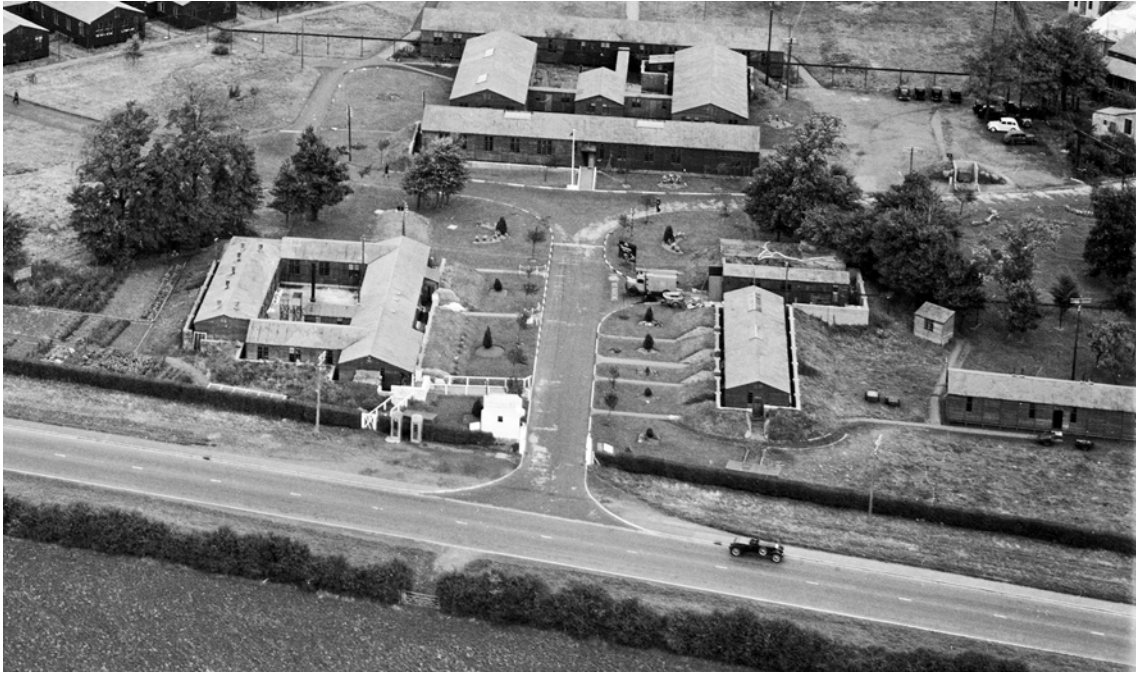
Figure 80 Main entrance to RAF Locking in 1946. Detail of AFL 61390/EAW002969 2-Oct-1946 © Historic England (Aerofilms Collection)

The layout of this station can be seen on RAF aerial photographs taken in the 1940s and Aerofilms photographs taken in 1946. Two entrances to the camp were on the south side off the A371 (Fig 80). The main entrance led to a road laid out in a crescent, but north and east of this a grid pattern was followed (Fig 81). The camp consisted of a range of different building types. They can be loosely organised in to three functions: administration, accommodation and training. However, a more detailed interpretation is possible as certain building designs were used for specific functions.

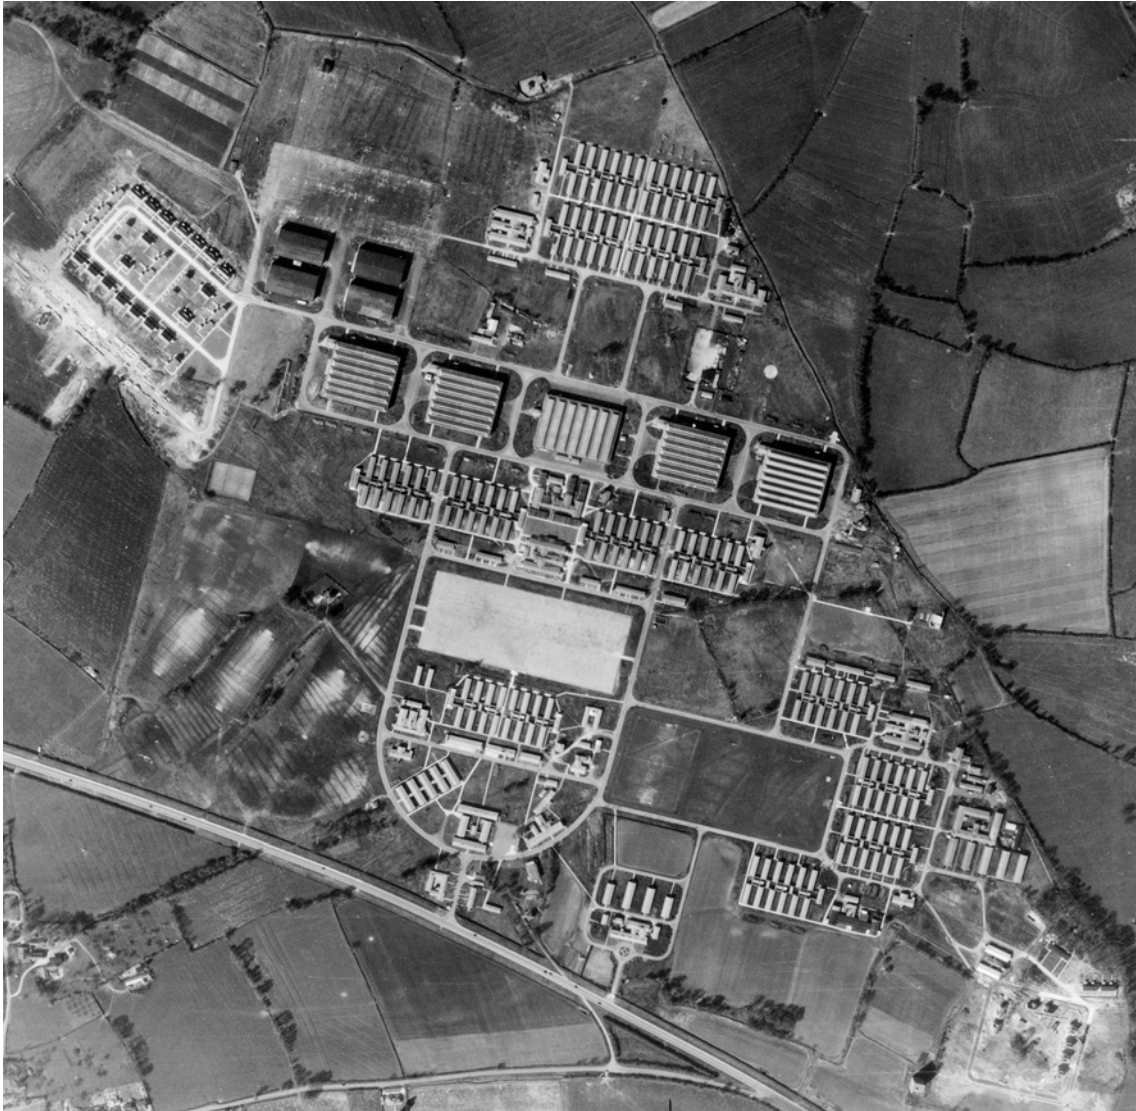
Figure 81 RAF Locking in 1951 showing entire camp including two new areas of housing under construction top left and bottom right. RAF/540/479 RS 4008 22-APR-1951 Historic England Archive (RAF Photography)

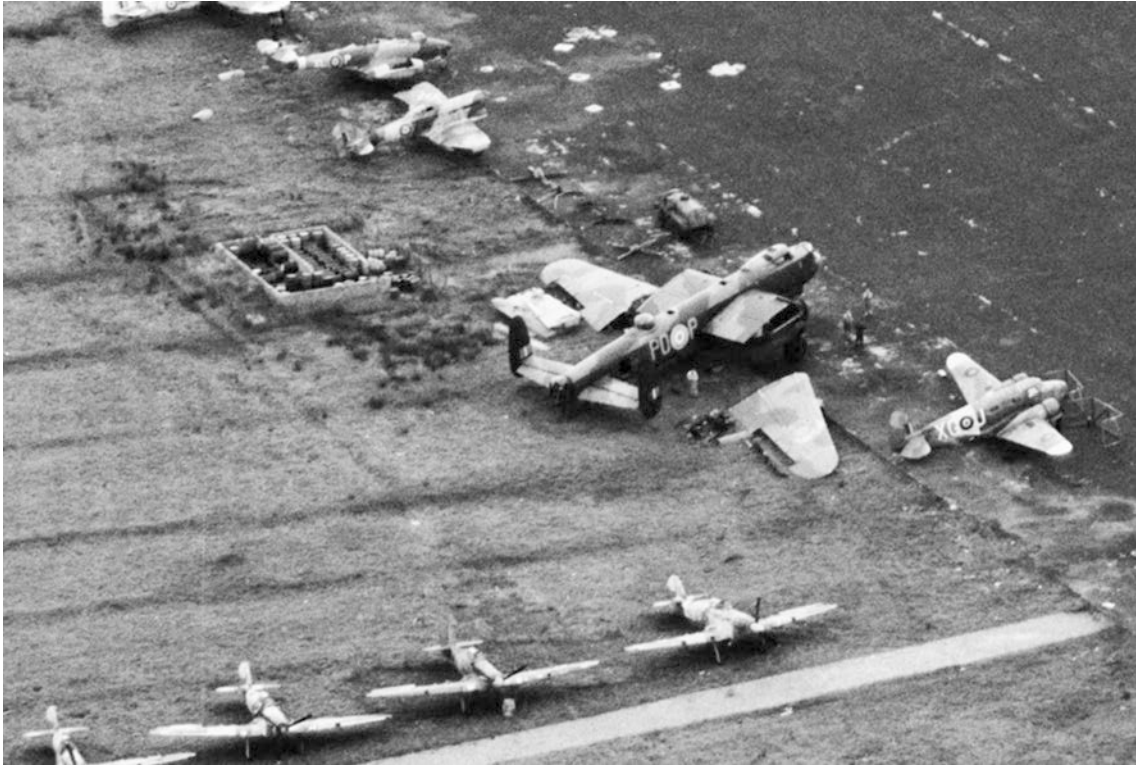
Figure 82 Aircraft at RAF Locking in 1946. Detail of AFL 61390/EAW002966 2-Oct-1946 © Historic England (Aerofilms Collection)

The barrack blocks where the troops slept are arranged in groups of 12. These were linked via corridors to ablution huts and bathhouses. The classrooms may have been based on similar huts to the barracks, but with the exception of a toilet block would not have any other associated buildings. Most administration buildings and classrooms appear to have been situated towards the southern end of the camp. Practical training would have taken place in the five large hangars. Many aircraft were kept on the site (Fig 82).

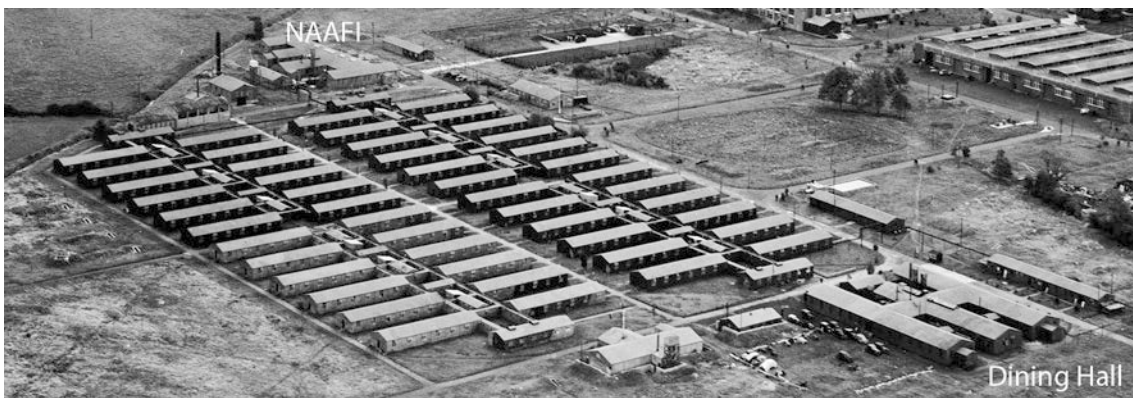
Figure 83 detail of north of camp in 1946, compare with top of Fig 80. Detail of AFL 61390/EAW002965 2-Oct-1946 © Historic England (Aerofilms Collection)

A 1930s design of dining halls and NAAFI (Navy, Army, Air Force Institute) can be identified at RAF Locking. These are positioned close to the barrack huts and this grouping can be best seen at the northern end of the camp (Fig 83). A total of 48 barrack huts were arranged in groups of twelve. Each group was linked via corridors to ablution huts and a bathhouse. A dining hall was to the west and a NAAFI to the east. A Decontamination building was located to the northwest and a Boiler house and Quartermasters store to the northeast.

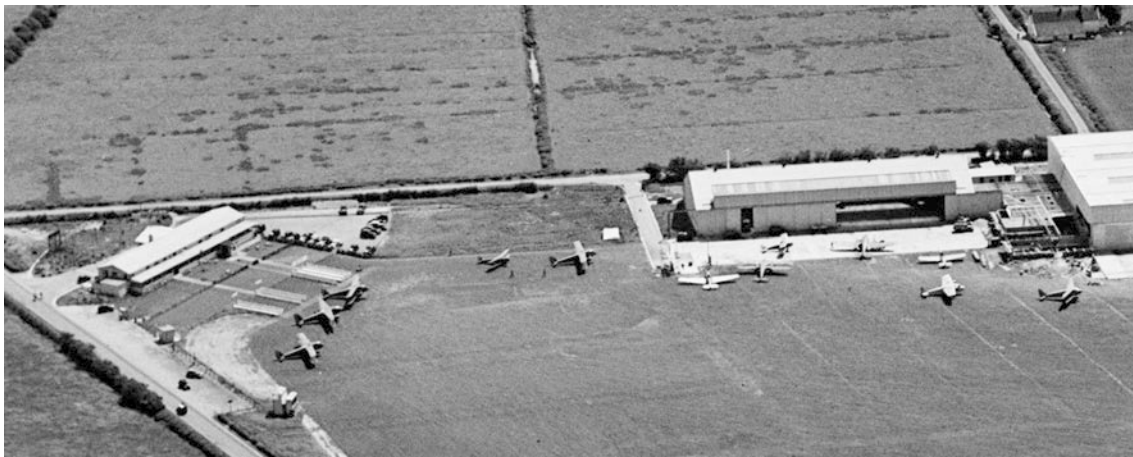
Figure 84 Weston airfield in June 1939, a few months before its requisition by the RAF. Detail of AFL 61273/EPW062079 30-Jun-1939 © Historic England (Aerofilms Collection)

RAF Weston-super-Mare was created in 1940 with the requisition of Weston's civilian airfield (Fig 84). It was primarily used as a training school but was also home to the Air Torpedo Development Unit and used intermittently by a fighter squadron. At the end of the war, the airfield reverted to civilian use (Ashworth 1982, 204-207).

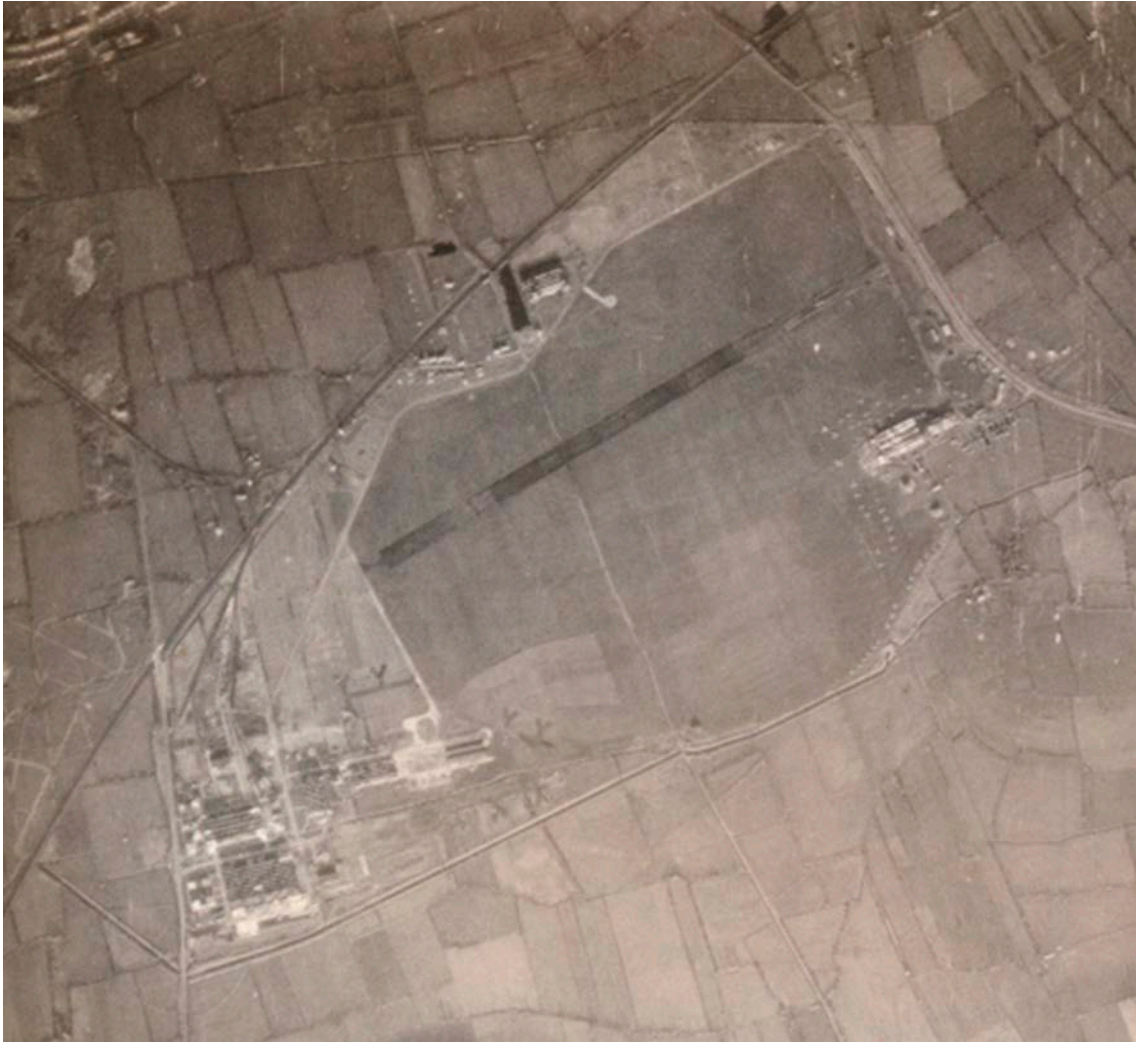
Figure 85 A small scale aerial photograph of RAF Weston-super-Mare and the Oldmixon aircraft factory (bottom left) in November 1945. Detail of RAF/3G/TUD/T/94 Vp2 5135 27-NOV-1945 Historic England Archive (RAF Photography)

A number of RAF aerial photographs were taken of RAF Weston throughout the 1940s (Fig 85). The earliest in September 1940 shows the factory and the hangars. The view is obscured by clouds and it is not clear which of these buildings are complete or still under construction. At that date the main access to the south-western end of the site was via a lane from Oldmixon. This lane continued north to Weston and by 1942 had been converted into a metalled road carried over the main railway line by a new bridge. These remain in use today as Winterstoke Road.

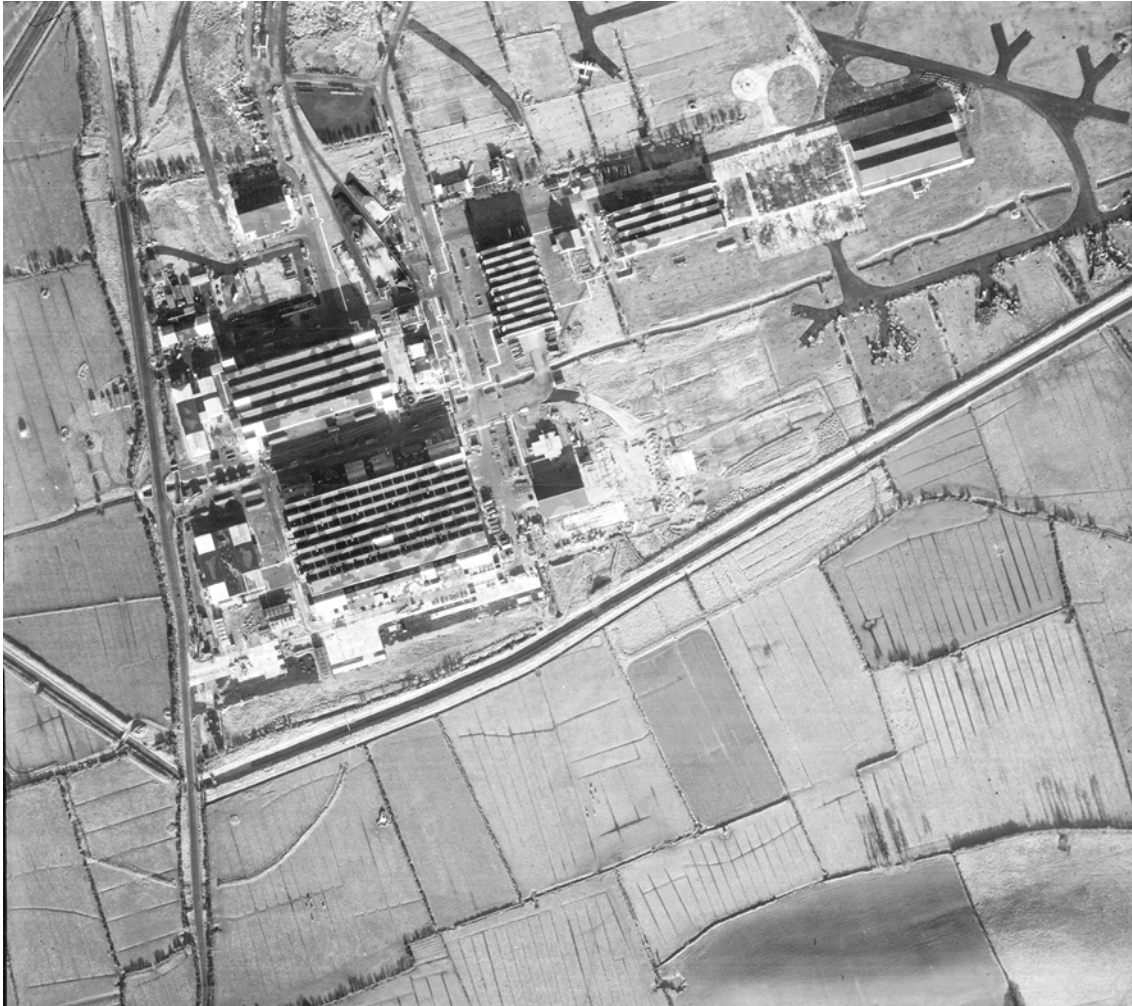
Figure 86 Detail of Great Rhyne forming the southern boundary to RAF Weston. Detail of RAF/3G/TUD/UK/21 V5253 13-JAN-1946 Historic England Archive (RAF Photography)
