Weston-super-Mare, North Somerset: Great Weston Heritage Action Zone, Aerial Investigation and Mapping Project

Research Report Series no. 50-2018

Great Weston Heritage Action Zone
Aerial Investigation and Mapping Project

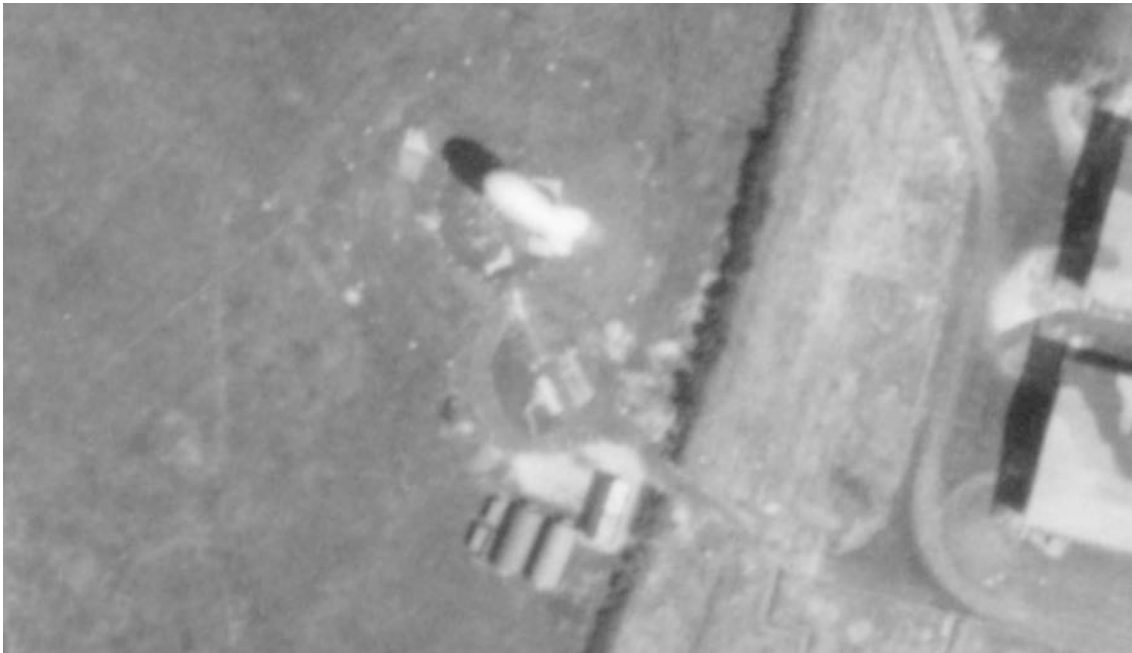
Figure 87 A barrage balloon on the western edge of RAF Locking photographed in 1942. RAF/FNO/37V 6028 11-JUL-1942 Historic England Archive (RAF Photography)

The distribution of balloons is densest on the south and east sides of the airfield. The barrage balloons are first seen on aerial photographs taken in 1942 and are either grounded or flying. The sites themselves followed a relatively regular layout and consist of the tethering points that are arranged in concentric circles. Associated with the tethering points are huts, gun emplacements and an approach road laid out in a loop. All of the barrage balloon sites include a variation on this arrangement

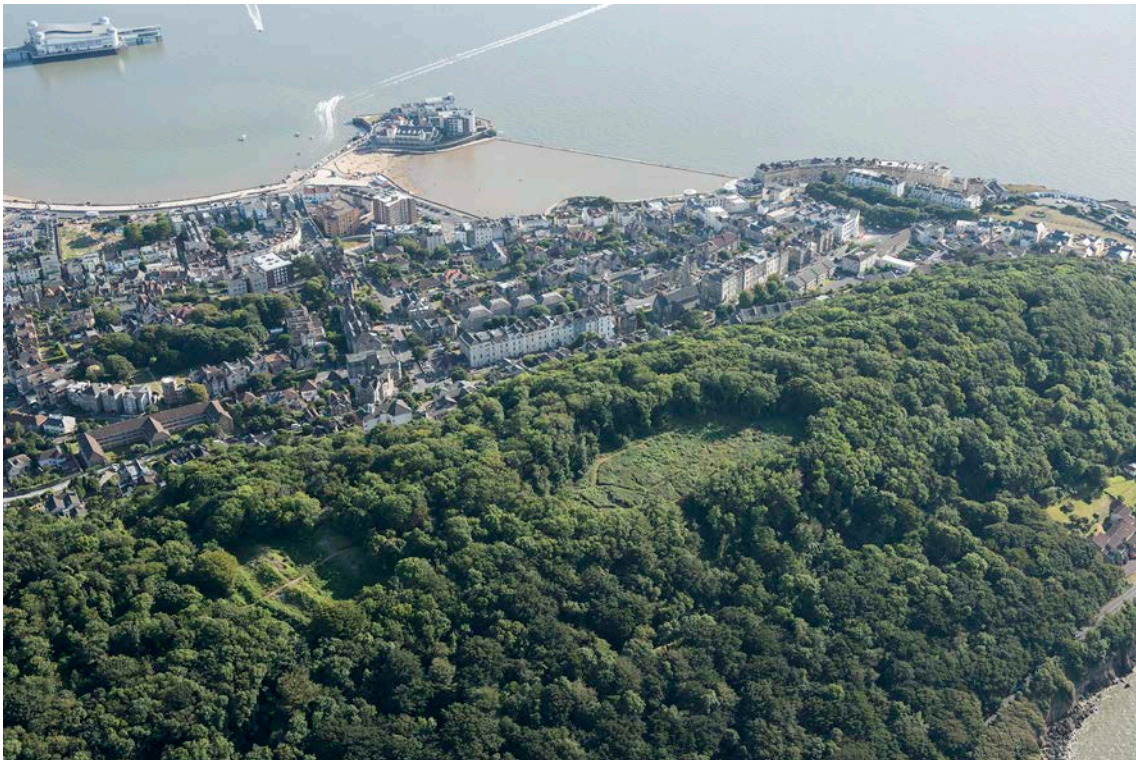
Figure 88 Worlebury Hillfort in 2016. Part of the eastern ramparts can be seen in the clearing on the left.33066_03716-AUG-2016 © Historic England Archive

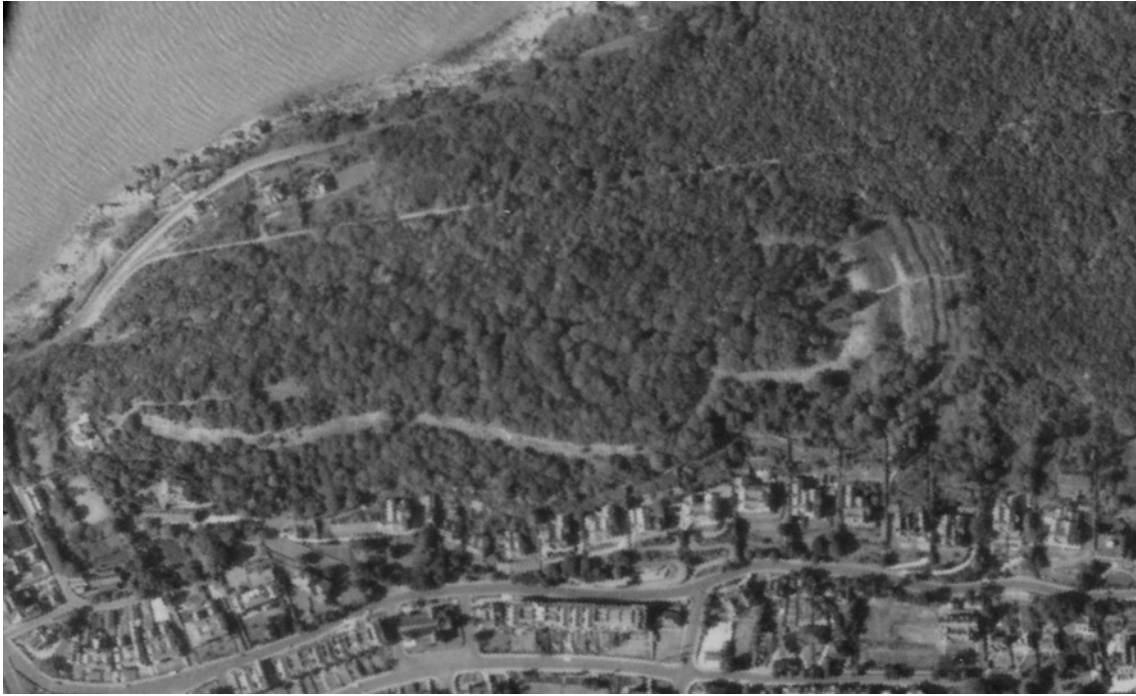
Figure 90 Only one line of the southern rampart and parts of those to the east can be seen in the clearing in the trees on this aerial photograph taken in the 1950s. Detail of RAF/58/2180 F42 63 27-MAY-1957 Historic England Archive (RAF Photography)

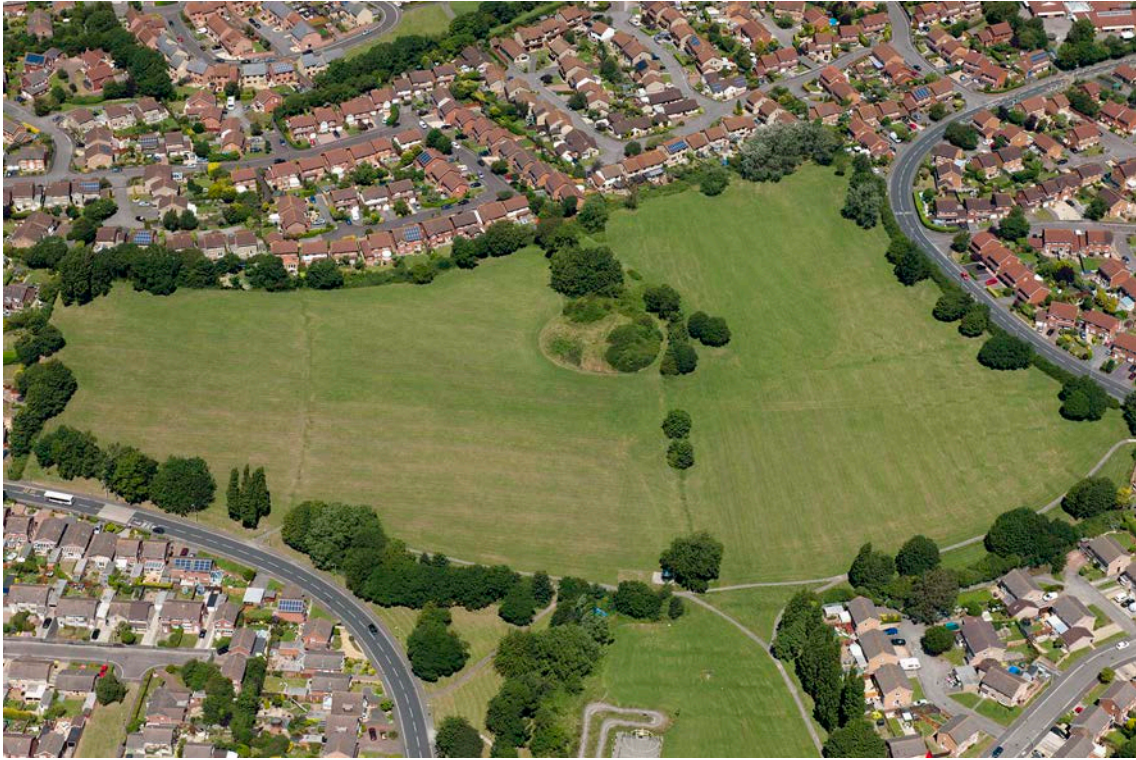
Figure 98 Castle Batch in 2014. 29085_026 10-JUL-2014 © Historic England Archive

Limited excavated evidence is dated to the medieval period. Small finds and excavated features indicate that salt making was still important to this area in the medieval period and may have been carried out at West Wick in the 11th and 12th centuries (Powell 2008, 165). The surviving earthwork of Castle Batch (Fig 98) and the motte and bailey at Locking Head show that they were probably strategic or manorial centres in the earlier medieval period.

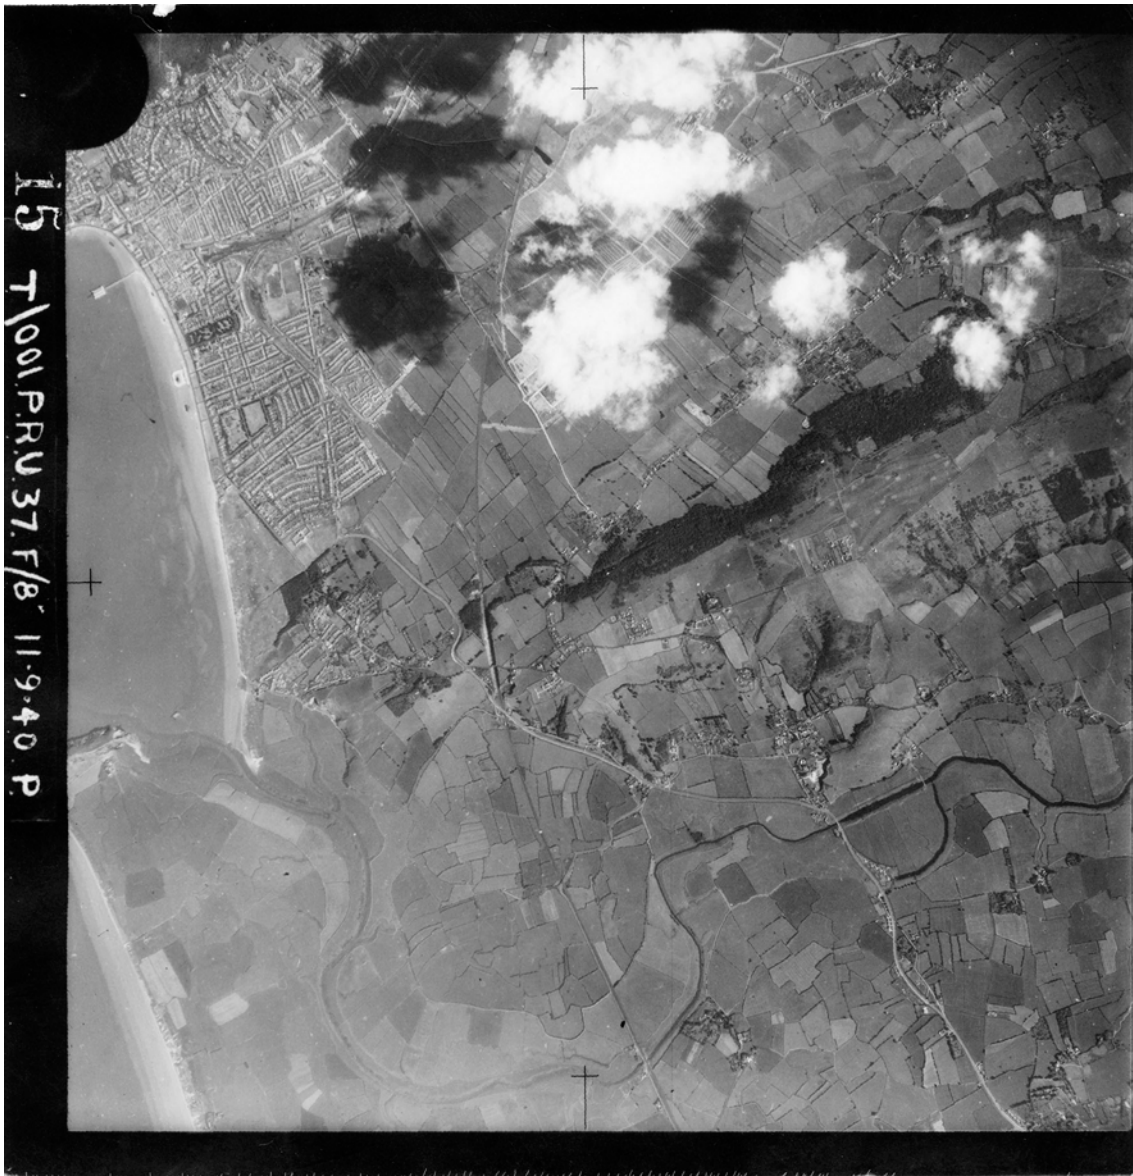
Figure 99 One of six photographs taken on 11 September 1940. This small-scale photograph shows much of Weston-super-Mare top left. To the bottom the meander of the River Axe.

The vertical aerial photographs used in this project consist of prints and digital images. The earliest vertical photographs of the Great Weston HAZ project area (in the Historic England collection) were taken by the RAF in September 1940. This is one of a number of sorties that were flown during the Second World War, but not all parts of the project area were flown every time. The RAF flew reconnaissance sorties over Weston every year (bar 1943) from 1940 to 1951 and again in 1954, 1956, 1957, 1959, 1960, 1962, 1963. The coverage varies year by year as does the scale at which the photographs were taken. For example, six photographs were taken in 1940, but at 1:54,000, although the entire project area is included, detail is very difficult to interpret (Fig 99). In contrast, 26 photographs were taken in May 1941. At 1:7,500 they are much easier to interpret, but they only cover the coastal area of the town.

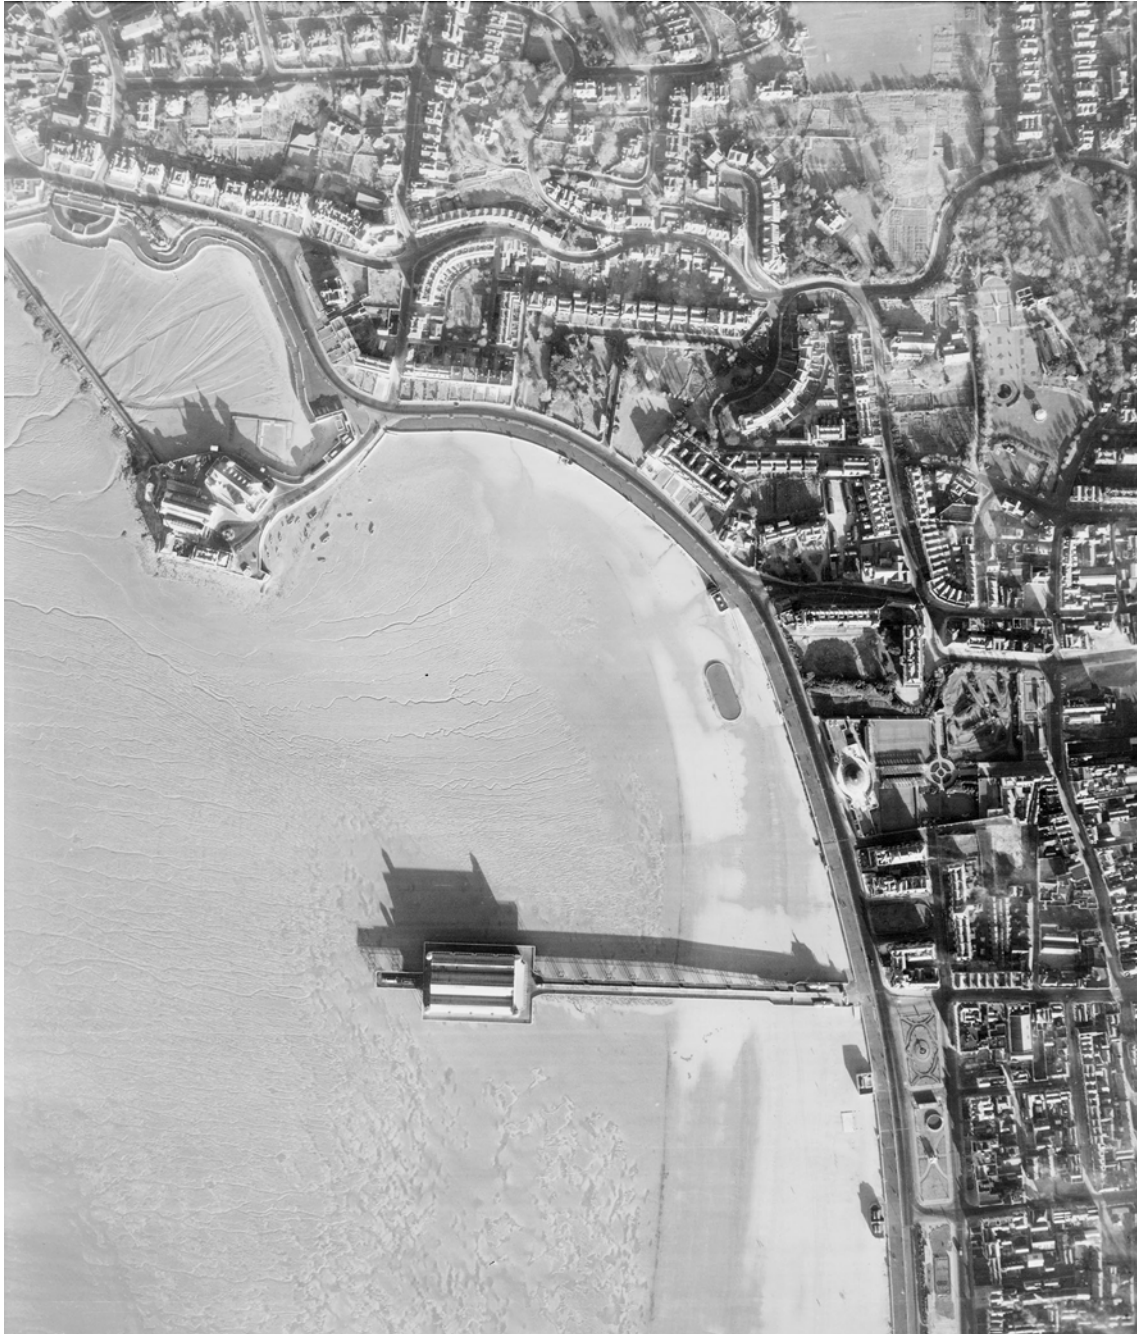
Figure 100 This RAF photograph was taken in 1946 at a scale of 1:5,000. Compare detail with Fig 2. Historic England Archive RAF Photography

RAF sorties flown between 1945 and 1949 were undertaken as part of a national aerial survey of Britain called Operation REVUE (Fig 100). The Ordnance Survey used these photographs to create a series of air mosaics at a scale of 6 inches to the mile (1:10,560). These were used to revise the Ordnance Survey maps, but the mosaics were also used by those involved in town and country planning to supplement the existing maps. The Ordnance Survey began taking their own photographs from the 1960s and these are held in the Historic England archive.

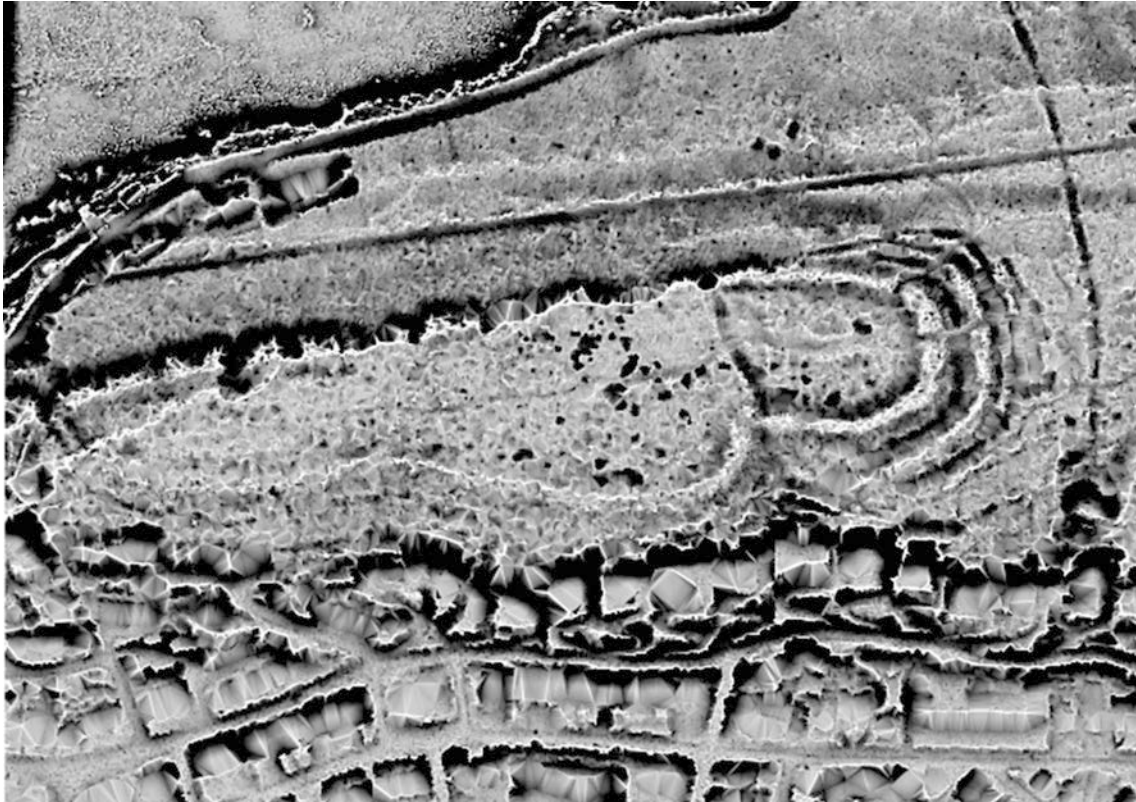
Figure 101 Lidar Openness Positive of Worlebury hillfort. Compare with lidar 16 direction of same view shown in Fig 91. LIDAR ST3162 Environment Agency DTM JAN-FEB 2010 © Environment Agency copyright 2010. All rights reserved

A number of other forms of visualisation, including slope, local relief model and openness, calculated the data in a different manner, emphasising the height difference between points in the data and allowing an enhanced view of cut and large sloping features (Fig 101). For more information on lidar visualisations see Crutchley 2010 and Historic England 2018.
