Clifford Castle, Clifford, Herefordshire: Archaeological, Architectural and Aerial Survey and Investigation

Research Report Series 069-2018

NGR: SO 244 056

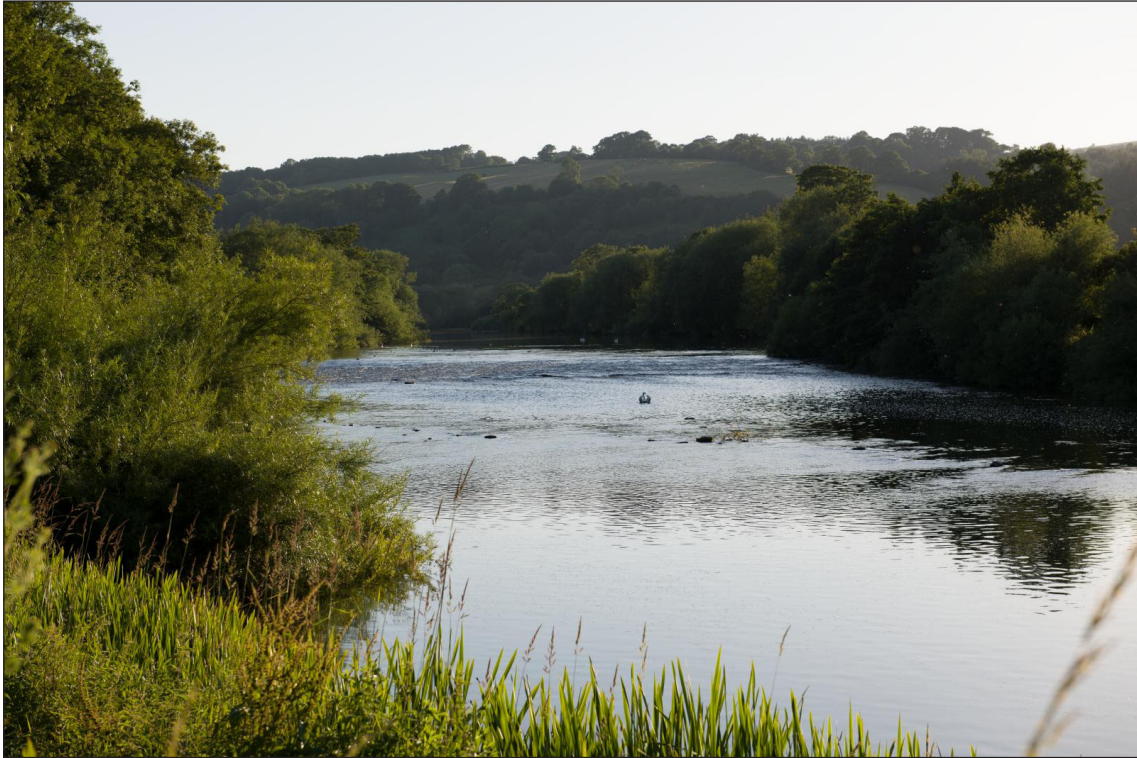
Figure 2 The ford at Clifford, visible during low river levels in the summer of 2018 (DP220720)

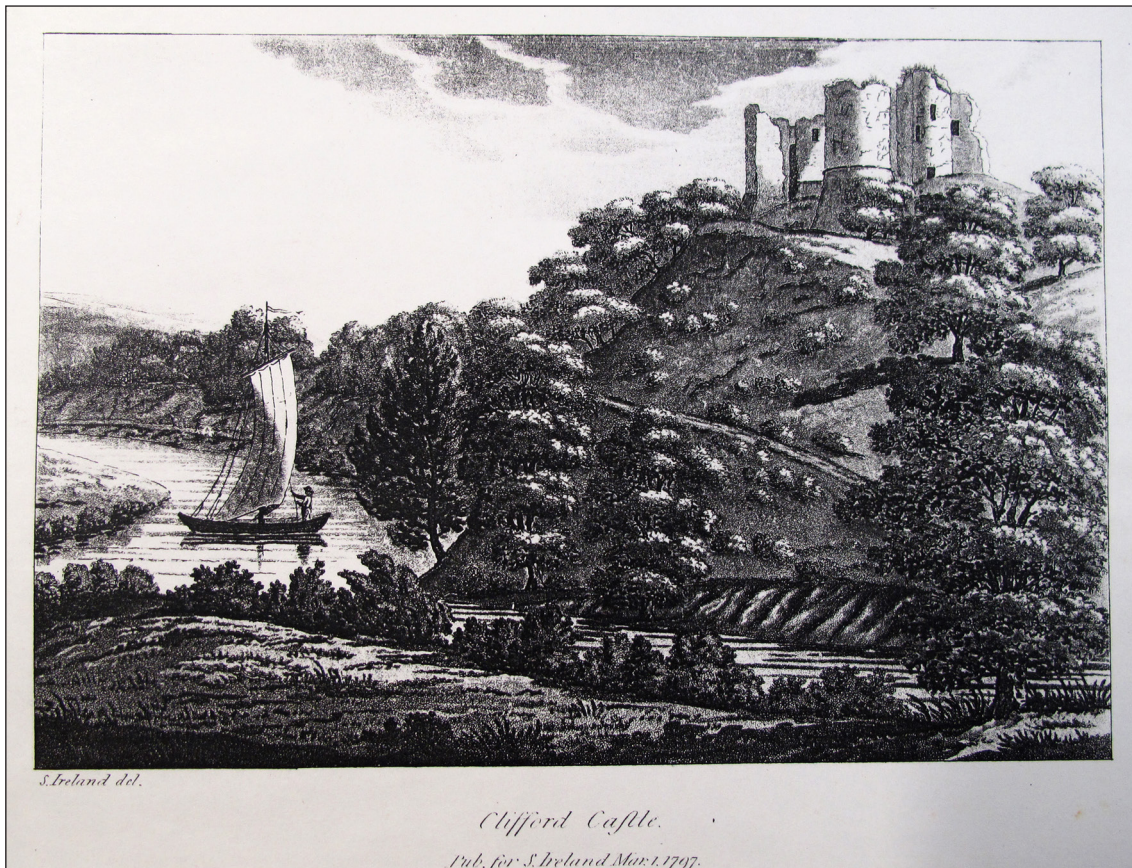
Figure 3 Clifford Castle as depicted by Samuel Ireland in 1797 (Reproduced with permission of Herefordshire Archives CE91/23)

By the 18th century the site was obviously the subject of interest, clearly for its Picturesque qualities as a romantic site overlooking the Wye. A series of engravings produced in the late 18th and early 19th century appear designed to highlight the romance of the site (including HA BE60/48 and CE91/23/1; Figure 3). The northern side of the castle is often shown with the River Wye in the foreground, often with sailing boats, cattle or other subjects of interest. Depictions of the ruins of the castle themselves focus on the buildings on the motte, and do not appear to be particularly accurate. Of note however, is the consistent depiction of the northern side of the motte sloping straight down to the river. Whilst the engravings may not be accurate, given the later truncation of the motte (*see* below) these views potentially provide some indication of the original profile of the mound.

The railway (**v-v**) which runs all along the northern side of the castle, between it and the river, has modified the landscape and the castle earthworks to some degree. Late 18th- and early 19th-century engravings (*see* Figure 3) show the steep slopes below the castle descending uninterrupted to the river but there may be an element of artistic licence in these depictions. Clearly some of the bailey and a portion of the western platform and subsidiary western bailey have been lost but a perhaps surprisingly small portion of the motte has gone; this may reflect the railway engineers' care in trying to preserve this part of the castle with its masonry buildings. It is notable that they have revetted part of the cutting here with stone,

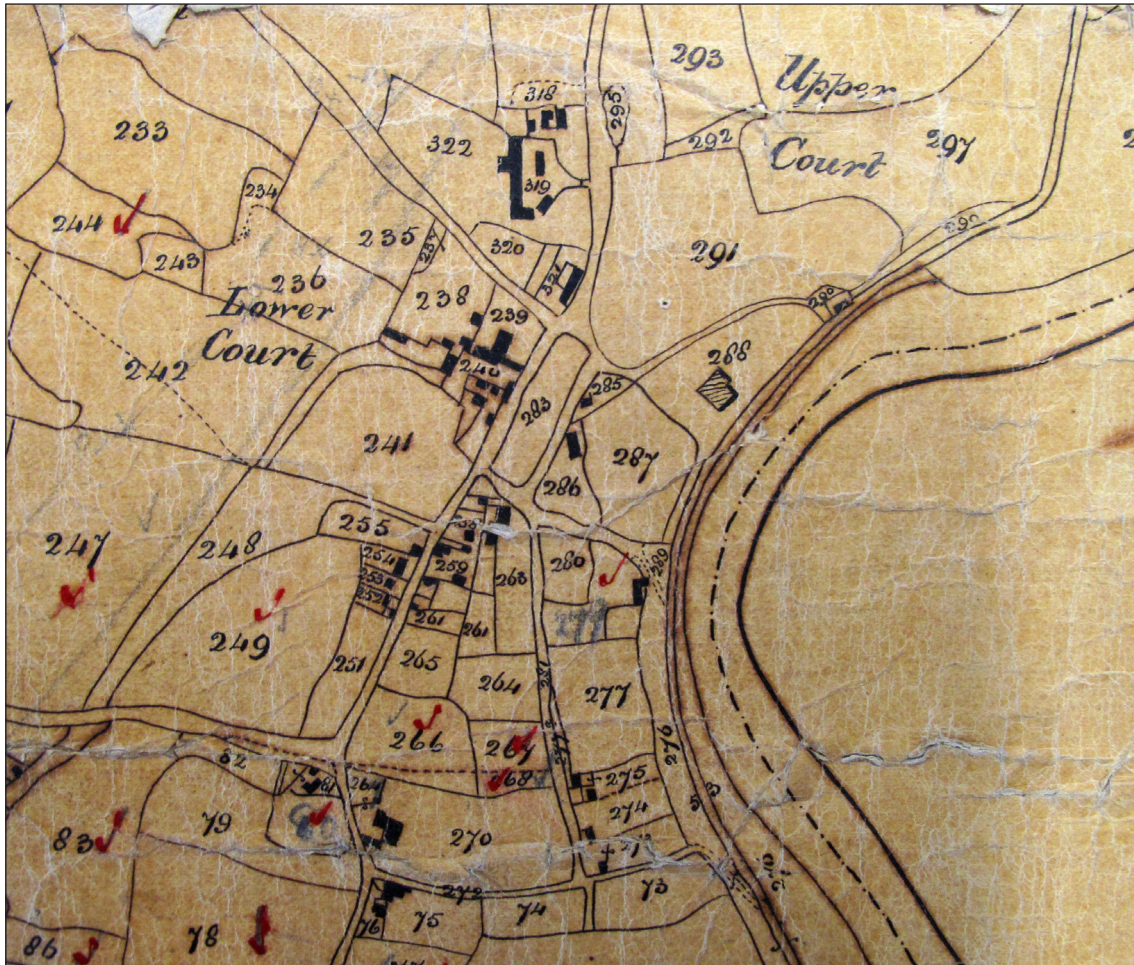
Figure 5 Extract from the Tithe map of 1847, showing the castle at 288 (Reproduced by permission of Herefordshire Archives AR1/117)

The site is shown on the First Edition 1-inch Ordnance Survey mapping of 1831-3, and on the Tithe Map in 1847. Both of these maps are in fact consistent with the way the site is depicted in a more stylised way on the 1783 map (Figure 5). The area of the motte and associated high ground are shown with a boundary around the level area of the bailey, and a further division roughly along the line of the south-west corner of the bailey. Both show the tram road already in place. The Tithe map

also shows a trackway running around the southern side of the motte towards a small building that appears to have been built adjacent to the trackway. The tithe apportionment marks this area as waste or common land, so it is possible that this is a squatter's cottage.

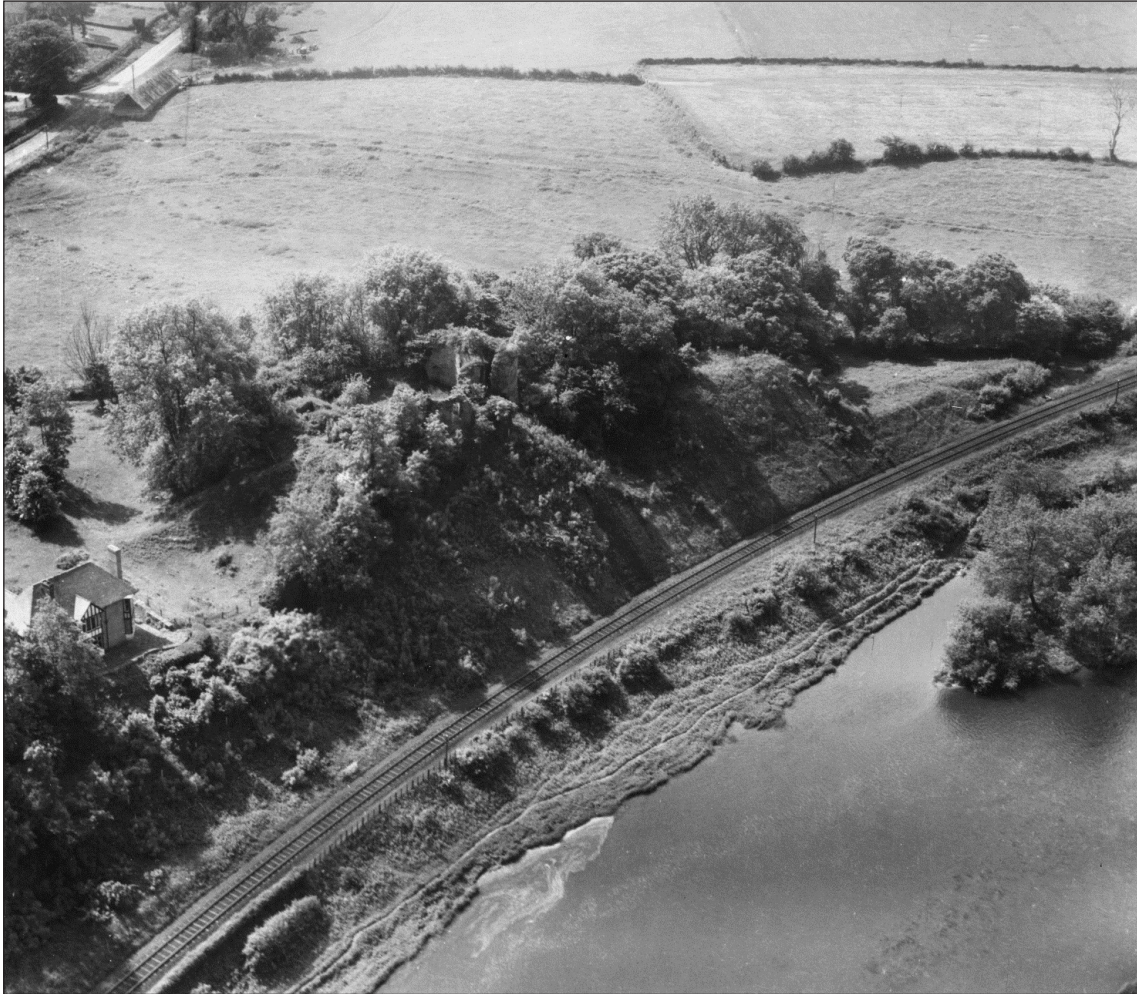
Figure 6 Clifford Castle with the Hereford Hay and Brecon Railway running beneath it along the bank of the Wye June 1947 (AFL/61506 EAW007987 30-JUN-1947)

In the early 1860s the earlier tramway route past the site was re-used as part of the route of the Hereford to Brecon Railway (Figure 6). This opened in stages from 1862, with the stage to Hay being opened in 1864 (NHLE 105981).

One problem of describing and interpreting the remains of Clifford Castle is that a potentially substantial but unknown portion of its north side has been removed by the 19th-century railway cutting (Figure 7 and *see* Figure 6). This has to be borne in mind during all considerations of the castle's morphology.

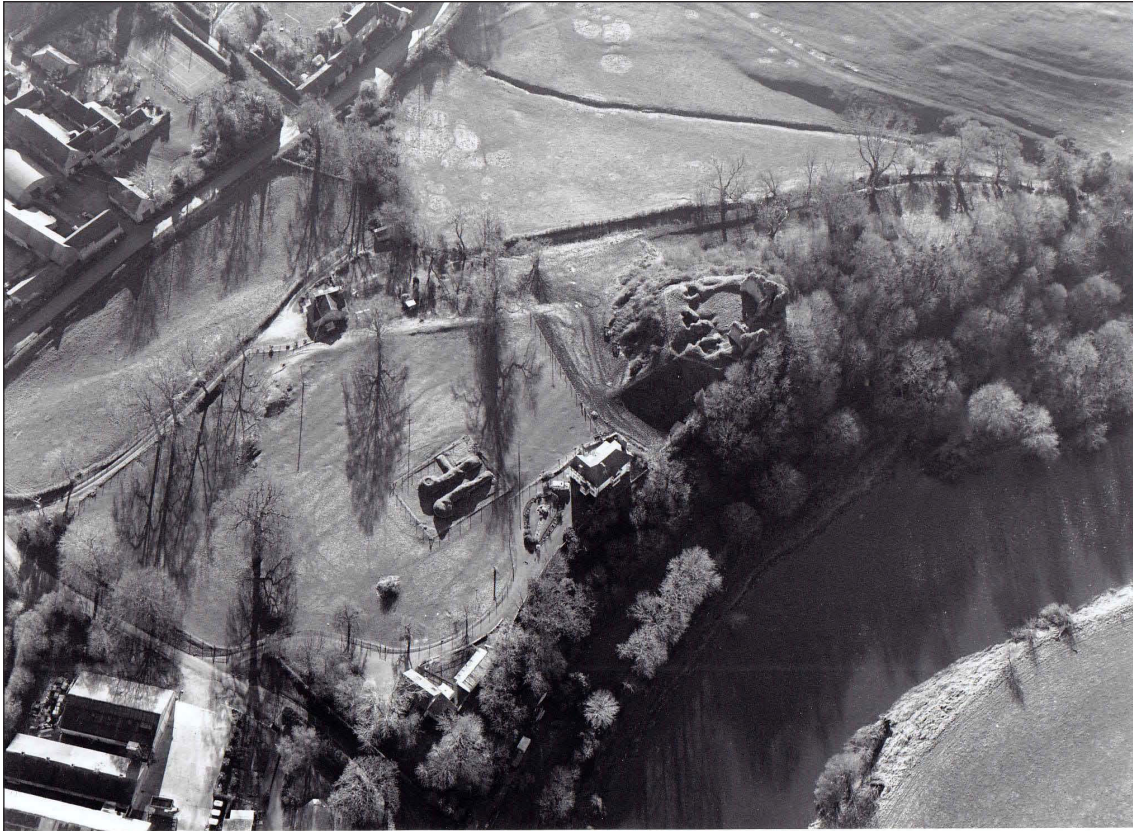
Figure 7 Clifford Castle; the bailey and gatehouse are in the centre with the motte to the right; north is towards the bottom of the image. The earthworks of orchard ridging can be seen within the bailey. In the top left corner is part of the field with lynchets and trackways (NRHE 104889). HEA SO 2445/9 18-Jan-2000

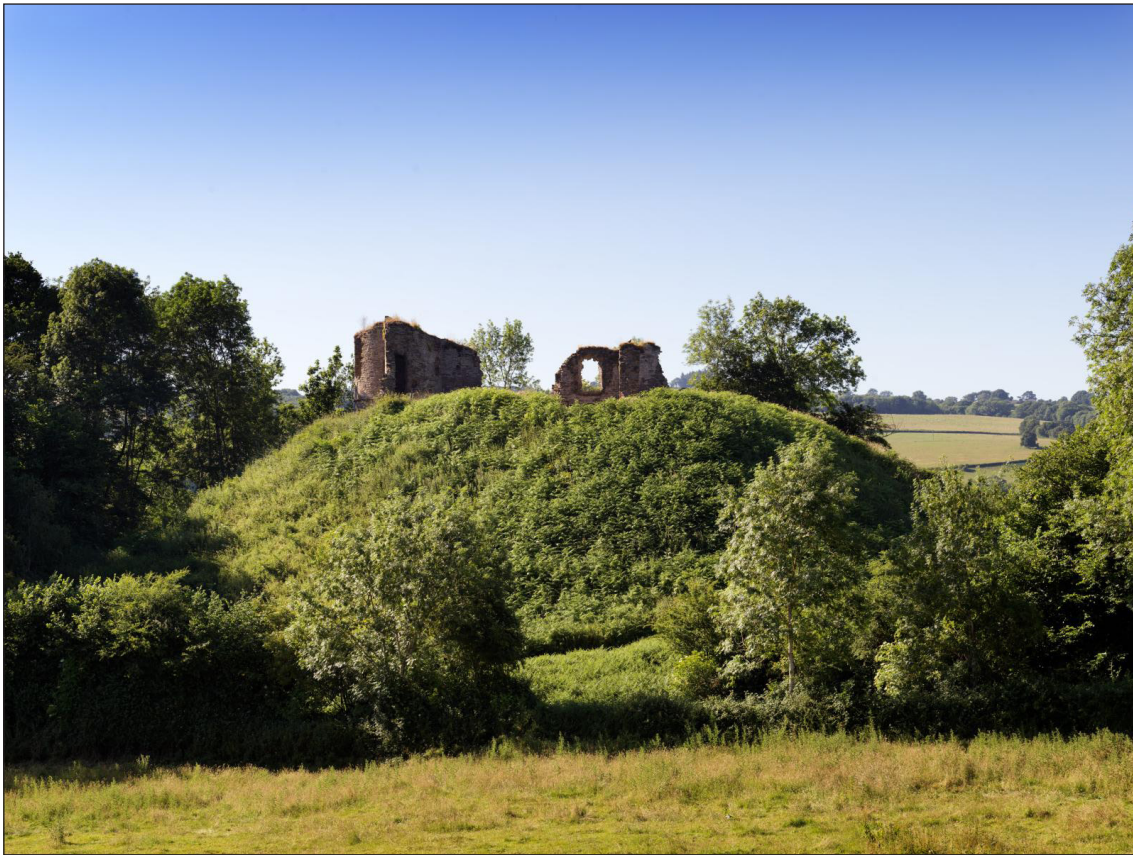
Figure 10 The profile of the motte viewed from the south (DP220706)

The motte at Clifford is very large and steep-sided (Figure 10 and *see* Figures 8 and 9). It is approximately 17.5m high to the south, approximately 60m in diameter at the base and 30m across at the top. The top now appears to be a rough quadrilateral but was presumably originally circular and has been modified by the addition of masonry buildings in the 13th century. The motte top is now very uneven, largely as the result of 20th-century excavations; a hollow around the edge of the

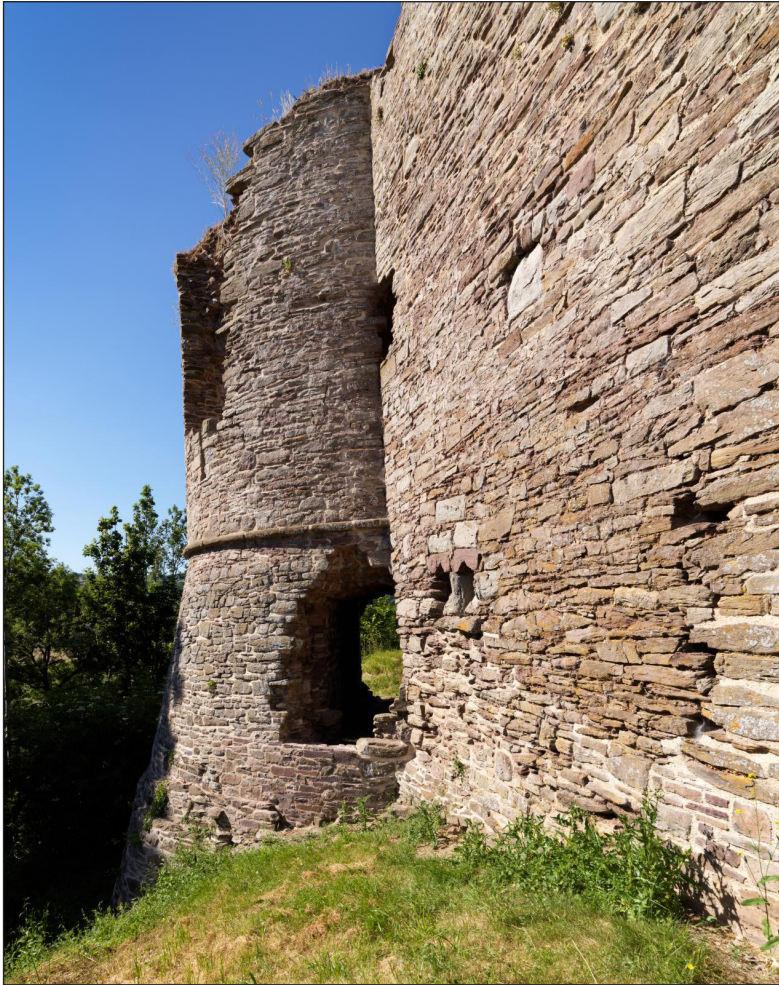
Figure 13 The northwest tower and the west curtain wall on the top of the motte (DP220701)

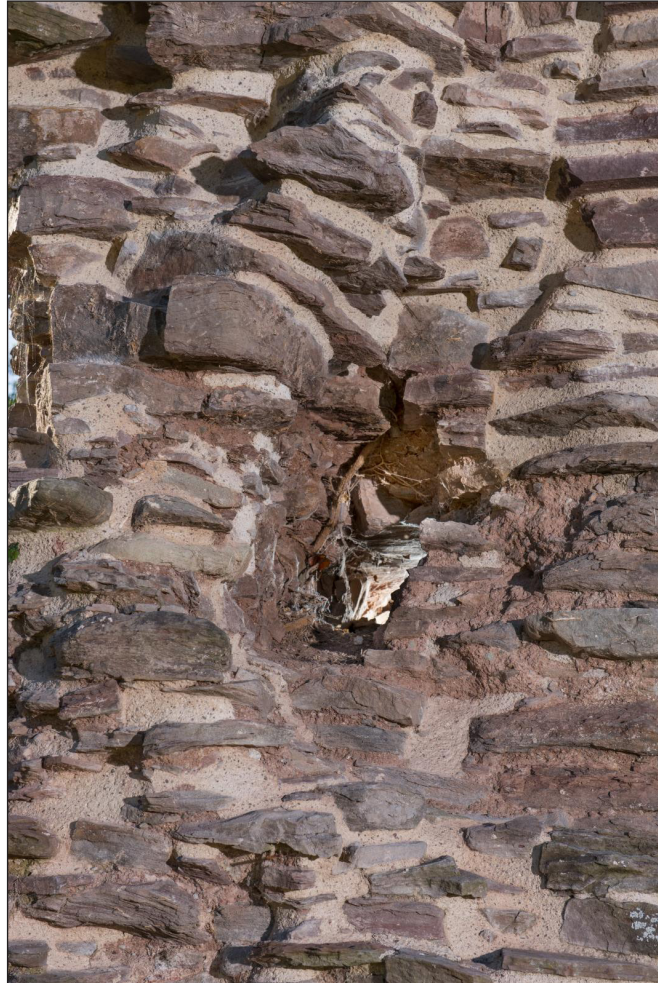
Figure 14 The empty slot in the east wall of the so-called 'hall block' (DP220714).

wall of the hall block at the level of the first floor (Figure 14). This appears to run along the wall (north to south), rather than across it, except where a stone has fallen out of the eastern face providing access to the northern end of the slot. Baker (2018) has observed that the entrance to the hall was probably at the east end of the building, accessed via an external stair, as a single stone from the eastern jamb of the doorway can be identified surviving at first-floor level. It is therefore suggested that the slot might relate to the position of a timber beam which would have projected out beyond the southeast corner of the building in order to support the top of the stair, or perhaps a small landing area in front of the doorway. Such external stairs were frequently provided in castles and other high status residences in the medieval period. Although timber examples now survive rarely, they were probably typically self-supporting. A projecting beam such as this however, would have allowed the stair structure to be tied into the building more successfully than with a completely free-standing structure. Although survivals of such an arrangement are rare, the late 13th century stair at Stokesay Castle, Shropshire within the great hall, rather than external, may represent a comparable arrangement. This has two large beams projecting from the wall face, and braced to the wall below, supporting a small landing in front of the first-floor doorway.

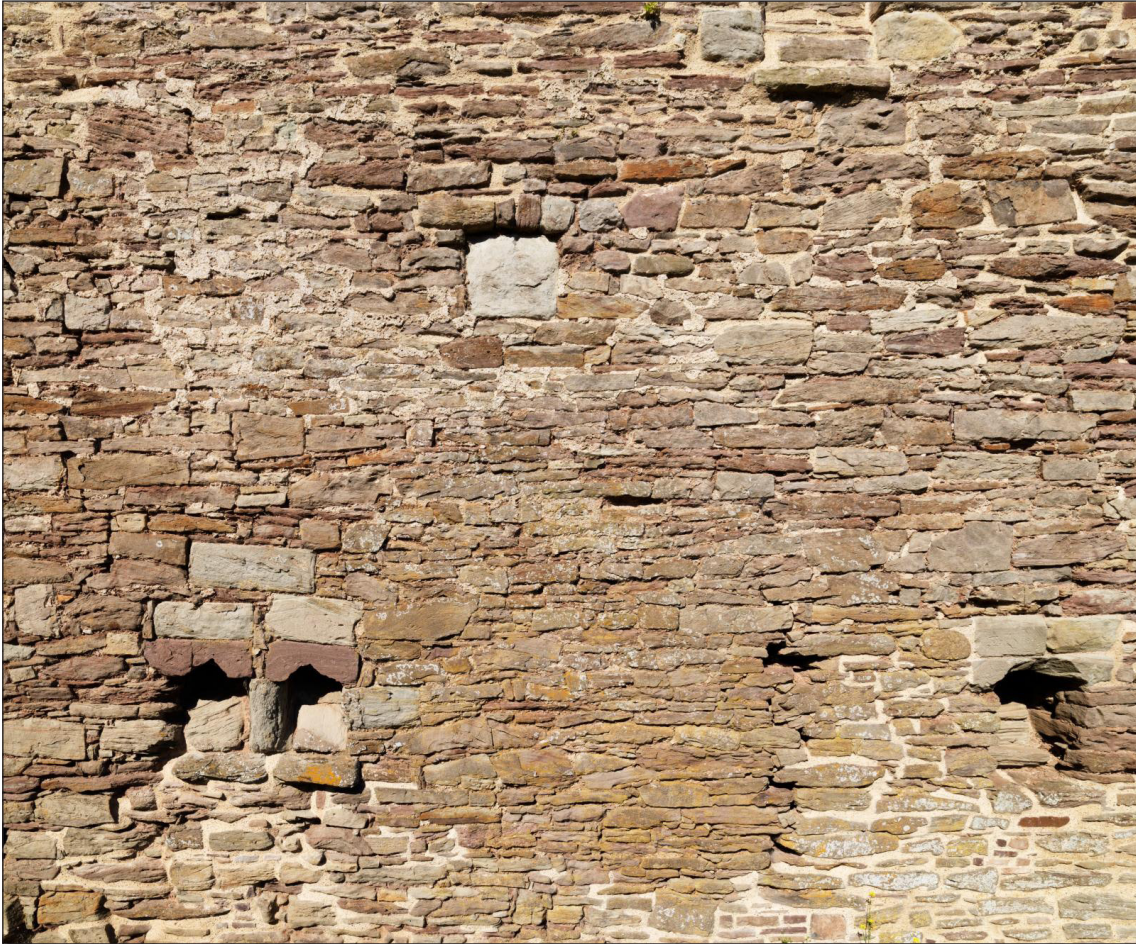
Figure 16 West curtain wall today showing traces of render (DP220701)

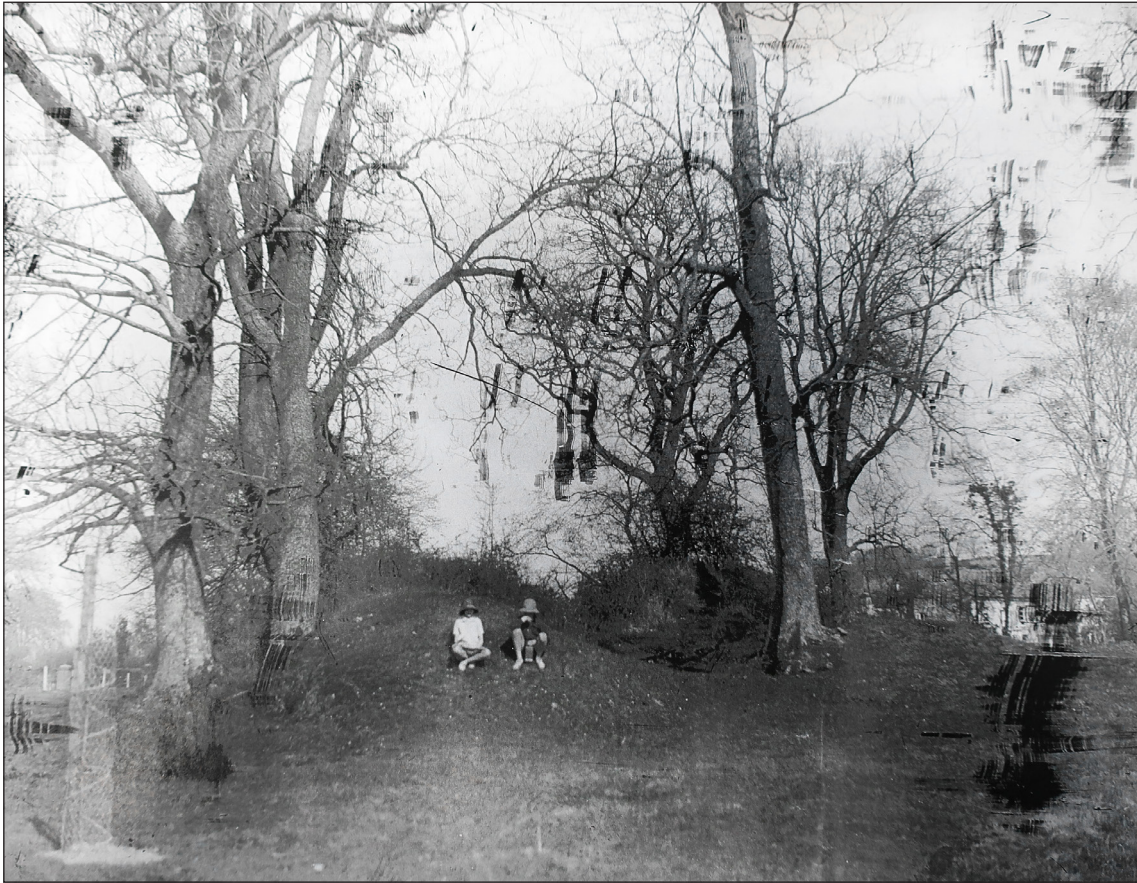
Figure 17 A 1920s image of the gatehouse prior to excavation (glass plate negative slightly damaged). Reproduced courtesy of Herefordshire Archives CJ68/1

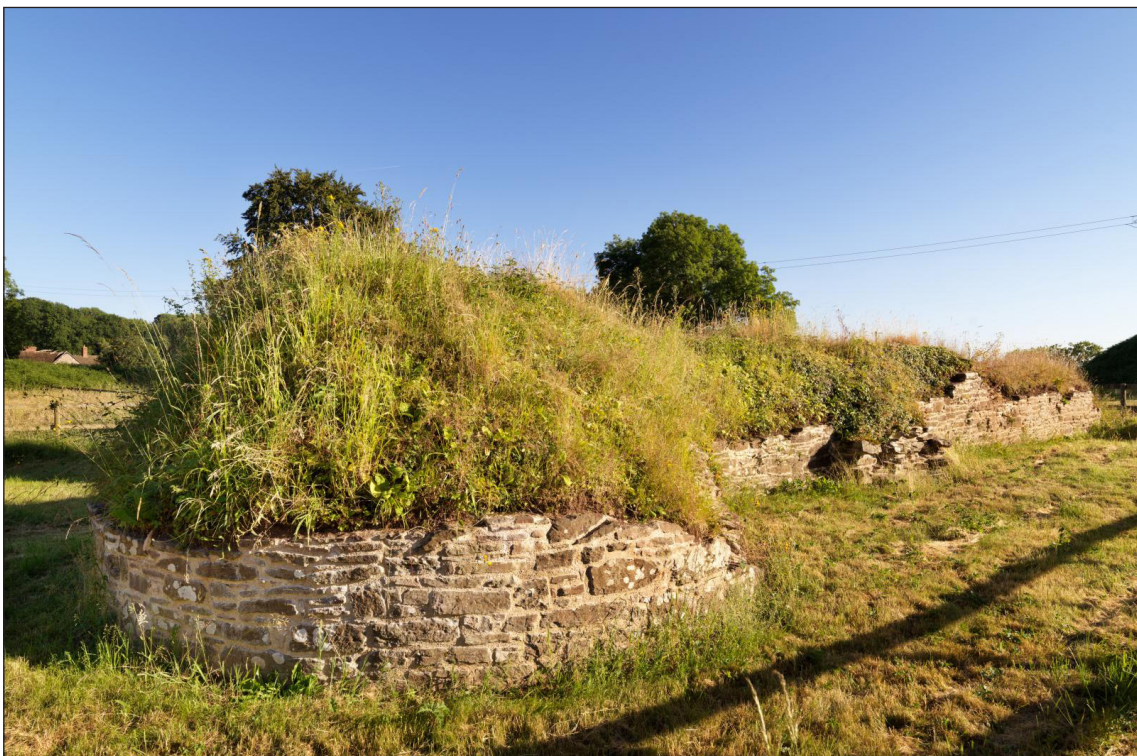
Figure 18 The gatehouse from the northeast, showing the solid drum tower to the east and the long passageway beyond (DP220709)

As surviving the gatehouse is represented by a pair of solid drum towers to the west, with a long gatehouse passage between, stretching back some 17m (*see* Figure 10 and Figure 18). A slight off set in the walling of the passageway where the curve of the towers meets the passageway may be related to the position of a pair of doors which would have opened outwards at the front of the passageway. Centrally placed along the passageway is the rebate for a portcullis and an associated offset in the walling to allow for a further pair of doors which would have been opened inwards, and again would have been able to lie flat along the passageway. Behind this there are recesses on either side of the passageway which may have provided the position of seats, or alternatively some form of storage. There is no sign of a guardroom or other associated structures, which normally would have been accessed from within the gatehouse passage. It is possible that there was a structure to one side of the gatehouse which served in this way, and that there may have been some form of window or other high-level opening to allow supervision of the gatehouse passage.

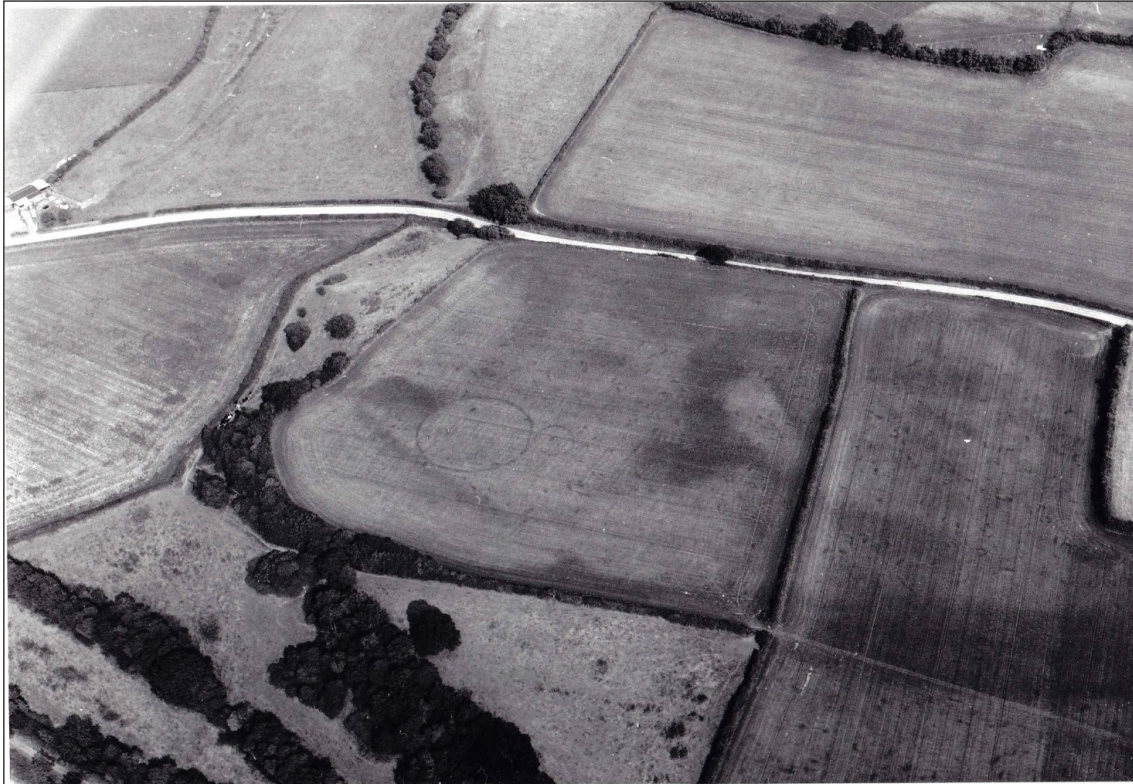
Figure 21 Two ring ditches, probably barrows (HEA SO 2446/27 22-JUL-1996)

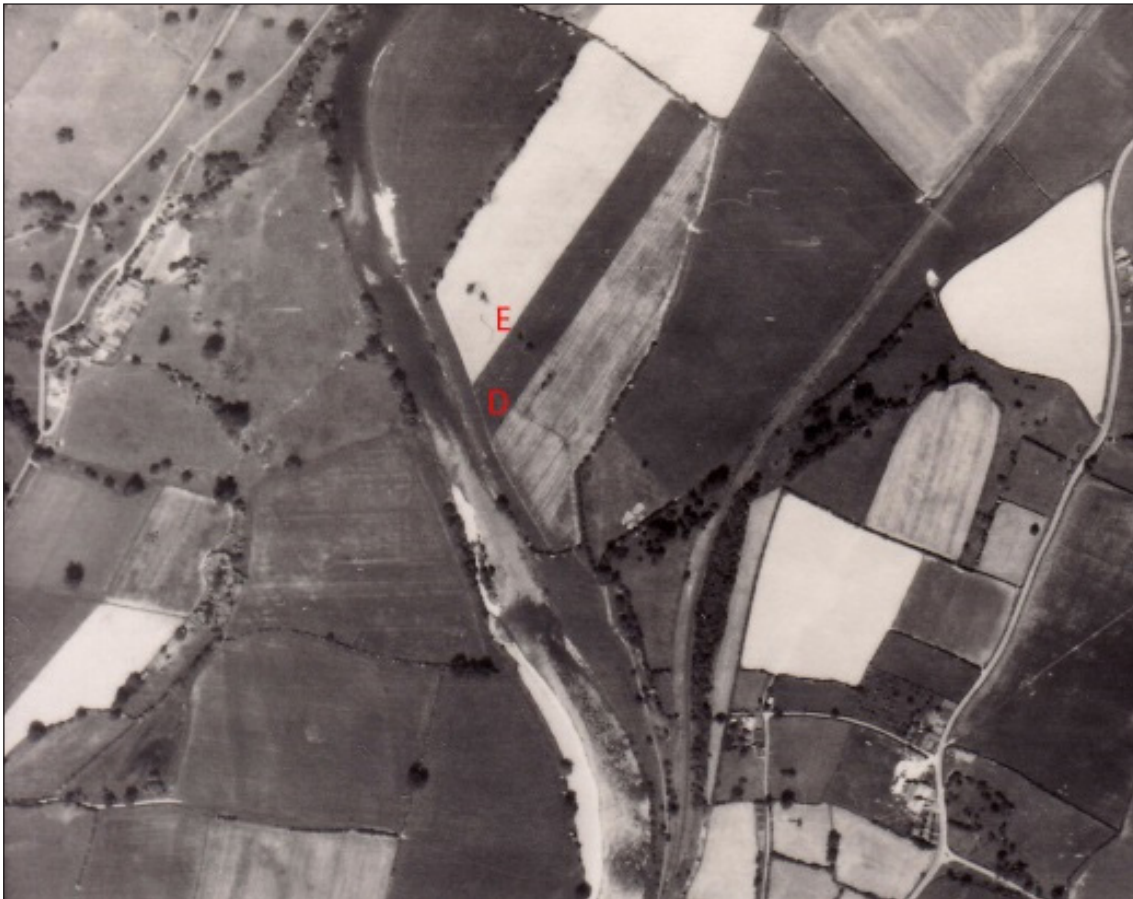
Figure 24 Only linear D is visible as a cropmark and the outline of linear E, marked by isolated trees, which also match up with trees marked on the OS 1st Edition 1:2500 sheet. (RAF 540/225 5184 22-JUN-1949)

A narrow linear ditch 'E' (NRHE 1616710) connects with the northern corner of 'B', and heads north-west, following a line more or less parallel with 'D'. This feature is also indicated by a broken line of trees on RAF photographs from 1949, although like 'D', this line is not marked on OS maps (Figure 24). However, the presence of trees suggests its use as a boundary into the post-medieval period, which makes the connection with enclosure 'B' intriguing. The form and size of enclosure 'B' might suggest a later prehistoric, perhaps Iron Age, or Early Roman date (*see below*), which would mean that linear 'E' may have remained in use as a boundary for some considerable time. The fact that it is parallel with 'D' may be coincidental, but again there is a clear relationship between 'D' and enclosure 'B' suggesting a degree of contemporaneity.

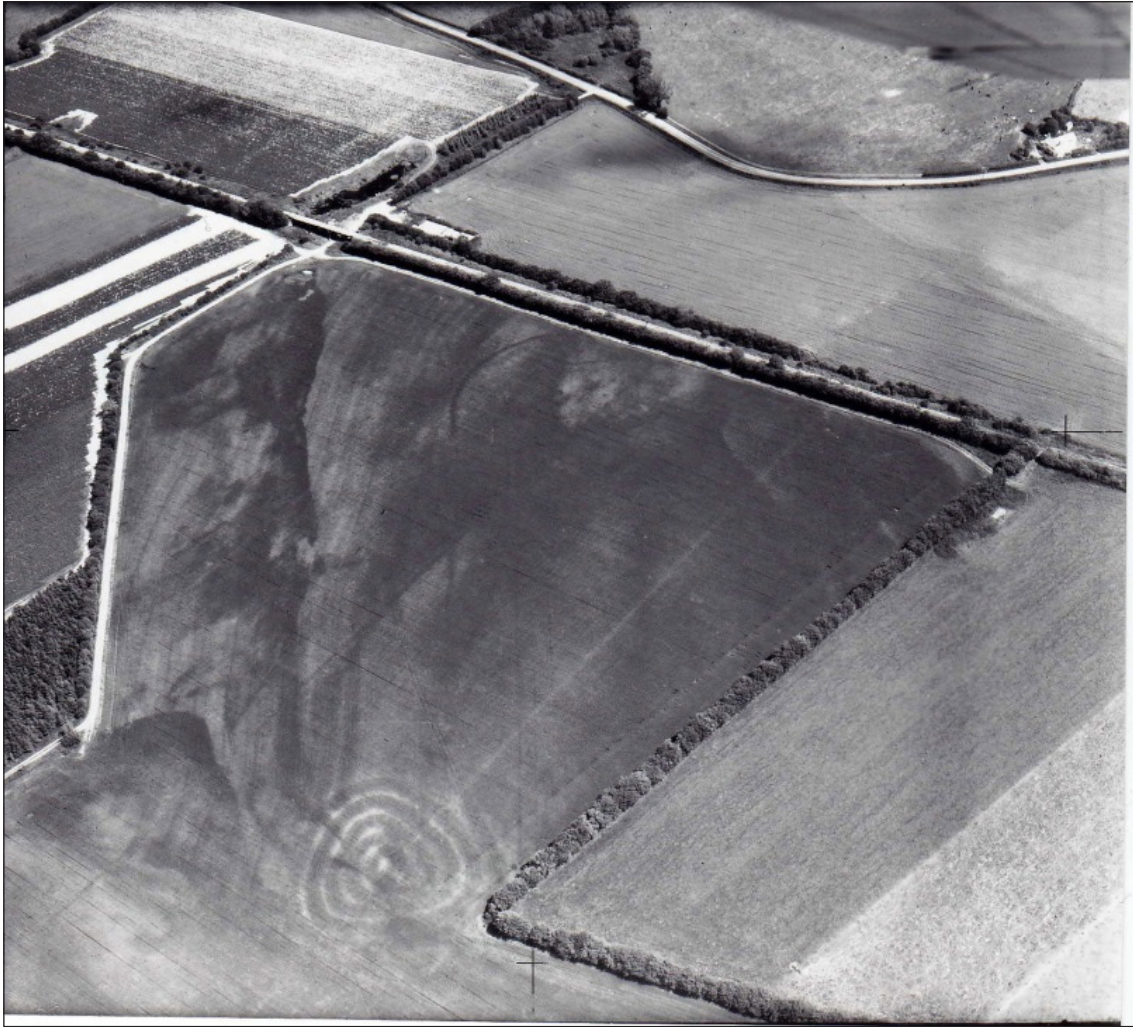
Figure 25 Aerial photography of the cropmarks of Clifford Roman Fort (north is at the bottom left). The curving corner of the outer ditch marking the north-eastern side of the fort is visible in the centre of the photograph, close to the road's edge. The spiral cropmark close to centre bottom of the image is an agricultural mark, probably caused by a vehicle. (NRHE 1138355). CUCAP 7860 10 22-JUN-1972

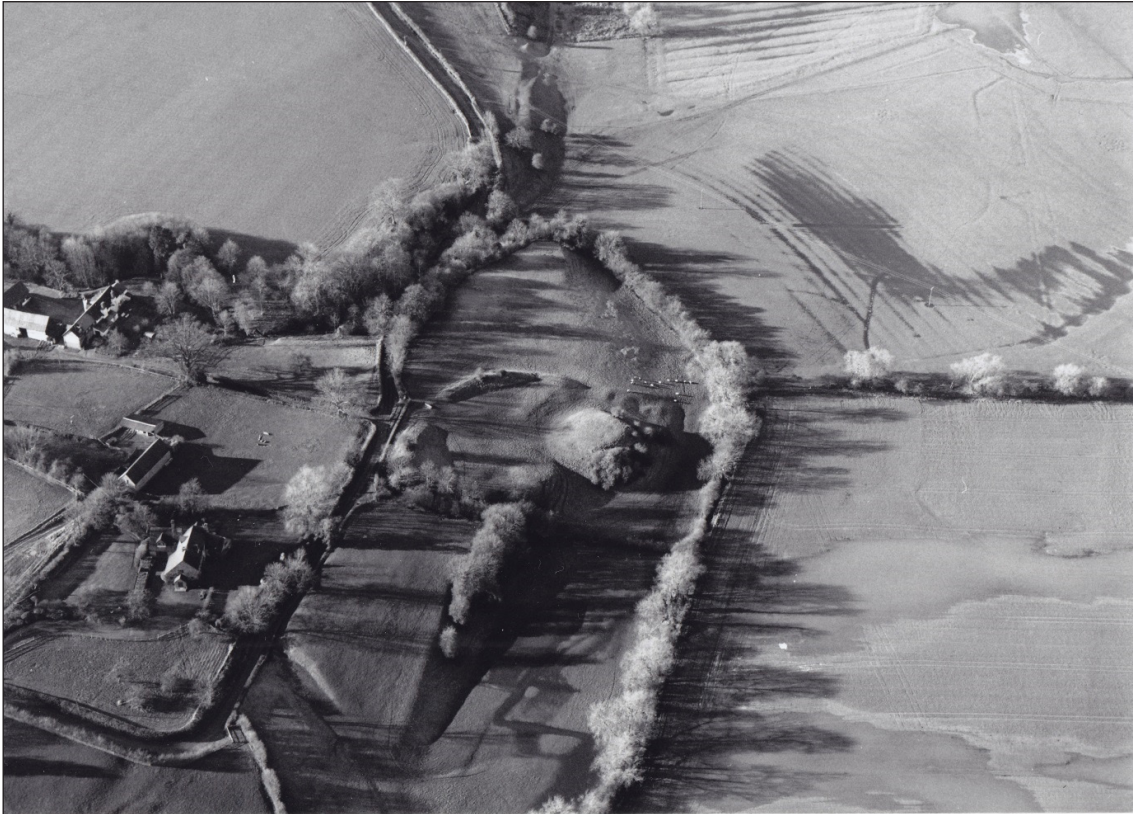
Figure 27 Oblique photograph of Castleton motte and bailey, in the centre of the photo, with Lower Castleton Farm to the left. Curving medieval ridge-and-furrow overlain with trackways is visible top right, and is different from the straight, regular post-medieval orchard ridging at top. At bottom left the start of the hollow way (NRHE 1618984) that may have once continued on to Clock Mill is visible. HEA MIL 196292/40 09-Jan-1999

Old Castleton (NRHE 104842; SO 283 456) is a small motte and bailey earthwork castle at the eastern end of the parish, situated downriver and just under 4km due east of Clifford Castle (Figure 27). Unlike Clifford, Castleton sits on relatively low ground and is only just elevated above the immediate floodplain. It is defined by a circular motte with a semi-circular bailey consisting of an inner bank and outer ditch adjoining the southern side of the motte (Figure 28). A break in the bailey earthworks along the southernmost edge may not be an original entranceway – it could have been caused by erosion arising from the fact that it backs here onto the modern road that runs between Old Castleton and two 17th century farmsteads, Upper and Lower Castleton Farm.

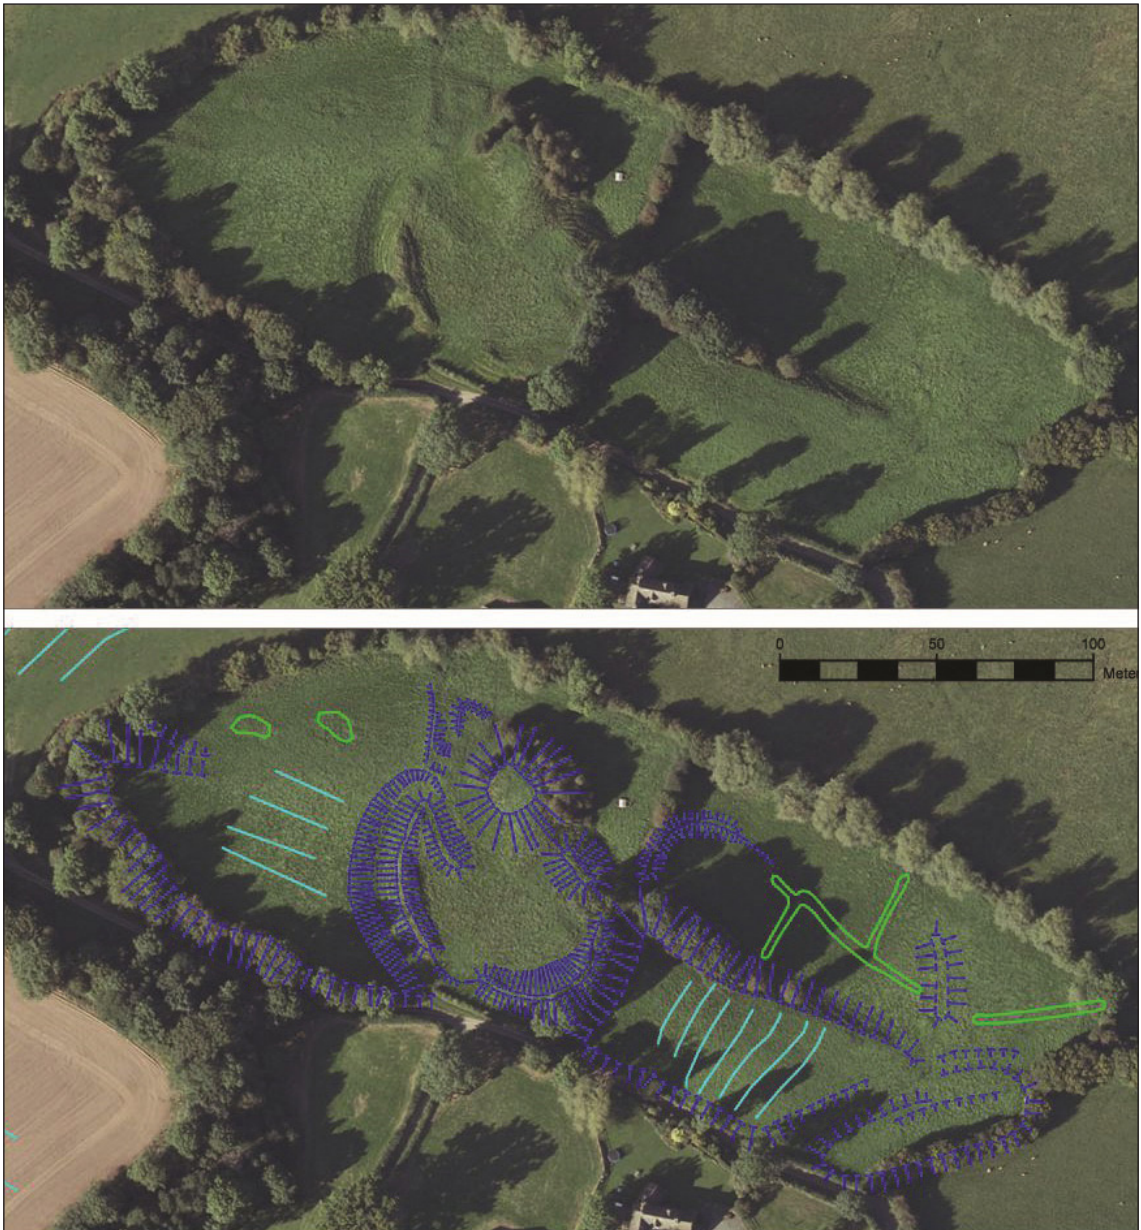
Figure 28 Castleton motte and bailey; showing mapped earthworks overlain on a modern aerial photograph. The square earthwork at the north-western base of the motte, centre top, is highlighted by shadow © APGB SO2845 12-Sept-2009

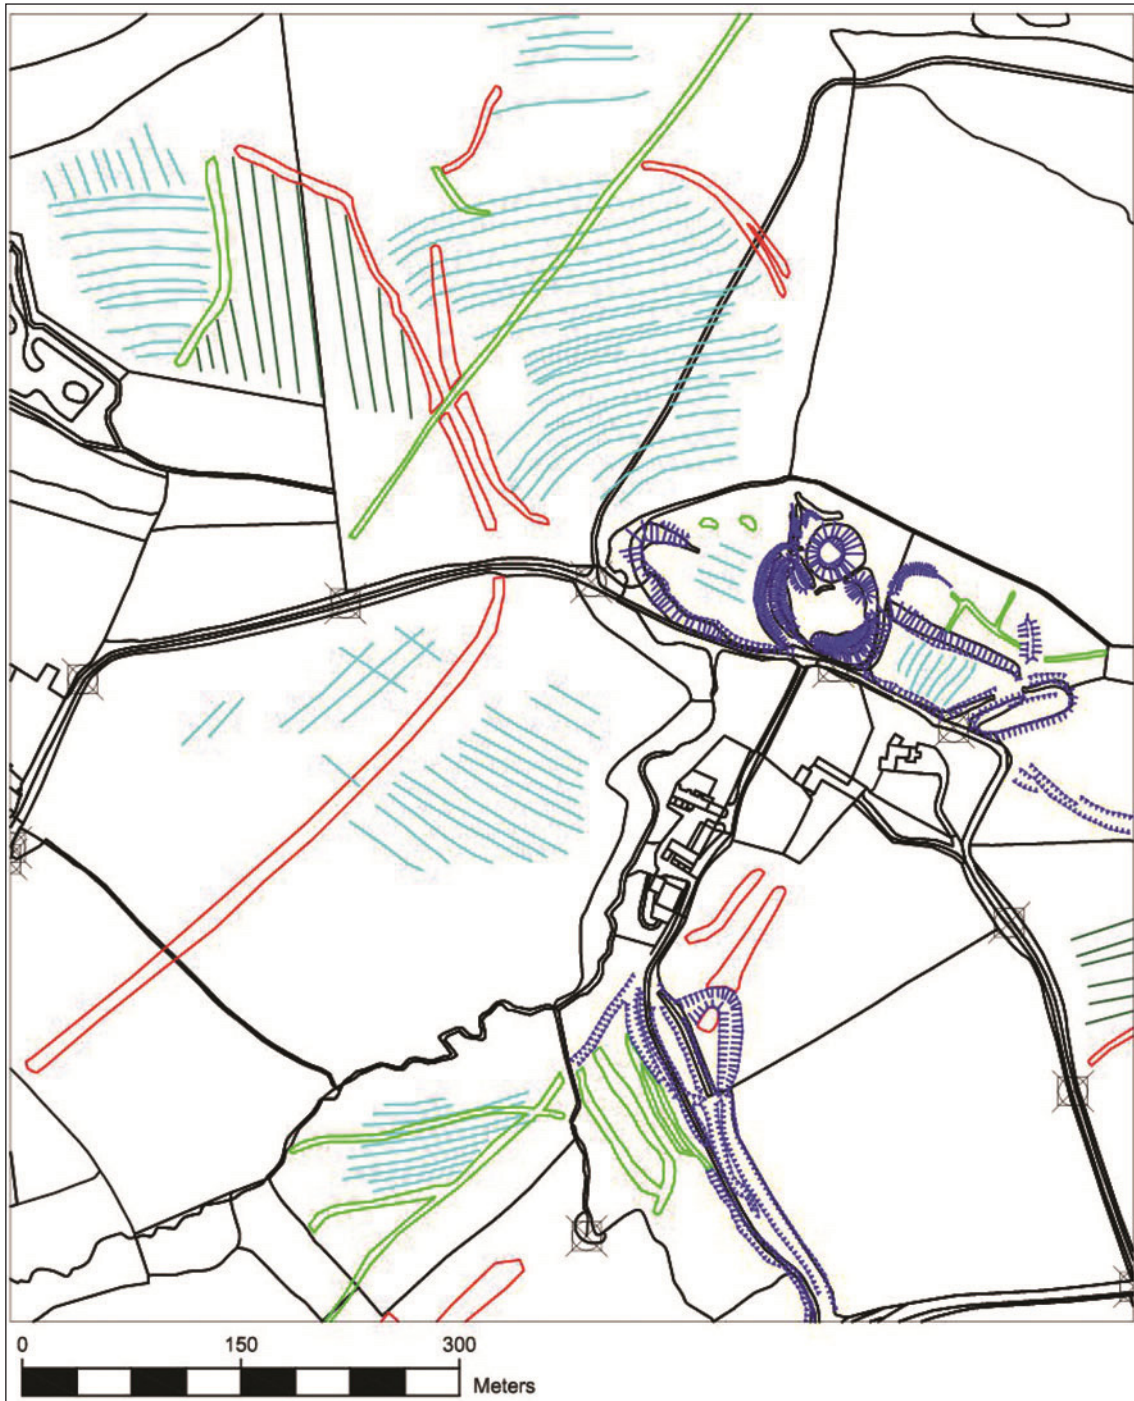
Figure 30 Castleton earthworks showing ridge-and-furrow, mostly mapped from lidar sources to the north of Castleton, but from photographic sources to the south of it.

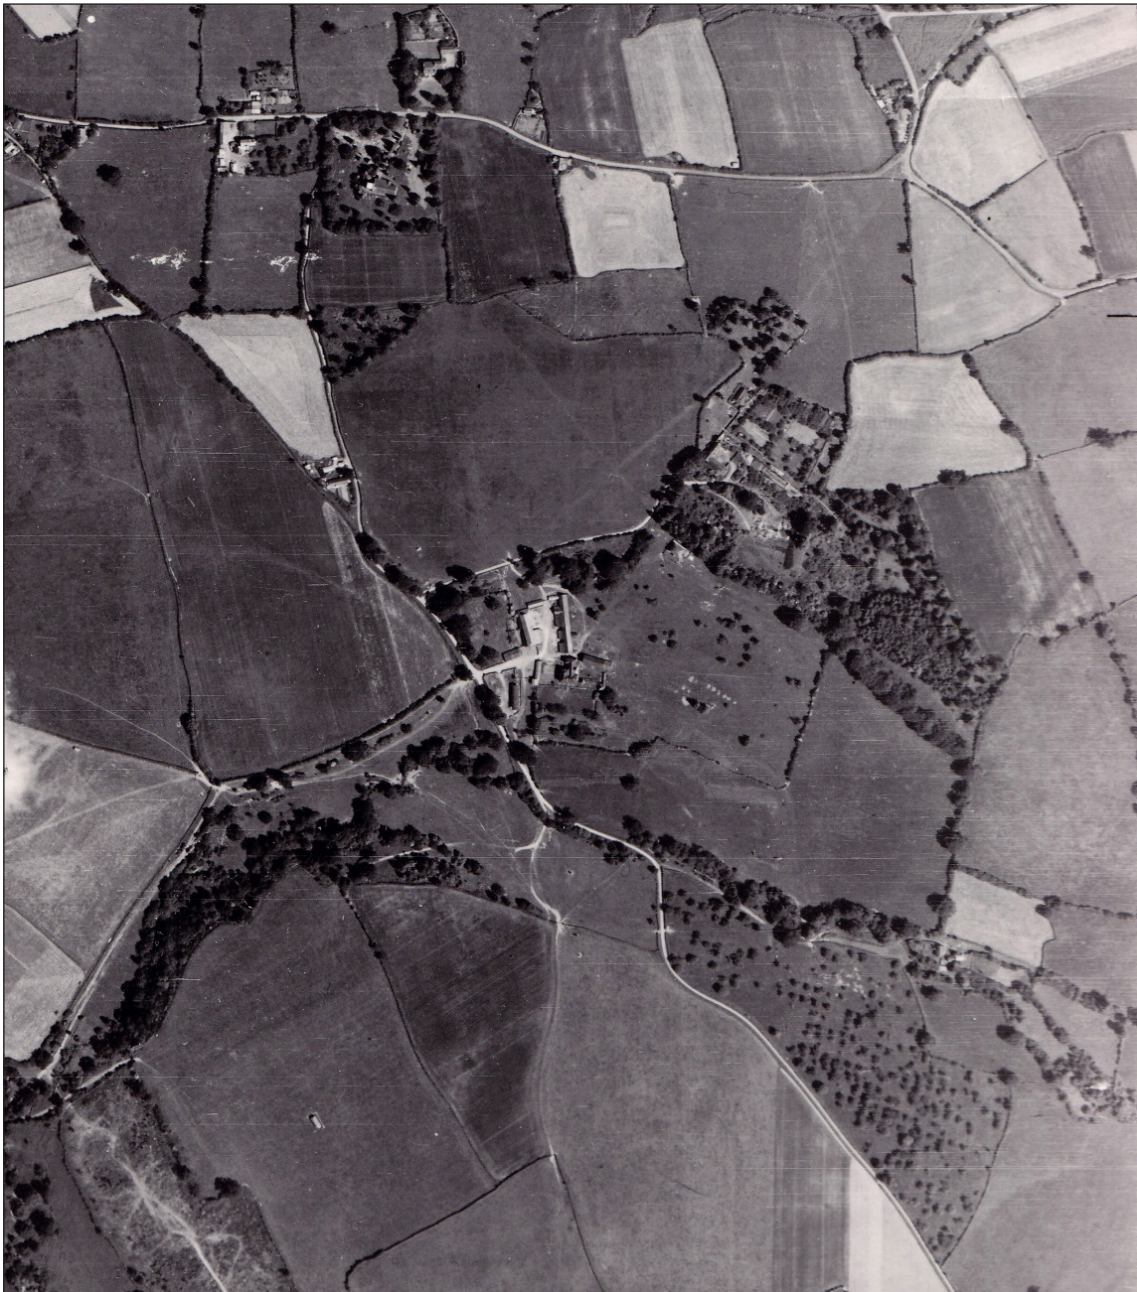
Figure 32 RAF 1946 vertical aerial photograph showing Priory Farm in the centre, with faint parchmarks in pasture representing the fishponds. St. Mary's church is top left. RAF 106G/UK/1652 54,11-July-1946
