Clifford Castle, Clifford, Herefordshire: Archaeological, Architectural and Aerial Survey and Investigation

Research Report Series 069-2018

NGR: SO 244 056

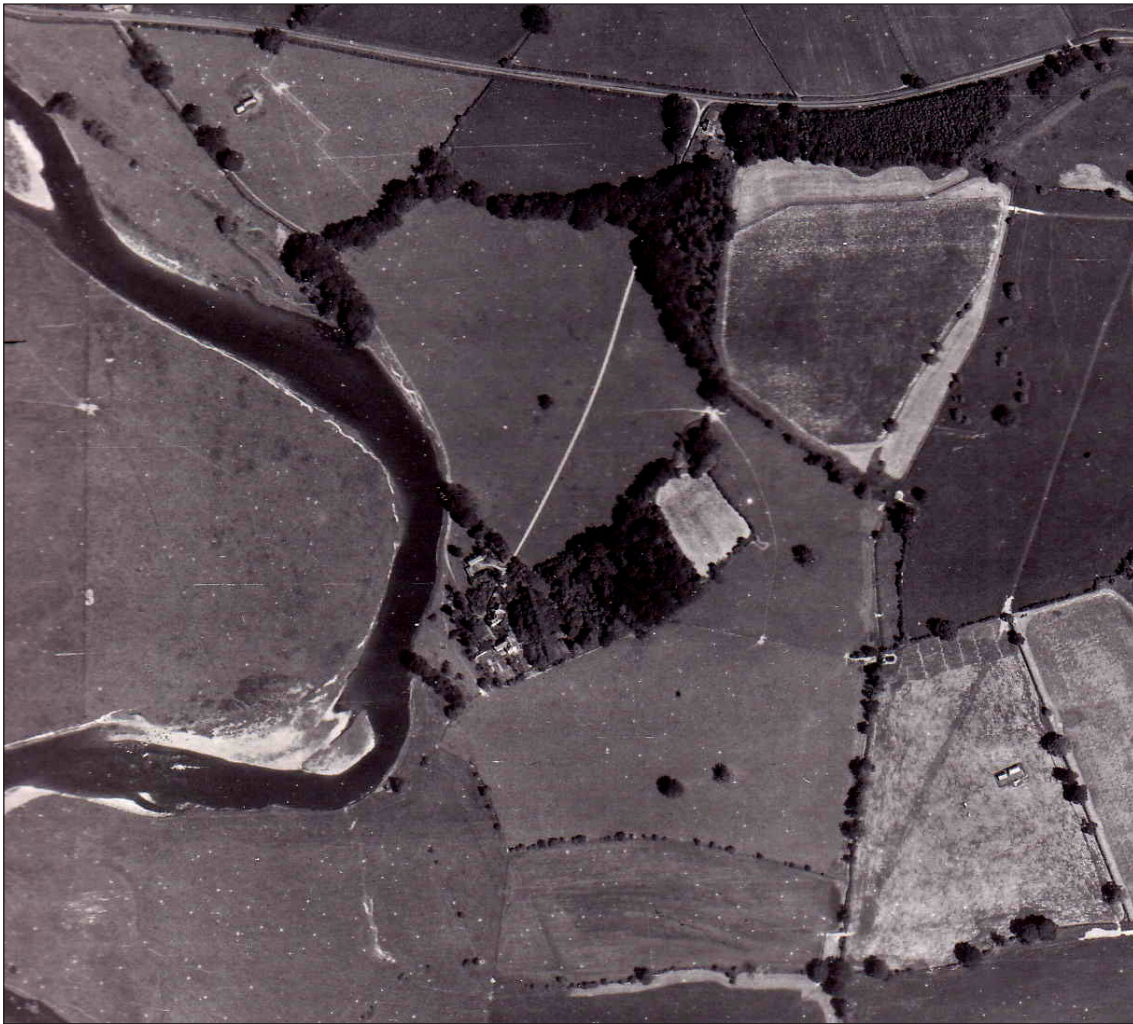
Figure 38 Whitney Old Court; shown in an aerial photograph of 1946. Some of the buildings can still be seen. The original driveway approach to the Manor ran along the western edge of the field, close to the river; however, the break in the treeline at the river's edge shows the changes in the Wye, which probably influenced the creation of the new driveway. RAF 106G/UK/1652 3407 Jul-1946

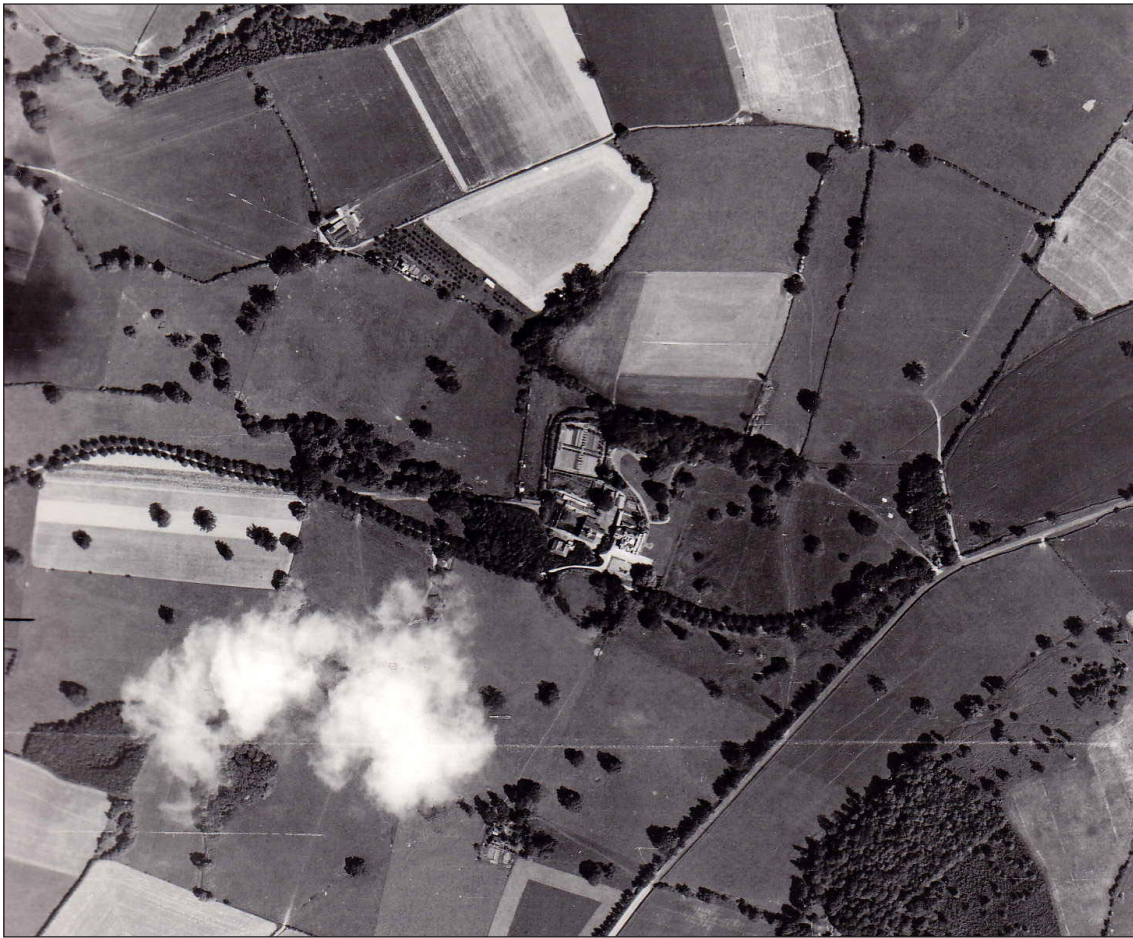
Figure 39 The Moor in 1946. RAF 106G/UK/1652 4412 Jul-1946

The post-medieval buildings of the manor are visible as extant structures on RAF photographs taken in 1946, shortly before they were demolished in 1952 (Whitehead and Patton 2001, 361; Figure 39), but for this project it was possible to map the buildings from aerial photographs taken in 1996 during a drought, when the buildings' foundations showed up clearly as parchmarks (Figure 40). These mostly correspond to the outline of buildings shown on the 1887 1st Edition 1:2500 OS map and additionally show internal features and possible room divisions. Other features included trackways that followed the edge of the kitchen garden and passed around a central square fountain, which may have been fed by the large circular

RAF photographs show that the area around the earthwork field system, and the overlying 19th century field system, are both cut through by the western half of the winding tree-lined driveway. This same area is also dotted with isolated trees within those enclosed fields (see Figure 39). These trees may have been part of a wooded park planted for the estate's landscape, but Whitehead and Patton (2001, 361) assert that tree cover was never extensive. The earthworks were probably preserved during the time they were enclosed within the private parkland and may represent the preceding earlier post-medieval or possibly medieval landscape.

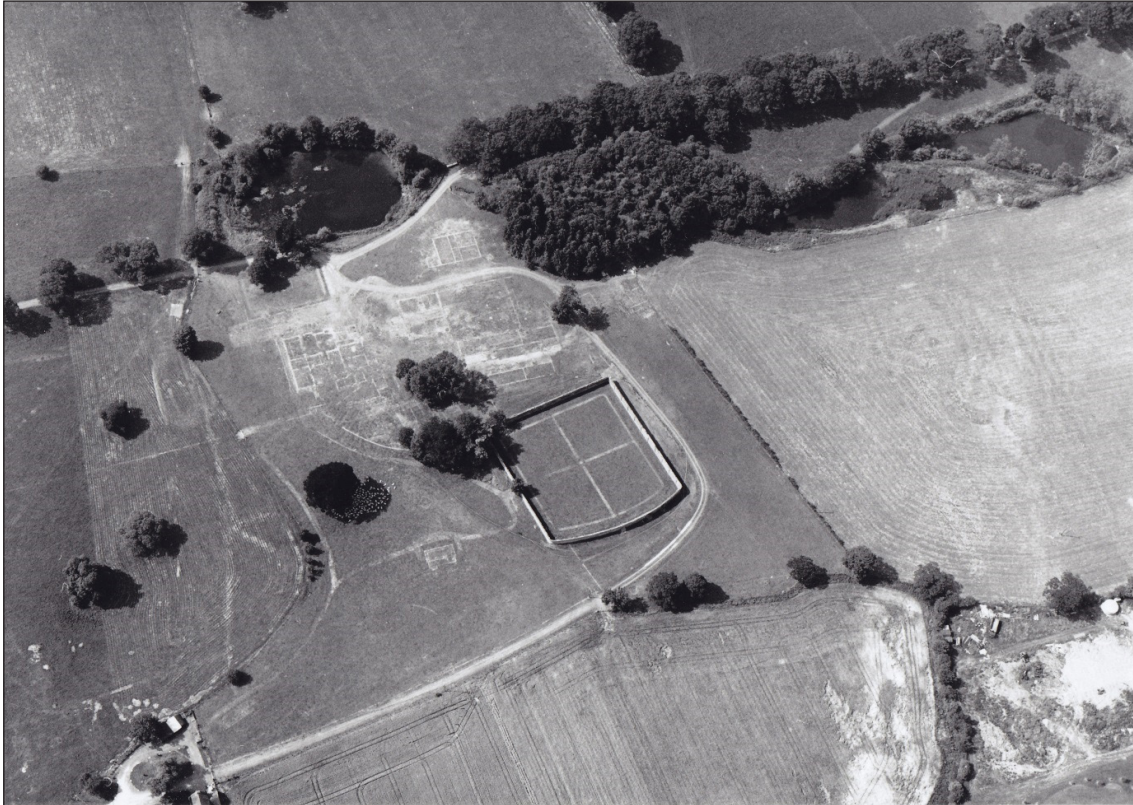
Figure 40 Aerial photograph of the site of The Moor, showing up as parchmarks in grass in 1996. HEA CPT 16875/256 22-Jul-1996

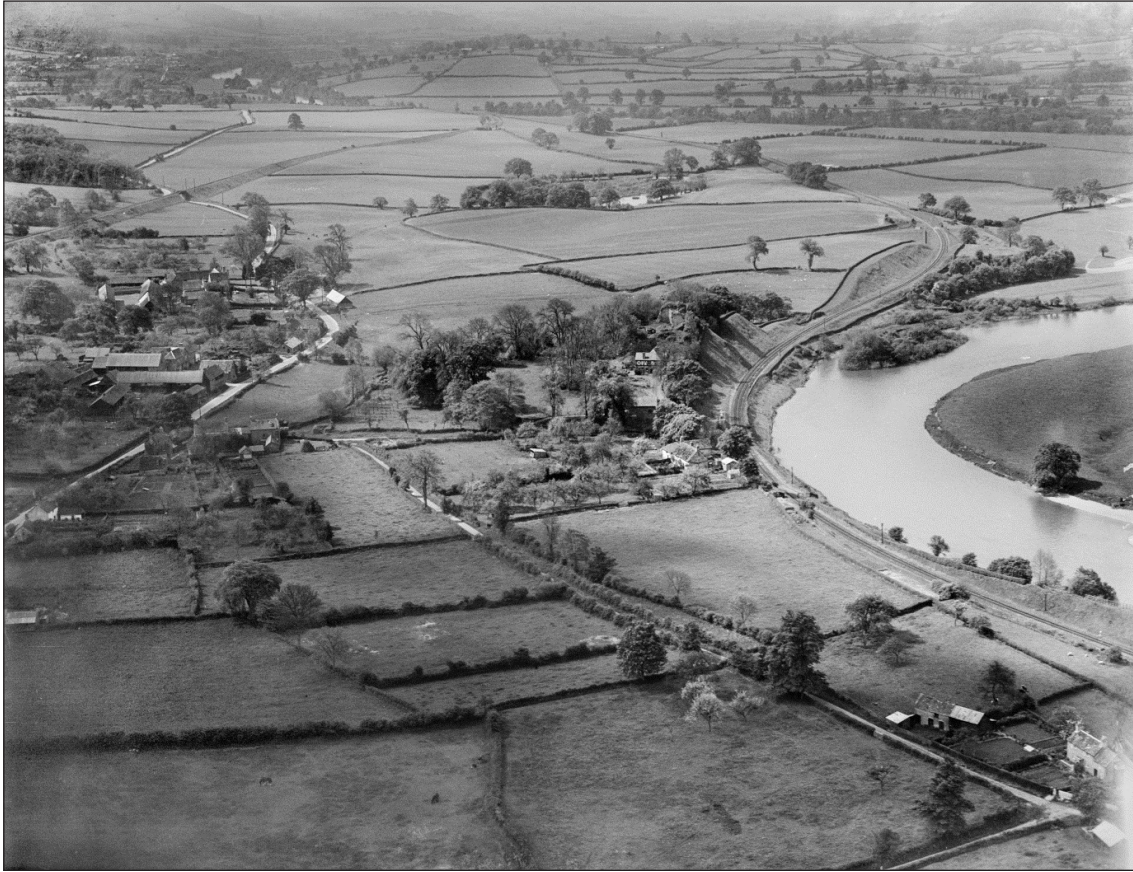
Figure 44 Clifford Castle and village with the Golden Valley railway line at top left and the Hereford, Hay and Brecon Railway on the right. May 1932 (AFL/60803 EAW038176)
