British Camp
Or
Herefordshire Beacon

SURVEY REPORT

BRITISH CAMP
OR
HEREFORDSHIRE BEACON

County: Herefordshire Unitary Authority & Worcestershire
District: Malvern Hills (Worcs.)
Parish: Colwall & Little Malvern
NGR: SO 760 400
NMR No: SO 74 SE 3

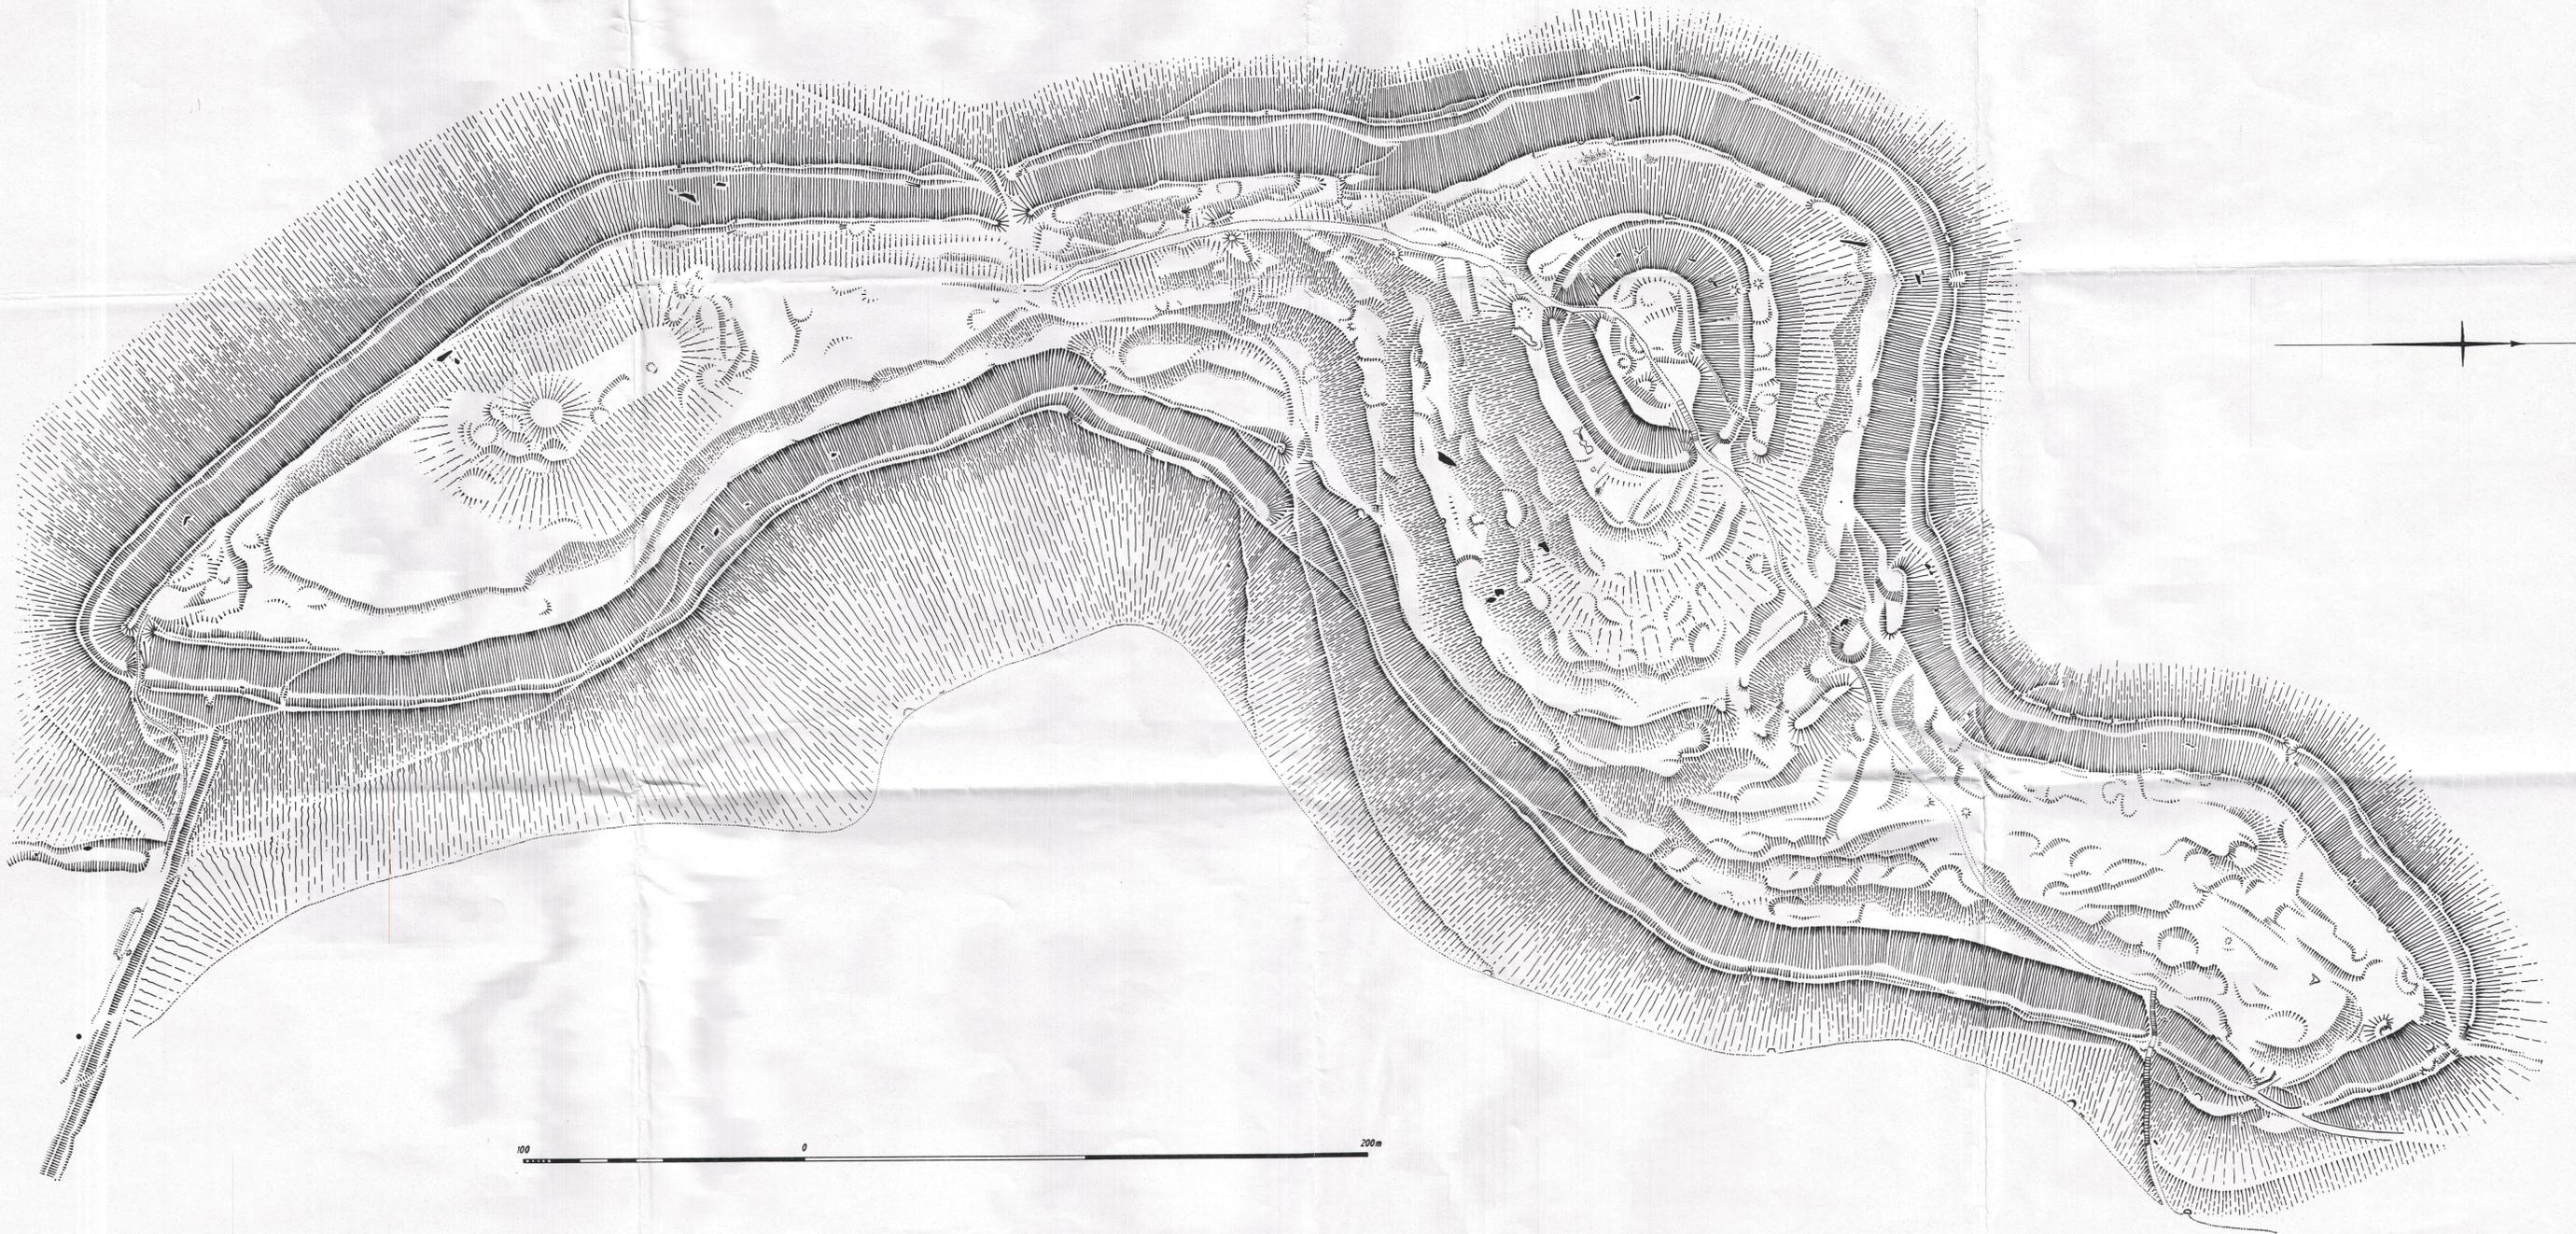
ROYAL COMMISSION ON THE HISTORICAL MONUMENTS OF ENGLAND				
OFFICE OF ORIGIN <i>NMRC</i>	COUNTY <i>Herefs/Worcs</i>	SCALE OF SURVEY <i>1:1000</i>	METHOD <i>EDM plane table graphic</i>	OS MAP No <i>SO 74 SE</i>
PROJECT NAME <i>Malvern</i>	DISTRICT	DATE OF SURVEY <i>1999</i>	ASSOCIATED PLANS	NAR No <i>3</i>
SITE NAME <i>British Camp</i>	PARISH <i>Cadwal</i>	SURVEYOR(S) <i>mcbb</i>		SAM No <i>H/W 3a 3b</i>
DOCUMENT STATUS	NGR <i>SO 760 400</i>	© Crown Copyright	SHEET	CATALOGUE No

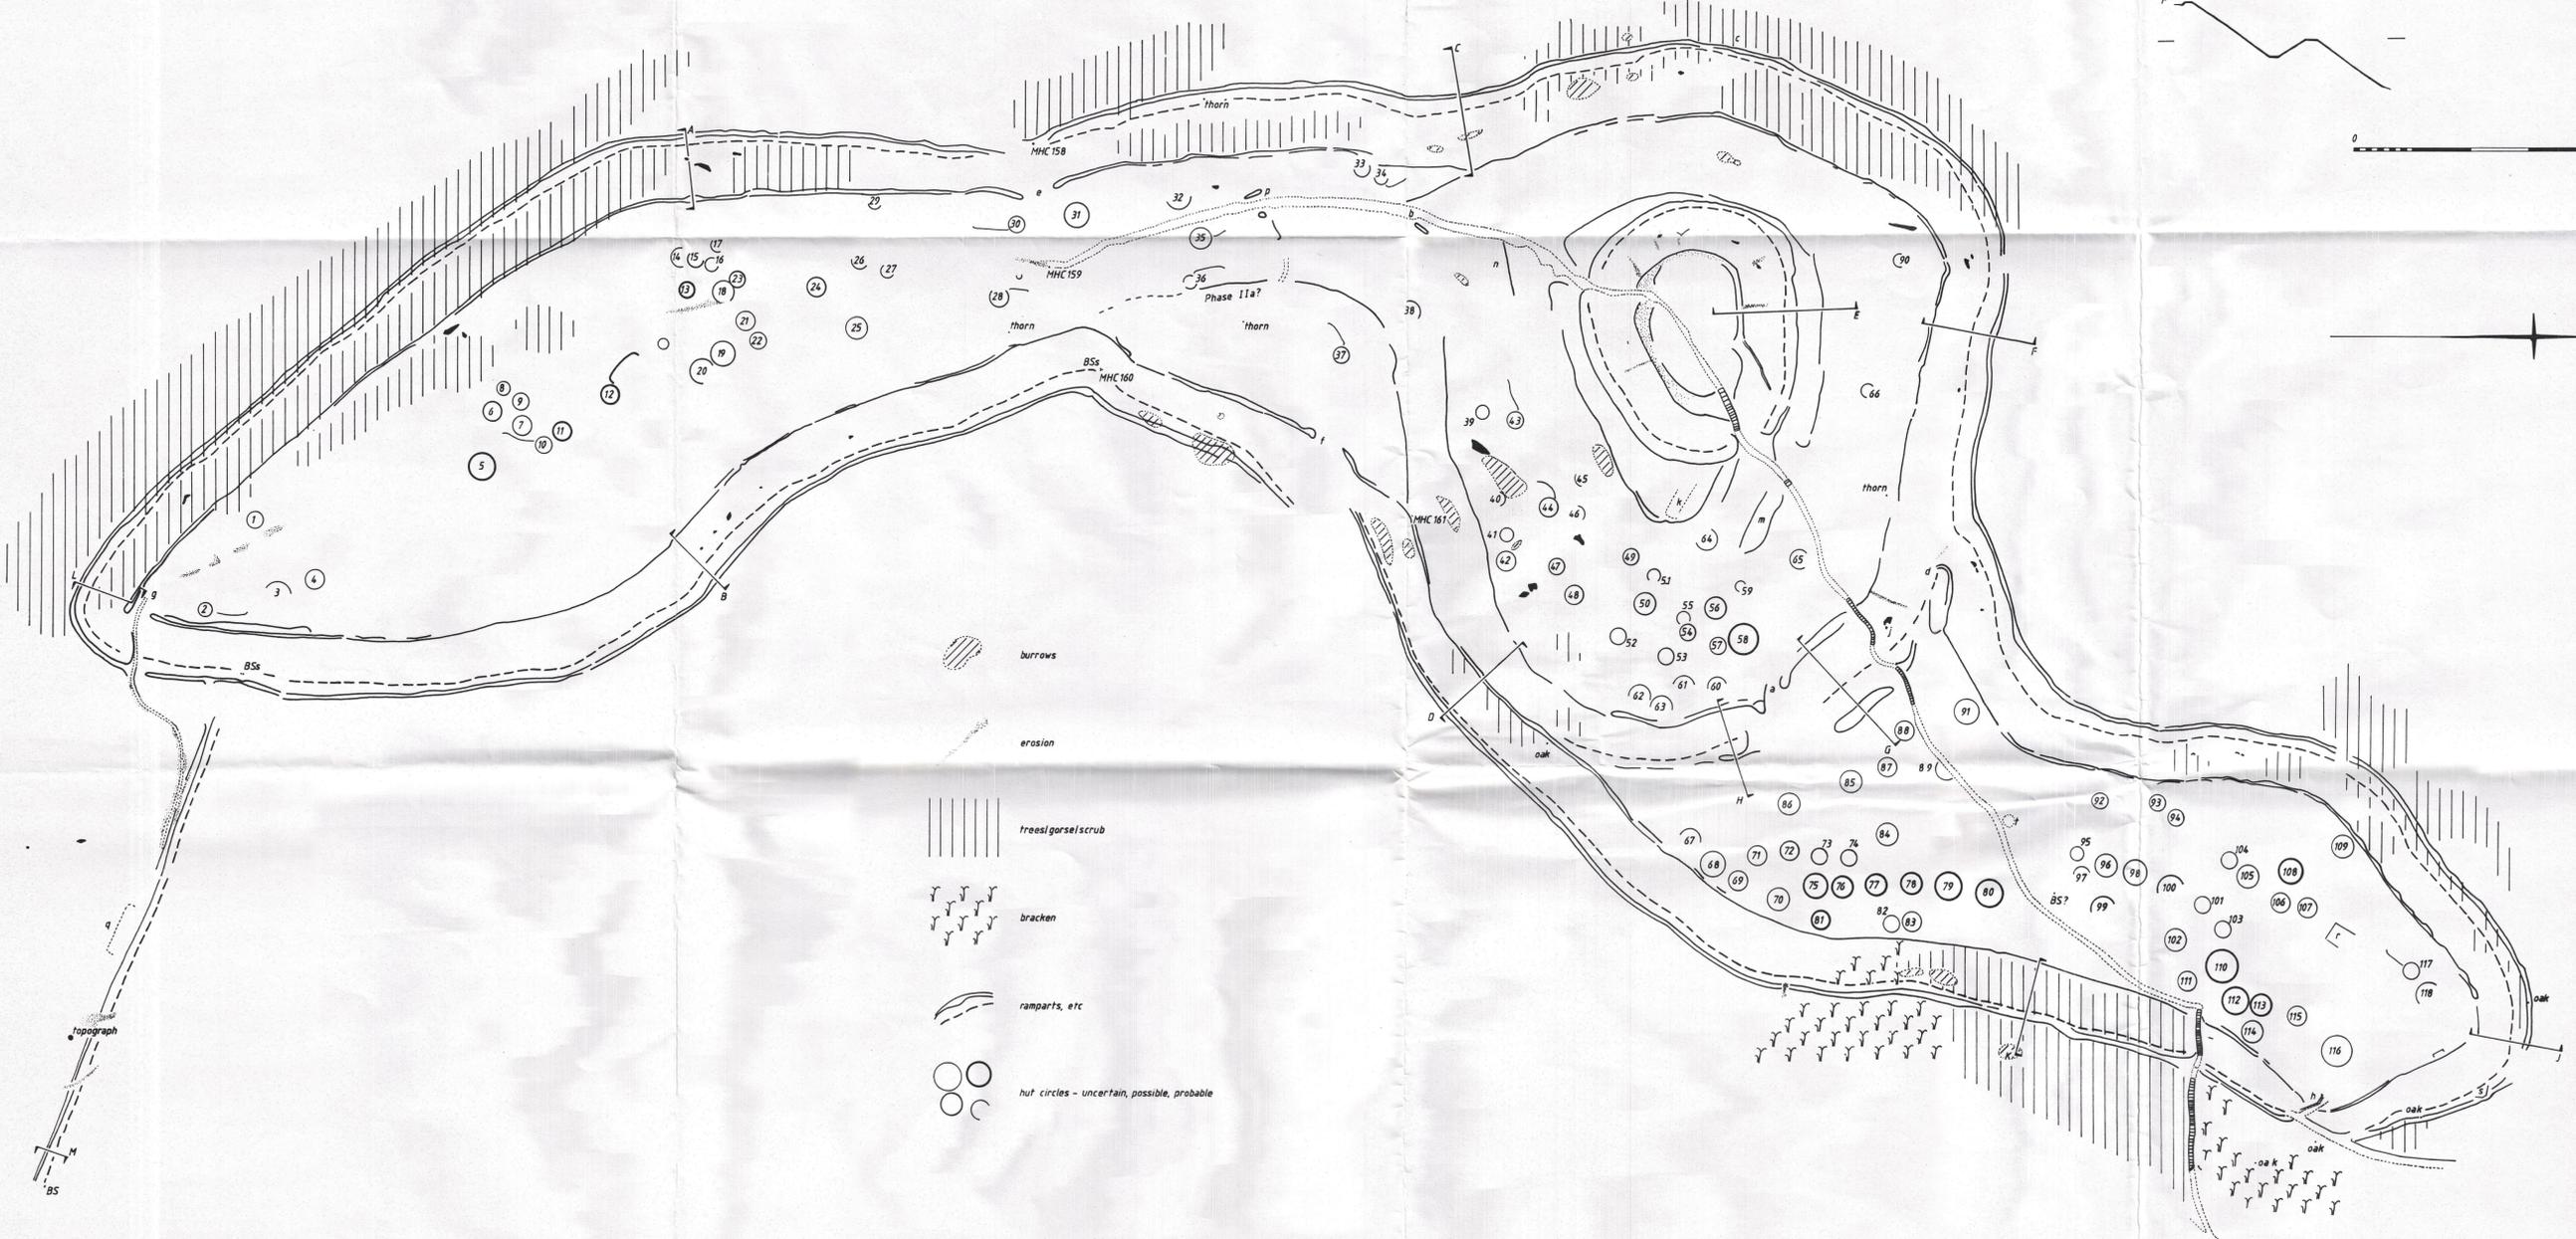
RCHM ROYAL COMMISSION ON THE HISTORICAL MONUMENTS OF ENGLAND				
OFFICE OF ORIGIN NHRC	COUNTY Herefs/Worcs	SCALE OF SURVEY 1/1000	METHOD	OS MAP No SO 74 SE
PROJECT NAME Malverns	DISTRICT	DATE OF SURVEY 1999	ASSOCIATED PLANS 1/1000 hachured survey	NAR No 3
SITE NAME British Camp	PARISH Colwall	SURVEYORS mcbb		SAM No H/W 3a 3b
DOCUMENT STATUS	NGR SO 760 400	© Crown Copyright	SHEET	CATALOGUE No
