# Richmond Castle and Environs: Aerial Investigation & Mapping Report

### AERIAL INVESTIGATION & MAPPING REPORT

This report summarises the results of a landscape analysis of Richmond Castle and its wider setting from aerial photographs held in the Historic England Archive. The work was undertaken in support of an English Heritage Trust project to develop the interpretation at Richmond Castle.

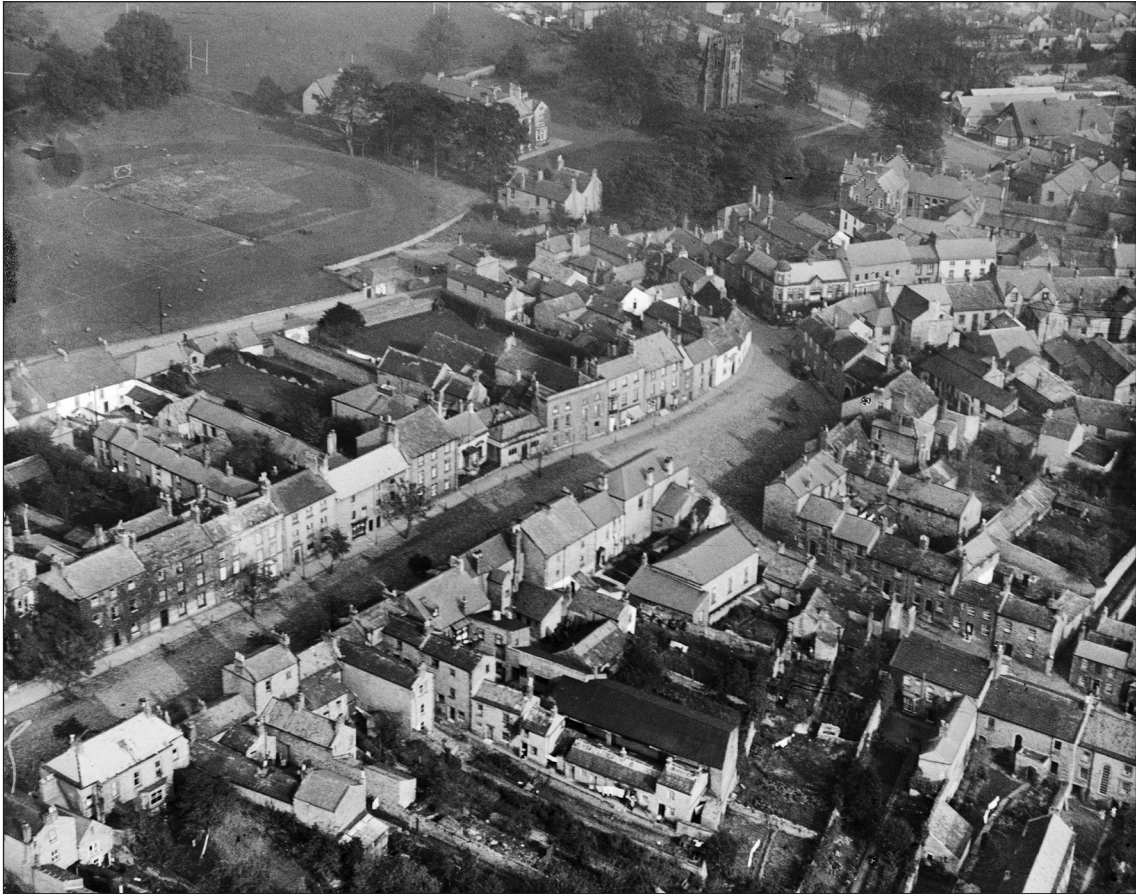
*Fig 3: An Aerofilms Ltd photograph from October 1927 looking north-east along Newbiggin towards Grey Friars' Tower. © Historic England Archive. Aerofilms Collection EPW019864.*

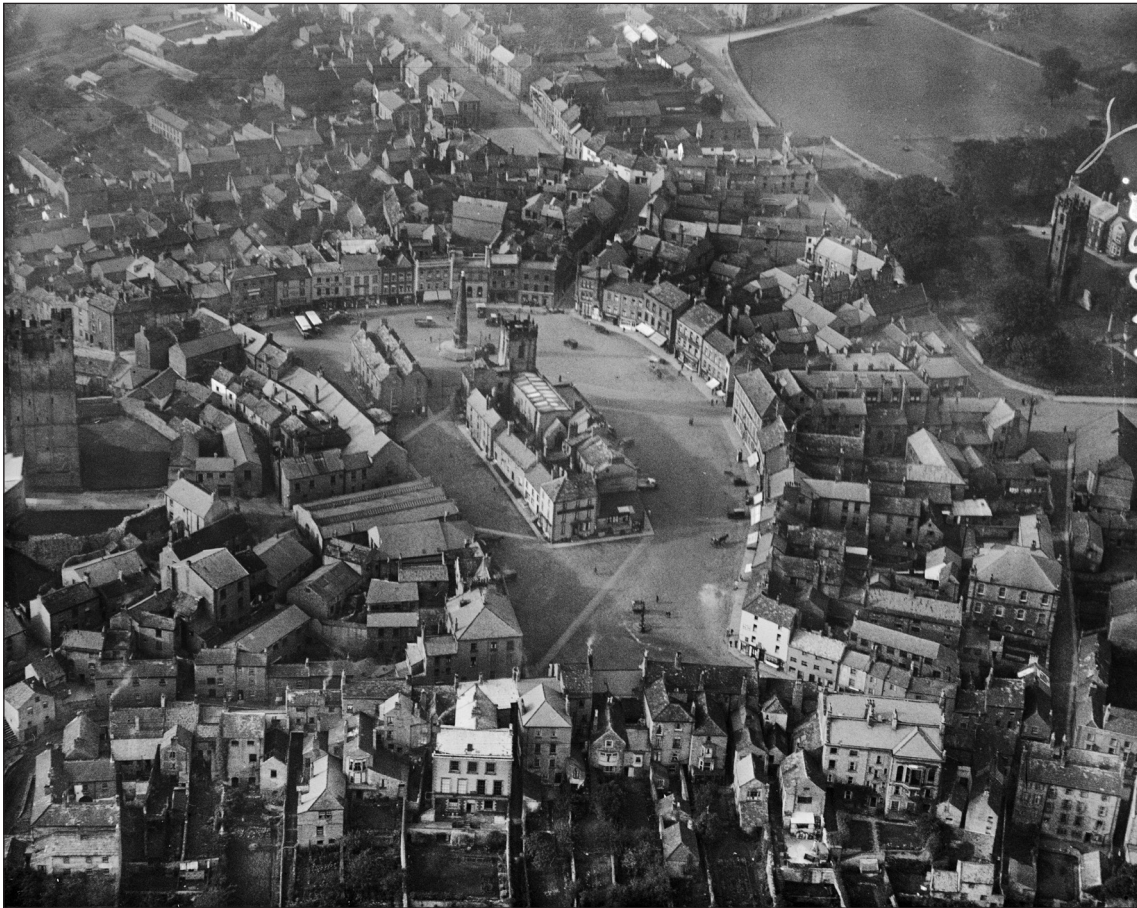
*Fig 5: An Aerofilms Ltd photograph from October 1927 showing the market place. The toll booth is visible in the south-west corner. © Historic England Archive. Aerofilms Collection EPW019862.*

Seven of the Aerofilms photographs date from October 1927 and represent the earliest aerial images of Richmond in the Historic England Archive collection. Two show the extant Victorian barrack block, four years before its demolition in 1931 (Fig 2) and although both have some photo blemishes they provide a unique aerial view of the castle in this period. Others images include a view along Newbiggin towards Grey Friars' Tower (Fig 3), and Frenchgate (Fig 4). Three illustrate the market place with a small number of motor vehicles, including two charabancs (Fig 5).

*Fig 12: Detail from a 1949 Aerofilms Ltd image showing the market place busy with cars and coaches. The toll booth visible in Fig 5 had been demolished the previous year. © Historic England Archive. Aerofilms Collection EAW023519 28-MAY-1949 (detail).*

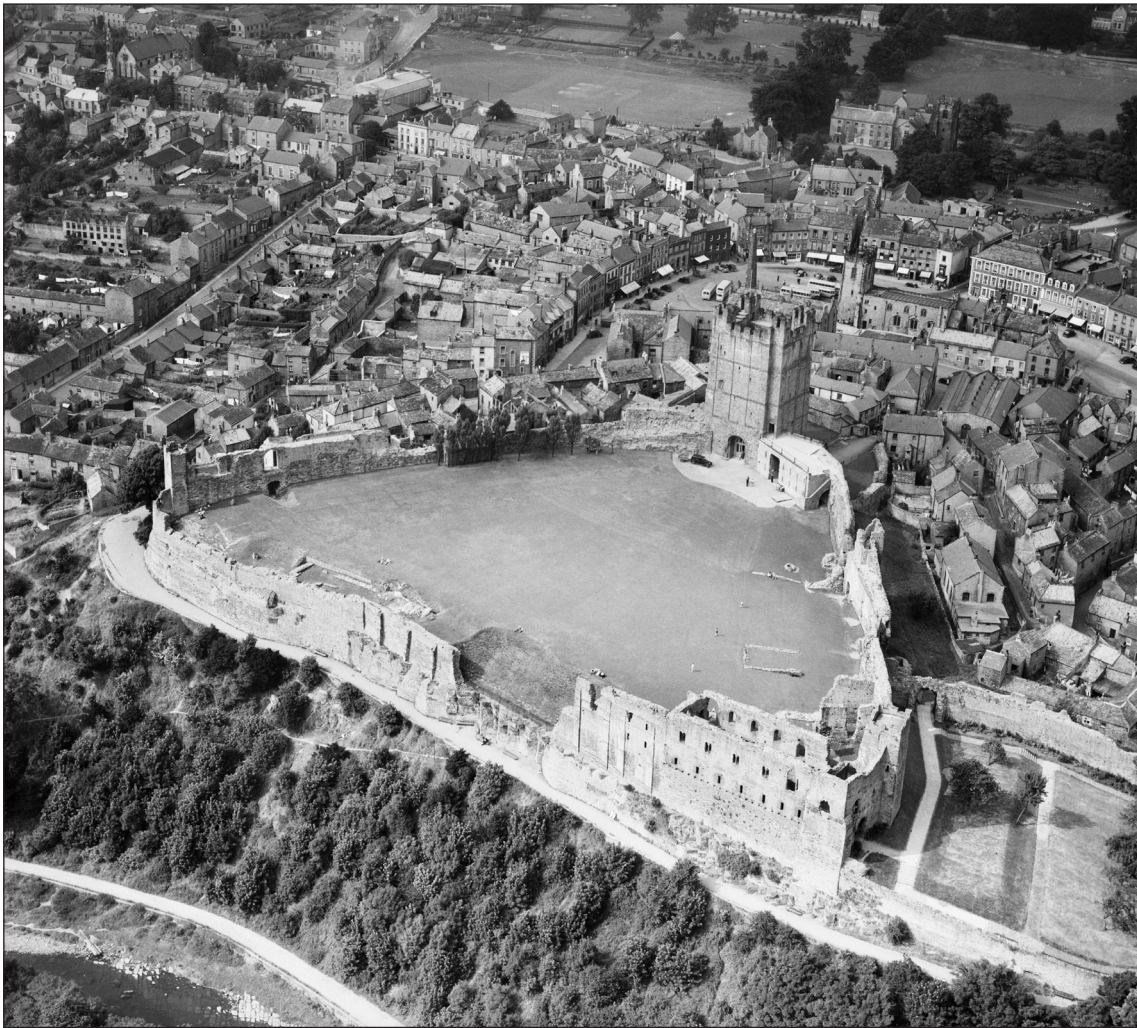
*Fig 8: A detailed view of Richmond Castle in 1947. The site is busy with visitors and a car and trailer are parked in front of the keep. © Historic England Archive. Aerofilms Collection EAW009259 11-AUG-1947.*

Richmond was revisited by Aerofilms in August 1947 and May 1949. Images include broad landscape views of the town (Fig 7) and frames focussing on the castle (Fig 8). Interesting details include lost buildings such as the toll booth that once stood in the south-west of the market place and was demolished in 1948 (Hatcher 2000, 142). They also illustrate changing aspects of social history such as the rise in car ownership and tourism.

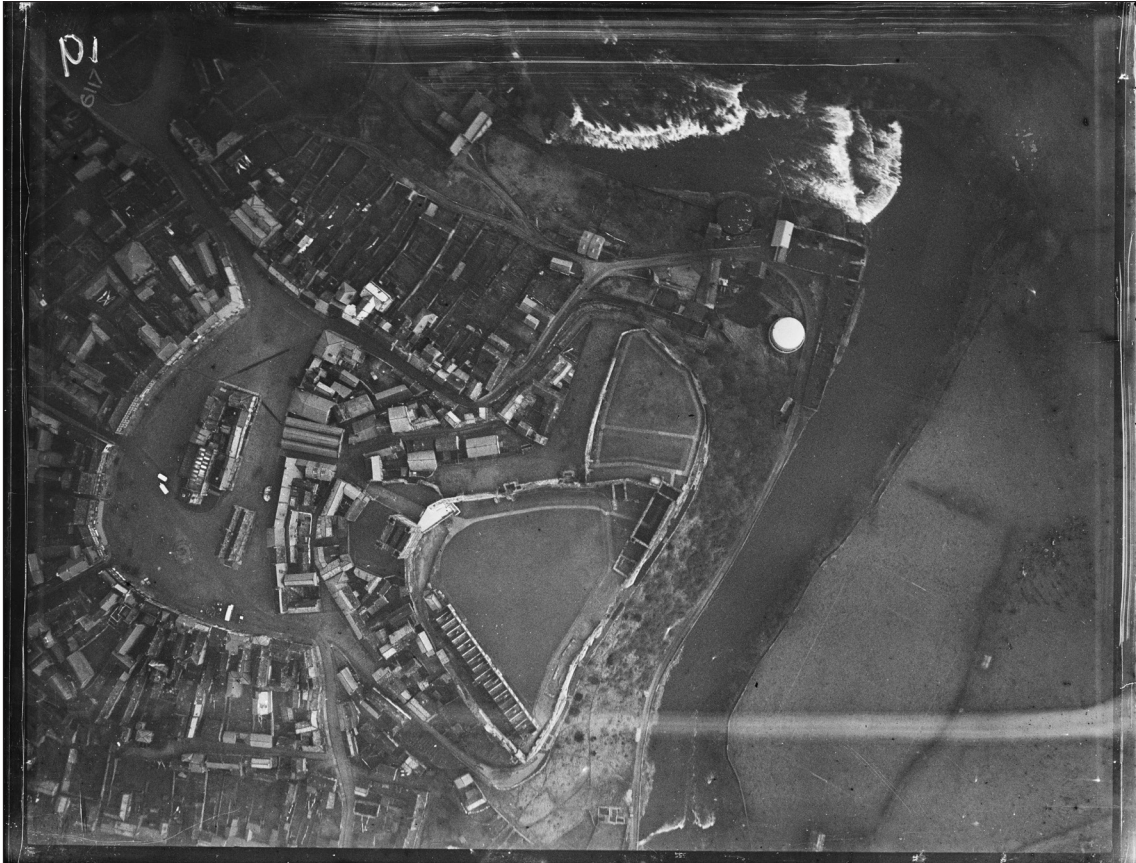
*Fig 9: A vertical photograph of the market place and castle taken pre-1931. North is to the left of the frame. CCC 9201/6117 date unknown. © Historic England Archive (Crawford Collection).*

The earliest vertical images are two frames from the Crawford Collection showing the castle and market place (Fig 9). Although the exact date is unknown, the extant barrack block within the castle indicates that they pre-date 1931. Other images from the Crawford Collection date from 1937 and show Richmond and Easby Abbey (Fig 10). Like the early Aerofilms images noted above, these photographs could provide good illustrative material.

The earliest dated photographs of the castle are three Aerofilms images from October 1927, although two undated vertical photographs are likely to have been taken at a similar time (see Figs 2 and 9). The images show the extant Victorian barrack block. Although the War Office's lease of the castle had ceased in 1913 (Grenville *et al* 2001, 56) it appears that the barracks were being reused in 1927 to provide married quarters for the Green Howards during their deployment as part of the Shanghai Defence Force (*The Yorkshire Post* January 25 1927). There was a broad track running between the cells and Scolland's hall. This appears to have been removed by 1937 – the poor quality of the photography makes it difficult to be certain – but is clearly gone by the time of the 1945 RAF vertical aerial photographs. The 1927 images also show an area to the south of the keep is fenced off, possibly relating to work being undertaken on the castle by the Office of Works.

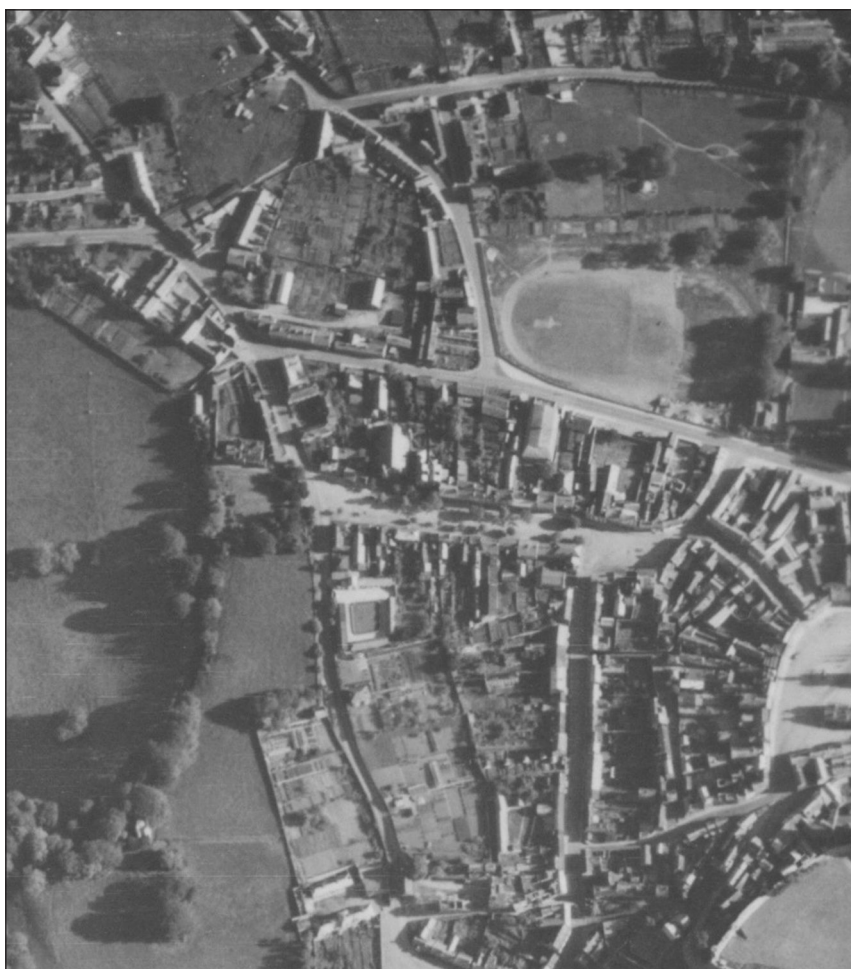
*Fig 13: Detail from a 1945 RAF vertical photograph showing allotment gardens. RAF/106G/UK/394 RS 4049 17-JUN-1945 Historic England Archive RAF photography (detail).*

Within the historic core of the town, Richmond's street pattern has remained relatively unchanged since the first half of the 20th century but the aerial photographs chart the gradual expansion of housing in the following decades. Large allotment gardens are recorded on 1945 photography at Nun's Close and Temple View (Fig 13), both of which were also noted on OS maps of the late 1800s. The site of the Nun's Close allotments is now a car park while Temple View has been developed into housing. Smaller areas of allotments can also be seen behind the site of Richmond Workhouse and along the northern edge of the cricket ground. It is possible that these related the temporary allocation of land to food production during the Second World War. Photographs from 1947 and 1952 also show that site of the former cattle market had been developed into a temporary prefab housing estate (Fig 14). The design of the prefabs indicates that they were of a type manufactured by Tarran of Hull.

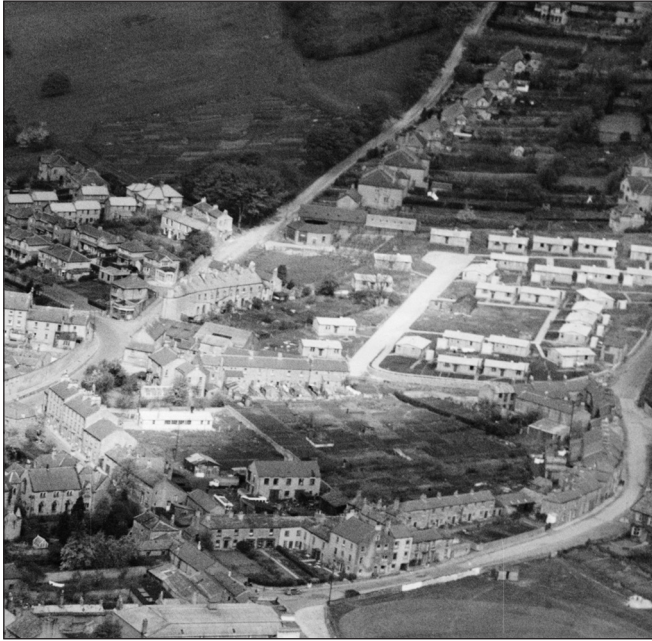
*Fig 14: A prefab housing estate seen in the background of a 1947 Aerofilms Ltd photograph. It was constructed on the site of the cattle market around 1945 but had been demolished by 1956. © Historic England Archive. Aerofilms Collection EAW005578 17-MAY-1947 (detail).*

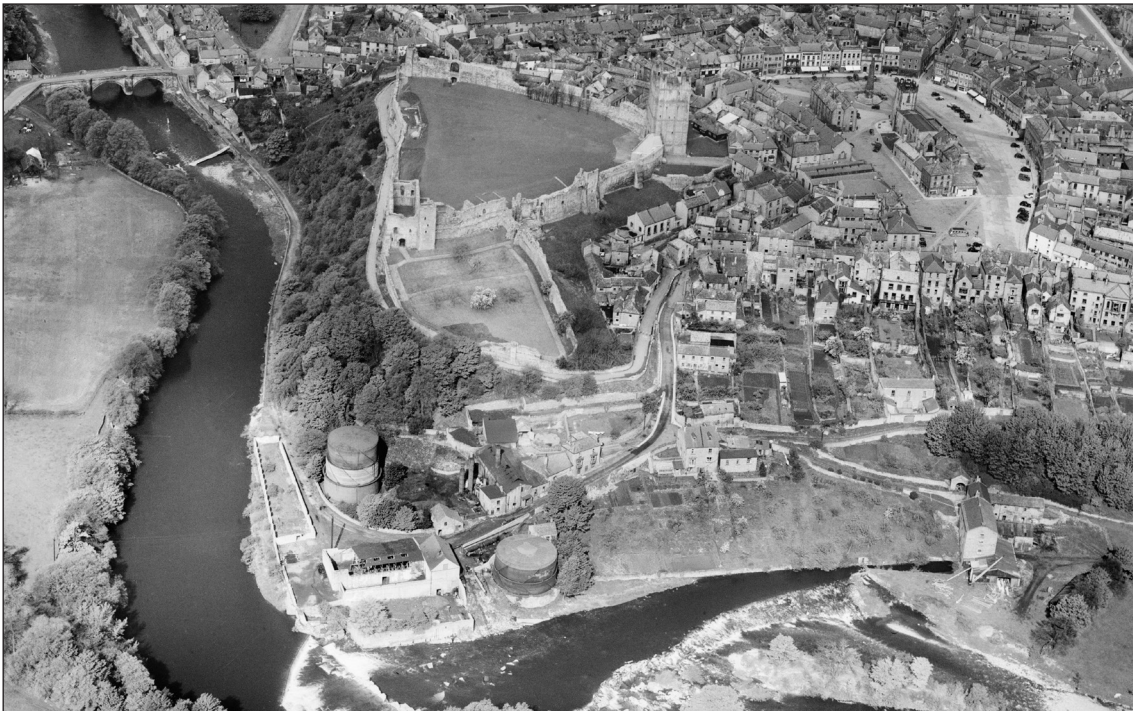
*Fig 15: The town gasworks seen in 1947. Church Corn Mill can be seen in the bottom right hand corner of the image. © Historic England Archive. Aerofilms Collection EAW005578 17-MAY-1947 (detail).*

Richmond had become one of the first towns in Europe to be lit by gas after the construction of the gasworks on the banks of the Swale in 1820 (Hatcher 2000, 167). The gasworks and associated gasometers are visible on aerial photographs until the early 1980s, but are most vividly illustrated on Aerofilms images from 1947 (Fig 15). Other industrial buildings include Church Corn Mill which was demolished in 1969 (Hatcher 2000, 227).

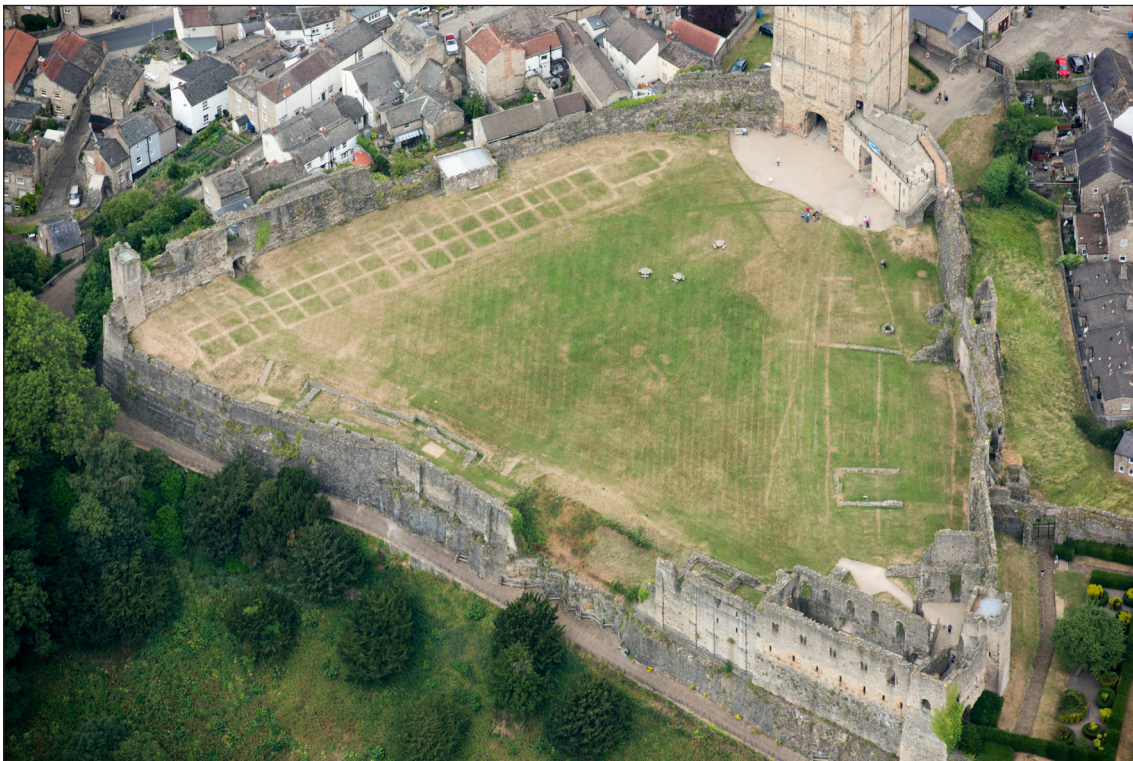
*Fig 16: Parchmarks revealed within the castle courtyard during the drought of 2018. Features revealed include the buried remains of the Victorian barrack block. 34050\_027 19-JUL-2018 © Historic England Archive.*

Parchmarks of the Victorian barrack block had been observed from the castle and photographed from the air on several occasions but the long hot summer of 2018 provided optimal conditions for the formation of parchmarks within the courtyard (Fig 16). The castle was photographed on two occasions in 2018 and the images revealed the clearest details of surviving sub-surface deposits to date.

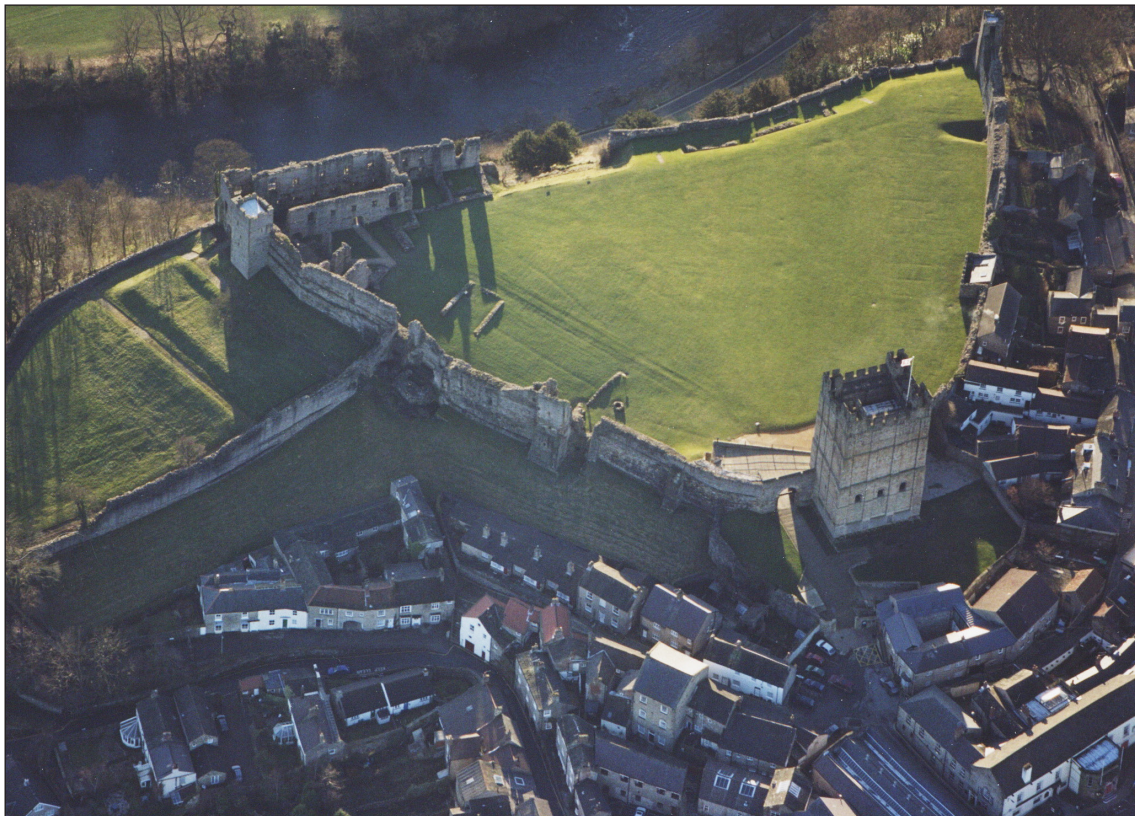
*Fig 18: Low sun reveals slight earthworks within the castle courtyard. some relate to features identified as parchmarks in 2018, including the Victorian barrack block. 17520/20 08-JAN-2001 © Historic England Archive.*

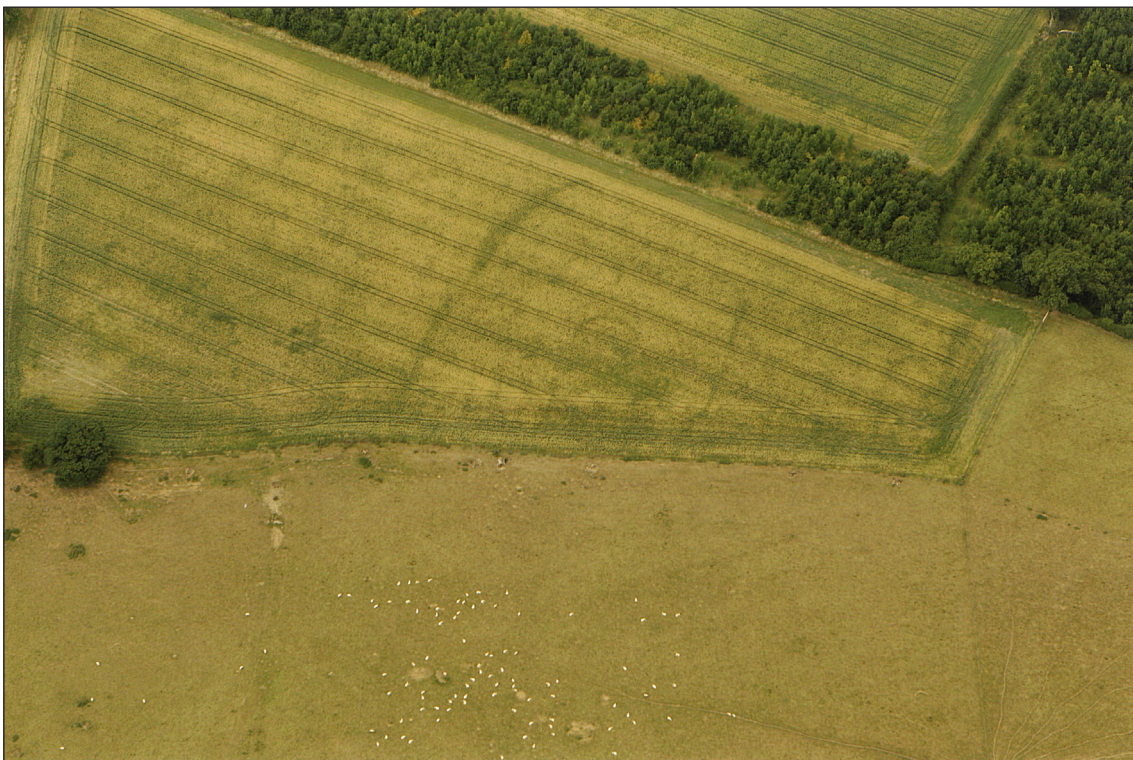
Fig 19: The cropmarks of a probable Iron Age/Roman settlement. 20391/28 27-JUL-2005 © Historic England Archive.

In 2005 a potential Iron Age and/or Roman settlement was photographed as a cropmark to the south of St Trinian's Hall at NZ 193 001 (Fig 19). Although the cropmarks are fragmentary, they appear to indicate the buried remains of a large ditched enclosure containing two arcs of ditch. The arcs probably represent parts of the drip gully that once surrounded two round houses of about 14m in diameter. To the south, traces of ditches are also visible as cropmarks and these could relate to fragments of field boundaries associated with the settlement.

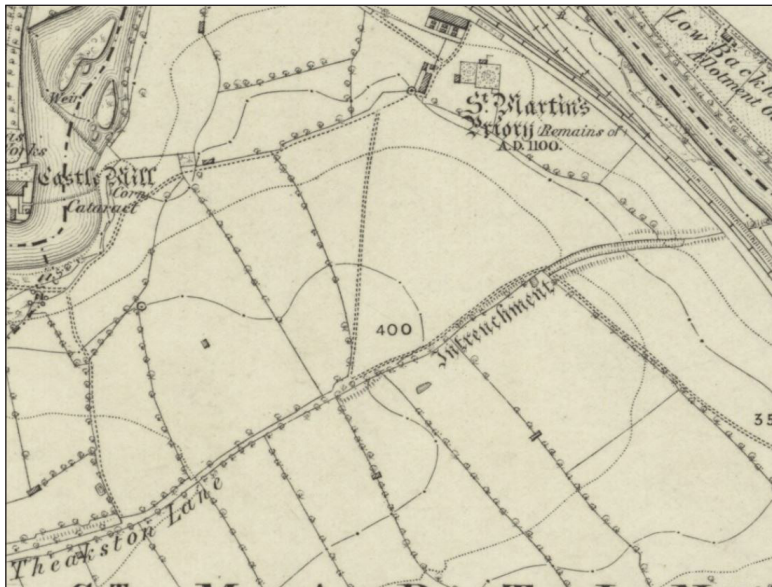
Fig 21: 1857 OS six-inch mapping showing Scots Dyke as 'Intrenchment'. Reproduced with the permission of the National Library of Scotland.

Scots Dyke, a Scheduled Monument thought to be an early medieval or earlier boundary, runs for a distance of around 14km from the River Swale in the south to the River Tees in the north. Some sections are now plough levelled, sometimes identified as cropmarks, but others survive as earthworks. Earthwork remains of the dyke are visible in several locations within the project area (Fig 20). The most substantial run north-east from Sandford House where traces of the ditch flanked by a broad bank can be seen on lidar. To the south-west of Sandford House the course of the dyke survives as a broad ditch running downslope towards the River Swale. On the opposite side of the river are more denuded traces of the ditch but early edition OS mapping indicates that more of the monument survived at this location until Theakston Lane was extended in the middle of the 20th century (Fig 21).

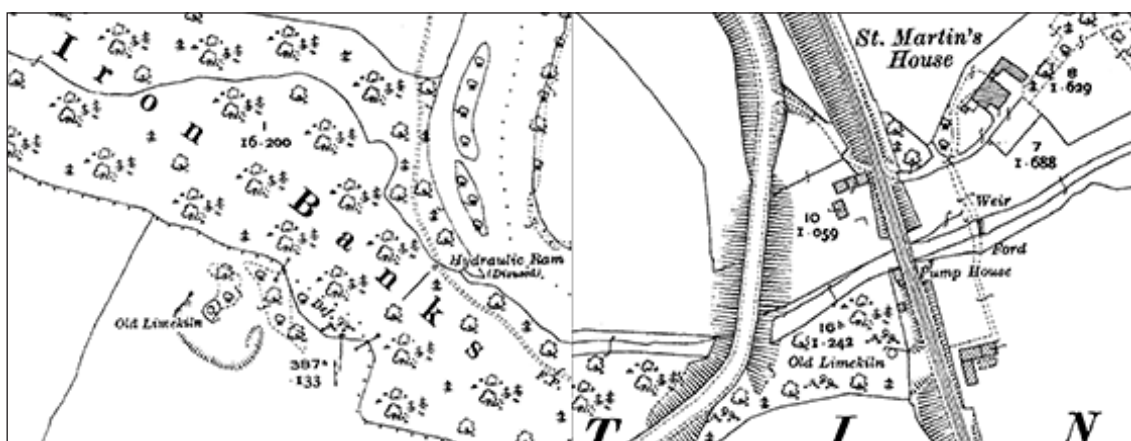
Fig 28: Limestone quarries with associated lime kilns. Ordnance Survey 1:2,500 published 1928 © and database right Crown Copyright and Landmark Information Group Ltd (All rights reserved 2018) Licence numbers 000394 and TP0024.

Narrow bands of limestone are present in the project area and there is evidence for small-scale exploitation of this resource. Two small quarries are located in Spring Wood and a larger quarry, containing the remains of a limekiln, lies to the south of Iron Bank. A second limekiln is noted on early edition OS mapping in the east of Sandbeck plantation, but no trace of this was identified on aerial photographs or lidar (Fig 28). Quick lime produced in kilns such as these was used during the 18th and 19th centuries for land improvement and to make mortar. It is not clear whether the kilns in the project area were producing quick lime for agricultural use or for building.

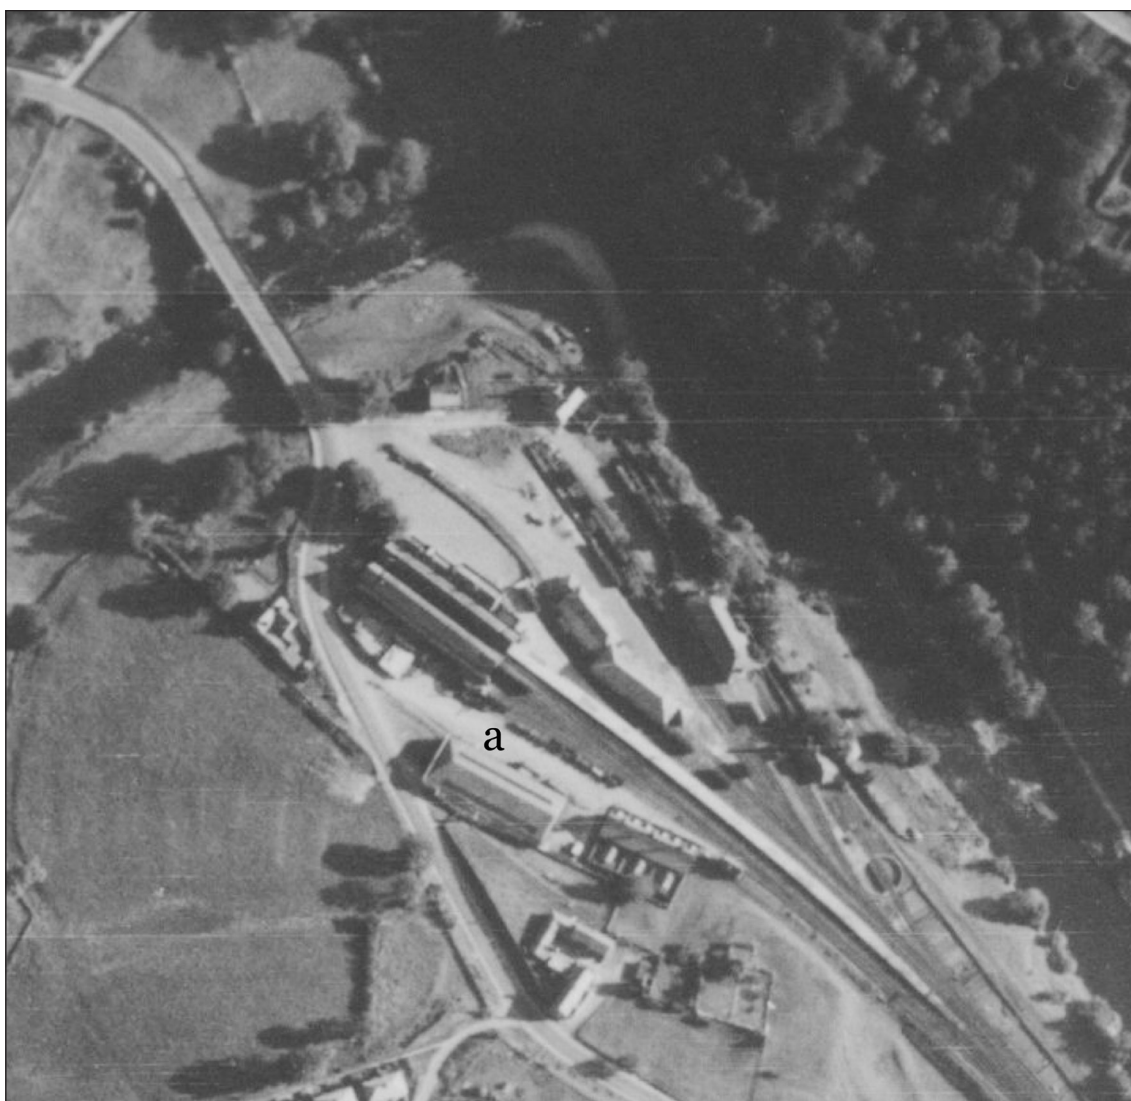
*Fig 30: Richmond station in 1945. The large shed to the south (a) is a bus depot. RAF/106G/UK/394 4049 RS 17-JUN-1945 Historic England Archive RAF photography (detail).*

Richmond was linked to the Victorian railway network by the Eryholme-Richmond branch line which opened in 1846. Richmond railway station, designed by G T Andrews of York, opened the following year (Fawcett 2011, 165). RAF photography from 1940 onwards illustrates the station whilst still in use and records now-demolished structures such as the goods sheds, coal depot and turntable (Fig 30). The railway closed in March 1969 and OS photography from just four months later shows the derelict line. By the 1970 OS photography the track had been lifted. Several sections of the line survive as extant embankments and cuttings and are visible on modern aerial photographs and lidar data.

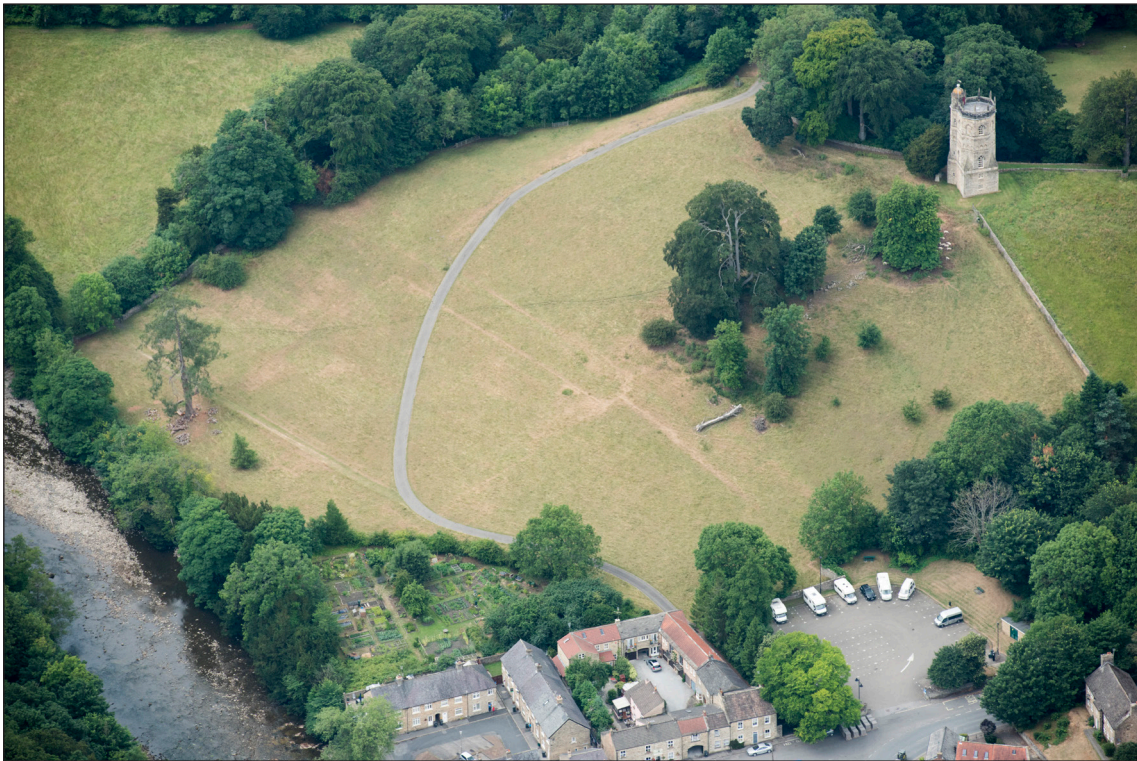
*Fig 33: Parchmarks of buried wall foundations within Temple Grounds revealed as parchmarks in 2018. 34050\_030 19-JUL-2018 © Historic England Archive.*

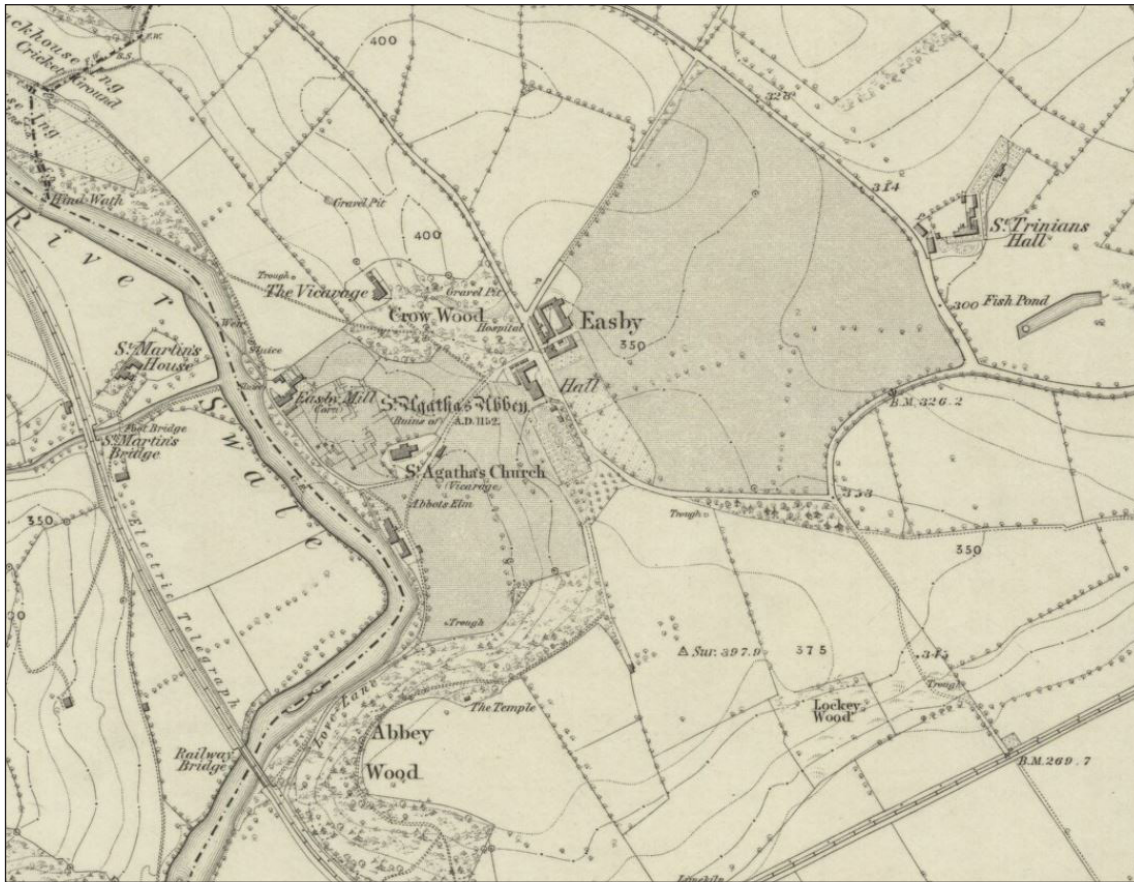
Fig 34: Parkland associated with Easby Hall depicted on an OS six-inch map of 1857. Reproduced with the permission of the National Library of Scotland.

Easby Hall (later Easby House) was constructed around 1730 for Rev William Smith who had acquired the manor of Easby in 1729 (NHLE 1318260). The 1857 OS six inch map depicts parkland to the front and rear of the hall, straddling the original drive (Fig 34). To the SW the parkland incorporated the ruins of Easby Abbey and the field to the south, bounded by Abbey Wood.
