Historic England

Conserving Stained Glass using Environmental Protective Glazing

Prepared for Historic England by

Tobit Curteis, Tobit Curteis Associates
and Léonie Seliger, Canterbury Cathedral Stained Glass Studio
in association with
Naomi Luxford, Shane Slater, Tracy Manning, and Robyn Pender

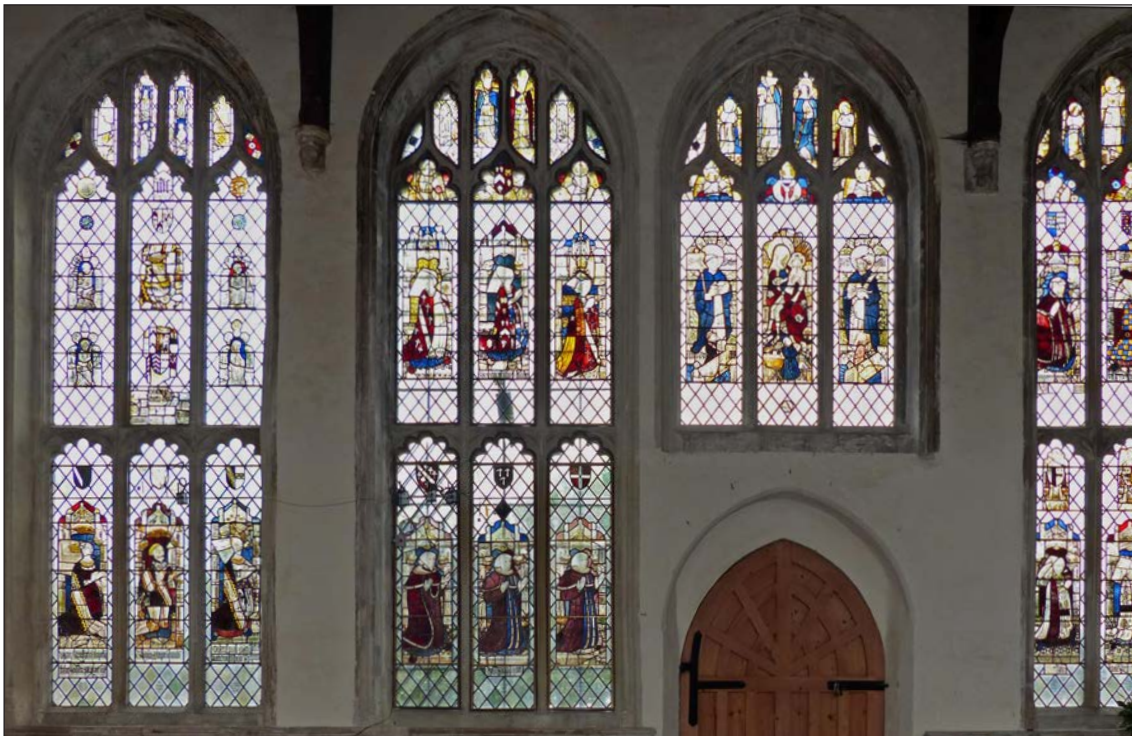
Figure 1: Stained glass can appear perfect from the ground.

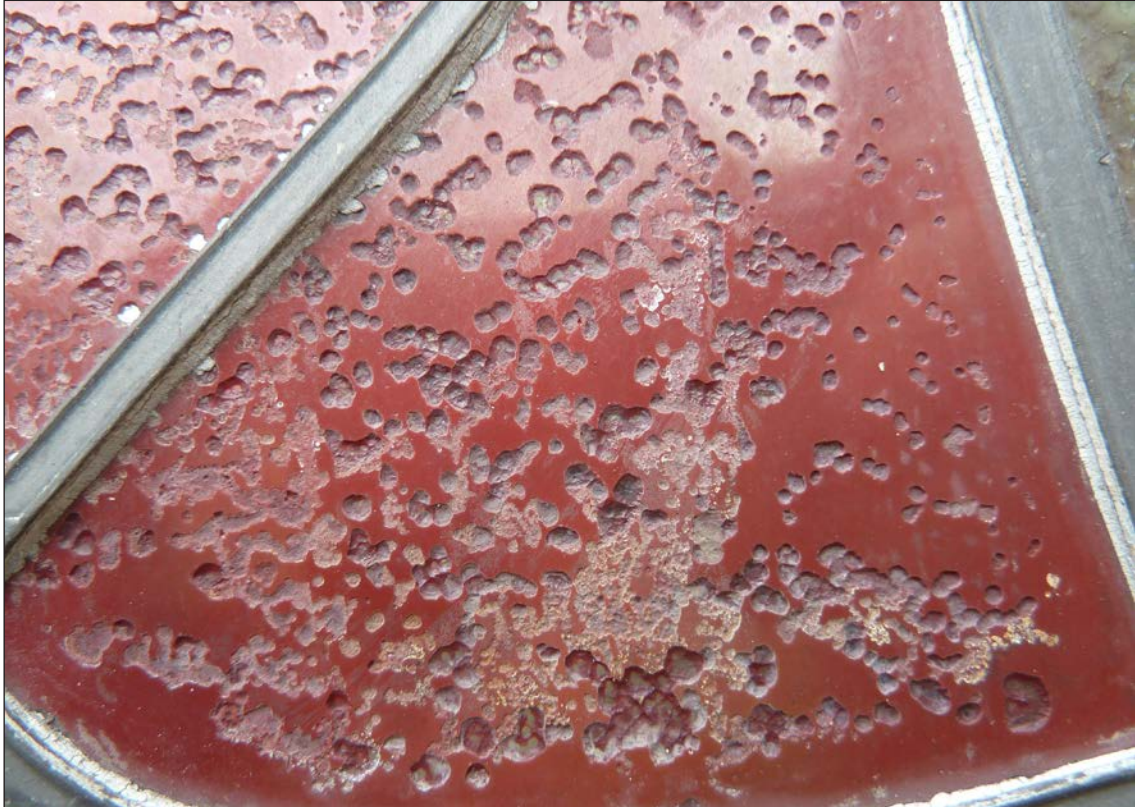
Figure 2. Closer inspection reveals corrosion pits have damaged the red glass layer.

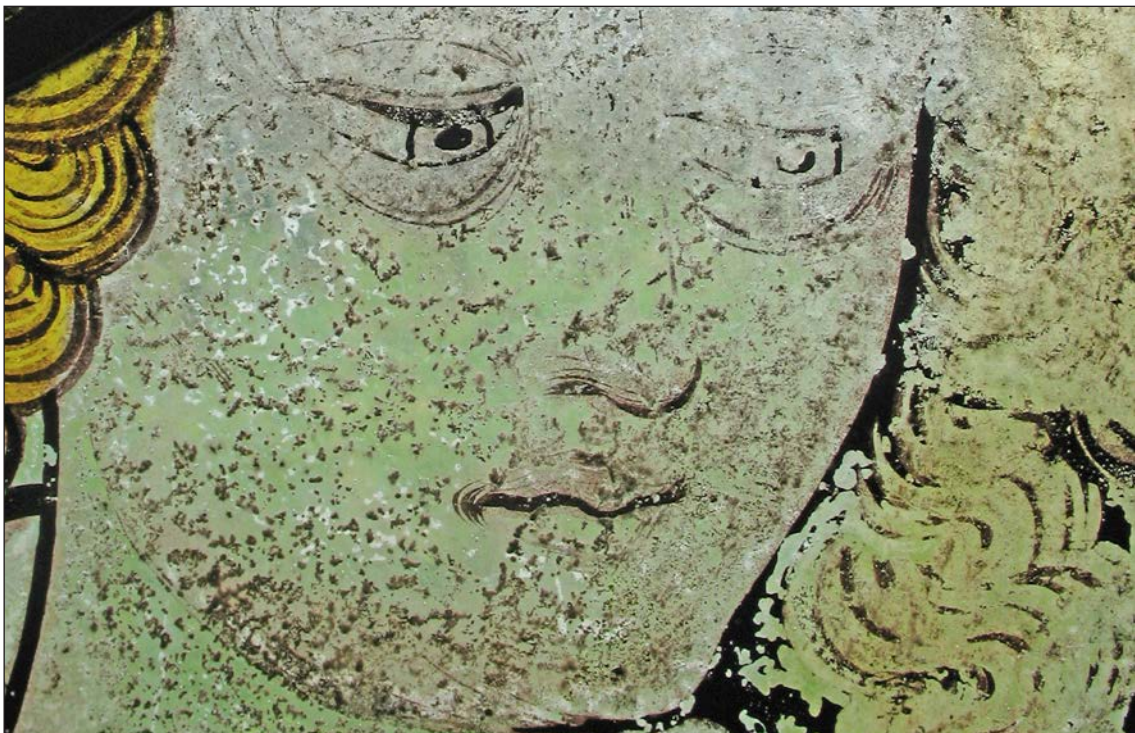
Figure 3. Closer inspection shows black paint details are flaking inside. ©Léonie Seliger

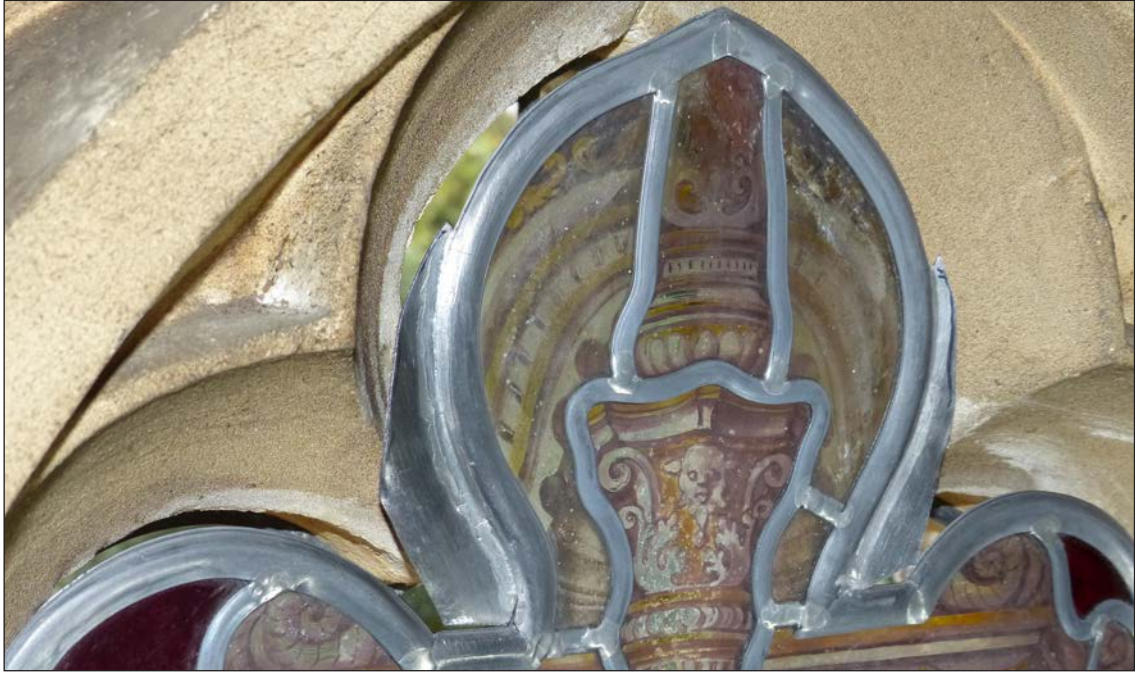
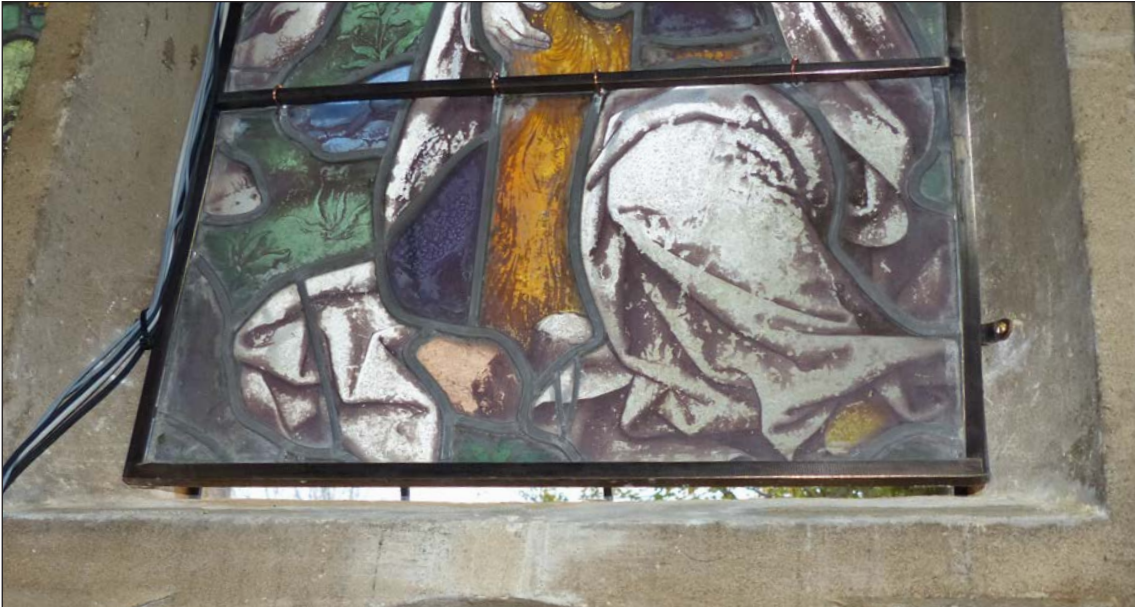
Figures 7, 8. Ventilation openings at the top and bottom of a recently installed internally vented system at the Vyne, Berkshire.

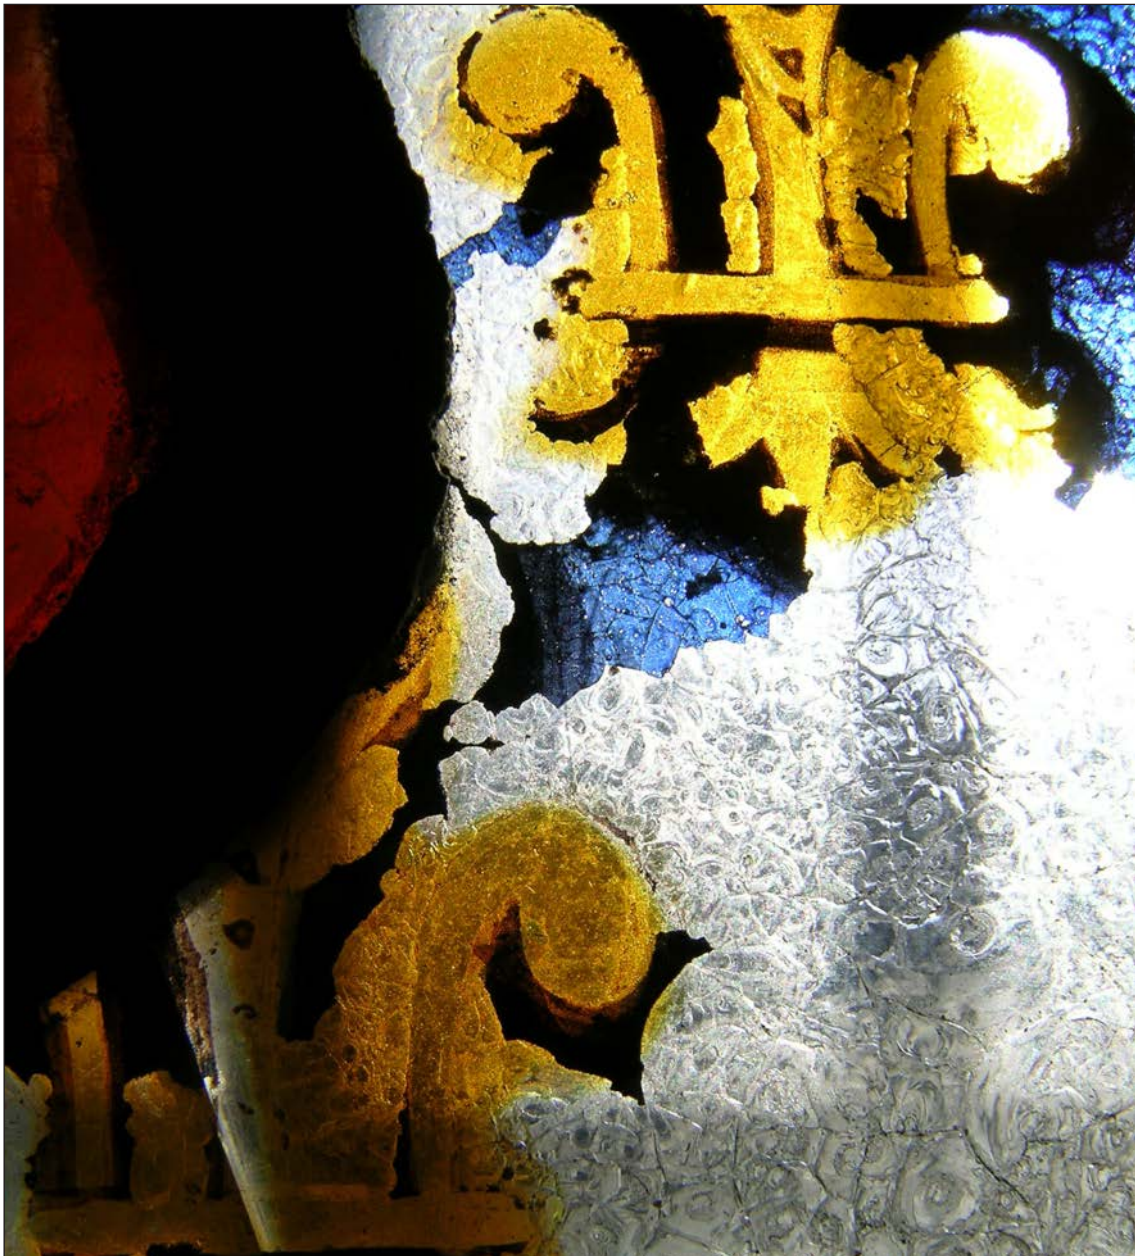
Figure 9. Flaking blue enamel on 18th-century glass. ©Léonie Seliger

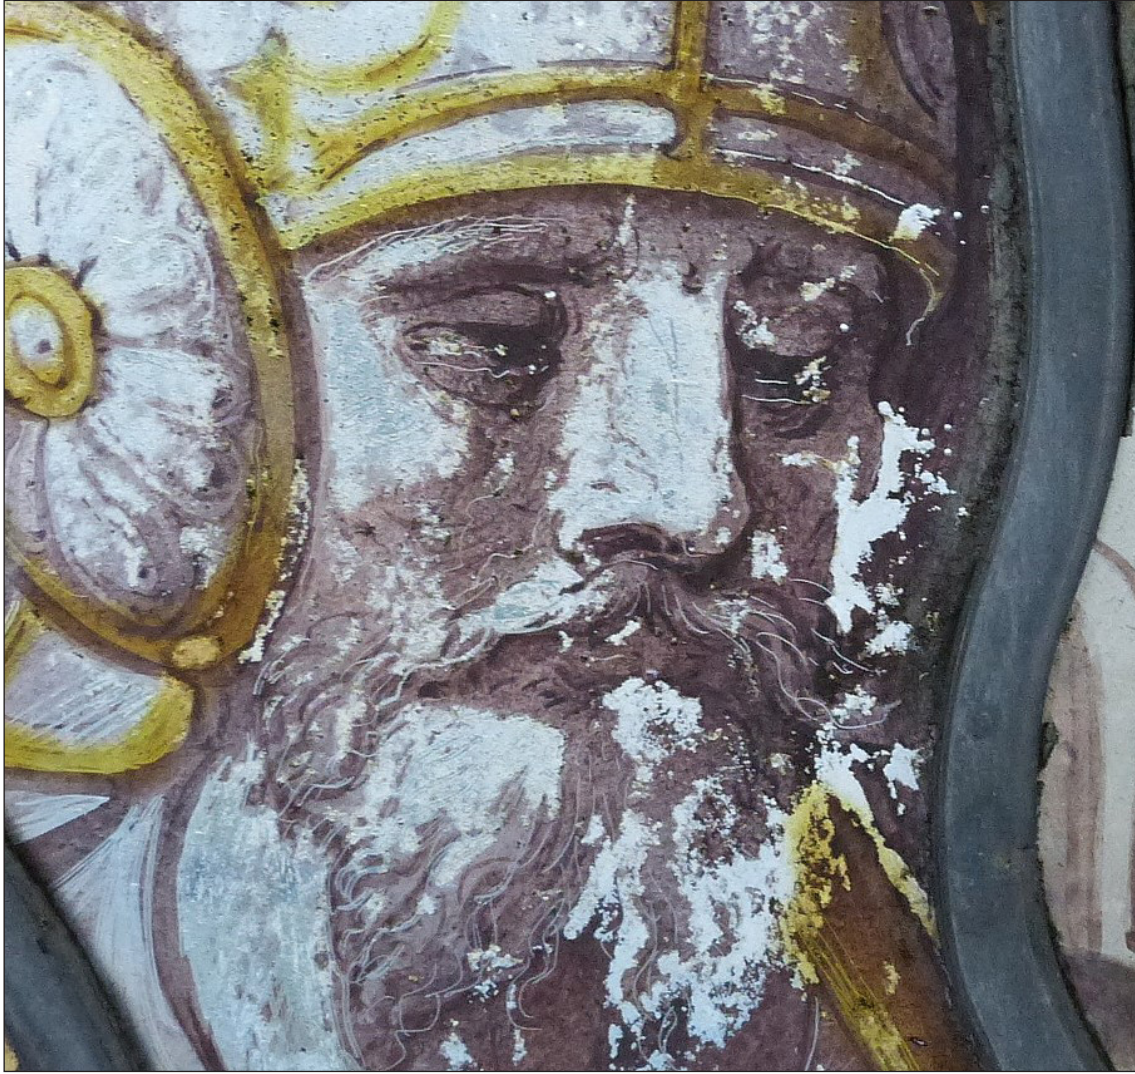
Figure 10. Loss of grisaille details on 16th-century glass at The Vyne.

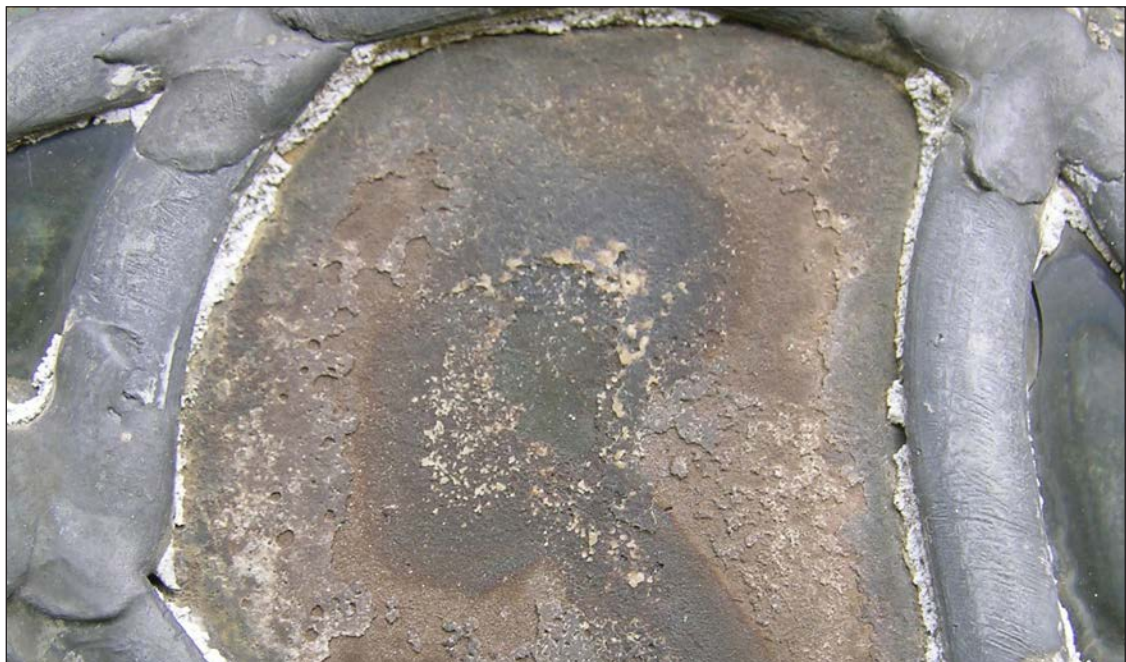
Figure 11. Weathering crust on the external surface of glass at Canterbury Cathedral.

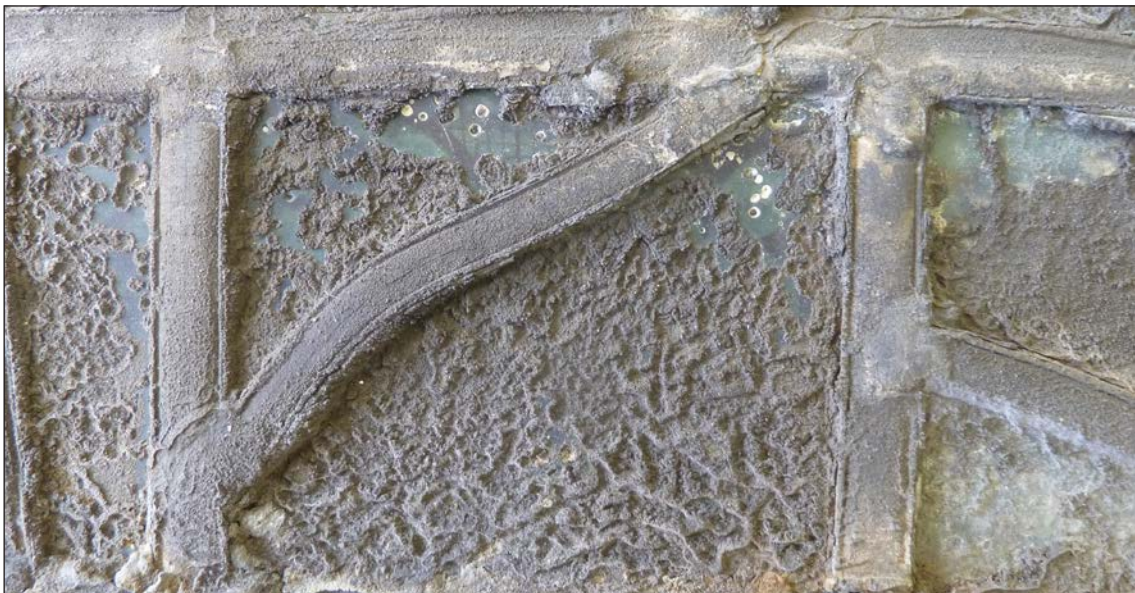
Figure 16. Pollutants accumulating on the external surface of historic glazing at Lincoln Cathedral.

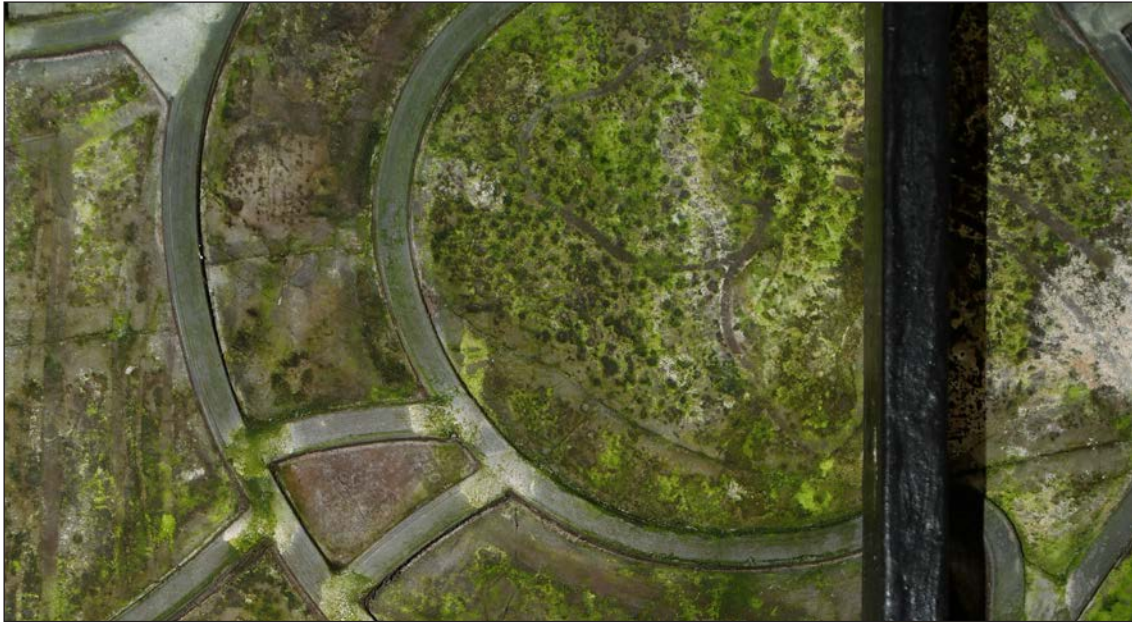
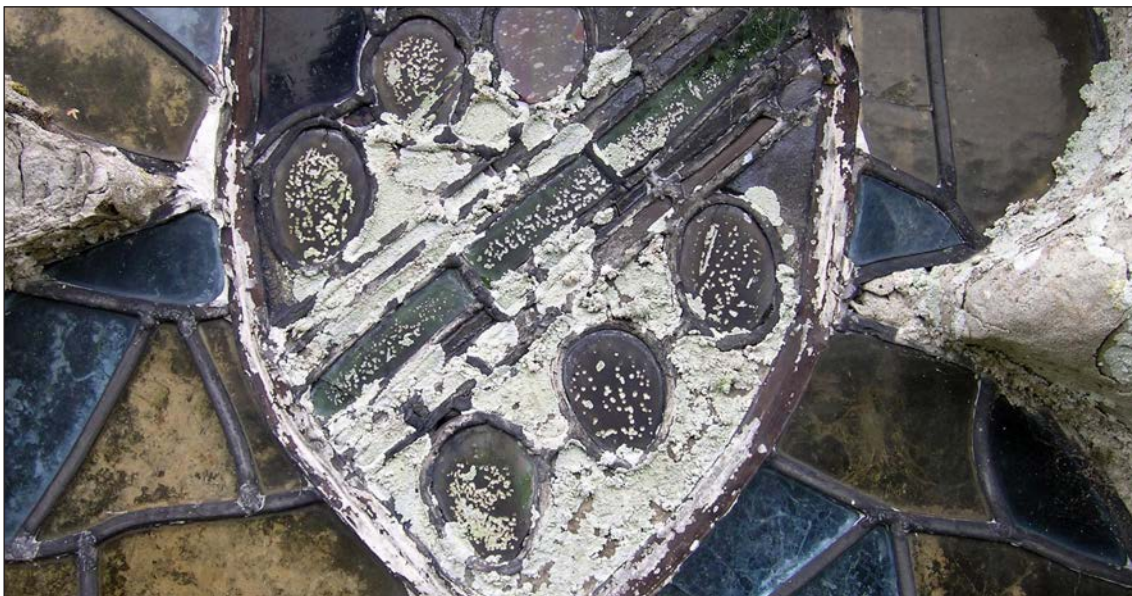
Figures 17, 18. Microbiological attack is both unsightly and can cause chemical deterioration of the glass as well as retaining moisture. Damage can occur internally as at Norbury in Derbyshire (top) or externally as at Boughton Aluph in Kent (bottom, ©Léonie Seliger).

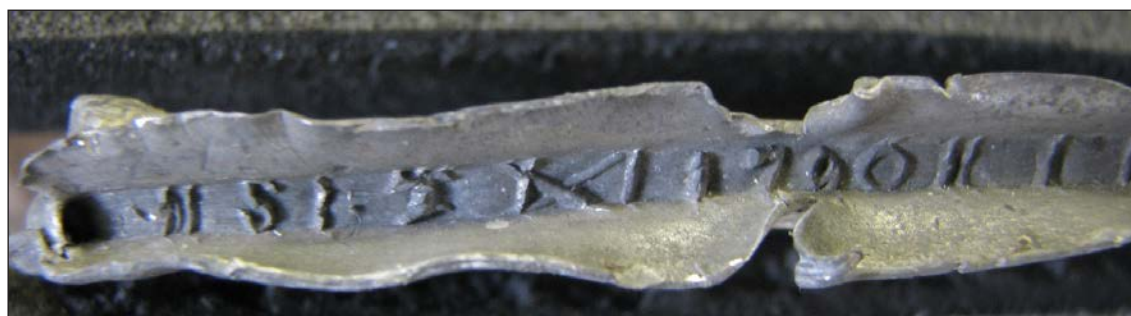
Figures 19, 20. Details of historic lead comes showing milling and makers marks.

Even though lead types and milling marks may only give date ranges, this information can be invaluable archaeological evidence for dating the glazing of a window, and indeed for dating a repair or alteration.

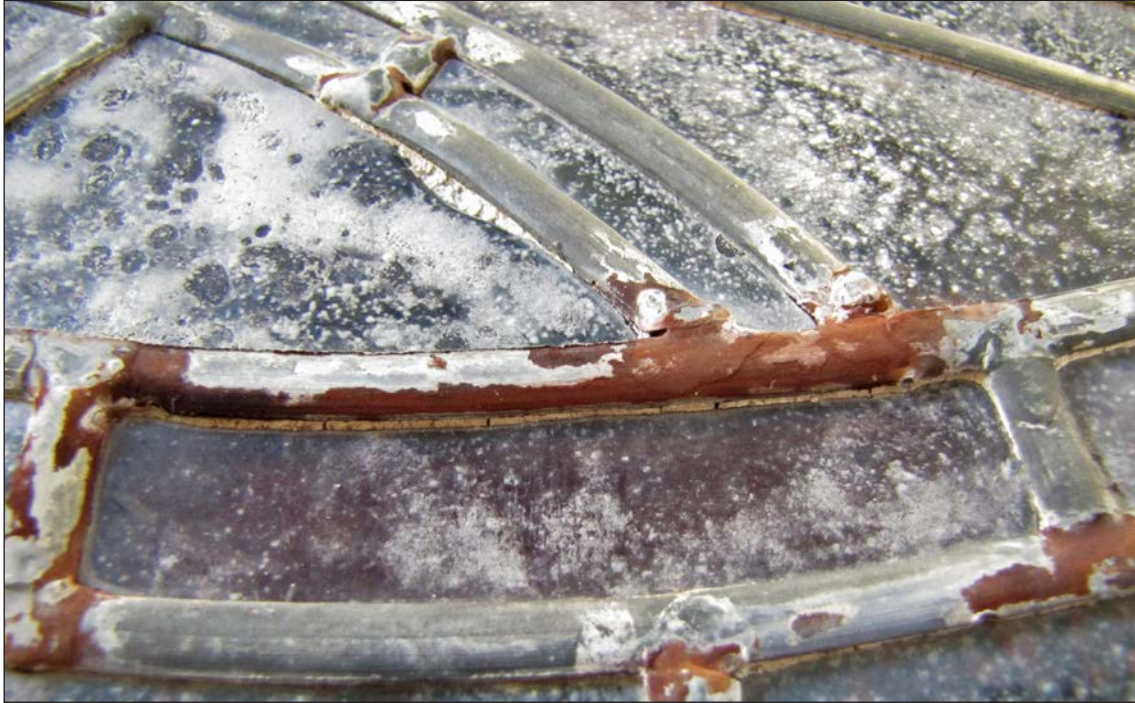
Figure 23. Superficial corrosion and discolouration of the lead came. ©Léonie Seliger

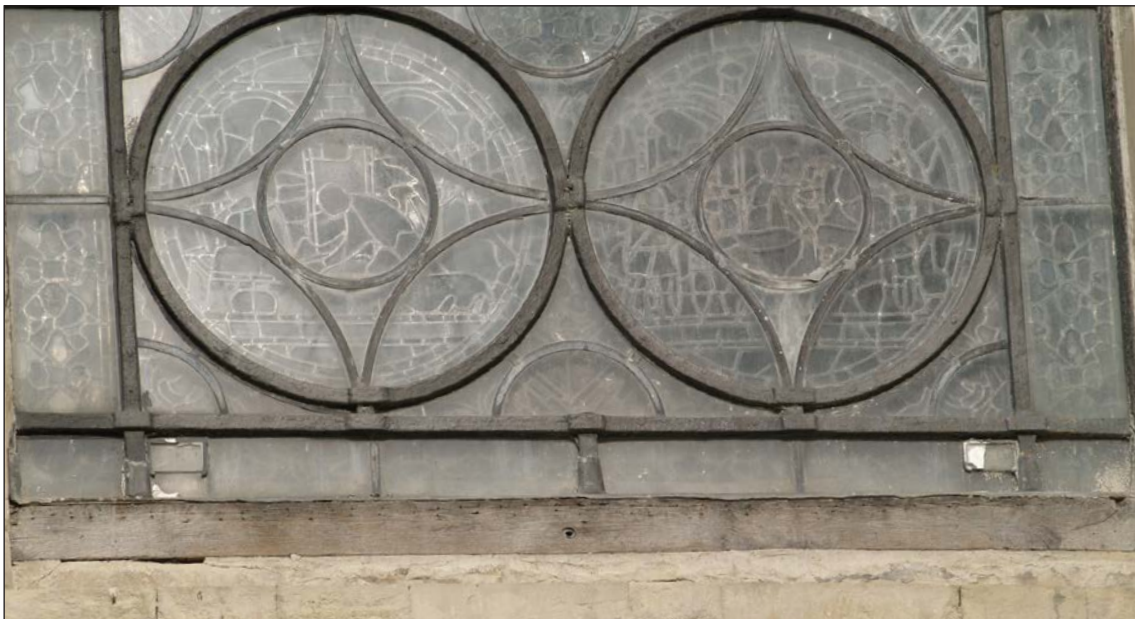
Figure 24. Ventilation openings at the bottom of an externally vented system installed in 1979 at Canterbury Cathedral.

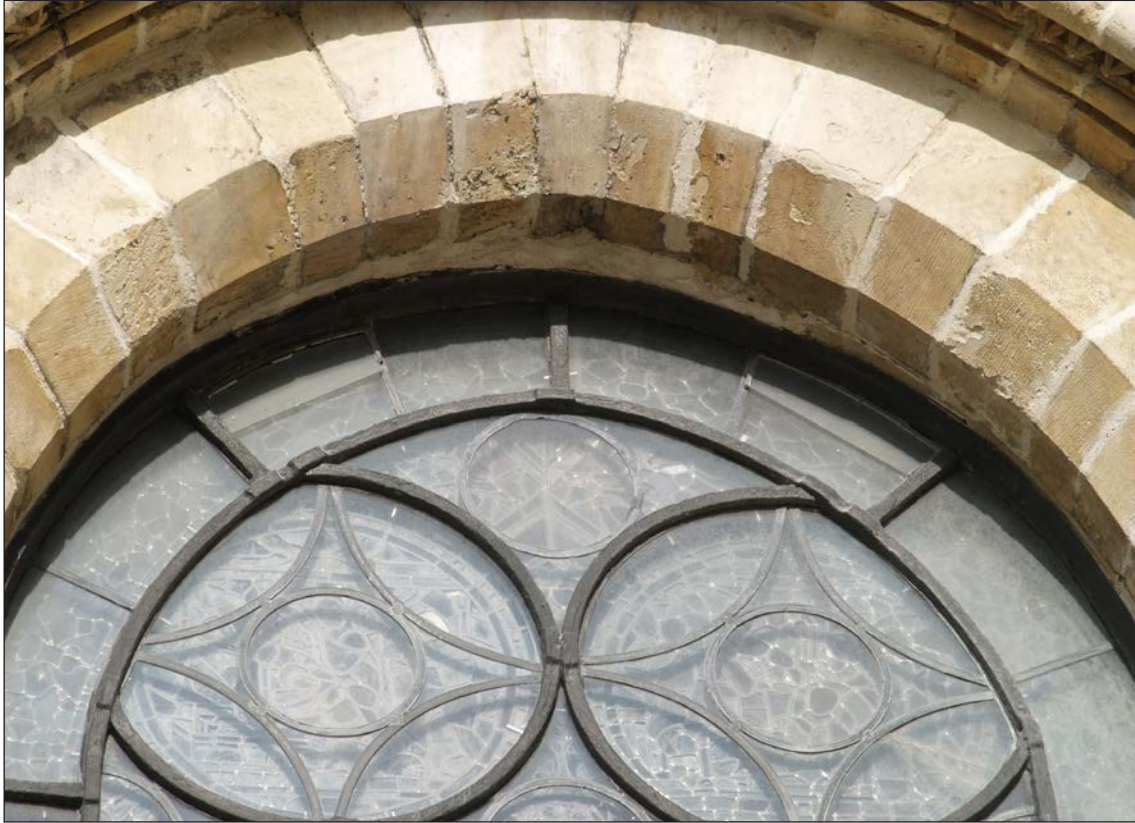
Figure 25. Ventilation openings at the top of an externally vented system installed in 1979 at Canterbury Cathedral.

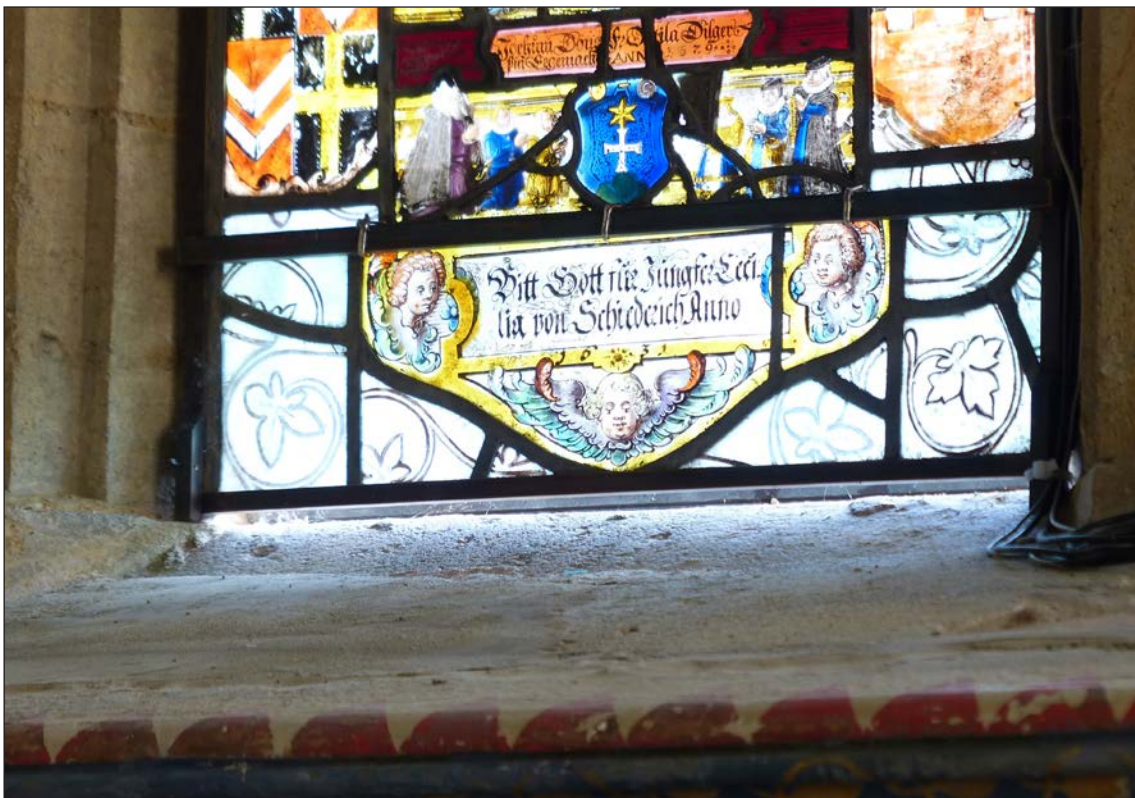
Figure 26. Internal ventilation openings at the bottom of the east window of St Andrew's Church, Trent, in Dorset.

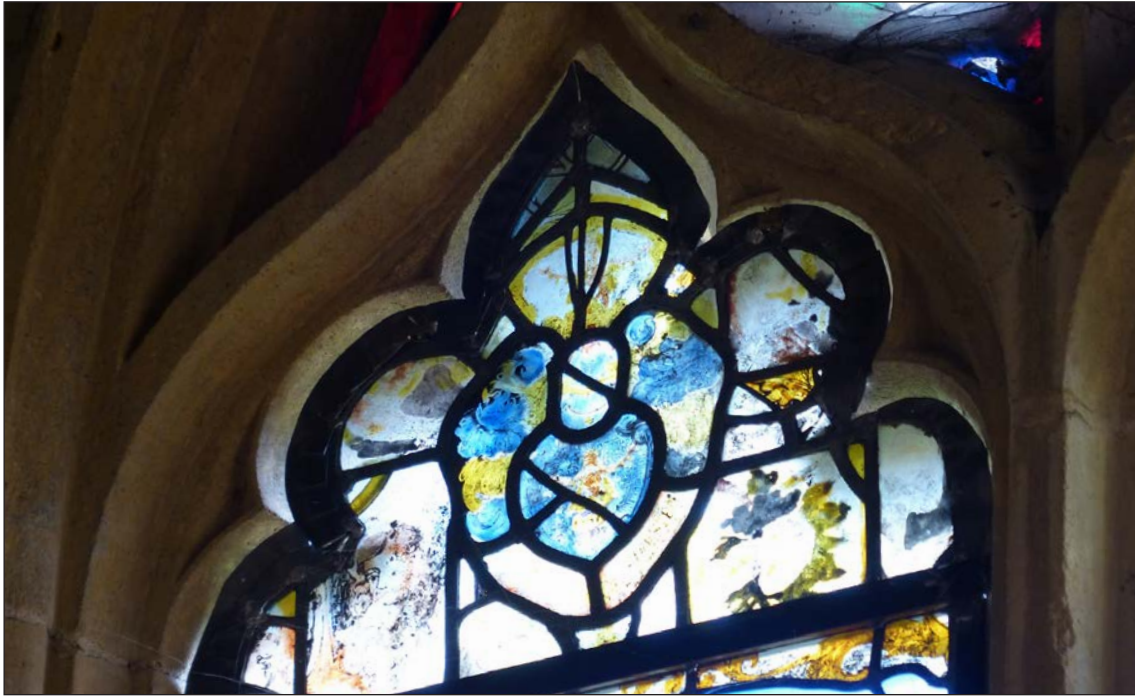
Figure 27. Internal ventilation openings at the top of the east window of St Andrew's Church, Trent, in Dorset.

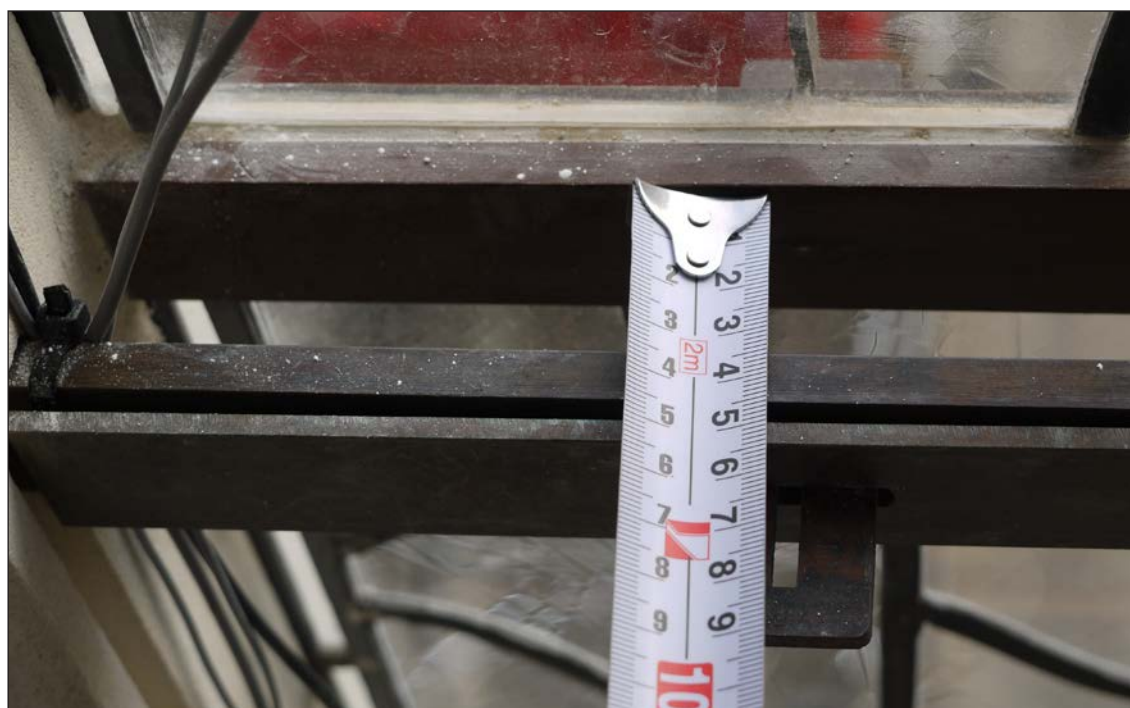
Figure 28. Interspace gap (before the reinstallation of the historic glazing).

In the VIDRIO research project the protective glazing in Saint Urbain Basilica in Troyes often performed worse than installations in Paris or Cologne. This was reported to be due to the smaller interspace of 3 cm, compared with 7 cm and 8 cm in Paris and Cologne, respectively. In addition in Troyes there were a large number of ferramenta, which are reported to reduce the interspace to 1 cm in parts, limiting air flow. The windows in Cologne were north facing and this also affected the results in some cases.

Oidtmann et al. comment that enlarging the ventilation openings reduced condensation at Cologne Cathedral.²⁹ In addition the authors note that whilst condensation decreases as the ventilation gaps are widened from 0.5 cm to 2 cm, there is only a small improvement upon furthering increasing the width to 4 cm. Therefore, whilst many authors comment on the importance of the ventilation gap and interspace size, there is little firm guidance on what makes the best or most efficient sizes when designing a protective glazing system.

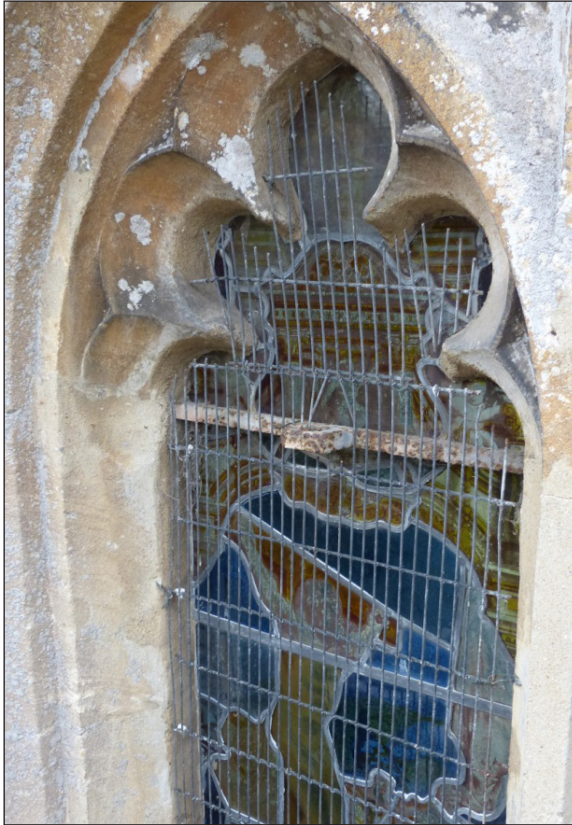
Figure 30 (top). New metal mesh guard.

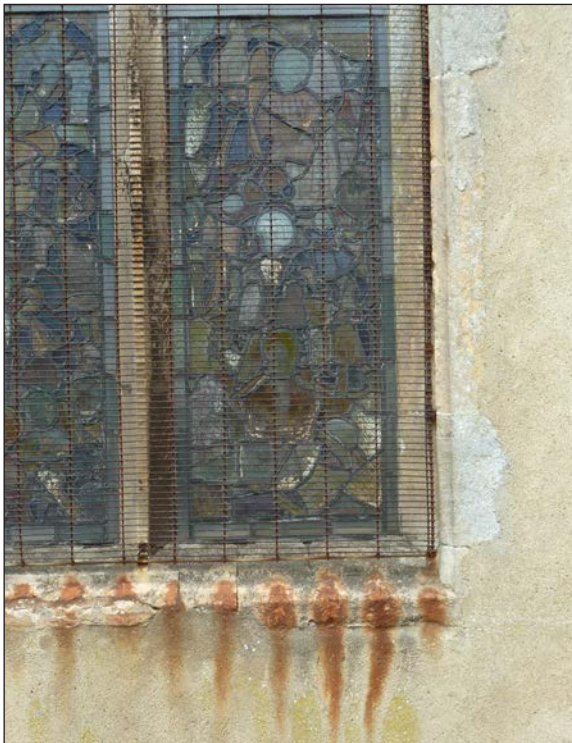
Figure 31 (bottom left). Old deteriorated guard.

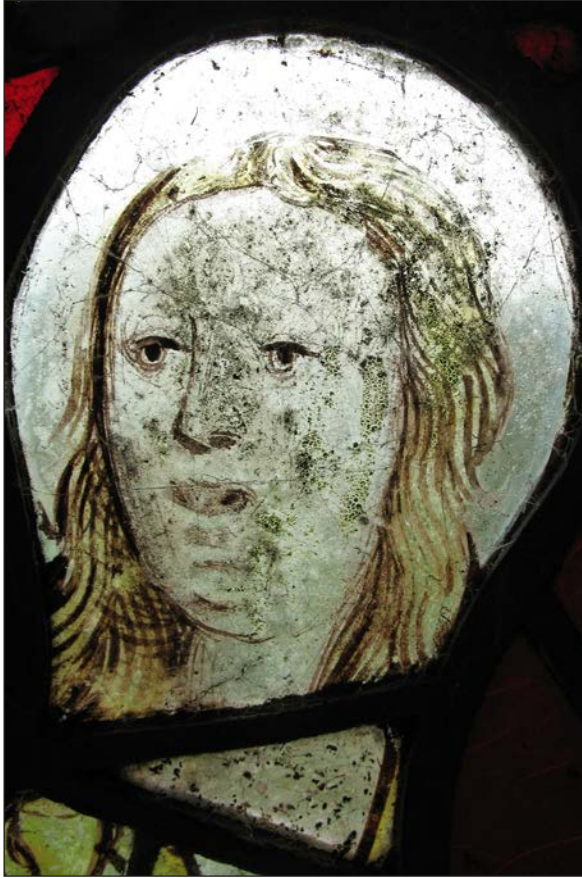
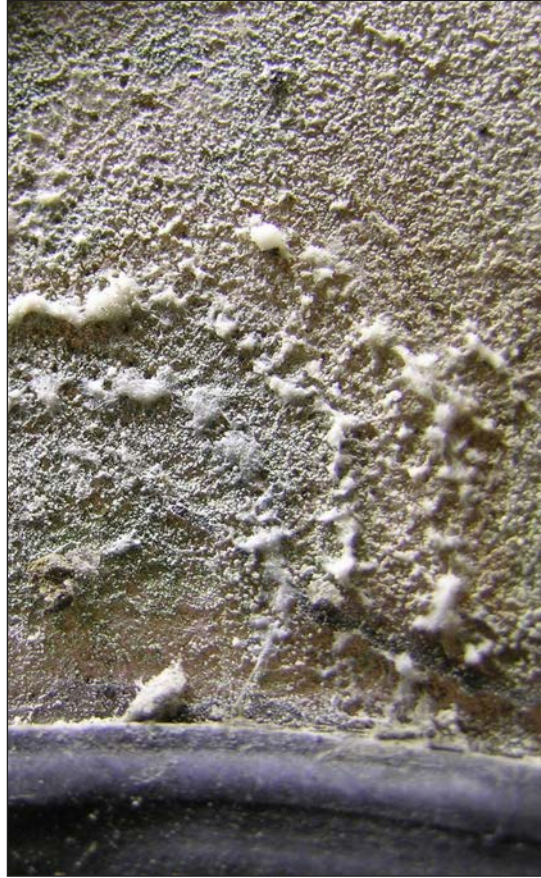
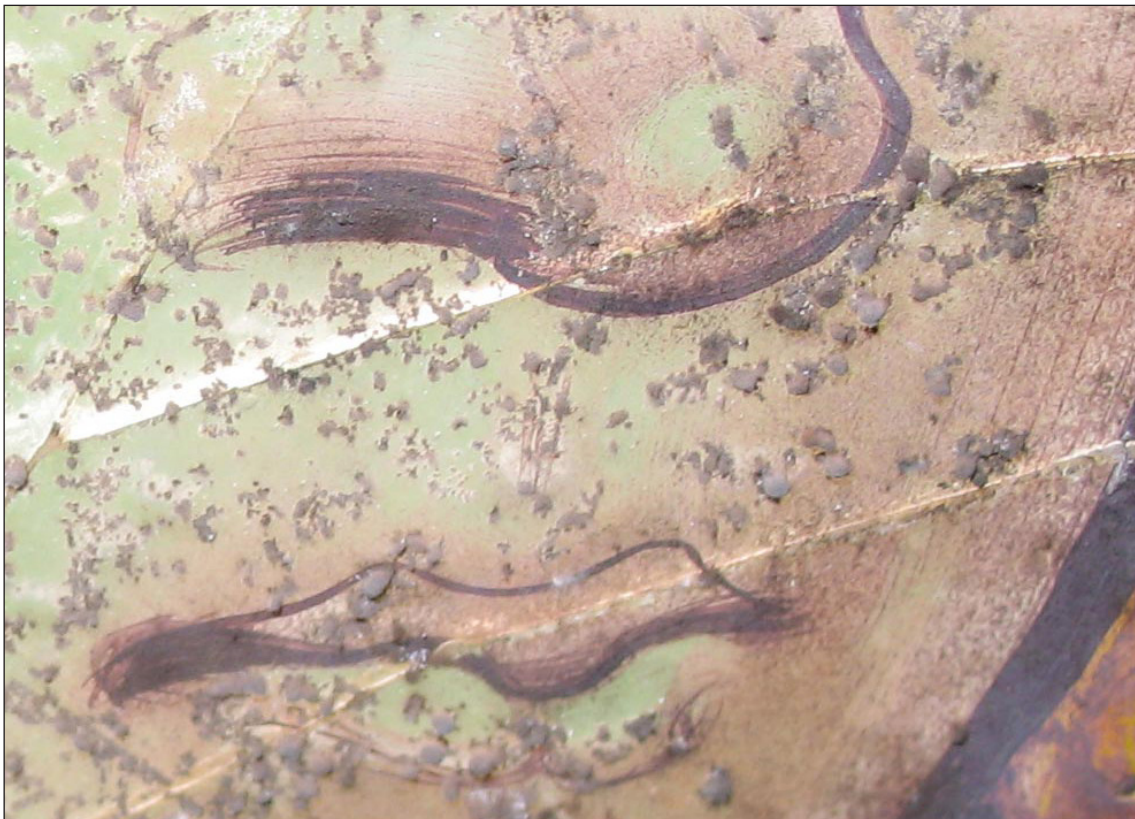
Figures 35, 36, 37. Microbiological growth can be both aesthetically disruptive and physically damaging.(all ©Léonie Seliger)

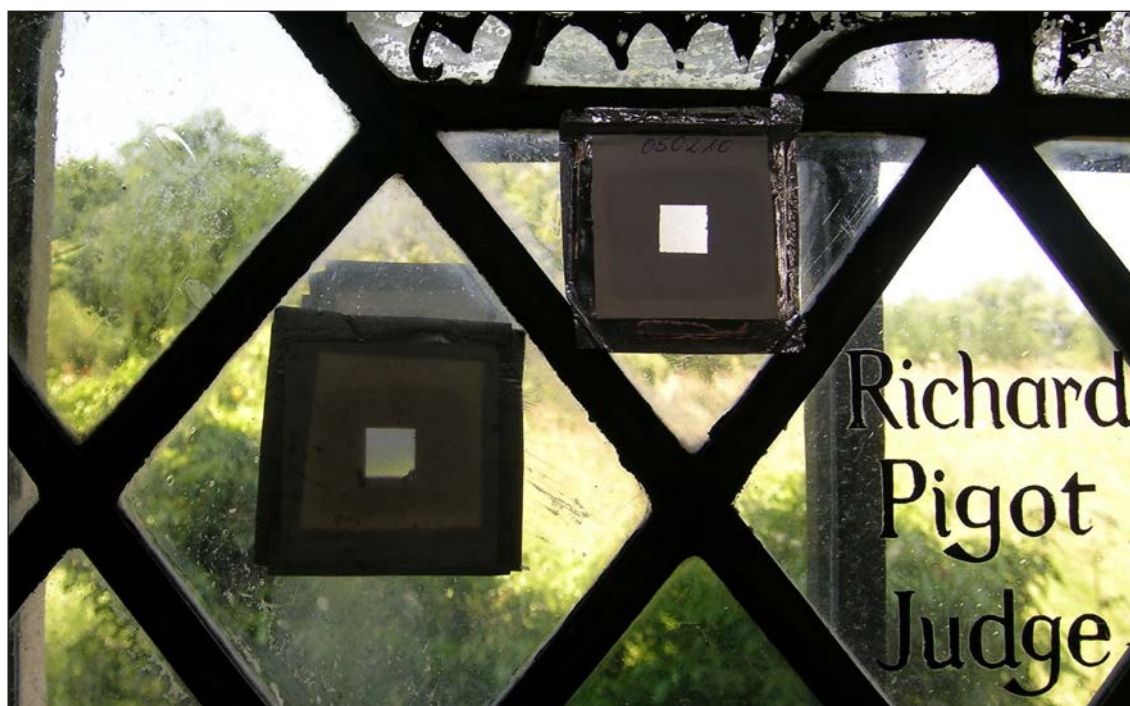
Figure 38. Glass sensors in place on the internal and external faces of the glazing at Holy Trinity Church, Long Melford.

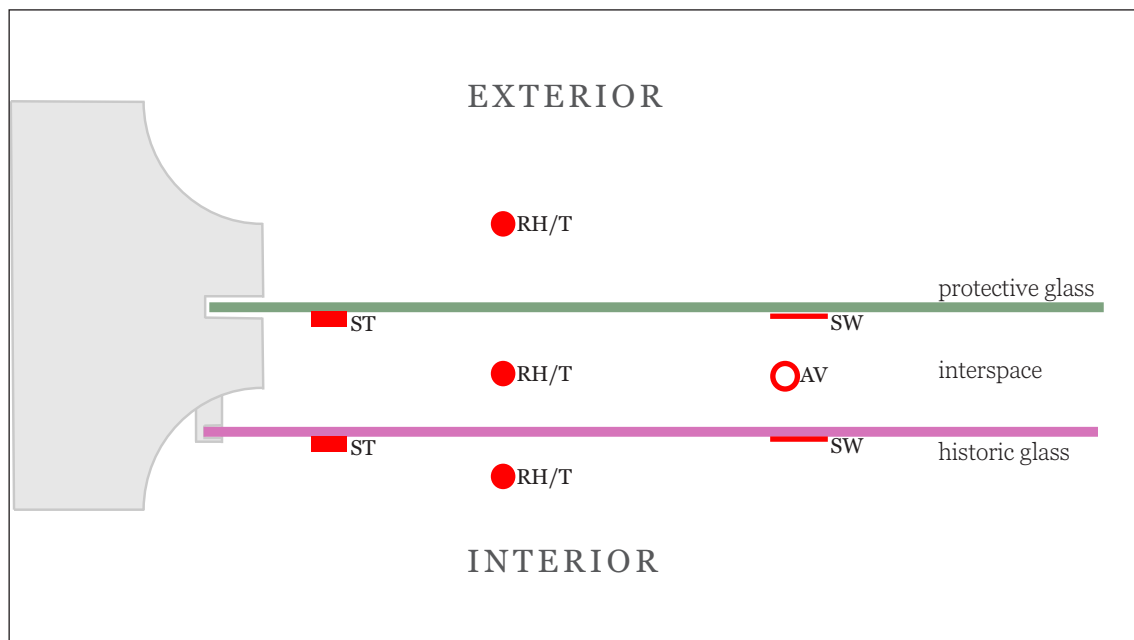
Figure 39. Sensors are often set up as illustrated, when looking down on the protective glazing in cross section.

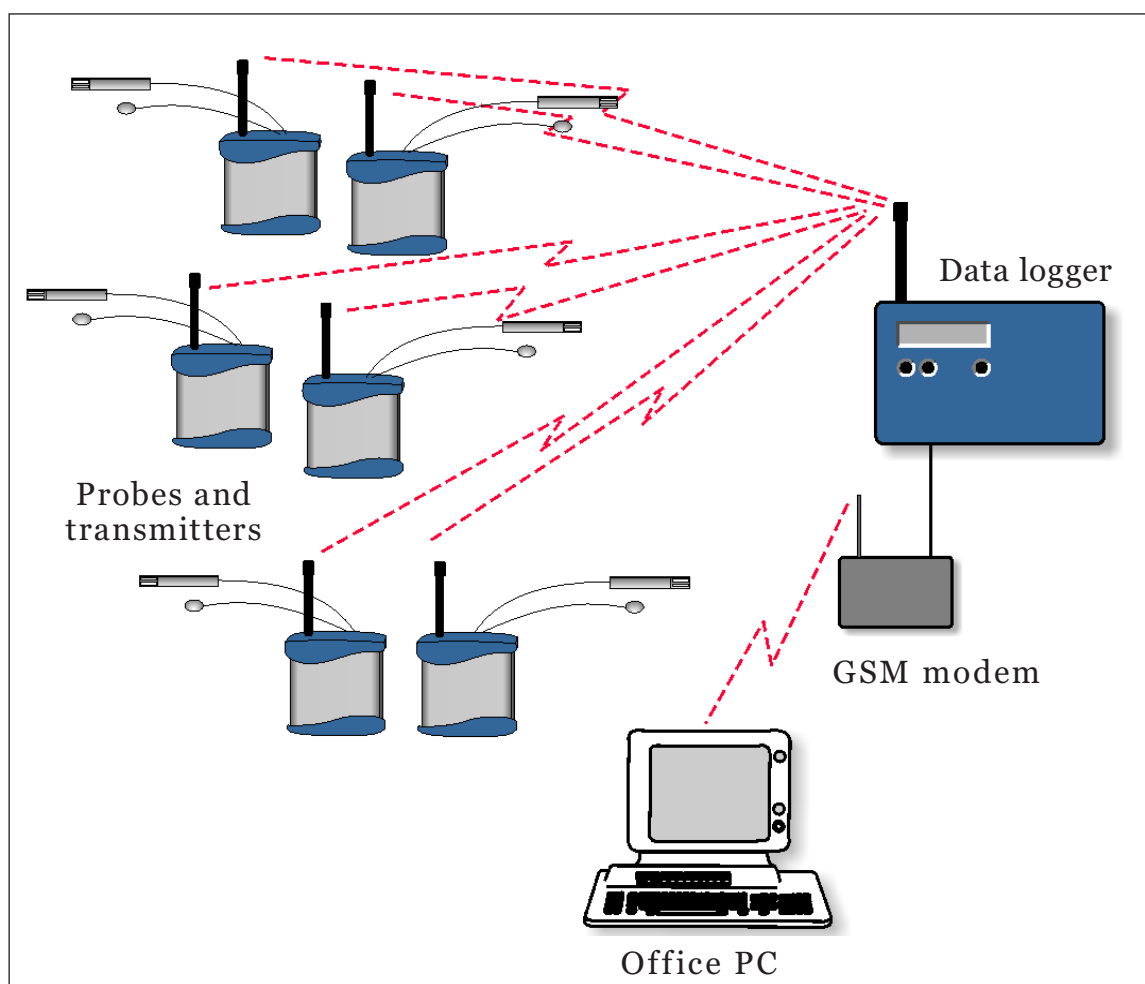
Figure 40. Schematic diagram showing the layout of the monitoring system.

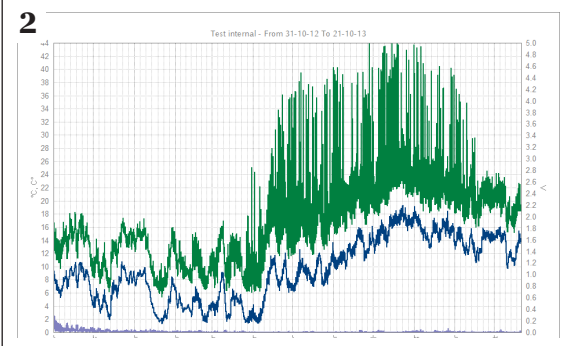
2. The results demonstrated that the surface temperature (green) of the protected historic glass remained around 5°C above the dew point (blue). This means condensation is unlikely to have occurred.

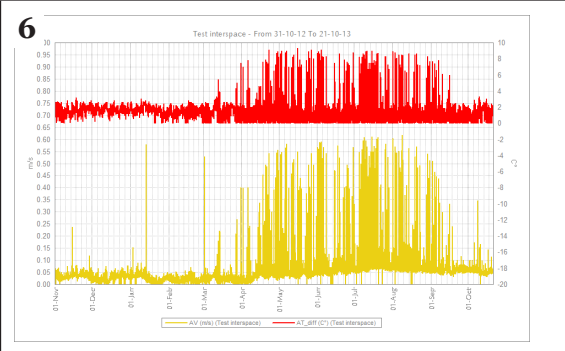
6. The air velocity (yellow) was found to follow changes in the size of the difference between the interspace and internal temperatures (red).

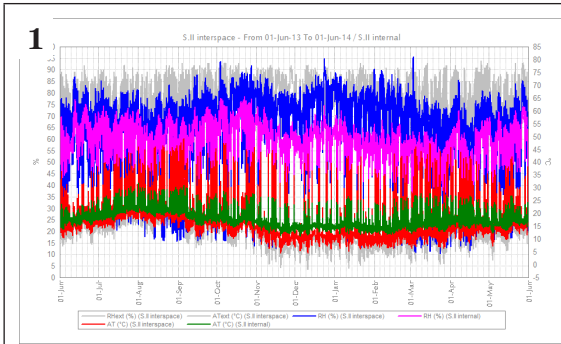
1. The lower sII window has clear patterns of solar gain leading to rapid drops in RH. These are smaller on the historic glass (green & pink) than on the modern glass.

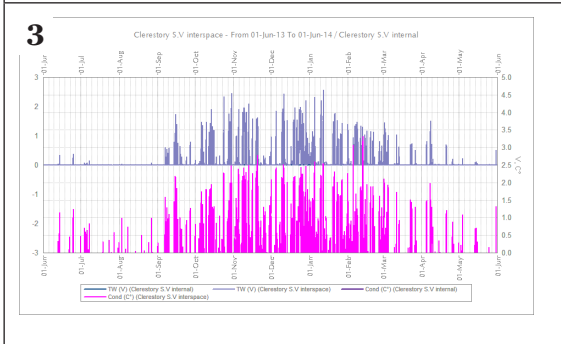
3. For the clerestory SV window there are again smaller internal variations compared with the interspace. The SV interspace has notable periods of surface wetness (grey) and condensation (pink), whereas the internal stained glass has almost none (blue & purple).
