Historic England

Conserving Stained Glass using Environmental Protective Glazing

Prepared for Historic England by

Tobit Curteis, Tobit Curteis Associates
and Léonie Seliger, Canterbury Cathedral Stained Glass Studio
in association with
Naomi Luxford, Shane Slater, Tracy Manning, and Robyn Pender

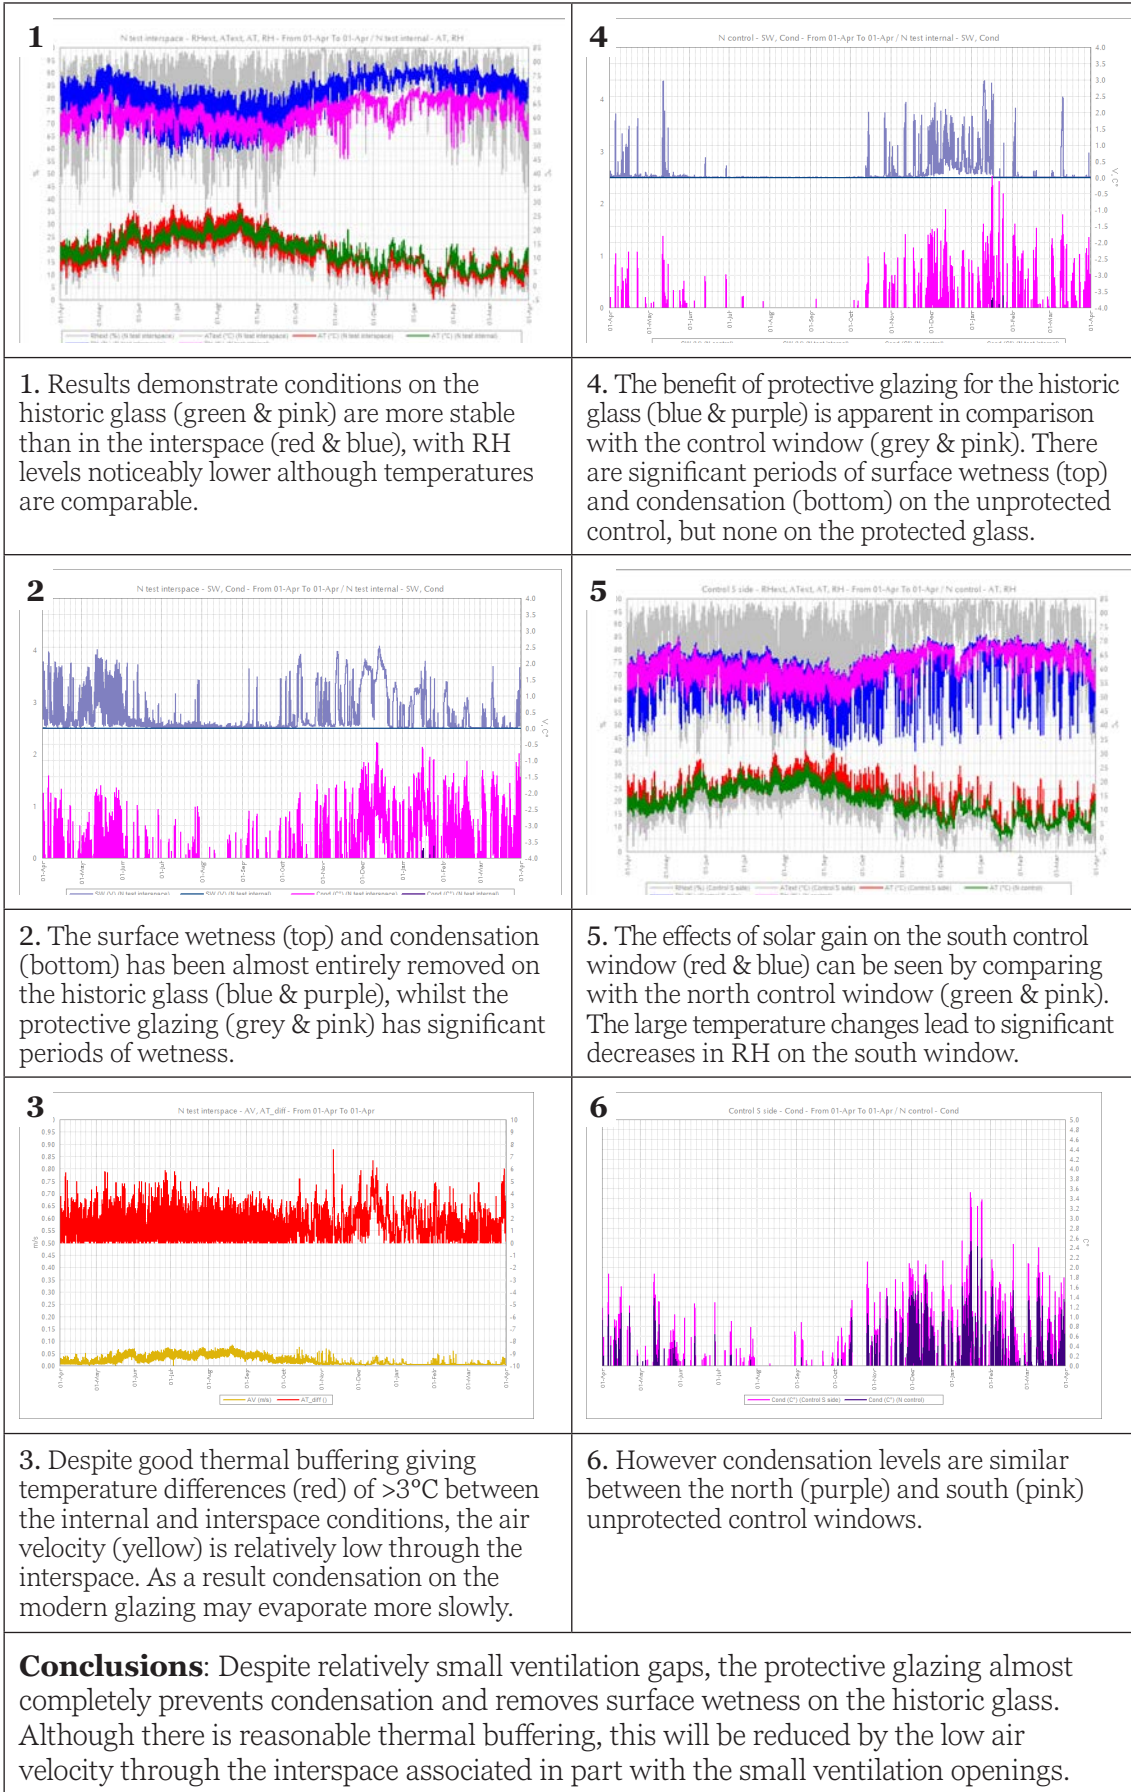
1. Results demonstrate conditions on the historic glass (green & pink) are more stable than in the interspace (red & blue), with RH levels noticeably lower although temperatures are comparable.

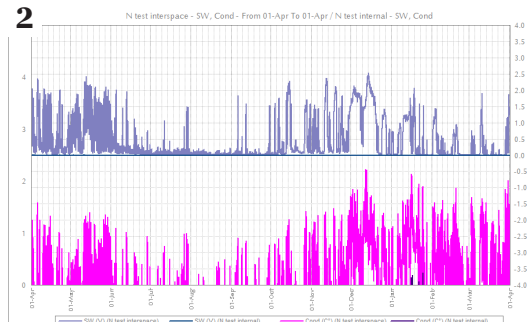
2. The surface wetness (top) and condensation (bottom) has been almost entirely removed on the historic glass (blue & purple), whilst the protective glazing (grey & pink) has significant periods of wetness.

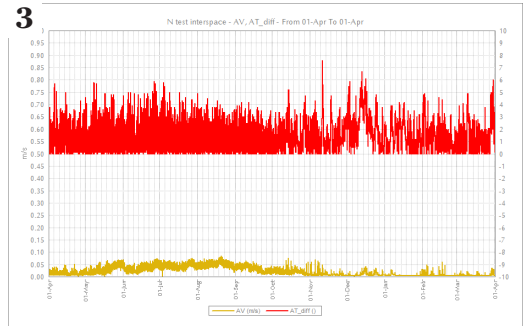
3. Despite good thermal buffering giving temperature differences (red) of >3°C between the internal and interspace conditions, the air velocity (yellow) is relatively low through the interspace. As a result condensation on the modern glazing may evaporate more slowly.

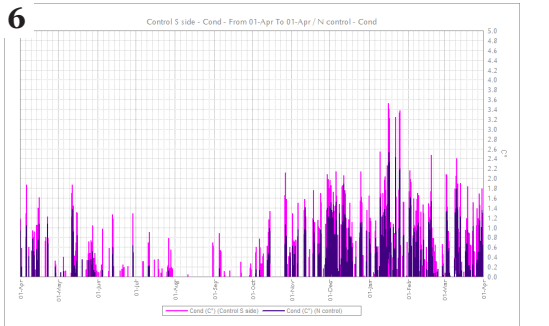
6. However condensation levels are similar between the north (purple) and south (pink) unprotected control windows.

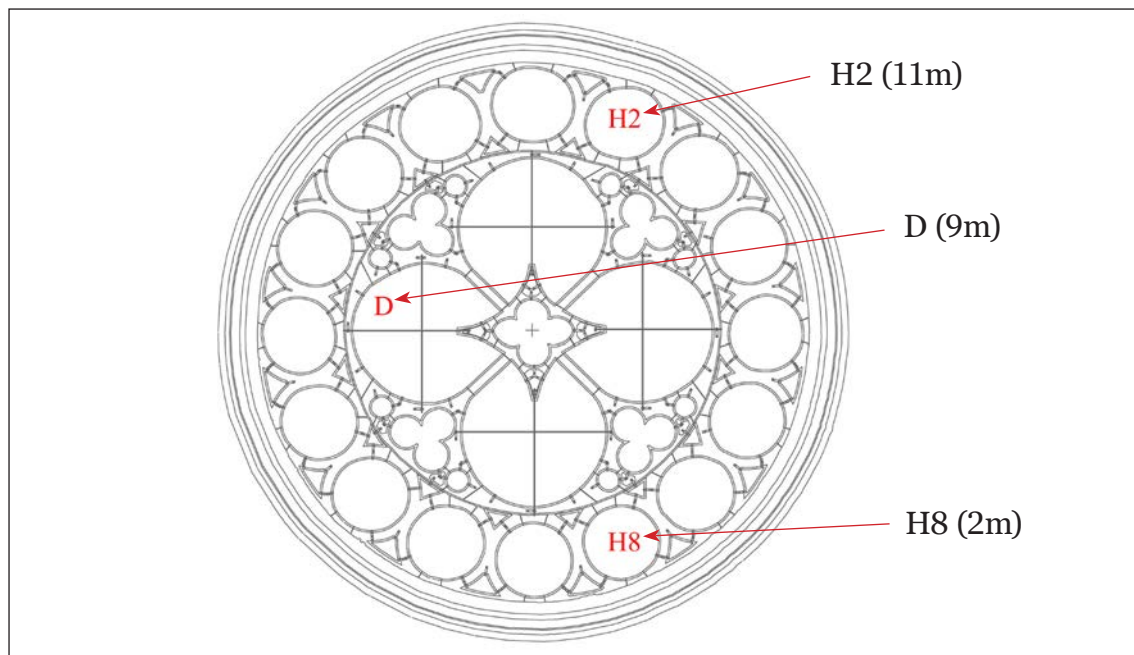
The window has 77 panels. Measurements were taken at three separate locations. Although the primary ventilation was at the top and bottom of each section of EPG, air leakage also occurred around the edges.

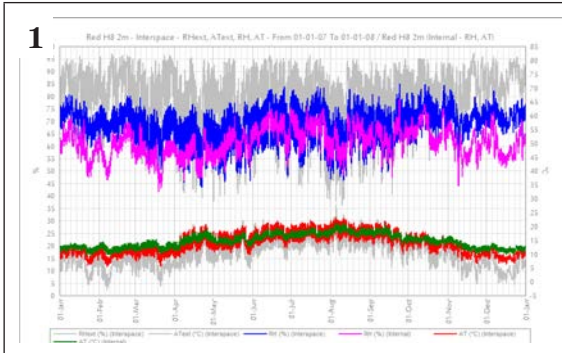
1. Although shown for position H8, data was similar for all three locations demonstrating the internal stained glass (green & pink) was subjected to smaller fluctuations in temperature and RH than the interspace (red & blue).

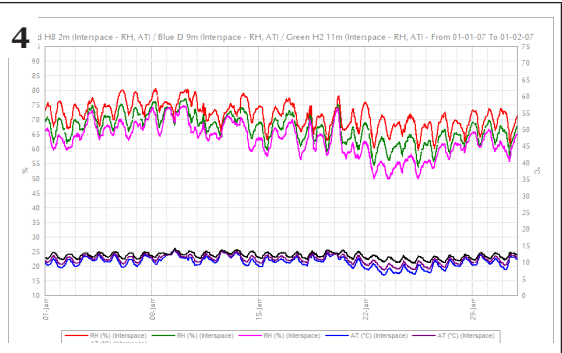
4. There is a clear separation in the interspace temperatures at different heights, most apparent in the winter (below), but seen across the year. H8 is lower, cooler and damper, then D, followed by H2, which is highest, warmest and driest.

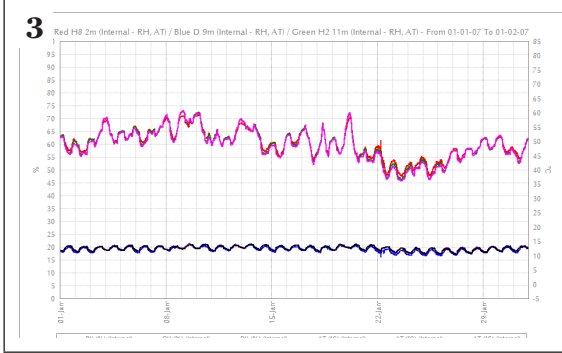
3. Internal conditions are relatively similar for all three measuring points, with very little difference recorded.

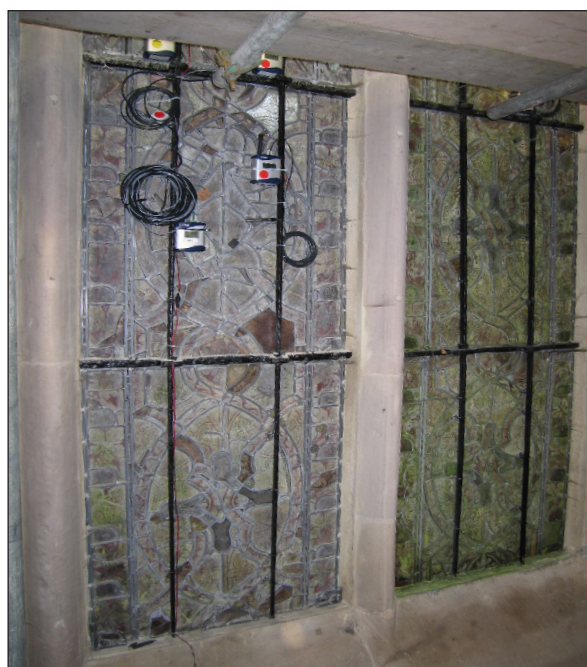
The trial demonstrated that protective glazing could limit algal growth, despite the damp building. Seen on the left is the N.IV stained glass light that was protected during the trial, and on the right is the unprotected control.

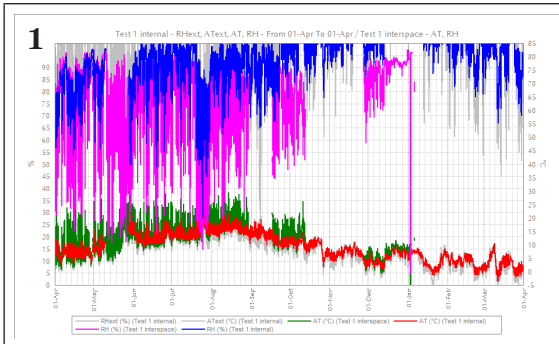
1. The historic glass had smaller temperature changes than the interspace protective glazing. However for the externally ventilated test 1 the interspace is drier than the internal glass, which is the opposite of the expected conditions.

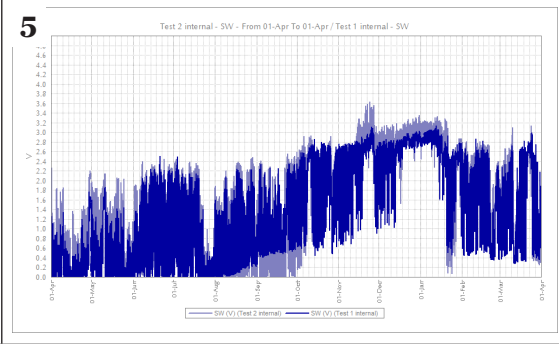
5. However the surface wetness data is similar for both test 1 (blue) and test 2 (grey) indicating that the internal face of the stained glass has been wet for significant periods.

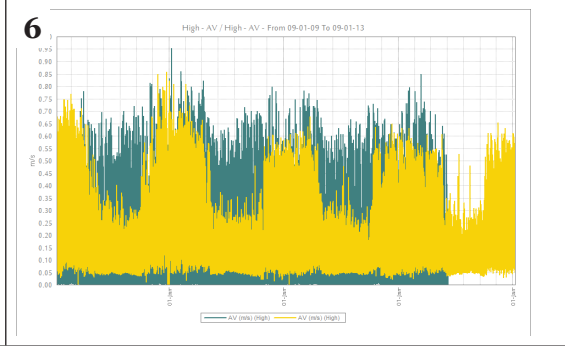
6. The greater temperature changes on the south window lead to more constant, high air speeds (green) compared to the north window (yellow). On the north window air velocity is comparable to the south window in the summer, but significantly lower in the winter months. The air speeds suggest condensation will rapidly evaporate.

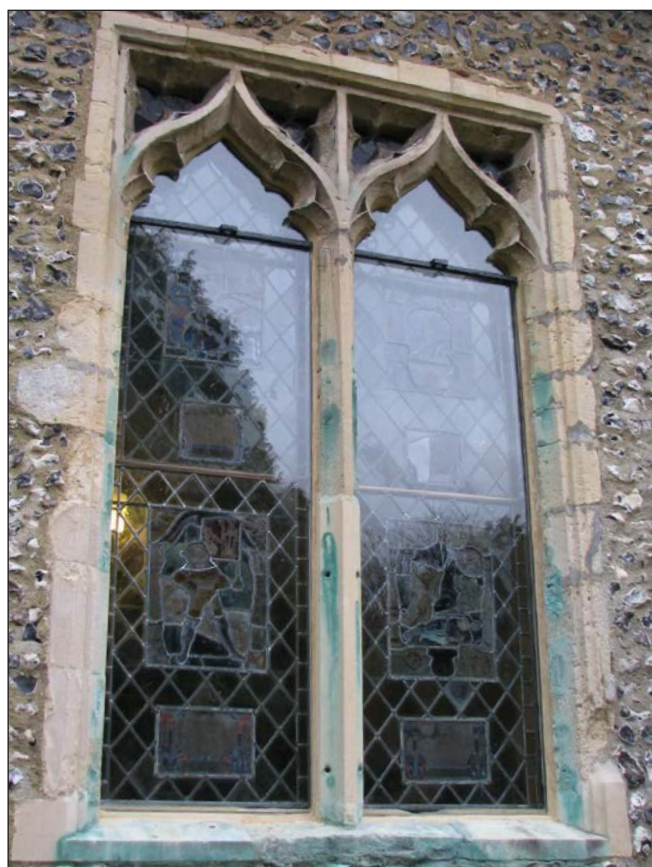
The ‘honest’ approach makes no effort to disguise the fact that a second modern layer of glazing has been added, and to accept or even to celebrate the modern addition in its own right. Large sheets of machine-made glass are a functional, relatively low-cost material, and can – as laminate glass – provide very effective protection from impact damage. In addition, this will cause little visual disturbance to the stained-glass window when viewed from inside the building. However, the external change in appearance can be significant.

Figure 52. Patrixbourne, laminate float glass. ©Léonie Seliger

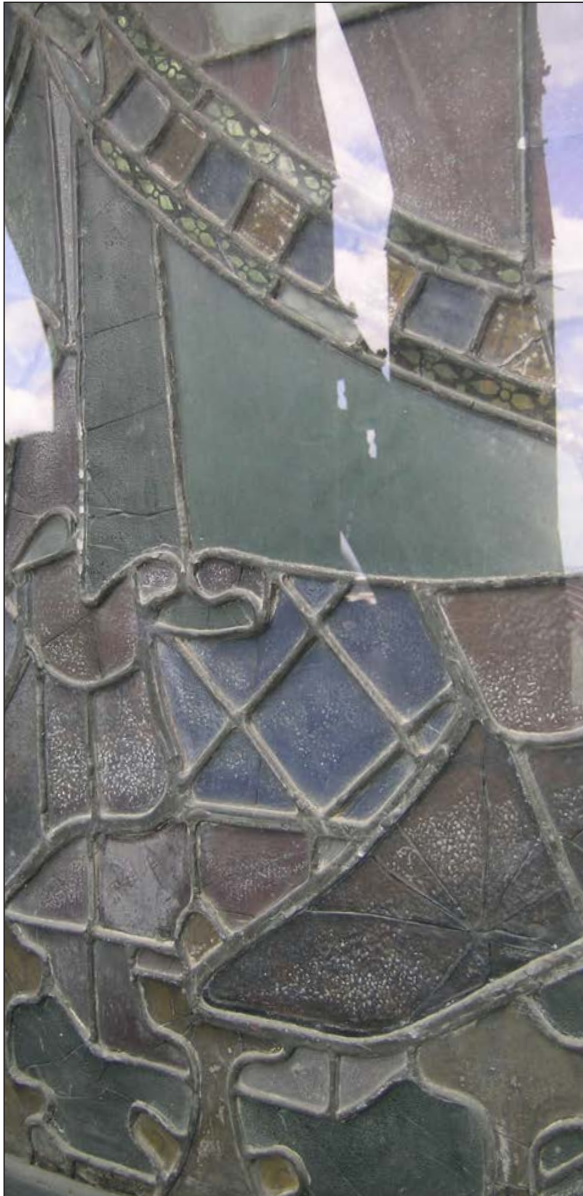
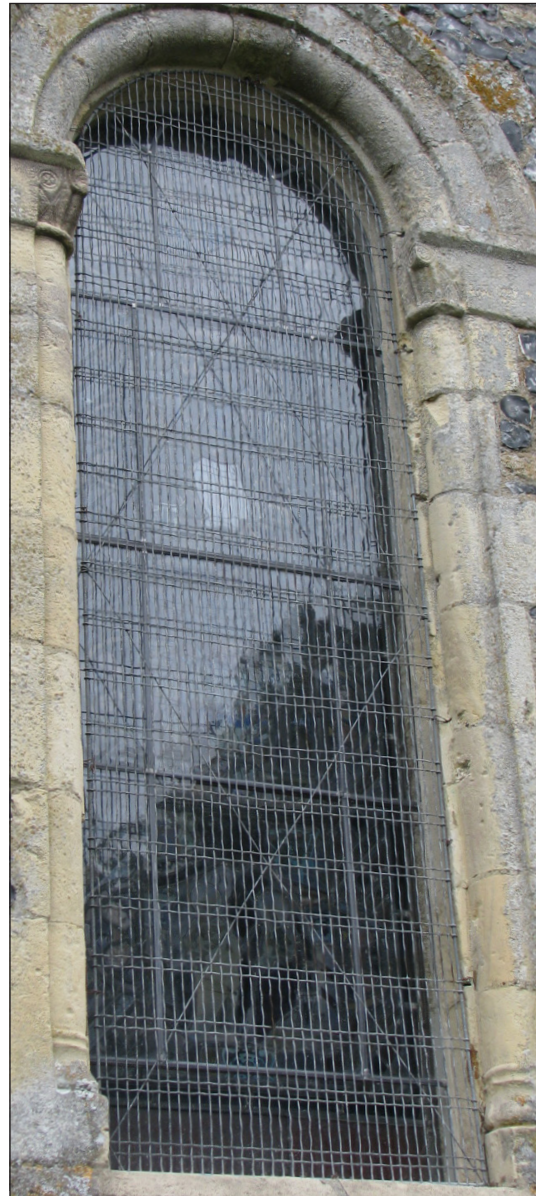
Figure 53. Cologne Cathedral, Schott low reflective glass. ©Léonie Seliger

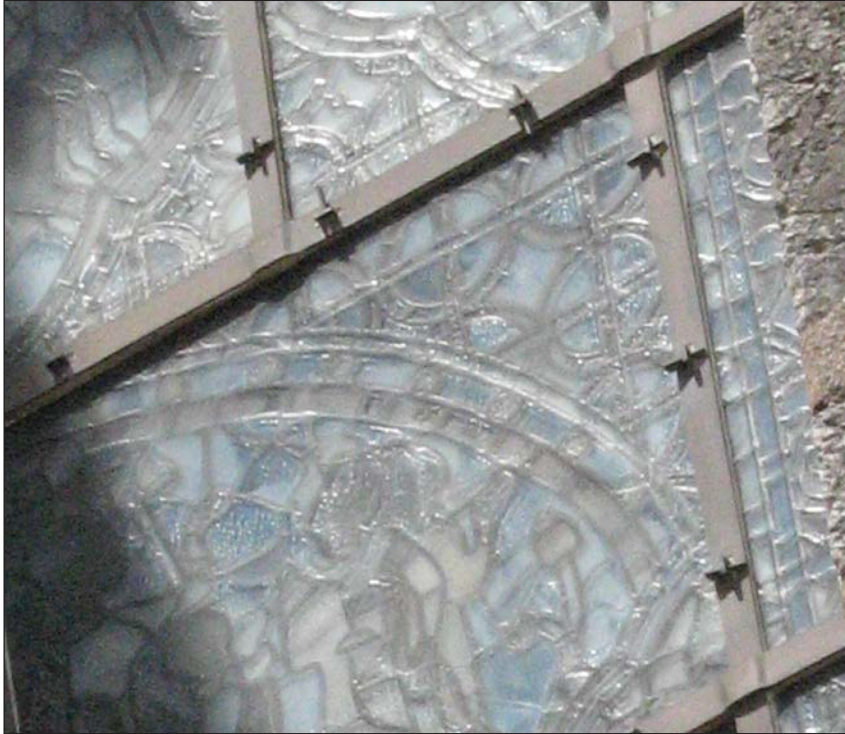
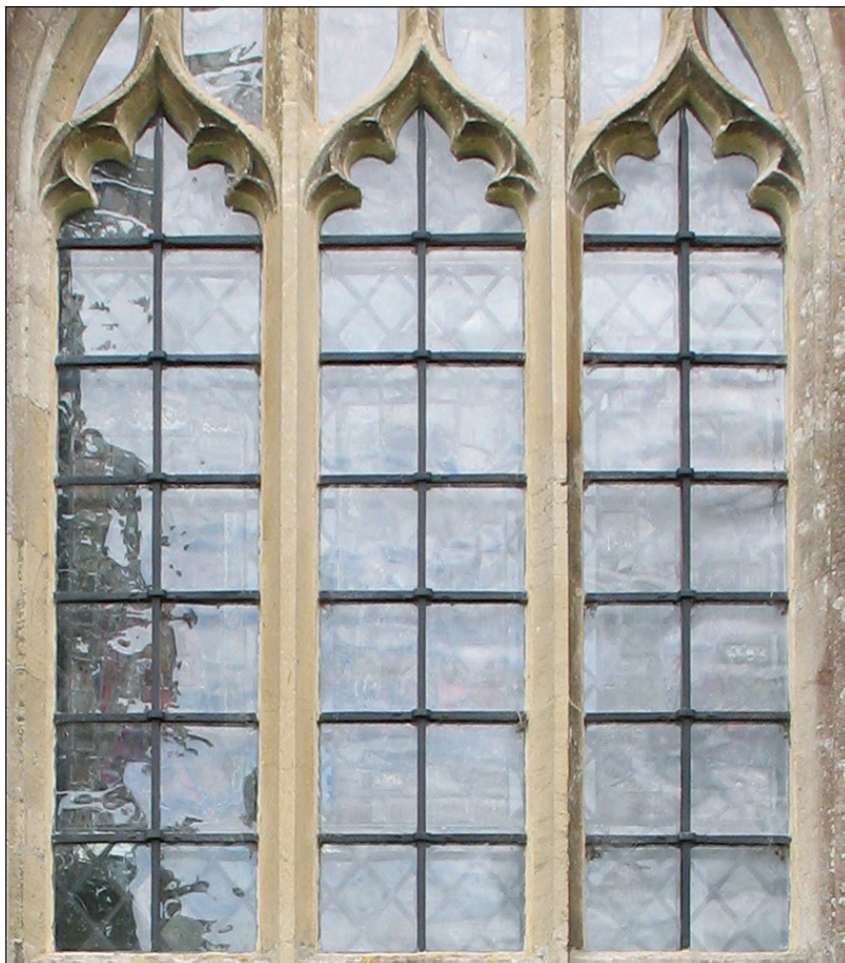
Figure 56. Chartres Cathedral, kiln-formed sheets slumped on moulds. ©Debitus
Figure 57. Long Melford, kiln-distorted glass pieces cut to coincide with ferramenta bars.

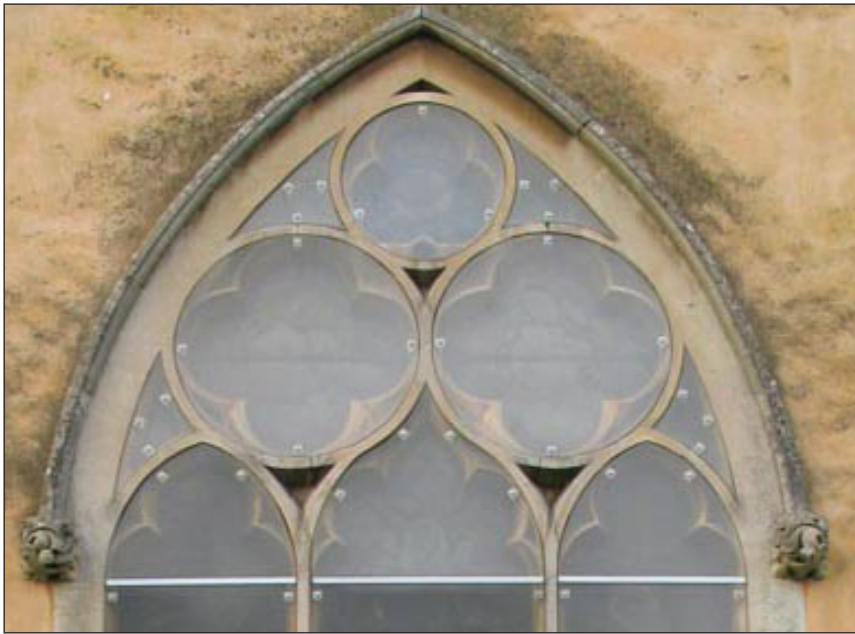
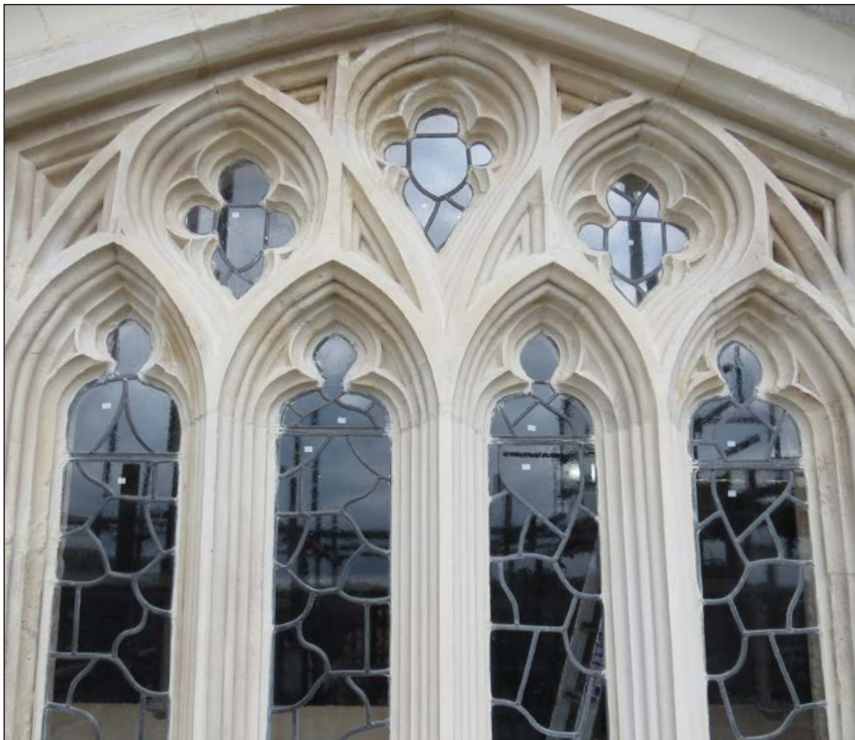
Figures 58, 59. Bad example (top) where the protective glazing covers parts of the stonework; and a good example (bottom) where the protective glazing is fitted into it.

Whichever approach is chosen, the protective glazing must be fitted into the individual openings so that all elements of the stone work remain visible, rather than covering the entire surface of the window. The same principle applies to wire guards. Where laminate glass is employed as the external layer, the more complicated shapes in heads and tracery are often made from plain glass, since laminate glass is very difficult to cut into shapes.
