# Rievaulx Abbey, Helmsley, North Yorkshire: Archaeological Survey and Investigation of the Precinct

Research Report Series 007-2019

**Archaeological Survey and Investigation of the Precinct**

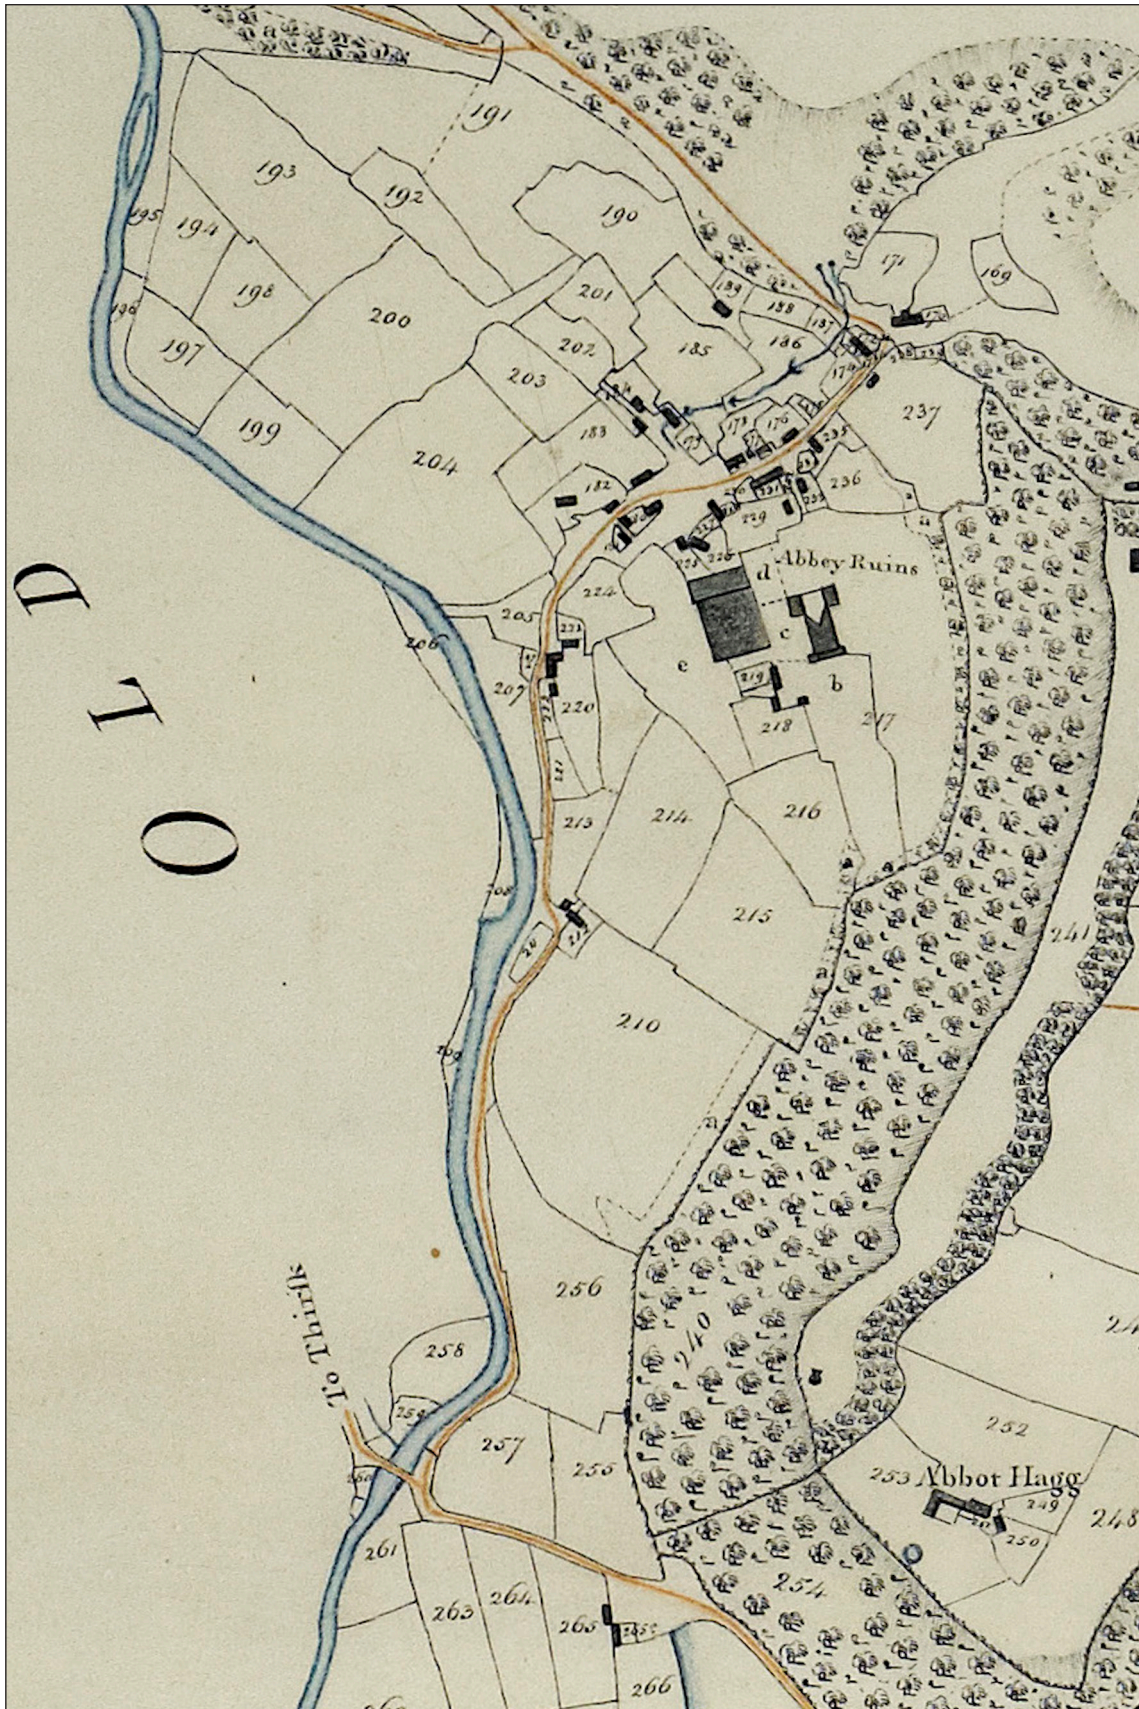
Fig 3. Part of Hornby's 1806 map of the township of Rievaulx, from the original held in the North Yorkshire County Record Office (ZEW20A4). Copyright reserved.

There was no opportunity during the present survey to investigate the network of leats and ponds that lie between the 18th-century mill and the spring source above Arden Lane. Hornby's 1806 survey shows some of the springs and leats but not the ponds (Figure 3). This may be an oversight and should not be taken as evidence that the ponds did not exist, as they do appear on Tukes and Ayer's estate map of 1822 and the ponds and connecting channels appear to have changed little since then. More detailed Ordnance Survey mapping (Ordnance Survey 1912) shows separate channels bringing the outflow from the individual springs together into an upper pond (Figure 35). This is heavily embanked on all but the uphill side as can clearly be seen in an early photograph as well as in the map depiction (Figure 36). The outlet appears to be on the uphill side of the pond, at the north corner, which has the effect of directing the flow away from what was probably its natural course further to the south, closer to the village street. A single channel then directs the flow into a middle pond and from there to a lower pond (shown as dry on current Ordnance Survey mapping) just above the site of the 18th-century mill.

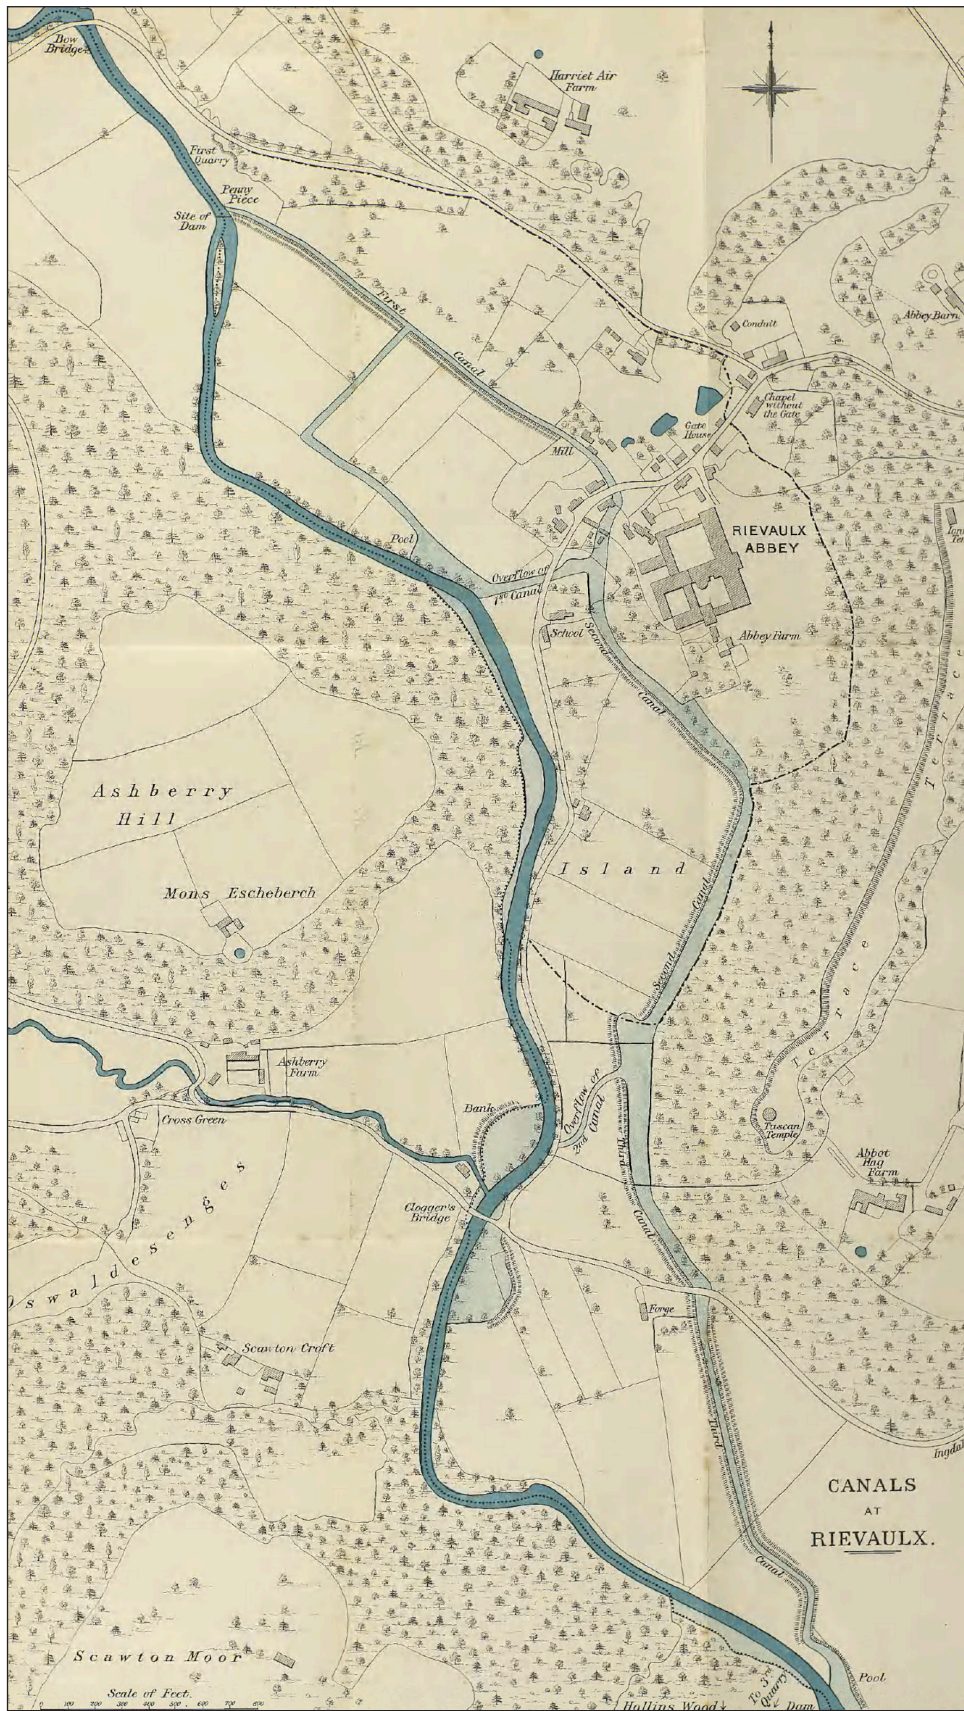
Fig 6. Rye's 1900 map of Rievaulx (Rye 1900, facing page 76).

of the 'canal' system than that previously offered by Atkinson. It seems to be based on the 1893 Ordnance Survey map with colouring added by Rye to pick out the supposed 'canal' system (Figure 6).

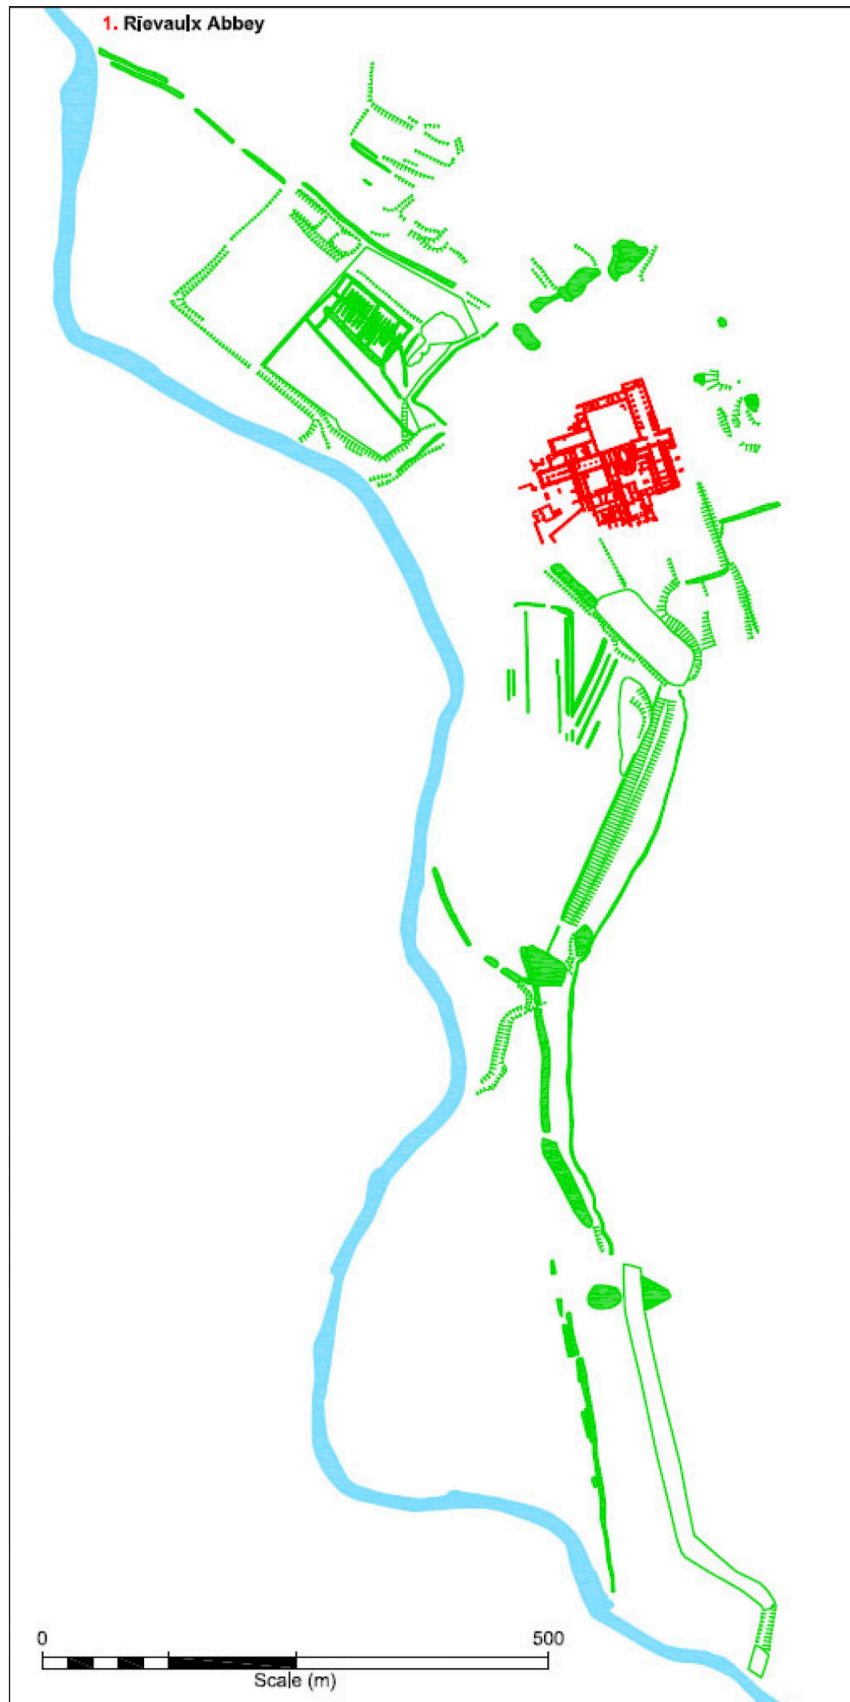
Fig 8. Features at Rievaulx recorded from aerial photography (Knight et al 2011, Figure 17). © Historic England.

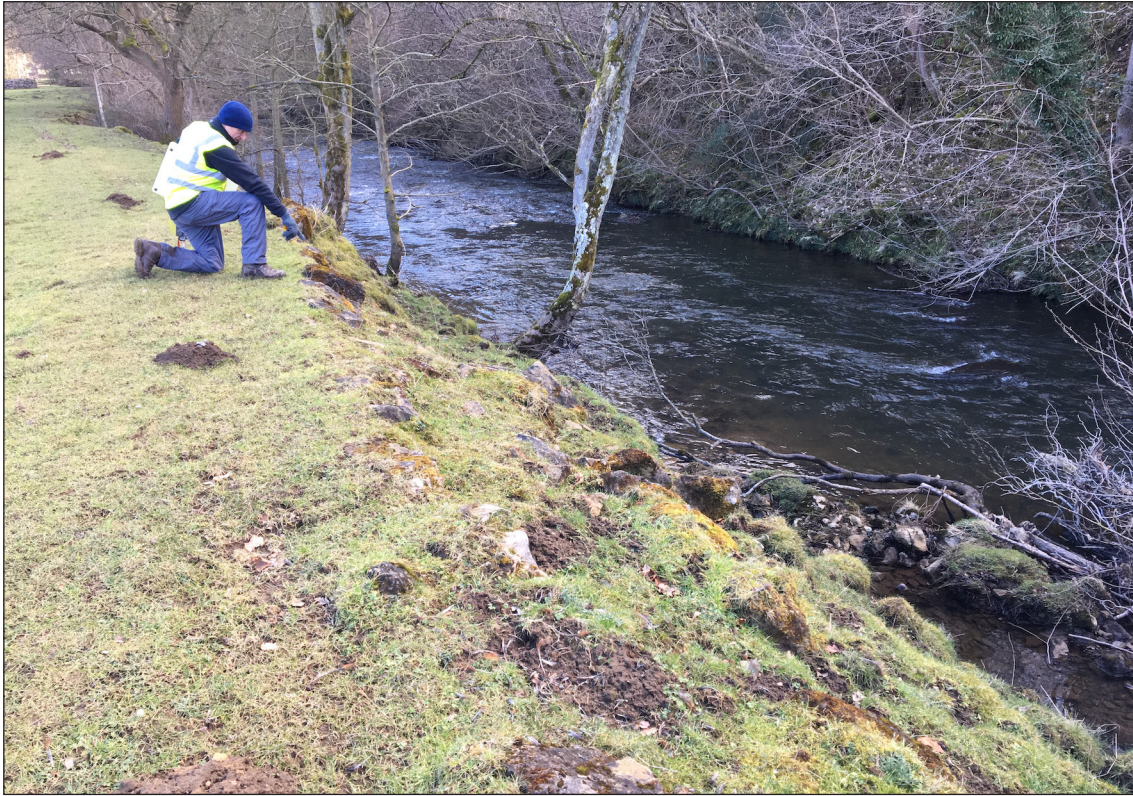
Fig 11. The river Rye to the north of the abbey showing remains of the precinct boundary wall on the east bank, February 2018. © Historic England.

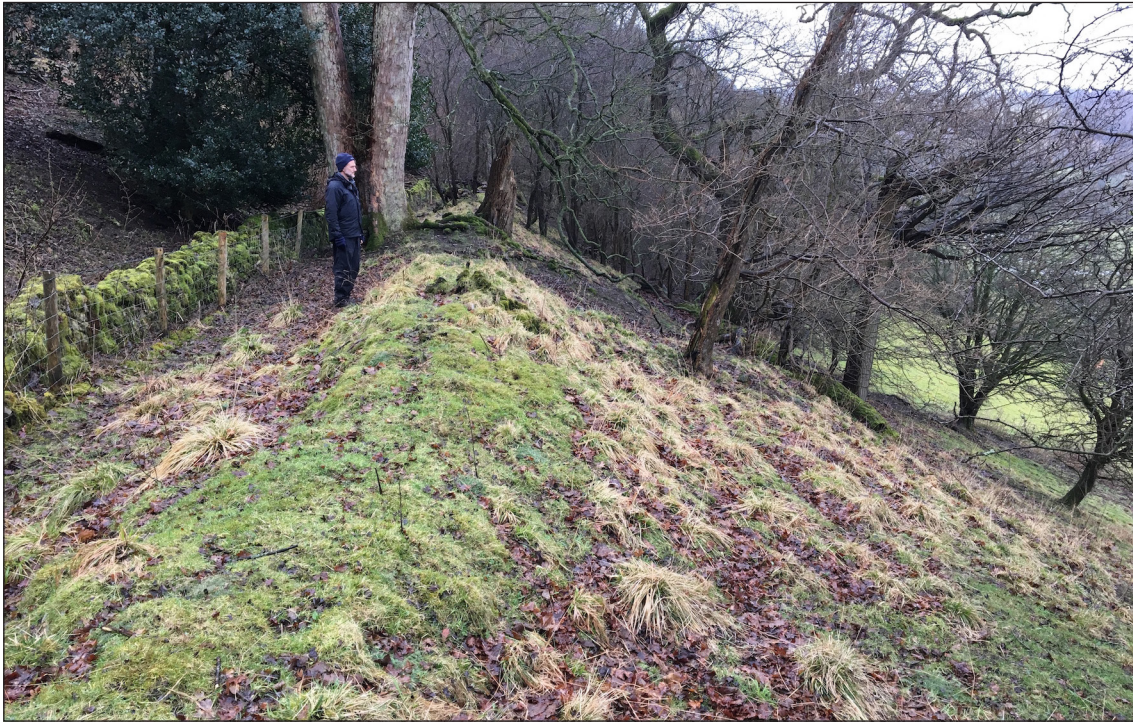
Fig 13. The bank defining the south-east side of the precinct, March 2018. © Historic England.

The south end of the precinct is defined by a low curving bank with occasional stones, including one concentrated stony area clearly indicating that this section was also walled. The bank is 160m long, emerging in the east from the edge of a pond bay (the South Pond - see Section 5.5 below) and ending in the west on the edge of the modern road north of Rievaulx Bridge, about 250m south of Rye House. At this point the road is lower than the field and it is possible that the drop in height marks the line of the precinct boundary for a short distance before it met the east bank of the river. For part of its length, the precinct boundary appears to follow the edge of a shallow natural depression which is visible on the digital surface model (Hannon 2015, 17-18) and which is also hinted at on Atkins' 1996 earthwork plan (Coppack 1999, 176 Figure 148). The depression is about 15m wide and 0.5m deep and bends in a broad arc eastwards to within about 60m of the present course of the Rye (Figure 14). It appears to be a palaeochannel, an ancient redundant river channel, which was utilised by the monks as a ready-made ditch to front the precinct wall, functioning like the artificial ditch found along other sections of the precinct boundary.

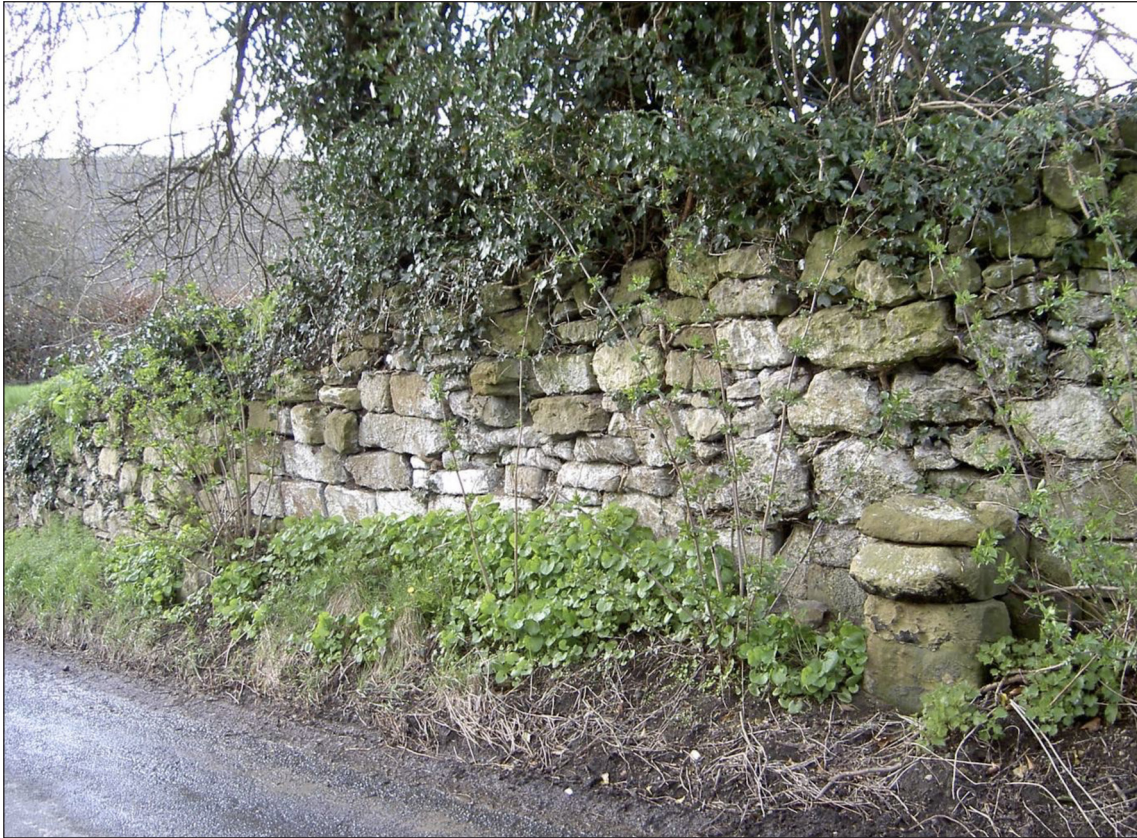
Fig 16. The length of walling on the west side of the village street believed to preserve part of the fabric of the abbey gatehouse. © Historic England.

The probable site of the abbey's outer gatehouse is just down the hill from St Mary's Church, below the point where Arden Lane branches northward from the village street. The visible remains (Figure 16) comprise a low wall on the west side of the road along with the base of the central gate pier. There is also a masonry arch on the east side of the road (Coppack 1986, 129). Russell noted two arches and the buried remains of a large rectangular building to the north of the gate in 1914, but neither the second arch nor the building survive as visible features (Russell 1914, 496). Coppack also noted surface evidence for what he suggested was a guard room to the west of the gatehouse, but that area was not investigated by the present survey and is obscured by trees on the 2015 digital surface model. The location is close to the projected line of the precinct boundary and is therefore a strong candidate for having been the outer gate into the abbey. St Mary's Church located just beyond the site of the gate, could have begun as the monastic gate chapel where the monks allowed lay people to worship without having to pass into the abbey precinct (Burton 1994, 146).

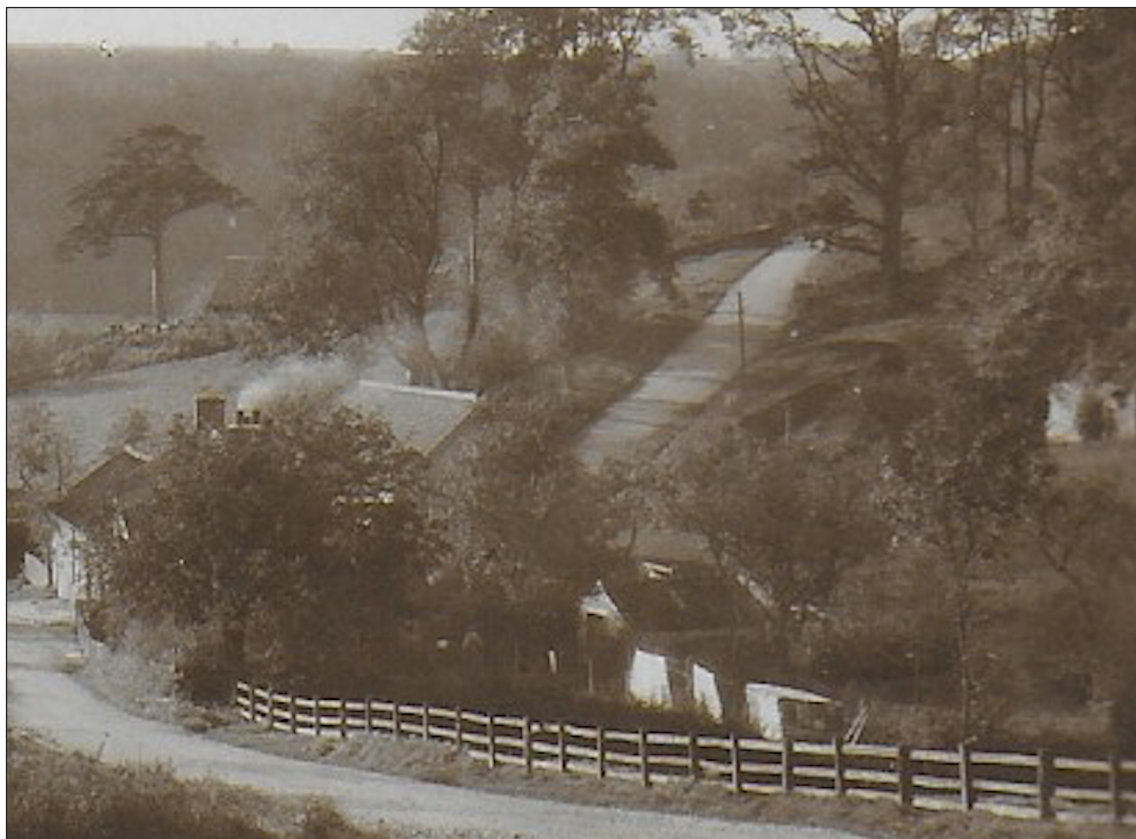
Fig 18. A photograph from the turn of the 20th century looking north across the road to the village with what may be the conduit house on the extreme right of the image; source author's collection.

The springs are situated between 200m and 270m north of the abbey church (Figure 17) and are clearly marked on historic Ordnance Survey mapping (Ordnance Survey 1856). A building in this area, described as a ruined cottage in 1914, was thought to have begun as a conduit house. It was then 'a narrow stone building .... roofless, without any architectural features' but with at one end 'the remains of a carefully built stone settling-tank' (Rye 1900, map facing page 76; Russell 1914, 496). The building stood below the main concentration of springs (Figure 18) and presumably gathered the water from these and possibly a pair of more distant springs around 100m to the east. The area was not investigated as part of the present survey to see if any remains of the conduit house survives. However, the site is around 20m above the level of the abbey and so would have provided a strong flow of water downhill. Today the springs feed a series of ponds on the valley side immediately below, having been redirected to serve the 18th-century water mill (now a private residence called Rievaulx Mill) and possibly the 16th-century blast furnace (see Section 5.7 below).

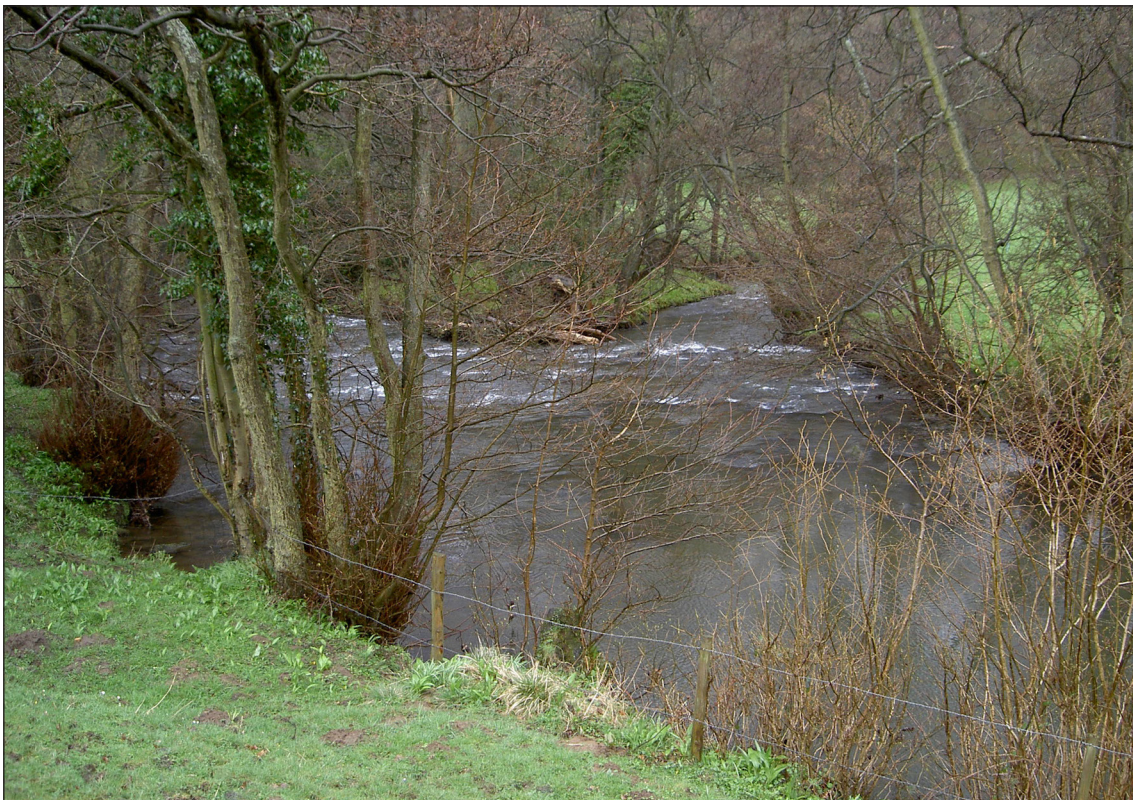
Fig 21. View looking west down the Rye from the start of the monastic leat showing the line of rough water crossing the river, April 2005. © Historic England.

The start of the leat at the northern end of the precinct is now set back and several metres above the river Rye. This is where Atkinson reported seeing traces of a 'dam' situated 'just above a small island lying in the bed of the stream' (Atkinson 1889, lxxii). If so, what he saw is more accurately termed a weir, since the purpose of the feature must have been to raise the water level sufficiently to be drawn off into the leat. Today, although no traces of a weir are visible in the river, there is a distinct band of white water upstream from a small island at just the place where it should be (Figure 21). Stone blocks on the edge of the river to the south of the start of the leat and stone slabs visible in the river bed point to some sort of structure here. However, the junction between leat and river is not well-preserved, partly because a public footpath heading north towards Penny Piece Quarry passes over this point and has caused erosion.

At its start the leat is around 6m wide and no more than 1m deep with steep sides at the point nearest to the river. There is a short length of walling visible immediately to the south of the leat at an angle which is part of the precinct boundary. Stones on either side of the leat suggest it was edged with walling at this point. There is also a short length of walling visible in the river bank which could have been intended to stabilise the bank near the start of the leat. Presumably surviving here is some buried evidence for how the flow into the leat was regulated, such as a sluice gate, which is no longer discernible on the surface.

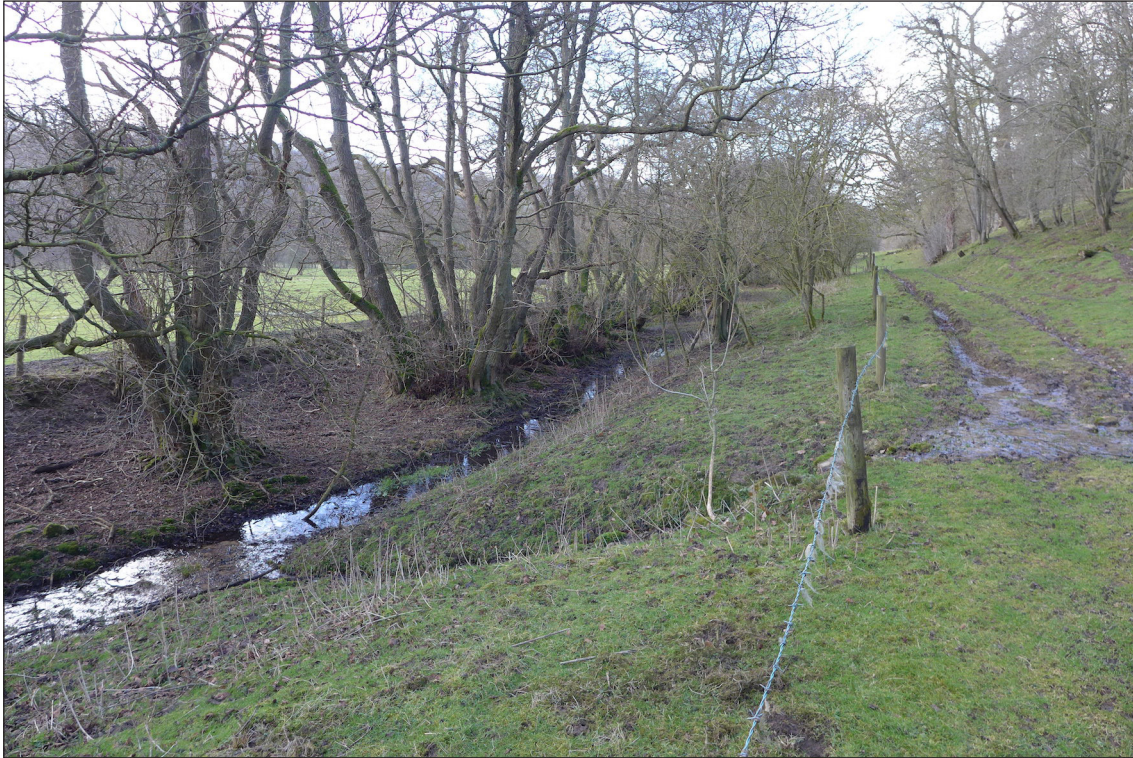
Fig 24. View looking north along the north section of the monastic leat with the line of the track to the east, February 2018. © Historic England.

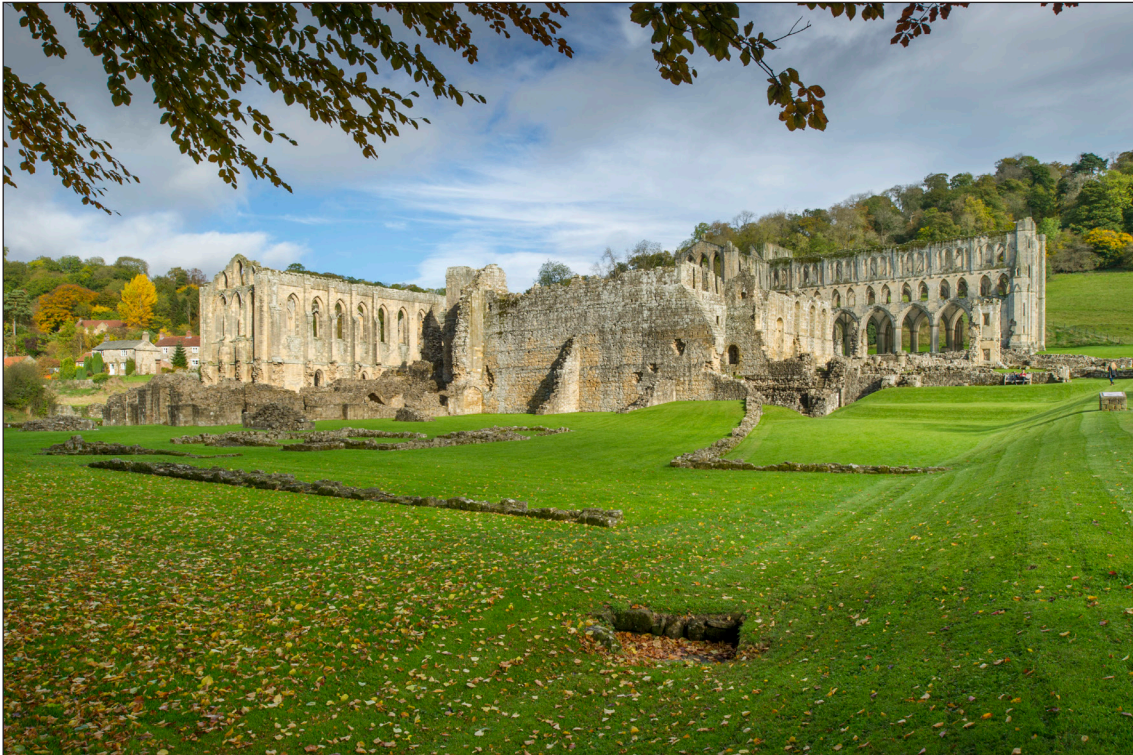
Fig 26. View looking north toward the abbey ruins showing the possible length of the monastic leat (foreground) with foundations of the fulling mill behind. Alun Bull, May 2015. © Historic England Archive, DP169422.

The suggested former alignment of the leat on the west side of the abbey is seen most clearly on historic Ordnance Survey mapping. The 1912 map shows a bank aligned south-east across the valley floor extending 180m from the rectilinear earthworks defining the site of the monastic fulling mill to the foot of the slope on the east side of the valley. There it turns and defines the west side of a mill pond (then termed 'Canal') stretching down the side of the valley (Figure 25). The line of this feature from the site of the fulling mill to the east side of the valley is not clear on the ground today because of subsequent dumping and landscaping in the area. However, it conceivably defined the line of the leat just as the embankment next to the leat does on the north of the precinct. Of the actual leat itself, the 1912 map seems to indicate some form of narrow channel at the foot of the bank on the side nearest to the site of the fulling mill. This may be the leat and part of it probably still survives on the surface as a 20m long low stone wall next to the foundations of the fulling mill, although all trace of the associated embankment has vanished (Figure 26).

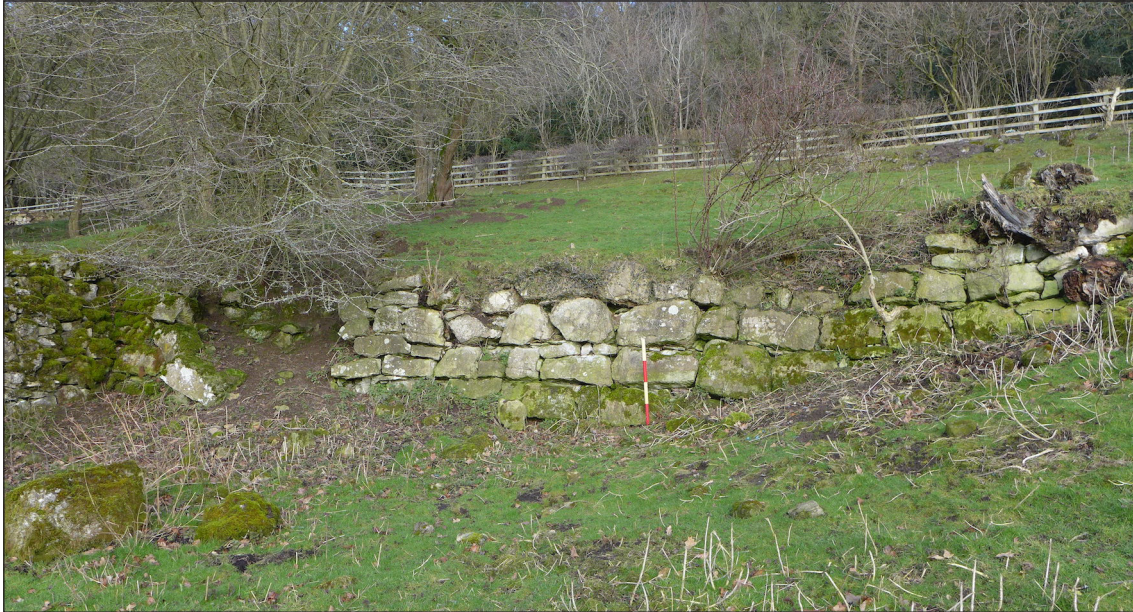
Fig 30. View looking north-east of the stone wall revetting part of the upper terrace, February 2018. © Historic England.

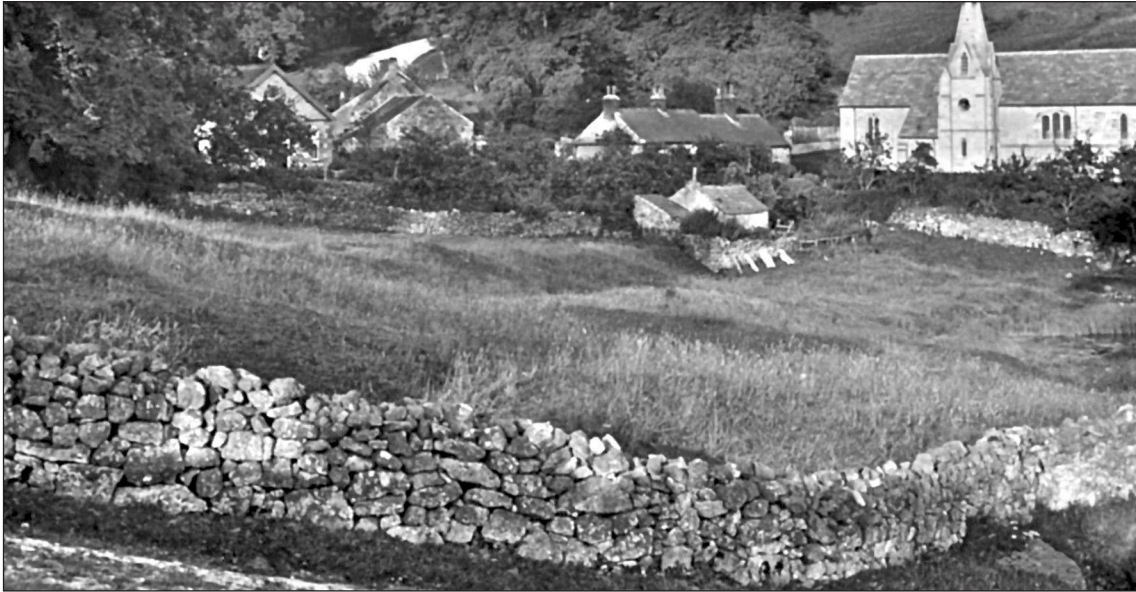
Fig 31. Photograph from the turn of the 20th century showing terraces and enclosures on the west edge of the village below the road to Bow Bridge; source author's collection.

There is no clear boundary to the terraces in the opposite direction, towards the abbey, as the ground is now divided between several private residences or is otherwise overgrown. The area was not investigated by the present survey and does not show up clearly on the 2015 digital surface model. However, the 1996 Atkins' survey does show two long terraces and a possible ditch or hollow way on the slope in this area, and there is also early photographic evidence of terraces here (Figure 31).

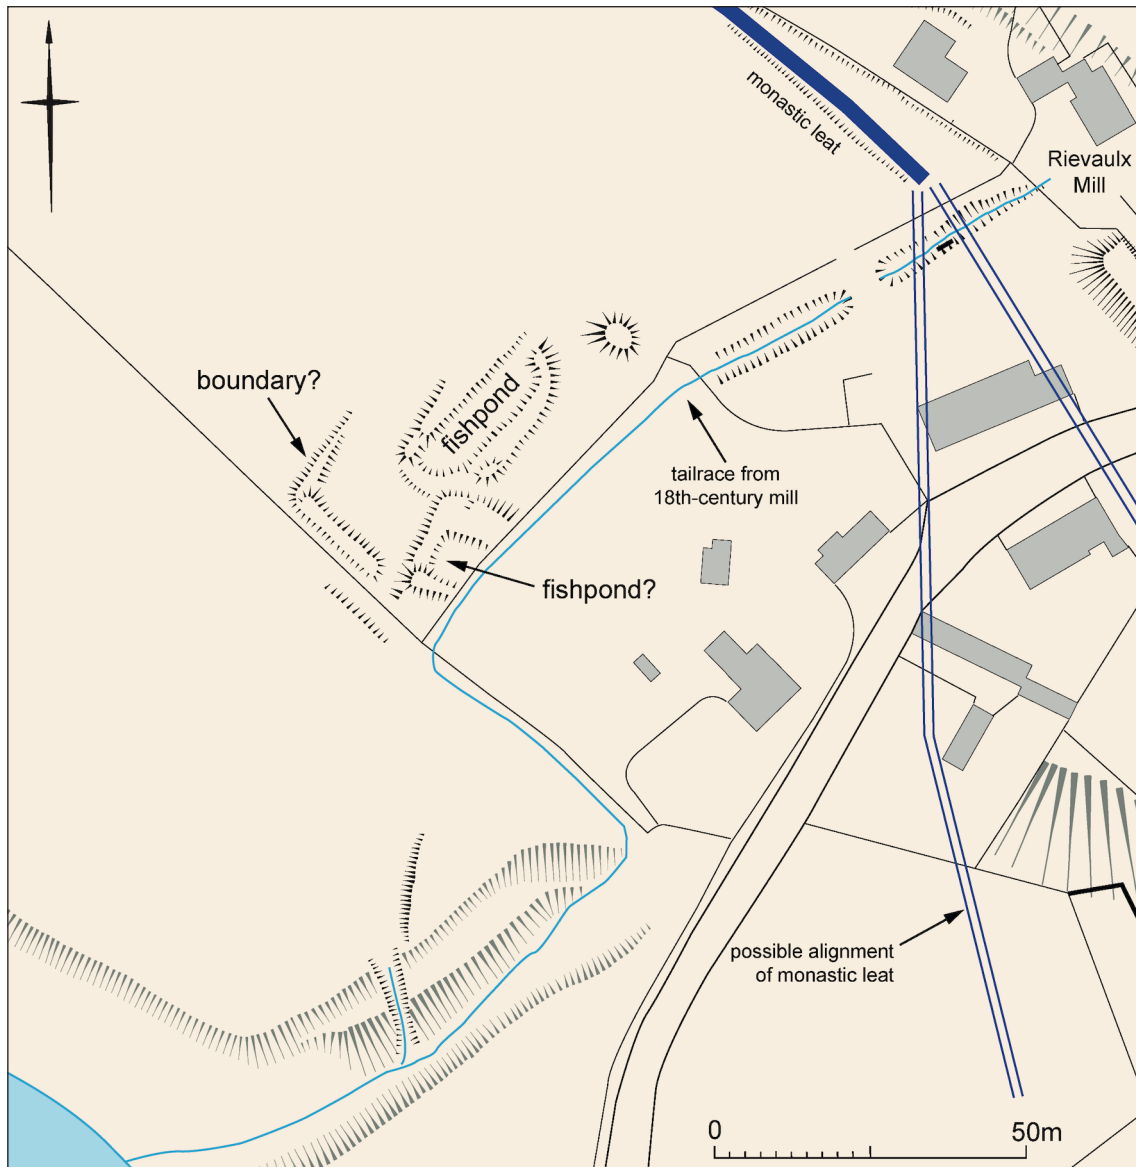
Fig 32. Extract from the 2018 survey plan (Figure 40, this report) showing the location of the fishponds in relation to the possible alignment of the monastic leat. © Historic England.

Fish were an important source of food in medieval monasteries, and fishponds were common within monastic precincts. At Rievaulx, however, the only extant example is a probable pair found on the valley floor about 160m to the north-west of the abbey ruins (Figure 32). One pond is clearly visible as a rectangular depression 20m long and 6m wide with traces of a slight bank around all four sides, and a gap at the north-east corner which might indicate the water inlet (Figure 33). Abutting the opposite corner is a second rectangular depression which looks like the end of a second pond set at right angles. A slight 'L' shaped bank stands apart from the two fishponds and could have been part of a boundary enclosing this area. Several of these features appear quite strongly on the 2015 digital surface model but were wrongly interpreted by Hannon as part of an ornamental garden (Hannon 2015, 24). The nearest watercourse passes just to the south of the ponds, but this is the outfall from the 18th-century mill and may not have been present during the medieval period. Alternatively, water could have been directed to the ponds from the monastic leat along a now buried channel. The leat passes 60m to the north-east and may have passed about the same distance to the south if, as seems likely, it turned and crossed the valley floor to reach the west side of the claustral range.

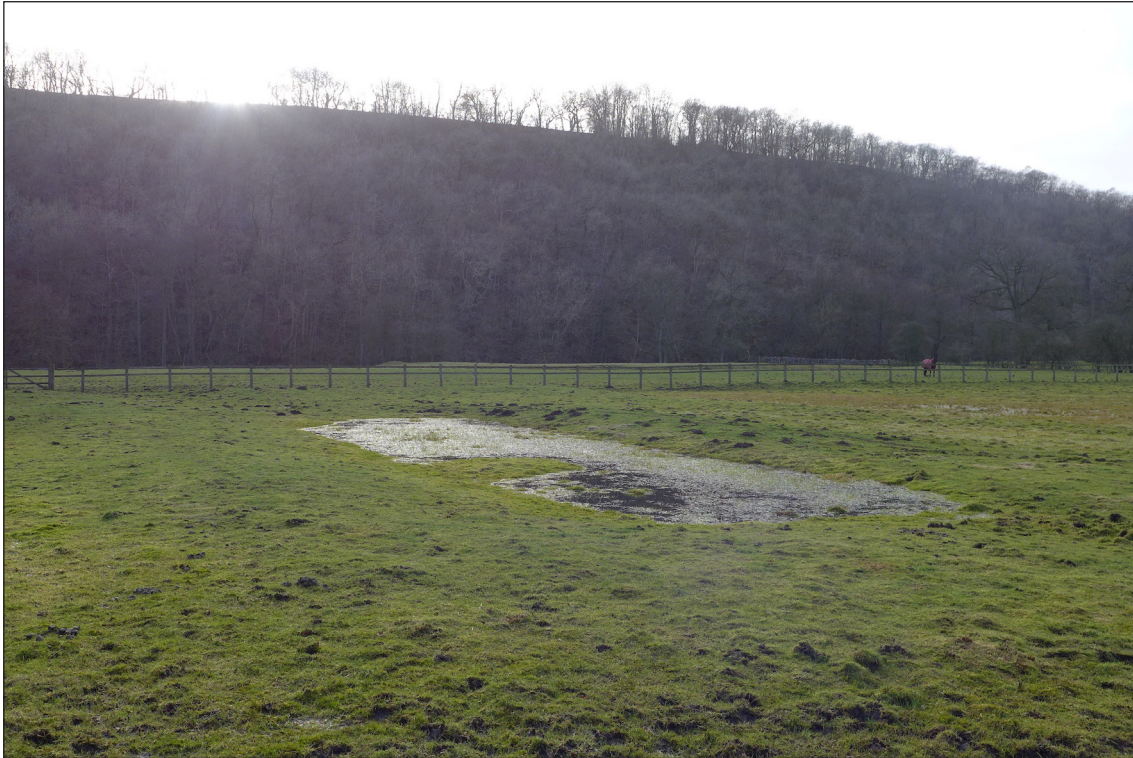
Fig 33. View of the one of the fishponds looking west, February 2018. © Historic England.

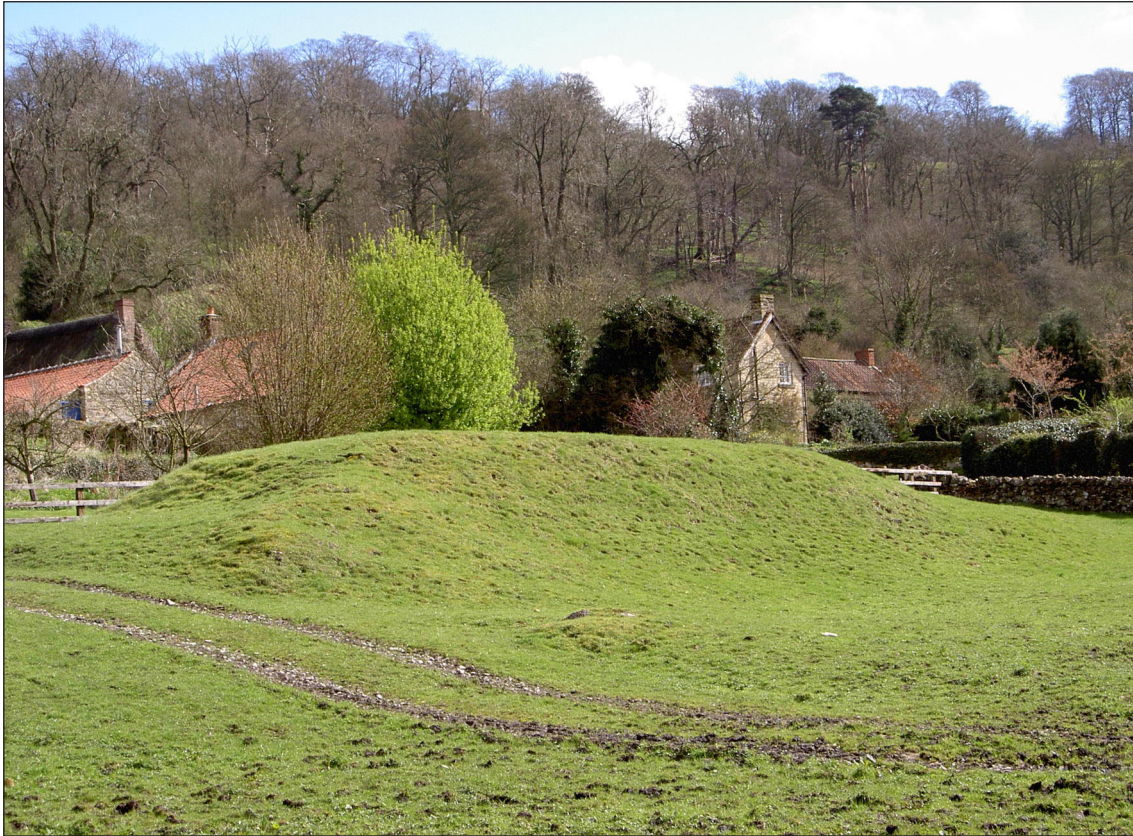
Fig 34. View looking north-east of the mound possibly associated with the post-medieval blast furnace, April 2005. © Historic England.

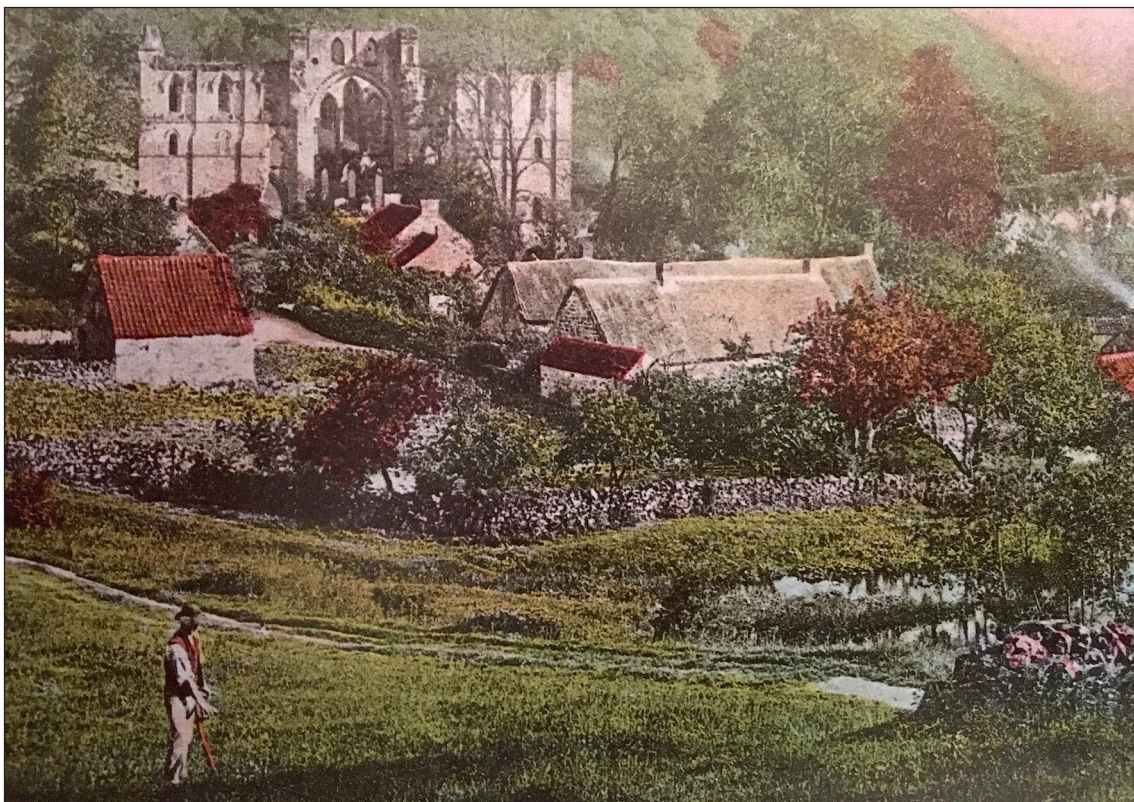
Fig 36. Colourised photograph from the early 20th century looking south showing the embanking on the south-east side of the upper mill pond; source author's collection.

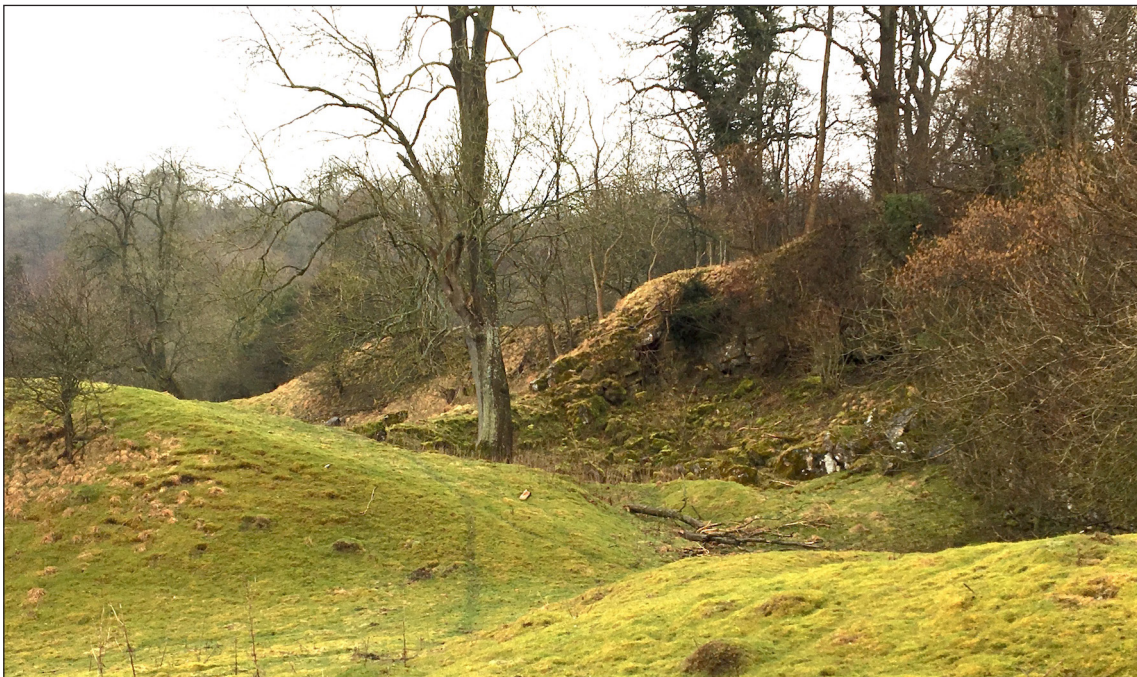
Fig 37. The quarry on the valley side to the east of the church and which destroyed part of the monastic precinct boundary, March 2018. © Historic England.
