# Rievaulx Abbey, Helmsley, North Yorkshire: Archaeological Survey and Investigation of the Precinct

Research Report Series 007-2019

**Archaeological Survey and Investigation of the Precinct**

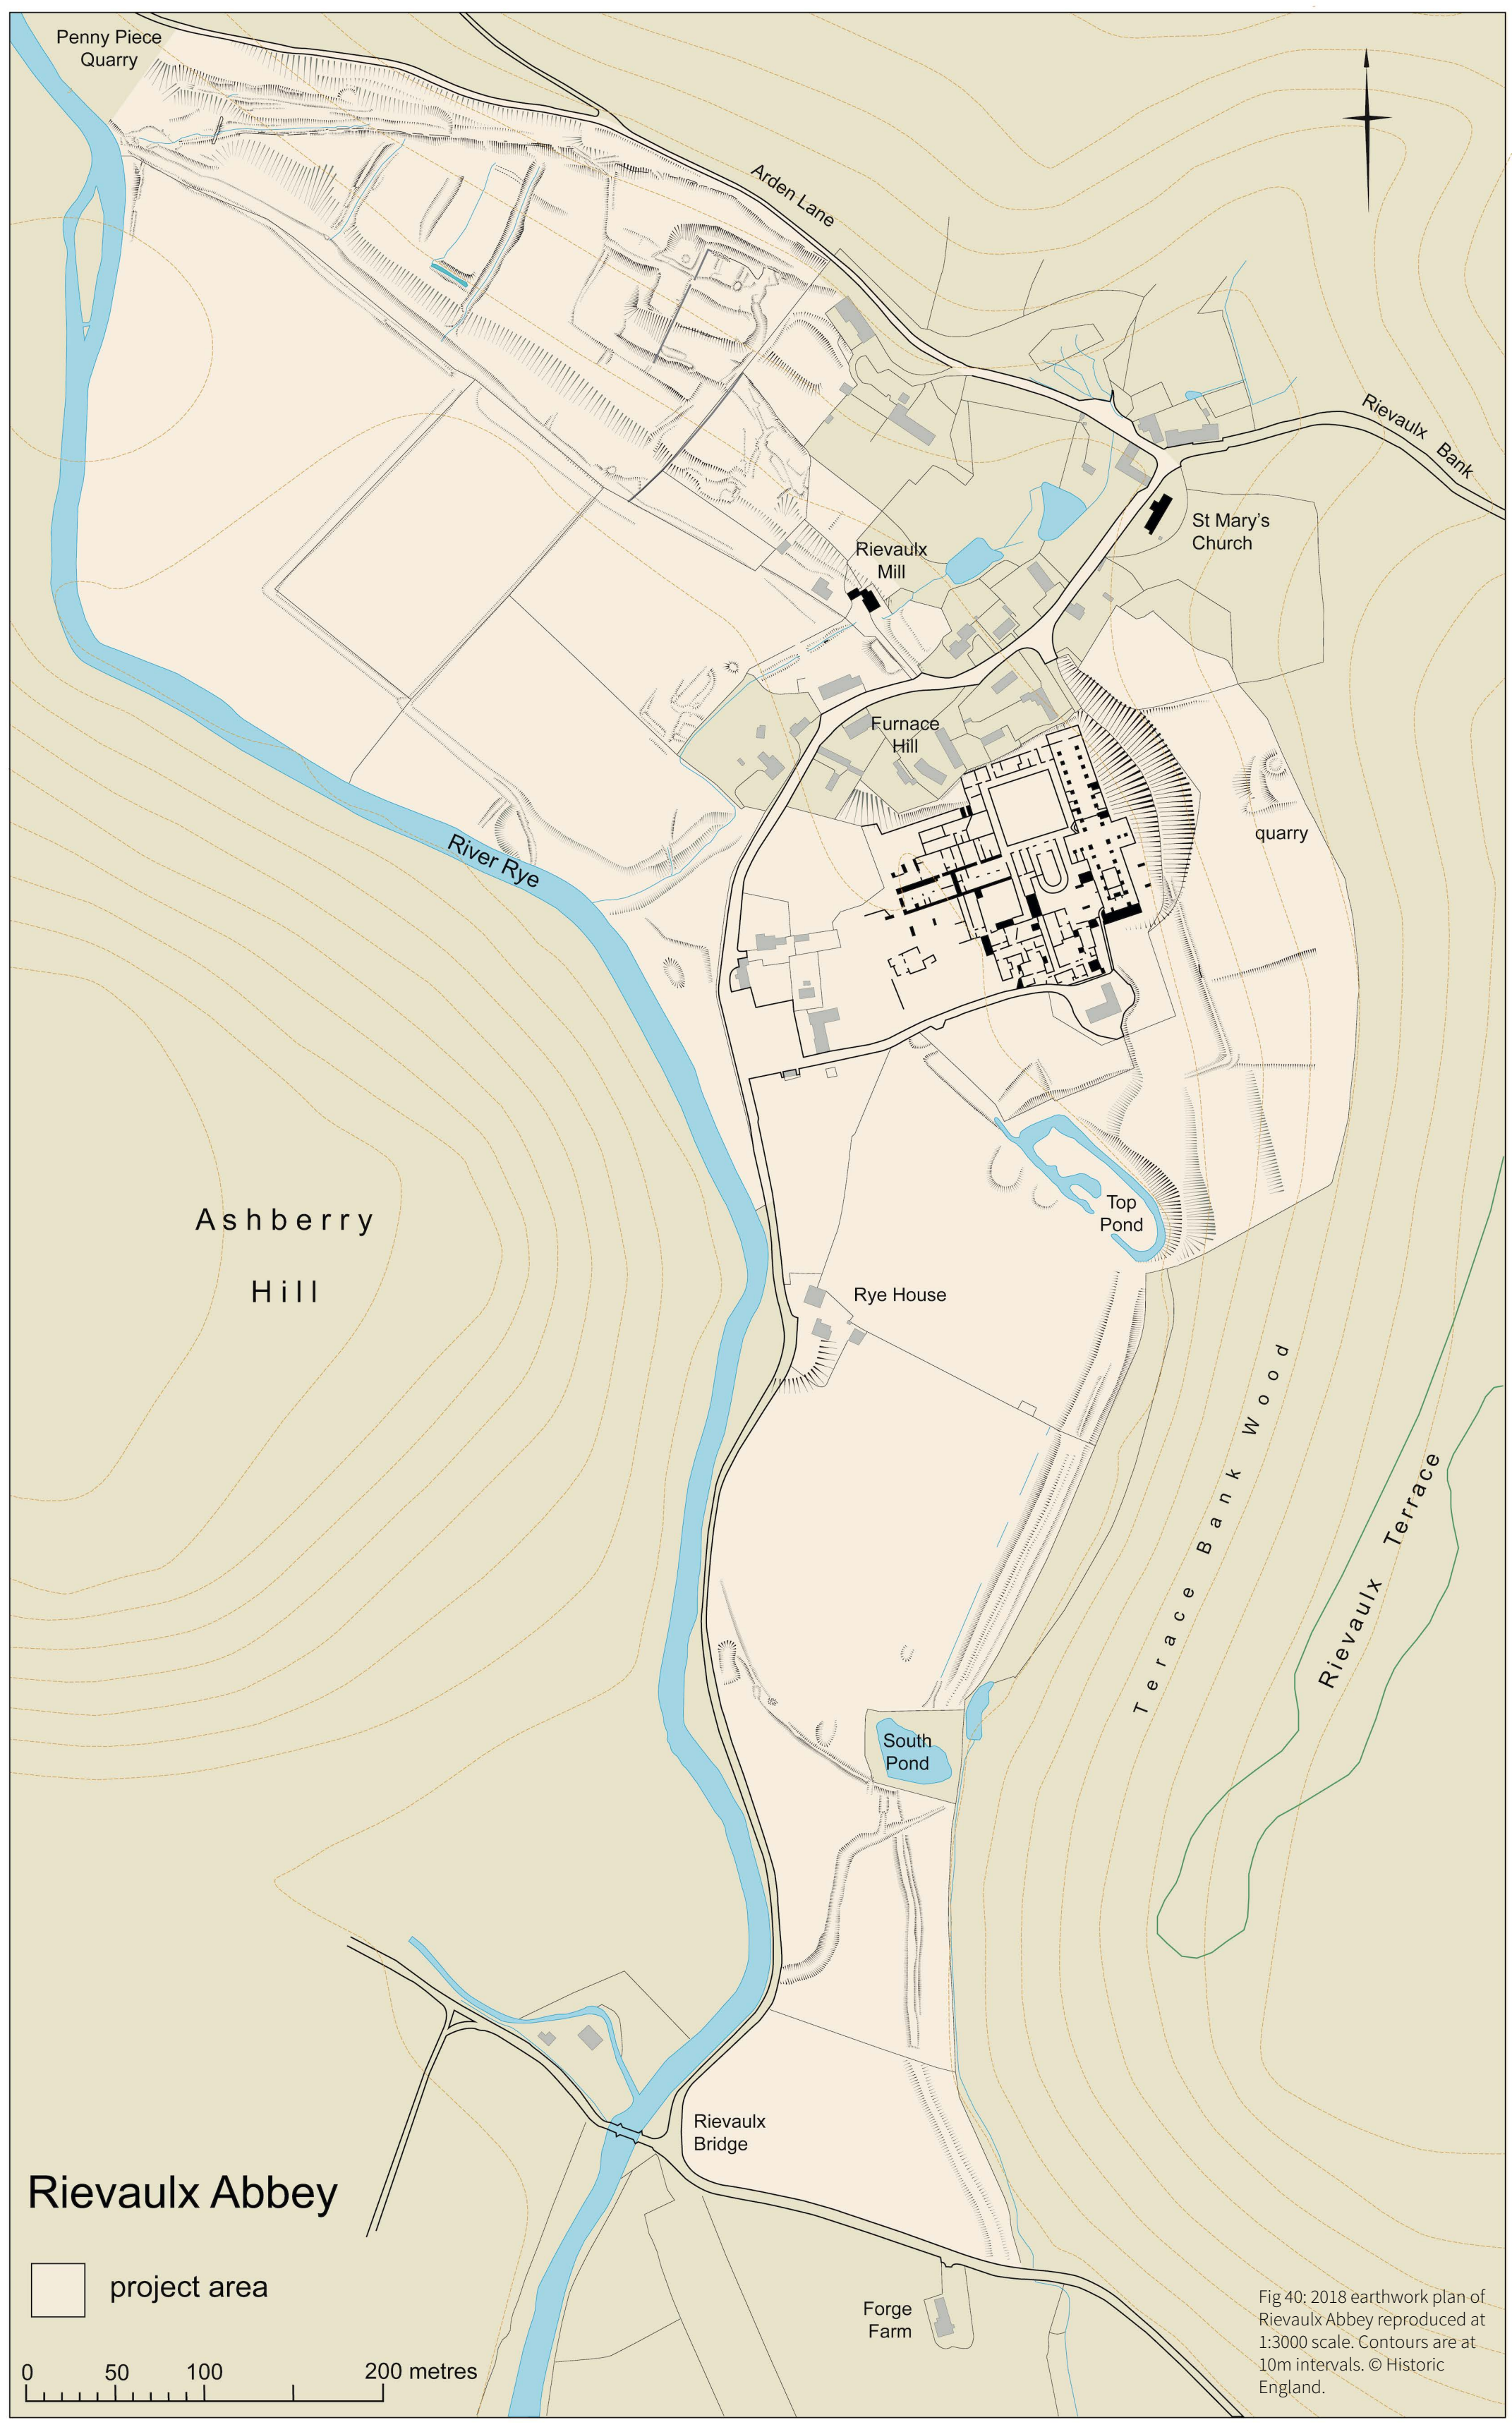
Fig 40: 2018 earthwork plan of Rievaulx Abbey reproduced at 1:3000 scale. Contours are at 10m intervals. © Historic England.

The plan resulting from the 2015 and 2018 surveys of the Rievaulx landscape is presented as Figure 40. The main findings are described and interpreted in chronological order below, supported by a range of written and cartographic sources. Extracts from the survey plan are used to illustrate aspects of the interpretation.

The leat around the west side of the abbey and the outfall from the reredorter drain joined to form a single outfall channel at a point now encompassed by the Top Pond, which itself has removed all physical traces of this junction (Figure 40). Beyond the Top Pond and extending southwards for over 500m along the east side of the valley, are the earthwork remains of a broad channel, cut into the foot of the valley side with a bank on the west, which Atkinson identified as the ‘Second Canal’. This feature is far too wide and long to be simply the outfall drain from the abbey. It may, however, represent more than one period of development, of which the last was as a linear mill pond associated with the post-Dissolution forge at Forge Farm. About half-way down its length, and just within the precinct boundary, the former mill pond it is intersected by a second modern pond (called the South Pond by JBA Consulting). Just beyond the South Pond a sharply-defined ditch heads south-west across the valley floor to the Rye and it is likely that this is the final section of the monastic outfall drain taking water away from the precinct and back to the river. These various features are described in more detail below.
