**CANONS ASHBY, Northamptonshire**  
**An archaeological survey by the RCHME**  
**December 1992**

SP 5783 5063 The Orchard. See SP 55 SE 1 plan I for location. The capital letters in the following text refer to the detailed survey, Plan II. Plan III shows the location of the surviving tree species, stumps and tree-holes.

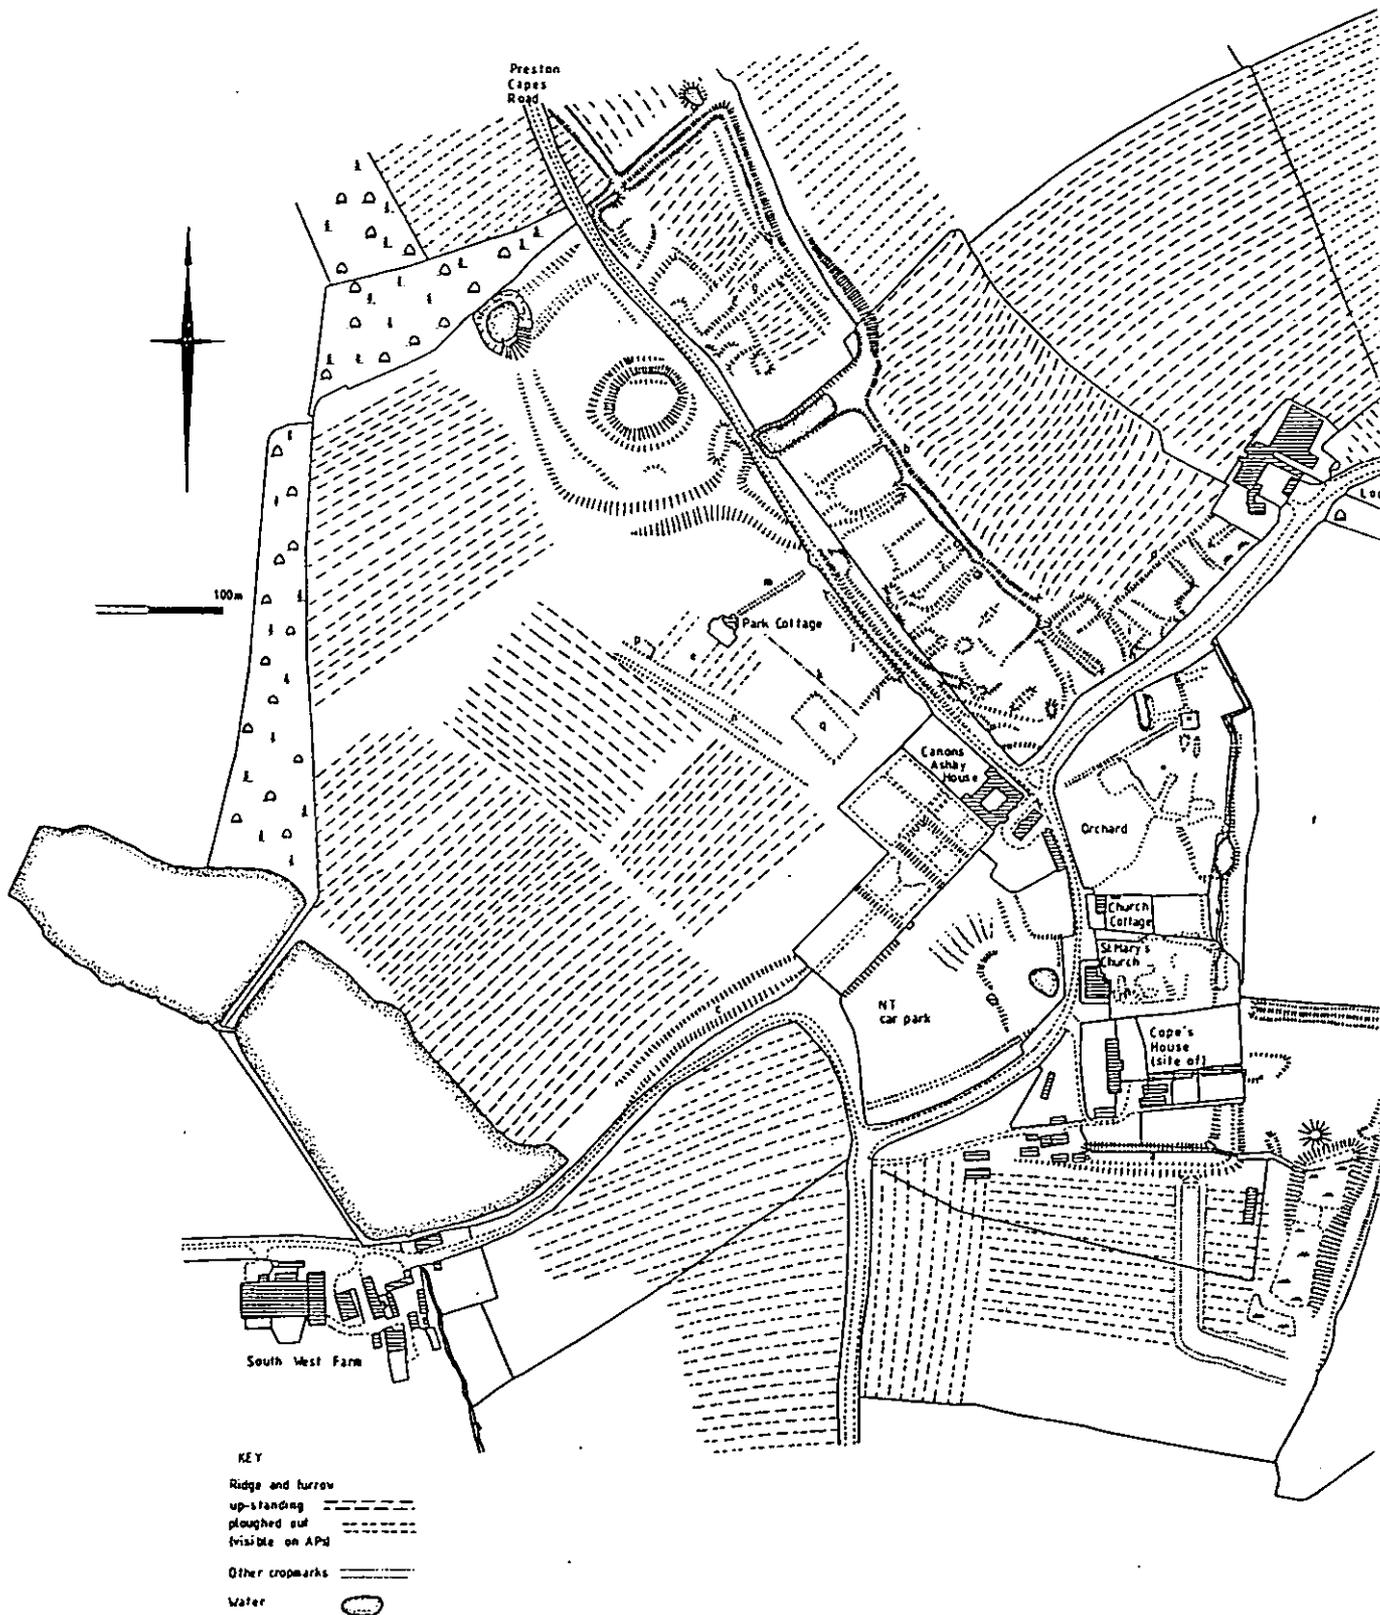
See plan I.

The deserted village remains at Canons Ashby are situated to the north of Canons Ashby House on Northampton Sand at 157m OD (12). The surviving earthworks comprise a linear settlement of numerous domestic enclosures (crofts), some with associated house platforms (tofts), all ranged along a system of medieval hollow-ways. The village is surrounded by ridge-and-furrow cultivation. The site was originally surveyed by the RCHME in 1981 for the Northamptonshire Inventory (12), the present account is derived from a brief re-examination by RCHME in December 1992 for management purposes.

The plan of the medieval village, which was largely deserted following enclosure for sheep in the sixteenth century (11a), can still be reconstructed from the earthwork remains. The village was arranged around a cross-roads with most surviving remains laid out along the north sides of the north-western and north-eastern arms of the cross, the Preston Capes and Adstone roads respectively. The southern arm leads to the Church and priory while the south-western arm followed a route now partially under Canon's Ashby House but visible as a hollow-way, c, west of the formal gardens.

The north-western thoroughfare of the village lay along the line of the Preston Capes road and is visible as a hollow-way, 6m wide and up to 0.8m deep, on the wide verge along the eastern side of the present road. The majority of surviving crofts are laid out along its eastern side up to a second, parallel hollow-way, b, surviving up to 7.0m wide and 0.5m deep, and identifiable as a back lane.

A second row of crofts survive along the northern side of the Adstone Road, ending similarly against a second, parallel hollow-way, d, 5.5m wide and almost 1.0m deep.

At some point, the village may have expanded over former open fields at the northern end of the site. This is suggested by the existence of crofts, g, which apparently overlie very degraded ridge-and-furrow, no more than 0.2m high (12). This expansion is enclosed by a bank and ditch, best preserved on the north where it is 8.0m wide and up to 1.2m high. The size and shape of this enclosure bears a strong similarity, perhaps fortuitously, to the Canons' Walk, a rectangular enclosure associated with the gardens of the post-Dissolution house (see SP 55 SE 13). This northern enclosure appears to disregard and overlie the broad ditches, elsewhere suggested to form part of the castle defences (see SP 55 SE 14). However, it is unclear whether the northern enclosure is contemporary with or later than the village remains in the area.

The crofts, or the individual properties of the medieval village, were rectangular in plan and aligned at right angles between the two principal hollow-ways. The divisions between the crofts were marked by low banks, spread between 2m and 5m in width and now less than 0.3m high, and/or ditches, up to 4.5m wide and up to 0.5m deep. The banks may have supported hedges or fences and in some cases the ditches are wide and deep enough to have formed minor trackways between properties; the southern end of h, for example, appears to splay allowing access in both directions along the Adstone road.

The crofts vary in size ranging from 35m by 25m up to 60m by 22m (0.08 ha to 0.13 ha), the largest properties fronting onto the Preston Capes road. Dwellings would have occupied a small area within the crofts, although the actual crofts are seldom evident. One of the few surviving examples, i, is a levelled area measuring some 20m by 12m, or approximately 25% of the area of its croft.

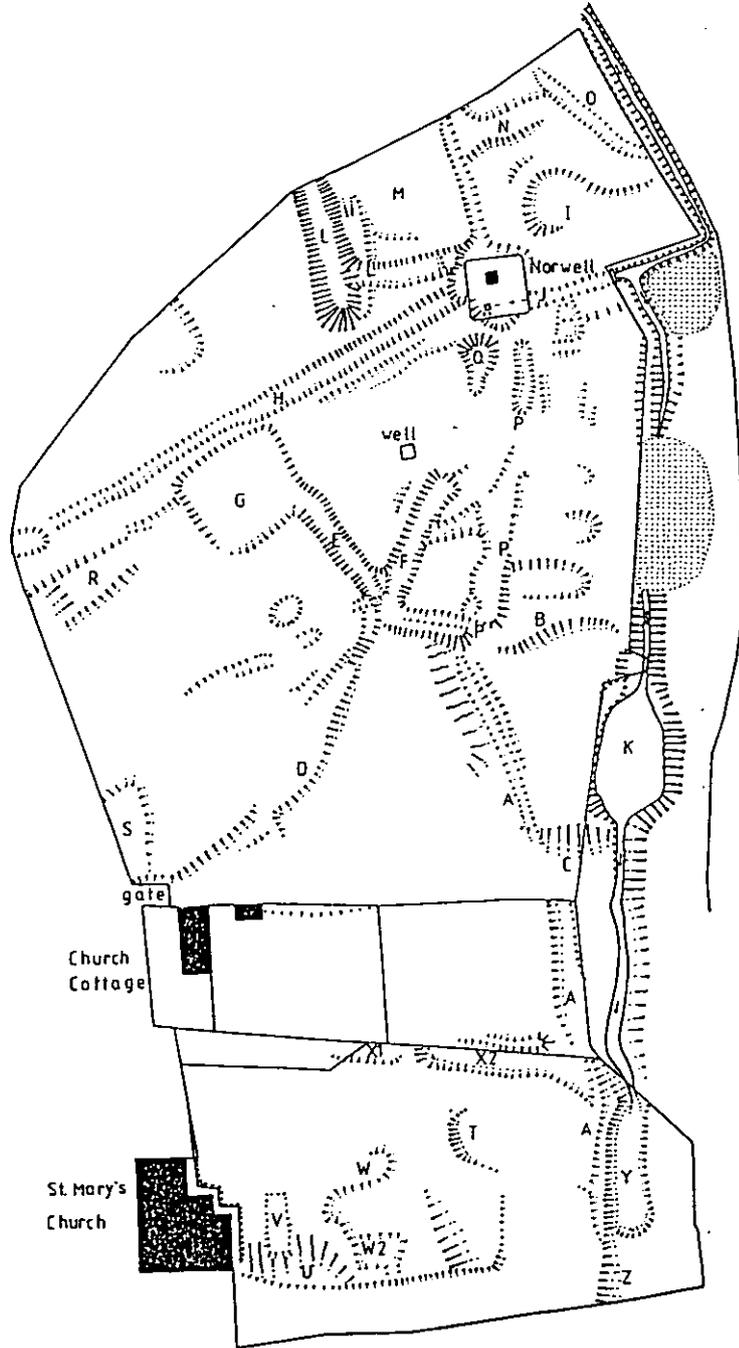
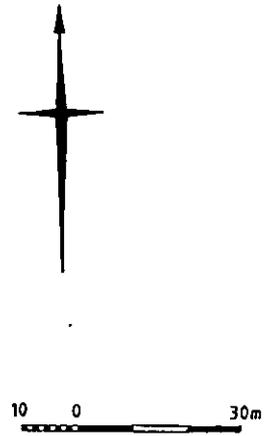
The Orchard is fairly flat, although the ground slopes gently away towards the southern part of the field. Its eastern boundary has been altered, possibly several times. A parallel bank and ditch, A, the bank no more than 0.3m high, follow the line of a boundary shown on OS maps of 1884 and 1900, although A extends further to the north (1c, 1d). The northern side of this earlier enclosure may be represented by B, a scarp up to 0.7m high, which heads eastward from the northern end of A to the present fence. The hollow immediately to the north of B could be a ditch associated with this boundary. A broad scarp C, no more than 0.4m high, in the far south west corner of the Orchard, may be the western end of a small dam associated with the pond, K, immediately to its east, or perhaps indicate where livestock were brought to drink at the stream; it appears to be earlier than boundary ditch A. Boundary A continues south into the churchyard, the ditch switching to the eastern side of the bank.

The Orchard's western boundary seems to have been more stable, and it is possible that the location of the gate in the south west corner of the field may be original. A shallow scarp D, up to 0.4m high, leads from the northern side of the gate towards the Norwell, probably indicating the edge of a track from the gate to the well. Near the centre of the field D meets two well-defined ditch-like features E and F, 4.4m and 5.9m wide respectively, and up to 0.5m deep. F continues the line of the track, D, towards the Norwell, but now ends abruptly some 35m short: the gap has probably been infilled but 8m south of the well-house a small depression, Q, up to 0.85m deep, may be a continuation.

Feature E diverges from track D north westwards to join G, a square sunken feature defined by steep sides, up to 0.5m deep, rising from a broad flat bottom. OS maps show a structure standing on this site: in 1883 (1c); 1899 (1d); and in 1978 when an electricity substation existed here (1e). Aerial photographs record that the building was still standing in 1977 and 1982, and illustrate its relationship to feature E. It had been demolished by January 1984 (1i). Features E and G are almost certainly contemporary, E representing a branch of the track D to the front of the former building at G. No other source indicates an alternative route.

Leading west from the Norwell is a steep-sided trench H, up to 5.5m wide and 1.0m deep at its eastern end. It becomes less well defined towards the west and fades before reaching the fence. Dryden's plans of 1864 show a water pipe running westwards from the Norwell to Canons Ashby House; H appears to be the trench for this pipe (1f). The building platform G distorts the line of H, suggesting that G is more recent. However, as H can only be loosely dated to a period following the Dryden family's acquisition of Canons Ashby House in the mid-sixteenth century (1b), this relationship is not useful for closely dating G.

The low-lying area, I, to the east of the Norwell, defined by gentle scarps up to 0.6m high, is probably subsidence associated with the underground reservoirs which extend east of the well-house (1f).

The present drainage system takes water from the Norwell east to the stream through a short culvert J which is less than 0.2m deep. The stream joins a field drain and flows south along the edge of the orchard into a pond K. The previous RCHME

The north end of the orchard has two main elements. The first, L, a sharply-defined ditch-like feature up to 1.0m deep, has a rounded southern terminal but is truncated on the north by the fence. A low mound, some 0.6m high, spread along its eastern side may be material deposited following re-cutting. L may have been the continuation of a track between medieval crofts originating north of the Adstone road (see plan I), although it is considerably deeper. Its well-defined southern terminal suggests that it never continued beyond its present southern end point; there is no apparent relationship with the water pipe trench H. The second feature, M, is an almost flat enclosure 18.6m wide and 0.6m high, defined by ditches 0.3m deep on the south and east but truncated on the north by the construction of the Adstone Road. The southern ditch cuts through upcast material on the eastern side of L, implying that the enclosure is the later feature. A slight hollow lies near the southern edge of M. Both ditches run into the hollow surrounding the Norwell, perhaps suggesting that they acted as drains. Enclosure M is possibly a small field or close associated with part of the deserted medieval settlement north of the Adstone Road but any clear relationship cannot be demonstrated.

The remainder of the orchard is scattered with less well-defined features. N, a low bank up to 0.5m high, is apparently truncated by M but too little survives to determine its original form. O, a slight ditch no more than 0.2m deep, feeds into the present field drain and may have cut across N: it may simply be a drain but its alignment hints at a possible association with the DMV. Various ditches and scarps, P, up to 0.3m high, although broken and confused by trees, appear to form a line turning a right angle and meeting F at its southern end. They may represent a field boundary, possibly associated with short sections of ditch to the west and the eastern ditch of M to the north.

A slight rectilinear raised area, R, near the western edge of the orchard, measures 19m by 12m and up to 0.5m high. Although possibly a building platform, it is not particularly level or well-defined. Another platform, S, near the gate, is even more irregular: it is no more than 0.25m high.

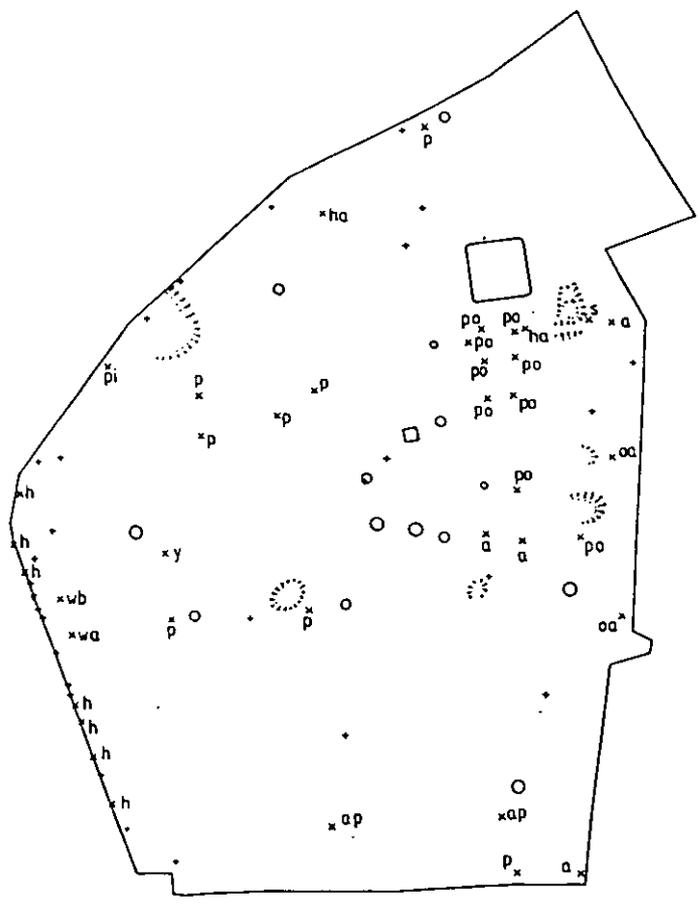
The remaining hollows, some up to 10m in diameter, seem to be tree holes. At some time there appears to have been a line of trees near the eastern side of the field and there are some random lines of tree holes and stumps, but little now survives of a regularly laid out orchard plan (see plan III).
