STRATTON PARK
Biggleswade, Bedfordshire

A moated site and associated
settlement earthworks

SURVEY REPORT

STRATTON PARK MOAT
AND ASSOCIATED EARTHWORKS,
BIGGLESWADE, BEDFORDSHIRE
AN ARCHAEOLOGICAL SURVEY BY RCHME
TL 24 SW 3 and 21
DECEMBER 1993

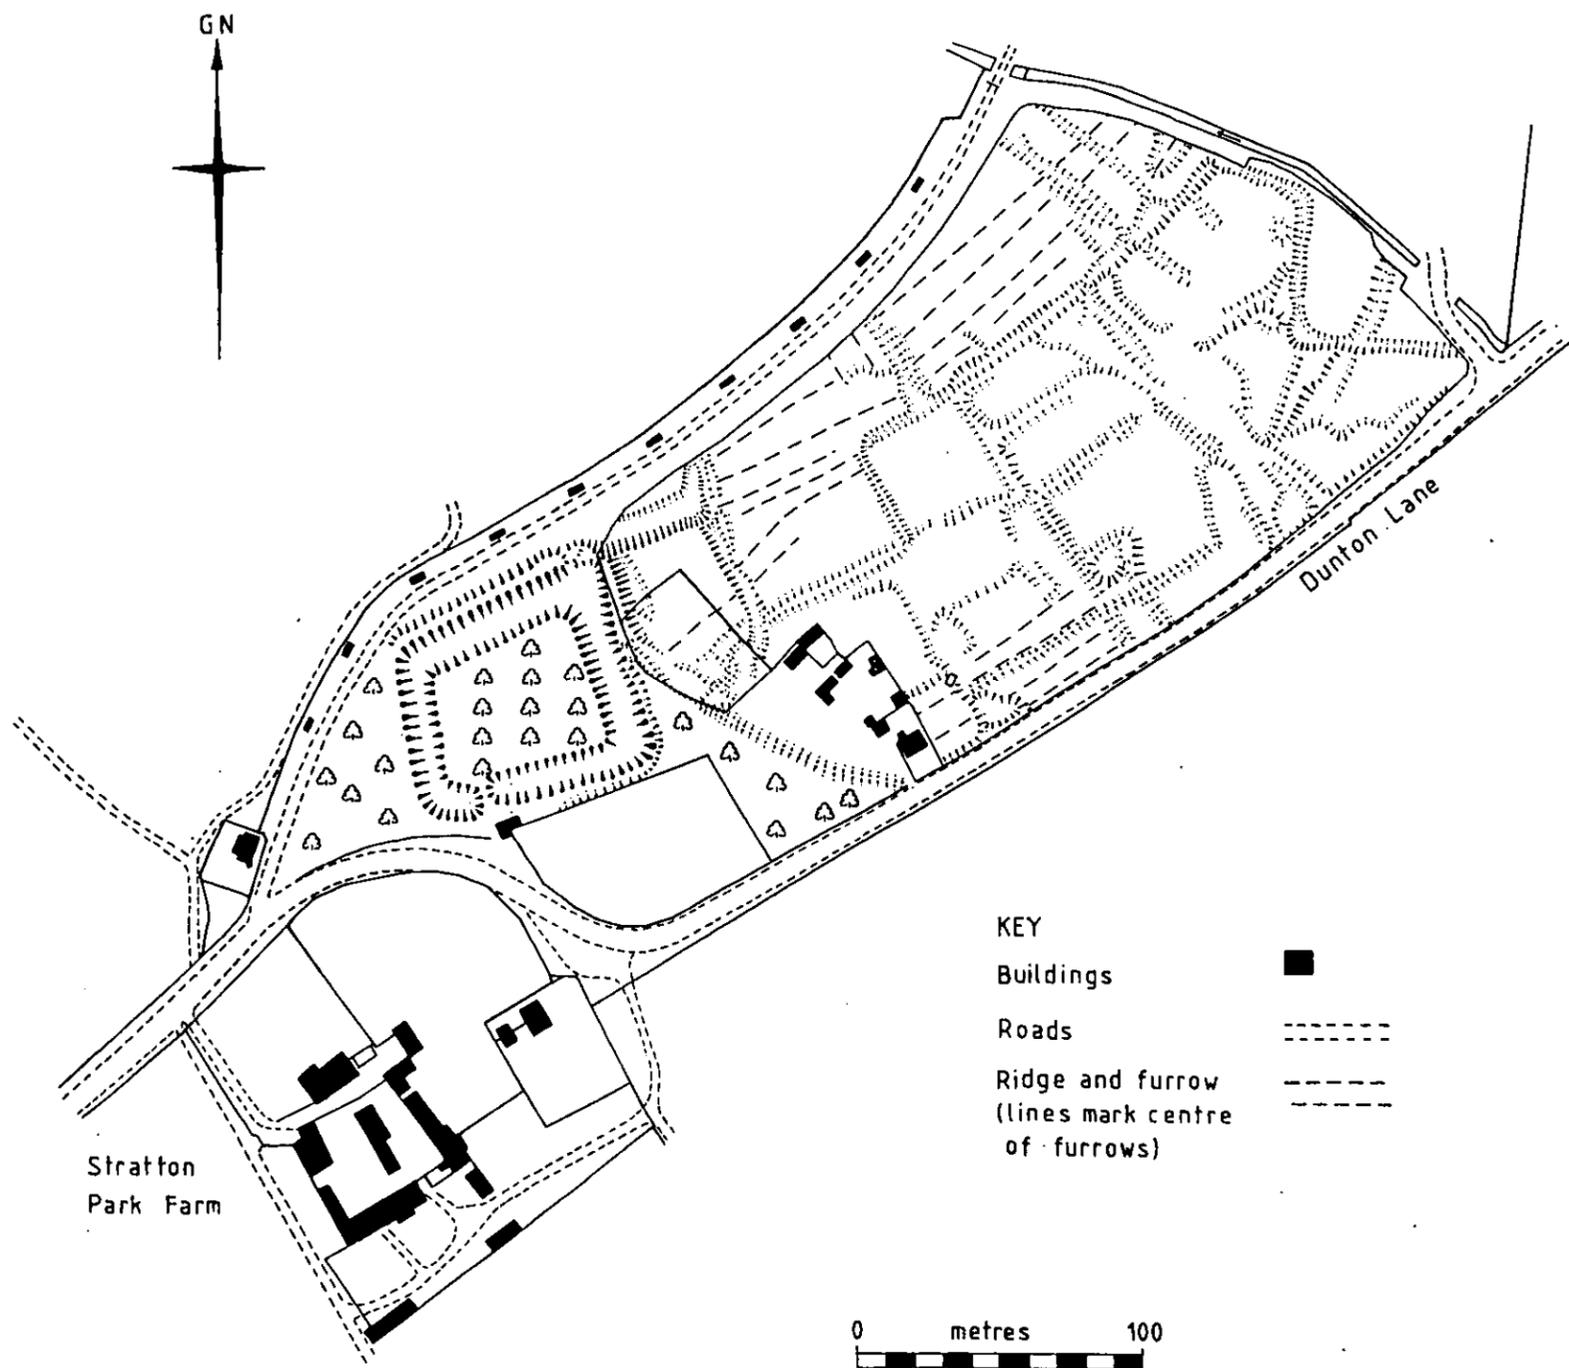
STRATTON PARK: SHEET 1

The Moat (plan sheet 1).

The moated site (TL 24 SW 3) is sub-rectangular in shape with an entrance causeway in its southern side. It is generally very well preserved, the only obvious disturbance being minor landscaping of the north-eastern corner for a garden. However, the moat and the area immediately around it is very heavily overgrown by trees, brambles and ivy, making a detailed inspection of the site difficult.

The site has overall dimensions of 76.0m by 75.0m, with an internal area of 0.3 hectares. The moat is up to 2m deep with an external bank along the northern, and part of the eastern sides, reaching up to 1m in height. The sides of the moat are steep, about 30 degrees, and the bottom appears to be fairly flat, and still holds water to a depth of over 0.5m. The causeway, about 4.5m wide, seems to be an original feature, and lies towards the western end of the southern side of the moat, between the slightly offset terminals of the ditch. The platform is generally level, and not noticeably raised above the surrounding ground surface, though it was not possible to take level readings to demonstrate this. There is no visible evidence of buildings on the platform, but the dense undergrowth makes identification of slight scarps almost impossible. The existence of buildings is not inevitable as some moats appear to have been used as stockyards, orchards or gardens, and on excavation provide no evidence for structures (Clarke 1984, 49, 59). The platform of the moat has been used as an orchard since 1838 (BRO (a)), if not before. It was recorded as an orchard in 1910 (BRO (b)), and aerial photographs show it was not overgrown until relatively recently (OS/67144 frame 031, 5-JUN-67); many of the apple trees still survive.

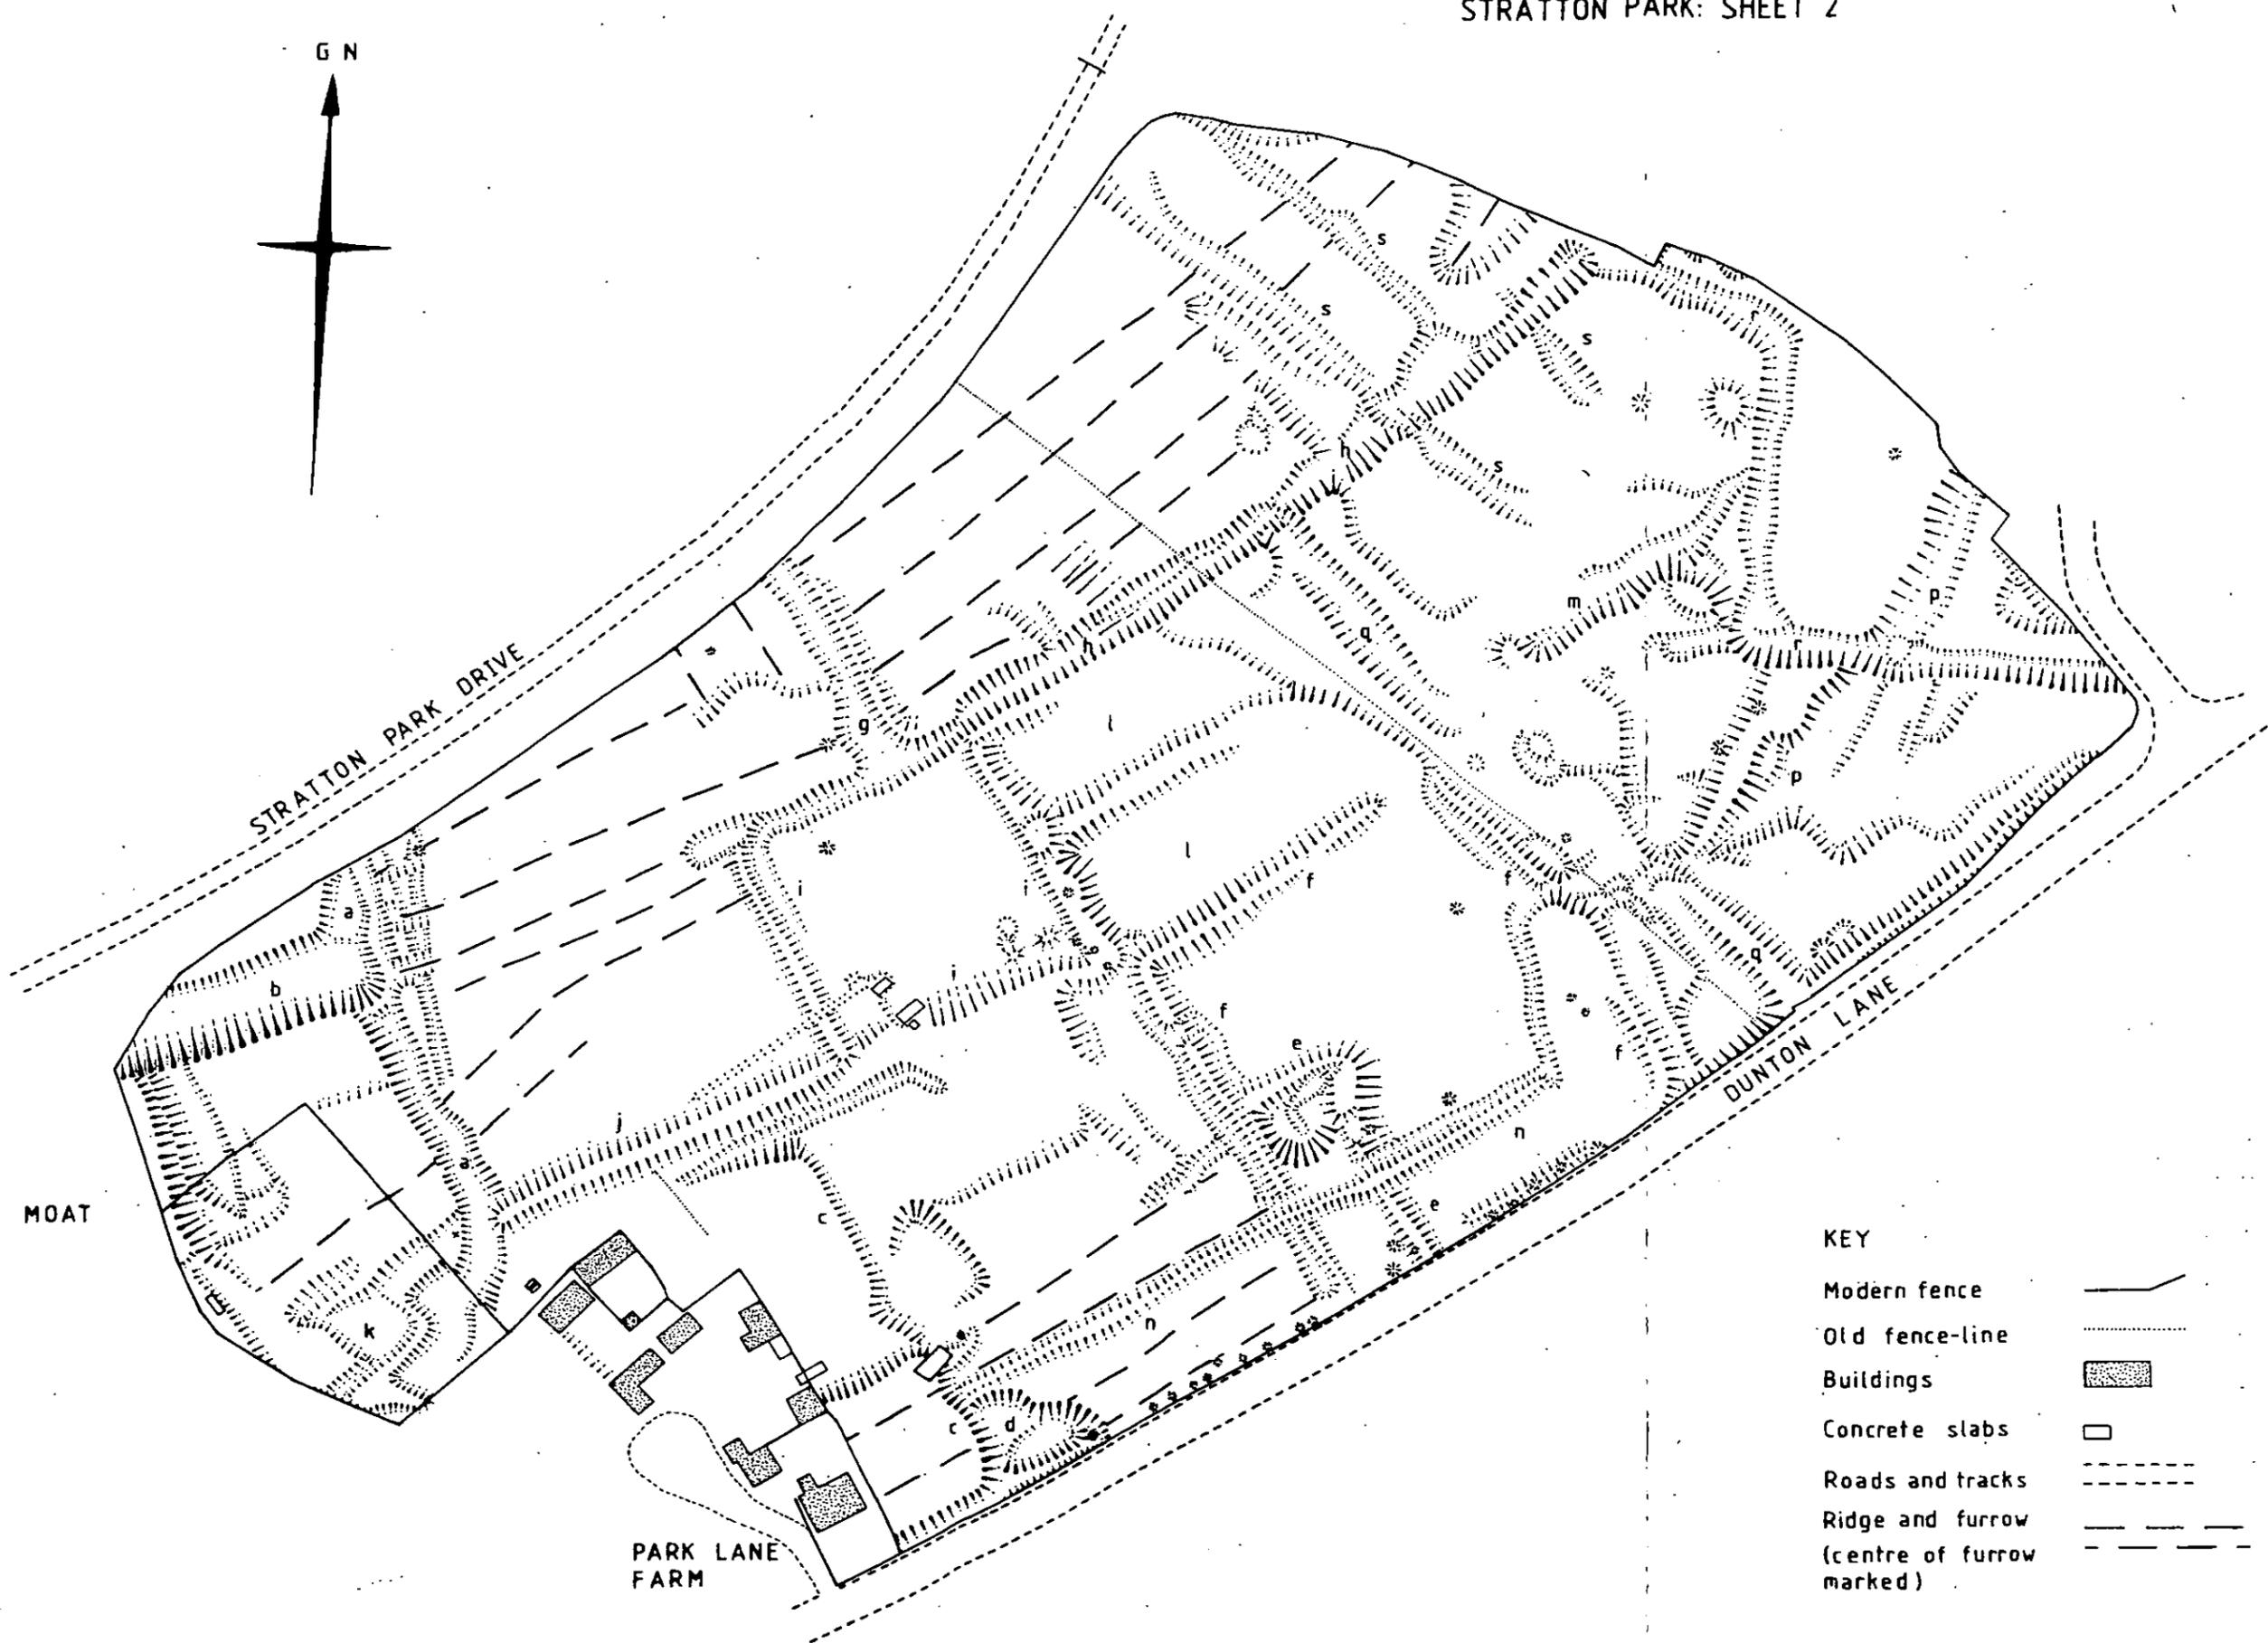
For relationship to the moat see plan sheet 1, for detail of the paddock see plan sheet 2. All bracketed letters refer to the latter sheet. Few of the earthworks can be clearly seen on any of the aerial photographs, but the best photograph is Aerofilms/91/Col/114 frame 1429, 20-AUG-91, held by the Bedfordshire SMR.

The paddock is covered with earthworks (TL 24 SW 21) representing various phases of use. A fence is shown crossing the paddock on the 1974 map (OS (a)), and its line can still be detected on the ground. North-east of the old fence-line the field has been confused by modern tracks and constructions, but the remainder of the field appears largely undisturbed by recent activity. Park Lane Farm has destroyed part of the south-western end of the paddock, confusing the relationship between the earthworks of the paddock and the moat.

parallel shallow ditch, 0.2m deep, on its eastern side. East of this is a ditch or hollow-way (a), up to 0.5m deep, which runs roughly north to south, and curving south-west at its southern end. Both this feature and the bank of the moat are cut at their northern ends by a long, pond-like feature (b). This is 1.1m deep on its steeper, southern side; its northern side is more gradual and only 0.4m deep. The eastern end of feature b is rounded, and the western end has been destroyed by Stratton Park Drive. Feature a seems to continue to the north of b, as a shallow linear hollow, also cut by Stratton Park Drive.

East of Park Lane Farm is a platform (c) with an east-facing scarp reaching 0.6m in height. The scarp is generally steep and well defined, and turns west at its northern end before fading. Despite its height cultivation ridges, up to 0.3m high, about 7.0m wide, and aligned south-west to north-east, cut across the southern part of feature c. These ridges are themselves cut by a small, kidney-shaped pond (d), 0.6m deep. The north-facing scarp, 0.4m high, running transversely across the platform, may define the northern boundary of this furlong, and a bank (e) up to 0.4m high, probably formed a headland to the east. There is no clear evidence of other ridges to the north in this area, so these features probably represent the northern edge of a furlong extending further south and west. Where bank e turns to form the corner of the furlong the corner itself is occupied by a small, sub-circular pond, 0.5m deep. Both the bank and the furrows appear to have been overlain by the western bank and ditch of a rectangular enclosure (f), though there is no trace on the ground of the furrows east of this boundary.

In the north-western part of the paddock there is well defined ridge and furrow, reaching 0.3m in height, and varying between 11.0m and 7.0m in width. Though later activity has confused the line of the furrows to some extent, it seems probable that originally the western headland of the furlong ran along the eastern side of feature a. The furlong appears to have been shortened in association with the construction of a series of small enclosures. A new headland formed to the east of a transverse ditch (g), 0.3m deep, to the south-west of which two shallow gullies may represent the tips of furrows running parallel to the ditch. This suggests a reorientation of the ploughing regime in this area, using one of the existing ridges as a headland.

A well-defined ditch (h) forms a south-eastern boundary to the ridge and furrow, and the north-western side of some of the enclosures, and is abutted near its south-western end by feature g. Ditch h has steep scarps up to 0.5m in height, despite being disturbed by later activity, and aerial photographs suggest that it continued north-east into the next field. The line of the ditch is just visible on some photographs (541/148 frame 3038, 31-AUG-48; CPE/UK/2169 frame 2066, 24-JUN-47). Adjacent to ditch h is a square enclosure (i) defined by banks and scarps up to 0.4m high, though its south-eastern side is disturbed by modern concrete slabs and drains. A well-defined bank (j), 0.3m high, extends south-west from the southern corner of this enclosure to feature a, which it overlies. To the north of bank j are the patchy remains of narrow furrows, less than 0.2m deep and about 5m in width, which run south-west from enclosure i. Two furrows change direction slightly at their western ends and become wider; the southern most of these continues west across feature a. Other slight scarps west of feature a suggest that all the ridges may originally have extended almost as far as the
