**A Rapid Assessment of the Archaeological
Landscape surrounding Howgrave Hall and
Banqueting House, Sutton Howgrave, North
Yorkshire**

Abby Hunt

Archaeological Survey & Investigation Internal Report

© English Heritage 2005

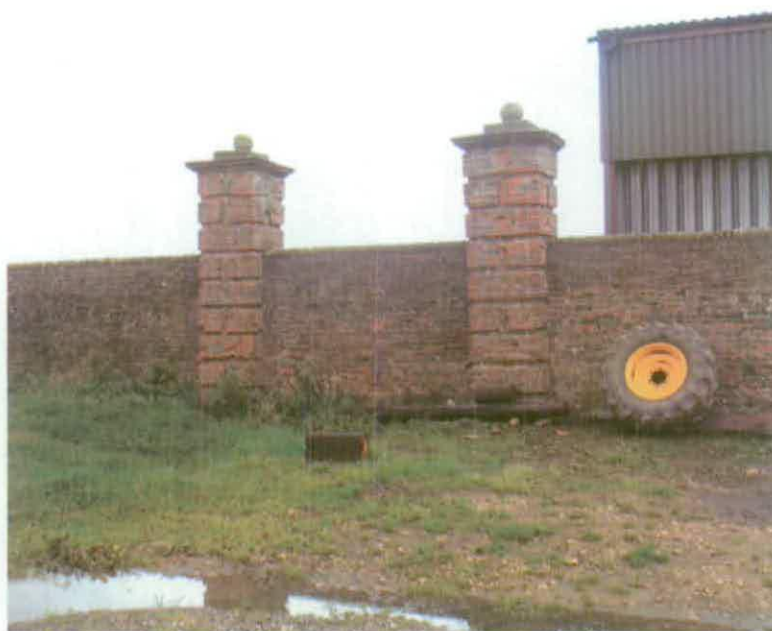
*Figure 2
The wall and gate
piers to the north-west
of the Banqueting
House*

The north-western edge of the walled enclosure is defined by a long stretch of brick wall, which incorporates a pair of gate piers close to its north-eastern end. This is a listed structure and is believed to date to c1700 (Listed Building UID 332650), making it broadly contemporary with the Banqueting Hall. Approximately 9m to the south-east of this wall, following a parallel course within the enclosure, is a hedgerow which defines a narrow strip of land. This hedgerow does not appear on the historic maps up to the 1830s but is shown on the Ordnance Survey First Edition map of the area (c1850).

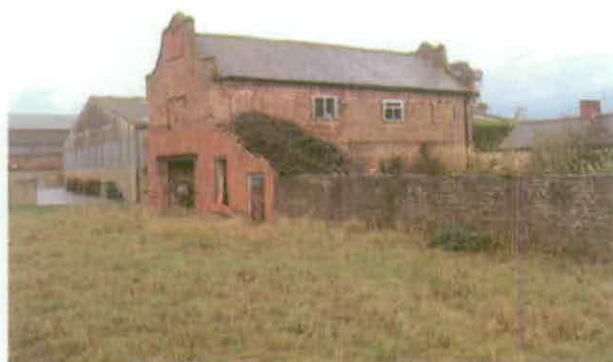
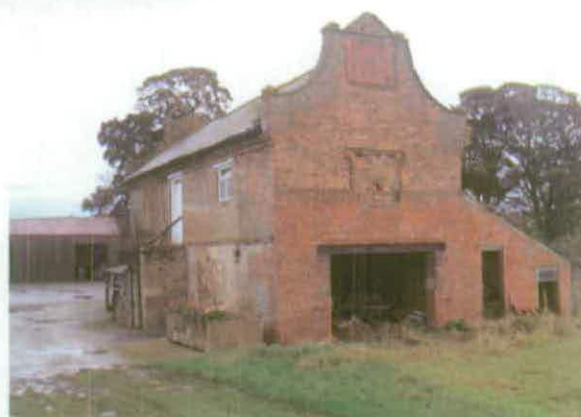
*Figure 3
Top: The Banqueting
House from the south.
These two elevations
would have been the
'show' faces of the
building.*

*Bottom: The
Banqueting House
from the west. The
exterior staircase
giving access to the
upper storey can be
seen to the left.*

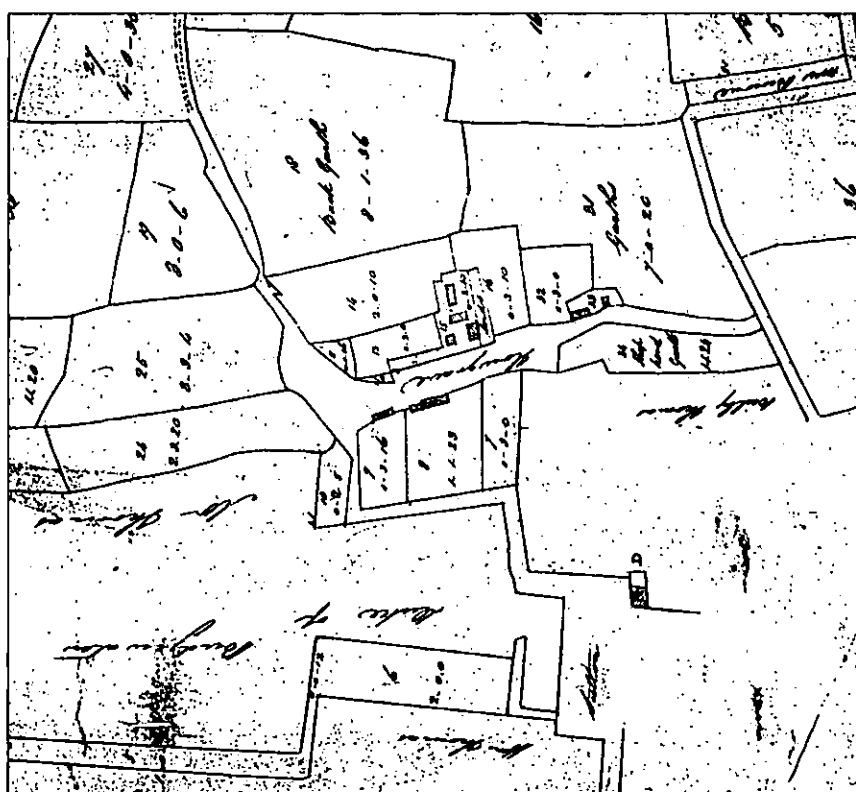
Figure 4
Extract from the 1760
plan of the estate of
Philip Bendlowes at
Sutton cum Howgrave.
Reproduced by
permission of
North Yorkshire
County Record Office.

A nineteenth-century copy of a plan of the estate of Philip Bendlowes at Sutton-cum-Howgrave originally dating to 1760 is held in the North Yorkshire County Record Office (NYCRO) (Ref: ZM1 132 MIC 1497/164-166; Figure 4). The plan shows that the walled enclosure containing the Banqueting House was, at this date, divided by a boundary on a north-east to south-west alignment. However, the long, narrow strip of land at the north-western of edge of this enclosure was apparently not in existence in 1760.

This plan also shows that the land occupied by the former village site was still subject to division at this point, with three unequal plots depicted, two of which have structures at their north-western ends. There is also a broad open area between these enclosures and the wall defining the walled enclosure and the extent of Howgrave Hall, labelled 'Howgrave'. This open area is accessed by a routeway from the west/north-west (labelled 'Public Bridle Route') and by another routeway from the north-east. The fact that this is a broad open area with access from both ends, adjacent to a row of plots, strongly suggests that it was originally a green associated with the former village. Although the plan does not extend far enough south to cover the whole of the area now occupied by Sutton Howgrave, it does show another open area here, this one labelled 'Sutton', in roughly the same location as the present village green. The existence of these two village greens concurs with the evidence

from the Domesday Survey that there were in fact two manors here. To the south-east of the plots (tofts) of Howgrave village, the plan shows a routeway, which is identifiable as the hollow way observed on the ground to the south of the large, rectilinear block of earthworks (Figure 6 - C).

The course of the 'Public Bridle Route' to the north-west of Howgrave Hall and the associated field boundaries shown on the 1760 plan create an anomalous curvilinear pattern in the landscape, which is distinctive from the other more regular field boundaries in this area. It may be that the bridleway was an established feature of some antiquity, in regular use at the time when the land was enclosed. The fields would thus have respected its course. Alternatively, the curvilinear boundary may perhaps have been a park boundary, creating an open landscape visible from the banqueting house, but requiring general traffic to and from the village to be diverted around the outside of it, hence the development of the bridleway. This curving field boundary no longer survives as an extant feature in the landscape, but has been fossilised as part of the course of the parish boundary of Howgrave CP.

It is interesting to note that there is apparently no road immediately to the north-east of the former village tofts shown on this plan, indicating that the present road, which is now the main routeway through the village, was in fact a post-1760 insertion.

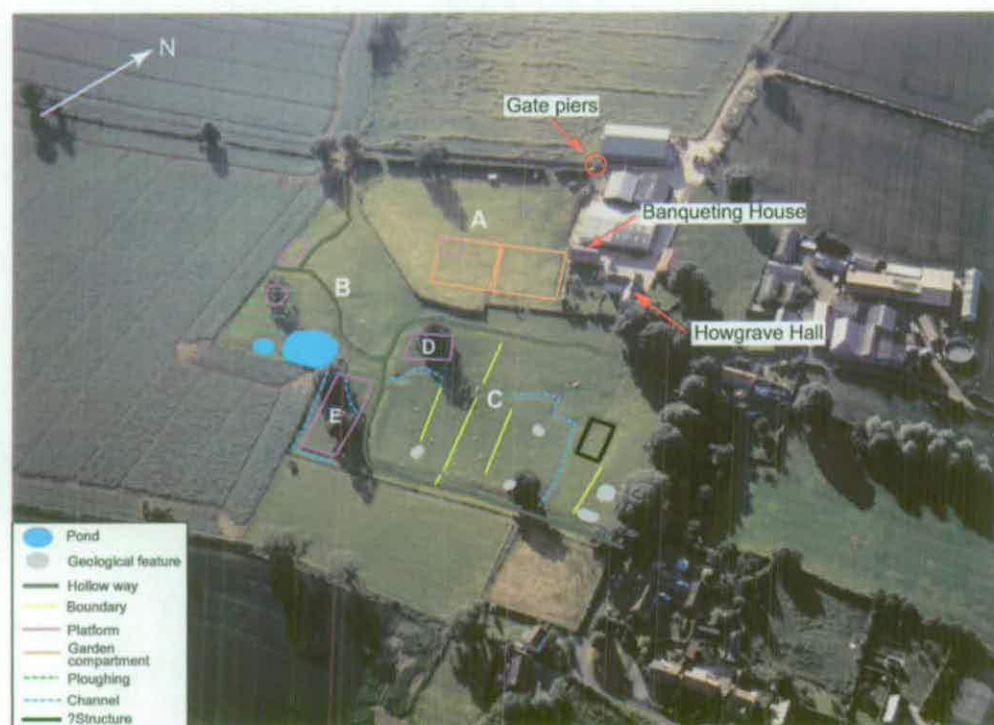
Figure 6
Annotated aerial
photograph of
Howgrave Hall
showing a schematic
depiction of the
principal features
observed during the
walk-over survey.
Photograph: ©English
Heritage. NMR 17288/
17 SE 3179/5 08-Jul-
1999

The features observed at the time of this site visit are shown as Figure 6, in schematic form superimposed on an aerial photograph of the site.

The Walled Enclosure (Figure 6 - A)

The north-western part of the walled enclosure is fairly level, with no particular features of note. However, the south-eastern part contains better defined earthwork remains. Parallel with the south-western end of the Banqueting House is a strong scarp, lying at right angles to the south-eastern enclosure wall. This defines a rectilinear area abutting the structure, probably a garden compartment, set at a lower level than the surrounding area. To the south-west of this is another rectilinear area, defined by a very low earthwork bank to the

In the western corner of the block defined by the hollow ways a rectilinear platform was also observed (Figure 6 - D). It is well-defined on three sides, but its south-eastern edge has been cut into by a channel (see below). There is presently a tree growing on this platform which is surrounded by stone fragments and a dense area of nettle growth, suggesting that it may be the remains of a former structure.

Situated in the corner of the modern field beyond the south-western edge of the large rectangular block of earthworks is a further rectilinear platform, close to the larger of the two ponds (Figure 6 - E). The platform is defined by the principal hollow way on two sides and by another linear hollow to the south-east and south-west. The latter is somewhat different in

form to the principal hollow way and has the appearance of a water-cut channel. Cutting across the northern corner of the platform is a shallow channel, possibly leading from one of the ponds. There are no obvious structural remains on the platform, but one possibility is that this may have been the site of a mill connected with the village. However, this platform is shown as a paddock on the 1760 plan of the site. In order to prove or disprove the suggestion of the mill location, a better understanding of the water management in this area is needed.

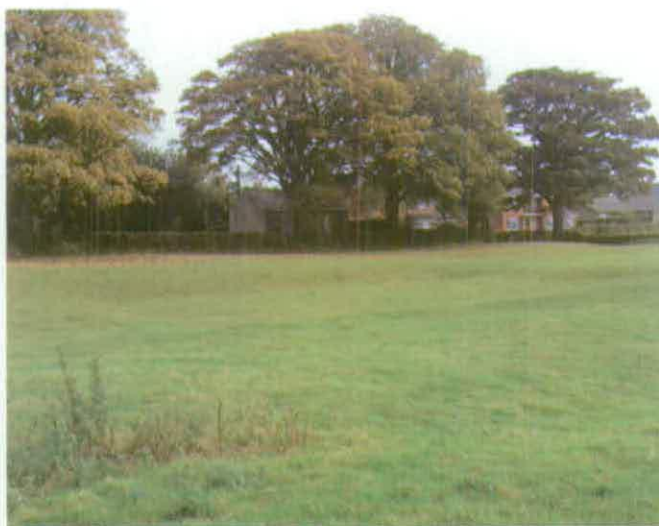
Figure 7
Rectilinear
depression close to
the north-east of the
medieval village
earthworks

west to south-east alignment. These correspond with the boundaries shown on the 1760 plan of the village (Figure 4), which, in turn, most likely respect and fossilise boundaries which originally formed part of the medieval village here. On a similar alignment is a deep rectangular hollow at the north-eastern end of the block of earthworks; this is approximately 1m deep in places (Figure 7). A slight bank within the hollow defines a shallow ditch around the interior of the feature. This may represent the location of a large building, perhaps an early incarnation of the manor house. The survival of the ditch would suggest that the building had subsequently been robbed out, with a trench dug to remove foundation stone. However, the ditch may be a little too regular and 'neat' to fully support this theory. Alternatively the feature may be later than the village remains, although their shared alignment suggests a degree of contemporaneity. A more detailed examination of this feature may bring a clearer idea of its original function.
