An Early Medieval Manor House and Landscape at Kilve, Somerset

An archaeological survey by English Heritage

County:	Somerset
District:	West Somerset
Parish:	Kilve
OS map no:	ST 14 SW
NGR:	ST 1462 4400
SAM no:	SO 480
NMR no:	ST 14 SW 17
SMR no:	33279, 33280, 33281
Surveyed:	July-Sept. 2002
Report by:	Elaine Jamieson
Surveyors:	E Jamieson, H Riley, B Thomason
Illustrations:	E Jamieson

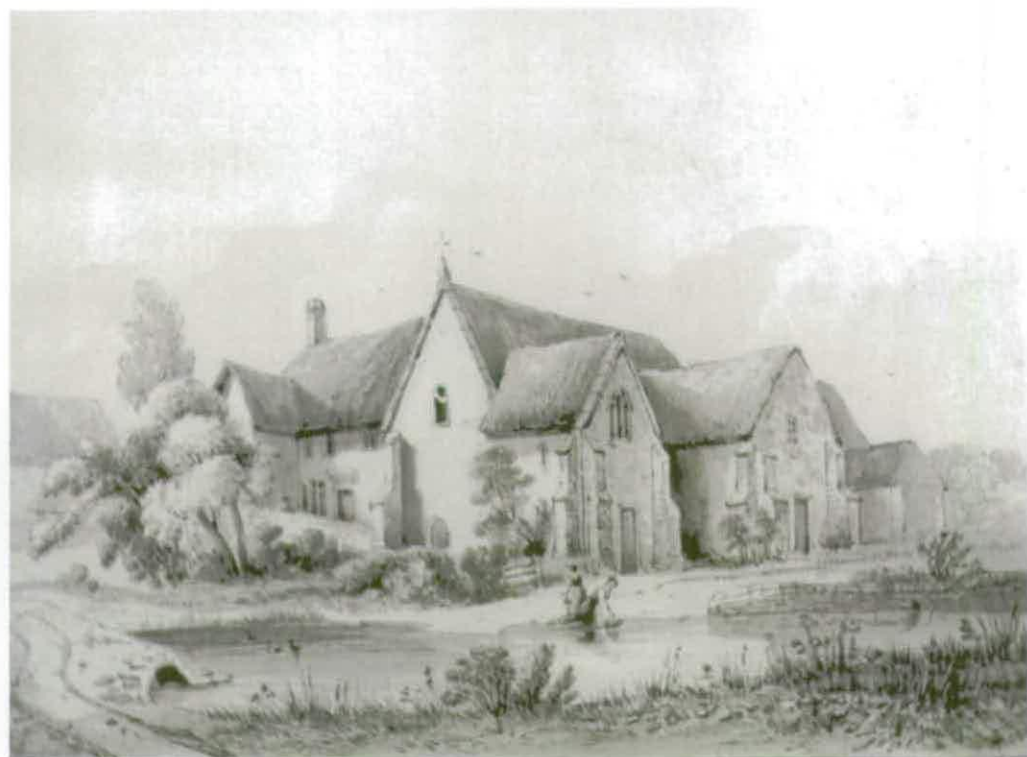
Fig. 2. 'Kilve Abbey' by WW Wheatley, 1847. Somerset Archaeology and Natural History Society.

There has been surprisingly little archaeological or historical work carried out on the medieval remains at Kilve. The buildings were referred to by the Rev. J. Collinson in his three volumes on the *History and Antiquities of the County of Somerset*, 1791. As part of an extra-illustrated copy of this publication, which was enlarged to 14 volumes, William W. Wheatley was commissioned to undertake a series of painting of the buildings at Kilve (Fig. 2). These paintings, dating from 1847, now form part of the Braikenridge Collection and give us an interesting insight into the appearance of both the buildings and their immediate surroundings in the first half of the 19th century.

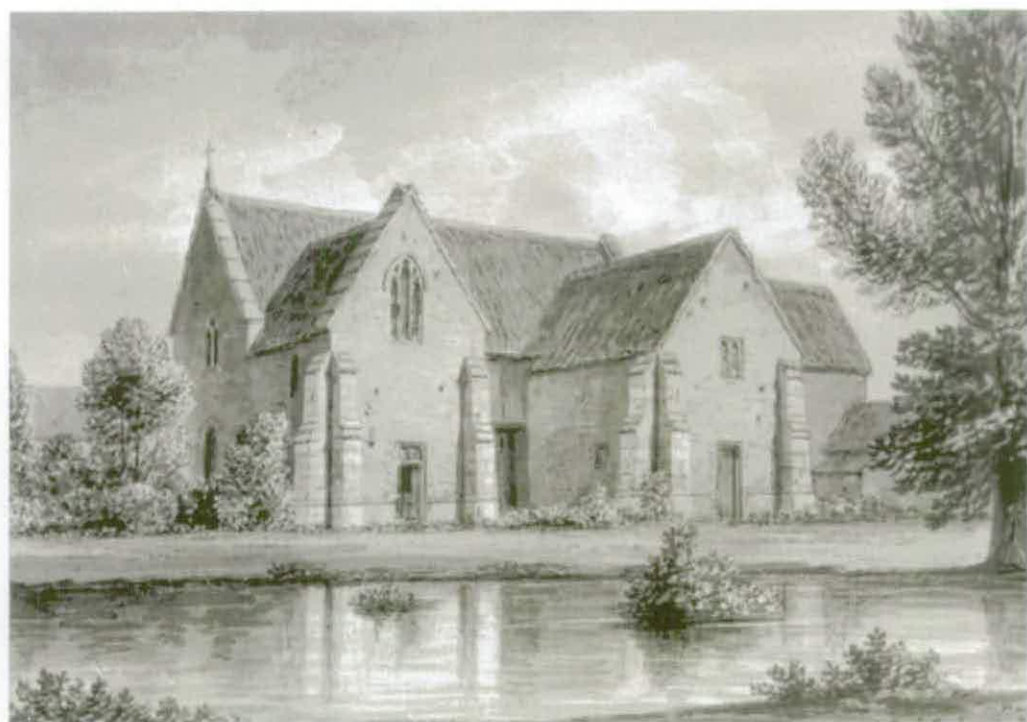
Fig. 3. 'Remains of Priory or Chantry' by J Buckler, 1840. Somerset Archaeological and Natural History Society.

There also exists a slightly earlier depiction of Kilve by John Buckler, dating from 1840, which forms part of the Pigott Collection, now held by the Somerset Archaeological and Natural History Society (Fig. 3). The painting was commissioned by John Hugh Smyth-Pigott and was to be included in his six volumes entitled *Illustrations of the Ecclesiastical and Domestic Architecture of Somersetshire*. Perhaps one of the interesting features depicted in all of these paintings is the large pond that appears in the foreground. Almost all trace of this pond has disappeared today but fortunately, through these paintings, we have a good idea of how it appeared and the impact it had on the immediate surroundings of the building.

The enclosure also contained several other features which help to identify the area as a manorial *curia*. These included a series of fish ponds which skirted the east and north-east sides of the manor house. The ponds at Kilve would have provided a ready supply of freshwater fish for consumption, however, it is increasingly being realised that even the largest complexes of ponds could not have provided a year-round supply (Bond 1998, 34). The close proximity of Kilve to the sea, and therefore to an easily accessible supply of sea fish, eels and shell fish, would perhaps indicate that these ponds may also have performed a more symbolic or ornamental role. The maintenance and breeding of fresh-water fish, and therefore their consumption, was a luxury only available to the upper members of society (Dyer 1988, 34). The ponds associated with these fish may therefore be viewed as symbols of this exclusiveness, indicators of rank and privilege. The importance of water in medieval designed landscapes is increasingly being recognised - its ability to surround, to reflect, and to support imagery (Everson 1998). The close proximity of the ponds at Kilve to the buildings may not simply be attributed to convenience and security, but could also have served an aesthetic purpose; the reflective quality of the ponds is clearly illustrated in Bucklers' painting of 1840 (Fig. 3).

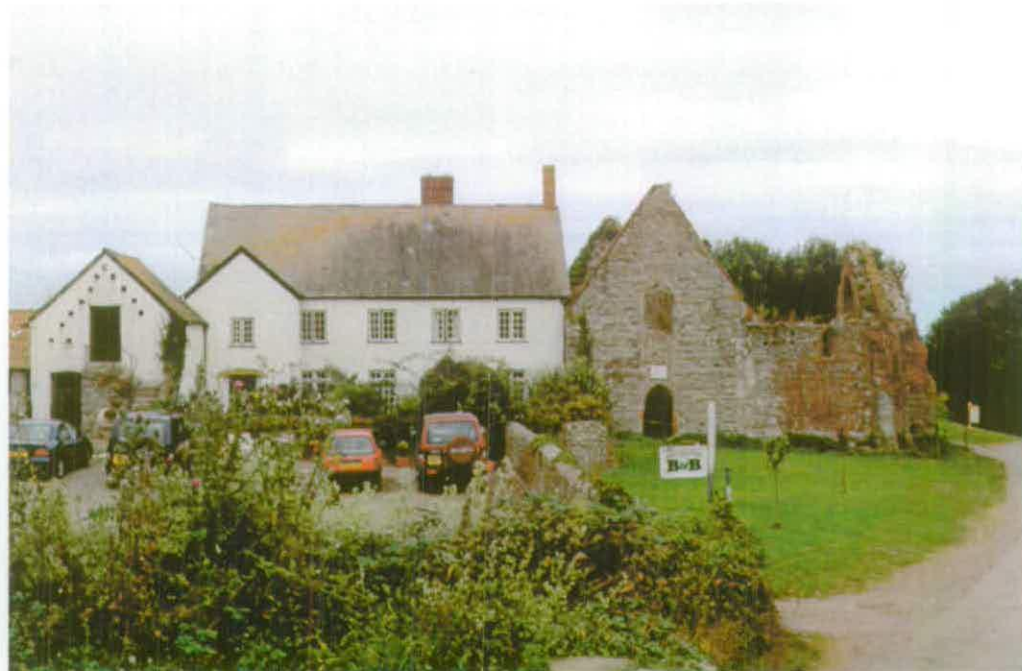
Fig. 6. Priory Cottage, Chantry Cottage and the remains of chantry from the south east.

The buildings at Kilve which now form *Priory Cottage*, *Chantry Cottage* and the *remains of chantry* represent the vestiges of a substantial medieval residence dating from the 13th or 14th centuries. The medieval elements of the house were built using lias rubble with some Ham-stone detailing, and comprise a hall range, a large (ruined) solar wing, with a chapel and extensive L-plan apartments adjoining. An in-line range of probable medieval date formerly stood at the western end of the hall, and although this no longer survives it most likely formed the service range of the house. A wing to the rear – the west wing – is positioned across the junction between the hall range and the site of the in-line range. This wing does not appear to be medieval in date, although its rendered finish may conceal evidence of such. There is a porch, fronting the entrance to the hall range, the ground floor of which may date from the medieval period. It is likely that the hall was originally aisled or that it had a roof form based on a close derivative of an aisled arrangement. Although the medieval roofs were destroyed by fire in the 19th century, their outlines are preserved in the gable walls of the hall, solar and chapel, demonstrating an arch-braced form of construction. Only *Priory Cottage* and *Chantry Cottage* remain roofed and now have a covering of Welsh slate, however, 19th-century depictions of the buildings show they were once thatched throughout, probably matching the original treatment of the roofs.

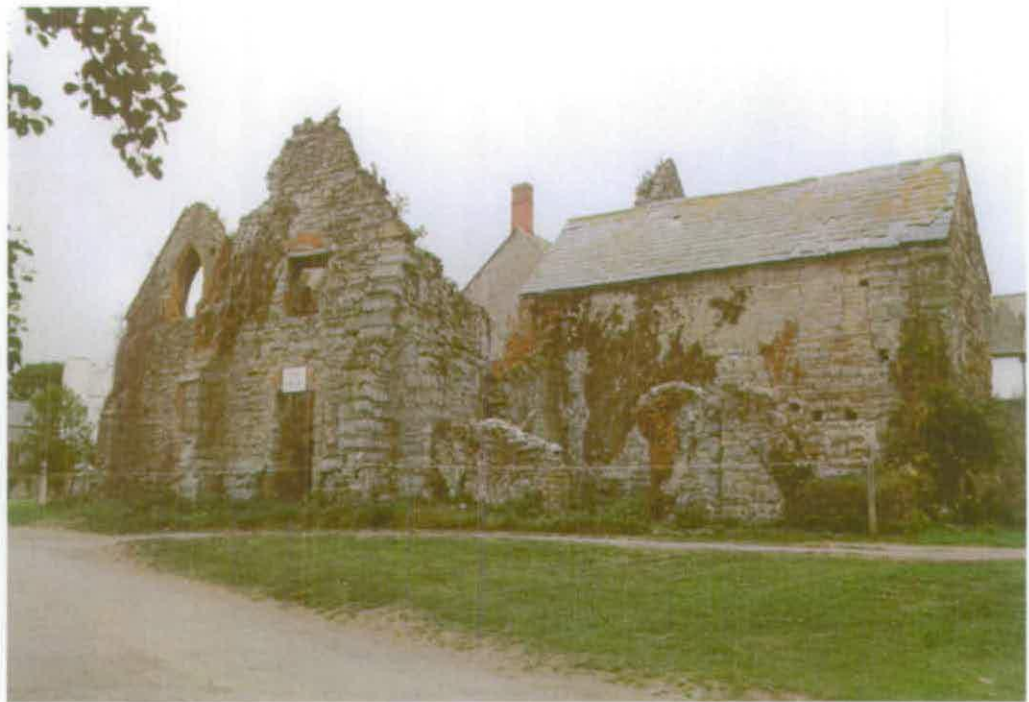
Fig. 9. North wing, east wing, and chapel from the north-east.

indicator of this is on the south-east elevation where the scar of a buttress that has been removed or has collapsed can be clearly seen. If the chapel was a later addition, then the design of the solar probably would have incorporated a pair of angle buttresses at the east corner. Internally, a short vertical joint, as well as a number of larger keyed stones, would also indicate the loss of a buttress where the chapel wall abuts. The second indicator of a phase between the solar and the chapel consists of a slight change in alignment between the south-east wall of the solar and the corresponding wall of the chapel. Further evidence is apparent in the north-west wall of the chapel, where there is a joint formed by the conjunction of the chapel and the solar. There is, however, no plinth visible along the south-east wall of the solar wing, possibly indicating that the chapel wing was envisaged in the original design. Contrasting stonework between the solar range and chapel again adds weight to the evidence for slightly later construction. There is a greater use of Ham-stone in the chapel wing than in the rest of the building, possibly explained by the particular status of the chapel. However, the form of the chapel's east window and the piscina's cusped head indicate that the chapel was probably built in the 14th century. Domestic chapels are a common feature of manorial properties of this period and were often located adjoining the main apartments. As the principal chamber of the solar was on the first floor then the chapel was normally also at that level, allowing the lord and his family to take private mass daily.

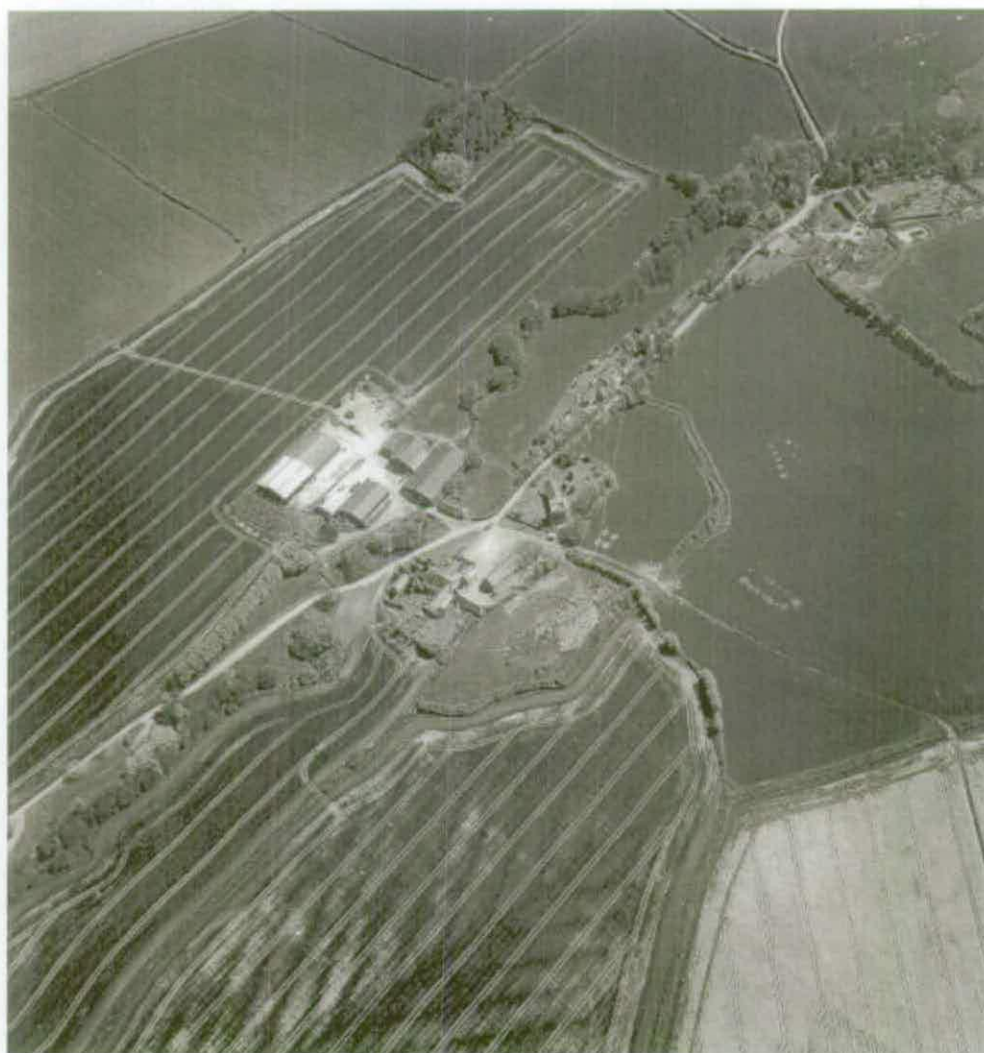
Fig. 10. Aerial photograph showing section of medieval enclosure fossilised in existing field boundary. (NMR 21189/01 © Crown Copyright).

The medieval manor house is bounded to the west by a substantial water-filled ditch and hedge-topped bank (Fig. 10). It is uncertain whether this boundary was always water-filled, but its form suggests it may represent the remains of a medieval enclosure, possibly defining the *curia* of the manor. The original area of the enclosure cannot be known for certain as there is no conclusive field evidence to indicate its eastern extent, however, the location of the modern field boundary on this side may give an indication as to the position of the original boundary. The enclosure would appear to be *c* 240m long from north-west to south-east and *c* 175m wide, covering an area of approximately 3.8ha (9.3 acres).

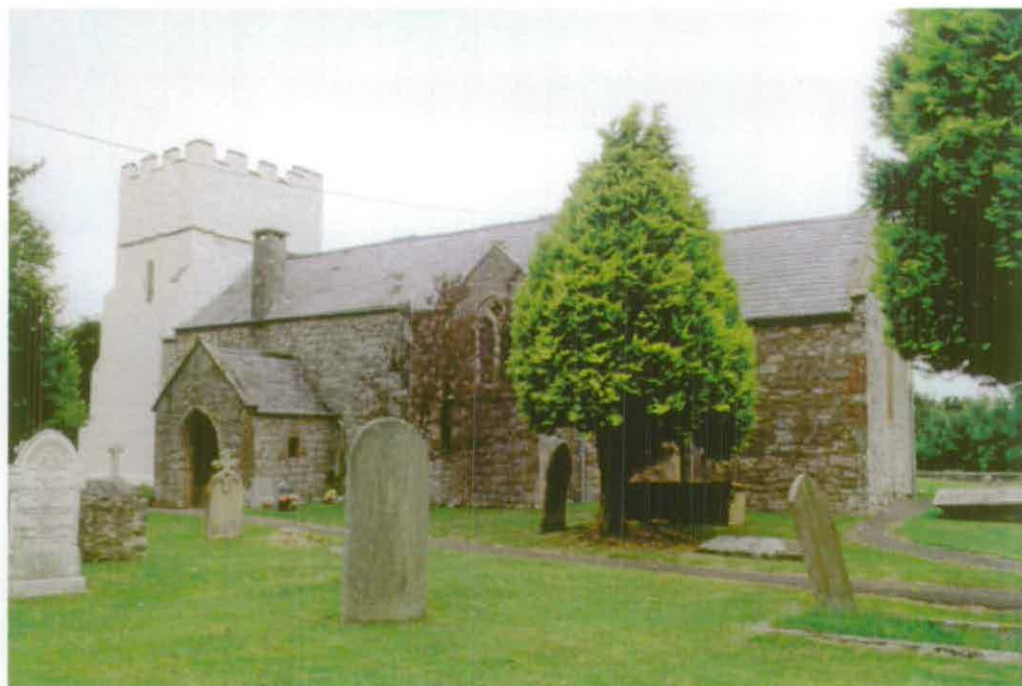
Fig. 11. St. Mary's parish church.

The Parish Church of St Mary's also lies within the medieval *curia*, *c* 50m to the south of the manor house, on the southern side of the principal approach. The main fabric of the church would appear to date from the 14th and 15th centuries, with the tower of possible early 17th-century date. However, a church has stood on or near this spot since much earlier times. There is a documentary reference to a rector of Kilve between 1265 and 1273 (VCH 1985, 101) which, combined with the 12th-century font in the tower, would indicate the existence of an earlier church. The form of the church, a simple two-celled building with no aisles, and the fact it lies within the manorial enclosure may also indicate an early origin. The latter suggests that the church may have been founded by the manorial lord, possibly as early as the 10th or 11th century as this period saw a great insurgence of small churches built by local landowners (Blair 1996, 13).

The existing building is constructed of local blue lias random rubble with a slate roof and was originally rendered with lime mortar. The render was stripped-off in the early 20th century, almost certainly as part of the 1913 restoration work, but has recently been reinstated on the

church tower. The main body of the church is *c* 24m east-west and *c* 6m north-south, with an entrance porch on the south side. The ribbed and plastered barrel-vaulted roof of the chancel dates from the 15th century; the nave roof is similar in date but was partly restored in the 19th century and the plaster removed. There is a small vestry adjoining the north side of the chancel which was added in 1876 and dedicated to the memory of William Greswell, a former rector of Kilve. The vestry is accessed from the chancel through a large two-centred arch dating from the 14th century. This almost certainly originally led through to a chantry chapel in which the chantry priests could say mass to their benefactor. This arch is very different in character from the chancel arch, which can also be dated to the 14th century, and its heavy, simple style would suggest that it was probably one of the first building projects to stem from the founding of Kilve Chantry (Jones 2003). This arch can be seen to form one of two bays, the second arch of which has been foreshortened, indicating the chancel and chapel were once longer. A single-bay gabled projection with an arched two-light window is located at the east end of the south wall of the nave. This projection abutts a two-light mullioned window and is partially blocked internally, with an ogee-headed blocked niche visible on the east side of the adjoining window; the projection almost certainly provided access and light to a rood loft. Until 1636 the church bells were housed in a separate thatched building (VCH 1985, 102).

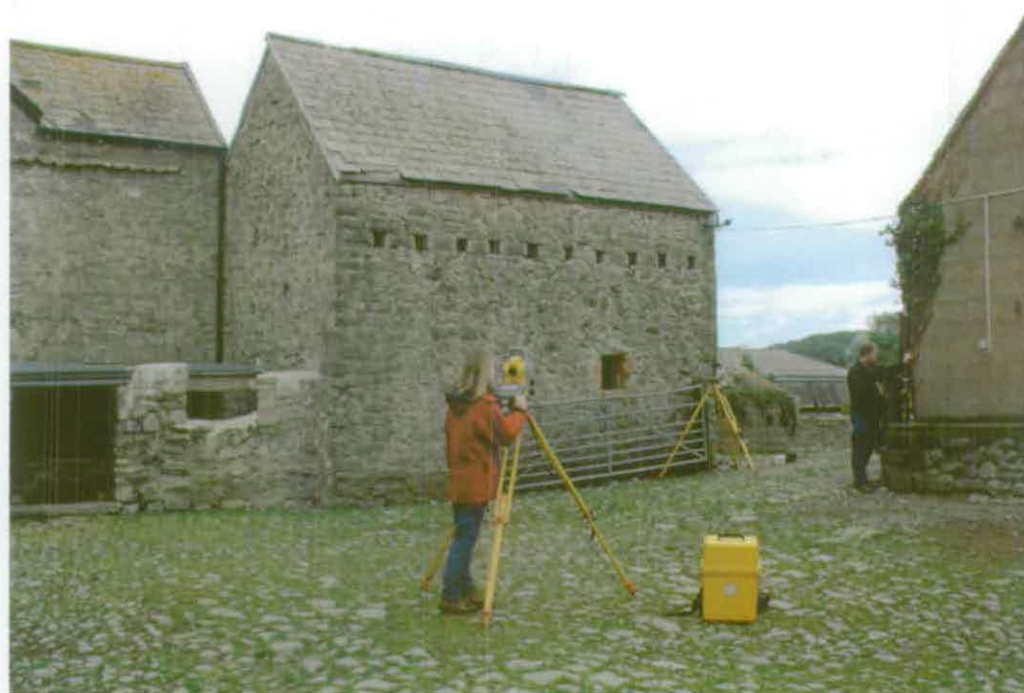
Fig. 12. Photograph looking east across cobbled yard towards dairy with dovecote above.

Documentary sources indicate that from the mid-17th century the buildings were known as Kilve Farm. With the exception of the main house however, the surviving farm buildings would not appear to date from any earlier than the late 18th or early 19th centuries. The farm buildings consist of a 7-bay shelter shed situated along one side of a cobbled yard west of the medieval remains, with an animal shed and stables located at right angles to the yard. A barn is depicted on the OS 1st edition where the animal shed stands today but the building had been demolished by the time of the 2nd edition in 1902 and only the earthwork remains of its southern extent survive. A small dairy with dovecote above forms part of the east side of the yard (Fig. 12). The survey has shown however that this cobbled yard was once the location of the service range of the medieval manor house which may have been demolished to accommodate these later farm buildings.

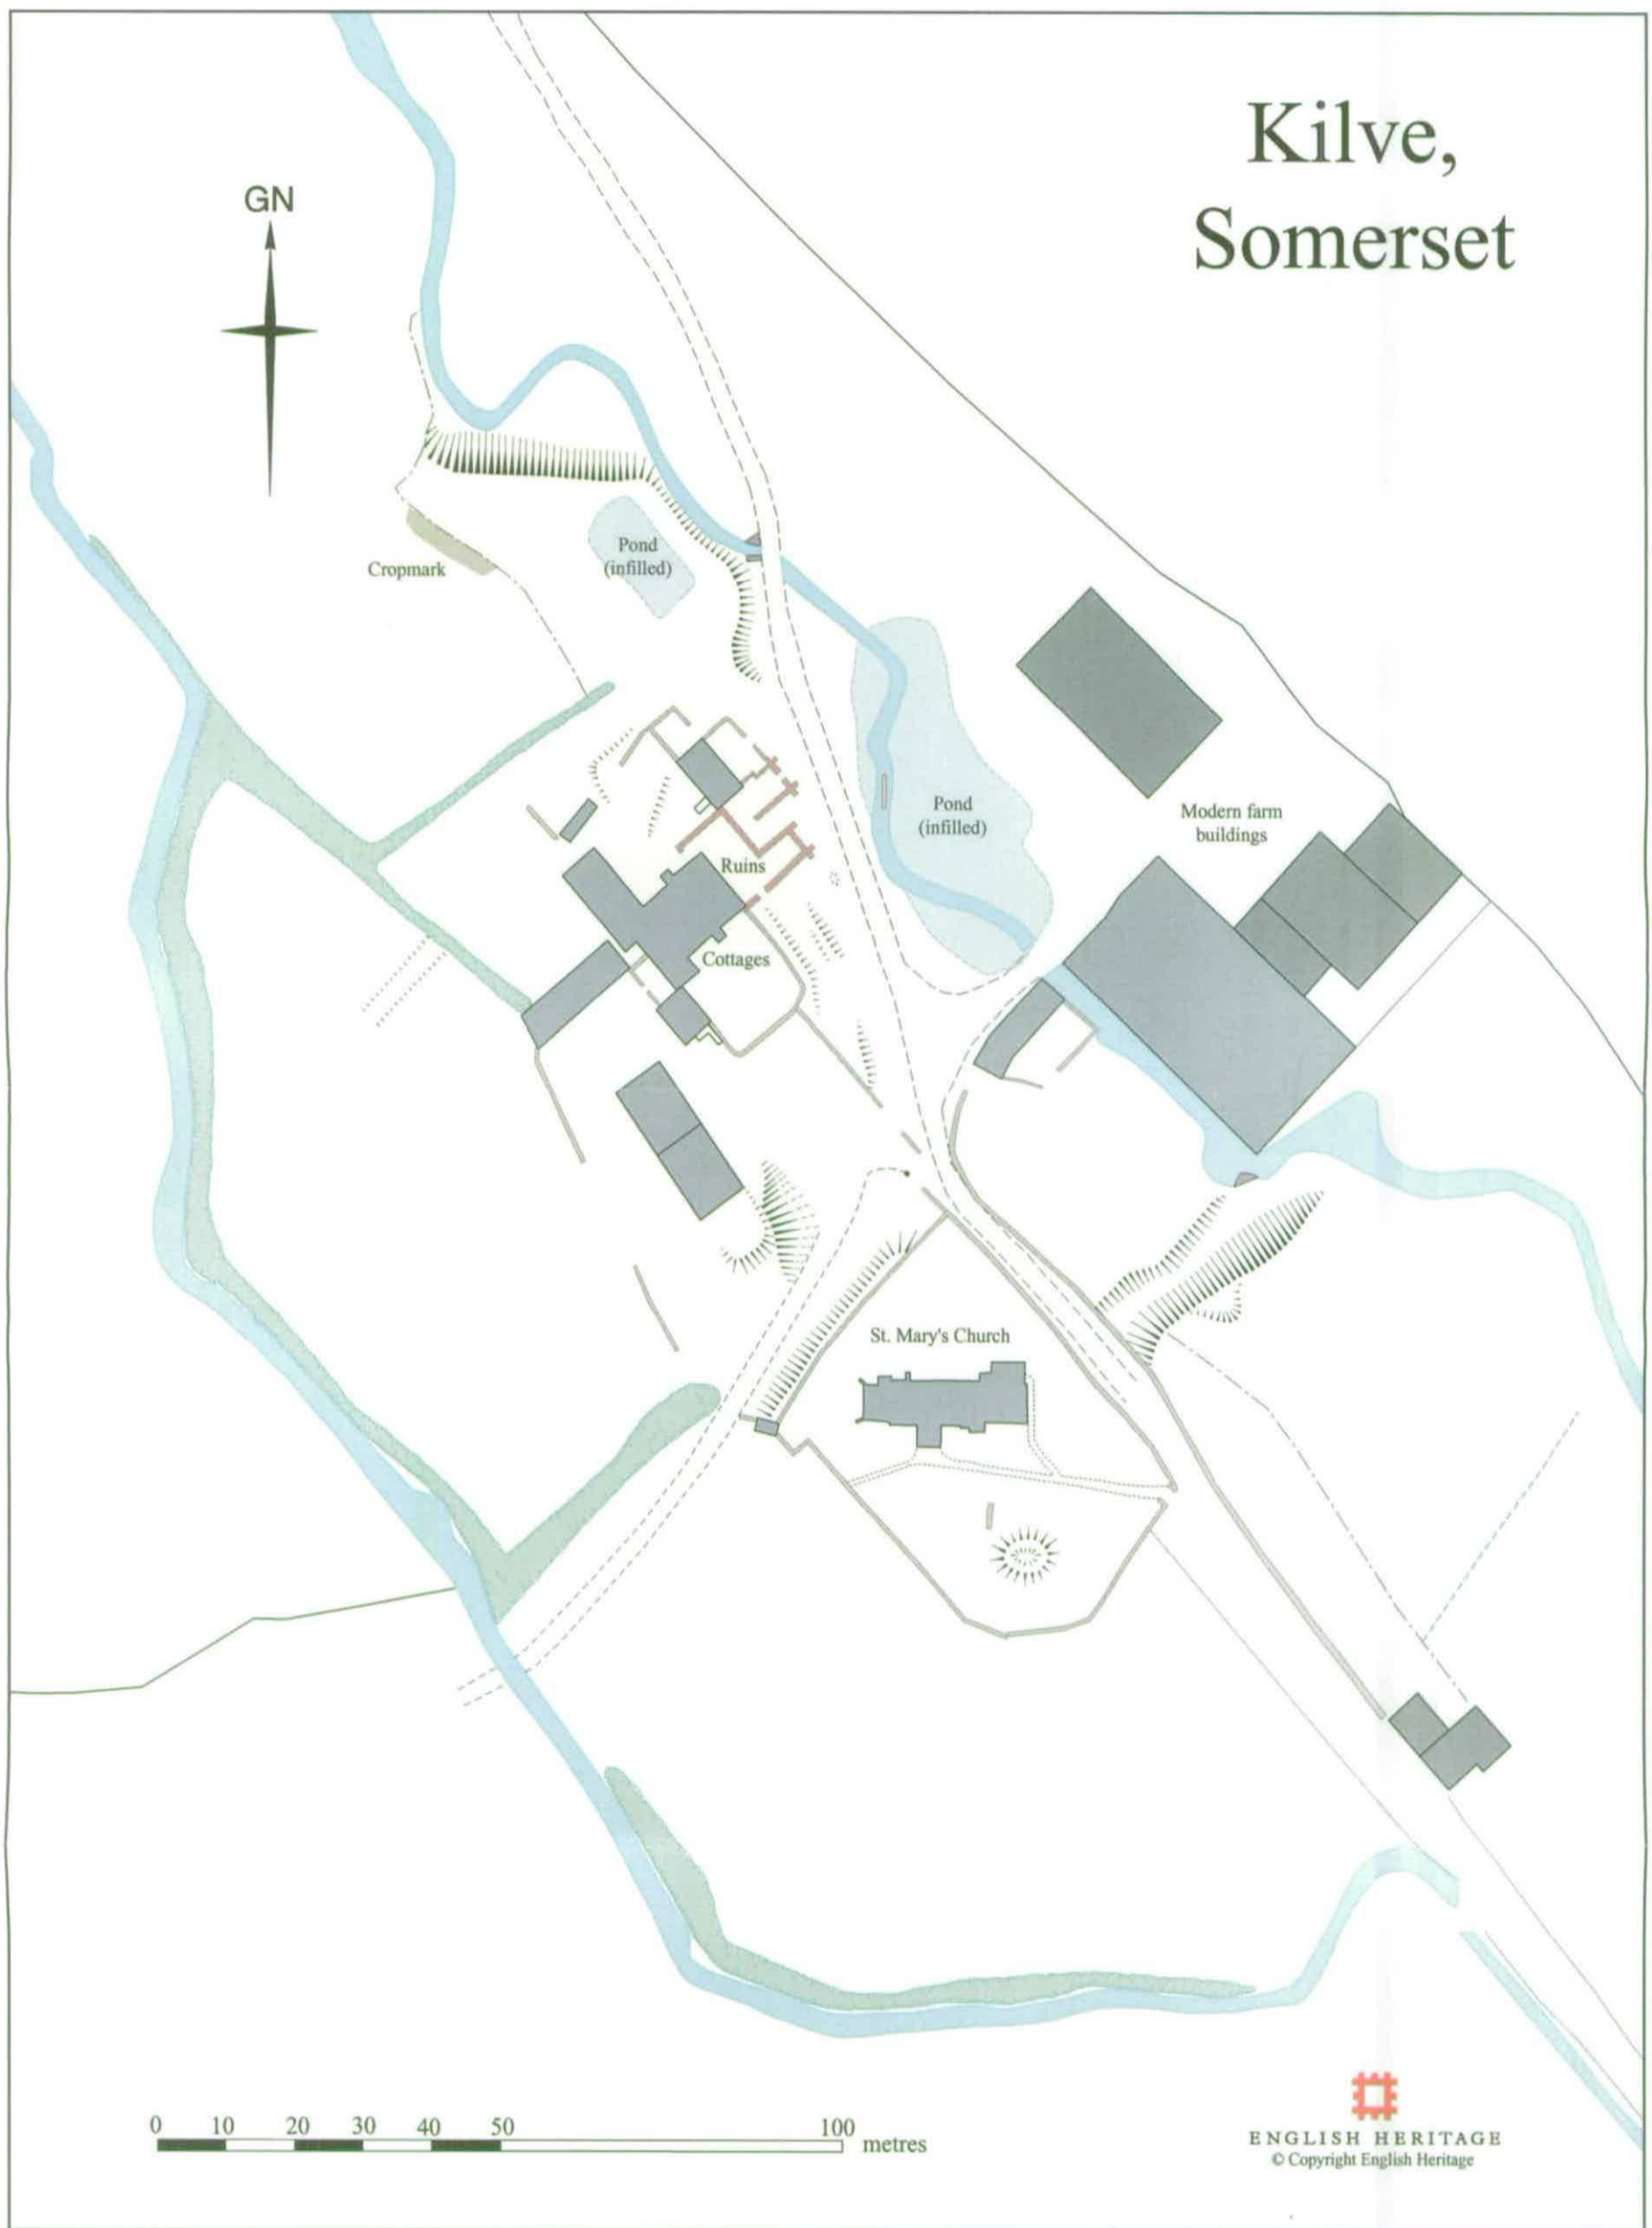
Fig. 14. Kilve, Somerset. English Heritage 1:500 survey (reduced).

The Manorial Enclosure (Fig. 14)

The topographical survey has highlighted that the building remains at Kilve form the focus of a complex medieval landscape. The manor house can be seen to command a dominant position within a clearly defined area which almost certainly formed a manorial *curia* or enclosure. This enclosure would have functioned on several levels: it would have had symbolic meaning, defining the area as an exclusively lordly space from which justice and authority were controlled; it would also have had a more practical function, providing the gardens and orchards surrounding the house with shelter and privacy as well as separating them from the deer park beyond. Stock-proof boundaries were an important feature of medieval properties and could take several forms ranging from a large moat, to a more modest ditch or fence. The new garden created at Rimpton in 1264-6 by the Bishop of Winchester was recorded as being surrounded by a substantial ditch and bank 5ft (1.6m) high and 7ft (2.2m) broad (Bond & Iles, 1991).
