**An Earthwork Survey at
Hobs Moat - Solihull,
West Midlands**

Summary

A substantial moated site covering an area of 1.5 hectares has been surveyed. The site comprises an island enclosed by a bank that is separated from a counterscarp by a deep, steep-sided ditch. Evidence for another outer ditch, which was located during excavation in 1955, was not evident. Field boundaries to the north and south were also recorded.

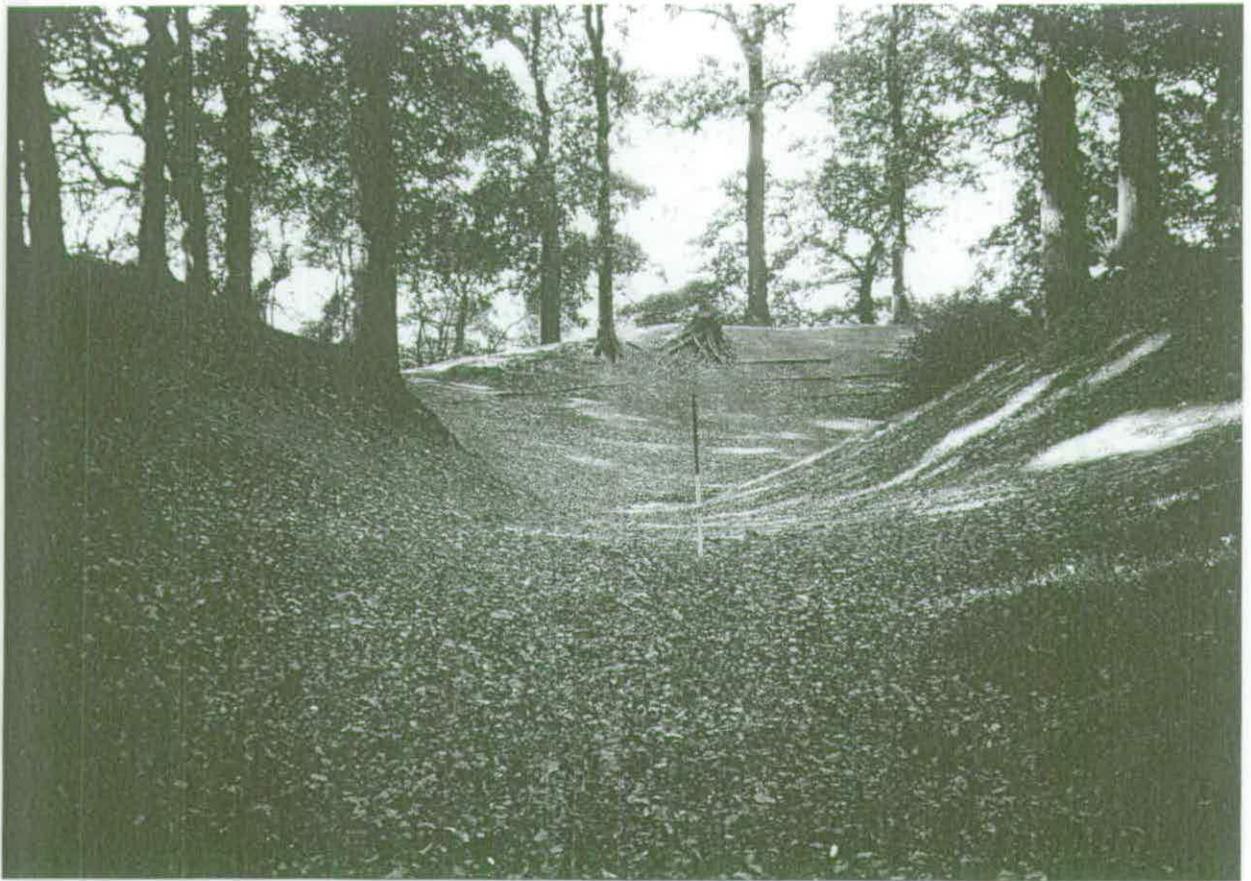
Fig. 1. The ditch at the north-west corner of Hobs Moat. Wood used in consolidation work can be seen on the far bank.

In 1987, in order to alleviate the erosion that was being caused by bicycles and motorbicycles, conservation work was carried out on the banks of the moat (Streeton 1994, 12). This work entailed placing pegged retaining boards parallel to the slope in order to stabilize an imported layer of soil and turf. Although the boards are now exposed in places (see fig. 1), they still provide a degree of protection for the monument.

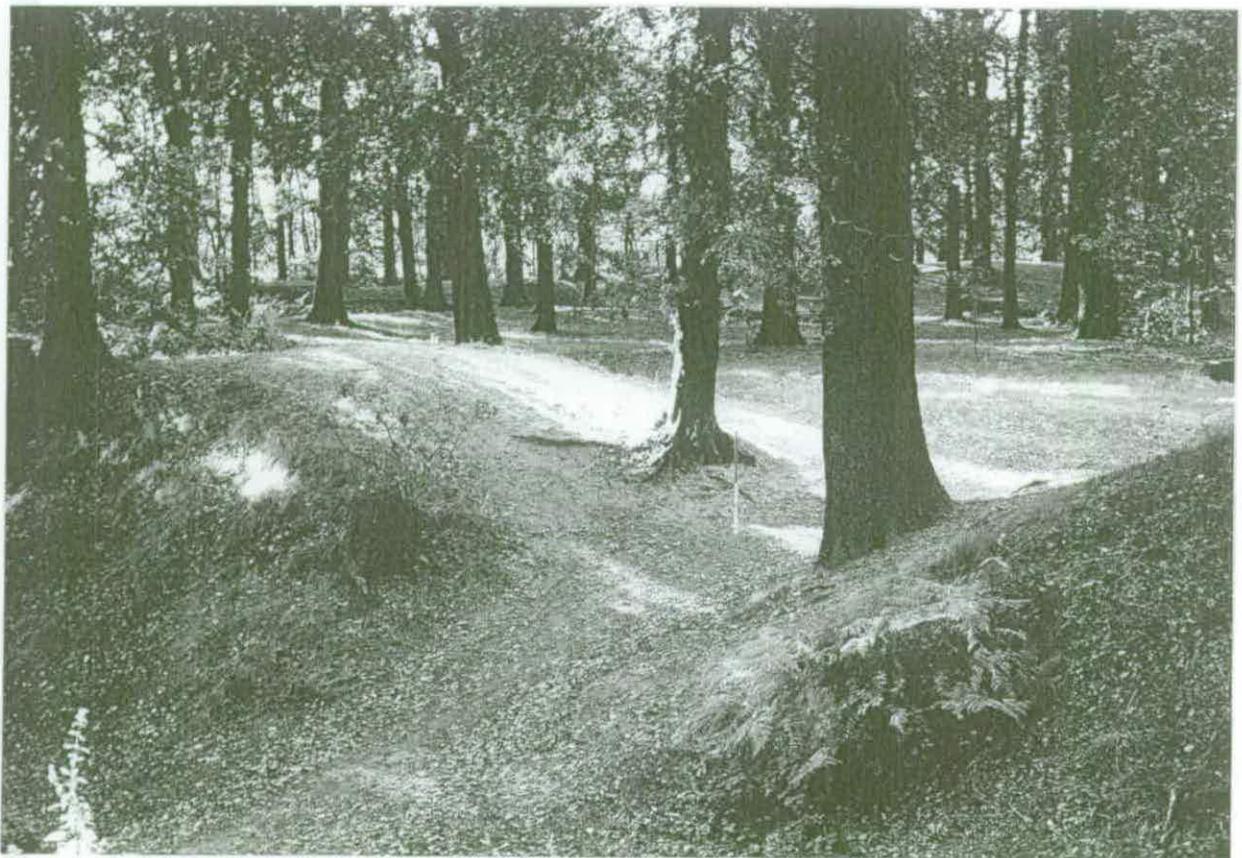
Fig. 2. The possible entrance on the inner bank of the moat island on the east side.

The moat island slopes gradually from south to north and covers an area of *c.* 0.65 hectares. Surrounding the island is a bank; on the west side it is complete and well preserved whilst on the southern side it is very degraded. Along the eastern bank there is evidence of extensive wear, and in two places there are breaks, the northerly break being in the area of the third excavation trench. There is also a break along the north side measuring 4m wide. Internally there is a spread linear bank measuring 35m long and up to 0.2m high that extends from the south side; the first excavation trench probably lies on this bank. To the north is an irregular shaped curving platform standing *c.* 0.3m high.
