**TONE WORKS,  
WELLINGTON, SOMERSET  
SURVEY AND ANALYSIS OF BUILDINGS,  
POWER SYSTEMS AND MACHINERY**

**VOLUME ONE: REPORT**

SURVEY AND ANALYSIS OF BUILDINGS,  
POWER SYSTEMS AND MACHINERY

Research Department Report Series No. 72/2007

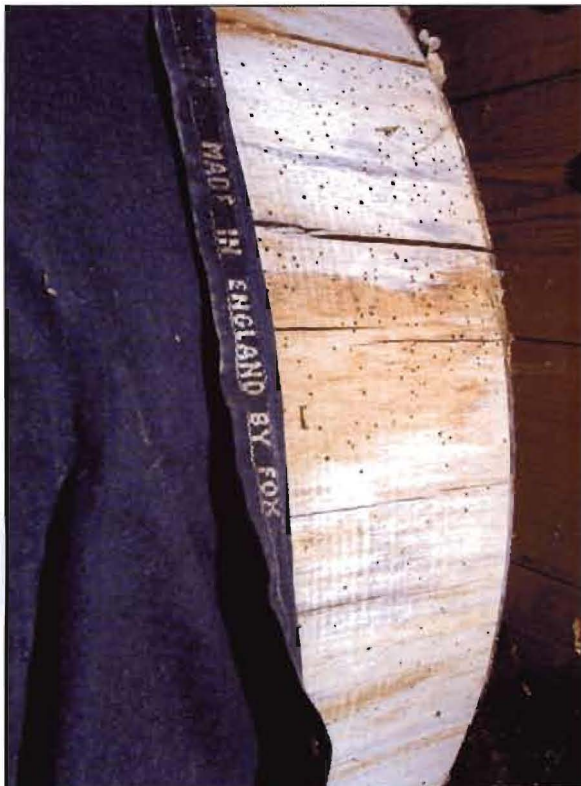
Figure 1.  
Partly-finished cloth left in a scouring machine, Tone Works,  
July 2007. [DP043821]

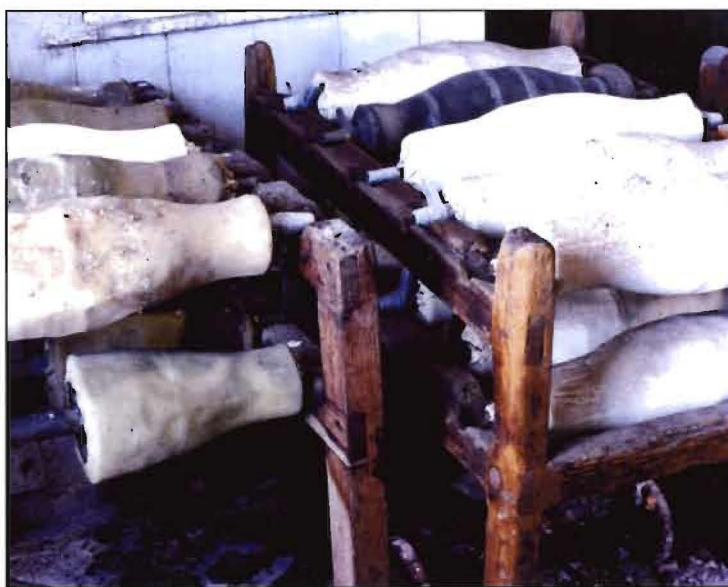
Figure 4.  
*Disused equipment used for moulding Fox's Patented Improved Puttees, photographed at Tonedale in 1995.[AA96/03915]*

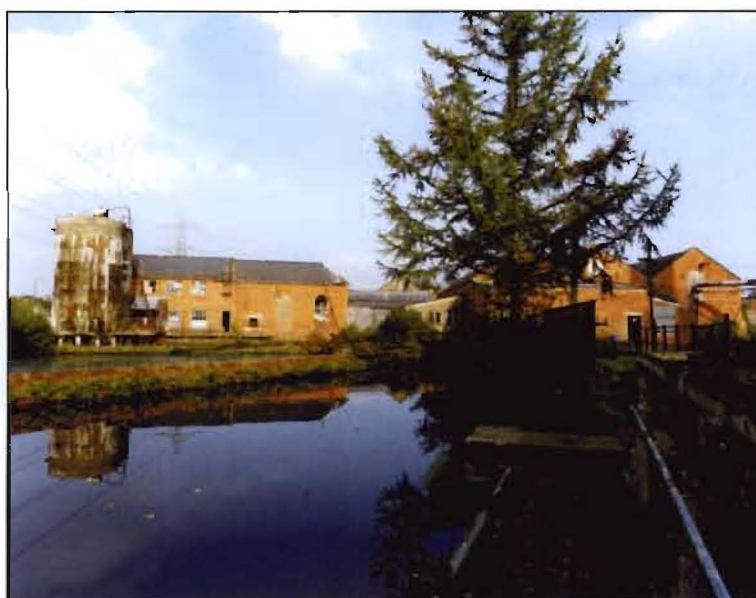
*Figure 8.*  
*The system of ponds, sluices and water treatment facilities had a major influence on the development of Tone Works.*  
[AA96/00691]

The supply of large quantities of river water for both power and processes was critical to the efficient operation of Tone Works and was greatly improved in this period, leading to extensive alterations to the surrounding landscape and influencing the expansion of the site (Figure 8). Engineering works included changing the course of the river, probably in 1871 and 1884, to help alleviate flooding and provide a new area of reclaimed land for building.<sup>13</sup> The western half of the U-bend in the river, shown on the Tithe Maps, was filled in and replaced by the weir and a new section of straight channel, which survives today. The OS plans of 1889 indicates that part of the old river channel was temporarily retained to form a leat feeding the headrace, with the newly-built stretch of the main river serving as a bypass, and that new buildings had already been built on the reclaimed area. A curved weir was built across the upstream end of the new river channel, at the head of the leat.<sup>14</sup> A bypass sluice was built in the side of the leat just below the weir so that flood waters could be diverted into the main river. The 1871 work also included construction of a bridge across the new section of the river, sited close to the confluence with the Back Stream flowing into the site from Tonedale Mills.

The ponds to the west of the Finishing Works date from 1892-3 (Figure 8).<sup>15</sup> The present form of the leat was created by straightening the remaining part of the old river channel with brick retaining walls. Immediately north of the leat the new ponds were excavated and enclosed by additional walls.

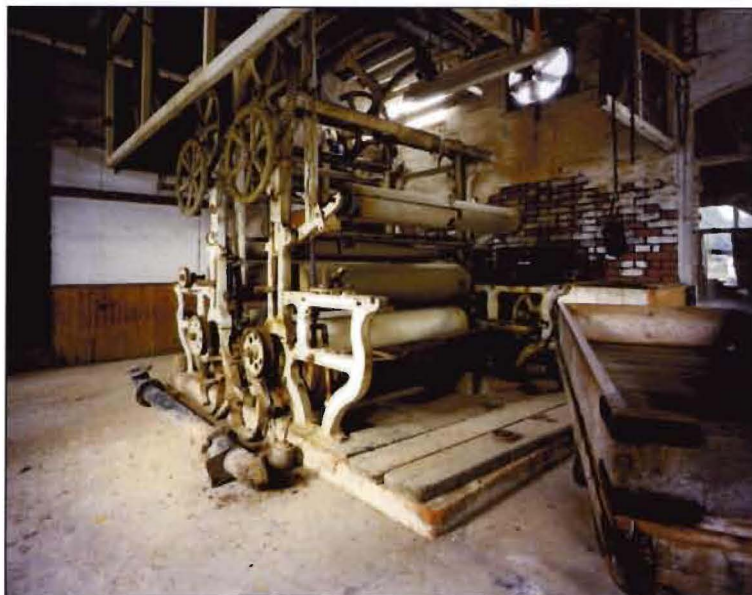
Figure 14.  
Machinery in Building 4 in 1995, later removed. [BB96/01711].

From the late 19<sup>th</sup> century white and grey cloths were in high demand and were produced in separate areas to avoid contamination of the colour from darker cloths. A 'White Room' was added to Tone in 1888-9; this was probably building 4 on the block plan (see Figure 10 above), which is shown in its original single-storeyed form on the c1886 letter head and was extended and raised to two storeys by 1904 (Figure 14; see Description and Analysis of Buildings).<sup>47</sup> In 1913-14 another building known as the 'Crystal Palace' was added for special heavy-milling of khaki and grey cloths<sup>48</sup>, possibly building 29 on the block plan. In 1930-31 this was re-equipped for finishing pure white cloths.<sup>49</sup>

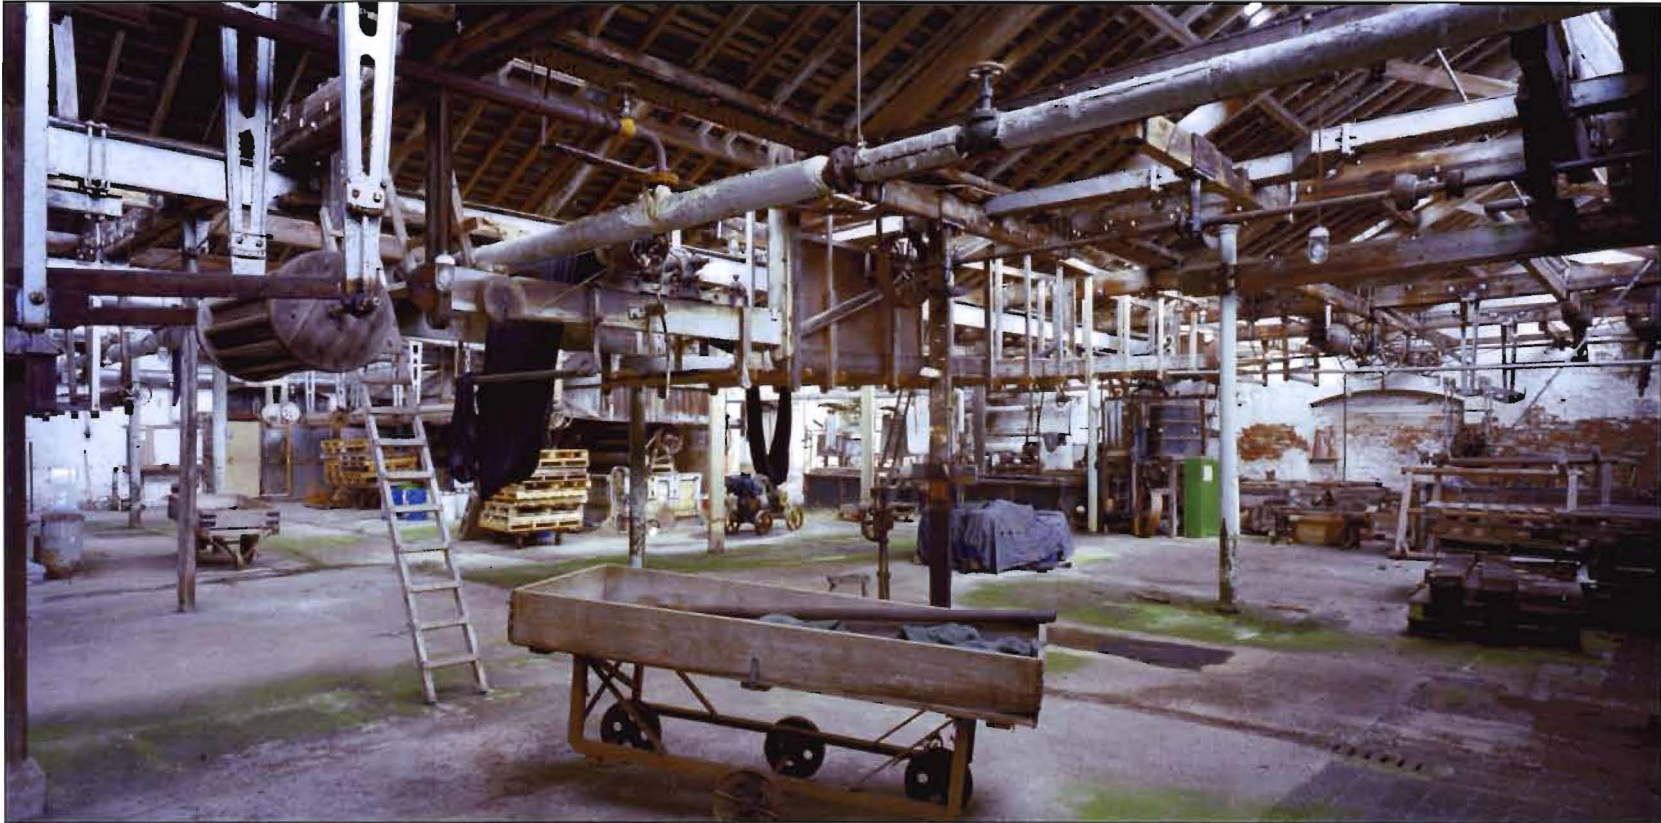
Figure 16.

Interior view of the Dye Works in 1995, showing in situ dye vats, winches and intact line shafting. [BB96/01695]

The dyeworks area has not been accessible during the current survey. Documentary sources, photographs taken in the 1990s and information kindly provided by Michael Fox and Jack Hudson has enabled a general assessment of the type and significance of the surviving machinery (Figure 16). Dyeing had ceased by the middle of the 20<sup>th</sup> century, and there has been little maintenance of the buildings in recent years, but machinery, line shafting and fittings which are of historic interest have all remained in place.<sup>61</sup>

In 1912 the Dyeworks was described as 'perhaps the largest Indigo Dye House in England' and was said to contain around 30 vats.<sup>62</sup> When it ceased operation it still contained around four indigo vats, along with vats used for other dyestuffs, an under-floor dye storage tank and a large cast-iron tank for softened water. The dye vats and related machinery are located in buildings 8 and 10 on the block plan (see Figure 10 above). It was a 'piece dyehouse' which was claimed to have the only continuous indigo dye vats in the country.<sup>63</sup> Cloth pieces were stitched end-to-end into a continuous loop which passed through a system of rollers, known as dye winches, located above the rectangular vats. The rollers were arranged so that the cloth was repeatedly dipped into the boiling liquor as it passed through the machine, thus speeding up the dyeing process. The dye winches appeared to have been belt-driven from line shafting when inspected briefly in the 1990s.

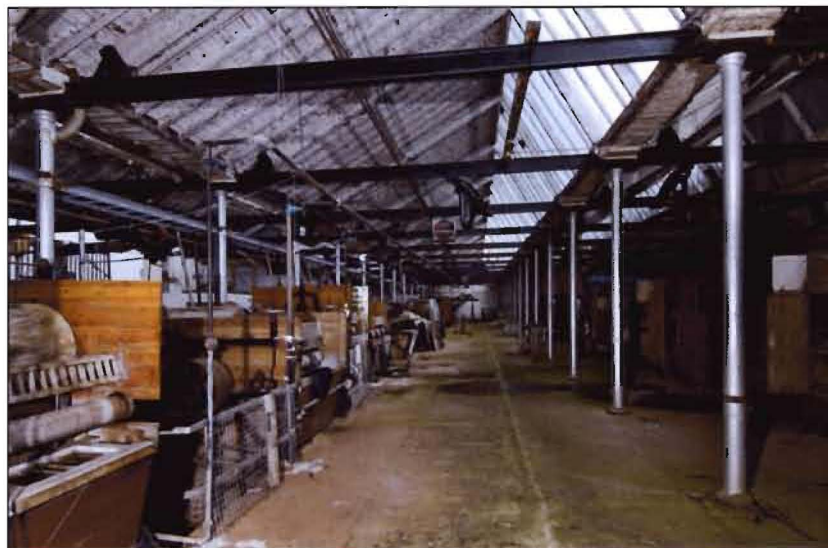
Figure 17.  
General view from the east end of the Finishing Shed; compare with Figure 12.  
[DP043932]

Finishing the dyed woollen and worsted cloths involved scouring, milling, tentering, raising and cutting. This sequence of processes was repeated for the better-quality woollen cloths, and variations were made to each stage to control the quality of the final product. An important part of the success of Fox Brothers was their successful development of cloth finishing techniques, and of scouring and milling in particular. The scouring and milling stages were equivalent to the slower fulling process that was widespread in the woollen industry up to the early 19<sup>th</sup> century. Thomas Fox is said to have developed the technique of dividing fulling into 'wet' scouring followed by 'dry' milling, and of repeating the whole sequence of finishing processes to produce high-quality fine woollen flannels.<sup>64</sup> The firm also finished a range of other cloths at Tone Works. Worsteds were scouring but not milled, and lower grades of woollen cloths were finished more quickly in combined scouring and milling machines. These combined machines were the type that was most widely used by other firms (Figure 17).

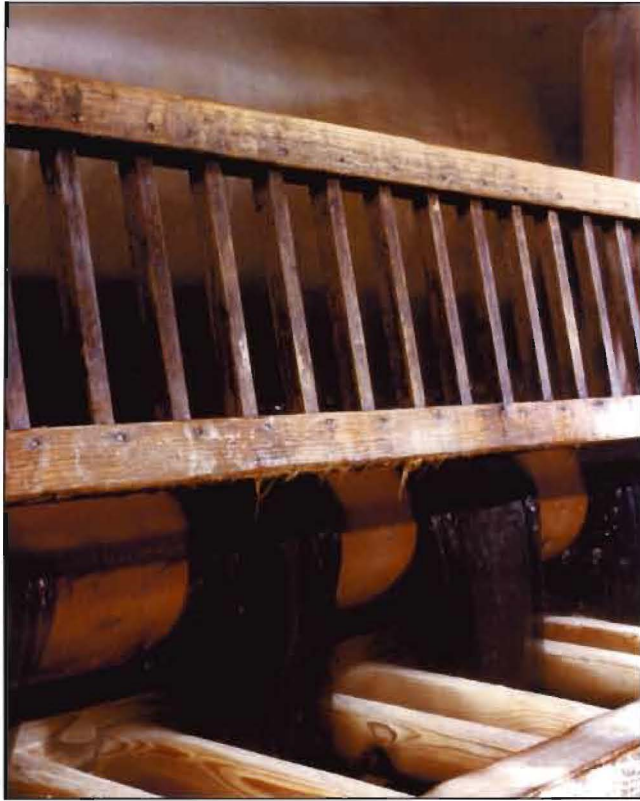
Figure 18.  
Three cloth pieces being scoured at Tone Works in 1995.  
[AA96/00664]

Scouring was a heavy washing process in which oils, fluff and surplus dyes were removed from the cloth.<sup>65</sup> After dyeing, the cloth was taken to the scouring machines in which it was passed through a liquor of hot water mixed with a soda solution (soap), which was then squeezed through the cloth between heavy wooden rollers (Figure 18). The ends of each piece were stitched together as it was fed into the machine to form a continuous loop, in a technique known as 'rope scouring'. The cloth was then repeatedly passed through the scouring machine for several hours; up to four pieces could be scoured side-by-side in each machine. The stitching was done with small portable sewing machines, many of which still remain on site. Depending on the type of cloth being produced, the edges of the piece might also be stitched together on a different type of sewing

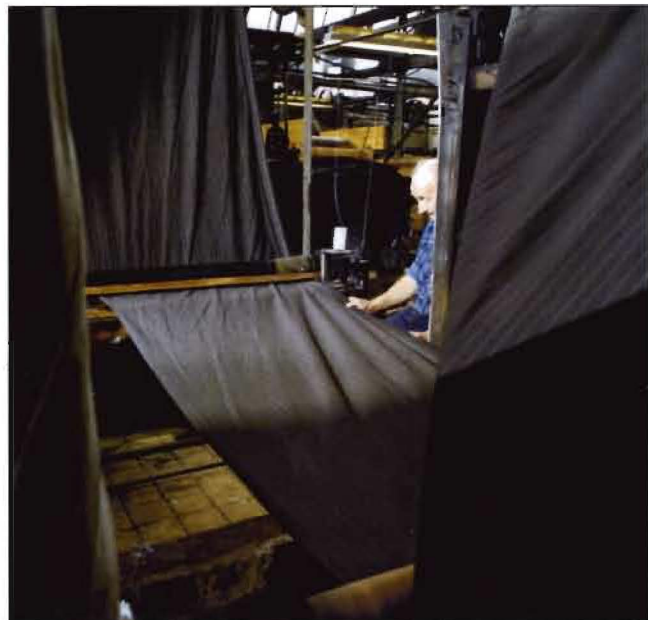
Figure 19.  
'Bagging' a cloth piece at Tone Works in 1995. [AA96/00644]

machine to form a continuous tube, which in Tone Works was known as 'bagging'. This increased the efficiency of scouring, as the liquor inside the tube was squeezed out evenly across the full width of the piece (Figure 19).

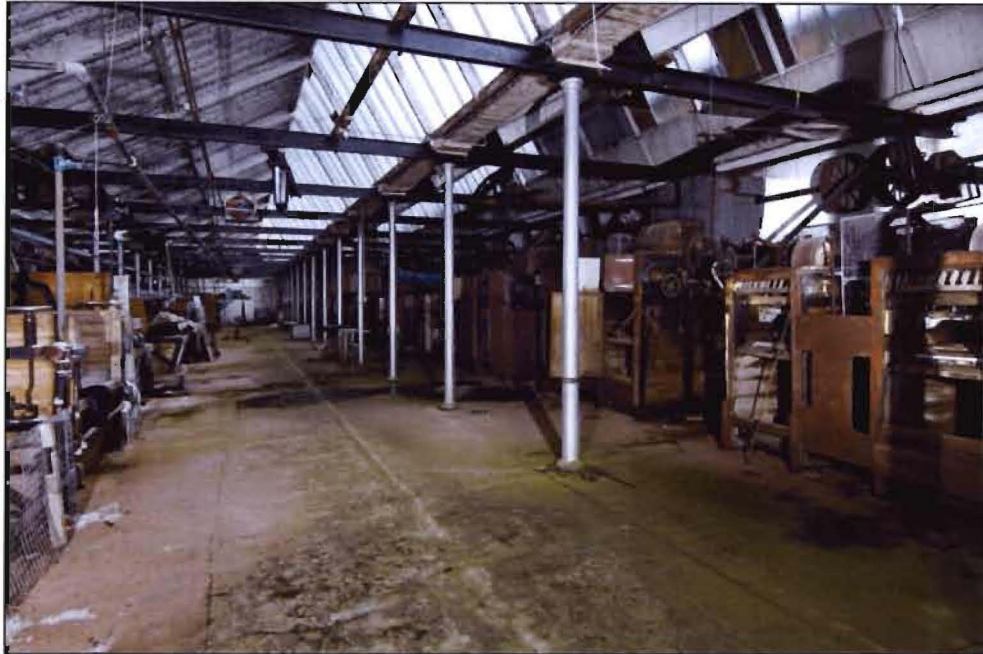
Figure 20.

*Milling machines grouped along the north side of the Finishing Shed; compare with Figure 12.*

In milling machines high-pressure rollers caused the cloth to shrink and to attain a matted surface in which the warp and weft threads were no longer visible. Milling was a 'semi-dry' process which did not involve further soaking of the cloth in hot liquor, although when the cloth was in the machines it was deliberately kept damp and a small amount of soap added. The milling machines are narrower, since

cloth was milled one piece at a time, and more heavily constructed than the scouring machines. They are grouped beneath the primary line shaft in the eastern half of the shed, and are not positioned above an open drainage channel (Figure 20).

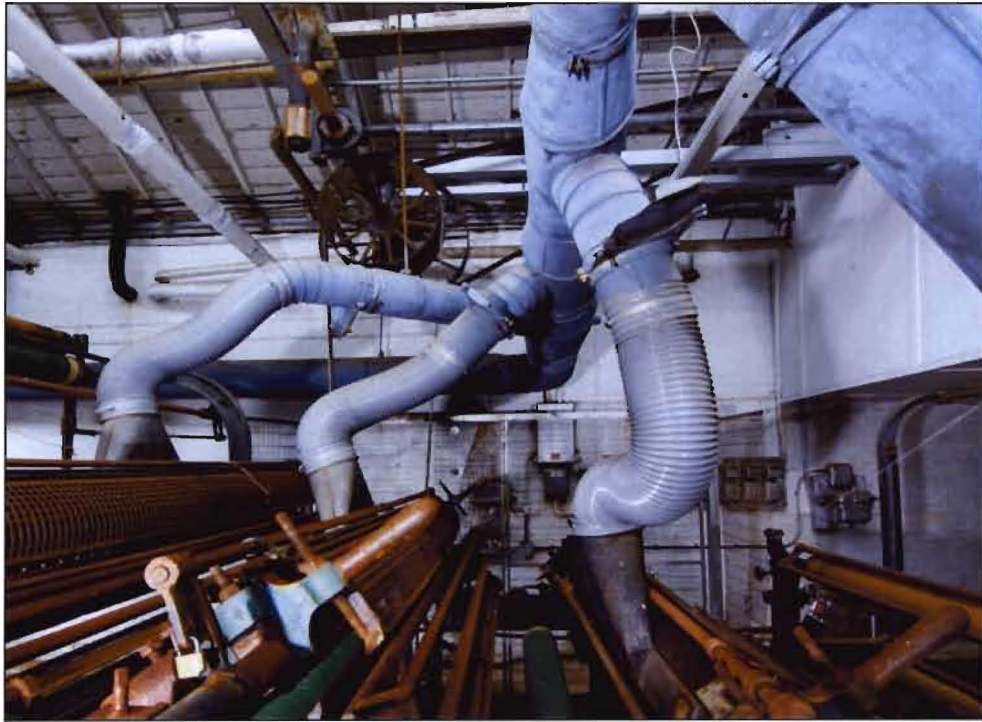
Figure 21.  
Detail of a modern rotary shearing machine. [DP043912]

process which was kept separate from the damp environment in the scouring and milling areas. The two *in situ* shearing machines are of late 20<sup>th</sup>-century date. In the 1990s they were positioned in a new room built inside the Finishing Shed which was equipped with extractors to remove the loose woollen fibres (Figure 21).

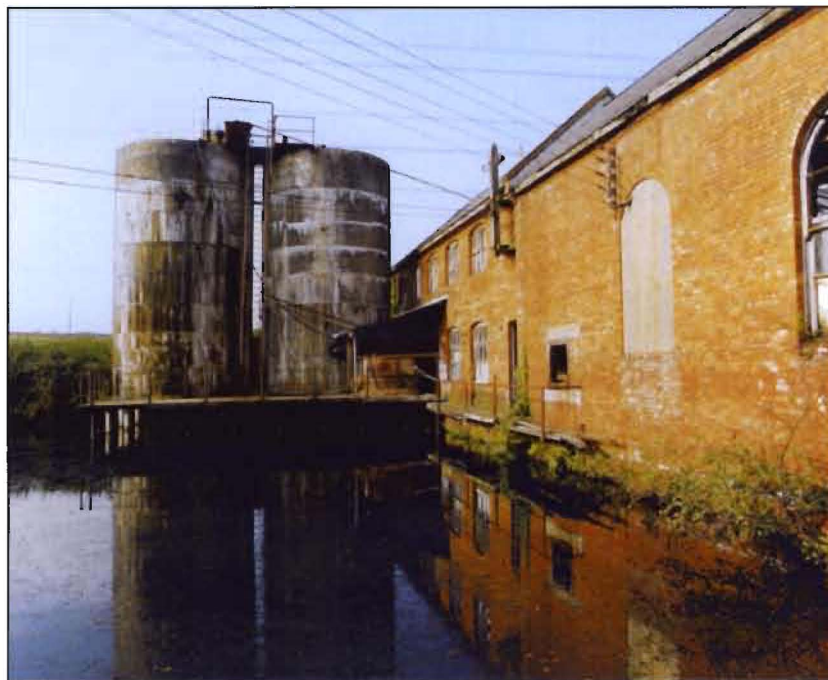
Figure 23.

*The 1893-5 Finishing Works Engine House, on the right, with the adjoining Motor Room, overlooking the soft-water reservoir. The two concrete towers are the lime soda water-softening plant installed in 1913-14. [AA96100690]*

The construction of the new Finishing Works in 1894-5 included a new attached Engine House, which used steam from the existing boiler house (Figure 23). The 1894-5 power transmission system appears to be completely intact, and may be the oldest intact example in the country.<sup>67</sup> It comprises a system of belt- and gear-driven line shafting occupying the full length of the Finishing Works and

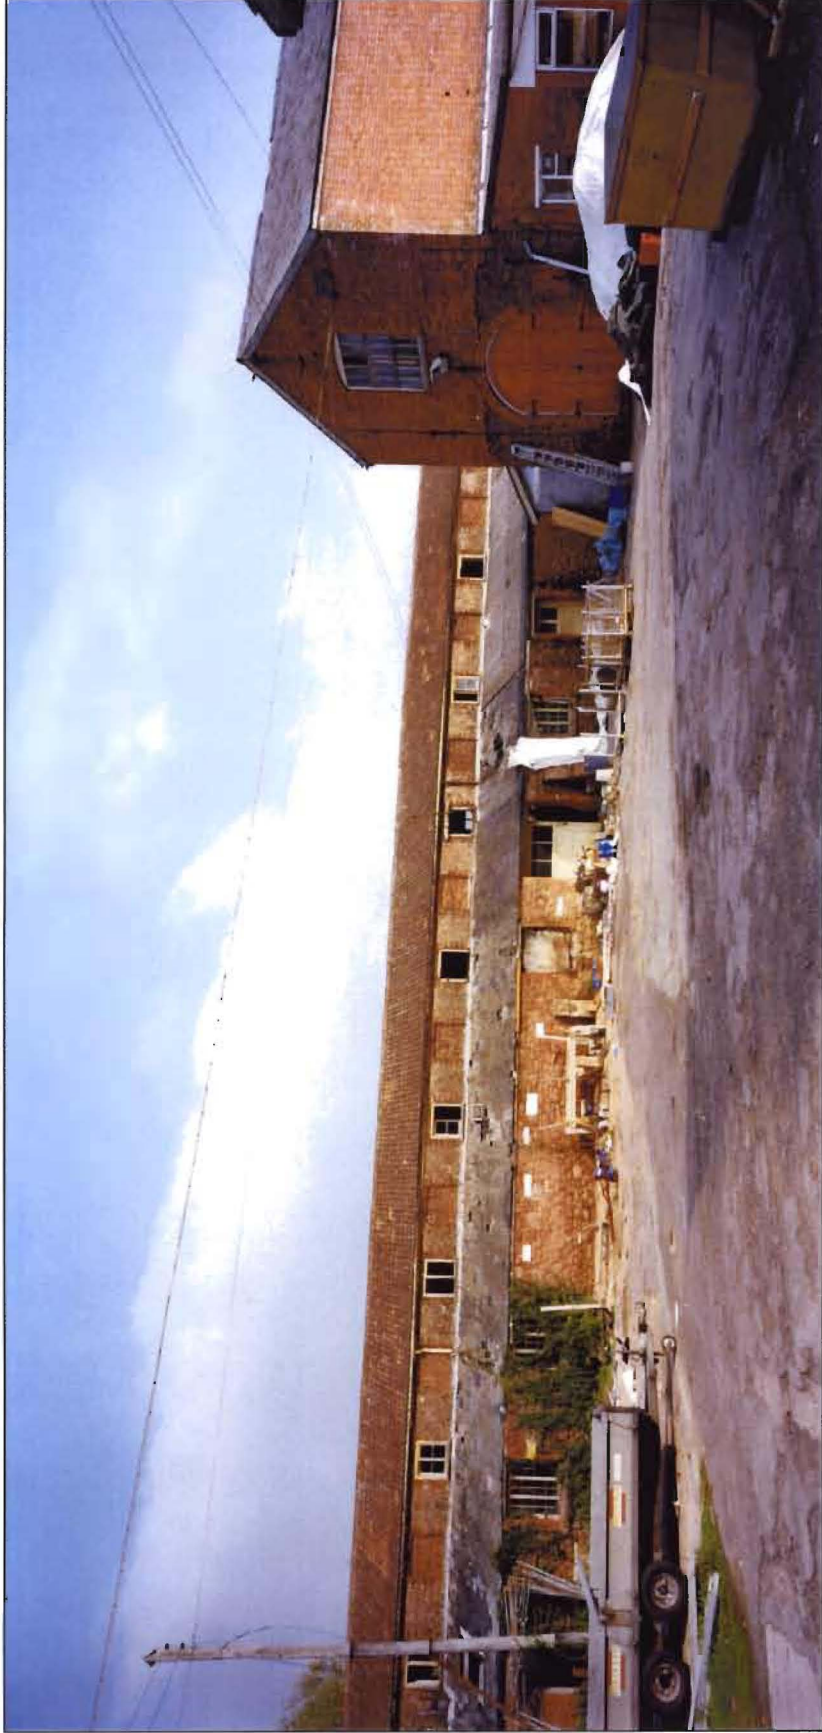
Figure 25.  
The South Dry House. [BB96/01703]

The South Dry House is the earliest intact building at Tone Works. It comprises an original central section, which is marked on the 1839 Wellington Tithe Map, with later extensions to both ends and along the west side. It has decayed in recent years, but is of interest as one of the best-preserved early dry houses in the South West, retaining most of its historic structural features. Specialist cloth dry houses, long narrow structures which usually combined heated and open-air drying, were a feature of the larger integrated mills in the 19<sup>th</sup> century, but fell out of use with the introduction of machine tentering and were often demolished (Figure 25).

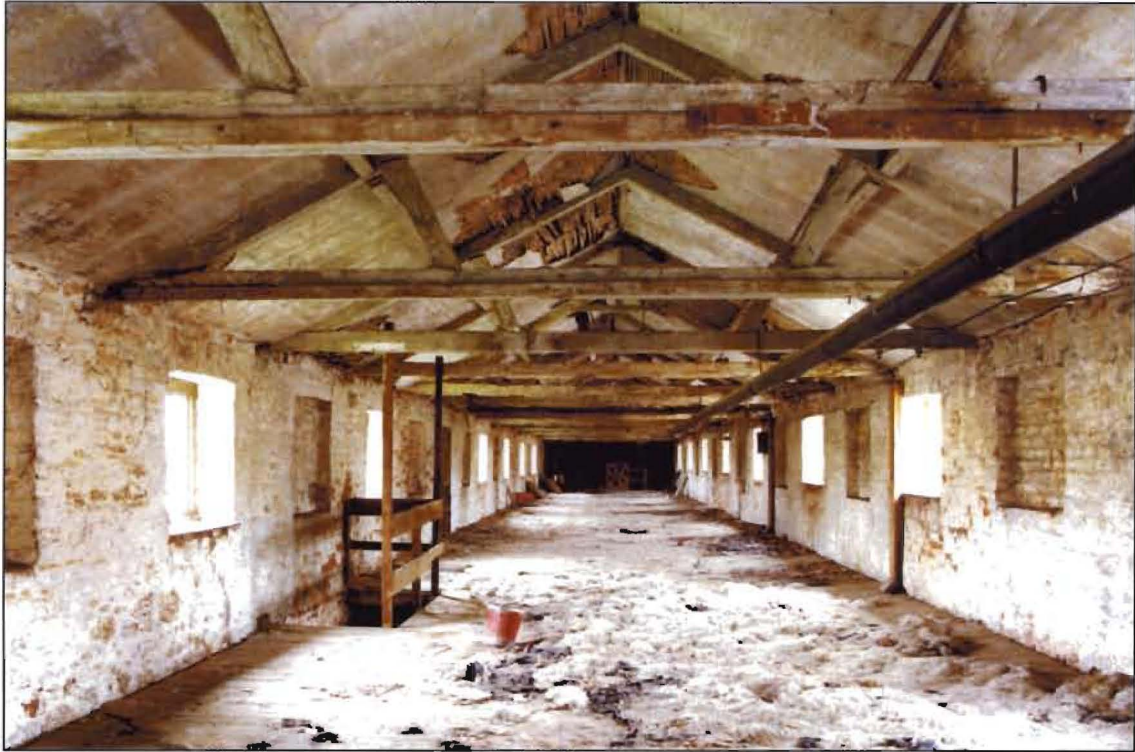
Figure 26.  
Attic of the South Dry House. [AA96/00720]

The upper floor is open to the gabled roof, which has an original plaster-on-lath ceiling attached to the rafters, presumably for insulation. The roof trusses comprise half-lapped principals with tie-beams at eaves height, a high collar supporting a short post, angled queen struts and a single rank of square butt purlins. The apex supports a diamond-set ridge piece and the purlins are morticed and pegged, all typical features of semi-vernacular industrial roofs of the very early 19<sup>th</sup> century. Some of the tie-beams retain rows of tenter hooks, and the soffits have similar shallow mortices to the ground-floor beams (Figure 26).

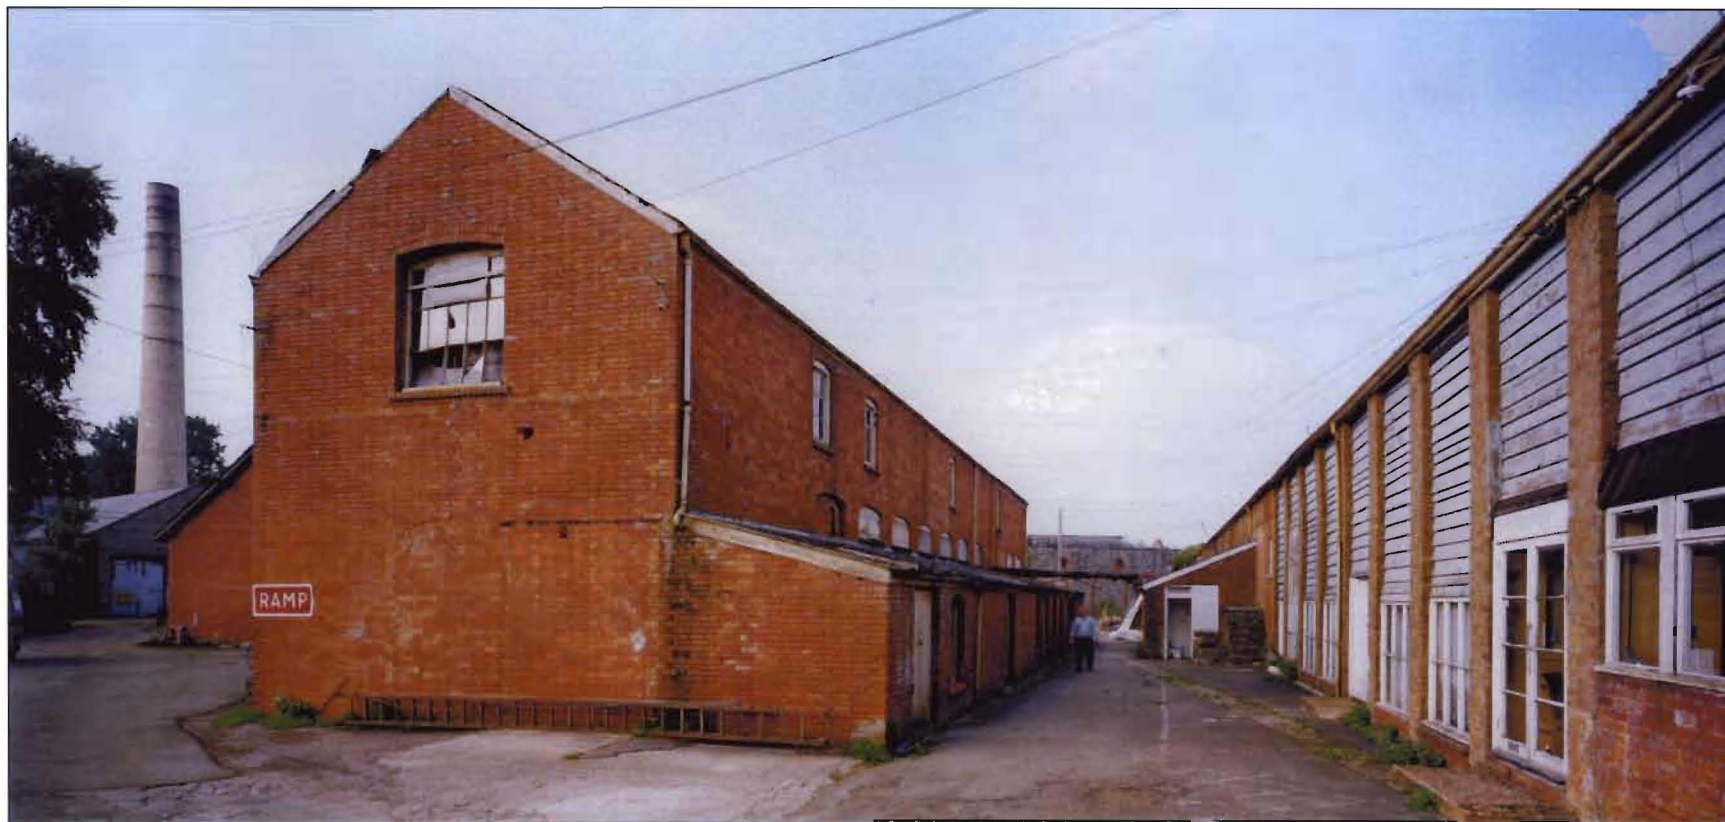
Figure 27.  
The pier-and-panel extension of the South Dry House (right), and the White Goods building (left). [BB96/01710]

The south end extension, which is shown on the 1889 O.S. plan, is of distinctive pier-and-panel construction (Figure 27). The piers are of similar proportions to those in the North Dry House, but built in a light grey brick. The building has not been accessible. Most of the original opening louvres in the panels have been replaced, but their former positions are indicated by paint stains on the sides of the piers. Some opening panels survive intact in the upper storey. The roof trusses are of sawn timber and have wide collars at the level of the purlins, but no tie-beams; there is no plaster ceiling. The south end of the original building has been removed, and stone walls of the earlier phase extend into the first bay of the extension; this suggests that the earlier building had a single-storeyed projection at the south end, a possible site for an external stove for warm-air drying.

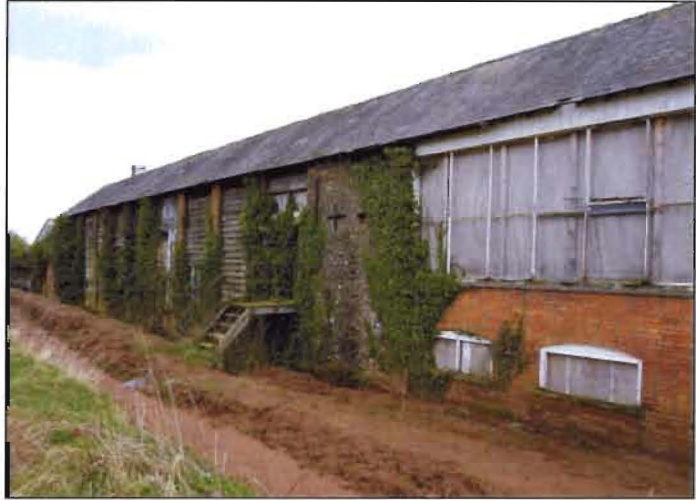
Figure 28.  
*The North Dry House, with in situ ventilation louvers to the left of the rubble wall. [DP046034]*

The North Dry House is also marked on the 1839 Wellington Tithe Map, when it was roughly the same length and width as the extant building, but has more alterations than the South Dry House. Structural evidence indicates at least four phases of partial demolition and rebuilding, but also suggests that a substantial part of the pre-1839 structure may survive. It was longer than the South Dry House with three drying floors, including the attic, and its position close to the other early buildings suggests that it may have been the original dry house at the site. It comprises a pier-and-panel section at the east end attached to a short stone-built central section, with two phases of late 19<sup>th</sup>-century rebuilding attached to the west (Figure 28).

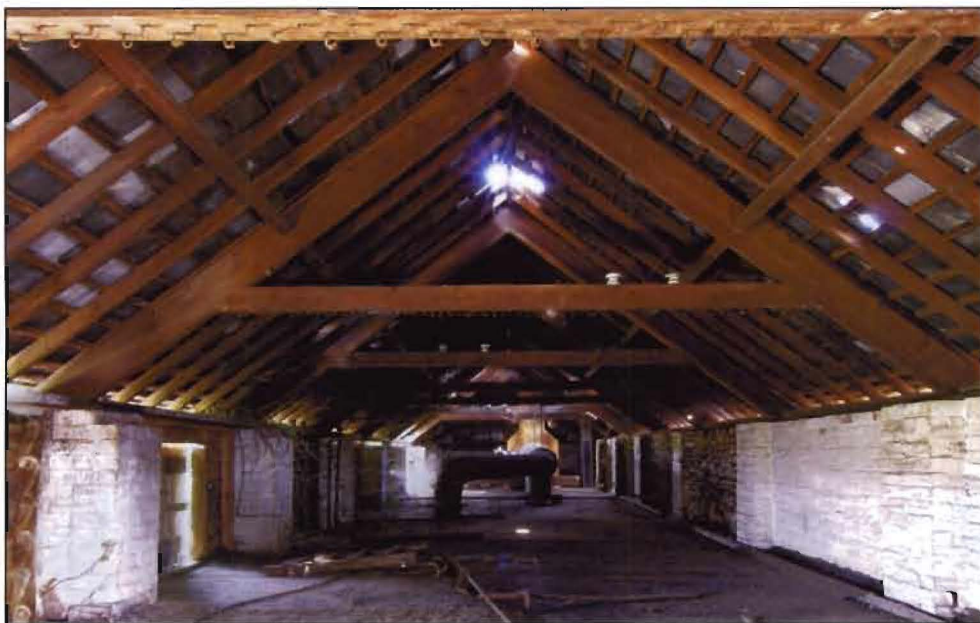
Figure 30.

*The attic of the North Dry House, with tenter hooks on the tie-beams. [DP046035]*

The roof of the whole building was probably replaced in the late 19<sup>th</sup> century, and may be contemporary with the rebuilt west end. It is of similar construction to the late 19<sup>th</sup>-century extension of the South Dry House, and to other late 19<sup>th</sup>-century roofs in the Dye Works area. The roof collars throughout the attic retain rows of tenter hooks, suggesting that the full length of the attic was used for drying (Figure 30).

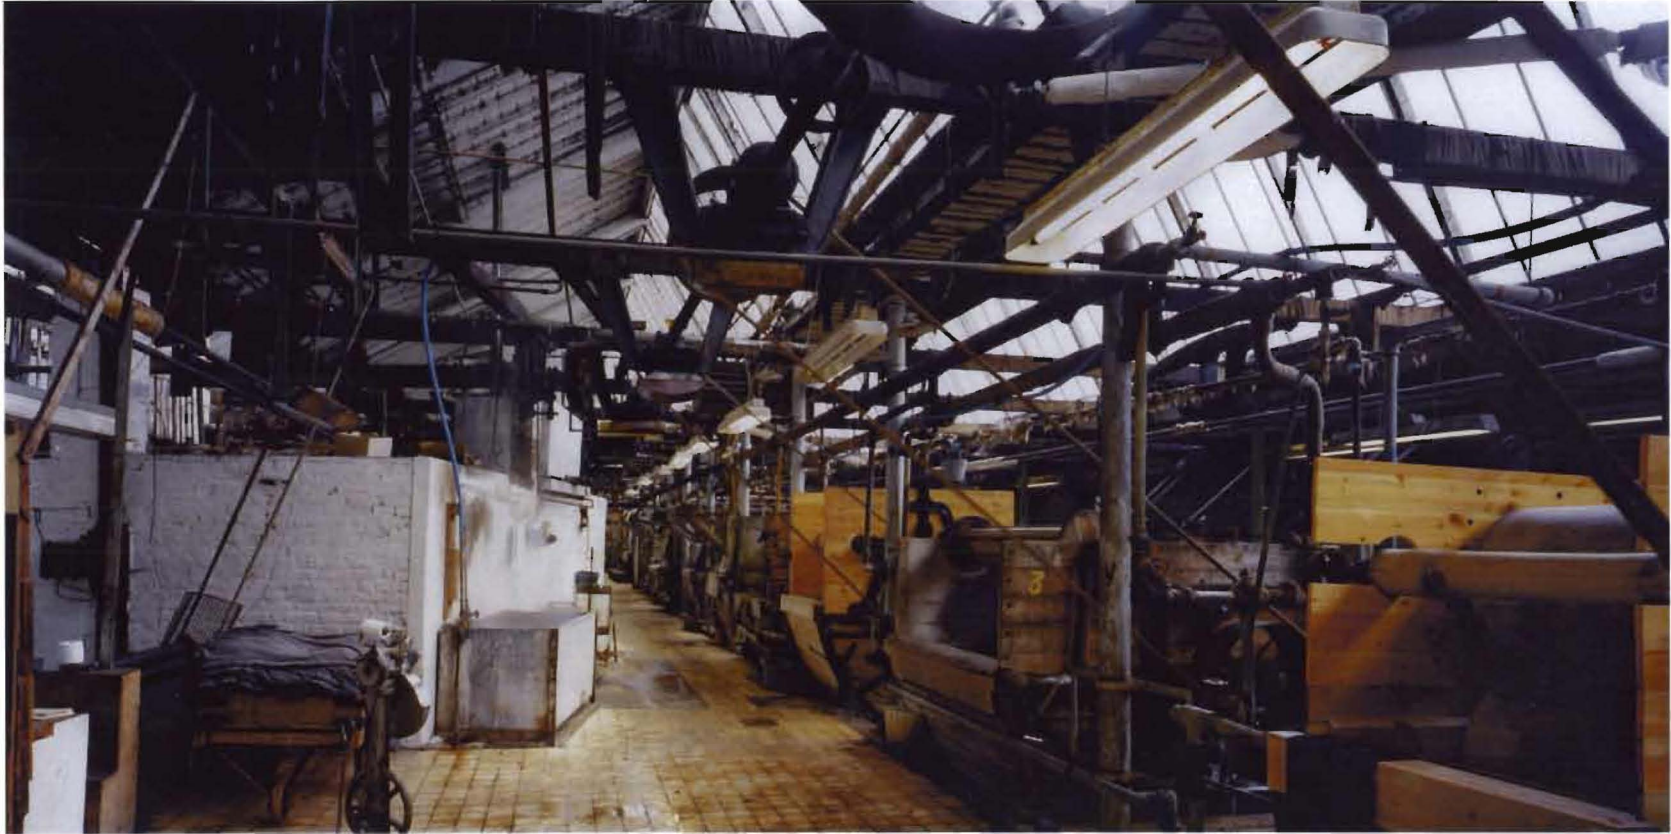
Figure 31.

The Finishing Shed in 1995, showing the wheel chamber on the left. Water- and steam-powered line shafts are suspended beneath the roof [BB96/01686]

The wheel chamber comprises a rectangular flat-roofed structure beneath the north-light roof of the Finishing Shed. It is of similar plan and orientation to the external wheel chamber shown on the 1839 Tithe Maps and is probably the modified remains of the early 19<sup>th</sup>-century water-power system (Figure 31). It contains the well-preserved wheel pit with parts of a suspension wheel, the penstock and good evidence of three phases of power transmission. The chamber is open to the intact head race, which is now culverted beneath the Finishing Shed floor; and the tail race tunnel. The watercourses have not been entered but the positions of both appear to be close to those indicated by the Tithe Maps.

The south side wall of the wheel chamber was entirely rebuilt in c1893-5 to support a belt-drive power transmission for the new Finishing Shed. It is thicker than the end walls, containing the massive cast-iron bearing boxes of the pinion shaft driven by the wheel and the shaft of a large belt pulley used to drive the shed's overhead line shafting. The belt drum and a pair of spur gears remain intact in a separate gear chamber located to the south of the wheel chamber, beneath the Finishing Shed floor. The south wall extends up above the wheel chamber roof to the level of the shed roof, where it supports the massive bearing box of the water-powered line shaft and the upper belt drum. In contrast, the rebuilt north side wall of the wheel chamber is just one brick thick and less well-built, but of similar red brick and black mortar to the south side, suggesting it is of similar date. Its construction blocked another pinion shaft driven from the north side of the waterwheel.

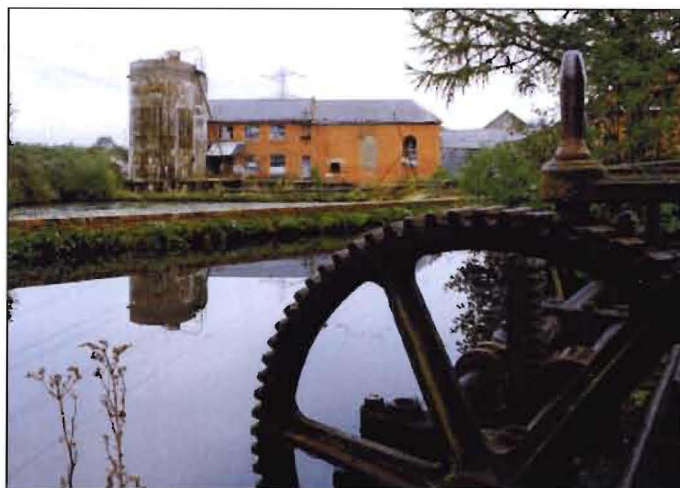
Figure 34.

*The headrace and bypass sluice in 1995. [AA96 00645]*

A large bypass sluice, which appears to be in working condition, is located on the south side of the entrance and is probably contemporary with the weir. It comprises a pair of cast-iron rack-and-pinion shutters to either side of a central brick pier. The shutters were controlled by separate hand-

wheels mounted on pedestals at the ends of the sluice. A later control mechanism employing a small gearbox has been added to the eastern hand-wheel, probably driven by an electric motor in a nearby shed (Figure 34).

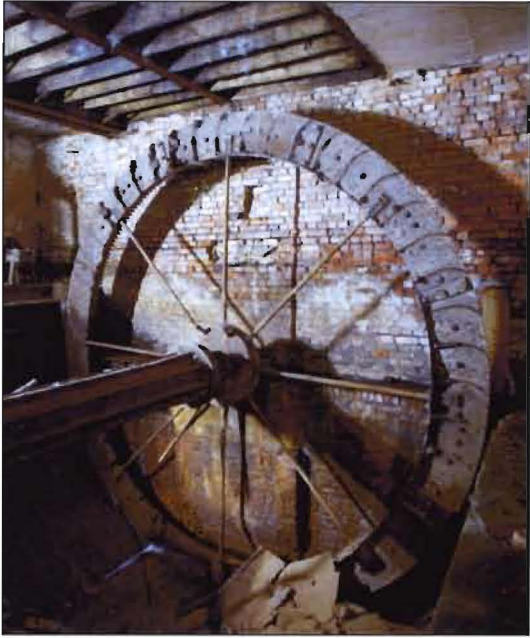
Figure 37.  
The surviving north shroud of the water wheel.  
[AA96/00680]

The shroud comprises eight segments, 45.7 centimetres (18 inches) deep and 1.2 centimetres (½ inch) thick, which are assembled with bolted lap joints. The middle of each segment is supported by a single spoke attached to a bracket cast onto its inside face which has a T-shaped housing. Curved flanges on the inside face of the shroud supported the ends of the buckets and the sole plate; each segment supported six buckets. Most of the bucket flanges were broken off the shroud during the partial dismantling of the wheel (Figure 37).

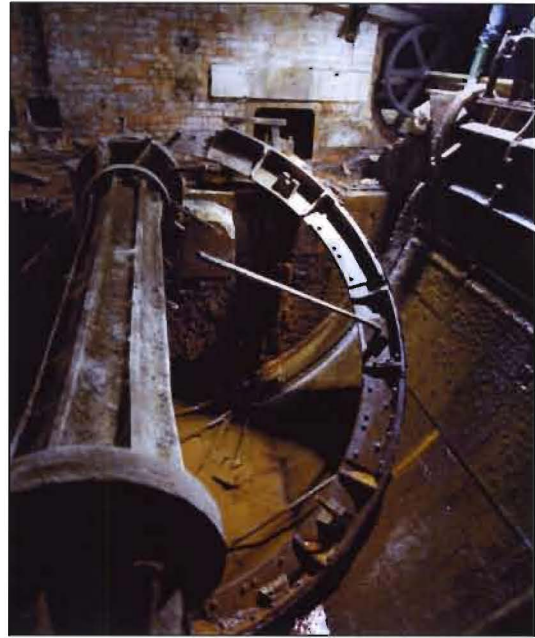
Figure 38.  
The partially-dismantled middle ring in the wheel pit.  
[AA96/00684]

The middle ring comprised eight T-section segments which were bolted together using fitch plates. Its outer horizontal flange supported the wheel's sole plate and the central row of bucket stays (see below). The vertical flange of each segment has a cast-on angled projection with a T-shaped housing to accept the ends of the angled spokes (Figure 38).

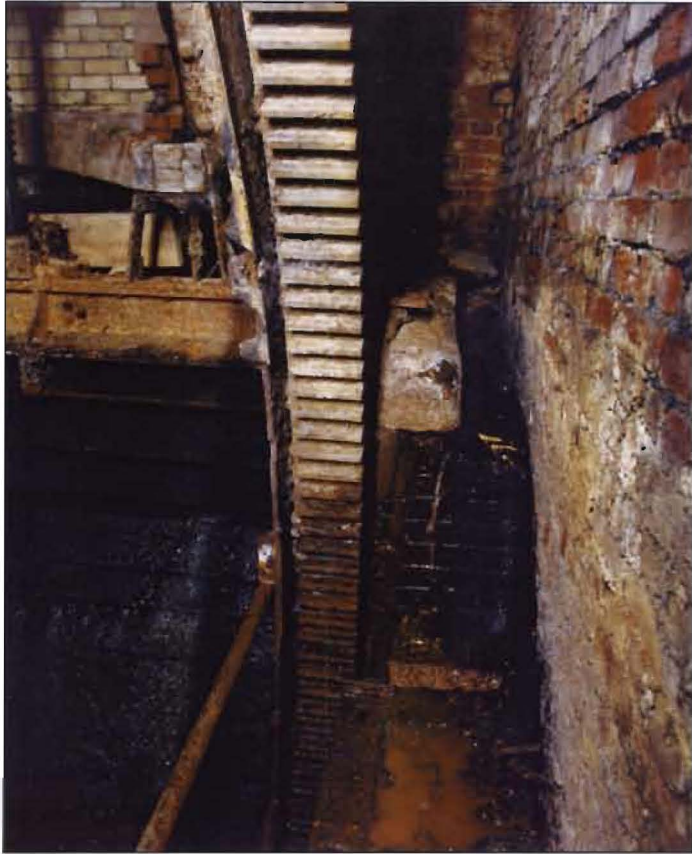
Figure 39.  
*The ring gear added to the north shroud. The base plate of a former pinion shaft bearing remains in situ on the edge of the wheel pit. [AA96/00683]*

An intact ring gear is bolted to the north shroud, and was associated with the use of power to the north of the wheel chamber in the mid- or late 19<sup>th</sup> century. The shroud casting did not include any flanges to support a ring gear, indicating that the ring was a later addition. The ring gear casting appears to be of mid- or late 19<sup>th</sup>-century date and its teeth are heavily worn, indicating that it was in use for some time (Figure 39). No clear documentary evidence has been found for a large powered building to the north of the wheel chamber, however, suggesting that the power was used for a minor ancillary process.<sup>70</sup> The present north wall of the wheel chamber is itself a later addition, probably contemporary with the Finishing Shed, and replaced any further evidence of the power transmission or adjoining buildings.

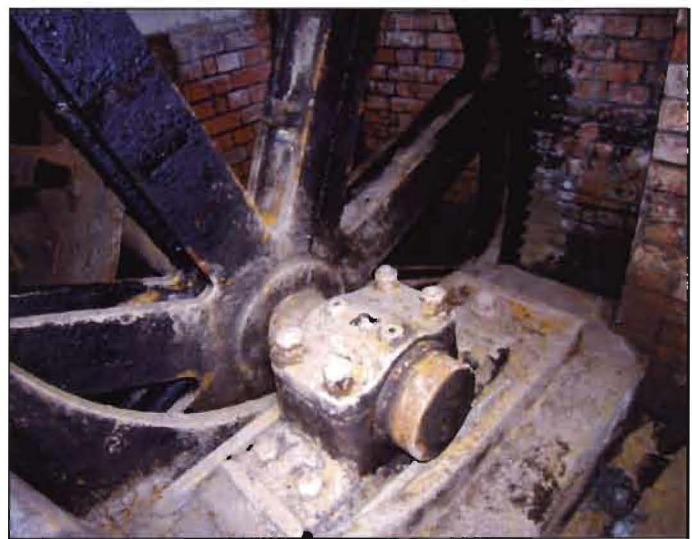
Figure 40.  
*Detail of the gear chamber, showing the main spur gear mounted on the pinion shaft. [DP046036]*

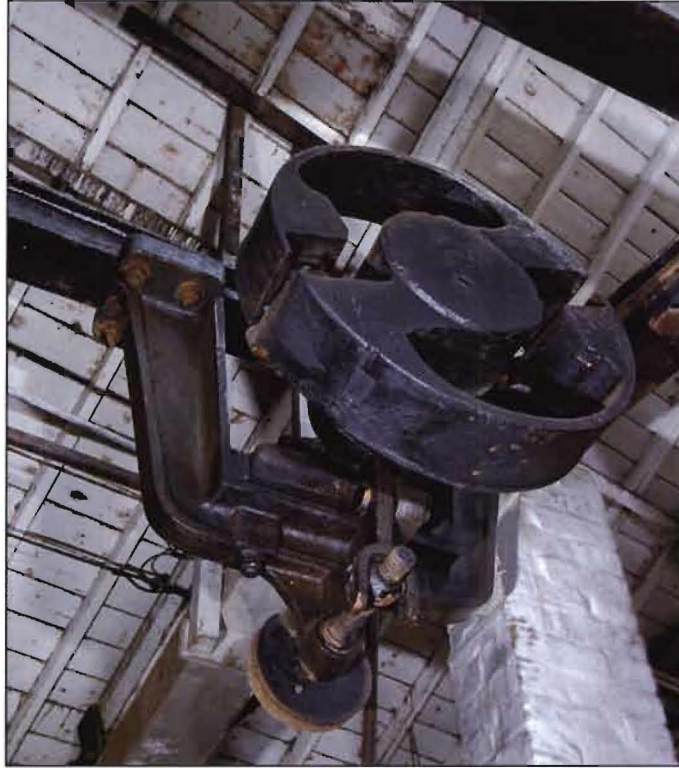
Figure 42.  
The friction clutch is still attached to the water-powered shaft above the wheel chamber. [DP043906]

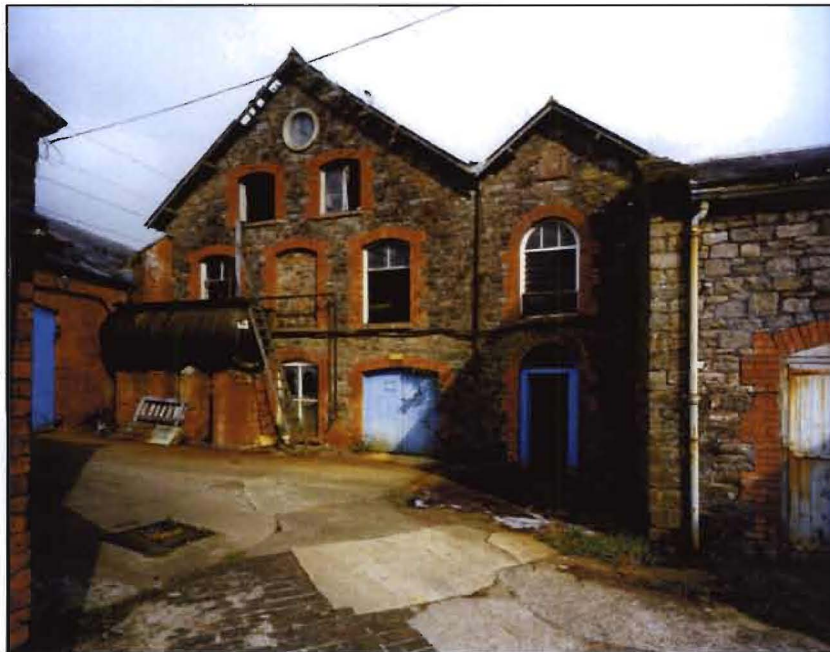
Figure 43.  
The front elevation of the Dye Works was rebuilt in the late 19th century, but incorporated a re-set 18th-century date stone. [BB96/01702]

The buildings facing the yard (buildings 13 - 15 on the block plan; Figure 10, above) comprise a two-and-a-half-storeyed building with a wide-gabled roof and a narrower two-storeyed gabled building attached to its south side (Figure 43). The larger building has three bays of segmental-headed windows and a double-width door, while the narrower building has a single round-headed door with a round-headed window above. The fenestration and proportions are

different to those shown on the c1886 letter head, and the absence of a straight joint suggests that both structures were re-fronted at the same time. The whole elevation is of squared grey rubble with red brick jambs and heads; the materials, fenestration and roof details all suggest a late 19<sup>th</sup>-century date. The larger building has a circular opening for a clock in the gable<sup>71</sup> and the smaller building has a re-set 18<sup>th</sup>-century date stone, suggesting that this was perceived to be the front of the works. Exposed parts of the roof have timber queen-strut trusses which also appear to be of late 19<sup>th</sup>-century date.

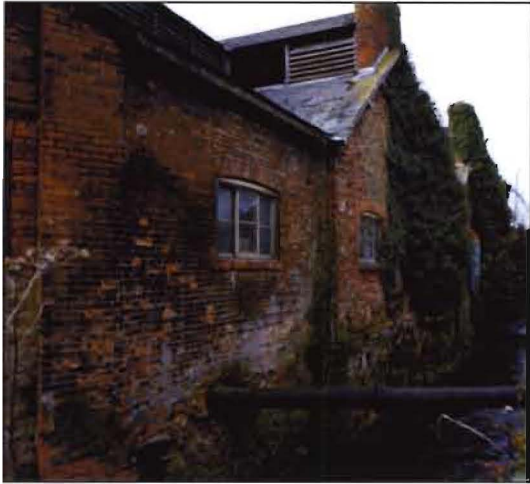
Figure 44.  
East elevation of the Dye Works in 1995.  
[AA96/00698]

The second group of Dye Works buildings, adjoining to the east, are single-storeyed with separate gabled roofs and external elevations, facing the river, of conglomerate rubble and red brick. The eastern elevation is currently overgrown, but variations in the stonework suggest several phases of repairs and extensions (Figure 44). The largest phase is roughly parallel with the river on a north-south axis. Its north end seems to be close to the position of a similar building on the Wellington Tithe Map, but appears to have been extended to the south (this requires on-site investigation). A red brick infill section in the east elevation may indicate the position of the south end of the structure shown on the Wellington Tithe Map; the brick section is of mid- to late 19<sup>th</sup>-century date, but contains a large opening behind a wooden panel that was added in the late 1990s. An additional phase of rubble wall adjoins it to the south. These buildings all have similar tall gabled roofs with prominent ventilation louvres; internal photographs show a complex arrangement of heavily-built queen-post trusses in this area (Figure 45). Similar roofs, but oriented east-west, are attached to the west, giving this part of the site a highly distinctive roof structure. The engraving on the c1886 letter head shows similar roofs but without the louvers; it also shows two nearby chimneys, suggesting

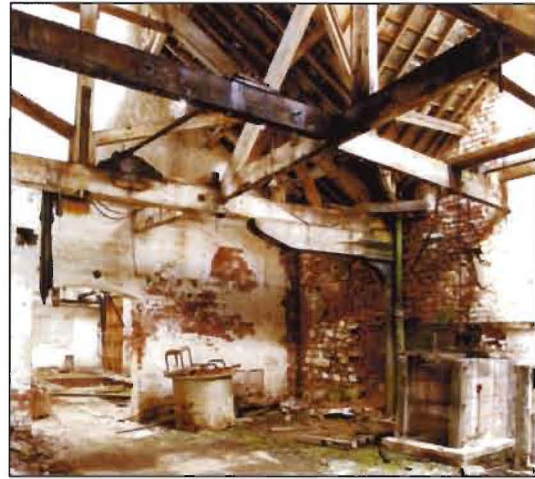
Figure 45.  
Heavily-built ventilated roofs and multiple phases  
of wall construction in the eastern part of the Dye  
Works. [AA96/00711]

that boilers were sited nearby. These buildings were clearly used for heated processes in the late 19<sup>th</sup> century, and their early date and proximity to boilers suggests that they may be the modified remains of the first purpose-built buildings for dyeing. The earliest available documentary reference to a separate dye house is dated 1846.<sup>73</sup>
