**TONE WORKS,  
WELLINGTON, SOMERSET  
SURVEY AND ANALYSIS OF BUILDINGS,  
POWER SYSTEMS AND MACHINERY**

**VOLUME ONE: REPORT**

SURVEY AND ANALYSIS OF BUILDINGS,  
POWER SYSTEMS AND MACHINERY

Research Department Report Series No. 72/2007

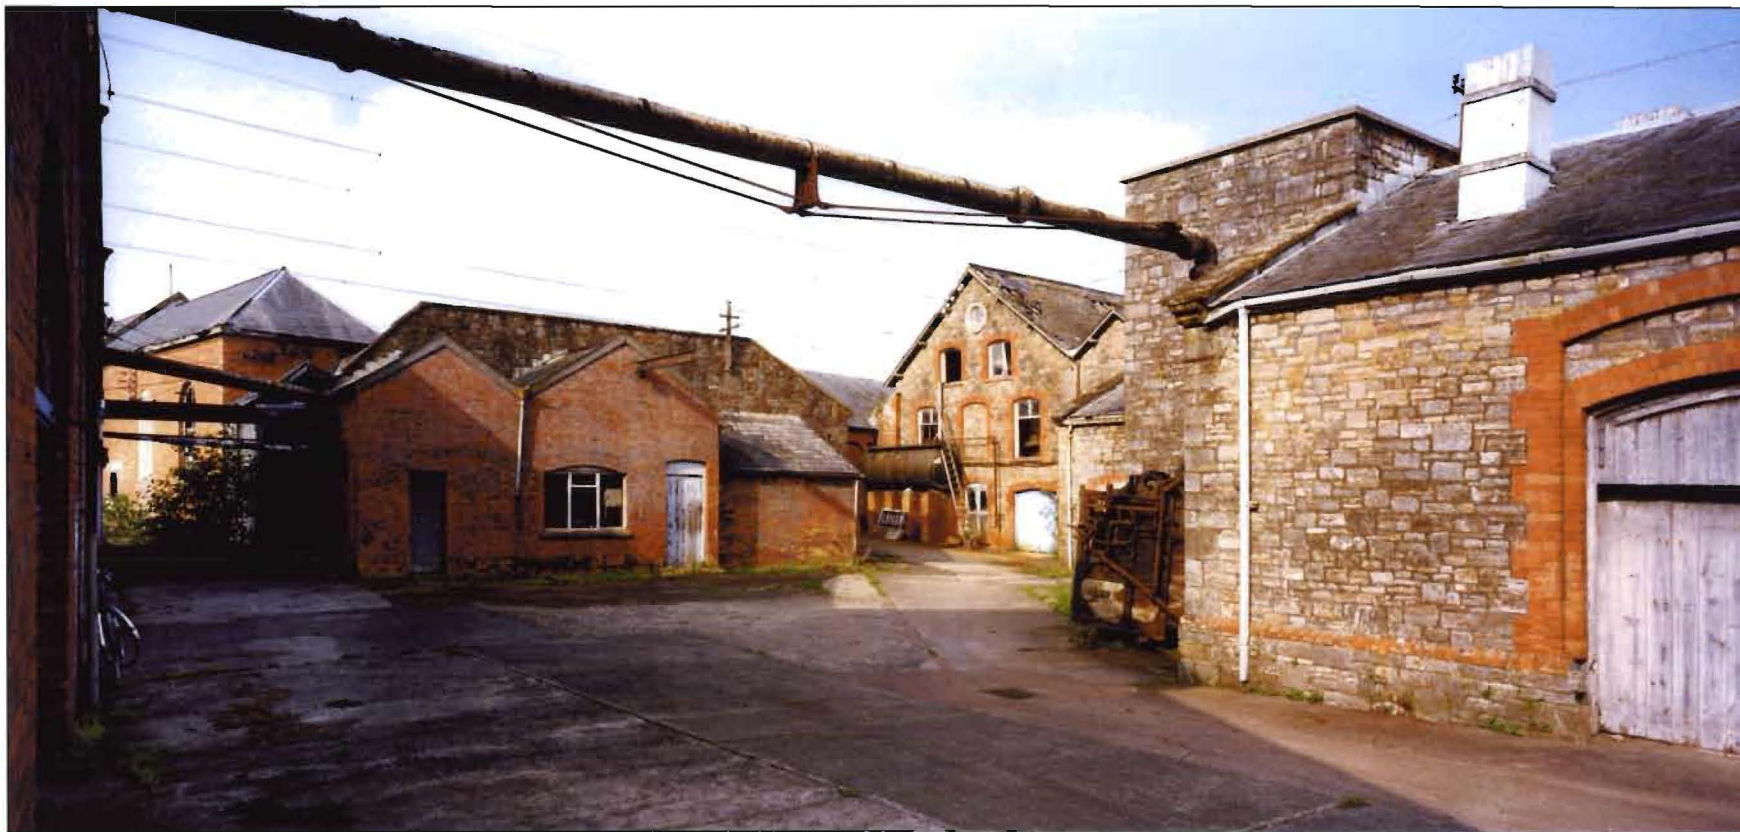
Figure 46.

The yard to the west of the Dye Works, with the Streaming Shop in the centre. [BB96/01678]

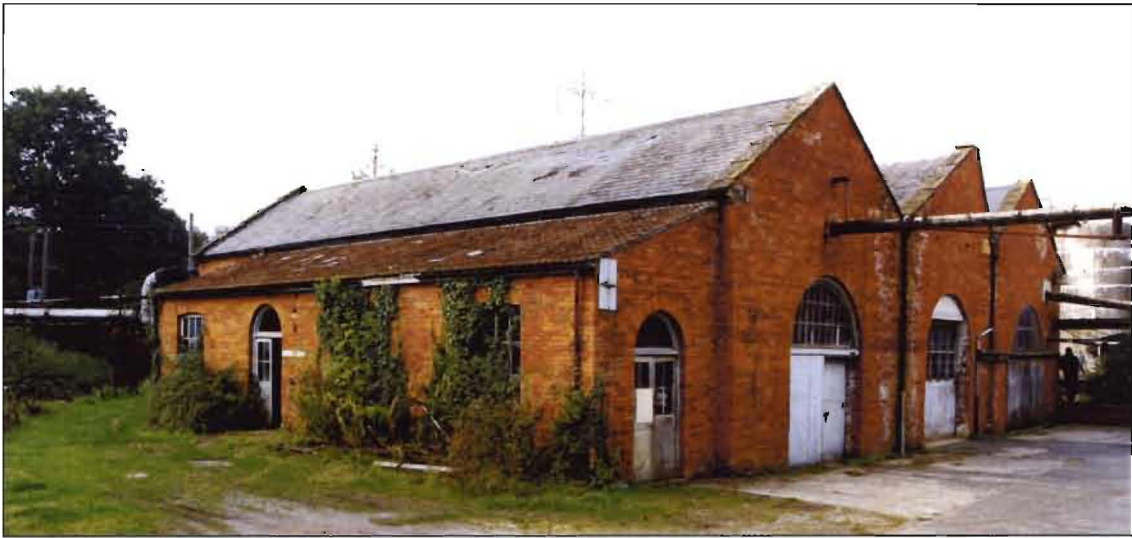
Figure 47.  
The 1884-5 Boiler House. [AA96/00730]

It is a tall single-storeyed building in red factory brick built to a roughly square plan with a triple-span roof (Figure 47). The roof originally comprised three symmetrical east-west ridges, but the central ridge was later replaced with north-light trusses and its gable end partly rebuilt. The front, east, elevation has a wide-arched opening beneath each of the gables. An original lean-to extension is attached to the south side, with a round-headed door matching the form of the other doors facing the yard. In 1995 a sign on the wall indicated that this was a disused fire station. An extension on the west side is of similar proportions, but replaces an earlier narrower extension shown on the 1904 OS plan. A third lightly-built extension, with a corrugated asbestos roof, was added to the north side, above the open head race, sometime after 1930.

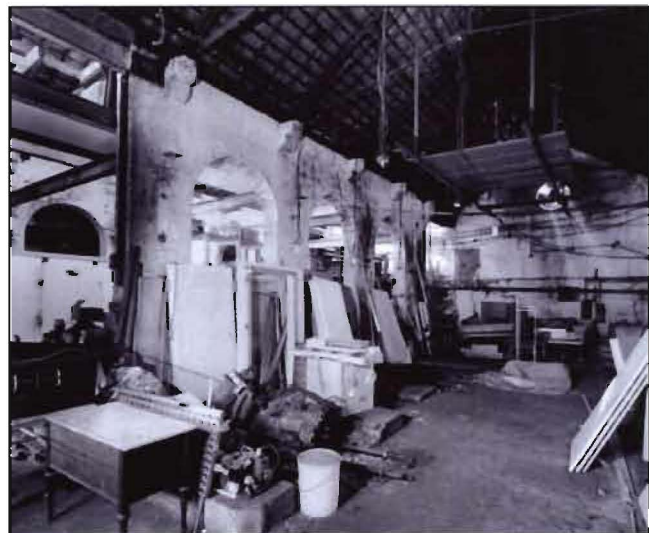
Figure 48.  
Interior of the 1884-5 Boiler House in 1995. [BB96/01707]

Internally the building comprises a single open space with a concrete slab floor and very little evidence of the former boilers (Figure 48). The outer aisles of the roof retain their original structure, comprising lightweight iron or steel principals, trussed with parallel tension rods and horizontal and vertical tie-rods. L-section common rafters support wooden laths. Similar roofs were built at this time on a new boiler house and other extensions at Tonedale Mills. The principals are mounted on moulded stone corbels; redundant corbels in the central aisle confirm that it formerly had the same type of roof. The absence of rooftop

ventilation is unusual for a purpose-built boiler house of this date, although this may have been removed when the central roof span was replaced.

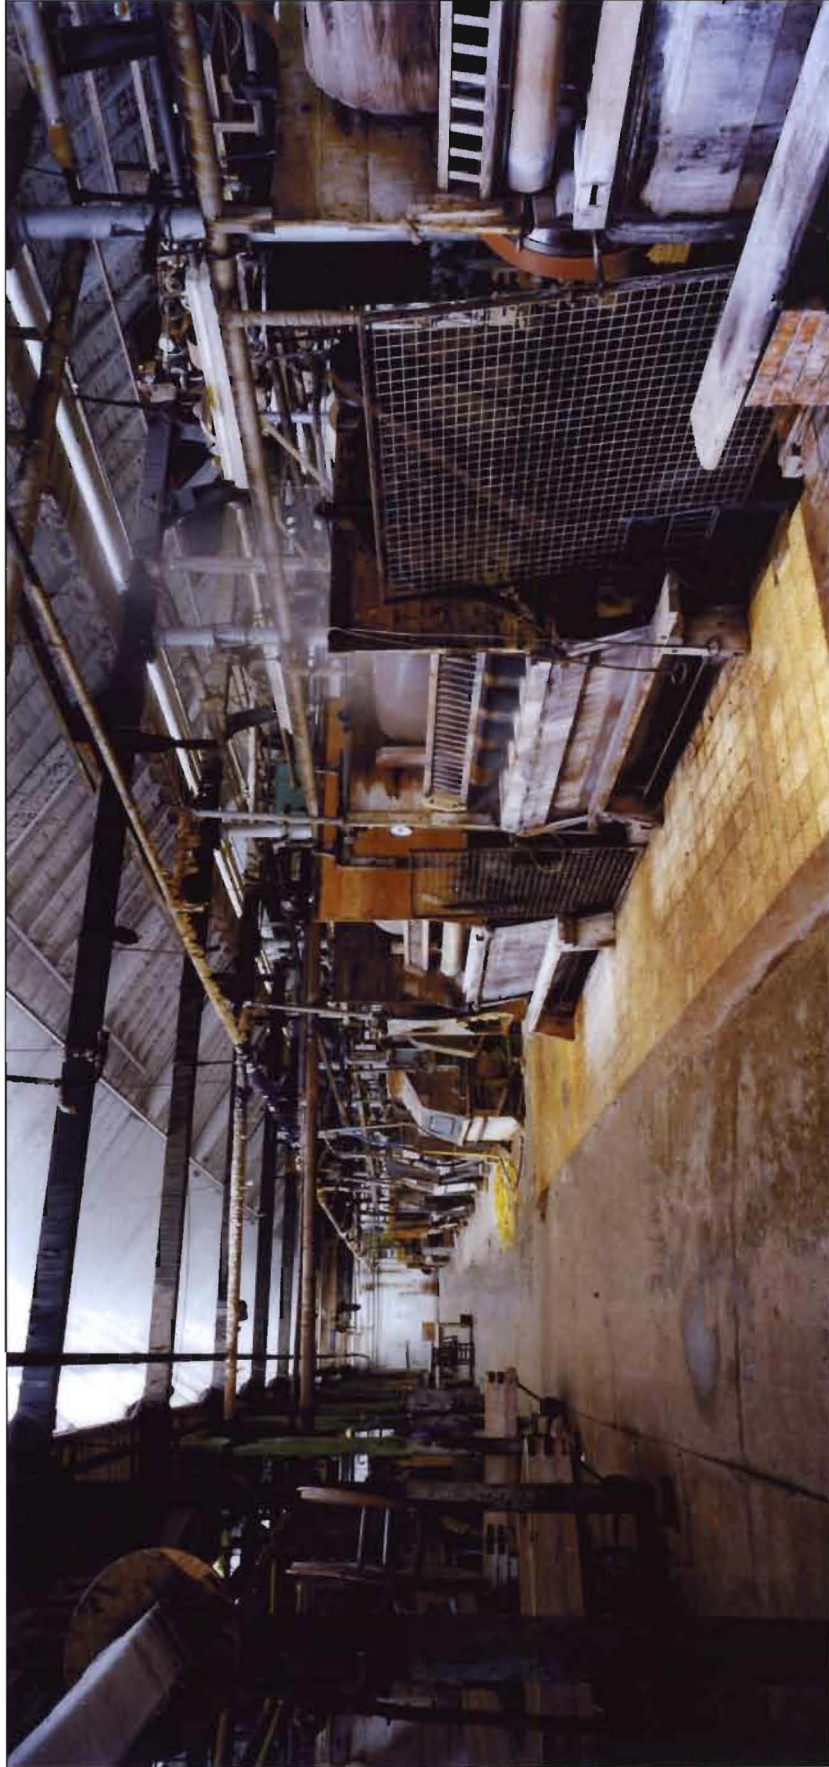
Figure 50.  
Interior of the Finishing Shed with working scouring machines, 1995. [BB96/01685]

The Finishing Shed is significant as one of the best-preserved 19<sup>th</sup>-century north-light shed factories in the country (Figure 50). As a building type, north-light sheds first appeared in the 1830s for power loom weaving and were later used for spinning, carding and cloth-finishing processes, as well as a range of other industries. From the 1860s single-storeyed factories were promoted as the most efficient type, and in the early 20<sup>th</sup> century they eventually replaced multi-storeyed buildings, especially in new industries such as motor manufacturing. The north-light shed was therefore one of the progenitors of the 20<sup>th</sup>-century factory. Its structure provided exceptionally good interior lighting but also allowed flexibility in the organisation of machinery and, importantly, an efficient means of supporting the line shafting of a power-transmission system. In the 19<sup>th</sup> century north-light sheds were built in huge numbers in the industrial regions, but by the late 20<sup>th</sup> century demolition was widespread and very few well-preserved examples survive. The Tone Works Finishing Shed is now one of only two intact 19<sup>th</sup>-century north-light sheds that are known to survive with the original power transmission system and the original type of machinery.<sup>77</sup> There are no other known examples with a combined steam- and water-power system or an intact early electric power system.

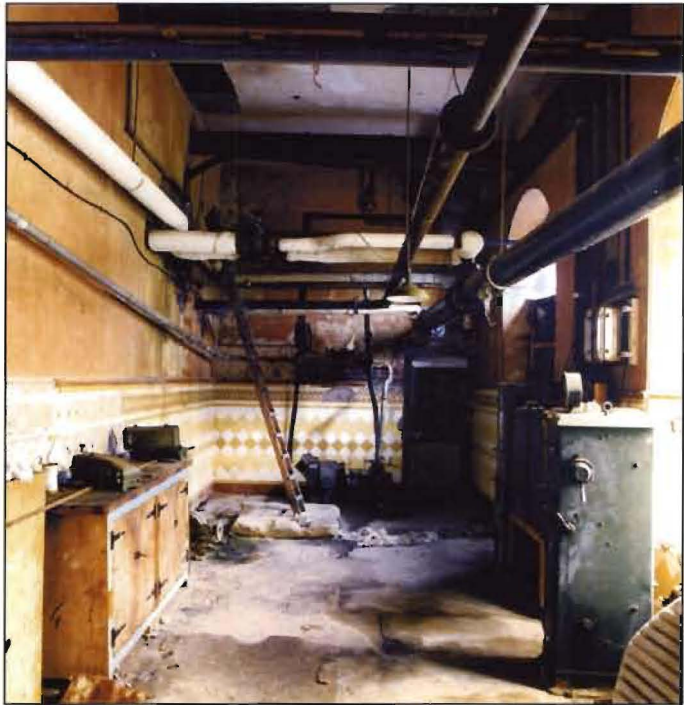
Figure 51.  
The Finishing Works Engine House. [AA96/00653]

The proportions of the Engine House indicate that it probably contained a tandem horizontal engine, a type commonly used in late 19<sup>th</sup>-century textile mills. The concrete and stone beds of the engine are exposed in the floor, including sawn-off bolts near its south end, possibly for a floor-mounted

condenser. The building retains much of its original ornamentation, with glazed tiles beneath a dado, some of the floor tiles and splayed window bays with a beaded edge moulding (Figure 51). The original roof is probably intact above an inserted ceiling. The rectangular engine beds are intact beneath the floor, with the remains of tie-down bolts for the flywheel shaft and the other main components. A small pump is still attached to the beds under the position of the flywheel shaft and appears to be original. The area to the west of the beds contains a rectangular platform supporting a bank of metal boxes of unknown function, possibly part of a DC electric system.

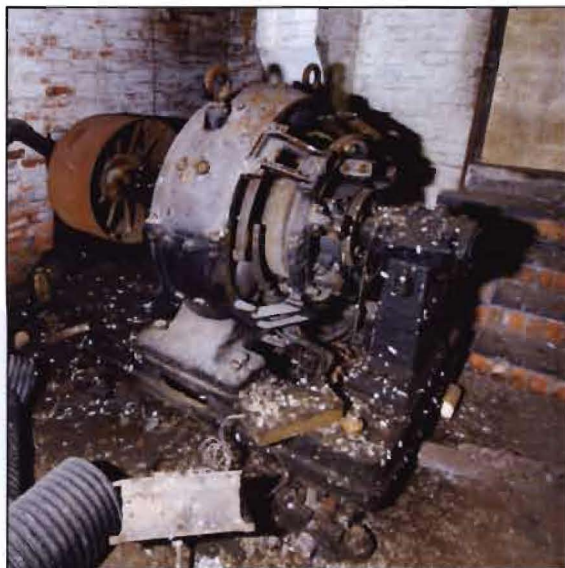
Figure 52.  
One of the 1922 DC electric motors in the Motor Room.  
[DP043927]

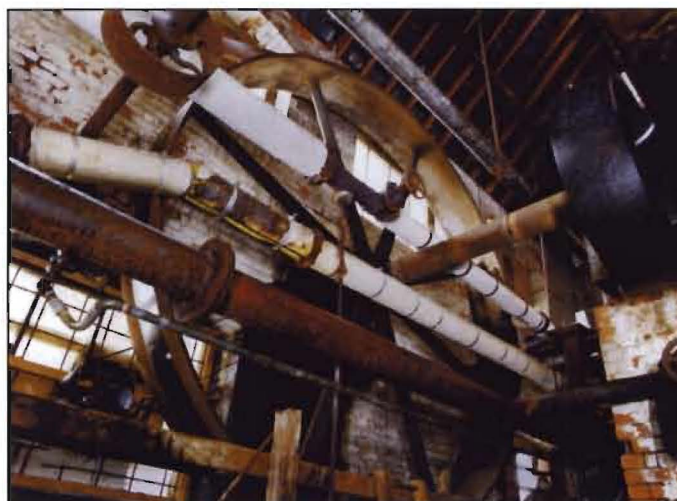
Figure 53.  
The belt pulley driving the primary line shaft in the Motor Room.  
[AA96/00677]

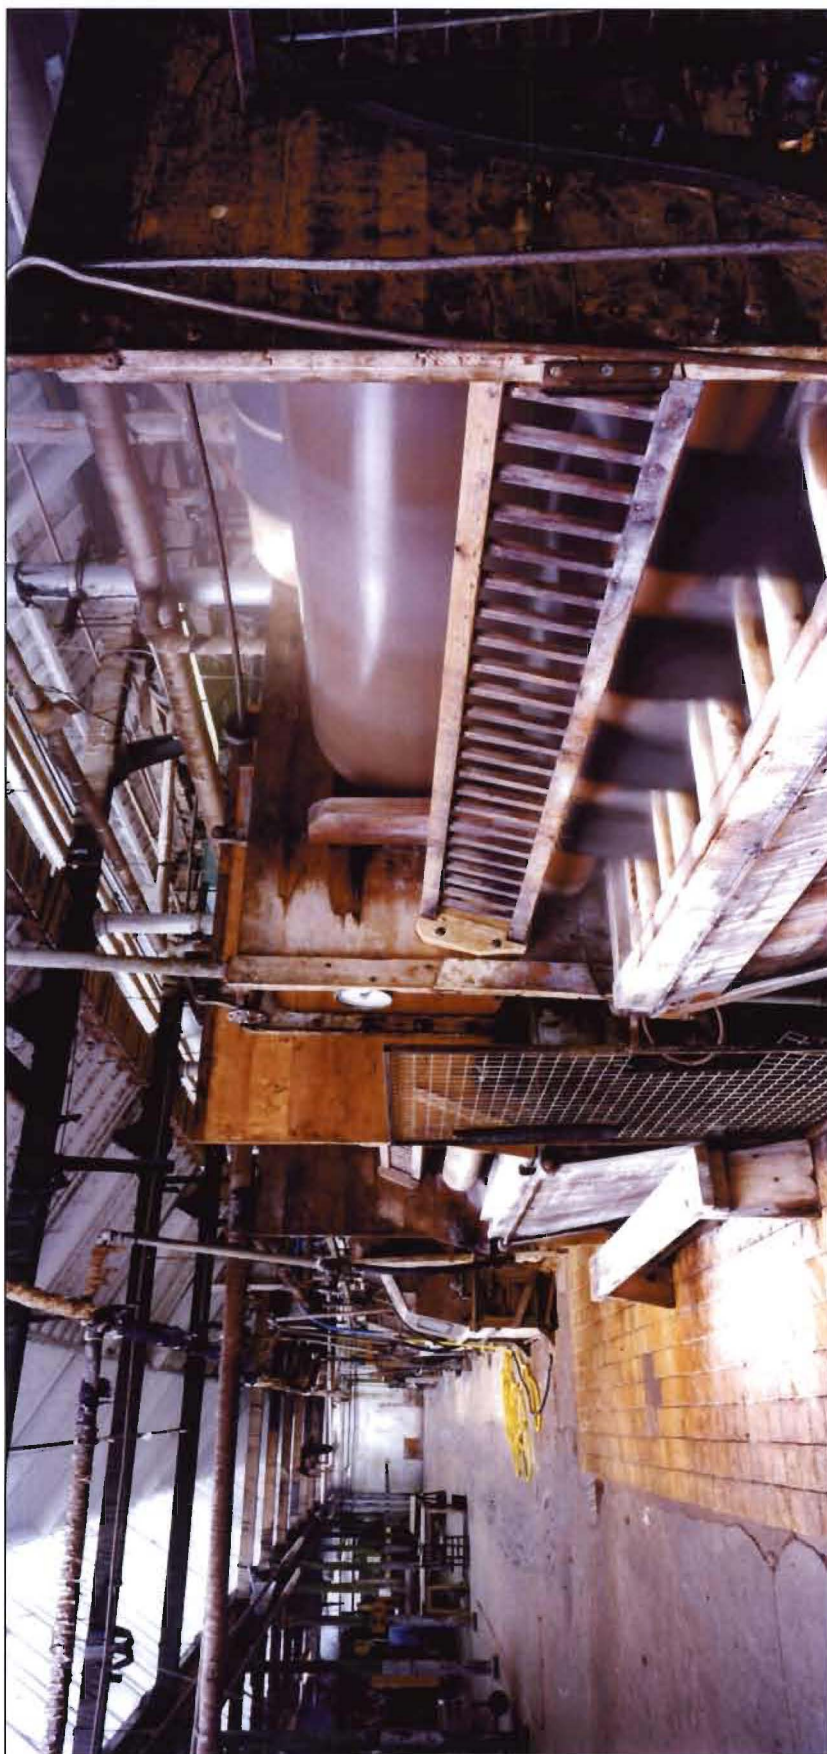
Figure 56.  
Scouring machines in use, 1995. [BB96/01681]

The *in situ* scouring machines are arranged in two rows above the main drainage channels, and include a variety of examples installed to process different types of cloth (Figure 56). All show

evidence of the regular maintenance and replacement of mechanical components and those parts which were in contact with the moving cloth or the hot liquor. They are of broadly similar design, each comprising a cast-iron framework supporting horizontal rollers above a wooden tank containing the liquor. A smaller internal wooden trough beneath the rollers collected the waste after it was squeezed through the cloth, keeping it separate from the liquor in the tank. The machines were belt-driven from the line shafts, and could be stopped by the use of either a fast-and-loose pulley or a friction clutch.

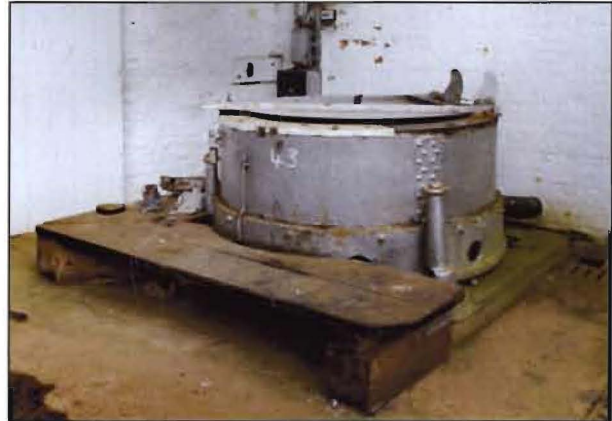
Figure 57.  
One of the two centrifuge drying machines [DP043916]

A late refinement of the finishing process was to partially dry the cloth after scouring in two large centrifuges, 1.8 metres (6 feet) in diameter, located at each end of the shed. These are of early to mid-20<sup>th</sup> century date and powered by a single large DC motors situated beneath the floor (Figure 57).<sup>81</sup>

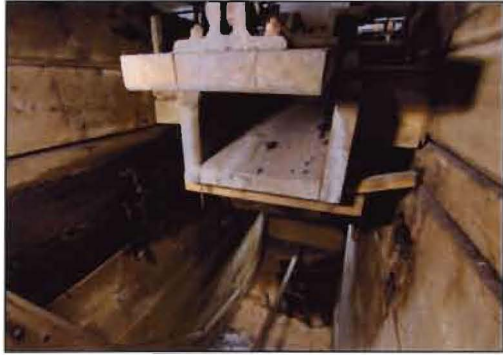
Figure 59.  
Mechanism for agitating cloth inside a milling machine. [DP043864]

Most of the milling machines are of mid-20<sup>th</sup> century date, of either British or German manufacture and made entirely of cast-iron, although some older machines are of similar iron and wood construction to the scouring machines (Figure 58). Similar wooden milling machines are shown in the same locations in the 1912 photograph. The *in situ* machines all have a single pair of narrow wooden milling rollers constructed of segments arranged with the grain radiating from the axis, which enabled the rollers to be used at high pressure. Before it entered the rollers the cloth passed through a rectangular wooden box with a pivoted top panel. A lever mechanism caused

the top panel to repeatedly slap the cloth, thus agitating it to help resist the formation of 'rigs' or creases (Figure 59).

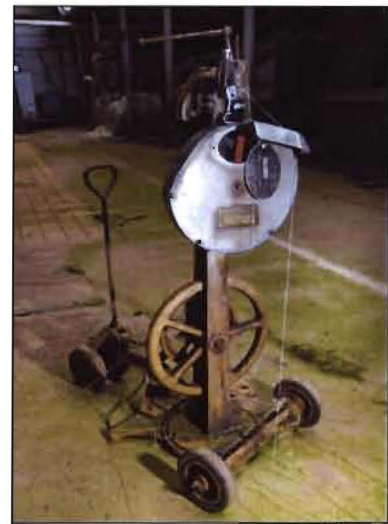
Figure 60.  
One of the portable sewing machines used for stitching cloth pieces. [DP043861]

stitched into a continuous loop, after first being fed through the machine, using portable sewing machines operated by a foot treadle, several of which remain in the building (Figure 60). It was sewn into a tube for milling using a 'bagging' machine, two of which remain in the south-east corner of the shed (Figure 19, above). The folded pieces were transported around the building on low two-wheeled wooden trolleys, measuring about 6 feet by 3 feet, one of which is shown in the 1912 photograph.

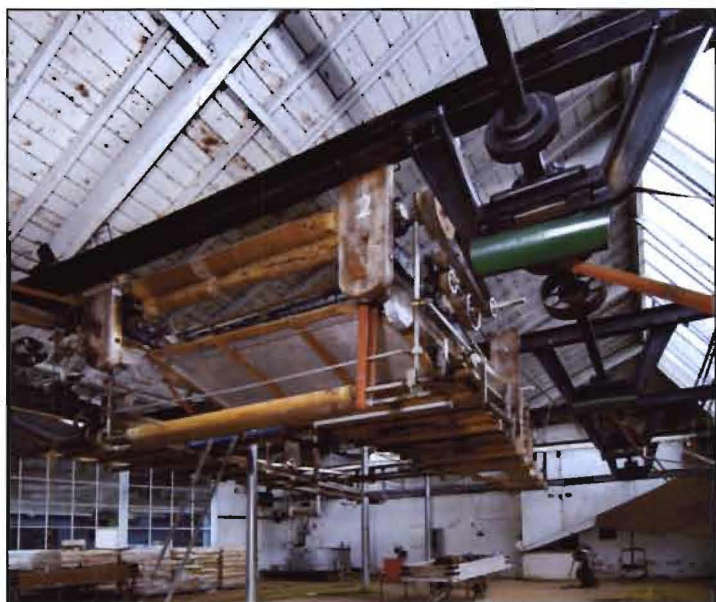
Figure 61.  
A stretching frame suspended from the Finishing Shed roof. [DP043915]

After scouring, the cloth pieces formed a tightly-compressed 'rope', which needed to be unwound and flattened before stitching and milling. This was achieved using two large triangular stretching frames, which are suspended from the ceiling in the south-west corner (Figure 61). The cloth was drawn through the narrow end of the frame by rollers at the wide end, which were powered from the line shafting. The rollers had helical ridges which were angled outwards from the centre, thus flattening the cloth and stretching it to its full width. Another roller on a pivoting frame then folded the cloth onto a trolley which was parked underneath (Figure 62).

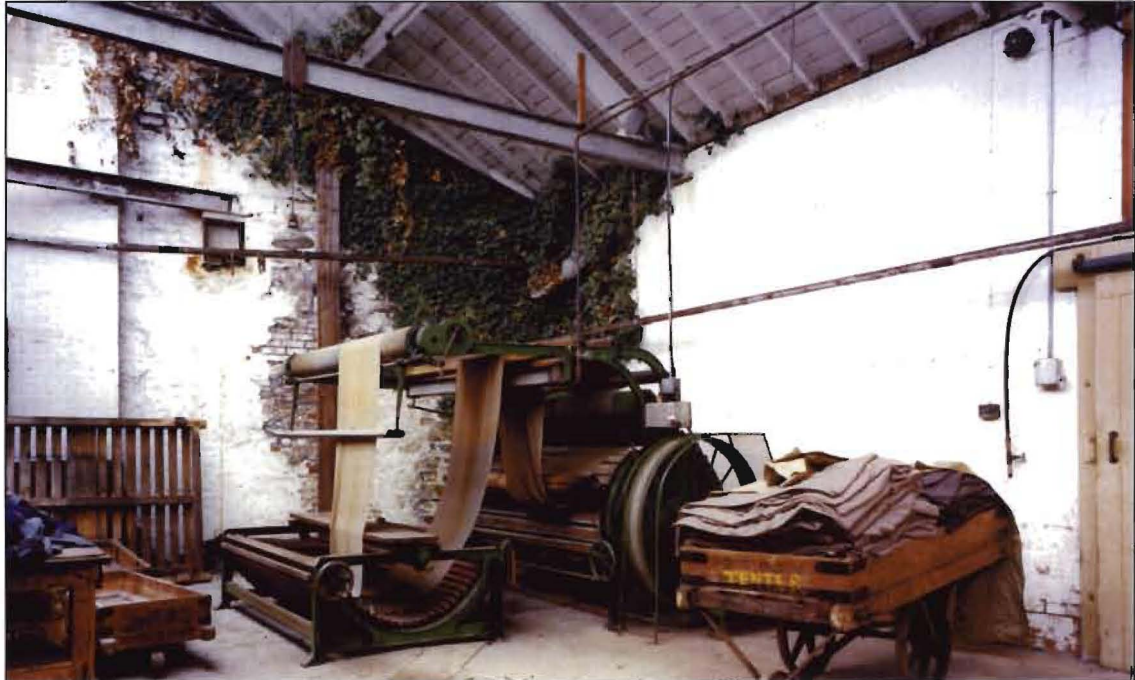
Figure 63.  
A teazle gig ready for use, 1995. [BB96/01677]

The raising and cutting machinery remains *in situ* in segregated rooms, but is mostly later than the scouring and milling machines. The two raising gigs are only partly accessible in room 16a, one using a roller with teazles and the other with metal wires (Figure 63). Additional machines in room 16 were used for 'de-rigging' cloth pieces that had become creased; this was achieved by winding

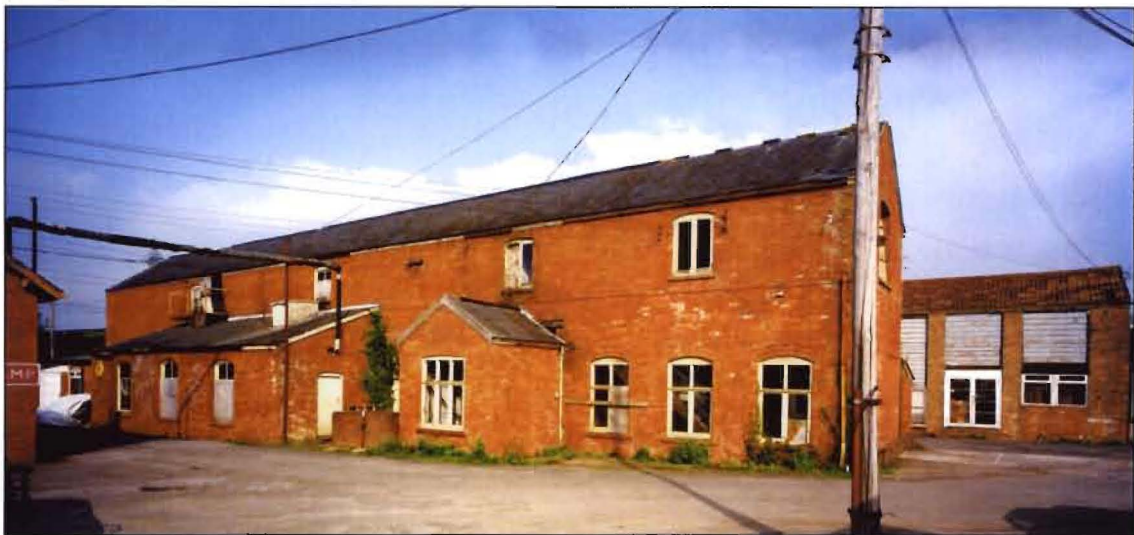
Figure 65.

The two buildings added to the south of the river were probably built for the segregated production of white and grey goods (see Historical Background). The White Goods building (Figure 24; 4 on the block plan, Figure 10) is shown on the c1886 letter head as a single-storeyed building of six or seven bays, with a small lean-to extension at the north end of its west side. The 1886-7 OS plan confirms this layout and shows the building with a central cross-wall, suggesting that it had been extended. The stone rubble side walls and north end of this building are now enclosed by the early 20<sup>th</sup> century red brick extensions, most of which are shown on the 1904 OS plan (Figure 65).

*The White Goods Building. The earlier phase is located at the left end of this view. [BB96101 709]*

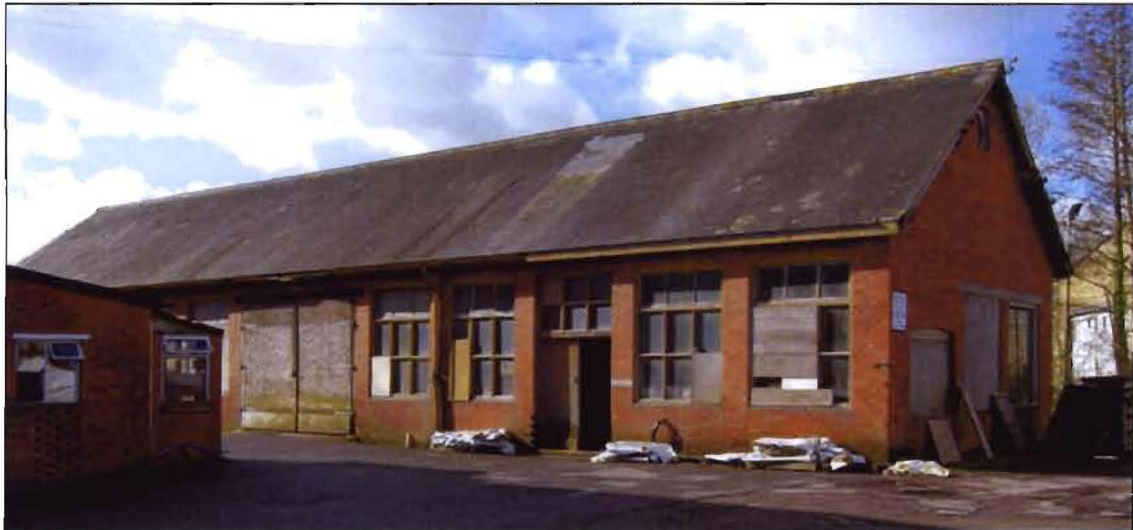
Figure 66.

Immediately to the west is an early 20<sup>th</sup>-century wide-gabled single-storeyed building of 12 bays (Figure 24; 29 on the block plan, Figure 10). This was the last manufacturing building to be added to Tone Works. Built in similar red brick to the White Goods building, it was originally used for milling grey cloths and was later converted for finishing white cloths (see Historical Background). Internally it was probably open to the roof, which is currently hidden by plastic sheeting, and does not retain any textile machinery (Figure 66).

*The Grey Goods Building. [DP046037]*

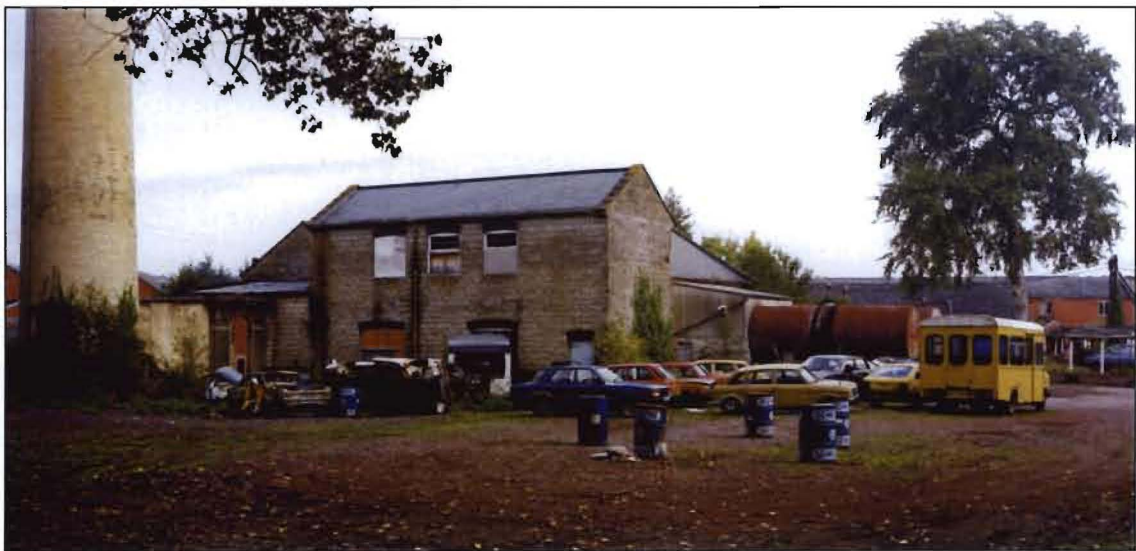
Figure 67.

The interior of the Power House has not been accessible for this survey but was photographed in the mid-1990s (Figure 24, above). External evidence indicates that most of it was built to the same compact layout shown in the 1922 Building Control Plans (Figure 15, above). Constructed mostly of cement or concrete blocks, it comprises a boiler house for three Lancashire boilers, a two-storeyed economiser house attached to the west end, a full-height single-storeyed generator room attached to the north side and a tall free-standing chimney (Figure 67). The firing floor at the east end of the boiler house retains its three original arched double doors, one facing each boiler. The boiler house and generator room have similar gabled slate roofs with light metal trusses. The two-storeyed

*The Power House, with the economiser building in the foreground. [BB96/01714]*

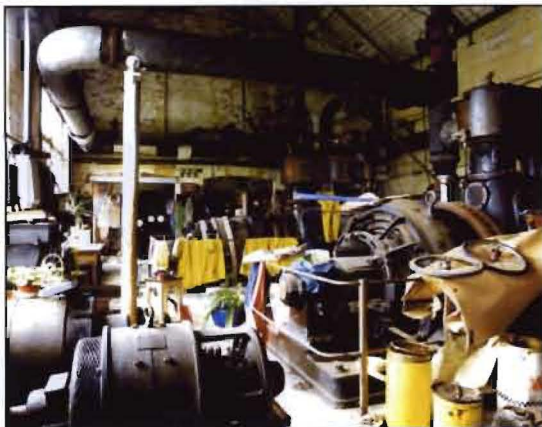
Figure 68.

economiser house is attached across the full width of the boiler house and projects beyond its south side. Its first floor is reached by an external stair and the ground floor by a door in the west elevation. The generator room has a separate gabled roof and is about five bays long (Figures 68 and 69). The three eastern bays of its north side are of earlier red brick with blocked segmental-headed windows, and are the remains of the 19<sup>th</sup>-century carpenter's shop marked on the Building Control Plans. The chimney is in a slightly different position to that shown in the plans. It is a tall circular stack of yellow brick and dominates this part of the site. The Building Control Plans show it adjoining the north-west corner, but it was built slightly further to the west. Its base is linked to the Power House by a flat-topped rectangular structure containing metal hatches to give access to the flue. This structure includes blocked narrow-arched openings on both sides which are distinctively-finished in a broadly-classical style; the function of the openings is not clear, but they may have contained part of the economiser or a powered fan.

*The interior of the generator room, 1995.*

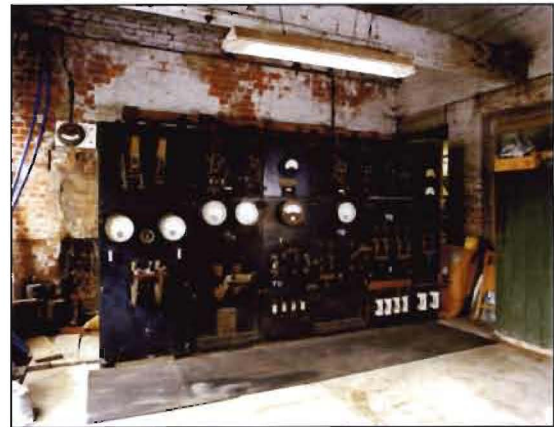
Figure 69.

*Slate switch panel in the generator room, 1995.*
