# Archaeological Investigation Report Series AI/23/2002

# Dowsborough Camp, Holford, Somerset An archaeological survey by English Heritage

January 2002

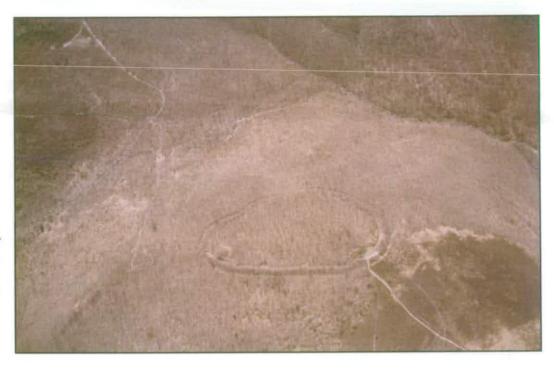
Fig. 2. Air photograph of Dowsborough Hill looking south. NMR 21136/02. © Copyright English Heritage.

Dowsborough Camp lies towards the eastern edge of the Quantock Hills AONB, centred at ST 160 391. It encloses the summit of a domed hill, one of the most distinctive topographical features of this part of the commons. The site occupies one of the highest parts of the Quantock Hills, at an altitude of over 330m OD. The hill falls away steeply on all sides. The head of Holford Combe lies to the west and south, with Bincombe to the south-east. The northern and eastern sides form part of the eastern escarpment of the Quantock Hills. The hill is covered for the most part in coppiced sessile oak. A clear area on the north-western edge of the site affords views across the Bristol Channel to Wales. Before the woods were planted there would have been

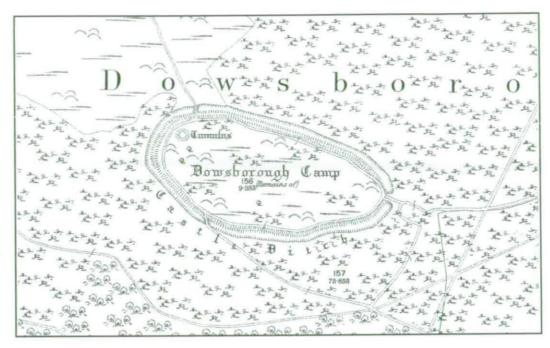
Fig. 3. Dowsborough Camp: Ordnance Survey 1st edition, 1888, Somerset 49.5.

A narrow, hollowed path or track which runs just behind the southern rampart is defined by the back of the rampart and a slight stony bank. It runs from the eastern entrance to the gap carrying a well-used path on the southern side. This path forms part of the track running right around the interior of the fort, behind the ramparts, which is marked on the Ordnance Survey 1st edition map (OS 1888) (Fig 3).

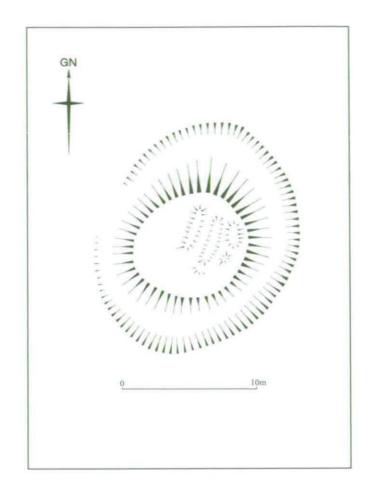
The earliest archaeological feature to survive on the hill is a large Bronze Age barrow in the north-western corner of the hillfort, at ST 1590 3915. It is a roughly circular, flat-topped mound, with an encircling ditch. The mound measures 12m in diameter and stands some 1.1m high. Some scrub oak has recently been cleared from the mound. The ditch is 1m wide at its base and 0.7m deep, and is well-defined, apart from on the western edge where a track encroaches on it. The southern part of the ditch is particularly sharp and has the appearance of being relatively recently re-cut or cleaned out. The top of the barrow has a small rectangular hollow in it, measuring some 4m x 0.6m and 0.2m deep, with associated stony mounds of spoil. The sharp appearance of this hollow suggests a recent origin, rather than antiquarian excavation. It could be associated with the use of the hillfort and its environs in the Second World War (below). A small slit trench lies just to the east of the barrow.

Fig. 4. The barrow in the north-western corner of Dowsborough Camp: English Heritage 1:200 scale earthwork plan (reduced).

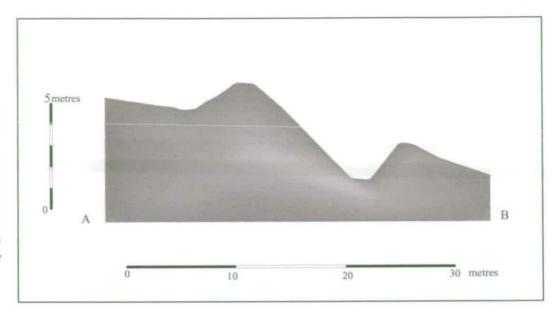
The earthworks enclose an area of some 3 hectares. The hillfort is an elongated oval in shape. The earthworks run roughly along the 325m contour, but the hill rises up to over 330m in the eastern part of the site. The earthworks comprise a rampart and external ditch, with an intermittent counterscarp bank, with an overall width of 20m. The rampart is 1-1.5m wide and 1.2m high. It is composed of earth and stone. The stone content is high, and much surface stone is visible just to the north of the eastern entrance and on the western side of the circuit. The ditch is 1m wide and 4.5m deep. The counterscarp bank is present for most of the circuit, being absent on the north-western angle and for some 50m on the northern side. The counterscarp bank is some 1m high and 1m wide.

Fig. 6. Dowsborough Camp: section of the earthworks.

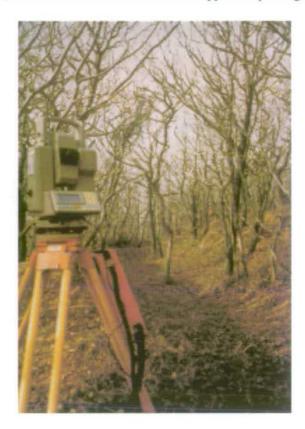
Fig. 7. Dowsborough Camp: surveying the earthworks.

The earthwork survey was undertaken by the Exeter Office of English Heritage, as part of the archaeological survey of the Quantock Hills AONB. The survey was begun in September 2001, in order to record the position of consolidation work carried out on the northern ramparts by Somerset County Council and English Heritage. The survey work was completed in January 2002. The earthwork detail was recorded using a Leica 1610 total station theodolite and completed in the field using graphical methods (Fig 7). The site was located to the National Grid (OSGB36) using Leica single frequency differential GPS (Global Positioning System) equipment.

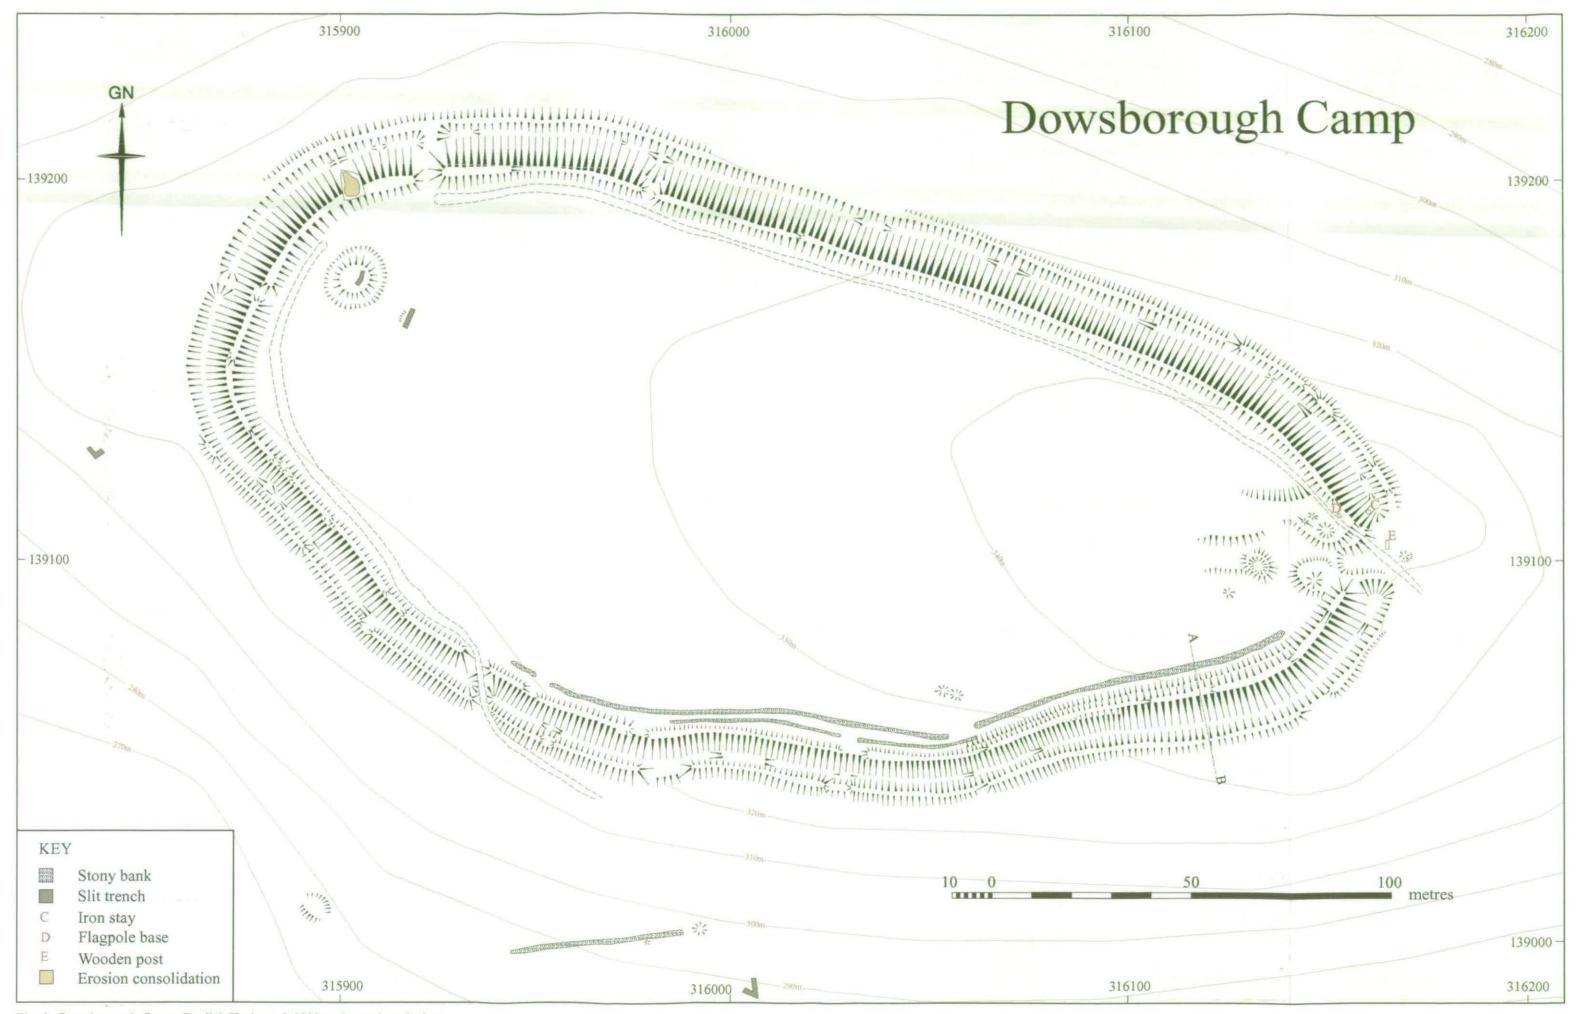
Fig. 5. Dowsborough Camp: English Heritage 1:1000 scale earthwork plan.

There are four well-defined breaches in the circuit. Of these, only one appears to be contemporary with the hillfort. The two breaches on the north-west side and that on the southern side all take recent tracks or paths across the earthworks, and clearly cut the prehistoric ramparts and ditch. The breach in the north-west angle is narrow and may have been formed when Dowsborough was used during the Second World War. The gaps carrying the well-used paths on the north and southern sides are both marked on the Ordnance Survey 1st edition map (OS 1888; Fig 3). The gap at the eastern angle is the original entrance to the hillfort. It has been disturbed, but it appears to have been a simple gap through the earthworks with a quite pronounced inturn of the rampart as it approaches the entrance from the southern side. Both the northern and southern rampart terminals show a distinct rise in height at the entrance.

The area immediately behind the entrance contains three large circular hollows, with several smaller hollows or holes. The area is defined by a scarp, which runs for some 15m westwards from the rampart. The large hollows measure some 5m in diameter, are some 0.8m deep and are surrounded by a rim of stony material. Two are located behind the rampart terminals, the other lies a short distance away. They have been variously interpreted as a watch tower and fire beacon pits (Nichols 1873, 14); fire hearths (Page 1890, 291) and circular guardhouses (SMR record no 33306, source 8).
