RESEARCH REPORT SERIES no. 62-2014

# DAUNTSEY HOUSE, CHURCH LANE, DAUNTSEY, WILTSHIRE TREE-RING ANALYSIS OF TIMBERS

SCIENTIFIC DATING REPORT

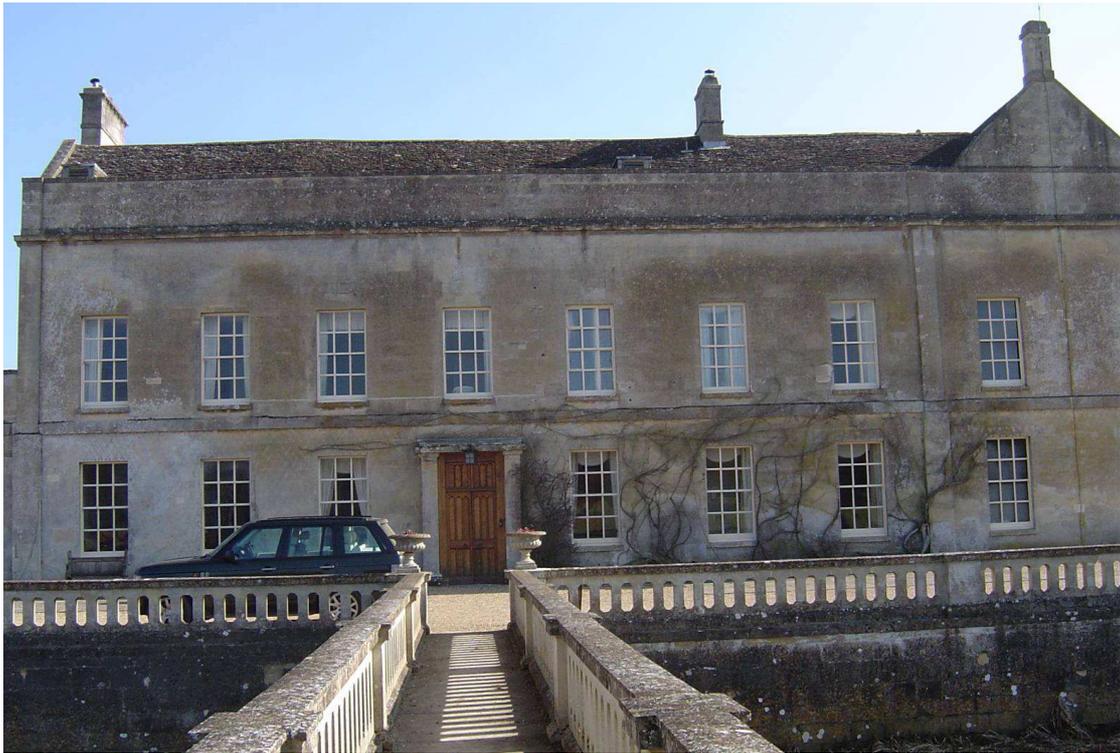
Figure 3: The west (principal) front (Avis Lloyd)

medieval origins of the building as it has been so extensively extended that the original core is completely encased in later fabric (Fig 3).

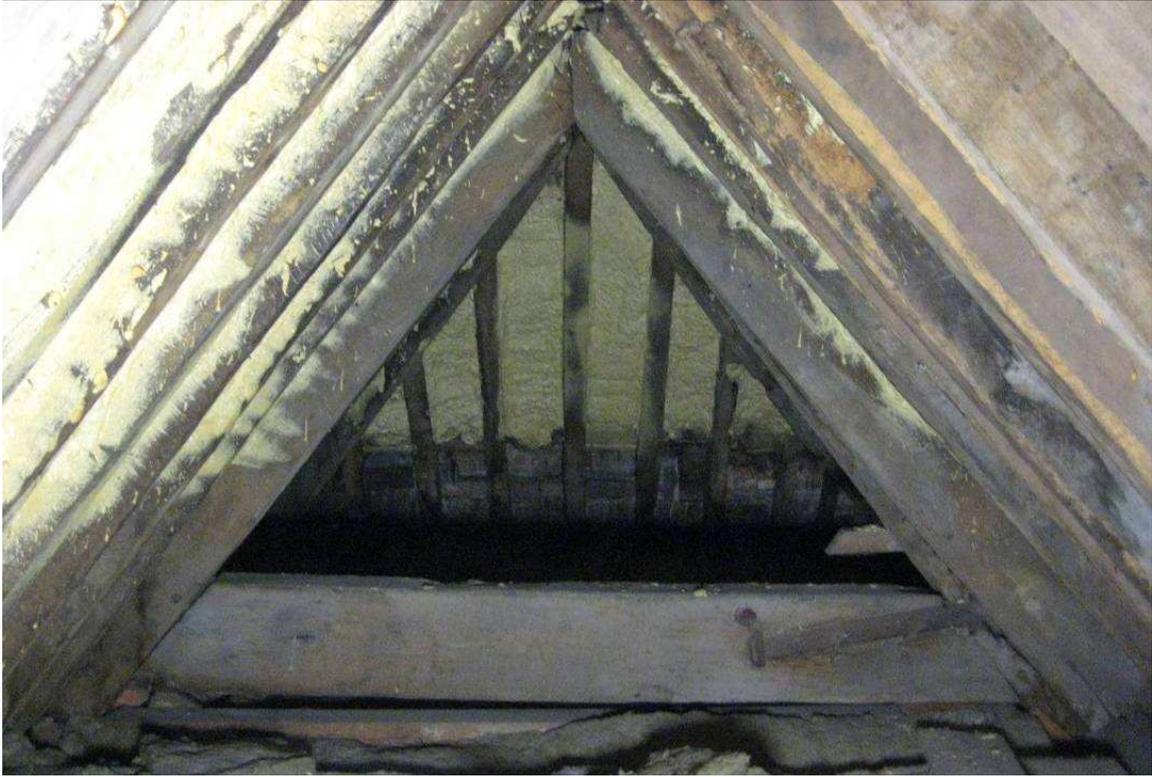
*Figure 5: Cross-wing, truss 4 viewed looking east (Matt Hurford)*

The cross-wing is at the north end of the hall and is set on a lower level. The extant roof comprises three trusses, with principal rafters and collars, and twenty common-rafter frames (Figs 5 and 6). Based on the assembly marks present on the principal rafters it is thought that this roof was originally extended by a further truss to the west.

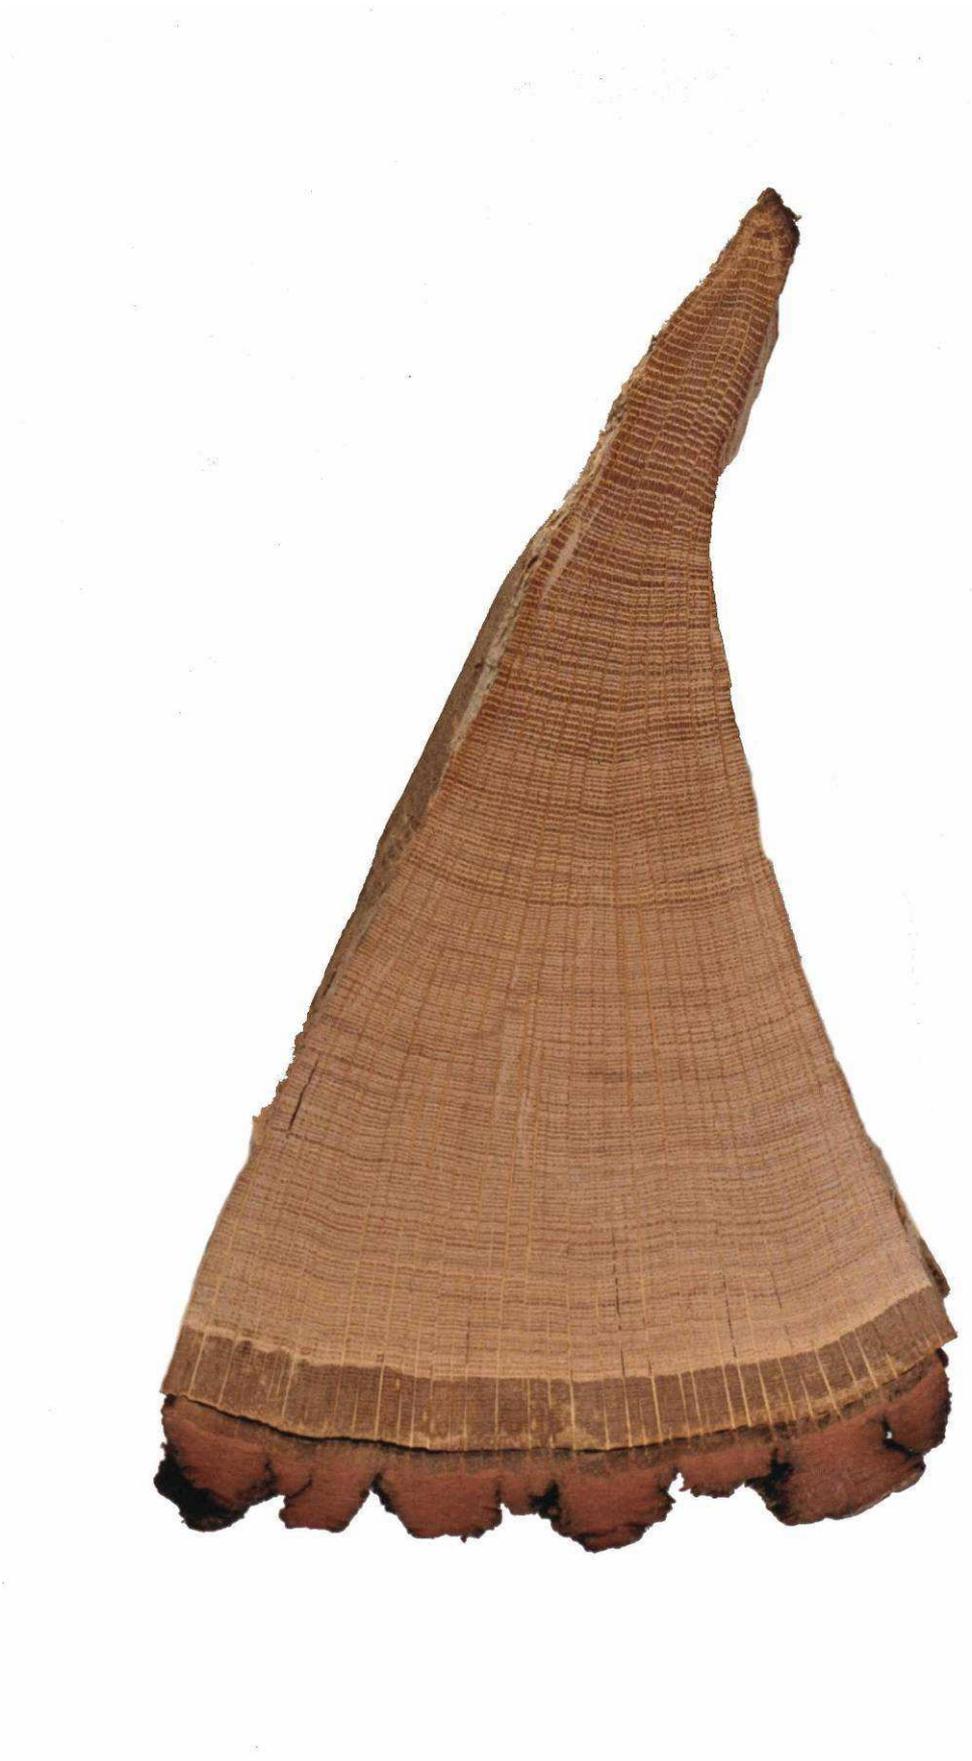
*Figure A1: A wedge of oak from a tree felled in 1976. It shows the annual growth rings, one for each year from the innermost ring to the last ring on the outside just inside the bark. The year of each ring can be determined by counting back from the outside ring, which grew in 1976*

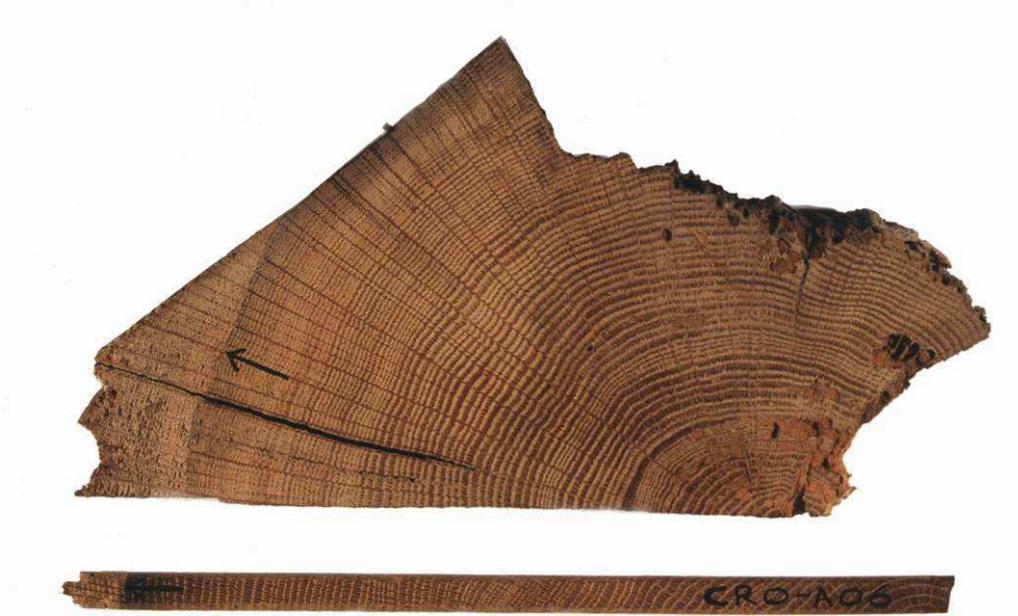
*Figure A2: Cross-section of a rafter, showing sapwood rings in the left-hand corner, the arrow points to the heartwood/sapwood boundary (H/S); and a core with sapwood; again the arrow is pointing to the H/S. The core is about the size of a pencil*

Quite often some, though not all, of the original outer rings are missing on a timber. The outer rings on an oak, called sapwood rings, are usually lighter than the inner rings, the heartwood, and so are relatively easy to identify. For example, sapwood can be seen in the corner of the rafter and at the outer end of the core in Figure A2, both indicated by arrows. More importantly for dendrochronology, the sapwood is relatively soft and so liable to insect attack and wear and tear. The builder, therefore, may remove some of the sapwood for precisely these reasons. Nevertheless, if at least some of the sapwood rings are left on a sample, we will know that not too many rings have been lost since felling so that the date of the last ring on the sample is only a few years before the date of the original last ring on the tree, and so to the date of felling.

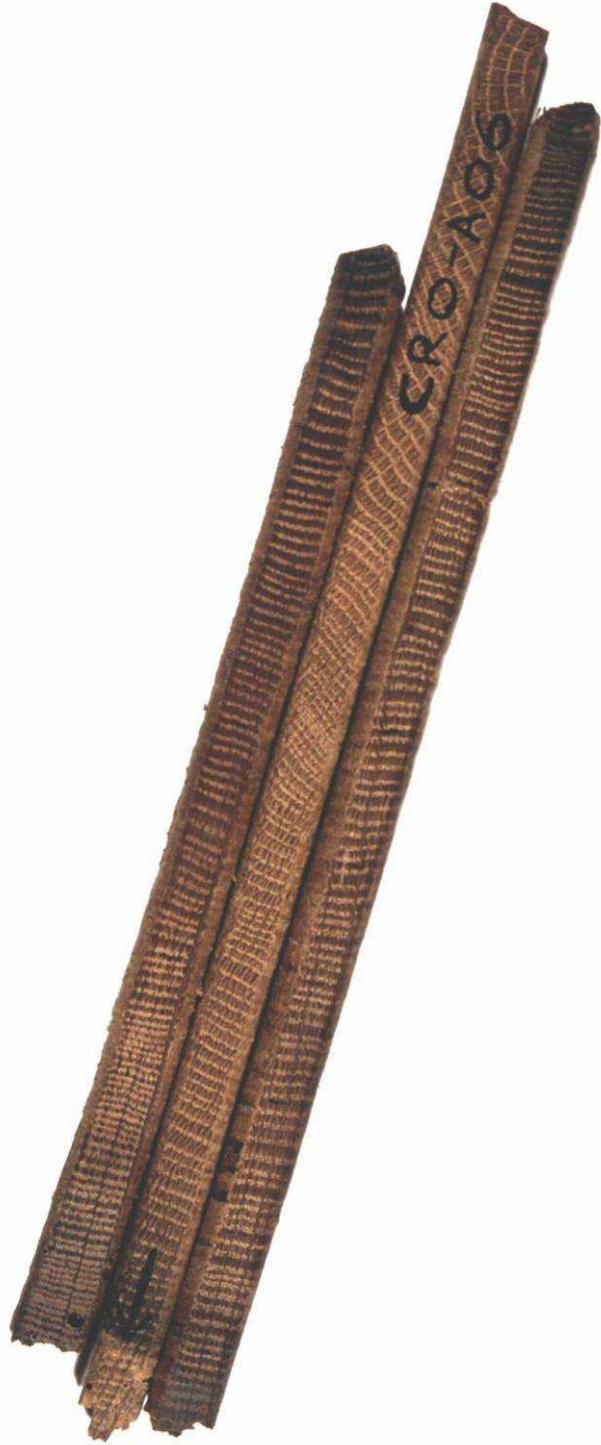
Figure A4: Three cores from timbers in a building. They come from trees growing at the same time. Notice that, although the sequences of widths look similar, they are not identical. This is typical
