HOPTON CASTLE SHROPSHIRE

A SURVEY OF THE EARTHWORKS

ISSN 1478-7008 Archaeological Survey & Investigation Report Series AI/20/2005

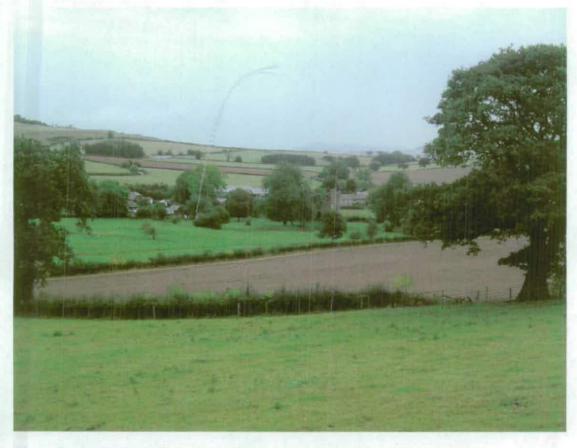
Fig 4: view to the Castle from Hopton Park, across 'Coney Green'

the tower from the deer park (Fig 4). However, the fact that they are not in precisely the same alignment as the tower would normally be thought to indicate non-contemporanaiety. Special pleading is therefore required if they are to be regarded as part of a coherent scheme. It could be argued, for instance, that the tower is set at a slight angle so that it does not present a flat face to any of the possible walks set out alongside the ponds or the northern arm of (C) and that three of the corner turrets are visible, maximising the apparent size of the building. from the most prominent viewpoints. There is nothing in the known later medieval history of the Castle to suggest that such gardens might have been added then. However, the construction of the 'new brick house' in the early 17th century would form another occasion for the laving out of gardens. As this was undertaken by the absentee owner Robert Wallop, 'a linchpin of the parliamentary war effort' (DNB) and a man of puritan persuasion, an element of 'quietism' engendered by fishing ponds might be an appropriate element in the design of such gardens (Everson and Williamson 1999, 147-50)). This probably does not explain the origin of the ponds; the scale of them fits the magnificent 13th or 14th-century tower, not the apparently rather modest 17th-century house. However, it could explain the retention of at least one of them, (F), when the others had been drained (D, E) or allowed to silt up (e and possibly elsewhere in C).
