The Ackling Dyke  
Roman Road in  
Puddletown  
Forest  
Dorset

SURVEY REPORT

**An archaeological survey of part of the  
THE ACKLING DYKE ROMAN ROAD**

Archaeological Investigation Report Series AI/37/2004

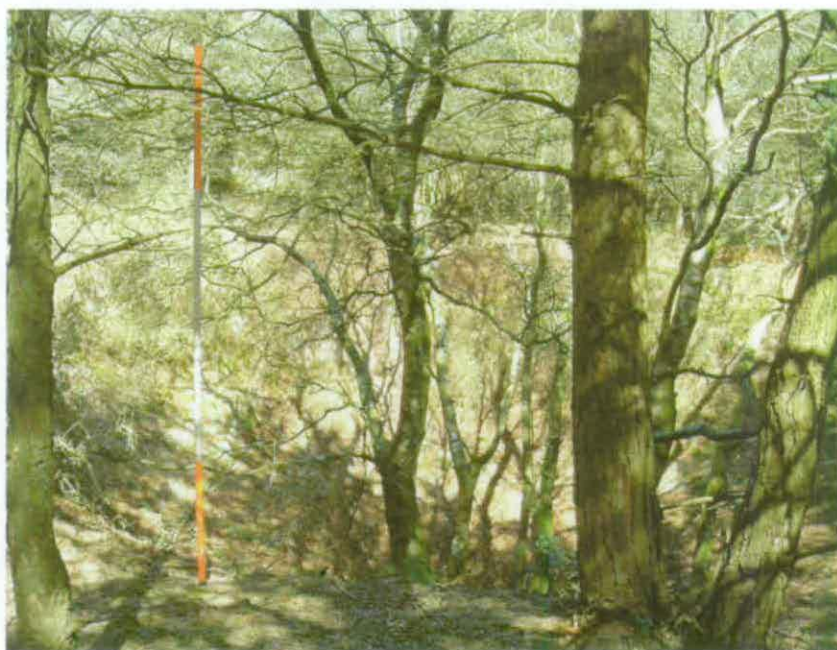
*A deep sink hole with a mature tree growing out from the side of the slope just above the bottom (C9 on plan)*

features. They occur entirely randomly across the landscape, often in bunched concentrations on level or sloping ground. Usually circular they survive in a surprising variety of depths and diameters, often with fairly precipitous sides. A number straddle the Roman road, a particularly impressive example is at SY73159223 (C9 on plan). This hole is 20m across, 7m deep with a 3.3m diameter flat bottom and a mature tree growing out from the side just above the bottom.

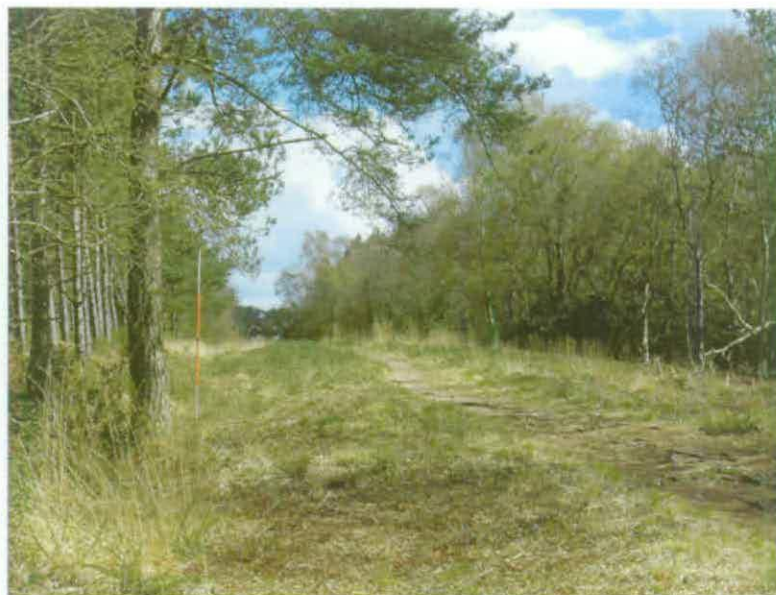
*View of the agger  
flanked by trees,  
looking north-east.  
Note the well-worn  
footpath*

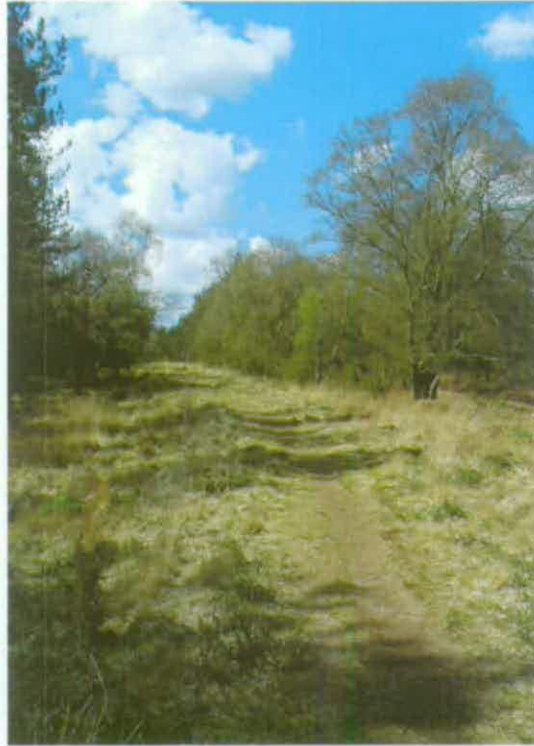
*Second  
view of the  
agger and  
the footpath  
looking  
north-east*

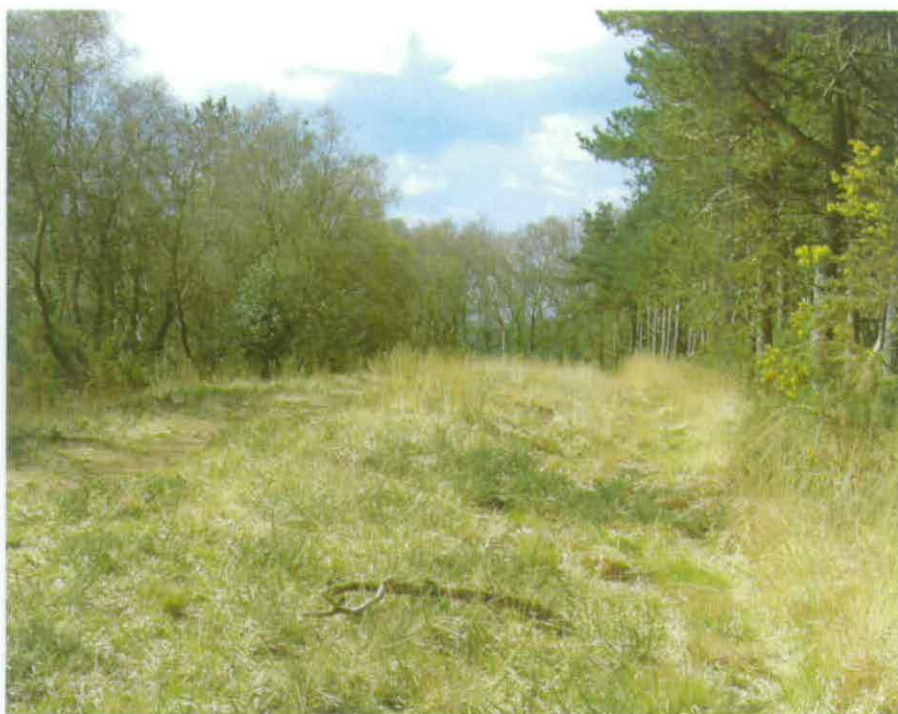
*The agger and pronounced side ditch - looking southwest*

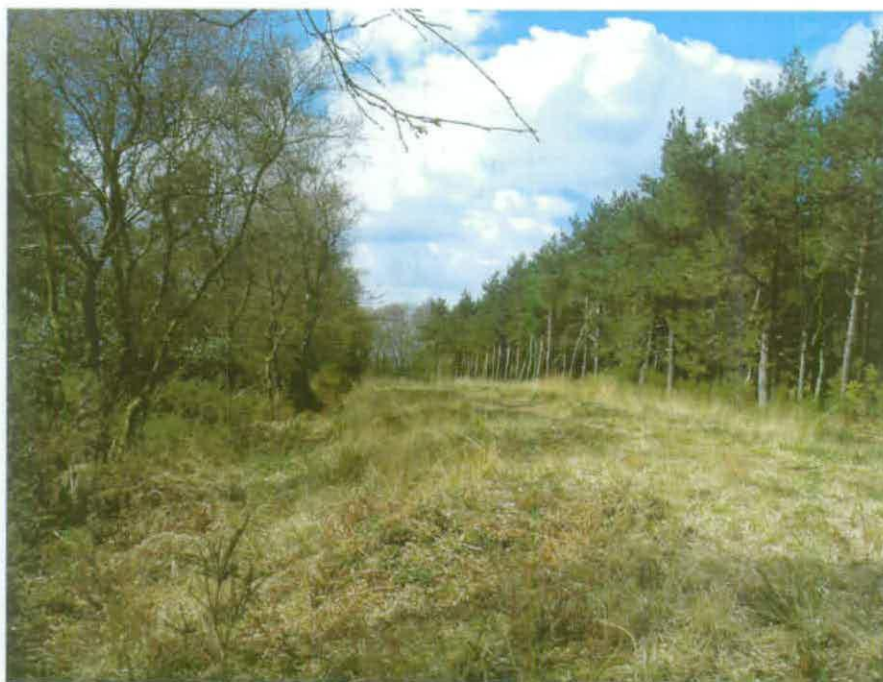
*View of agger looking north east with a side. Flanked by trees*

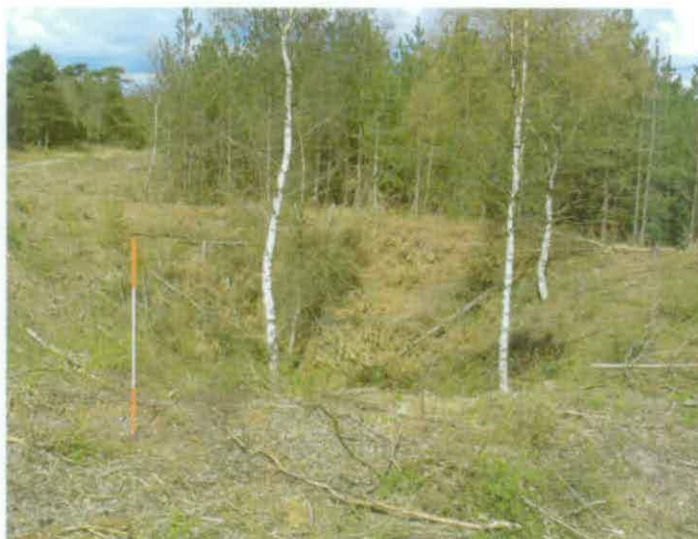
*A deep, vegetation-filled sink hole (D1 on plan).*

A broad swathe of the plantation located on the ridge slope was clear-felled by the Forestry Commission circa 1989 (1979 APs). It was also cleared of bushes and ground cover in 2003-2004. The intention is to re-establish a natural heathland habitat across an area that was depicted as unenclosed grassland called Puddletown Heath on the OS 1889 map. The road is crossed by a well-used scarp-edge track (D); here the profile of the agger, side ditches and outer slopes are clearly revealed. As it approaches the crest of the steep natural east-facing ridge-slope the road turns to the SE apparently to avoid a substantial sink hole (D1). This impressive natural conical hole, which is 3m deep and 26m in diameter, now interrupts the line of the outer bank and also cuts into the side ditch of the agger. This earthwork evidence tends to indicate that the sink hole has expanded since the road was constructed; perhaps it is still growing both in area and depth.

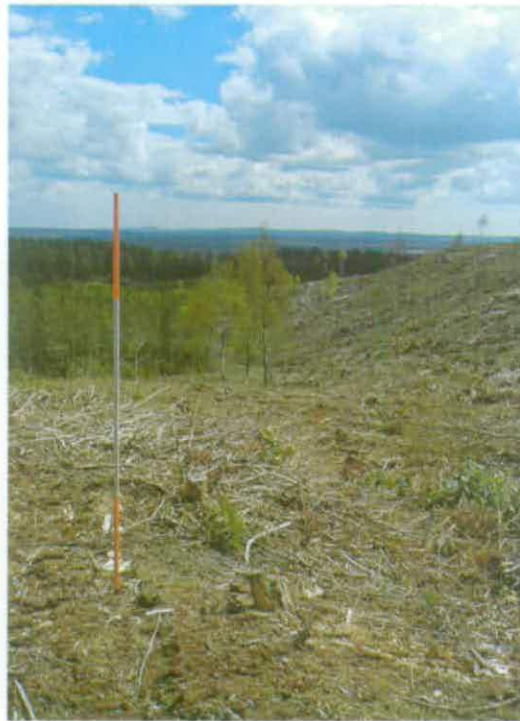
*The cleared ridge slope viewed towards the north east, showing the southern side of the agger and the new landscape dramatically revealed by tree clearance (D4 on plan).*

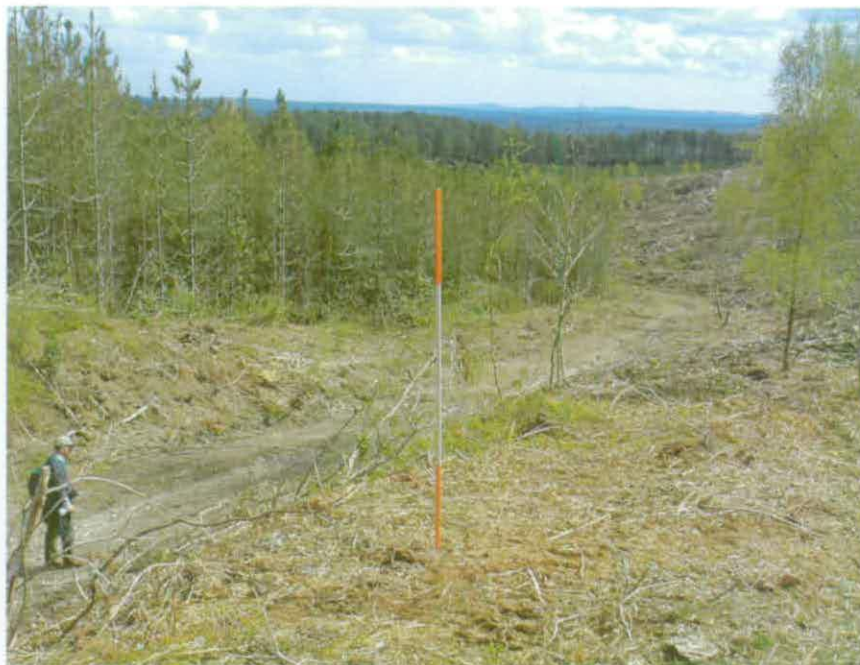
*The lower slopes cleared of timber with the impressive distant view from the east-facing ridge slope*

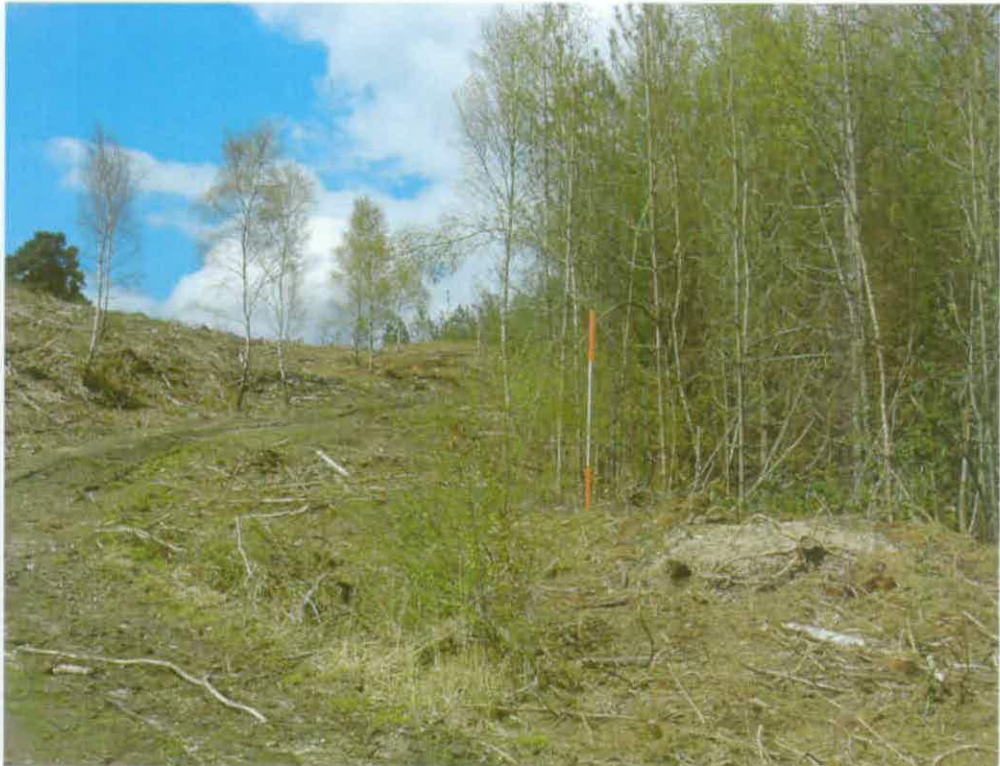
*The side of the agger with a slight terrace and natural slope (D5)*

side survives with a slight terrace at its foot. This terrace merges into the natural ridge slope and provides the necessary water run off without the need for a side ditch soakaway – a feature recorded elsewhere (C4). The overall width of the road from scarp top to scarp top is 24m.

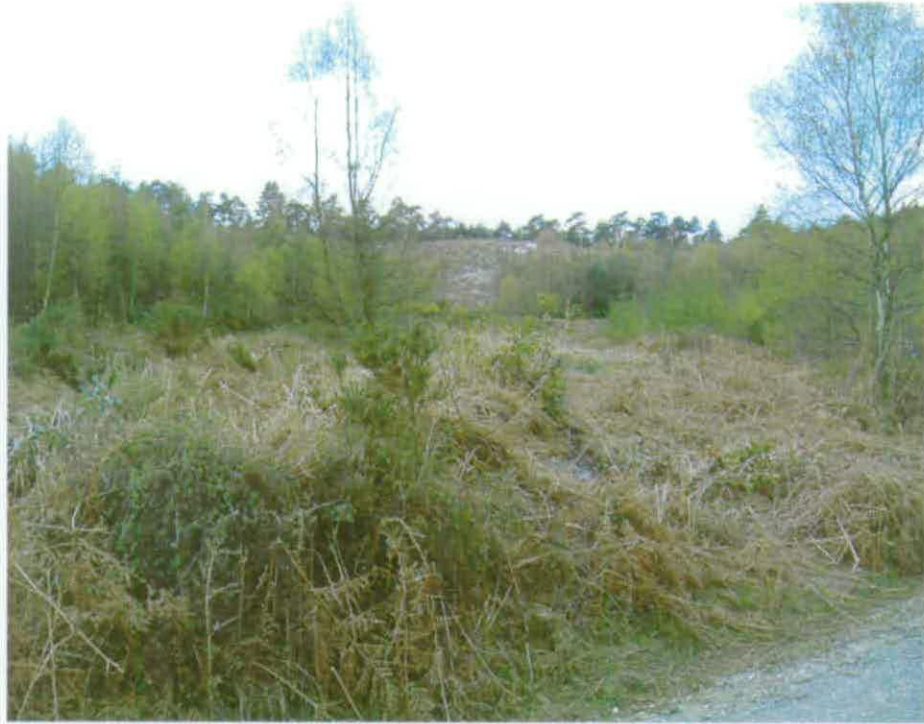
*The vegetation cloaked and damaged agger looking west (near E1 on plan).*

The agger, which once must have been a prominent earthwork, has been partially overlaid by forest tracks. It has also been badly damaged by surface quarrying dug to exploit a ready source of material when the forestry tracks were constructed (E1). A few of these tracks have a compacted layer of imported gravel on their cambered tops with clean-cut side drainage ditches. In this form they resemble a cambered and metalled Roman agger

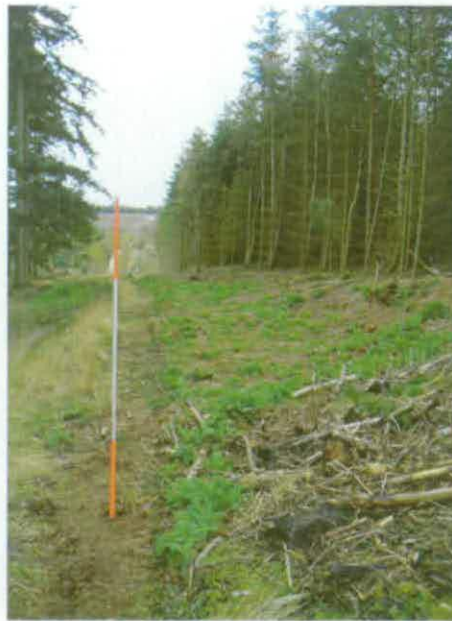
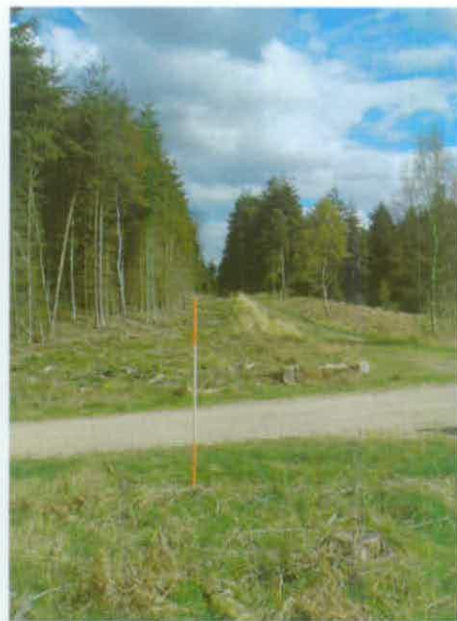
*The views looking east and west along a damaged part of the road (F on plan)*

The road, which is now fringed by blocks of conifer plantations of various ages, has an overall width of 26m. The agger width however cannot now be ascertained because it has either been overlaid by a track (F1) or extensively effaced (F2). Both the track and the damage to the agger are depicted in 1889 and thus pre-date the forestry plantations (OS map 1889). Recent damage in the form of large wood clearance bonfires and also disturbance caused by walkers and more recently cyclists has confused the picture. A linear earthen

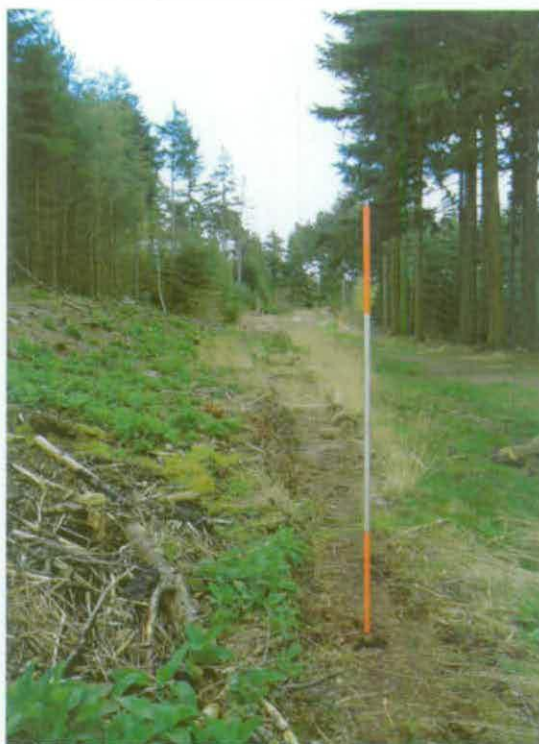
*The northern side of the road showing the wet and marshy area. (F9 on plan)*

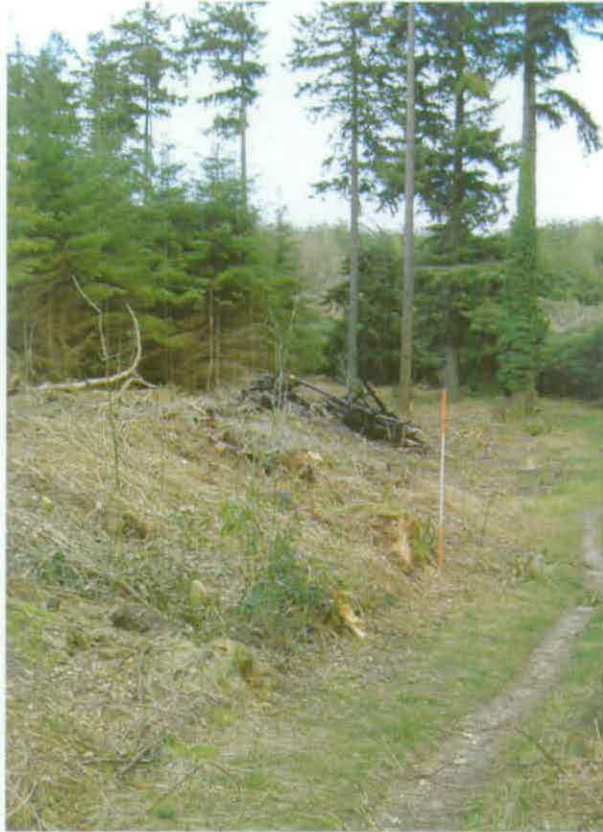
*The northern side of the road showing clearance and the remains of one of the bonfires*

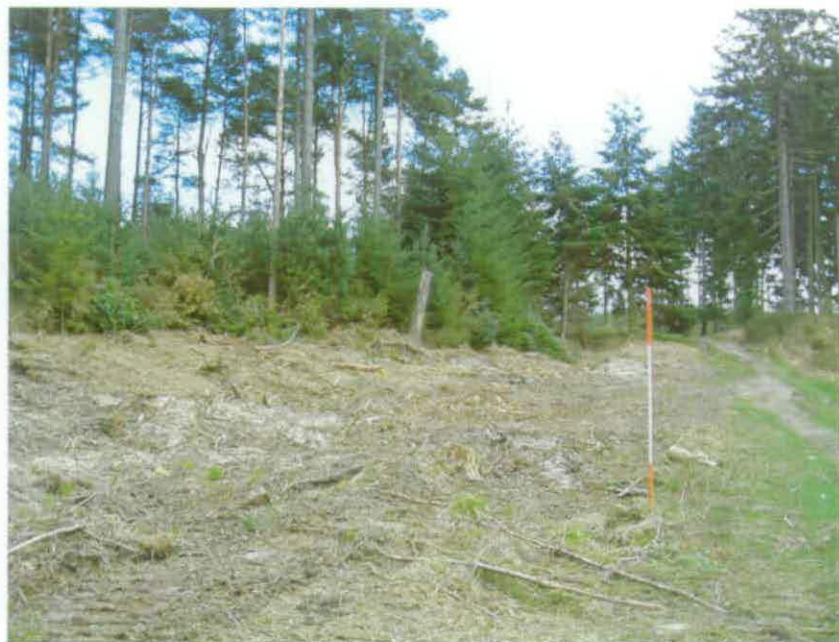
*Recent shrub clearance showing damage to the agger*

This short and very overgrown stretch of the Ackling Dyke demonstrates the problems for woodland clearance. Here there are circa 100 year old tall conifers with very high canopies which allow rhododendron and brambles to proliferate beneath. Future clearance of the vegetation covering the delicate archaeological features must be undertaken by hand and not by heavy forestry machinery. The reason for this can be seen to the west (F14) where the agger was flattened and the ground surface damaged during mechanical clearance of the dense scrub.
