Stokes Bay, Gosport: Five Centuries Of Coastal Defence

Mike Williams and Olaf Bayer

Stokes Bay, Gosport: Five Centuries Of Coastal Defences

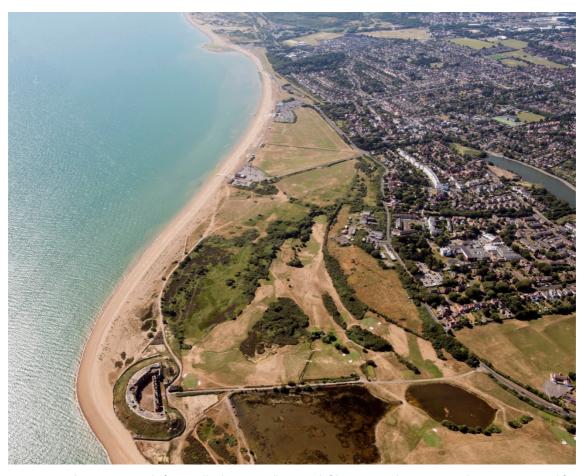
Figure 1. Stokes Bay extends from Gilkicker Point (bottom left) to Browndown Point. The area was used for important coastal defence building from the late 16th to the mid-20th century (33561_023 26/06/2018 © Historic England Archive).

The shoreline of Stokes Bay is a crescent-shaped south-west facing shingle beach, running from Browndown Point at its north-west end to Gilkicker Point in the south-east. Behind the beach is a low-lying open area that was formerly a tidal marsh. Located close to the historic military town of Gosport, Stokes Bay is now characterised by a mixture of suburban and seaside development but also retains evidence of an unusual variety of historically-significant coastal defences that were built between the late 16th and the mid-20th century (Fig 1).

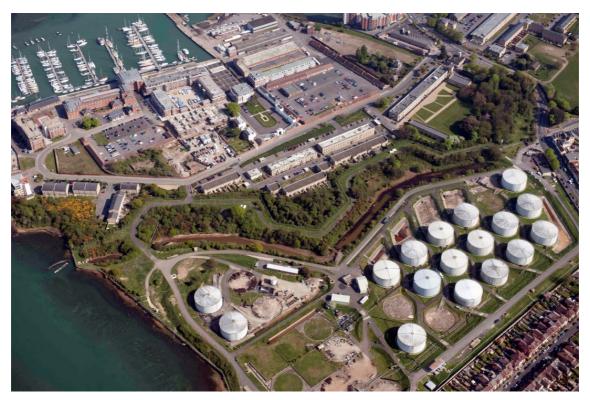
Figure 3. Part of the defensive rampart and moat built at Gosport in the late 17th century by de Gomme, running from mid-left to upper right of the image. Below is an early 20th century naval fuel depot (26941_003, 19/04/2011, © Historic England Archive).

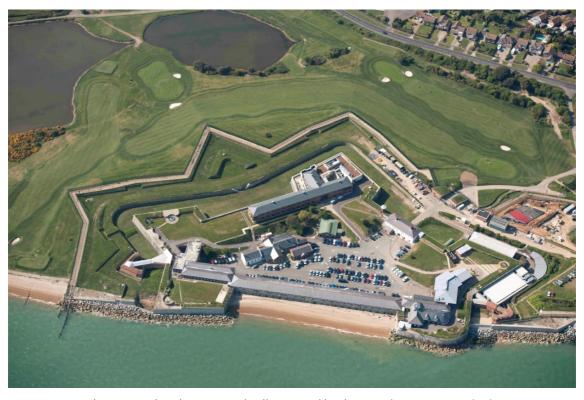
Figure 4. Fort Monckton, completed in 1790 and still occupied by the MOD (26941_041, 19/04/2011, © Historic England Archive).

Comparison of Fort Monckton with late 18th century plans indicates that most of the original fort survives intact, with later alterations adding to the original structure rather than replacing it (Fig 4; Fort Monckton is not open to the public). Its design combined the established features of the bastioned fortress with some advanced new features. It was built to defend the main approach to Portsmouth Harbour from the west, with a main battery of 22 casemated guns housed in a straight curtain wall facing The Solent. Casemates were an advanced feature that became more common in mid-19th century defences. A single storey barracks block was built above the casemates; a pair of octagonal cookhouses were built to the rear of each end of the barracks block but do not survive. Officer's quarters were added to both ends of the barracks in the early 19th century. The main ramparts were built to a roughly triangular plan with bastions at the main apexes flanking curtain walls (Williams 1979, 45-7). An additional pair of bastions flanked the seaward-facing battery. All five bastions and the landward-facing ramparts were built in Purbeck stone and had top-mounted guns in embrasures, a more typical 18th century arrangement. The ramparts and bastions were enclosed by a dry moat. Another advanced feature was the use of two caponiers, projecting into the dry moat behind the bastions flanking the seaward-facing battery. The caponiers were strongly built in brick to a distinctive arrow-head plan and provided additional cover for the ends of the dry moat, which were open to the beach. The main entrance to the fort was a substantially-built two storeyed gatehouse in the centre of the north-facing curtain wall, flanked by the embrasures of the projecting bastions. The original magazine was of massive brick-vaulted construction and survives partly intact.

The fort was surrounded by an extensive system of defensive earthworks, originally more than double the area of the fort itself, most of which are well maintained in the same layout shown on the early plans (Fig 4). The dry moat was enclosed by a covered way and a glacis, defined by stone-walled embankments which conform to the polygonal plan of the bastions and ramparts. The lake in the course of the River Alver, which formerly entered the sea to the west of the fort, was adapted to form the western limit of the glacis (Williams 1979, 57). The covered way included two triangular ravelins projecting into the glacis, sited in front of the fort's curtain walls. It was spanned by ten traverses, low-

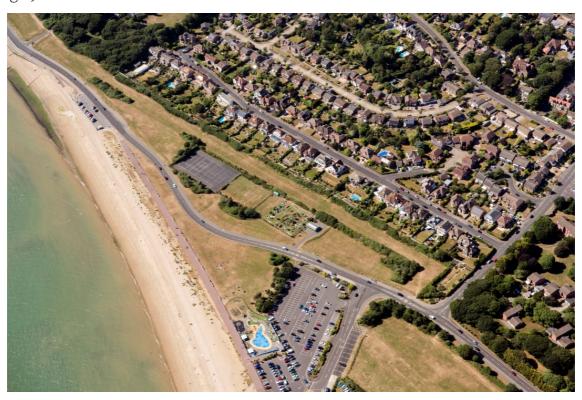
Figure 5. The angled design of the Stokes Bay Lines had a marked influence on later development (33560 $_$ 027 26/06/2018 \otimes Historic England).

dated 1892: Historic England Archive WD670 (Fig 17), WD671, WD675, WD676, WD677 and WD678). It was designed by Colonel WFD Jervois, Assistant Inspector General of Fortifications, but was heavily influenced by the earlier recommendations of James Fergusson. The largest feature of the Stokes Bay Lines is an earthwork rampart fronted by a ditch, which extended for 2.7 Km (1.7 miles) along the full length of the bay. Five new batteries were built into or immediately behind the rampart, which were of varied designs to defend either the area behind the beach or the Lines themselves. The layout of the moat and rampart was partly determined by military requirements and partly by the coastal topography, comprising a series of angled straight sections built on the low-lying area between the beach and the higher ground to the north. Most of the batteries projected forwards to enable guns to fire parallel with the rampart, along the moat, and were close to the positions of the earlier redoubts and batteries built in the late 18th and the mid-19th century. The angled plan ensured that flanking fire from the batteries could cover the full length of the Lines while avoiding each other's range of fire (Fig 5).

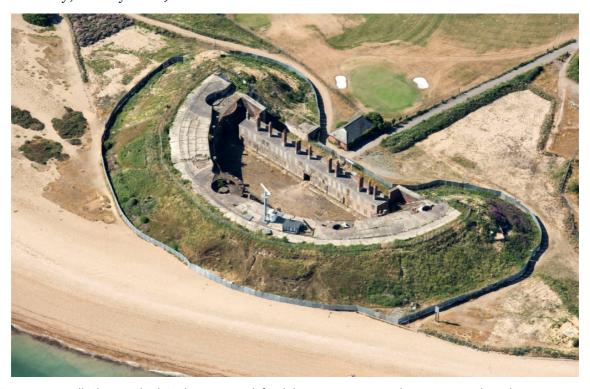
Figure 6. Fort Gilkicker was built in the 1860s to defend the western approach to Portsmouth Harbour (33561_015 26/06/2018 © Historic England).

Another major addition to the Stokes Bay defences was the construction of Fort Gilkicker, which still dominates the headland at the south-east end of the bay (Fig 6). The first defensive position on this site was an Auxiliary Battery of Fort Monckton built in 1858, comprising earthwork ramparts built to a splayed three-sided plan similar to that of Battery 5. It was connected to the fort by a long rampart. The battery had embrasures for eleven guns and faced south-west to defend both the western approach to Portsmouth Harbour and Stokes Bay beach. It was one of the defences to be criticised as inadequate in the late 1850s, and it was replaced by a south-facing fort whose primary role was to cover the approach to the harbour; Stokes Bay itself would be defended by the

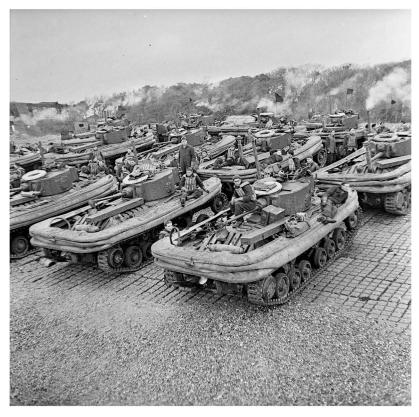
Figure 8. Valentine tanks, with modifications for amphibious landings, on one of the Stokes Bay Hards (copyright Imperial War Museum, H 35177).

An early addition was the construction of four concrete slipways, known as hards, built at intervals along the beach in May and June 1942 (Dobinson 1996, 6). By 1944 hards had been built at numerous strategic sites along the coast between the Thames estuary and South Wales, but those at Stokes Bay were part of an earlier building programme to support exploratory raids. Hards were built to a standard design which only varied to suit the angle and composition of the beach. They comprised a solid concrete apron, built between an access road and the high tide line, beyond which a flexible mat of connected concrete slabs continued down to the low tide line (Fig 8). The sides were splayed out in

a distinctive radius where they met the access road. The width of the hard enabled four large LCTs (Landing Craft Tanks) to be loaded side by side. Each hard had a central jetty for loading, which terminated in a "dolphin", a steel structure to which the landing craft were moored. The four hards at Stokes Bay were identified as G1, close to Battery 2, to G4 which was sited west of the pier. Parts of the concrete aprons survive, later converted to car parks, and fragments of the flexible matting remain embedded in the shingle.

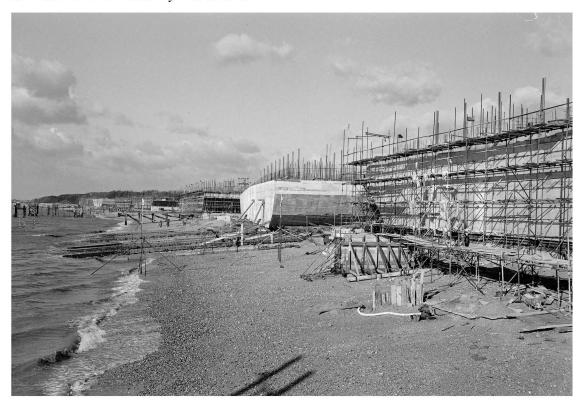
Figure 9. Phoenix caissons under construction at Stokes Bay, 1944 (copyright Imperial War Museum, H 35554).

Archive photographs show the main stages of Phoenix construction, and aerial photographs taken shortly after the war show the huge scale of the project (Fig 9, 56 and 57). The building sites included engineering facilities and storage yards for materials, and completely dominated Stokes Bay by early 1944. The caissons were built on low sleeper walls and moved around in sequence using powered winches. They were launched down steel slipways for completion when afloat, then towed to "parking" areas along the coast ready for deployment after the D-Day invasion. The construction sites were cleared in the 1950s but archaeological evidence survives of the sleeper walls and the foundations of the launching slips.

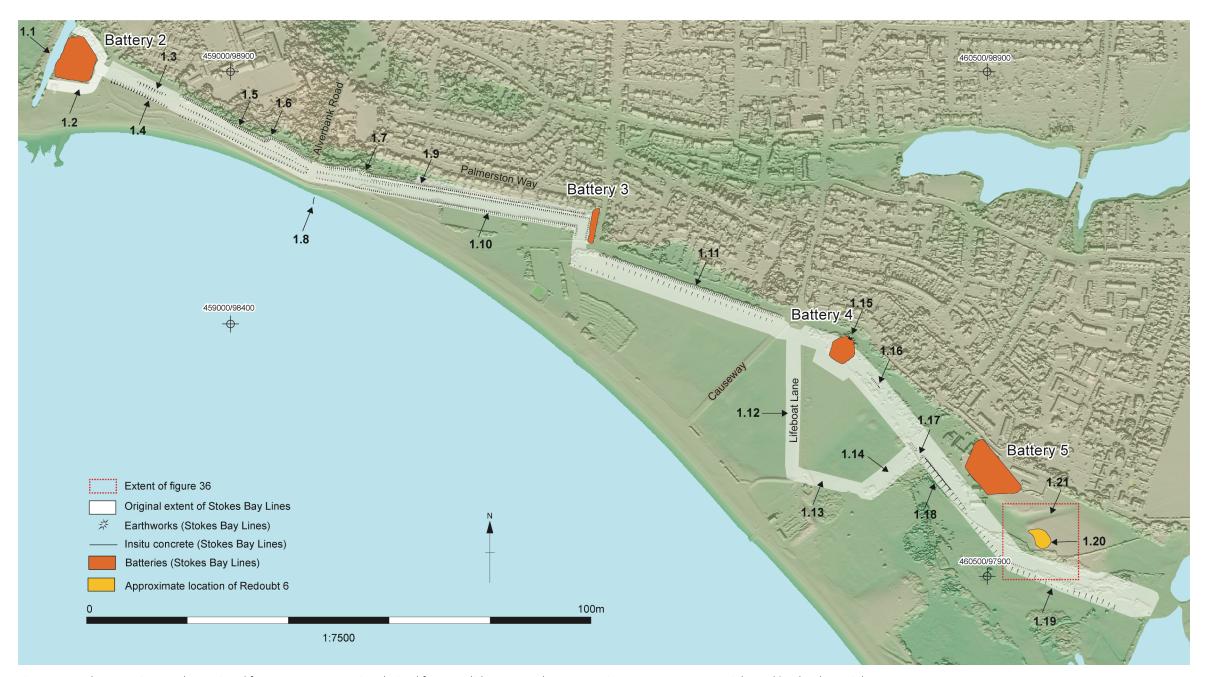
Figure 13. Stokes Bay Lines and associated features. Base mapping derived from 1m lidar DSM and DTM © Environment Agency copyright and/or database right 2018.

a) Battery 2 to Palmerstone Road (centre SZ 59015 98770) Immediately to the west of Battery 2 the Stokes Bay Lines survive as a water filled channel (Fig 18 and 38) carrying the River Alver south to the sea (1.1). No surface traces survive of the moat surrounding Battery 2 (1.2, Fig 13). The Lines were substantially flattened and/or infilled between Battery 2 and Palmerston Road in the mid-1950s (Moore 2014, 20) (Fig 19). In this area (1.3) traces of the moat survive as a very faint linear depression *c*22m wide with a maximum depth of *c*0.2m. A short length of *c*0.1m high earthwork (immediately to the east of Battery 2) is the only possible surviving remnant of the southern bank of the defences in this area (1.4).

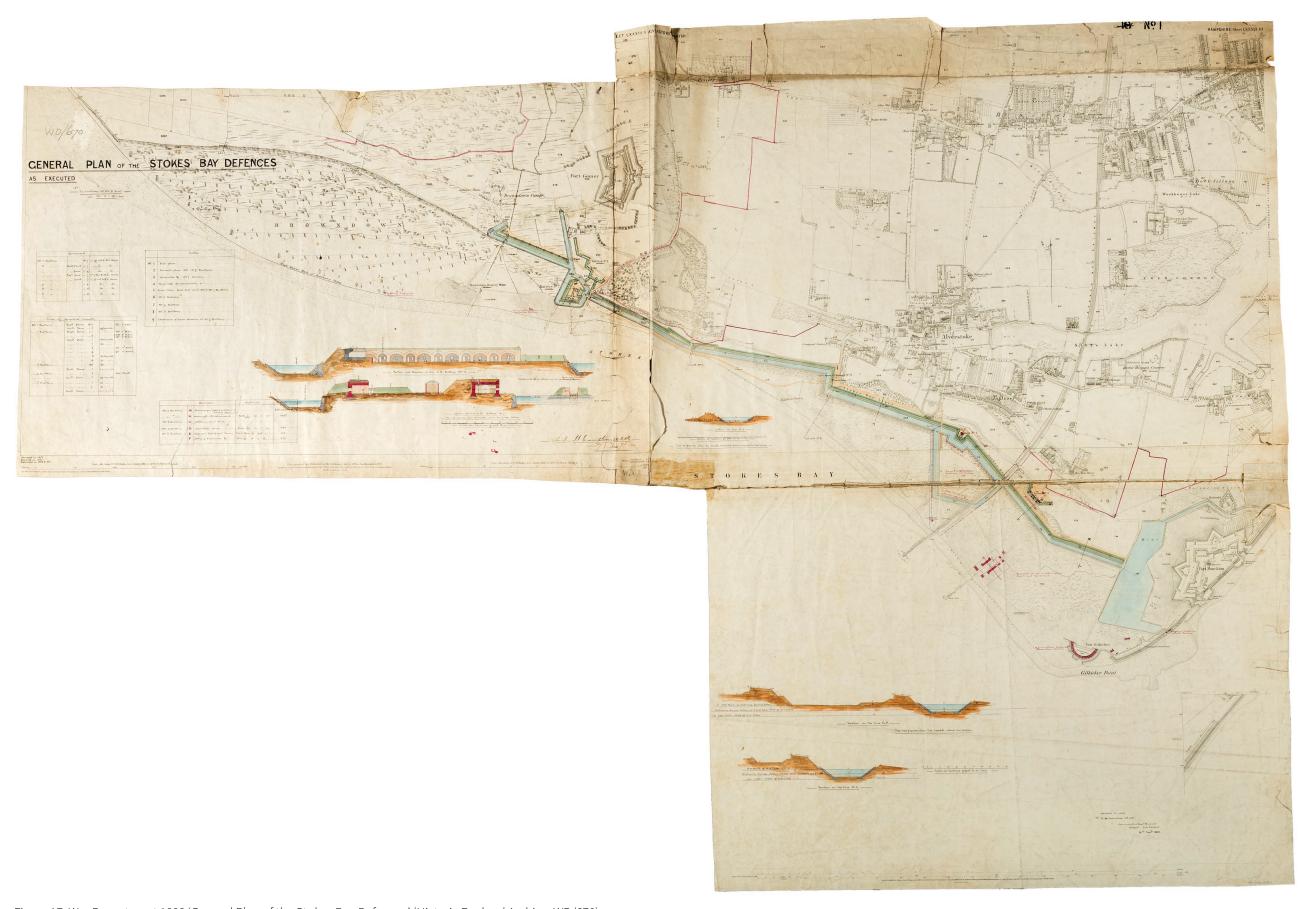
Figure 17. War Department 1892 'General Plan of the Stokes Bay Defences' (Historic England Archive: WD/670)

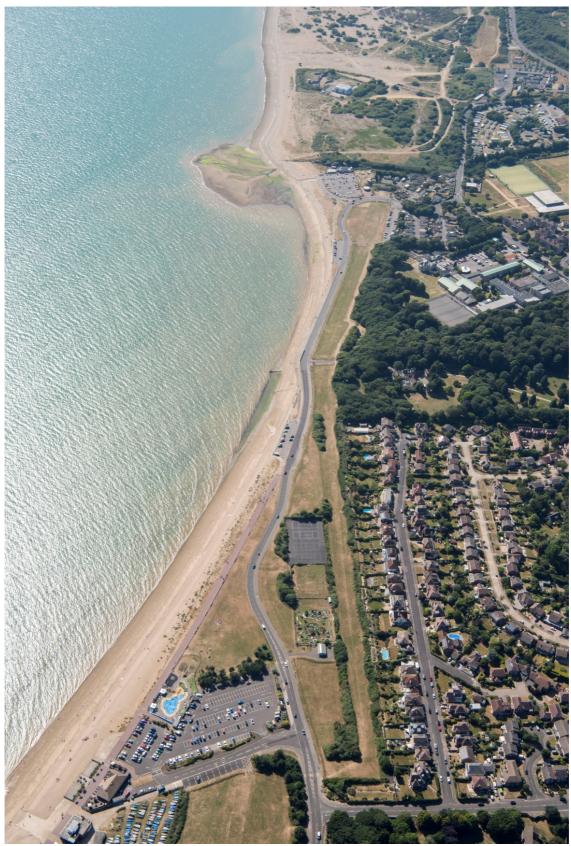
Figure 19. Western end of Stokes Bay looking west. Showing the course of the infilled Stokes Bay Lines from Battery 3 to Battery 2. Embarkation hards G3, G2 and G1 are visible at the back of the beach (33560_029 26/06/2018 ©Historic England Archive).

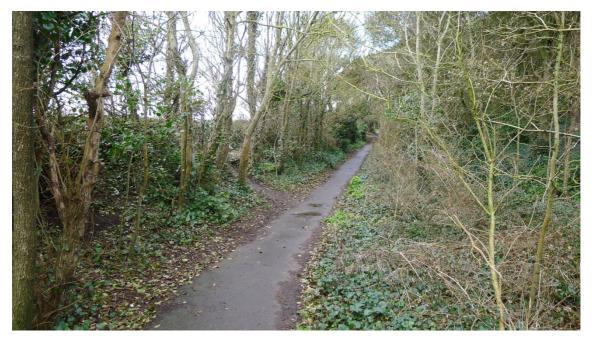
Figure 20. The rear of the Stokes Bay Lines between Alverstoke Road and Battery 2 (© Historic England, photograph Wayne Cocroft).

Traces of the northern bank of the defences survive to the east of the footpath linking Stokes Bay Road with Bay House School. Here a pronounced drop of up to 1.5m (Fig 20) runs parallel with the northern side of the moat (1.5). This feature corresponds closely with the line of the northern bank shown on historic mapping (OS 1933), and is likely to represent the truncated remains its outer (northern) face. The top of the bank, including the firing step and the inner (southern) face no longer survive as surface features, having been removed during the levelling and infilling of the moat. The southern edge of the bank is visible as a parch mark in dry weather (Fig 21).

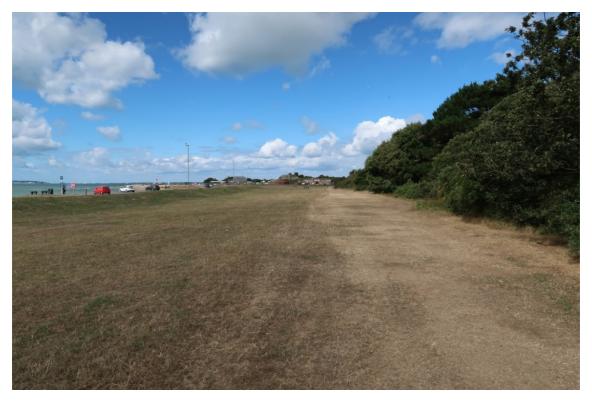
Figure 21. Parch mark showing the northern edge of the Stokes Bay Lines looking west towards Battery 2 ($^{\circ}$ Historic England).

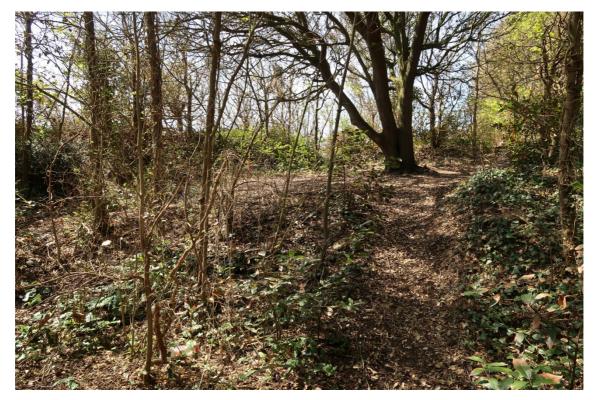
Figure 22. Firing step at the rear of the Stokes Bay Lines, 1m scale (see figure 3 point 1.7). (© Historic England).

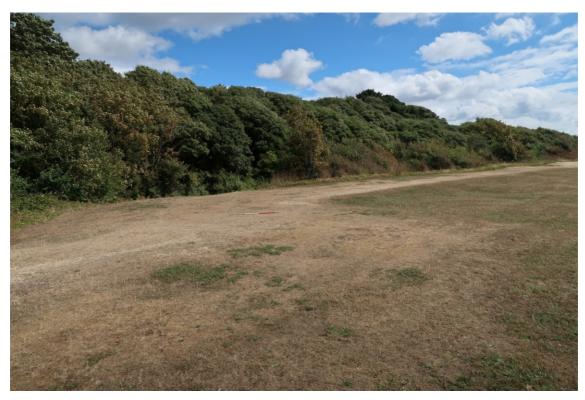
Figure 23. Parch mark showing kink in Stokes Bay Lines to the west of Alverstoke Road, scale 1m (see figure 3 point 1.6), (© Historic England).

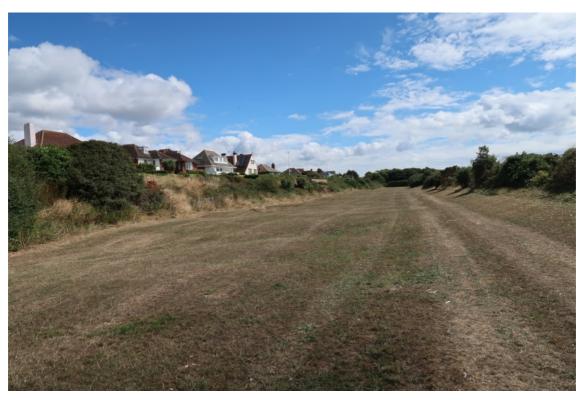
Figure 25. The Stokes Bay Lines south of Palmerston Way looking east towards Battery 3. Buildings on the left side of this image are the first floors of houses behind the substantial northern bank of the Stokes Bay Lines, scale 1m (© Historic England).

c) Palmerston Way to Battery 3 (centre SZ 59447 98650)
The best-preserved segment of the Stokes Bay Lines (1.9) is between SZ 59275 98675 and the site of Battery 3 (SZ 59720 98595). In this area although the moat has been partially filled and grassed over, its line is clearly visible and survives to a depth of approximately 1m (Fig 25). The 0.75m high bank (1.10) immediately to the south of the moat, and forming the northern boundary of tennis courts/crazy golf course may preserve part of the Lines' southern bank. The northern bank survives as a substantial earthwork to a height of between 2.5 to 3m (Fig26). This feature was deliberately retained in the 1950s to provide a barrier between the gardens on Palmerston Way to the north and the open ground of Stokes Bay to the south (https://www.fortgilkicker.co.uk/lines.htm).

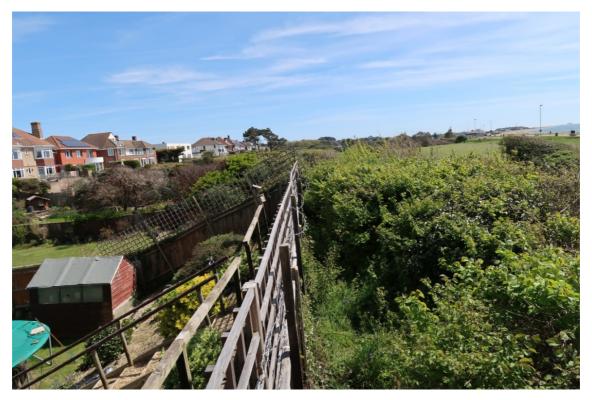
Figure 26. Looking east along the top of the northern bank of the Stokes Bay Lines south of Palmerston Way (© Historic England).

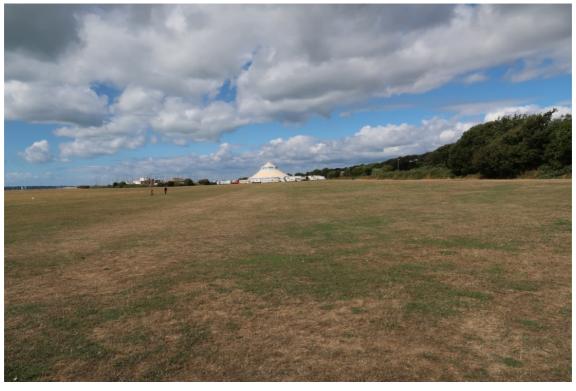
Figure 27. Parch marks and slight earthworks looking west along the Stokes Bay Lines towards Battery 3, south of Stokes Bay Road (© Historic England).

- d) Battery 3 to Lifeboat Lane (centre SZ 59892 98485)
 Between Battery 3 and Lifeboat Lane the Stokes Bay Lines survive as a very slight earthwork and show as parch marks in dry weather (Fig 27). The moat is visible as a shallow linear depression between 0.1 and 0.2m deep. The northern edge of the moat was identified between Battery 3 and the causeway leading from Stokes Bay Road to the beach close to embarkation hard G4. Only a short length of its southern edge was identified close to Battery 3. No trace of the southern bank of the lines was observed. It is likely that the approximately 1m drop topped by a c 0.5m high bank (1.11) along the southern edge of Stokes Bay Road is in part formed by the Lines' northern bank (Fig 28). No traces of the Lines were identified between the causeway and Lifeboat Lane.

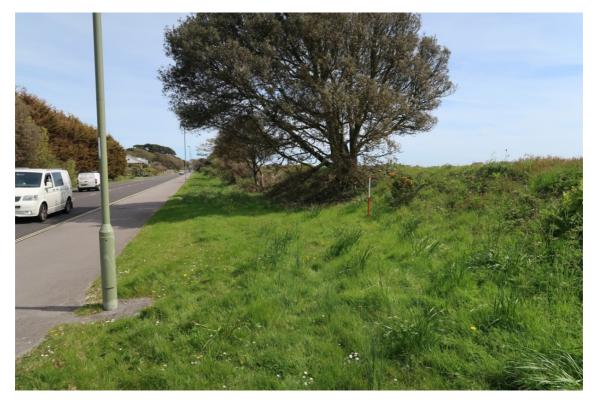
Figure 28. The northern edge of the Stokes Bay Lines looking east along Stokes Bay Road, scale 1m (\bigcirc Historic England).

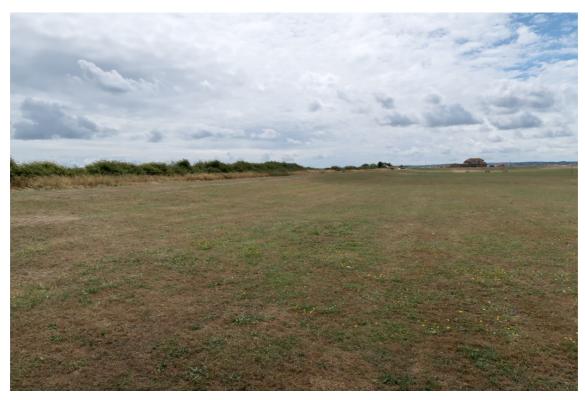
Figure 29. Looking south along Lifeboat Lane. The slight earthwork underlying the lane is the remnant of the eastern bank of the Stokes Bay Lines (© Historic England).

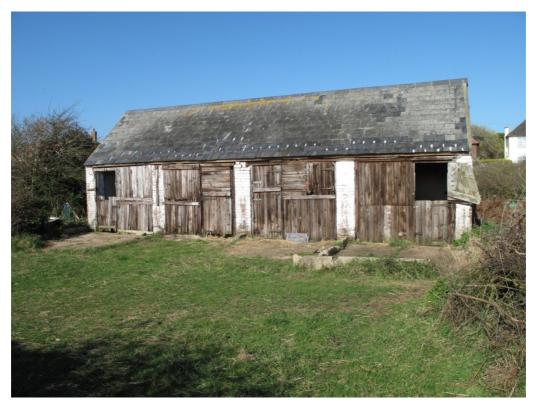
Figure 30. Southern elevation of brick building on the northern edge of Battery 4 (© Historic England).

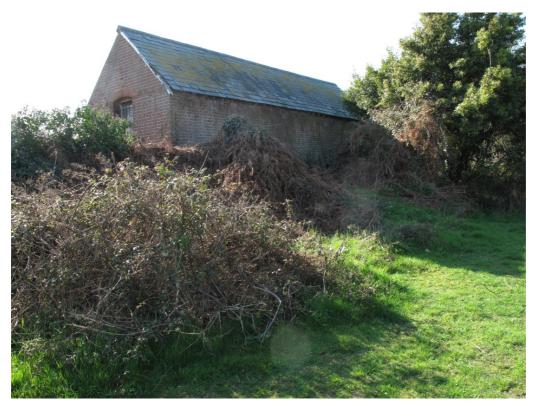
Figure 31. Eastern and northern elevations of brick building on the northern edge of Battery 4, and underlying earthwork, (© Historic England).

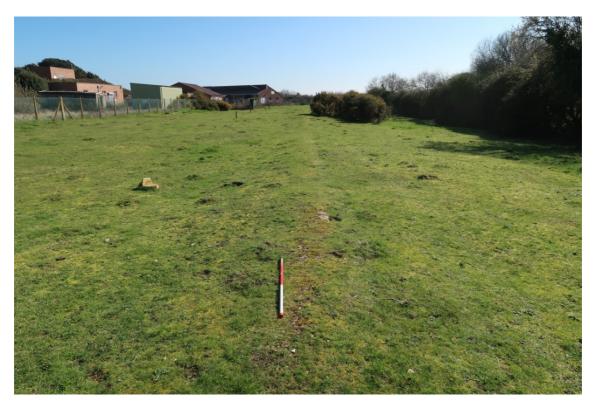
Figure 32. Looking east along the Stokes Bay Lines south of Battery 5. The southern edge of the moat's concrete lining is visible, 1m scale (© Historic England).

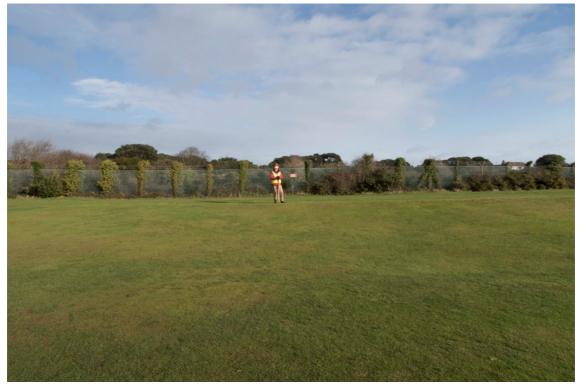
Figure 33. Looking north towards the southern bank of the Stokes Bay Lines east of Battery 5, scale 1m (\bigcirc Historic England).

h) Stokes Bay Golf Course (centre SZ 60600 97900) Running east across Gosport and Stokes Bay Golf Course from the fenced area surrounding Battery 5 to their eastern end at Gilkicker Lake the Lines have been substantially levelled (Fig 33 and 34). Tree planting along some of their length has also compromised their visibility. In open areas of the golf course the Lines' southern bank (1.19) survives to a height of up to 1m. No traces of the northern bank were observed. Landscaping and golf course features have removed all surface traces of the very eastern end of the Lines.

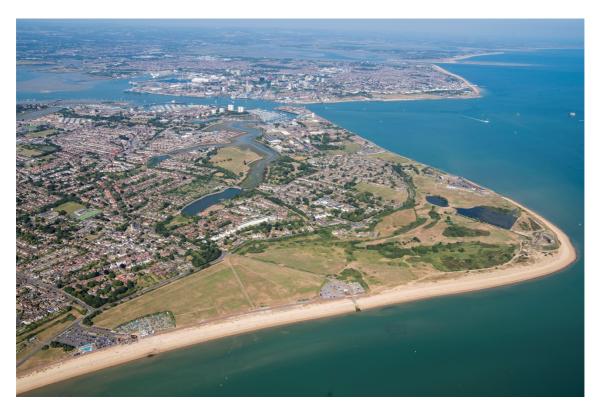
Figure 34. Looking north east across the eastern end of Stokes Bay towards Portsmouth Harbour. Image shows the eastern end of the Stokes Bay Lines from Battery 4 to Gilkicker Lake (33561_002 26/06/2018 ©Historic England Archive).

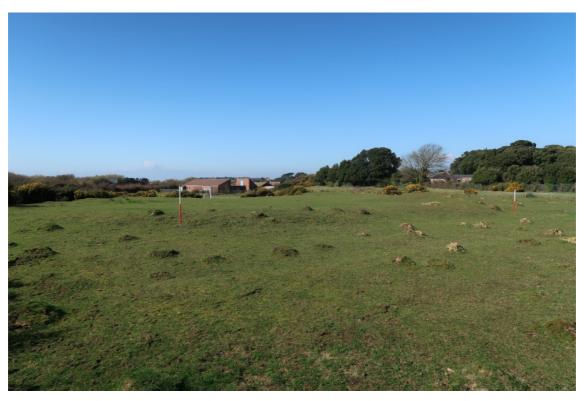
Figure 35. Looking north-west across potential Redoubt 6 towards Battery 5, scales 1m (© Historic England).

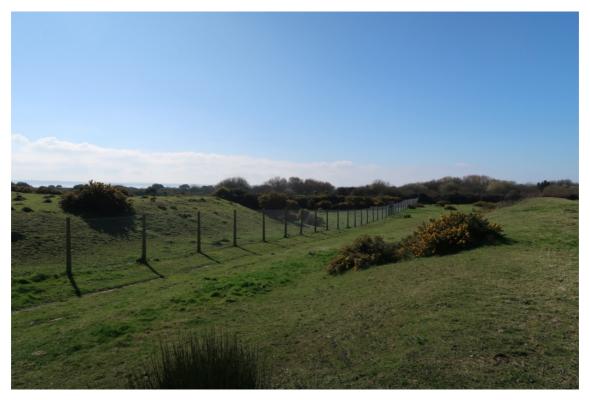
Figure 37. Trackway between Battery 5 and site of Redoubt 6, view to north (© Historic England).

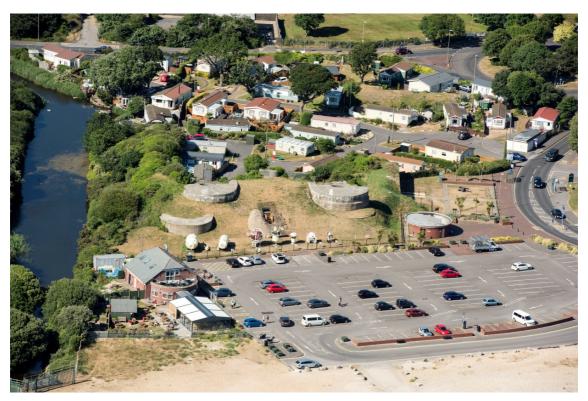
Figure 38. Battery 2, with the surviving section of the moat to the left and Battery 1 ramparts to the rear. $(33562_003\ 26/06/2018\ \text{@Historic England})$.

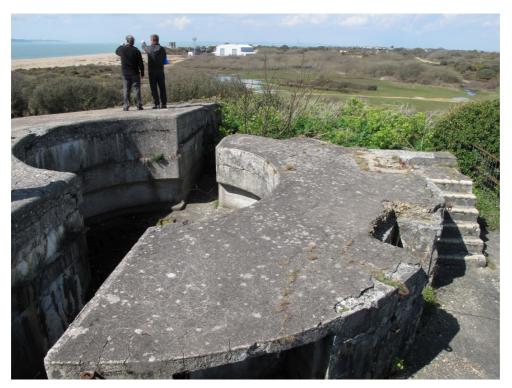
Figure 39. Battery 2 modified gun emplacement, c1901. (Photograph Mike Williams © Historic England).

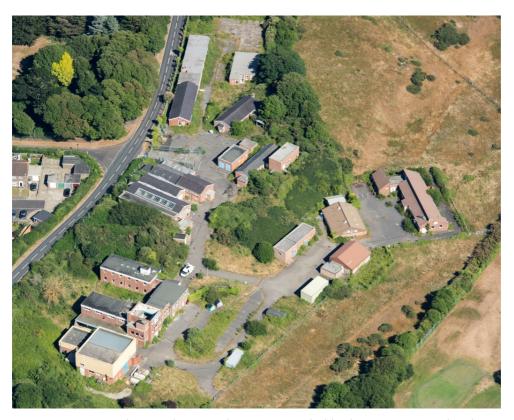
Figure 40. Battery 5, showing the original ramparts part hidden by vegetation, mid-20th century hutments and the later buildings of the Royal Naval Physiological Laboratory (33561_040 26/06/2018 ©Historic England Archive).

The site comprises three groups of structures (Fig 40)

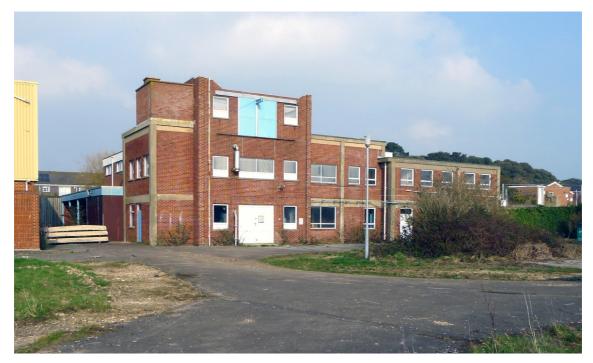
Figure 41. A building of the Royal Naval Physiological Laboratory, formerly used for decompression experiments. Part of the Battery 5 rampart visible to the right. (© Historic England, photograph Wayne Cocroft).

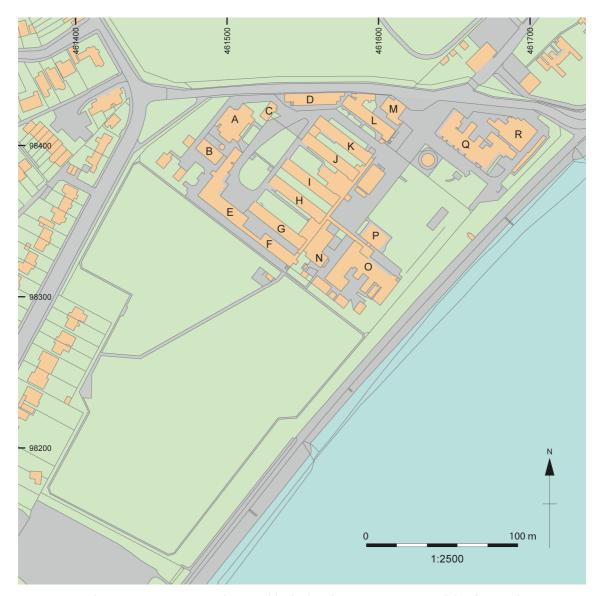
Figure 42. Haslar Immigration Removal Centre block plan. (Base mapping @ and database right Crown Copyright (All rights reserved 2019) Licence nos. 000394 & TP0024).

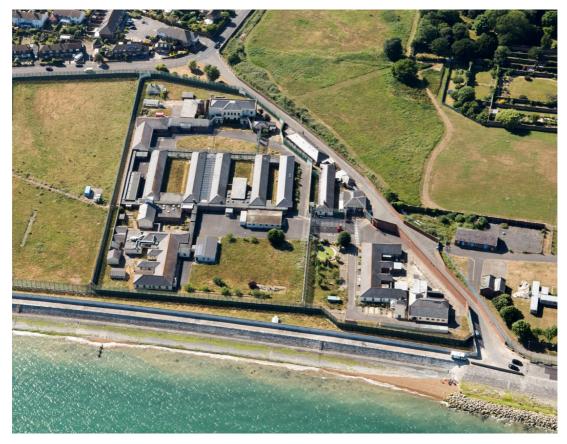
Figure 43. Haslar Barracks originated in the early to mid 19th century. It was later used as a hospital and finally as an Immigration Removal Centre. (33563_011 26/06/2018 ©Historic England Archive).

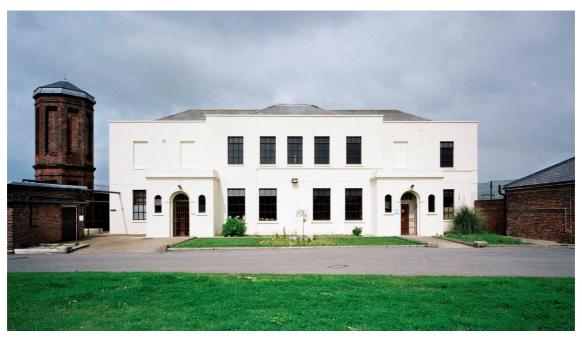
Figure 44. Headquarters building at Haslar Barracks, later the Haslar Immigration Removal Centre. Early to mid 19th century building with later porches, used as Infectious Wards at the end of the 19th century, photographed in 1998. (© Historic England photograph AA98_08858).

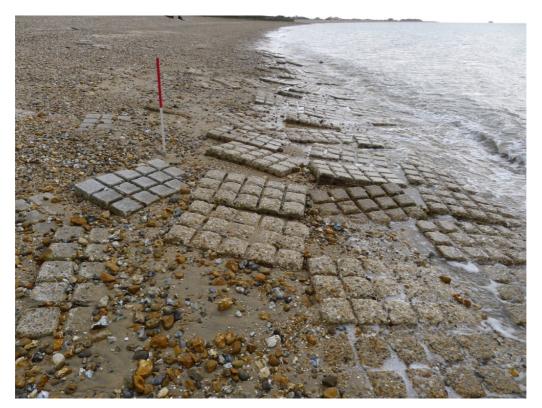
Figure 45. Disturbed areas of 'chocolate block' concrete matting at embarkation hard G1, view to east, scale 1m (© Historic England, photograph by Wayne Cocroft).

- a) Embarkation hard G1 (SZ 58900 98750)
 - At area of 'chocolate block' flexible concrete matting (2.1) measuring 75m wide (east-west) by 13m deep (north -south) was recorded in the area of embarkation hard G1 (Fig 45). Much of this matting appears to have been slightly displaced from its original location. A greater extent of surviving concrete matting is likely to survive in this area buried by beach deposits. Several iron posts (2.2), probably the foundations for a mooring dolphin, were identified at SZ 58893 98759 (Fig 47). The concrete apron is shown on post-war historic mapping (OS 1965) and on RAF vertical aerial photography from 1946 (Historic England Archive: RAF 1946d RAF/3G/TUD/UK/163 V 5109 20-APR-46). It is now covered by a Gosport Borough Council car park (Fig 46) on the southern edge of Stokes Bay Road (2.3). A 2.5m long (east-west) alignment of 4 timbers (2.4, Fig 48) was recorded approximately 50m to the east of G1 at SZ 58979 98739. The original purpose of these timbers and their relationship with landing hard G1 is unclear.

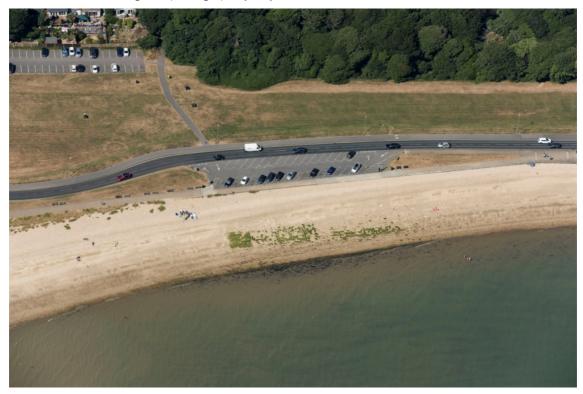
Figure 46. Looking north towards the concrete apron (under car park) and concrete matting (under sea weed on the foreshore) at embarkation hard G1. The circular parch in the centre left of the image is from a storage tank associated with the amphibious tank facility. (33560_018 26/06/2018 ©Historic England Archive).

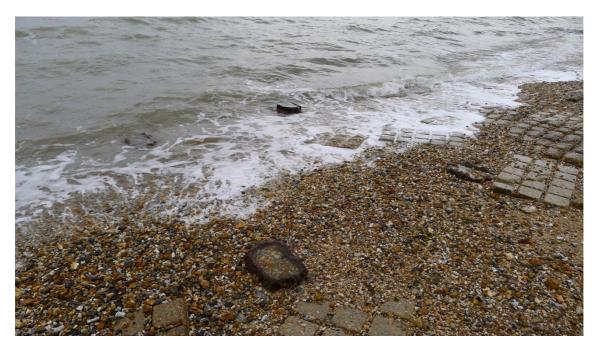
Figure 47. Detail of iron posts associated with embarkation hard G1 ($^{\circ}$ Historic England, photograph Wayne Cocroft).

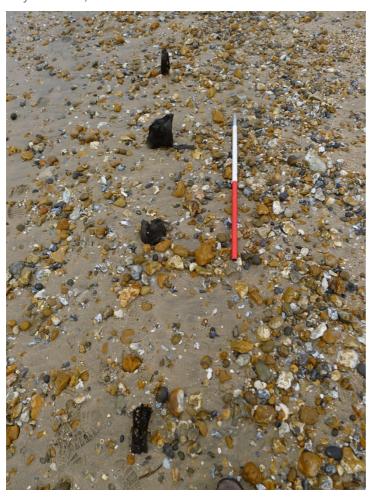
Figure 48. Line of timber posts east of embarkation hard G1 (\bigcirc Historic England, photograph Wayne Cocroft).

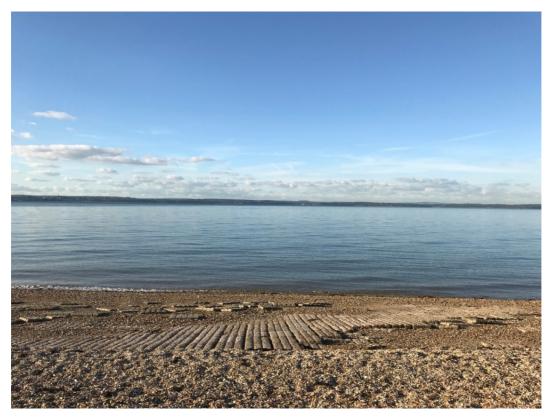
Figure 49. Looking south across 'chocolate block' concrete matting on the foreshore at embarkation hard G2 (© Historic England).

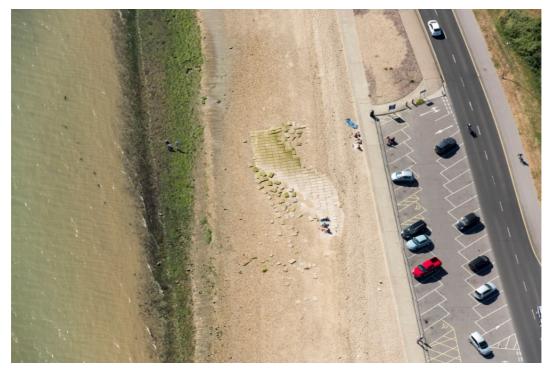
Figure 50. Looking west across the concrete apron (under car park) and concrete matting (exposed on the beach) at Embarkation hard G2 (33562_026 26/06/2018 ©Historic England Archive).

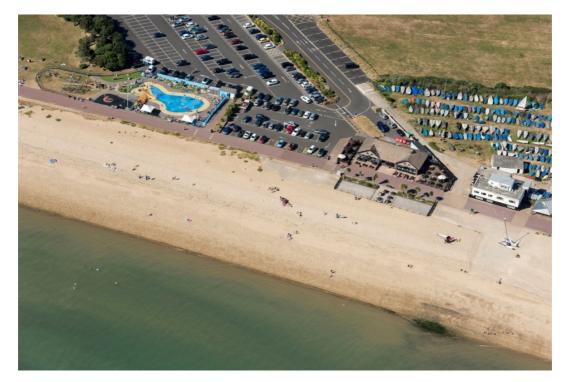
Figure 51. Looking north across the area of embarkation hard G3. Elements of the concrete apron survive between the promenade and the beach immediately to the south of the carpark. The D-Day control centre forms the eastern half of the two storey white building on the right edge of the photograph $(33562_040 26/06/2018 © Historic England Archive)$.

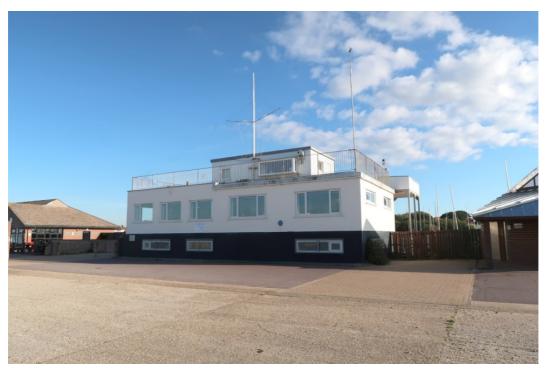
Figure 52. The southern and eastern elevations of the D Day control centre (now Stokes Bay Sailing Club). The western third of this building (to the left of the step in the roof line) is a post war addition (© Historic England).

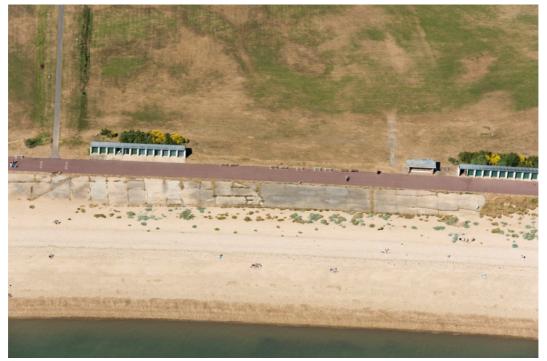
Figure 53. Looking north across embarkation hard G4. The two larger areas of concrete with sweeping landward corners in the centre and right of the image comprise the apron for the hard. The smaller slabs of concrete in the centre and left of the image comprise the south eastern corner of Phoenix caisson construction site 1 (33562_046 26/06/2018 ©Historic England Archive).

No 'chocolate block' flexible concrete matting was observed on the foreshore in the area of hard G4. Conversations with staff at the lifeboat station and photographs on the Fort Gilkicker website (www.fortgilkicker.co.uk/Dday.htm) suggest that concrete matting is visible here at very low tides. An area of concrete (2.10) measuring c 75 x 12m at SZ 59955 98120 between the present-day promenade and the beach is the apron for hard G4 (Fig 53). This area of concrete is visible on RAF vertical aerial photography (Historic England Archive: RAF 1946d RAF/3G/TUD/UK/163 V 5109 20-APR-46; RAF 1948c RAF/CPE/UK/2463 V 5012 26-FEB-48 and post-war historic mapping (OS 1949b). The apron is contiguous with concrete associated with Phoenix construction site 1 (see discussion below); however, the apron can be distinguished by its curved landward corners.

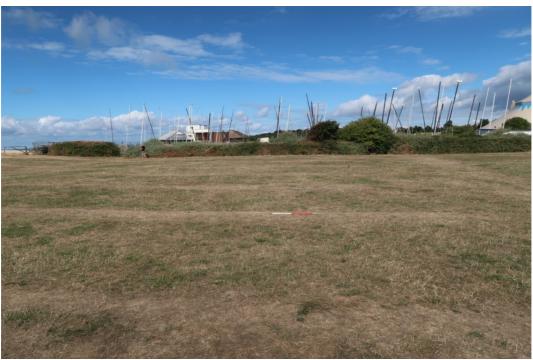
Figure 54. Looking west towards Stokes Bay Sailing Club with the second storey of the D Day control centre visible against the skyline. The slight parallel earthworks in the foreground are grassed over remnants of Phoenix caisson construction site 1, scale 1m (© Historic England).

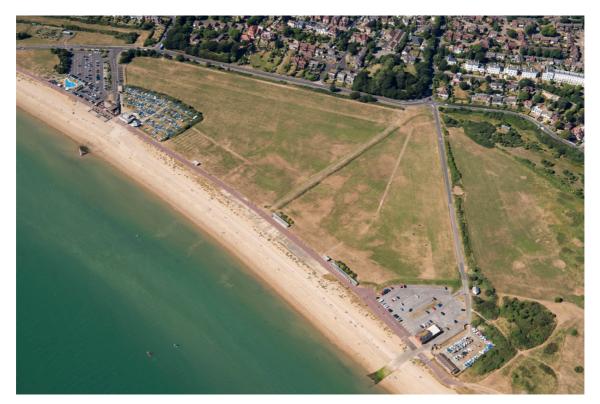
Figure 55. Looking north across the areas of embarkation hards G3 and G4, and Phoenix caisson construction site 1 (showing as parch marks in the grassed areas and concrete slabs between the promenade and the beach). Elements of Gilkicker Heavy Anti-Aircraft Battery are visible as parch marks on the right edge of the photograph. Pre and post-war features including the Stokes Bay Lines between Batteries 3 and 4, the embankment and the bathing pool pathways are also visible (33560_036 26/06/2018 ©Historic England Archive).

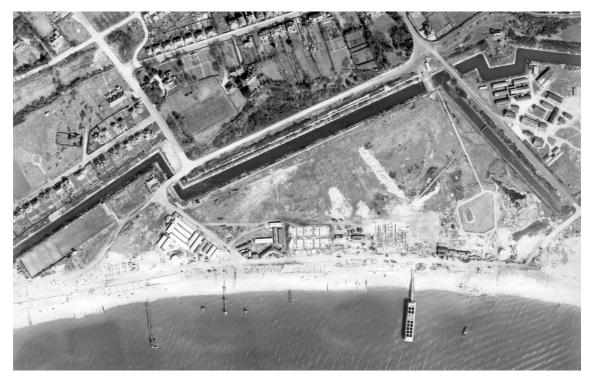
Figure 56. Approximately the same area as figure 55 in March 1946. Mooring dolphins associated with embarkation hards G3 and G4 are clearly visible in the water and on the beach. Phoenix caisson construction sites 1 and 2 are immediately behind the beach. The hutted encampment associated with Gilkicker Heavy Anti-Aircraft Battery is visible on the right of the image. Pre-war features include the bathing pool and associated paths on the right of the image and the still water-filled Stokes Bay Lines zigzagging from left to right across the centre of the image. RAF/106G/UK/1322 V 5025 28-MAR-46, Historic England Archive (RAF Photography).

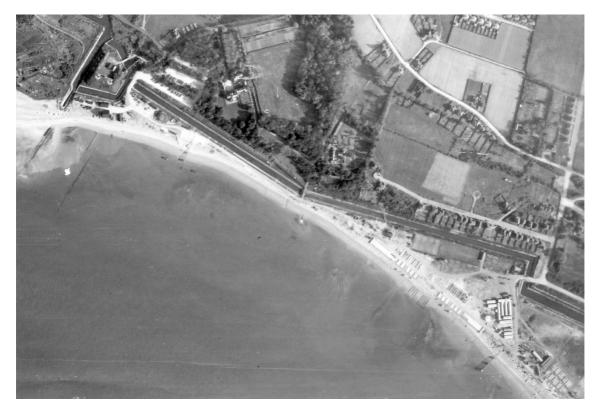
Figure 57. The western end of Stokes Bay in February 1948. From left to right elements of the amphibious tank training facility, embarkation hards G1 and G2 and Phoenix caisson construction site 2 are visible on, or immediately inland from, the foreshore. The water filled moat of the Stokes Bay Lines between Batteries 2 and 3 is also visible. RAF/CPE/UK/2463 V 5032 26-FEB-48, Historic England Archive (RAF Photography).

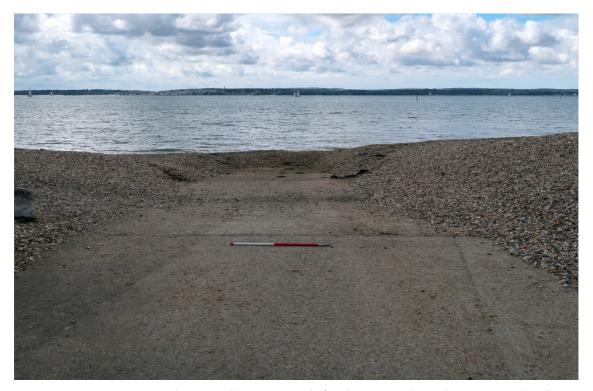
Figure 58. Post-war concrete slipway at the western end of Stokes Bay, scale 1m (© Historic England).

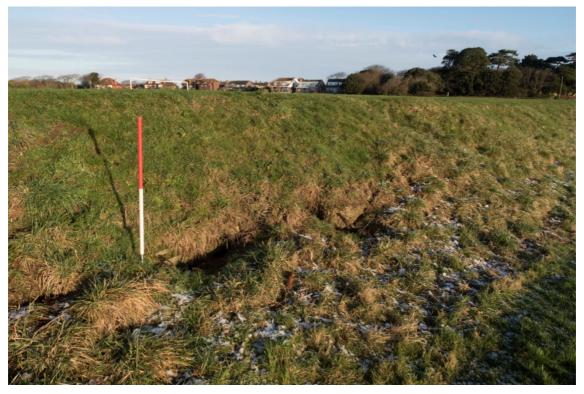
Figure 59. 1950s causeway made from reinforced concrete fragments derived from clearing Phoenix caisson construction sites. Concrete is visible in the face of the embankment, scale 1m (© Historic England).

A c1.5m high causeway carrying a tarmac road (2.12) runs south-west from the junction of Stokes Bay Road and Anglesey Road towards embarkation hard G4. The body of this feature is constructed from reinforced concrete slabs cleared from Phoenix caisson construction site 1 (Fig 59). It is shown under construction on oblique aerial photography from 1950 (Historic England Archive: RAF/SFFO/540/317O005422-APR-50).

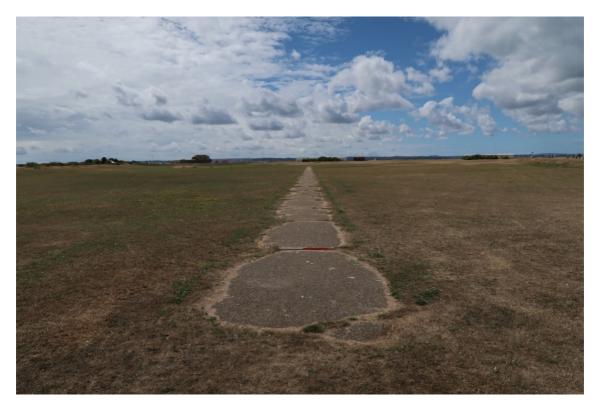
Figure 60. Looking south along the concrete path to the former bathing pool, scale 1m (© Historic England).

Two lengths of 2.3m wide concrete paths (2.16) were recorded to the west of the causeway (Fig 60). These paths would have linked the southern end of Anglesey Road with a now removed paddling pool at SZ 60010 98185, and the paddling pool with the beach. The northern path is first shown on pre-Second World War mapping (O S 1933). Both are seen in 1946 vertical aerial photography (Historic England Archive: *RAF/106G/UK/1322 V 5025 28-MAR-46*).

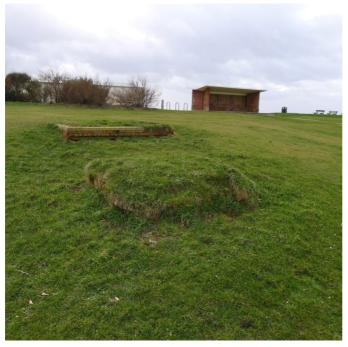
Figure 61. Two unidentified late twentieth century brick structures (see figure 4 point 2.17), (© Historic England).

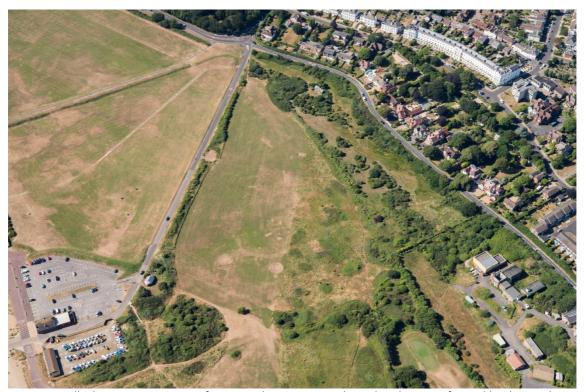
Figure 62. Gilkicker Heavy Anti-Aircraft Battery showing as parch marks. The site is framed by the southern protrusion of the Stokes Bay Lines and Batteries 4 and 5. The causeway and elements of the bathing pool footpaths are visible on the left of the image (33561_037 26/06/2018 ©Historic England Archive).

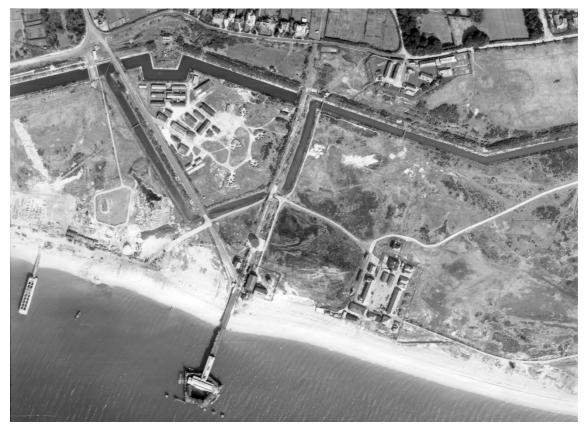
Figure 63. Gilkicker Heavy Anti-Aircraft Battery and its associated hutted encampment in March 1946, framed by the southern protrusion of the Stokes Bay Lines and Batteries 4 and 5. A mooring dolphin associated with embarkation hard G4 and Stokes Bay Pier are visible on the foreshore. Barrage balloon site 2.28 is a circular feature in the top right of the image. The bathing pool is visible on the left of the image and the School of Electrical Lighting and associated tramway is on the right of the image. RAF/106G/UK/1322 V 5037 28-MAR-46, Historic England Archive (RAF Photography).

An RAF air photograph of 1946 indicates that circular structures, possibly foundations, were located to the west and east of the battery in the Second World War period (Fig 63; Historic England Archive RAF/106G/UK/1322 V 5037 28-MAR-46). That to the west was accessed by the path cut thorough the western rampart. The eastern structure was larger, comprising two concentric circles in the adjoining field, with no obvious means of access from the battery site.

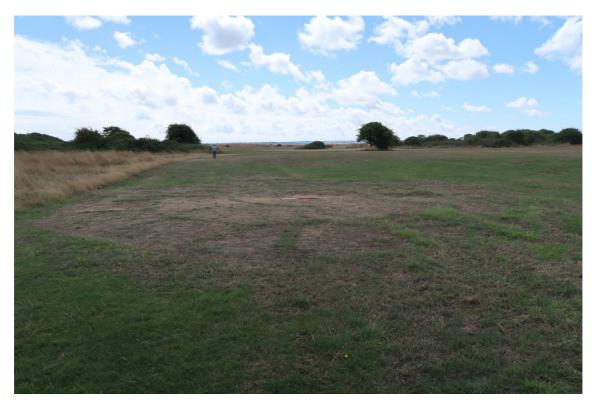
Figure 64. Parch marks of Gilkicker Heavy Anti-Aircraft Battery, scale 1m, (© Historic England).

The fixed gun positions were of a 1938 pattern, comprising octagonal concrete platforms enclosed by low defensive walls and earth embankments. The design included six ready-use ammunition magazines projecting inwards from the walls, with each position entered by a double gate facing the command post (Dobson 2001, 143, 145). The guns were secured to the concrete foundation by a ring of holdfast bolts.

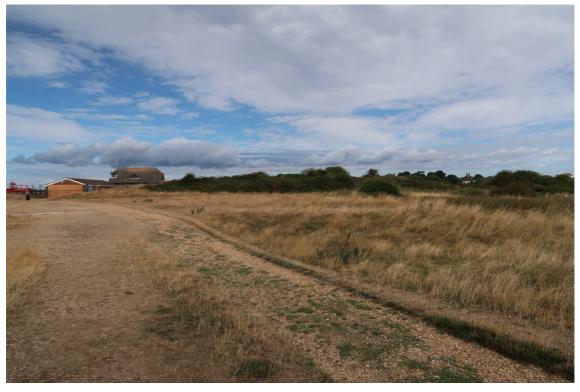
Figure 65. Looking west towards potential remains of the embankment for the Stokes Bay railway line. (© Historic England).

No surface traces of Stokes Bay Pier were recorded during the survey. Similarly little trace of the Stokes Bay railway was recorded. It is possible that elements of an earthwork bund (3.1) on the south-east side of Stokes Bay Angling Club (SZ 60135 97985) is partly formed from the south-eastern end of the embankment that carried the railway to the pier (Fig 65). The line of the embankment is partly obscured by areas of thick vegetation. In open areas no surface traces of the embankment were observed.

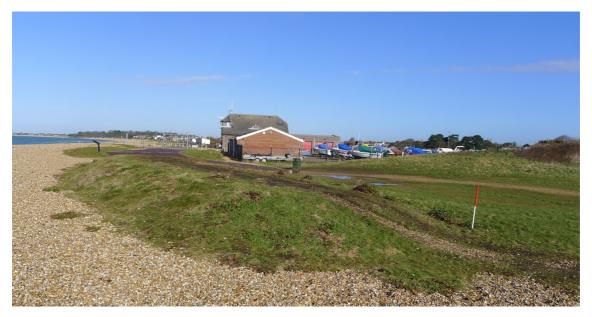
Figure 66. Looking west towards a late twentieth century earthwork close to Stokes Bay Angling Club, scale 1m, (© Historic England, photograph Wayne Cocroft).

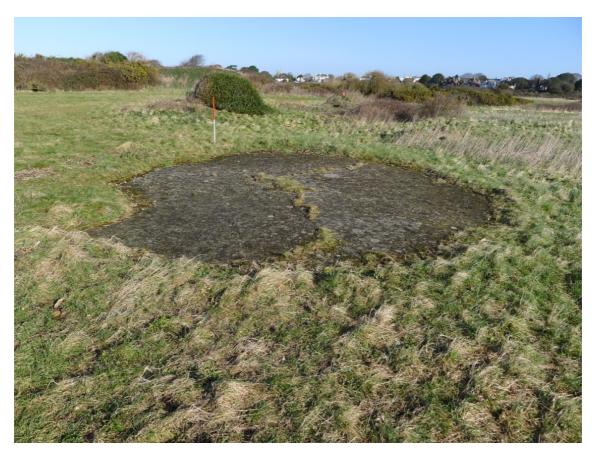
Figure 67. Circular storage tank pad associated with Stokes Bay Pier, scale 1m, view to north (© Historic England, photograph Wayne Cocroft).

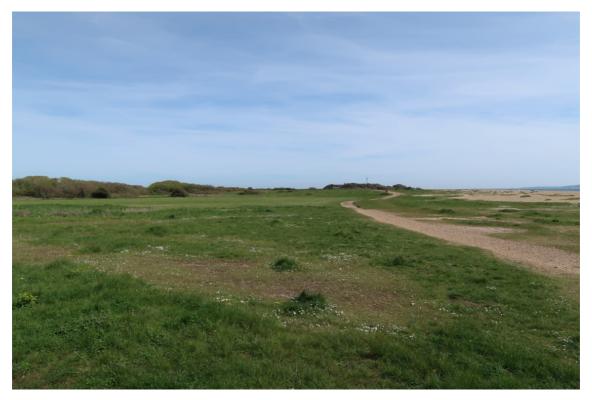
Figure 68. Looking south east towards the platform for the School of Electrical Lighting, Fort Gilkicker in the background (© Historic England).

Historic mapping, post-War aerial photography (Historic England Archive: RAF/CPE/UK/2463 V 5006 26-FEB-48; RAF/SFFO/540/317 V 0052 22-APR-50) and terrestrial photography (http://www.fortgilkicker.co.uk/school.htm) show the school built on top of a substantial earthwork platform. It is suggested that this platform is a manmade feature constructed to raise the area above the surrounding marshy low-lying topography. The platform recorded during the current survey has a slightly larger footprint than that shown on historic mapping. This enlargement was potentially caused by material derived from the levelling of the school buildings in the 1970s
