Stokes Bay, Gosport: Five Centuries Of Coastal Defence

Mike Williams and Olaf Bayer

Stokes Bay, Gosport: Five Centuries Of Coastal Defences

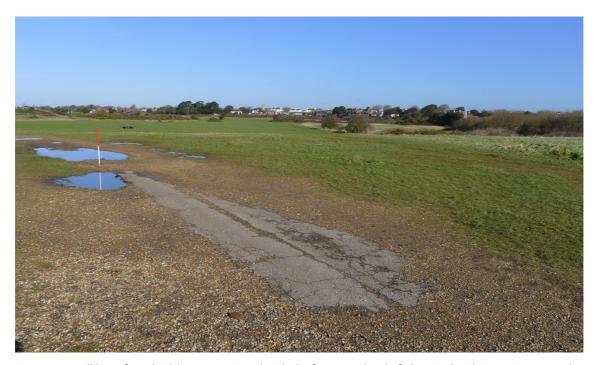
Figure 69. Wall lines from buildings associated with the former School of Electrical Lighting, view to northwest, scale 1m (© Historic England, photograph Wayne Cocroft).

(http://www.fortgilkicker.co.uk/school.htm). Truncated brick and concrete foundations on top of the platform (Fig 69) correspond closely with the position

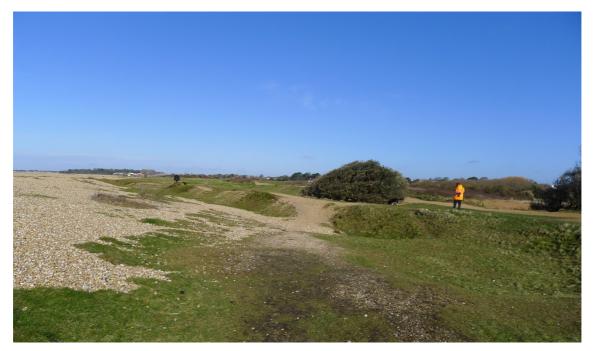
Figure 70. Looking north–west towards the tramway running east from the School of Electrical Lighting (© Historic England, photograph Wayne Cocroft).

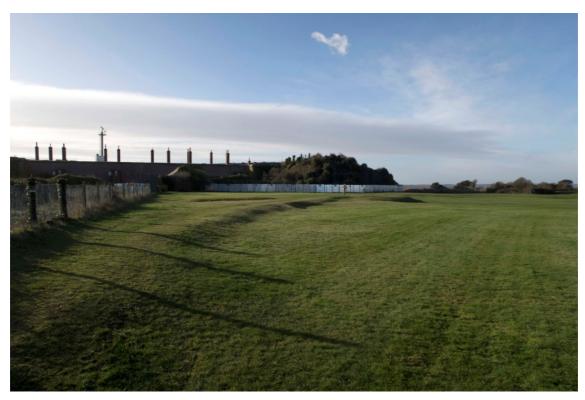
Figure 71. Looking south-west along the line of the tramway running north-east from the School of Electrical Lighting. Fort Gilkicker is in the background (© Historic England).

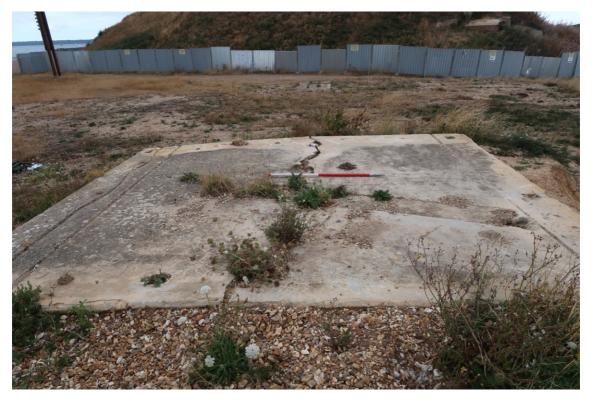
Figure 72. Concrete base for search light position 1, looking west towards Fort Gilkicker, scale 1m ($^{\circ}$ Historic England).

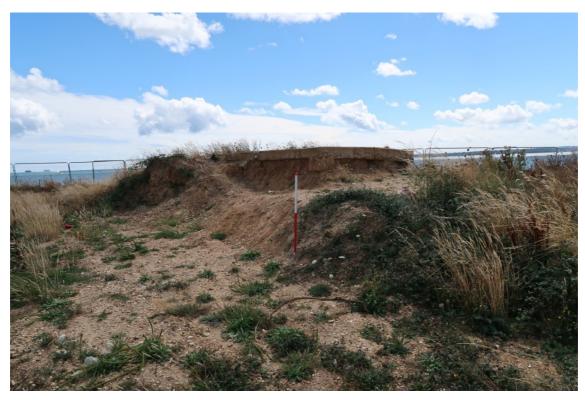
Figure 73. Mound and concrete base for search light position 1, looking south, scale 1m (© Historic England).

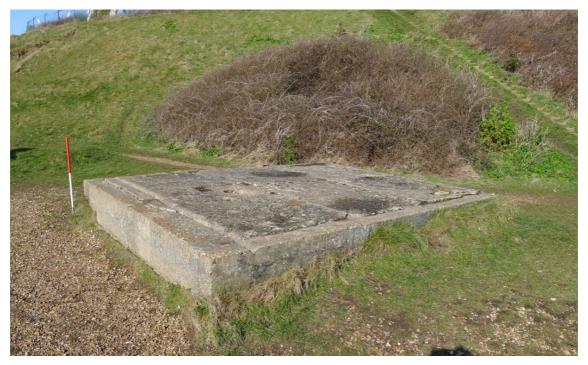
Figure 74. Concrete base for search light position 2, looking west towards Fort Gilkicker, scale 1m (© Historic England, photograph Wayne Cocroft).

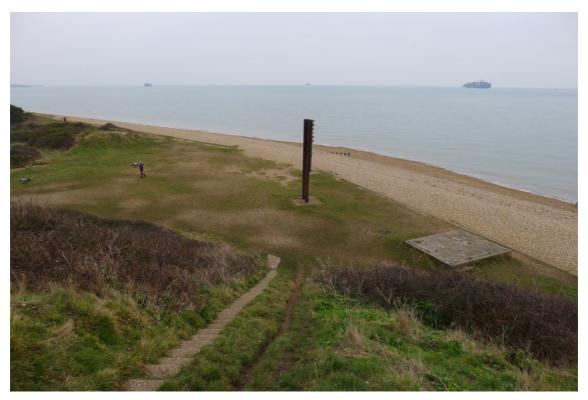
Figure 75. Looking south-east from Fort Gikicker towards search light positions 1 and 2, and the measured mile mark. (© Historic England, photograph Wayne Cocroft).

The south-eastern of 4 'measured mile' markers (3.12) is located close to the eastern base of Gilkicker rampart. The marker consists of two iron uprights carrying a slatted black and white painted wooden marker (Fig 75 and 79). The uprights are set into a concrete base measuring c. $2.5 \times 2.5 \,\mathrm{m}$. The marker was constructed by 1939

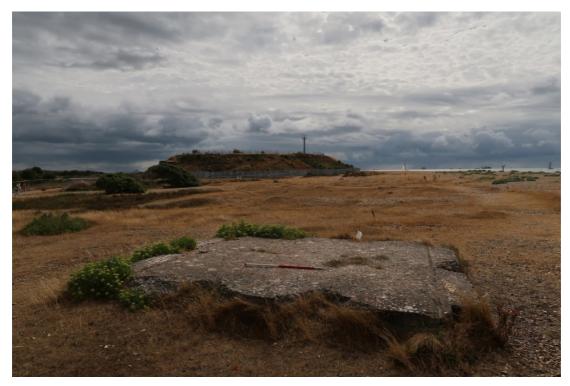
Figure 76. Looking south east towards the concrete base for search light 4 with Fort Gilkicker in the background, scale 1m (© Historic England).

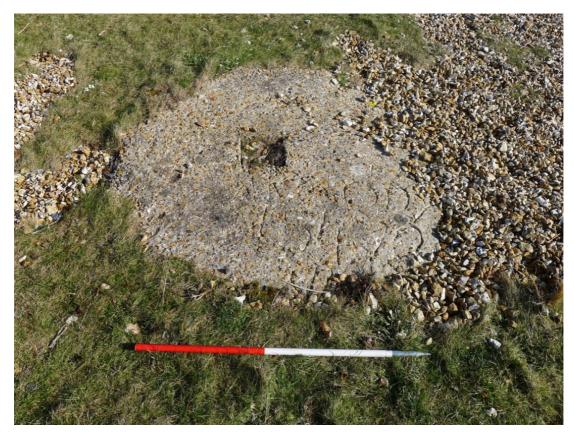
Figure 77. Circular concrete slab with square post hole to west of Fort Gilkicker, scale 1m (© Historic England, photograph Wayne Cocroft).

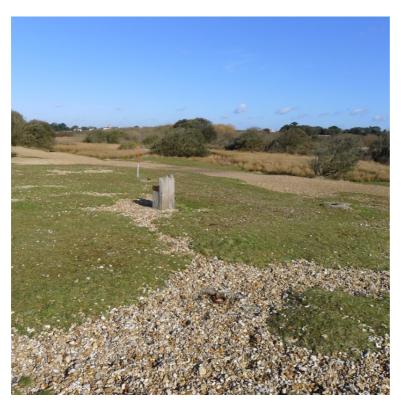
Figure 78. Stub of wooden flag pole and anchor rings to west of Fort Gilkicker, scale 1m ($^{\circ}$ Historic England, photograph Wayne Cocroft).

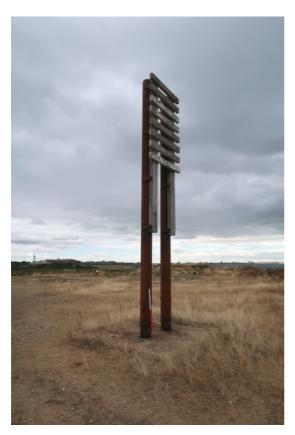
Figure 79. Measured mile mark to the east of Fort Gilkicker, looking east, scale 1m (© Historic England).

Constructed to calculate ships' speed, the 'measured mile' system consists of 4 markers arranged in two pairs of markers exactly one nautical mile apart. Each pair consisted of a seaward 'foresight' marker and a landward 'backsight' marker. The western pair (now removed) were at the Browndown end of the bay and the eastern pair survive at the Gilkicker end of the bay. The landward marker (3.13, Fig 80) of the eastern pair survives approximately 550m to the north between Fort Road and the northern end of Gilkicker Lake SZ 60850 97995.

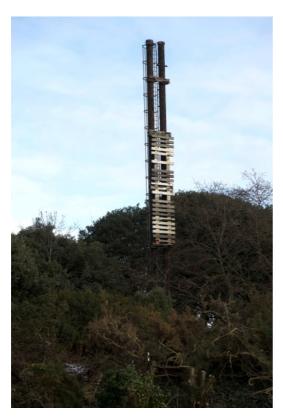
Figure 80. Measured mile mark at the northern edge of Stokes Bay Golf Course, looking north (© Historic England).

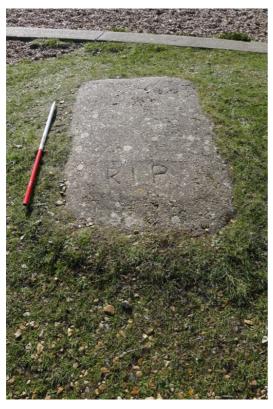
Figure 81. Small concrete slab to the east of Fort Gilkicker, scale 1m (\odot Historic England, photograph Wayne Cocroft).

An unidentified concrete slab (3.14) measuring 1.8 by 1m was recorded 8m to the south-east of the measured mile mark (Fig 81). This feature is visible on post-Second World War vertical aerial photography (RAF 46a) but is not shown on pre-war historic mapping (OS 1933).

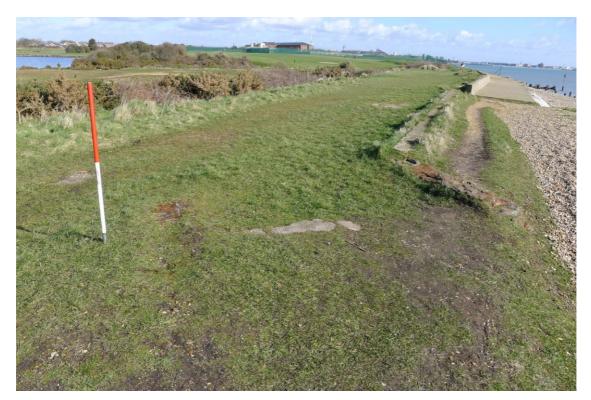
Figure 82. Looking north-east towards brick wall lines associated with former position-finding cell. Fort Monckton in the background (© Historic England).

Three sides of a brick and concrete foundation (3.15) measuring 3.2 by 1.6m and appended to the western end of a length of sea wall were recorded to the east of Fort Gilkicker (Fig 82). The origin of this structure remains unclear. It corresponds approximately with a series of rectangular structures labelled 'position finding cells' (presumably relating to Fort Gilkicker) on pre-Second World War mapping (OS 1933) and also shown on a 1935 oblique aerial photograph of Stokes Bay (http://www.friendsofstokesbay.co.uk/wp-content/uploads/2011/05/stokesbayaerial1935.jpg). These structures have been removed by 1946 with only possible foundations visible on post-Second World War vertical aerial photography (RAF 46a).

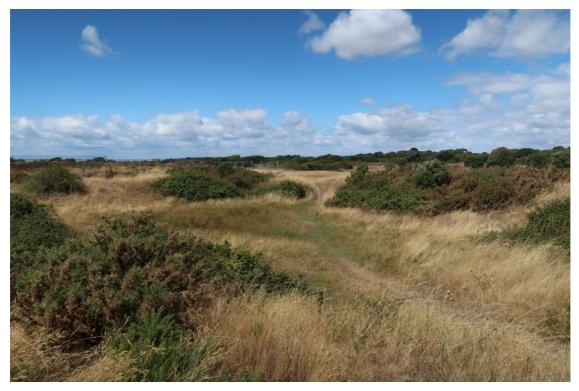
Figure 83. Looking north towards a quarry hollow between Fort Gilkicker and Gilkicker Lake, scale 1m ($^{\circ}$ Historic England).

A gravel quarry (3.16, Fig 83) and two trackways (3.17) were recorded between Fort Gilkicker and Gilkicker Lake. The quarry pits and elements of the tracks are visible on aerial photography from 1935

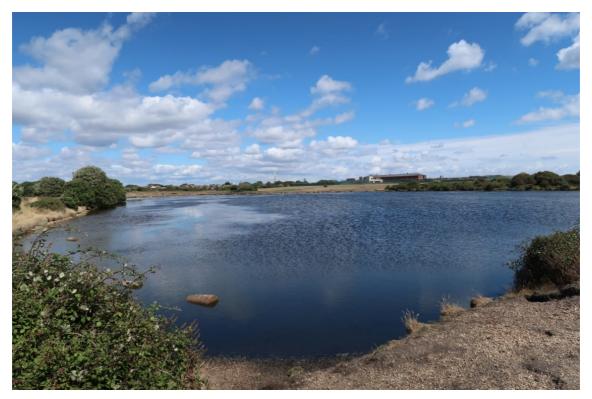
Figure 84. Looking north-east across Gilkicker Lake towards Fort Monckton (© Historic England).

- c) Gilkicker Lake/Fort Monckton Moat (centre SZ 60860 97730)
 Gilkicker Lake (3.19) was constructed in the early 19th century, forming the western defensive moat for Fort Monckton (Fig 84 and 85). Originally covering an area of approximately 5ha the lake formalised a wet area close to the former mouth of the River Alver, known previously as Alverstoke Marsh, Stokes Morass or Stokes Marsh (http://www.friendsofstokesbay.co.uk/gilkicker-lake/). From 1860 onwards the Lake was filled via the Stokes Bay Lines moat along which the River Alver was diverted (https://www.fortgilkicker.co.uk/alver.htm). Water levels are still controlled by a sluice at the south-eastern corner of the lake (Fig 86). A substantial area of the northern half of the Lake was infilled during the 1970s (http://www.friendsofstokesbay.co.uk/fort-monckton/). The lake, now bisected by a narrow causeway, has a combined area of about 3.5ha. Elements of the original eastern side of the lake are visible as a low earthwork and a hedgeline within the Gosport and Stokes Bay Golf Course.

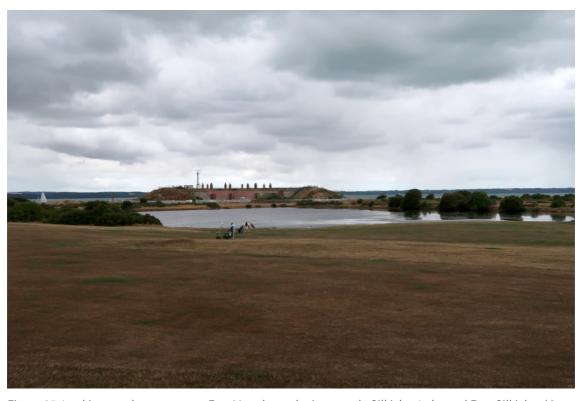
Figure 85. Looking south-west across Fort Monckton glacis towards Gilkicker Lake and Fort Gilkicker (© Historic England).

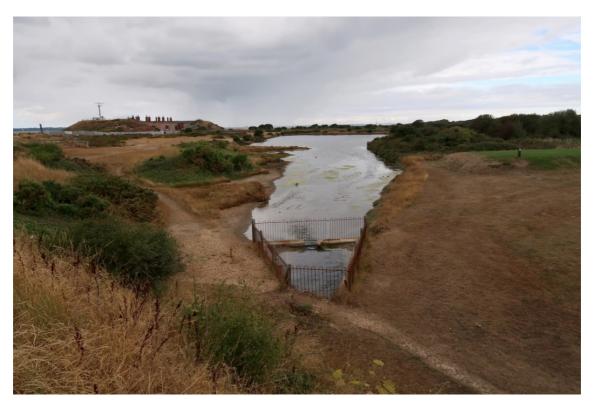
Figure 86. Looking south-west towards the sluice gate in the south-east corner of Gilkicker Lake towards Fort Gilkicker (© Historic England).

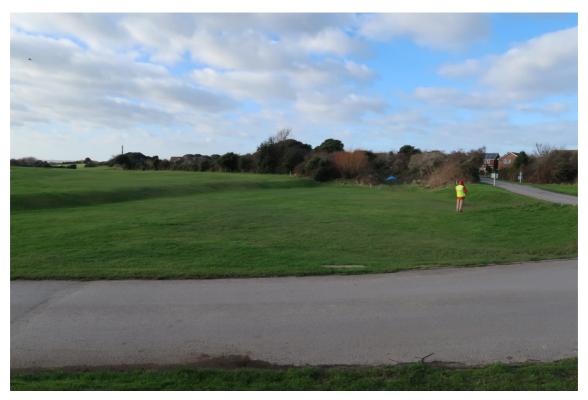
Figure 87. Looking west along the partly infilled line of Fort Monckton moat (© Historic England).

A moat (3.20) ran from the north-west corner of the Lake, and wrapping around the north-western and northern edges of Fort Monckton. Between Gilkicker Lake and the access road to Fort Gilkicker the moat has been substantially backfilled, surviving to a maximum of 27m across by 1m deep (Fig 87). Further east beyond the access road the moat (3.21) is a more substantial feature, surviving to a depth of over 3m (Fig 88).

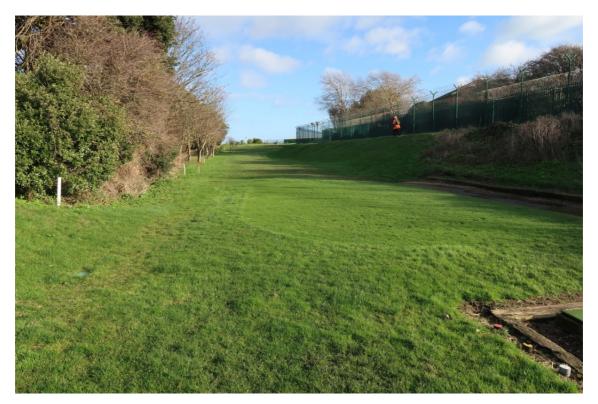
Figure 88. Looking east along Fort Monckton moat (© Historic England).

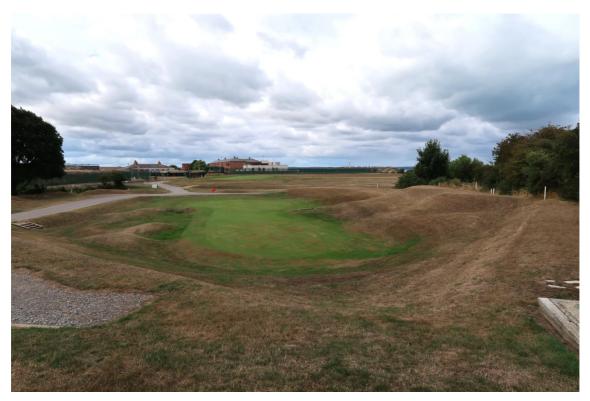
Figure 89. Looking south across the interior of Fort Monkton redoubt towards Fort Monckton (© Historic England).

The remains of a redoubt guarding the approach to Fort Monckton were recorded as an earthwork (3.22) within Gosport and Stokes Bay Golf Course immediately to the north of the moat surrounding the northern side of the Fort (Fig 89 and 90). To the west of the Golf Course access road the main body of the earthwork consists of an irregular crescent of bank up to 2m in height with a lower (c. 1m high) platform, probably a fire-step, on its inner edge. The earthwork is very similar in plan to that shown on late 19th century mapping of the site (OS 1892) (Fig 91) with once sharp corners having been softened by landscaping for the Golf Course. A substantial rectangular protrusion from the north-eastern edge of the redoubt is a late 20th century Golf Course feature. To the east of the Golf Course access road any surface traces of the redoubt have been covered by a golf green.

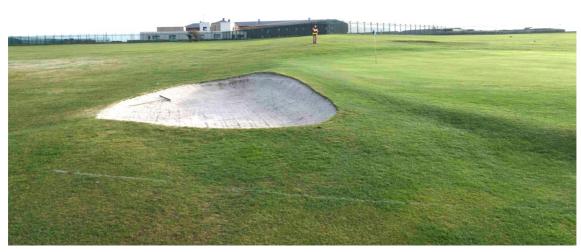
Figure 92. Looking east along one of the spines of Fort Monckton glacis towards Fort Monckton (© Historic England).

A glacis (3.23) exists between the outworks surrounding the western side of Fort Monckton and the eastern edge of Gilkicker Lake. The glacis consists of four spinal ridges with sloping sides which project the centre lines of the fort's two westernmost bastions and western ravelin, westwards to the edge of Gilkicker Lake (Fig 92 and 93). The glacis survives as a series of slight earthworks underlying the eastern side of Gosport and Stokes Bay Golf Course.
