# Broad Bottom Old Hall Broad Bottom Lane, Mytholmroyd Hebden Bridge West Yorkshire

Tree-Ring Analysis of Timbers

**Tree-ring Analysis of Timbers**

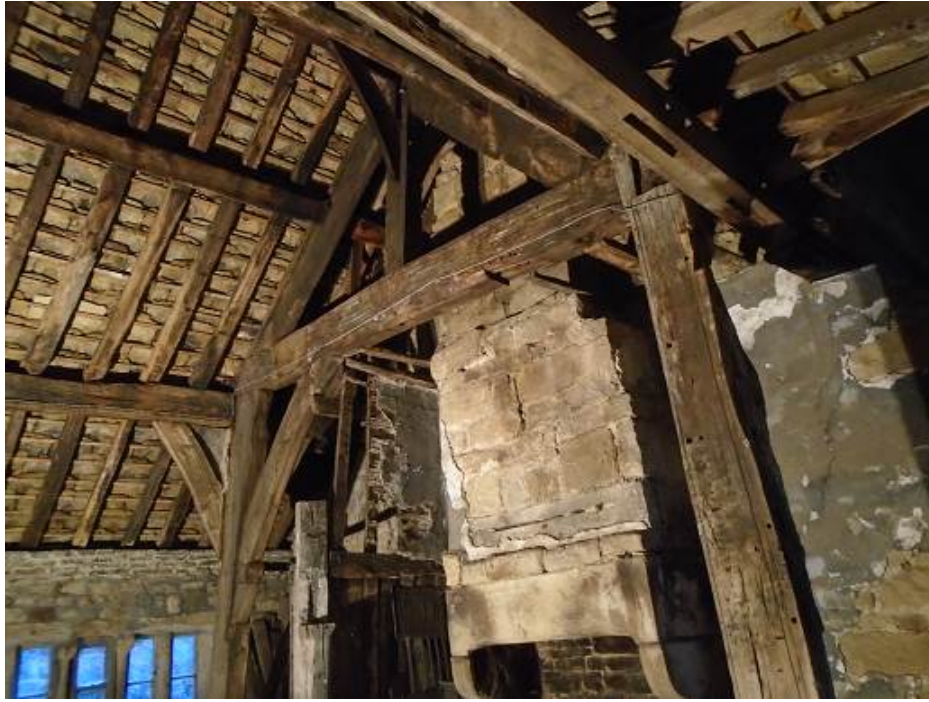
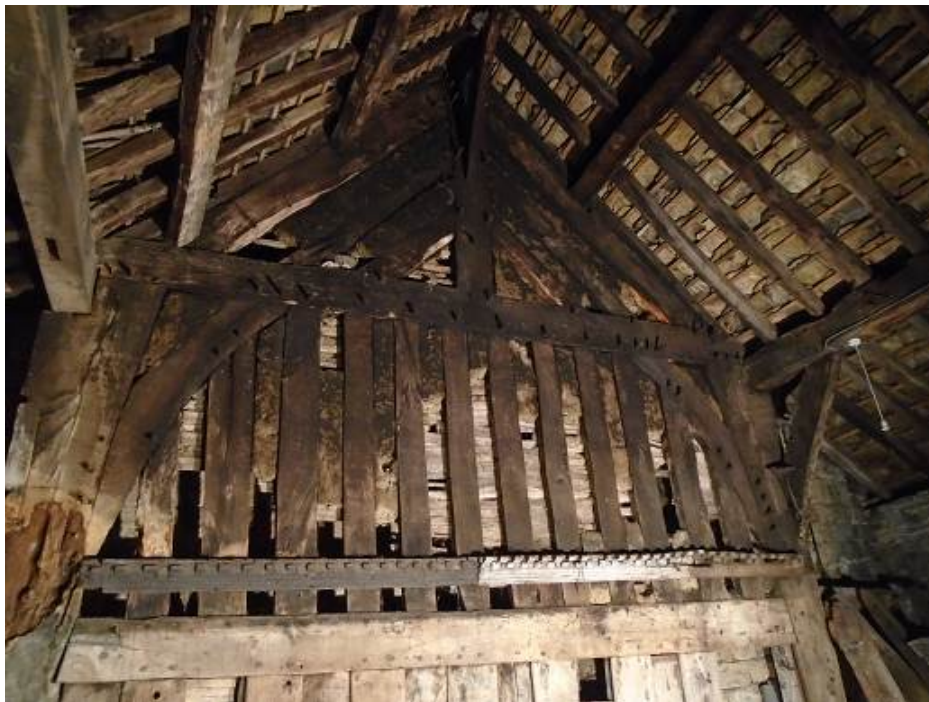
*Figure 3a/b: View of truss III, the open east truss (top), and truss IIII at the high west, or dias, end (bottom) (photographs Robert Howard)*

The remains of the hall house complex are fragmentary with neither wing surviving but two bays remain of what was once likely to have been a four-bay double-aisled structure (Fig 2; Stell 1965, fig 1), along with much of the encased timber frame and part of the cross passage. The eastern lower end of the hall, once containing the rest of the cross-passage and possibly a service end, has been lost to a later construction (Fig 2; Stell 1965, fig 1). At the west upper end of the extant hall, plank-and-muntin panelling remains to the lower part of the truss (truss III), with close-set vertical studs above and then a king post with braces (Fig 3a; Stell 1965 fig 1). The east extant truss (truss III) is also of king-post form (Fig 3b), and alongside the present fireplace which replaced the original open hearth in the eighteenth century is a thin, panelled fire-screen (Fig 3c). These two extant trusses carry double purlins to each pitch, which in turn carry the common rafters to the ridge. The northern aisle plate, with its curved braces from aisle posts to plate, appears likely to be original, unlike that to the south. The part of the building to the immediate east of the remains of the hall encompasses part of the former cross-passage but is now a store and a porch (Fig 2; Stell 1965, fig 1). Truss 1 is no longer extant but the middle (truss 2) and south gable (truss 3) trusses are also of king-post form, with truss 2 having short straight braces from tiebeam to king post (Fig 3d). These two trusses carry single purlins to each pitch of the roof, these in turn carrying common rafters.

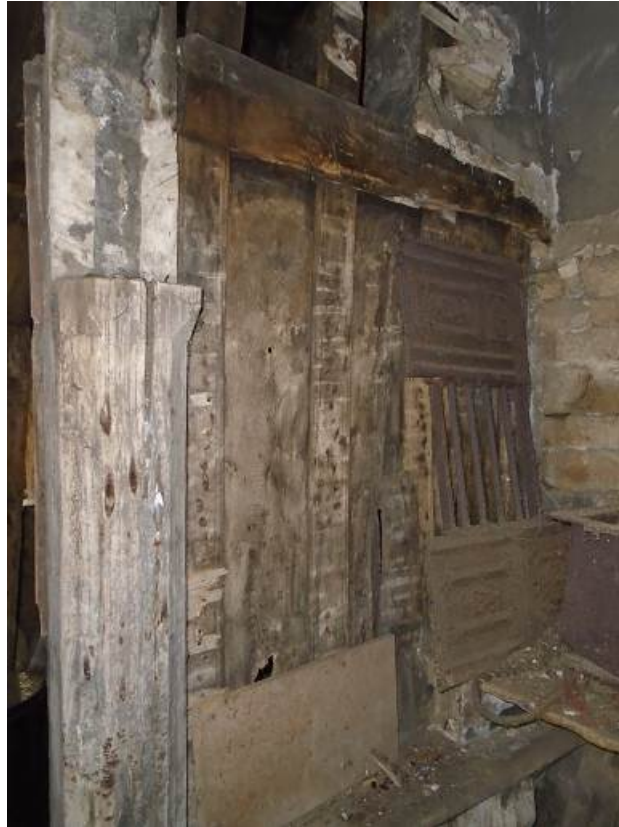
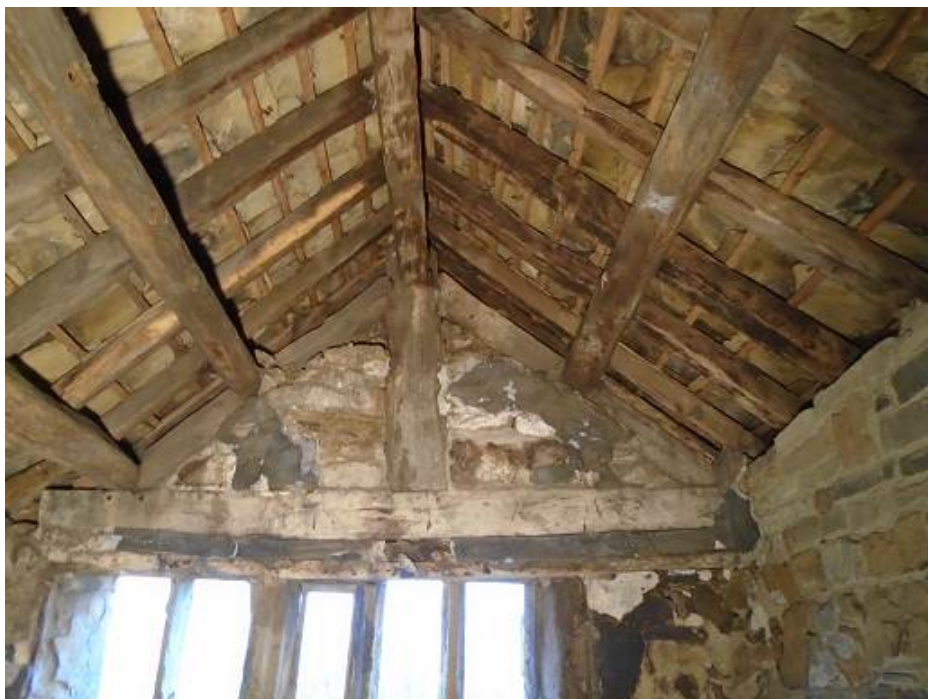
*Figure 3c/d: View of the fireplace screen in the hall house (top) and the roof of the east range (bottom) (photographs Robert Howard)*

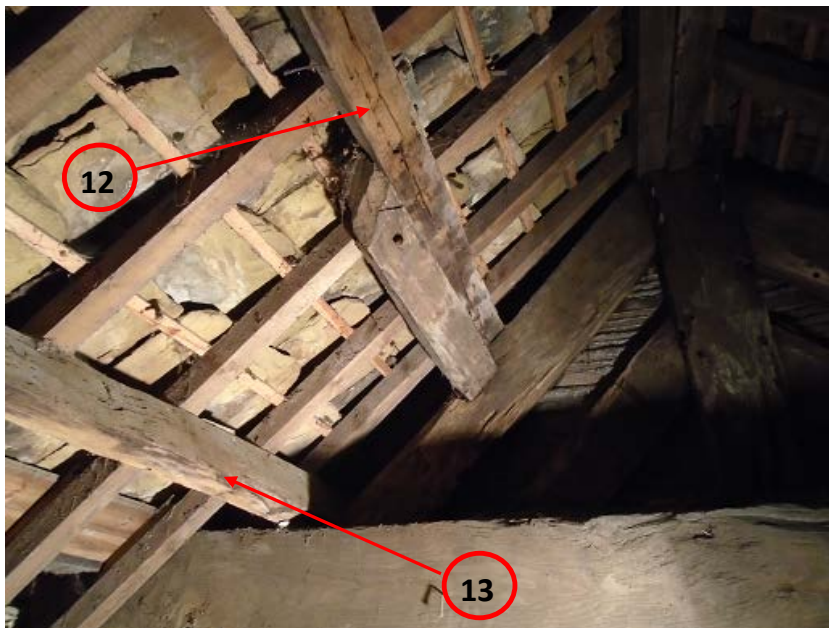
*Figure 5a/b: Annotated photographs of the east-range roof with sampled timbers identified (photographs Robert Howard)*

The sampled timbers are located either on the plans provided, or on annotated photographs taken at the time of sampling (Figs 4a/b, 5a–c). In this report the front of the building is deemed to face site south, the rear to face site north.

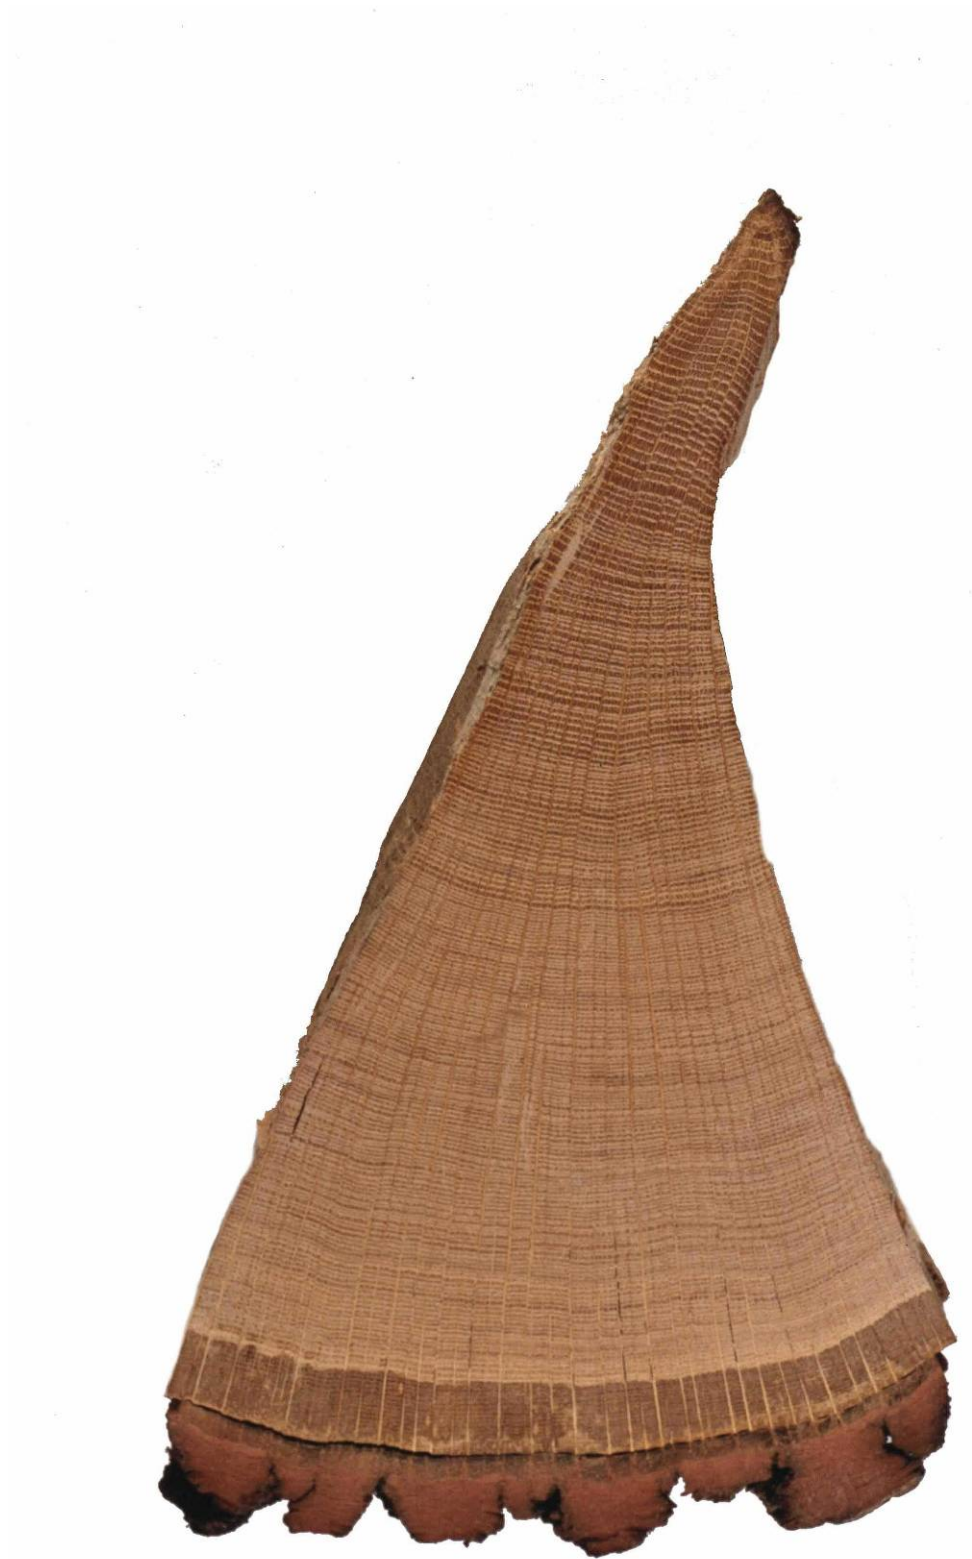
*Figure A1: A wedge of oak from a tree felled in 1976. It shows the annual growth rings, one for each year from the innermost ring to the last ring on the outside just inside the bark. The year of each ring can be determined by counting back from the outside ring, which grew in 1976*

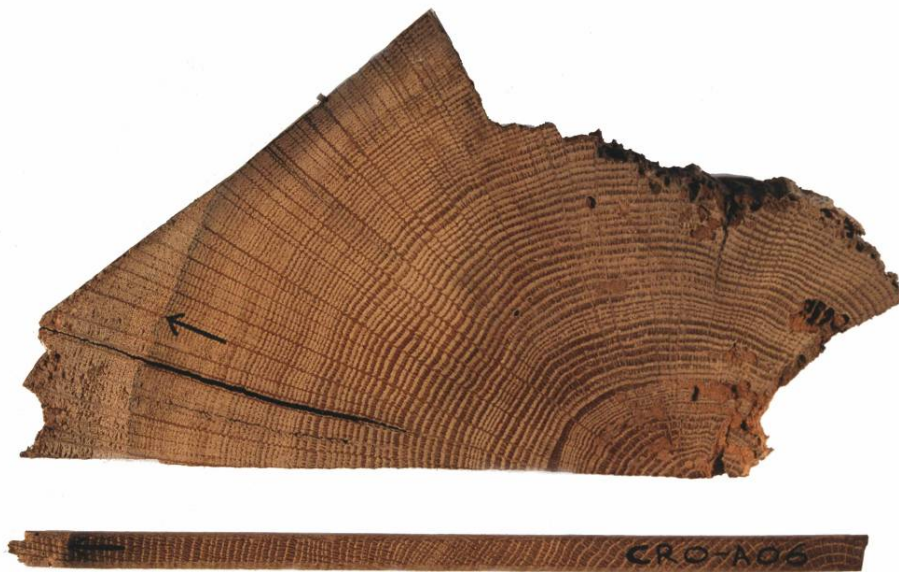
*Figure A2: Cross-section of a rafter, showing sapwood rings in the left-hand corner, the arrow points to the heartwood/sapwood boundary (H/S); and a core with sapwood; again the arrow is pointing to the H/S. The core is about the size of a pencil*

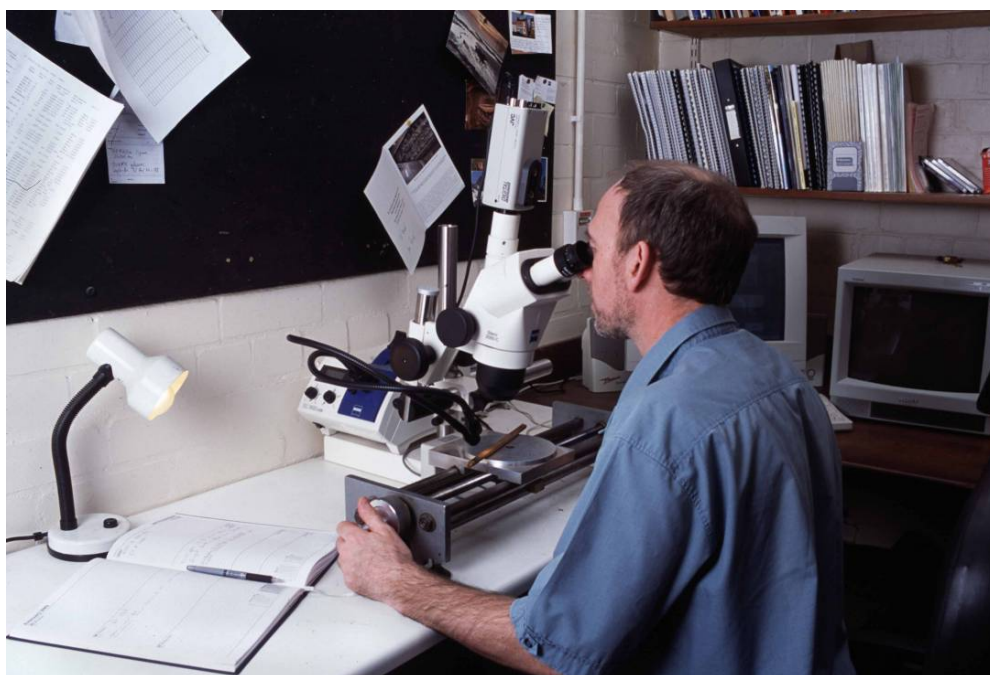
*Figure A3: Measuring ring widths under a microscope. The microscope is fixed while the sample is on a moving platform. The total sequence of widths is measured twice to ensure that an error has not been made. This type of apparatus is needed to process a large number of samples on a regular basis*

2. Measuring Ring Widths. Each core is sanded down with a belt sander using medium-grit paper and then finished by hand with flourgrade-grit paper. The rings are then clearly visible and differentiated from each other with a result very much like that shown in Figure A2. The core is then mounted on a movable table below a microscope and the ring-widths measured individually from the innermost ring to the outermost. The widths are automatically recorded in a computer file as they are measured (see Fig A3).

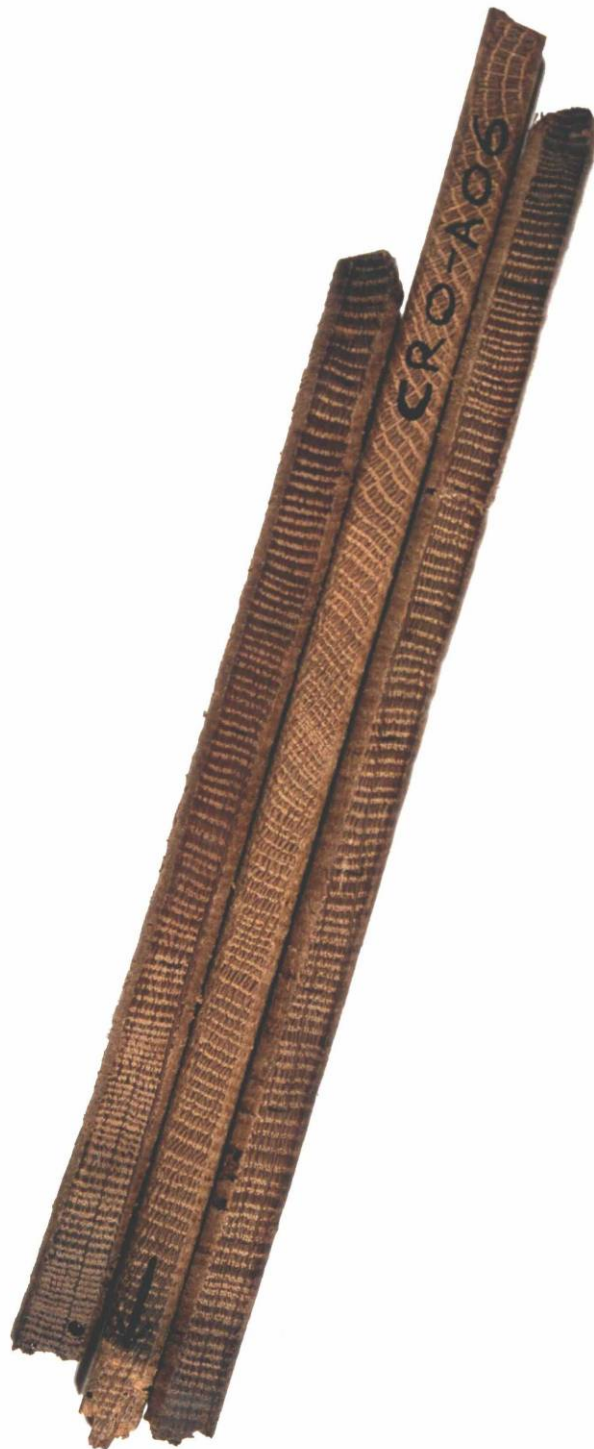
Figure A4: Three cores from timbers in a building. They come from trees growing at the same time. Notice that, although the sequences of widths look similar, they are not identical. This is typical
