Historic England

Bulldown Camp, Bramley, Hampshire: Analytical Earthwork Survey

NGR: SU 671 584

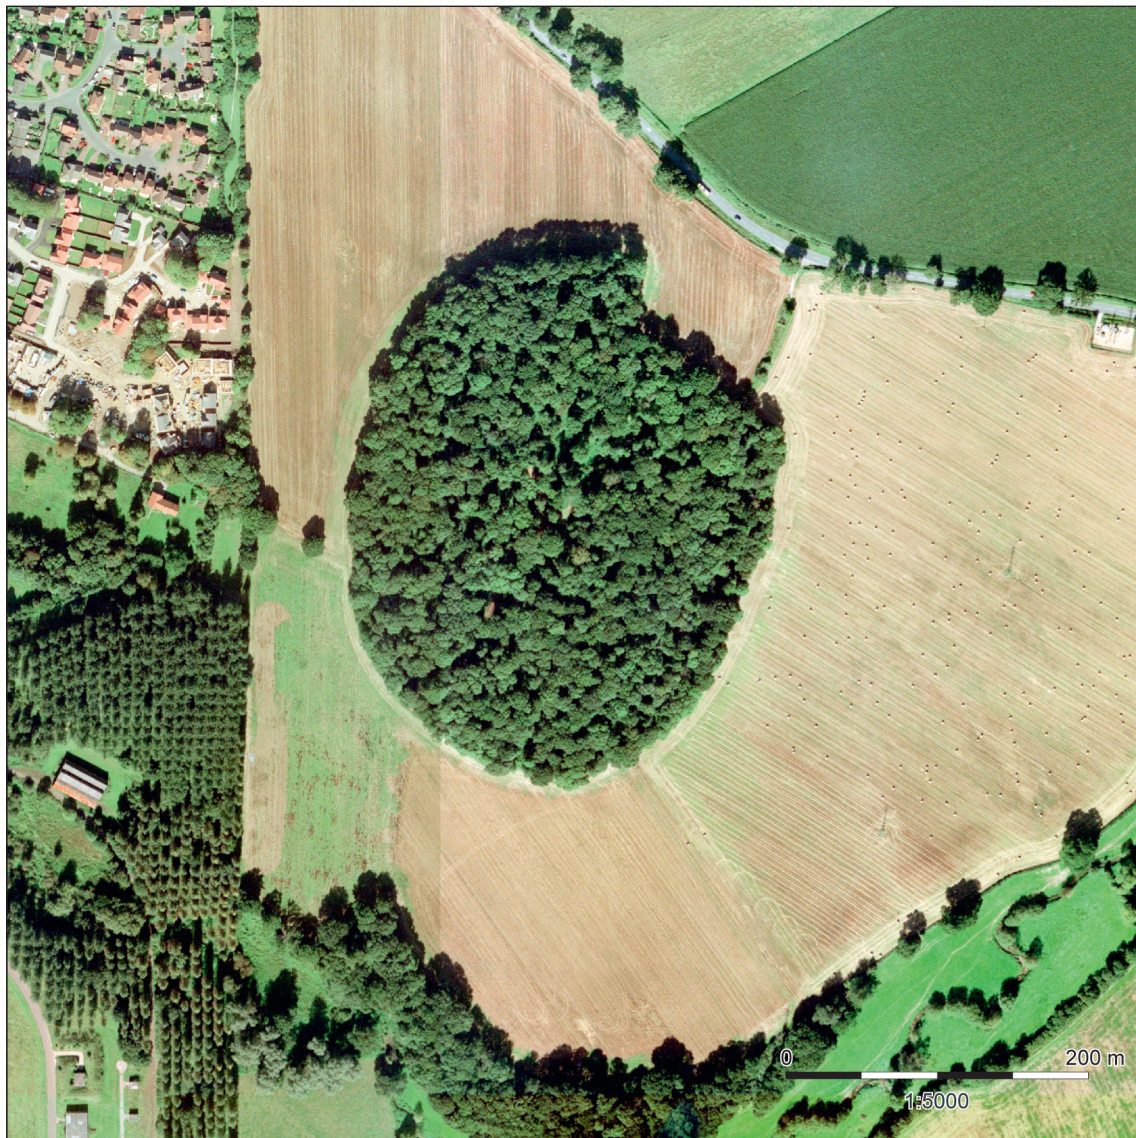
Figure 3: Bullsdown Camp land use. Contains 1999 25cm vertical aerial photography © Bluesky International Ltd; Getmapping PLC. .

Centred on SU 671 584, Bullsdown Camp lies at between 60 and 67m OD on a locally prominent plateau. It is surrounded on the southern and eastern sides by the confluence of the Bow Brook with the River Loddon, and is approximately 5km south-east of Calleva (Figs 1 and 2). Solid geology comprises clays, silts and sands of the London Clay Formation (BGS 2018), overlain by loamy clay soils of the Wickham 4 series (Soil Survey of England and Wales 1983). The site is currently planted with mature deciduous trees and surrounded by arable fields on all sides (Fig 3).

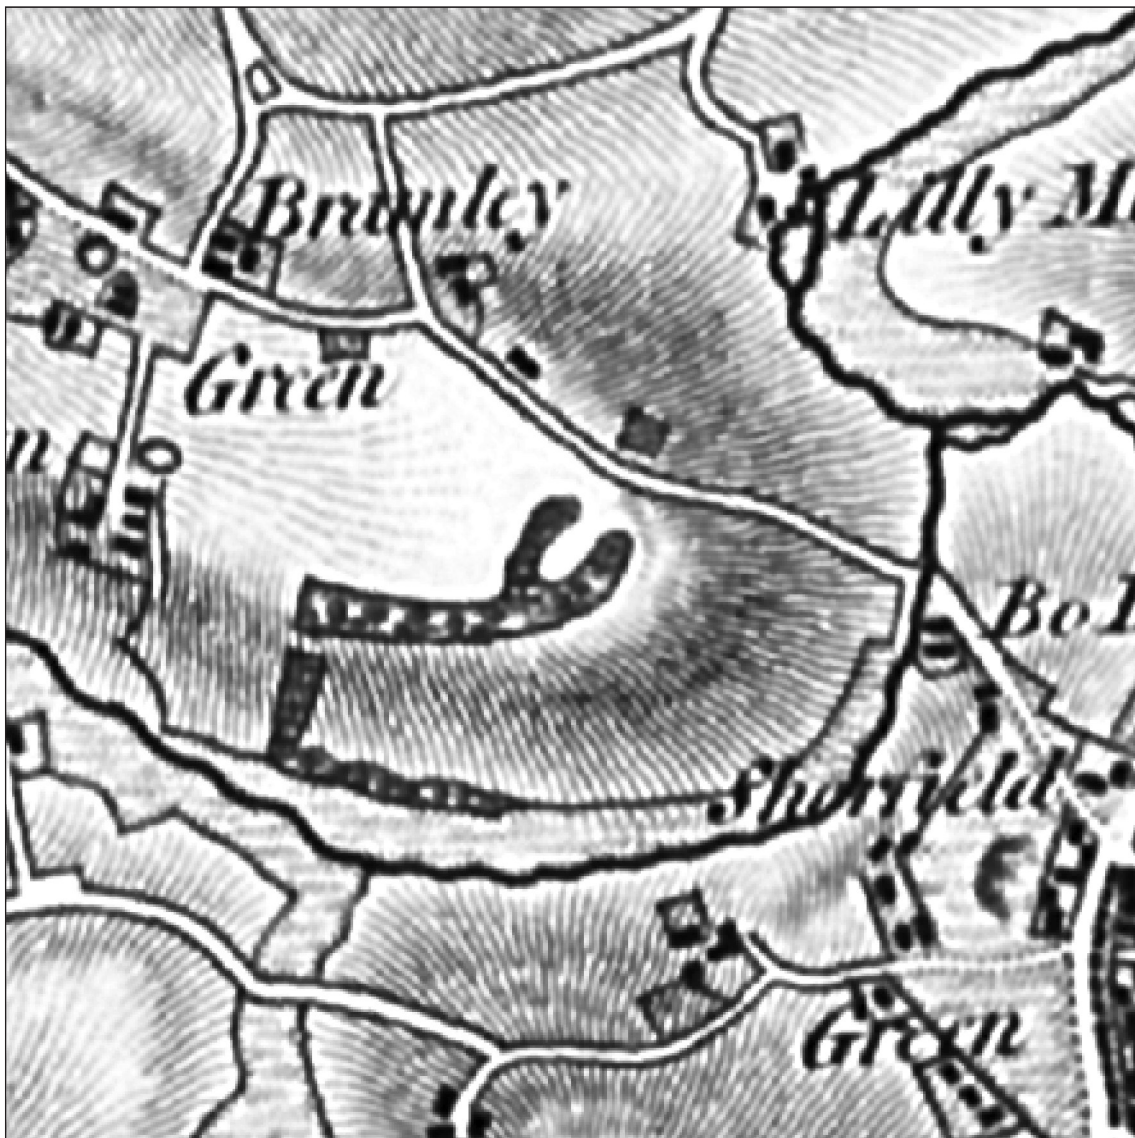
Figure 4: Extract of Ordnance Survey One Inch map (1816-17). © and database right Crown Copyright and Landmark Information Group Ltd (All rights reserved 2018). Licence numbers 000394 and TP0024

The 1816-17 Ordnance Survey One Inch map (Fig 4) shows Bullsdown Camp in the same state as the 1808 Surveyor's Drawing.

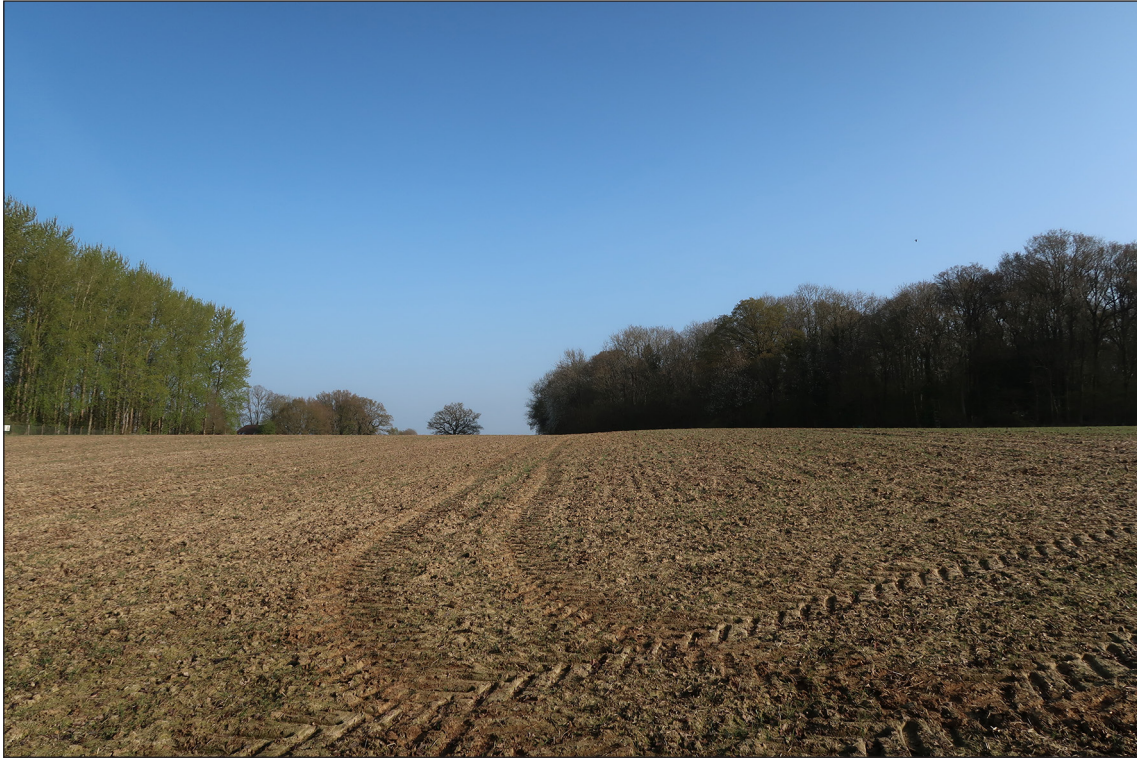
Figure 7: Curving boundary as a low earthwork under cultivation looking north towards Bullsdow Camp (© Historic England).right 2018. All rights reserved.

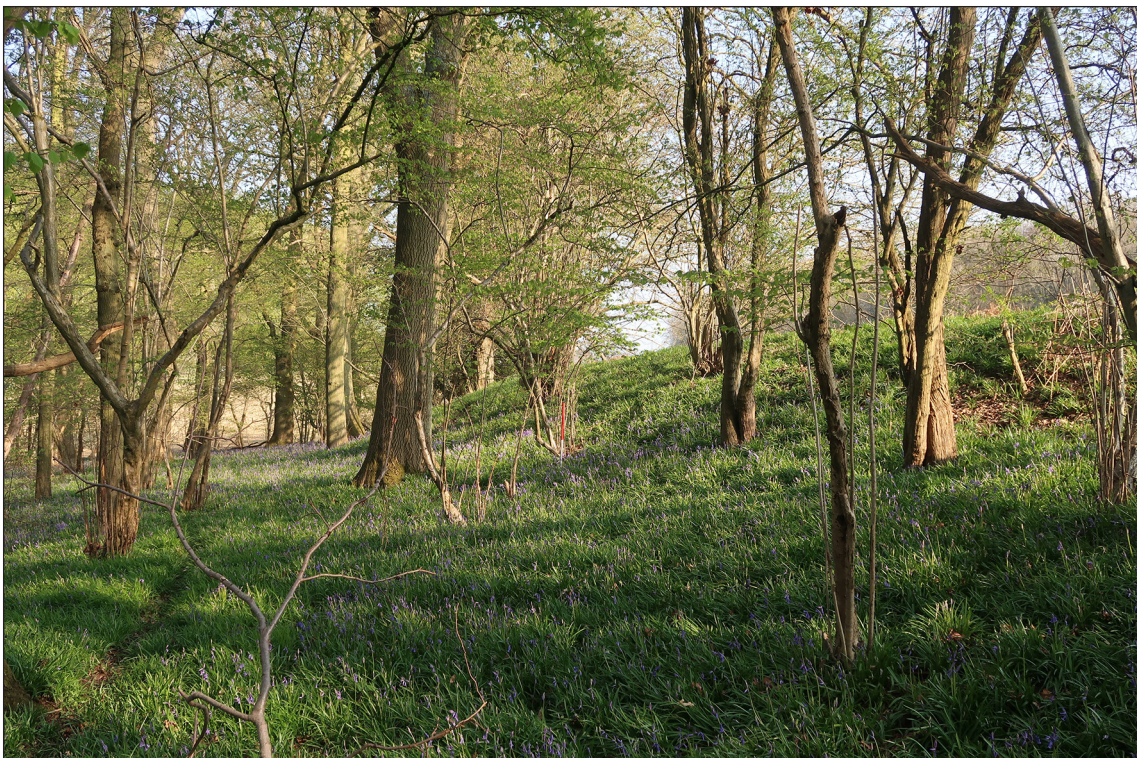
Figure 8: Curving boundary as a pronounced earthwork within Bullsdow Copse to the south of Bullsdow Camp, looking north-west. (© Historic England).

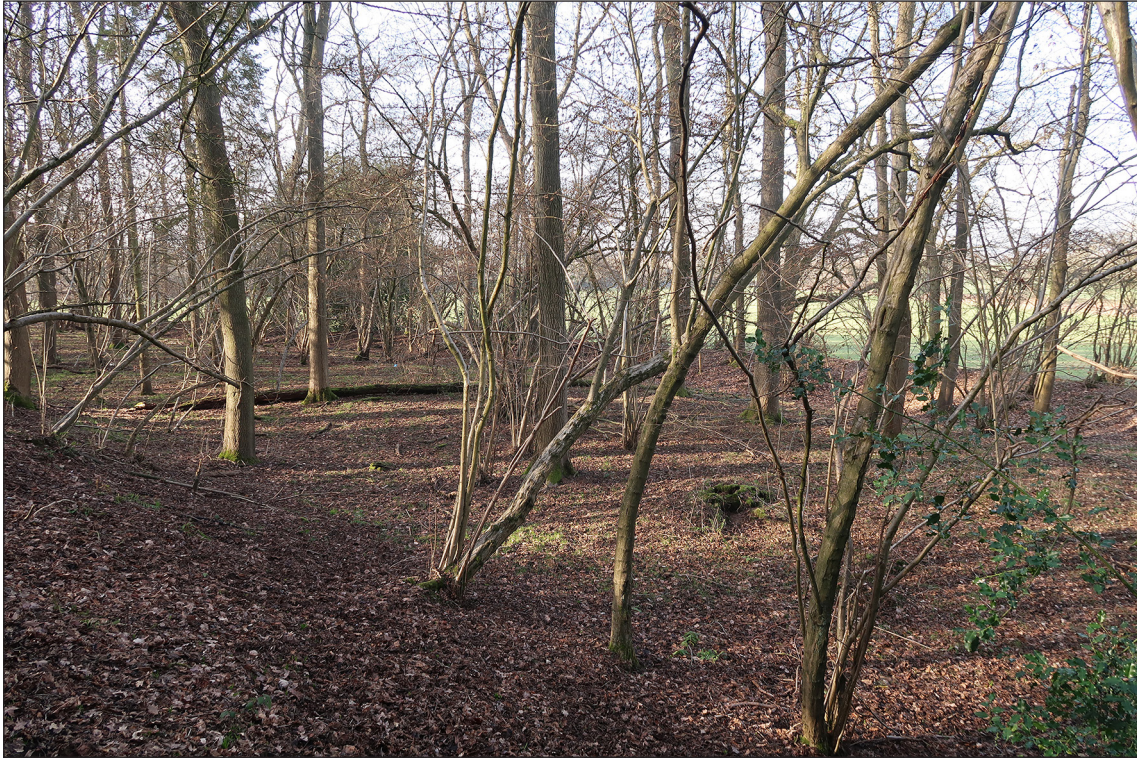
Figure 16: Looking west across levelled ramparts on the western side of Bullsdow Camp (© Historic England).

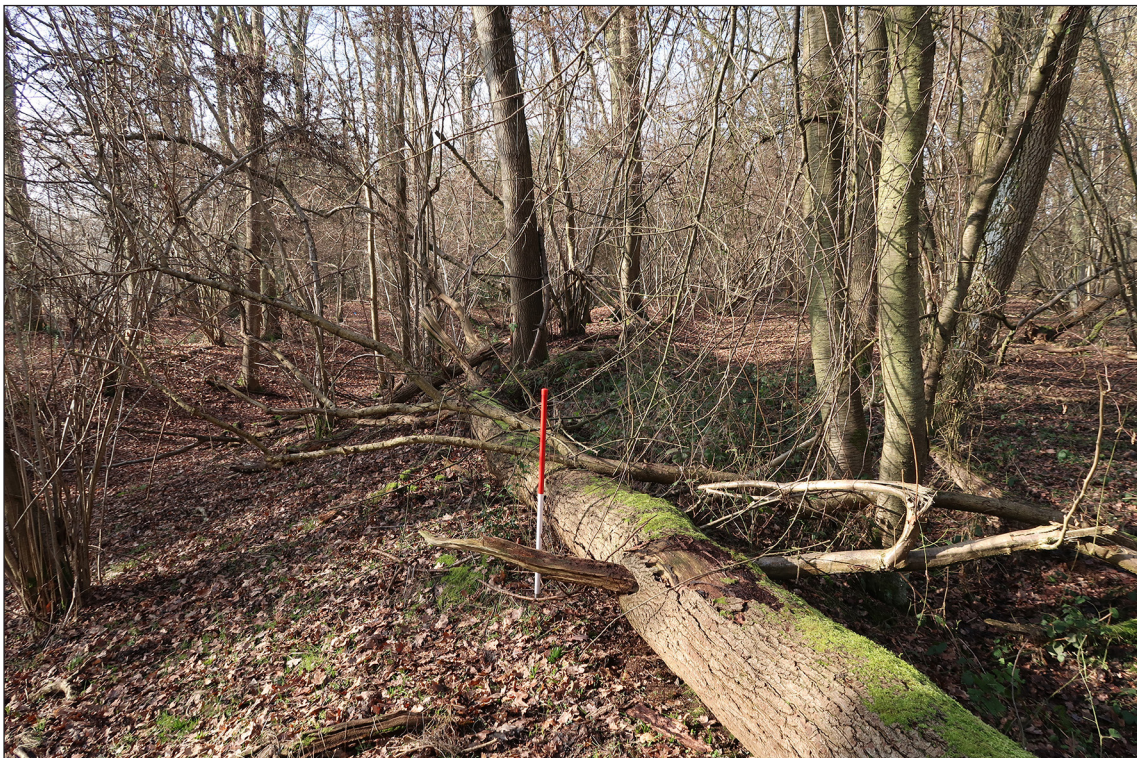
Figure 17: Inner bank (1.1), view to west, scale 1m (© Historic England).

Traces of a slight bank form the innermost element of the ramparts (Fig 17). This feature is most pronounced along the eastern and southern sides of the hillfort where it survives to a width of between 5 and 10m and a maximum height of 0.35m above the interior. To the north and west of breach (2.19), caused by trackway (2.33), this inner bank is broader and more diffuse, surviving to a width of between 7 and 10m and up to 0.1m above the hillfort interior. The inner bank is consistently cut by post-medieval ditches (2.1) and (2.7).

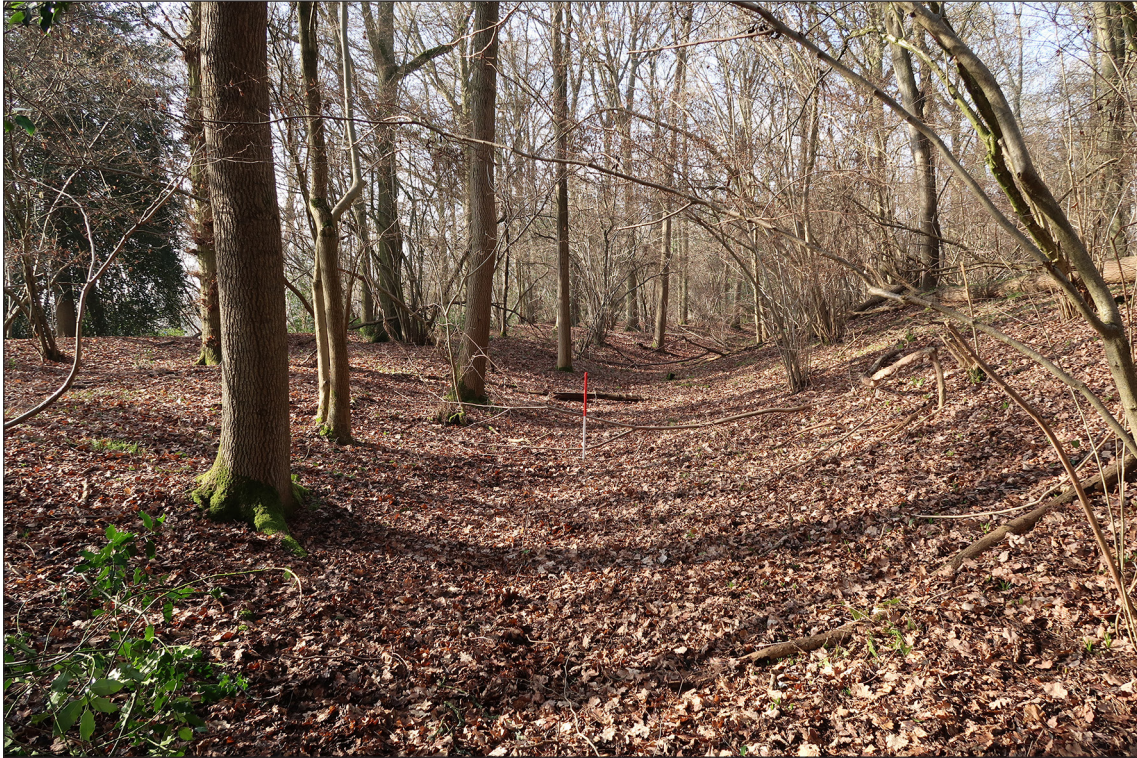
Figure 18: Inner ditch (1.2), view to west, scale 1m (© Historic England).

An inner ditch (1.2) is visible around most of the defensive circuit (Fig 18). This feature is most prominent on the southern and eastern sides of the hillfort where it measures between 12 and 18m wide by up to 2.1m deep. To the north and west of breach (2.19) the inner face of ditch (1.2) consistently presents as a well-defined outward facing scarp between 1.1 and 1.5m high. In this area the outer face of ditch (1.2) becomes increasingly ill-defined, surviving as a slight depression up to 0.2m deep, before disappearing altogether to the east of possible entrance (1.18).

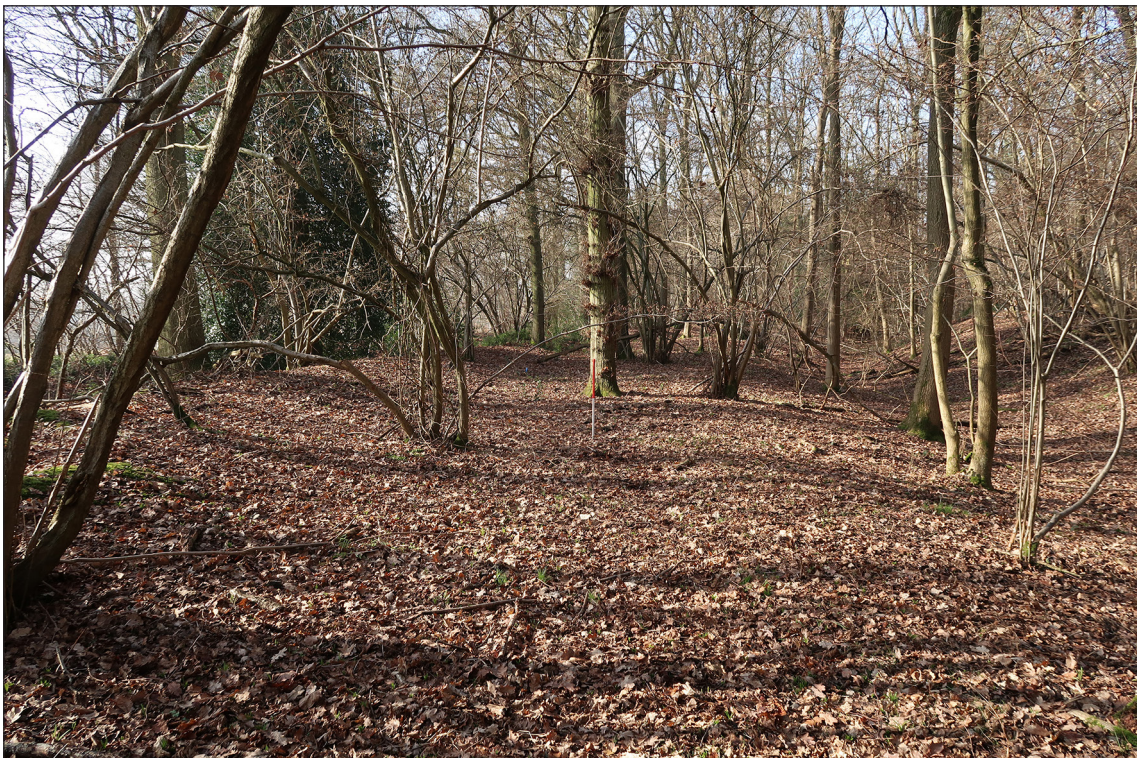
Figure 19: Slight traces of inner counterscarp bank (1.3) on inner edge of central berm, view to west, scale 1m (© Historic England)..

Traces of a very slight counterscarp bank (1.3) up to 0.15m high and 2m wide were recorded on the outer edge of ditch (1.2) (Fig 19). Counterscarp (1.3) is only visible in the south-east of the site.

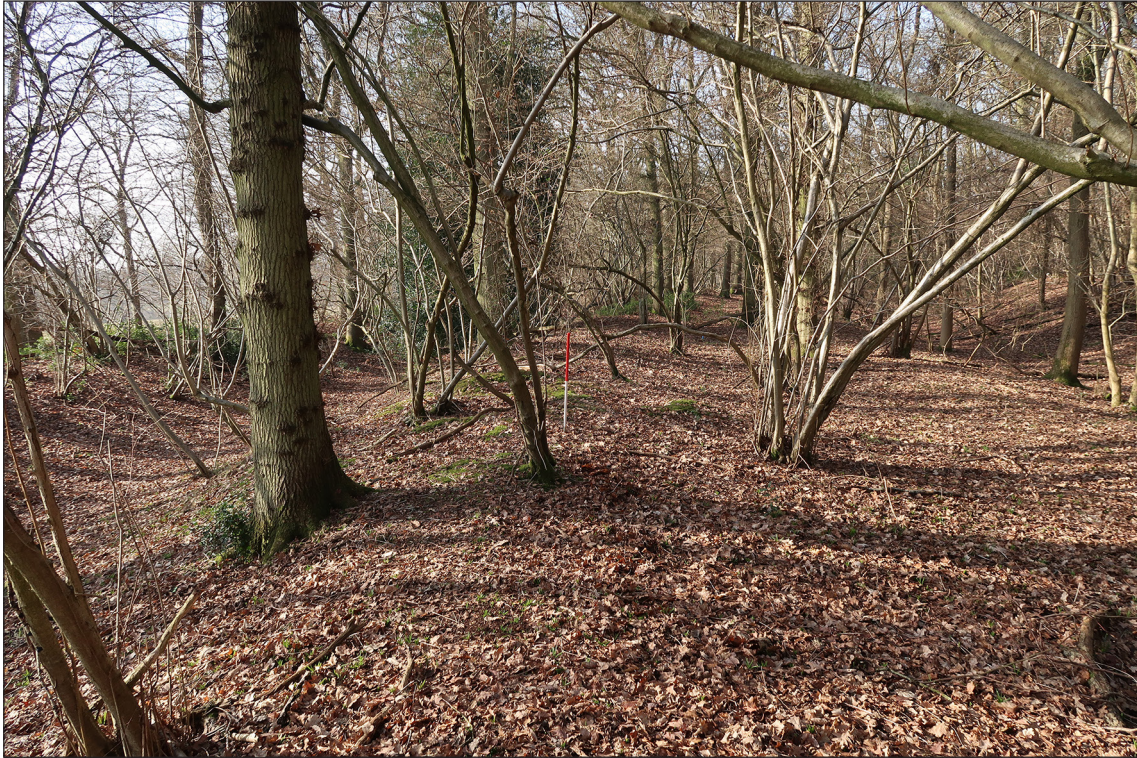
Figure 20: Outer bank (1.4) on outer edge of central berm, view to west, scale 1m (© Historic England).

A small outer bank (1.4) was recorded at the inner edge of outer ditch (1.5) (Fig 20). To the east of breach (2.19) this is a well-defined feature between 2 and 4m wide and up to 0.5m high. To the west of breach (2.19) bank (1.4) is often much broader (up to 6m wide) with a generally shallower profile (0.25m) and a less defined inner edge.

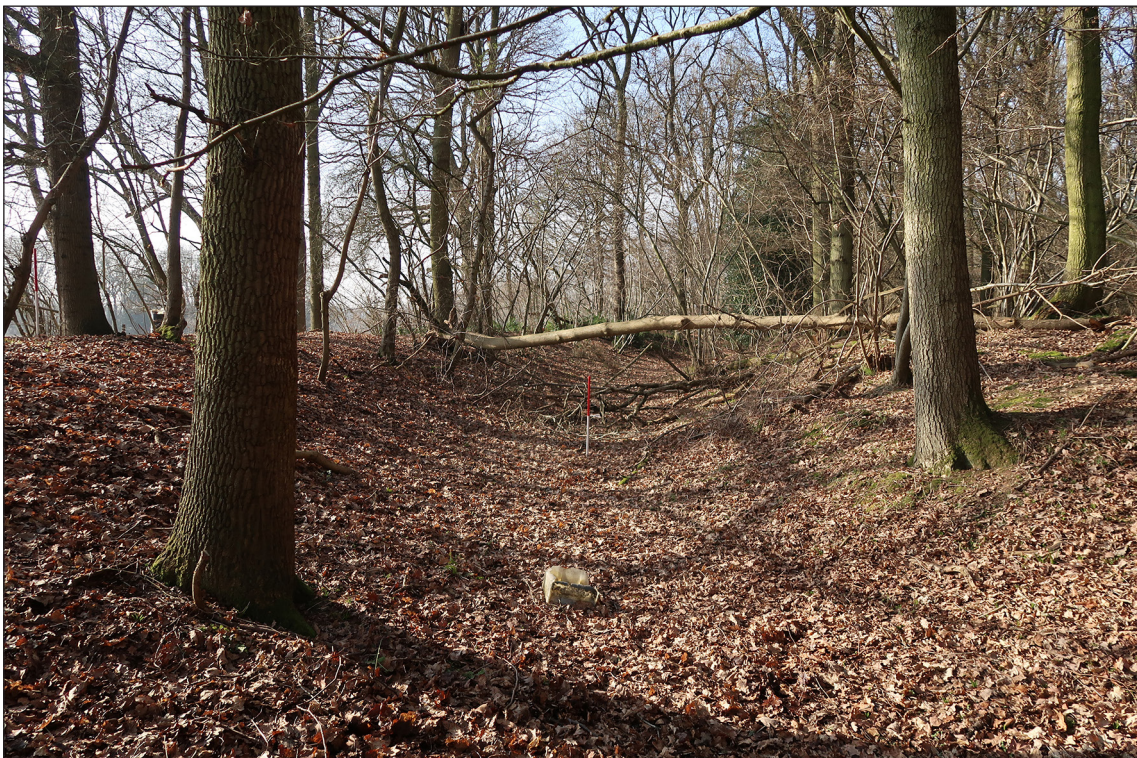
Figure 21: Outer ditch (1.5), view to west, scale 1m (© Historic England).

An outer ditch (1.5) is recorded around the entire surviving ramparts (Fig 21). The ditch is up to 14m wide and ranges between 1.6 and 2m deep. To the east of possible entrance (1.18) the outer ditch (1.5) is shallower at approximately 0.75m.

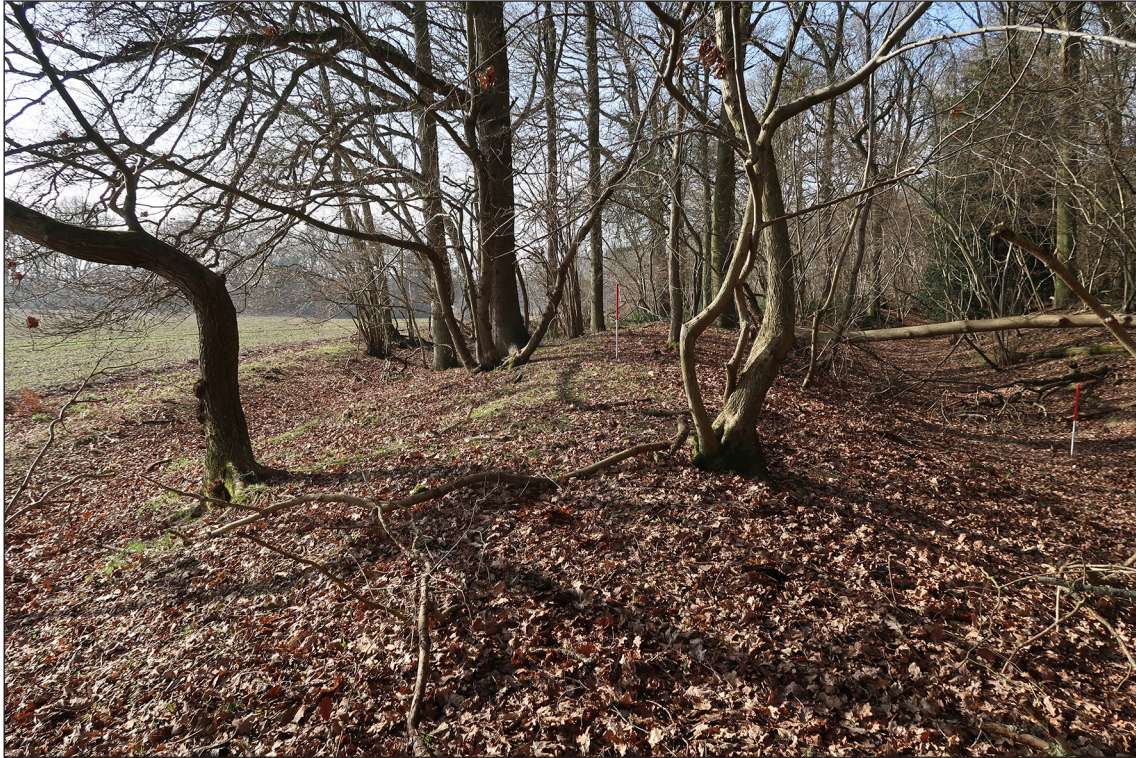
Figure 22: Outer counter scarp bank (1.6), view to west, scale 1m (© Historic England).

The outermost component of the ramparts is an outer counterscarp bank (1.6) (Fig 22). The outer bank is between 1 and 4m wide, and ranges between 0.75m high on the southern and eastern sides, and 0.4m high in places on the western side.

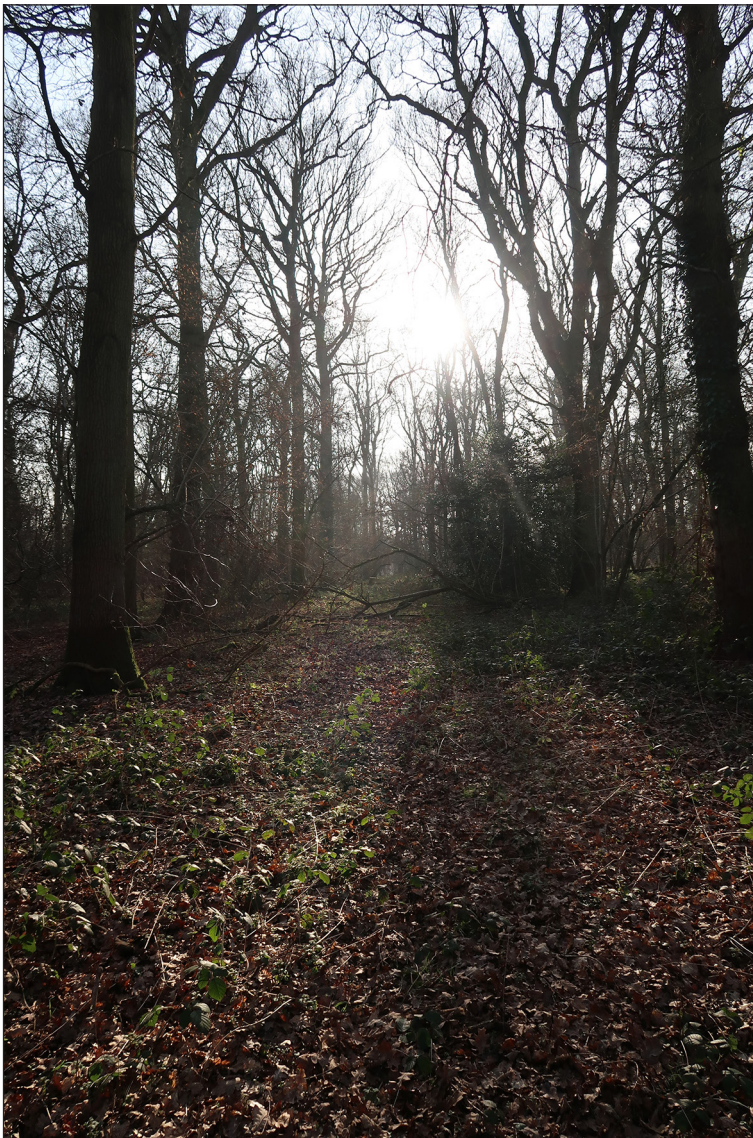
Figure 23: Looking south-west along the southern end of the eastern trackway (2.32), (© Historic England)

Trackway (2.32) to the south-east is more obvious (Fig 23). It can be traced both as an approximately 10m wide gap in the mature woodland, and as a slightly sunken earthwork at its north-eastern end becoming less distinct to the south-west. The course of trackway (2.31) to the north-west is less distinct. Only a short length of this

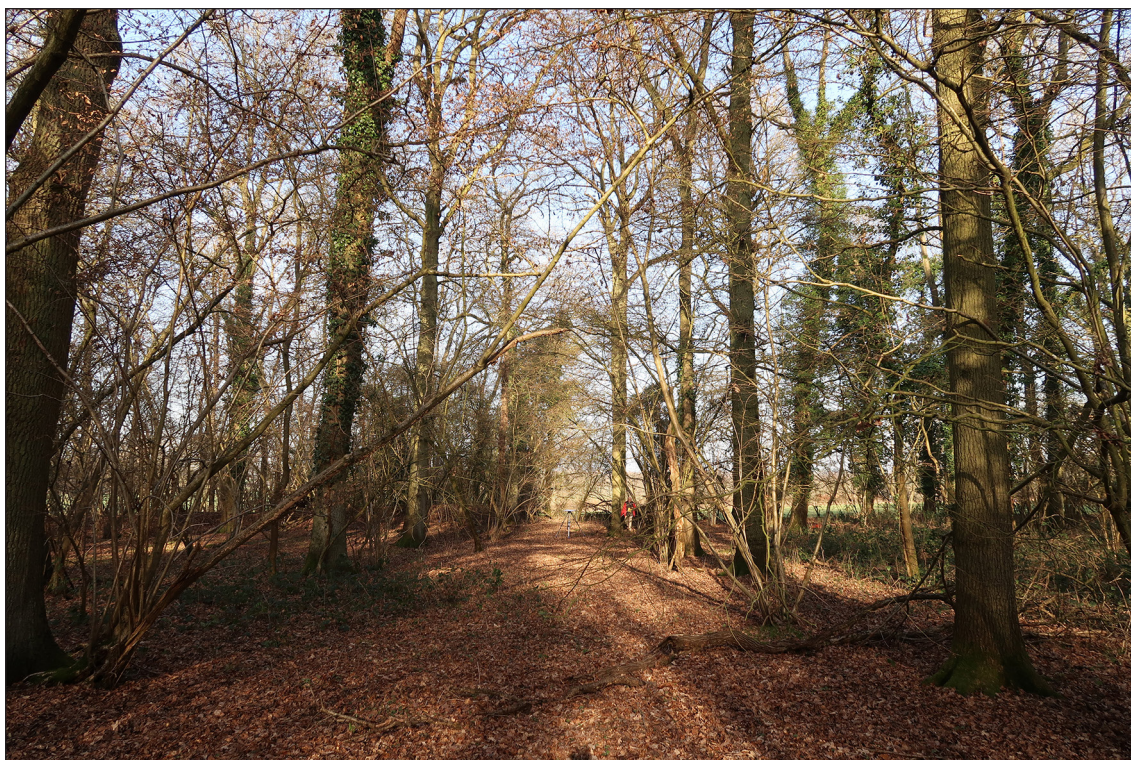
Figure 24: Looking north-east along the northern end of the western trackway (2.31), (© Historic England)..

feature was traced as a linear gap in mature woodland at its north end (Fig 24); no traces were observed further to the south-west.

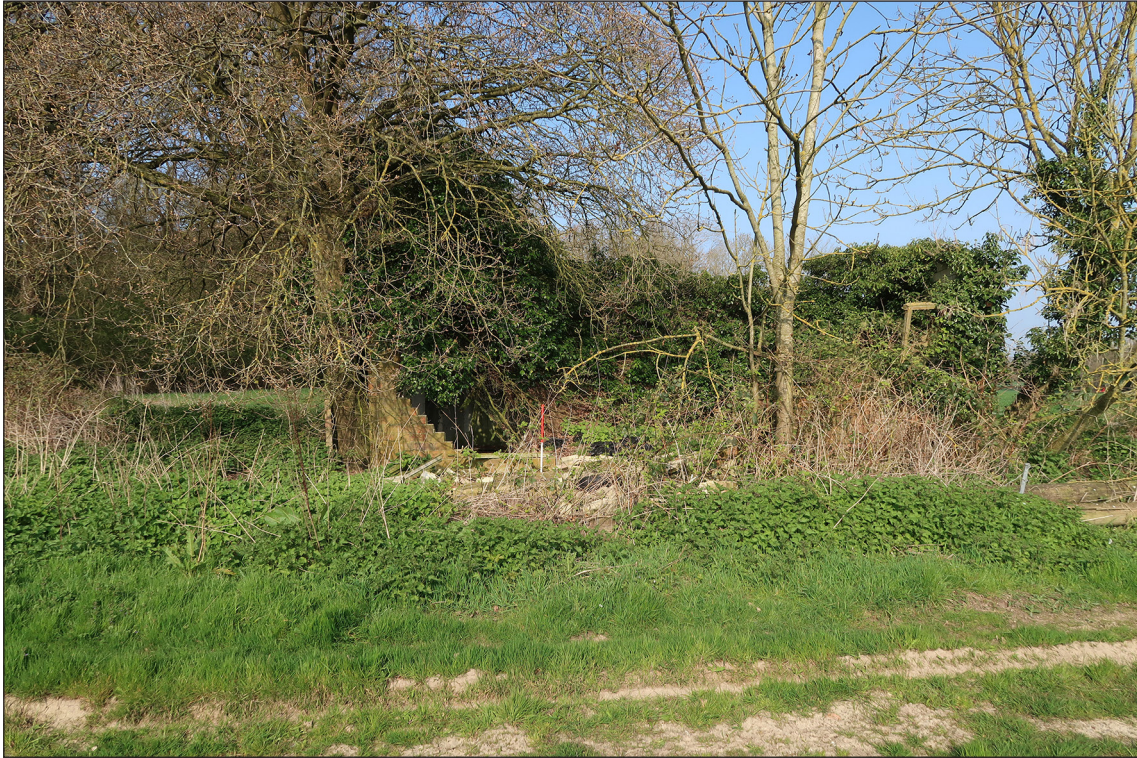
Figure 25: Building (2.34), view to west, scale 1m (© Historic England).

Two small brick-built single storey buildings (2.34) (Fig 25) and (2.35) (Fig 26), measuring 8m by 4m and 11m by 5.5m respectively, were recorded on the western side of track (2.33) to the north of the hillfort. They are both built against the line of removed field boundary (2.36). Both have enclosing baffles (blast walls) at their entrances. The buildings are not shown on 1934 aerial photography (see cover photograph), but appear on 1947 RAF vertical area photography, and are considered likely to represent outlying Second World War military buildings associated with Bramley Ordnance Depot (Truscoe 2018, 183) less than 1km to the south-west.

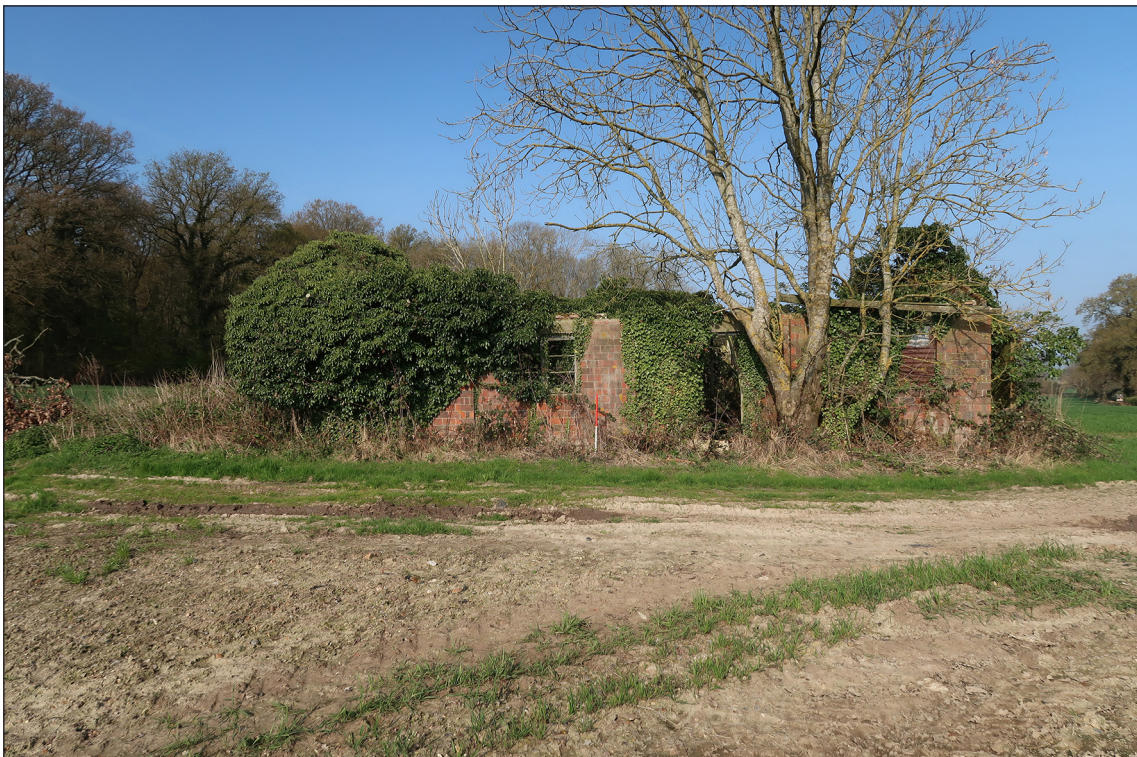
Figure 26: Building (2.35), view to west, scale 1m (© Historic England).

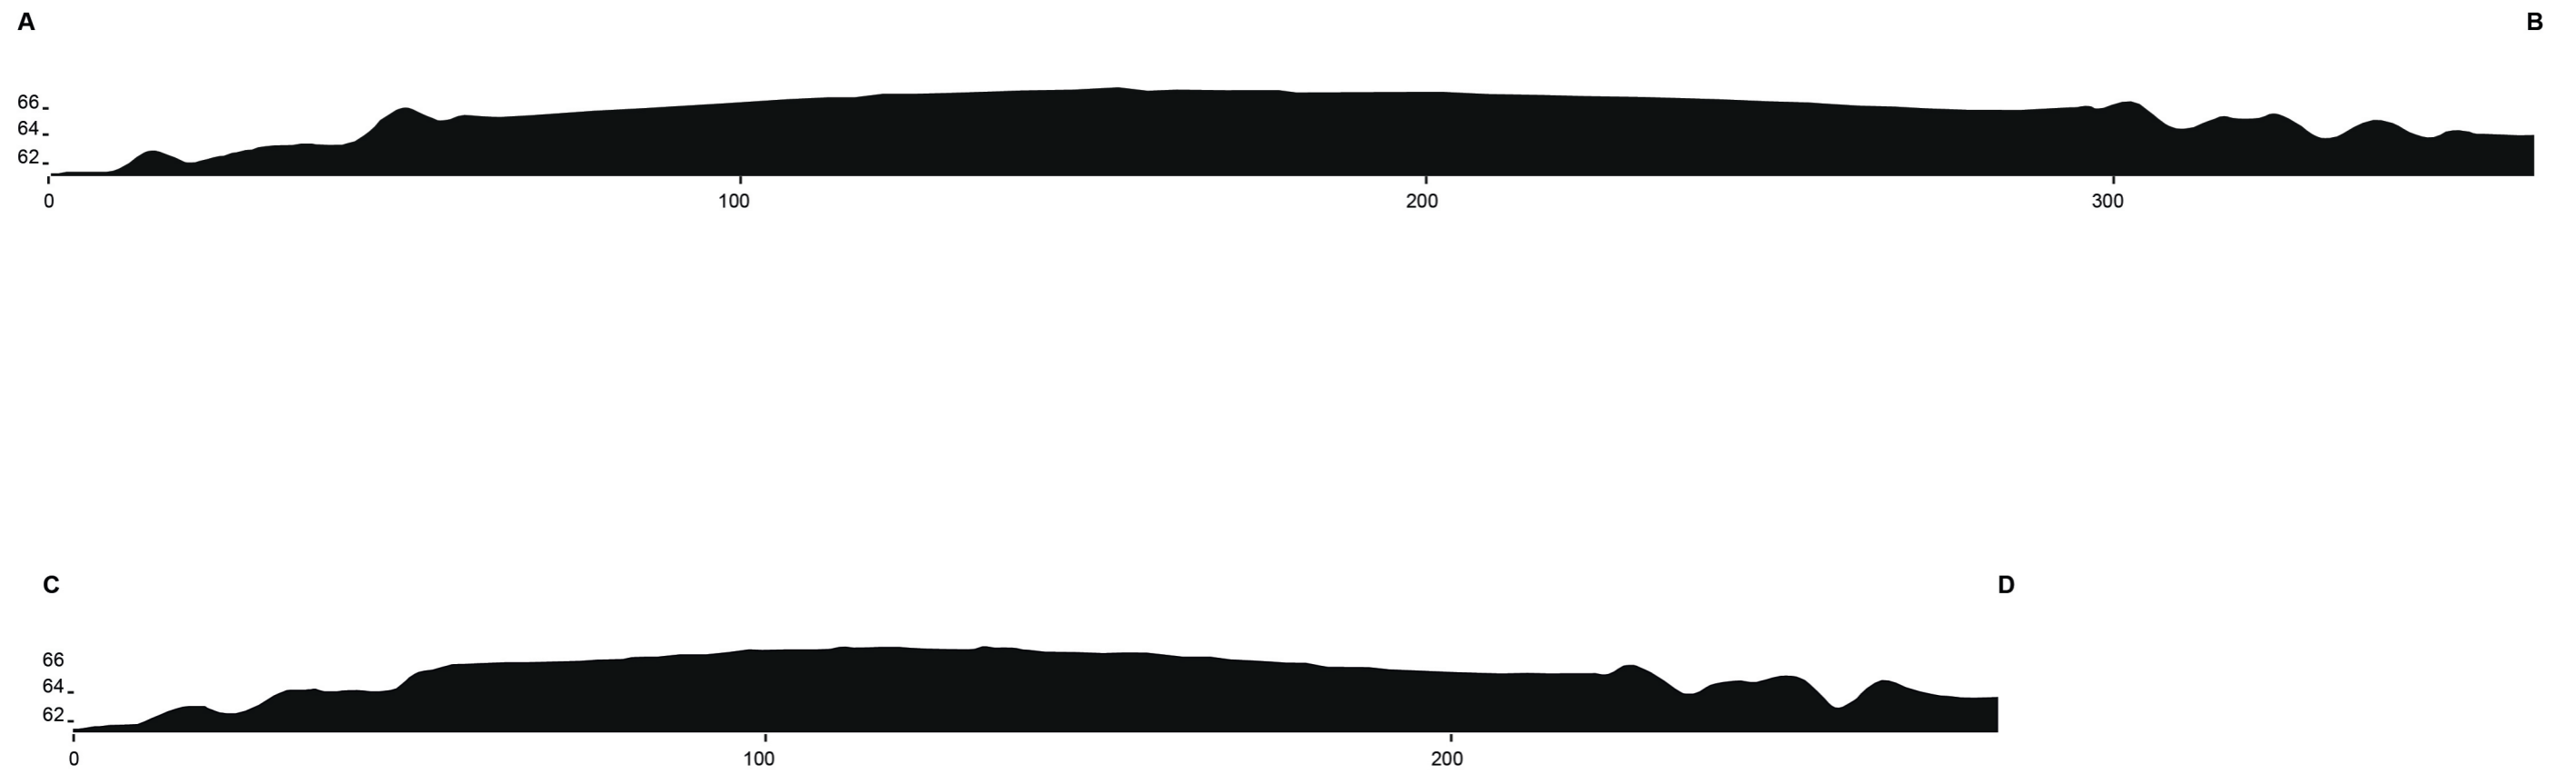
Figure 30: Profiles A-B and C-D across Bullsdown Camp (1:1000 horizontal axis and 1:500 vertical axis).

Variability in the morphology of the ramparts is better shown in two profiles across the ramparts. Profile A-B on the southern side of the hillfort broadly reflects the sequence shown in plan, but emphasises a wide berm separating the inner and outer ditches. In his accompanying text attention is drawn to this feature as a “*broad platform about 27 feet in width, which forms the summit of the middle rampart throughout its whole length. It is slightly worn down in the middle, and is in part occupied by a cart track*” (1915, 361). Profile C-D on the western side is much gentler. Here there is no back to the inner bank, the outer edge of the inner ditch grades gently towards an ill-defined central berm, followed by a shallower outer ditch and a slighter outer bank.

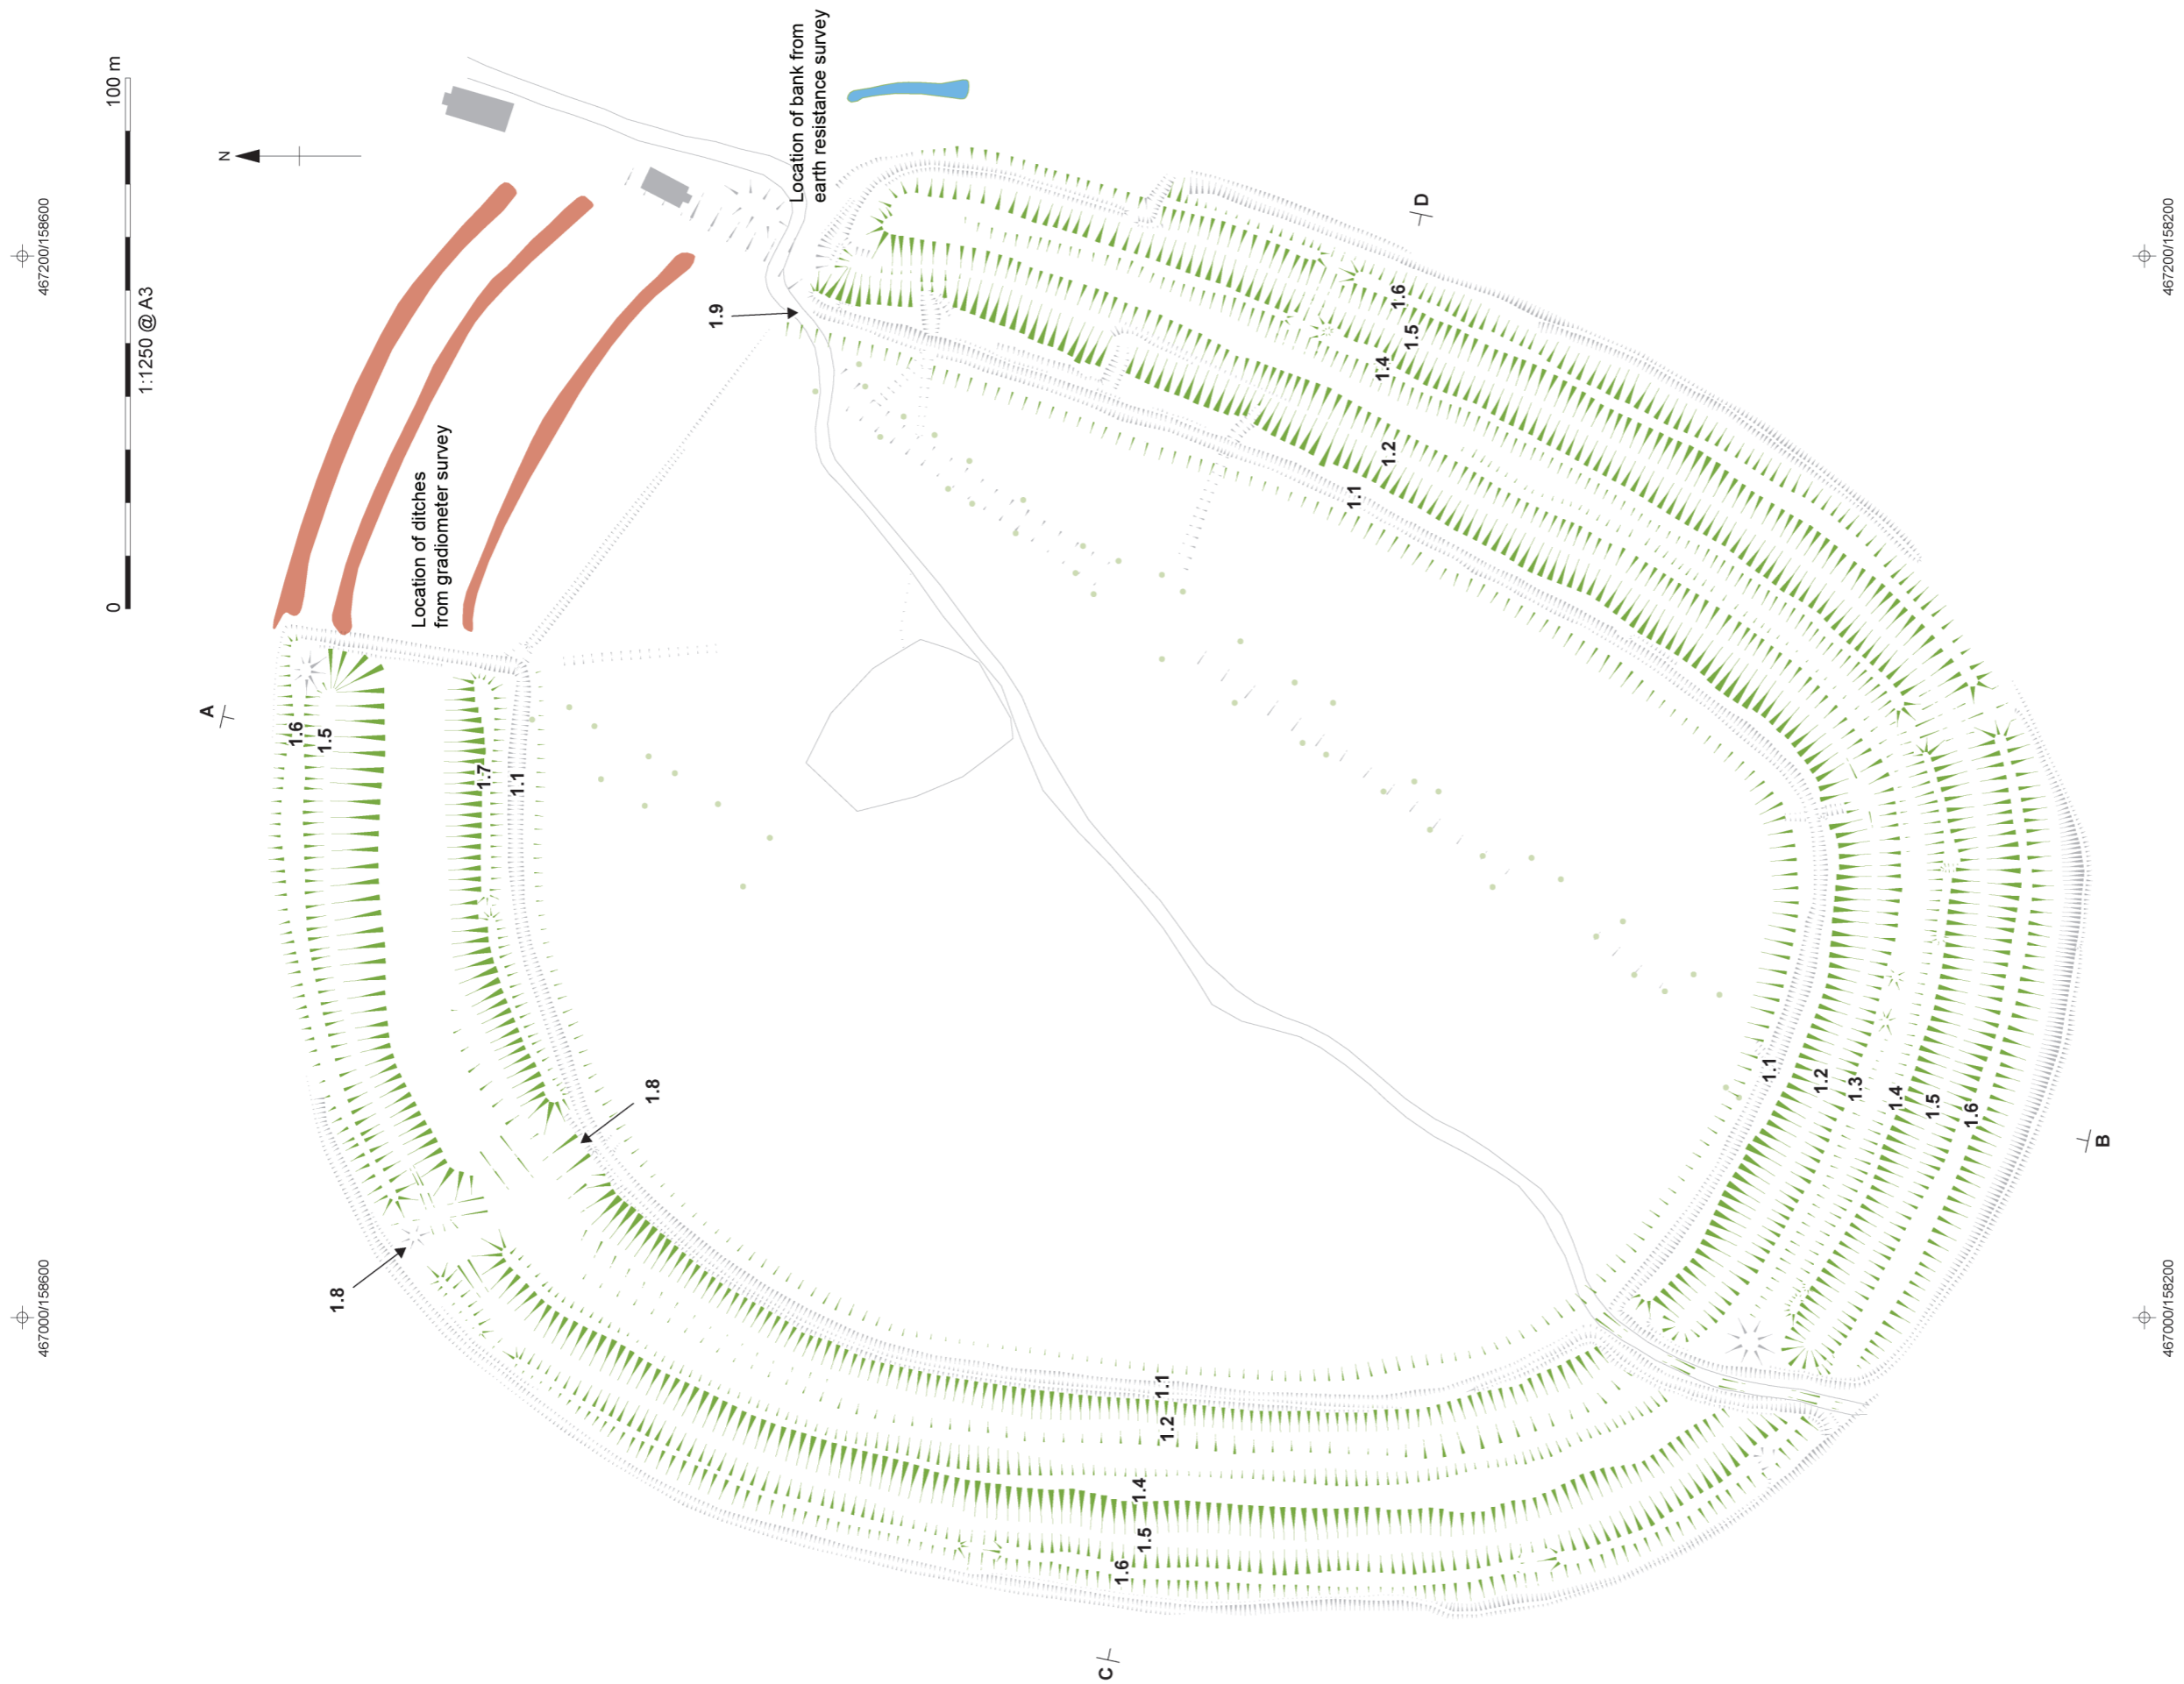
Figure 31: Iron Age features at Bullsdown Camp (reduced to 1:1250 from original survey drawing at 1:1000).

For ease of reference earthwork features are grouped together into two phased and annotated plans (Figs 31 and 32), and are presented below as text descriptions. All bracketed numbers refer to annotated features on Figures 31 and 32. All feature numbers with a '1' prefix refer to figure 31, all feature numbers with a '2' prefix refer to figure 32.

The hillfort is the earliest phase of activity recorded by the survey (Fig 31). It is sub-oval in form, measuring 320m north – south by 250m west – east. It encloses an area of approximately 3.4ha, and has an entire footprint of approximately 7.3ha. Nearly 90% of the hillfort's defensive circuit survives as extant earthworks. Approximately 85m of the ramparts have been removed in the hillfort's north-east corner (see discussion of feature (2.26/2.27) below). The ramparts are defined by an inner bank (1.1), inner ditch (1.2), with intermittent counter scarp (1.3), outer bank (1.4), outer ditch (1.5) and outer counter scarp bank (1.6). The character of the ramparts is noticeably different on the western side of the hillfort between breach (2.19) and possible entrance (1.8). Here the central portion of the ramparts between the outer face of inner ditch (1.2) and the inner face of outer ditch (1.5) appears as a substantially flattened terrace (Fig 16). It is suggested this is the result of deliberate levelling of the earthworks after the Iron Age and does not reflect their original form.
