Rampier Copse, Silchester, Hampshire: Analytical Earthwork Survey

Rampier Copse, Silchester, Hampshire: analytical earthwork survey

NGR: SU 635 620

A Level 3 analytical earthwork survey at Rampier Copse, Silchester, Hampshire was undertaken by Historic England as part of the Silchester Environs Project in late 2017 and early 2018. The survey covered an area of approximately 14ha immediately outside the south-west corner of the Roman town of Calleva Atrebatum. The earliest recorded feature was a sub-circular enclosure, or small hillfort, of presumed mid to late Iron Age date, abutted by a linear earthwork of presumed late Iron Age date. Elements of the enclosure are massively enhanced and are incorporated into the outer earthwork surrounding the late Iron Age oppidum. Part of the oppidum's inner earthwork, Roman roads, and quarrying, woodland banks and boundaries of presumed post-medieval date were also recorded.

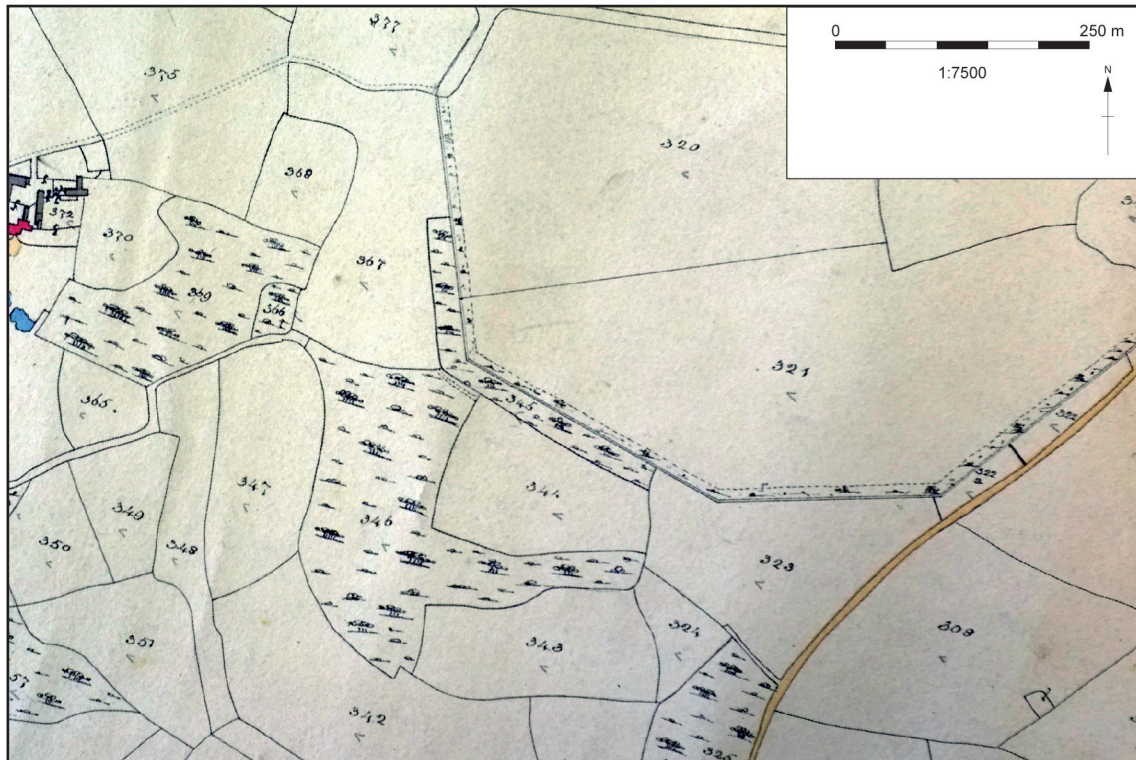
Figure 5. Extract of Silchester tithe map 1841. Hampshire Record Office: 21M65/F7/209/2.

The Silchester parish tithe map is the first accurate depiction of the area (Fig 5). It shows the configuration of the fields and boundaries surrounding Rampier Copse in a very similar form to that seen today. No earthworks are depicted. Whilst the tithe map adds detail to field boundaries, the configuration of the landscape is very similar to that shown by Colt Hoare in 1818. A short trackway following the southern edge of area 7 in its south-corner is the only substantial addition. Each of the large fields bordering the town defences is under arable cultivation, and the remaining open areas are under either pasture or meadow. The majority of the study area is owned and occupied by the Rev John Coles. Two fields (areas 6 (344) and 7 (323)) on the eastern edge of the survey area are owned by the Duke of Wellington and leased to William John Barton.

Feature (7.12) is a south-west facing scarp running north-west to south-east across area 7 (Fig 38 and see profile 20). It is suggested that this feature is a lynchet resulting from the cultivation of the northern part of area 7 against a, now removed, field boundary shown on historic mapping (see Figs 5-7). This runs contrary to Boon's (1969, Fig 1) and Creighton and Fry's (2017, Fig 9.7), suggestion that it is a continuation of the outer earthwork. The narrow gap between the eastern end of this feature and woodland bank (7.8) is likely to be the lane shown on historic mapping (see Figs 5 and 6). Spread (7.13) on the southern edge of scarp (7.12) is probably the result of cattle erosion.

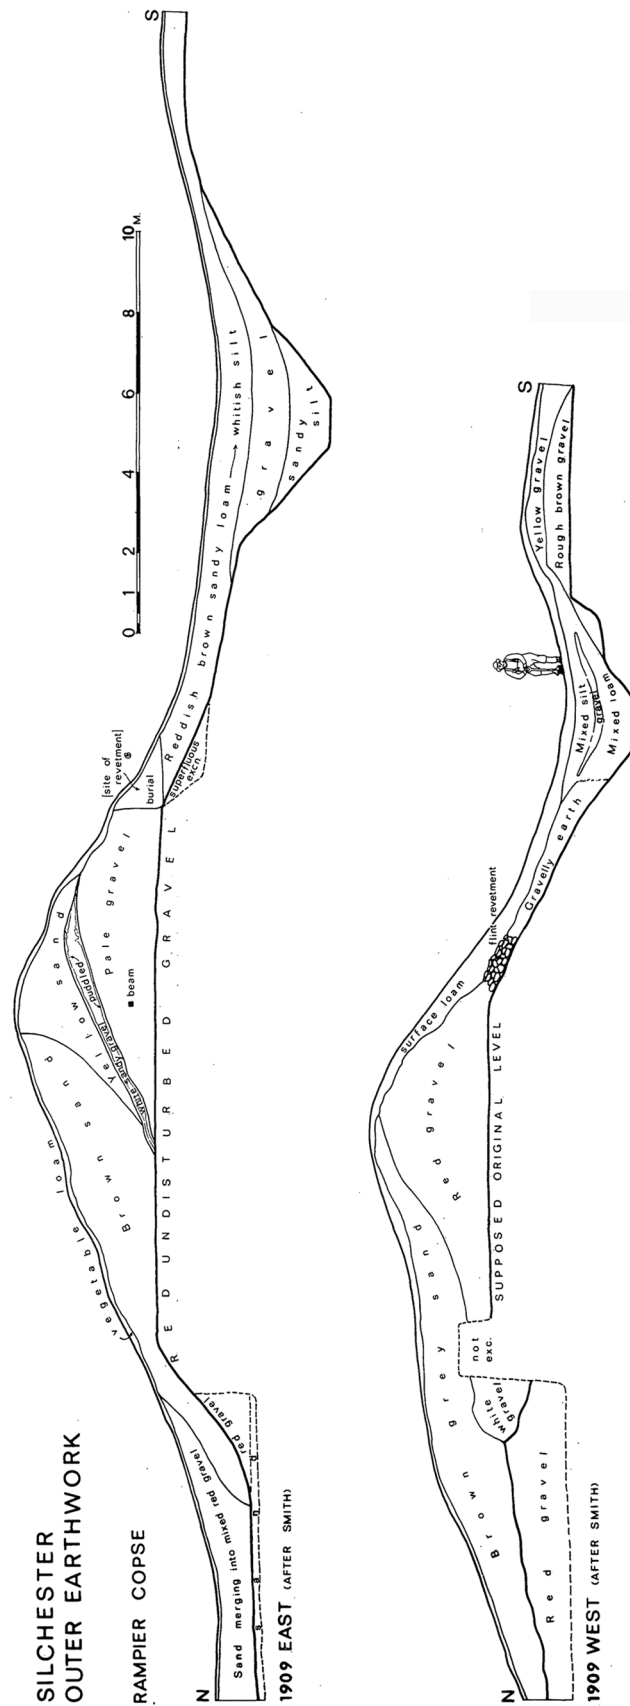
Figure 8. Society of Antiquaries 1909 sections across bank (3.2) and ditch (3.4). After Boon (1969, plate IX). Reproduced by kind permission of the Society of Antiquaries of London.

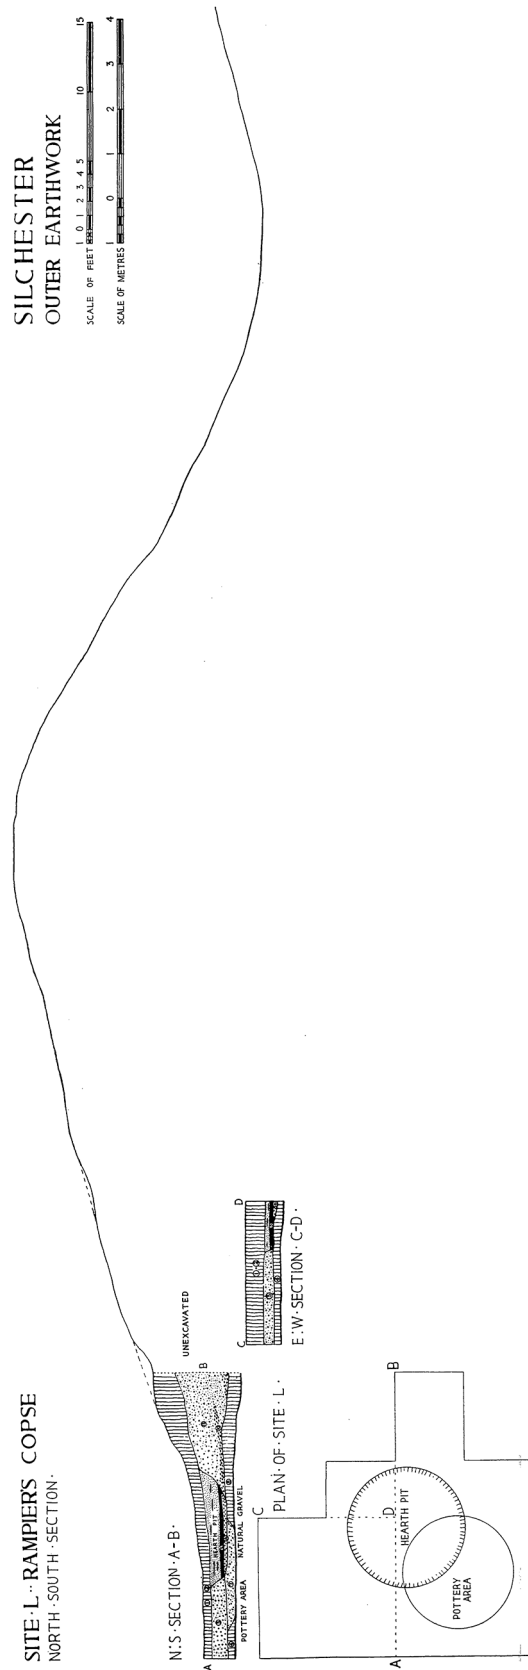
Figure 10. Cotton's 1939 section and profile across bank (3.2) and ditch (3.4). After Cotton (1947, plate XXXVIII). Reproduced by kind permission of the Society of Antiquaries of London.

Further excavation was carried out at Rampier Copse in 1939 by Cotton on behalf of the Ministry of Works. Cotton's excavations consisted of a series of small trenches focused on the curved portion of the main earthwork (Fig 10 and see Fig 12). Her largest trench, cut into the tail of the bank, produced Roman brick from what she saw as a primary context, leading her to interpret the Rampier Copse earthwork as early Roman in date (1947, 139-40; Fig 10). She concluded that "*The earthwork itself is built in a native tradition rather than a Roman, and it would therefore seem that it must have been erected by a collective of native peoples under the direct stimulus of Roman leadership*" (Cotton 1947, 140). A further trench excavated close to the gap between the eastern end of the curving main earthwork and the south-eastern projection revealed ditch deposits suggesting that the gap was not an original entrance (Cotton 1947, 140).

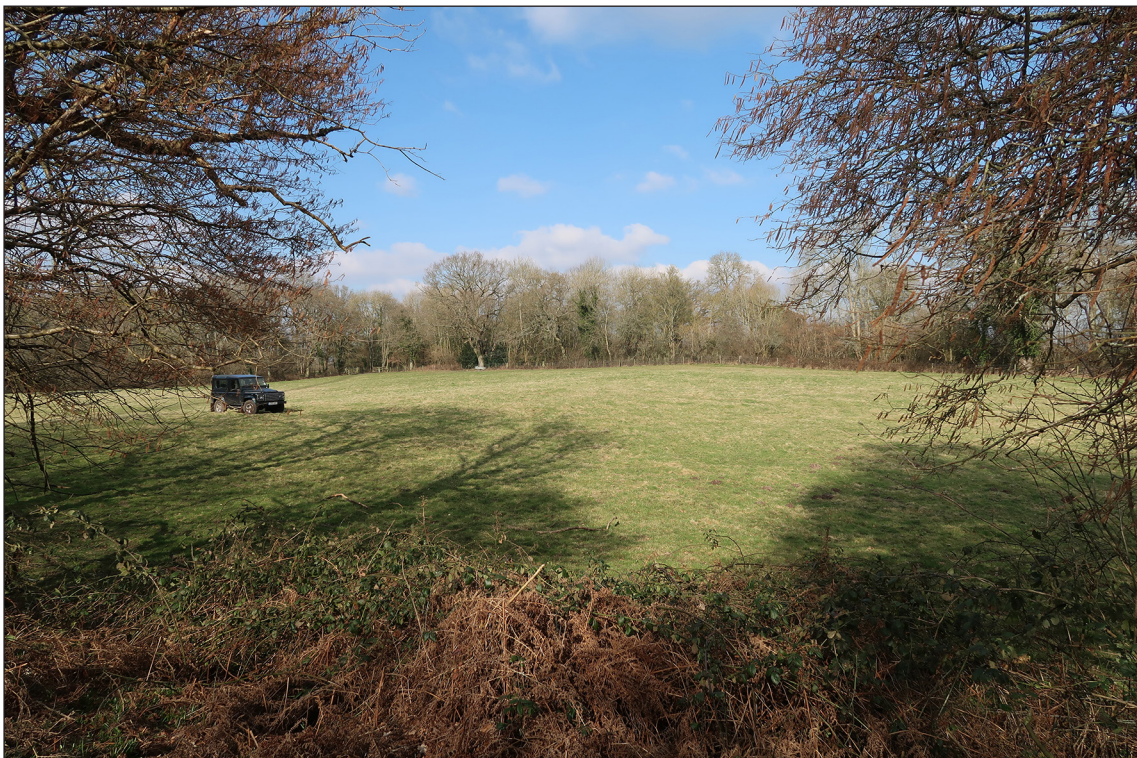
Figure 19. Plough-levelled remains of enclosure bank (1.2). Looking north towards the southern defences of Calleva under woodland (©Historic England).

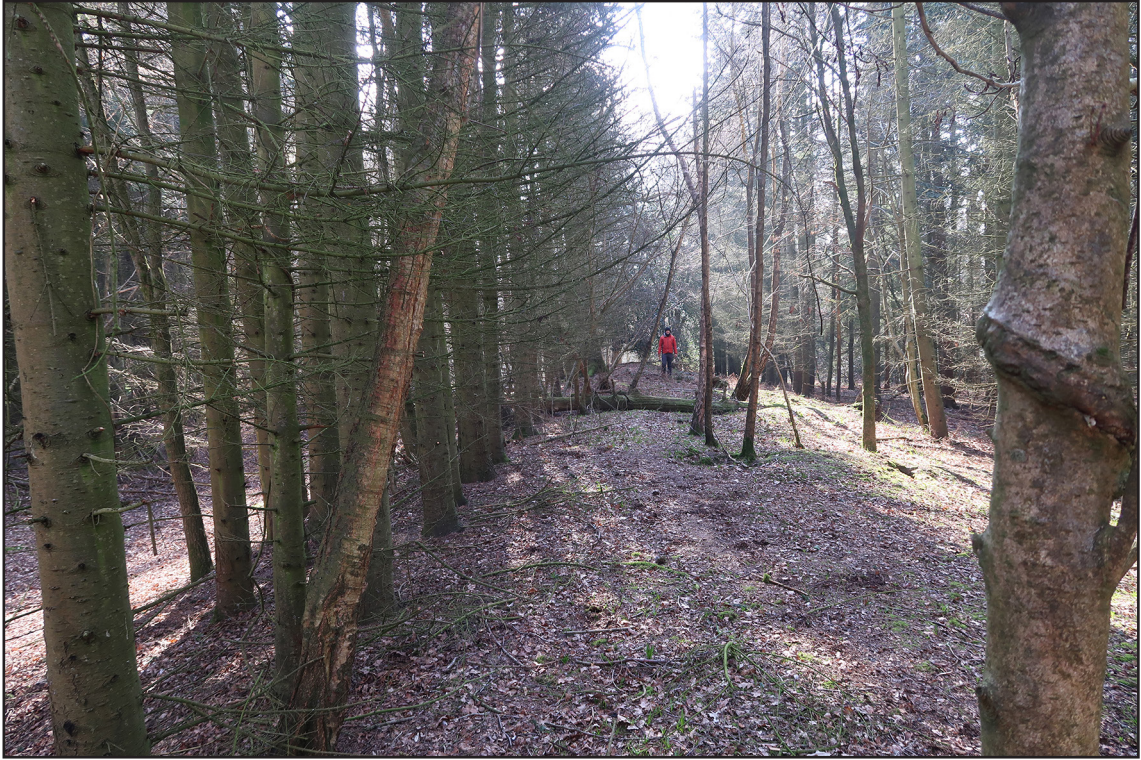
An approximately 80m length of the Dickers Farm Dyke linear earthwork was surveyed south of bank (3.2) and ditch (3.4). Here the Dyke (Figs 20 and 21) consists of bank (2.1) measuring 12.5m wide by 1m high with a ditch (2.2) measuring 7m wide by up to 1.3m deep on its eastern edge (see profile 3). The eastern edge of ditch (2.2) appears to have been steepened presumably when it formed the eastern edge of area 4. Ditch (2.2) appears to wrap around the northern terminus of bank (2.1) but at 0.6m deep is noticeably shallower in this area.

Figure 20. Looking south along the Dicker's Farm linear earthwork bank (2.1) (©Historic England).

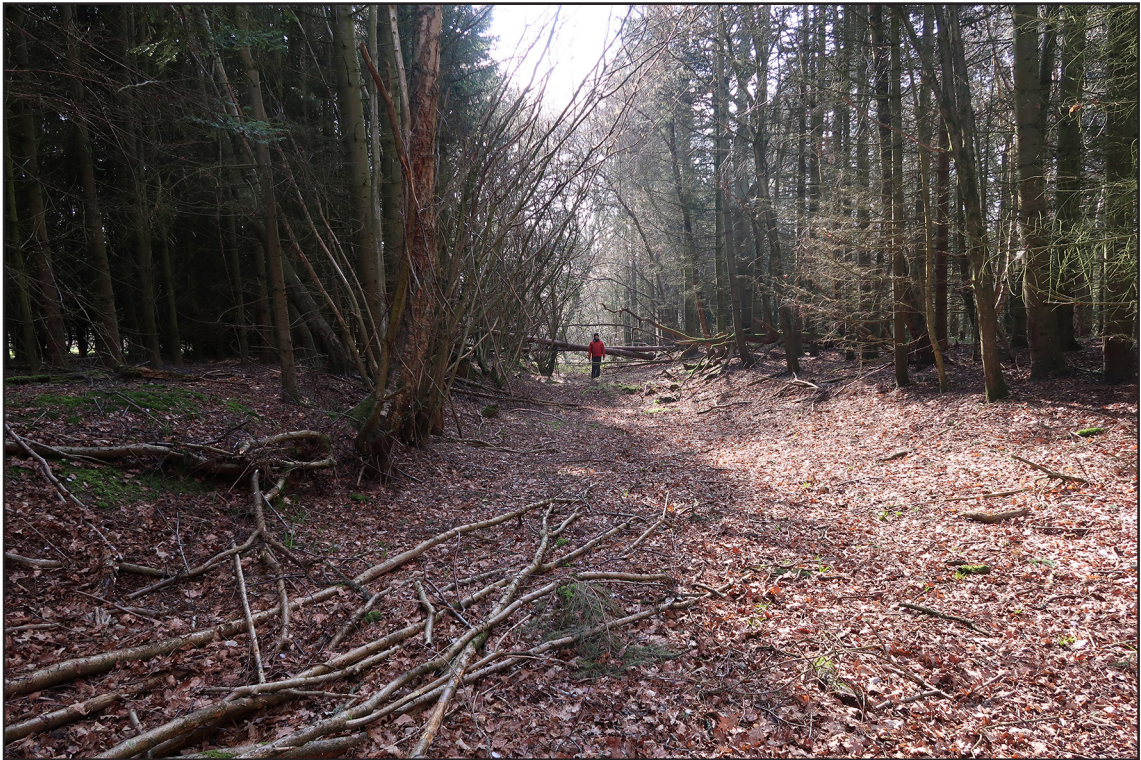
Figure 21. Looking south along the Dicker's Farm linear earthwork ditch (2.2) (©Historic England).

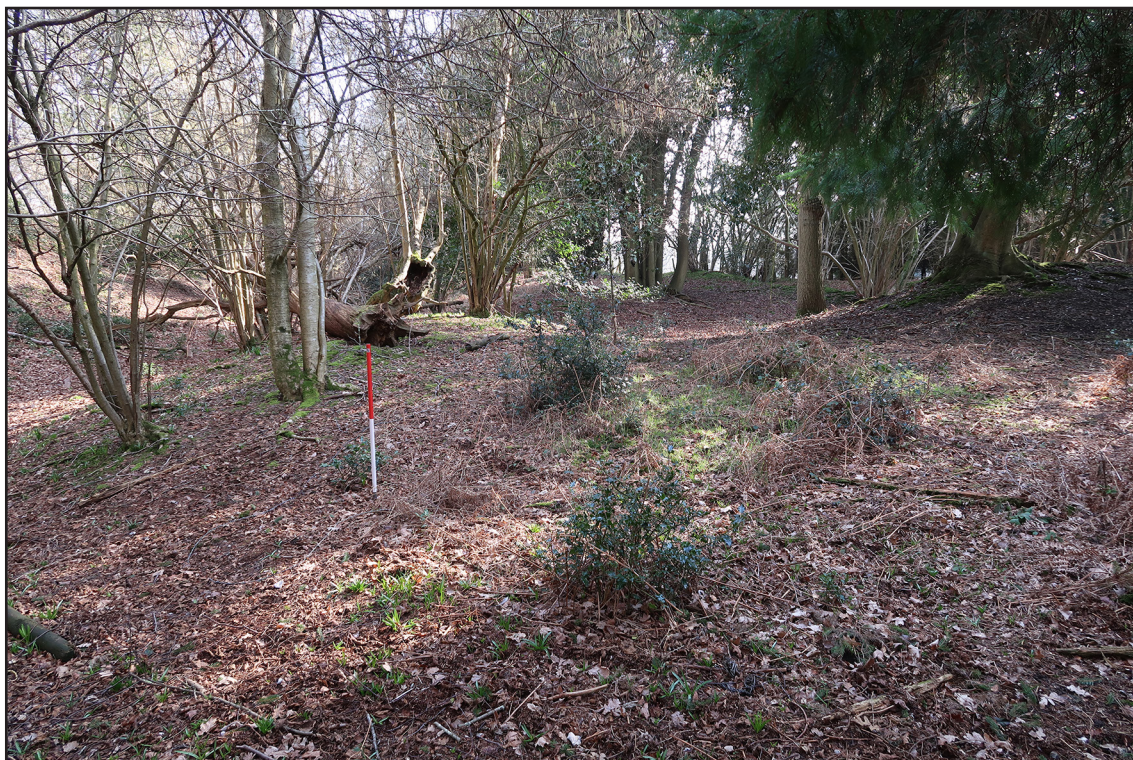
Figure 22. Looking east towards the northern end of the Dicker's Farm linear earthwork (2.1) to the right and bank (3.7) to the left, scale 1m (©Historic England).

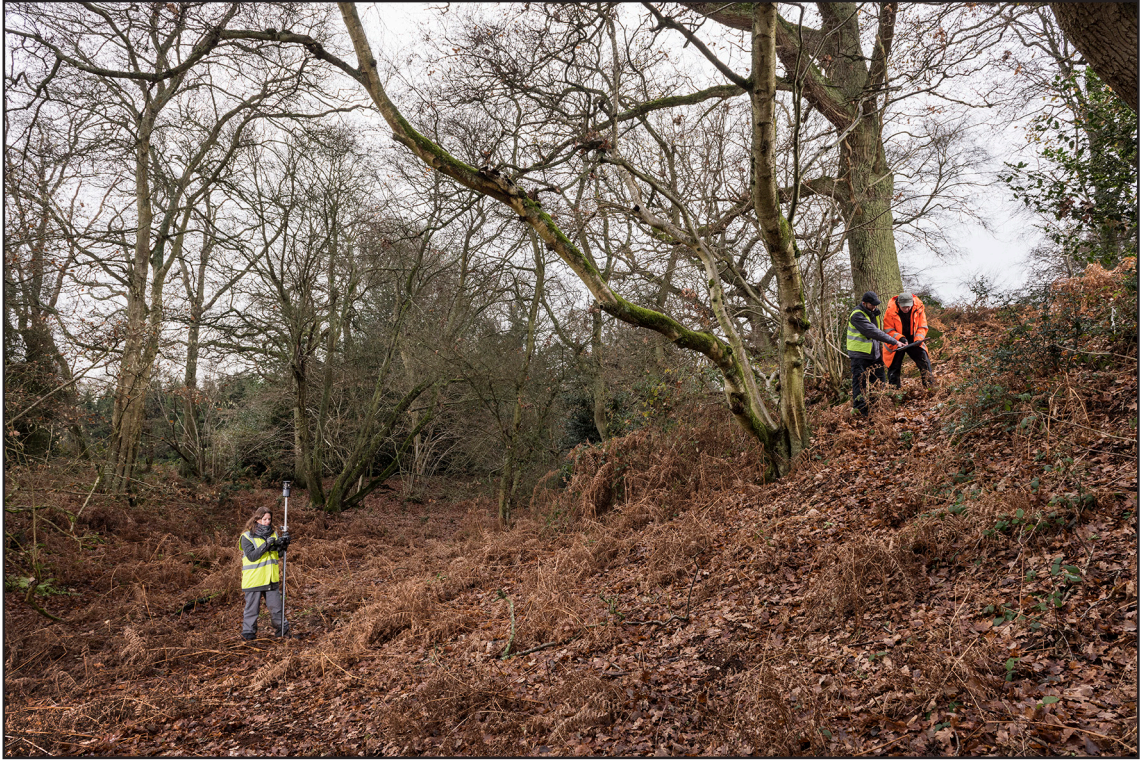
Figure 23. Looking north-west from ditch (3.4) towards enhanced bank (3.2), (DP218211 © Historic England, photograph Steve Baker).

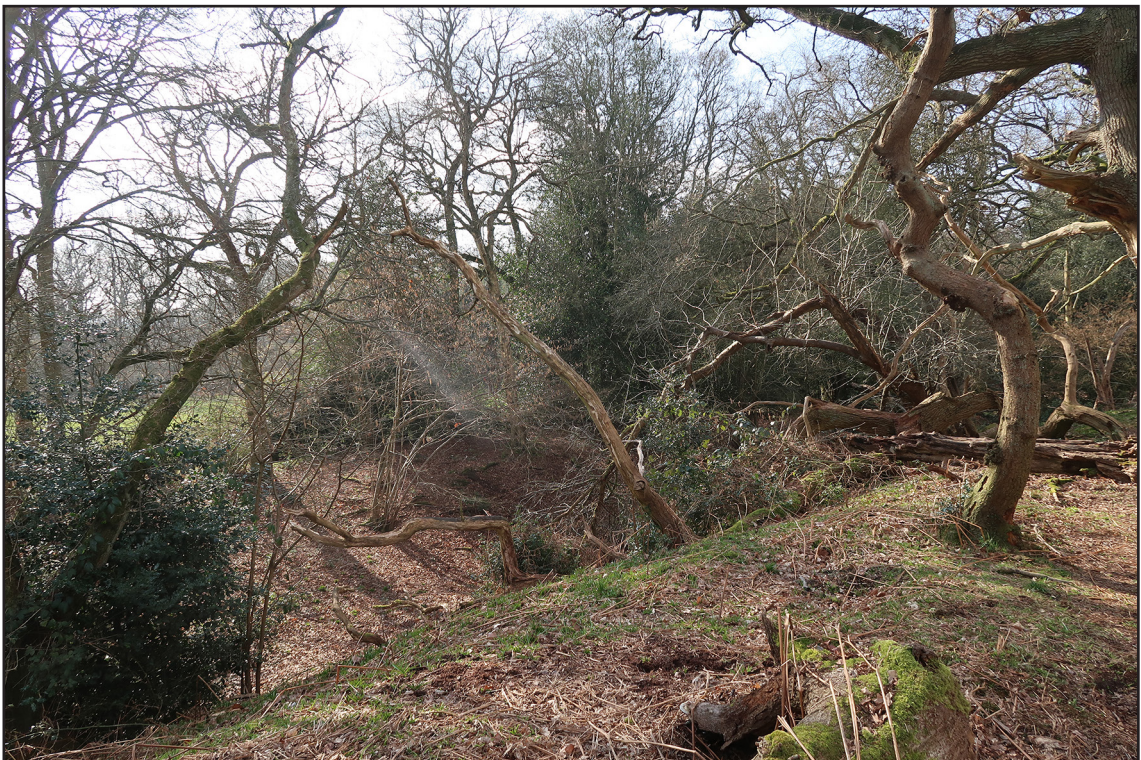
Figure 24. Looking south-west from the top of enhanced bank (3.2) across ditch (3.4) (©Historic England).

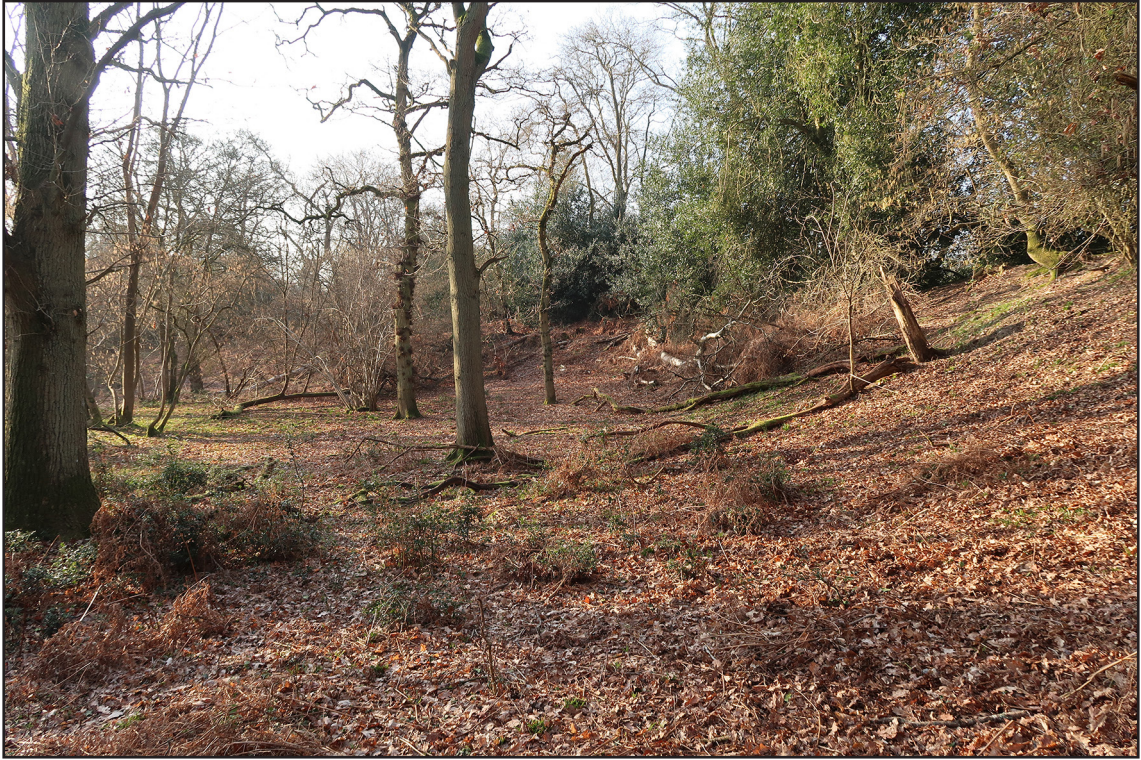
Figure 25. Looking east towards the curving inner edge of enhanced bank (3.2) (©Historic England).

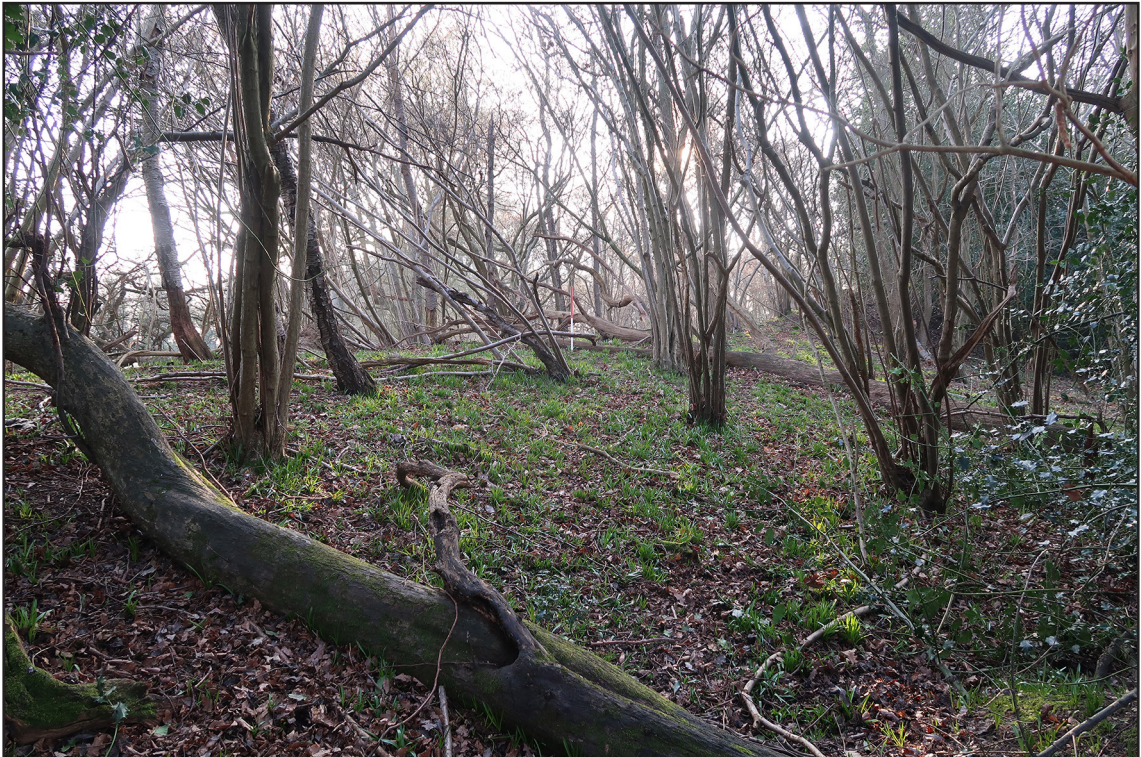
At some point after its construction, enclosure (1.1/1.2) is massively altered. Its southern and western elements (1.1) are incorporated into a much bigger, north-west to south-east running curvilinear earthwork (3.2). Enhanced bank (3.2) (Figs 23, 24 and 25) measures between 20 and 25m wide at its base, between 3 and 5m wide at its top, and between 3.5 and 5m in height (see profiles 5-10). There are several pronounced undulations in the top of bank (3.2); these probably reflect a combination of former excavation trenches (see below), and damage caused by badgers and fallen trees. Bank (3.2) has abrupt termini at its north-western (Fig 26) and south-eastern ends.

Figure 26. Looking south-east along bank (3.1) with north-eastern end of enhanced bank (3.2) in the background, scale 1m (©Historic England).

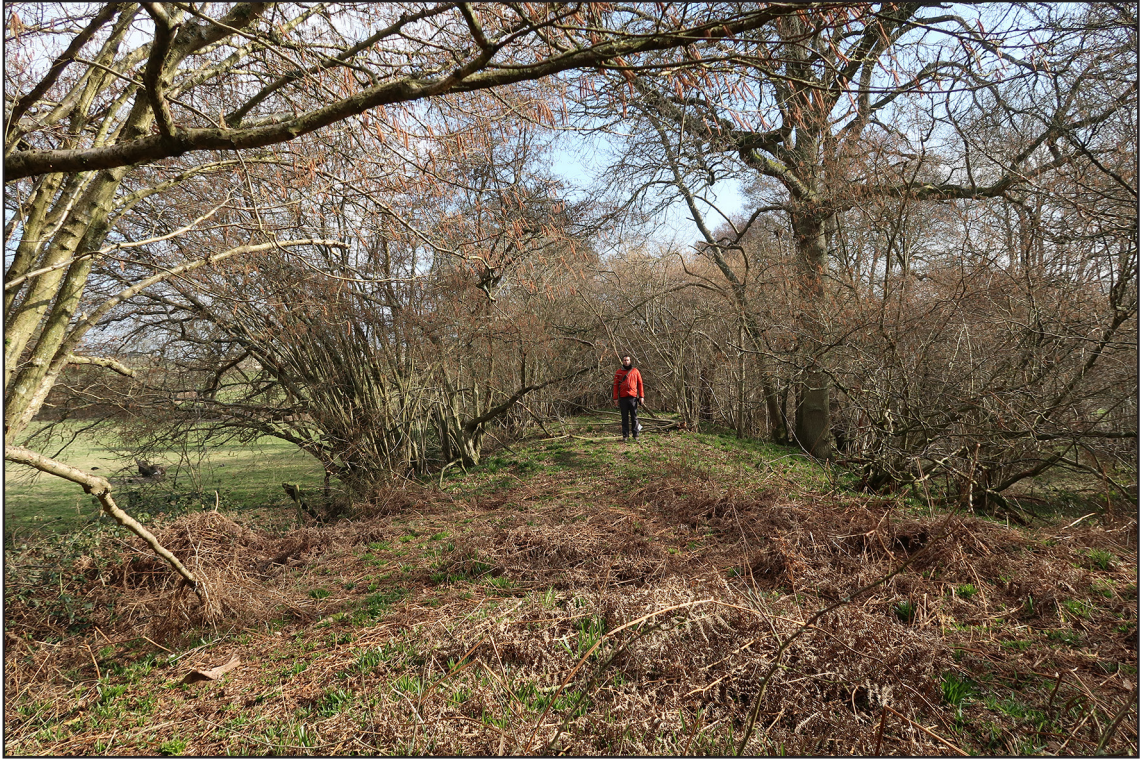
Figure 27. Looking east along bank (3.3) (©Historic England).

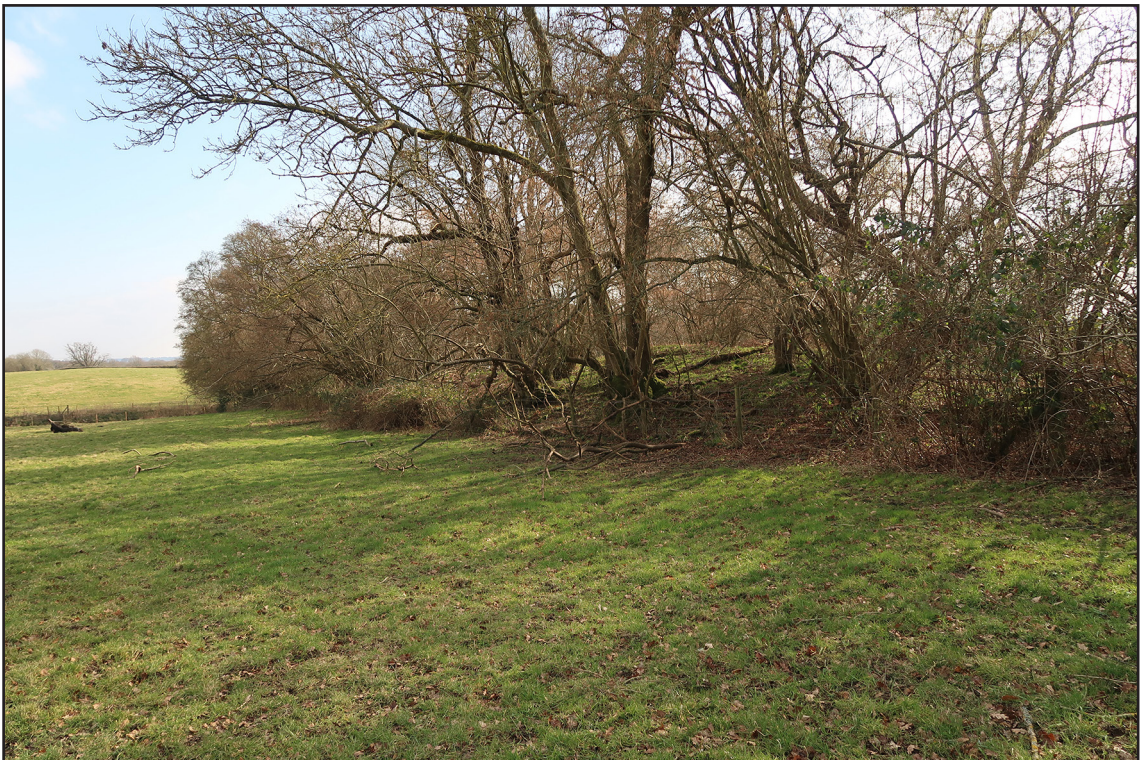
Figure 28. Looking south-east towards bank (3.3) under woodland (©Historic England).

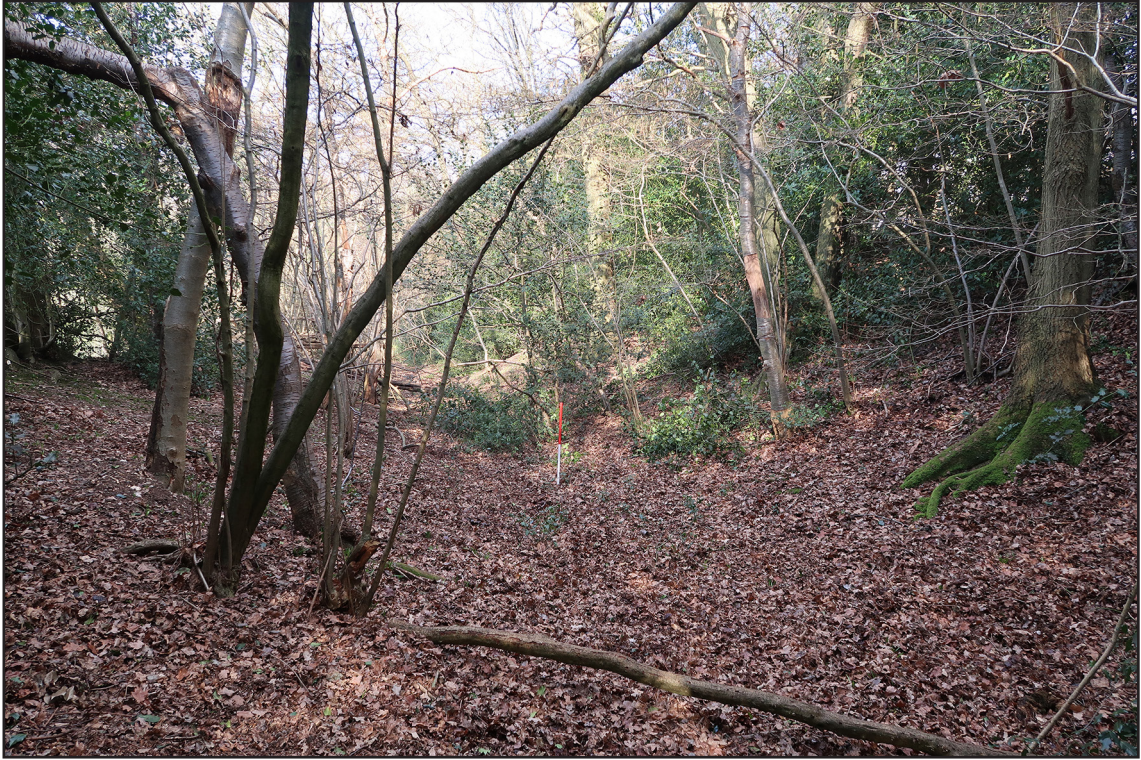
Figure 29. Looking north-west along ditch (3.4), scale 1m (©Historic England).

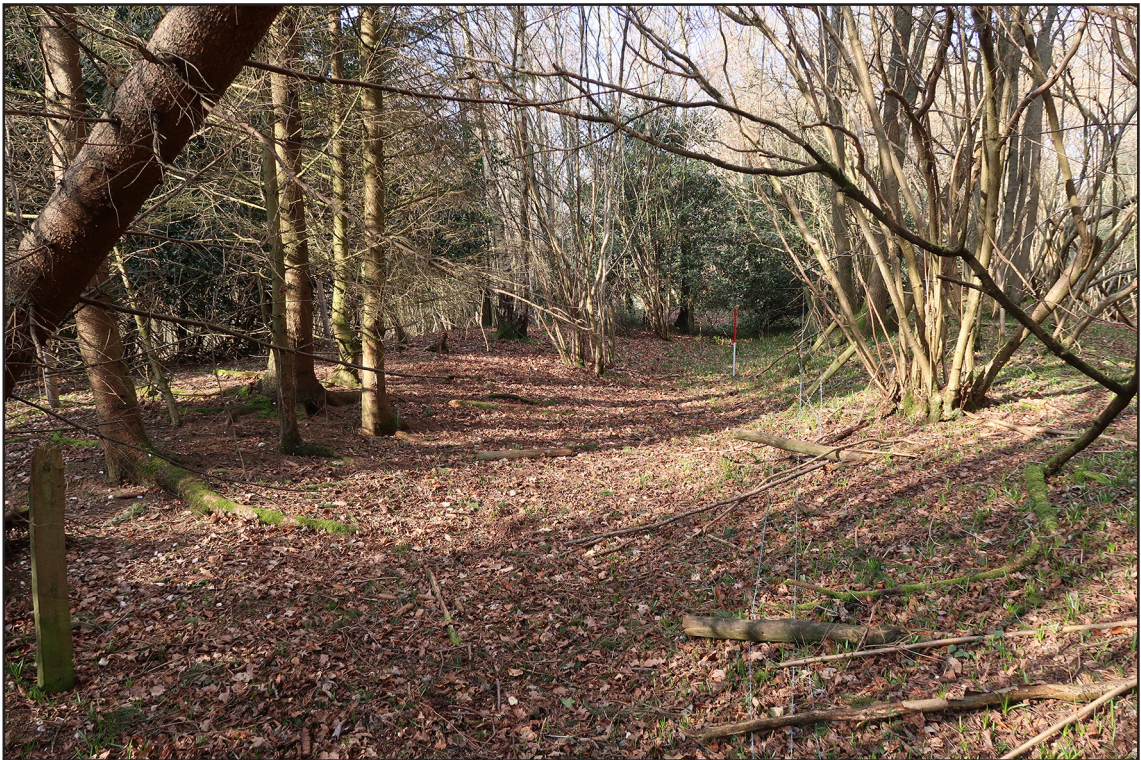
Figure 30. Looking north-west along counter scarps (3.9) to the left and (3.8) to the right, scale 1m (©Historic England).

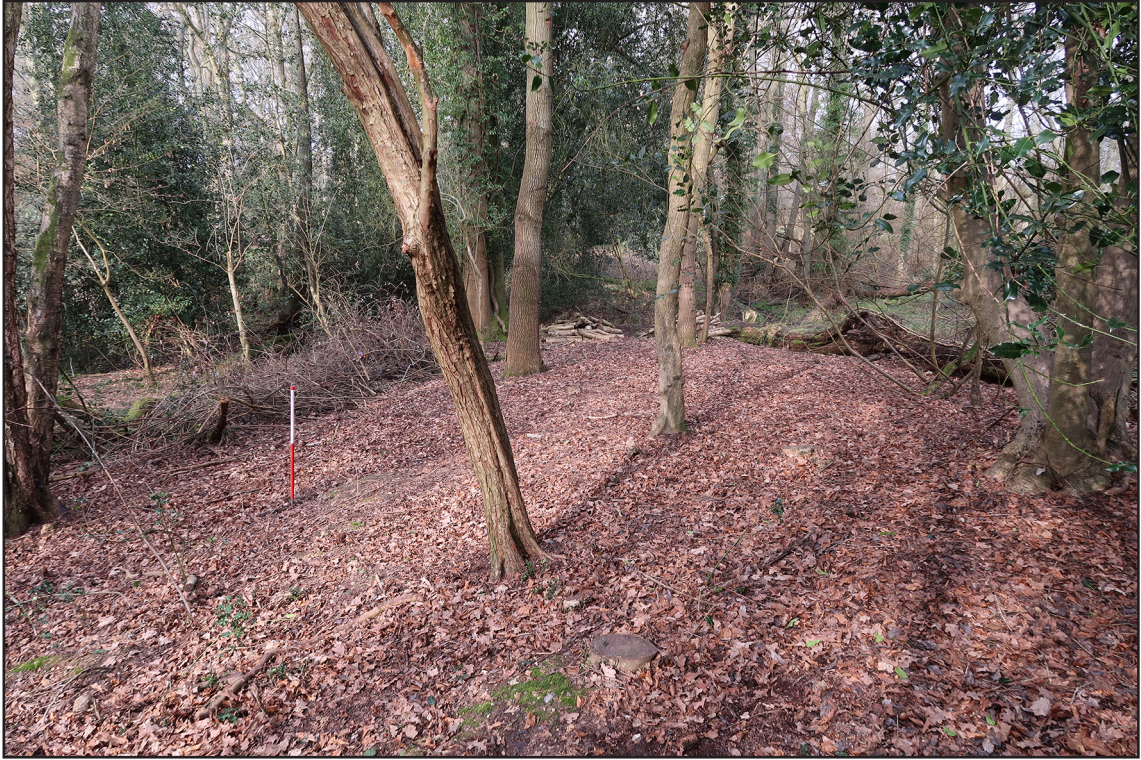
The line of bank (3.1) continues to the north-west into area 2 after a gap of approximately 40m. Here bank (3.11) measuring 9.5m wide by 0.6m high (see profile 12) continues downslope to the western stream (Fig 31). This line is continued on the western side of the stream as bank (3.12) which measures 11m wide by 0.25m high (Fig 32 and see profile 13). The southern end of bank (3.12) has been covered by garden waste. Neither banks (3.11) or (3.12) display any trace of a ditch on their western edge.

Figure 31. Looking north-west along bank (3.11) downslope towards the western stream, scale 1m (©Historic England).

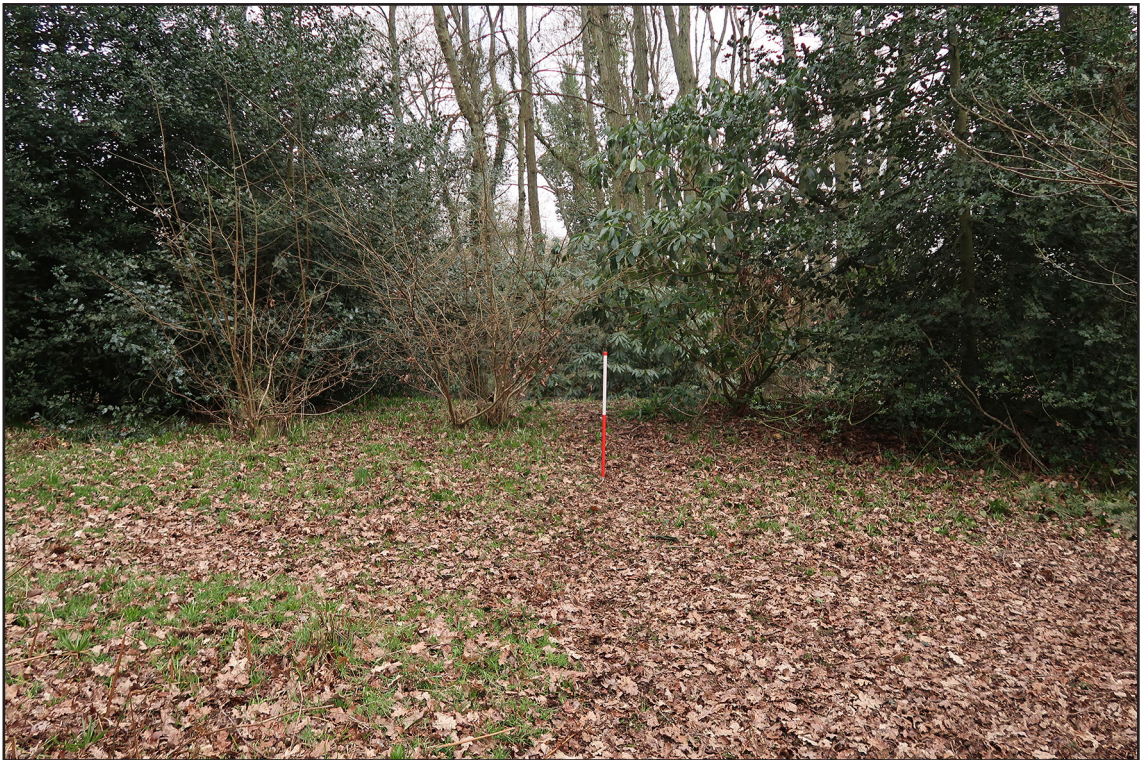
Figure 32. Looking north-east across bank (3.12), scale 1m (©Historic England).

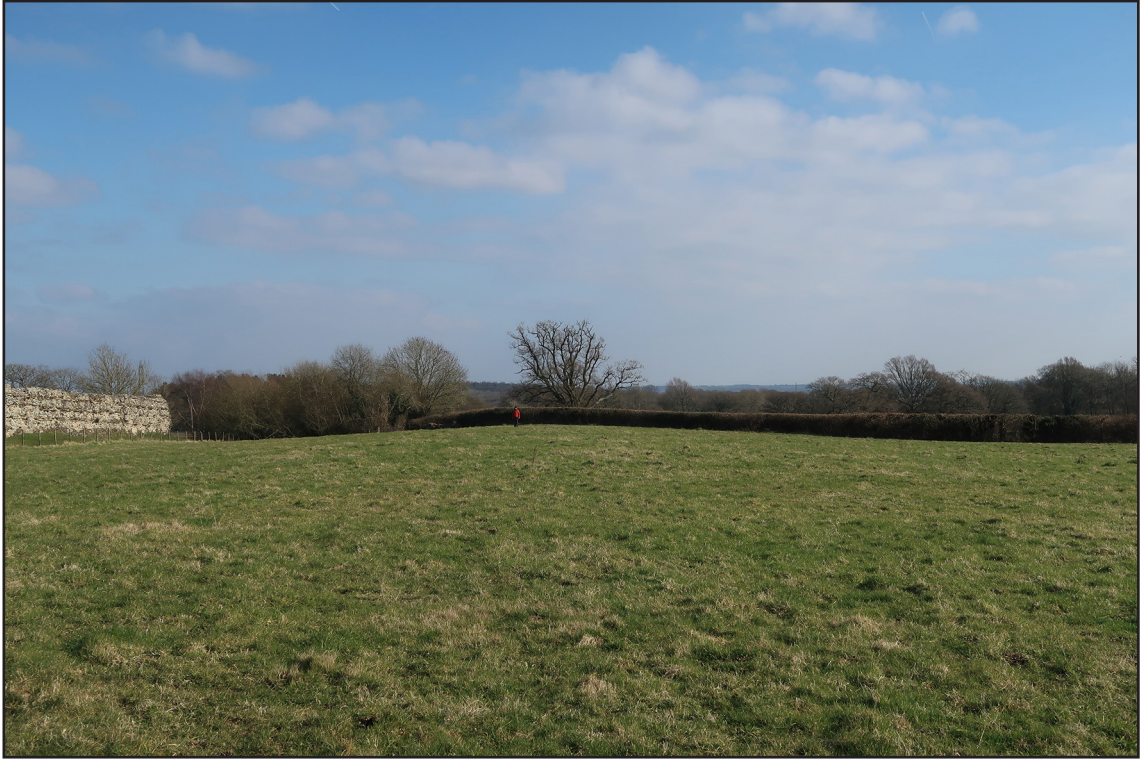
Figure 33. Looking east along inner earthwork (4.1) towards Church Lane. Calleva southern defences to the left (©Historic England).

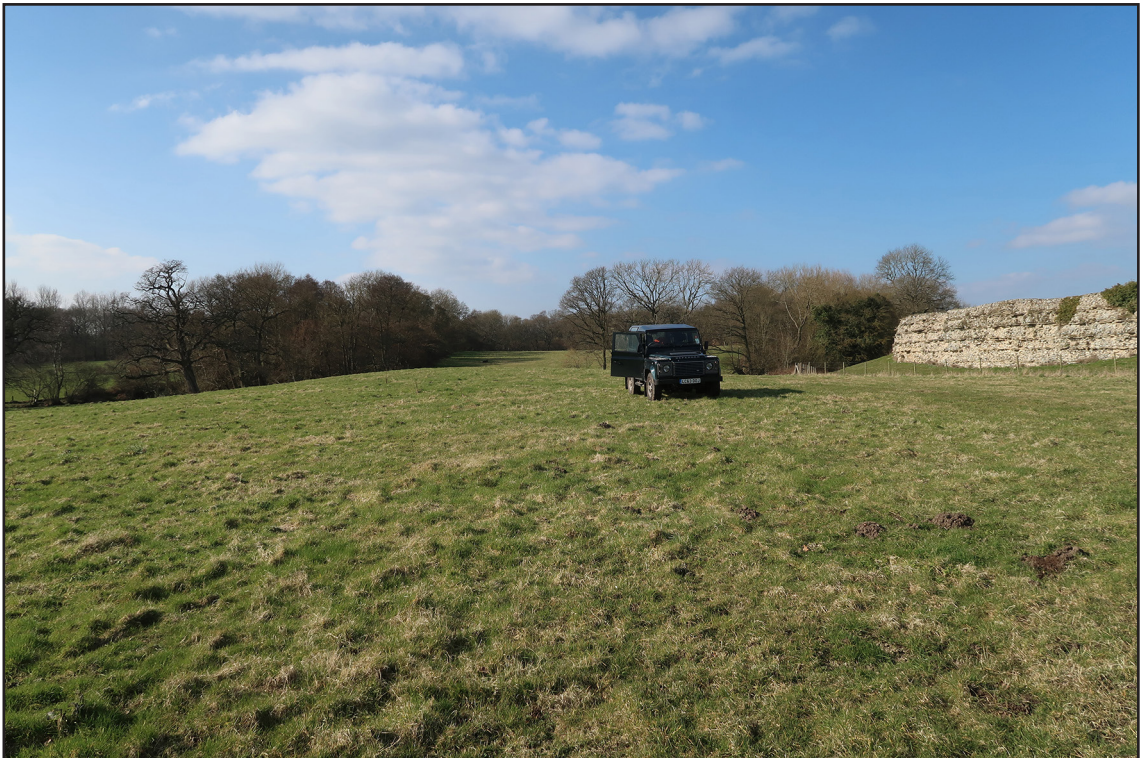
Figure 34. Looking west along inner earthwork (4.1) towards the eastern stream and Rampier Copse. Calleva southern defences to the right (©Historic England).

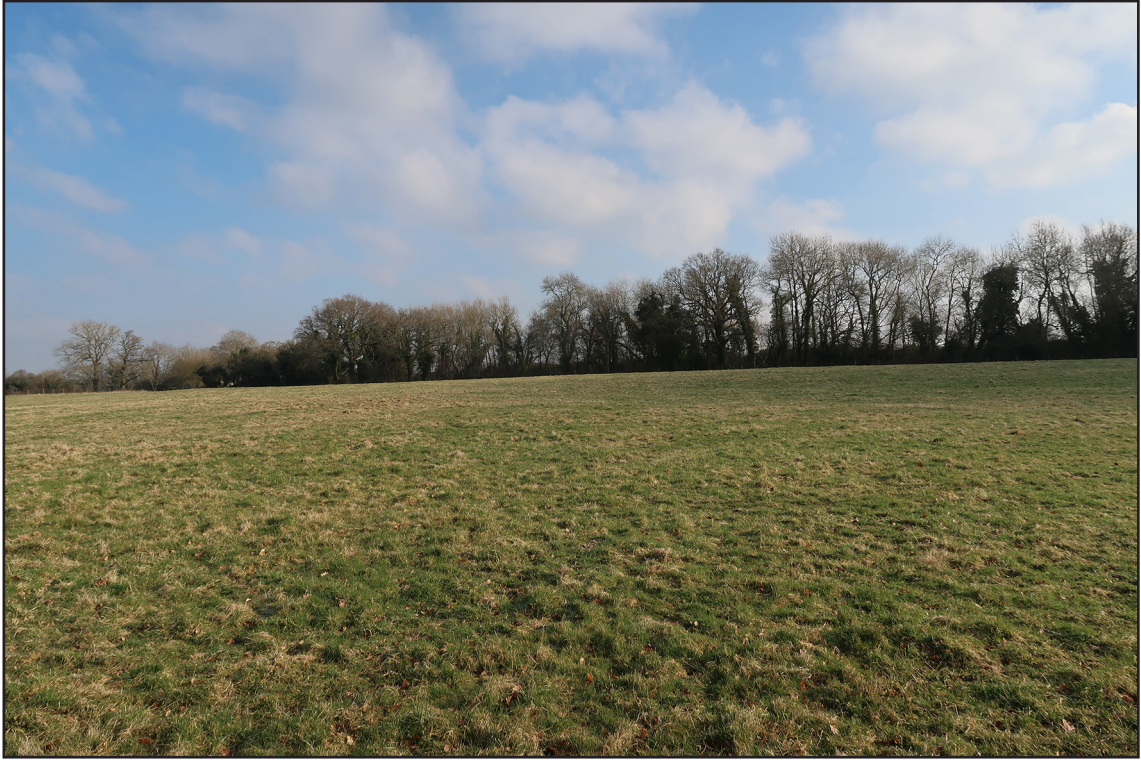
Figure 35. Looking east across the inner earthwork (4.4) towards Calleva western defences under woodland (©Historic England).

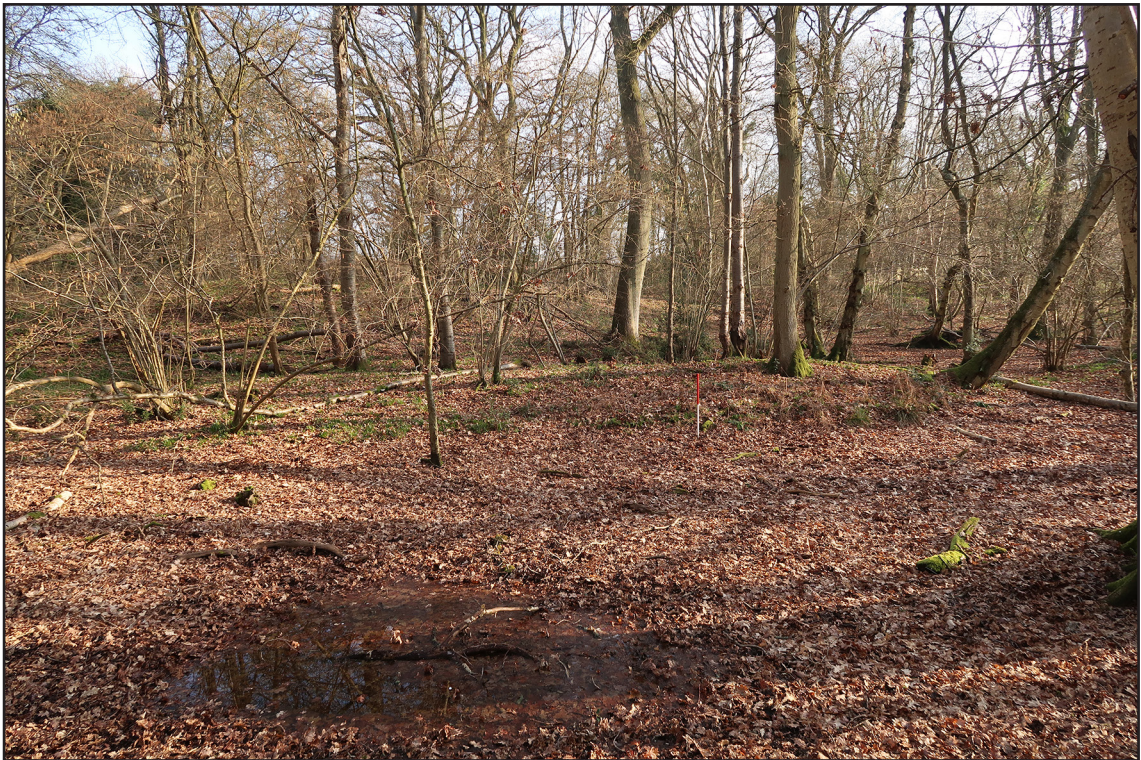
All traces of natural topography have been removed by a series of gravel quarries (6.1) in much of the northern part of area 1 (Fig 36). The quarries are deepest (up to 2m) towards the northern edge of area 1, and are shallower (0.5m) closer to the back of the main rampart (3.2). The quarries show a degree of internal structure being arranged in a series of irregular bays, separated in some instances by low banks. The central and southern parts of the quarries are wet, and a series of shallow ditches (6.2), typically 1.5m wide by up to 0.2m deep, have been dug in an attempt to drain this area.

Figure 36. Looking north across quarrying (6.1), scale 1m (©Historic England).

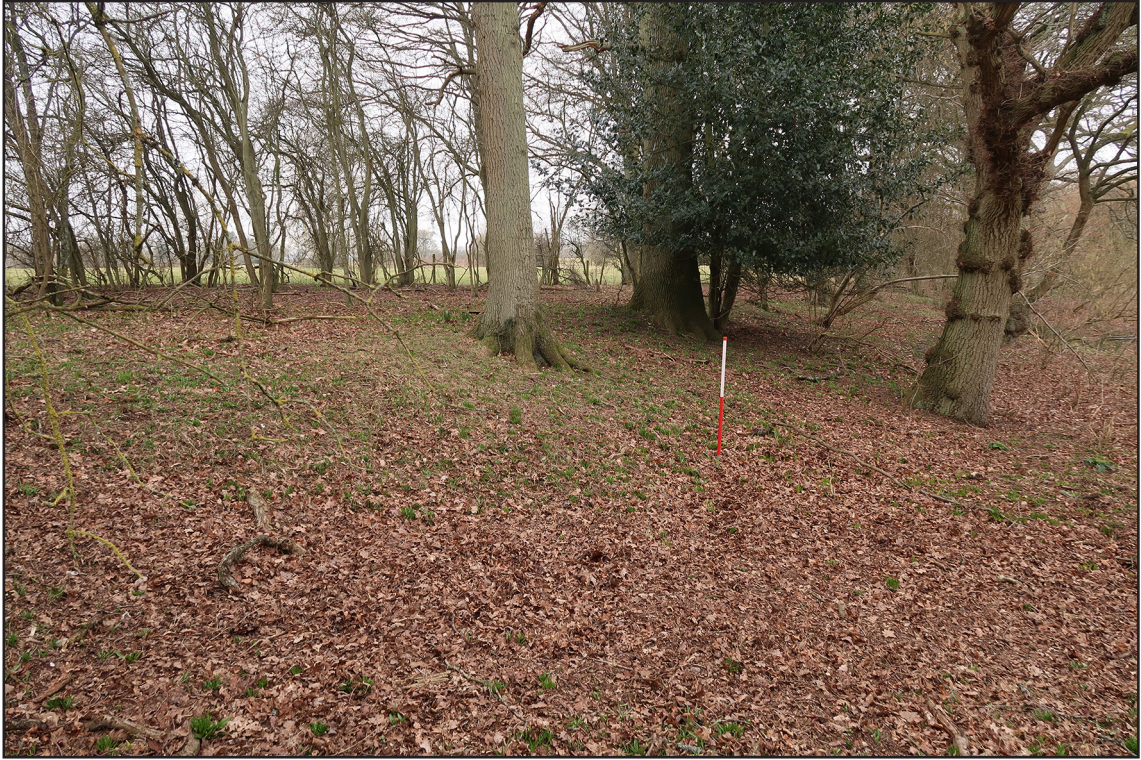
Figure 37. Looking north-west along scarp (7.11), scale 1m (©Historic England).

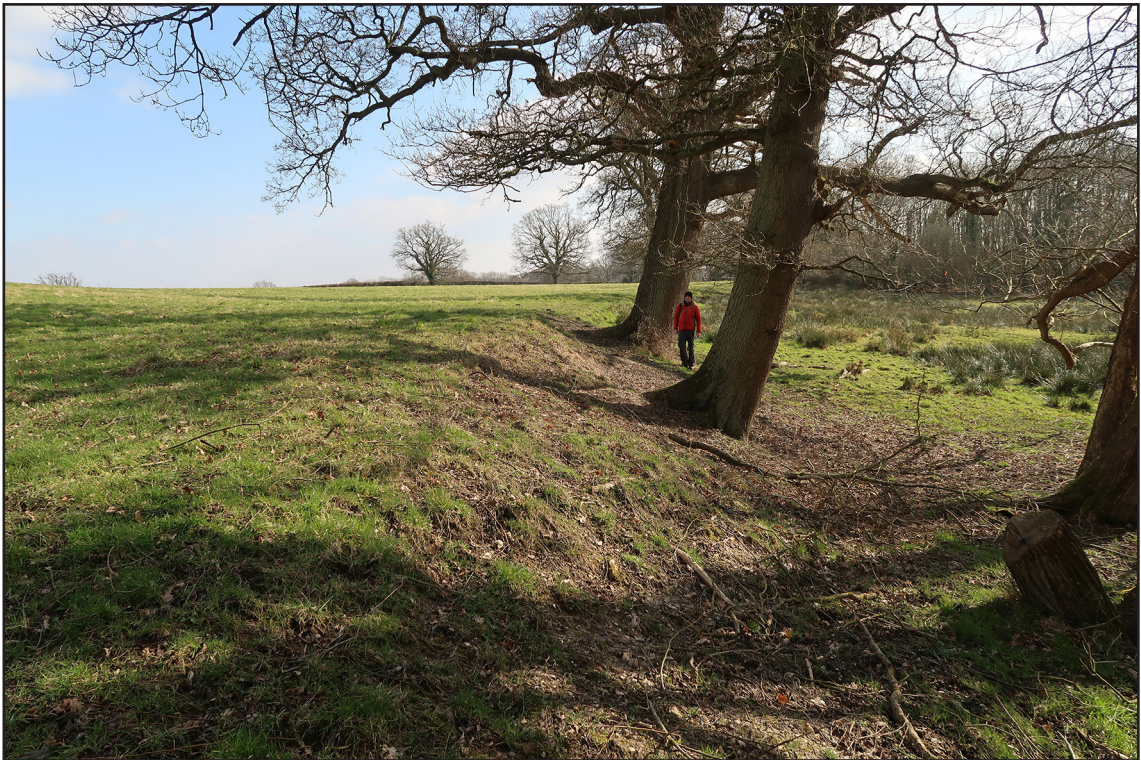
Figure 38. Looking south-east along scarp (7.12).
