Rampier Copse, Silchester, Hampshire: Analytical Earthwork Survey

Rampier Copse, Silchester, Hampshire: analytical earthwork survey

NGR: SU 635 620

A Level 3 analytical earthwork survey at Rampier Copse, Silchester, Hampshire was undertaken by Historic England as part of the Silchester Environs Project in late 2017 and early 2018. The survey covered an area of approximately 14ha immediately outside the south-west corner of the Roman town of Calleva Atrebatum. The earliest recorded feature was a sub-circular enclosure, or small hillfort, of presumed mid to late Iron Age date, abutted by a linear earthwork of presumed late Iron Age date. Elements of the enclosure are massively enhanced and are incorporated into the outer earthwork surrounding the late Iron Age oppidum. Part of the oppidum's inner earthwork, Roman roads, and quarrying, woodland banks and boundaries of presumed post-medieval date were also recorded.

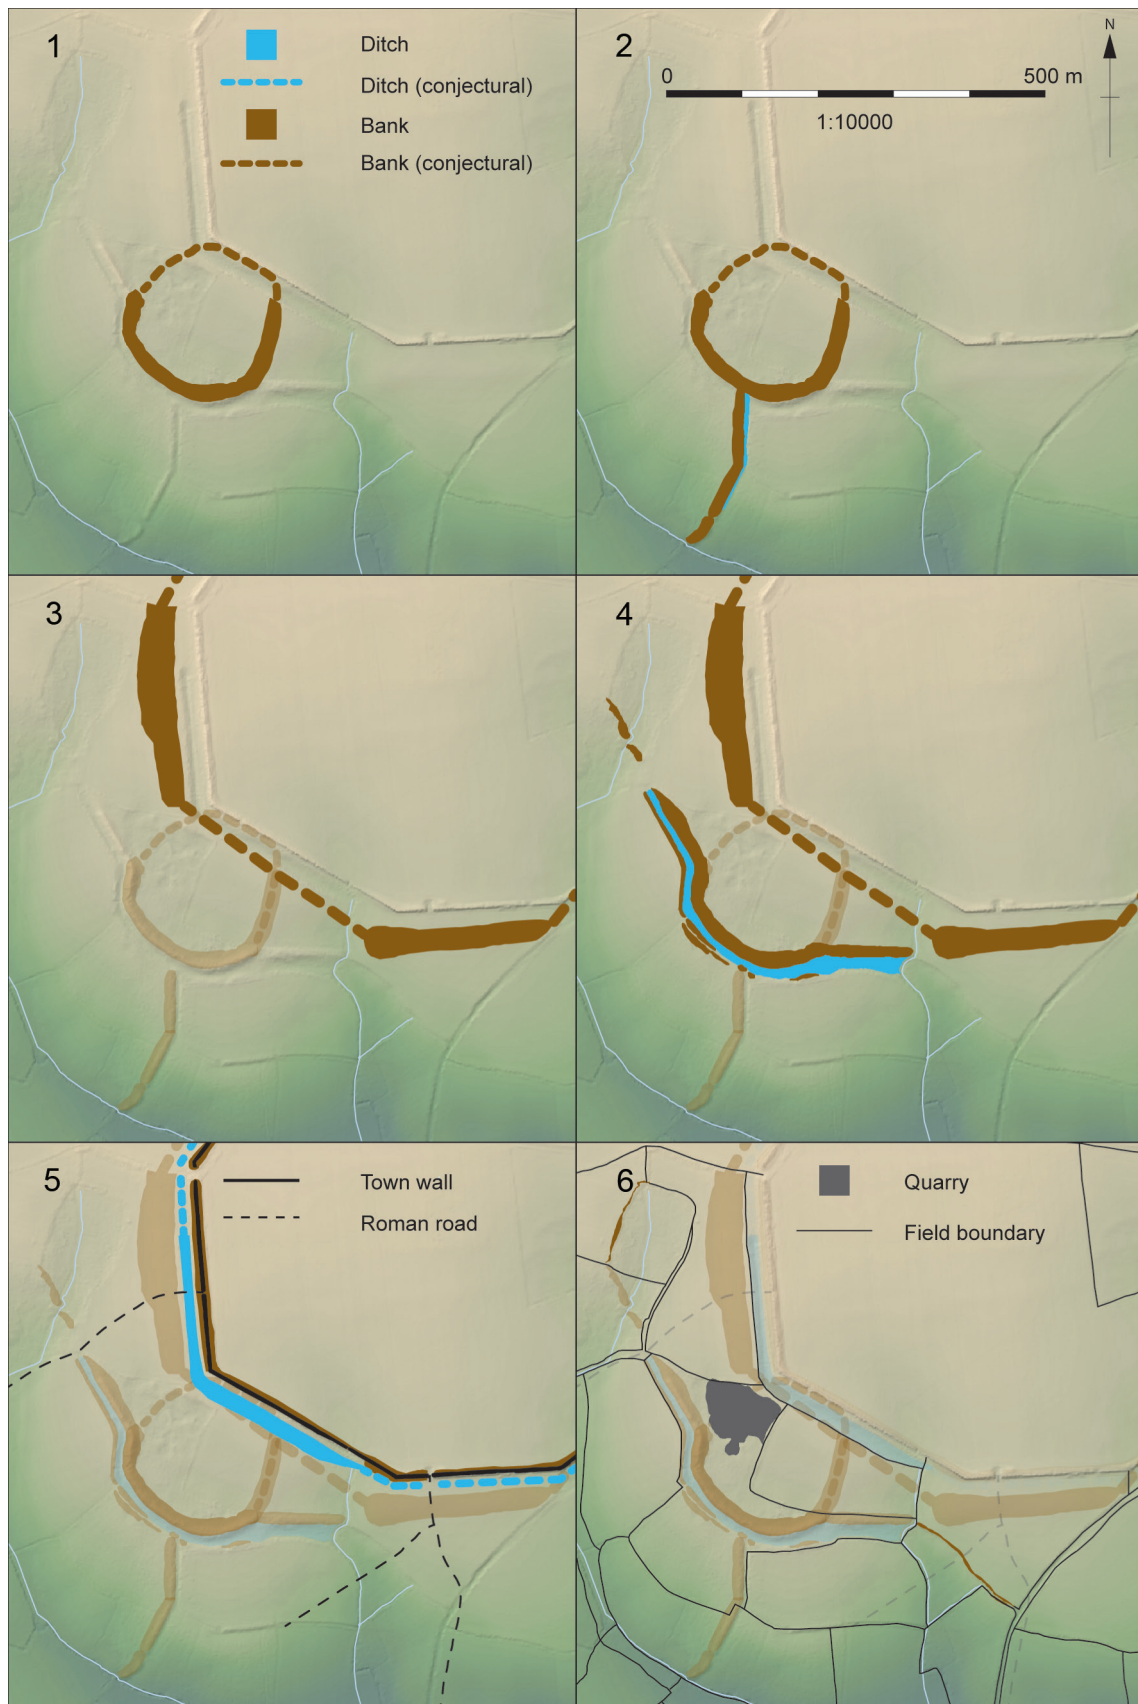
Figure 39. Development of the Rampier Copse earthwork complex. Topography derived from 1m lidar © Environment Agency copyright/database right 2019. All rights reserved. Water courses derived from OS data © Crown Copyright and database right 2019. All rights reserved. Ordnance Survey Licence number 100024900. Roman roads based on Creighton and Fry (2016b, supplementary data, 26_Grad_ Interpretation_Roads).

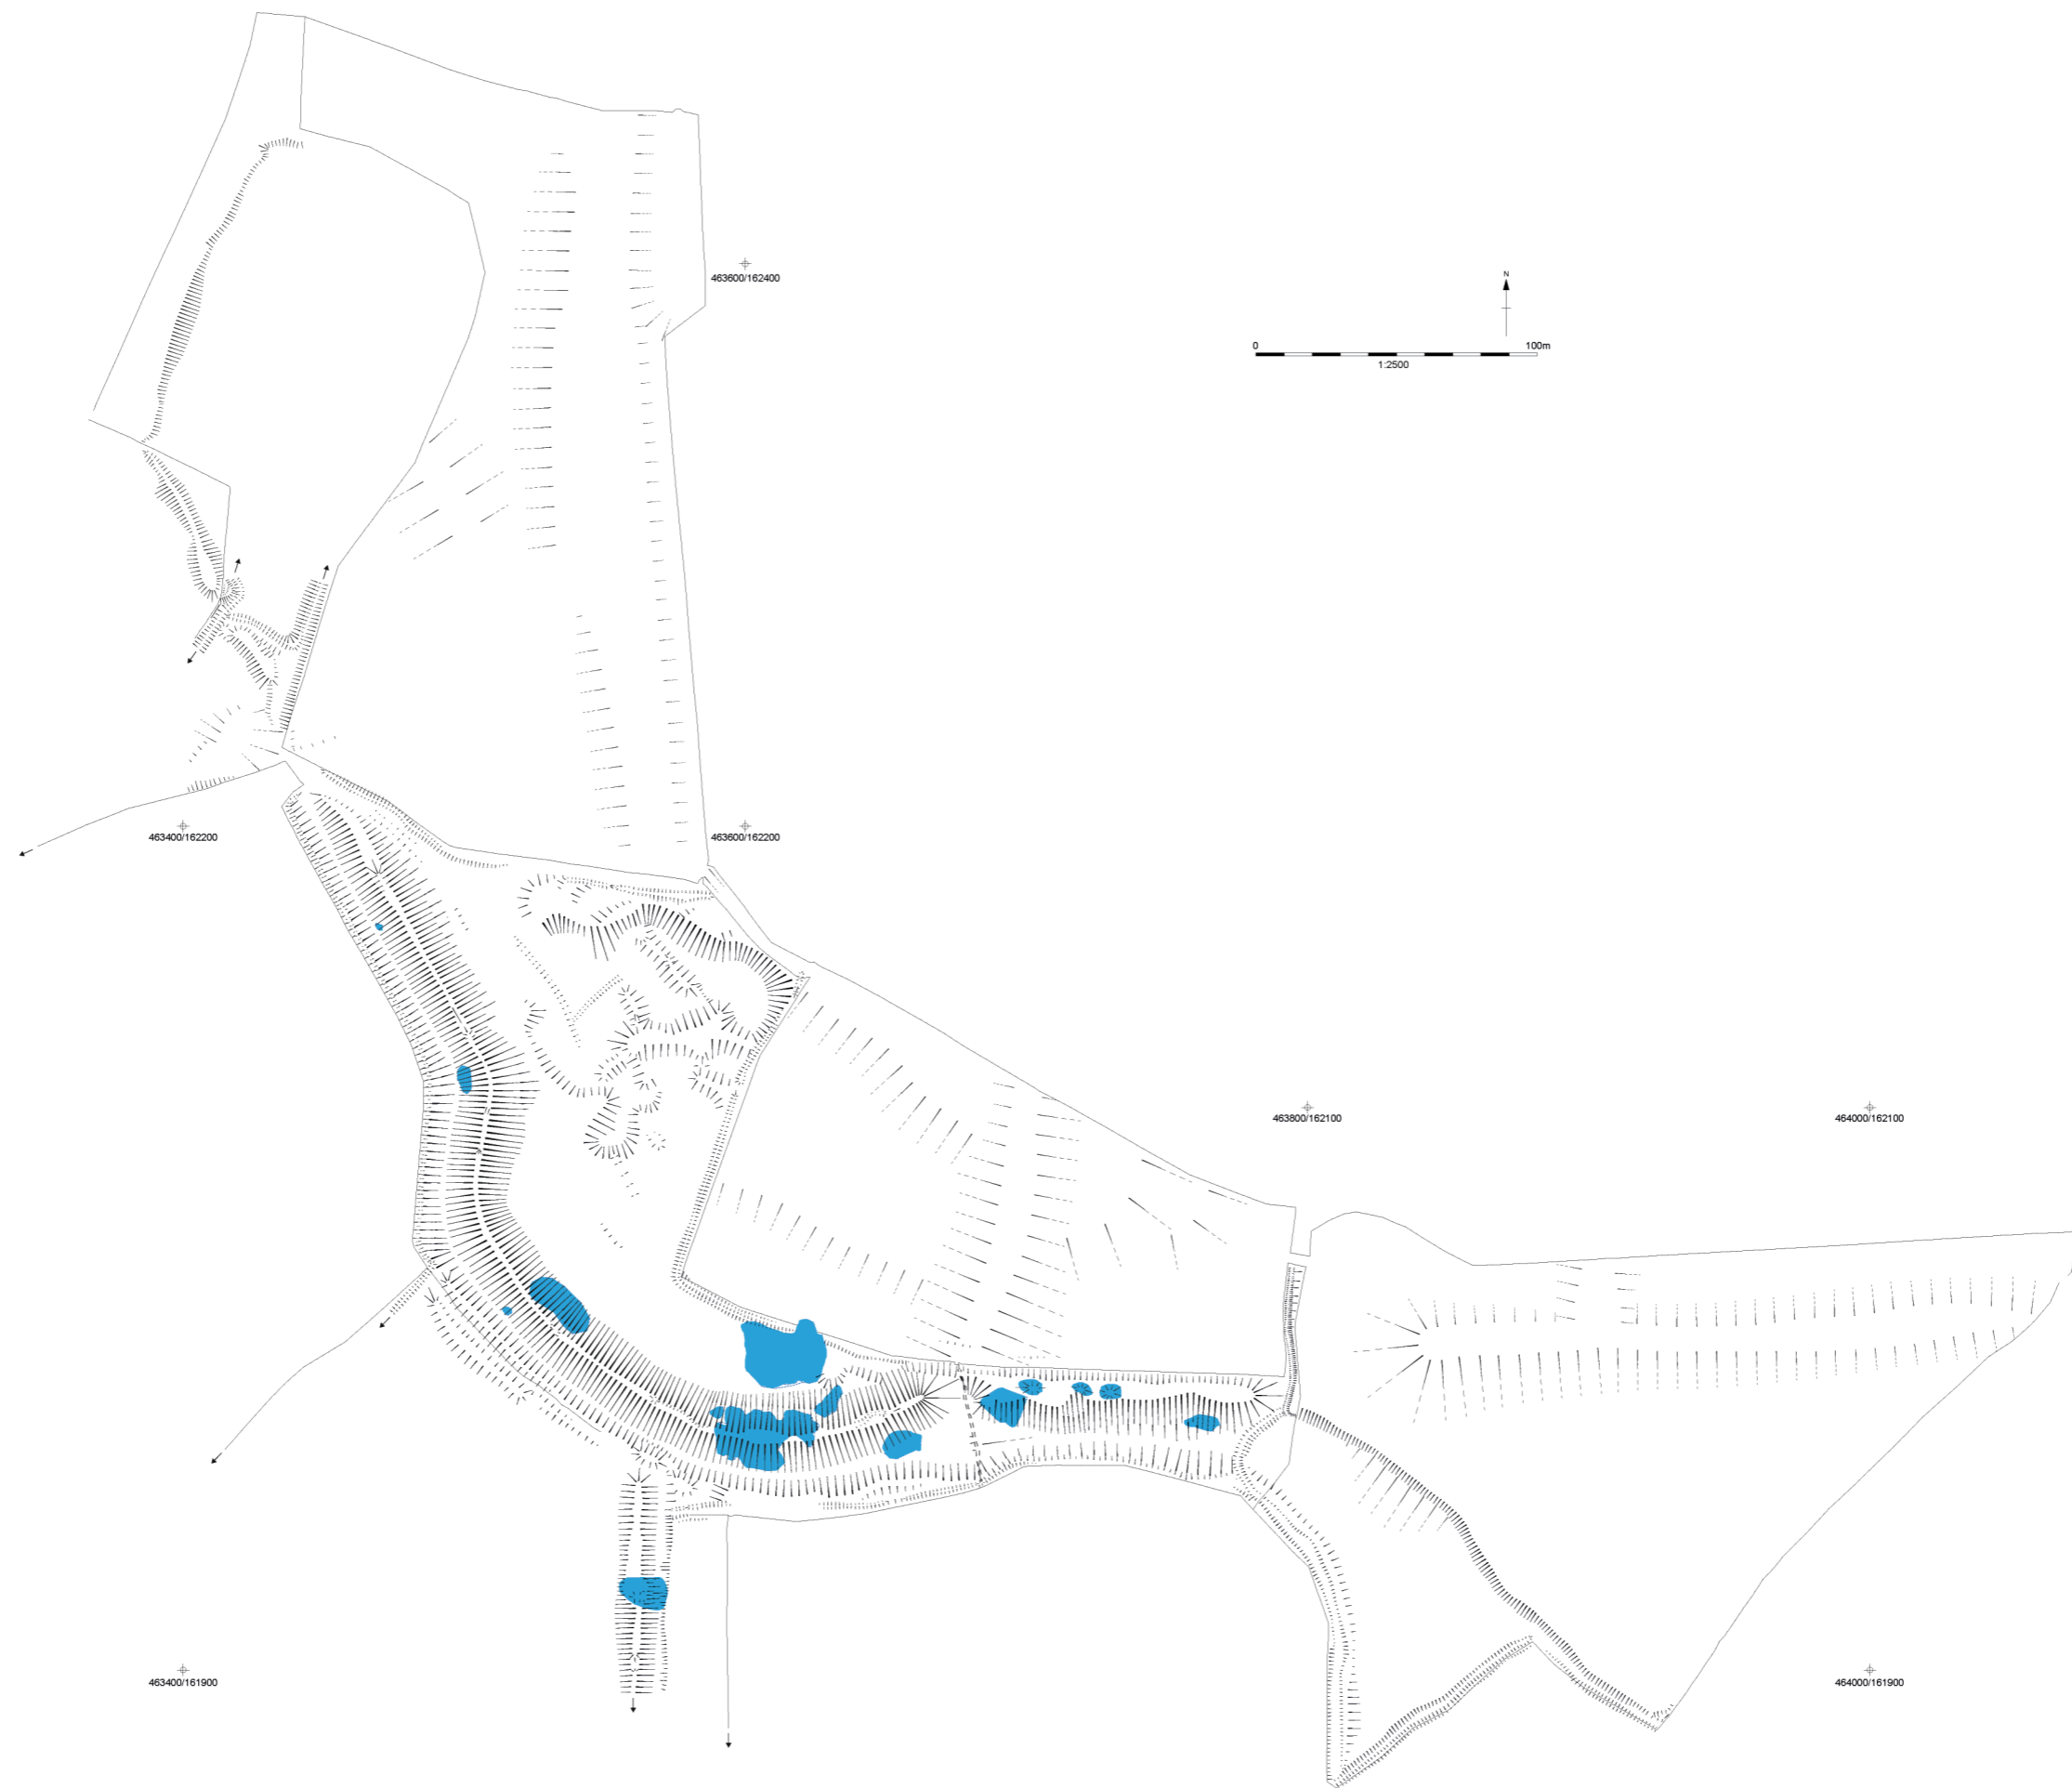
The problem of damage caused by burrowing animals does not appear to be solely a recent one. Both Karslake (1910, 330), and St John Hope and Stephenson (1910, 326) mention the disturbance at the beginning of the twentieth century. Although the Rampiers Copse earthworks are large in scale (banks 2.1, 3.1, 3.2 and 3.3 in particular) badger activity is extensive (Fig 44), is undoubtedly disturbing archaeological deposits, and poses the greatest ongoing threat to the monument.

Figure 44. Analytical earthwork survey of Rampier Copse showing principle areas of badger damage (in blue) in early 2018 (scale 1:2500 reduced from original survey drawing at 1:1000, ©Historic England).
