Grimsby Heritage Action Zone An Assessment of the Historic England Archive Aerial Photographs

An assessment of the Historic England Archive Aerial Photographs

This report summarises the results of an assessment of the aerial photographs held in the Historic England Archive for the Greater Grimsby Heritage Action Zone. The project covered 2.8sq km and encompassed the entirety of the Heritage Action Zone with an additional buffer to provide a broader landscape context.

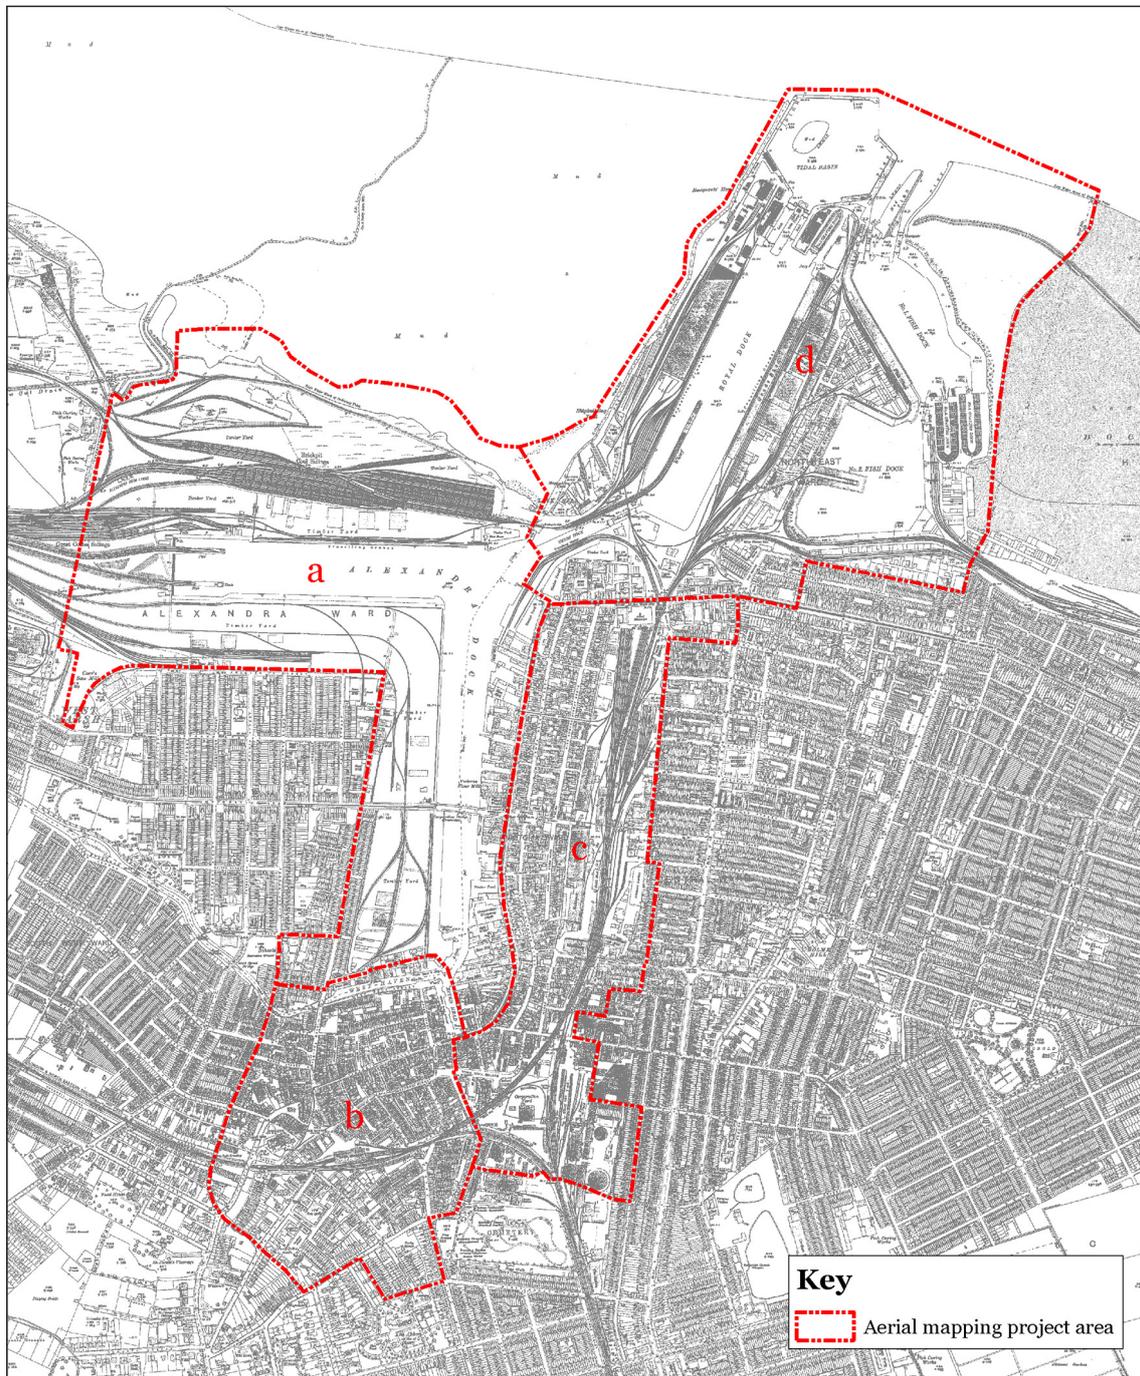
Fig 2: The study areas covered within the report are a) Alexandra Dock, b) the old town and commercial district, c) East Marsh and d) Royal Dock and Nos. 1, 2 and 3 Fish docks. Ordnance Survey 1:2,500 published 1933 © and database right Crown Copyright and Landmark Information Group Ltd (All rights reserved 2019) Licence numbers 000394 and TP0024.

For the purposes of the assessment, the urban development of Grimsby is discussed within this report in four geographically defined areas (Fig 2). Although linked by a common thread, each has adapted to economic and social changes in subtly different ways. The old town centre and commercial district retain elements of the medieval street pattern but have adapted to the changing commercial sector, particularly with the construction of the Riverhead shopping centre in the 1970s. The character of the

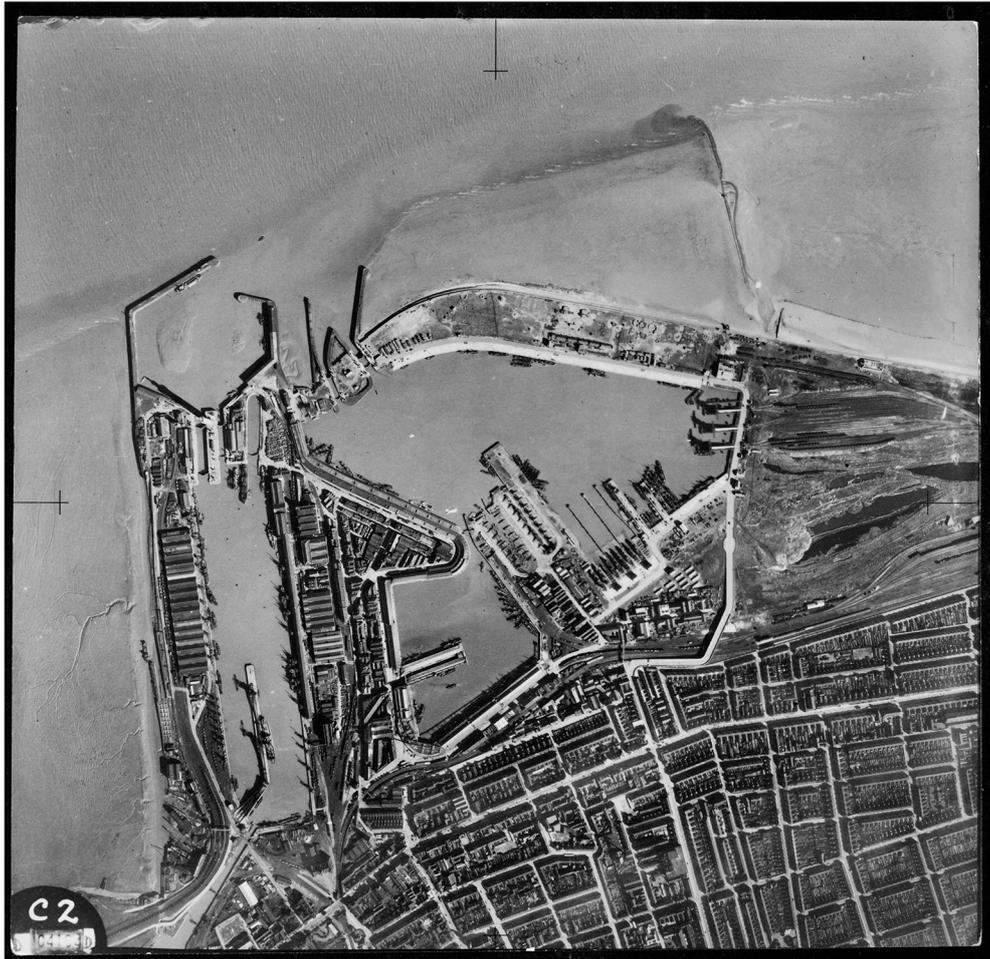
Fig 3: An example wartime RAF vertical photography showing Grimsby Docks and the East Marsh area of the town. RAF/613D/BR52/VC/0002 13-MAR-1941 Historic England Archive RAF Photography.

Four frames from 20 August 1942 provide coverage of the southern part of the project area but are partially masked by cloud cover. A further four frames date from 6 September and show the northern part of the project area, including the docks but these are quite grainy and so only of moderate quality. Three frames from 27 January 1943 are of similar quality but useful for assessing bomb damage.

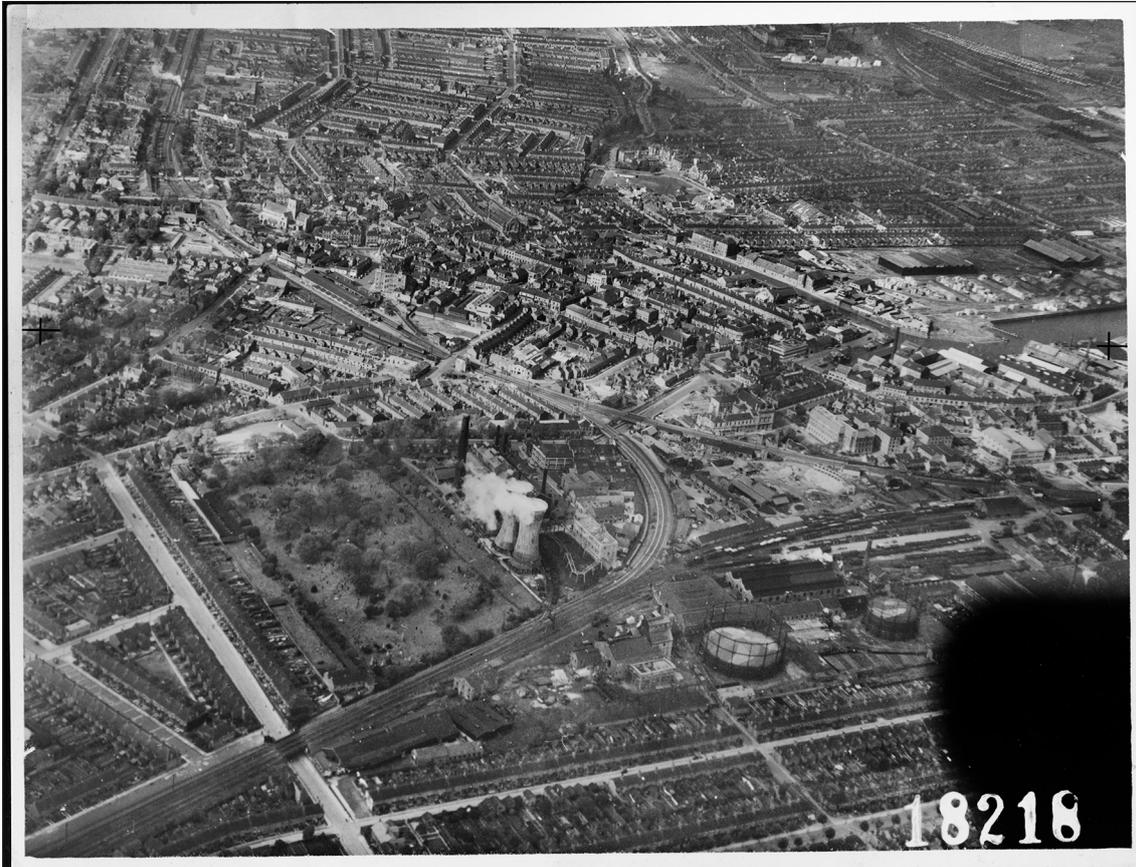
Fig 4: An RAF oblique photograph looking towards West Marsh with the town gasworks in the foreground . RAF/1CU/18000/O-18218 07-OCT-1943 Historic England Archive RAF Photography.

Two RAF oblique photographs are also held in the collection. One is a view north-west from the gasworks towards West Marsh taken on 7 October 1943 (Fig 4). The second dates from 6 July 1941 and is a view from Wellow towards the docks.

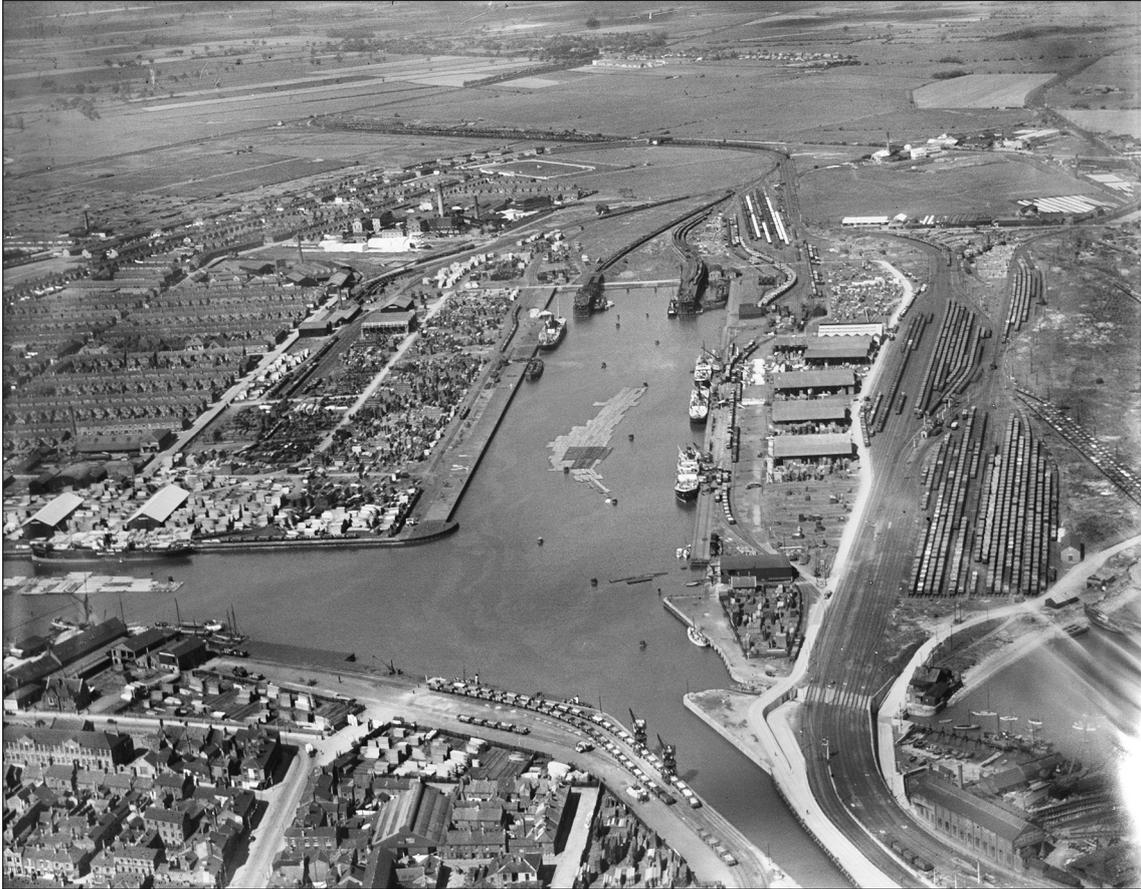
Fig 9: A view of Alexandra Dock looking westwards. The two coal drops can be seen at the western end of the dock along with extensive railway sidings to the north. © Historic England Archive. Aerofilms Collection EPW053388 31-MAY-1937.

Fig 16: By 1968 roads had replaced the rail infrastructure on Alexandra Dock. The coal drops which were located at the end of the western dock (see Fig 9) had also been removed by this date. MAL/68056 V 112 16-AUG-1968. Reproduced by permission of Historic England (detail).

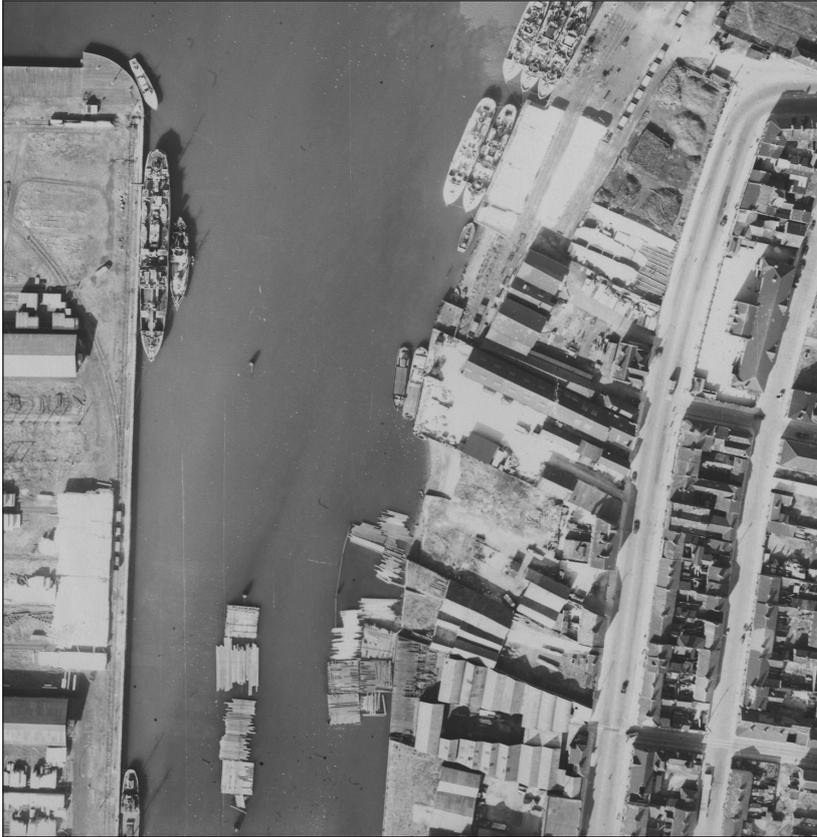
Fig 10: Plots to the east of Alexandra dock occupied by timber yards and saw mills. RAF/106G/UK/809 RVp2 6013 17-SEP-1945 Historic England Archive RAF Photography (detail).

Photographs from 1925 and 1937 show the yards to the west stacked with vast volumes of sawn timber. Contemporary newspaper reports noted a revival of the Grimsby timber trade in 1937, with imports more than doubling compared to the previous year (*Hull Daily Mail* 1937; *Leeds Mercury* 1937). A number of large storage sheds – open sided with pitched roofs – were located in the yards. Photography from 1937 is detailed enough to make out the names of three of the timber merchants operating on Alexandra dock – ‘Winteringham & Son’, ‘Hewson Chapman & Co Ltd’ and ‘Marshall Knott & Barker Ltd’ (Fig 11).

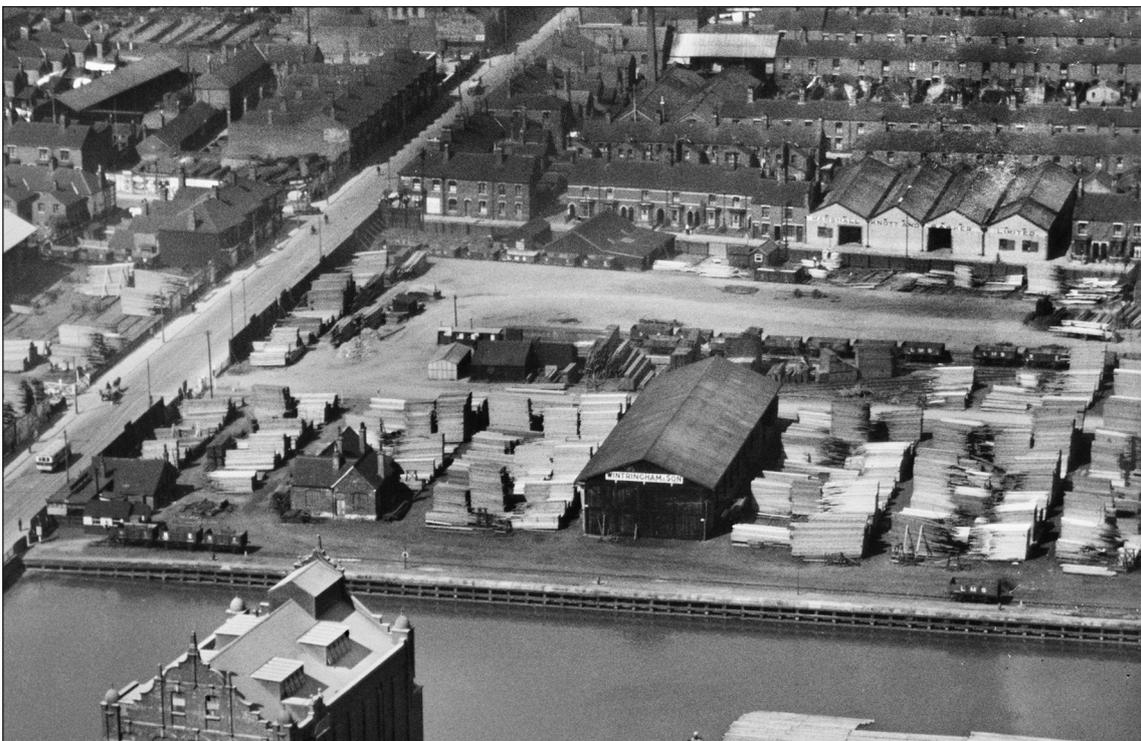
Fig 11: A view westwards across Alexandra Dock to the timber yards of Winteringham & Son and Hewson Chapman & Co Ltd. © Historic England Archive. Aerofilms Collection EPW053405 31-MAY-1937 (detail).

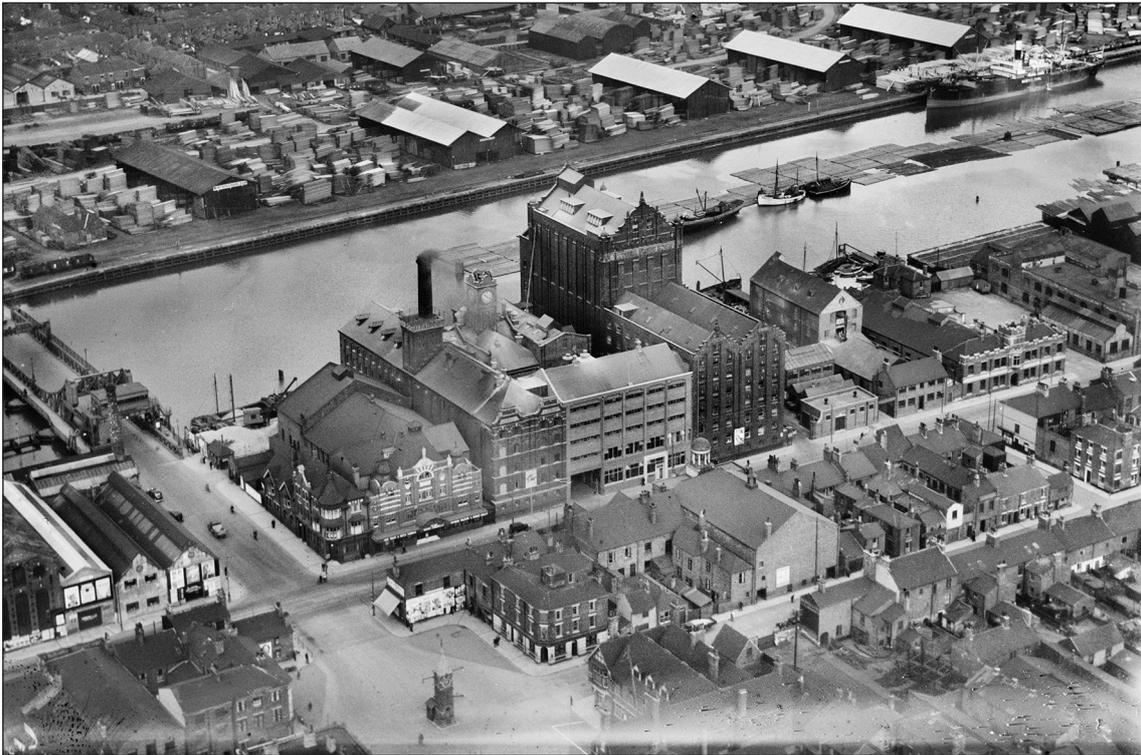
Fig 12: A view of Victoria Street North in 1937 looking to the west. Victoria Flour Mills is in the centre of the image with the Palace Theatre to the left. Tudor Revival Castle Press can be seen on the right. © Historic England Archive. Aerofilms Collection EPW053403 31-MAY-1937 (detail).

Pre-war photographs also illustrate the yards, warehouses and other significant buildings to the east of the dock. These include some of the few historic buildings that still survive – including the Grade II listed Castle Press (formerly an artillery drill hall built between 1890 and 1904 in the Tudor Revival style) and Victoria Flour Mills – as well as many which have since been lost such as the Palace Theatre (Figs 12 and 13). Details of working life are vividly captured. The docks are busy with cargo vessels being loaded and unloaded and, while there are several motor vehicles visible, horse-drawn transport is still being used to carry goods (Fig 14). Advertising hoardings, including Hovis, Guinness, Bass, Oxo and Players, line the fences and buildings along Corporation Street and Freeport Wharf. One billboard on the gable end of a building on Victoria Street includes the name W H Jackson & Co, a firm of advertising agents and bill posters that were located further north on Victoria Street (Kelly's Directory Lincolnshire (1919): 256).

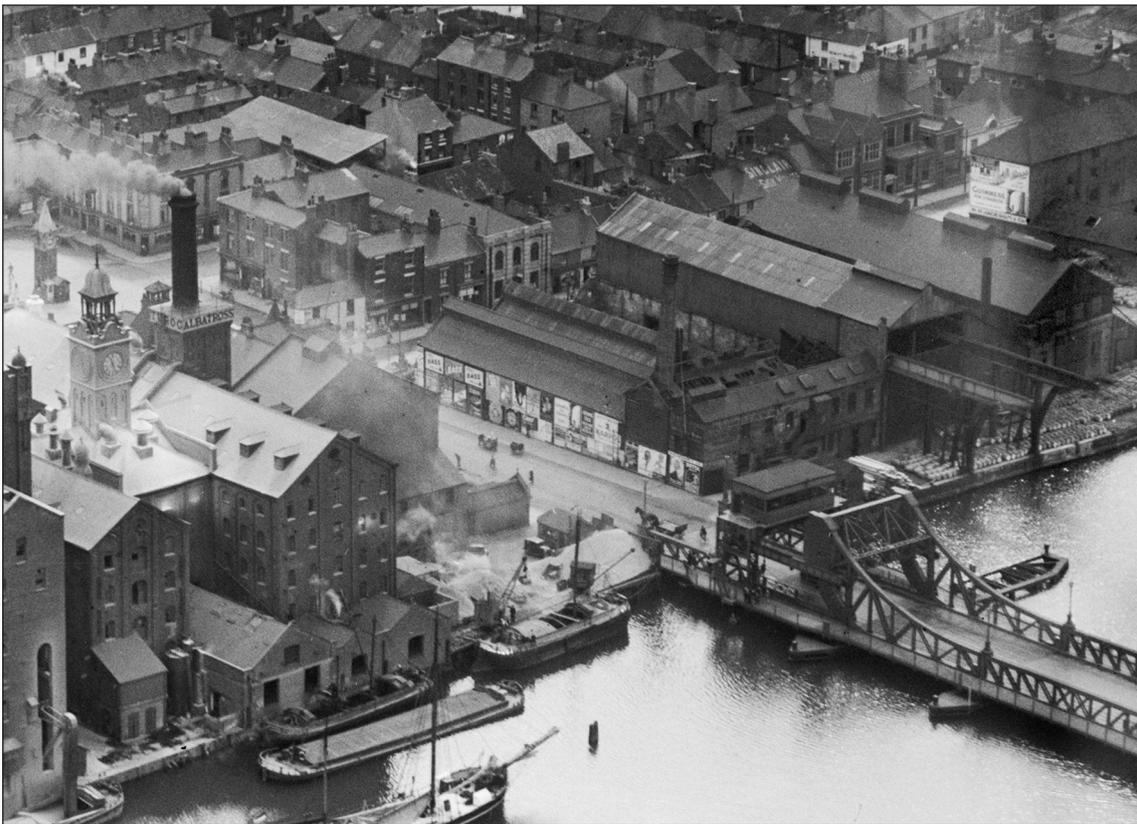
Fig 14: Advertising hoardings lining the buildings on Freeport Wharf. Horse-drawn traffic can be seen crossing the Corporation Bridge. Also of interest is the signage advertising the 'Albatross' brand of flour around the chimney of Victoria Flour Mills. © Historic England Archive. Aerofilms Collection EPW042806 AUG-1933 (detail).

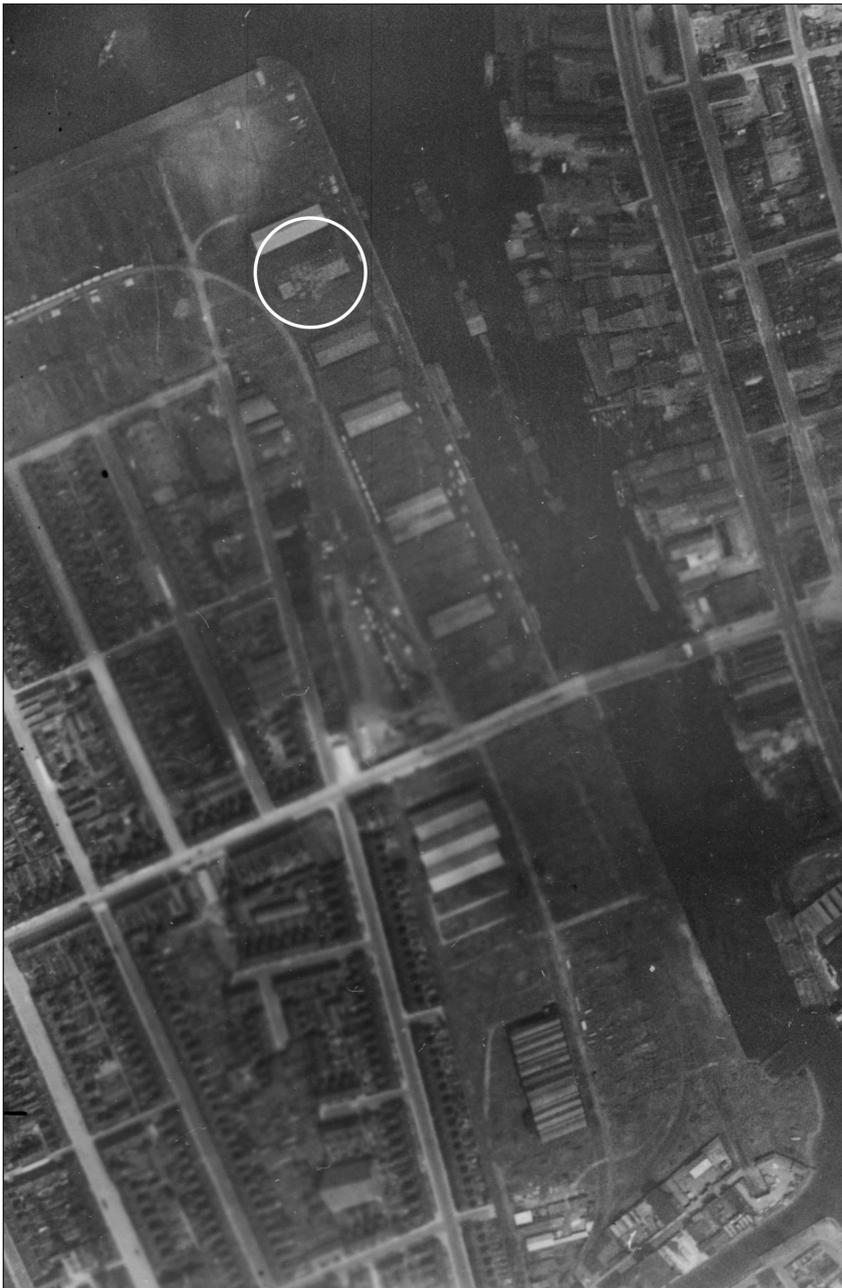
Fig 15: The timber yards on Alexandra Dock showing the severe depletion of stocks in 1942. One of the sheds (circled) has been partially destroyed by a bomb. RAF/FNO/108 FS 210 20-AUG-1942 Historic England Archive RAF Photography (detail).

Imports by Hewson Chapman & Co had dropped by almost 40% to 17,149 loads (*Grimsby Daily Telegraph* 1939). This was soon exacerbated by the outbreak of hostilities. By September 1940 photography shows declining stocks of timber and by August 1942 the yards surrounding Alexandra Dock are all but empty (Fig 15). One of the sheds has also been severely damaged by a bomb. Aerial photographs record a continued slump in the timber trade post-war. Throughout the late 1940s stocks of timber appear diminished and it is not until 1953 that evidence of increased trade can be observed.

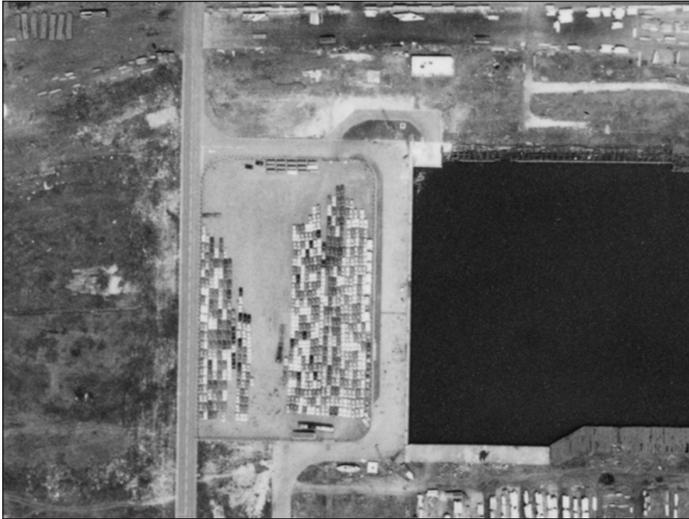
Fig 17: New roll-on/roll-off car handling facilities on Alexandra Dock seen in 1976. MAL/76037 V 178 06-JUN-1976 © North East Lincolnshire Council (detail).

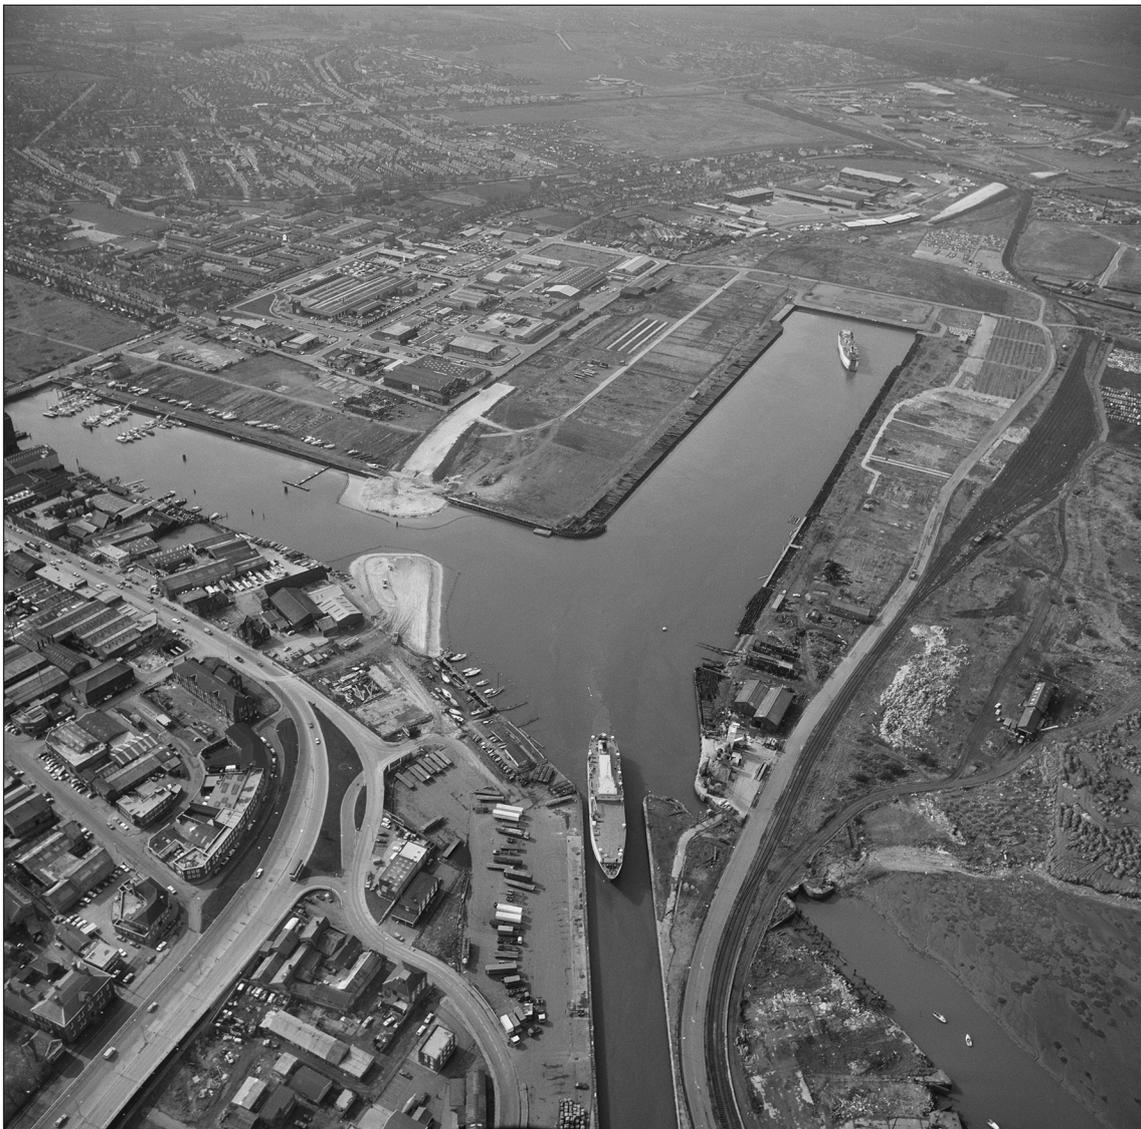
Fig 18: Construction of the embankment to carry the A180 in 1982. By this time the timber yards had largely disappeared. © Historic England Archive. Aerofilms Collection EAW418777 19-MAR-1982.

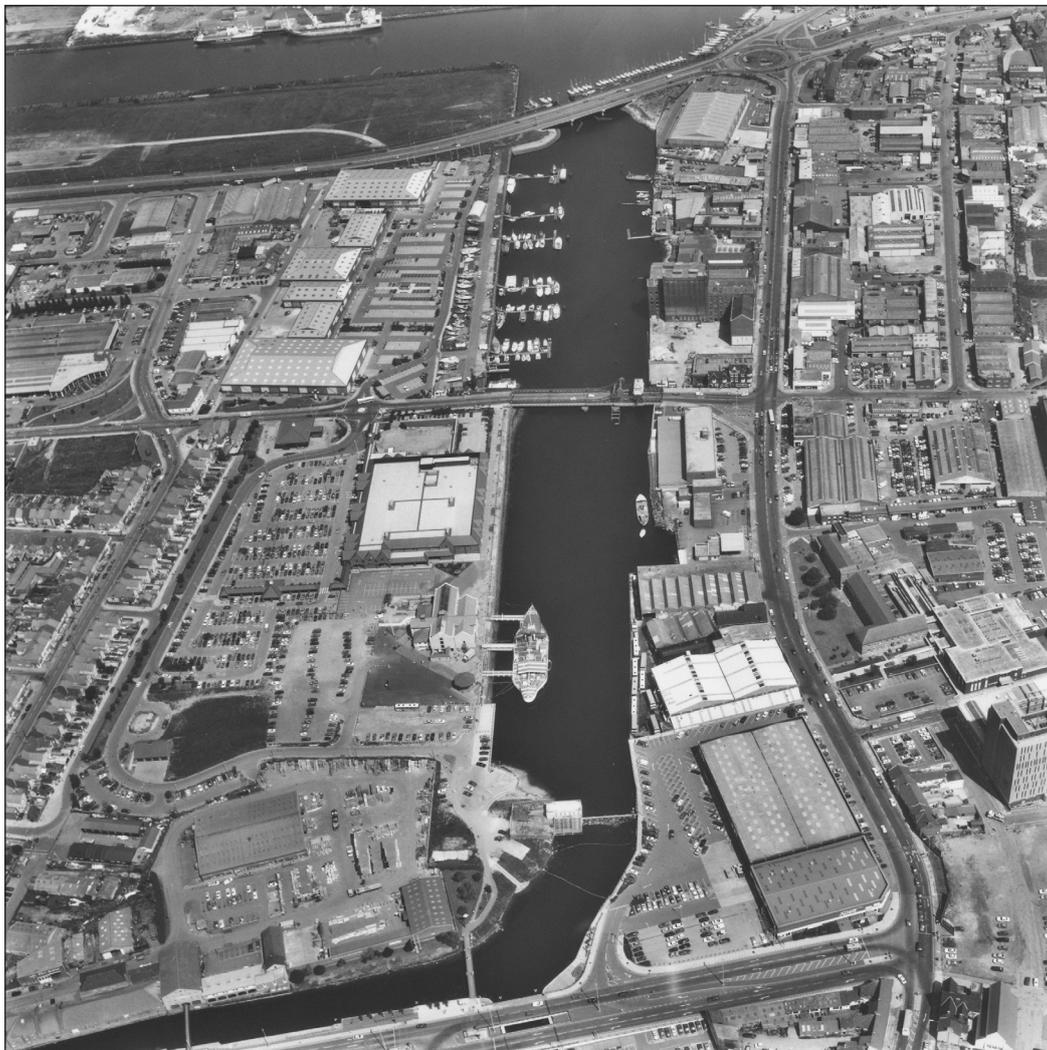
Fig 19: Alexandra Dock in 1992 looking north. The former timber yards to the west had been developed into a retail park by this date. 12257/73 12-JUN-1992 © Historic England Archive.

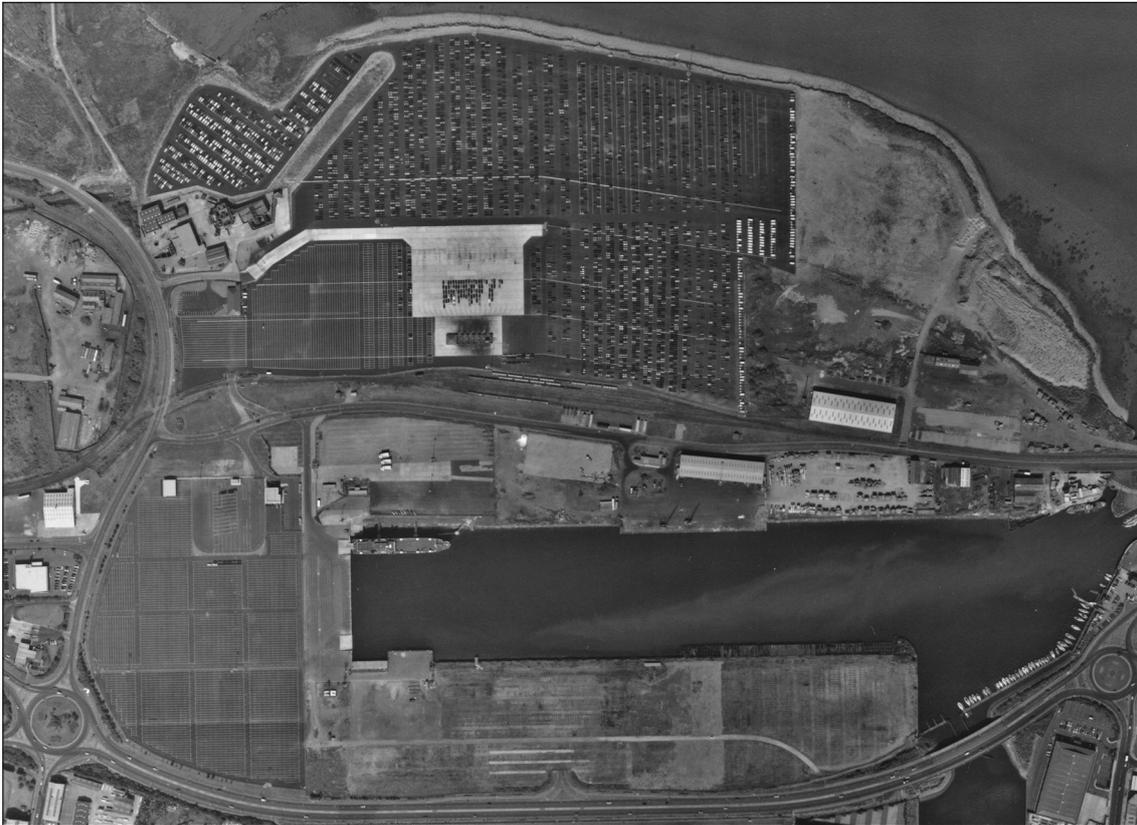
Fig 20: Car handling facilities around Alexandra Dock. OS/95725 V 117 19-AUG-1995. © Crown copyright. Ordnance Survey (detail).

Throughout the 1990s the aerial photographs record the steadily expanding infrastructure associated with car importation. By 1995 car storage facilities covered much of the land previously occupied by the Brickpit coal sidings and the former coastal marshes (Fig 20). Currently these facilities cover around 0.6sq km, a vast area of land accommodating the import of over 500,000 vehicles a year (Associated British Ports 2018).

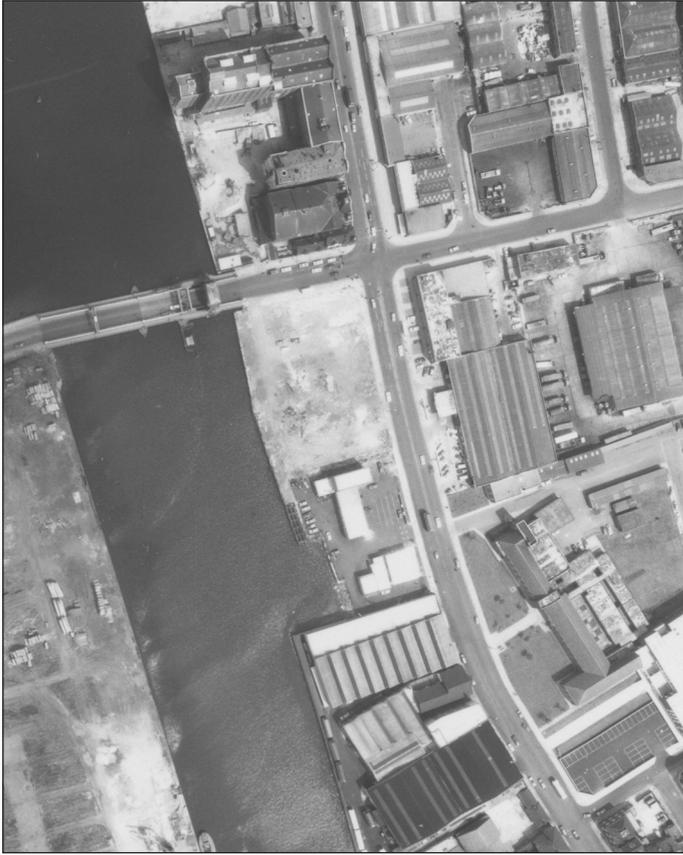
Fig 21: Clearance of land to the south of Freeport Wharf. MAL/70056 V 082 18-JUL-1970. Reproduced by permission of Historic England (detail).

Aside from small adaptations, the character of the eastern dockside changed relatively little between the end of the war and the late 1960s. By 1970 areas of clearance were emerging. Parts of the Victoria Flour Mills had been demolished and the former warehouses to the south of Freeport Wharf –including one of Grimsby's old ice factories – had been cleared. A new garage and filling station occupied part of the site (Fig 21). Further development had taken place south of Freeport Wharf by 1988 with the construction of Bridge House. More of the Victoria Flour Mills complex had also gone by this date along with The Palace Theatre which had been demolished in 1979. To the north, there is less evidence of large-scale change other than the demolition of some of the old timber yards for the A180 and an associated roundabout. Around 1990, however, further modern development can be seen encroaching from the north with a large warehouse retail development which was followed by a second to the south in the late 1990s (Fig 22).

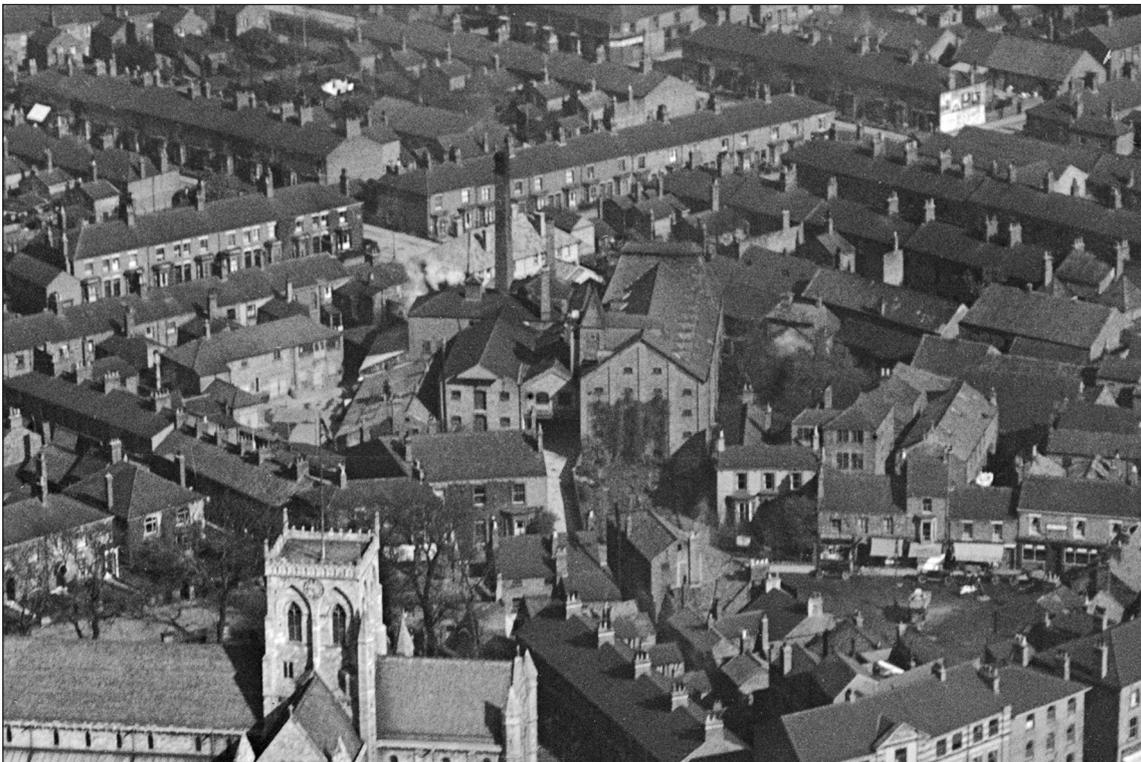
Fig 23: The Hewitt's brewery in Bull Ring. The five-storey building on the right is the malthouse. © Historic England Archive. Aerofilms Collection EPW012667 06-MAY-1925 (detail).

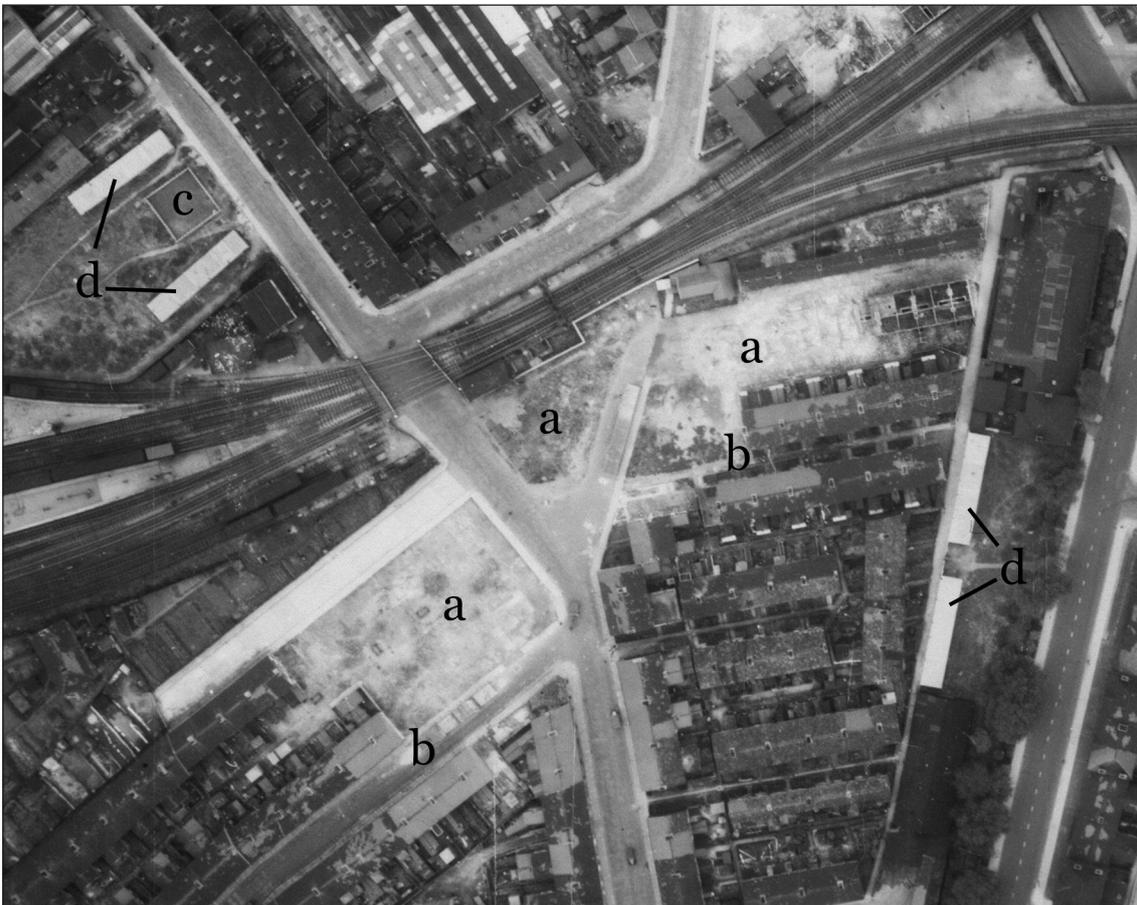
Fig 25: Bomb damage to the east of the railway station in 1945. Cleared bomb sites (a) can be seen along with repaired roofs (b) showing as lighter tiles. An emergency water supply (c) and surface air raid shelters (d) are also visible. RAF/106G/UK7687 RVp4 6286 10-SEP-1945 Historic England Archive RAF Photography. (detail).

Several areas of bomb damage are evident on 1940s photographs (Fig 25). While some appears to be relatively minor – identifiable by the replaced roof tiles – other damage is more severe. A cluster of large cleared bomb sites lie to the east of the station on Garden Street, Duchess Street, Railway Terrace, King Terrace and Abbey Walk while smaller areas of clearance are located on Abbey Drive East and Dean's Gate. Aside from these areas, the pattern of late 19th and early 20th-century housing remained largely unchanged until the late 1960s.

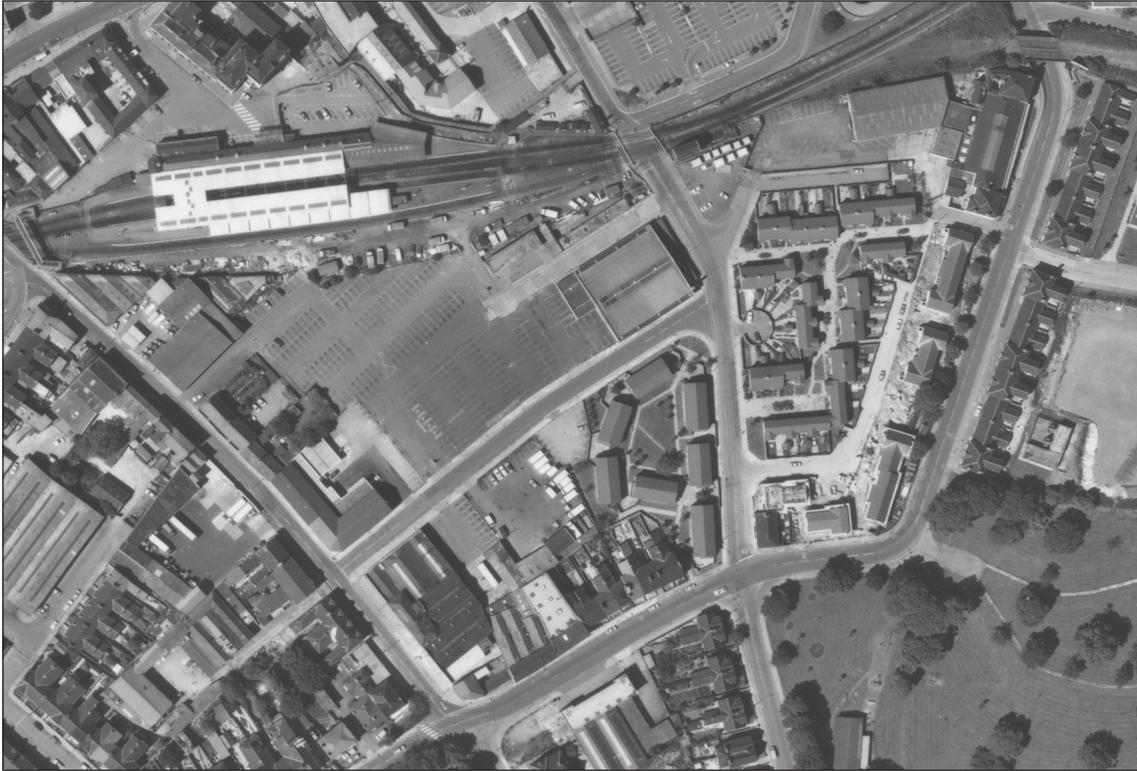
Fig 26: The terraced housing seen in Fig 25 was cleared in the 1970s and 1980s and redeveloped into car parks and new housing estates. OS/88158 V 12-JUN-1988. © Crown copyright. Ordnance Survey (detail).

Large-scale demolition began with the Riverhead Centre development (see below) which resulted in the clearance of housing in West Dock Street, Sanctuary Lane, Clayton Street, Flotter Gate, Worsley Street, Silver Street, Brewery Street and Haven Street (see Fig 28). Less than a decade later, in 1976, further areas had been cleared to the east and south of the station. While some were turned into car parks, others were replaced with modern estates (Fig 26).

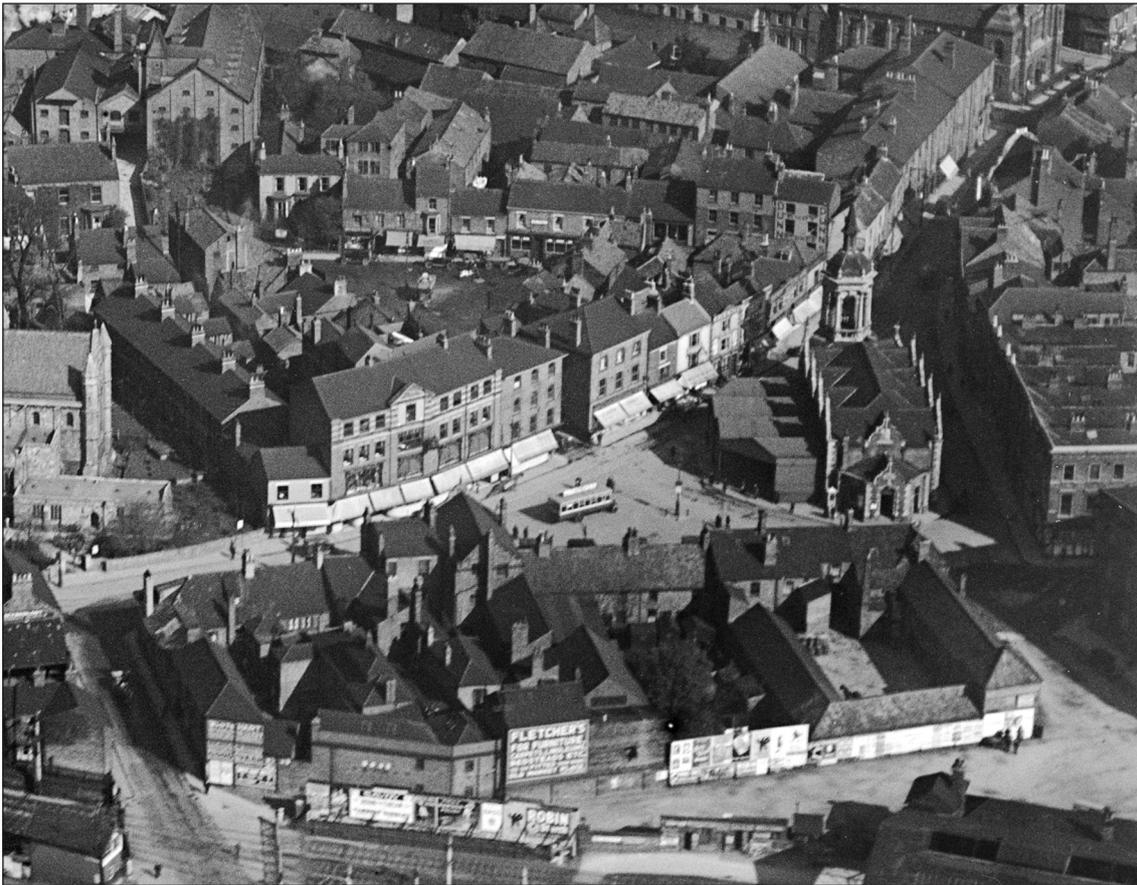
Fig 27: The old market place in 1925 showing the Victorian corn exchange (centre right). © Historic England Archive. Aerofilms Collection EPW012667 06-MAY-1925 (detail).

The area of Grimsby centred on Victoria Street has historically been the commercial heart of the town. By the 16th century two markets a week were being held (Gillett 1970, 104). The old market place was also the location of the 1857 corn exchange which was demolished in the 1950s (Fig 27). To the south of the railway line on Brighowgate was the cattle market which had opened in 1875 (Gillett 1970, 238). This later became the site of a bus station (see below). Photographs from 1925 illustrate the shops in the commercial district, many of which have been lost to later redevelopment (Fig 27) while another image captures a market day in 1933 (see Fig 34). Advertising hoardings line the approach to the station, including one for Fletcher's furniture, while the premises of Dunn's boots and shoes on Bullring Lane can be seen in the background.

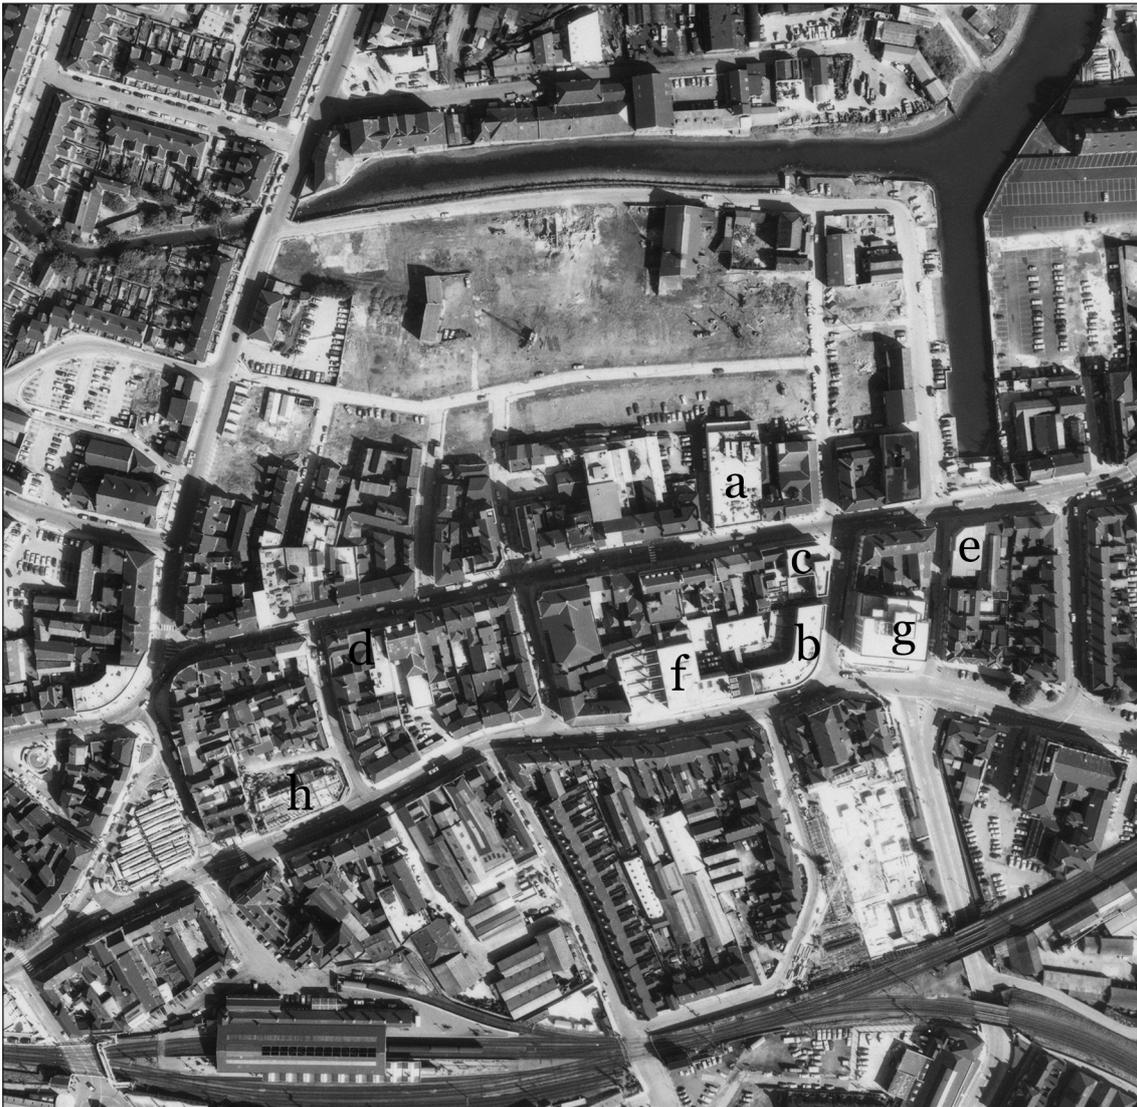
Fig 28: Cleared streets in advance of the Riverhead Centre development. To the south, post-war development includes Woolworth's (a), New Oxford House (b), Pearl Assurance House (c), 22-24 Victoria Street (d), 96-100 Victoria Street (e), Royal Mail sorting office (f), Central Library (g) and Yorkshire Bank (h). MAL/68056 V 128 16-AUG-1968. Reproduced by permission of Historic England (detail).

By 1965 other small commercial developments had been completed, including Pearl Assurance house by Elsworth Sykes & Partners, Hull (NELC 2015, 82), 22–24 Victoria Street, and 96–100 Victoria Street. But just three years later, in 1968, more radical redevelopment was in progress. On Osborne Street new developments included the Royal Mail sorting office and Grimsby Central Library, designed by borough architect JM Milner (NELC 2017, 170). Sir Charles Nicholson Rushton's brutalist Yorkshire Bank was under construction on this date – he also designed Hampton House on Church Lane (NELC 2015, 96; 98). The most significant change, though, is the clearance of the area between West Haven, Sanctuary Lane and Clayton Street in advance of the construction of the Riverhead Centre (Fig 28).

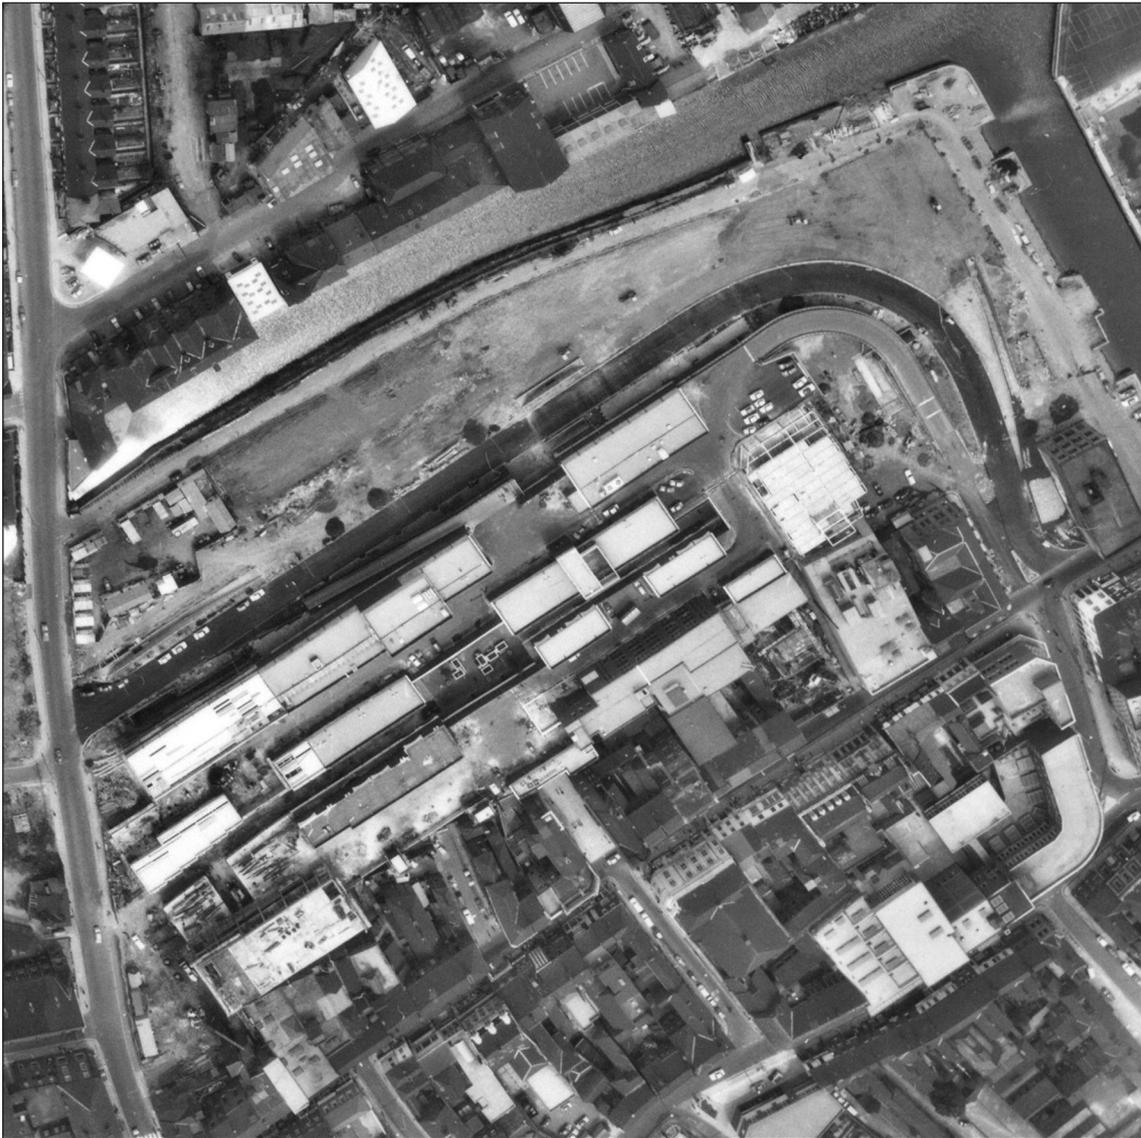
Fig 29: The Riverhead Centre under construction in 1970. MAL/70056 V 135 18-JUL-1970. Reproduced by permission of Historic England (detail).
