Grimsby Heritage Action Zone An Assessment of the Historic England Archive Aerial Photographs

An assessment of the Historic England Archive Aerial Photographs

This report summarises the results of an assessment of the aerial photographs held in the Historic England Archive for the Greater Grimsby Heritage Action Zone. The project covered 2.8sq km and encompassed the entirety of the Heritage Action Zone with an additional buffer to provide a broader landscape context.

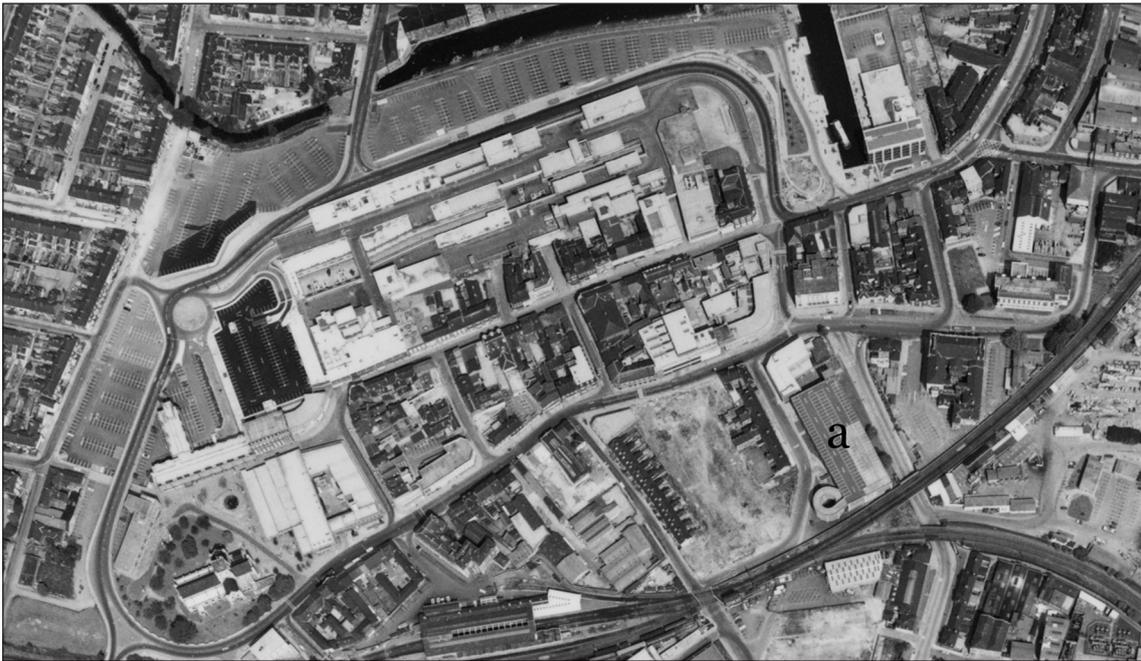
Fig 30: Development around St James's Church and the Riverhead Centre as well as the Abbey Walk multi-storey car park (a). MAL/76037 V 205 06-JUN-1976 © North East Lincolnshire Council (detail).

The Riverhead Centre incorporated rooftop parking accessed by a sloping ramp but this was supplemented by a multi-storey car park on Abbey Walk which replaced the 1950's car park illustrated in Figure 38 (see Fig 30). The cast concrete relief panels, designed by local sculptor Harold Gosney, have been noted as one of the best examples of this kind of decoration of a car park (Morrison and Minnis 2012, 209). Similar arrangements can be seen in other contemporary town centre developments such as in Blackburn and Rochdale (Morrison 2003, 256). By 1976 another multi-storey car park had been appended to the western end of the centre and large areas of open-air parking were located to the north and west.

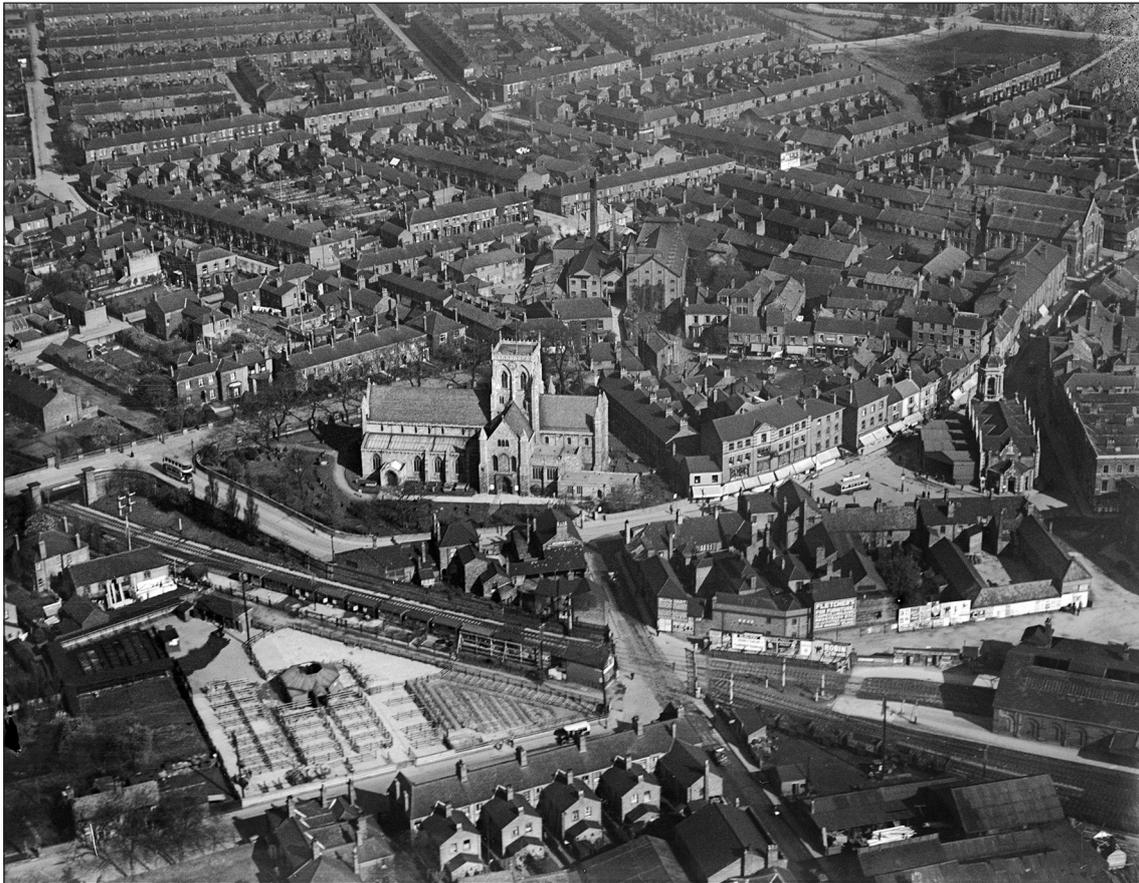
Fig 33: St James's Church and the cattle market in 1925 looking northwards towards the Bull Ring. © Historic England Archive. Aerofilms Collection EPW012667 06-MAY-1925.

Photographs from 1925 show views of St James's church, the station and the surrounding streets (Fig 32). Just one month before this image was taken the Grimsby Corporation had purchased all of the tramways and they went on to introduce trolley buses later that year. One image shows a tram about to turn onto Deans Gate from Church Lane while a motor bus can be seen parked on the old market place (Fig 33). Aside from a single van, the streets are largely devoid of traffic.

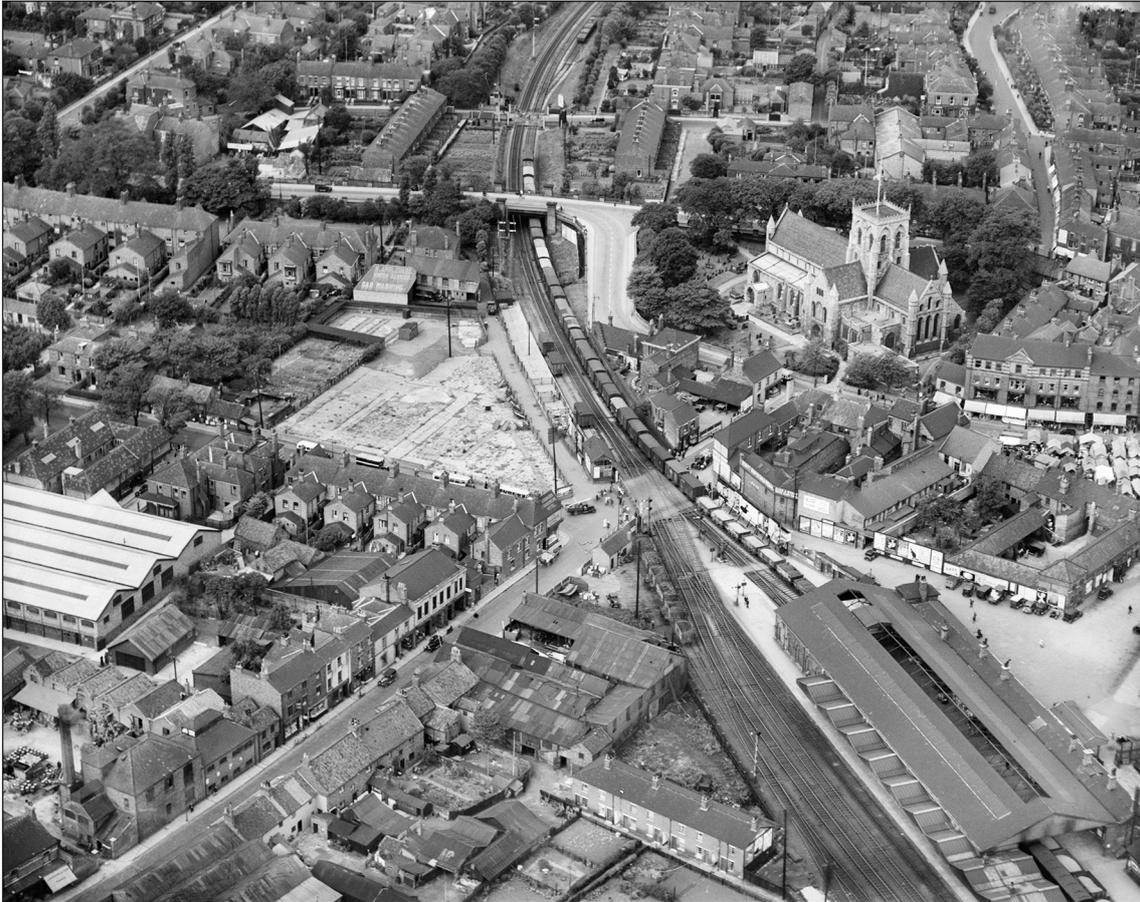
Fig 34: Motorised traffic seen in 1933. The large shed on the left is marked as a garage on later OS maps. Wellowgate Brewery can just be seen in the bottom left of the frame. © Historic England Archive. Aerofilms Collection EPW042805 AUG-1933.

A photograph taken in 1933 shows a very different scene with numerous cars and vans on the road and parked at the station, including four Albion buses on Brighowgate, which had begun running on some of the routes in 1928 (Fig 34). A large shed on is also visible on Manor Avenue which is marked as a 'garage' on later OS maps. The size of this building seems to indicate that it related to motor buses rather than cars. Other interesting details include the signage of 'H. Appleyard Motor Carrier. Car Washing' painted on the roof of a building next to the old cattle market. By 1937 this site had been redeveloped into a new bus station (Fig 35) and contemporary newspaper adverts were promoting excursions to Skegness and Mablethorpe.

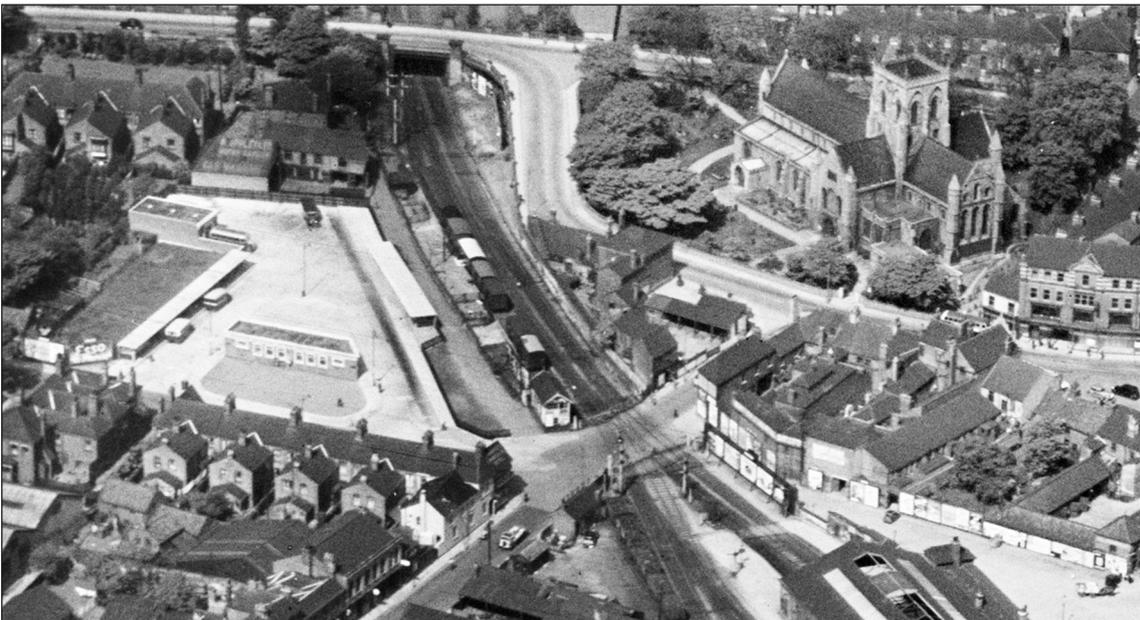
Fig 35: The bus station on the redeveloped site of the old cattle market. © Historic England Archive. Aerofilms Collection EPW053387 31-MAY-1937 (detail).

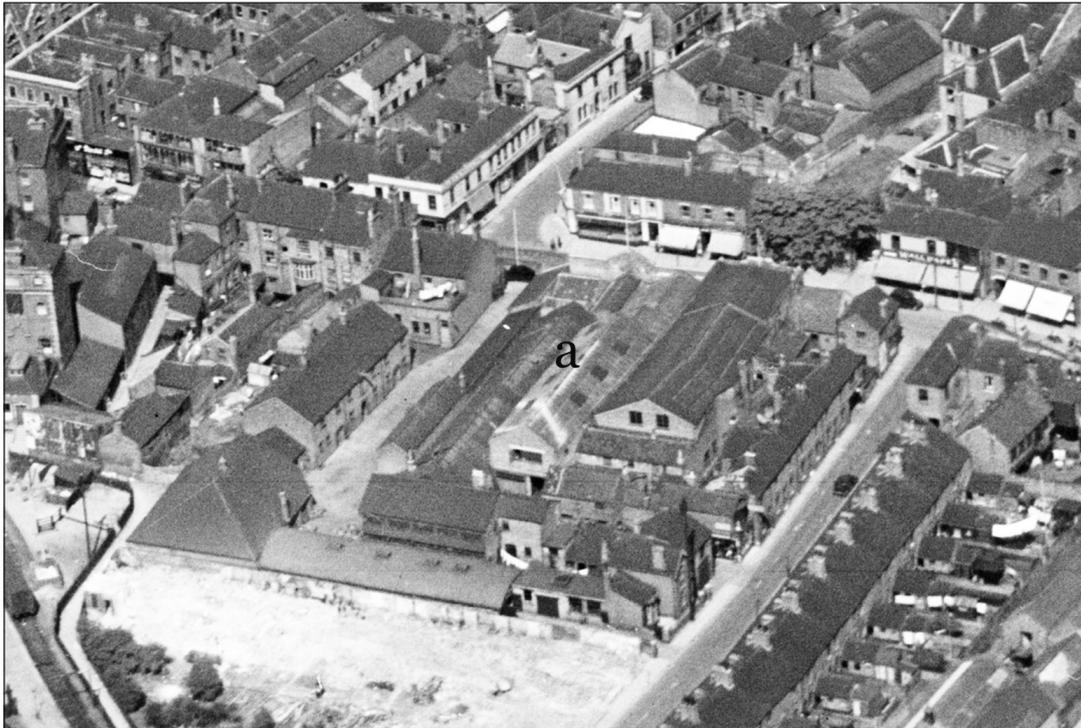
Fig 36: A rear view of the probable premises of the Grimsby Motor Garage Company on South St Mary's Gate (a). © Historic England Archive. Aerofilms Collection EPW053387 31-MAY-1937 (detail).

As far back as 1919 The Grimsby Motor Garage Company were advertising motor trucks (*Boston Guardian* 1919) and in 1934 were promoting 'new and second-hand cars. Prices to suit all pockets' (*Lincolnshire Standard* 1934). The company was located in South St Mary's Gate and it is likely that the large shed with a parapet wall topped frontage seen on 1937 photographs is their premises (Fig 36). Burtons Garage on Wellowgate first appears on photographs in 1951 (Fig 37) and the company was advertising self-drive hire cars in 1952.

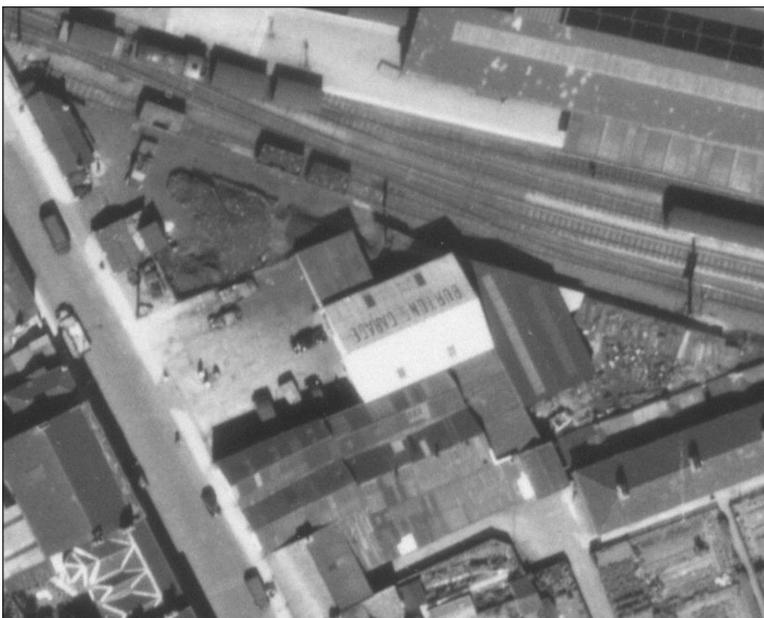
Fig 37: Burtons Garage on Wellowgate seen in 1958. RAF/58/768 Vp4 5018 30-JUL-1951. Historic England Archive RAF Photography (detail).

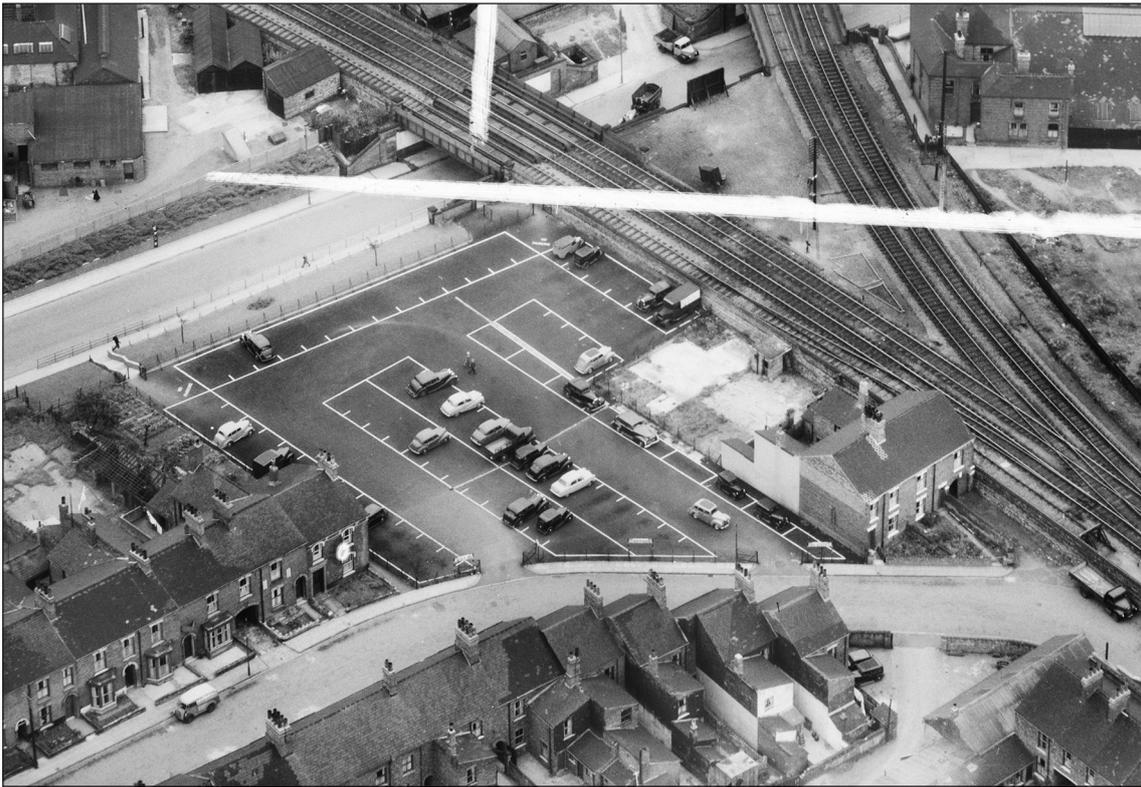
Fig 38: Abbey Walk car park captured on an Aerofilms photograph in 1953. The white lines are where the original image has been marked up for cropping. © Historic England Archive. Aerofilms Collection EAW052053 07-SEP-1953 (detail).

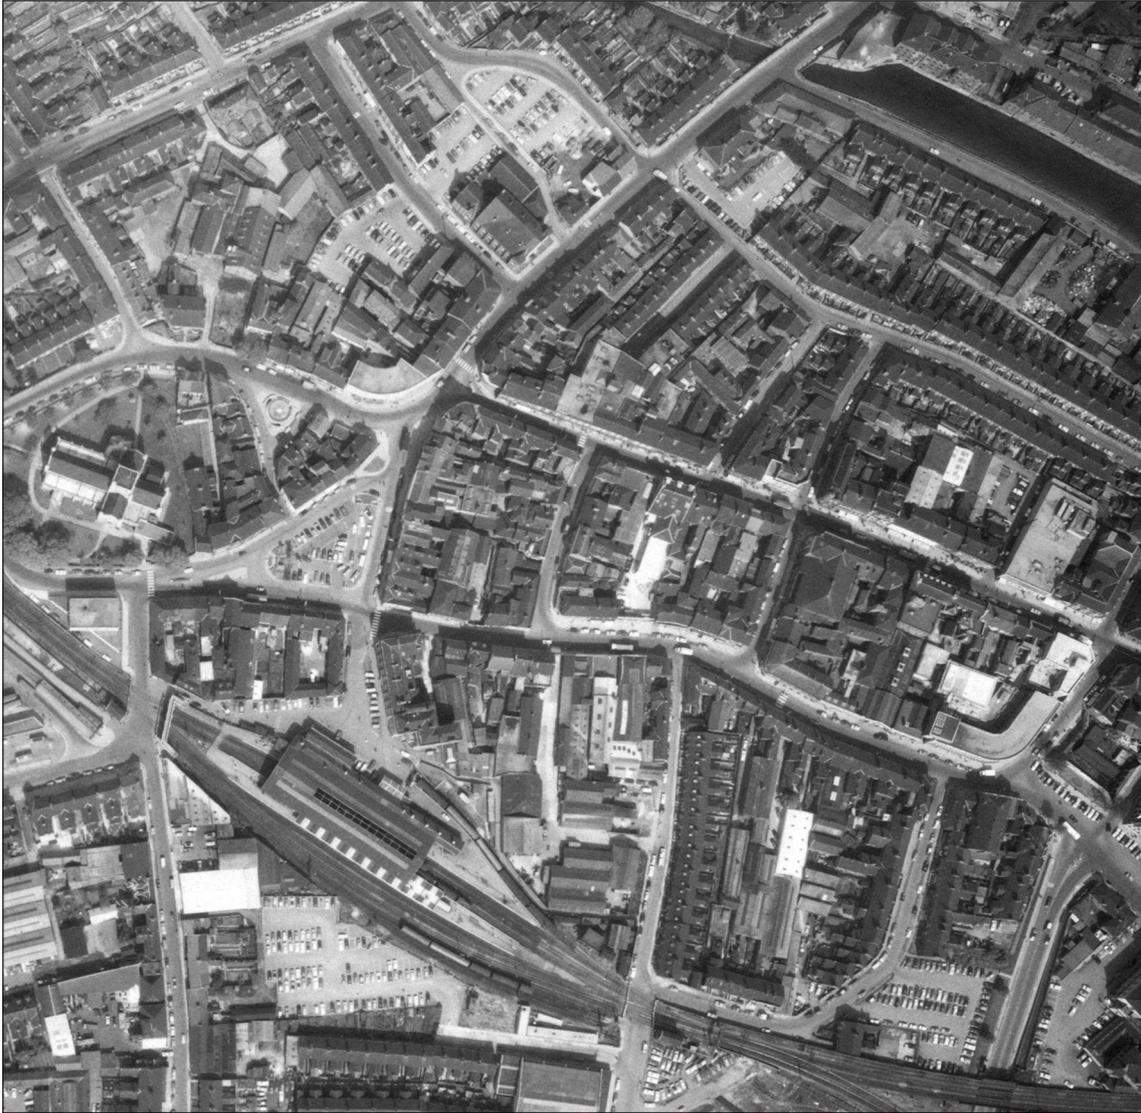
Fig 39: Car parks in and around the commercial district in 1965. MAL/65051 V 151 20-MAY-1965
Reproduced by permission of Historic England (detail).

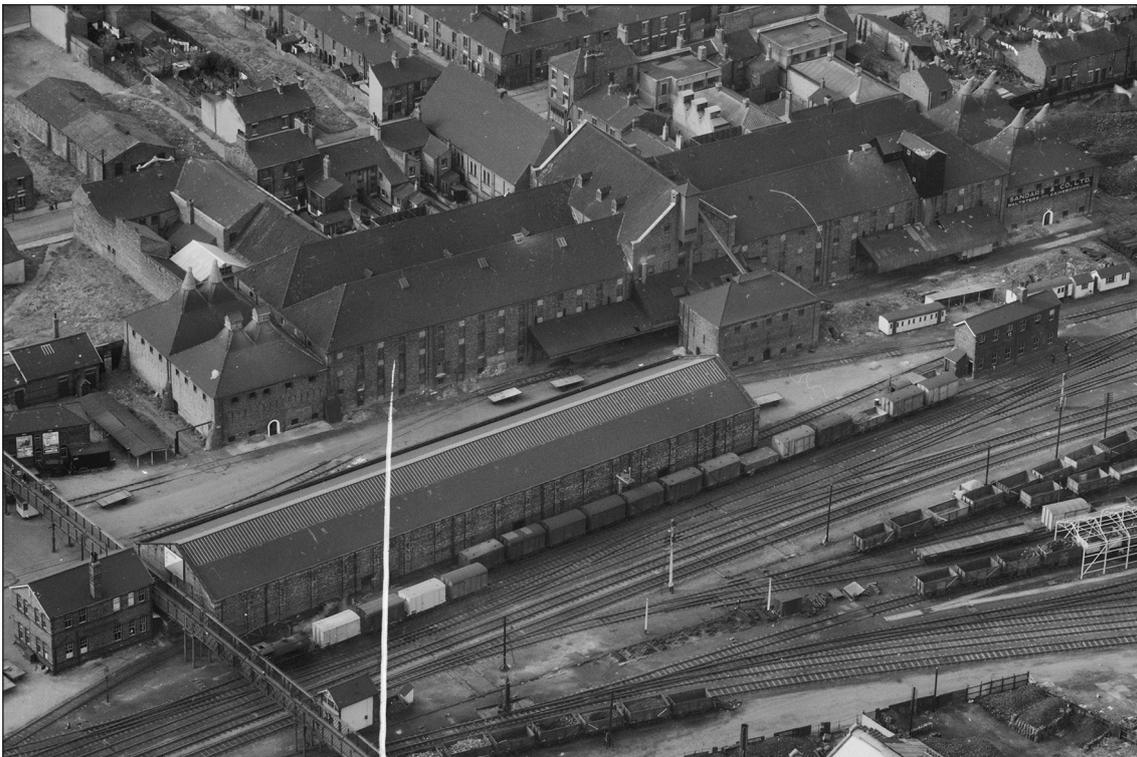
Fig 40: Sandars' northern (No. 3) malthouse. © Historic England Archive. Aerofilms Collection EAW052367 19-SEP-1953 (detail).

The land to the east of King Edward Street was dominated by the three large malhouses constructed in the late 19th century by Arthur Soames & Son (Fig 40). Their location had largely been influenced by the cost savings of acquiring imported barleys at the point of entry into the UK, thus avoiding transportation costs (Brown 1983, 38). They also benefited from a direct railway link via the Grimsby and New Holland Railway which opened in 1848. By the end of the 19th century Soames' Grimsby malhouses were capable of producing 80,000–100,000 quarters of malt a year (Brown 1983, 31). In 1916 Arthur Soames & Son was acquired by Sandars of Gainsborough (Clark 1998, 144).

Throughout the 1960s, the aerial photographs record the steadily changing character of East Marsh as further areas are cleared and replaced with large industrial units. By 1968 the former Gilstrap and Earp malthouse on Victoria Street had been demolished and in 1970 demolition of Sanders northern (No. 3) malting was underway (Fig 53). By 1988 only the central (No. 2) malting survived but its closure in 1992 would lead to its eventual demolition in the late 1990s.

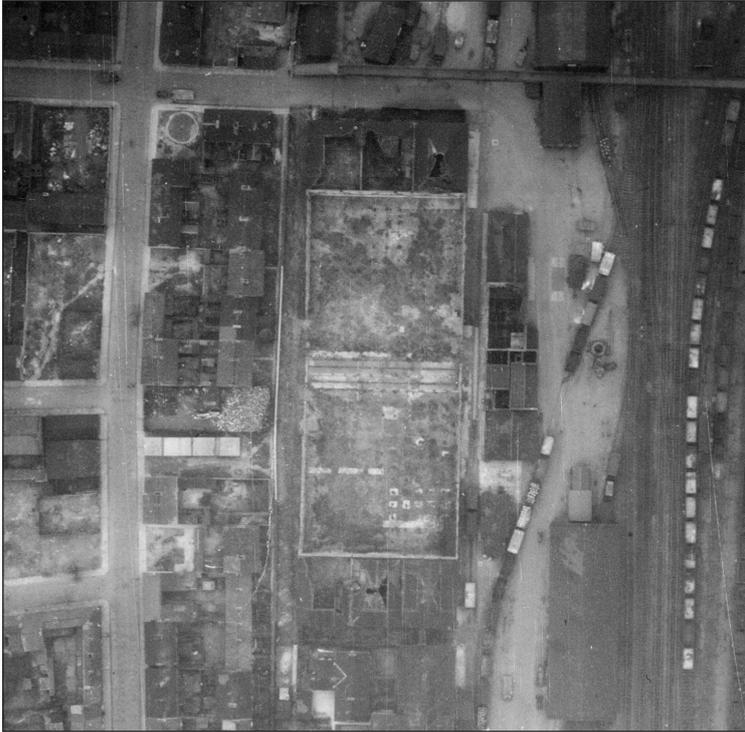
Fig 41: The bombed-out remains of Sandars' No. 2 malthouse .
RAF/106G/UK/787 RVp3 6213 10-
SEP-1945 Historic England RAF
Photography (detail).

The central (No. 2) malthouse was largely destroyed during an air raid at some point after 27 January 1943 – the date of the last aerial image to record the building intact (Fig 41). Sanders had also lost malthouses in Manchester and took the decision after the war to rebuild the Grimsby site to replace these (Brown 1983, 94). The new malthouse was the last floor malting to be constructed in England but incorporated a high degree of mechanisation (Patrick 2004, 30) and was described at the time as ‘the most modern of its type in the country’ (*The Yorkshire Post and Leeds Mercury* 1954). Photographs from 1950 capture the new malthouse under construction (see Fig 51) and images taken in 1953 show the site a year after it began production (Fig 42).

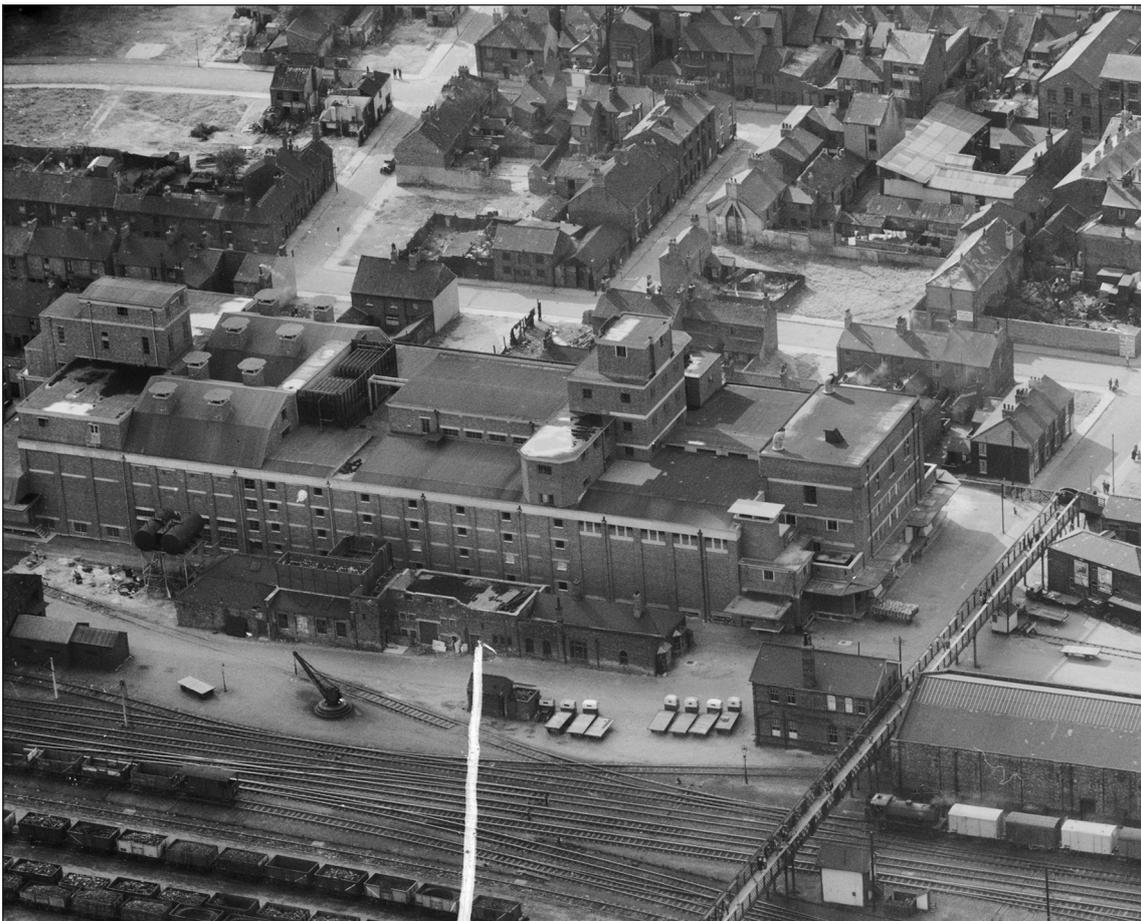
Fig 42: The rebuilt Sandars malthouse seen in 1953. © Historic England Archive. Aerofilms Collection
EAW052366 19-SEP-1953 (detail).

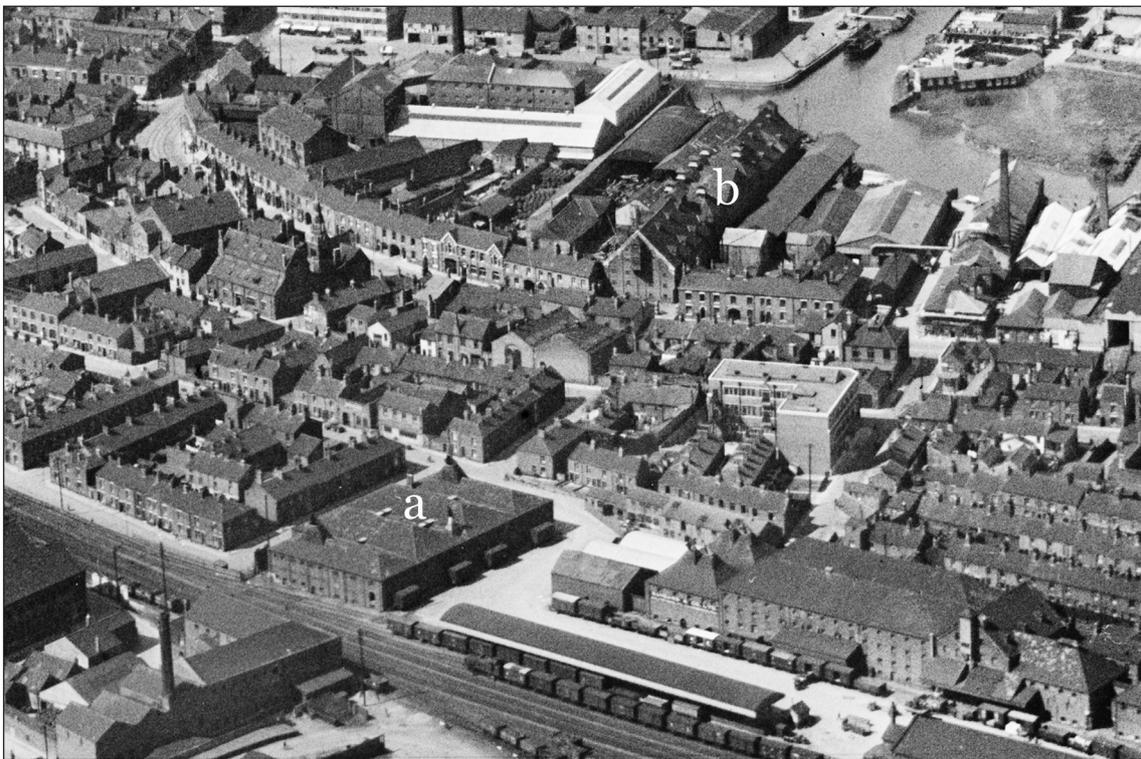
Fig 43: The former Gilstrap and Earp malthouse (a) and Hewitt Brothers malthouse (b). © Historic England Archive. Aerofilms Collection EPW053390 31-MAY-1937 (detail).

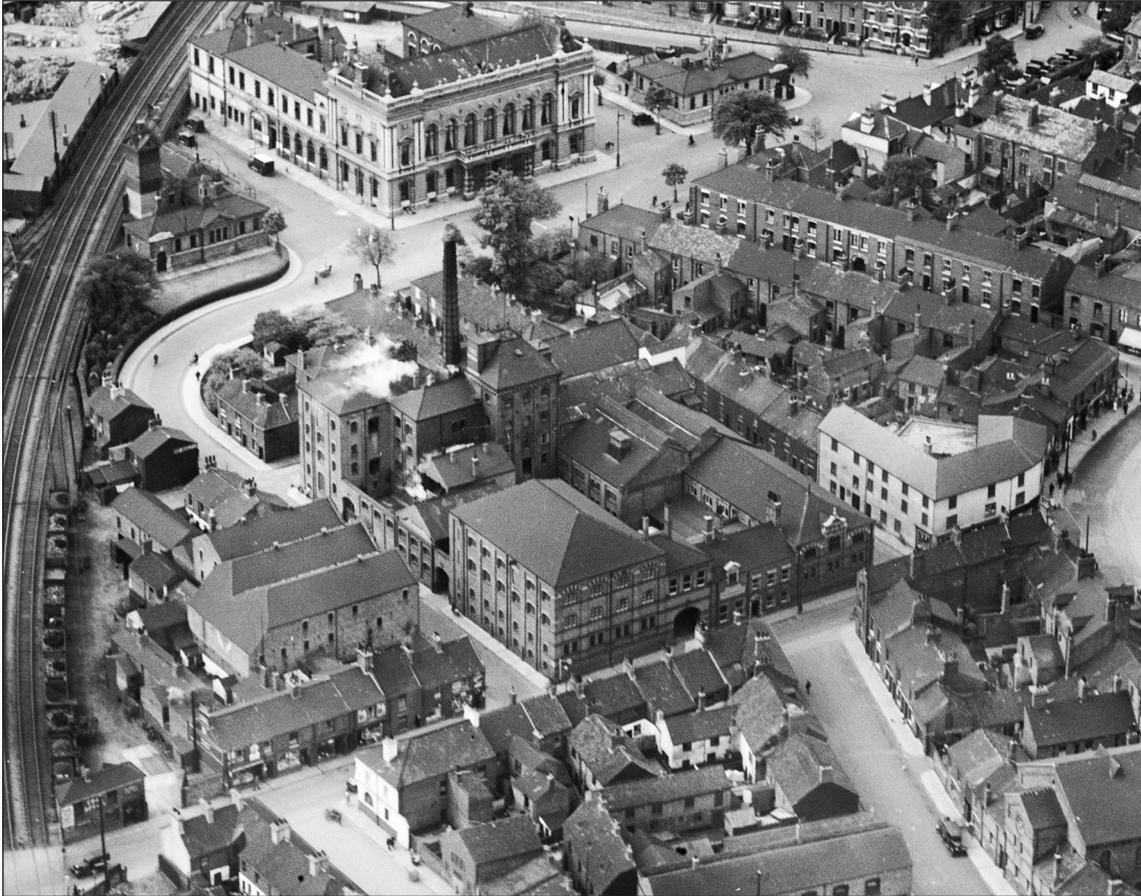
Fig 44: Hewitts Tower Brewery on Pasture Street. © Historic England Archive. Aerofilms Collection EPW042807 AUG-1933 (detail).

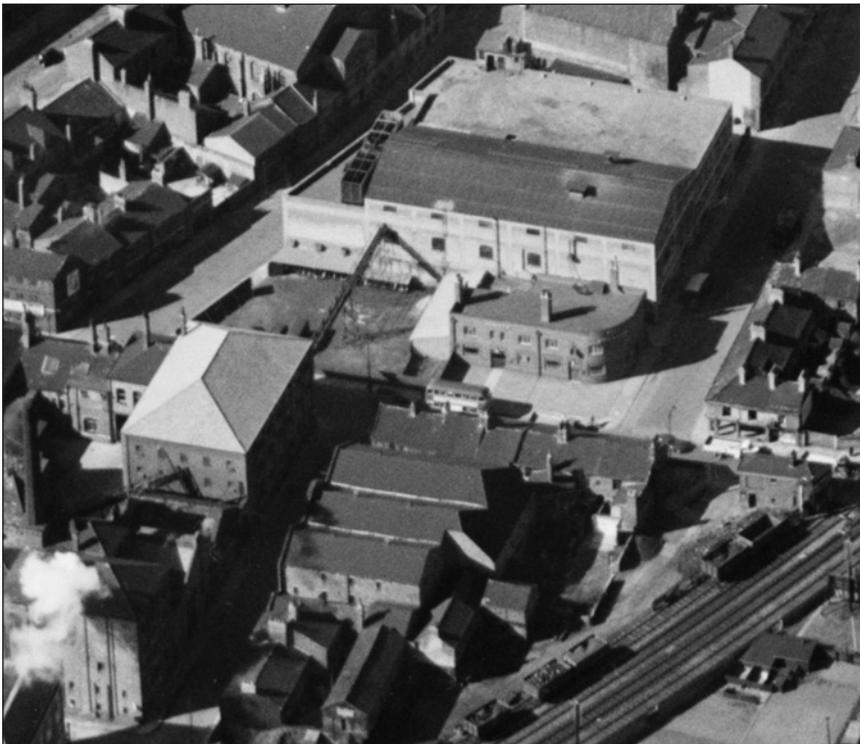
Fig 45: The new Tower Brewery bottling stores and curve-fronted Duke of Wellington pub. © Historic England Archive. Aerofilms Collection EAW029026 10-MAY-1950 (detail).

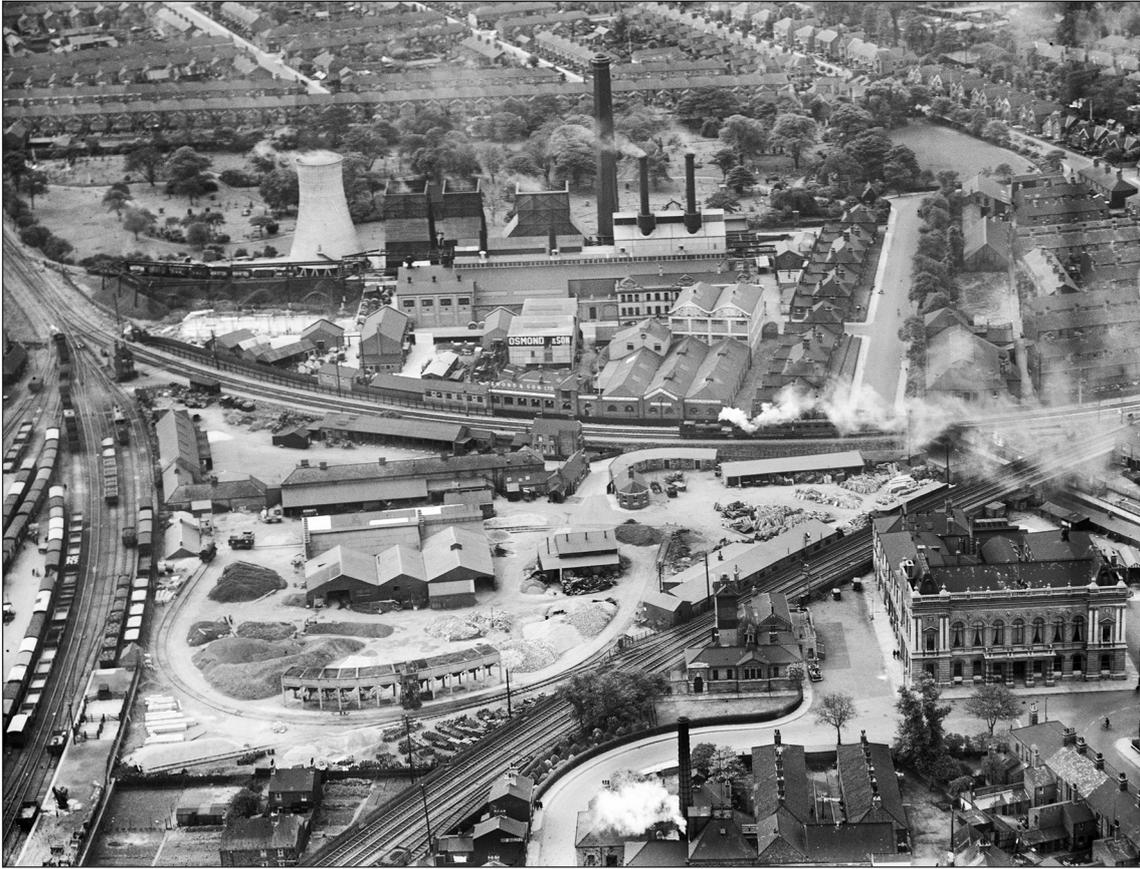
Fig 46: A view across Corporation Yard towards Osmond & Son. © Historic England Archive. Aerofilms Collection EPW042804 AUG-1933.

Other large industries in Grimsby were also covered by Aerofilms including agricultural chemists Osmond & Son Ltd (Fig 46) and the town gasworks (*see cover image*). As well as the larger industrial concerns, the Aerofilms images also record some of the smaller firms operating in the East Marsh District in the mid-1900s. These include John Everett, Kool Products and the Great Grimsby Coal, Salt and Tanning Company, all on Railway Street (Fig 47).

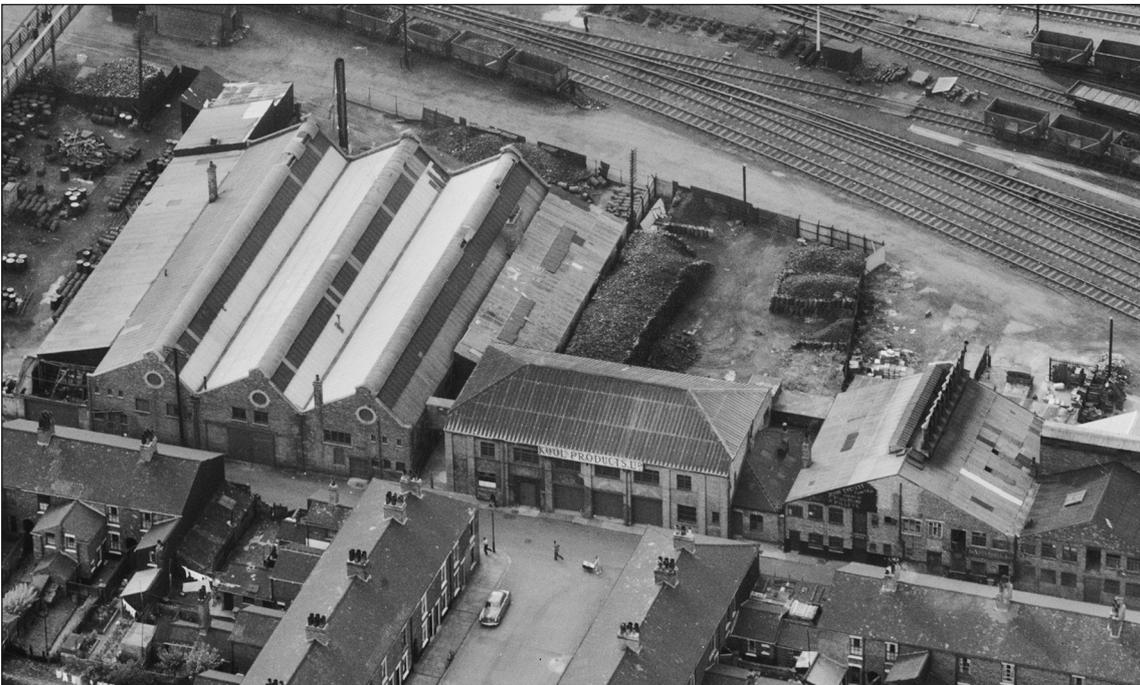
Fig 47: Kool Products and John Everett. © Historic England Archive. Aerofilms Collection EAW052366 19-SEP-1953 (detail).

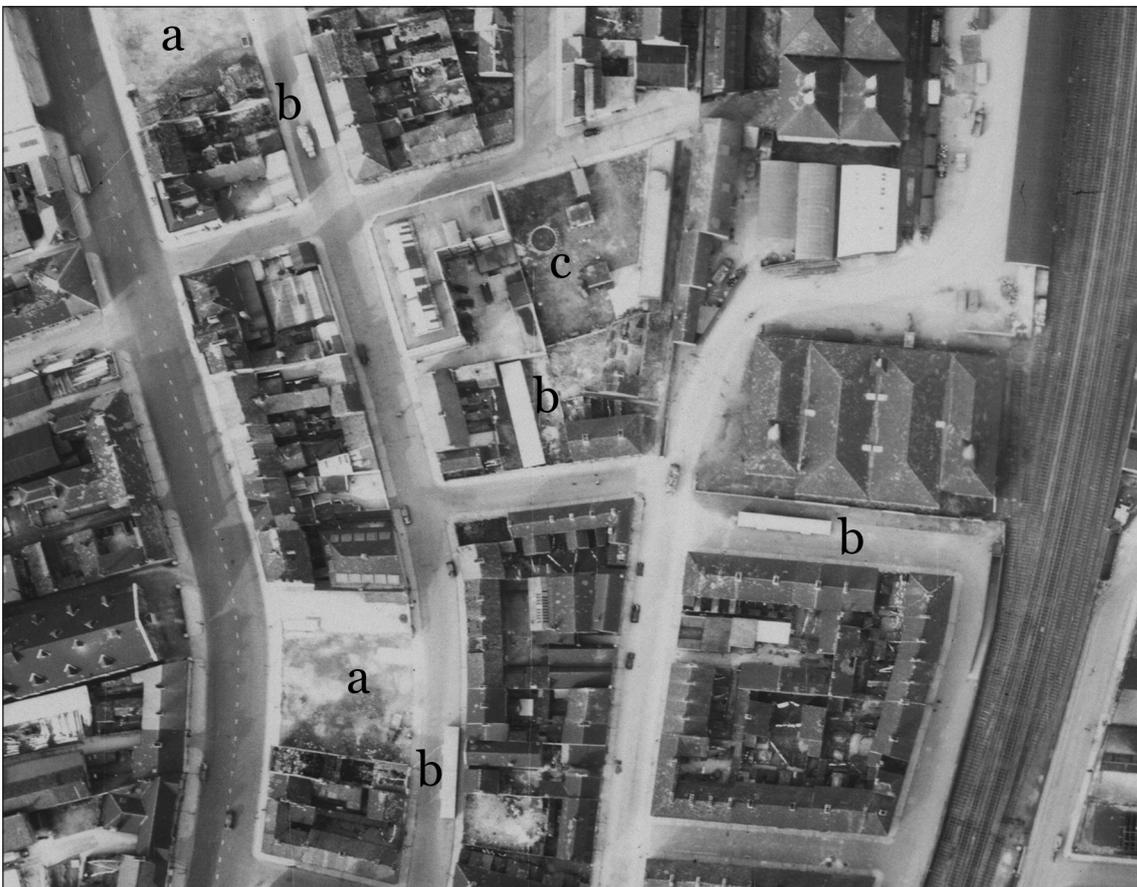
Fig 48: Cleared bomb sites in East Marsh in 1945 (a). Other Second World War features include several surface air raid shelters (b) and an emergency water supply (c). RAF/106G/UK/809 RVp4 6190 17-SEP-1945 Historic England RAF Photography (detail).

RAF photographs from 1945 show a considerable amount of bomb damage in East Marsh. Several cleared bomb sites can be identified along with evidence for damaged buildings in close proximity to these (Fig 48). Over 40 concrete and brick surface shelters were recorded, some of which were located on cleared bomb sites. Covered trench shelters were also located around the railway sidings (Fig 49).

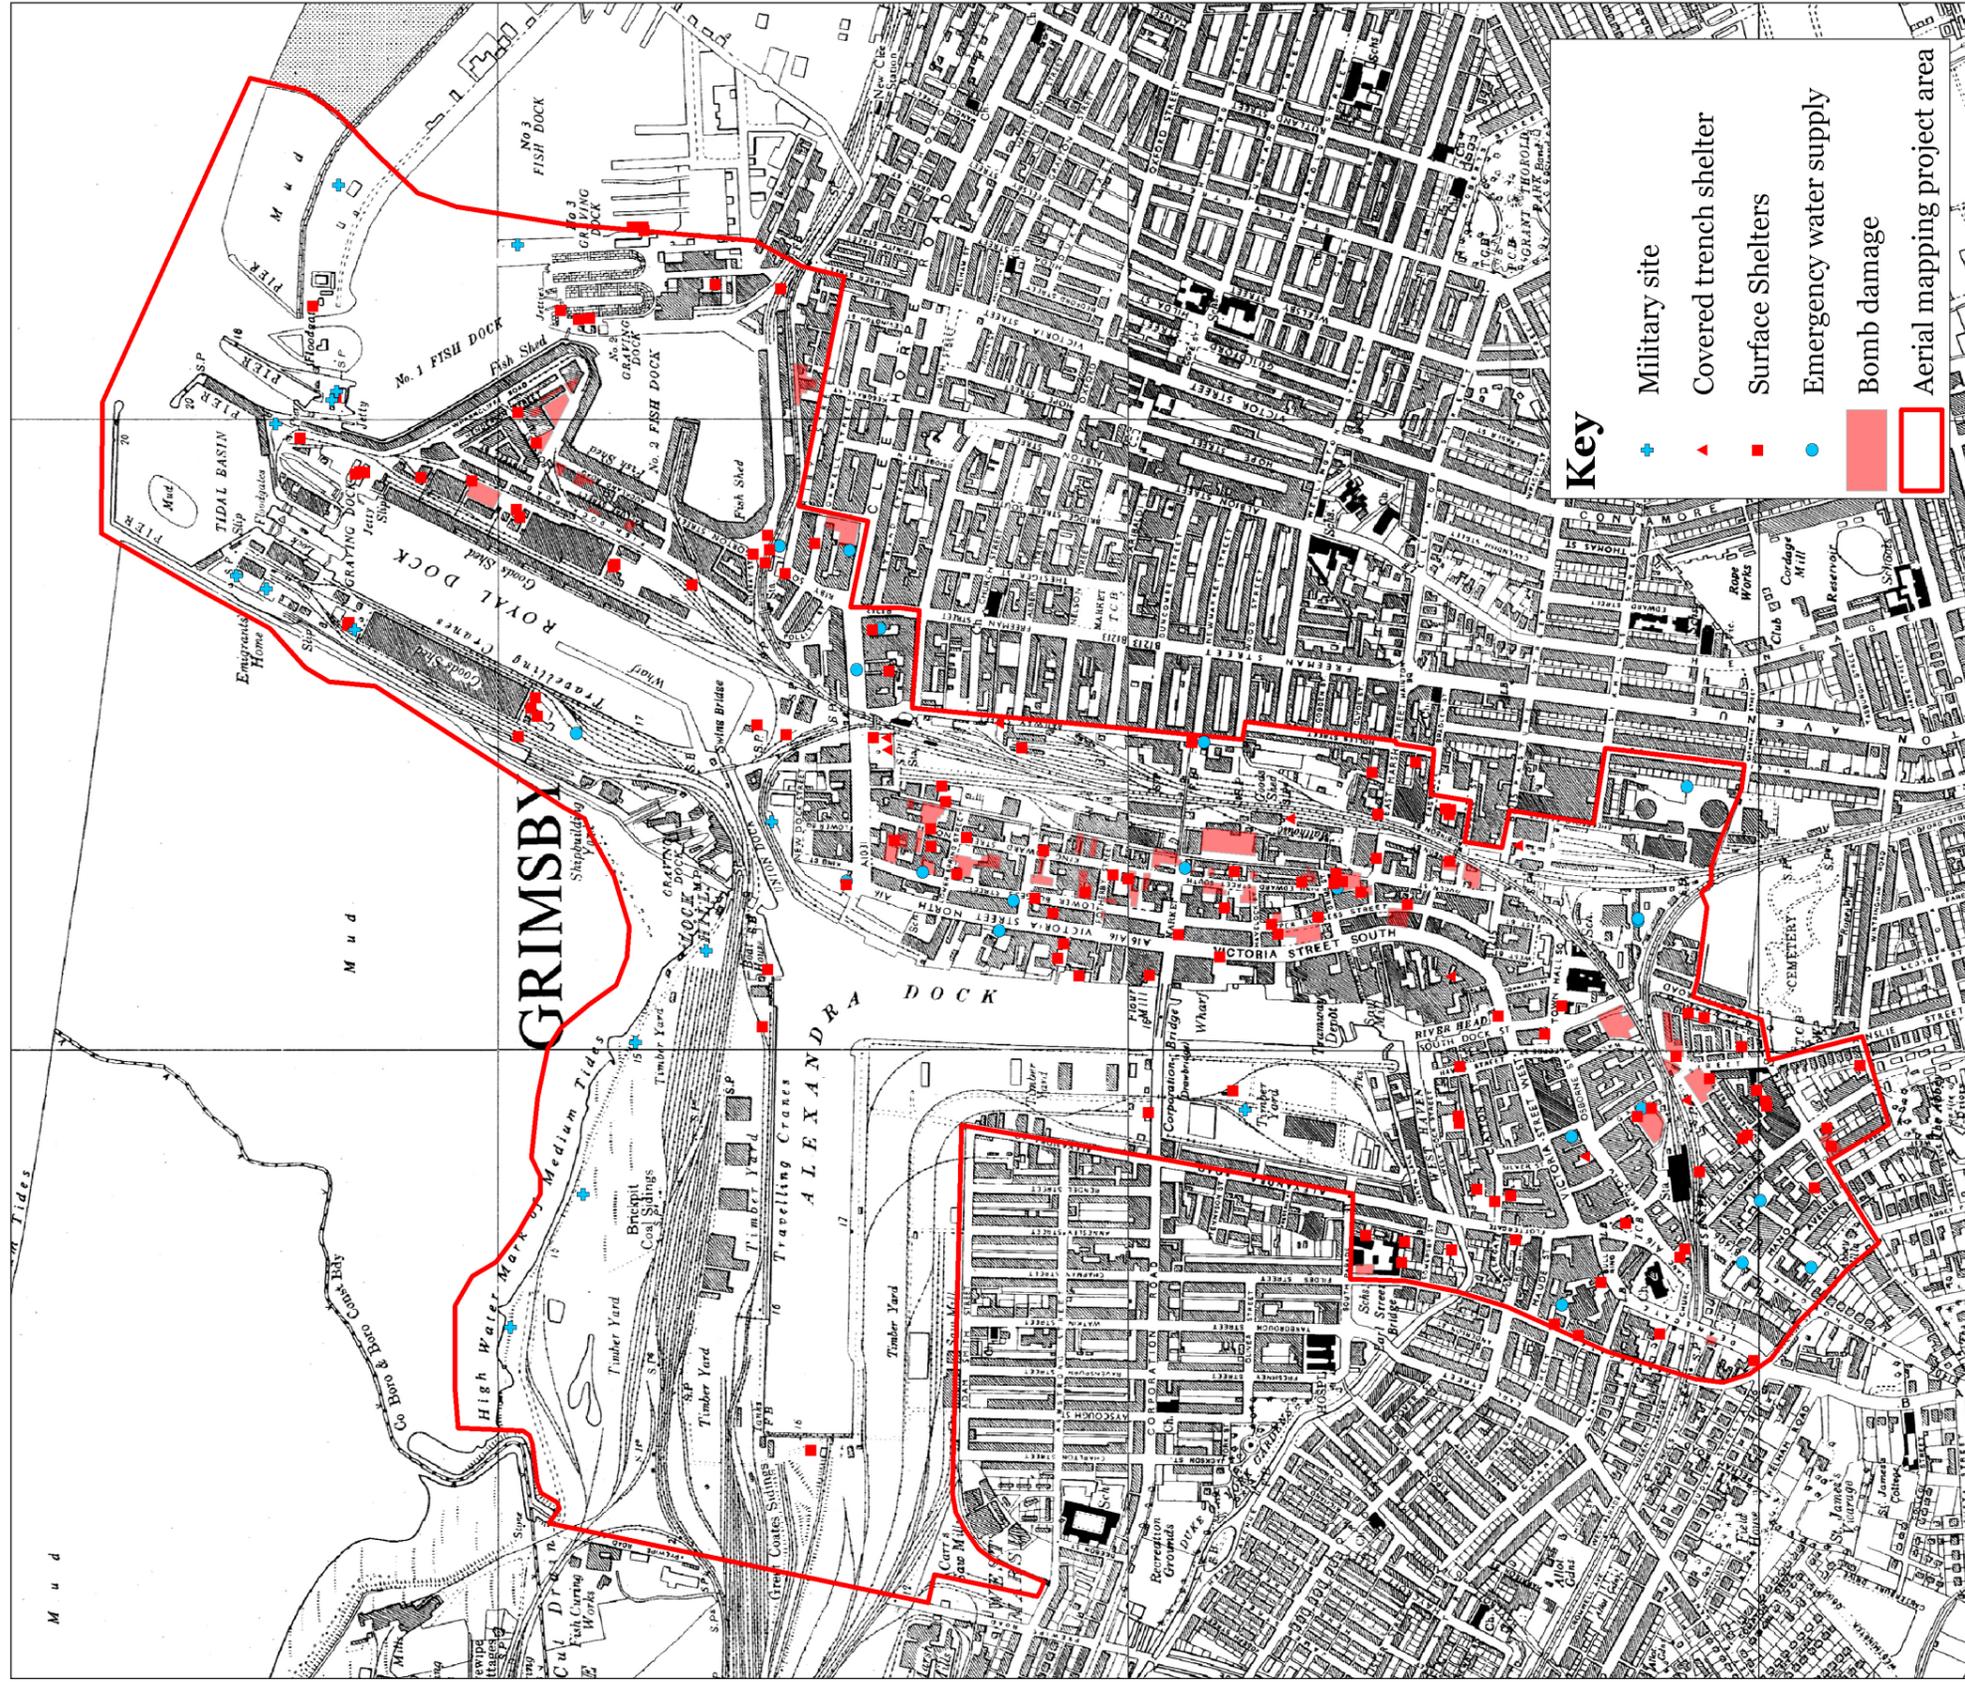
Fig 49: Second World War features in the project area. Ordnance Survey 1:10,560 published 1956 © and database right Crown Copyright and Landmark Information Group Ltd (All rights reserved 2019) Licence numbers 000394 and TP0024.

Elsewhere in the docks a number of surface air raid shelters can be identified on 1940s photographs (see Fig 49). Some of these survived into the 1950s and appear to have been repurposed for storage and other uses (Fig 62). Just one now survives and is located in the car park of the Dock Offices building on Royal Street (Fig 63). The docks suffered bomb damage through the course of the war and several buildings in the Kasbah area were destroyed or demolished, the largest being the bonded warehouse (Fig 64).

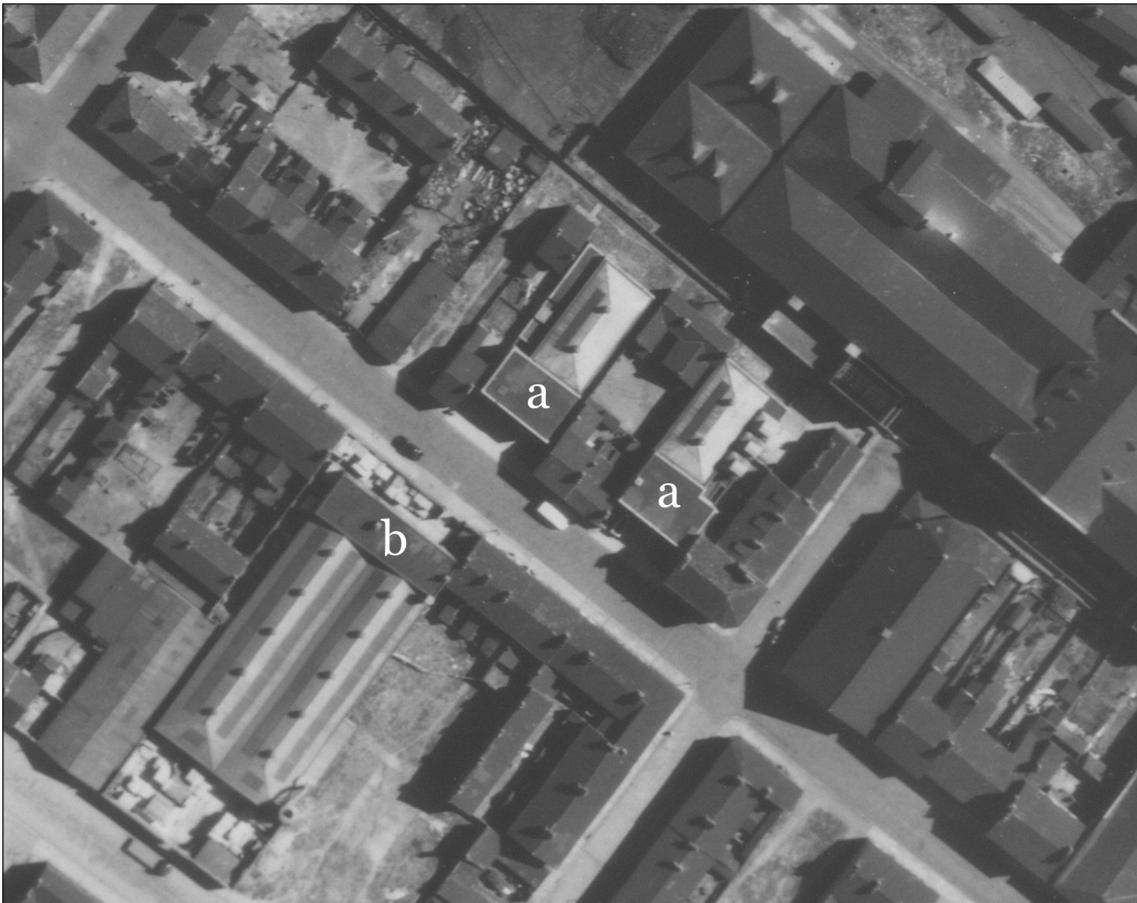
Fig 50: Anglo-Danish House (a) with a second similar post-war office and factory development (b).
RAF/58/768 Vp3 5137 30-JUL-1951 Historic England RAF Photography (detail).

Along with the rebuilding of the Sandars malthouse noted above, other smaller areas of early post-war development are evident in the late 1940s and early 1950s. Anglo-Danish House, located on King Edward Street, was designed by Grimsby-based architect William Wells in 1946 and comprised a bacon factory and smokehouse with offices fronting onto the road (North East Lincolnshire Council 2017, 127). The first phase of construction was a pair of units which utilised two bomb sites. These can be seen under construction in 1947 and were completed by 1950 (Fig 50). They were later incorporated into the existing office building which appears to have slightly adapted the façade. A similar factory and office building can be seen on the opposite side of the road.

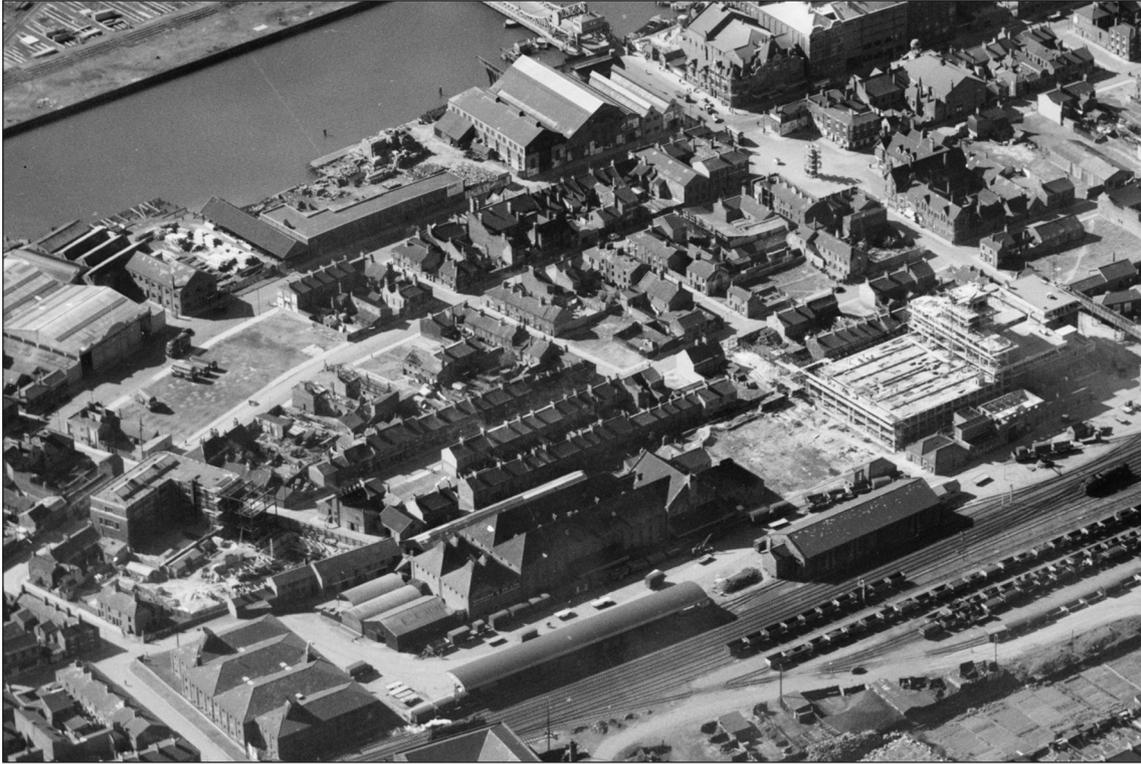
Fig 51: The telephone exchange extension (left) and new malthouse (right) under construction in 1950. © Historic England Archive. Aerofilms Collection EAW029028 10-MAY-1950 (detail).
