Grimsby Heritage Action Zone An Assessment of the Historic England Archive Aerial Photographs

An assessment of the Historic England Archive Aerial Photographs

This report summarises the results of an assessment of the aerial photographs held in the Historic England Archive for the Greater Grimsby Heritage Action Zone. The project covered 2.8sq km and encompassed the entirety of the Heritage Action Zone with an additional buffer to provide a broader landscape context.

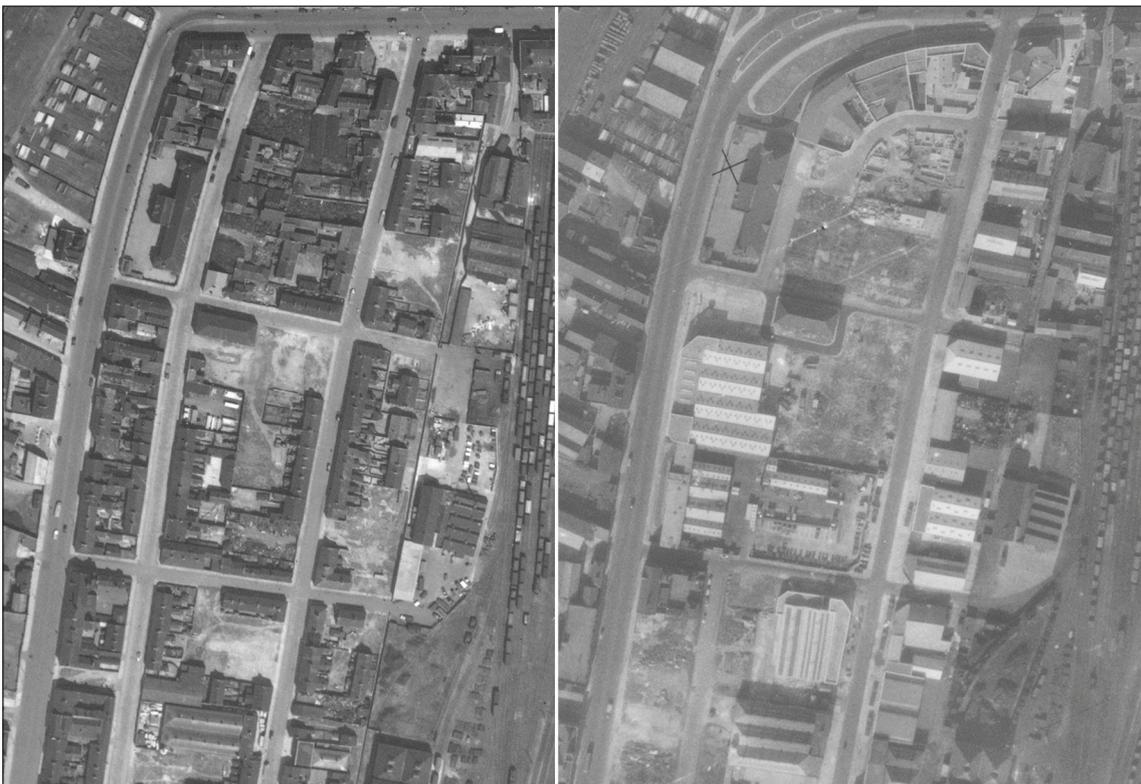
Fig 52: East Marsh in 1952 (left) and 1959 (right). RAF/58/893 V 5406 10-JUN-1952 Historic England RAF Photography (detail). MAL/59042 V 29-SEP-1959 Reproduced by permission of Historic England (detail).

By the mid-1950s a more systematic programme of clearance had commenced with the terraces between Victoria Street and the railway sidings being demolished and replaced with new industrial units. Photographs from 1957 show the first of these under construction and photography from subsequent years records the gradual development of the area (Fig 52). Many of the new units were fronted by red brick offices in the Neo-Georgian style – placing them at the end of the period from 1914 to 1960 when this style dominated (Powers 2017, 14). The development also included the Oberon public house which was constructed in the same manner.

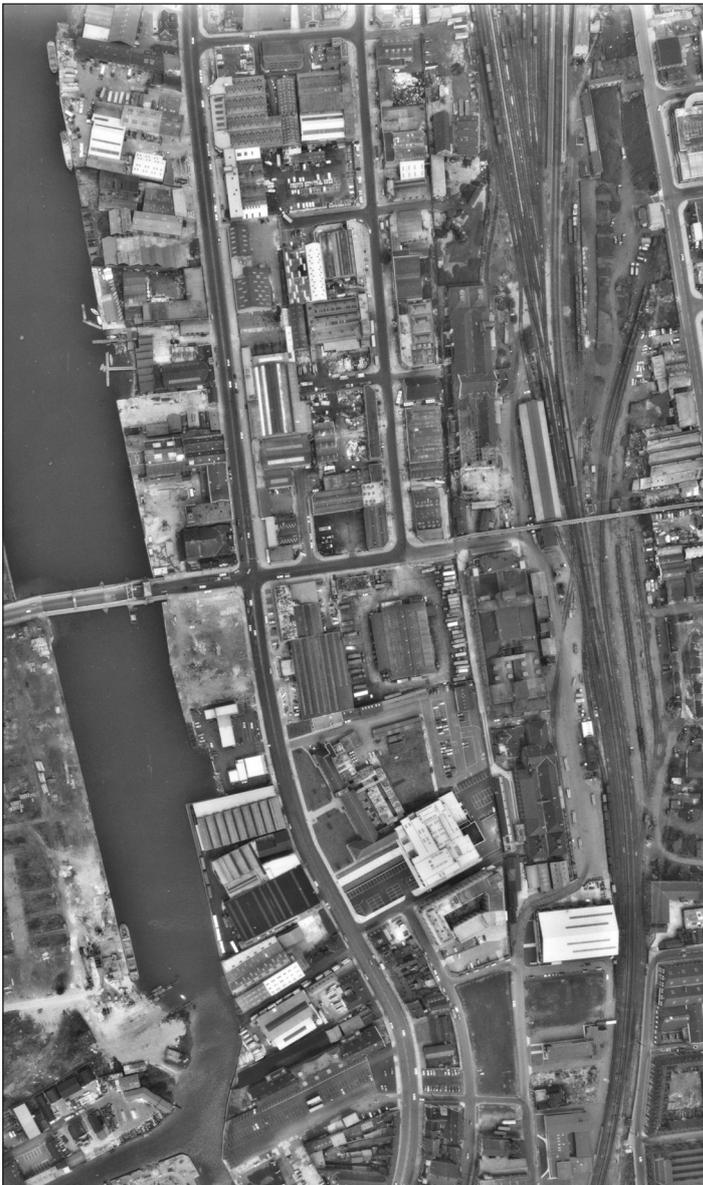
Fig 53: East Marsh in 1970 with the demolition of the northern Sanders malthouse in progress. MAL/70056 V 134 18-JUL-1970. Reproduced by permission of Historic England (detail).

Throughout the 1960s, the aerial photographs record the steadily changing character of East Marsh as further areas are cleared and replaced with large industrial units. By 1968 the former Gilstrap and Earp malthouse on Victoria Street had been demolished and in 1970 demolition of Sanders northern (No. 3) malting was underway (Fig 53). By 1988 only the central (No. 2) malting survived but its closure in 1992 would lead to its eventual demolition in the late 1990s.

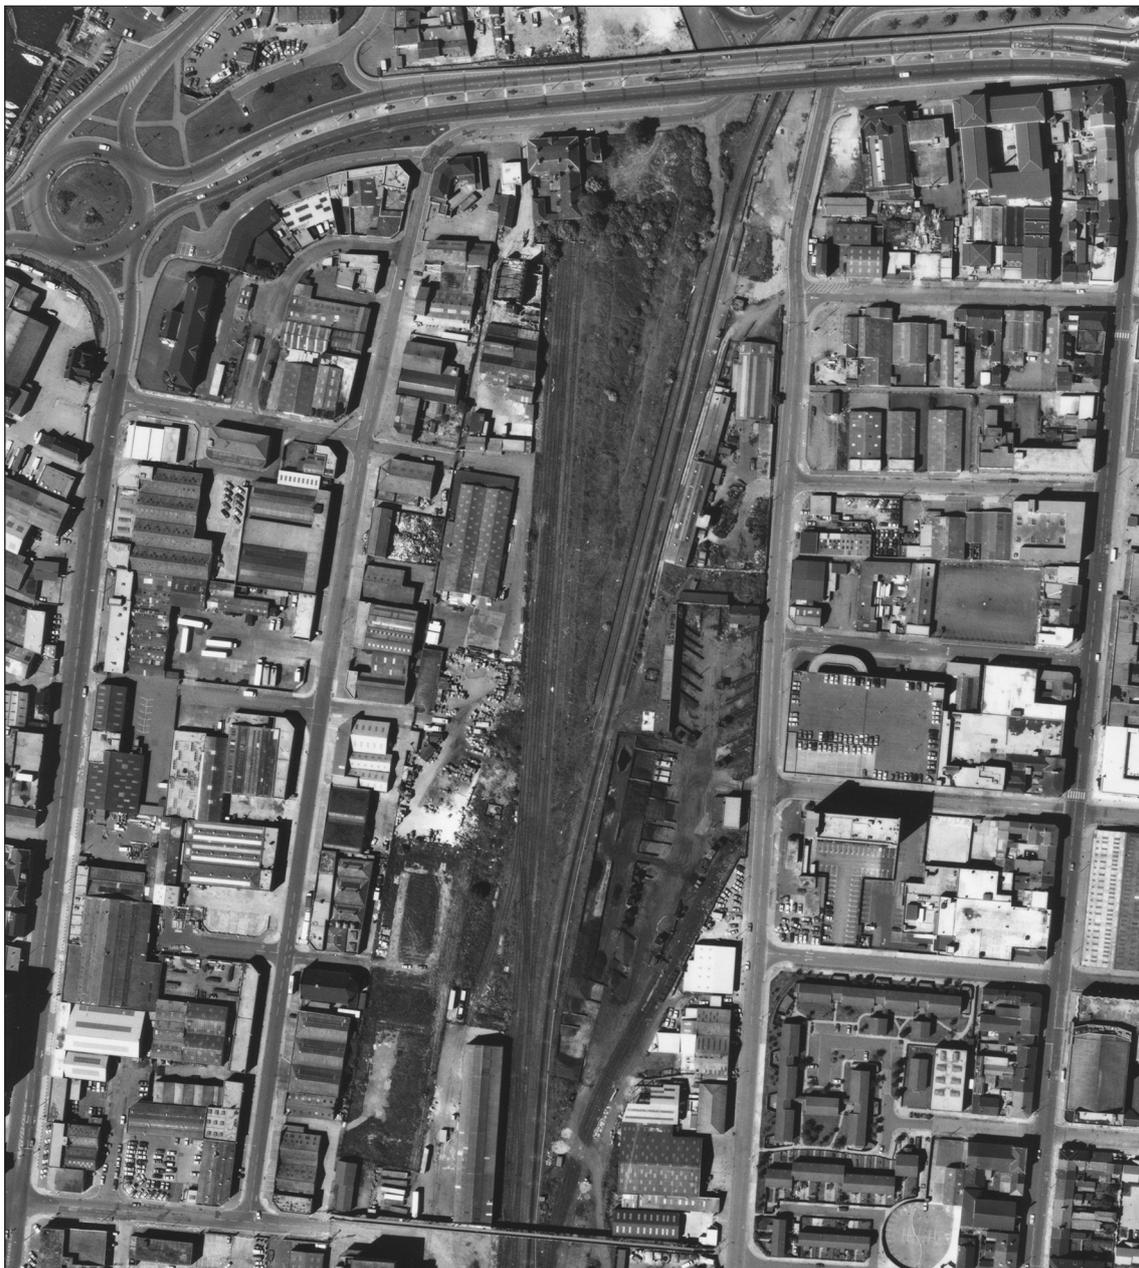
Fig 54: The East Marsh railway sidings in 1988 © Crown copyright. Ordnance Survey (detail).

The Grimsby and New Holland railway had opened in the mid-1800s and large sidings developed in East Marsh. The railway sidings – through a combination of industrial decline and the increase in road haulage – also fall into dereliction during this period. OS photography from 1990 shows all but the existing main line removed and by 1995 redevelopment of the site had begun (Fig 54).

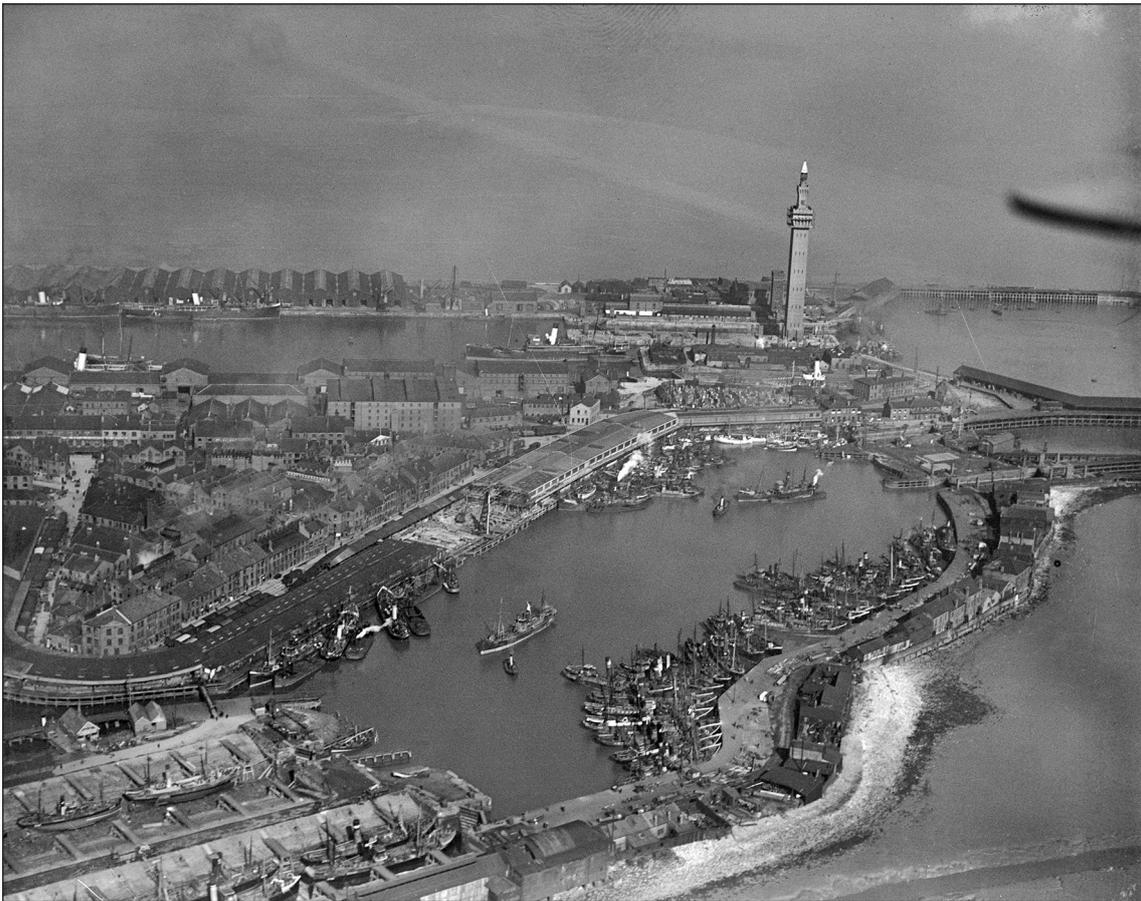
Fig 55: A view of No. 1 Fish Dock towards Royal Dock and the Grimsby Dock Tower in 1925. The eastern quay of the dock can be seen towards the bottom right of the image. © Historic England Archive. Aerofilms Collection EPW012666 06-MAY-1925.

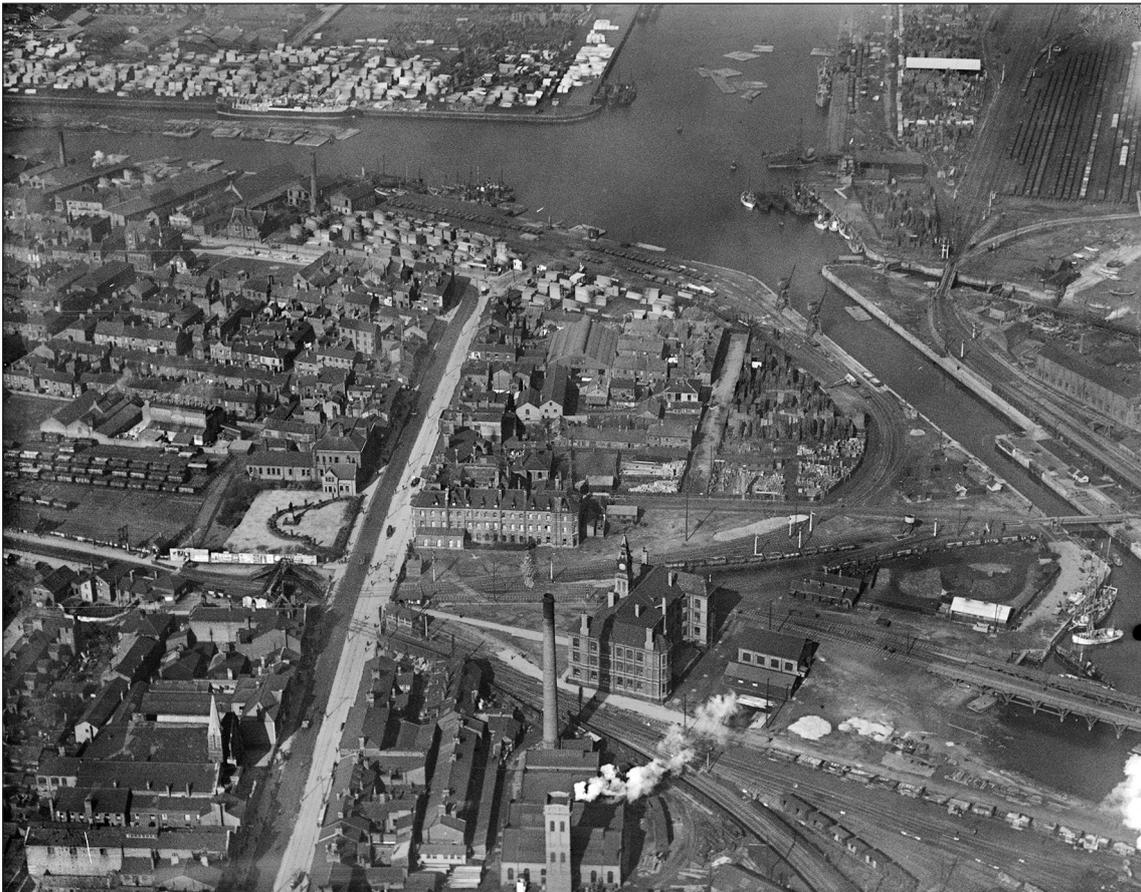
Fig 56: A view westwards towards Alexandra Dock with the Grimsby Dock offices in the foreground. The piers of one of the 19th-century coal drops is just visible in the bottom right corner of the image. © Historic England Archive. Aerofilms Collection EPW012669 06-MAY-1925.

A second frame from 1925 shows a view westwards from the dock offices towards Alexandra Dock (Fig 56). One of the late 19th-century coal drops which served the Royal Dock can just be seen on the right of the frame. This was removed around five years later, along with the connecting railway line. On another image a boat is being maintained in the graving dock and scaffolding can be seen around the dock tower (Fig 57).

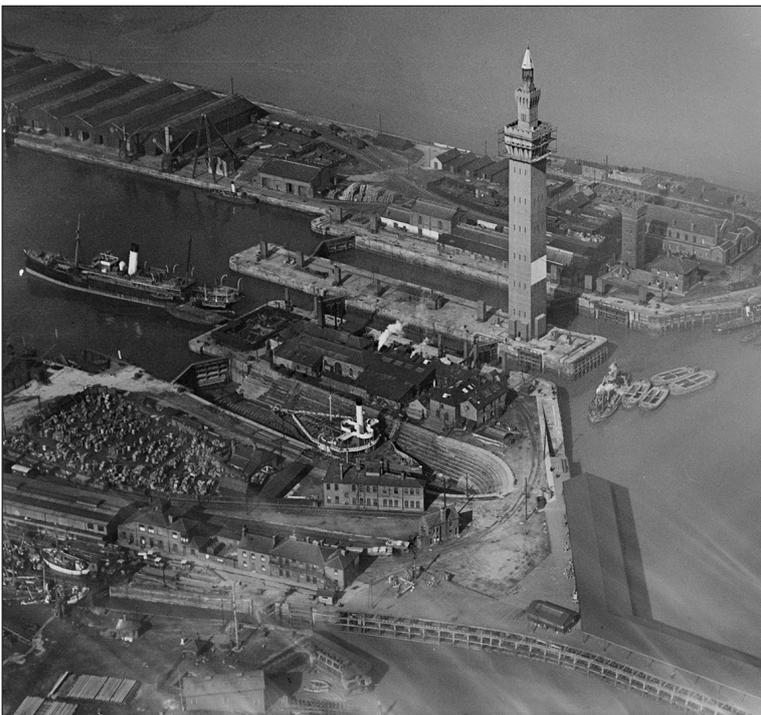
Fig 57: An image from 1925 showing scaffolding around the top of the Grimsby Dock Tower. © Historic England Archive. Aerofilms Collection EPW012668 06-MAY-1925 (detail).

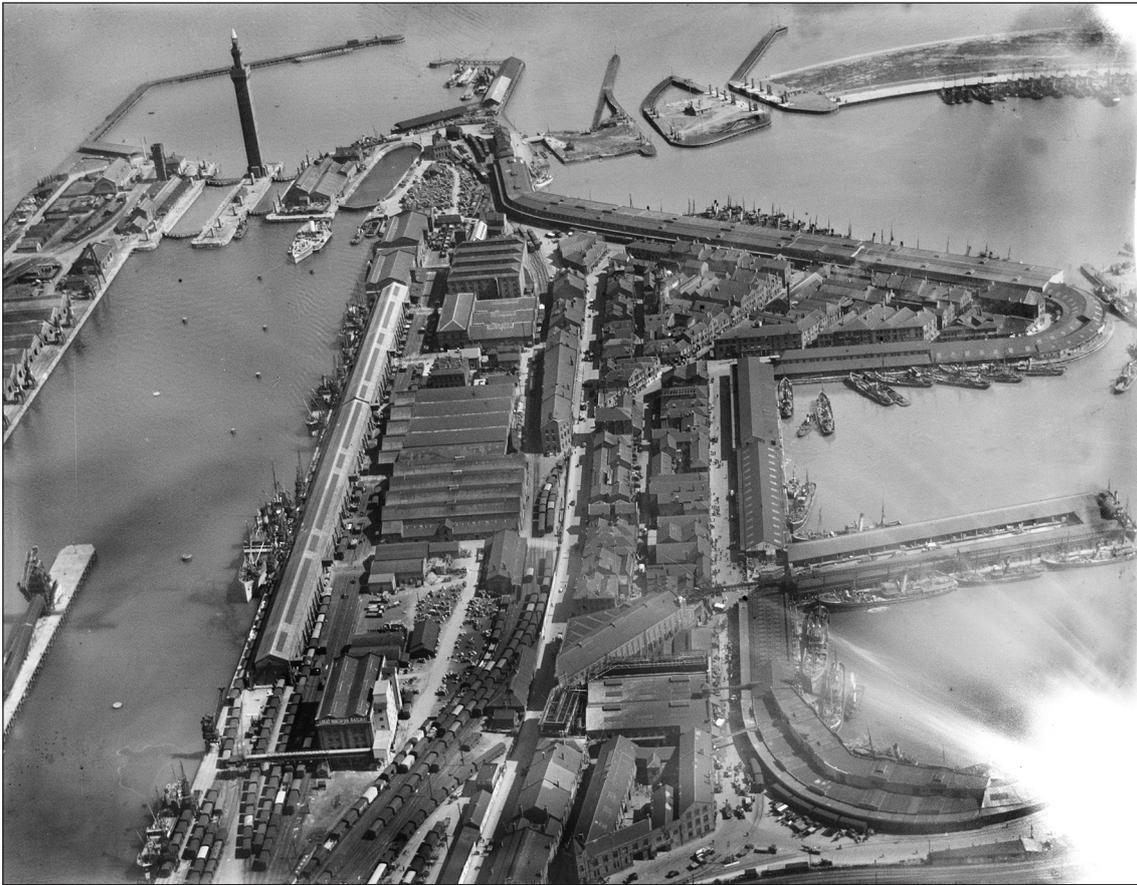
Fig 58: The Kasbah looking north in 1937. © Historic England Archive. Aerofilms Collection EPW053393 31-MAY-1937.

One photograph in particular encapsulates the busy atmosphere of the Kasbah. Taken in 1937, it shows the fish docks busy with shipping, railway wagons, motor vehicles and people (Fig 58). Several buildings that were lost during the war can be seen, including the bonded warehouse. The images also provide a record of the numerous buildings that were lost in the post-war years. In Royal Dock the warehouses and travelling cranes that loaded and unloaded cargo are illustrated and the photography also provides good views of the coal drops which were removed in the late 1960s (Fig 59).

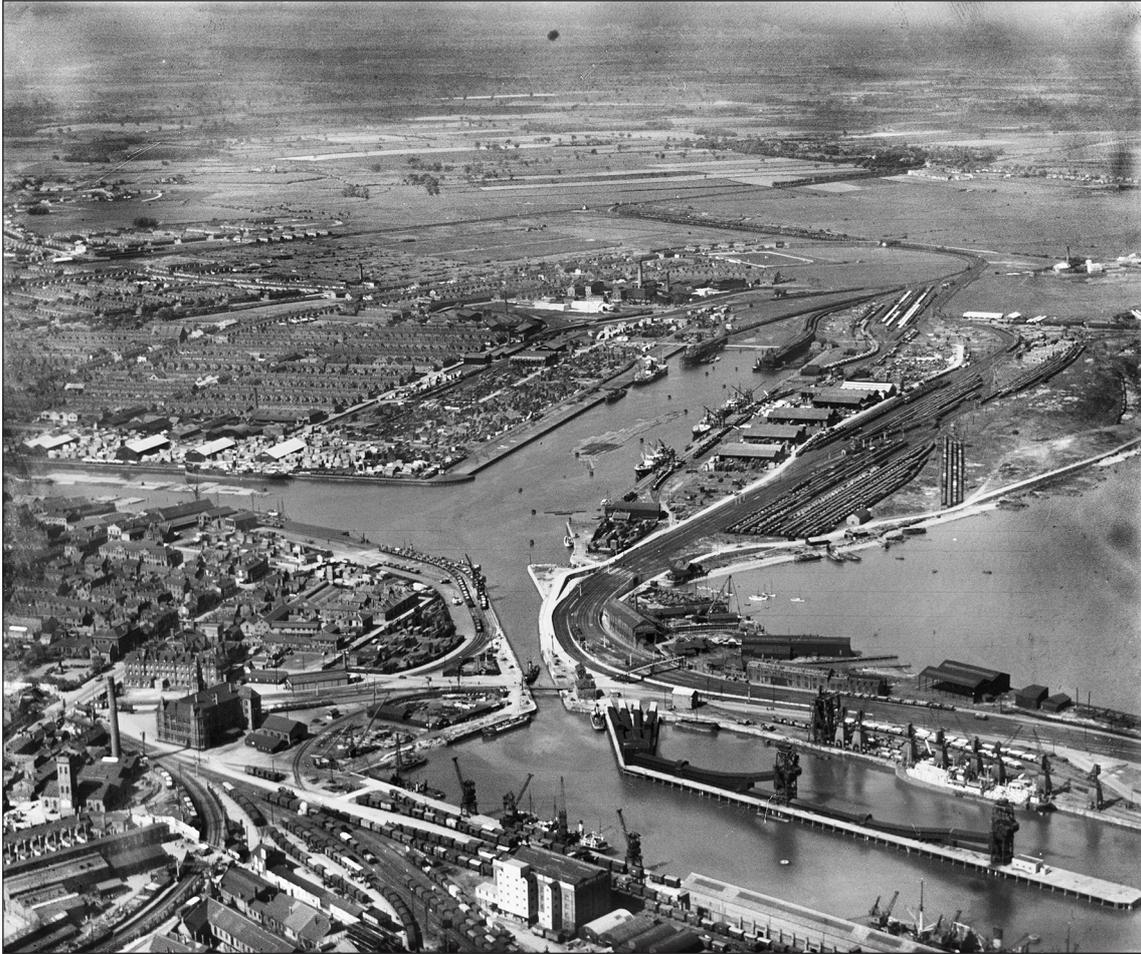
Fig 59: Royal Dock looking towards Alexandra Dock. The coal drops and cranes serving Royal Dock can be seen in the bottom right of the image. © Historic England Archive. Aerofilms Collection EPW053389 31-MAY-1937.

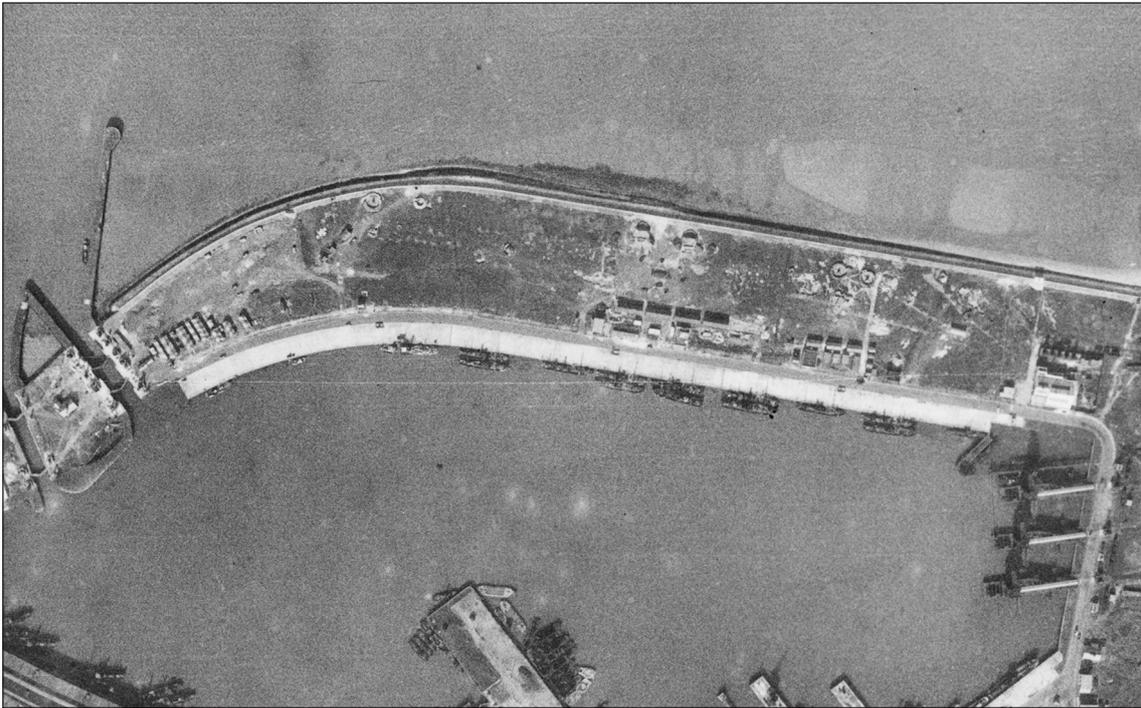
Fig 60: The anti-aircraft battery located on the northern quay of No. 3 Fish Dock photographed in the year that it became operational. RAF/613A/BR19/3/VJ/0019 02-SEP-1940 Historic England Archive RAF Photography (detail).

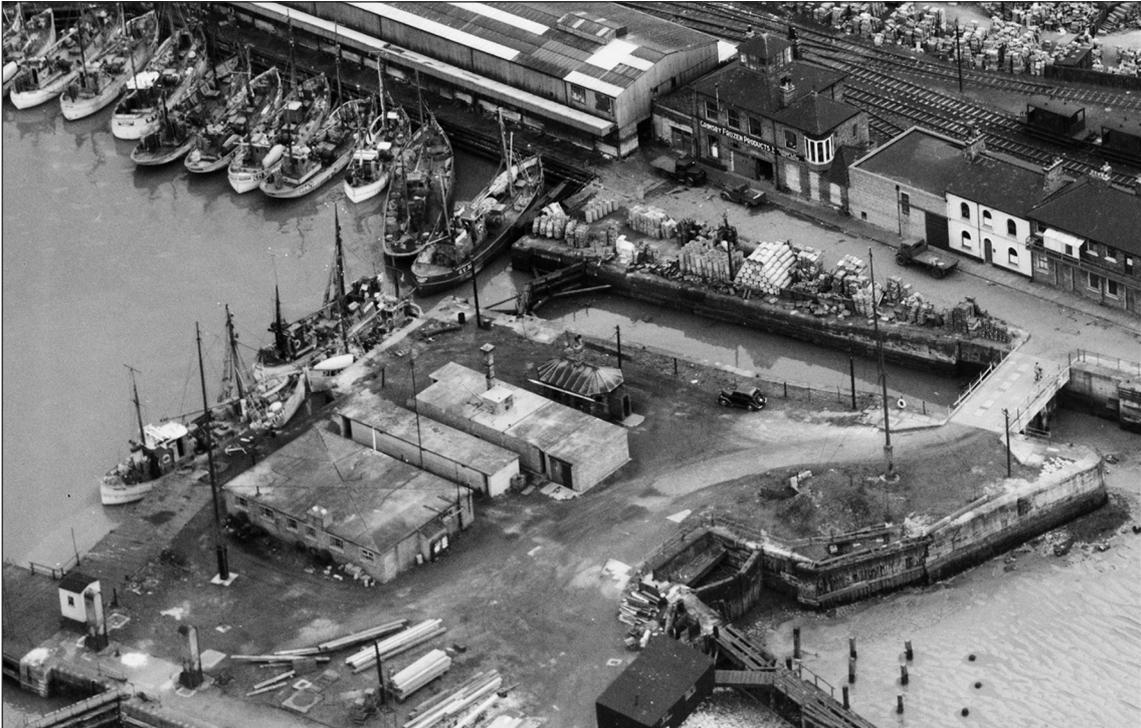
Fig 61: Military buildings built over a filled-in lock crew room, surface air raid shelter and possible decontamination centre with water tank and chimney. © Historic England Archive. Aerofilms Collection EAW029405 05-APR-1950 (detail).

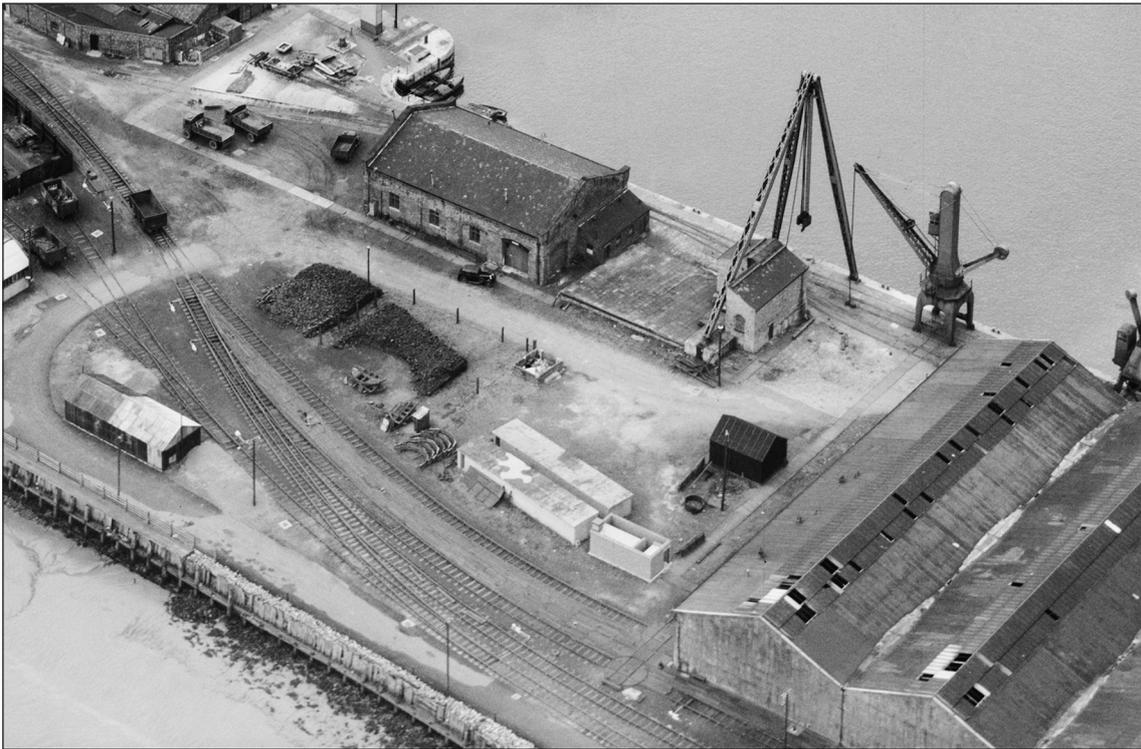
Fig 62: Two surface air raid shelters photographed in 1950 with traces of their camouflage paint scheme. The small building next to them is a potential home guard arms store © Historic England Archive. Aerofilms Collection EAW029407 05-APR-1950 (detail).

Elsewhere in the docks a number of surface air raid shelters can be identified on 1940s photographs (see Fig 49). Some of these survived into the 1950s and appear to have been repurposed for storage and other uses (Fig 62). Just one now survives and is located in the car park of the Dock Offices building on Royal Street (Fig 63). The docks suffered bomb damage through the course of the war and several buildings in the Kasbah area were destroyed or demolished, the largest being the bonded warehouse (Fig 64).

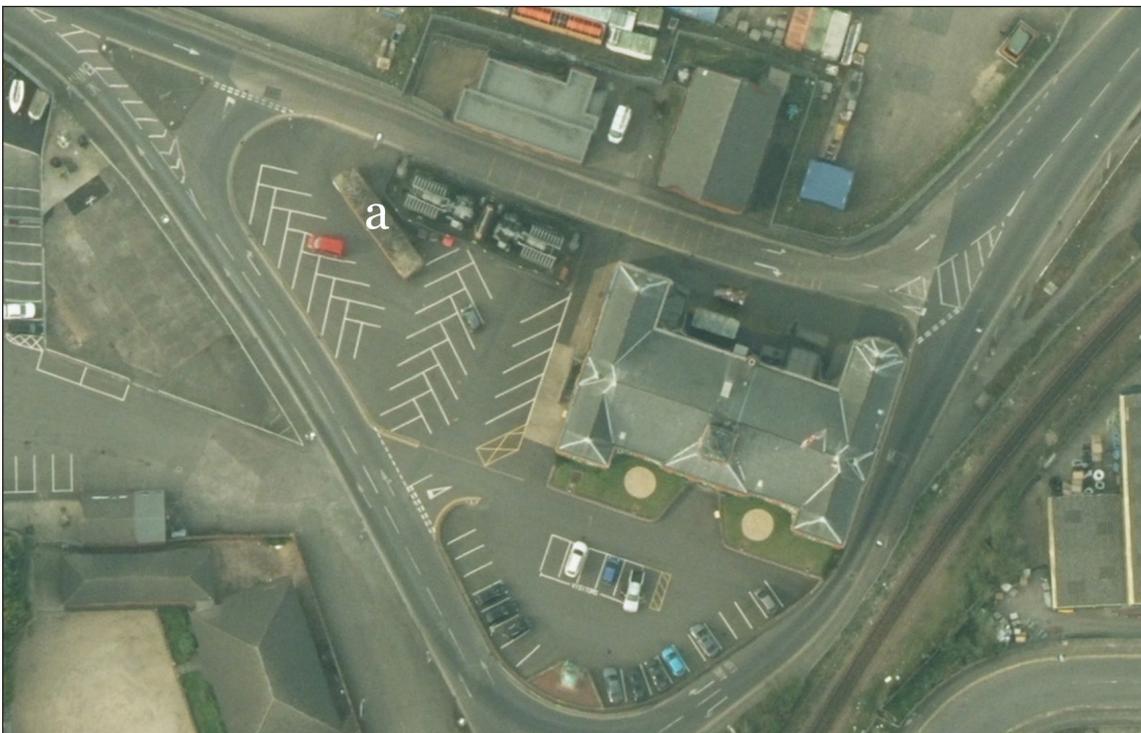
Fig 63: A surviving surface air raid shelter (a) in the car park of the Dock Offices building. TA2710 21-APR-2016 © Bluesky International/Getmapping PLC.

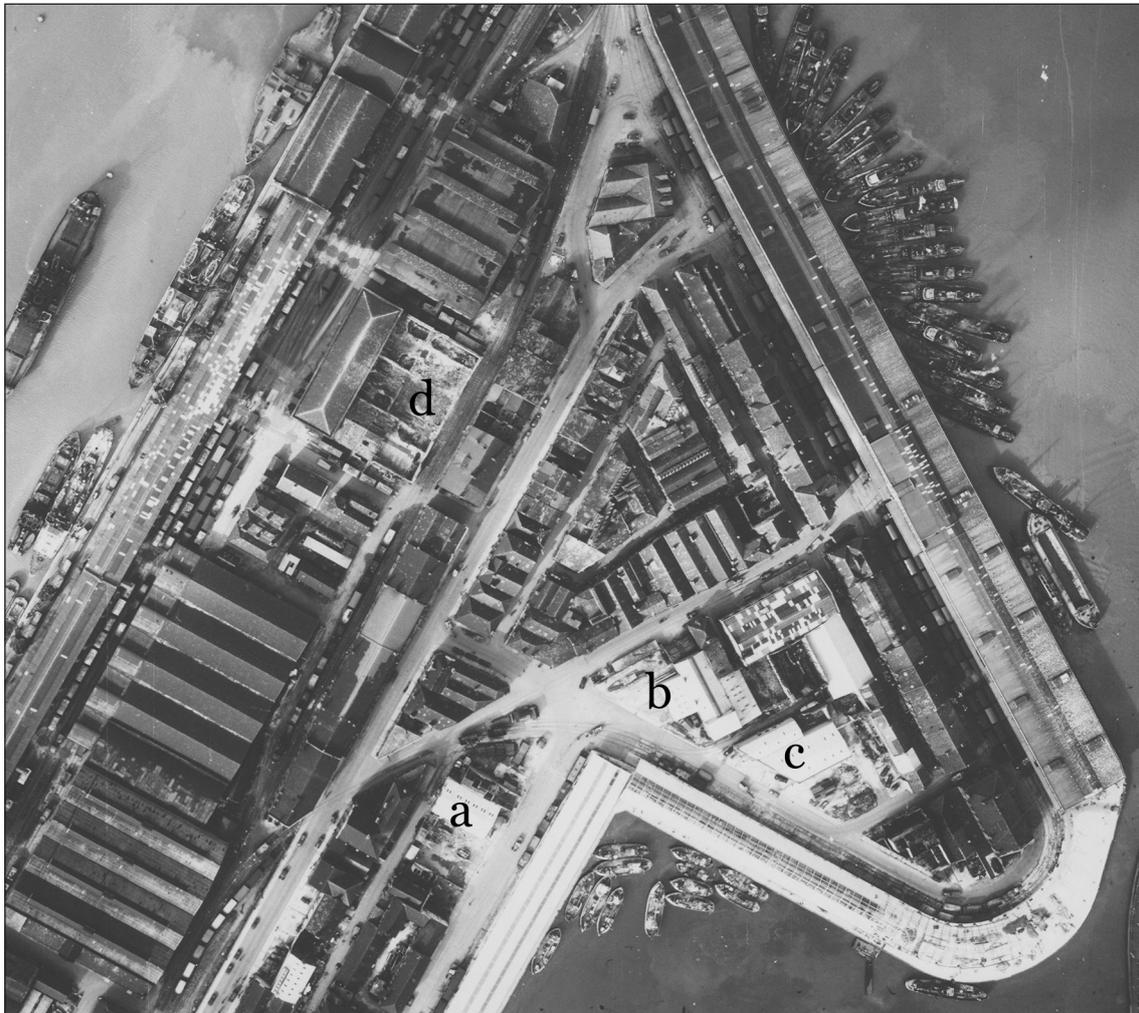
Fig 64: Redevelopment of bomb sites in the Kasbah (a-c). Other bombed out buildings such as the bonded warehouse (d) remained. RAF/106G/UK/809 RVp2 6091 17-SEP-1945 Historic England RAF Photography (detail).

RAF photographs from 1945 show a number of buildings which appear to have to be newly constructed on former bomb sites, indicating that rebuilding had commenced in the later years of the war or very soon after it had ended (Fig 64). Further areas of redevelopment are evident by the early 1950s. By 1949 the former post office building on the junction of Cross Street, Hutton Road and Auckland Road had been rebuilt along with a bomb site a couple of properties to the south. Others were redeveloped on Fish Dock Road (Fig 65).

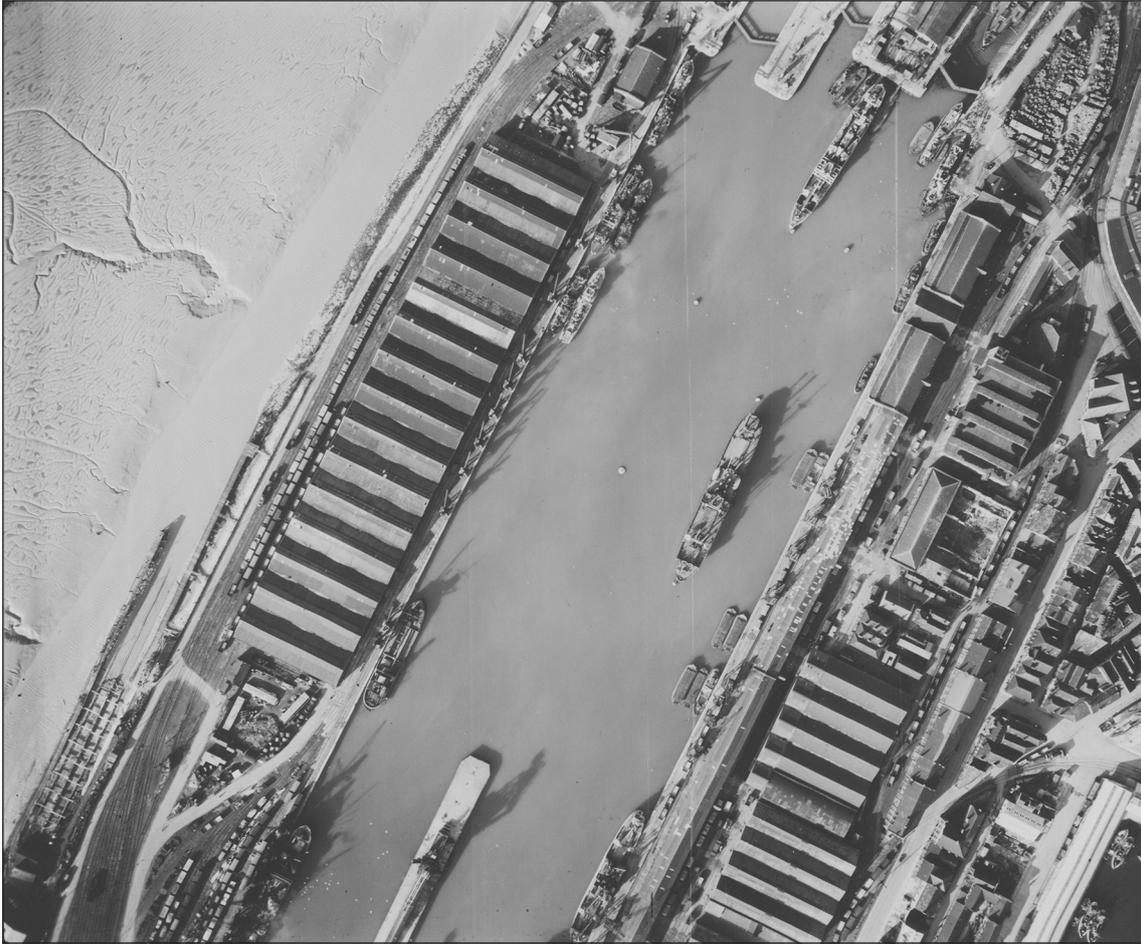
Fig 66: Warehouses lining the Royal Dock. The railway sidings serving the dock can be seen running alongside the large warehouse on the western quay. RAF/106G/UK/849 RV 6038 28-SEP-1945 Historic England RAF Photography.

The Royal Dock had traditionally handled Grimsby's trade in the various goods being imported into and exported from the UK. The quaysides were flanked by large warehouses, all linked into the railway system that served the docks (Fig 66). By 1959 the large transit shed on the western quayside had been reduced in size. The site of the bonded warehouse, which had been destroyed in the war, had also been redeveloped by this date. Within two years further modernisation of the eastern quayside can be seen (Fig 67). The two 19th-century warehouses to the north-east of the long transit shed (Fig 68) had been demolished along with one of the larger warehouses to the east. Another appears to have been re-roofed or entirely rebuilt.

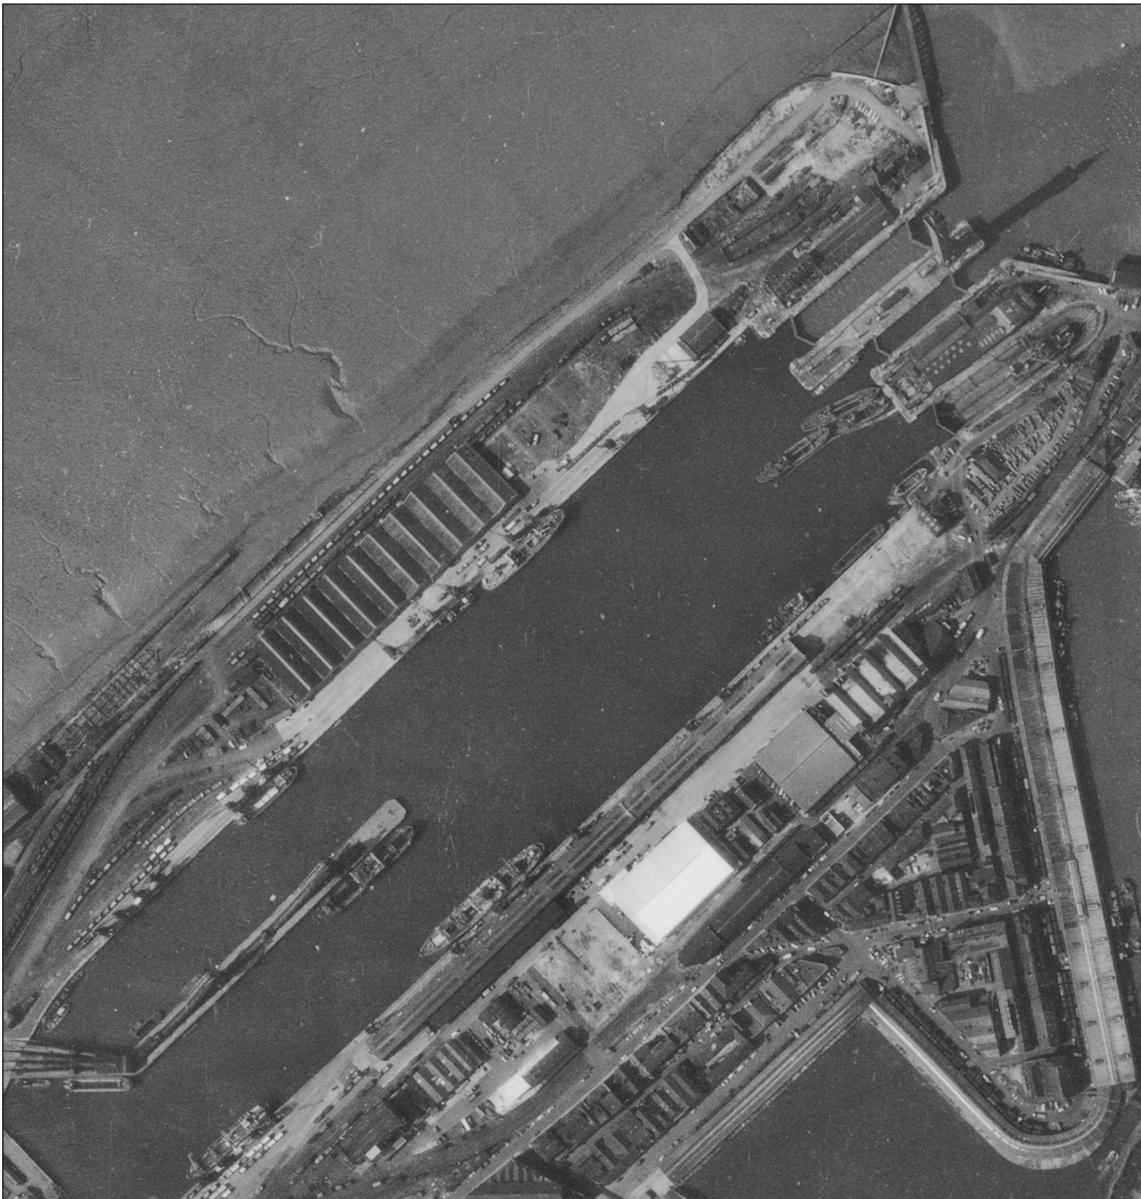
Fig 67: Modernisation of the quayside facilities on Royal Dock. These include new warehouses to the east of the dock. MAL/61499 V 95610 29-AUG-1961. Reproduced by permission of Historic England (detail).

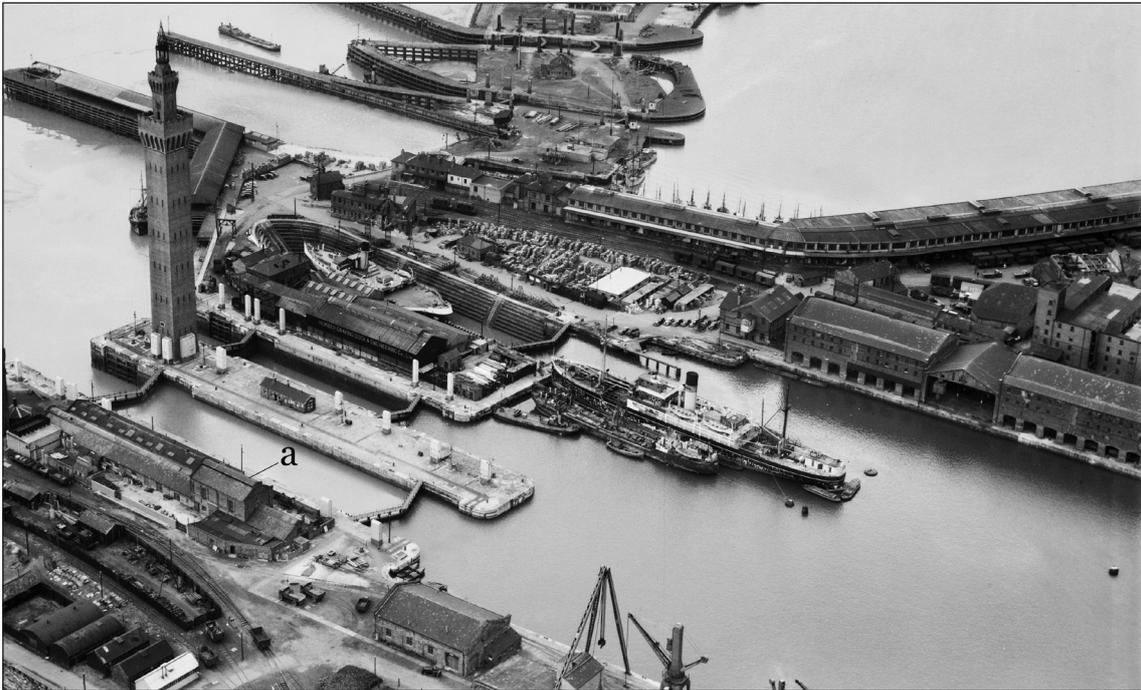
Fig 68: One of the 19th-century warehouses on Royal Dock that were demolished around 1960 visible to the right of the photograph. The long building to the west of the Grimsby Dock Tower (a) was converted for use as a First World War Army slaughter house. © Historic England Archive. Aerofilms Collection EAW029407 05-APR-1950 (detail).

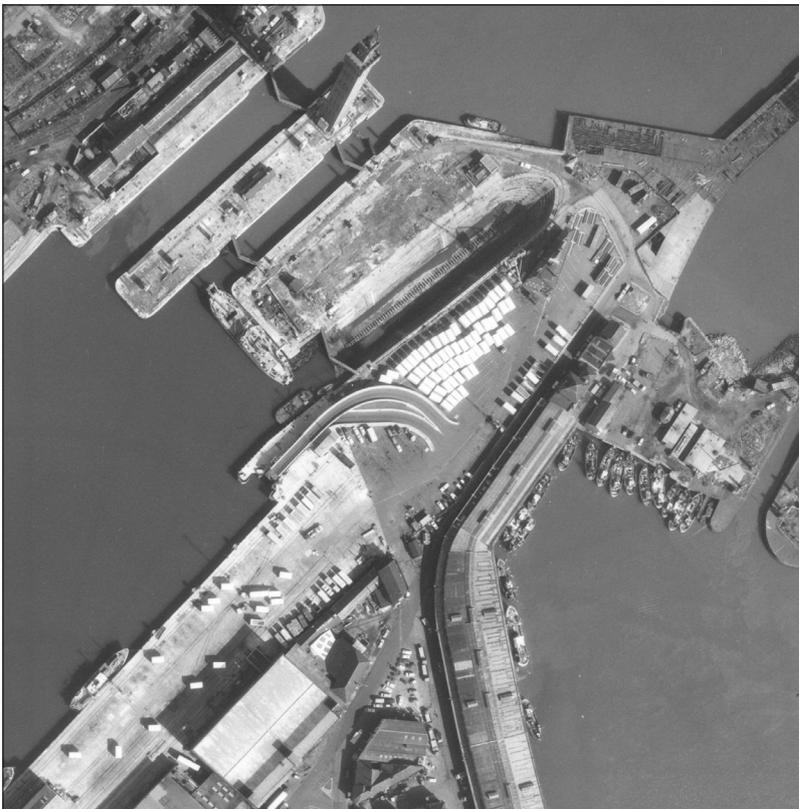
Fig 69: The newly constructed roll-on/roll-off ramps at the northern end of Royal Dock. MAL/6856 V 0105. Reproduced by permission of Historic England (detail).

In the late 1960s the introduction of the shipping container changed the face of many UK ports. As well as significantly reducing the number of workers required to handle cargo, it also led to the concentration of activity in a smaller number of ports with facilities that could accommodate the new infrastructure required (El-Sahli and Upward 2017). This coincided with the rise in road haulage and decline in rail freight. Photographs from 1968 show a number of changes around the entrance to the Royal Dock (Fig 69). Most notable is the construction of a two-storey ramp next

to the graving dock which was built to accommodate roll-on/roll-off vessels. This development also included large areas of hard standing which had been previously occupied by warehouses and fish box storage. The facility had expanded by 1970 with further demolition of the transit shed and infilling of the graving dock. All of the workshops of the Humber Graving Dock & Engineering Co Ltd had been demolished by the late 1960s along with the former emigrants' dormitory building on the western quay. The coal drops, which were located on the jetty within Royal Dock had also been demolished. Reproduced by permission of Historic England

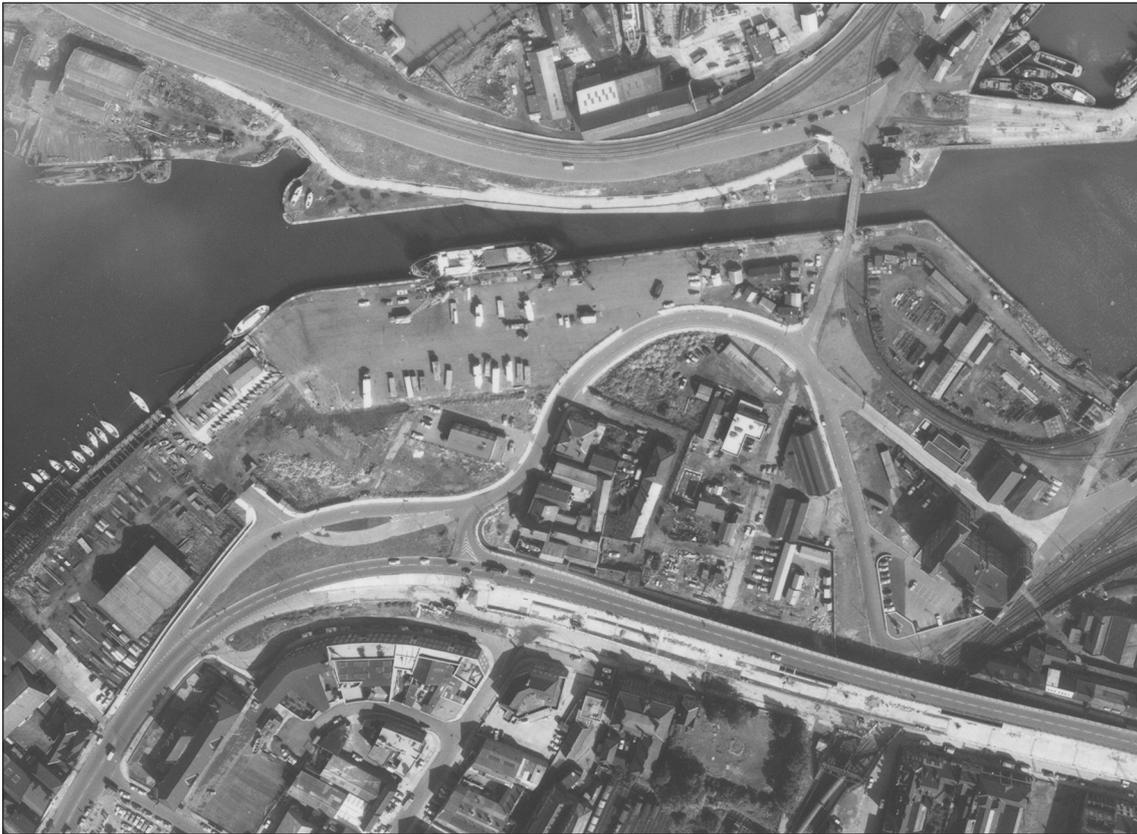
Fig 70: The redeveloped quayside on Union Dock, fully integrated into the road system. MAL/68056 V 136 16-AUG-1968. Reproduced by permission of Historic England.

New quayside facilities are also visible on Union Dock with access to the Cleethorpes Road flyover via a new road system which replaced the existing railway line and sidings (Fig 70). In the Kasbah area much of the railway infrastructure that had been so instrumental to the development of the docks was redundant by the mid-1970s or had been removed entirely. During the 1980s the character of the Royal Dock quayside continued to change. By 1988 the last vestiges of the transit shed had been removed and few other historic buildings remained (Fig 71). One of the few exceptions was the Great Northern Railway warehouse.

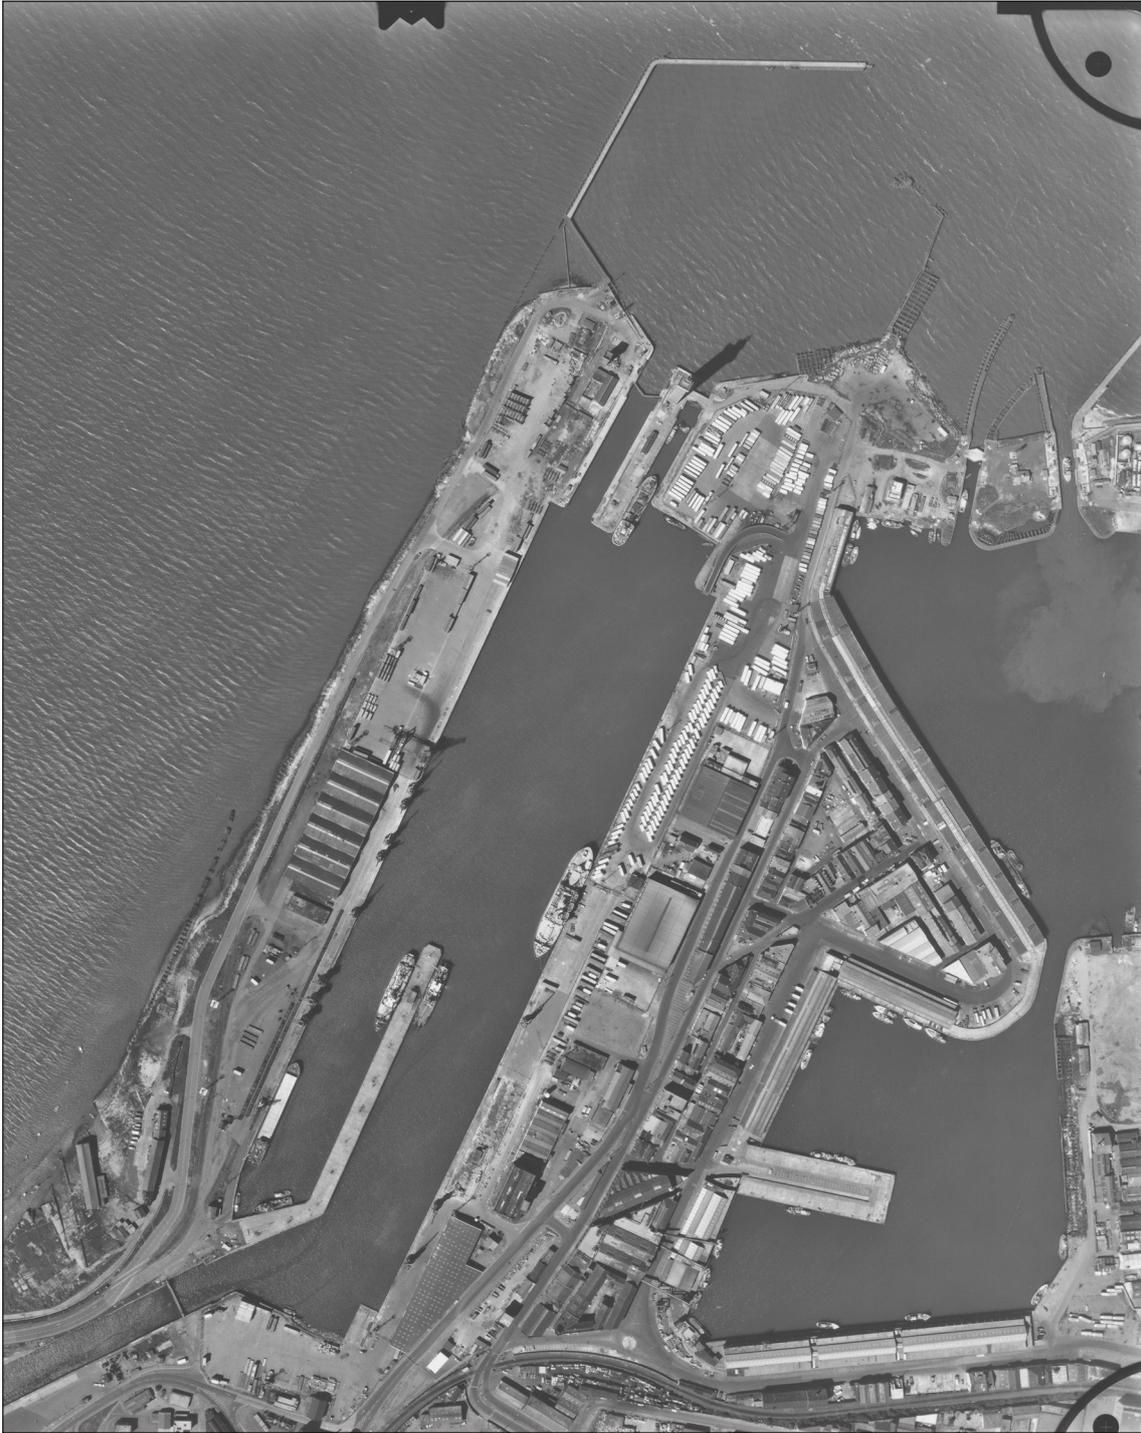
Fig 71: Further dockside redevelopment seen in 1988. By this point most of the original warehouses serving Royal Dock had been demolished. OS/88158 V 343 12-JUN-1988 © Crown copyright. Ordnance Survey (detail).
