Grimsby Heritage Action Zone An Assessment of the Historic England Archive Aerial Photographs

An assessment of the Historic England Archive Aerial Photographs

This report summarises the results of an assessment of the aerial photographs held in the Historic England Archive for the Greater Grimsby Heritage Action Zone. The project covered 2.8sq km and encompassed the entirety of the Heritage Action Zone with an additional buffer to provide a broader landscape context.

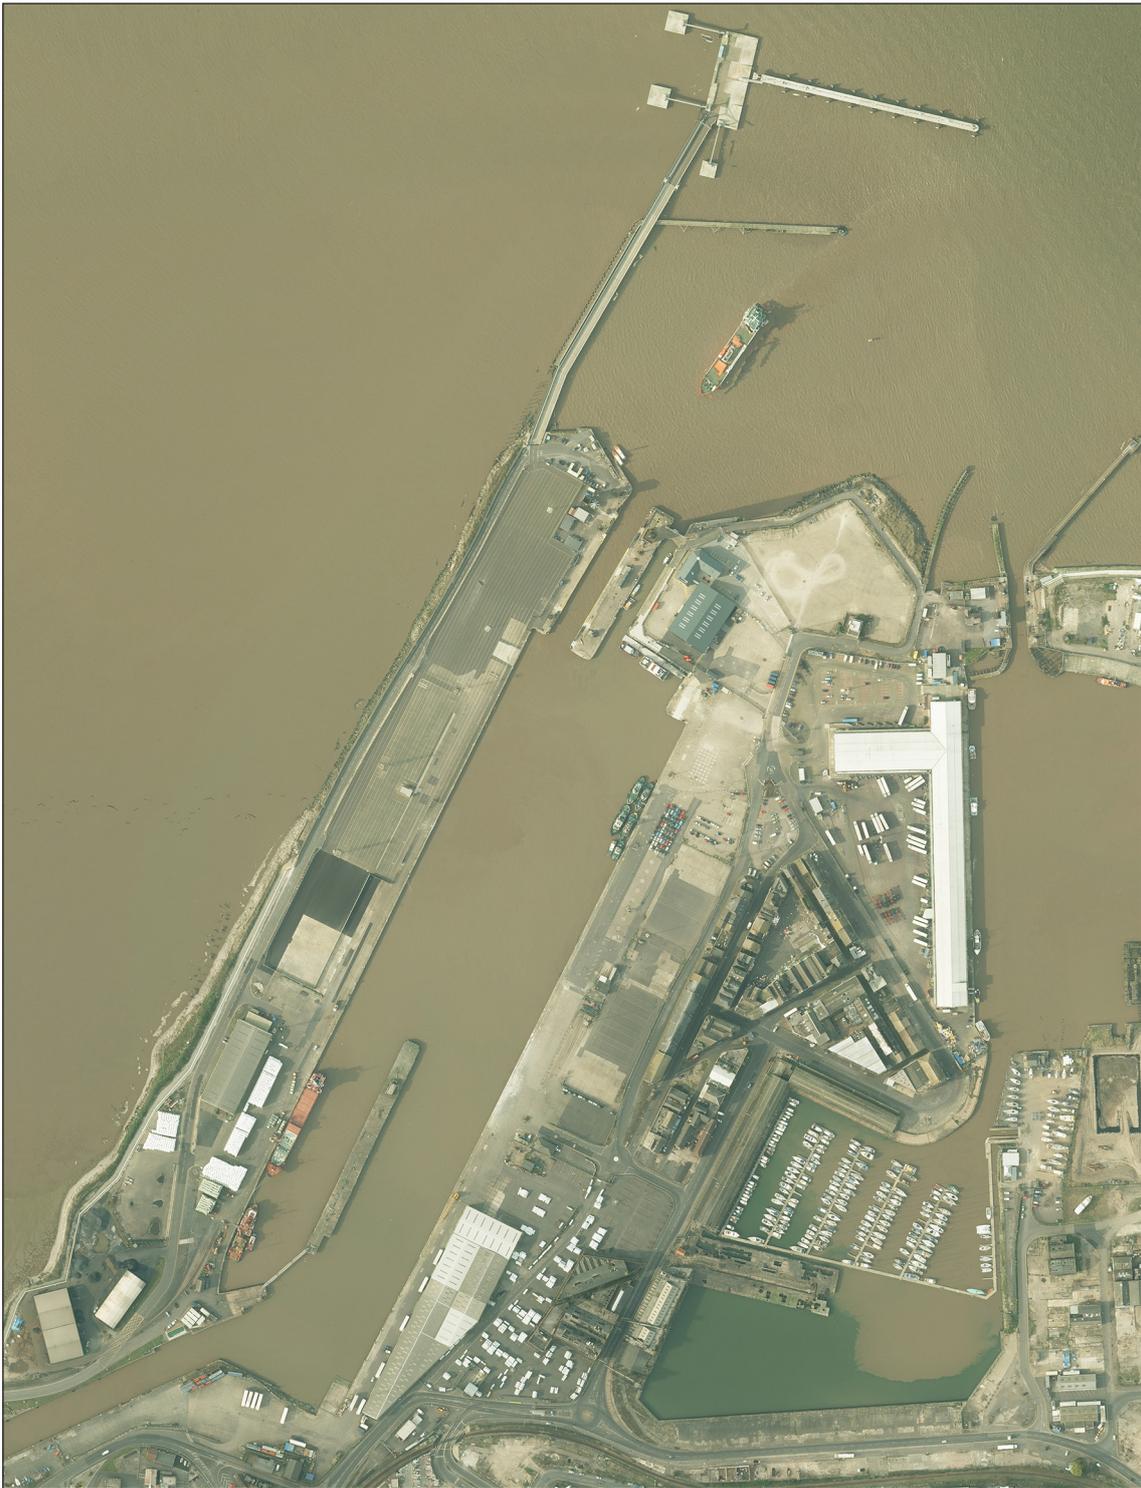
Fig 72: The docks in 2016. Much of the quayside infrastructure has been developed as car handling facilities, including the new river terminal seen at the top of the image. The new fish market is the large T-shaped building to the right of the photograph. TA2710, TA2711, TA2810 and TA2811 21-APR-2016 © Bluesky International/Getmapping PLC.

From the 1960s a variety of factors including dwindling fish stocks, lack of investment and the Iceland-UK 'Cod Wars' gradually pushed Grimsby's fishing fleet into decline (European Commission 2010, 28). Parts of the long fish market complex which ran along the quayside of the fish docks had been demolished between 1970 and 1976 but others had been removed by 1988 (*see* Fig 71). Adaptations to the west quay of No. 3 Fish Dock were being carried out in 1988 with the former graving docks being filled in. The quay between the entrances to Royal Dock and No. 1 Fish Dock was remodelled in this period to increase the area of hard standing associated with the roll-on/roll-off cargo operations. In the early 1990s a much larger remodelling of the area to the north of the Kasbah was undertaken – the most significant change to the layout of the docks since the opening of No. 3 Fish Dock in the 1930s. Over 2.5ha of dock were reclaimed for the construction of the new Grimsby fish market which opened in 1996 (Fig 72).

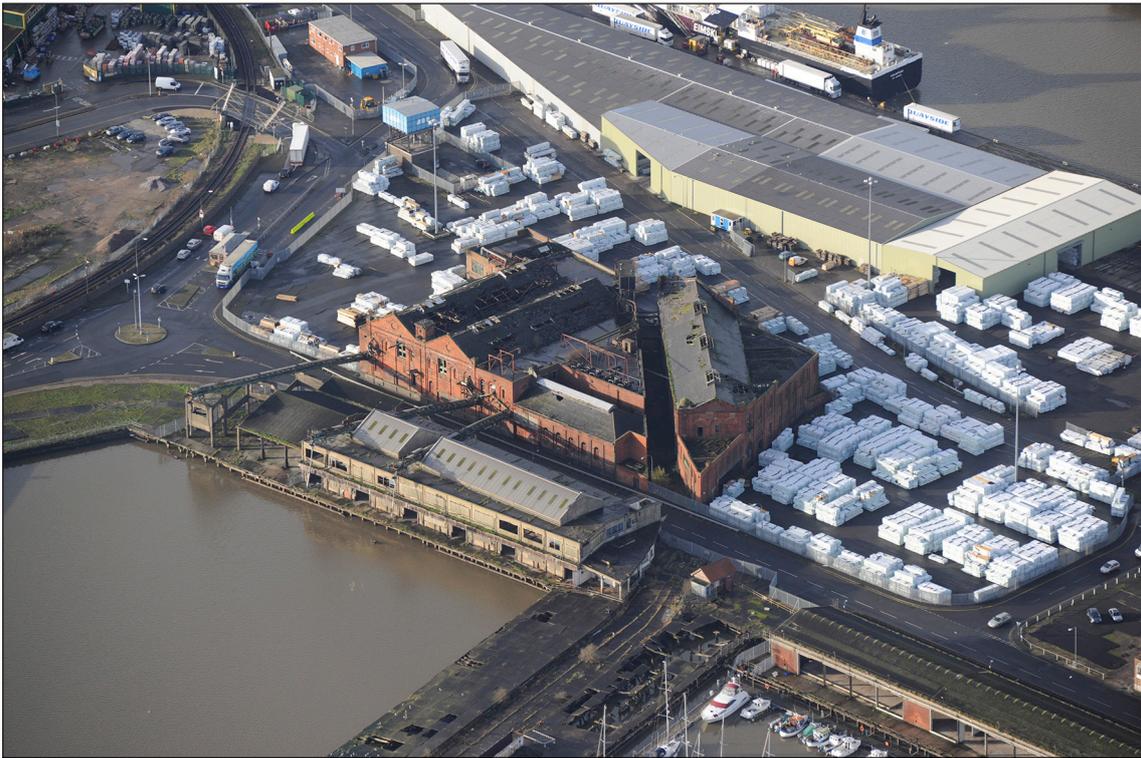
Fig 73: The ice factory and remains of the old fish market. 28844_015 13-JAN-2016 © Historic England Archive.

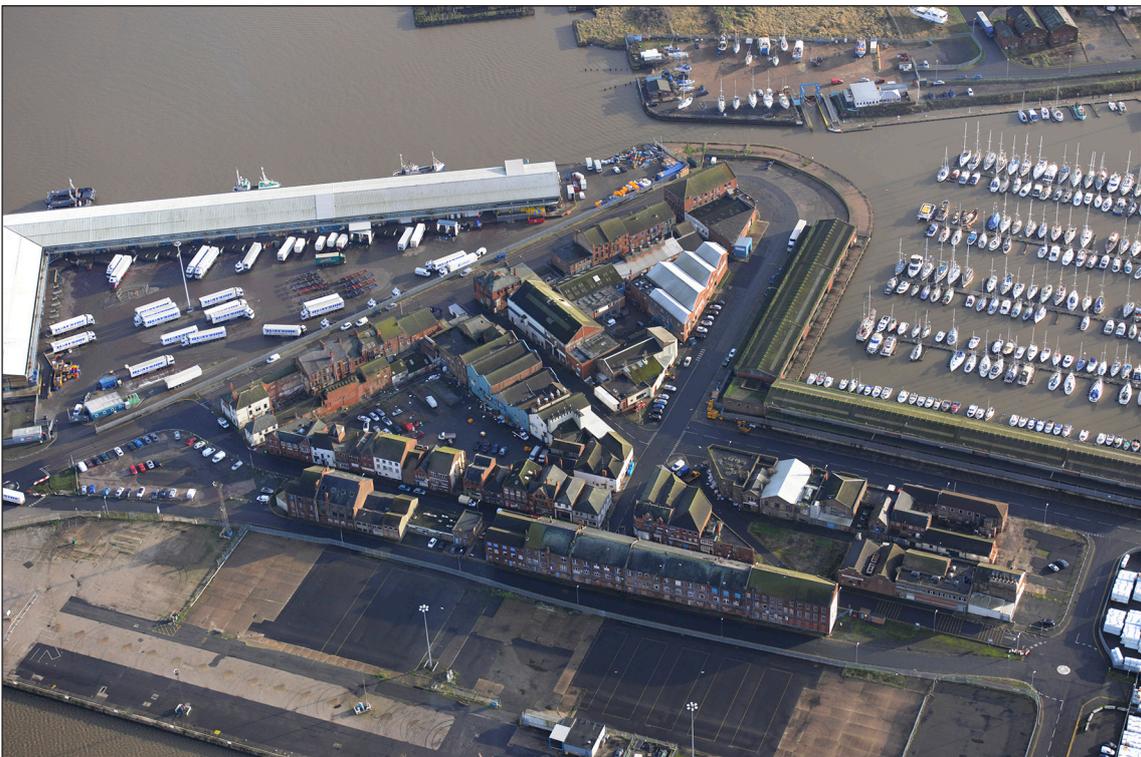
Fig 74: The remaining historic buildings in the Kasbah with the new fish market to the left. 28844_023 13-JAN-2016 © Historic England Archive.

The reduction in trawling and move towards seafood processing and handling meant that the buildings within the Kasbah complex became increasingly redundant throughout the later 20th century and early 2000s. Although a small number of businesses are still based in the Kasbah, the majority of buildings are now vacant. The Ice Factory – now Grade II* listed – was captured on an OS photograph in 1990, the year that it ceased operating. Throughout the early 2000s a number of buildings along Fish Dock Road, Maclure Street and Auckland Road were demolished, further diminishing the surviving area of the Kasbah and divorcing it from the Ice Factory (Figs 73 and 74).
