Burneside Hall Hall Road Burneside Nr Kendal Cumbria

Tree-ring Analysis of Oak Timbers

Research Report Series no. 51-2019

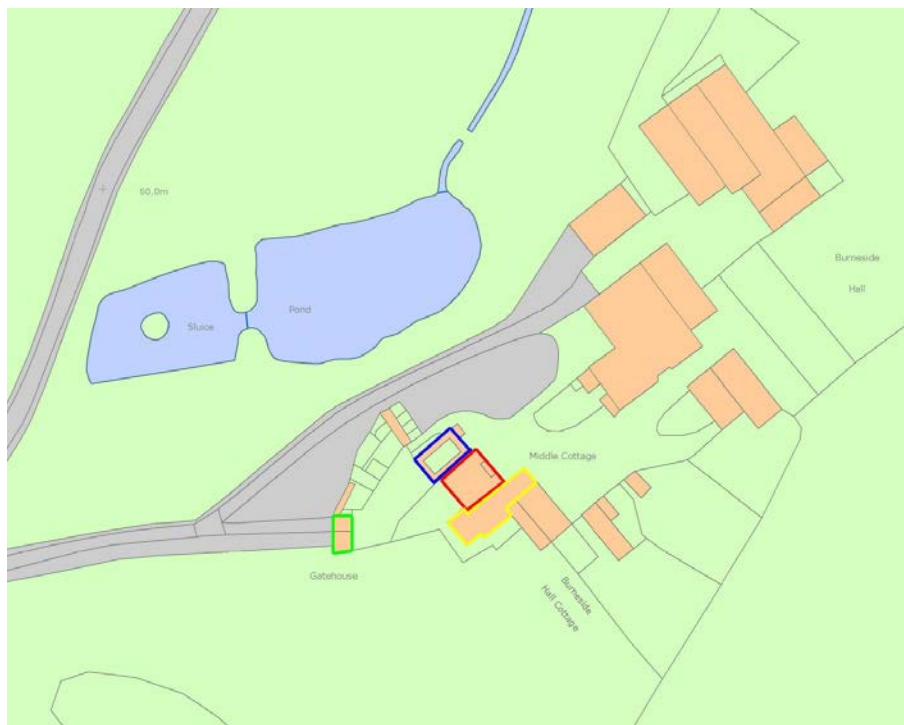
Figure 4: Map to show the Burnside Hall complex, with the tower (blue), hall (red), cross-wing (yellow), and gatehouse (green) marked. © Crown Copyright and database right 2020. All rights reserved. Ordnance Survey Licence number 100024900

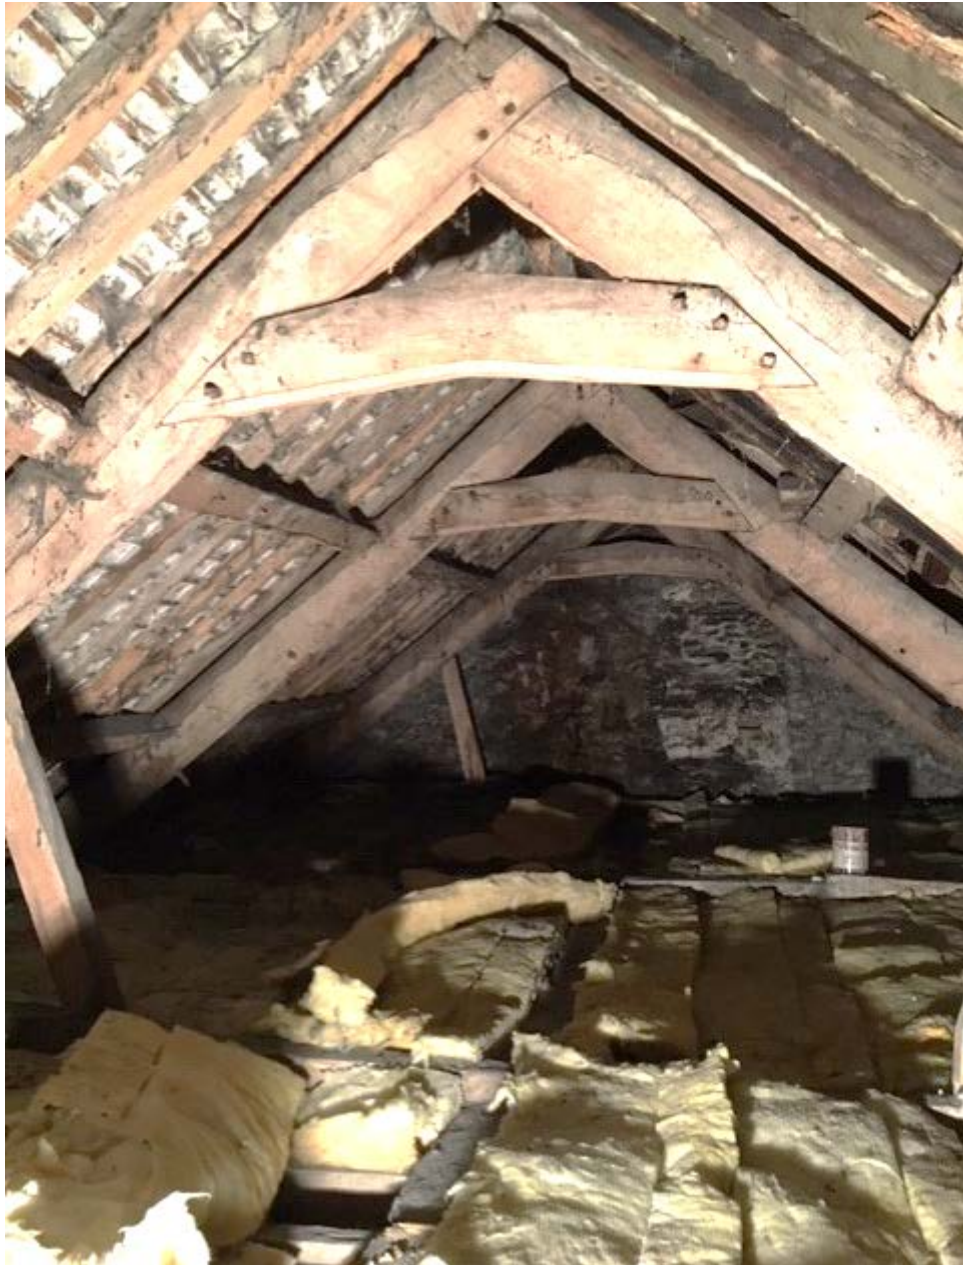
Figure 5: Hall roof, with truss 3 in the foreground, photograph taken from the south (Alison Arnold)

The roof over the hall part of the building consists of four principal-rafter and tiebeam trusses with cranked collars and queen struts, between which are two sets of purlins and common rafters (Fig 5). Visible at ground-floor level are two of the main floor beams of the floor above (Fig 6), and there is a timber partition between the main living space and stairs (Fig 7).

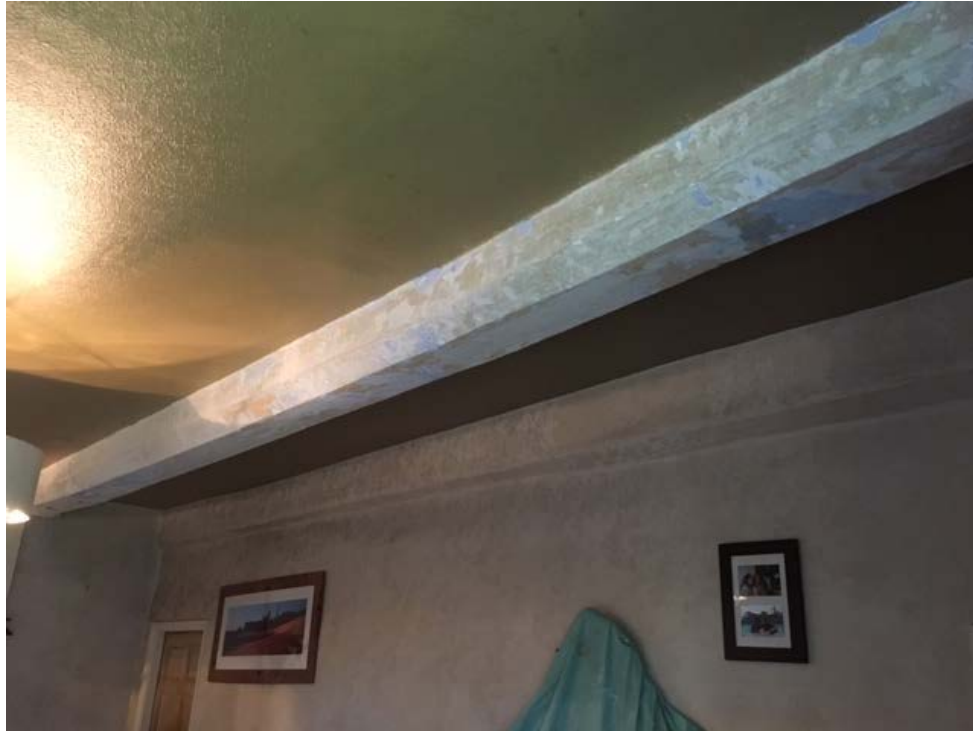
Figure 6: Hall - east-west first-floor beam, visible from the ground floor, photograph taken from the north-west (Alison Arnold)

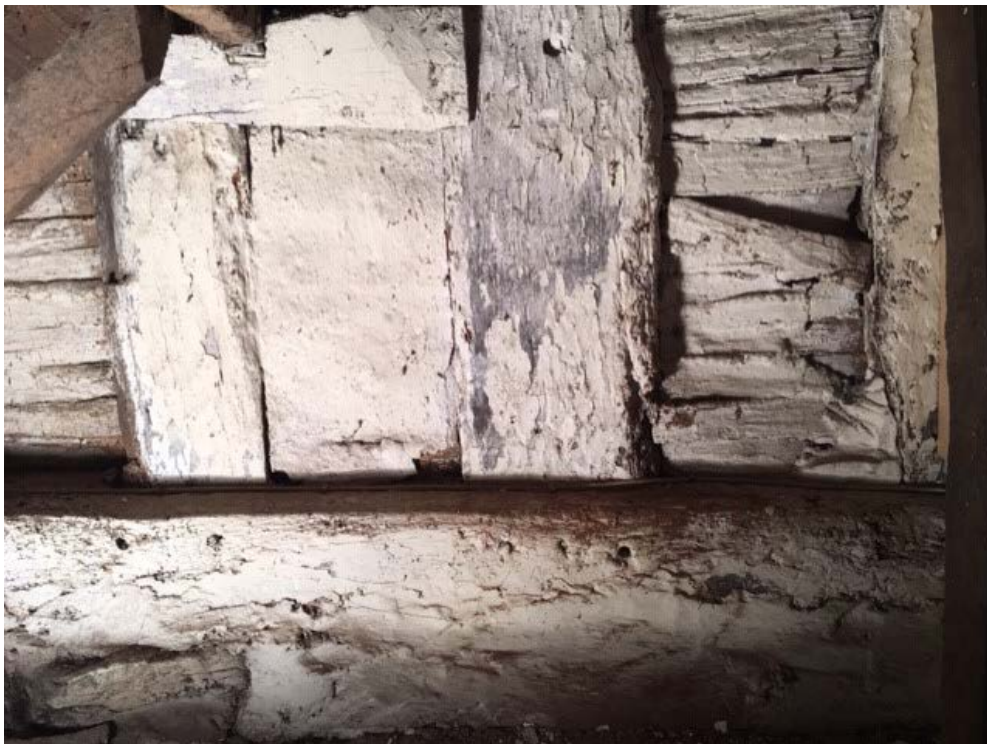
Figure 7: Hall - partition between the lounge and stairs, photograph taken from the south (Alison Arnold)

Only one of the samples, BUR-N55, taken from this partition has been dated. The last-measured ring on this sample, from a rail in the partition, is the heartwood/sapwood boundary and this dates to AD 1567, giving an estimated felling date for the timber represented to within the range AD 1582–1607.

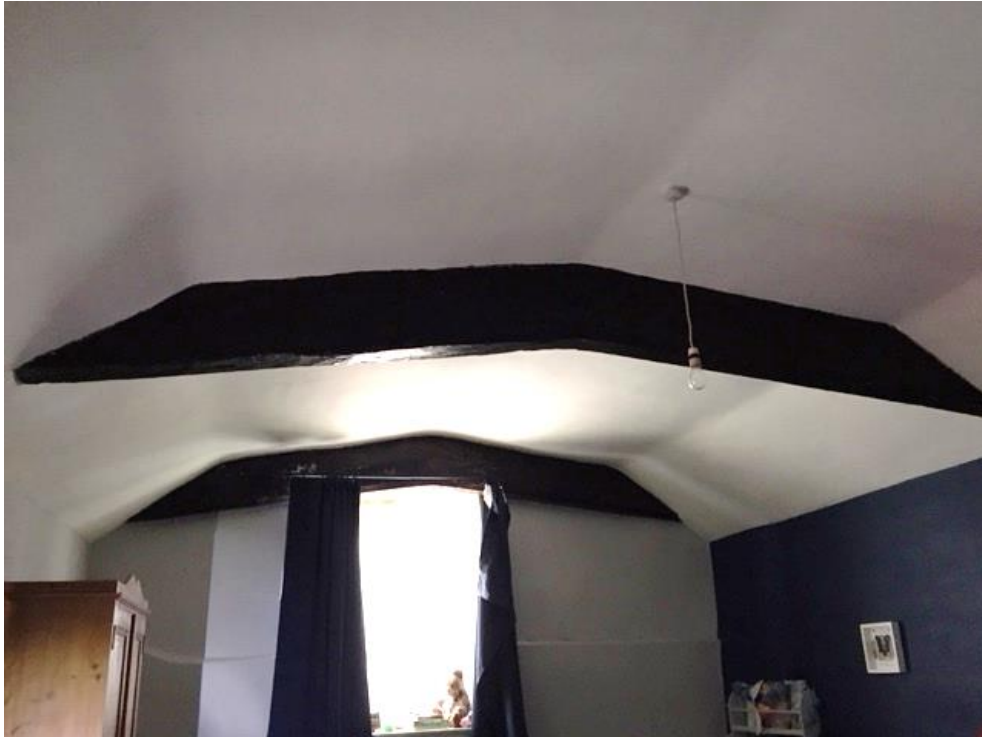
Figure 8: Cross-wing - the tiebeams of trusses 1 and 2, photograph taken from the west (Alison Arnold)

The roof over the cross-wing appears to be of more than one phase of construction. The only timbers of the easternmost trusses (trusses 1 and 2) currently visible are the two cranked tiebeams in a first-floor bedroom (Fig 8). Trusses 3 and 4 are two principal-rafter and tiebeam trusses with queen struts, between which are common rafters and purlins (Fig 9). Located behind a chimney is a principal-rafter and tiebeam truss with a collar; there are common rafters and two sets of purlins between this and the wall and chimney (Fig 10). There are a number of floor beams from the first floor that are visible at ground-floor level, four north-south aligned (Fig 11), and one in the western part of the wing, which is east-west aligned (Fig 12); there is a matching second-floor beam to this latter one, visible at first-floor level (Fig 13).

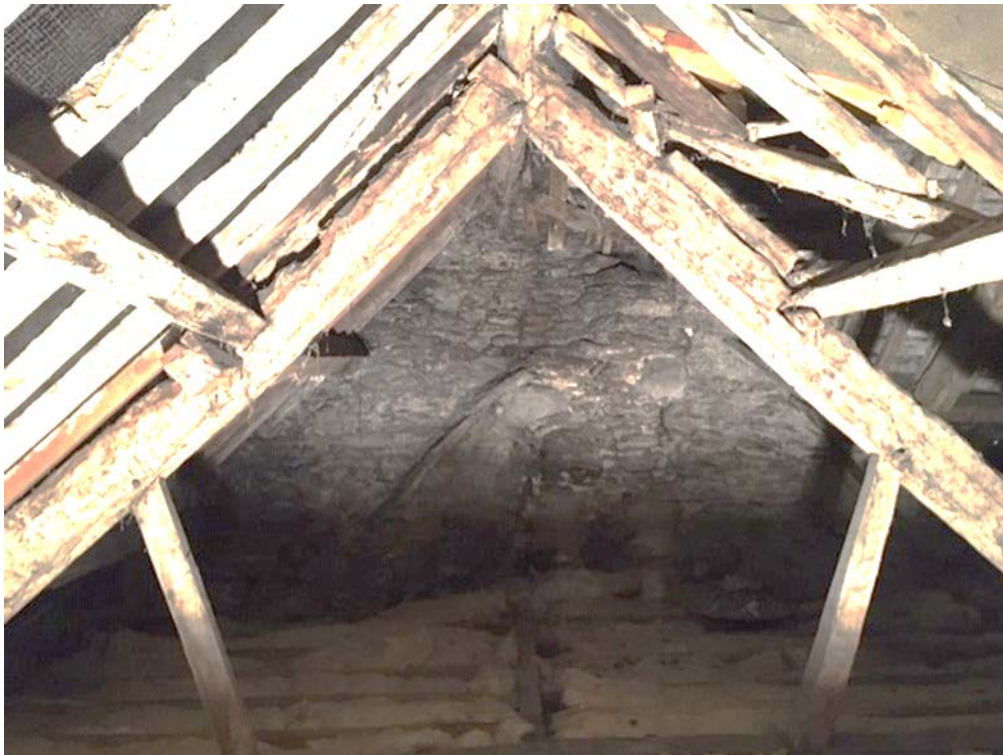
Figure 9: Cross-wing truss 4, photograph taken from the east (Alison Arnold)

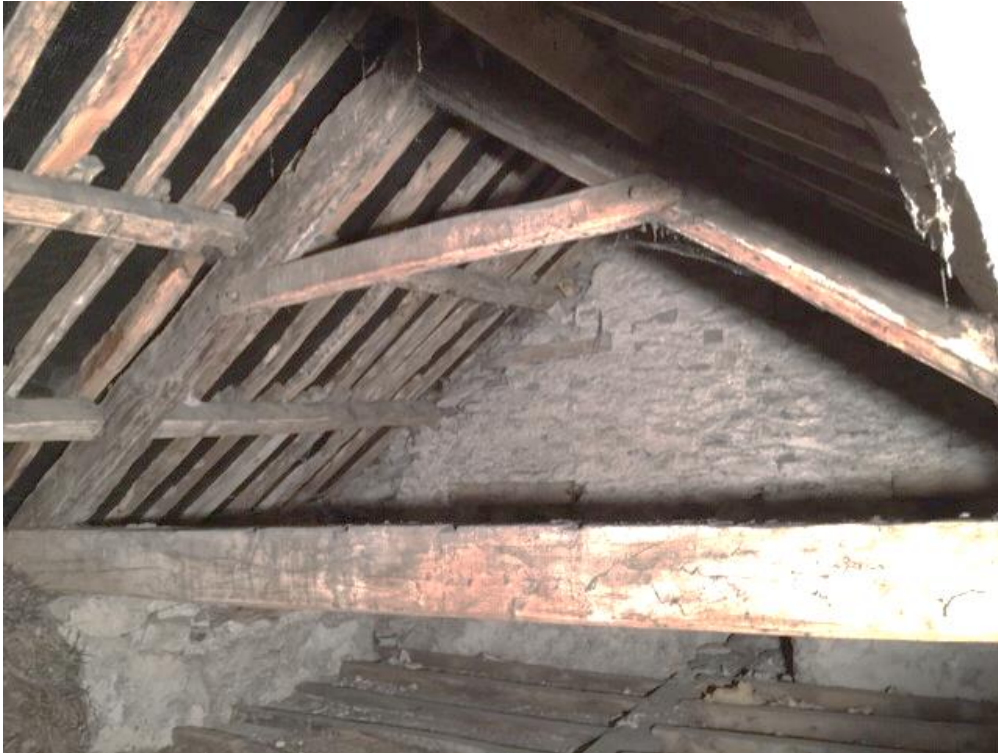
Figure 10: Cross-wing truss 5, photograph taken from the west (Alison Arnold)

The two samples (BUR-N25 and BUR-N26) representing the principal rafters from the westernmost truss, truss 5, demonstrate that these two timbers may have been derived from the same tree (t -value = 13.8). Sample BUR-N25 has the heartwood/sapwood boundary present, dating to AD1463, which produces an estimated felling date range of AD 1478–1503 for this pair of principal rafters.

The earliest timbers identified through dendrochronological analysis were utilised within truss 5 in the cross-wing. At the time of sampling this truss, the westernmost one situated behind the chimney, could be seen to vary visually from those trusses in the central portion of the cross-wing, raising the possibility that it might represent a different building phase. This westernmost truss has now been shown to be over 100 years earlier than the roof timbers associated with the central area of the cross-wing, constructed from timber felled in AD 1612–37, although it should be noted that a single purlin in the westernmost area of the roof is also of this date. It is unfortunate that neither of the only two accessible timbers from the two easternmost trusses in the cross-wing, the cranked tiebeams forming site sequence BURNSQ04, could be dated, thus leaving this area of roof undated. It therefore

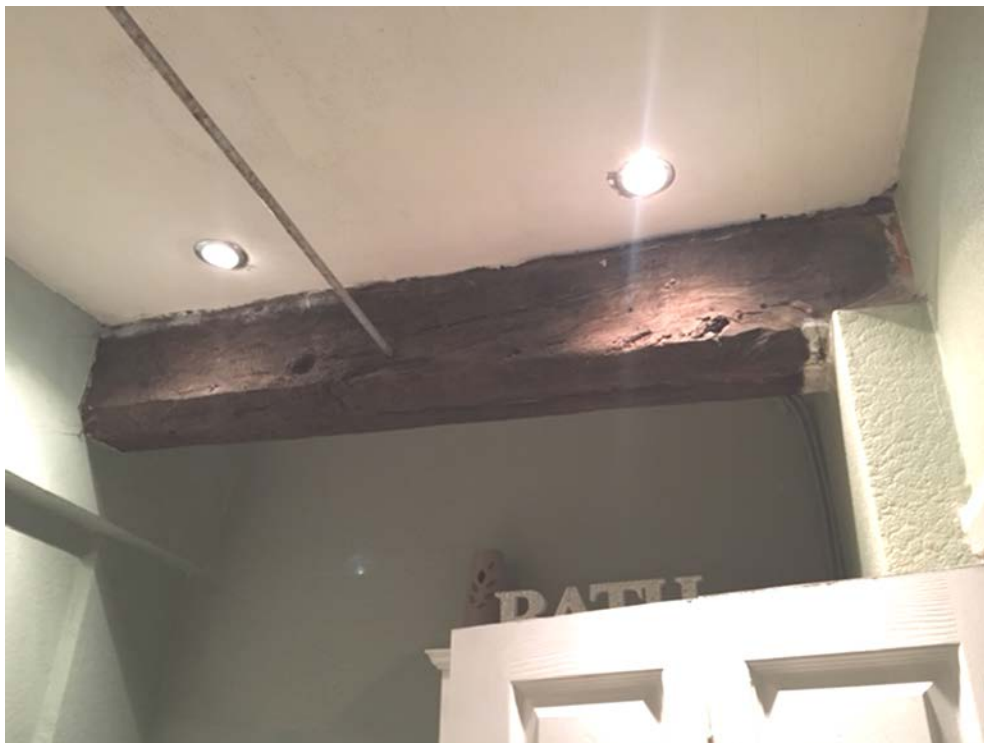
Figure 11: Cross-wing - north-south first floor beams, visible on the ground floor, photograph taken from the west (Alison Arnold)

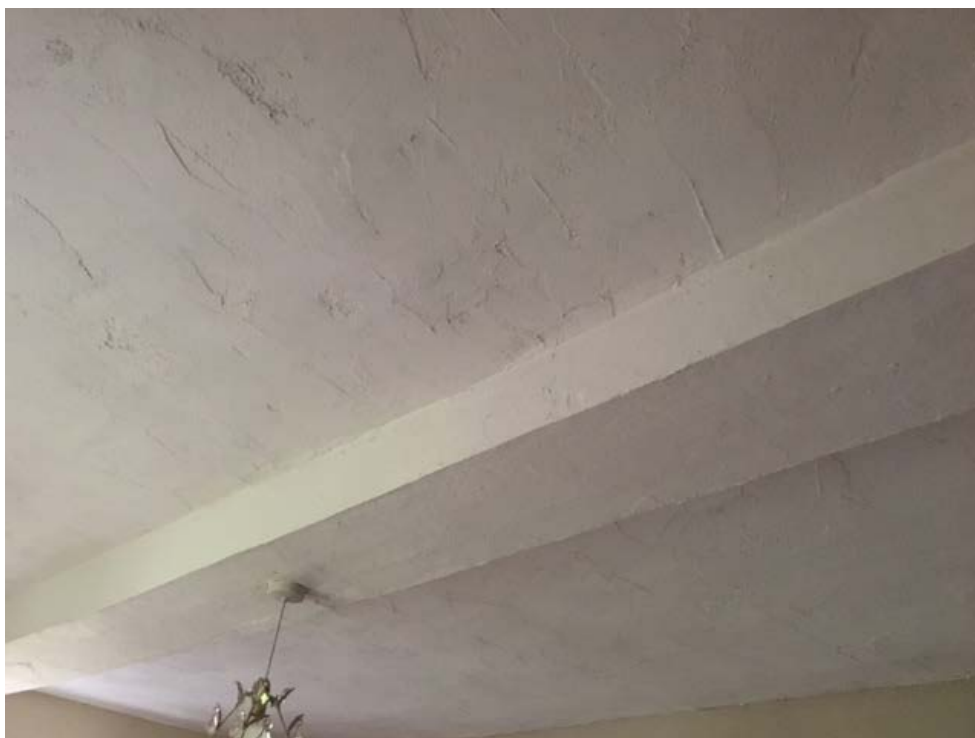
Figure 12: Cross-wing - east-west first-floor beam, visible from the ground floor, photograph taken from the south-east (Alison Arnold)

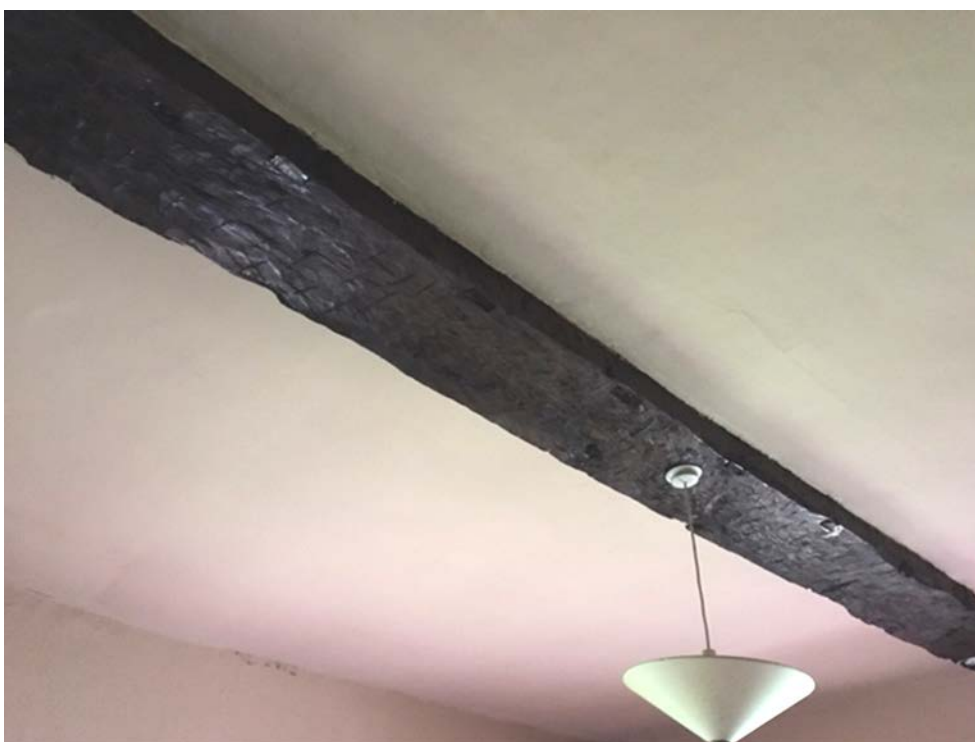
Figure 13: Cross-wing - second-floor beam, visible from the first floor, photograph taken from the east (Alison Arnold)

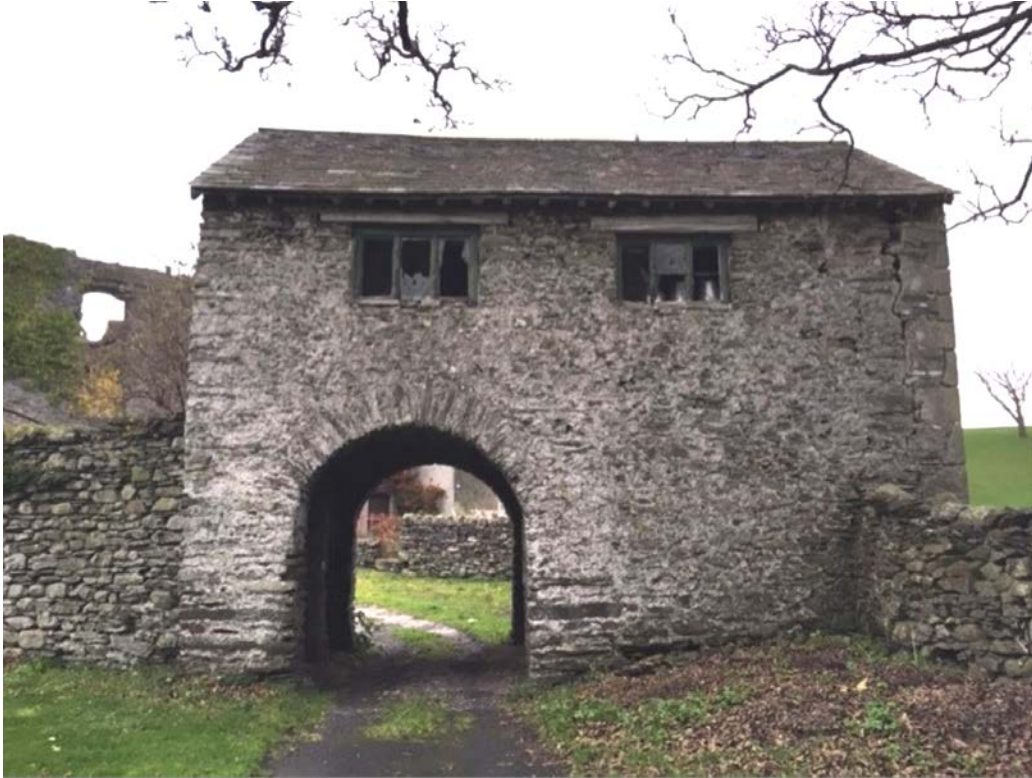
Figure 14: The Gatehouse, photograph taken from the north-east (Alison Arnold)

This two-bay building is of two storeys with access to the upper floor via an external stair (Fig 14). It is open to the roof at first-floor level; this consisting of three principal-rafter and tiebeam trusses with queen struts, between which are common rafters, a single tier of purlins, and a ridgepiece (Fig 15). Gates belonging to this building have previously been removed and are stored elsewhere on the estate (Fig 16).

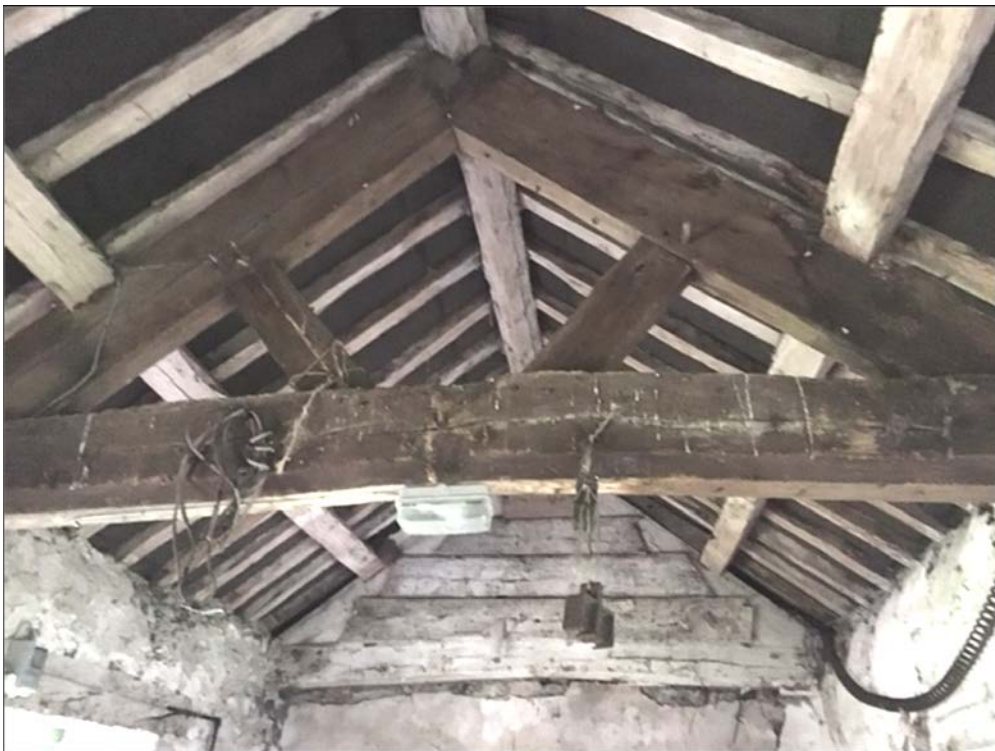
Figure 15: The Gatehouse, truss 2 in foreground, photograph taken from (Alison Arnold)

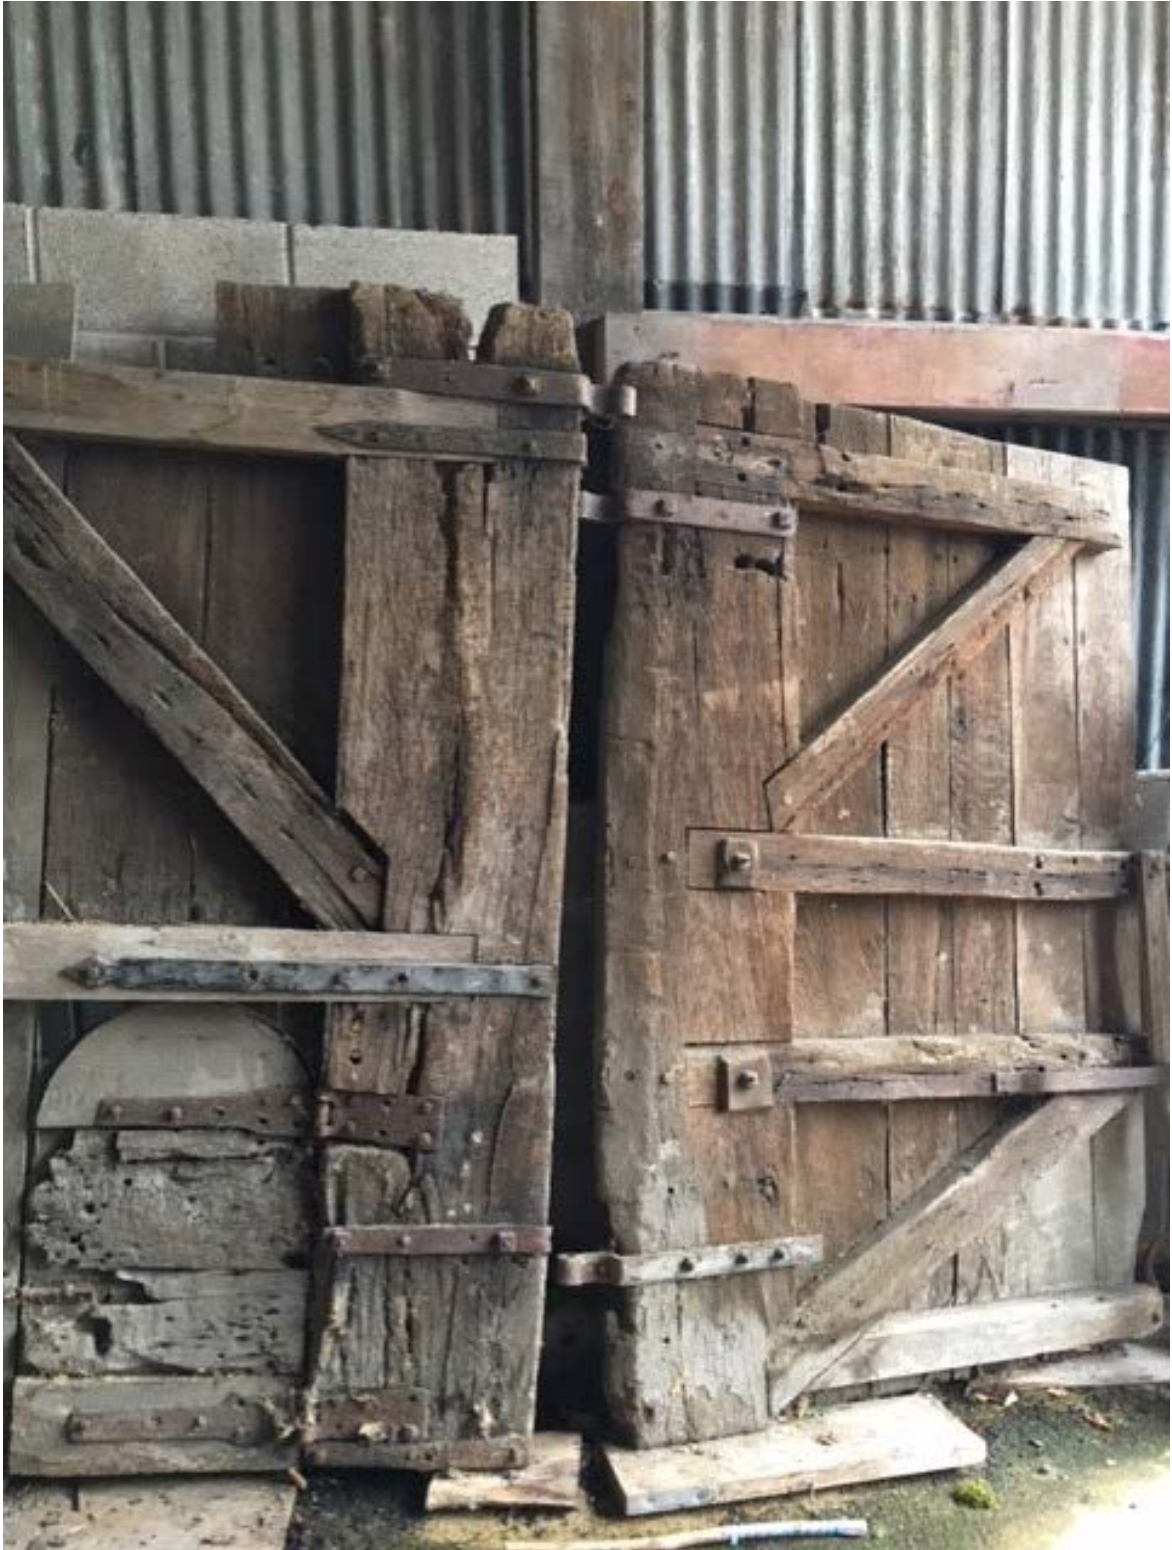
Figure 16: Gatehouse gates

The samples taken from the hanging stiles and *in situ* measurements from the two boards have been dated. Unfortunately, none of these have the heartwood/sapwood boundary ring and so estimated felling date ranges cannot be calculated for them. However, with last-measured ring dates of AD 1407 (BUR-N50), AD 1420 (BUR-N49), AD 1422 (BUR-N48), and AD 1457 (BUR-N51) these are estimated to have *terminus post quem* dates for felling of AD 1422, AD 1435, AD 1437, and AD 1472, respectively. The level of cross-matching between these samples, including a *t*-value of 8.9 between BUR-N48 (a board) and BUR-N50 (hanging beam), suggests that these timbers are likely to represent a single felling episode and are all, therefore, felled after AD 1472.

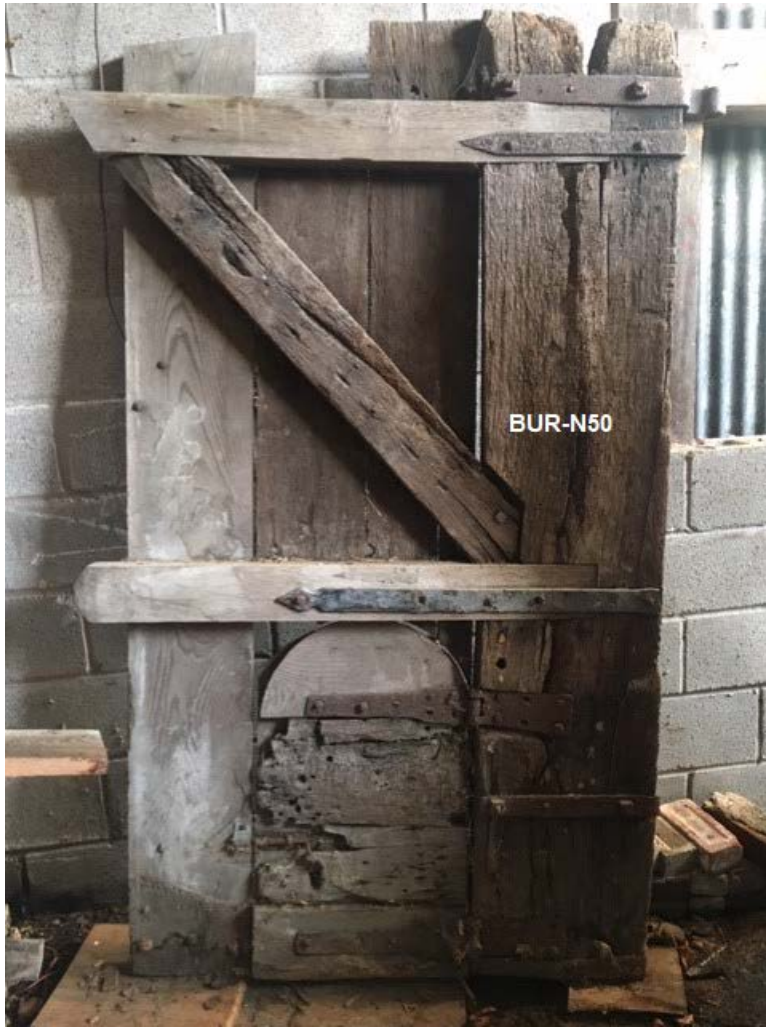
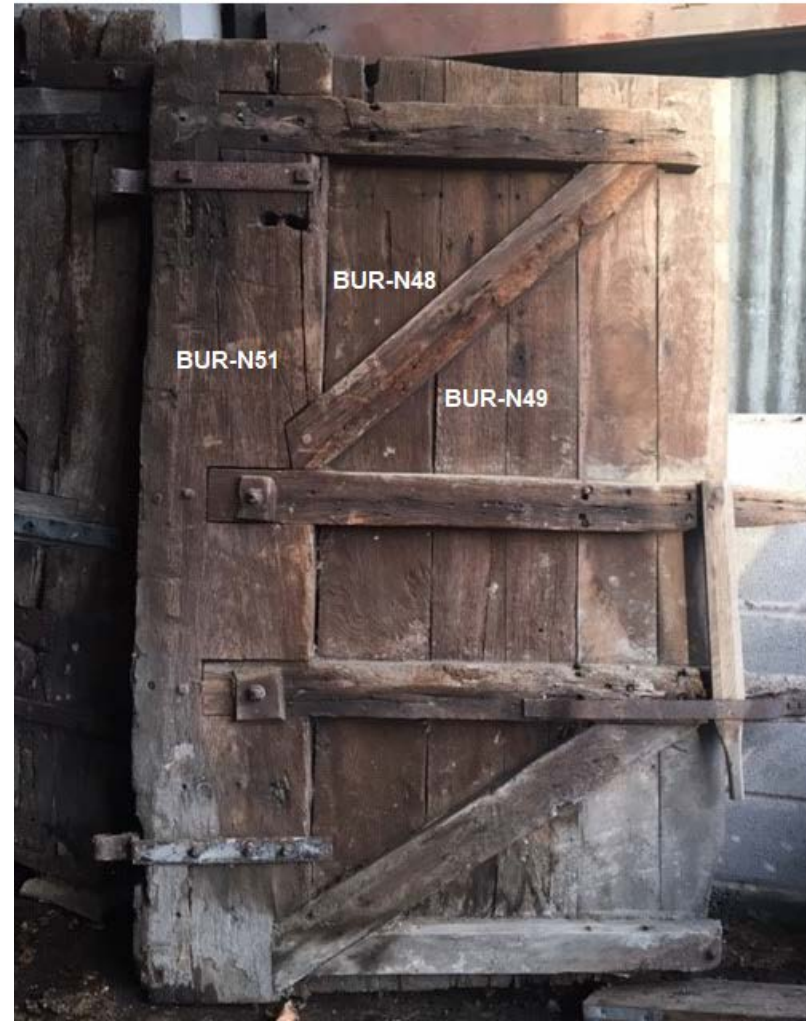
Figure 21: Photographs of the ex-situ gates, showing the location of samples BUR-N48-51 (Alison Arnold)

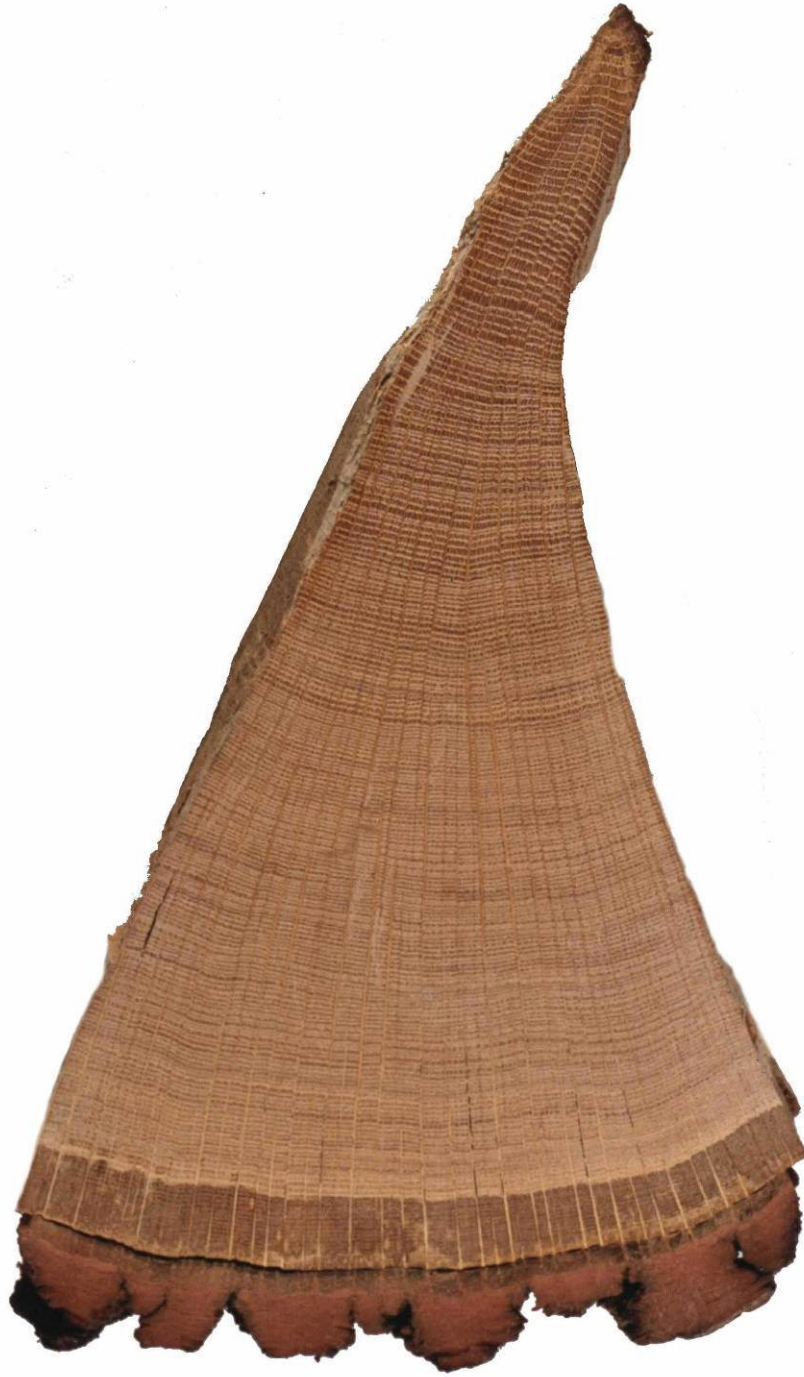
Figure A1: A wedge of oak from a tree felled in 1976. It shows the annual growth rings, one for each year from the innermost ring to the last ring on the outside, just inside the bark. The year of each ring can be determined by counting back from the outside ring, which grew in 1976

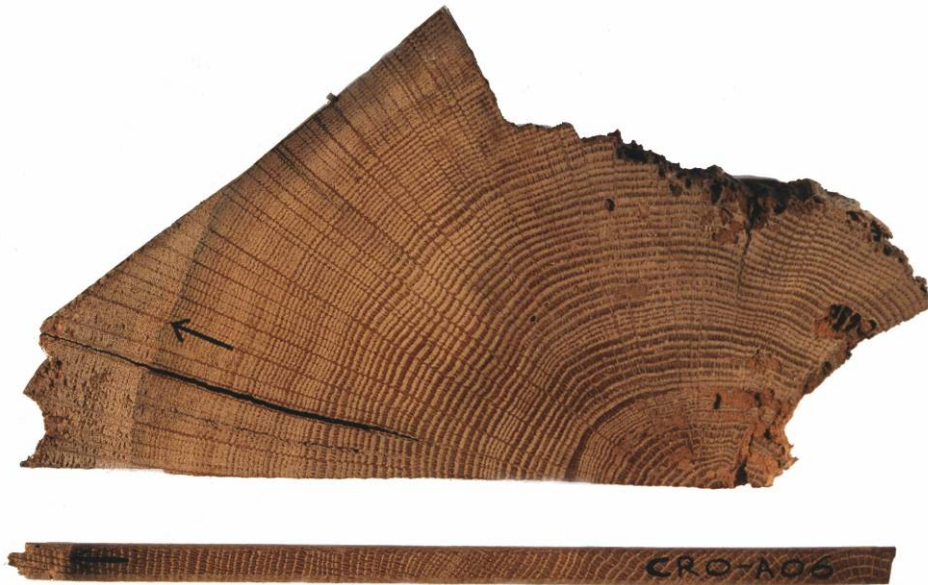
Figure A2: Cross-section of a rafter, showing sapwood rings in the left-hand corner, the arrow points to the heartwood/sapwood boundary (H/S); and a core with sapwood; again the arrow is pointing to the H/S. The core is about the size of a pencil

Quite often some, though not all, of the original outer rings are missing on a timber. The outer rings on an oak, called sapwood rings, are usually lighter than the inner rings, the heartwood, and so are relatively easy to identify. For example, sapwood can be seen in the corner of the rafter and at the outer end of the core in Figure A2, both indicated by arrows. More importantly for dendrochronology, the sapwood is relatively soft and so liable to insect attack and wear and tear. The builder, therefore, may remove some of the sapwood for precisely these reasons. Nevertheless, if at least some of the sapwood rings are left on a sample, we will know that not too many rings have been lost since felling so that the date of the last ring on the sample is only a few years before the date of the original last ring on the tree, and so to the date of felling.

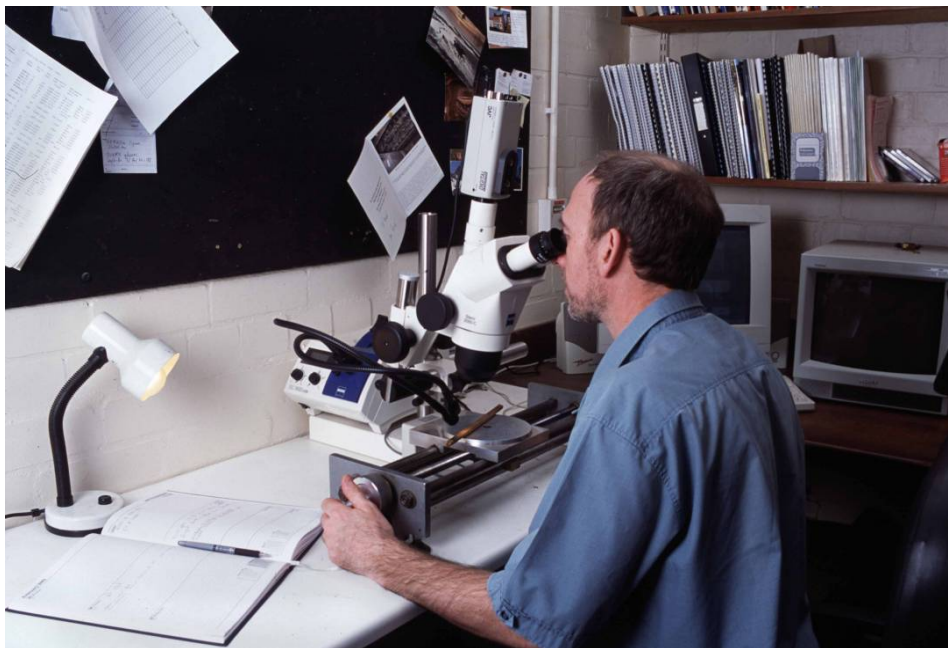
Figure A3: Measuring ring widths under a microscope. The microscope is fixed while the sample is on a moving platform. The total sequence of widths is measured twice to ensure that an error has not been made. This type of apparatus is needed to process a large number of samples on a regular basis

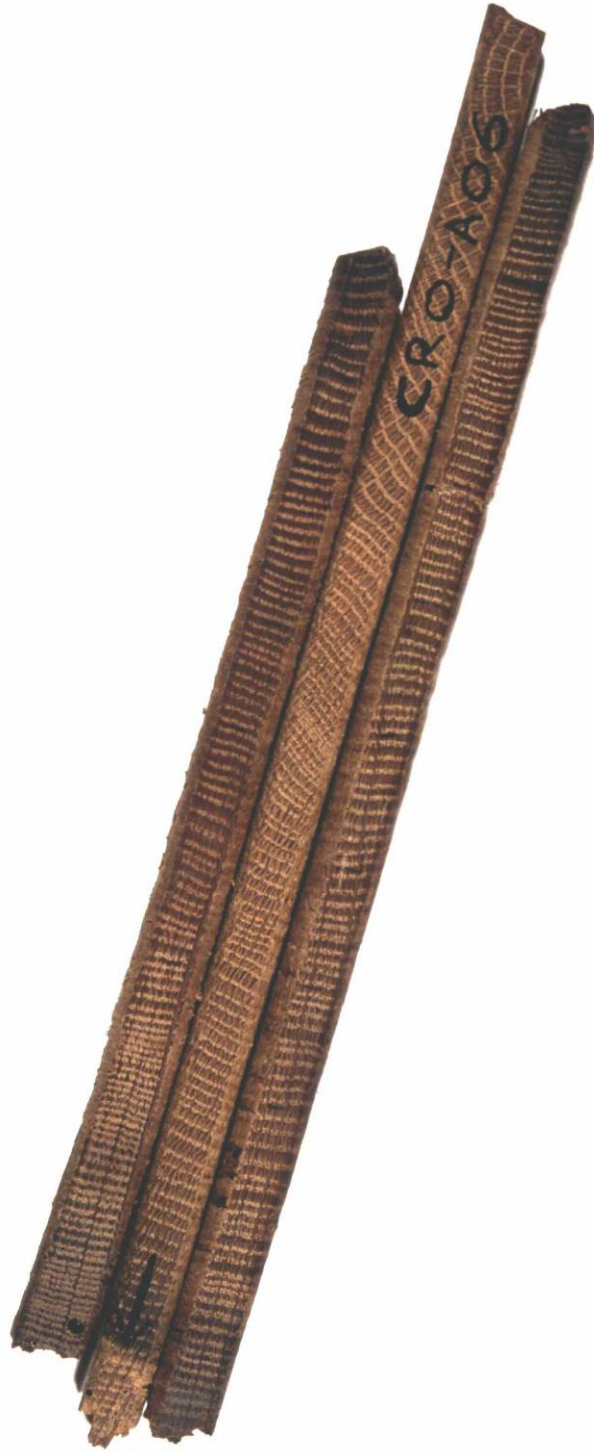
Figure A4: Three cores from timbers in a building. They come from trees growing at the same time. Notice that, although the sequences of widths look similar, they are not identical. This is typical
