Former Cooperage and Store of Hewitt Brothers Tower Brewery, East Street, Grimsby Lincolnshire Historic Building Report

HISTORIC BUILDING REPORT

Alastair Coey Architects

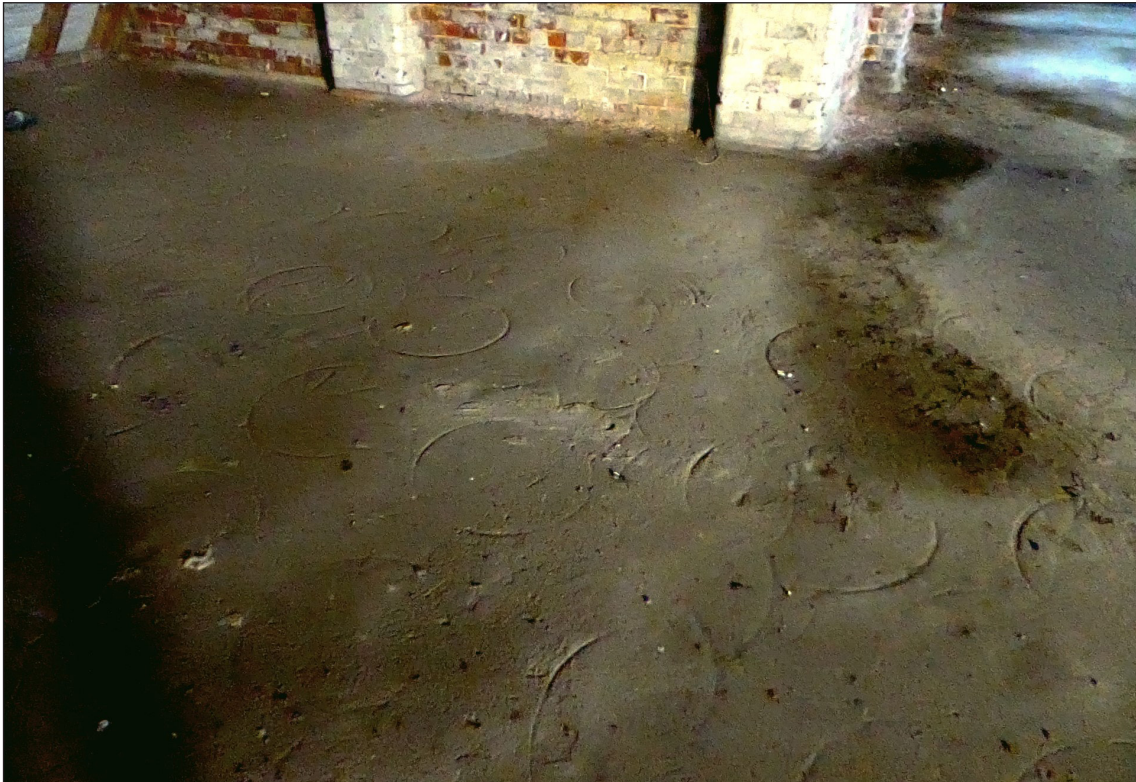
Casks were traditionally constructed by coopers, who served a seven-year apprenticeship. A 'barrel' is specifically the name for a cask that holds 36 gallons, the most commonly used volume. A correspondent, responding to a call for local information during the course of preparing this report, recalled that the cooperage at East Street in Grimsby worked with four sizes of cask, including the *barrel* (36 gallons), the smaller *kilderkin* (18 gallons), the *firkin* (9 gallons), and a small cask with a capacity of only 4.5 gallons, called a *pin*. This corresponds to the imprints of casks on the second floor of the warehouse (covered in a layer of soft asphalt), which suggest that four separate diameters of cask were stored here (Figure 2).¹²

Figure 2: Cask imprints on the second floor of the warehouse (© Historic England, photograph: Alastair Coey Architects 2019)

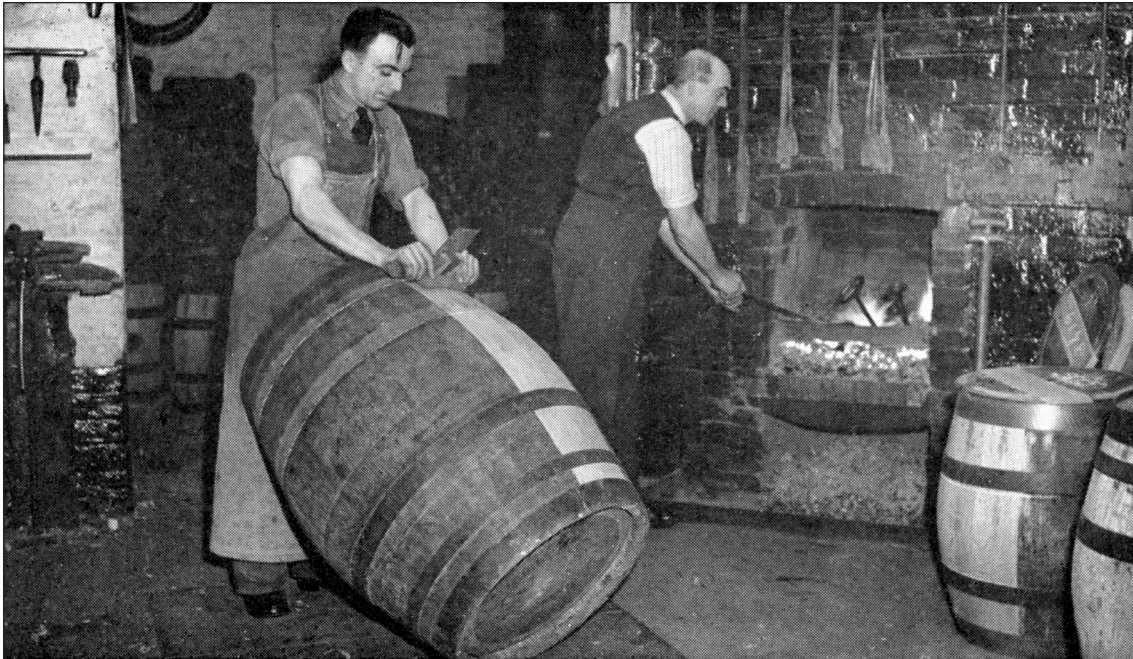
Figure 3: Coopers at work in the East Street cooperage; date not given, but assumed inter-war. (Photograph reproduced by kind permission of Lincolnshire Inspire Libraries Ltd) Ref. 1062

and the frame removed at some time before the photograph showing coopers at work was taken (see Figure 3; date unknown, but assumed inter-war). There is also a high-level window, introduced above the East Street entrance when the main building was constructed, between 1906 and 1933, and the decorative pediment removed.

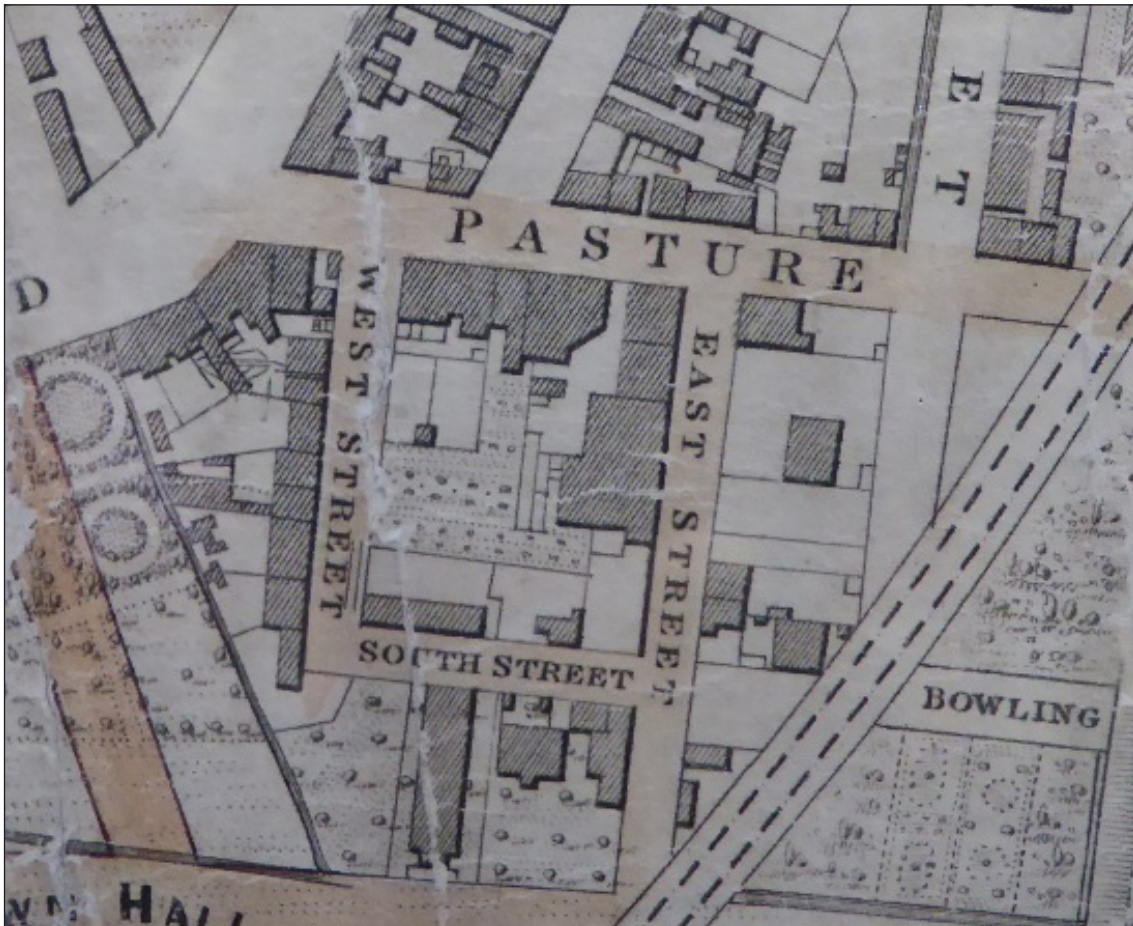
Figure 4: Pasture Street Brewery shown on James Meadows Rendel and John Fowler's Plan of the Town and Port of Great Grimsby, surveyed in 1848 (Reproduced by kind permission of North East Lincolnshire Archives) Ref. 3/611/A1011

A brewery was first established at Pasture Street in 1806, by John Garniss. This brewery was a relatively small concern, and was subsequently bought by John Hobson in 1831. The earliest map of the brewery site under John Hobson is the Rendel/Fowler Plan of the Town and Port of Great Grimsby of 1848 (Figure 4). East Street at this time was relatively undeveloped.

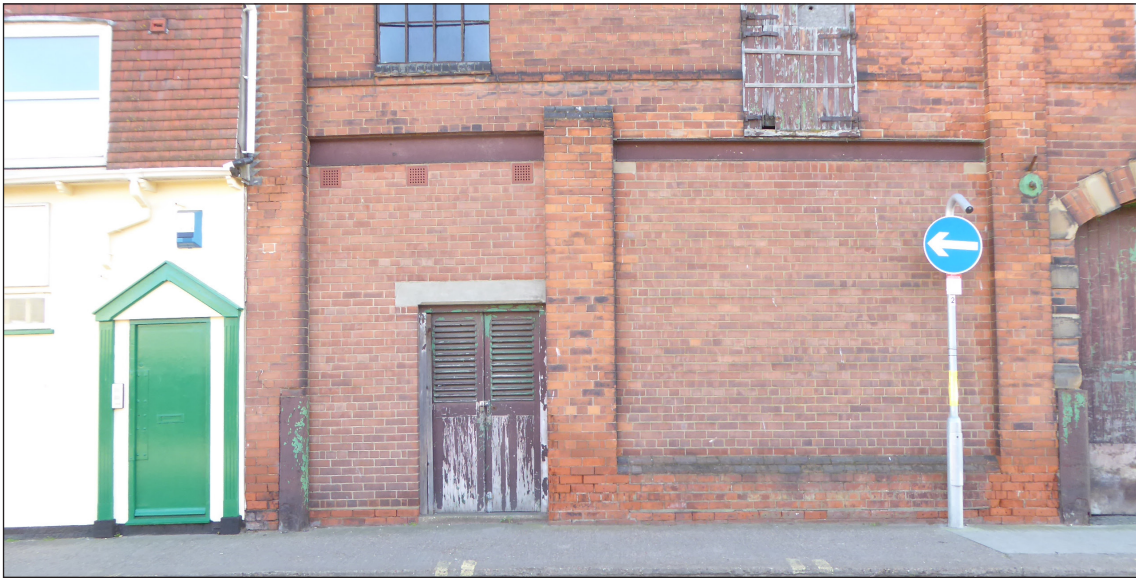
Figure 15: Infilling of a previous entrance to the west elevation (© Historic England, photograph: Alastair Coey Architects 2019)

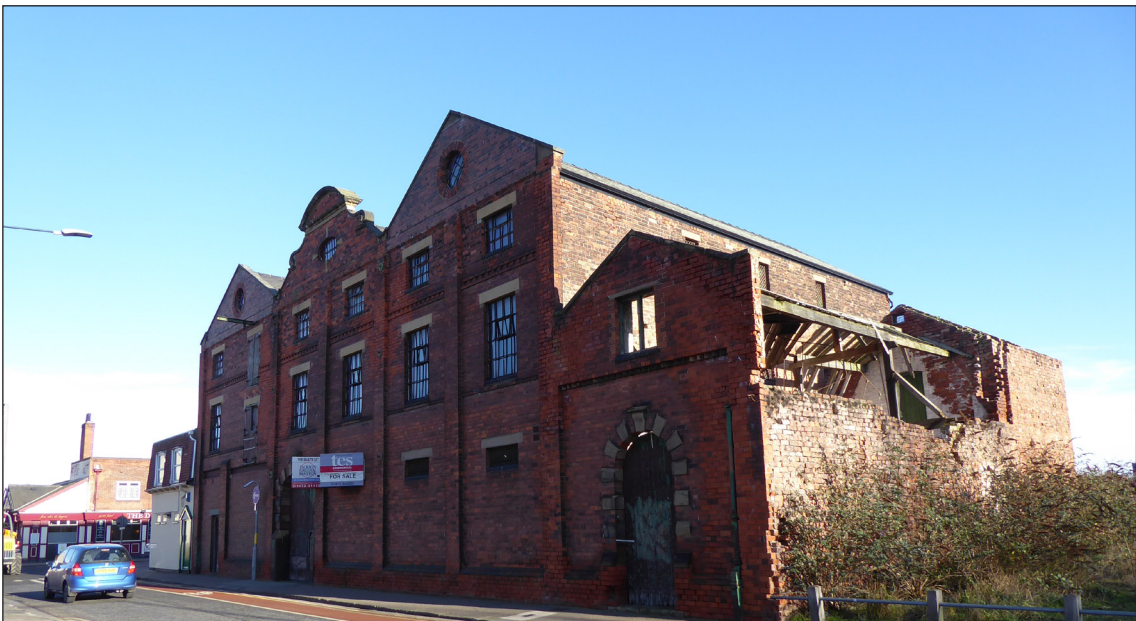
Figure 16: View of warehouse building as seen from East Street (© Historic England, photograph: Alastair Coey Architects 2019)

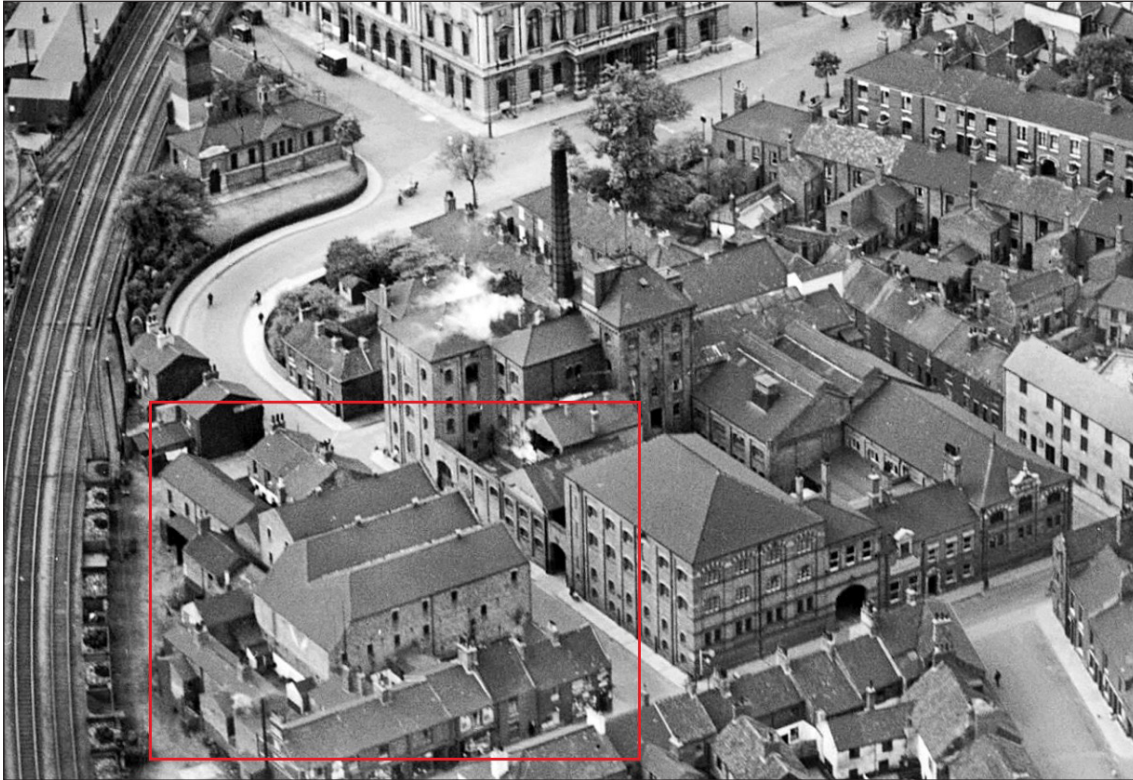
Figure 17: An aerial image of Hewitts Brewery in 1933 with the warehouse shown within the red square (© Historic England, Aerofilms Collection) Ref. EPW042807

Figure 17 shows the extent of the brewery in 1933, in its final year of private ownership. The warehouse is clearly visible in its current form, with the cooperage just visible to the rear, and the full extent of abutments still in existence. The site was not open to the railway, as it is at the time of writing, but was bounded to the east by terraced housing.

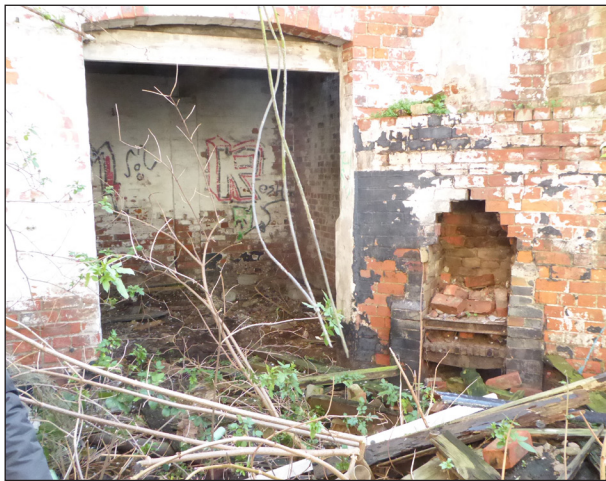
Figure 19: Surviving features of fireplace to coopers’ store (© Historic England, photograph: Alastair Coey Architects 2019)

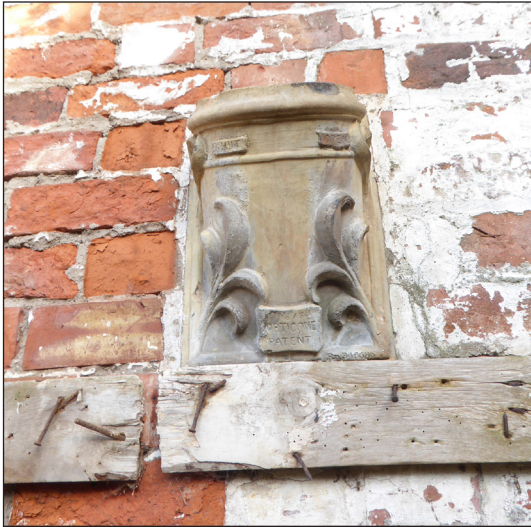
Figure 20: Surviving terracotta air vents in the coopers' store (© Historic England, photograph: Alastair Coey Architects 2019)

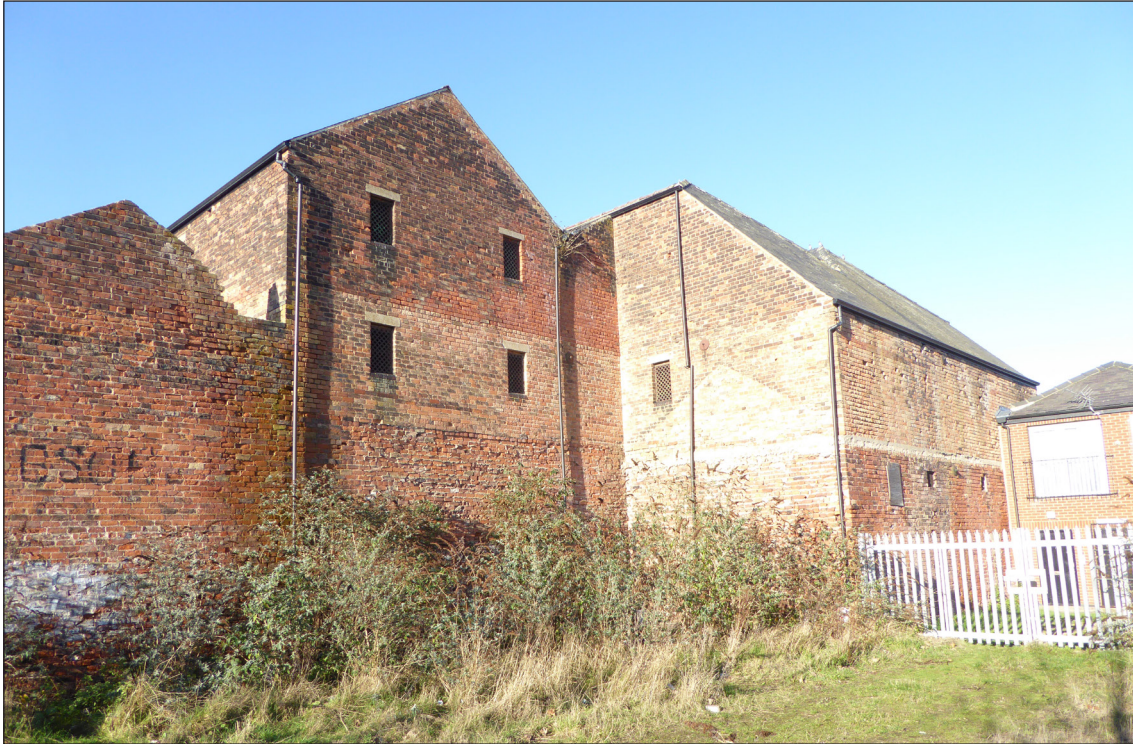
The east elevations are constructed in poor quality brick laid in English garden wall bond. Physical evidence, including remains of a lead cover flashing, suggests that the ground floor of the re-entrant corner was built against an existing pitched roof building, since removed. The brickwork at first floor differs in colour from that at second-floor but the reason for this is not clear; it may be that the first floor has been more recently re-pointed, which would affect the overall appearance of this section. The cast concrete first-floor floor slab can be seen on the east and south elevations of the north-east projection (Figure 24). The south elevation of the north-east projection contains one cast-iron diamond pattern ventilation grille at first-floor level and the east elevation of the south bay contains two similar openings at first- and second-floor levels.

Figure 24: East elevation and north-east projection with variations in brickwork colour and evidence of the cast concrete first-floor slab (© Historic England, photograph: Alastair Coey Architects 2019)

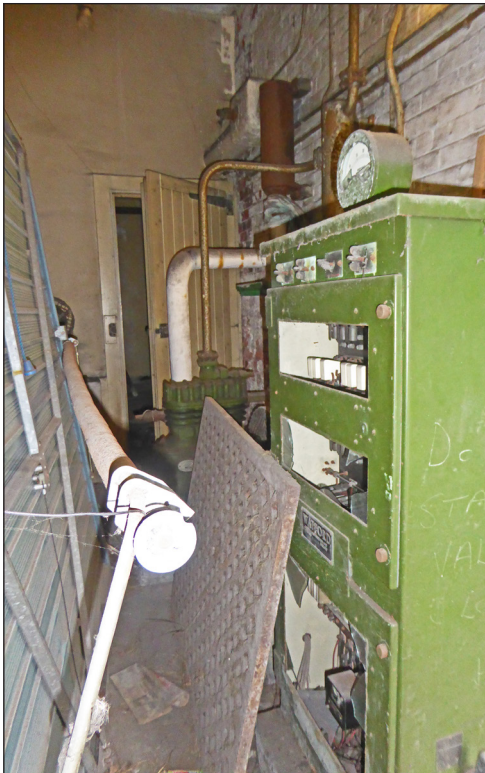
Figure 27: Looking east along Room GF1A with compressor seen on the right-hand side (© Historic England, photograph: Alastair Coey Architects 2019)

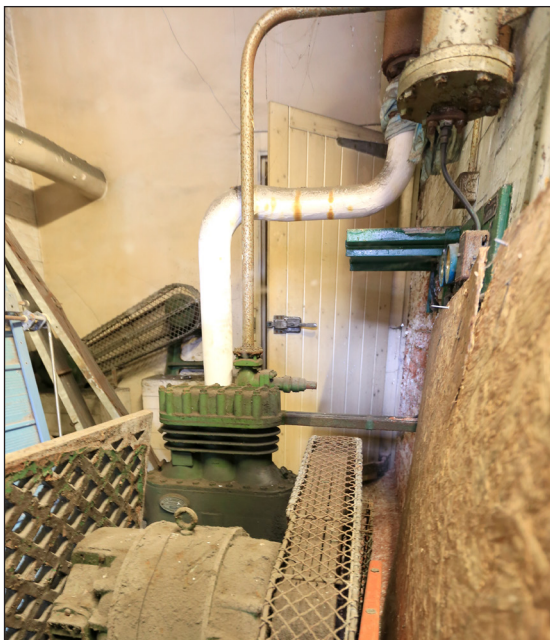
Figure 29: Vee-belt drive from motor to compressor (© Historic England, photograph: Alastair Coey Architects 2019)

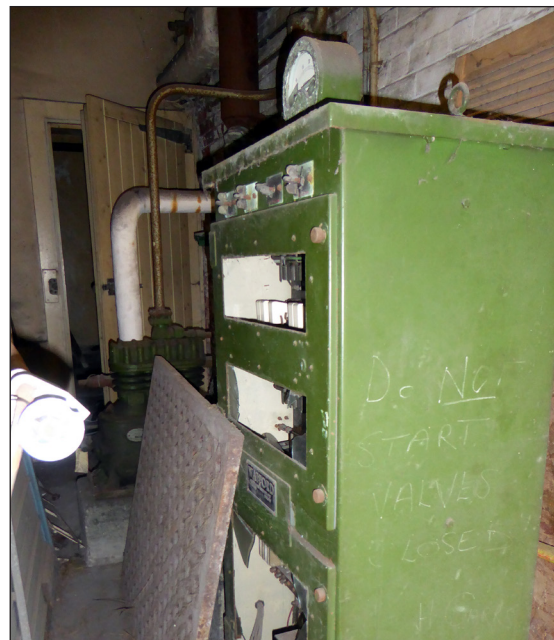
Figure 30: Motor control cabinet (© Historic England, photograph: Alastair Coey Architects 2019)

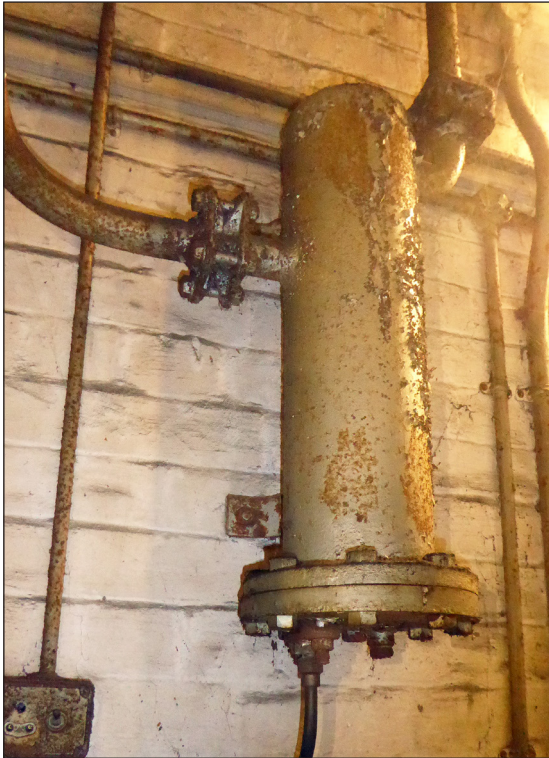
Figure 31: Oil separator (© Historic England, photograph: Alastair Coey Architects 2019)

All the plant and equipment in this room appears to be complete and in fair to good condition.

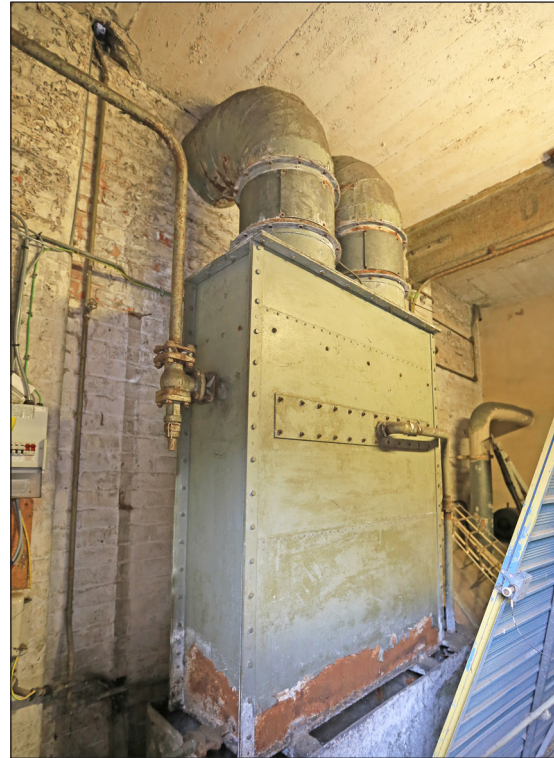
Figure 32: Condenser (© Historic England, photograph: Alastair Coey Architects 2019)

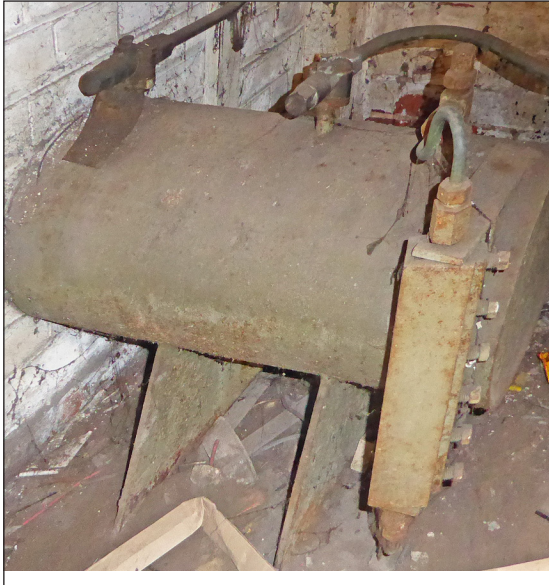
Figure 33: Receiver (© Historic England, photograph: Alastair Coey Architects 2019)

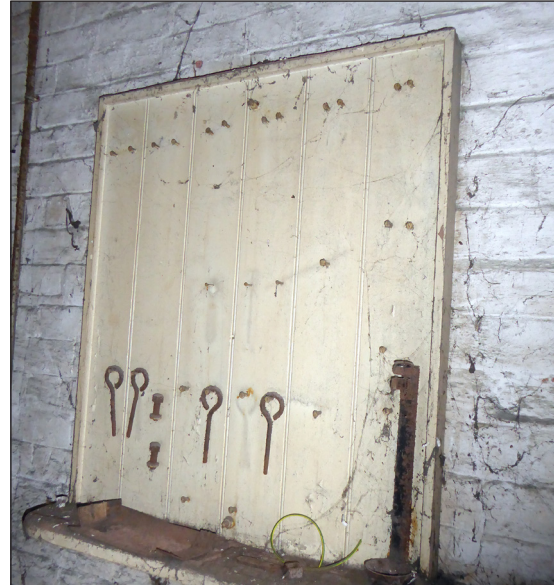
Figure 34: Wooden board for storing tools (© Historic England, photograph: Alastair Coey Architects 2019)

Mounted on the wall at right on entry is a wooden board (E) which is presumed to have originally held tools for adjusting and maintaining the equipment (Figure 34).

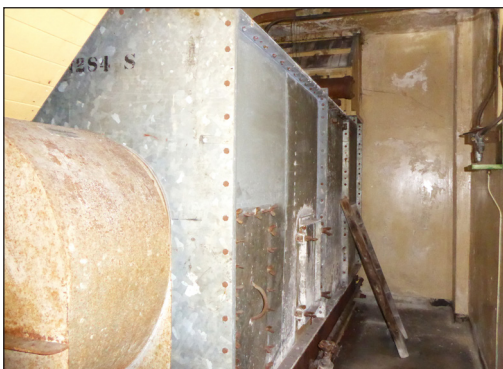
Figure 35: Room GF1B showing the fan, evaporator, and expansion valve (© Historic England, photograph: Alastair Coey Architects 2019)

Apart from some rust on the surfaces of the refrigerant pipework, the items in this room are complete and in good condition.

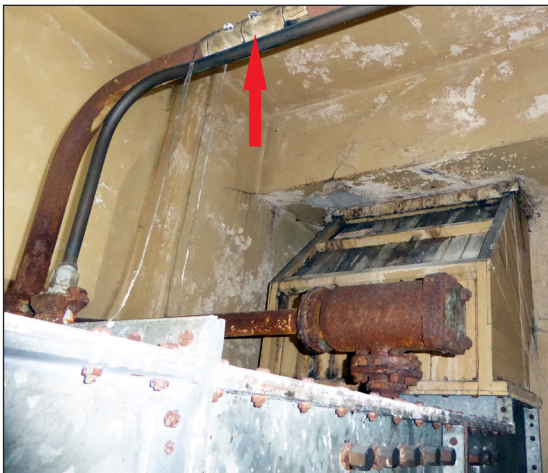
The air from the cold room was sucked into the evaporator along a wooden duct through the party wall by a centrifugal fan (B1) at its near end (Figure 36). This air was slightly warm due to contact with whatever was in storage. It was chilled by the refrigerant pipes as it passed through and was blown out back into the cold room by the same fan. The fan carries a plate reading 'Sirocco/ Fan no 71600 Works no 15847/ Davidson & Co Ltd/ Makers/ Belfast Ireland'. Established in 1881, this firm was a world leader in industrial fans and tea-drying machinery. It was acquired by James Howden & Co in 1998 and has since closed.³⁹ Messrs Hall had strong connections with Belfast. Their agent was Charles J Hill Ltd (in Queen Street), and they also supplied refrigeration equipment to the world-famous ship builders, Harland & Wolff.⁴⁰

The fan was driven through vee belts from an electric motor (B2) on a concrete plinth at the north-east corner of GF1A (Figure 37). Mounted on top of the evaporator is what is presumed to be a liquid separator (3a), the purpose of which was to remove any liquid which had not been vaporised before it passed into the compressor. A tap at the back end of the base of the evaporator was probably for draining off melt water when it was being defrosted. The water escaped through a hole in the floor (with a wooden plug).

Figure 36: Intake duct to evaporator with liquid separator (© Historic England, photograph: Alastair Coey Architects 2019)

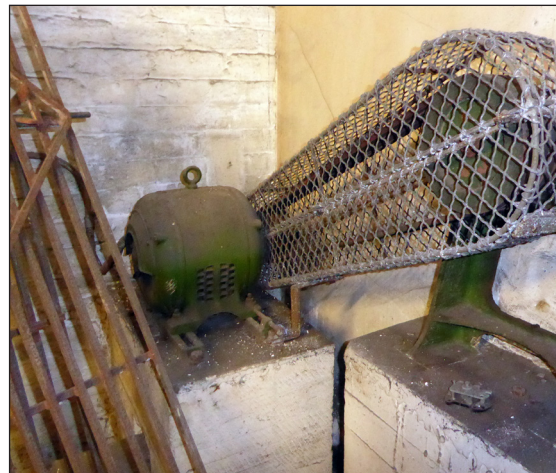
Figure 37: Fan motor (© Historic England, photograph: Alastair Coey Architects 2019)

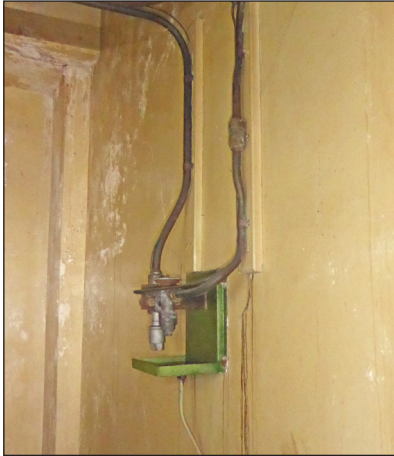
Figure 38: Expansion valve (© Historic England, photograph: Alastair Coey Architects 2019)

in Figure 36). A capillary tube containing either a liquid or gas connects it to the expansion valve. If the sensor heated up due to the air passing through the evaporator becoming warmer (if, say, the cold room door was opened), the pressure in the tube increased and caused a diaphragm in the expansion valve to open. This allowed more refrigerant into the evaporator and thus increased the rate at which it could extract heat. As the temperature of the air decreased, the sensor cooled down and the flow of refrigerant decreased.

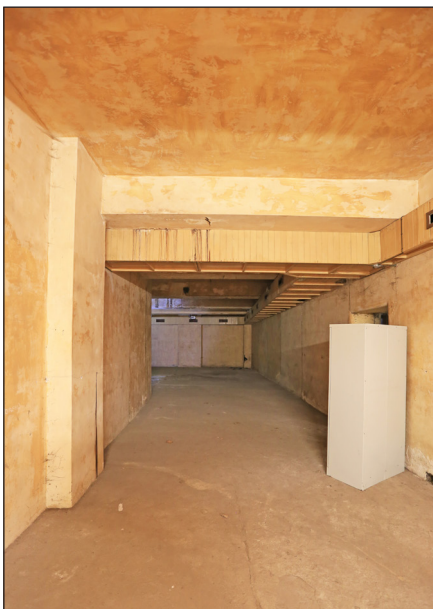
Figure 39: Looking east along cold room to back end (© Historic England, photograph: Alastair Coey Architects 2019)

This was the actual cold room in which the beer was stored (Figures 39-41). It is accessible only from the main part of the ground floor (GF2) via an insulated door similar to that into GF1B. Its clasp latch and emergency escape mechanism are also identical to the door into GF1B. There may well once have been a second latch lower down. Like GF1B, its internal walls are also heavily insulated.

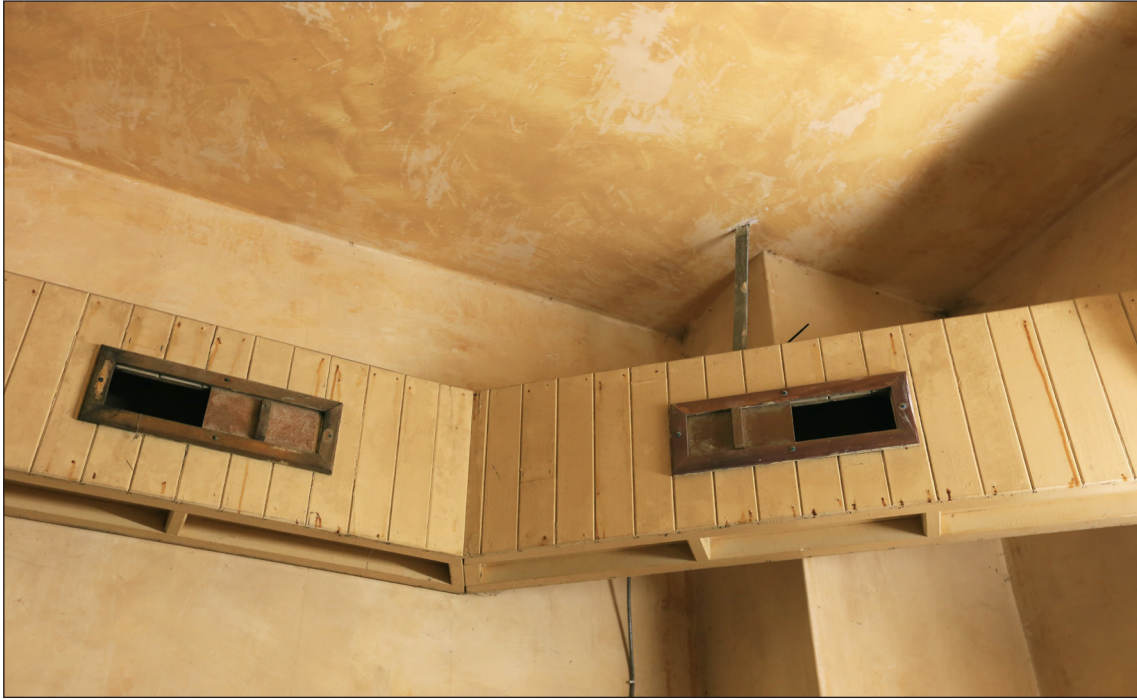
Figure 40: Adjustable openings in chilled air duct (© Historic England, photograph: Alastair Coey Architects 2019)

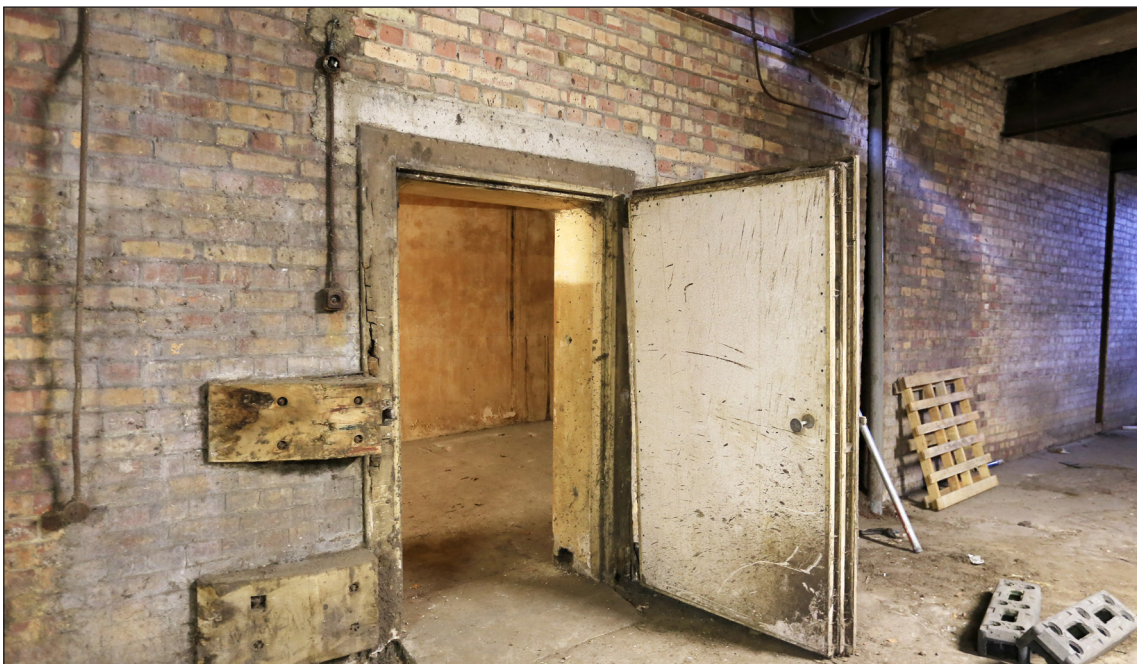
Figure 41: Entrance to cold room (© Historic England, photograph: Alastair Coey Architects 2019)
