7 Market Street
Chipping Norton
Oxfordshire

Tree-ring Analysis of Oak Timbers

Research Report Series no. 175-2020

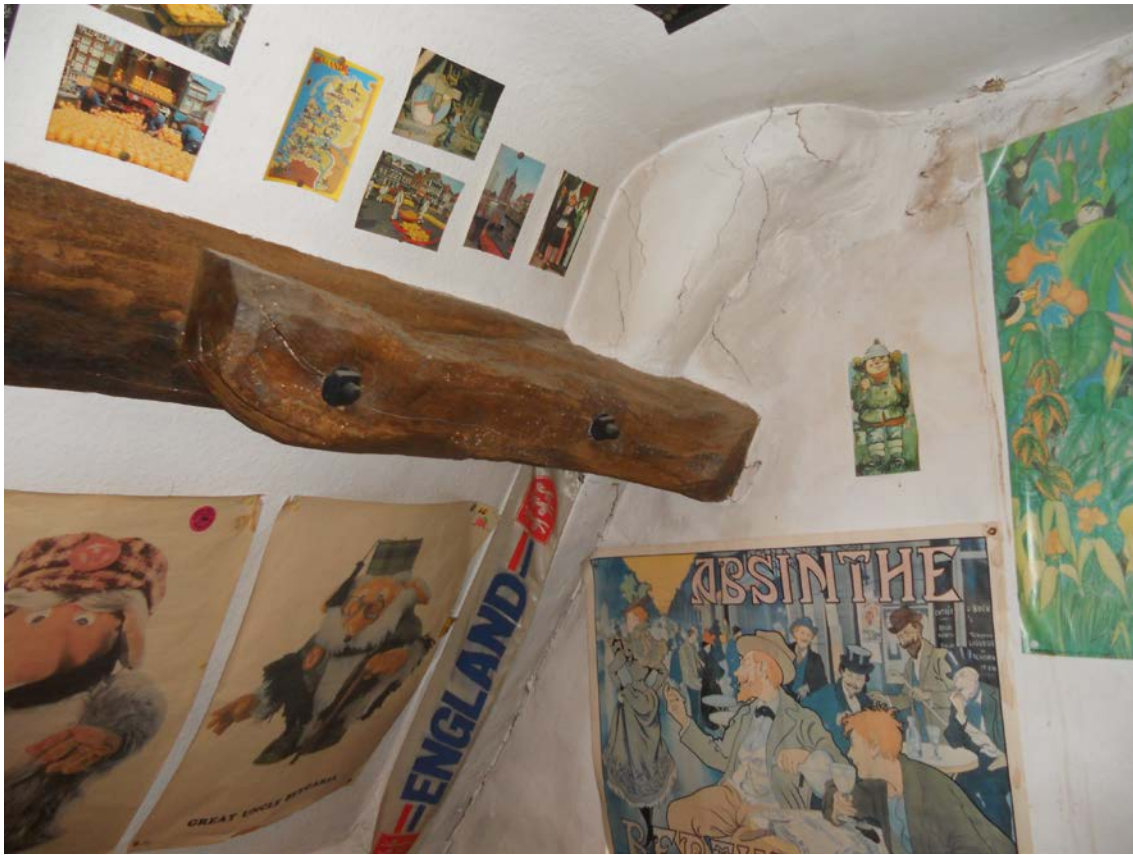
Figure 6: The attached 'knee' added to the west purlin in the north attic room (photograph Martin Bridge)

The 'knee' (cn7mkt10), attached to the west purlin in the north attic room, is thought to be a later addition (Fig 6) and showed a more typical growth pattern (Fig 7). It also failed to date but individual 60-year series are relatively rarely securely dated.
