Church of St Julitta Lanteglos Cornwall

Tree-ring Analysis of Oak Timbers

CHURCH OF ST JULITTA
LANTEGLOS
CORNWALL

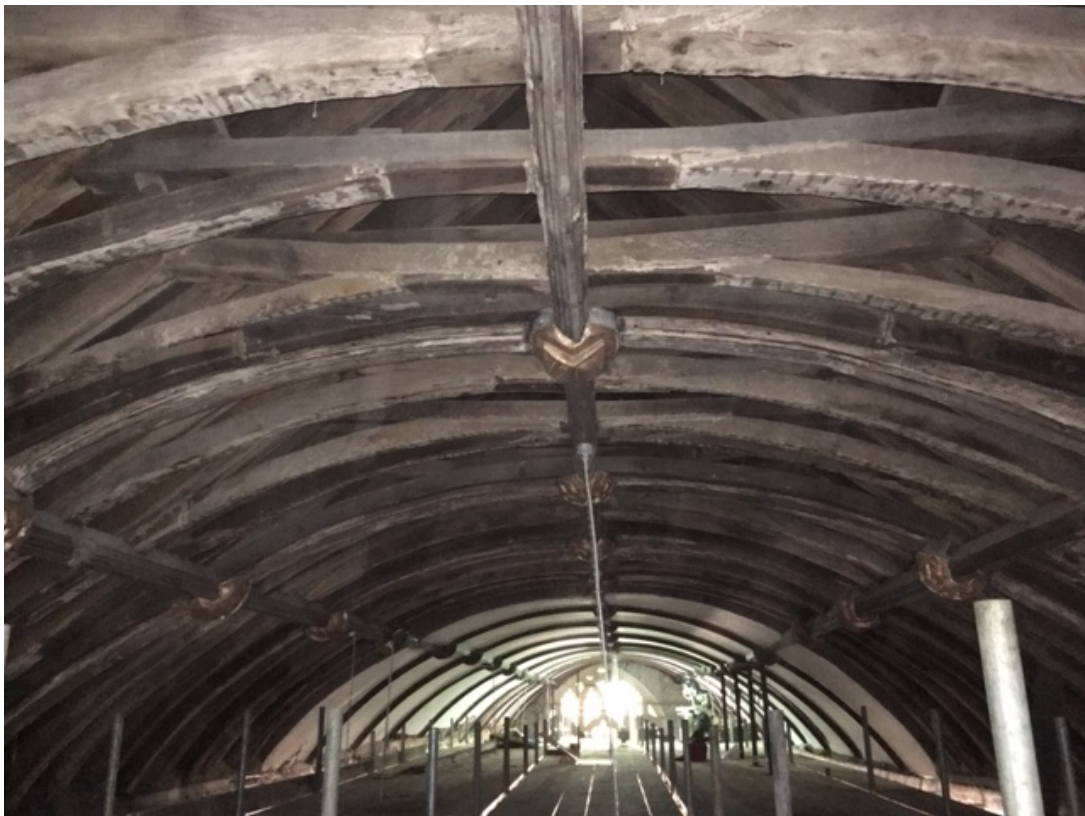
Figure 3: Nave roof, photograph taken from the east (Alison Arnold)

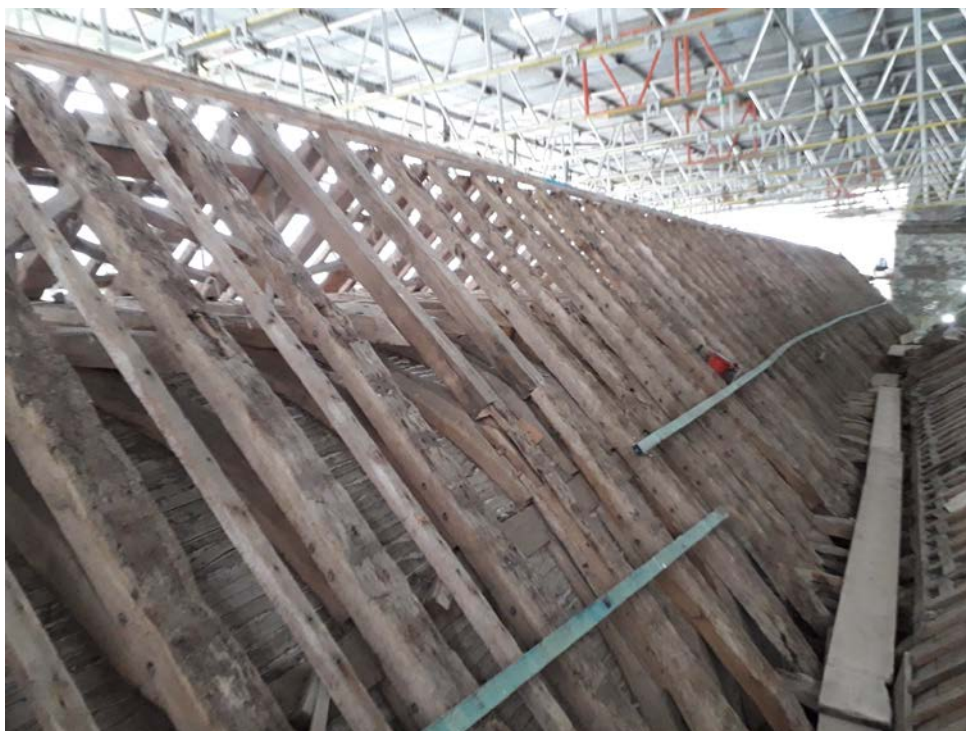
Figure 4: South aisle roof, photograph taken from the east (Alison Arnold)

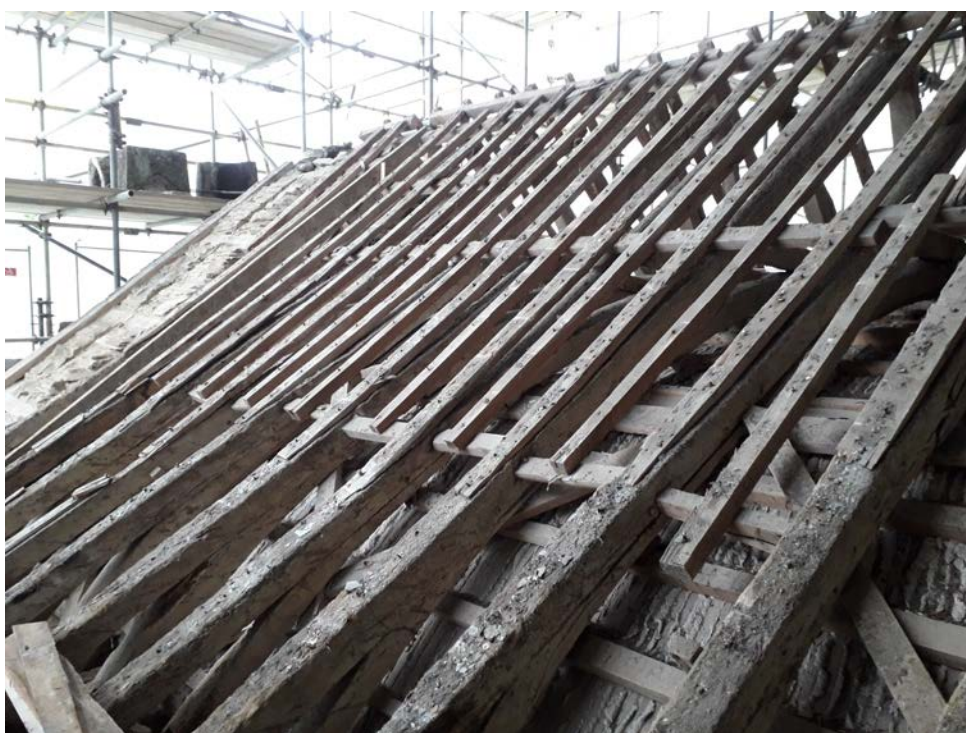
Figure 5: North transept roof, photograph taken from the north-east (Alison Arnold)

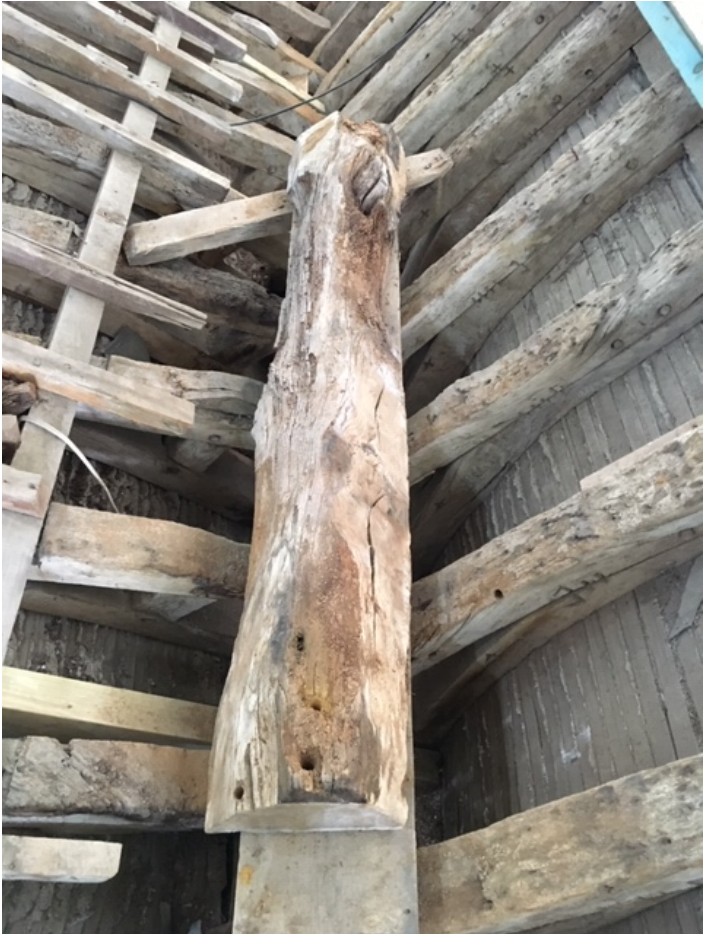
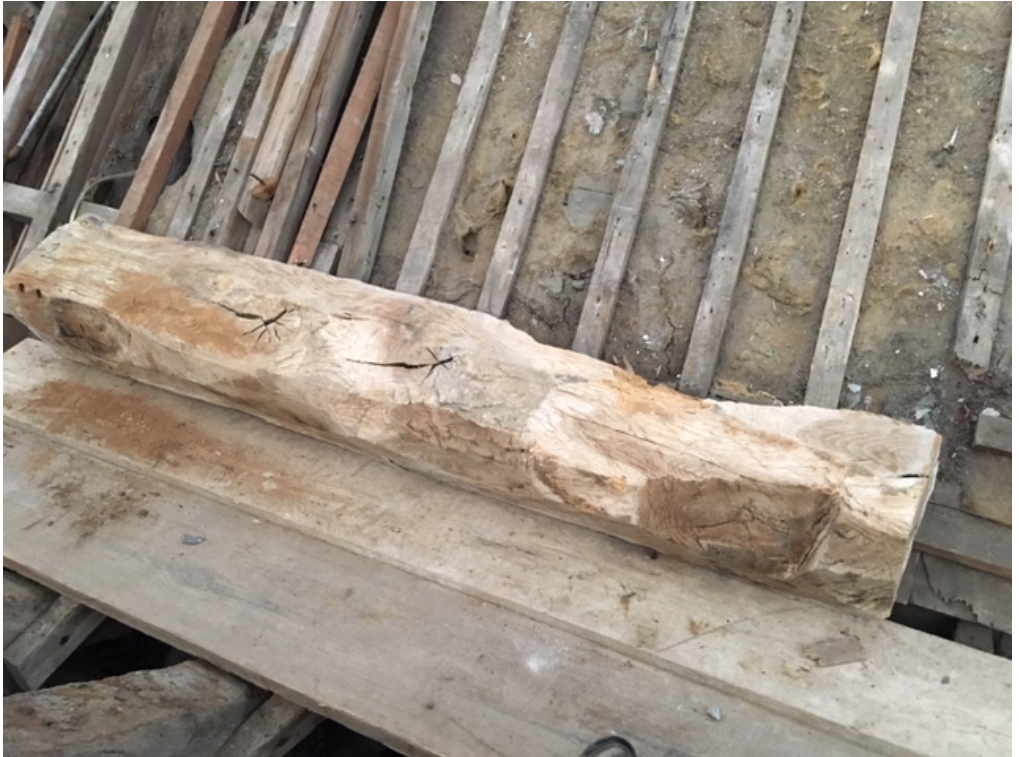
Figure 6: Valley gutter beams, beam 1 to the left and beam 2 to the right (Alison Arnold)

The roofs are of wagon-roof type with common-rafter couples, upper and lower braces, and soulaces. A typical example truss from the south aisle is illustrated in Figure 2. Figures 3–5 show the roofs of the nave, south aisle, and north transept respectively. There is little variation between these roofs but some of the beams in the north transept are moulded. The typology of wagon roofs remains relatively poorly understood (Thorp 2013) but it is thought that these three roofs are likely to be broadly contemporary and date to the fifteenth century. The date of the two large beams located in the valley between the south aisle and nave roofs (Fig 6) is, however, uncertain.

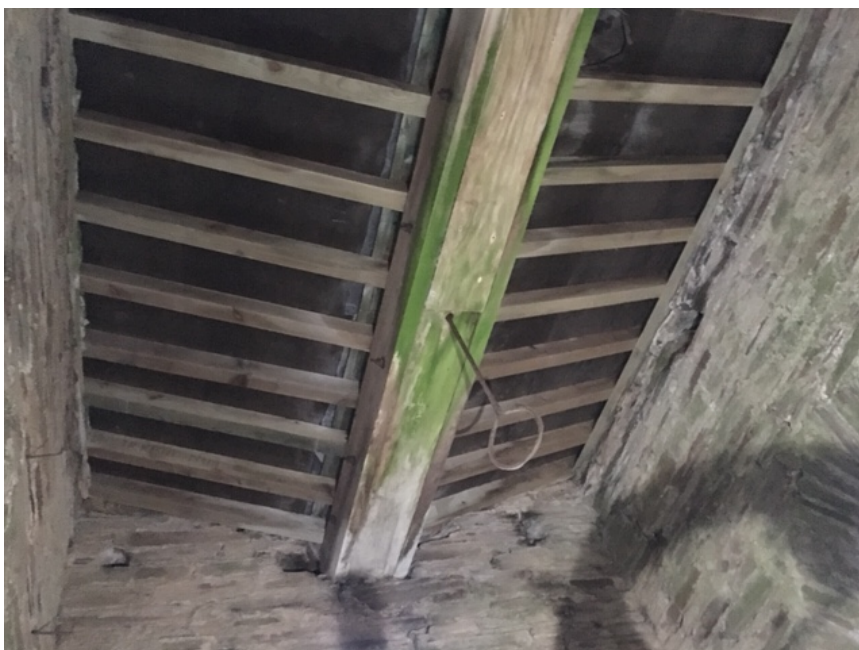
Figure 8: Tower roof, photograph taken from the east (Alison Arnold)

The tower was also assessed for its suitability for tree-ring dating but was found to be a relatively recent structure (Fig 8). Also assessed were two pieces of painted wood (Fig 9), thought to be fragments of the rood screen, to see whether it would be possible to measure a combination of exposed rings and grain. However, it was found that one of the pieces had too few rings for secure dating to be a possibility (less than 40), and the other could not be prepared to a standard where the growth rings could be accurately and reliably measured.

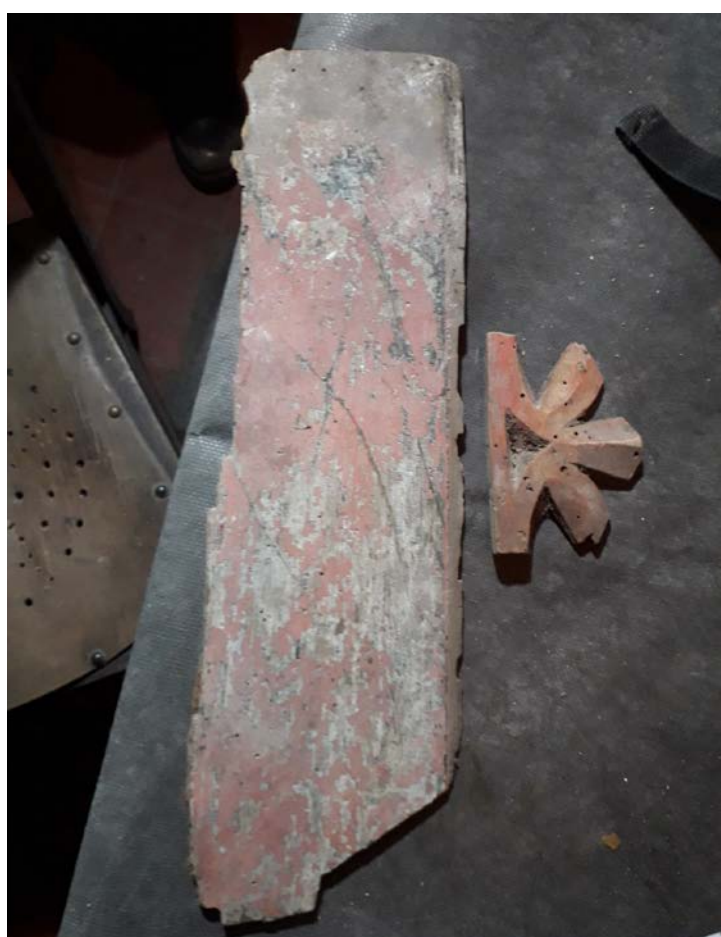
Figure 9: Painted wooden fragments thought to be from the rood screen (Alison Arnold)

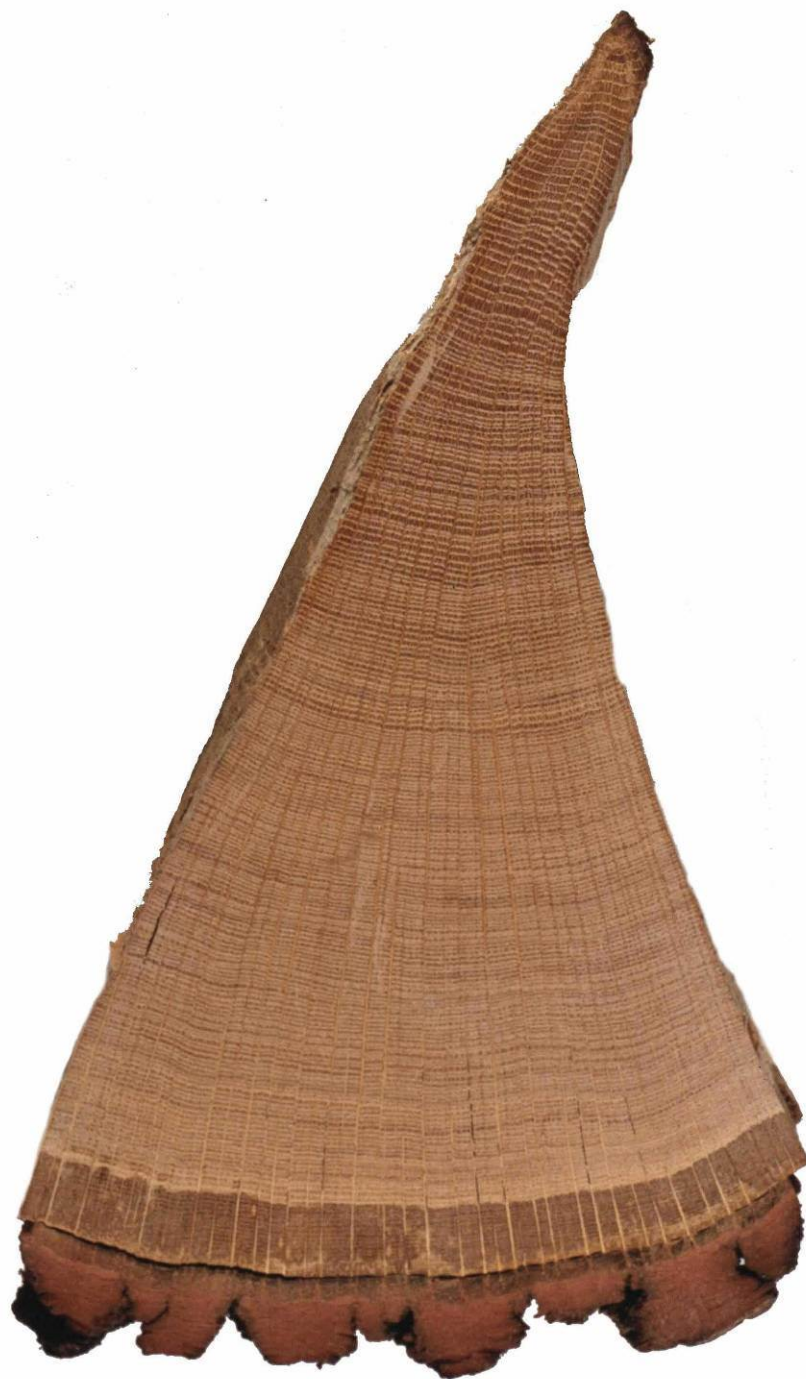
Figure A1: A wedge of oak from a tree felled in 1976. It shows the annual growth rings, one for each year from the innermost ring to the last ring on the outside just inside the bark. The year of each ring can be determined by counting back from the outside ring, which grew in 1976

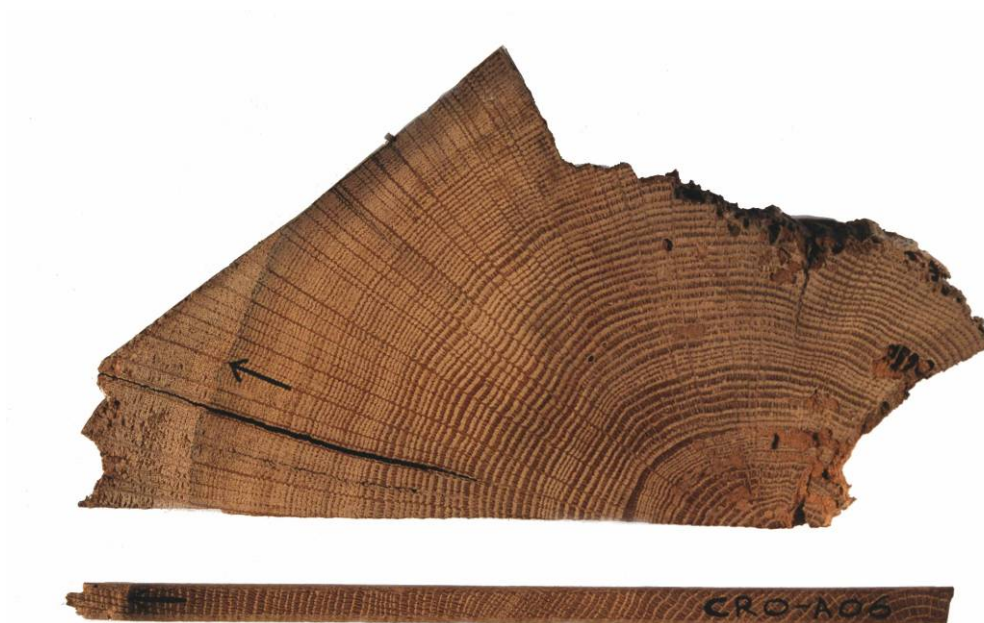
Figure A2: Cross-section of a rafter, showing sapwood rings in the left-hand corner, the arrow points to the heartwood/sapwood boundary (H/S); and a core with sapwood; again the arrow is pointing to the H/S. The core is about the size of a pencil

Quite often some, though not all, of the original outer rings are missing on a timber. The outer rings on an oak, called sapwood rings, are usually lighter than the inner rings, the heartwood, and so are relatively easy to identify. For example, sapwood can be seen in the corner of the rafter and at the outer end of the core in Figure A2, both indicated by arrows. More importantly for dendrochronology, the sapwood is relatively soft and so liable to insect attack and wear and tear. The builder, therefore, may remove some of the sapwood for precisely these reasons. Nevertheless, if at least some of the sapwood rings are left on a sample, we will know that not too many rings have been lost since felling so that the date of the last ring on the sample is only a few years before the date of the original last ring on the tree, and so to the date of felling.

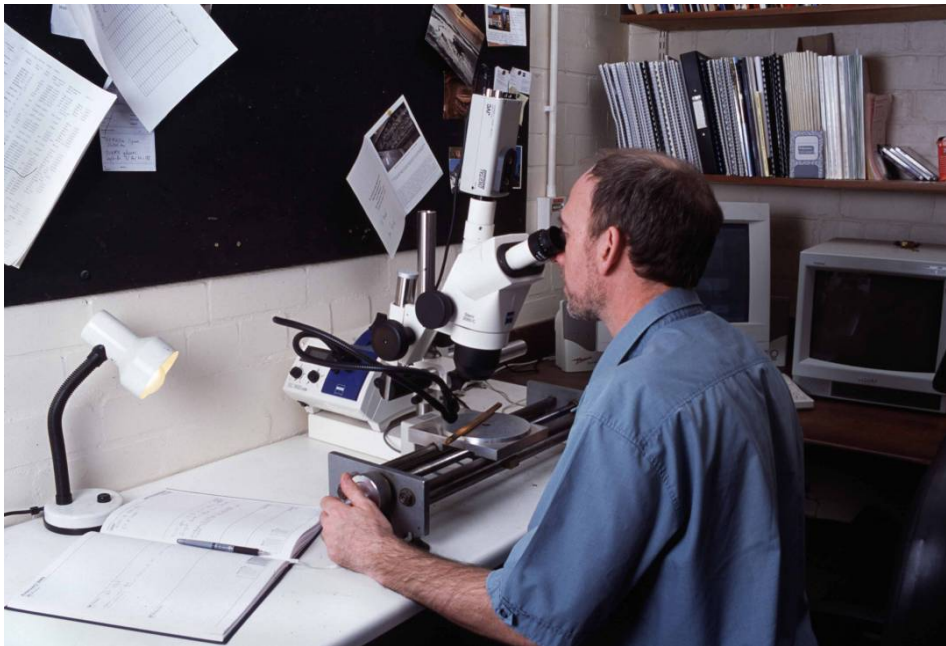
Figure A3: Measuring ring widths under a microscope. The microscope is fixed while the sample is on a moving platform. The total sequence of widths is measured twice to ensure that an error has not been made. This type of apparatus is needed to process a large number of samples on a regular basis

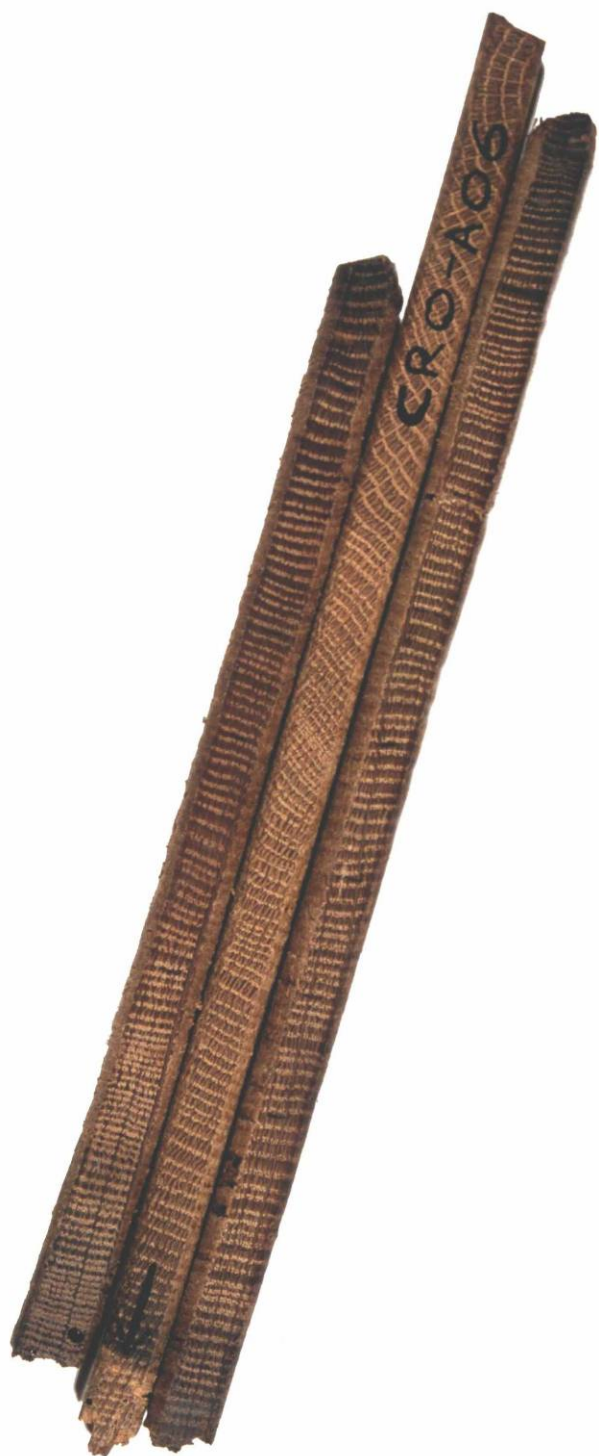
Figure A4: Three cores from timbers in a building. They come from trees growing at the same time. Notice that, although the sequences of widths look similar, they are not identical. This is typical
