# Falcon Hotel Chapel Street Stratford-upon-Avon Warwickshire

Tree-ring Analysis of Elm and Oak Timbers

Research Report Series 106-2019

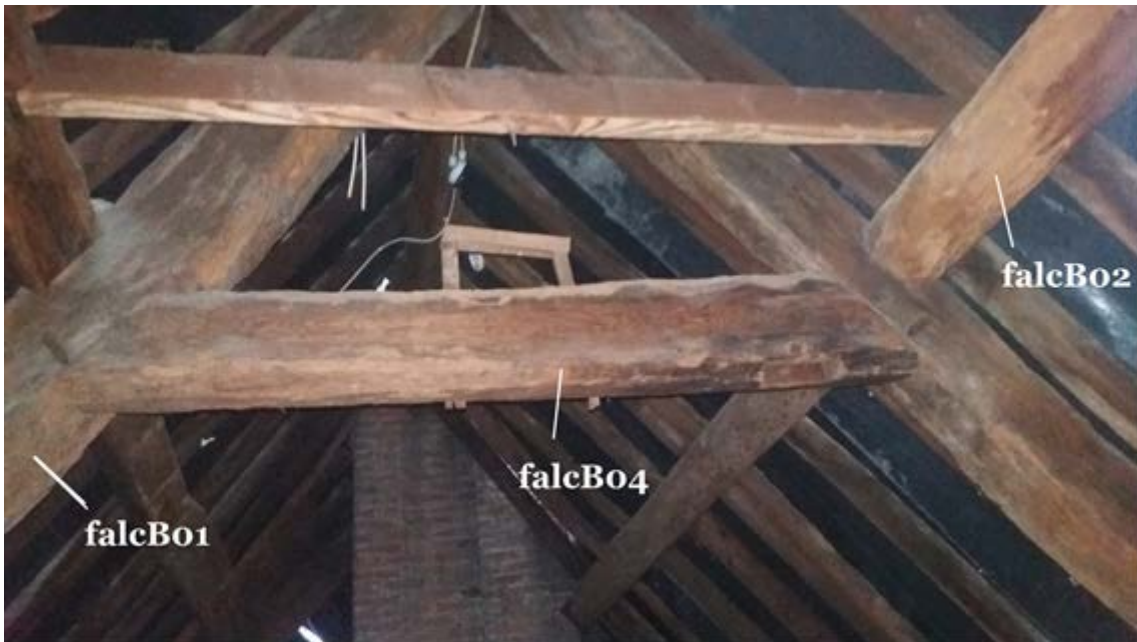
Figure 4: View looking west from the entry into the elm roof, showing truss 2 and the stack behind, with some of the timbers sampled (photograph Martin Bridge)

The third elm truss from the entry into the roof from the main range was behind a brick stack (Figs 3 and 4), and where the floor was unsafe, thus this truss was not sampled. Nine samples, eight elm and one oak (Table 1; Figs 4 and 5), were taken however the plans and photographs available did not make it possible to show the locations of samples falcB03, falcB05, falcB06, and falcB07. The elm samples showed a range of lengths of sequence, and one sample showed a clear distinction between heartwood and sapwood, not always evident in elm. The ring width measurements are given in the Appendix. Comparison of all nine series highlighted some potential matches statistically, but these were short overlaps, and none were

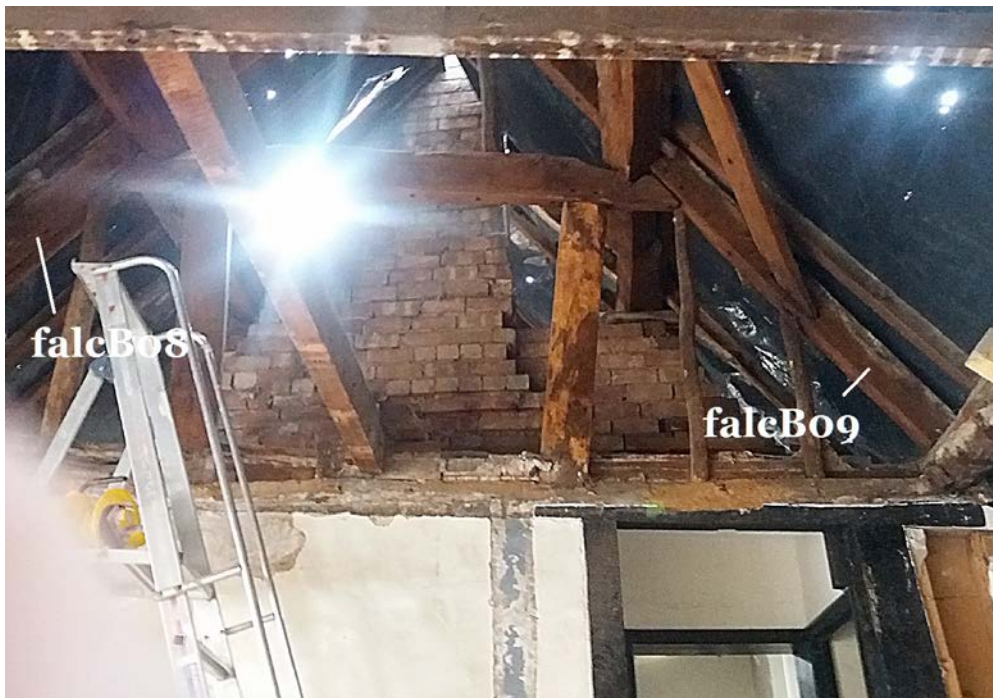
Figure 5: View looking east, showing truss 1, with some of the timbers sampled (photograph Martin Bridge)
