SPAB Building Performance Survey 2019

Final Report
May 2020

The SPAB RESEARCH REPORT 2

The SPAB Building Performance Survey Final Report

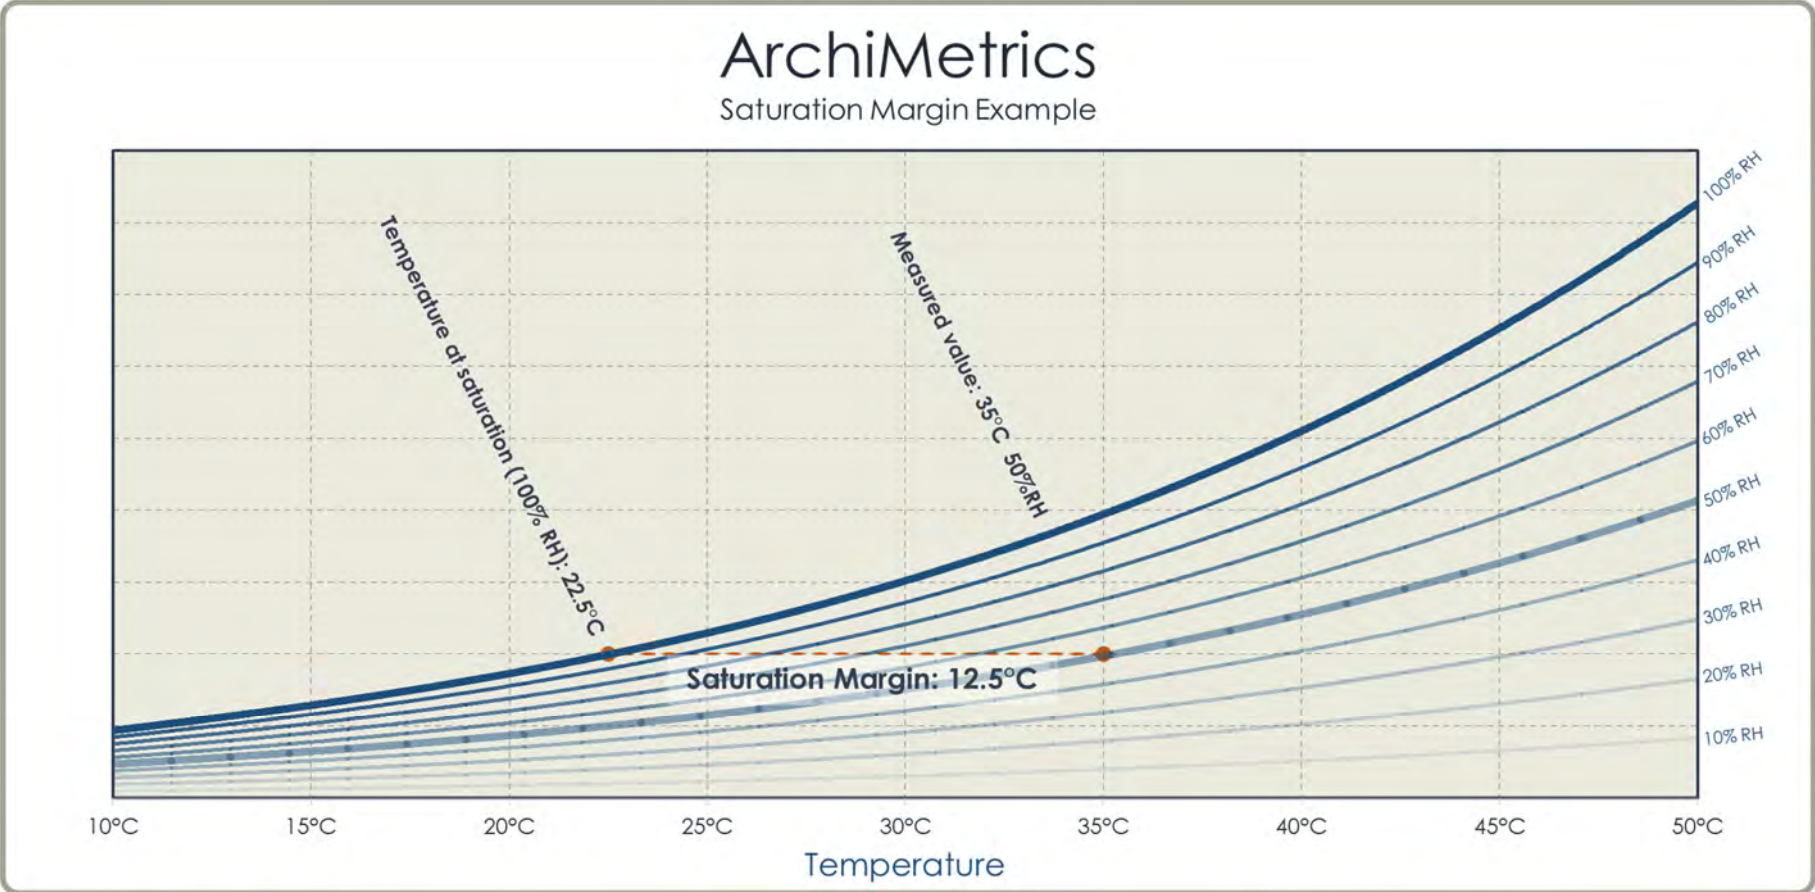
Figure 1. Illustration of saturation margin principle

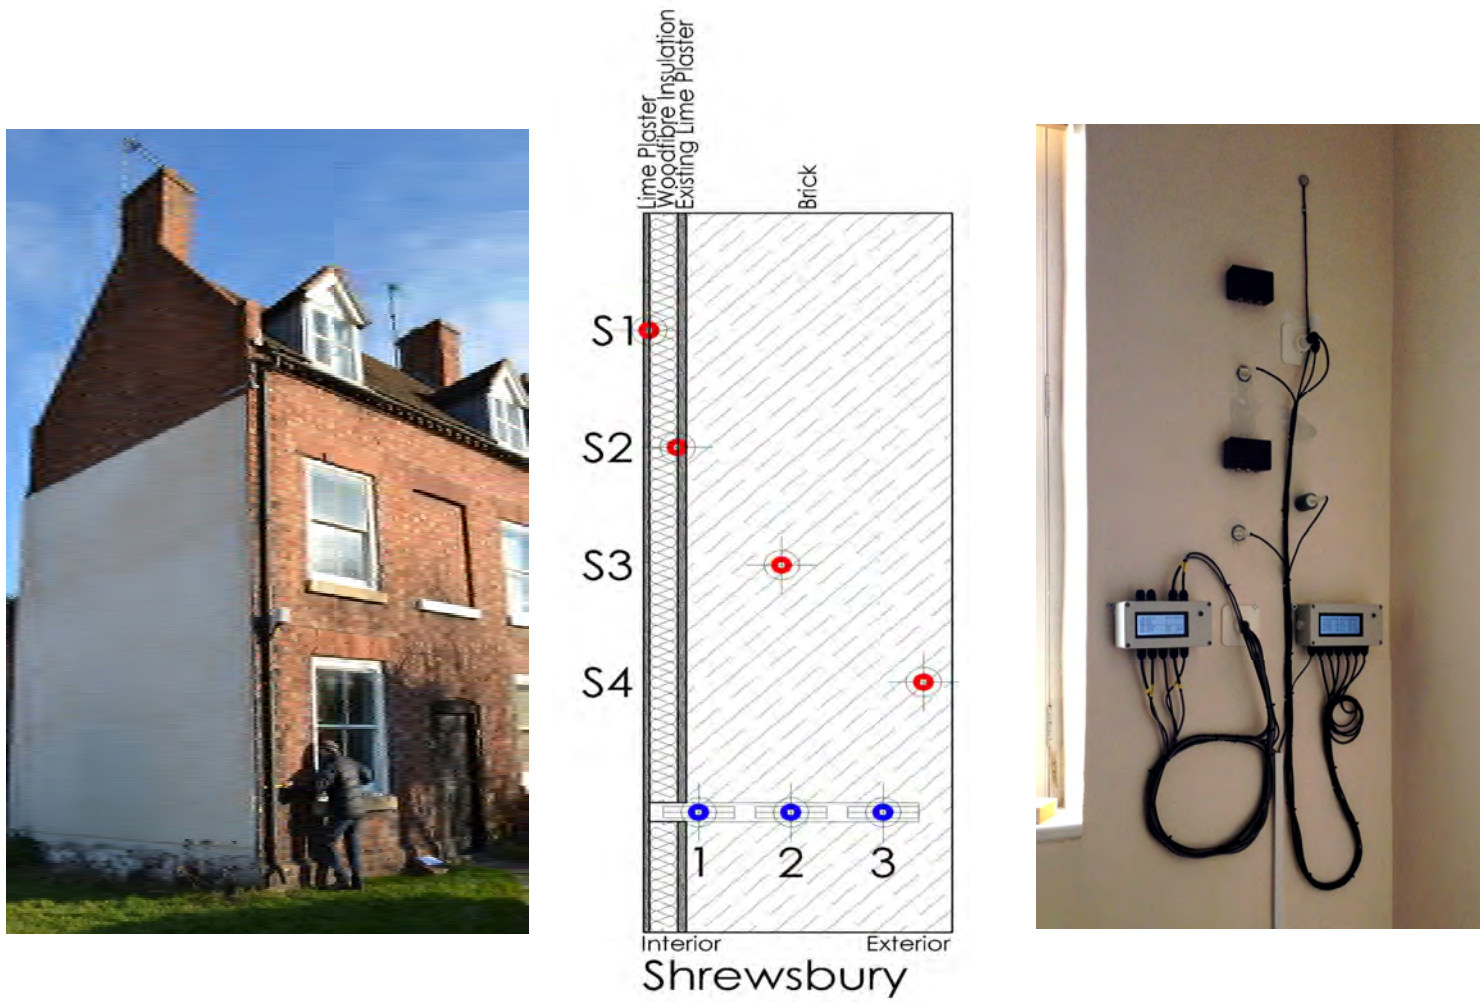
Figure 2. Interstitial hygrothermal gradient and material moisture monitoring, Abbeyforegate, Shrewsbury 2014.

The brick wall monitored in the study is found in a late Georgian building (1820s) located on Abbeyforegate, in the town of Shrewsbury. All the monitored walls are at ground floor level and floor plans showing monitoring locations are provided in Appendix A. The wall at Shrewsbury is south-facing and made of low-fired, relatively soft, porous and permeable brick bedded in lime mortar. It is a brick-and-a-half thick, $\approx 14\text{''}/350\text{ mm}$, with some areas of pointing in poor condition. As part of the refurbishment of the house in 2012, the wall was internally insulated with 40 mm of woodfibre insulation board with a thermal conductivity (λ) value of 0.039 W/(m K) and finished with lime plaster and silcate paint. Table 1 provides details of the depths of combined RH and temperature monitoring

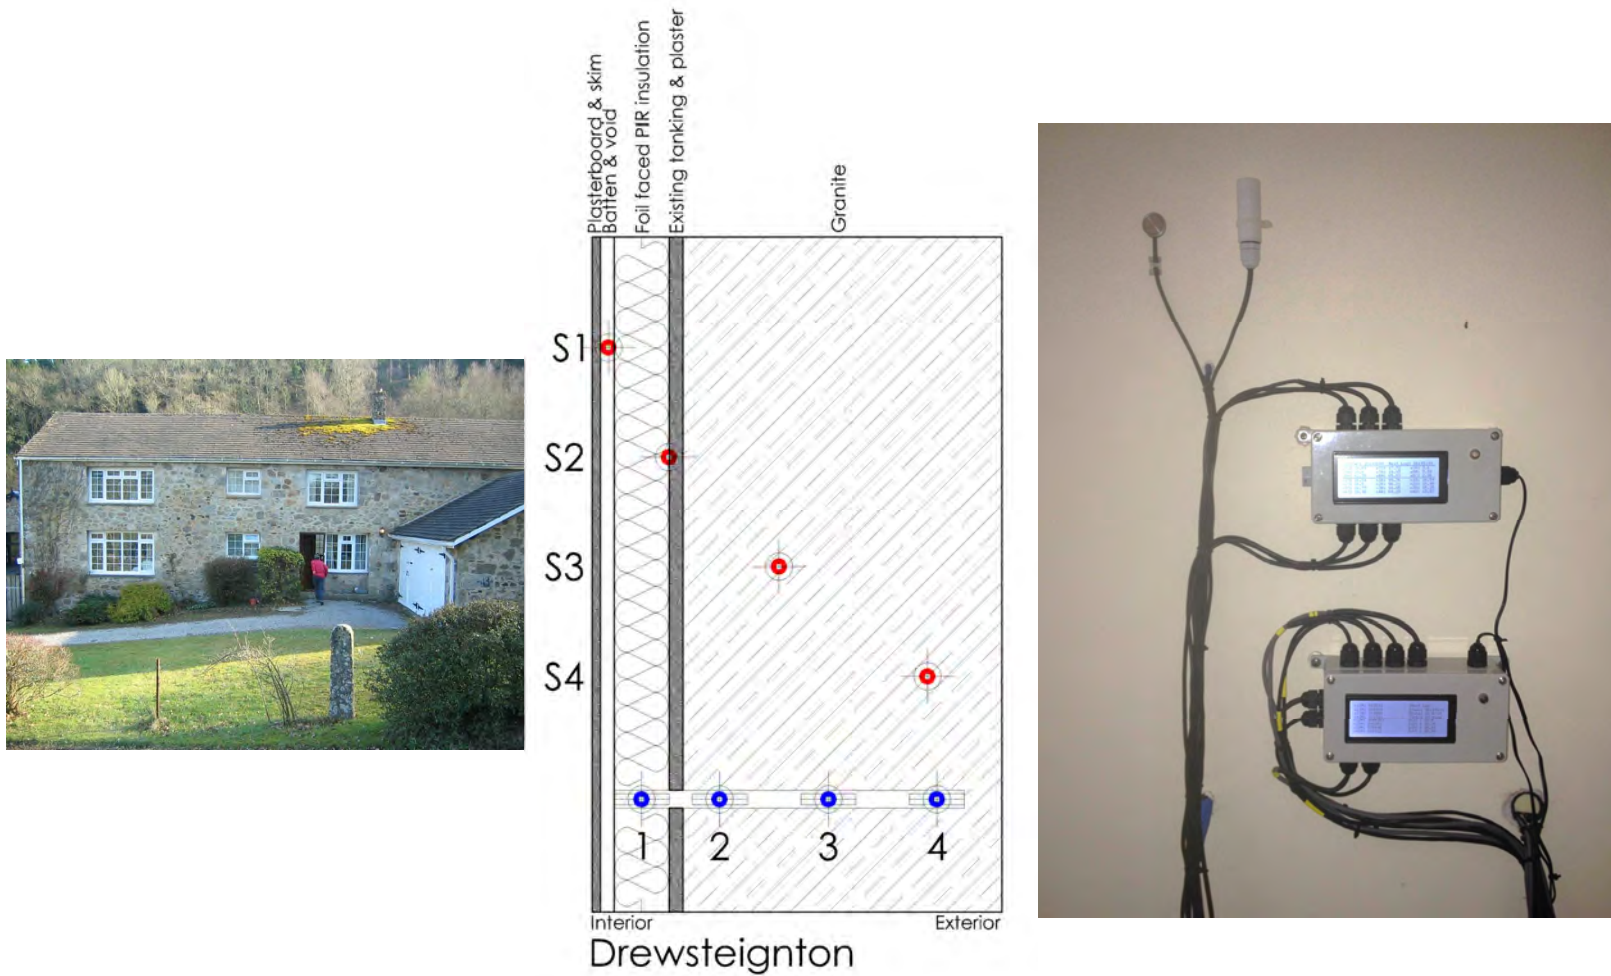
Figure 3. Interstitial hygrothermal gradient and material moisture monitoring, Drewsteignton, 2014.

The two other walls that were the focus of the extended wall moisture study were based in Devon: a granite stone wall in Drewsteignton and a cob wall in the village of Riddlecombe. The granite wall is north-west facing and as with many stone walls is quite thick, measuring approximately 600 mm. The quality of the granite is quite variable; with some blocks being harder than others, some with a dense, compact matrix and others with larger individual pieces of feldspar visible. Granite stone is considered relatively non-porous and not permeable although this can be quite variable, for example, where feldspar has been washed out, and the stone can contain fissures and fractures by which moisture might migrate. The stones are also bedded in lime mortar which is both porous and permeable. For the purposes of this research, in 2012 a floor-to-ceiling section of this wall was internally insulated with 100 mm of polyisocyanurate (PIR) insulation with a thermal conductivity (λ) value of 0.022 W/(m K) and dry-lined (Figure 3). The dimensions of the complete build-up are given in Table 2, the position and depth of the 25 mm air gap being as per the insulation manufacturer's recommendations at the time of installation.

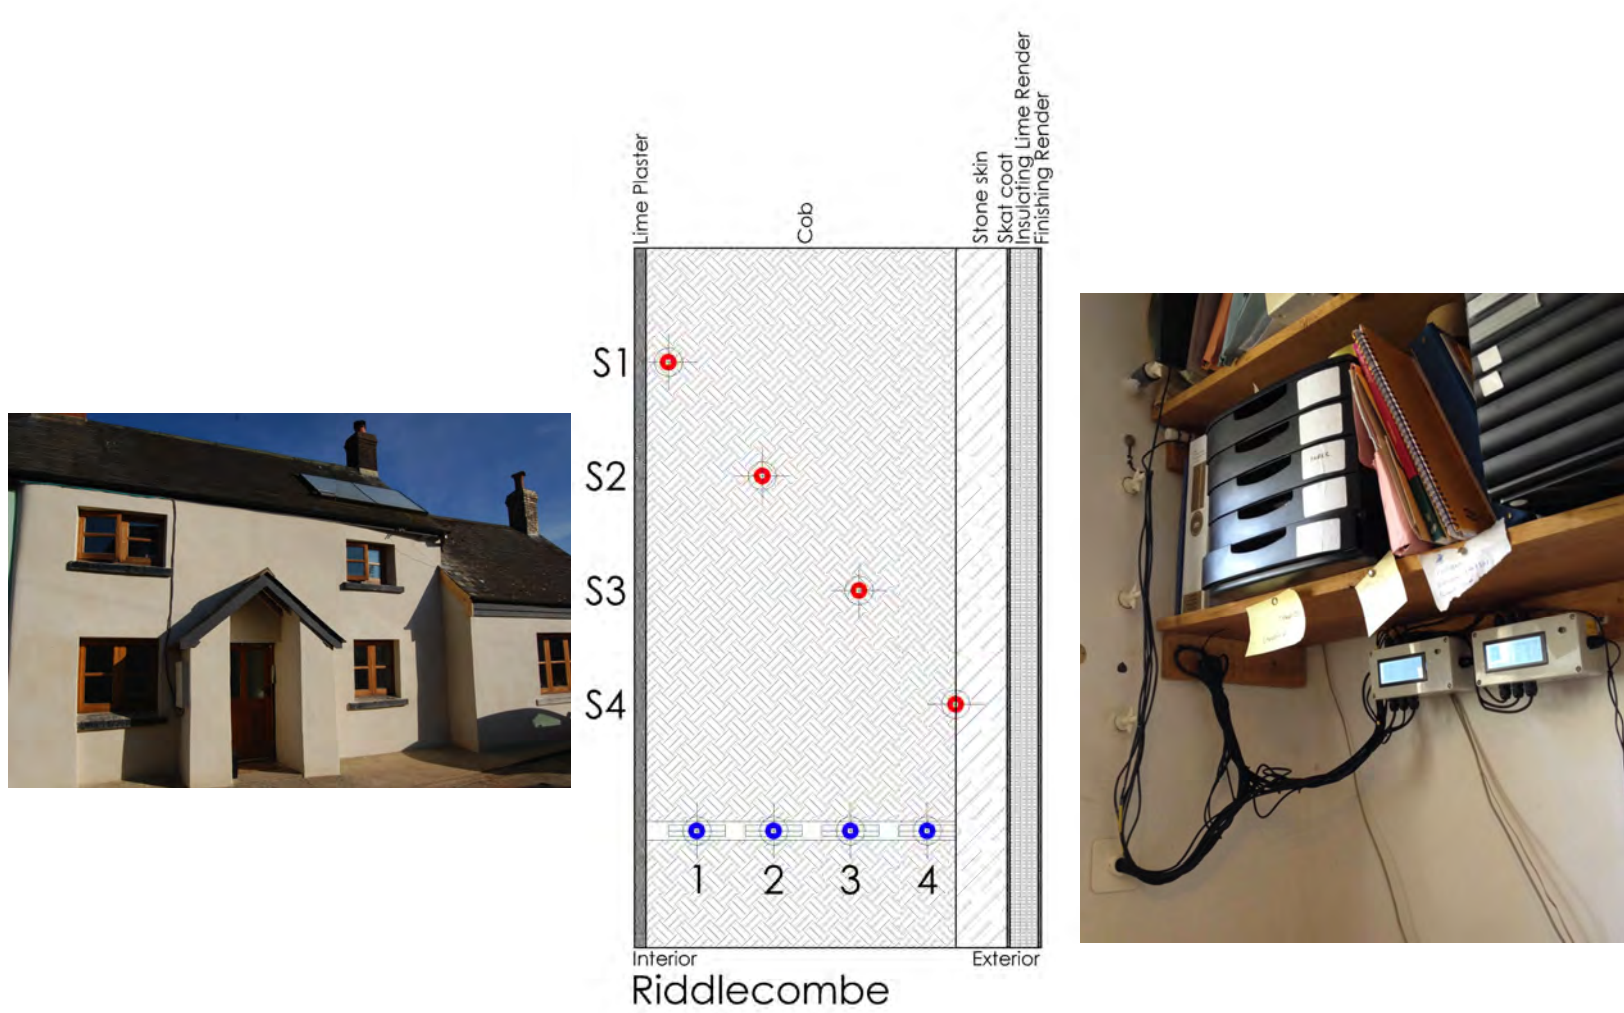
Figure 4. Interstitial hygrothermal gradient and material moisture monitoring, Riddlecombe.

The third building under study is somewhat different not being a masonry construction; it is built of cob (monolithic unbaked earth) and located in the village of Riddlecombe in north Devon. The wall is south-facing and, once again, as is usual for this material, is quite thick, around 550 mm. At the site of monitoring it had been historically reinforced or repaired with a layer of stone facing. Cob, made of clayey sub-soil sometimes containing aggregates and mixed with straw, is both eminently porous and permeable. Prior to refurbishment, the wall had an exterior cement render which was in poor condition and cracked. As part of refurbishment this was removed in 2012 and replaced with 60 mm of an insulating lime render incorporating perlite, with a thermal conductivity (λ) value of 0.066 W/(m K) (Table 3 and Figure 4).

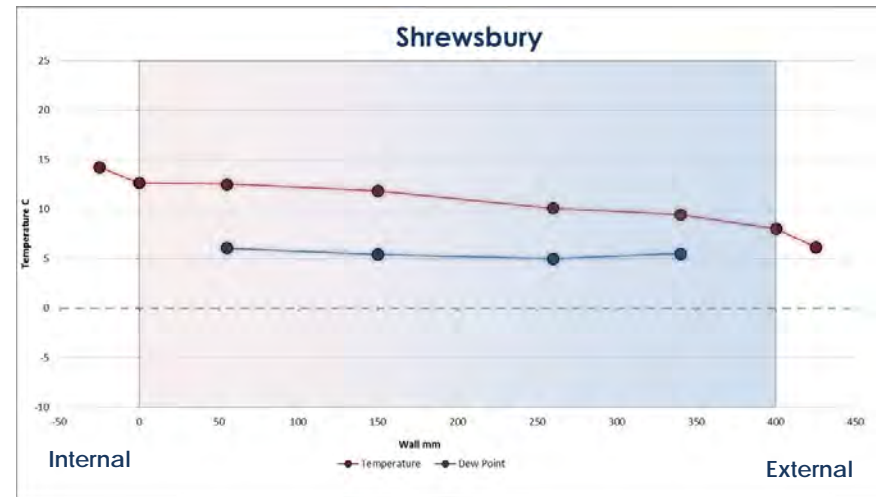
Figure 5. Temperature and dewpoint gradients for Abbeyforegate, Shrewsbury, 2011.

Shrewsbury was found to have good correlation between its measured and calculated U-value; giving some certainty to a U-value of around 1.50 W/m²K for the wall. The temperature gradient plotted through the wall shows on average only a 4°C difference internally and externally and the report notes that internal heat input was quite low during the monitoring. The difference in the gradients between measurement nodes indicates a less homogenous thermal transfer response through the section. Heat loss towards the external side of the wall is increased due, perhaps, to the effects of air movement and/or wet materials. As measurements were taken in winter, during the coldest part of the year, some convergence towards the outside is expected between the plots of measured temperature and dewpoint temperature; the wall is cooler towards the external side resulting in the air within the wall being closer

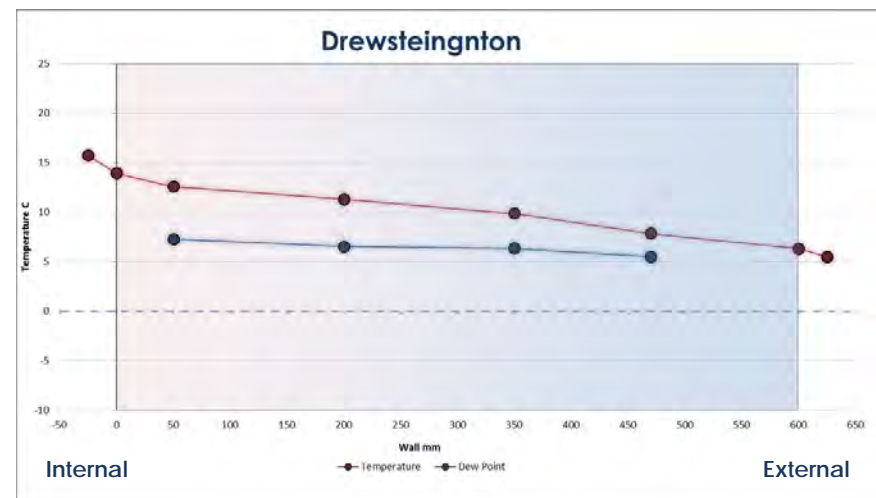
Figure 6. Temperature and dewpoint gradient for Mill House, Drewsteignton, 2011.

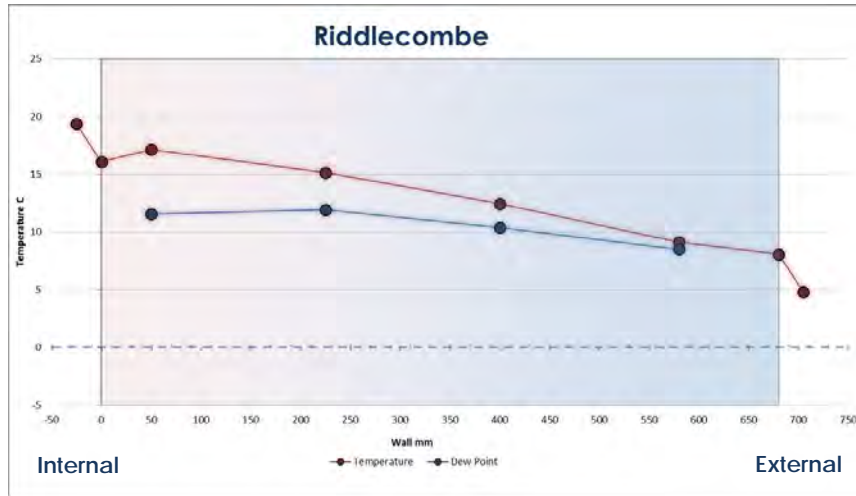
Figure 7. Temperature and dewpoint gradient for The Firs, Riddlecombe, 2011.

As with the other thick wall in the study, Drewsteignton, there was on average an 8°C internal/external surface-to-surface temperature difference for this wall during the monitoring period and the consistency of the gradients between sensing nodes shows a very homogenous thermal response. Indeed, during drilling the cob material was found to be very uniform and seem to include very little aggregate. Of the three walls pre-refurbishment, the hygrothermal section for Riddlecombe showed the greatest convergence of temperature and dewpoint gradients and the saturation margin at node 4, towards the external side of the wall, was found to be on average only 0.6°C pointing to the possibility of wet or damp conditions. As has been previously noted, this

wall was finished with a cracked cement render and it was surmised that this was likely to be admitting water which was then unable to evaporate, leading to damp conditions within the cob in proximity to the external wall face.

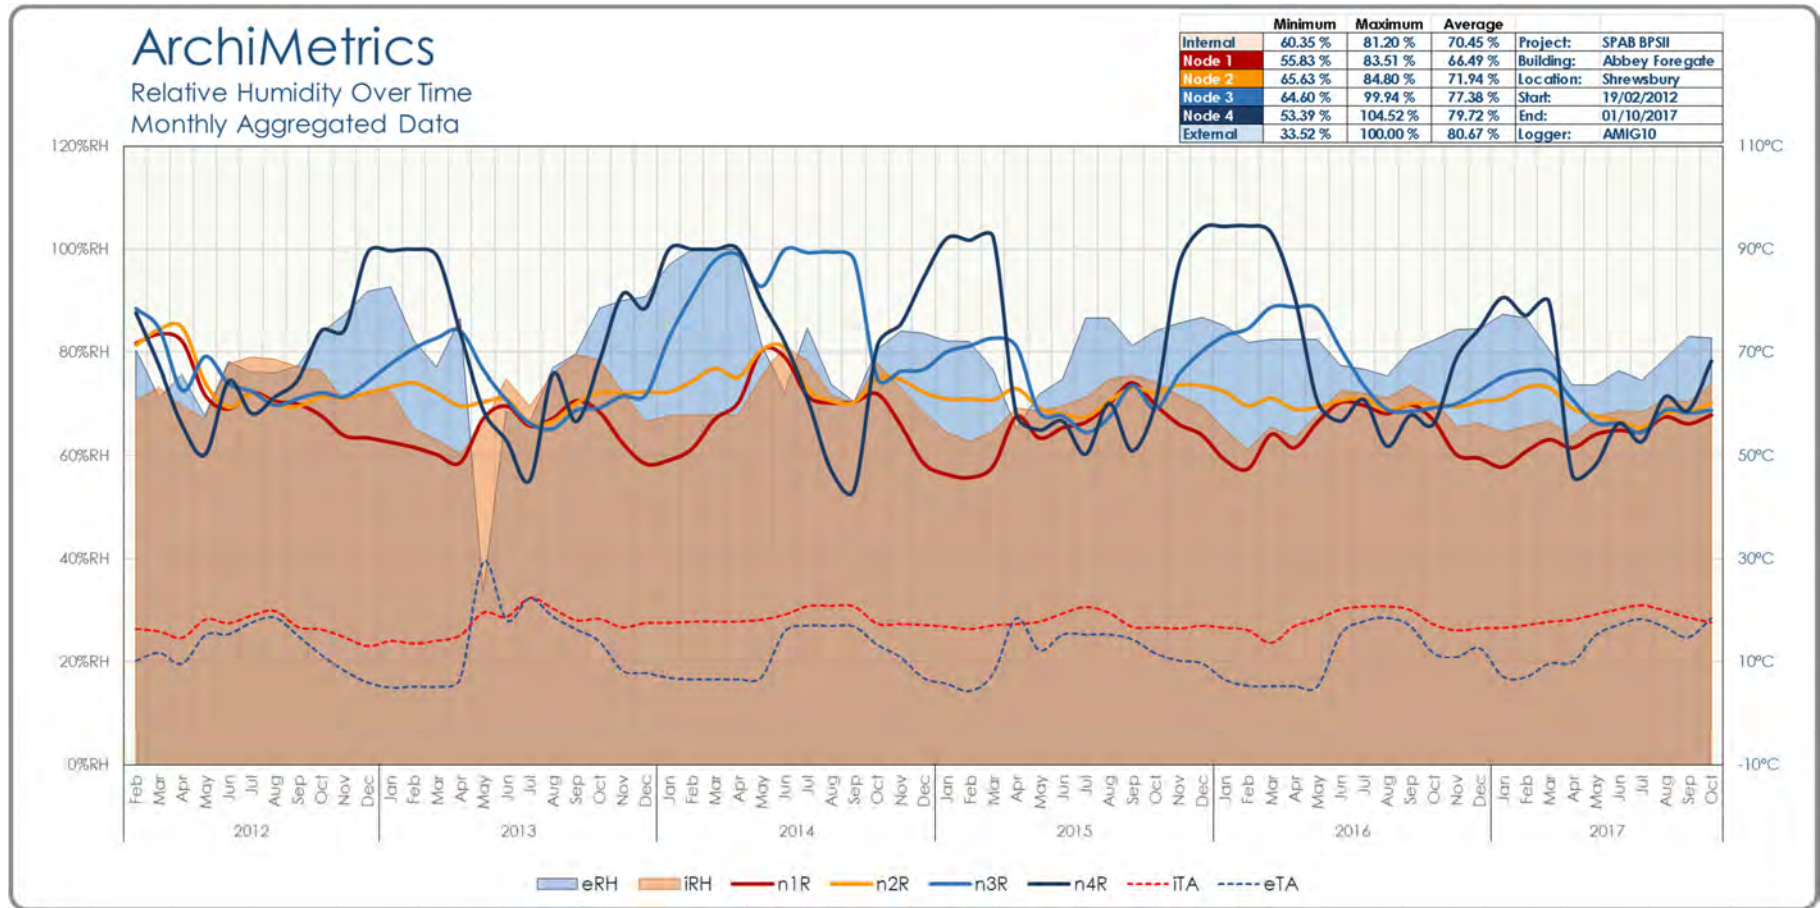
Figure 8. Relative humidity over time – post-refurbishment, Shrewsbury 2012–2017.²

condensation. At Shrewsbury, over six years we can see that, despite the volatility observed towards the external side of the wall at n2, RH stays within a relatively narrow range and over six years averages 72%. There are only two occasions in the monthly aggregated data when levels are seen to exceed that of 80%; early on in the post-refurbishment monitoring, as a result of the wet materials used on the internal side of the wall (lime plaster) as part of the refurbishment. (It is also possible to see a decrease in RH at n1 and n2 as these materials dry to a dynamic equilibrium by June 2012.) Then again in May–June 2014, in response to the exceptional wetting that has taken place that year due to winter storms. We have surmised that the relatively stable RH response plotted at n2 is a result of the hygroscopic properties of the wood fibre insulation in close proximity to it. This ‘buffers’ vapour in the air resulting in a more even, less extreme, RH response.

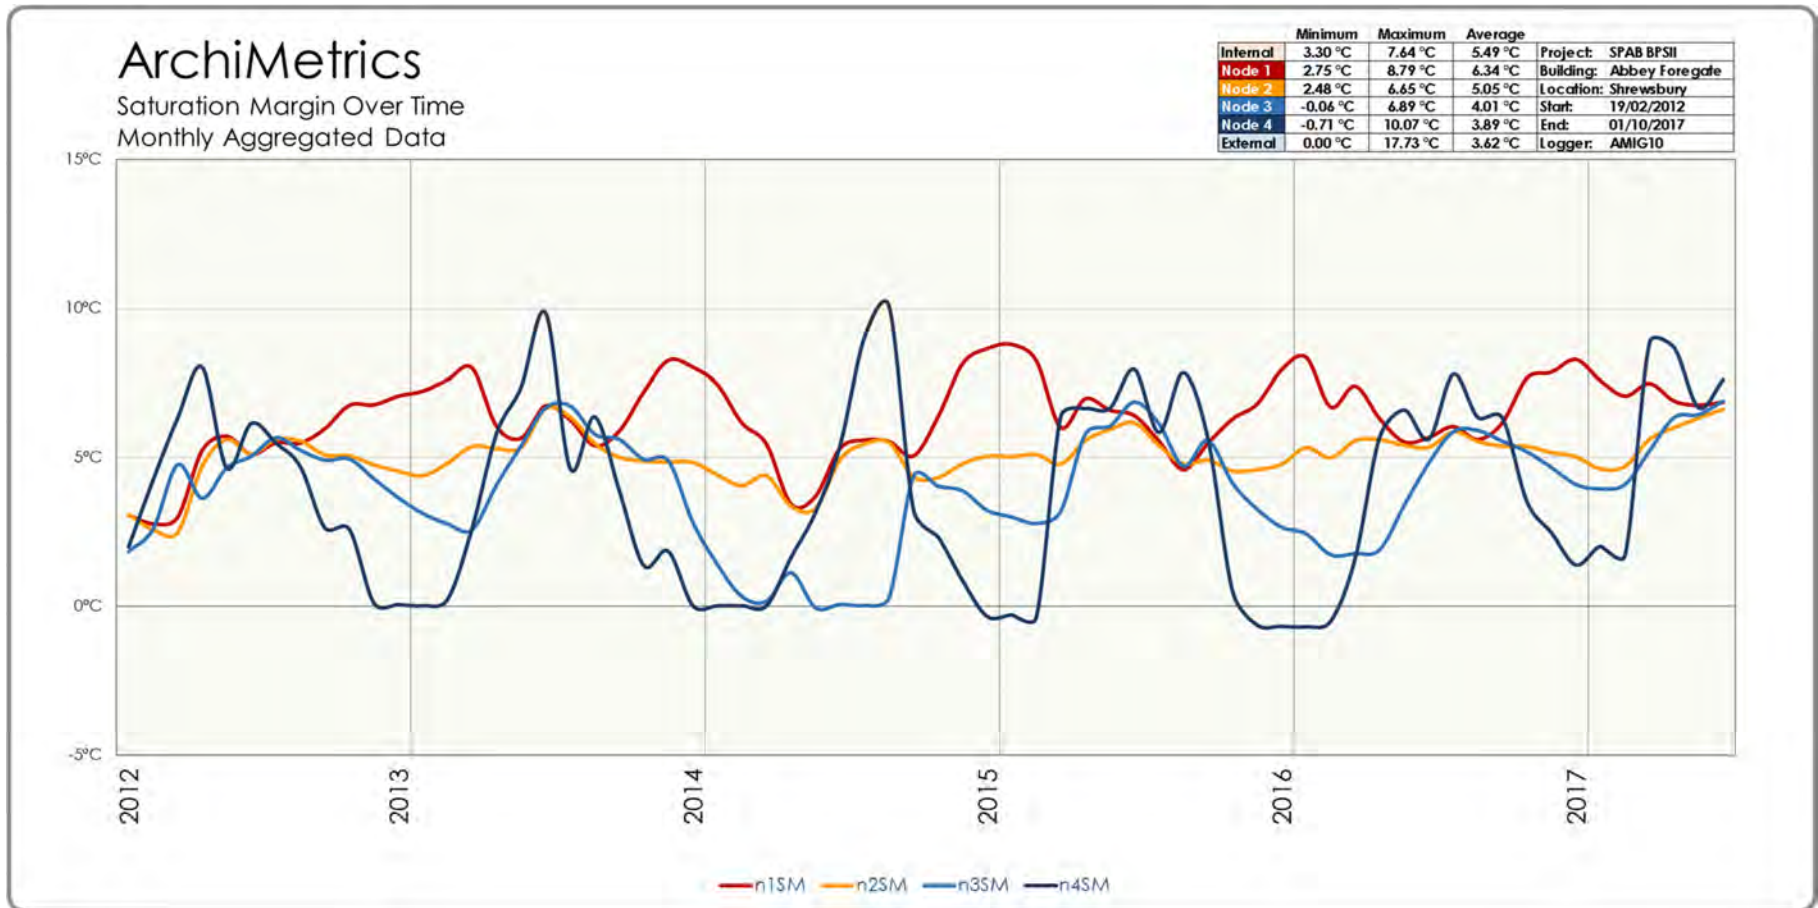
Figure 10. Saturation margin over time – post-refurbishment, Shrewsbury 2012–2017.

Based on measurements of RH, we have also looked at moisture vapour behaviour within the wall in Shrewsbury in terms of risk in the form of ‘saturation margins’. These quantify the risk of the air within the wall becoming saturated. A saturation margin is the difference between measured temperature and dewpoint temperature and thus indicates, in °C, how close the air at a particular location is to 100% RH. Whilst this does not relate directly to predictions of mould fungus formation, it is, nevertheless, indicative of a particular state within the fabric, suggesting high concentrations of vapour and the possibility of condensation and the deposition of water within fabric. In Figure 10, periods of the year where the wall reaches 100% RH (mostly only at n4) inevitably correspond with saturation margins of 0°C. But, as with the RH record, these margins quickly improve as residual winter moisture is dried from the fabric. So whilst parts of this wall do exhibit high vapour records for part of the year, this vapour also reduces annually and the average saturation margins calculated overall for six years for the wall; n1, 6.34°C, n2, 5.05°C n3, 4.01 and n4, 3.89°C are much wider than those found for the other two walls in the study.

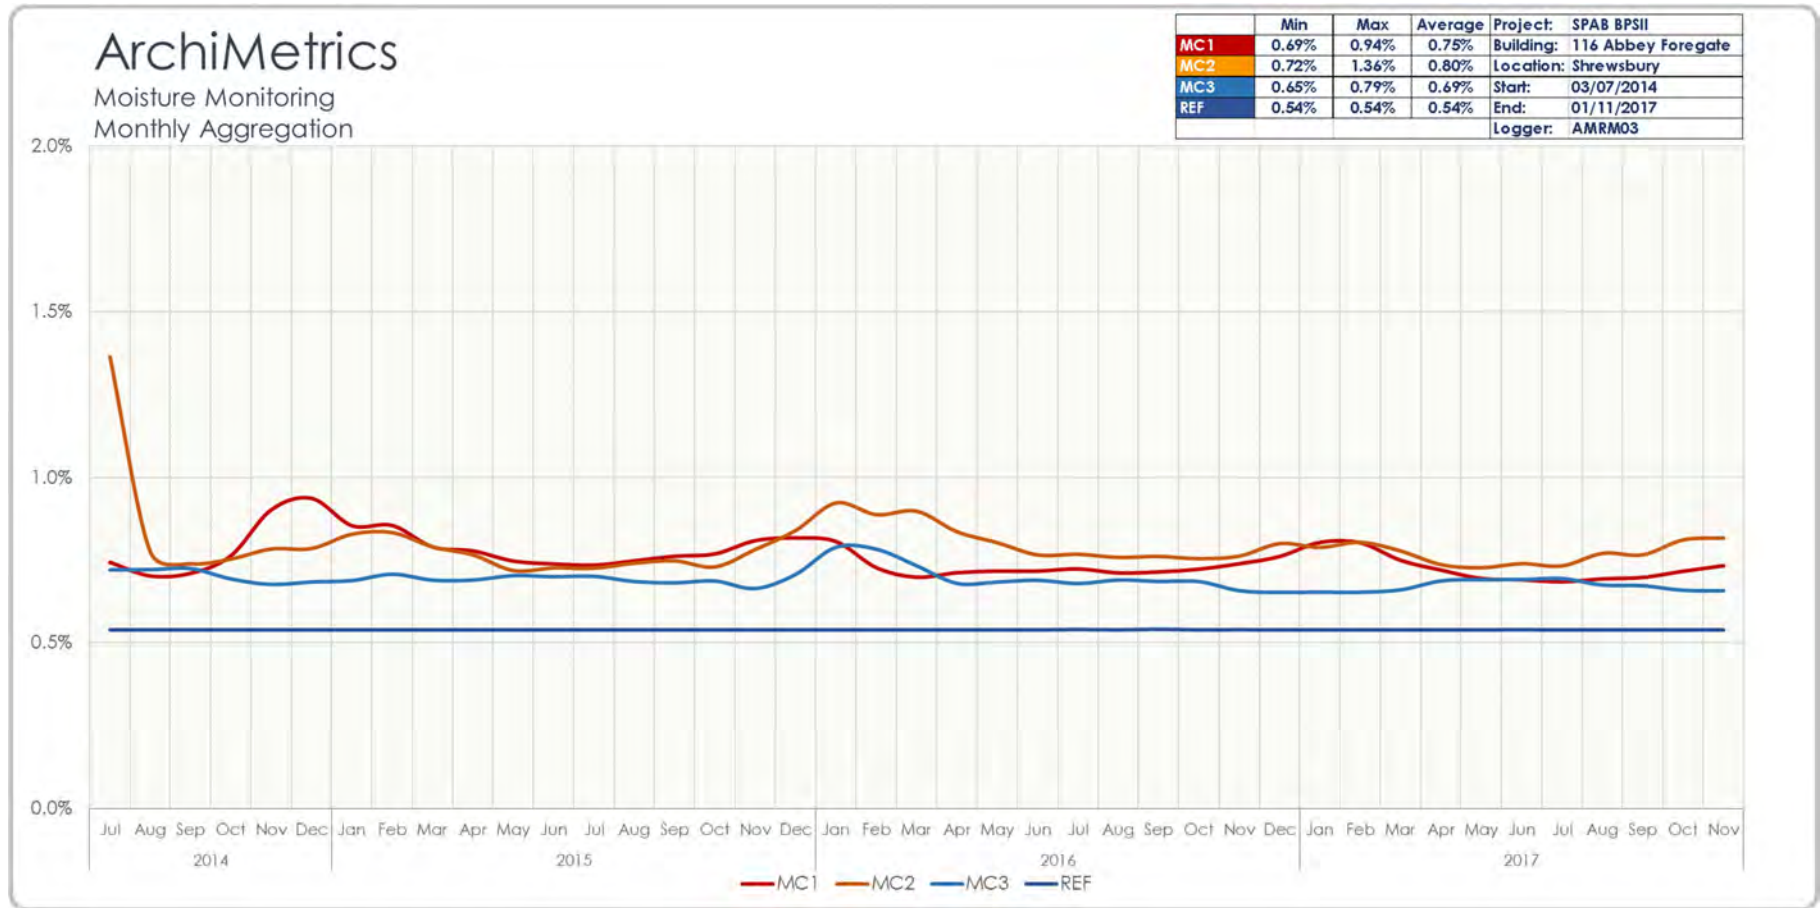
Figure 11. Material moisture over time – post-refurbishment, Shrewsbury 2014–2017.

Thus far, our analysis has looked at moisture recorded as vapour within the wall. From July 2014 onwards, material moisture (%MC) monitoring was installed in Shrewsbury, Figure 11. This shows that overall the brick wall measures low %MC through its section. The start of the analysis, July 2014, shows higher but reducing %MC at MC2. This signature is an indication of the moisture introduced into the wall via the lime mortar, which is used to embed and couple the gypsum sensors to the fabric, drying and being dispersed. It is likely that this effect is only seen at MC2 as it is positioned in the centre of the wall further away from an evaporative surface. 'Drying' processes occurred more rapidly at MC1 and MC3 in proximity to internal and external surfaces and have already taken place prior to the analysis commencing in July 2014. Thereafter, throughout the remaining three-and-a-half-year period, slight temporary increases in %MC are observed annually over the winter but %MC is not seen to rise above 1%. Interestingly, for two of these winters, 2014/15 and 2016/17, these increases are measured only at MC1 and MC2, the two sensors located toward the centre and internal side of the wall face. The impact of colder, wet and windy weather is most pronounced in the vapour record at n4, near the external wall face, yet measurable increases in %MC in these years occur deeper within the fabric. As has already been mentioned, the winter of 2016/17 was quite dry with an annual (September–August) rainfall total for Shrewsbury of 334 mm. This total is not dissimilar to that of the year 2014/15, with a total rainfall of 352 mm, whereas the winter of 2015/16 was wetter and total rainfall that year is considerably higher, 489 mm. Over that winter, an increase in %MC is measured at MC3, closest to external conditions, as well as MC2. During the other monitored winters, 2014/15 and 2016/17, the wall was subject to less wetting overall and on sunny winter days enough evaporation took place towards the external side of the wall face, around n4, to ensure that residual moisture (measured as %MC) did not increase towards the external side and increases only show deeper within the fabric. This difference is not something that would show in the RH (vapour) record as RH would remain high during these winter periods and would only register as lower RH record once

residual moisture has been reduced (something that occurs later in the year, around April or May). Therefore evaporation, as well as wet weather, is part of the high RH picture over winter at this location.

Overall, however, as with the vapour records, the wall is clearly able to recover from the impact of winter weather as it returns to a lower baseline %MC during the summer months. And throughout the three-and-a-half years of monitoring, as has been previously stated, %MC quantities are low. No doubt, once again, the qualities of this wall, including its aspect, thinness and porous and permeable materials, ensure that the drying of excess moisture takes place over an annual cycle.

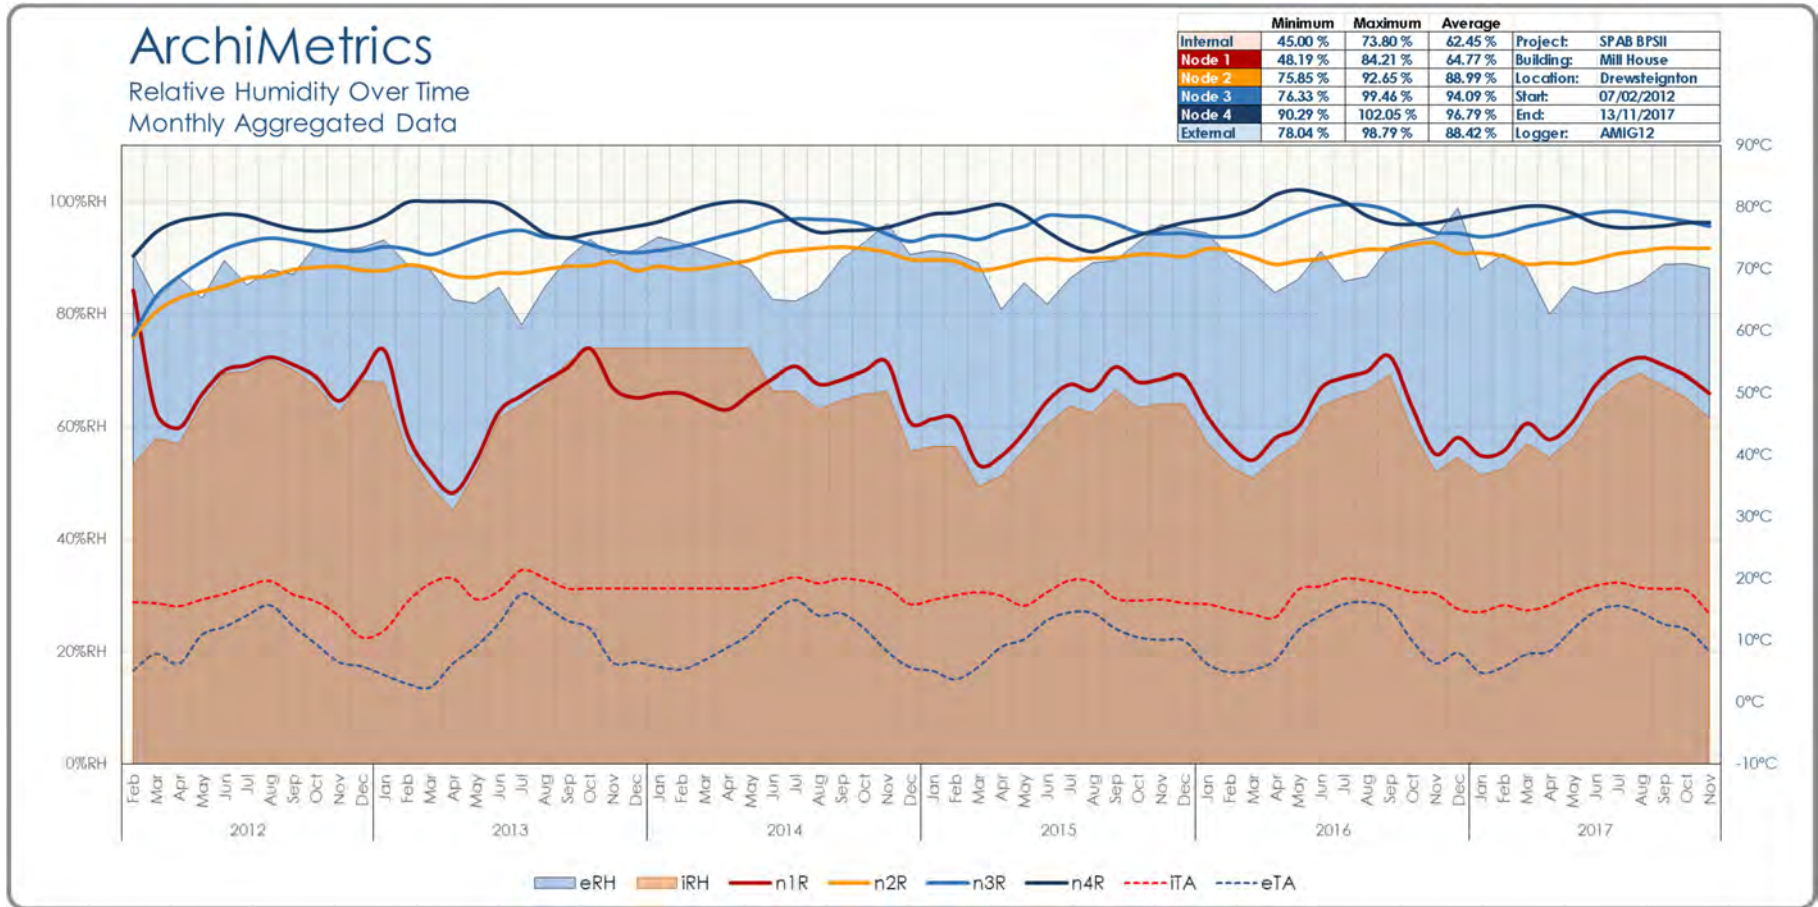
Figure 12. Relative humidity over time – post-refurbishment, Drewsteignton 2012–2017.

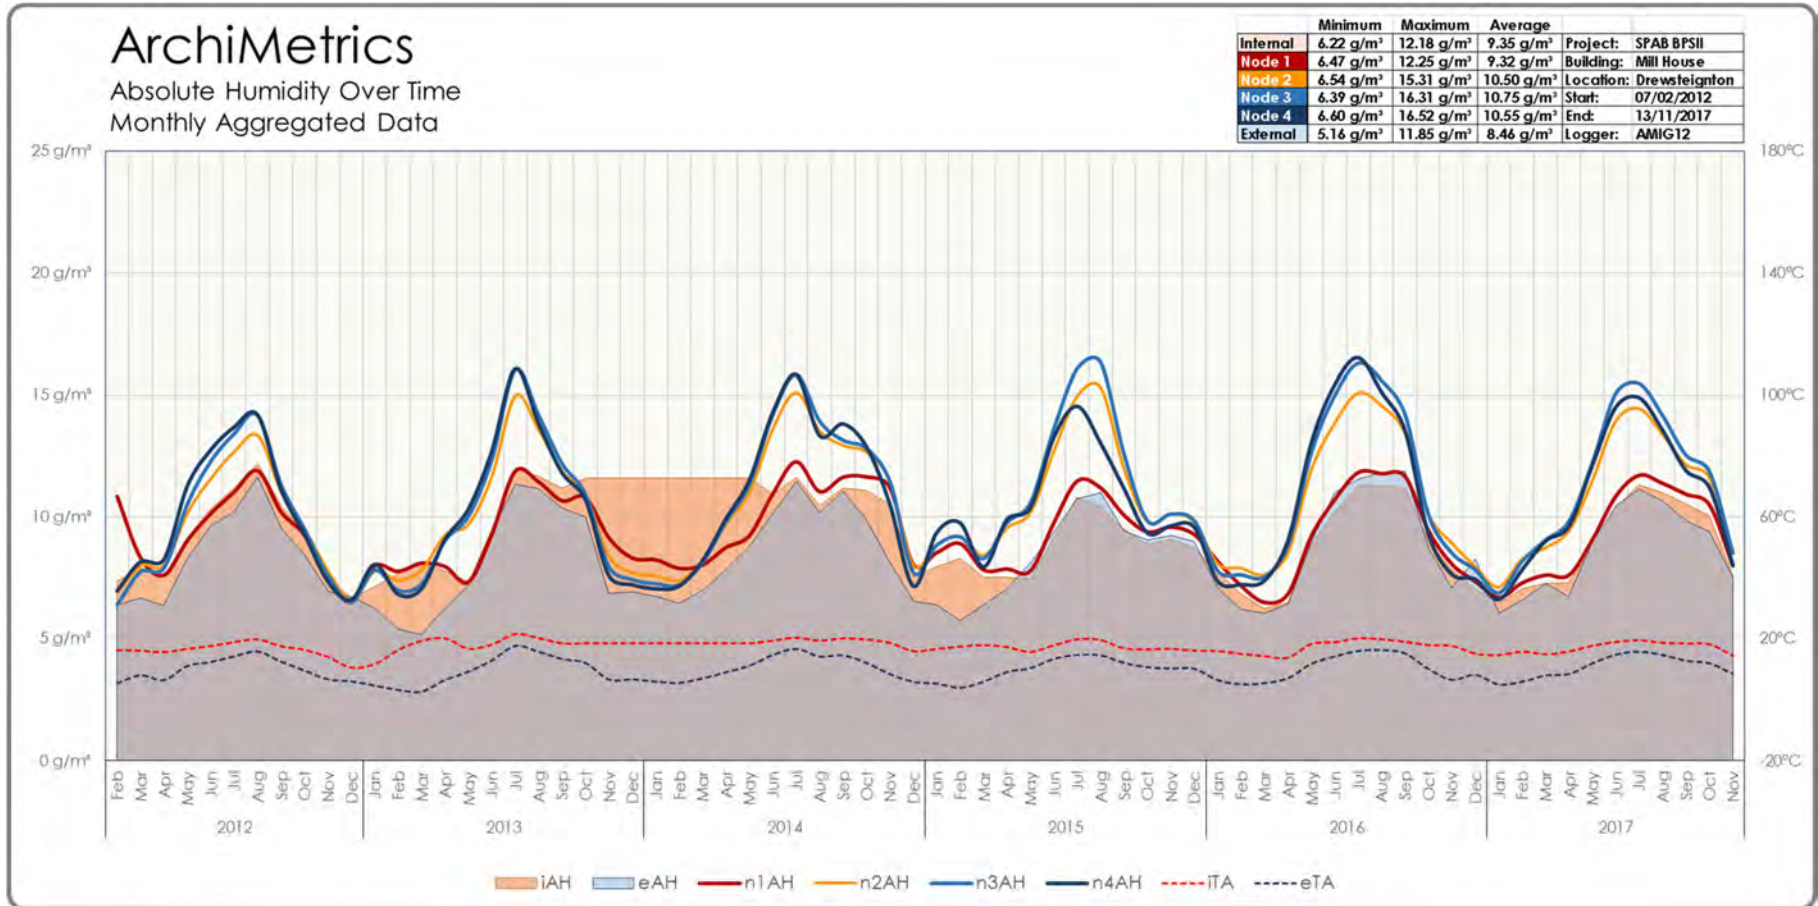
Figure 13. Absolute humidity over time – post-refurbishment, Drewsteignton 2012–2017.

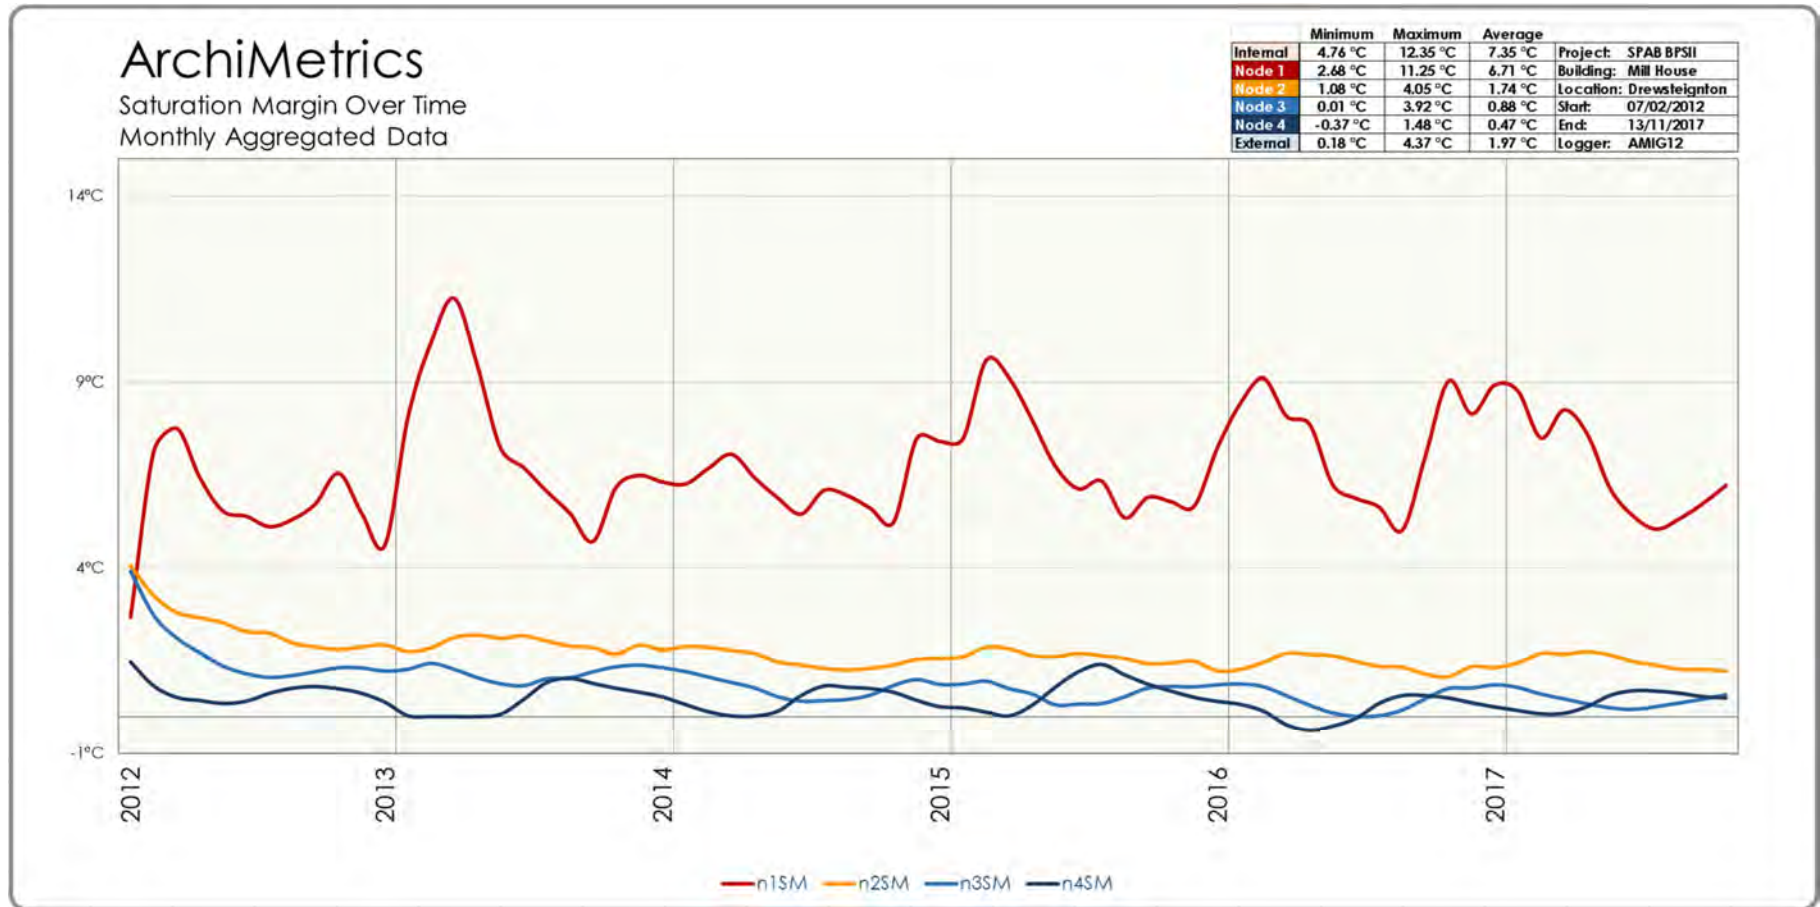
Figure 14. Saturation margin over time – post-refurbishment, Drewsteignton 2012–2017.
