SPAB Building Performance Survey 2019

Final Report
May 2020

The SPAB RESEARCH REPORT 2

The SPAB Building Performance Survey Final Report

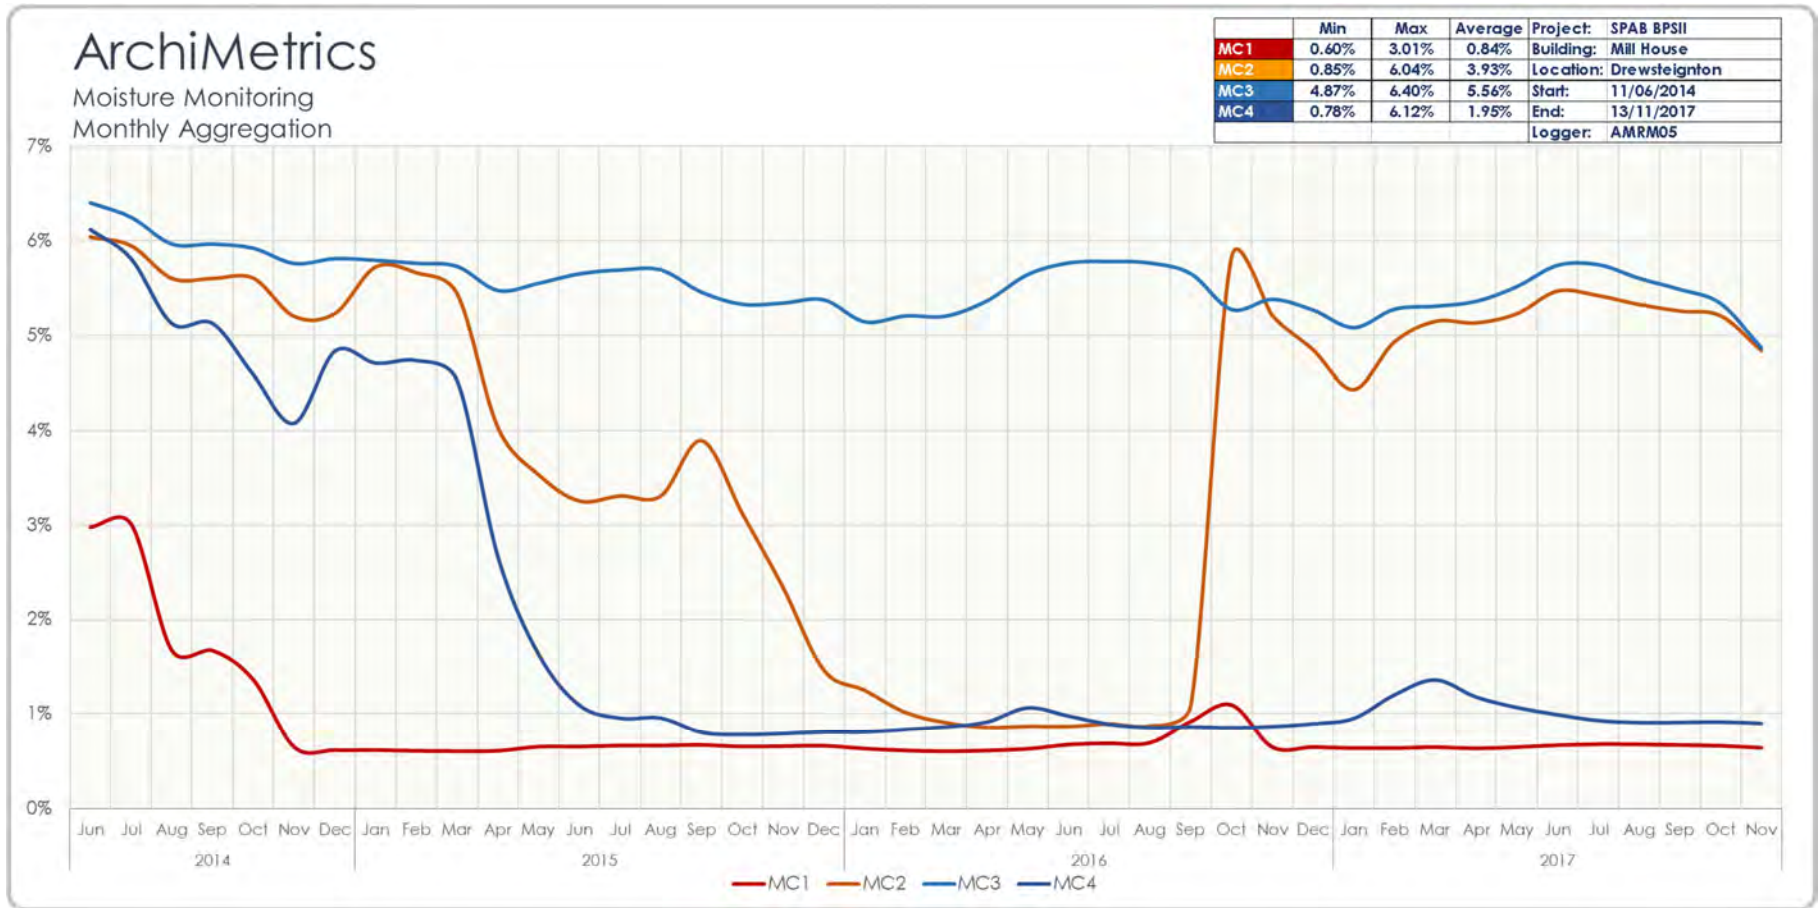
Figure 15. Material moisture over time – post-refurbishment, Drewsteignton 2014 – 2017.

The %MC analysis for Drewsteignton, Figure 15, clearly shows 'drying' taking place following the introduction of wet lime mortar used in the installation of moisture monitoring sensors. This response is measured over an extended period, some parts of the wall, MC2 and MC4, only seeming to reach equilibrium around the middle of 2015, a year after sensors were embedded. The prolonged 'drying' seen at the start of the monitoring indicates a qualitative difference between the way this wall deals with moisture in comparison with that of Shrewsbury, where a less extreme and faster 'drying' response was measured following installation of moisture monitoring sensors.

seen at MC1 at this time). We think that the change in %MC quantities seen around September/October 2016 is reflective of a recovery in moisture measurements, rather than a change in moisture conditions within the wall, and from this time onward the measurements made at MC2 may be a more accurate indication of material moisture quantities in this part of the wall than those made previously. This is supported, in part, because, thereafter, from November 2016 the trace from MC2 follows a pattern not dissimilar to that found for the other 'central' wall node, MC3, albeit showing slightly lower %MC.

The moisture behaviour revealed by the %MC monitoring at Drewsteignton shows both similarities and differences with that of vapour measurements. As with the %RH records, %MC values are high in this wall when looked at in comparison with those of Shrewsbury. However, there is a difference between where peak RH quantities are measured within the wall section in comparison with %MC. %RH is found to be highest at n4, towards the external wall face but %MC is highest at MC3 in the centre of the wall. This is because peak measurements of %RH are determined principally by the evaporation of moisture bound within wall materials. Within the wall fabric at both Shrewsbury and to a lesser extent at Drewsteignton, this evaporative process occurs primarily in response to external conditions; warmer atmospheric temperatures including heat from solar gain and air movement, resulting in increases in moisture vapour which also dry the fabric, reducing the moisture load within materials. This results in high RH at n4 (particularly during spring) but lower %MC at MC4 in proximity to these evaporative influences/external conditions. The %MC measurements show the central part of the wall, MC2 and MC3, to have higher moisture content because more moisture remains bound within materials at this location where less evaporation takes place deeper within the wall, further away from the conditions that encourage drying.

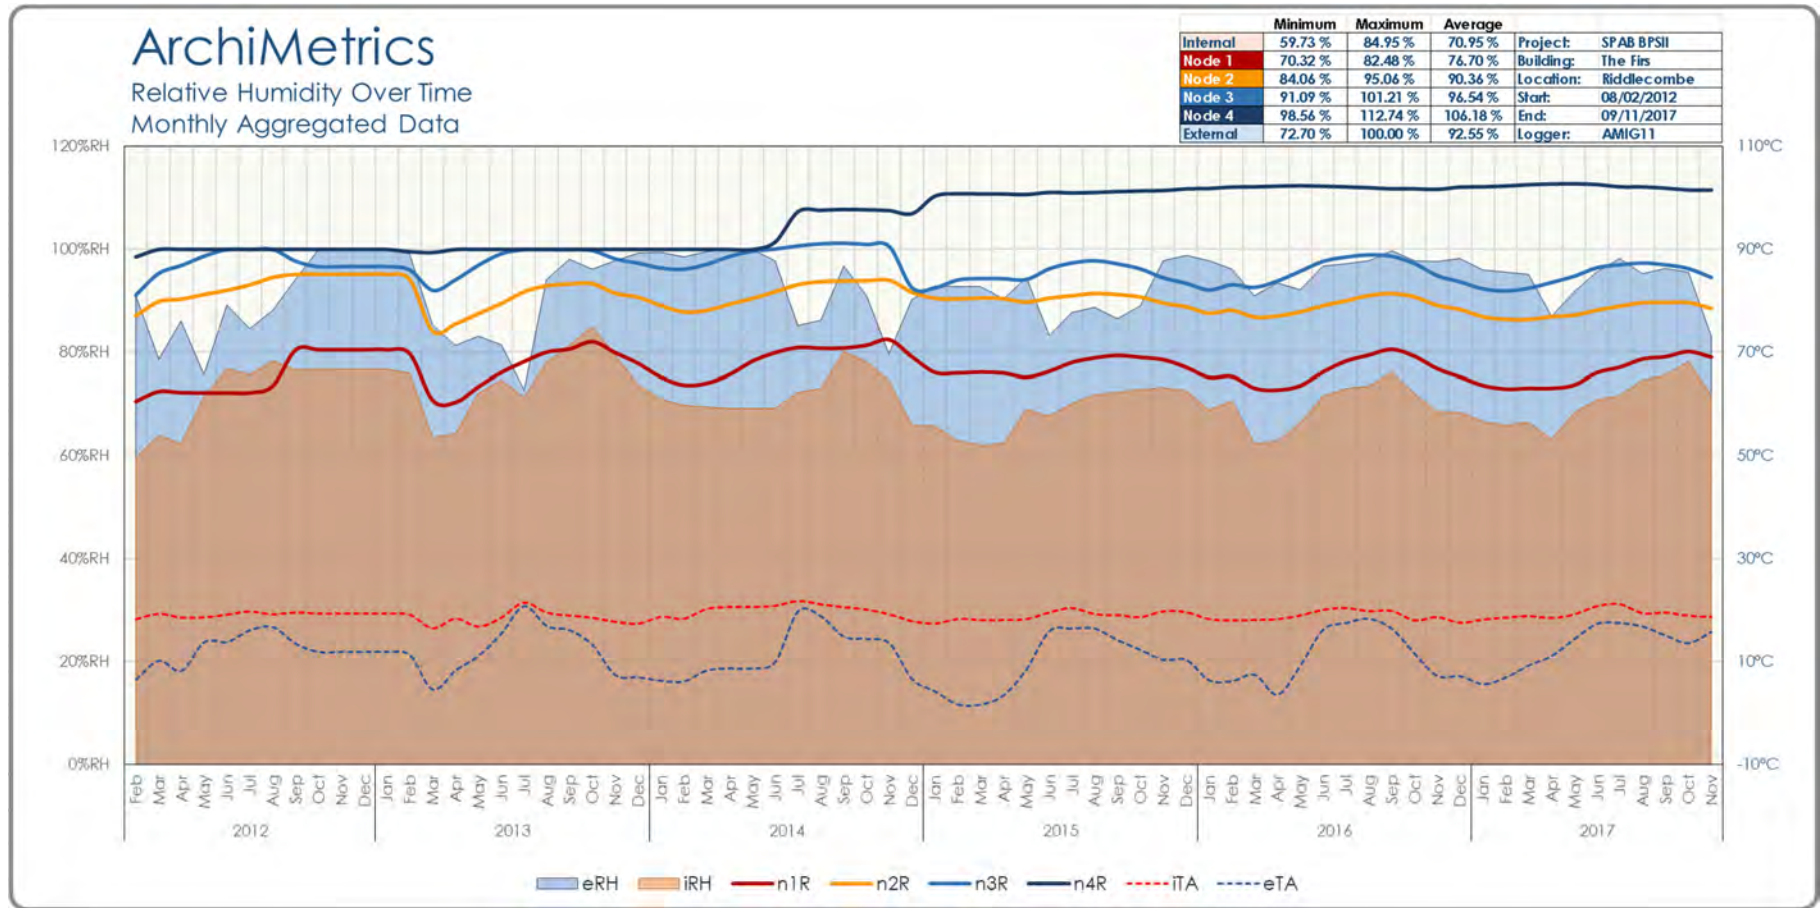
Figure 16. Relative humidity over time – post-refurbishment, Riddlecombe 2012–2017.⁶

⁶ There is a flat line for all measured quantities, October 2012–January 2013, as a result of data loss over this period. The same is visible in all the over-time analyses graphs for Riddlecombe.

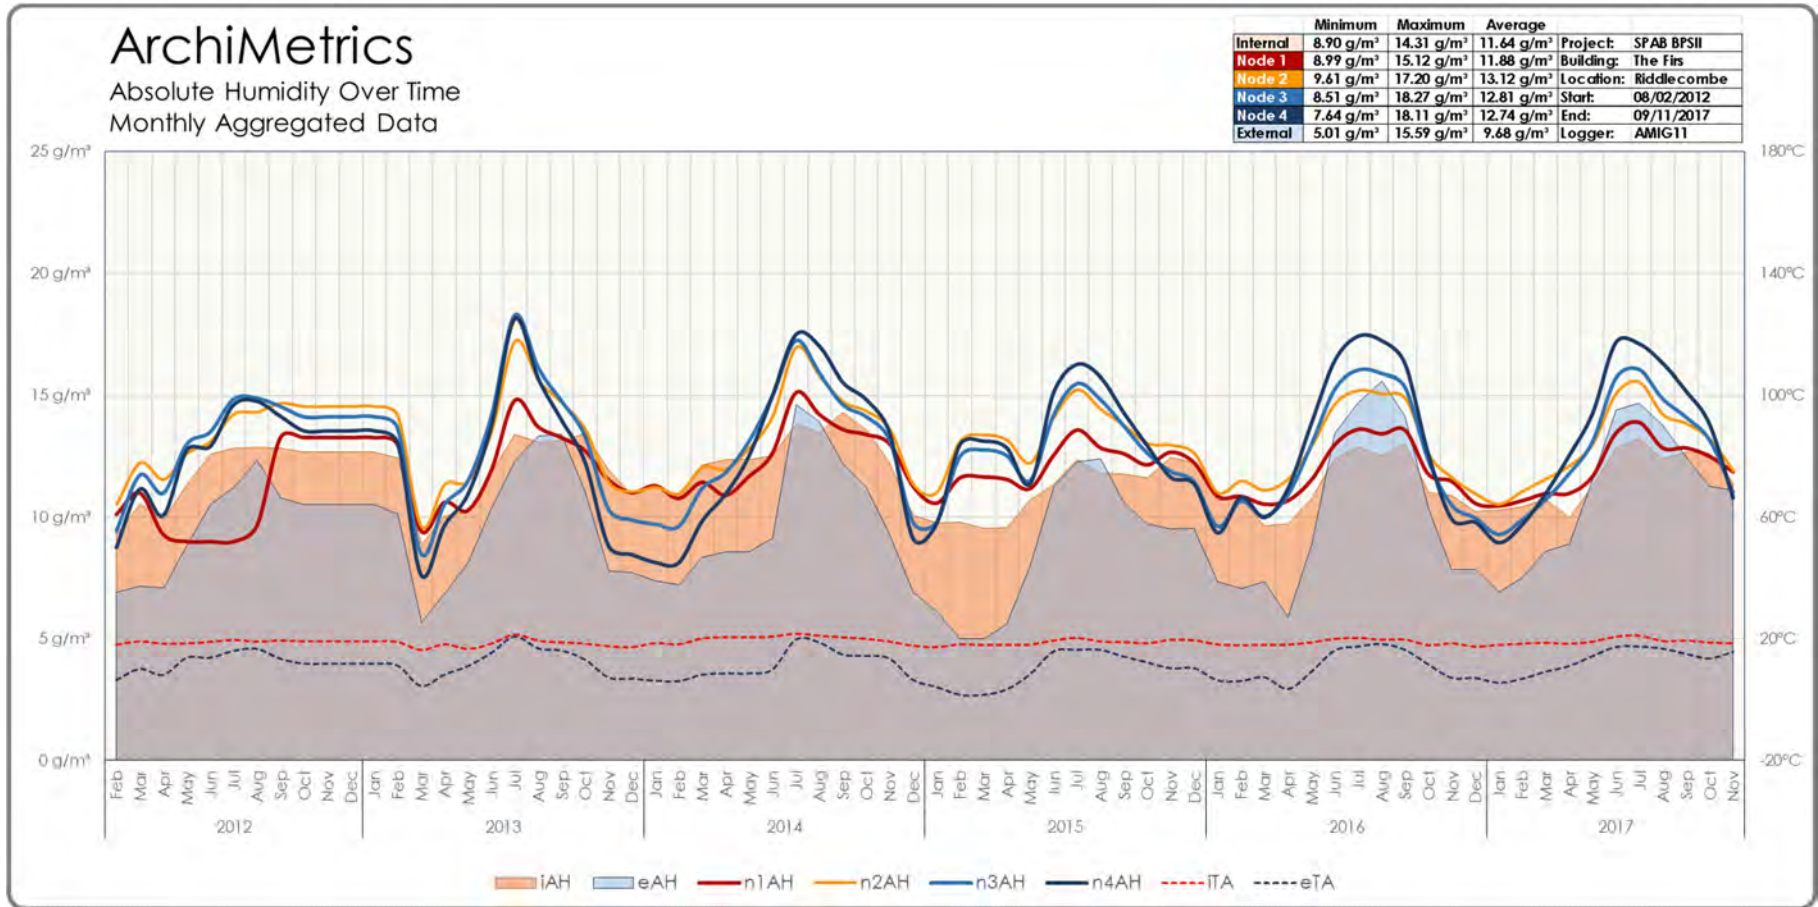
Figure 17. Absolute humidity over time – post-refurbishment, Riddlecombe 2012–2017.

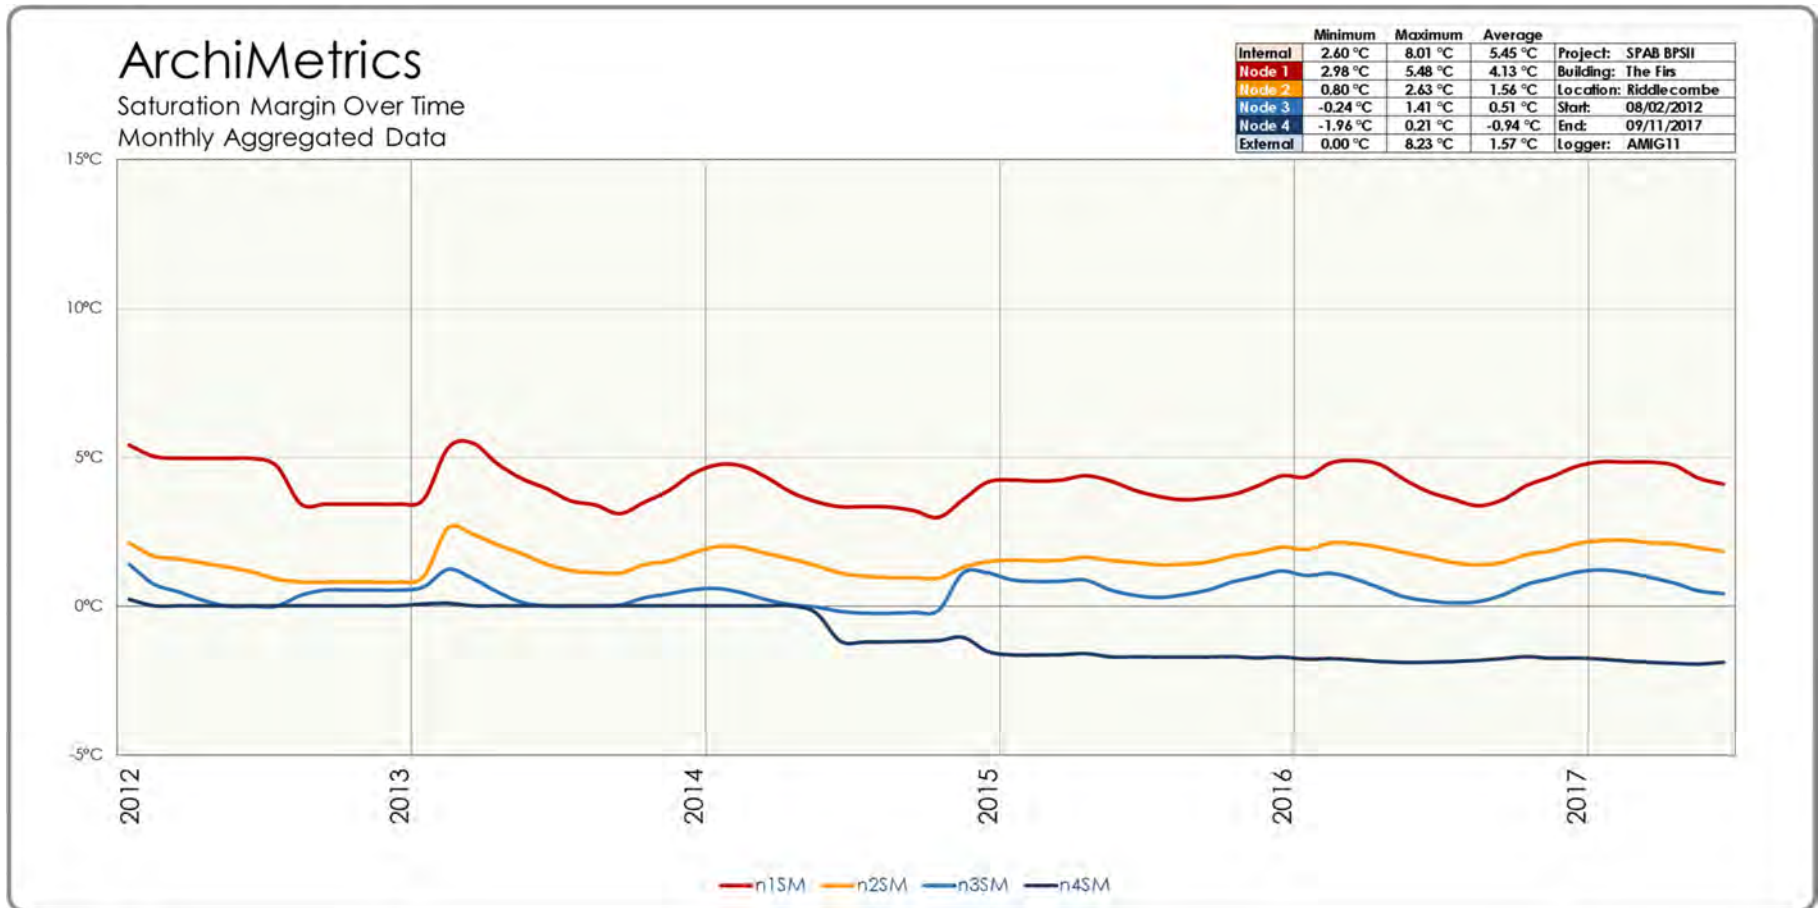
Figure 18. Saturation margin over time – post-refurbishment, Riddlecombe 2012–2017.

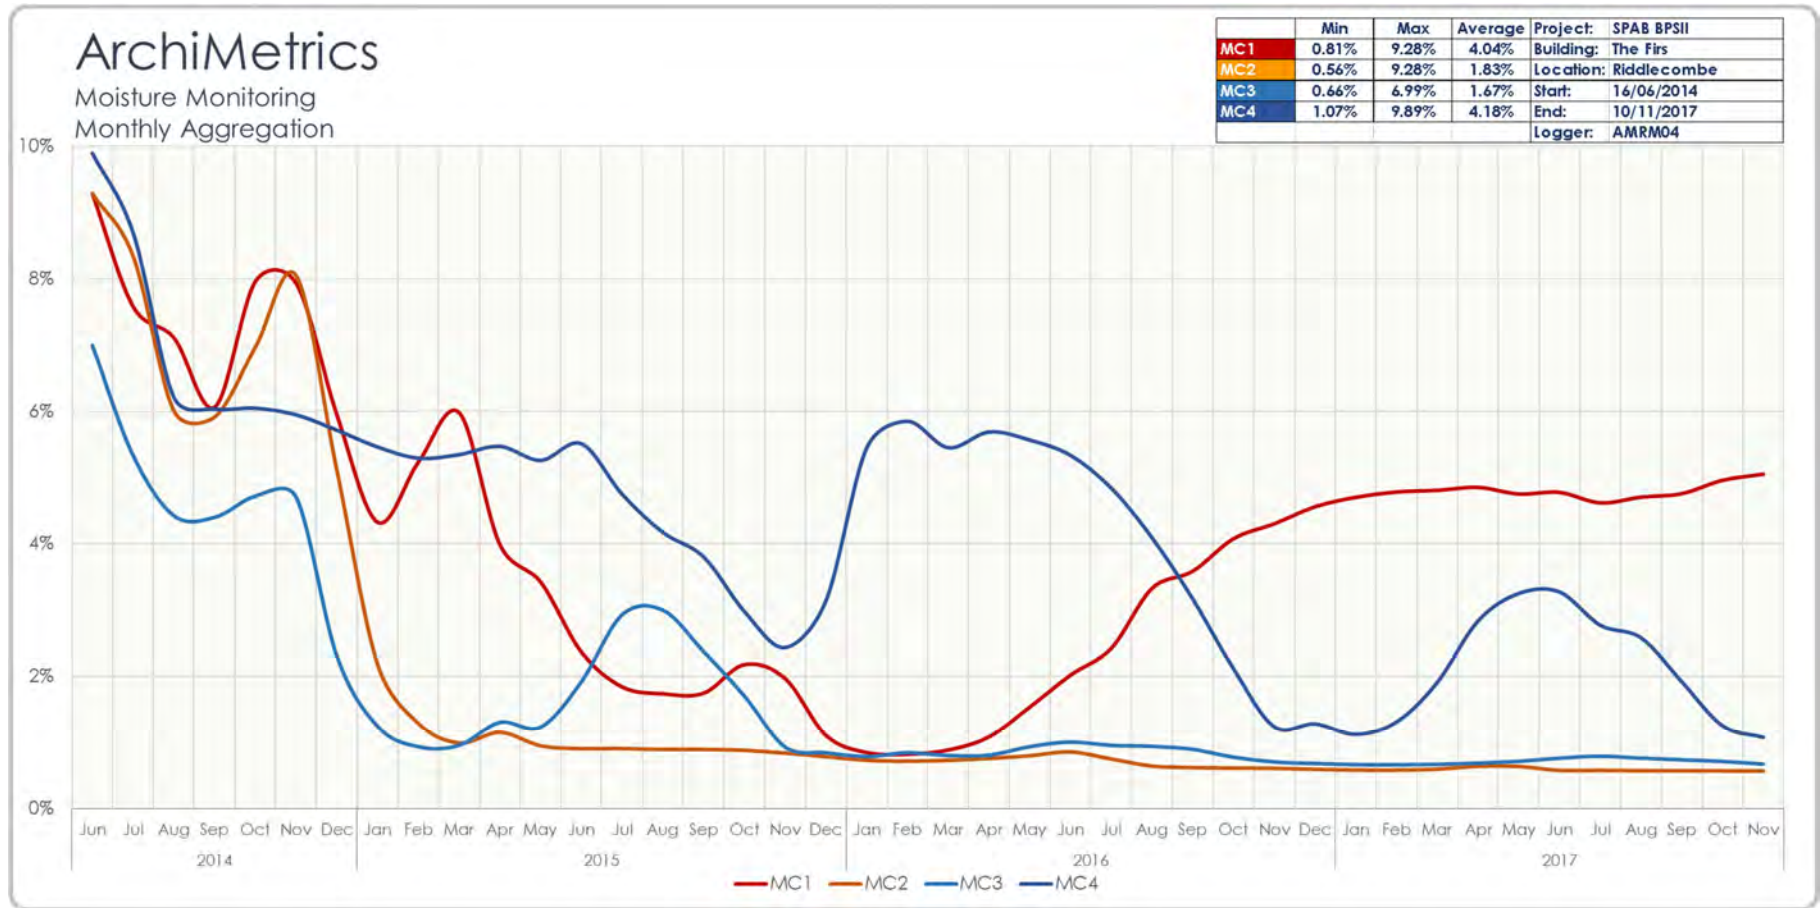
Figure 19. Material moisture over time – post-refurbishment, Riddlecombe 2014–2017.

The wall at Riddlecombe initially shows higher %MC than that of the other two walls under study. It also shows that, overall, %MC is decreasing in the wall at all but one of its sensor positions, MC1 (Figure 19). Reductions in %MC are seen at all four nodes at the commencement of measurements, June 2014, indicating the 'drying' of lime mortar used to bond the sensors to the substrate. There is a hiatus in this downward drying curve from September–November; over this time %MC increases at MC1, MC2 and MC3 and flatlines at MC4. Reductions in %MC recommence in November and fall sharply at MC1, MC2 and MC3 but more gradually at MC4. It is likely that the difference between %MC behaviour seen at MC4, where reductions in %MC take place over a longer period, are the result of the presence of the stone buttress in proximity to this location, whereas the other three measurement sensors are surrounded by cob material. The sensors in the central part of the wall, MC2 and MC3, share a similar drying curve and, after a separate spike in quantities measured at MC3 over the summer of 2015, thereafter record similar and comparatively low %MC. The trace for MC1, towards the internal side of the wall face, includes a few temporary increases in %MC with reducing peaks indicating overall a trend of %MC reduction until conditions here become similar to those measured at MC2 and MC3, with low %MC measured January–March 2016. Unlike the two central wall sensors, however, after this time %MC starts to increase again at MC1 and is still on a rising trajectory at the cessation of measurements in November 2017. As previously mentioned, moisture behaviour at MC4 towards the external side of the wall seems retarded in comparison to that of the other interstitial node locations. %MC has been reducing slowly here up to November 2015 but then increases again, starting a pattern which sees winter/spring increases in %MC and summer/autumn decreases. (This is not present for the 2014 year due to the injection of moisture into the wall at the time of sensor placement and subsequent drying of this.) This pattern is the opposite of that measured for RH further back in the wall where RH peaks in the summer/autumn. However, like that of RH behaviour, this pattern is likely to be driven by the input of heat

Towards the external side of the wall progress is slowed perhaps by the presence of the less permeable stone buttress but also the thick lime render, resulting in higher RH at this location and overall less opportunity for evaporation from materials and hence higher %MC. Toward the internal side of the wall a similar sequence might be in process complicated by the influences of the internal environment. The internal side of the wall is coated with a thinner layer of more permeable lime plaster although traces of the previous gypsum plaster may remain, and the house also measures low rates of air permeability/infiltration (Appendix C) Riddlecombe has lower room volume, high occupancy and the highest internal room (70%+) RH in comparison with the other properties surveyed (see Appendix D). On average, measured over the six-year post-refurbishment period, Riddlecombe has the highest rates of internal AH and RH, 11.64 g/m³ and 71% RH respectively. Internally generated vapour is of greater quantity within the room and may be dispersed less easily and this could inhibit and retard evaporation from the internal wall surface resulting in higher %MC in proximity to the internal side of the wall.

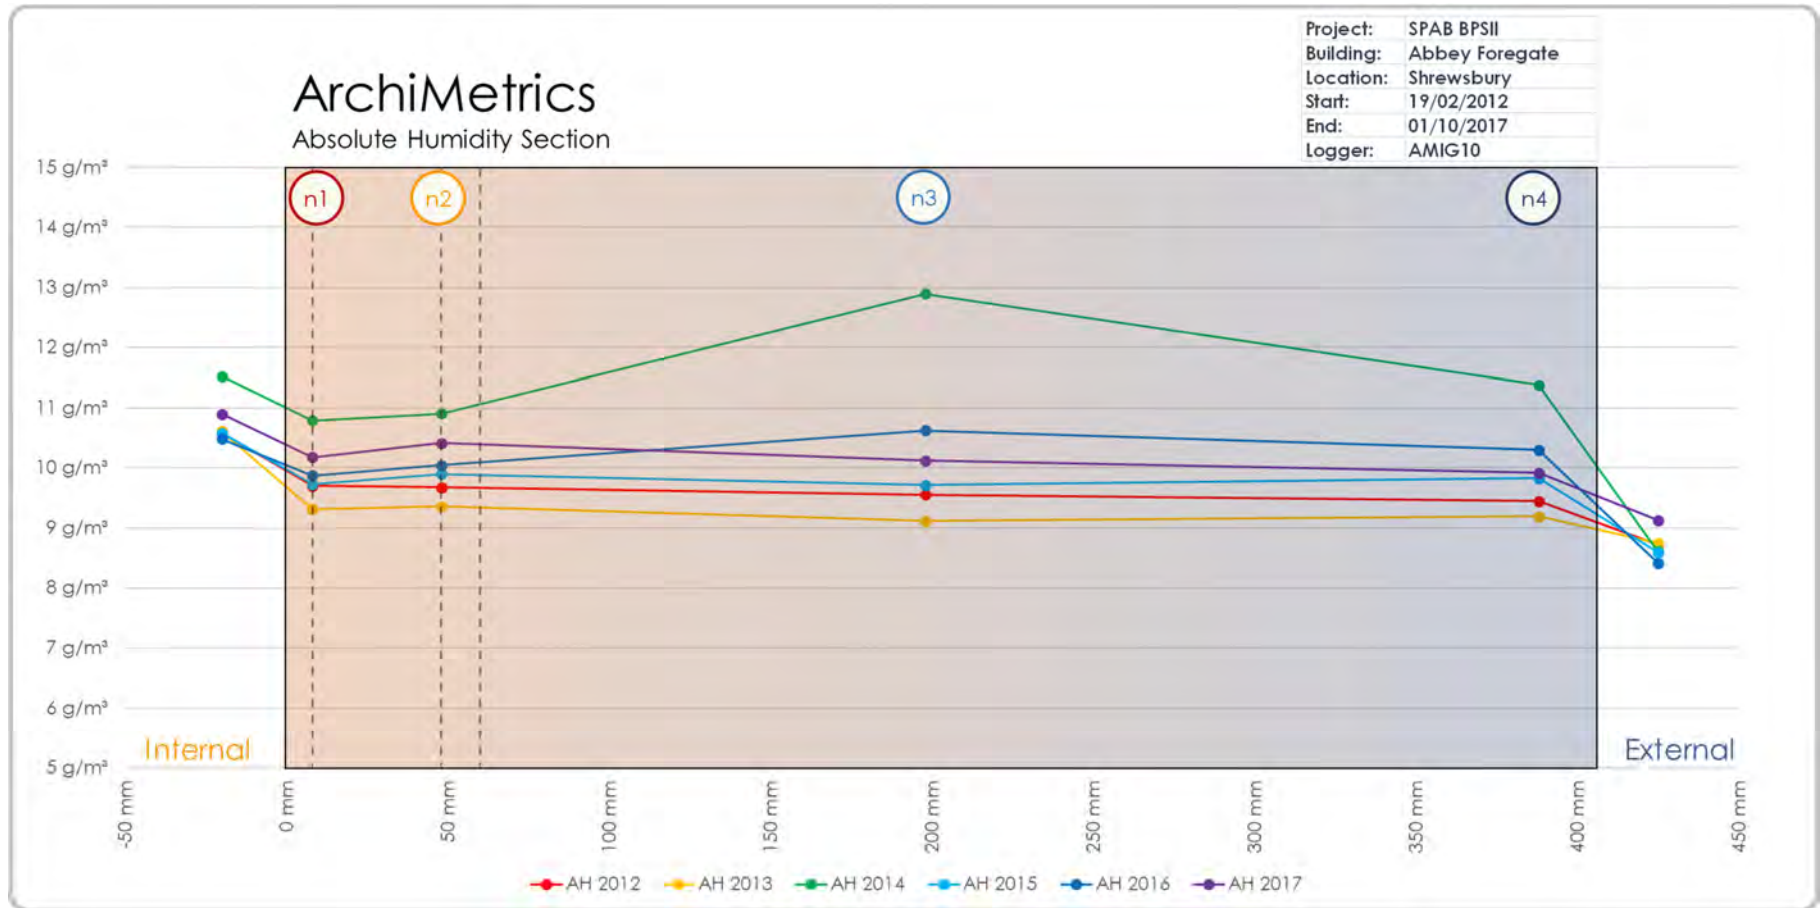
Figure 20. Annual average AH section – post-refurbishment, Shrewsbury 2012–2017.

Overall, these analyses suggest a fairly consistent annual picture of AH quantities for the wall at Shrewsbury (disregarding the aberrant 2014 year) whereas at Drewsteignton it seems that AH increases through the section in the later years of the study, being at its highest in the final year. At Riddlecombe, average AH decreases over time in the centre of the wall but increases at n4, towards the external side.

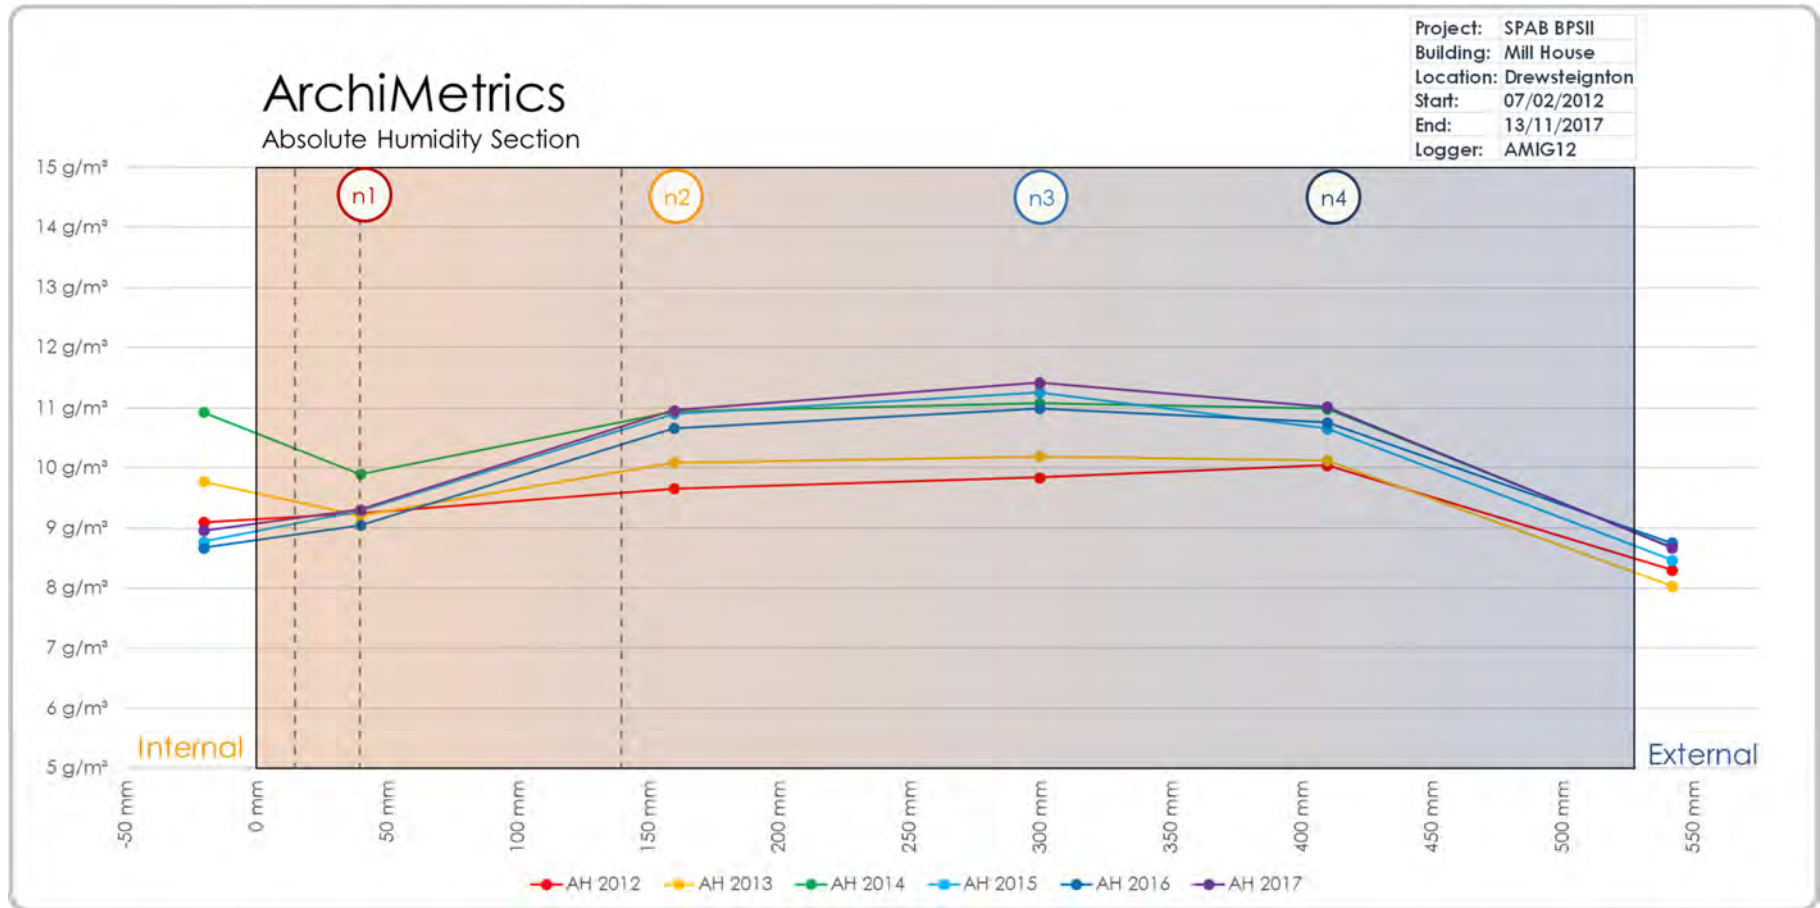
Figure 21. Annual average AH section – post-refurbishment, Drewsteignton 2012–2017.

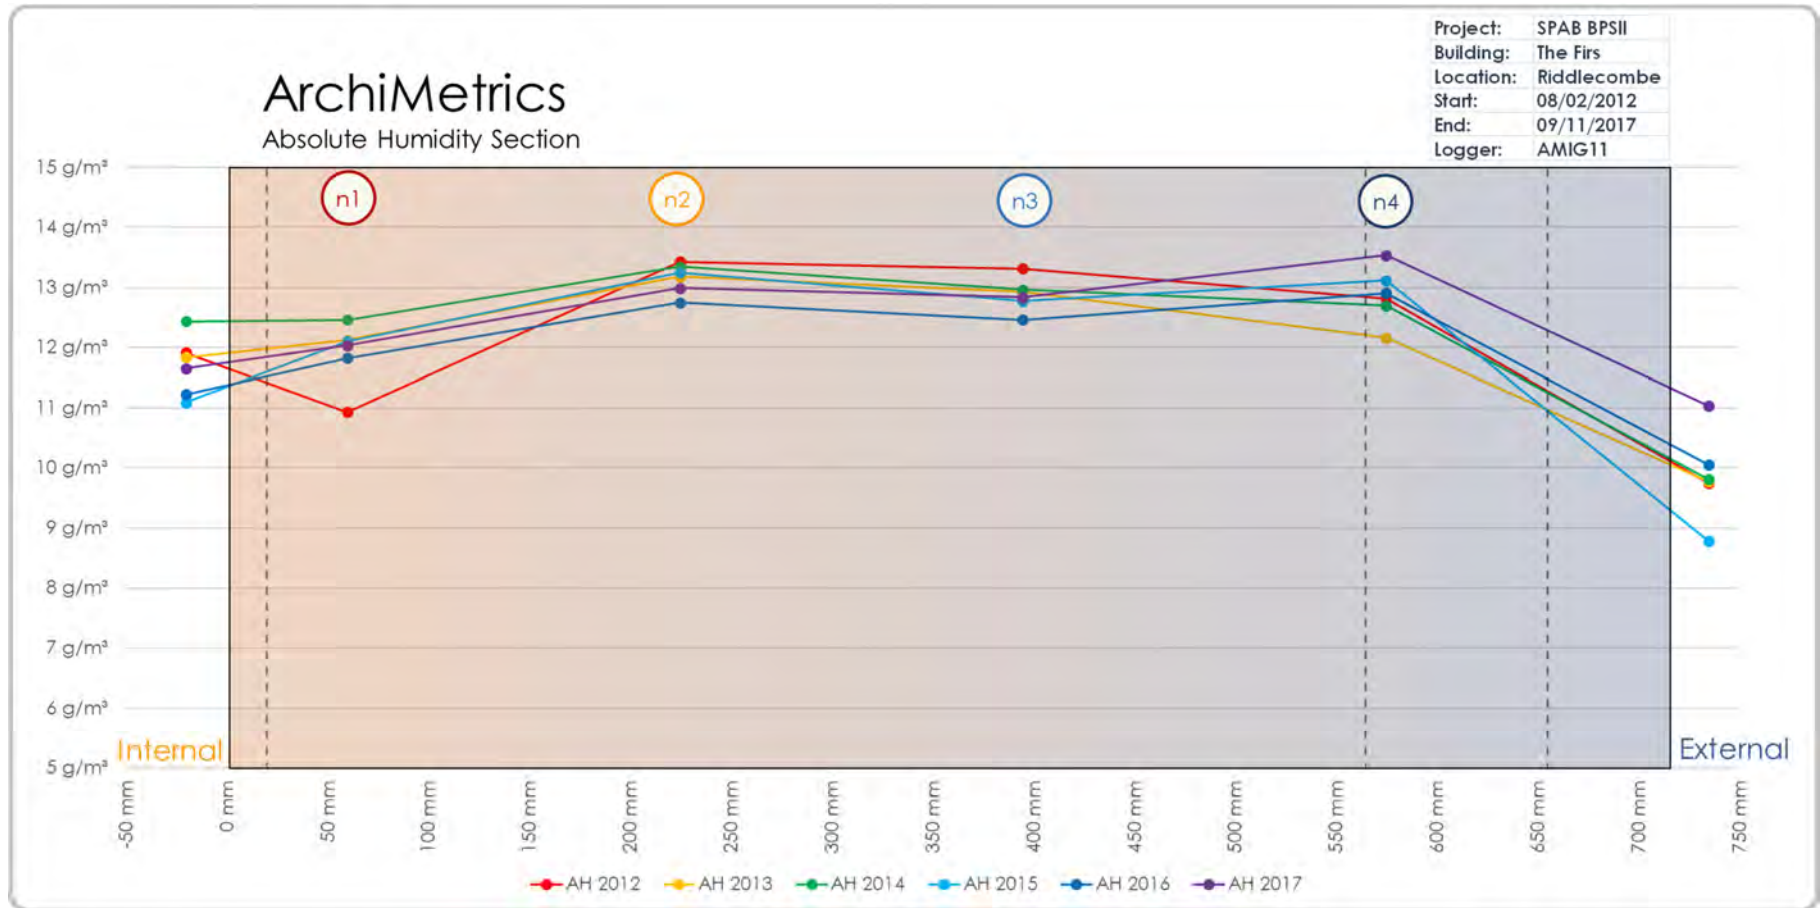
Figure 22. Annual average AH section – post-refurbishment, Riddlecombe 2012–2017.

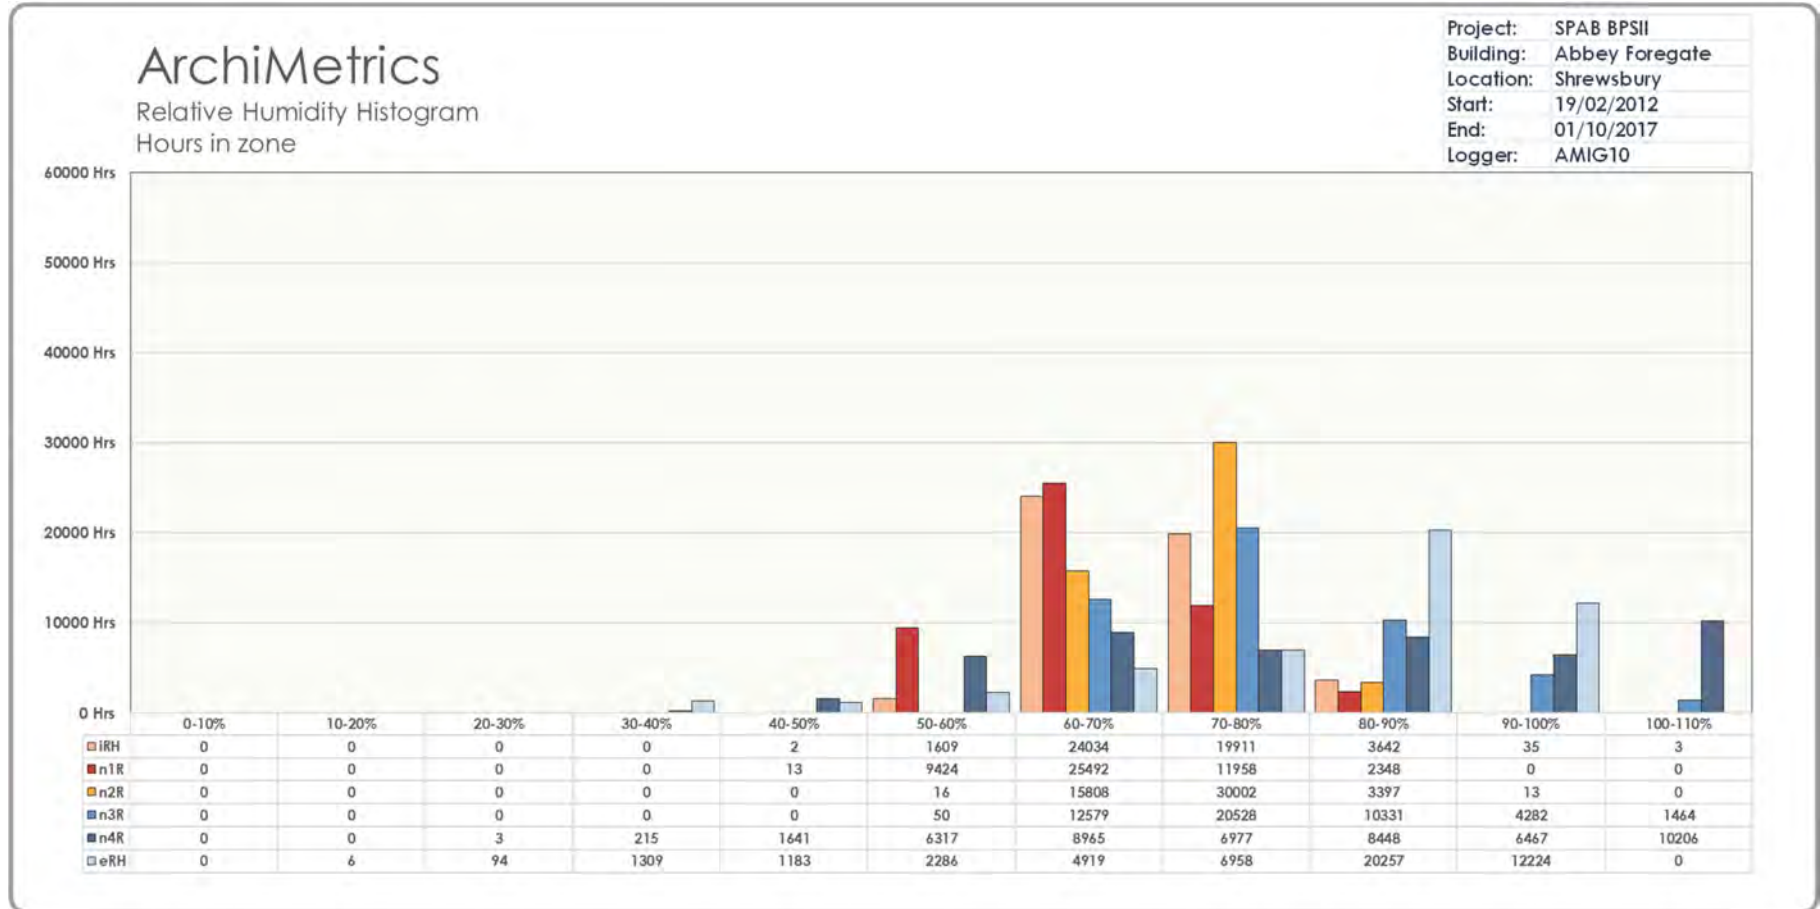
Figure 23. Relative humidity histogram – post-refurbishment, Shrewsbury 2012–2017.

Three histograms have been produced which identify the total number of hours for RH quantities in 10% RH brackets for each of the measurement locations through the wall section for the six years of study (Figures 23, 24 and 25). These show the predominant RH condition of the walls. Shrewsbury has the broadest spread of RH with the lowest quantities. Here n2 shows the highest number of hours of all four measurement nodes, indicating the greatest consistency/least change over the six years is at the interface between the wood fibre insulation and brick masonry; 30,002 hours between 71–80% RH. The wall at Drewsteignton has higher RH and at n2, the insulation/masonry interface, records 30,986 hours at 81–90% RH. However, a greater number of hours is found at n3 and n4: 47,862 hours and 43,695 hours respectively, with a higher measurement of RH, 91–100%; with n3 showing the greatest number of hours overall for the wall in this higher RH bracket. The cob wall at Riddlecombe (best able to hold vapour) has the highest RH of all three walls. RH is high at n3, 91–100% for 40,549 hours, but, of all the walls, is highest for longest at n4 behind the stone buttress, close to the interface between the original wall and the new insulated external render with 49,736 hours at 101–110%.

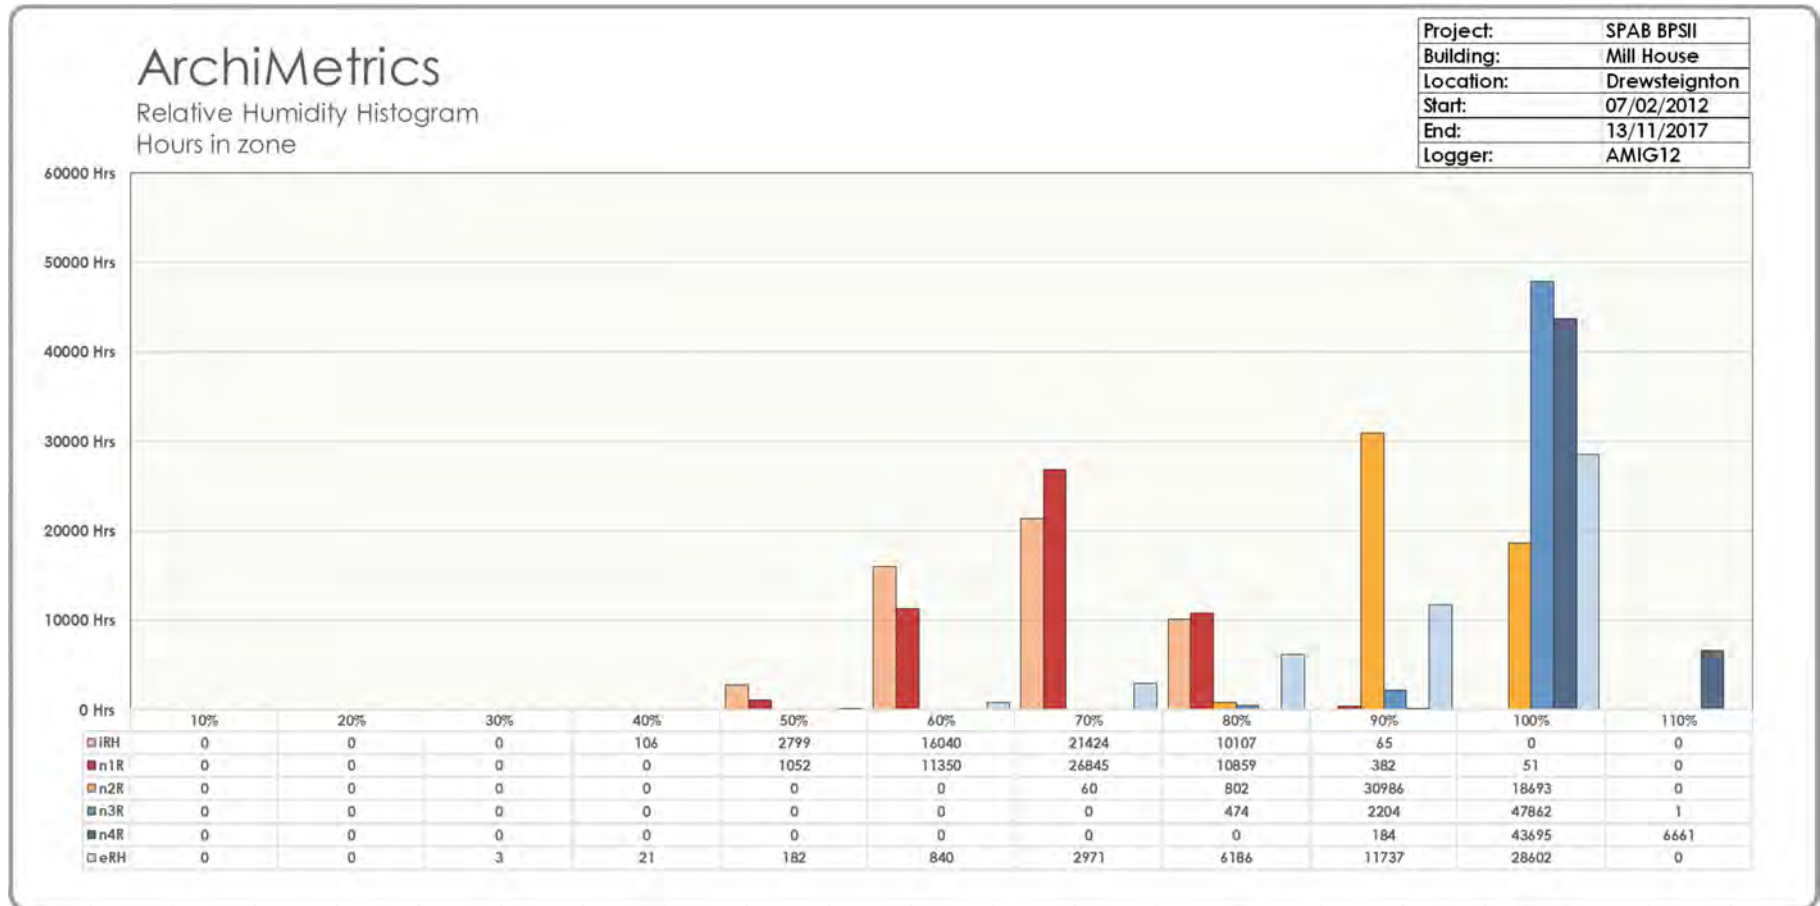
Figure 24. Relative humidity histogram – post-refurbishment, Drewsteignton 2012–2017.

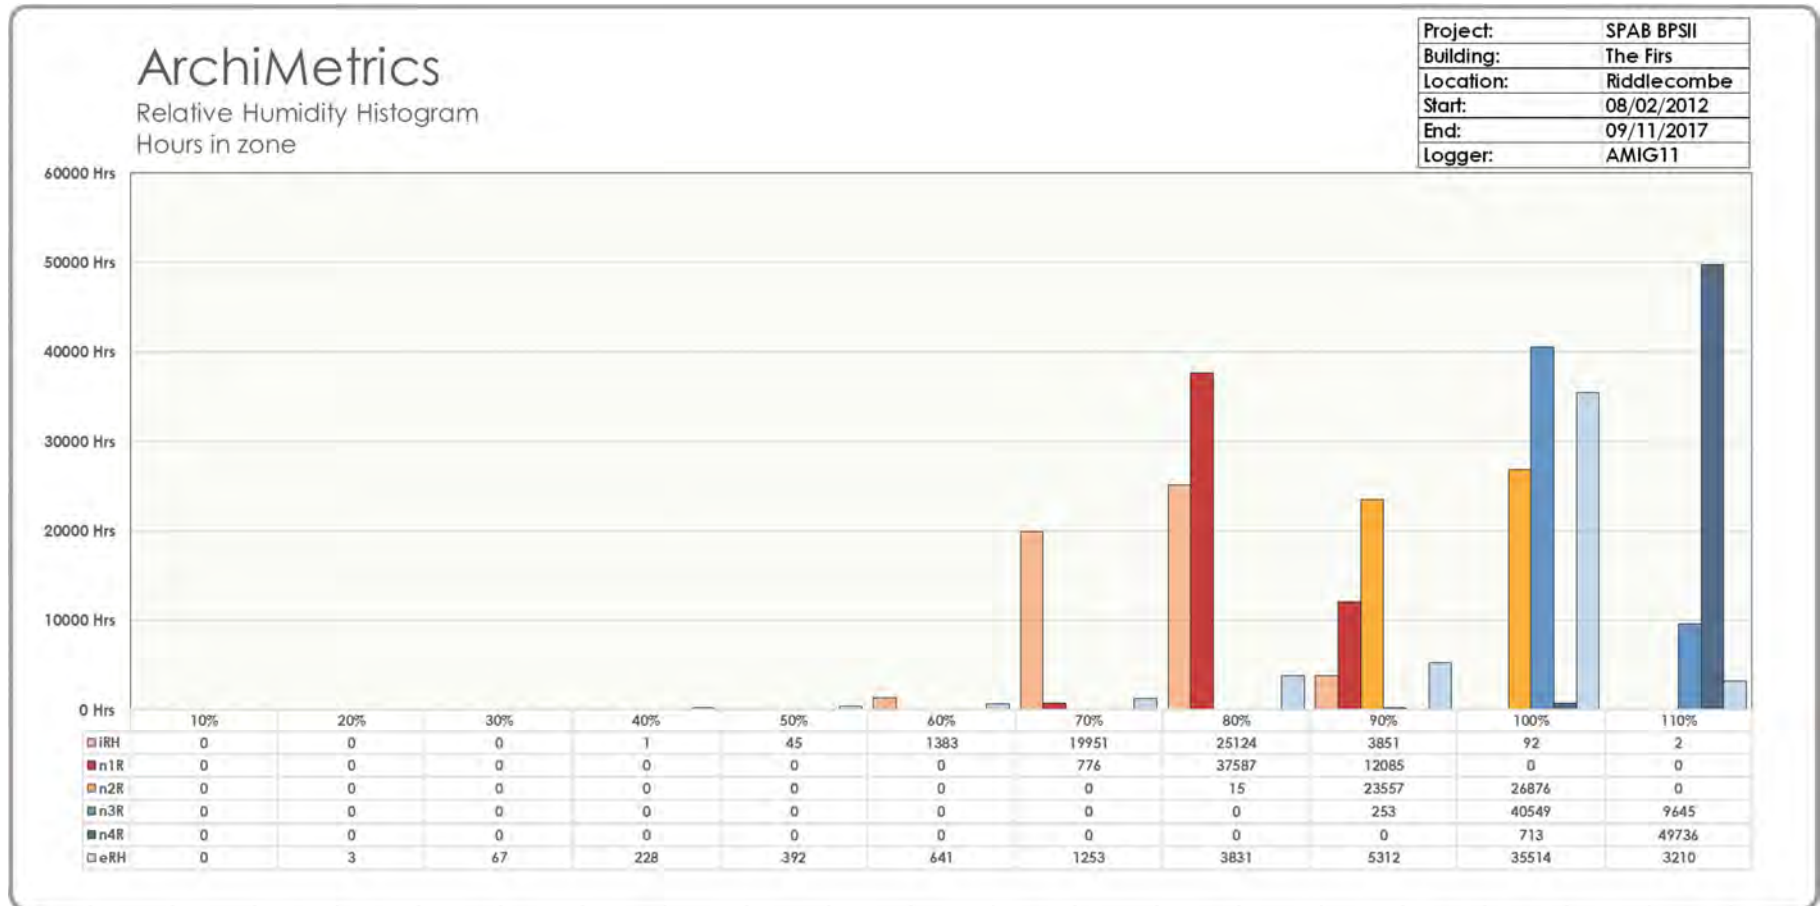
Figure 25. Relative humidity histogram – post-refurbishment, Riddlecombe 2012–2017.

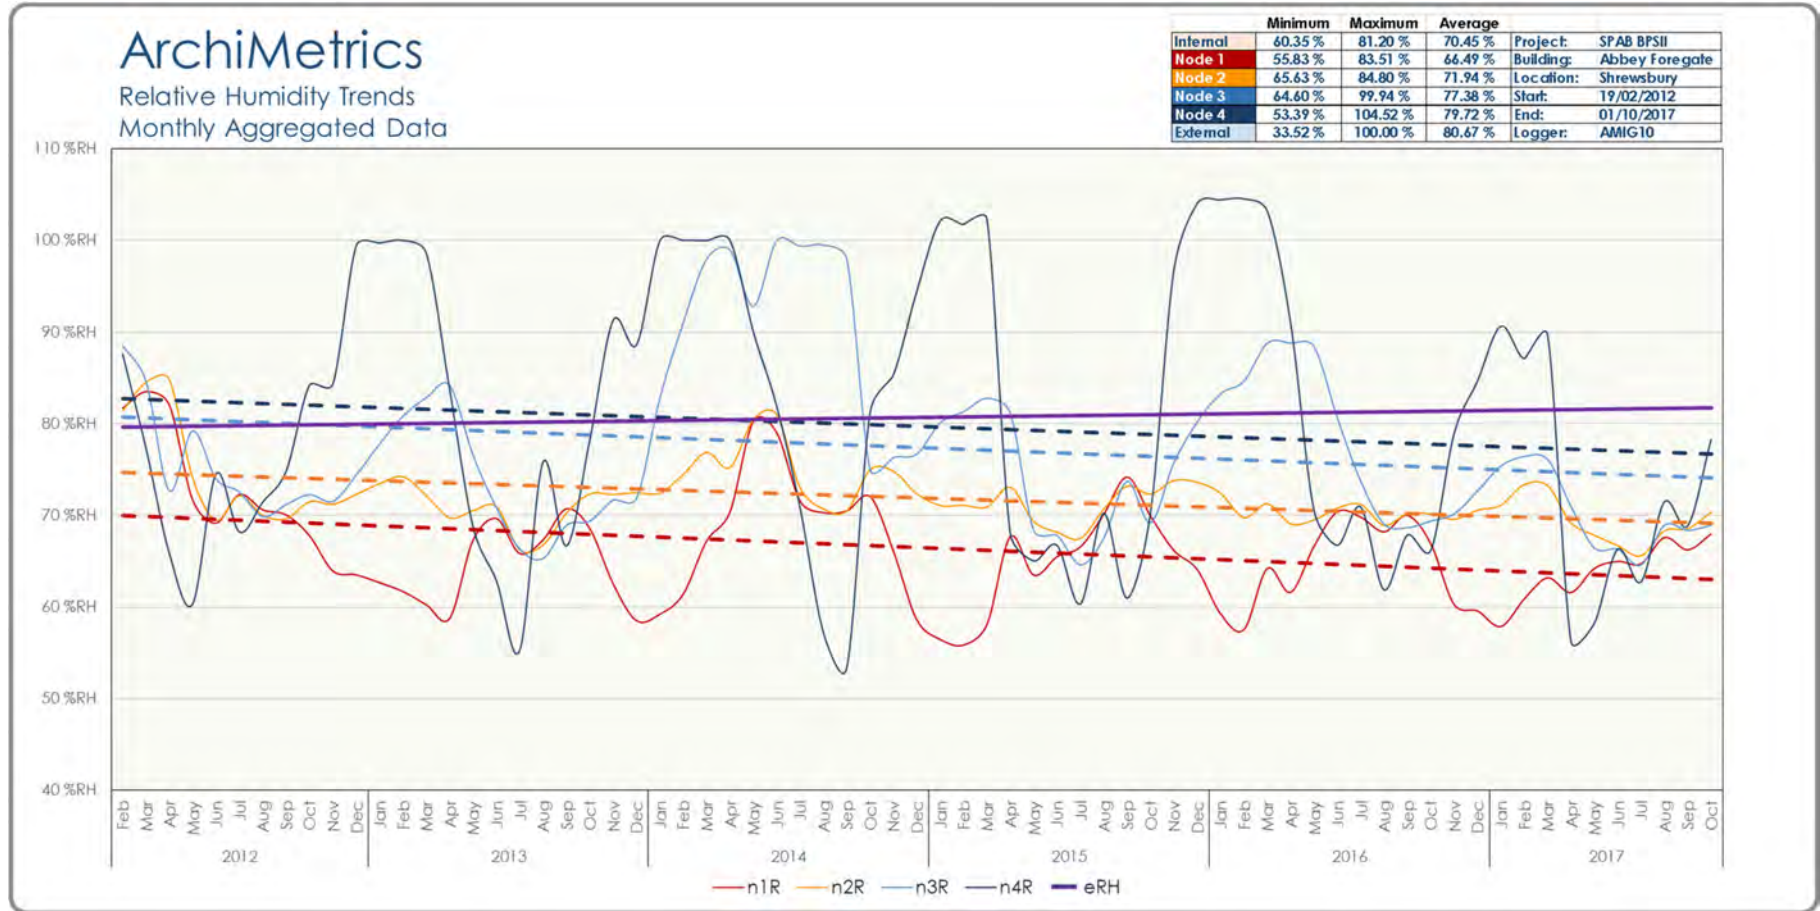
Figure 1 - Post-refurbishment, Shrewsbury 2012–2017.
