SPAB Building Performance Survey 2019

Final Report
May 2020

The SPAB RESEARCH REPORT 2

The SPAB Building Performance Survey Final Report

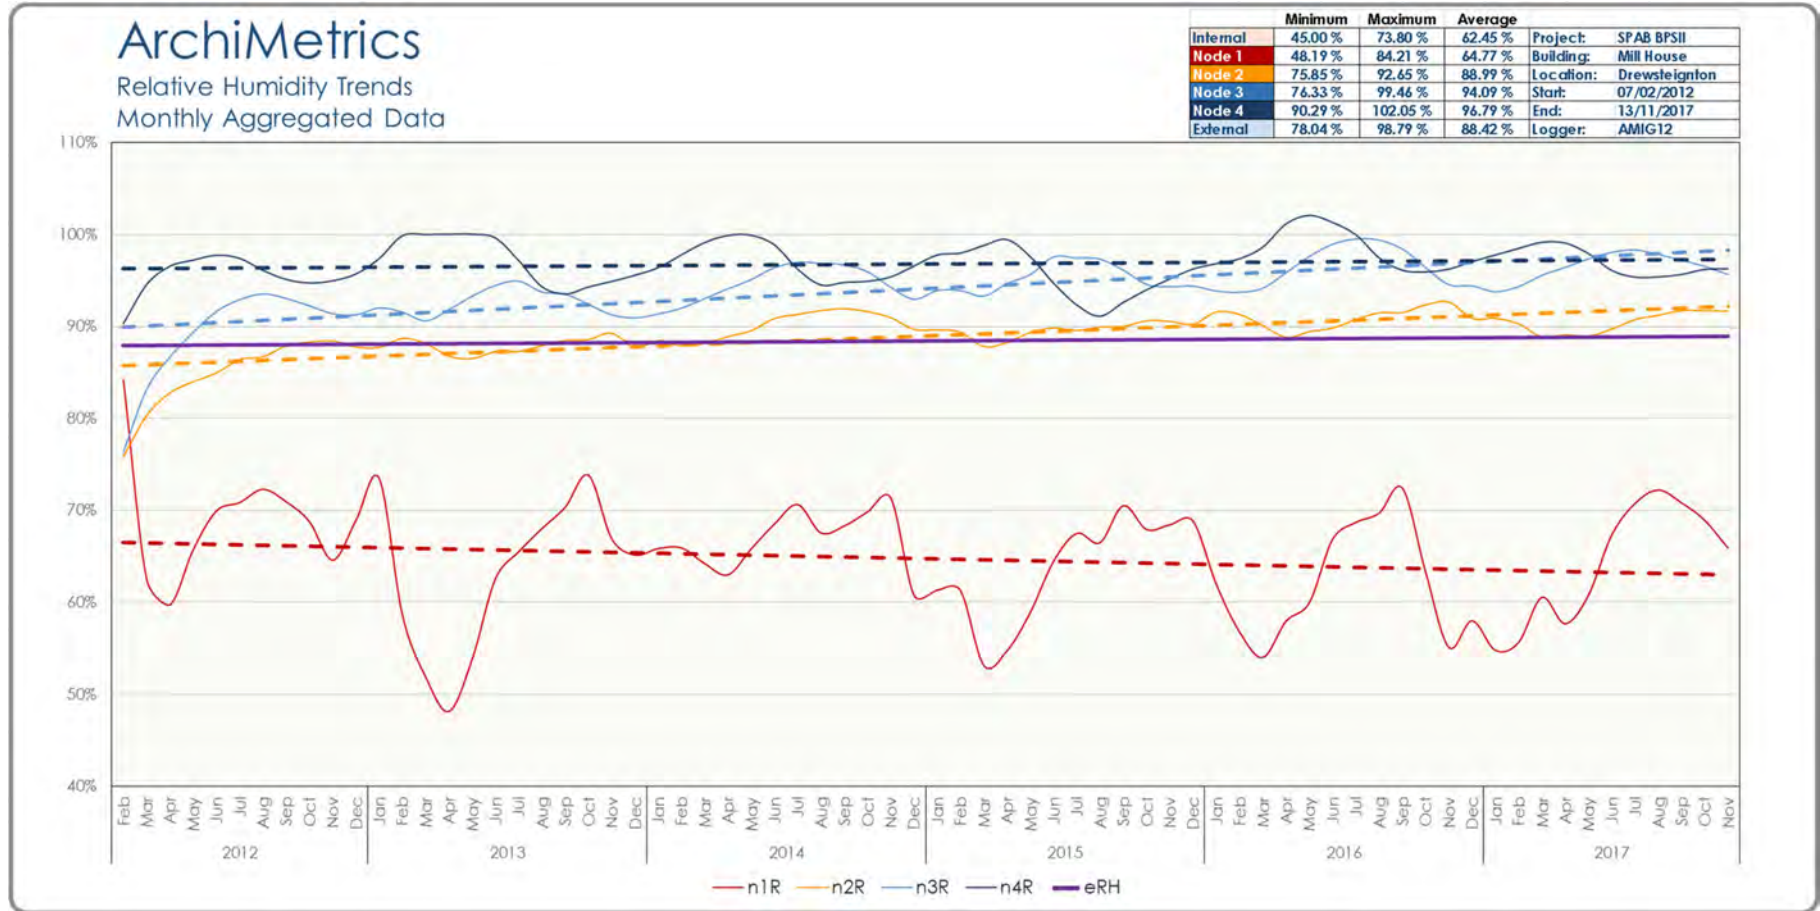
Figure 27. Relative humidity trends - post-refurbishment, Drewsteignton 2012–2017.

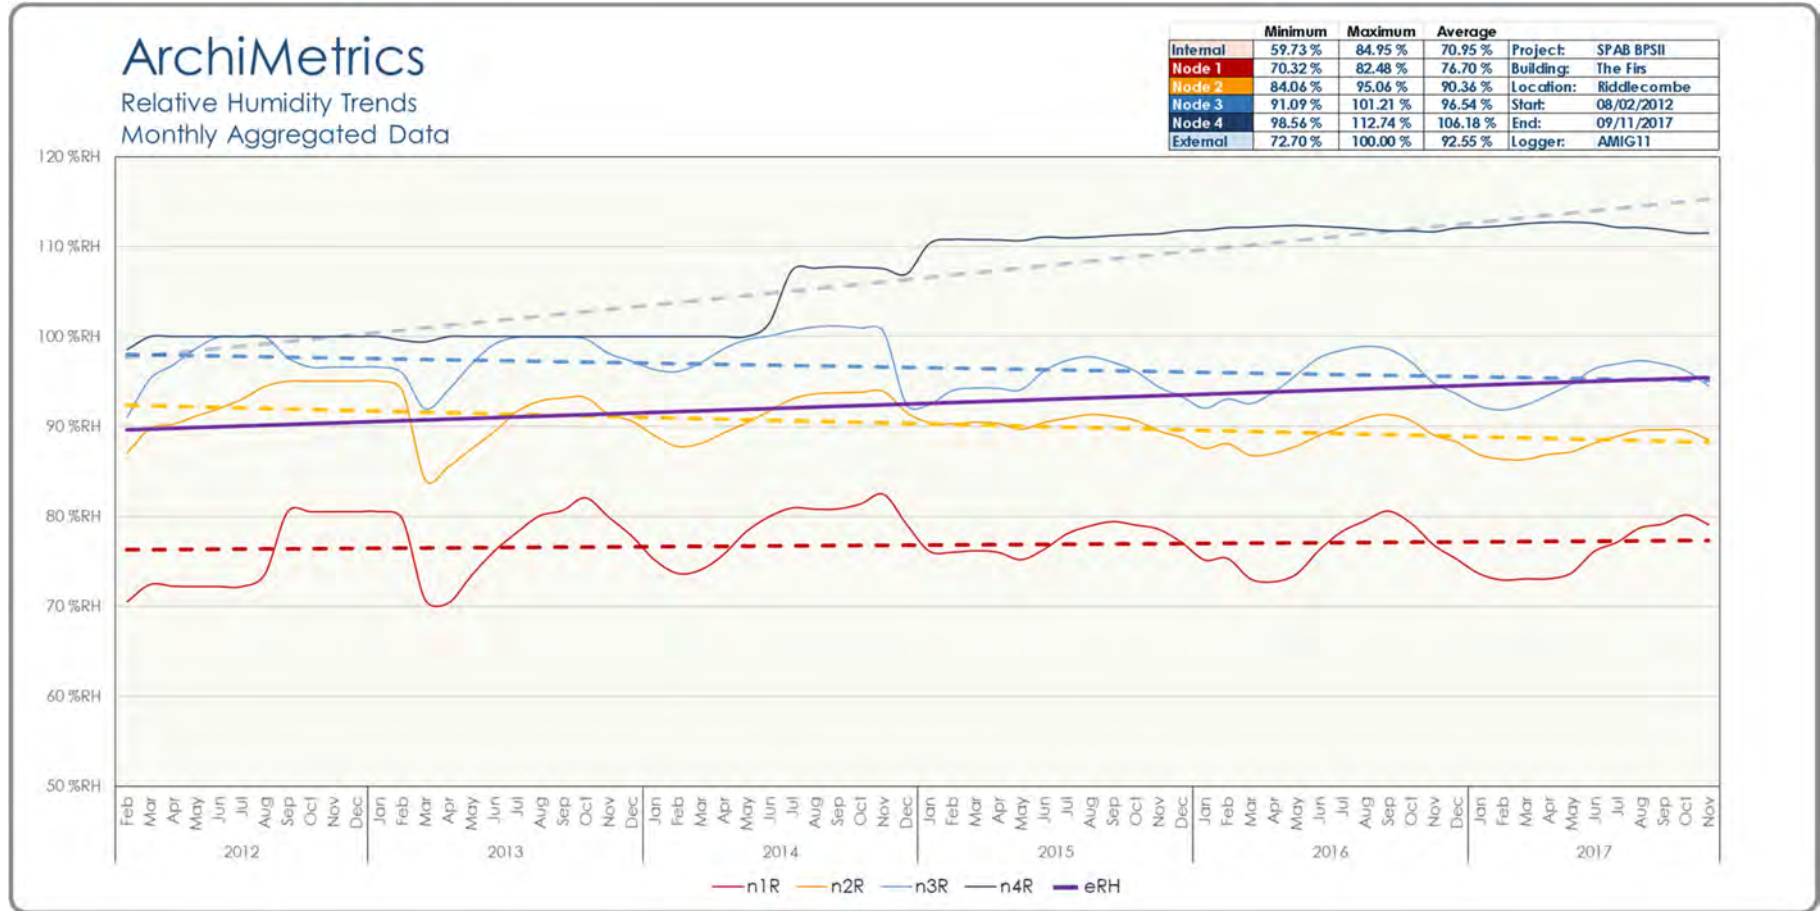
Figure 28. Relative humidity trends - post-refurbishment, Shrewsbury 2012–2017.

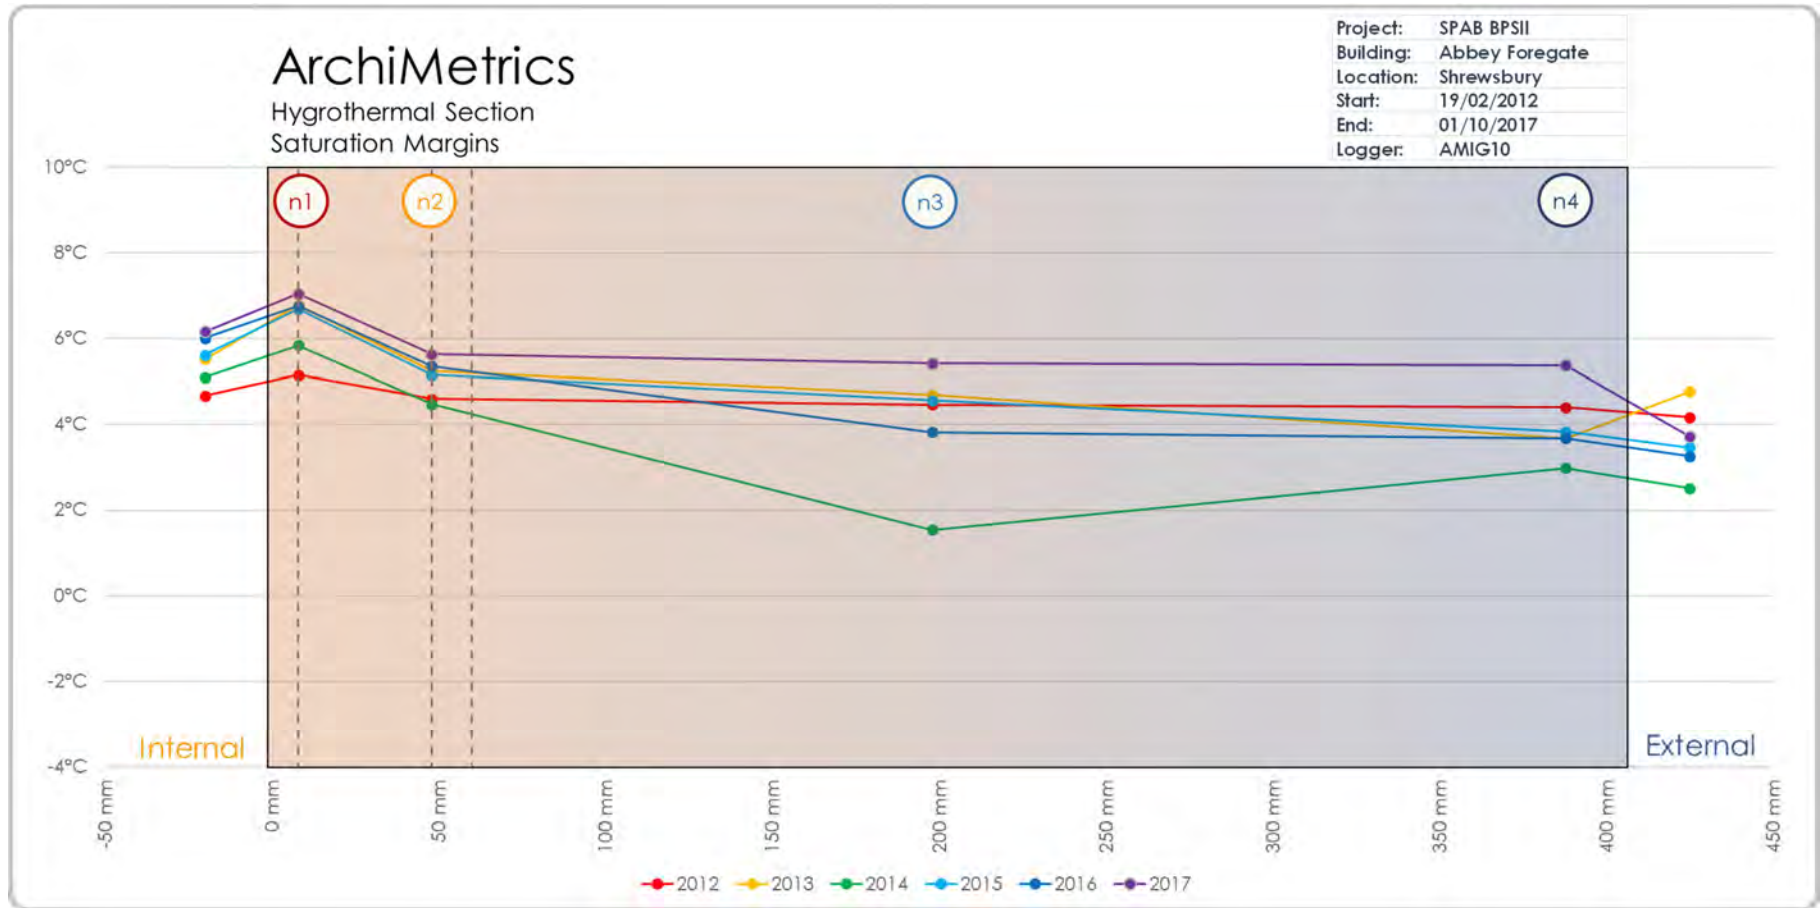
Figure 29. Saturation margins annual sections – post-refurbishment, Shrewsbury, 2012–2017.

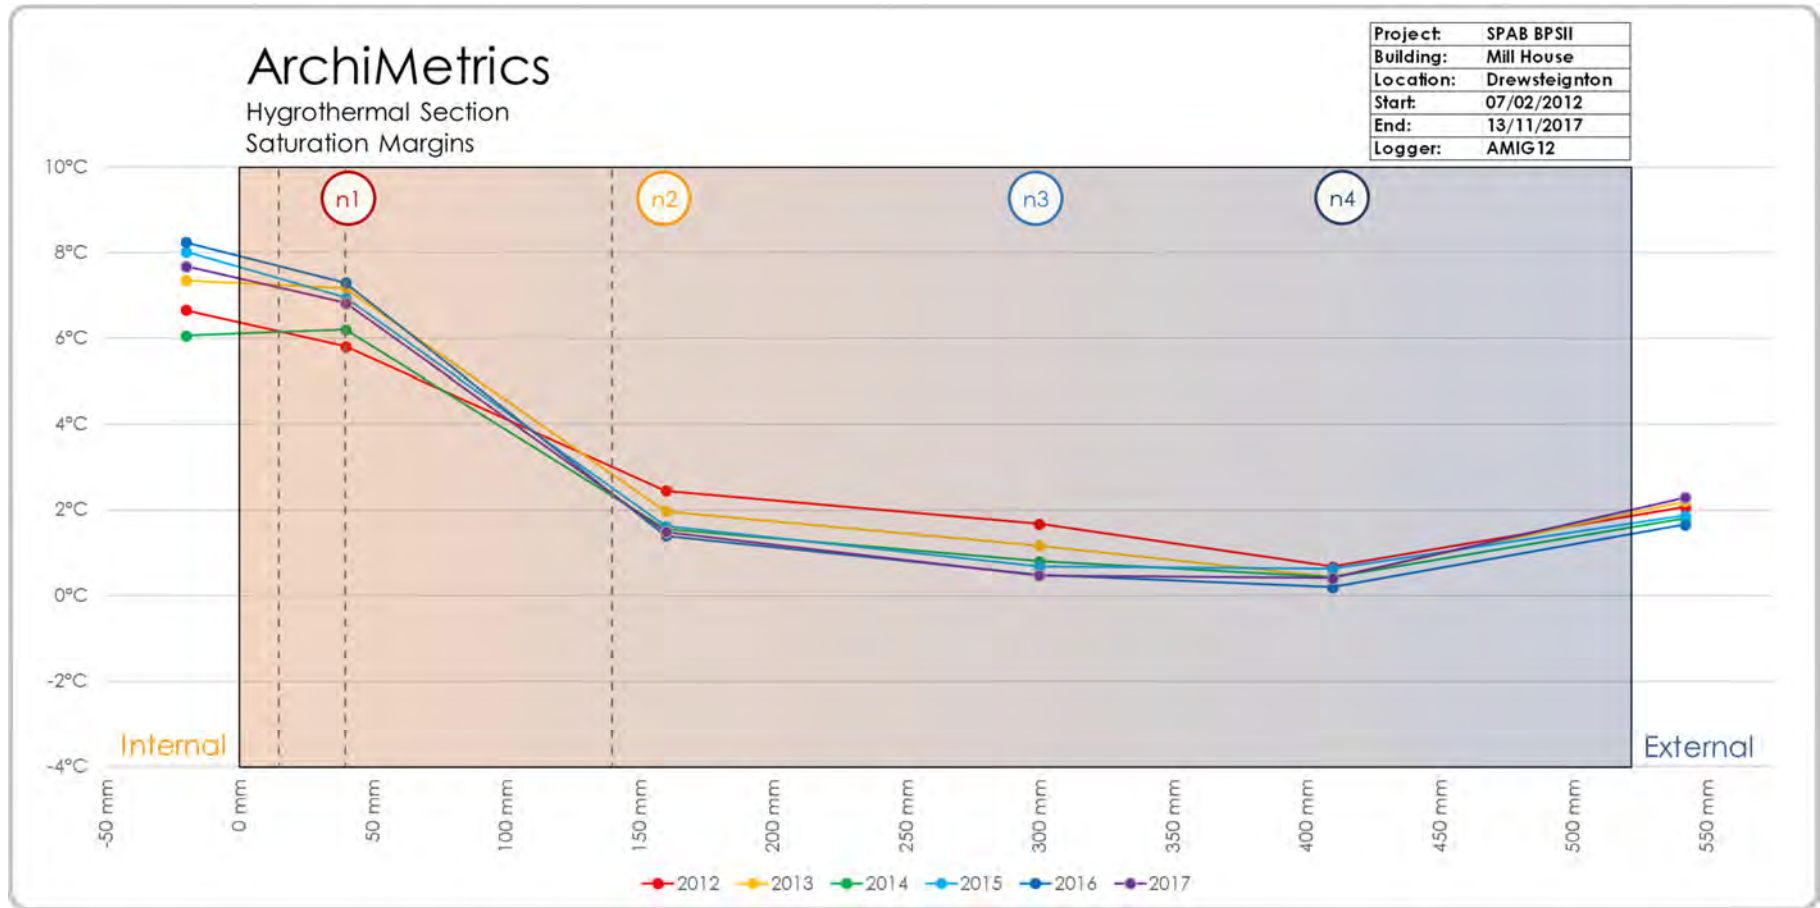
Figure 30. Saturation margins annual sections – post-refurbishment, Drewsteignton, 2012–2017.

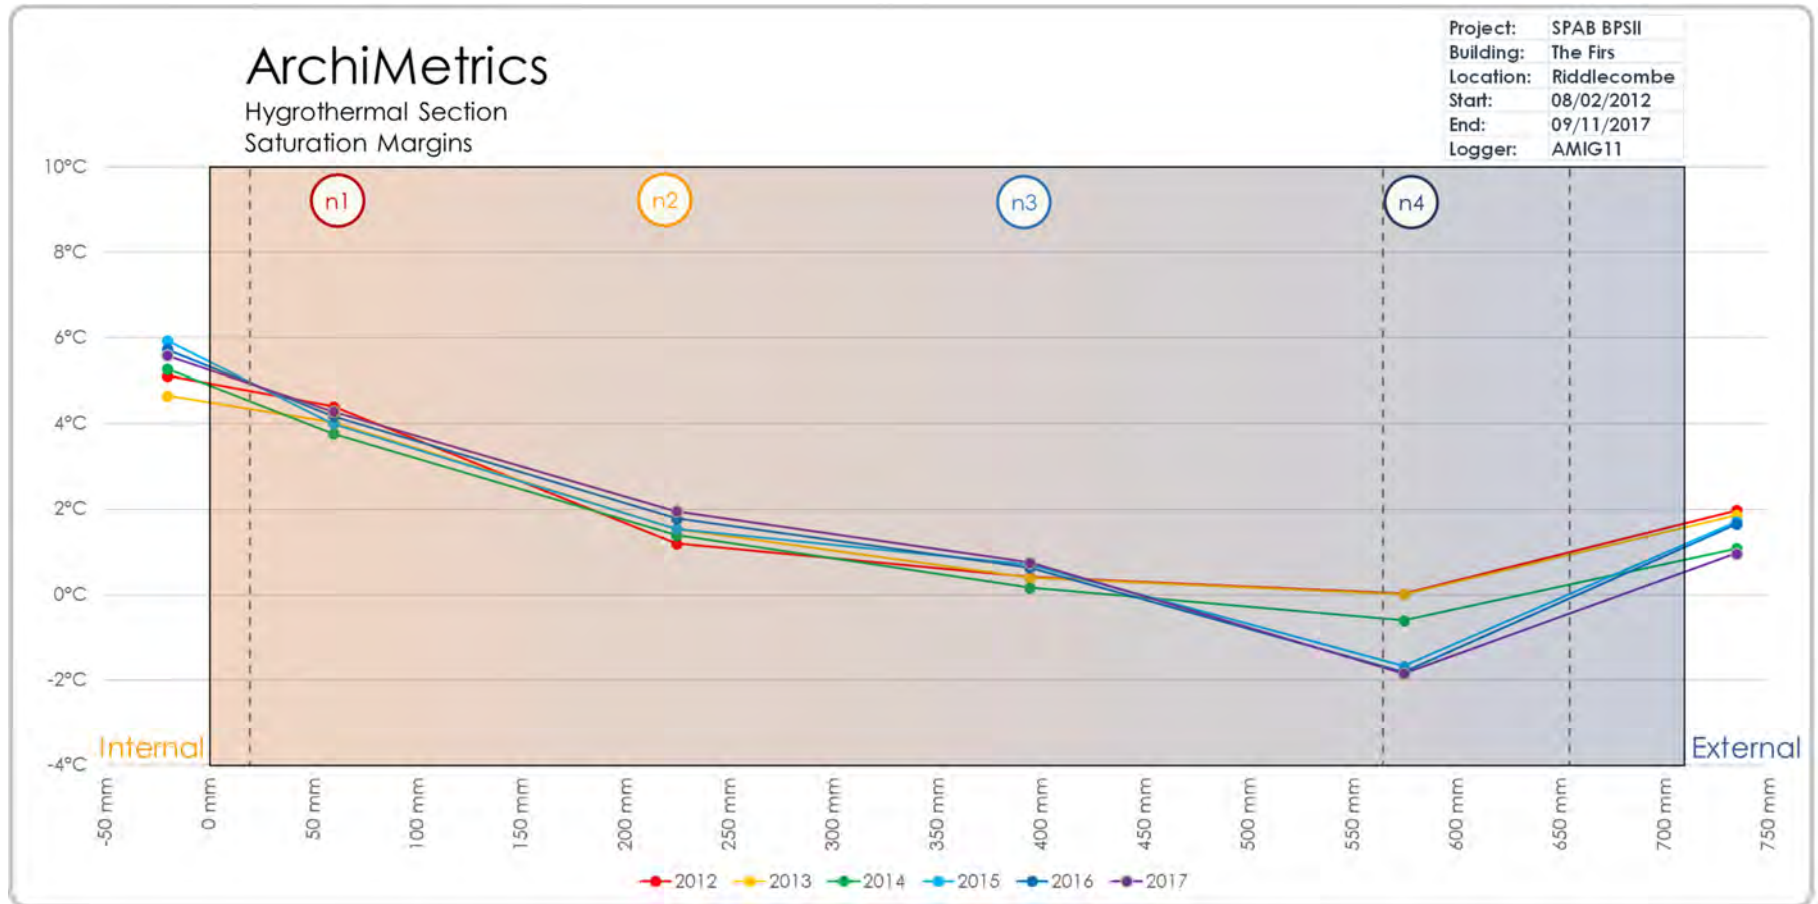
Figure 31. Saturation margins annual sections – post-refurbishment, Riddlecombe 2012–2017.

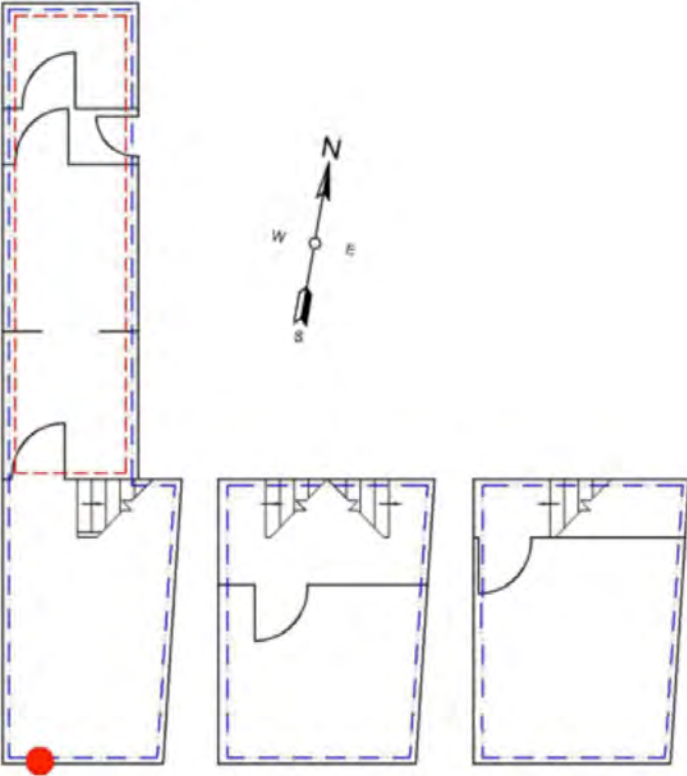
Figure 32. Plan of 116 Abbeyforegate, Shrewsbury (ground floor on left hand side). The red dot indicates the location of monitoring equipment.

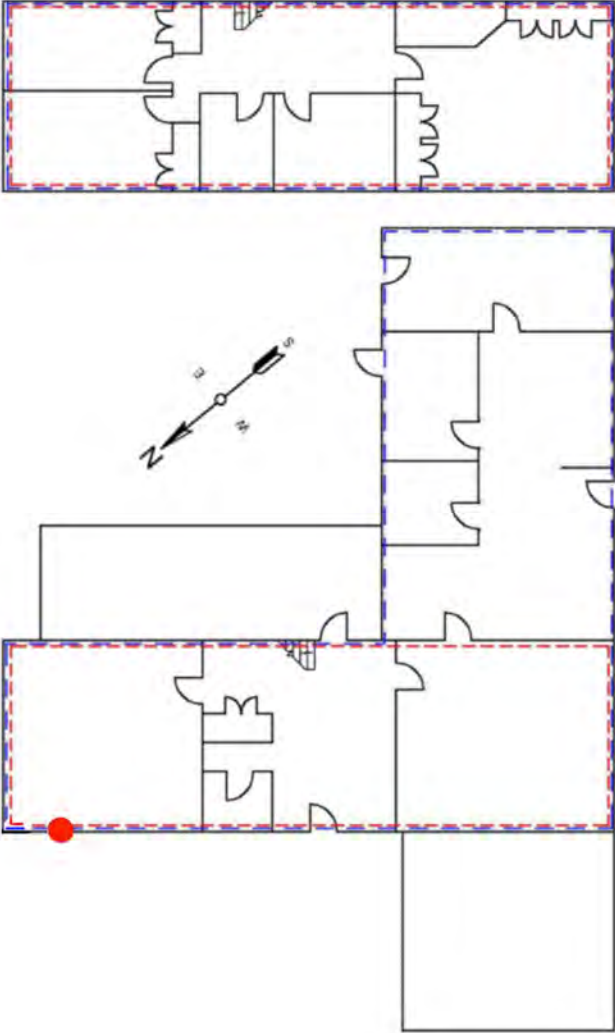
Figure 33. Plan of Mill House, Drewsteignton (ground floor in lower part of plan). The red dot indicates the location of the monitoring equipment.

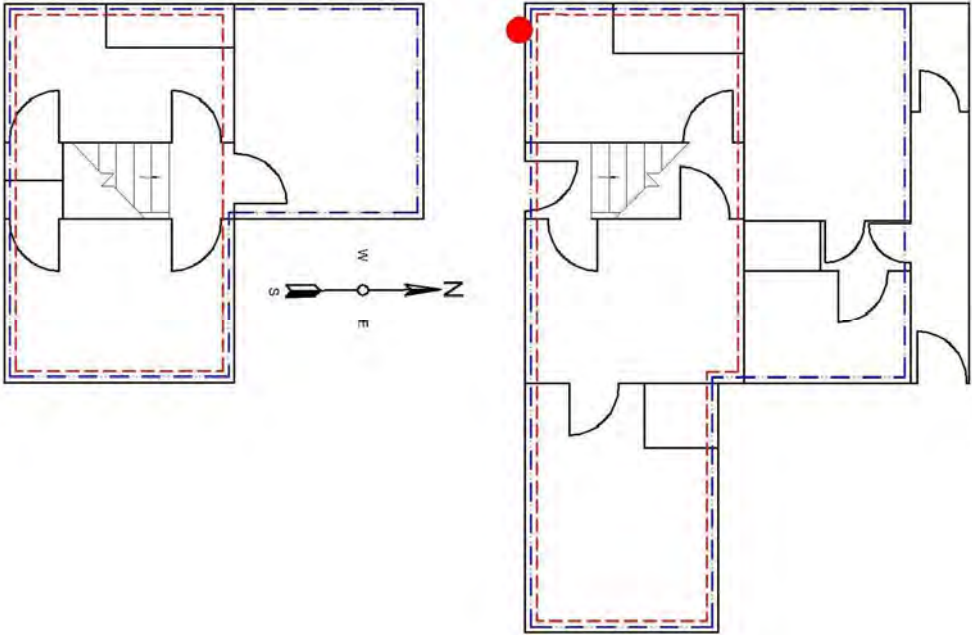
Figure 34. Plan of The Firs, Riddlecombe (ground floor on right-hand side). The red dot indicates the location of monitoring equipment.

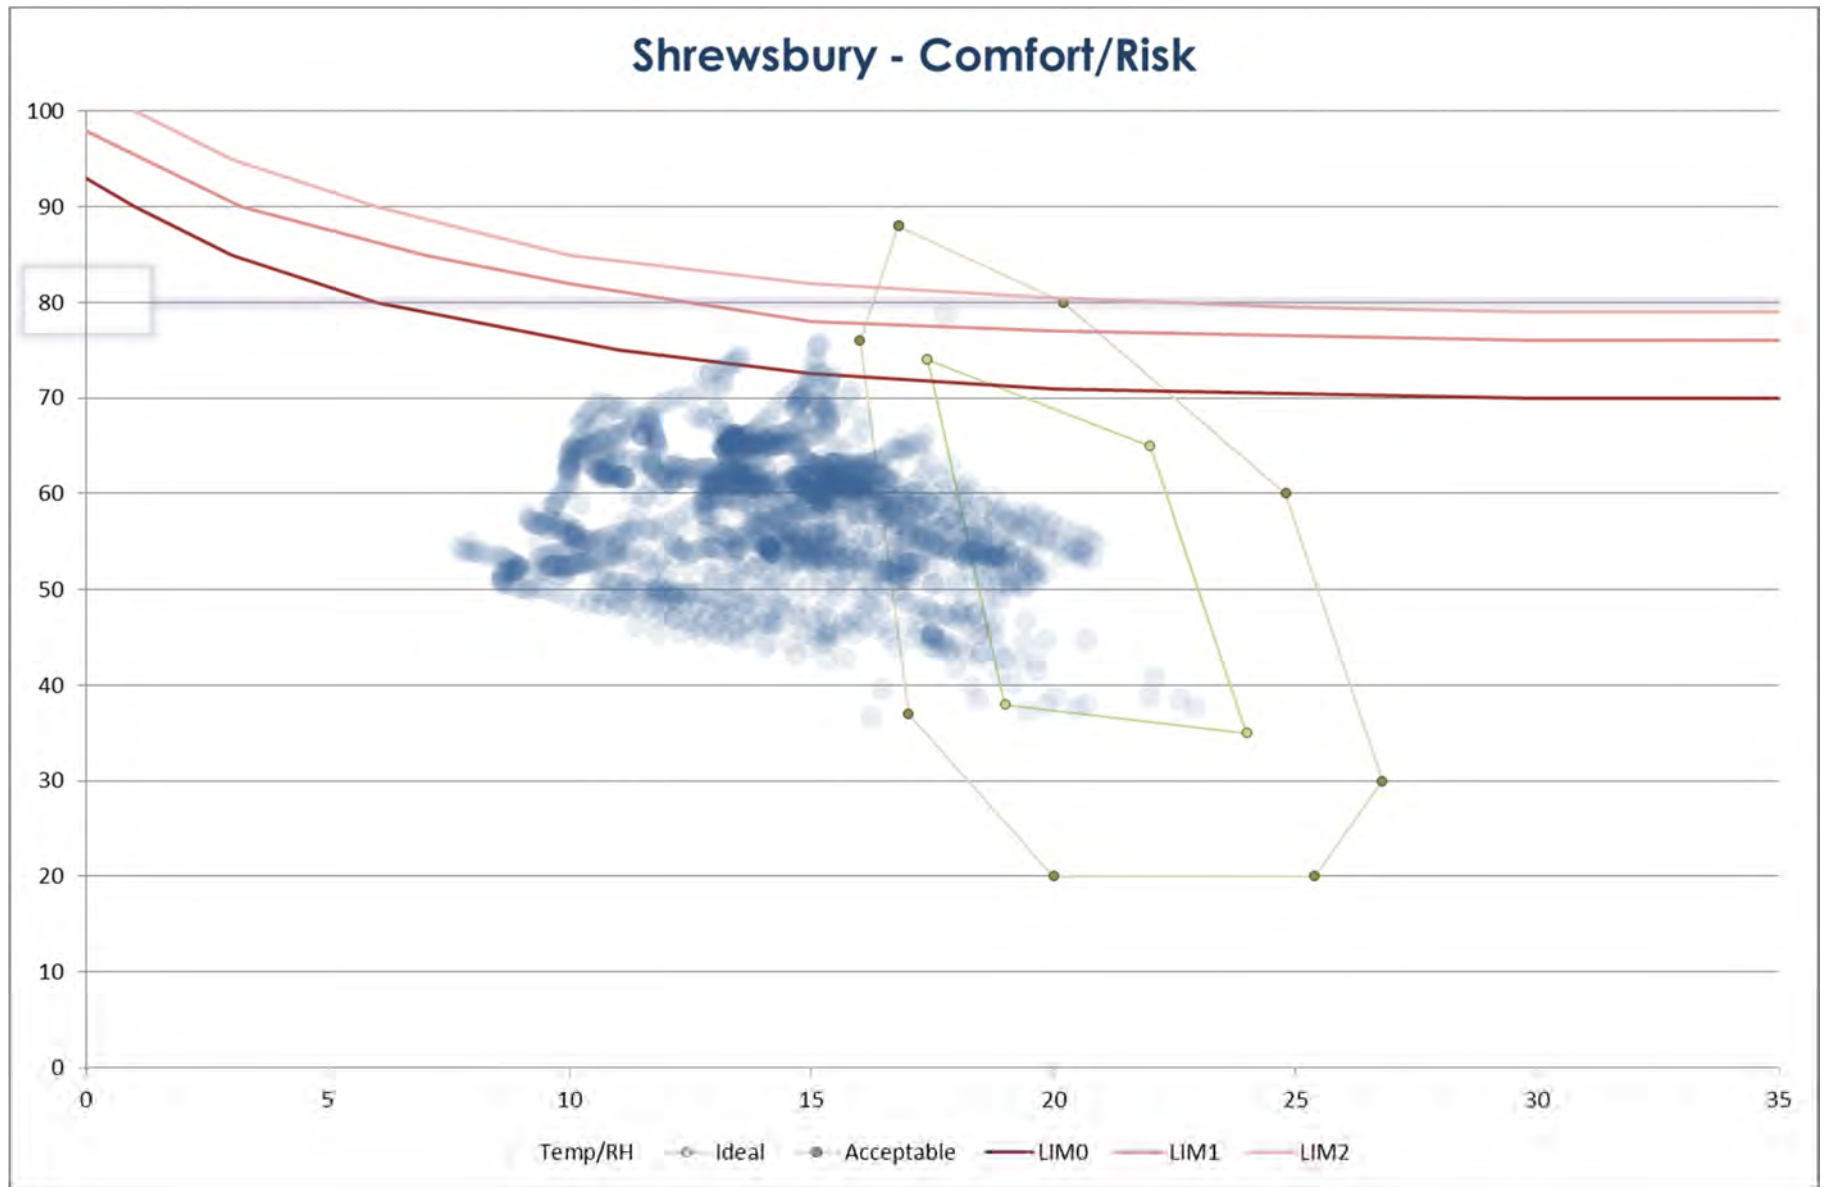
Figure 35. Comfort/risk analysis, Shrewsbury, 2011 – pre-refurbishment.

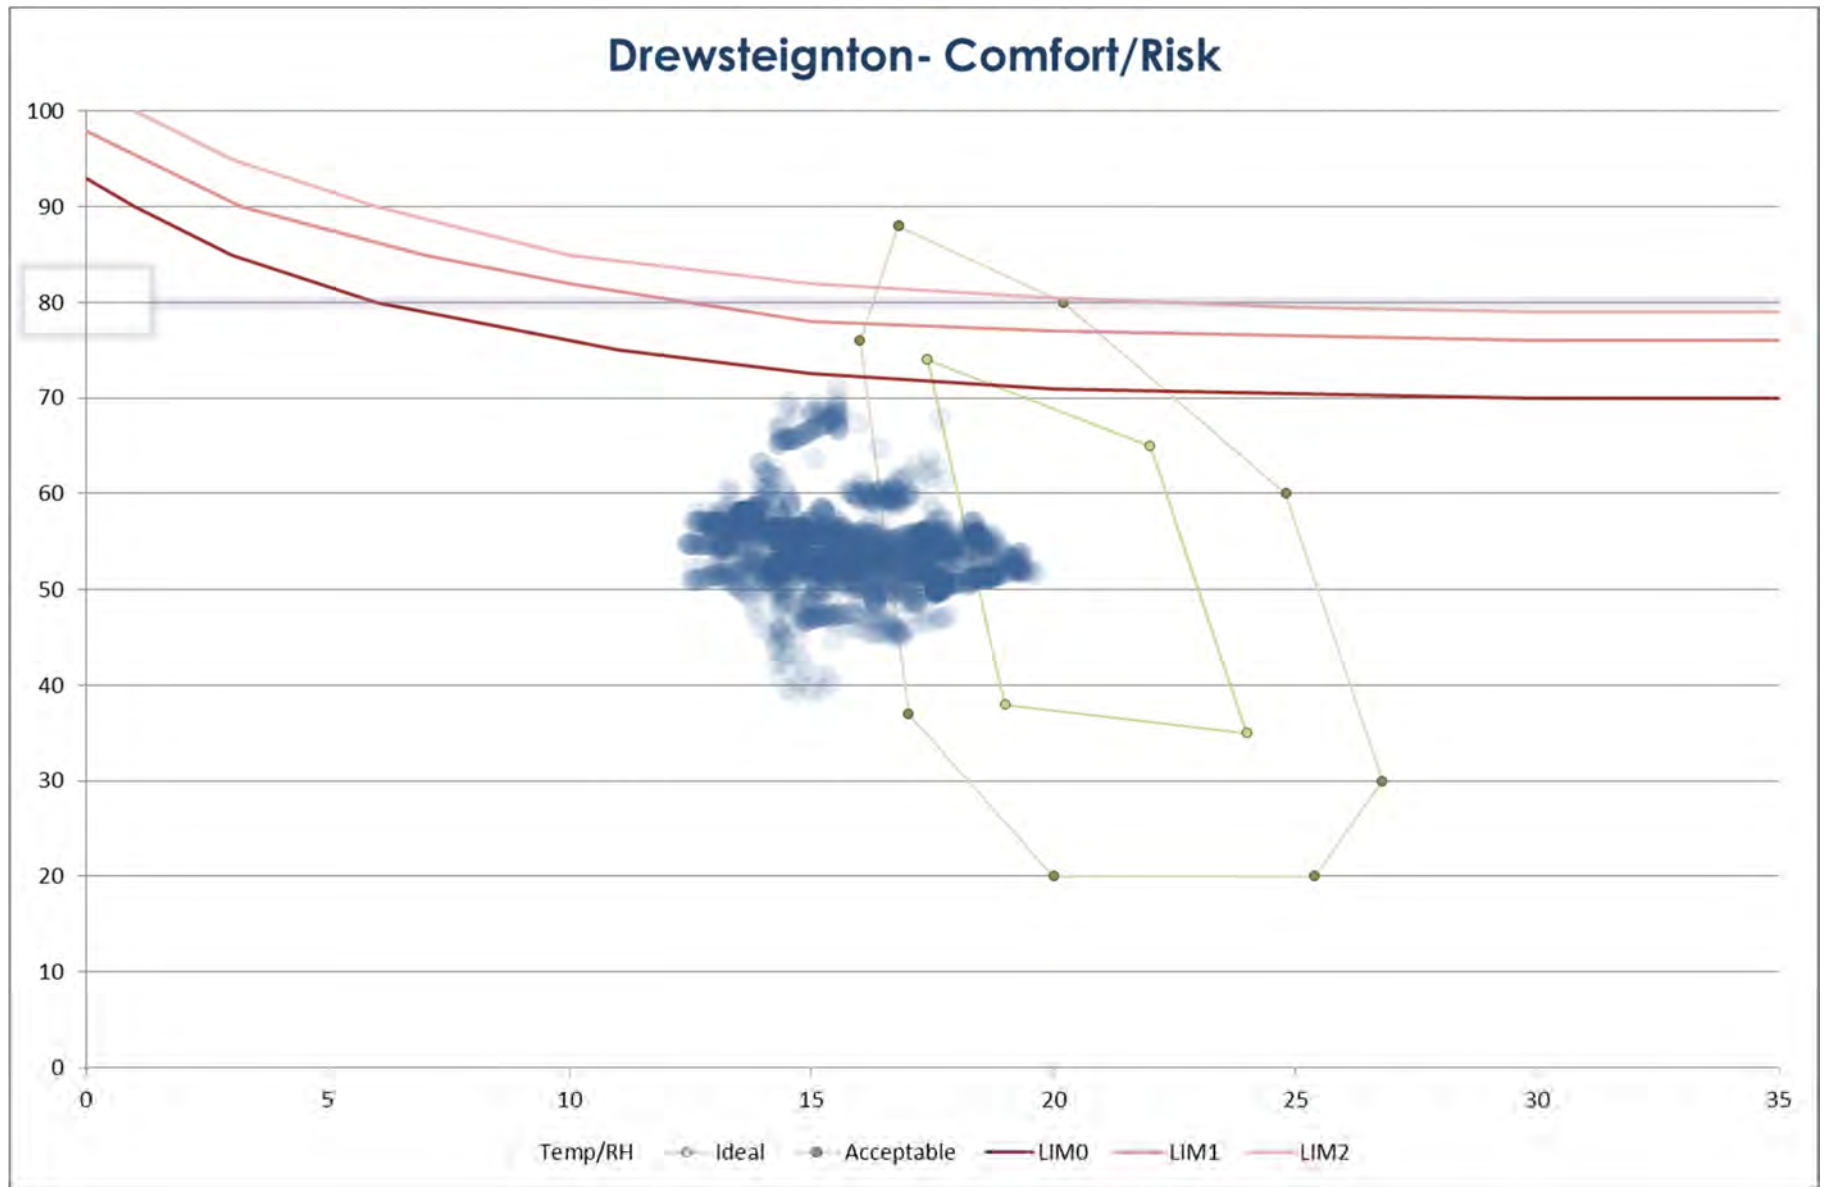
Figure 36. Comfort/risk analysis, Drewsteignton, 2011 – pre-refurbishment.

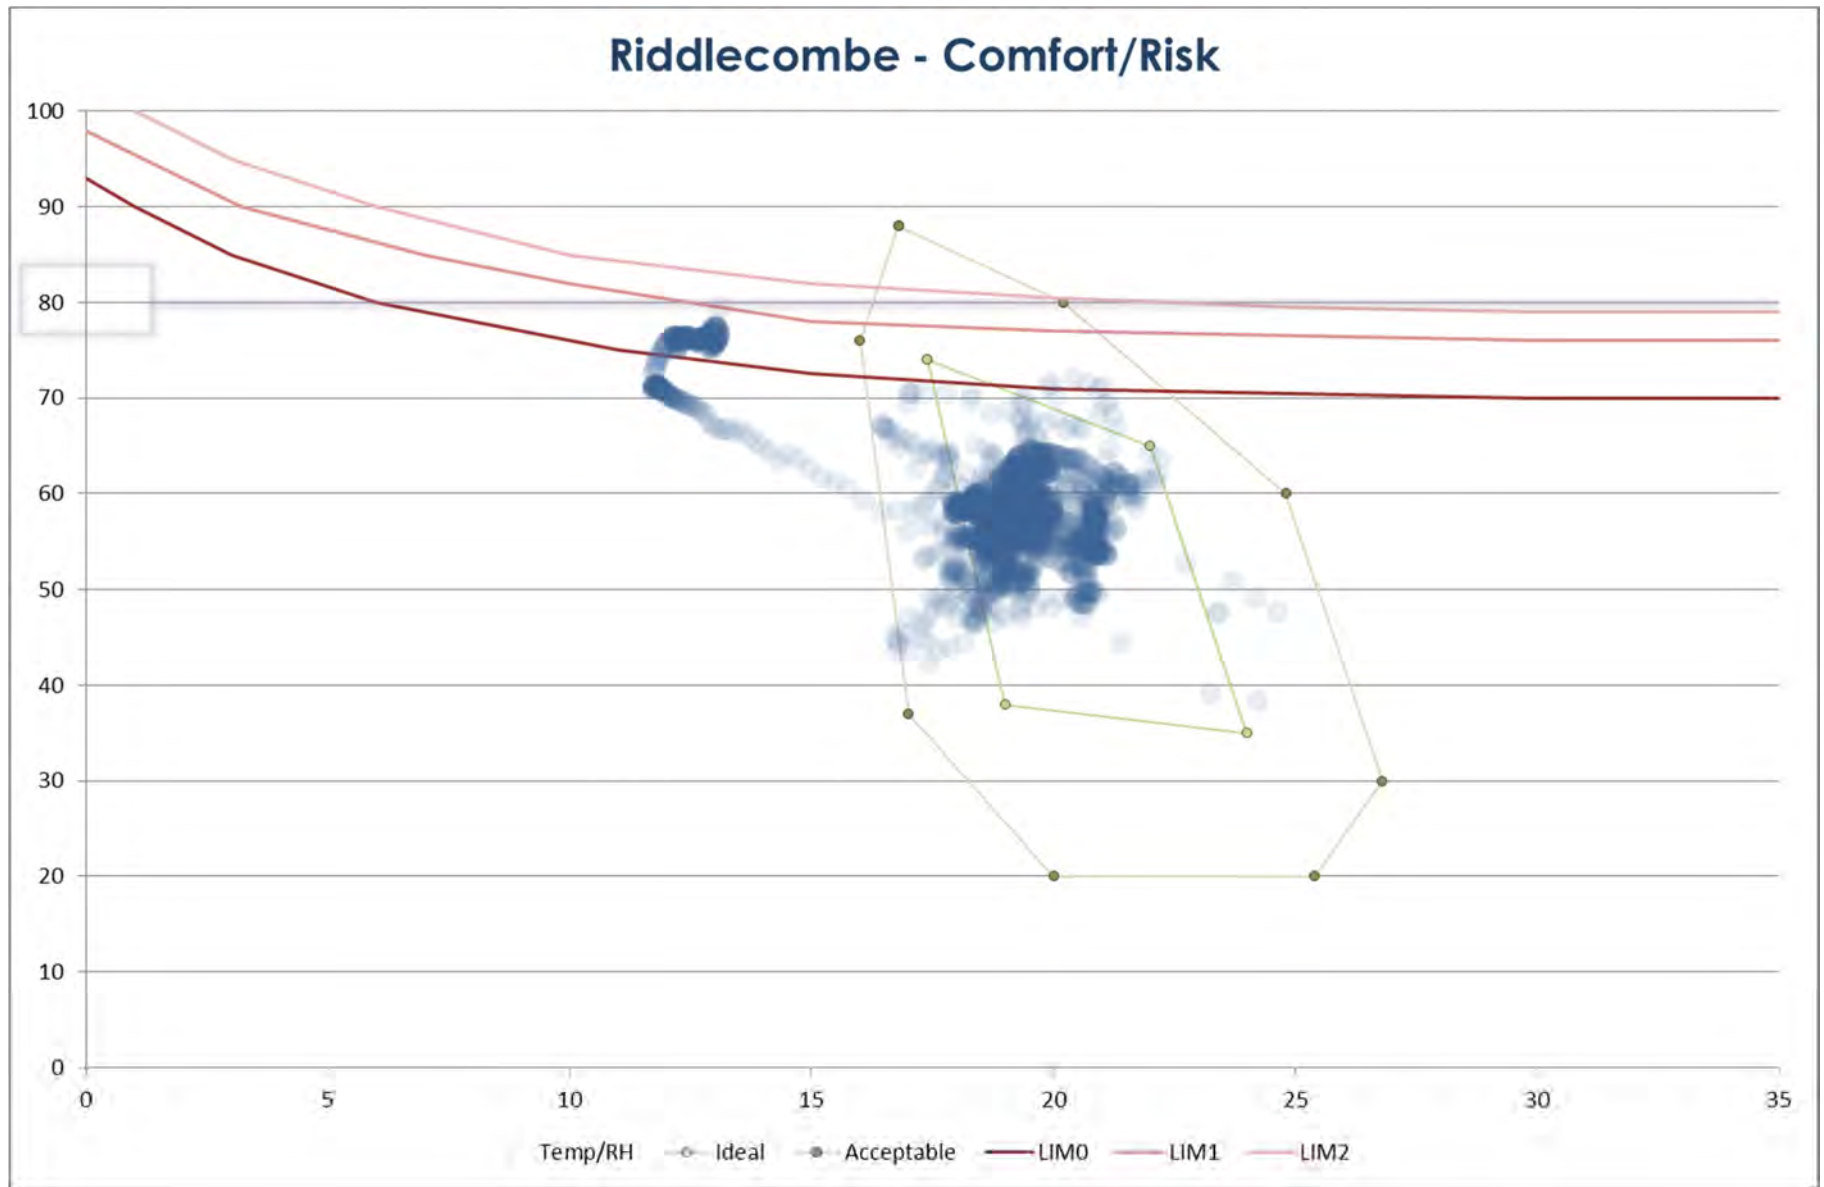
Figure 37. Comfort/risk analysis, Riddlecombe, 2011 – pre-refurbishment.

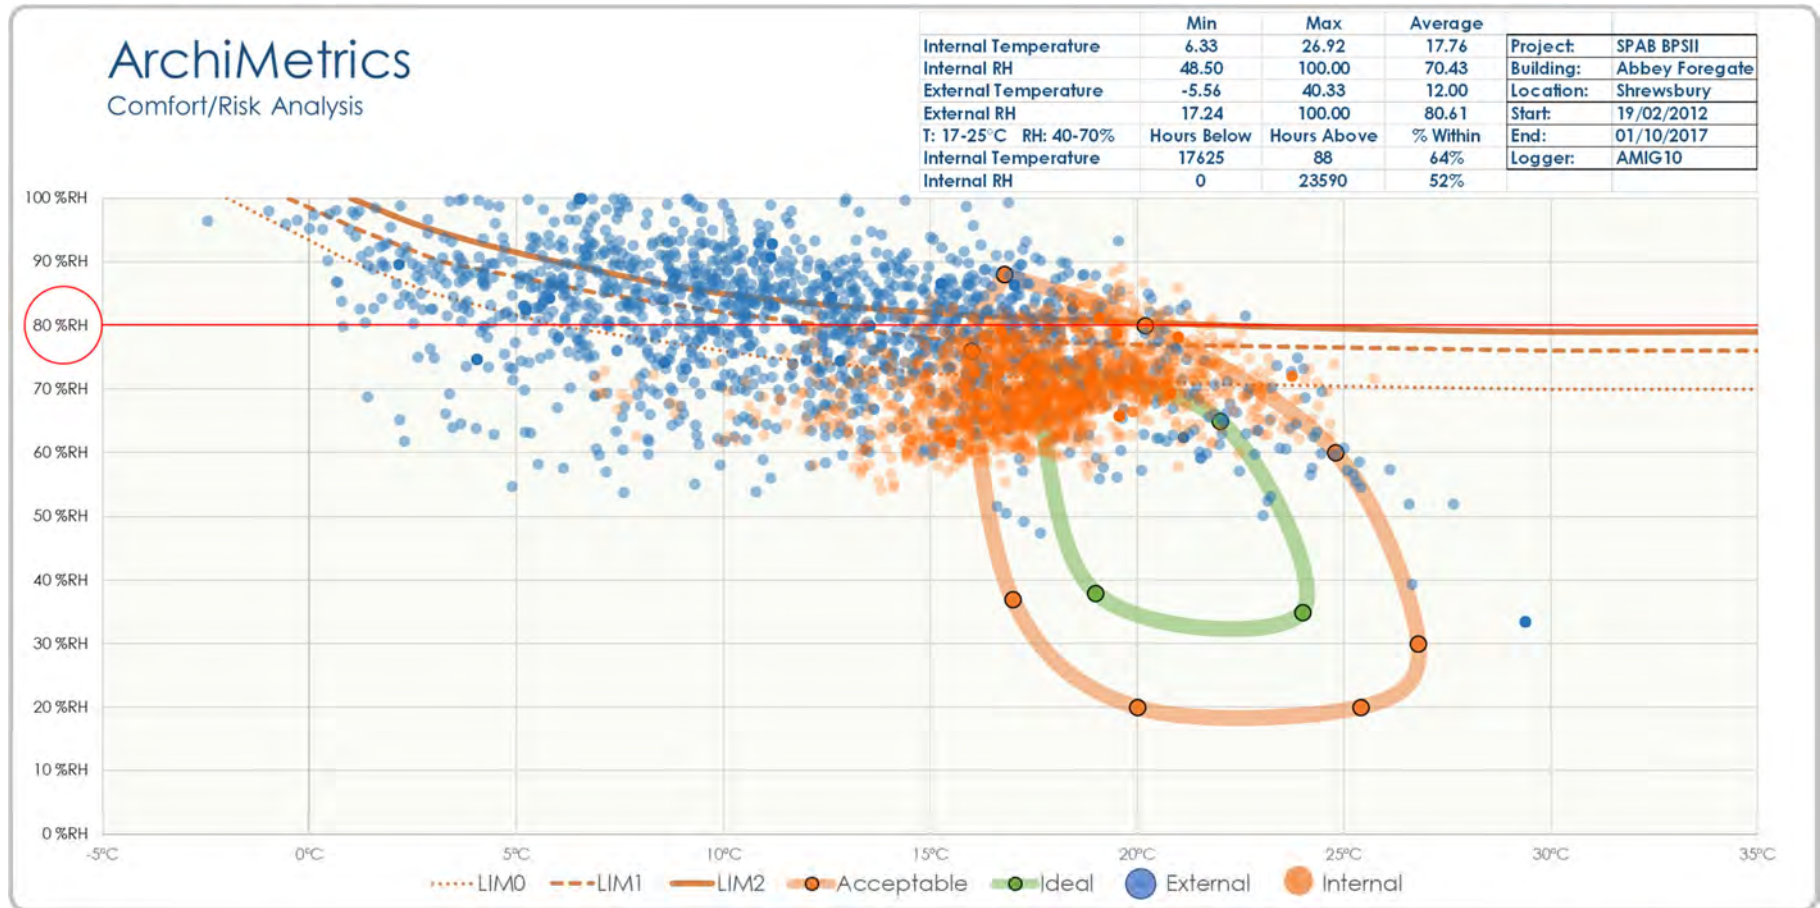
Figure 38. Comfort/risk analysis, Shrewsbury, 2012–2017 post-refurbishment.

The post refurbishment analyses for the rooms, Figures 38, 39 and 40, use nearly a full six years of measured temperature and RH data to map conditions within the rooms. These analyses also include external conditions and details of hours spent above and below 17–25°C and 40–70% RH for the three rooms and the commonly given 80% threshold for mould growth on surfaces is marked in red.

Because of the very different time series for the pre- and post-refurbishment room condition monitoring, it is not really possible to state whether the changes seen post-refurbishment are the result of improvements made to the fabric or just reflect warmer overall conditions. RH measured in all three rooms has increased but again this could just be a reflection of a much larger data set. However, temperatures have improved and there is no sign of mould growth in the two rooms of smaller volume where RH exceeds 80%.

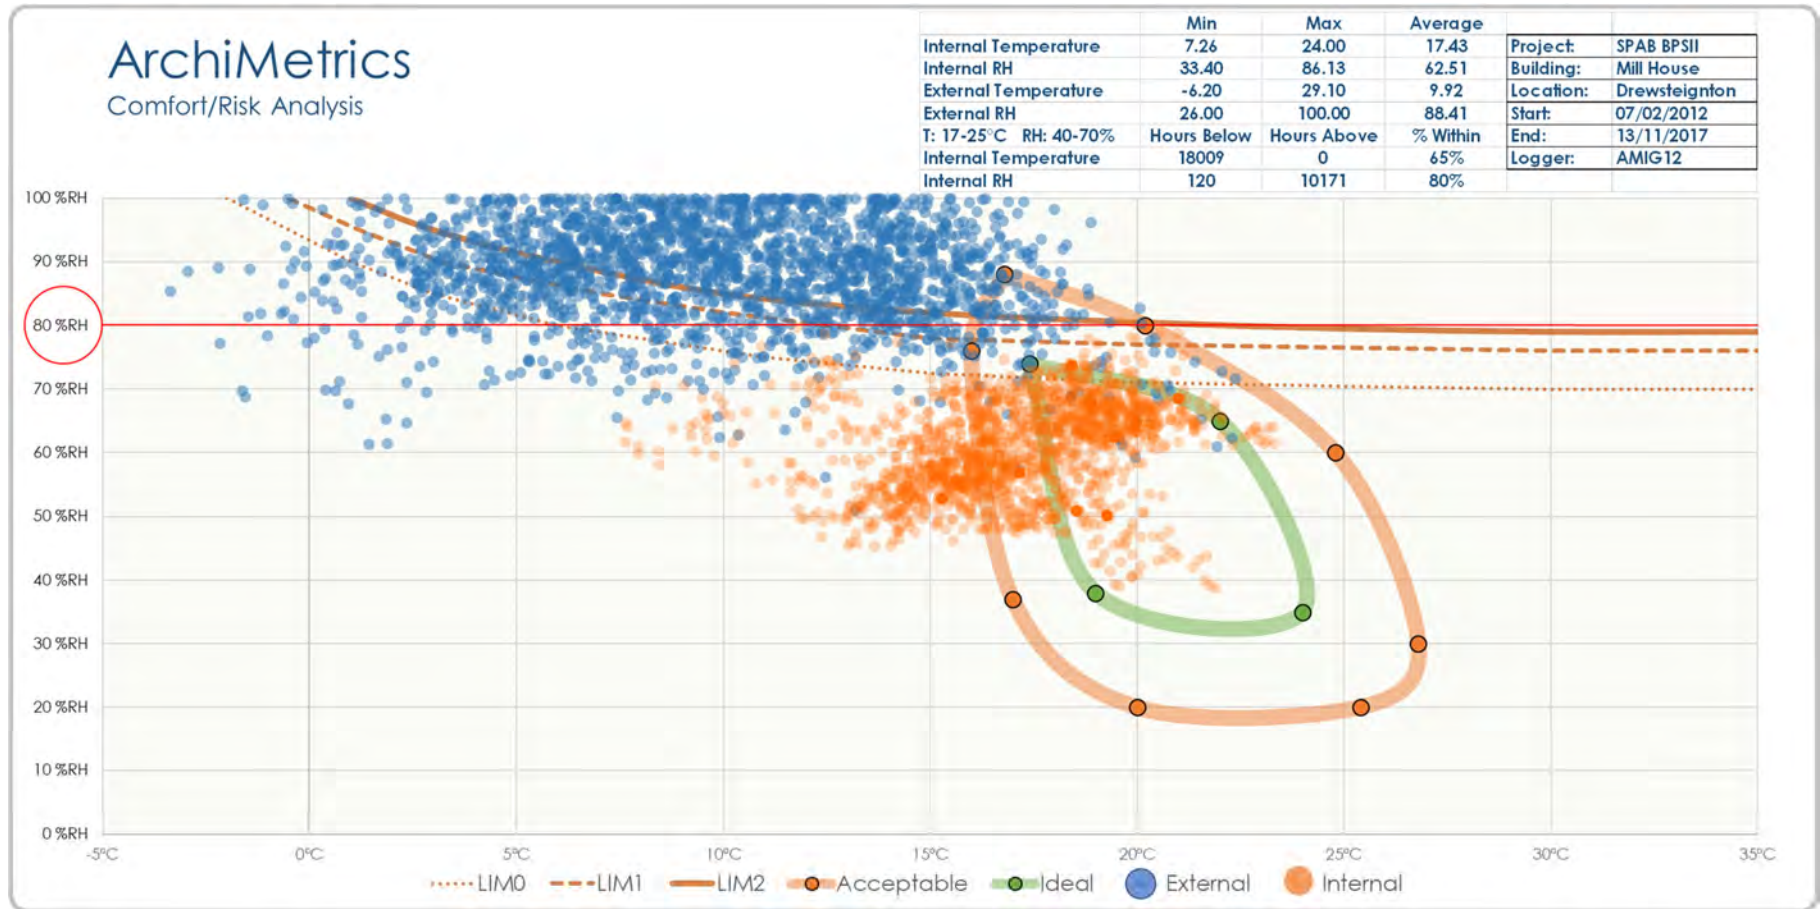
Figure 39. Comfort/risk analysis, Drewsteignton, 2012–2017 post-refurbishment.

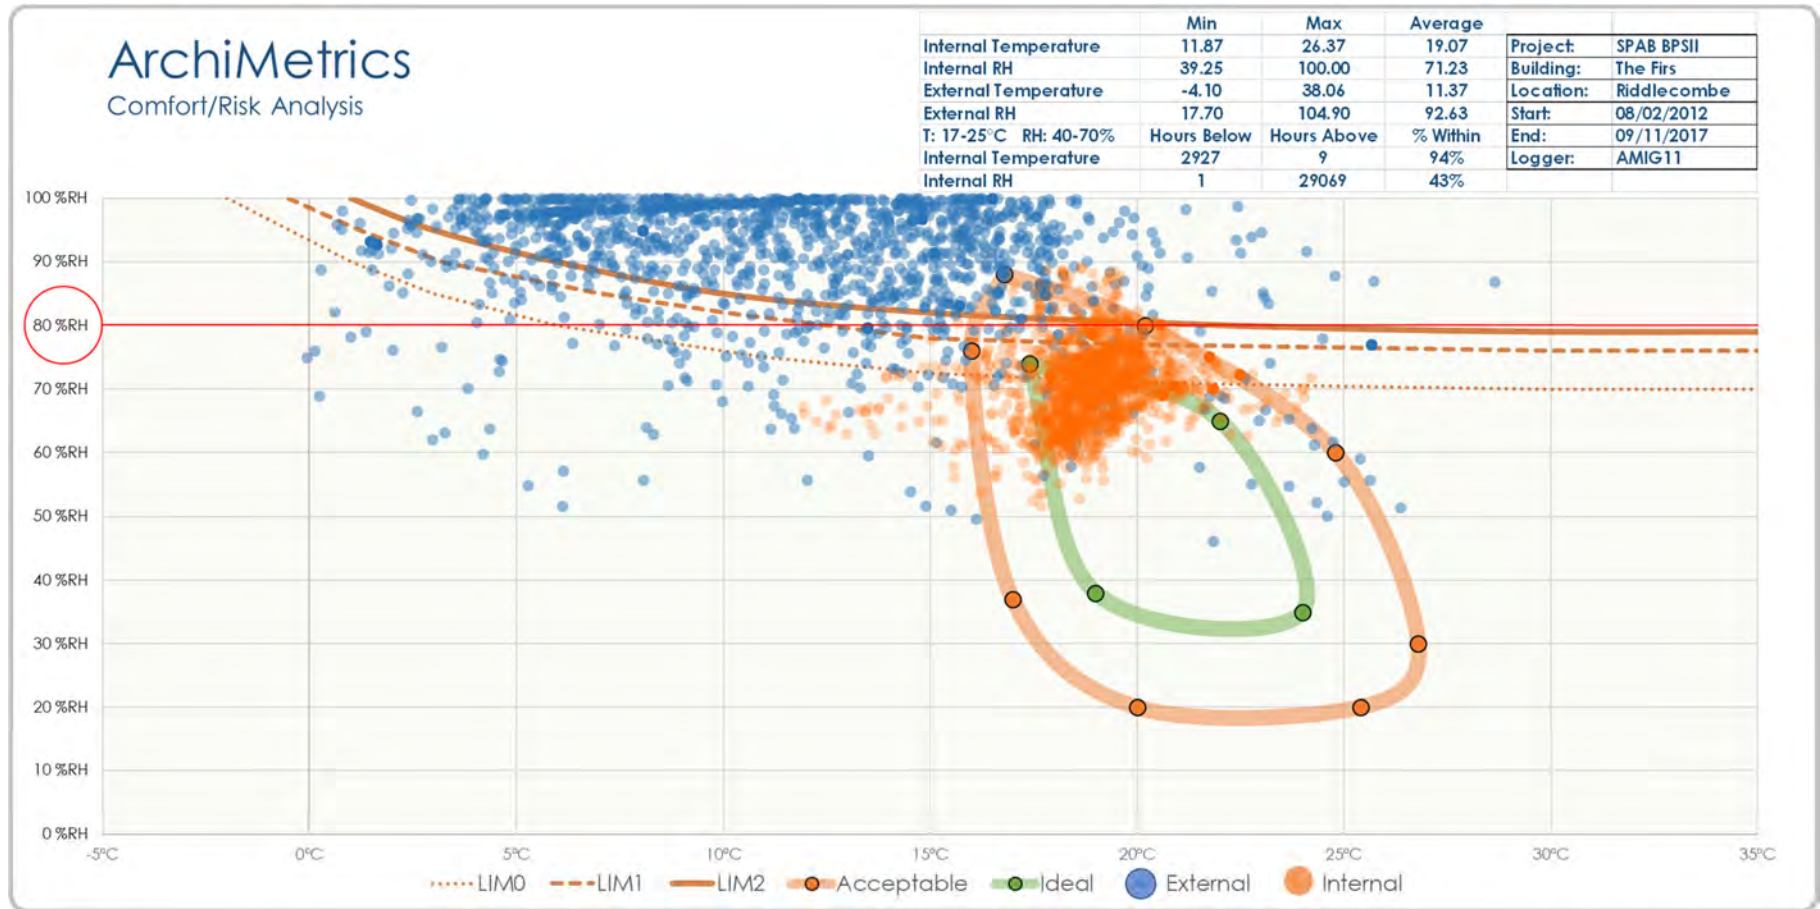
Figure 40. Comfort/risk analysis, Riddlecombe, 2012–2017 post-refurbishment.
