# Lesnes Abbey, Bexley, Greater London: An Archaeological Survey of Selected Areas of the Abbey Grounds

Lawrence Rees

NGR: TQ 4790 7881

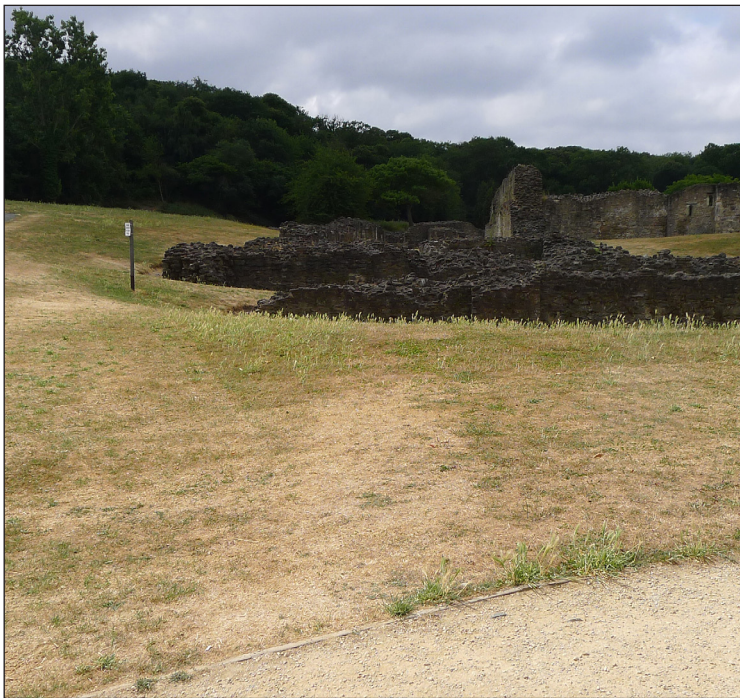
Figure 8: The line of the post medieval wall defining the eastern side of 'The Warren', visible as a parchmark and a very slight earthwork, extending north from the dormitory range at the north-eastern corner of the abbey ruins (view looking south from NGR TQ 4792 7888). It seems likely that the eastern boundary of the abbey precinct was located further to the east. 11-JUL-2018 ©Historic England.

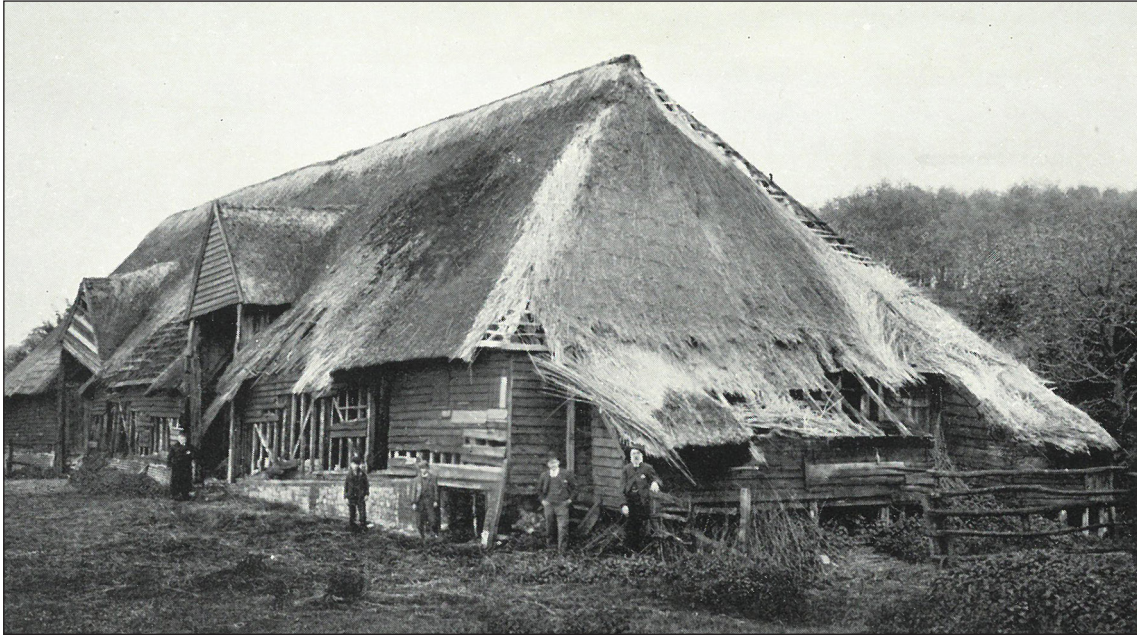
Figure 9: The northern elevation of the barn, looking south-east, as published in Clapham (1915, Pl VI).

Three photographs of the large barn survive, two of which were published in Clapham (1915, Plate VI, see Figs 9 and 10), and a third which is held in the Frederick Nunn collection in Bexleyheath Archive showing the Woolwich Antiquarian Society posed in front of it in 1895 (Bexleyheath Library and Archives PH/FWN/1/18-19). The photographs show a large aisled threshing barn (the threshing lift is visible on one of the photographs) with a collar rafter roof, windbraces and queen struts. It had two large barn doors (midstreys) on its northern elevation and, though it was in a state of collapse by the late 19th century, it retained a thatched roof. Any opposing entrances on the southern elevation would not have provided cart access due to the steeply-rising ground (cf Bond 2004, 128). Figure 9 also shows the rag-stone rubble plinth patched with brick described by Clapham (1915, 42). According to Clapham (1915, 43) the barn was 117ft 8in (36m) long and 38ft 9in (12m) wide (measurements from the 1st edition 25 inch Ordnance Survey map give the same width but a length of 44m). He describes the uprights as 'stood on oak plates resting on sleeper walls crossing the aisles and dividing them into eight bays'.

The style of timber frame suggests that the barn could have been of 17th-century date, but could equally date from the very end of the monastic period in the early 16th century. A reference cited by Clapham (1915, 28) certainly suggests that a new barn was being constructed around 1517, less than 10 years before the abbey was dissolved, at a cost of £16 5s 4d. If this barn did survive to the 19th century Clapham's dimensions would place it in the category of 'medium-sized' monastic barns (Bond 2004, 133). If it was not built in 1517, then construction in the 80 year period of the Cooke family's ownership from 1541-1620, or immediately following Christ's Hospital's acquisition of the site in 1633 seems most likely, in contrast to the intervening periods of unsettled ownership.

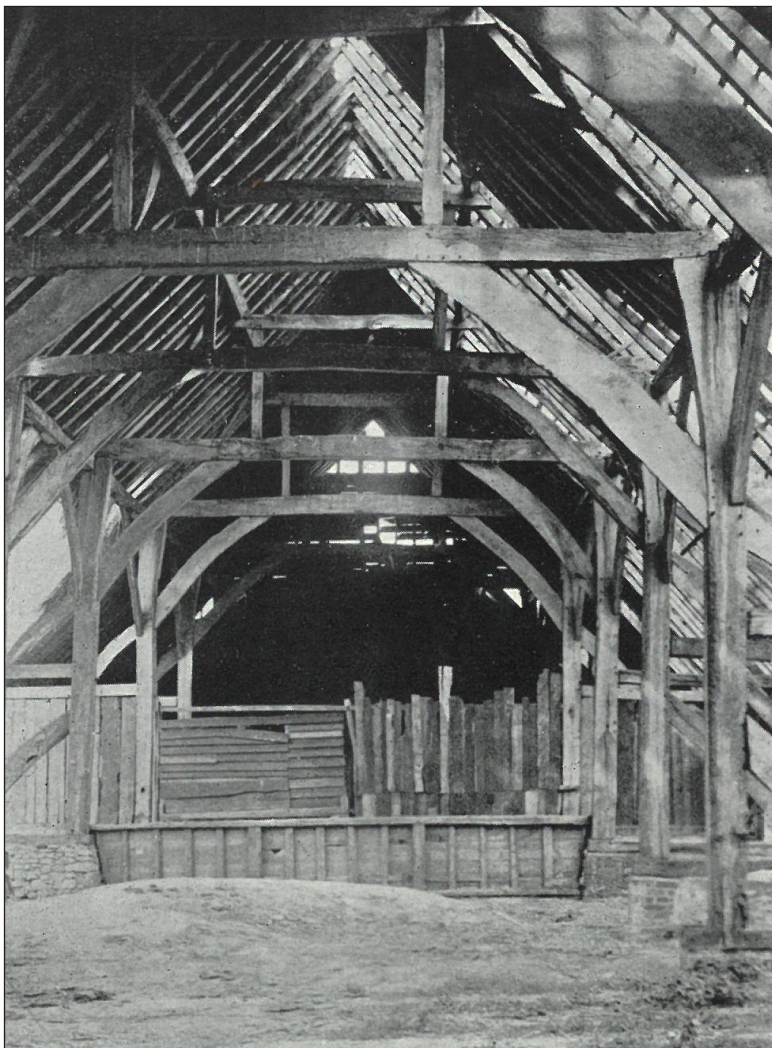
Figure 10: The interior of the barn as published in Clapham (1915, Pl VI).

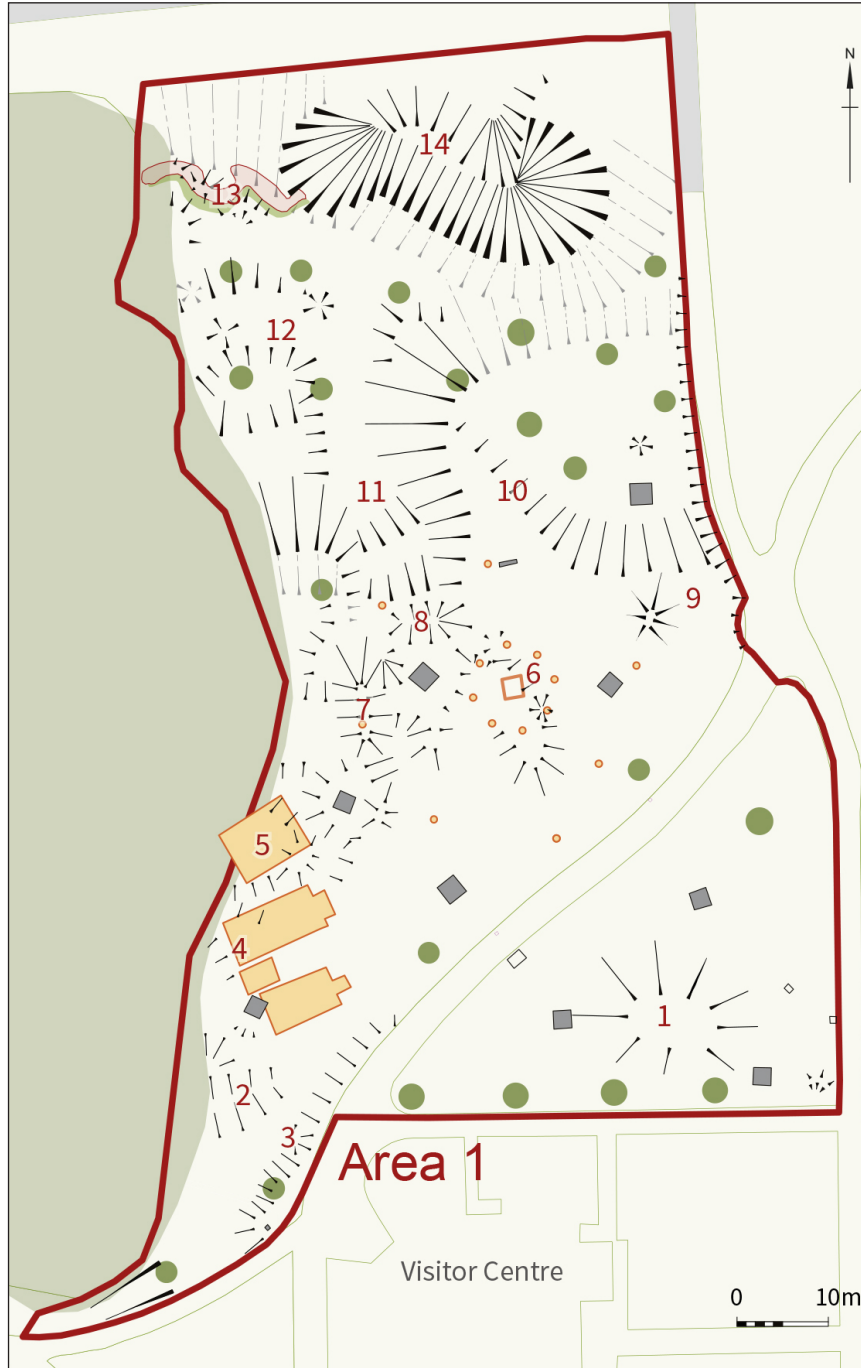
Figure 13: Survey Area 1 to the north-west of the scheduled area. The numbers refer to features mentioned in this section of the text. Image: Sharon Soutar (© Crown Copyright and database right 2019. All rights reserved. Ordnance Survey Licence number 100024900). Drawing 1:1000 scale when viewed/printed at A4.

The south-east of this survey area is defined by modern paths forming a triangular shape. The only notable feature is a low mound (Fig 13 [1]), measuring approximately 20.5m by 14m and up to 0.3m high, possibly the result of the demolition of late 19th- and early 20th-century buildings noted on the 1930 lease plan (Bexleyheath Libraries and Archive Service LALB/DA/1/26/26). These buildings post-dated the Ordnance Survey 1st edition 25-inch map of circa 1865 (Fig 15) and were located at the north-west corner of the rectangular enclosure originally described on the Daynes plan as the 'Kitchen Garden' (Fig 4).

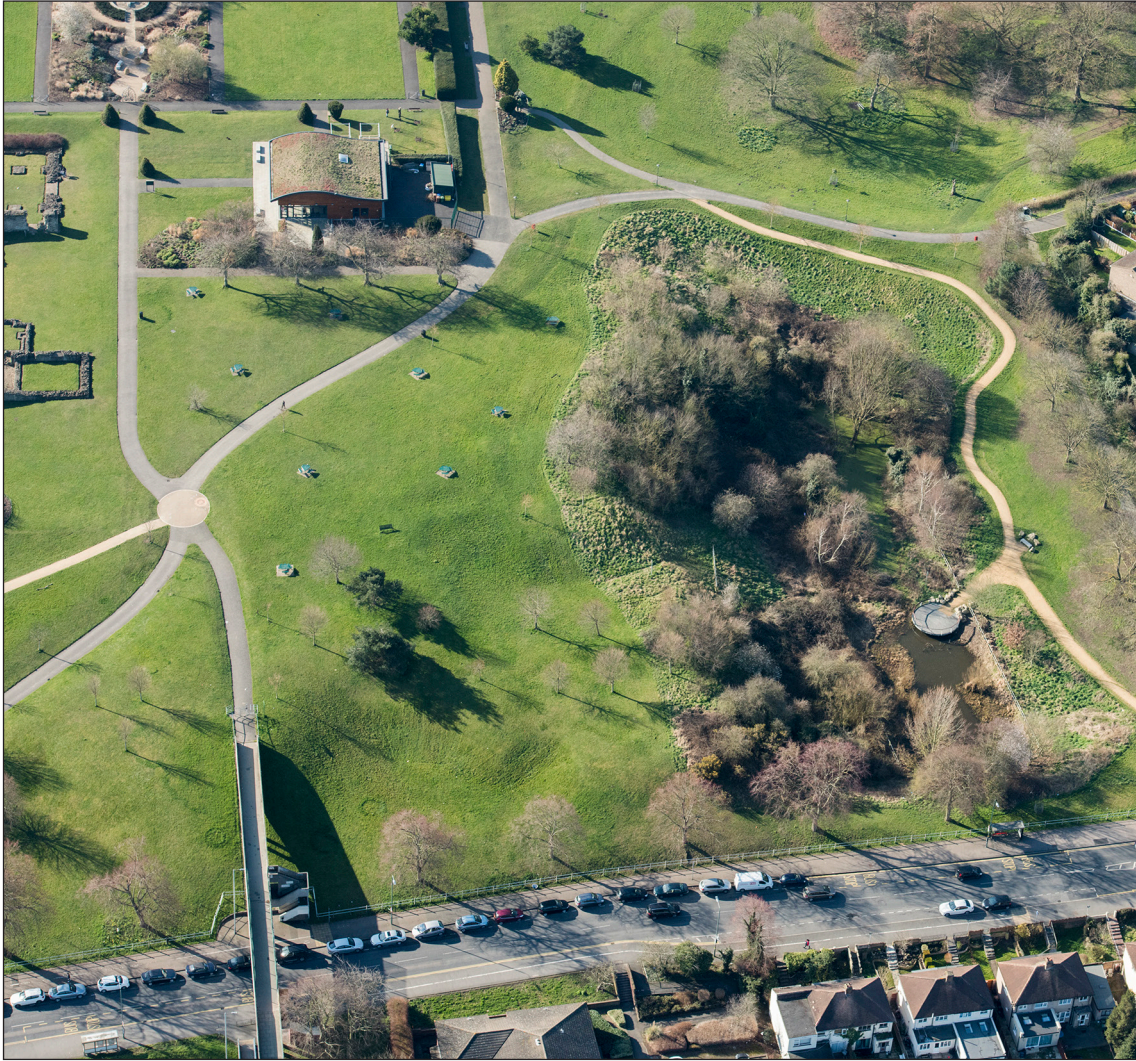
Figure 14: Survey Area 1 (looking south) located between the Dipping Ponds, visitor centre, footbridge and road (HEA 33454/009 26-MAR-2018) Image: Damian Grady © Historic England.

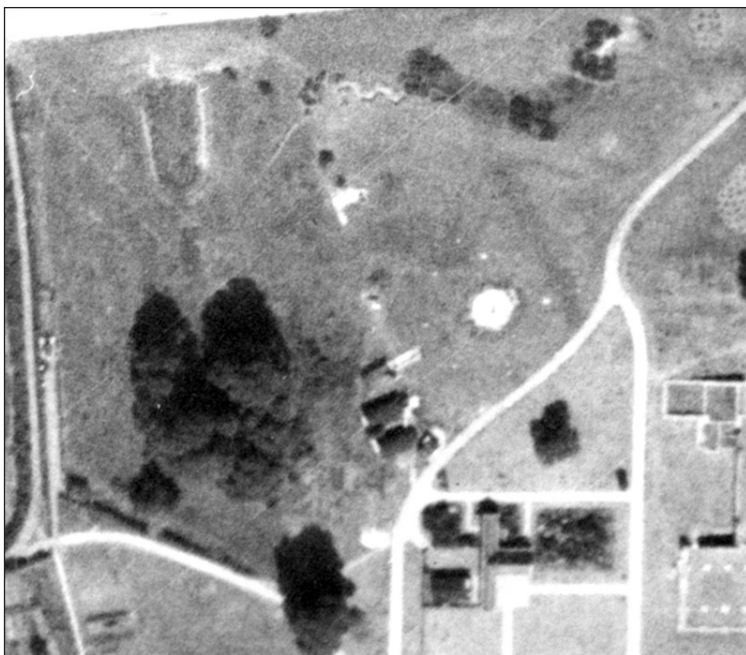
Figure 17: Detail from aerial photograph HEA RAF 106G/ LA31 3138 7-AUG-1944 showing a range of Second World War features including huts, a circular barrage balloon mooring position and a slit trench. Historic England Archive: RAF Photography.

These slight earthworks appear to mark the former positions of a group of four structures, apparently of military function, evident in 1940s aerial photographs, with one rectangular building set to the north of a row of three others (Fig 17). This row consisted of a pair of larger rectangular buildings with porches, both aligned on an ENE-WSW axis, with a smaller shed between them. Aerial photographs from 1946 show that the small shed was still extant, but the three larger buildings had been demolished (Fig 18).

From the aerial transcription, the northernmost building with a porch measured 10.1m by 5.2m, with the porch on its north-east gable measuring 3.1m by 1.5m, and the smaller rectangular shed approximately 2.7m by 3.7m. The southernmost rectangular building with a porch was slightly smaller, measuring 7.75m by 4.5m, with the porch on its north-east gable approximately 1.5m square. Beyond these three buildings to the north, the fourth structure measured 6m by 8.1m from the aerial photographic transcription. This structure was no longer visible on an aerial photograph from October 1945 (HEA RAF 106G/UK916 6151 11-OCT-1945).

To the east of these buildings, the aerial photographs from 1944 to 1946 (Figs 17 and 18) show the mooring points for a Second World War barrage balloon (Fig 13 [6]) to which the buildings are probably related. This consisted of a concrete base approximately 2.1m square, with two concentric rings of anchors, the inner ring of approximately 9m diameter with eight tethering points, and the outer ring 30m in diameter with seven tethering points. No clear evidence for this barrage balloon site was noted during the ground survey. The area of the barrage balloon mooring has some extremely slight, incoherent earthworks, but also a long low mound (Fig 13 [7]) measuring 13.4m by 5.7m, aligned approximately north-south, and a shallow scoop (Fig 13 [8]) approximately 9.7m by 4.9m. There is no obvious function for these two earthworks as part of the balloon mooring, although they can be seen in the 1946 aerial photographs (Fig 18) with an anchoring point on the long low mound, so they appear to predate the Second World War. As the name suggests the balloon moored here would have been one of a 'barrage' forcing enemy planes to fly higher. Other mooring positions can be seen on the 1944 aerial photographs including one in the far eastern corner of the abbey grounds on the recreation ground at NGR TQ 4826 7889 (HEA RAF 106G/LA30 3138 07-AUG-1944).

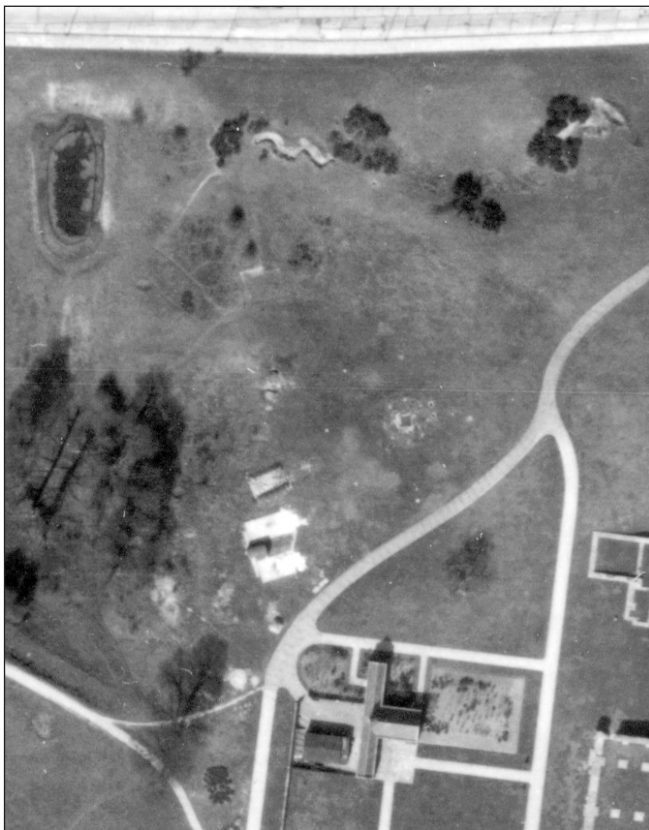
Figure 18: A detail from a 1946 aerial photograph showing the remaining huts, slit trench and barrage balloon mooring point (HEA RAF 106G/UK1356 5018 02-APR-1946). Historic England Archive: RAF Photography..

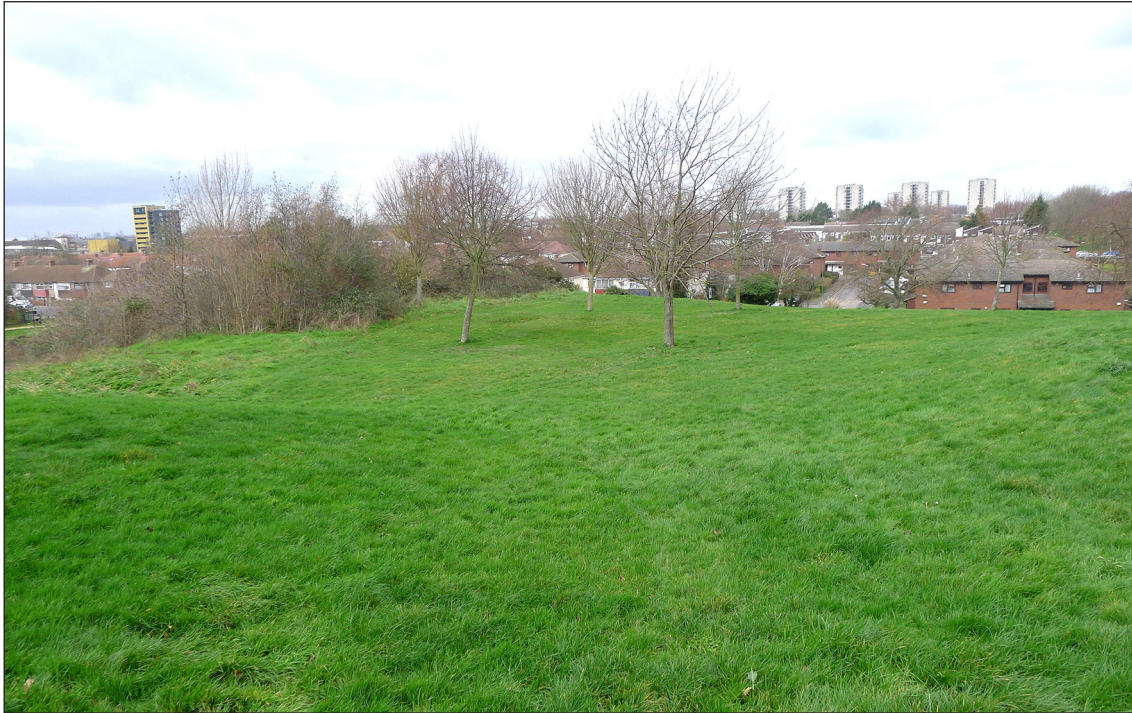
Figure 19: The gully leading down into the Dipping Ponds (located beyond the left-hand side of the image), looking north-west. © Historic England (14-JAN-2019).

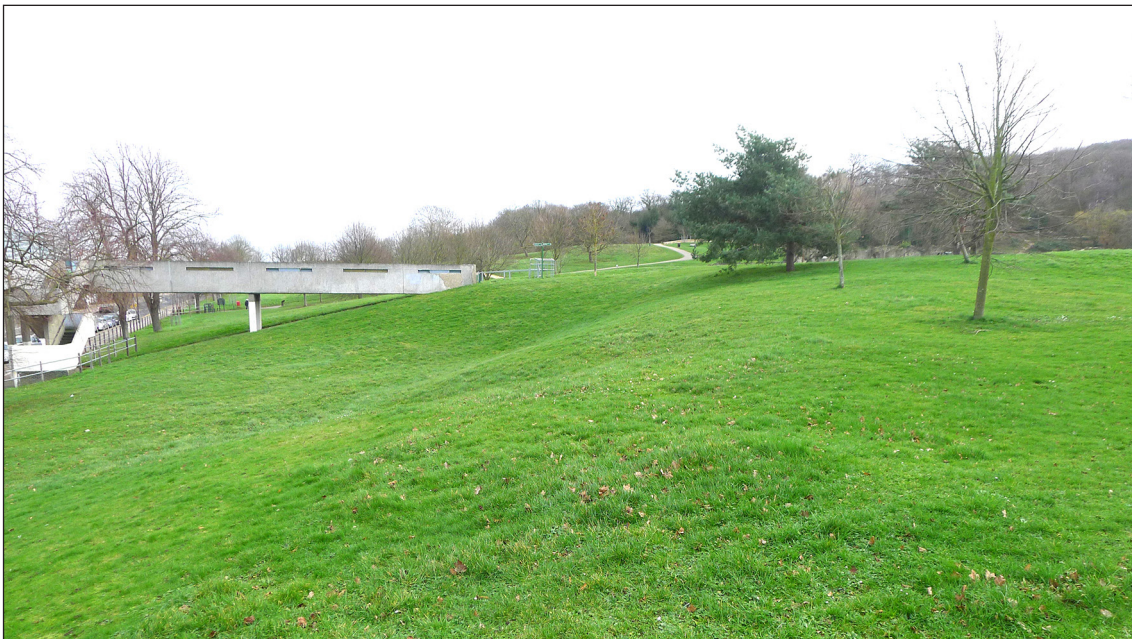
Figure 20: The probable quarry scoop in the north-facing slope adjacent to Abbey Road, looking east. © Historic England (14-JAN-2019).

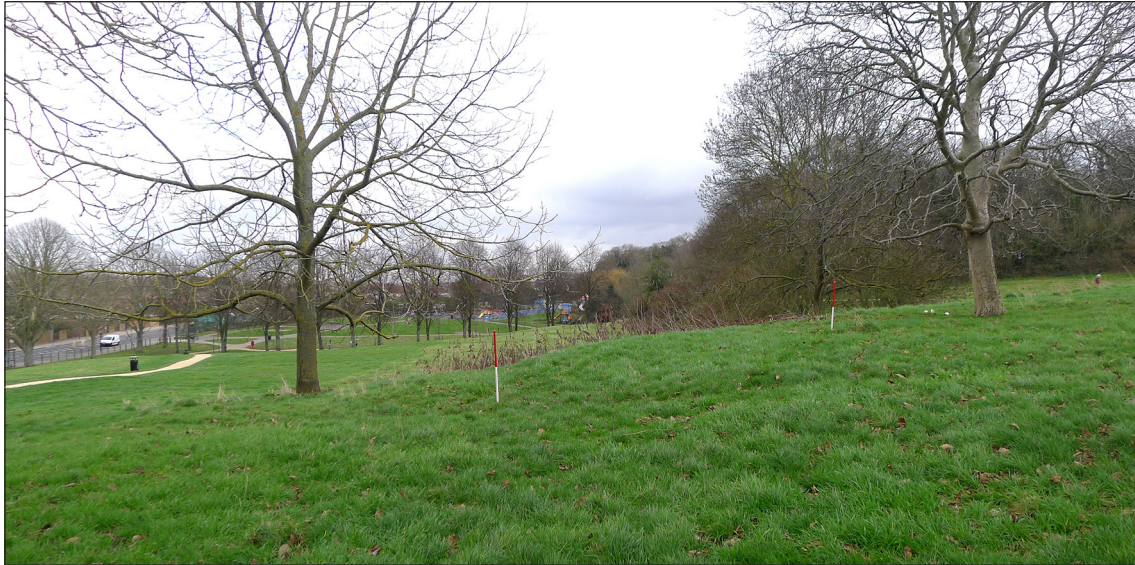
Figure 24: The platform which may represent the former site of the dovehouse shown on the Daynes plan of 1655, looking east. © Historic England (14-JAN-2019).

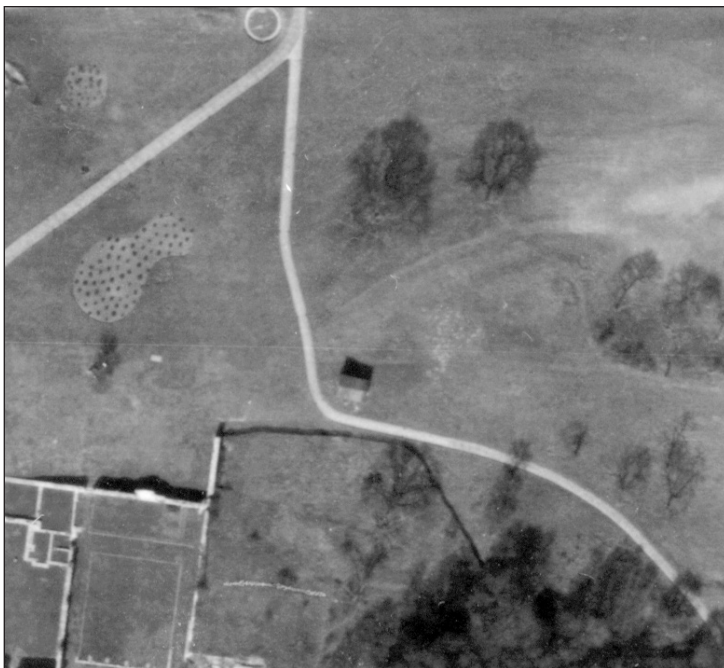
Figure 25: Detail of aerial photograph HEA RAF 106G/UK1356 5018 (2-APR-1946) showing Elliston-Erwood's site hut in the centre of the photograph. Historic England RAF Photography.

The site of the shed used during Elliston-Erwood's excavations was plotted from aerial photographs (Fig 21 [6]). It measured 6.1m by 5m, and is evident in aerial photographs between 1944 and 1955, but was probably removed shortly after excavations finished in 1960 (Fig 25). There was no evidence for this structure from field survey. To the east of the shed site was a scarp, approximately 12m long, cut into the slope (Fig 21 [7]). There is no obvious interpretation for this feature, but it may be associated with activities surrounding the shed.

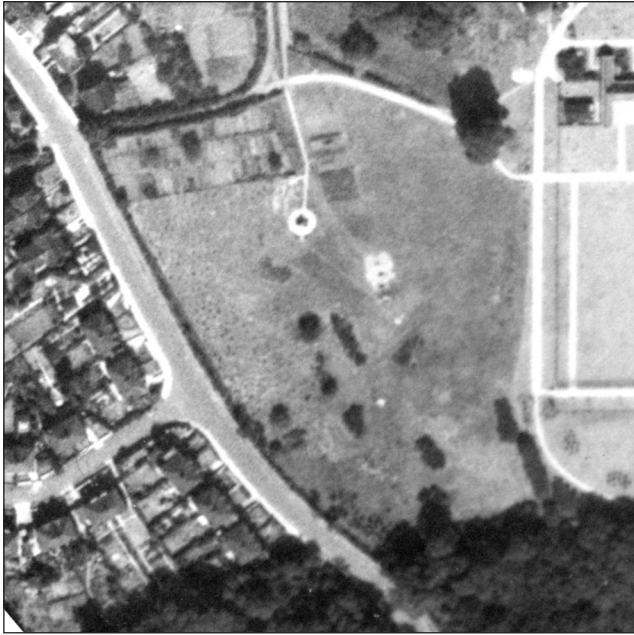
Figure 27: Detail of aerial photograph HEA RAF 106G/LA31 3138 (07-AUG-1944) showing the allotments in the north-west corner of Survey Area 3 and the temporary searchlight battery. Historic England: RAF Photography.

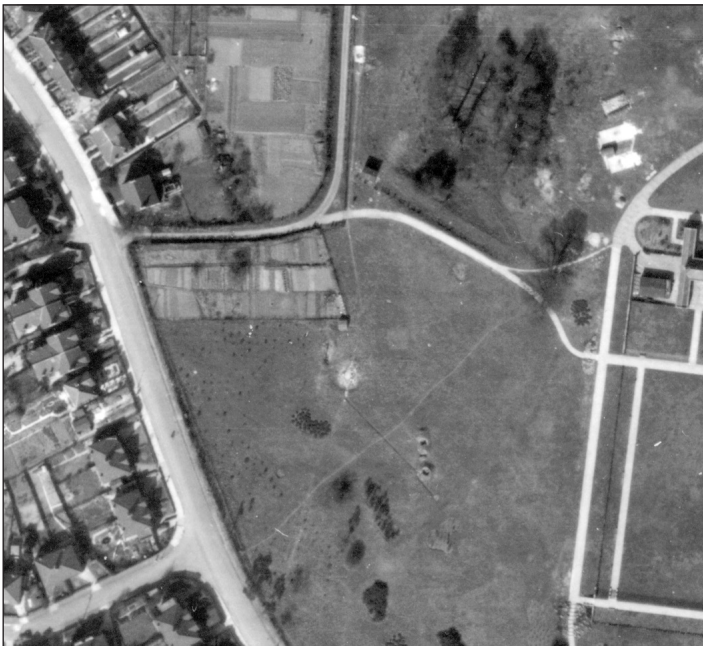
Figure 28: Detail from aerial photograph HEA RAF 106G/UK1356 5018 (02-APR-1946) showing the allotments, possible associated shed and the Second World War temporary searchlight battery. Historic England Archive: RAF Photography.

To the south of these scarps, and outside the former area of allotments, is a sub-circular shallow hollow (Fig 26 [3]). It is approximately 3.2m across, and coincides with the position of a small square shed as transcribed from the aerial photographs. The shed may have been associated with the allotments, though it was located outside the allotment boundary and could equally have been associated with the temporary searchlight (see below). This shed is evident in the 1946 aerial photographs (Fig 28), but is not visible in the 1955 aerial photographs.

The temporary searchlight battery consisted of what appears, from the aerial photographs, to be a sub-circular platform or hard standing approximately 9.7m across (Fig 26 [6]). On several of the photographs, a black dot can be seen in the middle of this platform, which may have been the mounting for the searchlight. A tree was later planted in the centre of this platform, possibly as a deliberate attempt to re-landscape the site. To the north-west of this platform, a slightly curved feature measuring approximately 7m long, and aligned roughly north-south, can be seen (Fig 26 [5]). This was possibly a temporary embankment, which could have been constructed of sandbags, to provide some sort of screening from the road.

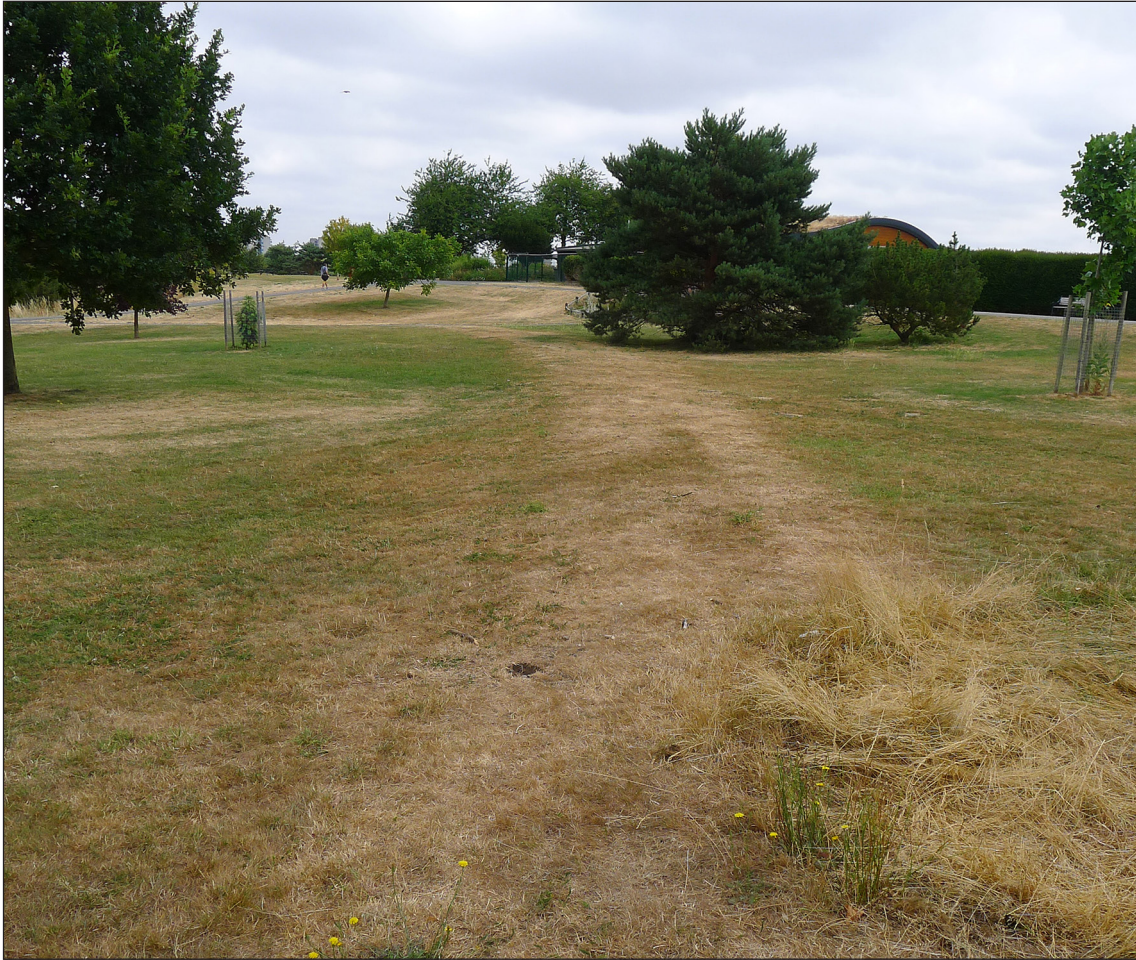
Figure 30: The raised trackway to the farm, looking north-east, visible as a clear parchmark in the very dry summer of 2018. © Historic England (11-JUL-2018).

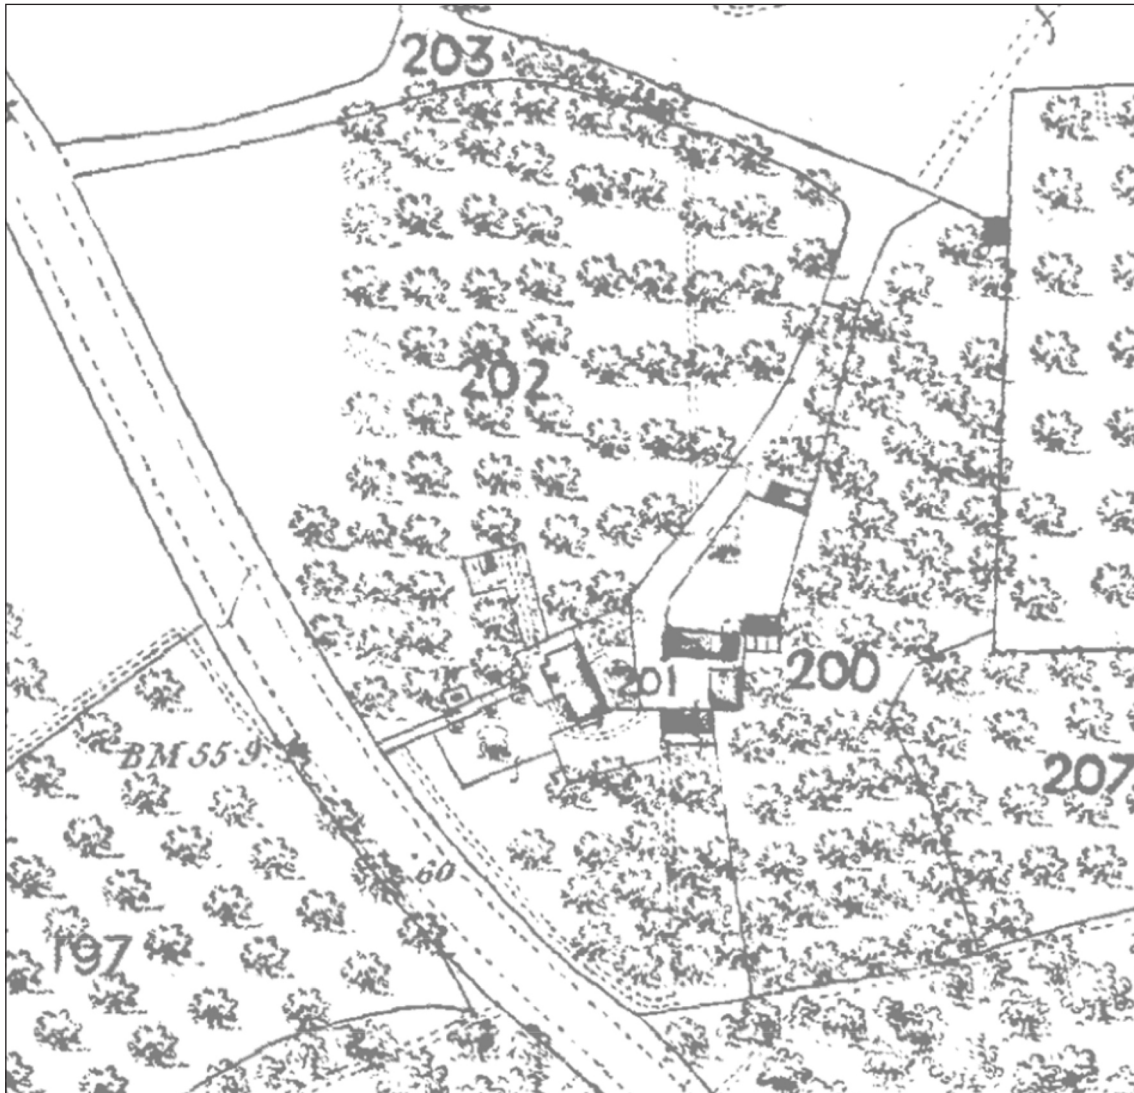
Figure 31: A detail from the 1st edition Ordnance Survey 25 inch map of Kent (II.12), surveyed 1862-63 and published 1865, showing the farm buildings and yards. © and database right Crown Copyright and Landmark Information Group Ltd (All rights reserved 2019) Licence numbers 000394 and TP0024. Not to scale.

The raised track (Fig 26 [12]) formed the west side of a narrow triangular yard, first noted as a 'Barn yard' on the Daynes plan (Fig 4). The Ordnance Survey 1st edition 6- inch map shows this yard had been divided into two enclosures with a small building between them (Figs 29 & 31), although this had been demolished by the time the 1890s Ordnance Survey maps were surveyed. A slight west-facing scarp (Fig 26 [15]), approximately 25m long and oriented NNE, was noted during field survey and may have defined the east side of this yard. The scarp to the east (Fig 26 [14]) that defines the edge of the north-south path has been created by modern landscaping.

The scarp described above (Fig 26 [16]) is oriented more to the south-east than the outline of the 'Barn yard' as indicated on various Ordnance Survey editions, which also show that the 'Barn yard' was defined to the south by a rectangular building approximately 13m by 7m, aligned east-west (Figs 29 and 31). This may be what

Two structures to the south of the potential barn were recorded on all 19th-century Ordnance Survey editions, but there was no evidence for them during field survey (Figs 29 and 31). Only one structure remained in this area on the 1909 3rd Edition 25-inch map (Fig 32), although it had been removed by the 1937 edition. The north-south scarp to the south of this building appears to terminate where the building was located (Fig 26 [23]).

Two parallel scarps 3.5m apart (Fig 26 [29]), running for 25m on a roughly south-east to north-west alignment, define a terrace which may represent a track from Orchard Cottage to Knee Hill Lane, possibly the one shown on the 1st edition 25-inch Ordnance Survey map (Fig 31), though this appears to be further north. These scarps are substantial features but it should be noted that they were recorded in an area of thick brambles and may not have been surveyed to the same level of accuracy as other features.

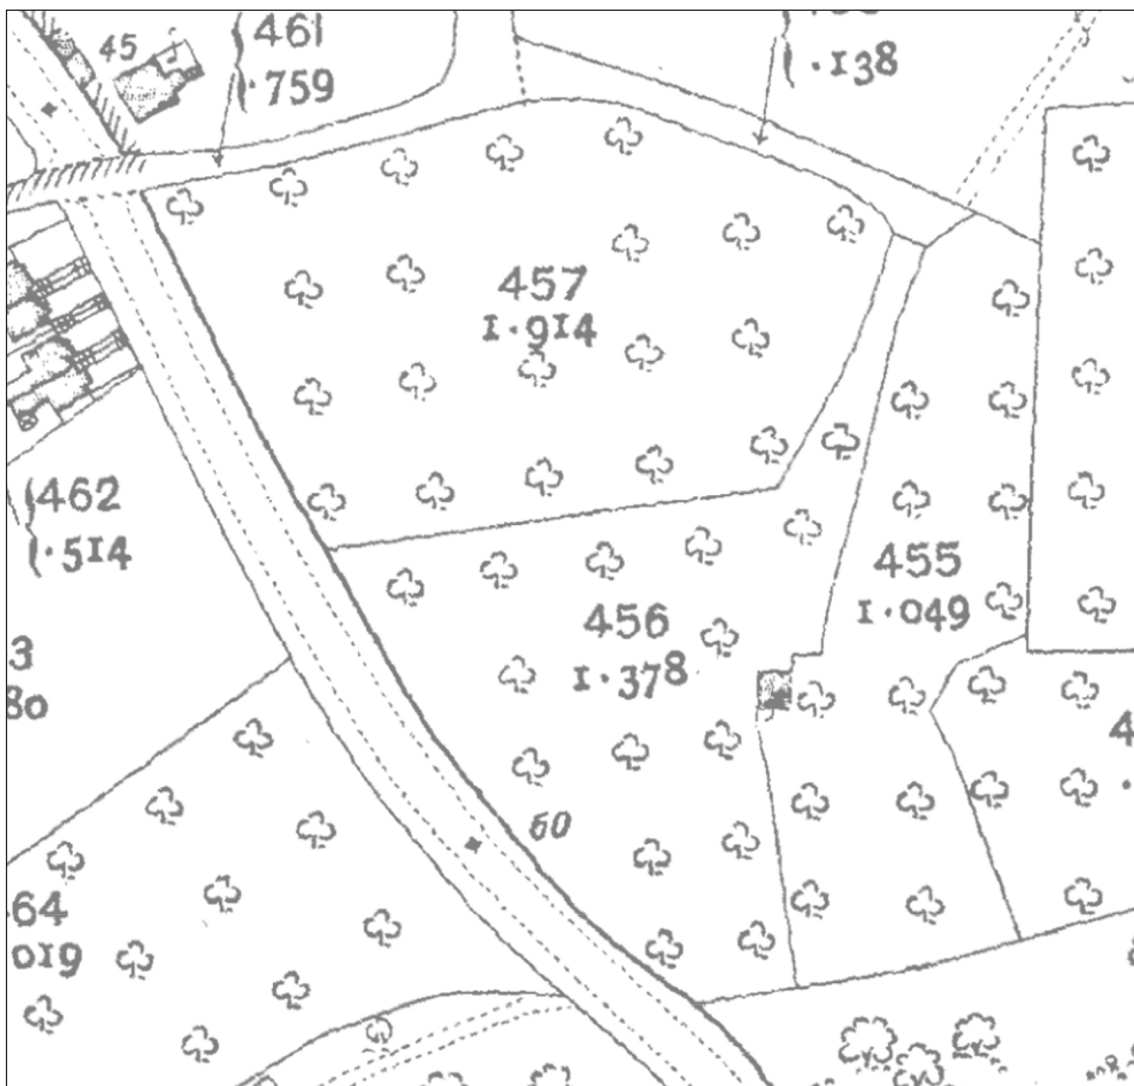
Figure 32: Only one building remained on the farm site by 1908 when the revisions were undertaken for the Ordnance Survey 3rd edition 25 inch map published in 1909. © and database right Crown Copyright and Landmark Information Group Ltd (All rights reserved 2019) Licence numbers 000394 and TP0024. Not to scale.

A north-facing scarp (Fig 26 [32]), located between the site of Orchard Cottage and the allotments, to the north of a steep north-facing slope, may align with a new field boundary evident on the 3rd edition 1909 25-inch Ordnance Survey map, which has since been removed (Fig 32).

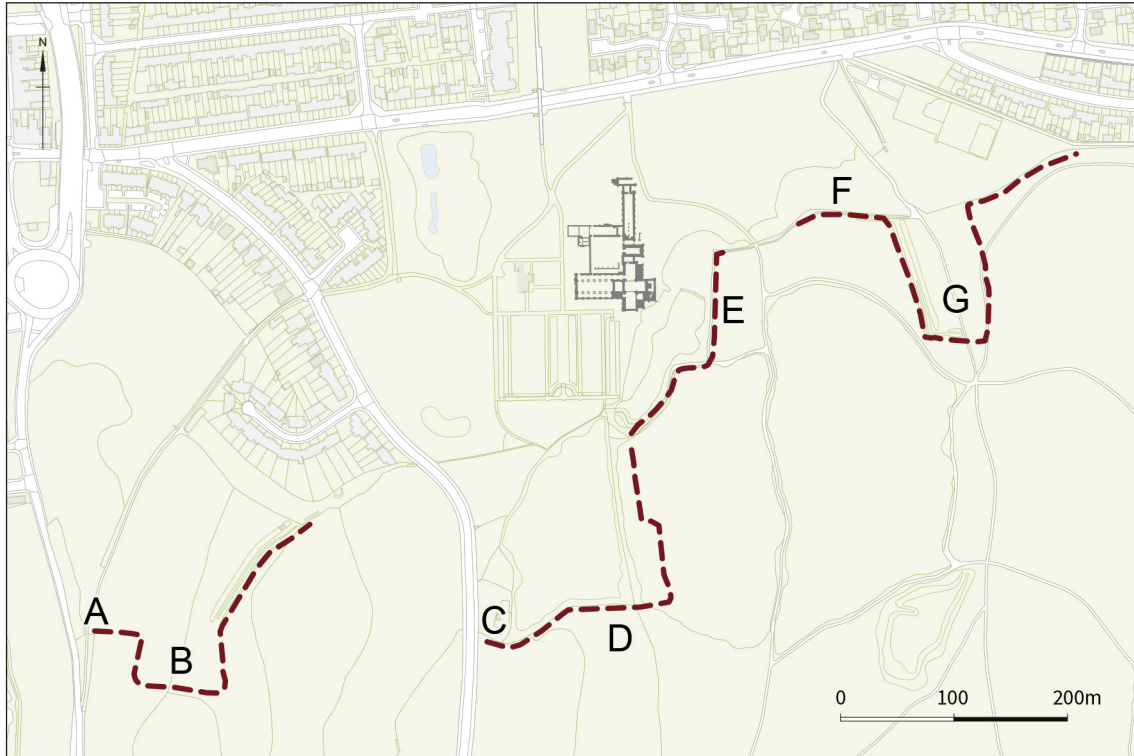
Figure 33: The location of banks and ditches to the south of the abbey as recorded from Lidar at 1:2500 scale. The letters refer to features mentioned in this section of the text. Image: Sharon Soutar. © Crown Copyright and database right 2019. All rights reserved. Ordnance Survey Licence number 100024900.

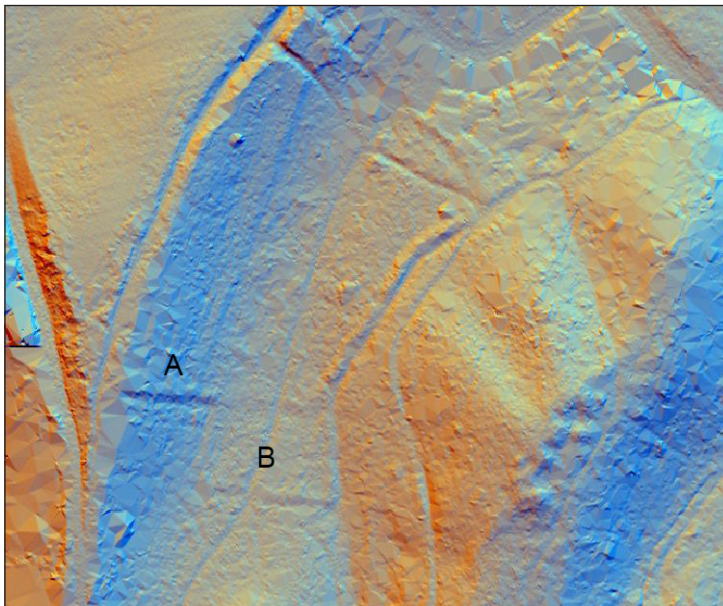
Figure 34: Lidar imagery showing the most-westerly stretch of bank and ditch boundary between Knee Hill Lane to the west and New Road to the east (A and B on Fig 33). Digital Terrain Model 16D Environment Agency Open Access 50cm composite Lidar TQ4778. © Environment Agency copyright and/or database right 2019. All rights reserved.

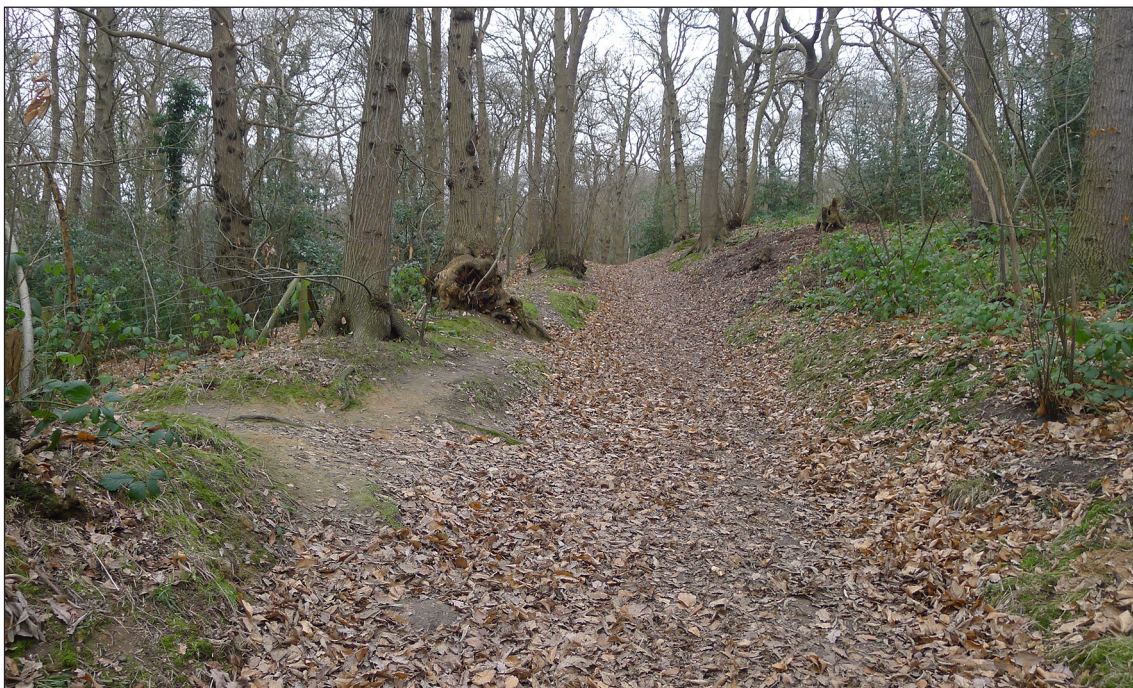
Figure 35: The view looking east along the stretch of bank and ditch boundary as it runs east from New Road ([D] on Fig 33). The bank is to the left (north) and the ditch is to the right (south) and contains the modern footpath. © Historic England (14-JAN-2019)..

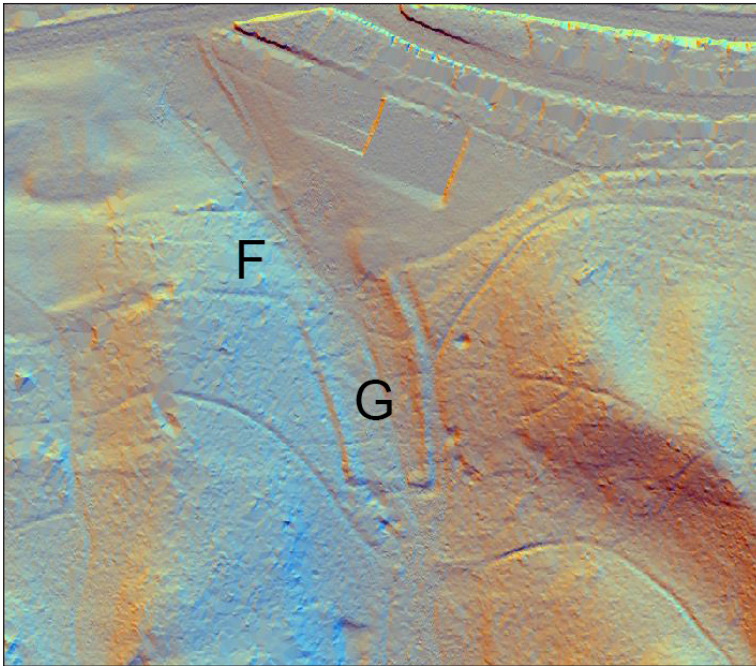
Figure 36: Lidar imagery showing the stretch of boundary bank and ditch to the east of the abbey ruins ([F] and [G] on Fig 33). The earthworks may have been intended to enclose or define the level ground in the valley bottom. Digital Terrain Model 16D Environment Agency Open Access 50cm composite Lidar TQ4878. © Environment Agency copyright and/or database right 2019. All rights reserved.

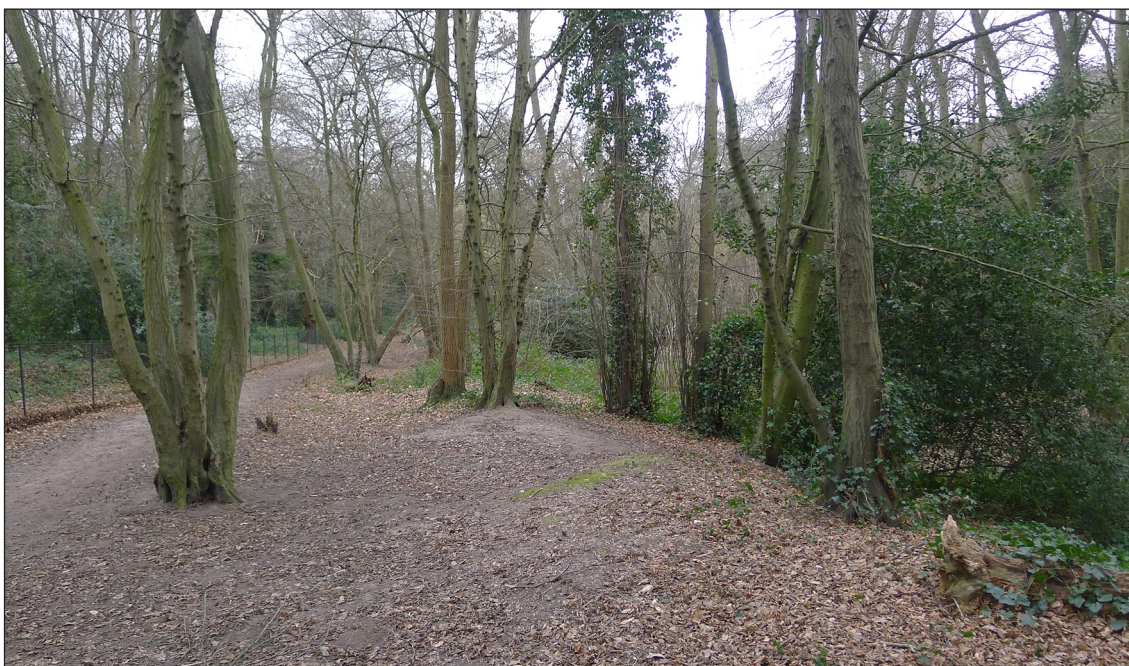
Figure 37: The much eroded bank on the eastern side of the enclosed level ground at the eastern side of the modern abbey site, looking south from NGR TQ 4823 7882 ([G] on Fig 33). © Historic England (14-JAN-2019).

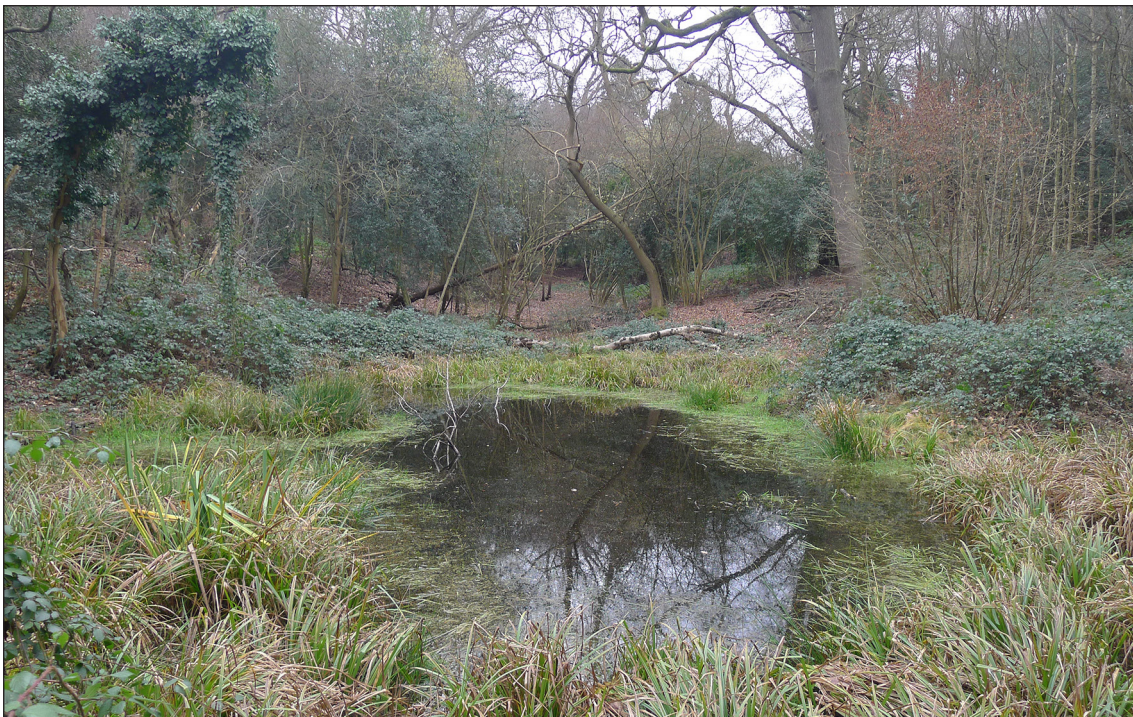
Figure 38: Conduit Pond, the possible water supply for the abbey, located in the woodland to the south of the ruins, looking south from NGR TQ 4794 7831. © Historic England (14-JAN-2019).

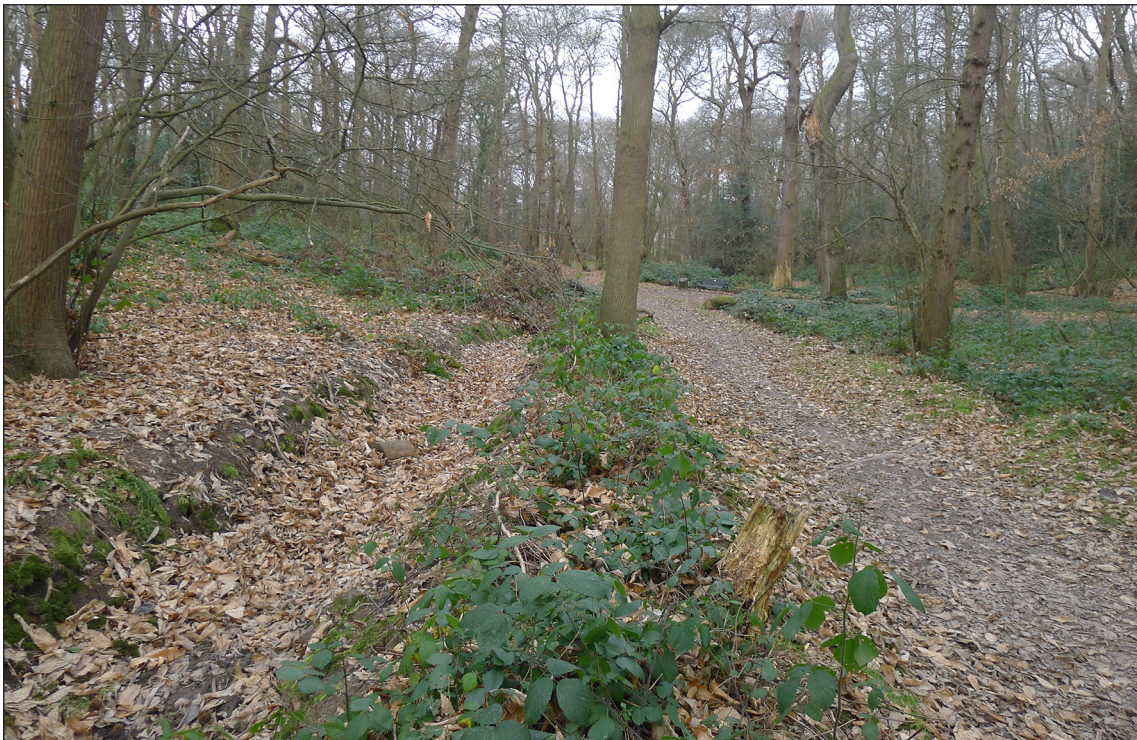
Figure 39: The narrow recut leat leading north from the Conduit Pond to the abbey ruins can be seen in this photograph to the west (left) of the footpath. View looking north. © Historic England (14-JAN-2019).

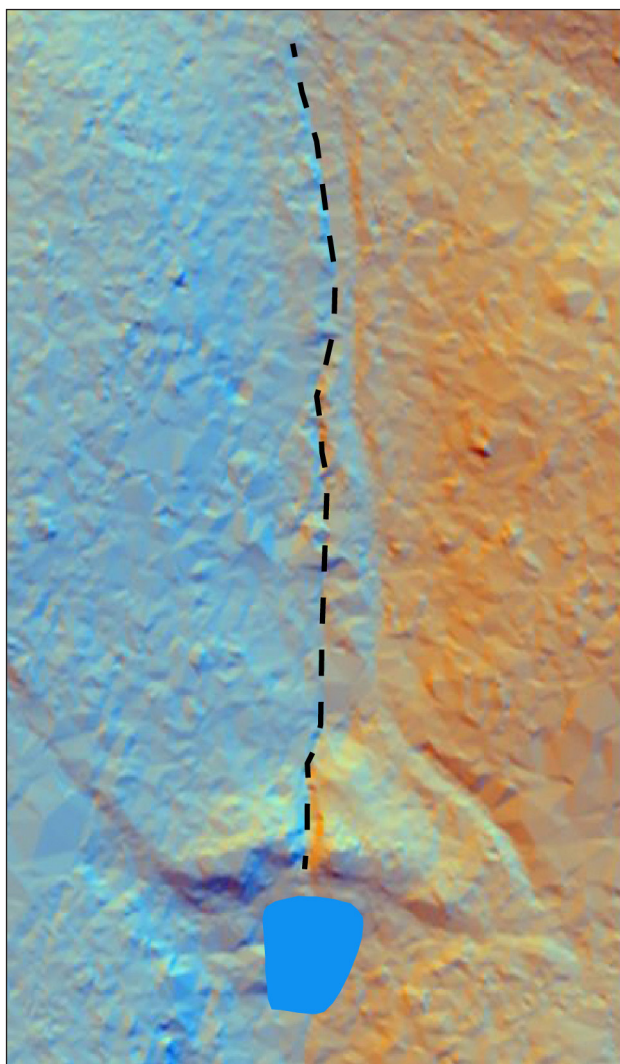
Figure 40: Lidar imagery showing the substantial dam to the north of Conduit Pond and the narrow channel running northwards parallel to the footpath. Digital Terrain Model 16D Environment Agency Open Access 50cm composite Lidar TQ4778 © Environment Agency copyright and/or database right 2019. All rights reserved.
