# Lesnes Abbey, Bexley, Greater London: An Archaeological Survey of Selected Areas of the Abbey Grounds

Lawrence Rees

NGR: TQ 4790 7881

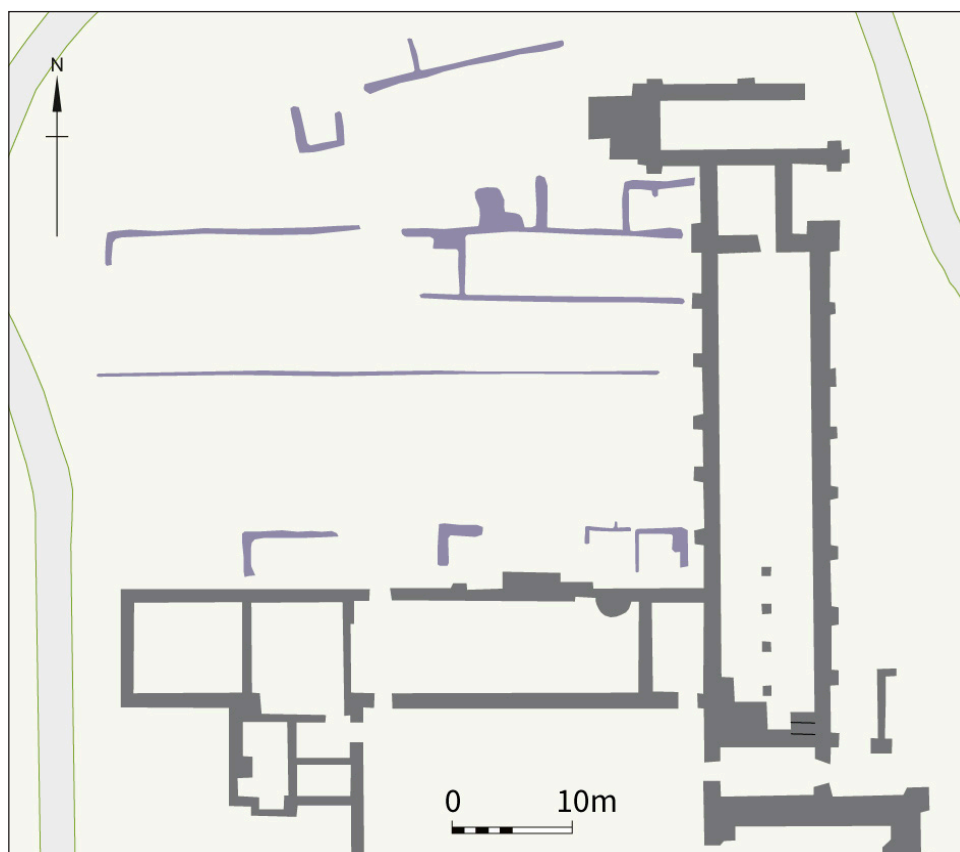
Figure 41: The buried foundations of the range of buildings that included Abbey Farm and possibly elements of the abbot's lodging (purple) as recorded from parchmarks on aerial photographs NB the evidence for a possible range of buildings on a different alignment to the north of the main group. Image: Sharon Soutar. © Crown Copyright and database right 2019. All rights reserved. Ordnance Survey Licence number100024900.

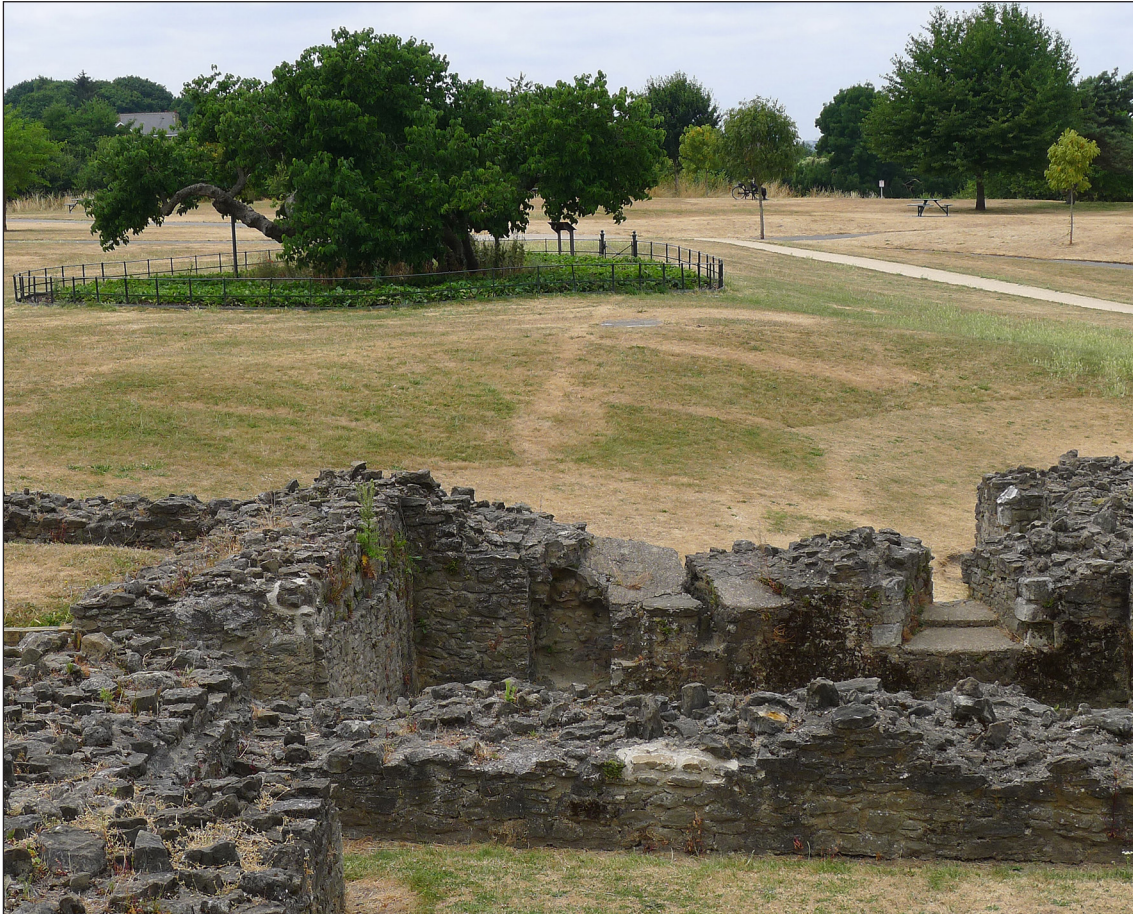
Figure 42: The foundations of Abbey Farm and possibly elements of the abbot's lodging visible as parchmarks where the grass has died over buried wall foundations in extreme drought conditions, looking west from NGR TQ 4792 7886. 11-JUL-2018. © Historic England (11-JUL-2018).

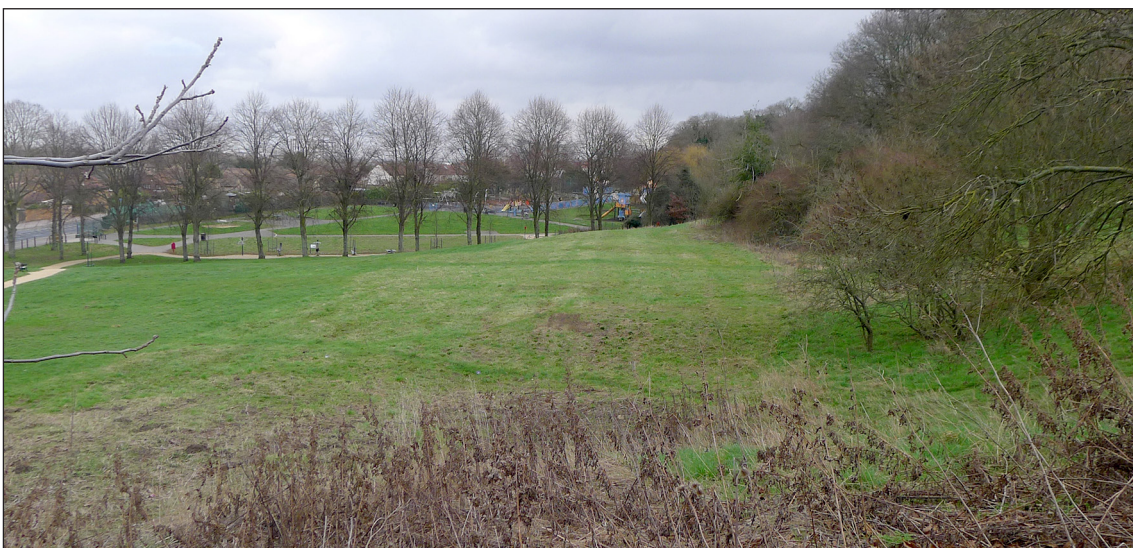
Figure 43: The former site of the threshing barn, visible as a large earthwork platform, looking east. © Historic England (14-JAN-2019).

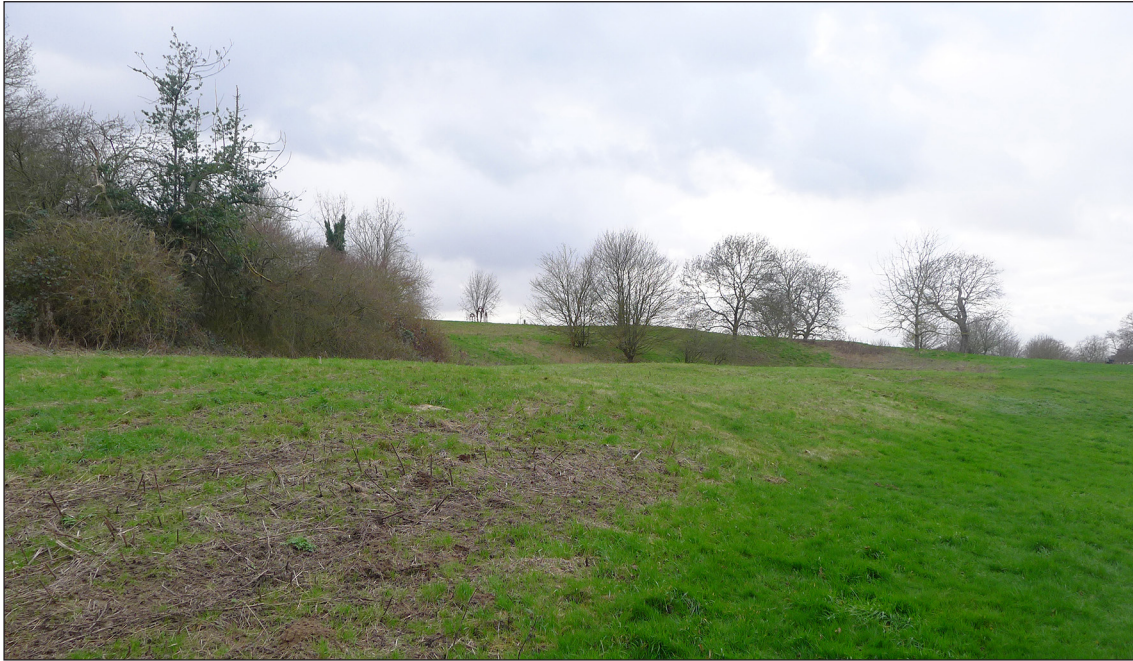
Figure 44: The barn platform looking south-west, showing how the building was sheltered by the hillslope to the south. © Historic England (14-JAN-2019).

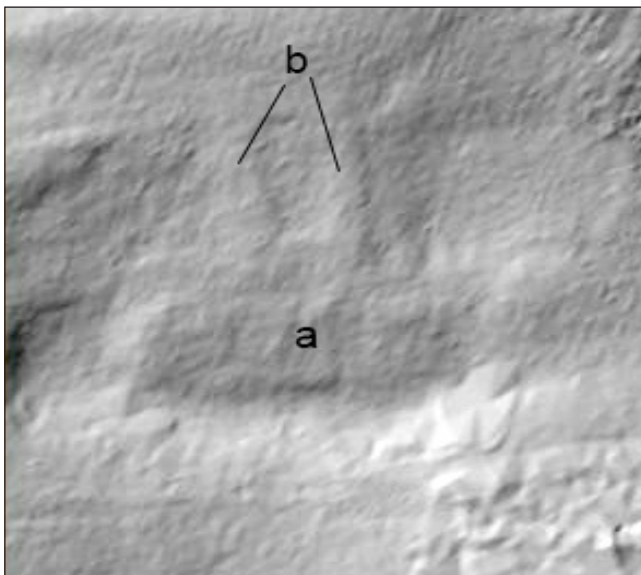
Figure 46: Lidar imagery showing the earthwork remains of the barn platform (a) and the raised trackways that led to the forecourt and entrance (b). North is to the top of the image. Digital Terrain Model 16D Environment Agency Open Access 50cm composite Lidar TQ4878. © Environment Agency copyright and/or database right 2019. All rights reserved.

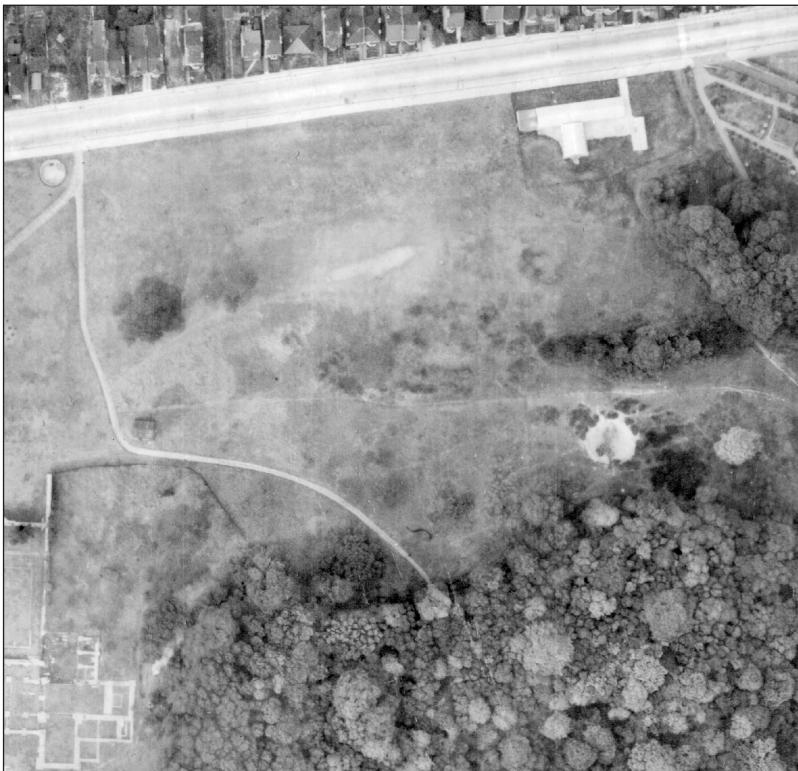
Figure 47: The circular hollow, thought to be a Second World War bomb crater, visible to the north-east of the abbey church on an aerial photograph taken in 1945 (centre-right on image). A probable circular Second World War reservoir can be seen in the top left-hand corner of the image just to the south of Abbey Road (HEA RAF 106G/UK/916 6151 11-OCT-1945). Historic England Archive RAF Photography.

To the east of the abbey grounds, south of the barn site at NGR TQ 48079 78857, a neat circular hollow, just over 14m in diameter is visible on aerial photographs from 1944 into the 1950s (Fig 47). The white appearance of the hollow suggests bare, unvegetated ground and, given that it is not recorded on any of the earlier Ordnance Survey maps, suggests that the feature was probably a Second World War bomb crater or another type of modern feature. The hollow is not visible on lidar and was not located on the ground.

A probable Second World War circular concrete reservoir, which no longer survives, is also visible on aerial photographs from 1944 and 1945 at NGR TQ 47914 78936, just to the south of Abbey Road (Fig 47). The structure appears to be covered or disguised in photographs from 1944 (e.g. HEA RAF 106/G/LA30 3137 07-AUG-1944) but it is clearly visible on the 1945 photographs. The reservoir was just over 8m in diameter and may have served as an emergency water supply in the event of a fire for the barrage balloon mooring site and searchlight/gun emplacement located to the south within the abbey grounds.
