Historic England

Farmstead and Landscape Statement

Mid Northumberland

NATIONAL CHARACTER AREA 12

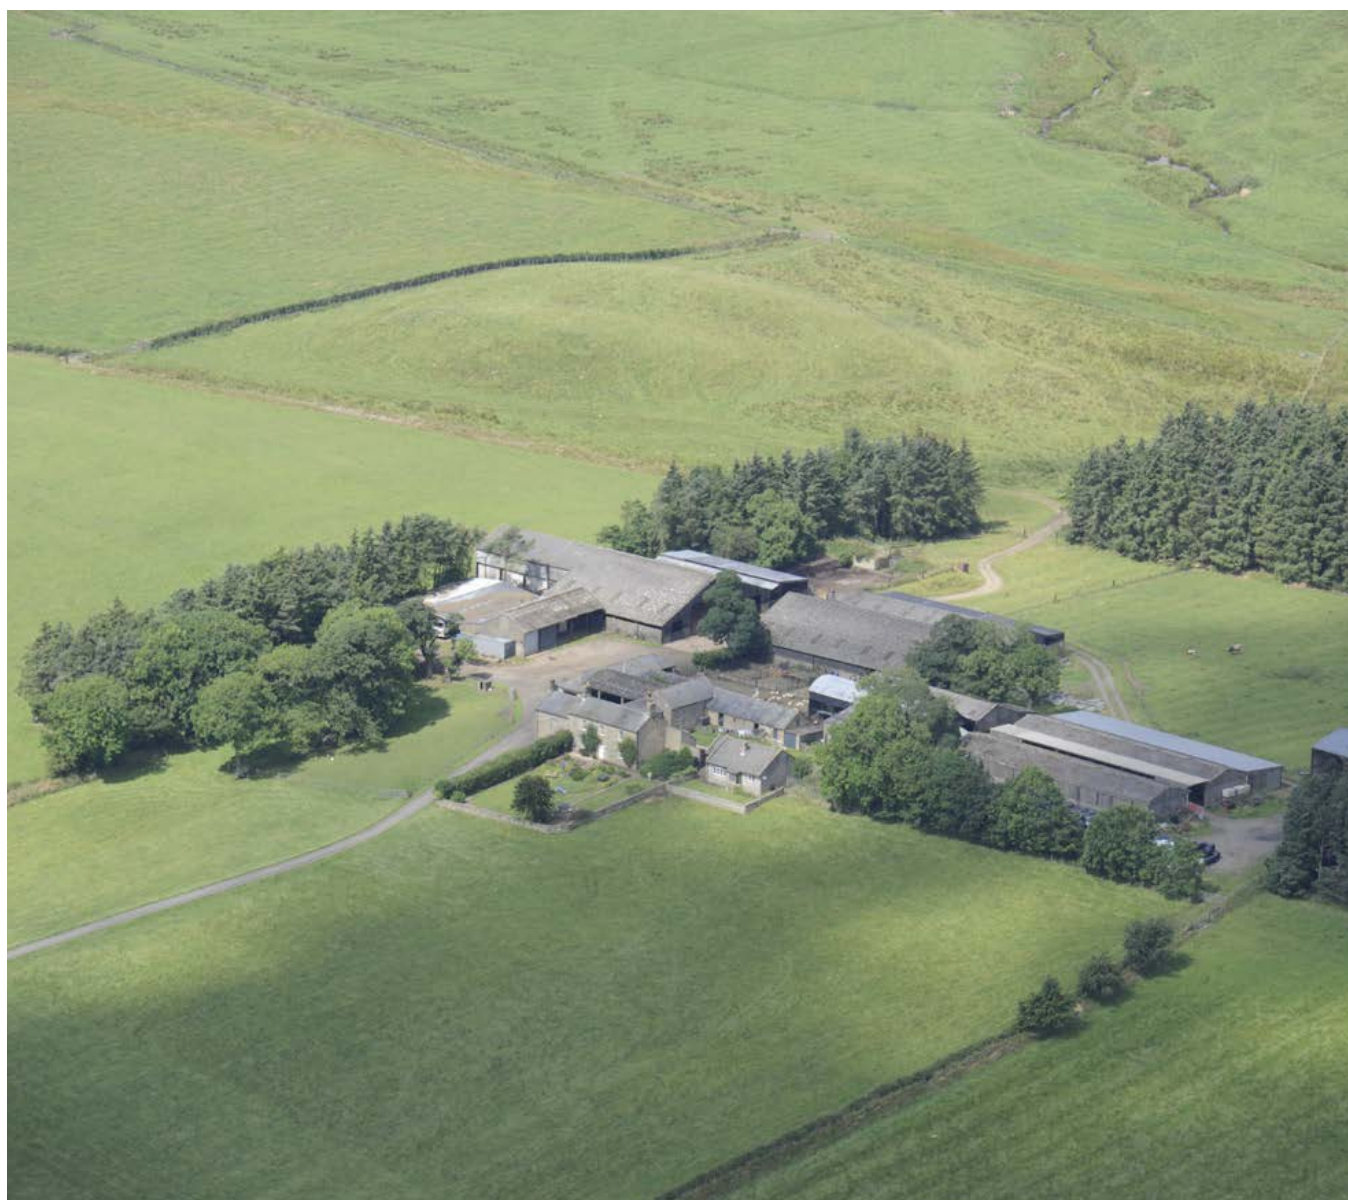
Front cover: Fairnley Farm, Rothbury, a planned farmstead set in regular enclosures. It is one of the earliest examples of a farmstead built to a design by Daniel Garrett, in 1764, with additions of 1840. Photo © Historic England 28562/001

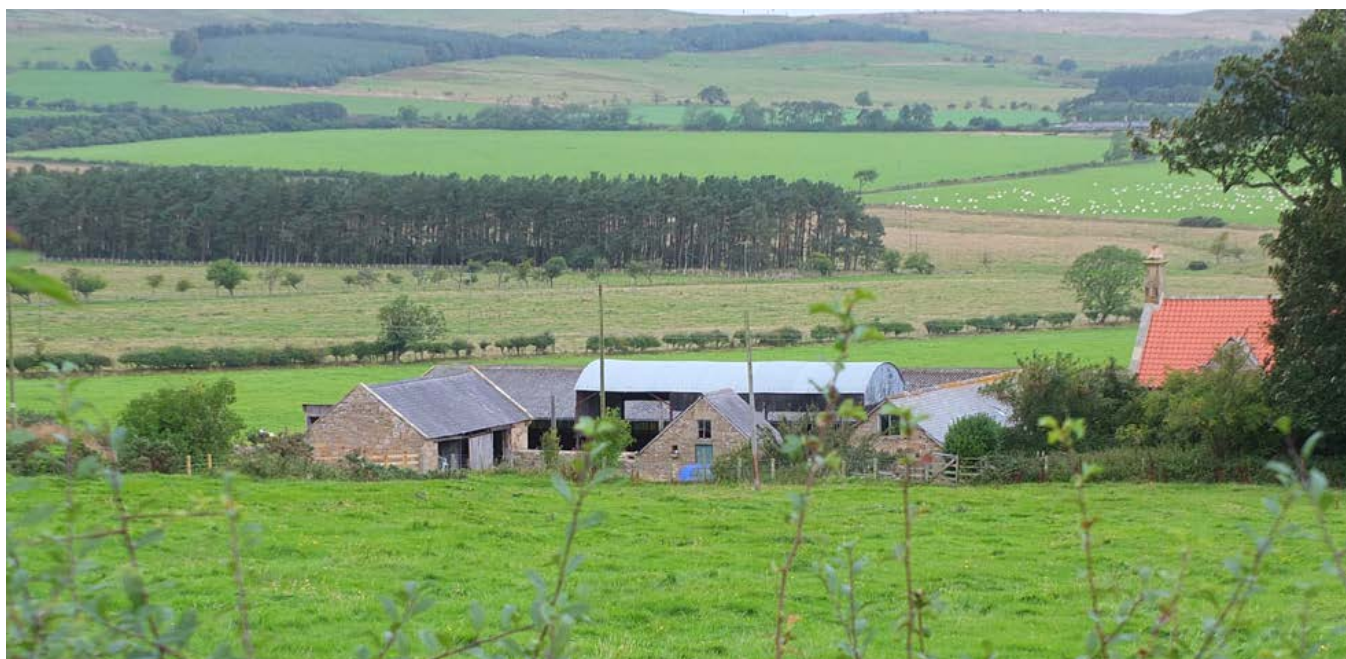
Small, isolated farmstead in an area of dispersed settlement south of Alnwick in the north of the area. The moors and Rothbury Forest are visible to the west. Scattered areas of conifer cover are found throughout. Not unusually for the area, the farmhouse was originally a bastle house of 16th-century origin, altered and adapted in the 18th and 19th centuries. The U-shaped yard to the rear is of the latter period. Photo © Jen Deadman

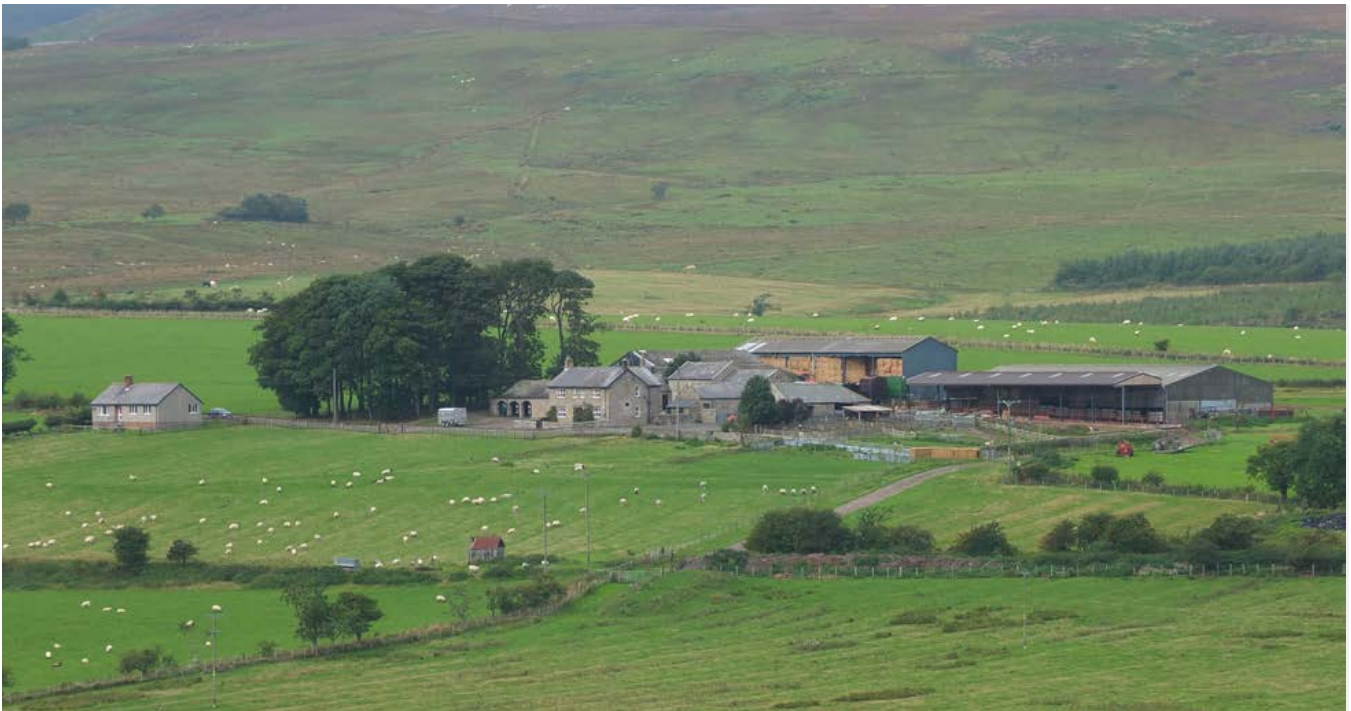
Ridge and furrow is widespread, particularly around isolated steadings with evidence for continuity of occupation since medieval times. This 19th-century farmhouse with its huddle of courtyard buildings is set in a landscape evidencing much earlier occupation. Photo © Jen Deadman

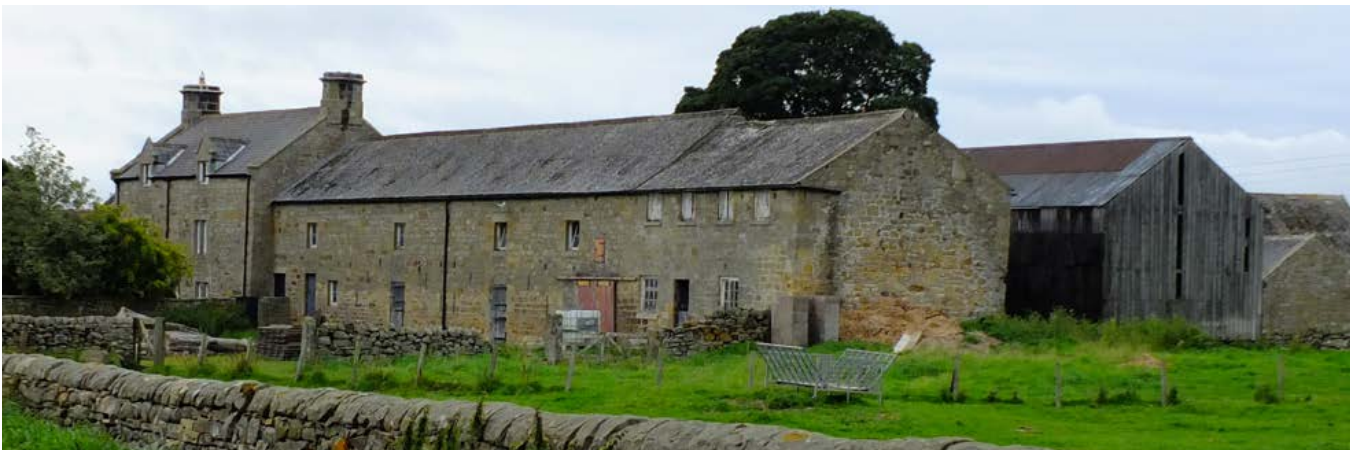
The present farmhouse and buildings across the road at West Fenwick replaced the bastle in the 18th- to early 19th centuries. The long front range is comprised primarily of byres for cattle with a full-length loft over, stabling and a granary. To the front is a walled enclosure, to the rear a yard with a loose arrangement of ancillary buildings, one of which is a small single-storey structure with crucks, latterly used as a cow house. Photo © Jen Deadman

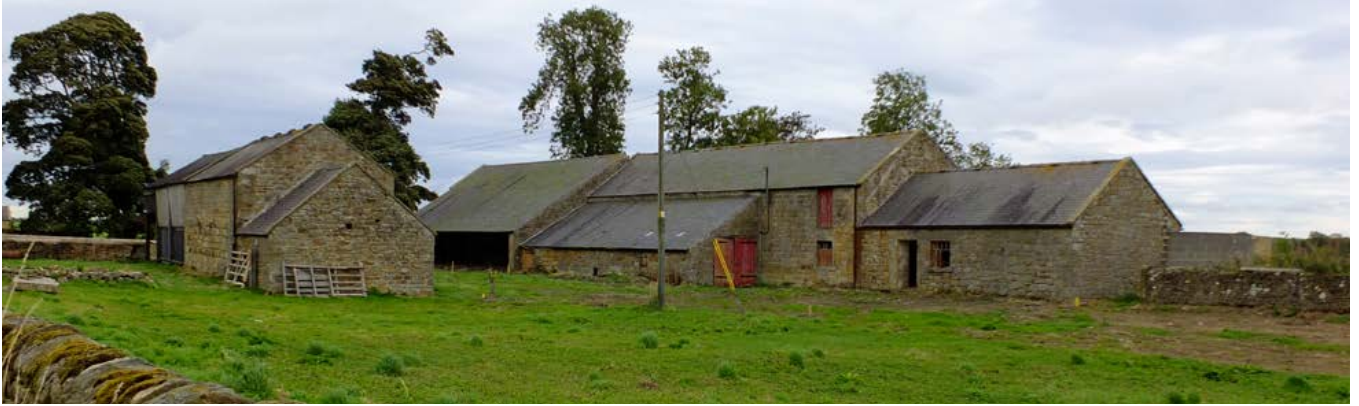
The former bastle of West Fenwick is now incorporated into a range of farm buildings. The bastle, of late 16th- or early 17th-century date (and marked in the photograph by the lean-to), was altered and extended in the late 18th or early 19th century to function as a combination barn with further buildings added to either end. The gable wall at the east end is over a metre wide and contains the original ground floor entry into the byre, above which would have been the living accommodation. Photo © Jen Deadman

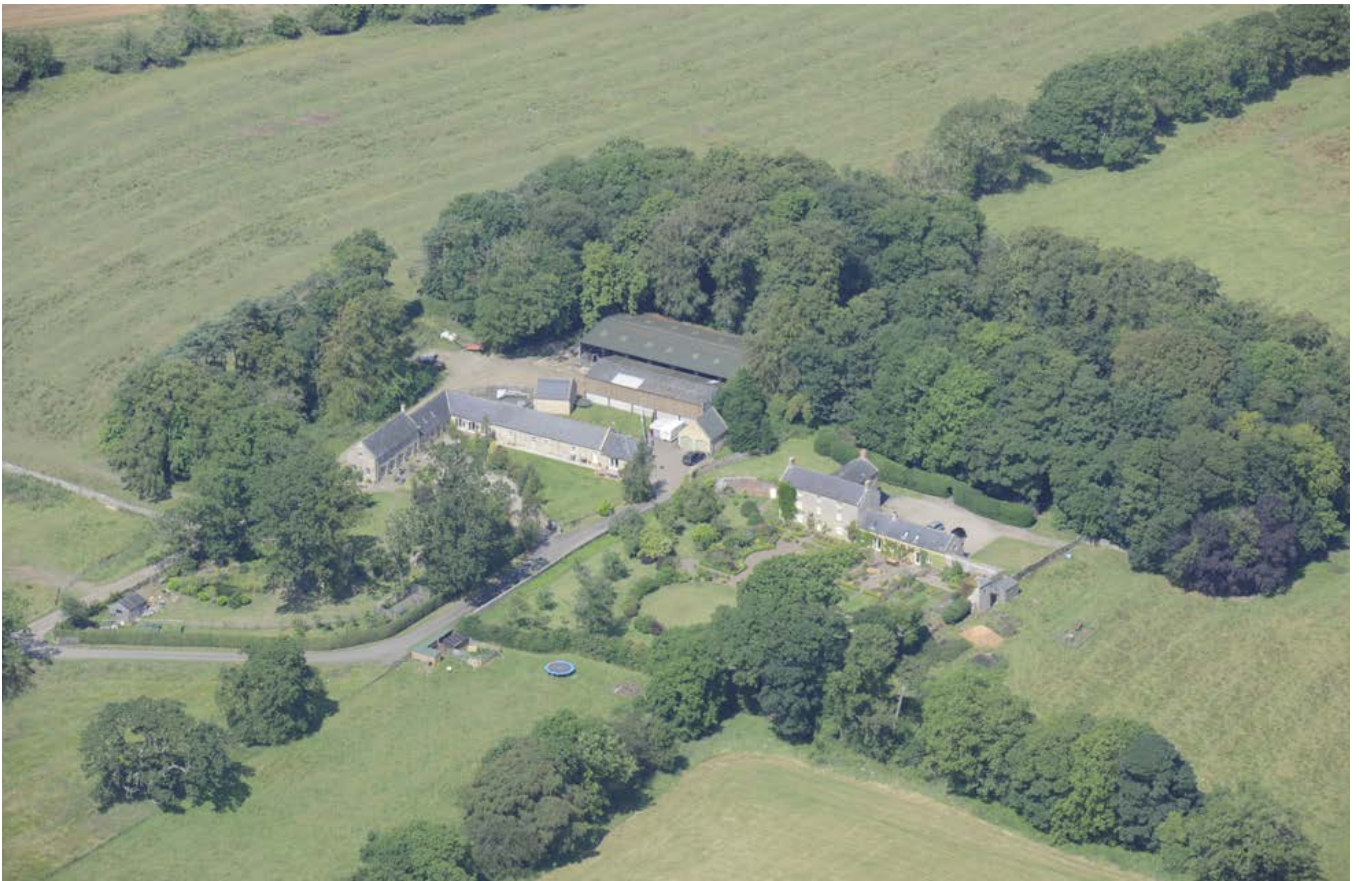
Corridge Farm in Wallington illustrates successive phases of 17th- to 19th-century improvement that are found across the estates of this area. The house and L-plan range of farm buildings, although rebuilt in their present form in the mid-19th century, have 17th- and 18th-century origins. To the east (right) is a walled garden with an attached dovecote. Photo © Historic England 28561/037

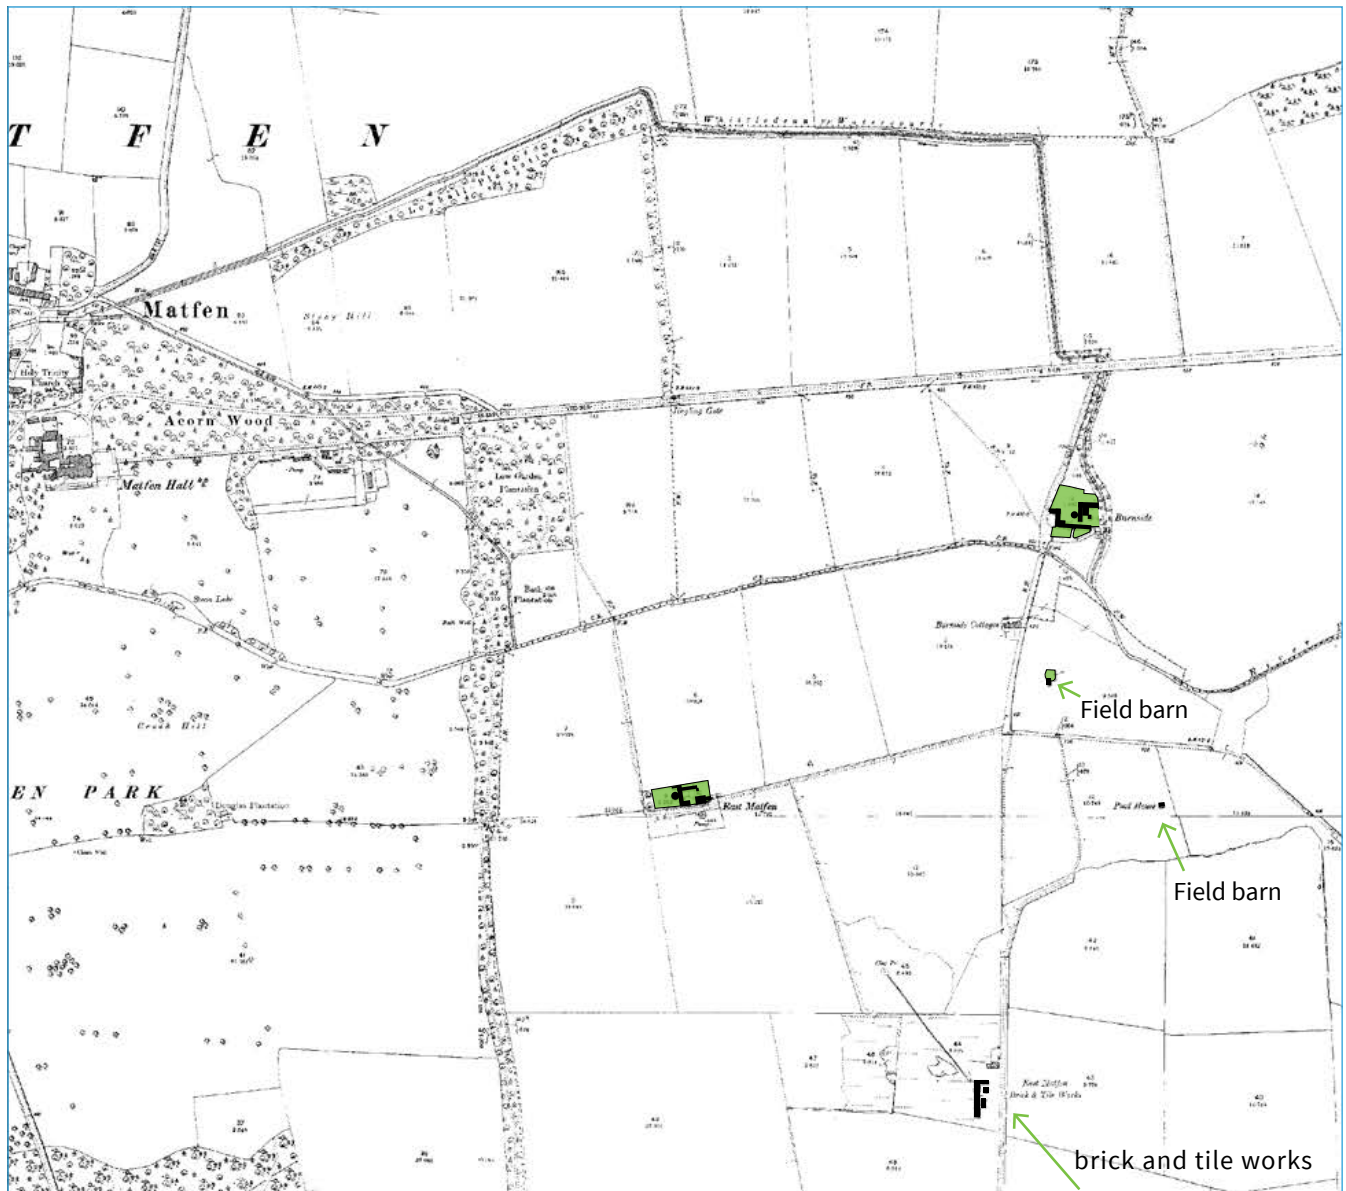
Ordnance Survey map of Matfen Estate

Maps are based on 2nd edition 25" Ordnance Survey maps, which show farmsteads after the last major phase in the building of traditional farmsteads in England.
© Crown Copyright [and database rights] 2020. OS 100024900

Farmstead, showing the buildings in black and the boundaries of the main yards (highlighted in green), working areas and gardens.

The Matfen estate was acquired by John Douglas of Newcastle in the late 17th century, who depopulated the village and dispersed the farms within reorganised farmland: East Matfen medieval village, planned to either side of a street in the late 11th or 12th century, and its open field system lies just to the east of this map. The farmhouse and buildings at East Matfen in the centre of the map date from the mid-18th century. All these large regular courtyard layouts had become fully mechanised by the early 19th century, with horse-engine houses projecting from their barns, and scattered field barns. Note the brick and tile works to the south-east.

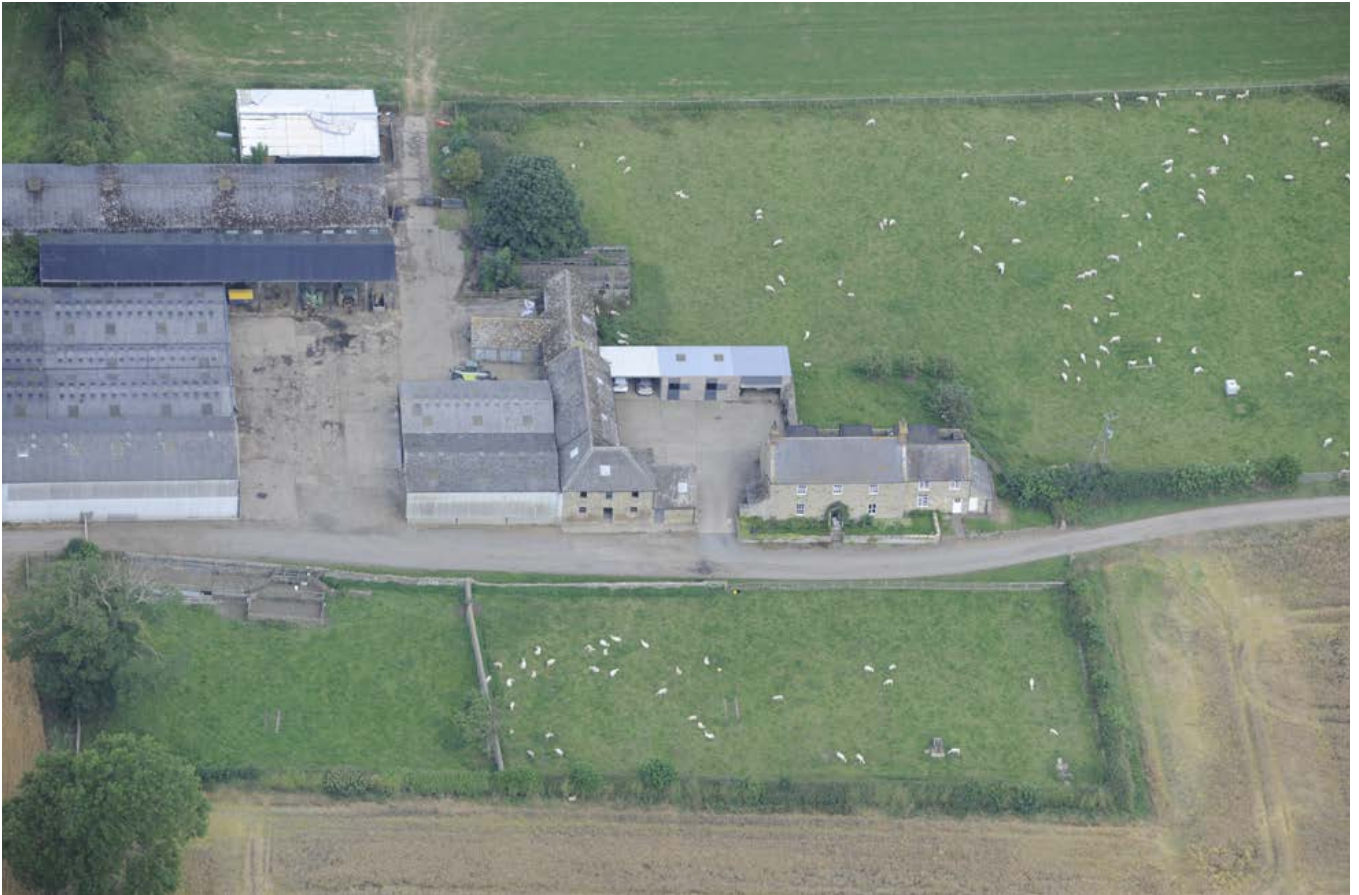
The farmhouse and buildings at East Matfen (see map on previous page) date from the mid-18th century, the stables and the main elevation of the house being aligned to the road. East Matfen Photo © Historic England 28561/020

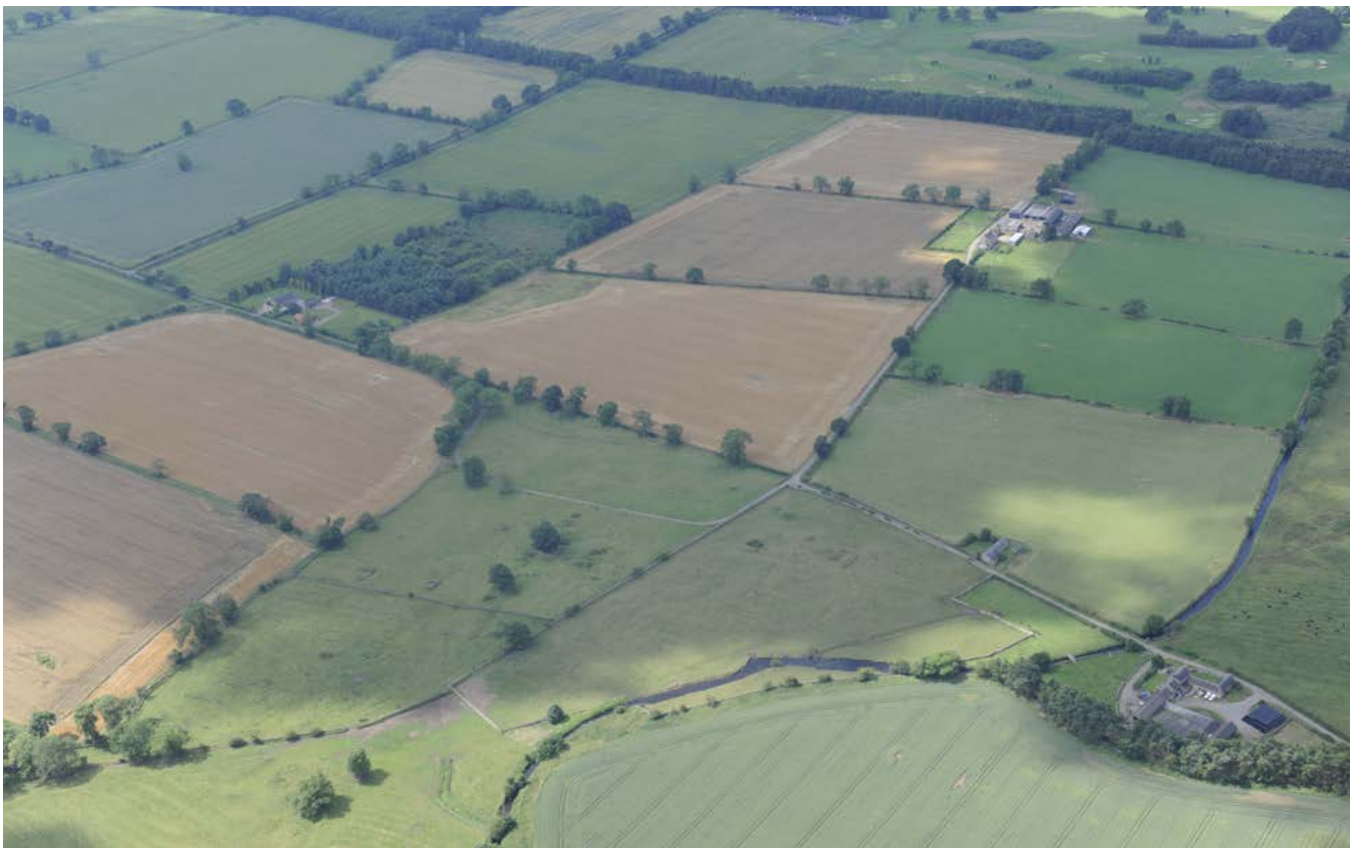
East Shaftoe, another estate landscape centred around the medieval tower house at East Shaftoe Hall and with Romano-British and earlier settlements within surviving areas of rough ground not taken in for improved agriculture. Photo © Historic England 28561/026

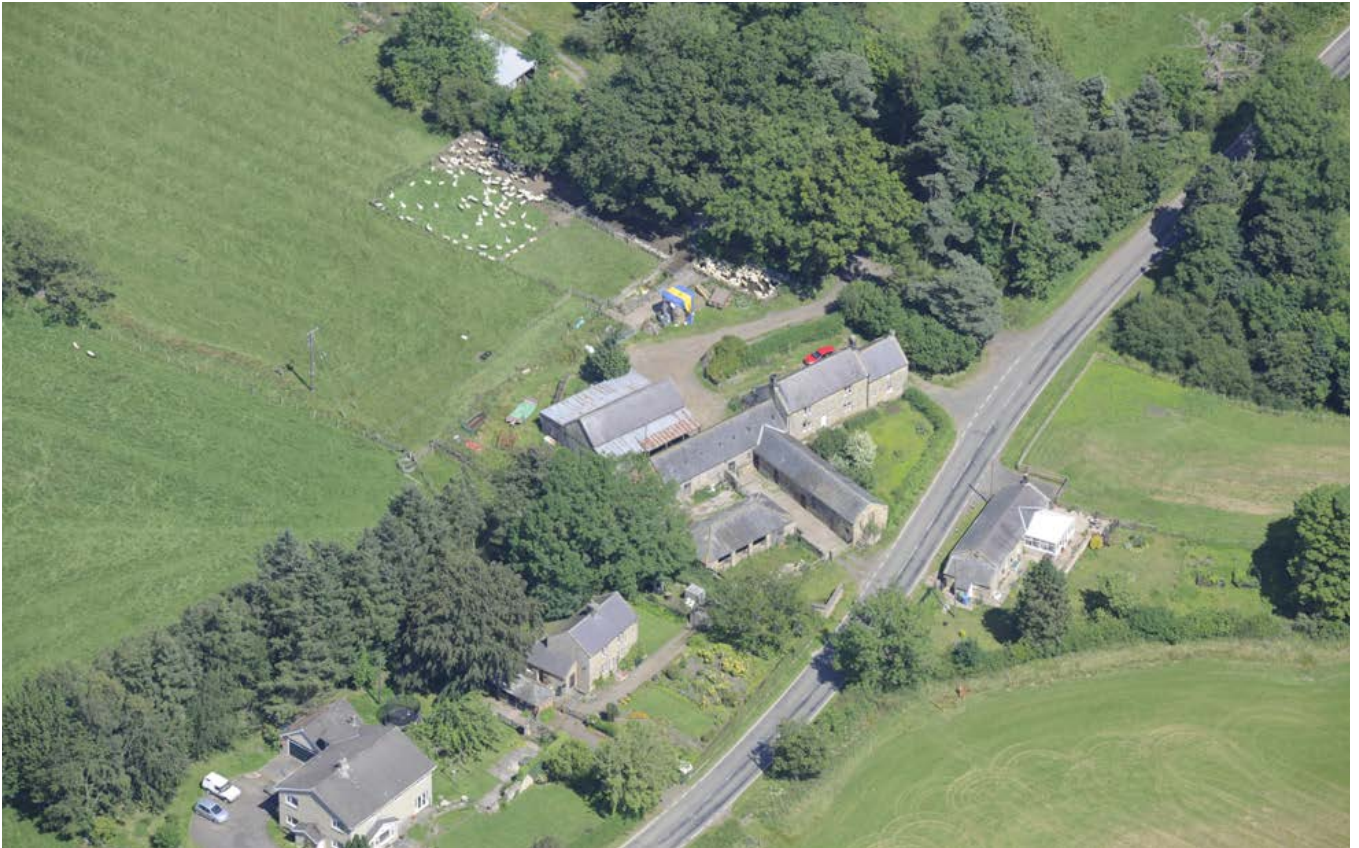
This group at Healey Cote south-west of Longframlington again has 18th-century origins, the house and working buildings being heightened in the early to mid-19th century. Photo © Historic England 28563/015

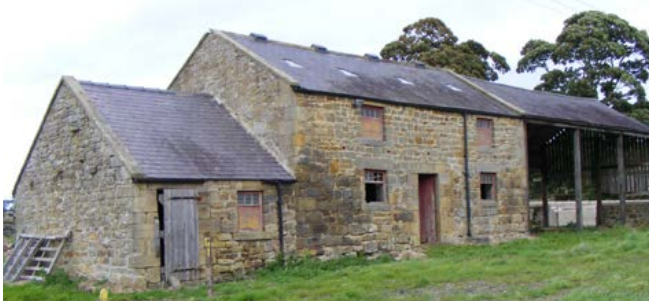
Mid-19th-century stables with attached loose box. Photo © Jen Deadman

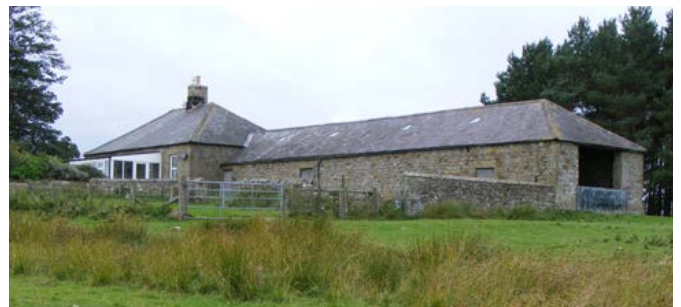
Isolated, late 19th-century smallholding on reclaimed moorland in the north of the area with evidence for small-scale quarrying close by. It comprises simply of a single-storey house with a cow house and integral cart shed attached. The cart shed entry in the gable end has been enlarged. Several small enclosures lie adjacent to the house. Photo © Jen Deadman

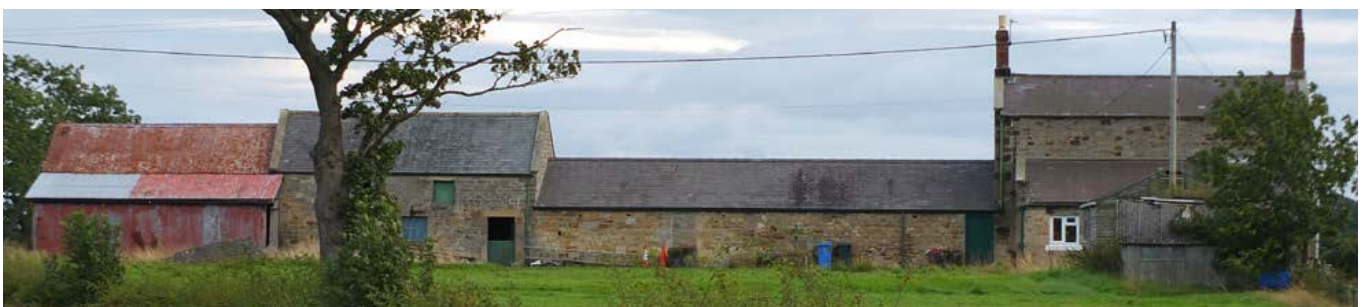
Linear steading in an area of dispersed farmsteads to the west of Morpeth set in small fields of piecemeal enclosure with evidence for ridge and furrow. A single-storey cow house adjoins the farmhouse with a combination barn adjoining to the west. To the rear are two walled enclosures. Photo © Jen Deadman

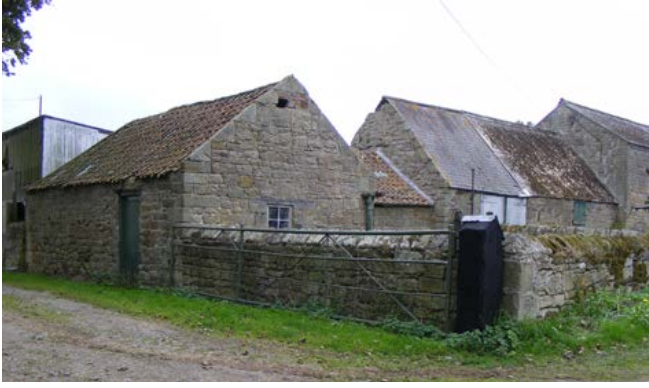
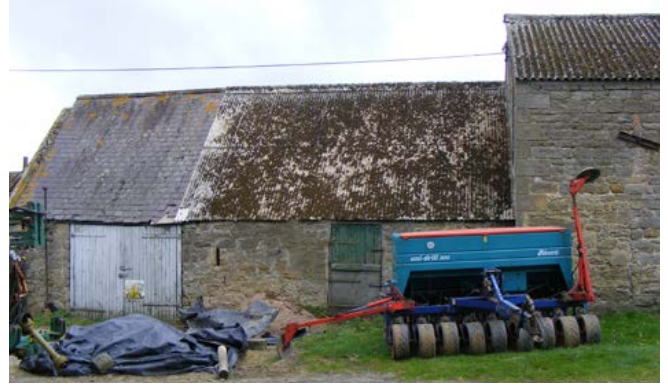
Part of a farmstead at Stanton, which was extended into a large-scale mechanised courtyard farm in the early to mid-19th century but retains elements of an earlier 17th-century farmstead including (to right) a three-bay byre with the remaining stubs of raised crucks in situ. The steep pitch would suggest the latter was originally thatched. Photos © Jen Deadman

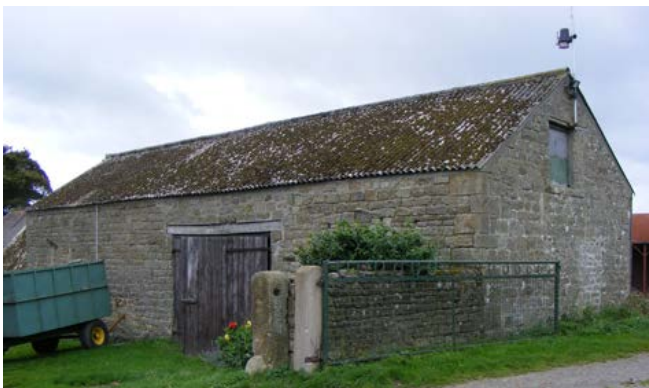
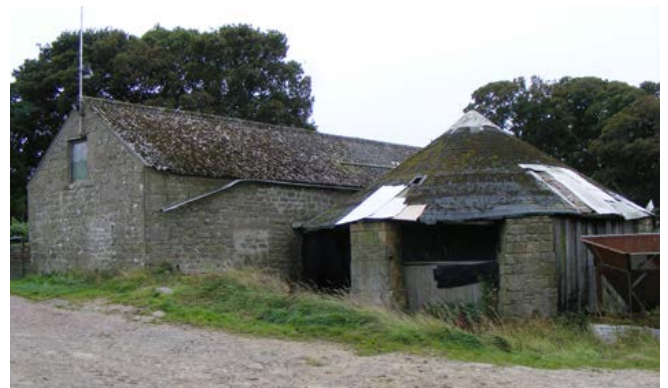
A threshing barn, its doorway enlarged, with a hexagonal wheel house (right) adjoining to the rear. Photo © Jen Deadman

- Wheel houses, locally termed horse gins, which had been used in mines for centuries, were adapted from the late 18th century to provide rotary power for powering threshing machines. They were built adjacent to the barn in which the threshing machine and other fodder-processing machinery was housed.

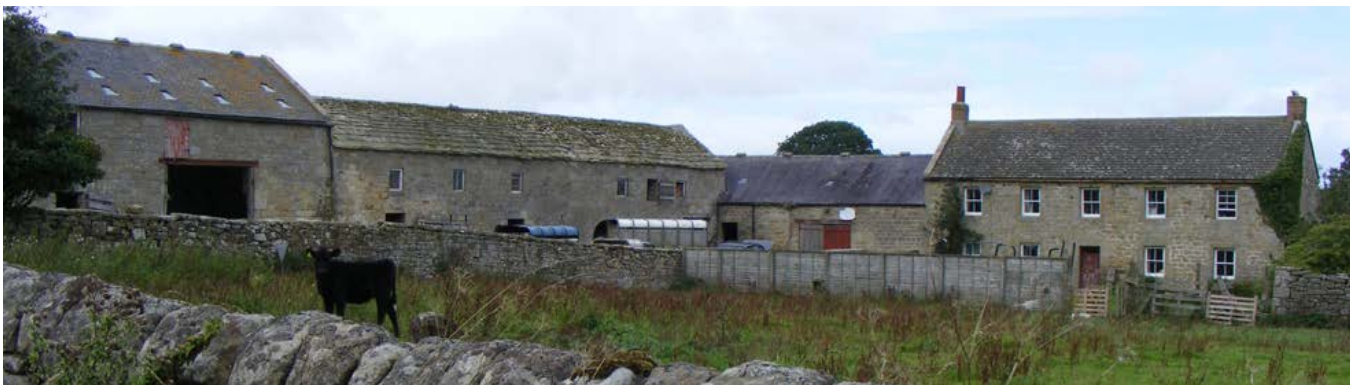
The long range on this farmstead to the west of Hartburn comprises a two-storey combination barn, 18th-century in date, raised in the 19th century and adjoined to the right by a two-storey granary block built in two phases, retaining its original stone slate roof. At first-floor level is a granary running the full length of the building, with stables and cart sheds below. The farmhouse, which is dated 1722, presents a symmetrical, five-bay façade to the road. The evidence for various phases of construction is typical of Mid Northumberland, many farmhouses retaining 17th- and 18th-century cores. Photo © Jen Deadman

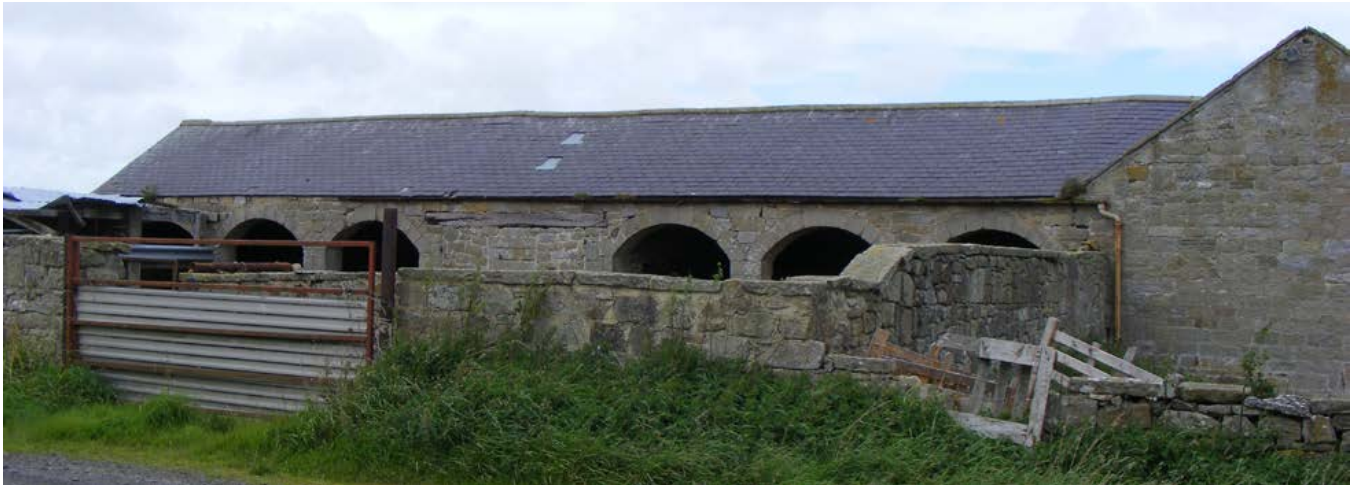
To the rear is a long range of hemmels: open-fronted sheds for cattle (below). Photo © Jen Deadman

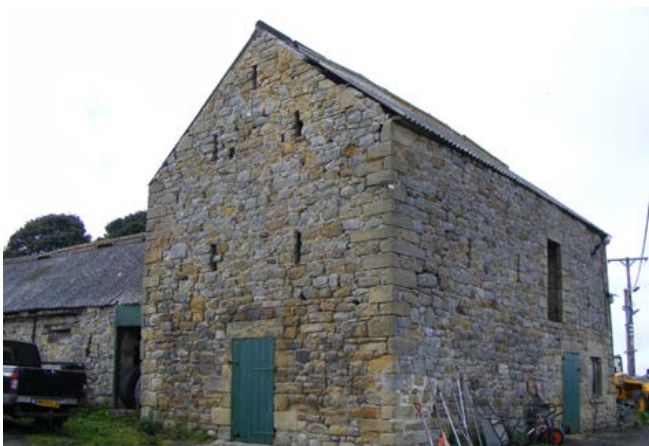
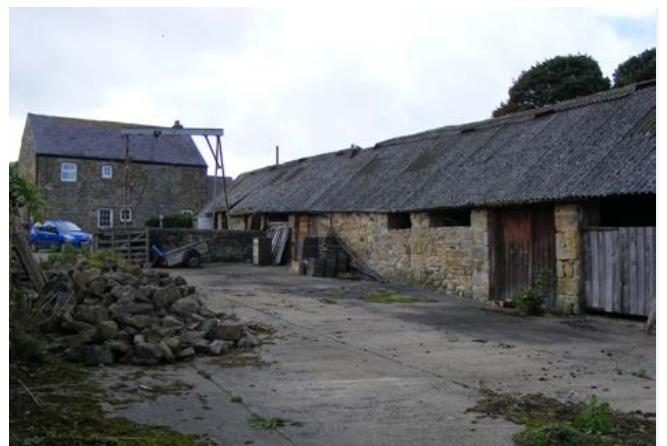
18th-century farmstead in Kirkheaton village. Here, a long yard runs parallel with the street, fronting a long, low range of hemmels and cart sheds. The farmhouse is set at right angles at one end of the range, the combination barn (right) at the other. Photo © Jen Deadman

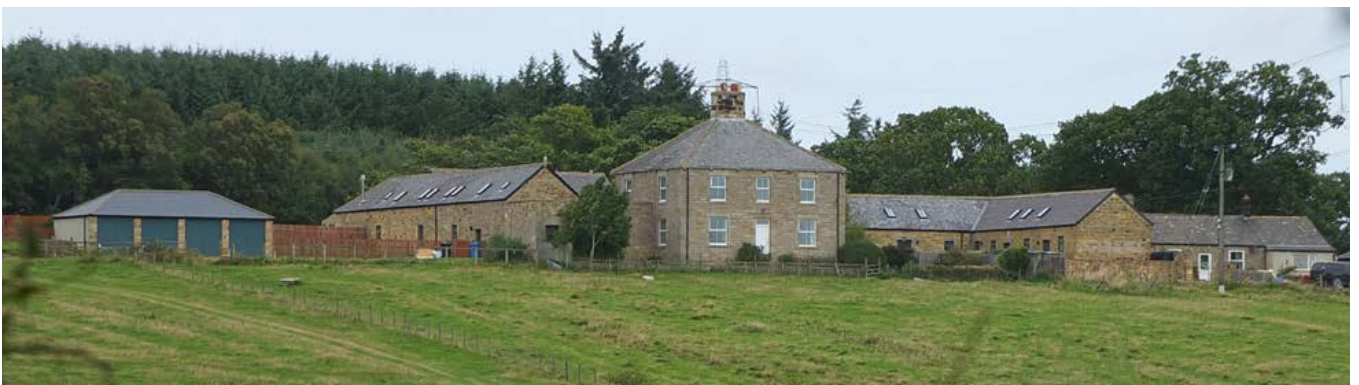
Shield Hill, one and a half miles north-east of Morpeth, consists of two farms: West Shield Farm and East Shield Farm which form a joint township with Hebron. Both were constructed in the mid-18th century. West Shield farm comprises a U-shaped plan form of linked buildings divided into two yards by a central range. Photo © Jen Deadman
