Historic England

Farmstead and Landscape Statement

Vale of Mowbray

NATIONAL CHARACTER AREA 24

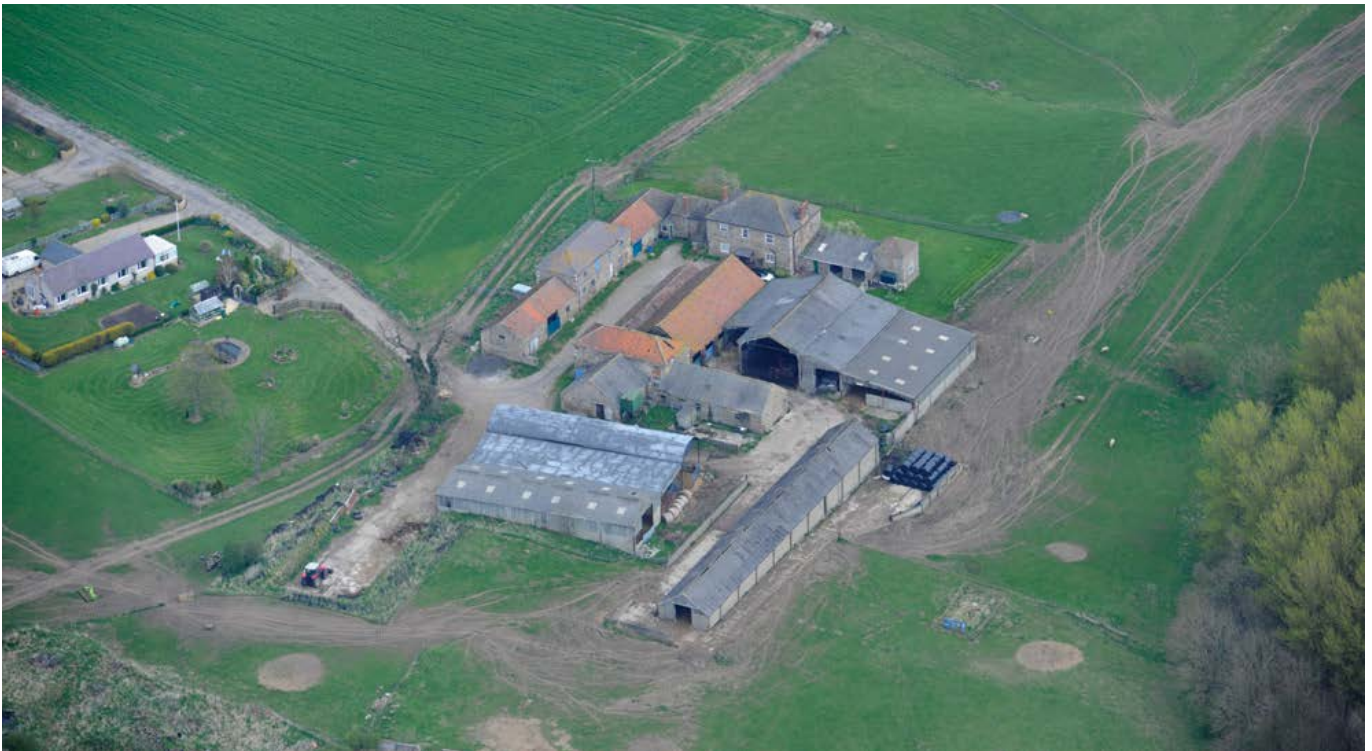
This area has some of the earliest planned and model farmsteads of the Age of Improvement. This is Home Farm on the estate of Lord Holderness, who commissioned the architect John Carr to build several farmsteads in the 1760s. Note the formal layout with the centrally-placed house facing away from the farmyard. Photo © Historic England 28523/023

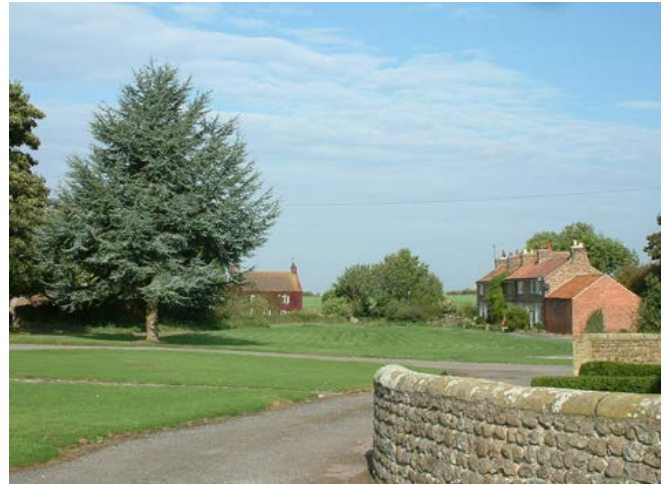
The small farming hamlet of Middleton Quernhow, in the west of the area, comprises a scattering of late 18th- and 19th-century working farms set loosely around a small green. The fabric of many of the buildings is an eclectic mix of sandstone, limestone, brick and cobble. Unlike Crakehall, Middleton Quernhow failed to thrive. The 17th-century manor house, now a ruin, lies close to the village green. Photo © Jen Deadman

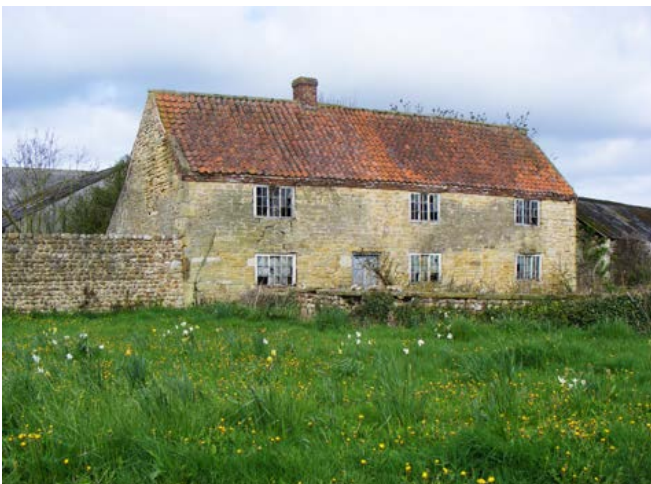
Mid-18th-century farmhouse on Middleton Quernhow village green. The lobby entry plan form is standard for 18th- and 19th-century houses in this area. The working yard is to the left, with access onto the green. Photo © Jen Deadman

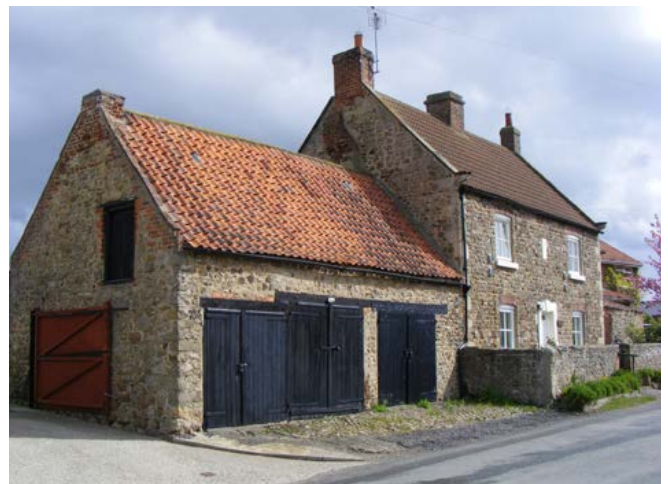
Kirkby Fleetham is one of a line of settlements set on low-lying ground to the west of the river Swale. Farmsteads play an integral part in the village streetscape. The farmhouse range fronts the yard with the house facing out onto the road. This farm, dated at 1797, is built of coursed rubble and cobble. Photo © Jen Deadman

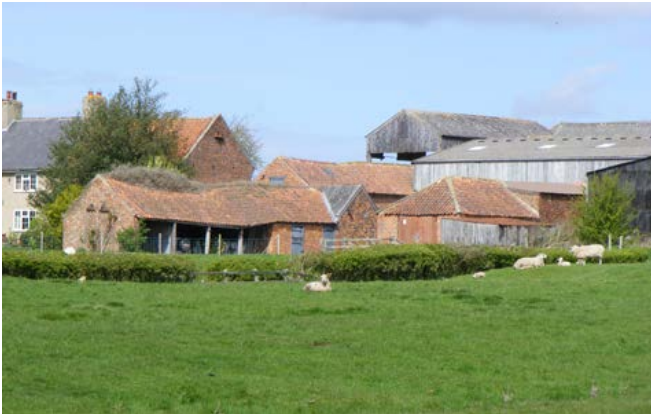
Farmstead set behind the main street of East Cowton – a linear village in the north of the area. The buildings are early to mid-19th century in date, the huddle of pantile roofs and mellow brick work a characteristic feature of the Vale landscape. Photo © Jen Deadman

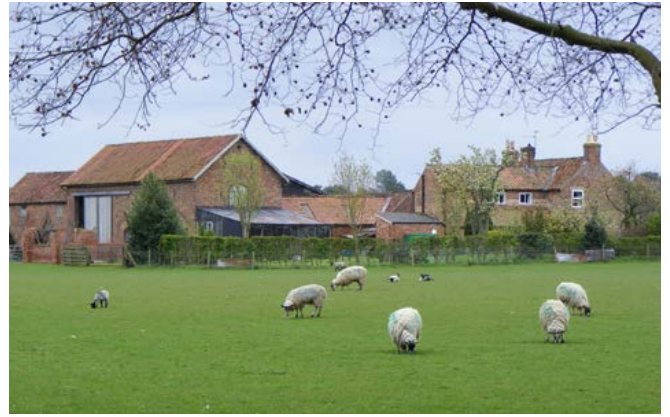
One of several dispersed farmsteads near Kirby Wiske in the south of the area, on low-lying land close to the flood plain of the river Swale. The landscape of the central Vale is dotted with substantial brick-built early and mid-19th-century courtyard farmsteads. Photo © Jen Deadman

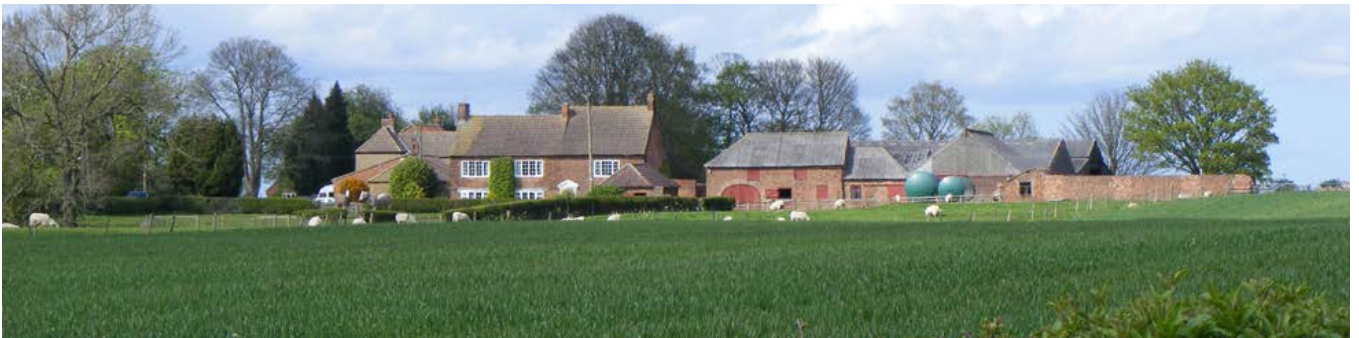
Farmstead with mid- to late 19th-century buildings situated on the edge of a small hamlet 6 miles north of Northallerton in the centre of the Vale with a view to the Hambleton Hills in the far distance. There is a moated site behind the village, evidencing former medieval settlement. The village brick works, now ruinous, are sited to the east. Photo © Jen Deadman

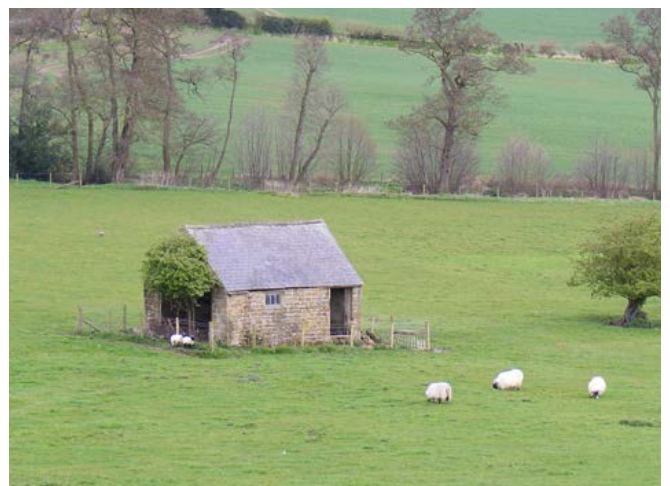
Field barn near Cowesby, on rising ground below Cowesby wood and moor on the edge of the Hambleton Hills. Photo © Jen Deadman

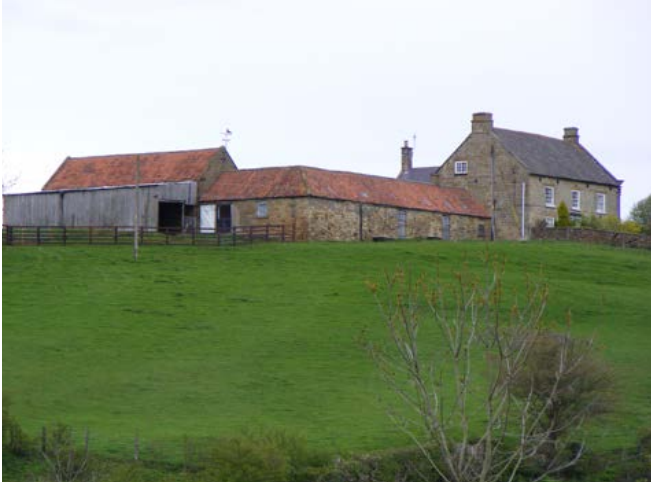
Isolated hilltop farmstead outside Boltby, in the south-east of the area. Immediately to the east lies the long swathe of Boltby Forest and the escarpment marking the edge of the Hambleton Hills. Brick gives way to sandstone as the predominant building material. Photo © Jen Deadman

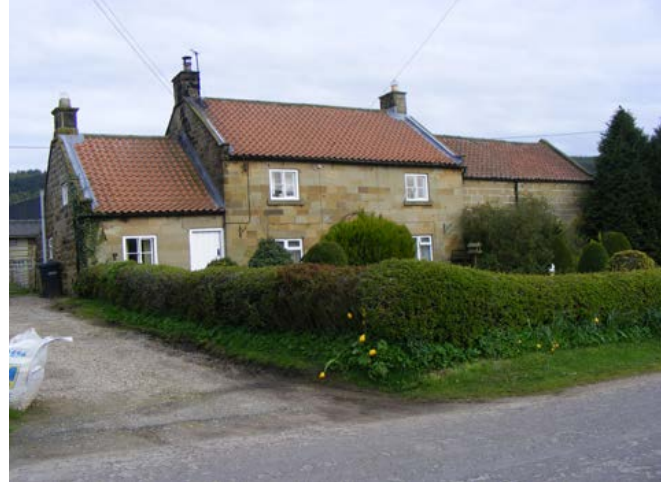
Thimbleby, lying south of Osmotherly in the extreme north-east of the area, close to the Cleveland Hills. The linear village is set on rising ground above the Vale in fields evidencing piecemeal enclosure and relict medieval strip fields. Above and stretching onto the moors is a large area of forestry plantation. Similar 20th-century forestry management is evident north south along the moor edge. Typically, this small village farm faces onto the road. In contrast to the brick buildings of the vale, it is built of squared and dressed coursed sandstone blocks, highly characteristic of the area and of the North York Moors to the east. Photo © Jen Deadman

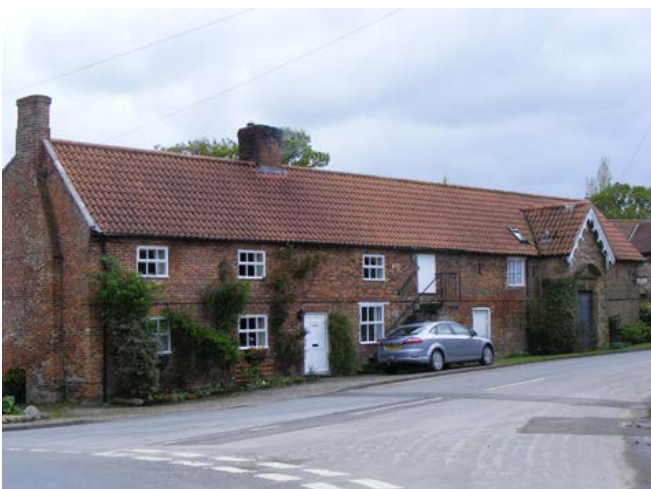
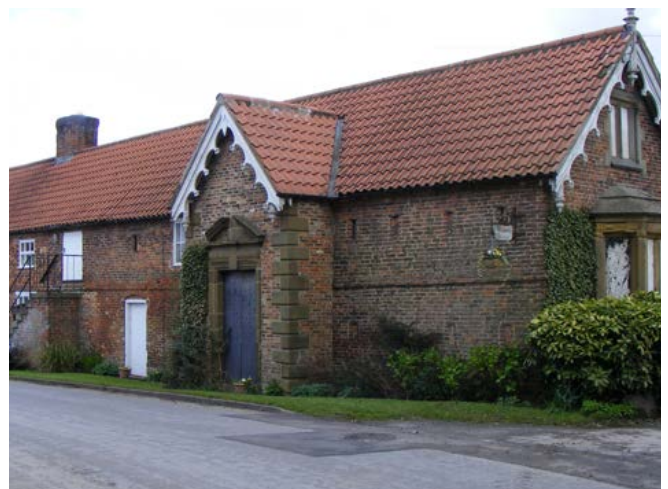
Linear plans

Newby Wiske village. Late 17th-century, former linear farmstead and rare example of a long house derivative plan form. The building formerly accommodated house body, granary, and a lofted or part lofted combination barn incorporating a threshing floor and cattle housing. The three areas were set under one roof line, but it is not known if they were interconnected. It is possible the building may contain timber elements of an earlier structure built to the same plan form.

The barn is an example of Victorian or earlier conversion to domestic use. The ventilation slits for the barn are still visible. The porch is sited where the cart entry would have been located. Photo © Jen Deadman

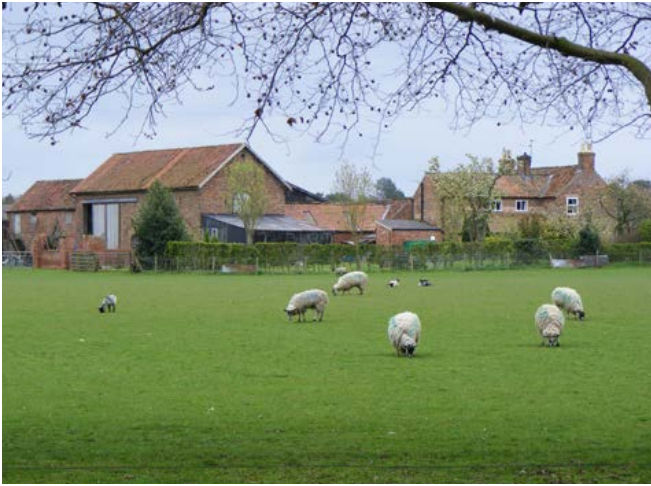
Courtyard plans

Mid-19th-century, brick built farmstead with combination barn, granary and cattle sheds interlinked around a central yard. The farmhouse forms part of the yard curtilage but faces away from the working buildings. Photo © Jen Deadman

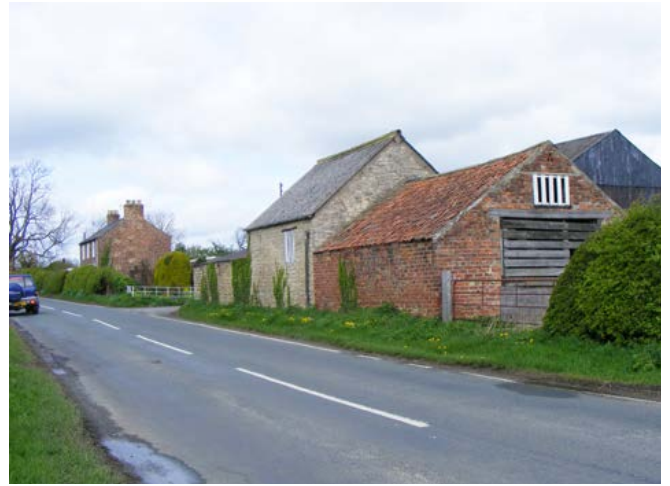
Smallholding close to Exelby, on the west side of the Vale. Late 19th or early 20th century in date, with range of working buildings set against the roadside and small yard with later buildings behind. The limestone barn appears to pre-date the brick buildings. There are many examples of 19th- and early 20th-century farmsteads in the Vale. Photo © Jen Deadman

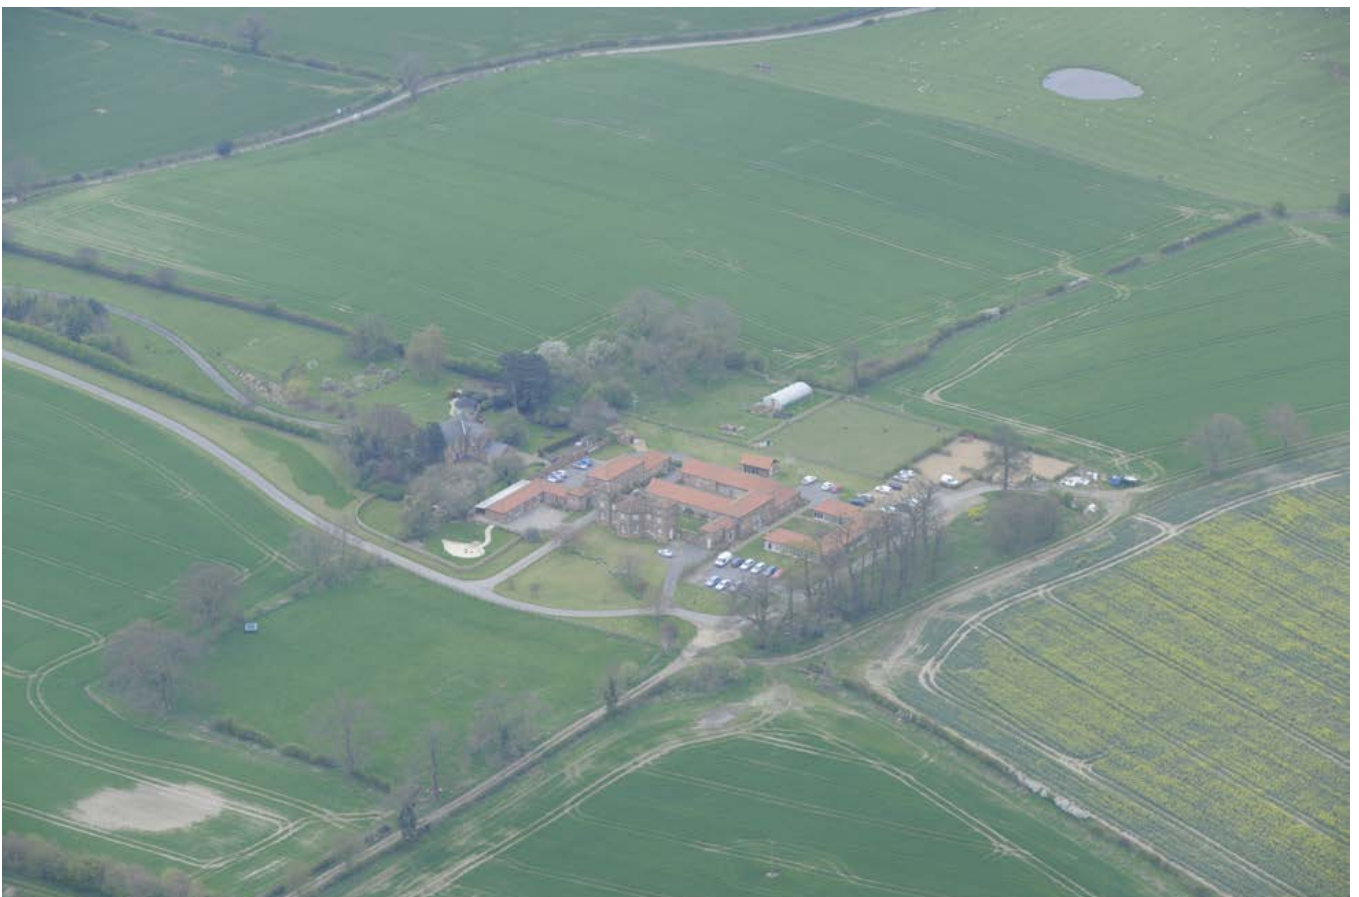
This farmstead is set in a designed landscape of regular enclosures. The farmhouse was built in 1768 by the architect John Carr for the Earl of Holderness. The farmstead, like other large-scale arable farms in this area, developed over the 19th century with additional cattle housing into a regular multi-yard layout. Photo © Historic England 28523/037

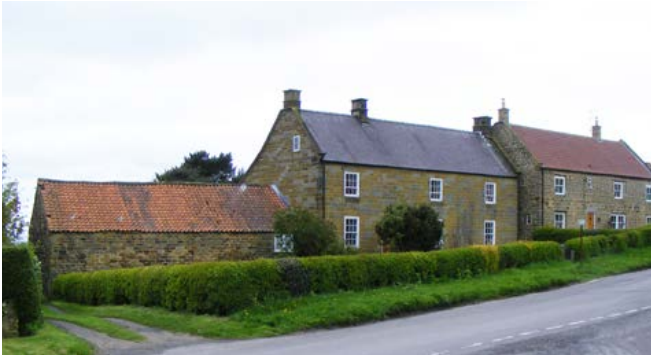
Borrowby, a hill village located below the Hambleton Hills and one of six in the locality, formerly in the Northallertonshire Bishopric of Durham. Here, two substantial farmhouses sit cheek by jowl on the roadside. That to the right fronts a small yard with two, single-storey, parallel ranges. Evidence would suggest that the farmhouse has been raised from one to two storeys, possibly in the 17th century. One of the ranges to the rear is a single-storey, four or five bay cruck barn, which may be indicative of the earlier form of the farmhouse. The yard has gradually evolved to form the U-shaped plan form evident today. Photo © Jen Deadman

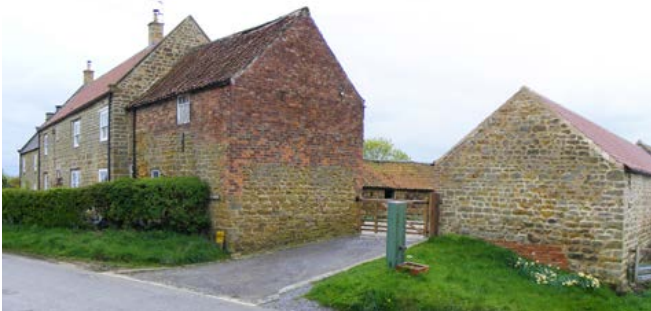
A stable with a loft over adjoins the farmhouse on the roadside. To the right is a cruck-framed range encased in stone. Photo © Jen Deadman

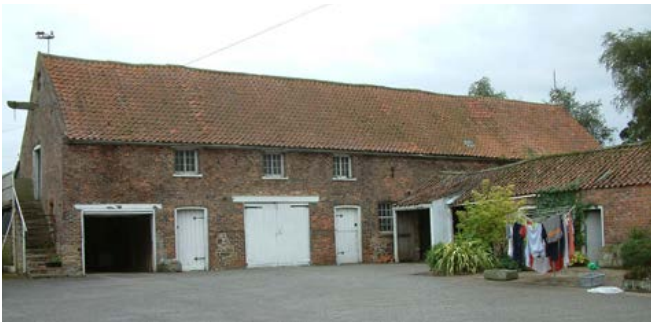
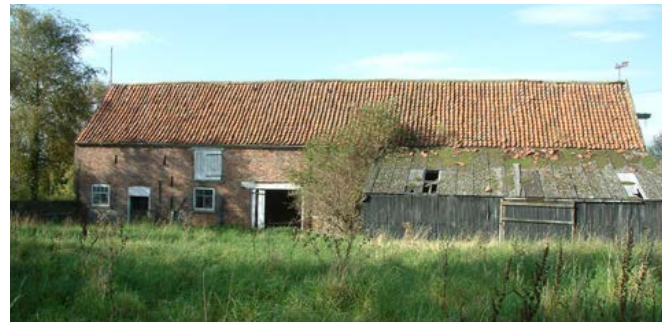
Combination barns

Greatly altered late 18th- to early 19th-century, nine-bay barn replacing earlier, smaller barn on the same alignment. Brick built under a pantile roof it originally comprised threshing floor, stabling for three horses, trap or cart shed and harness room with hay lofts over. A granary with grain hoist was sited at the northern end. A corn mill had been introduced below the granary by 1920 and stabling resited to the south end of the barn. A horse engine house, now demolished, adjoined the rear elevation. To the rear of the building is a corrugated lean-to, built to house a tractor-driven hammer mill in the early 1940s. Photos © Jen Deadman

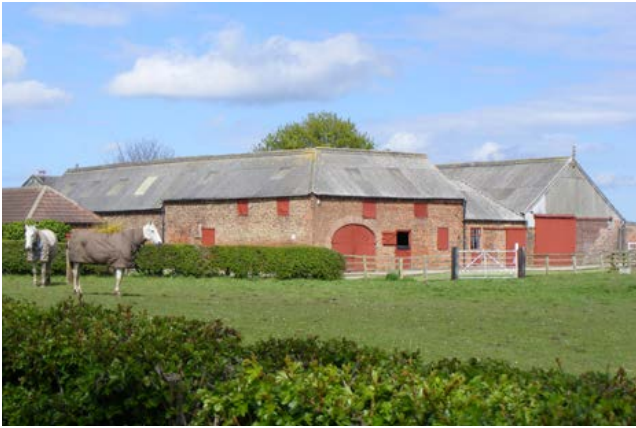
L-shaped combination barn occupying a corner plot on planned, 19th-century farmstead, providing animal housing, hay and fodder storage. Photo © Jen Deadman

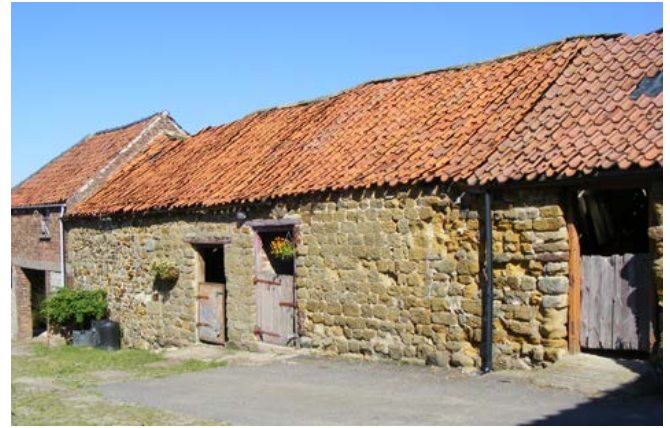
Four bay, cruck-framed, single-storey, multifunctional range with an early 20th-century cart shed and granary adjoining The range comprises threshing barn with two byres and a cart shed set under one roofline. To the rear behind the threshing barn is a horse engine house, now ruinous. The position of the drive shaft can be located on the rear wall of the barn. Photo © Jen Deadman
