Pevensey Castle, Pevensey, East Sussex: architectural, archaeological and aerial investigation

Architectural, Archaeological and Aerial Investigation

NGR: TQ 644 047

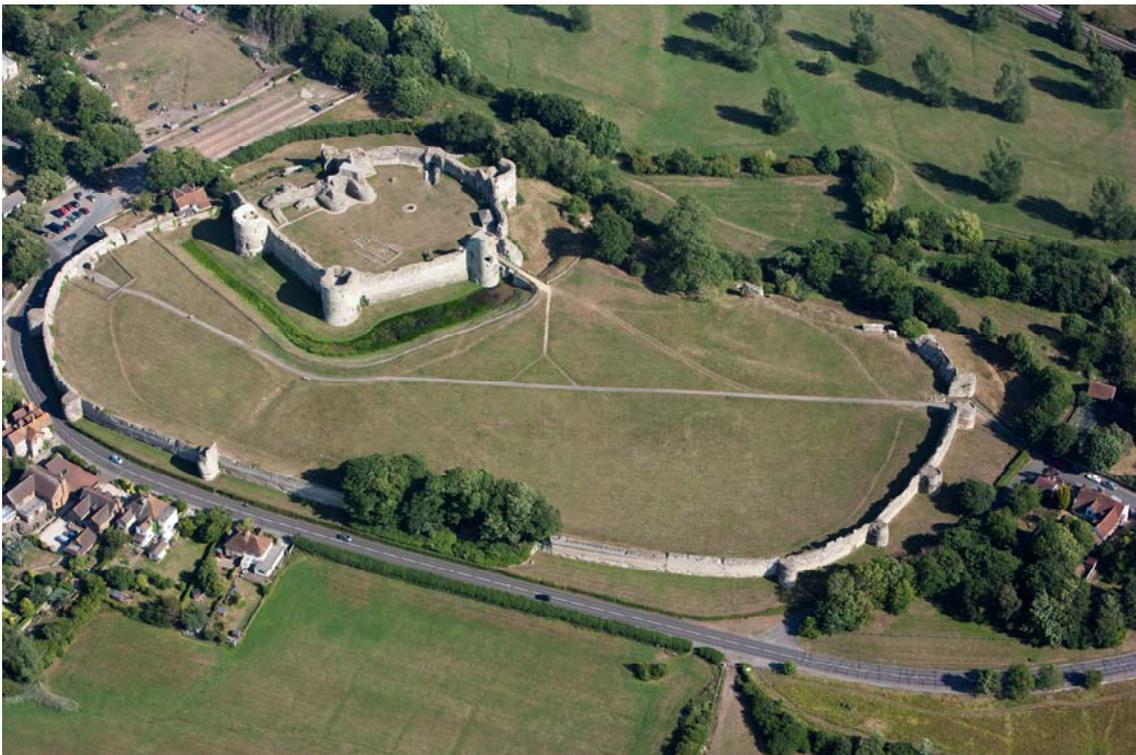
Fig 2: The extent of the Roman fortification from the north-west (NMR 26764/35 28-Jul-2010)

This report is not intended to discuss the Roman fortification but in order to understand the story of the medieval development of Pevensey Castle its general position and form have to be considered. When constructed, the Saxon Shore Fort was located at the tip of a peninsula, its eastern end overlooking the access to a

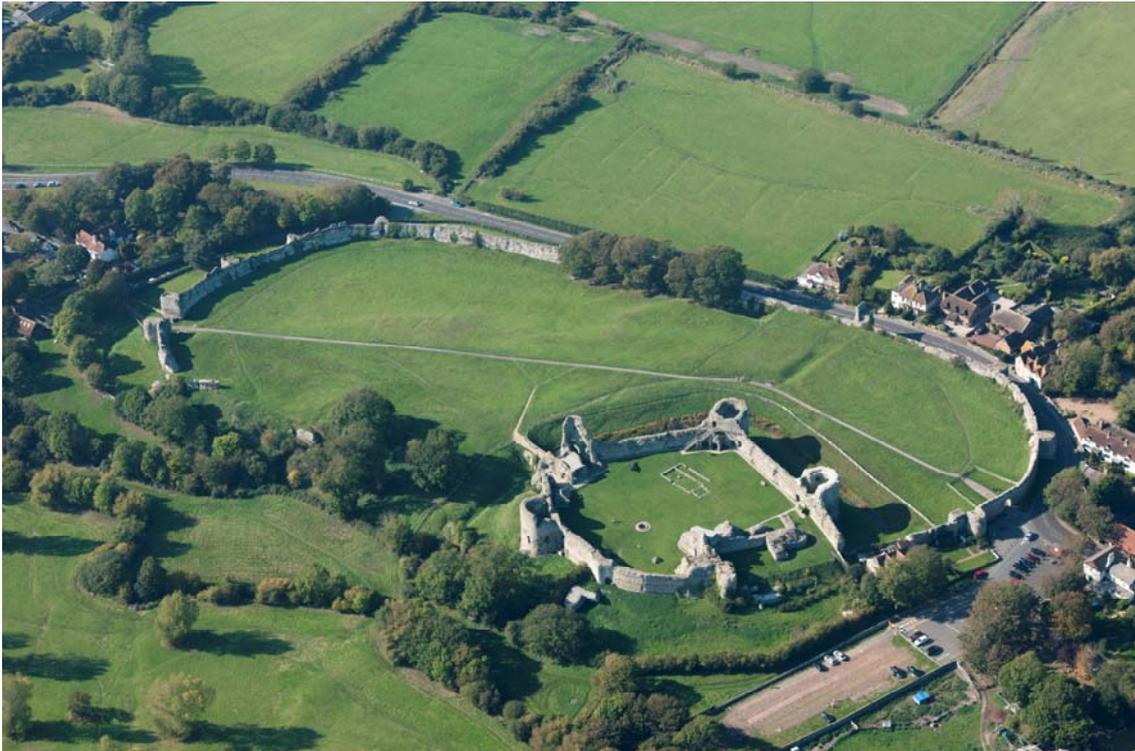
Fig 3: The site of the missing section of Roman wall on the south side of the fortification is now occupied by trees to the west (left) of the medieval castle (NMR 27303/024 29-Sep-2011)

The converse of deposition is erosion and there is evidence of erosion along the south side of the Roman fortification (Fig 3). In fact, the absence of large sections of Roman wall, even in their collapsed form, points to the action of the sea, first in undermining the wall, leading to its collapse, and then to much of its remains being washed away. The more common, though often unspoken, assumption is that this may have occurred somewhere between 1066 and the 16th-century abandonment of the castle. In the 1318 report on the state of the fabric of the castle, the breach was said to be 20 perches in length, just over 100m and therefore approximately half as long as the current gap in the wall (Salzmann 1906, 18; Fig 4). Lyne did consider an early date for the collapse in passing, but did not provide evidence for this idea (2009, 44). A display in the current Pevensey Castle exhibition suggests that the levels between Pevensey Castle and the current line of the sea had been created by the end of the Middle Ages, and recent published archaeological studies

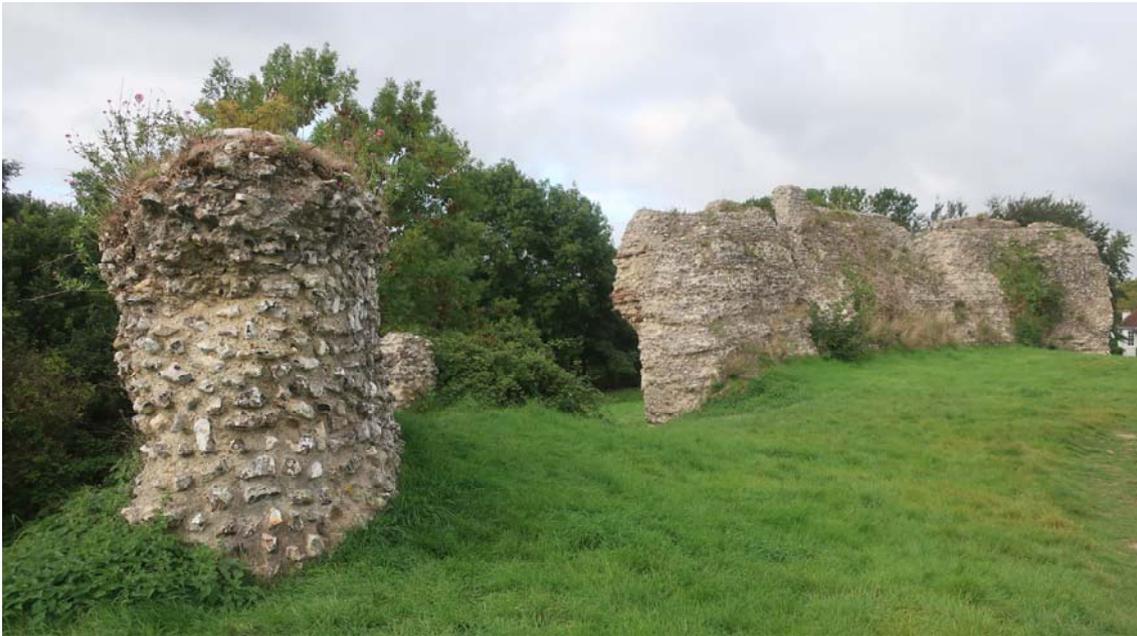
Fig 4: Fragments of the Roman wall on the south side of the fortification have survived, though at slightly perilous angles (Investigator Photograph)

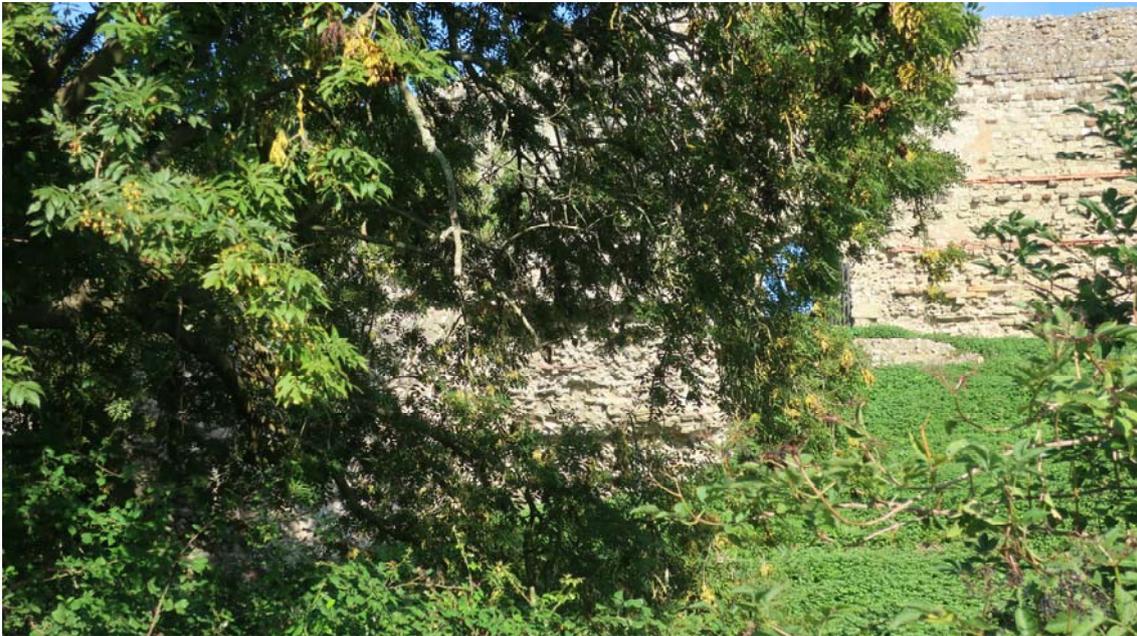
Fig 5: The ruins of Roman bastion 10 survive near to the top of the slope just to the south of the medieval postern gate (Investigator Photograph)

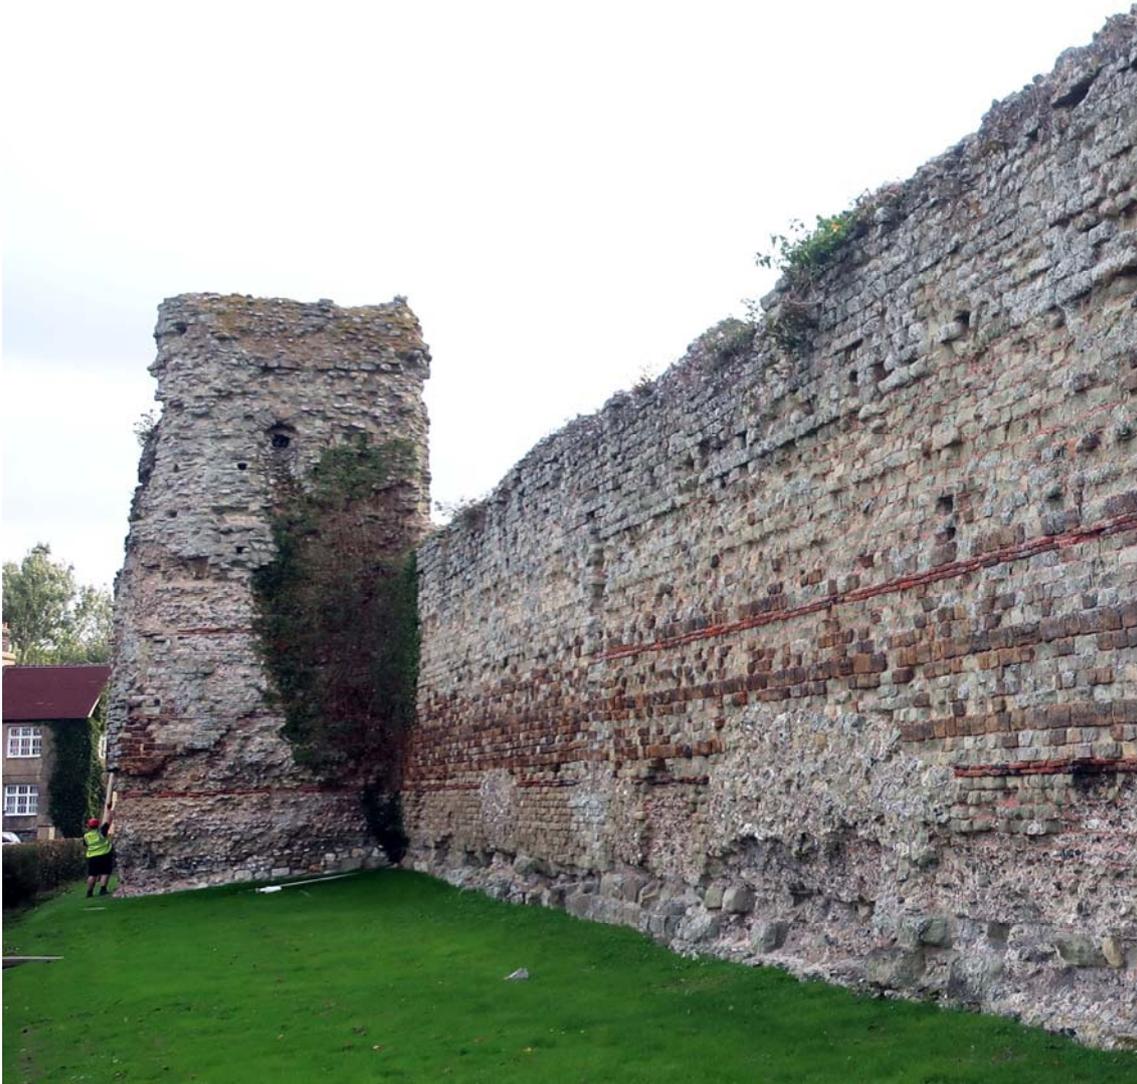
Fig 6: Bastion 3 of the Roman fortification is at the northern end of what was once thought to have been the line of the Norman palisade. It is possible that its raised storey may have housed a light to aid navigation (Investigator Photograph)

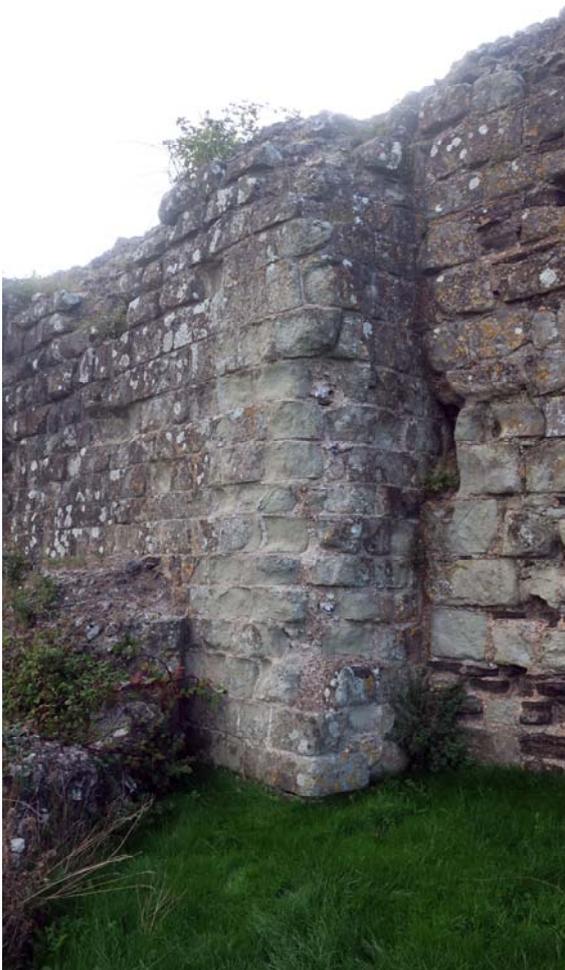
Fig 7: Straight joint between the west side of the postern gate and the south wall of the medieval castle to the right (Investigator Photograph)

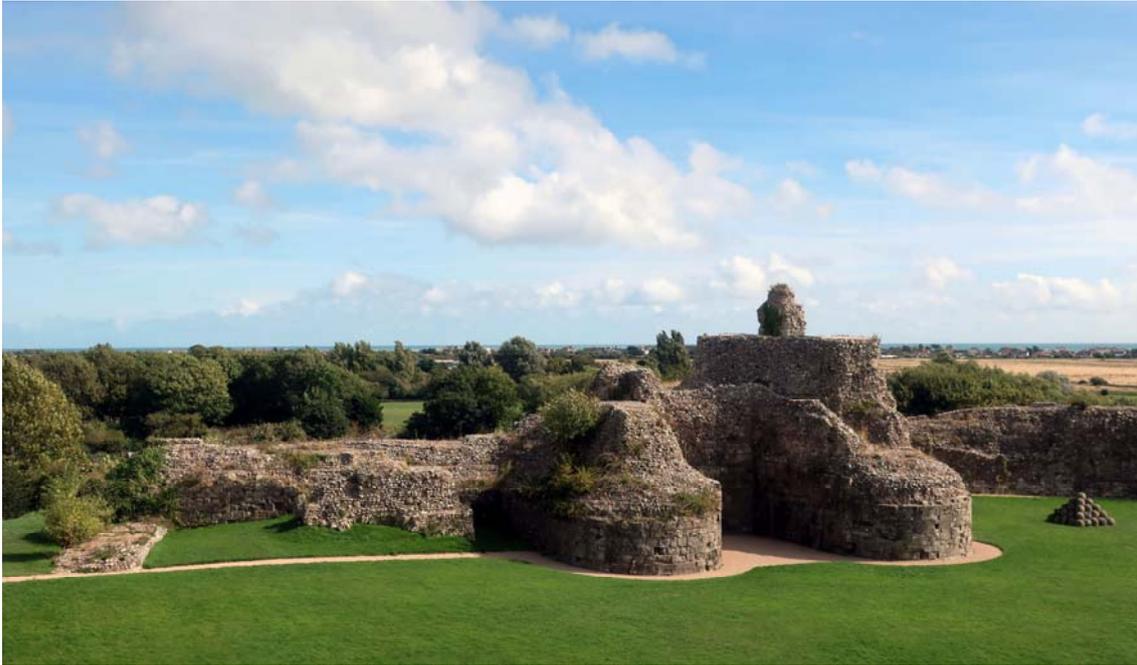
Fig 8: This general view of the keep from the north-west shows the monumental bastions projecting to the west (Investigator Photograph)

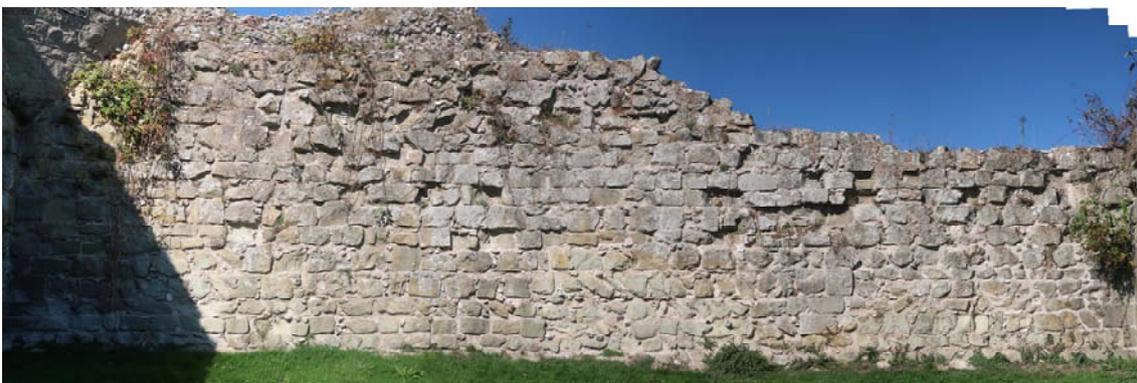
Fig 9: This panorama of multiple photographs shows the patching and perhaps a triangular shape in the west wall of the interior of the keep (Investigator Photograph)

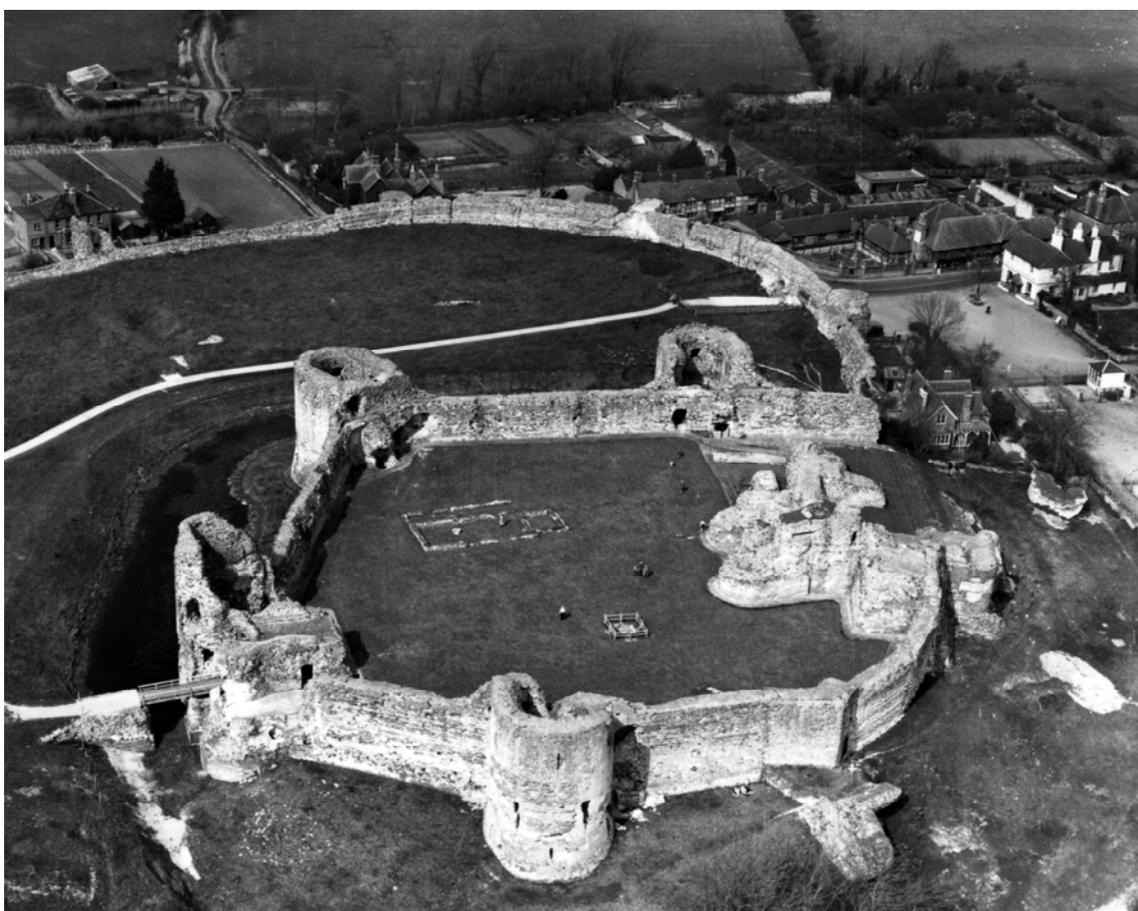
Fig 11: In this 1948 Aerofilms photograph the fallen Roman bastion and the replaced postern gate can be seen at the bottom of the image, to the east (right) of the 13th-century tower in the south wall EAW014356 ©Historic England Archive

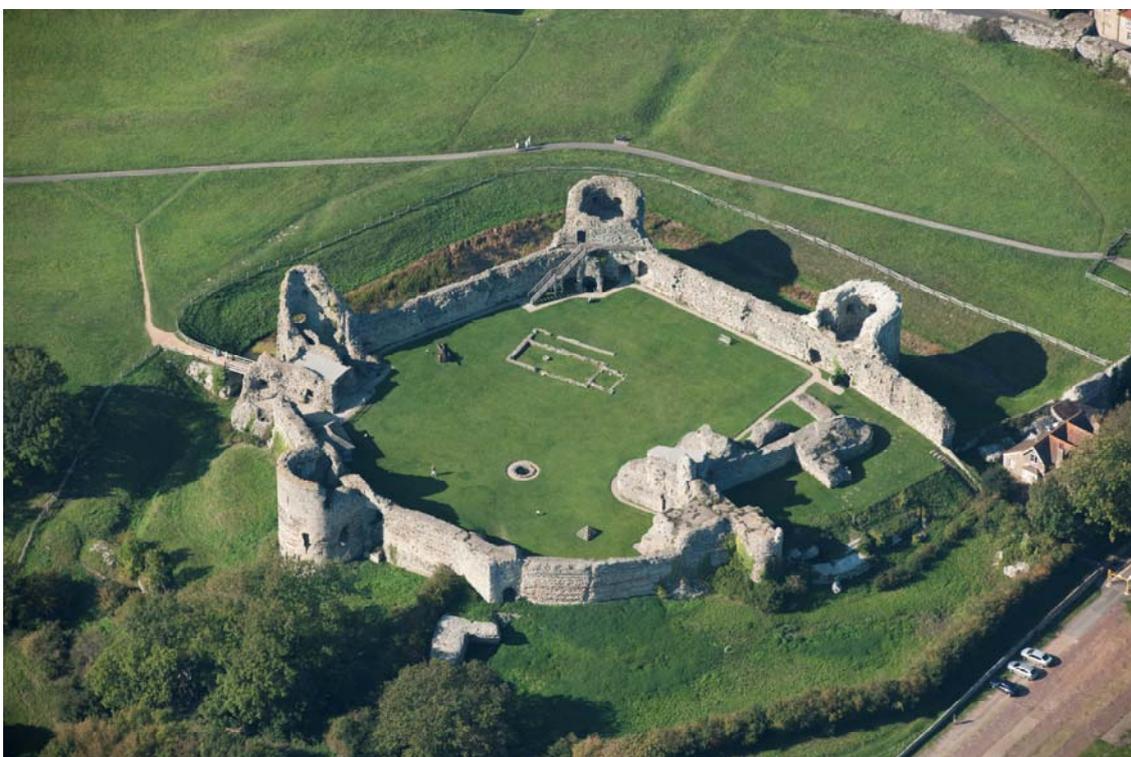
Fig 12: The current chapel footings, in the centre of the image, probably date from the early 14th century, when documents refer to the construction of a new timber-framed chapel (NMR 27303/023 29-Sep-2011)

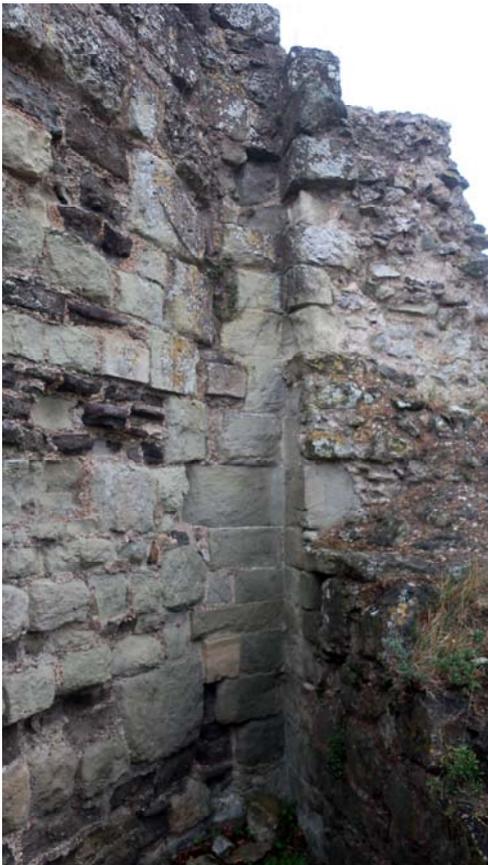
Fig 13: There is a clear joint between the main gatehouse on the right and the rubble of the south wall of the medieval castle on the left (Investigator Photograph)

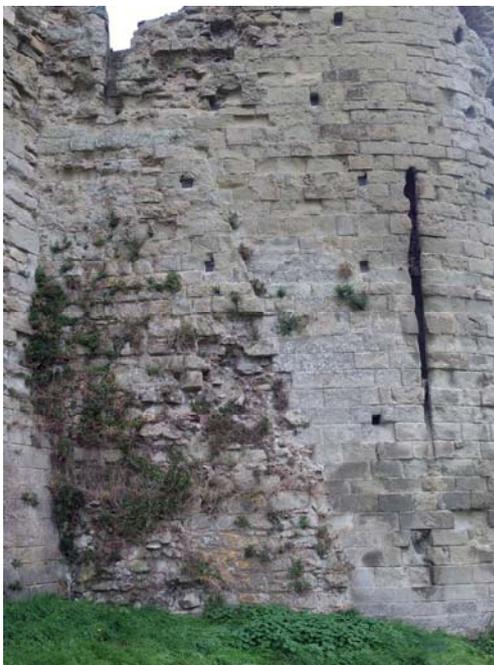
Fig 14: The fragment on the north side of the gatehouse looks confusingly both earlier, yet well integrated into, the fabric of the structure (Investigator Photograph)

Chapman proposed that the lower story of the gatehouse was earlier than the curtain wall, suggesting that it probably dated to the last decade of the 12th century

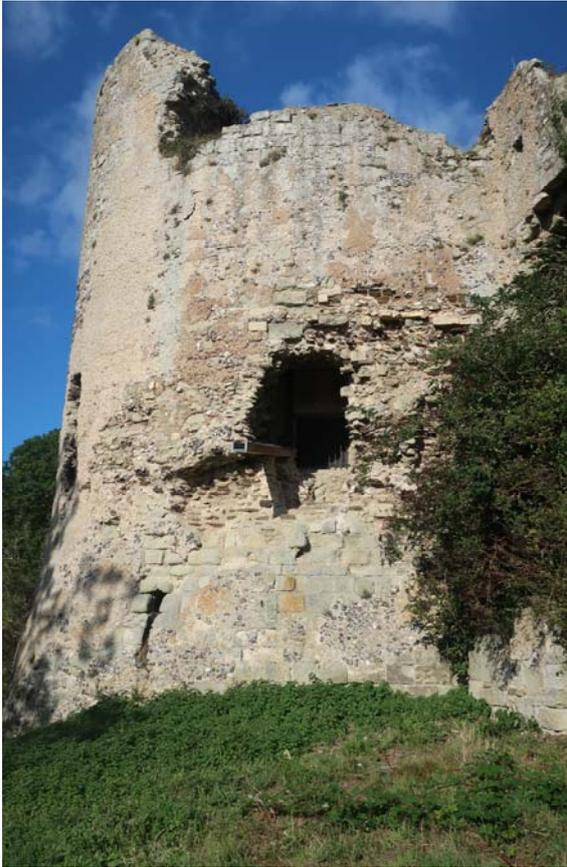
Fig 15: Assessing the character of the walling on the south side of the medieval castle is complicated by undergrowth and more intrusive 20th-century interventions and repairs. Nevertheless, it seems to be somewhat coarser in finish than the west and north walls of the castle (Investigator Photograph)

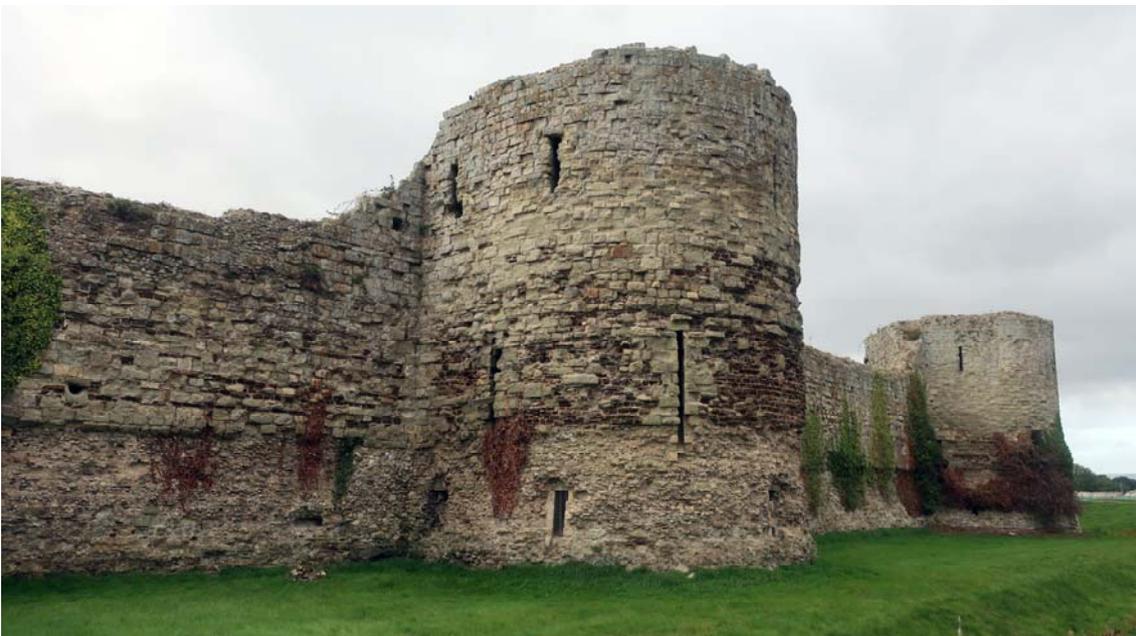
Fig 16: Despite the robbing of the good quality ashlar of the lower courses on the north side of the castle, the walling seems a little neater and more sophisticated than the south side of the castle (Investigator Photograph)

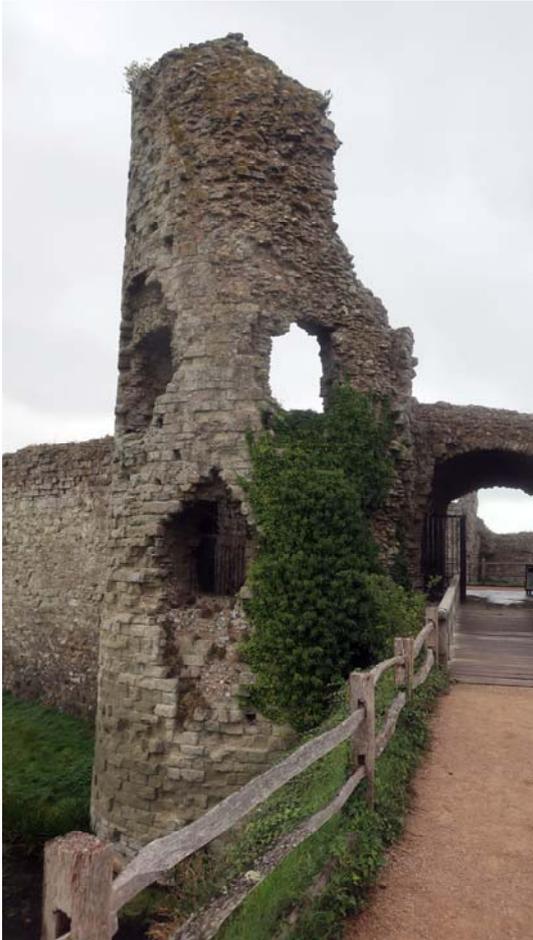
Fig 17: The north turret of the gate survives to a large extent and illustrates that the stonework is of superior quality to the flanking walls of the castle (Investigator Photograph)

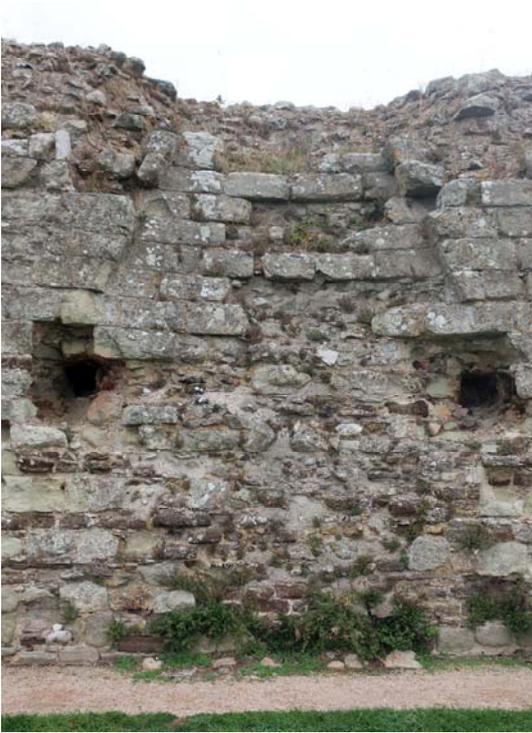
Fig 18: One of the fireplaces in the north wall of the medieval castle shows the typical arrangement of flanking holes where corbels were located (Investigator Photograph)

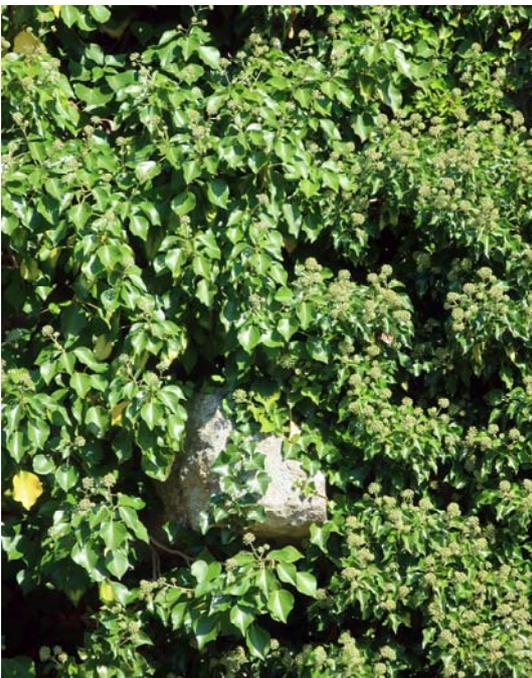
Fig 19: This projecting stone is at the right height to be a corbel flanking a fireplace, but vigorous plant growth is obscuring its precise function and form (Investigator Photograph)

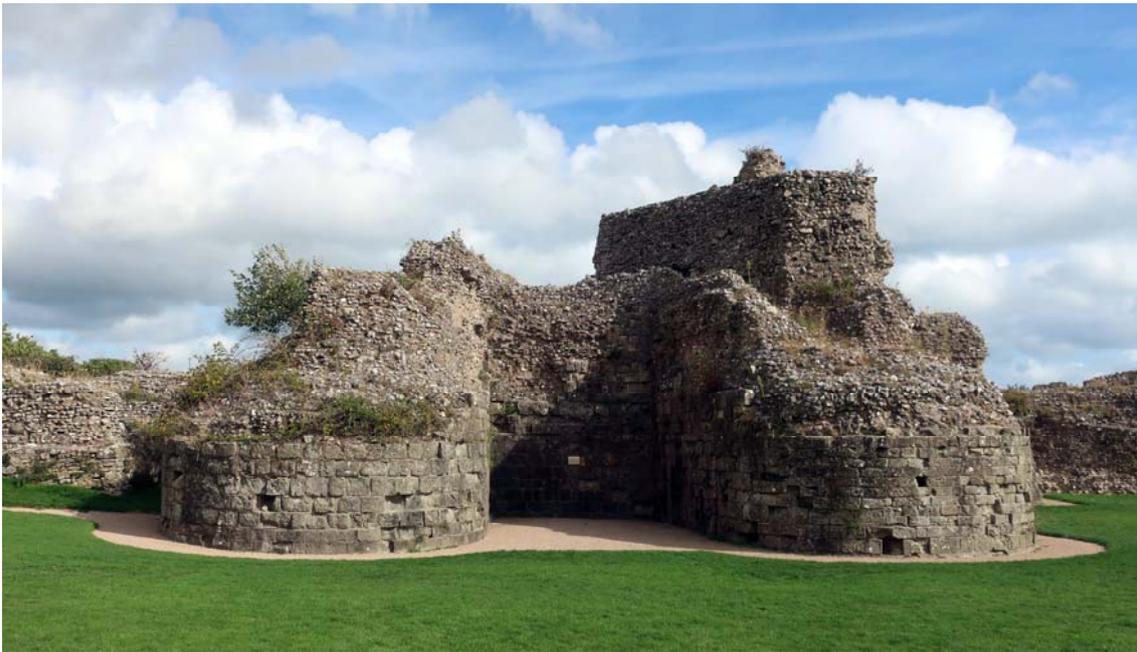
Fig 21: The keep from the west, showing the intact ashlar on much of its ground floor and the absence of any openings (Investigator Photograph)

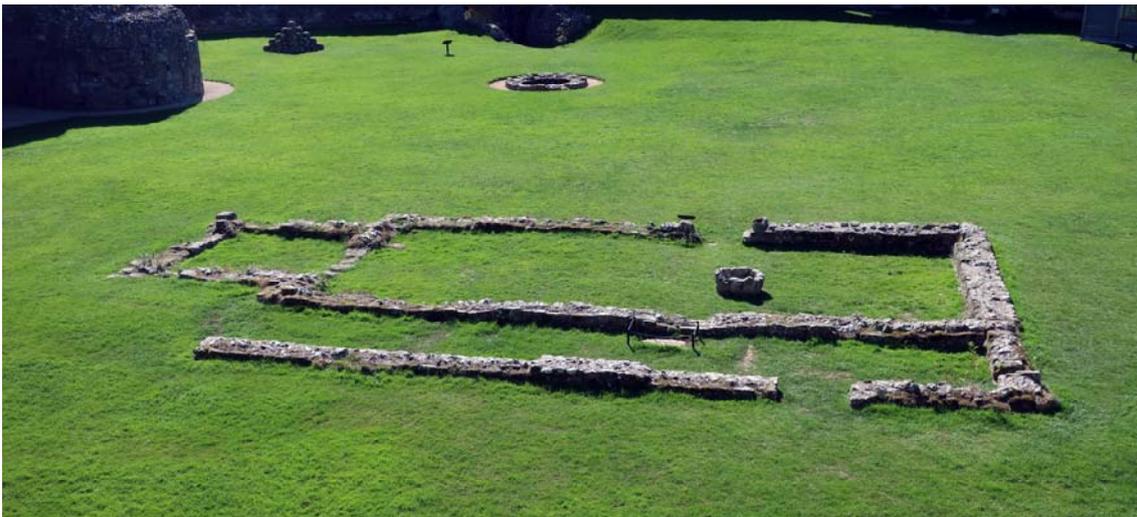
Fig 22: The footings of the chapel in the centre of the medieval castle, with its chancel to the east (left), could not predate the creation of the medieval castle in the mid-13th century (Investigator Photograph)

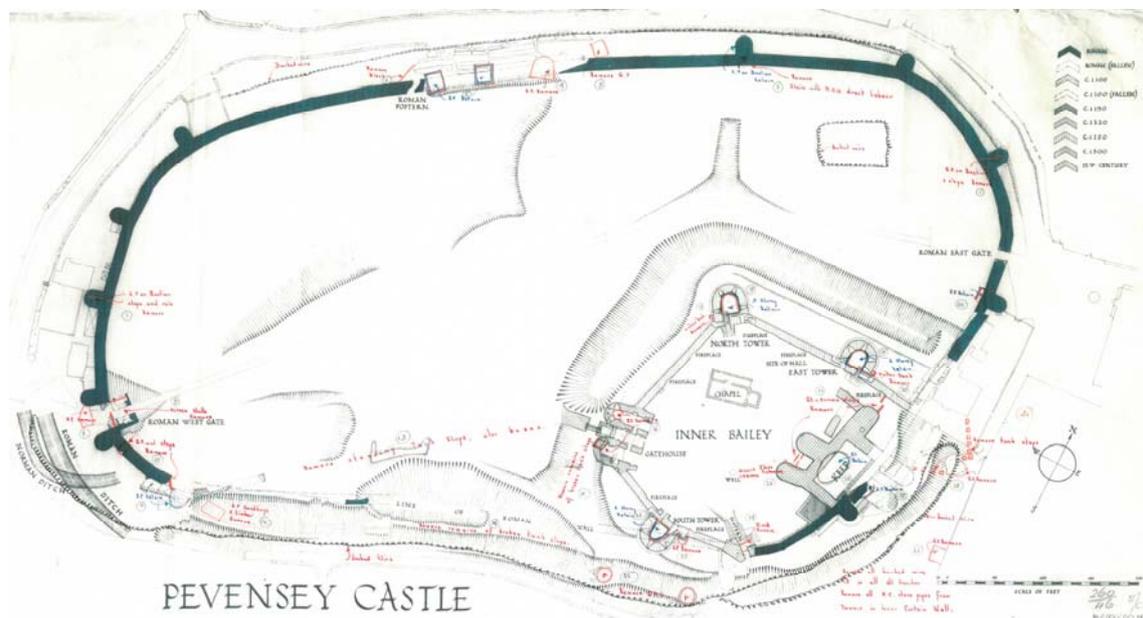
Fig 23: 1940s plan showing some of the military defences being removed; at the east side (right) can be seen the missing section of Roman wall facing towards the village (NMR MP/PEV0043)

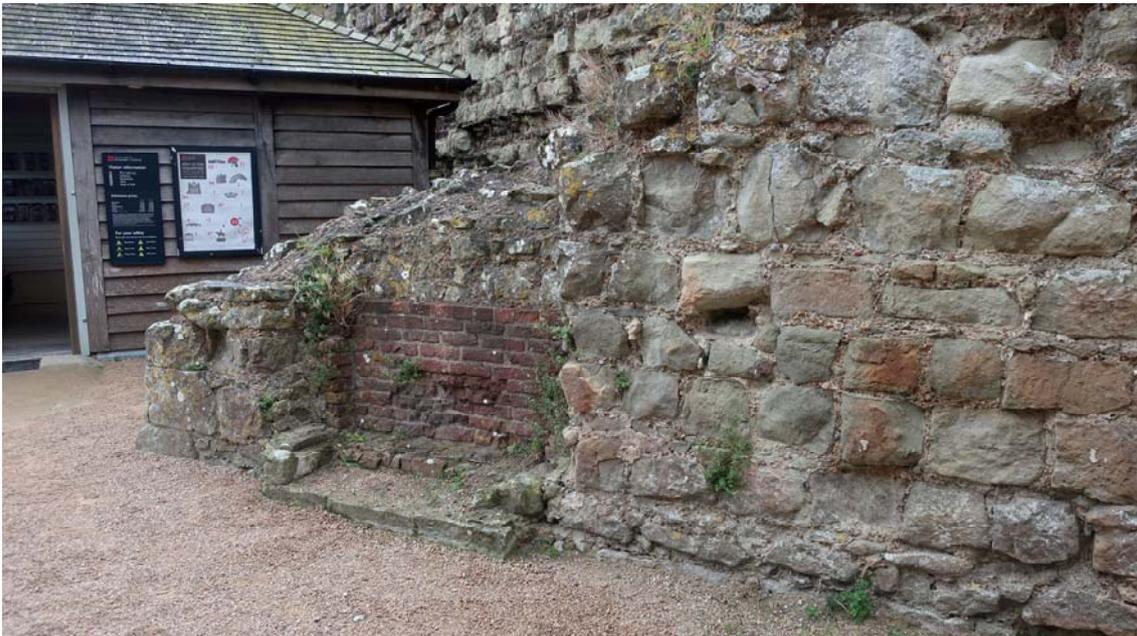
Fig 24: In the south turret of the gatehouse, the eastern room on the ground floor has bricks in the rear of its fireplace (Investigator Photograph)

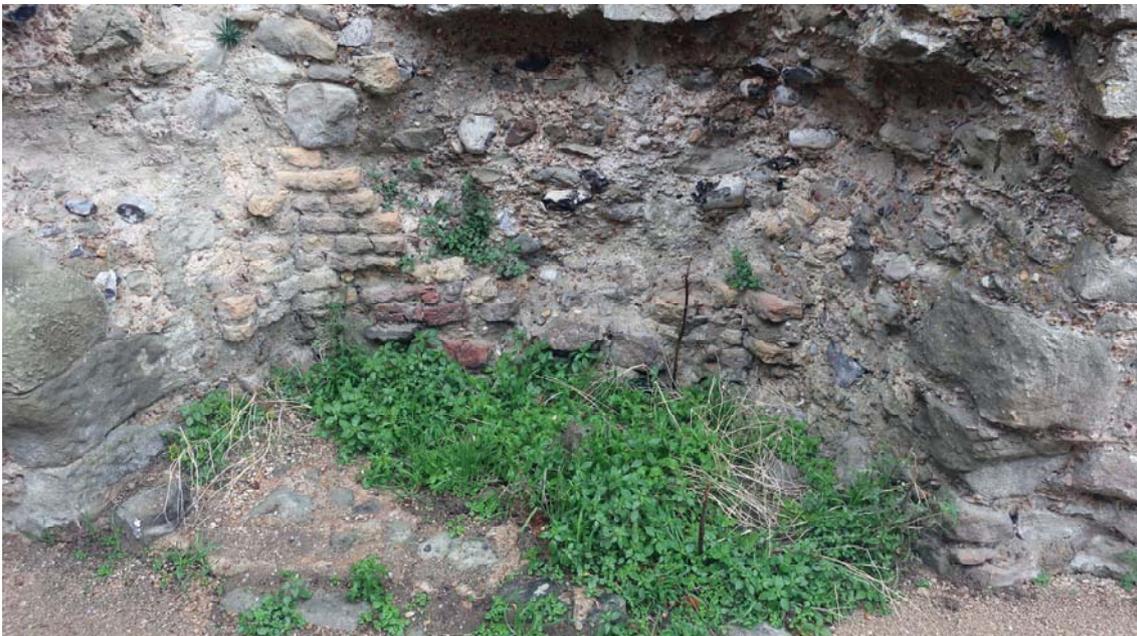
Fig 25: The north turret of the gatehouse also has bricks in its fireplace, though most of these have a distinctly reset quality (Investigator Photograph)

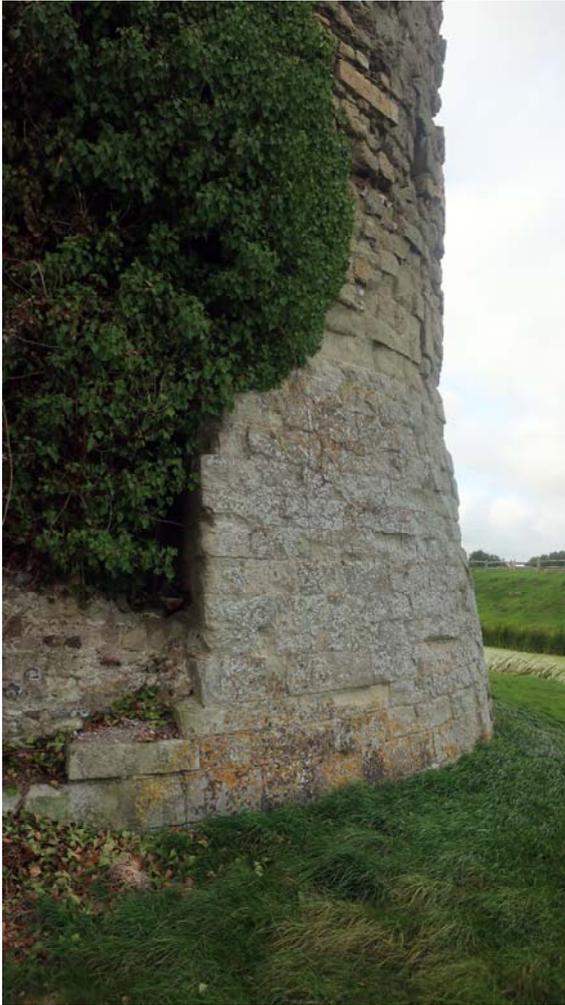
*Fig 26: The robbing of the ashlar ends abruptly on the north tower because this was where the moat as it existed in the 19th century prevented access to the walls
(Investigator Photograph)*

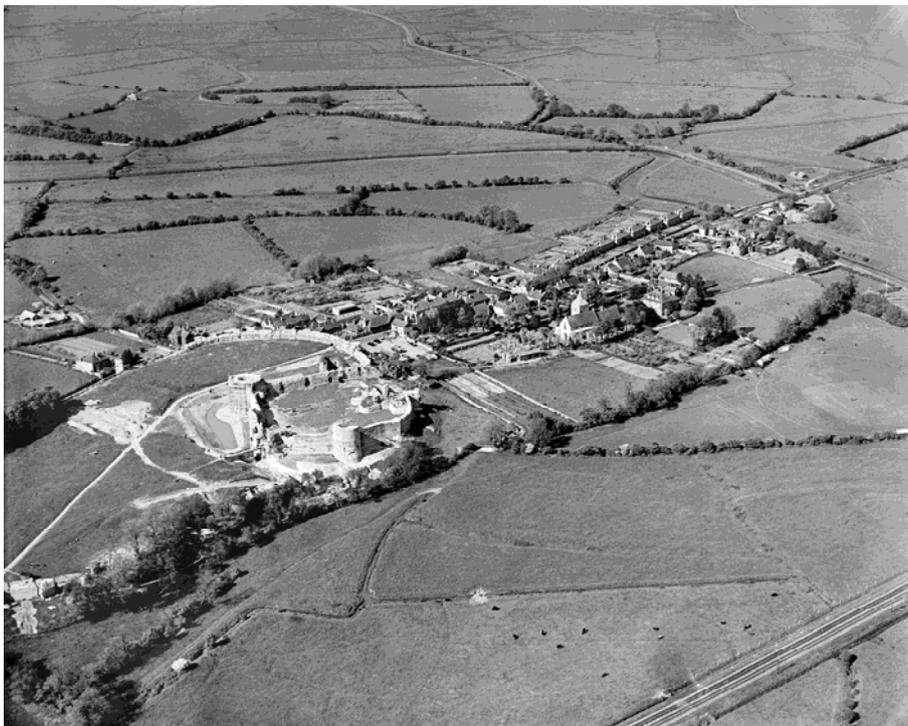
Fig 30: Aerofilms photograph, 25-May-1931, looking north-east across the eastern end of the castle and Pevensey village; scaffolding is visible on the north tower and the moat ditch is newly cleaned AFL19310525 EPW035326 ©Historic England Archive. Aerofilms Collection

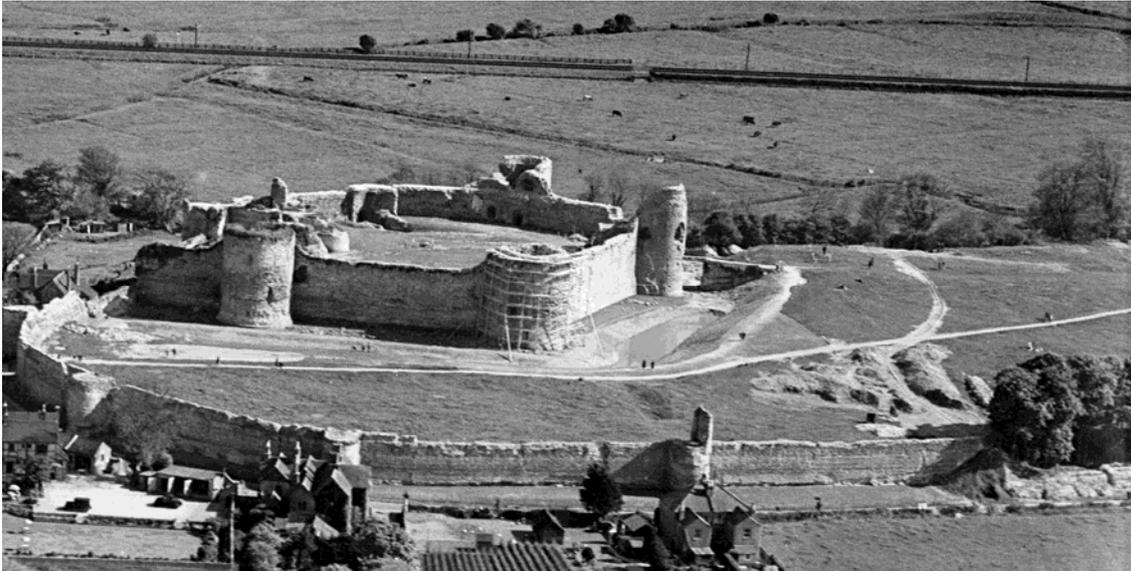
Fig 34: Extract from Fig 32, looking south, showing the north tower encased in scaffolding and piles of excavated material dumped on the near-side of the path through the bailey (to the right of the castle) ©Historic England Archive. Aerofilms Collection

The work undertaken by the MoW after the castle came into state guardianship in 1925 entailed repair to the medieval towers and curtain wall, clearing and re-damming the castle moat. It also involved removal of the mound of clay which partly sealed the remains of the Norman keep. The Aerofilms photographs from 1931 clearly show consolidation work under way (see Fig 30; Fig 34). The north-west tower of the inner bailey is still encased in scaffolding and the ruins of the keep have been exposed. The bare soil around the castle moat suggests that it had recently been cleared. It is already holding water around the northern and western sides. There is widespread evidence of on-going clearing and building works and what appear to be piles of newly excavated material on the north side of the path within the outer bailey, presumably removed from the ditch and keep.

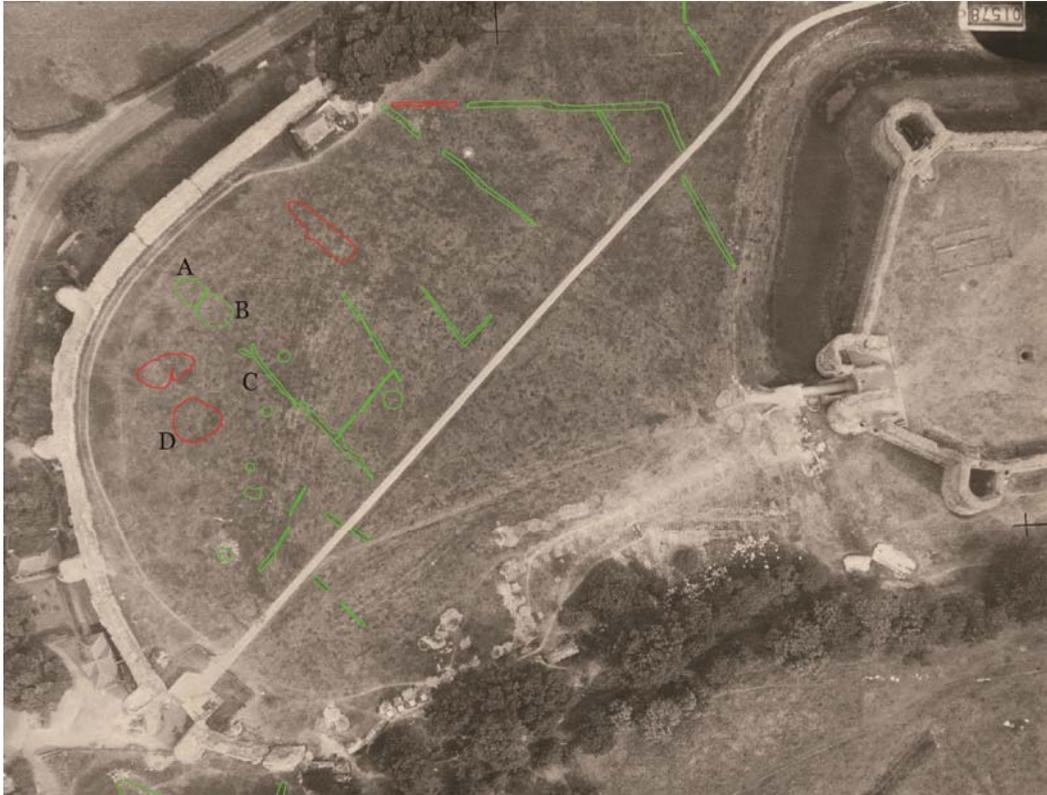
Fig 39: Archaeological remains transcribed from aerial photographs (green- ditch, red- bank), including earthworks and some buried remains seen as cropmarks, overlaid on the 1940 aerial photograph ©Historic England RAF/26C/UK/1442 1578 21-AUG-1940 Historic England RAF Photography

In addition to the masonry remains, there is evidence of a number of hollows, mounds and ditches seen as slight earthworks or cropmarks within the outer bailey (Fig 39). These can be compared with Salzmann's plan of his trenches dug between 1906 and 1908 in the northern half of the Roman fort (Fig 40).

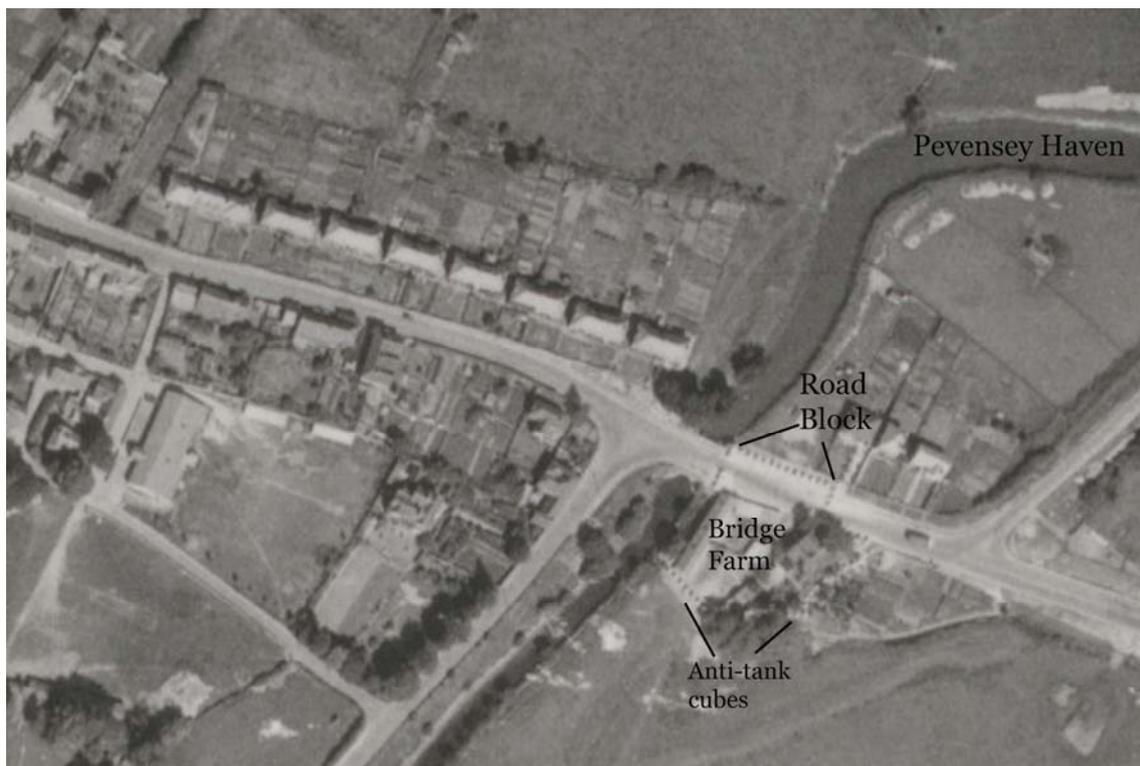
Fig 43: Extract of RAF photograph showing the road block and defended area at Pevensey Bridge and Bridge Farm RAF/26J/UK/1058/VC 6 29-JUL-1940 Historic England RAF Photography

Outside the castle, in the village of Pevensey and beyond Pevensey Bridge to the east, further anti-tank cubes form a heavily defended road block across the road to Bexhill. Concrete blocks also enclosed Bridge Farm to the south of the road on the eastern side of Pevensey Haven (Fig 43).

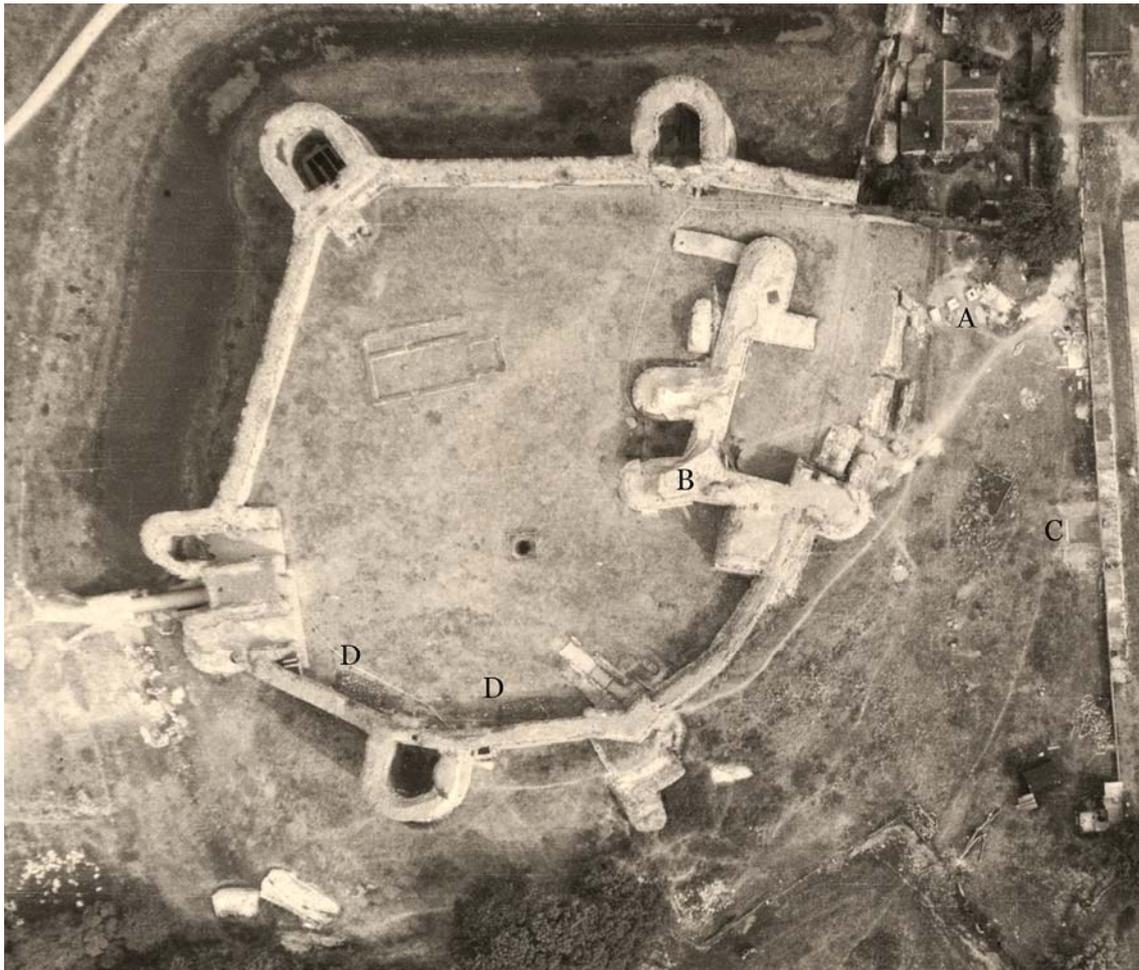
*Fig 46: Extract of 1940 RAF vertical showing details of military insertions and traces of on-going building works within and around the Norman castle
RAF/26C/UK/1442 1576 21-AUG-1940 Historic England RAF Photography*

The August photographs also capture continued construction both inside the inner bailey and outside the keep to the east of the castle where several ladders, cordons and platforms are visible (Fig 46). Further anti-tank cubes (A) can be seen blocking a gap between the end of the outer ditch and a house which abuts the eastern castle wall – these may have been in place in July 1940, but could not be seen on the photographs. The aerial photographs also record the pillbox constructed on top of the south-western tower of the keep (B) and the foundations of pillbox or gun

Against the southern inner bailey curtain wall there were piles of the numerous medieval stone ammunition balls (D) for trebuchet or other engines of war (not cannon) excavated from the castle ditch in the 1930s (Peers 1985, 26). These remained there until at least 1951 when they were recorded on aerial photographs (see Fig 55 below). The anti-tank defences on the west gate are clearer on 1951 aerial photographs, showing the staggered obstructions guarding the entrance and the concrete screen walls built inside the entrance.
