Pevensey Castle, Pevensey, East Sussex: architectural, archaeological and aerial investigation

Architectural, Archaeological and Aerial Investigation

NGR: TQ 644 047

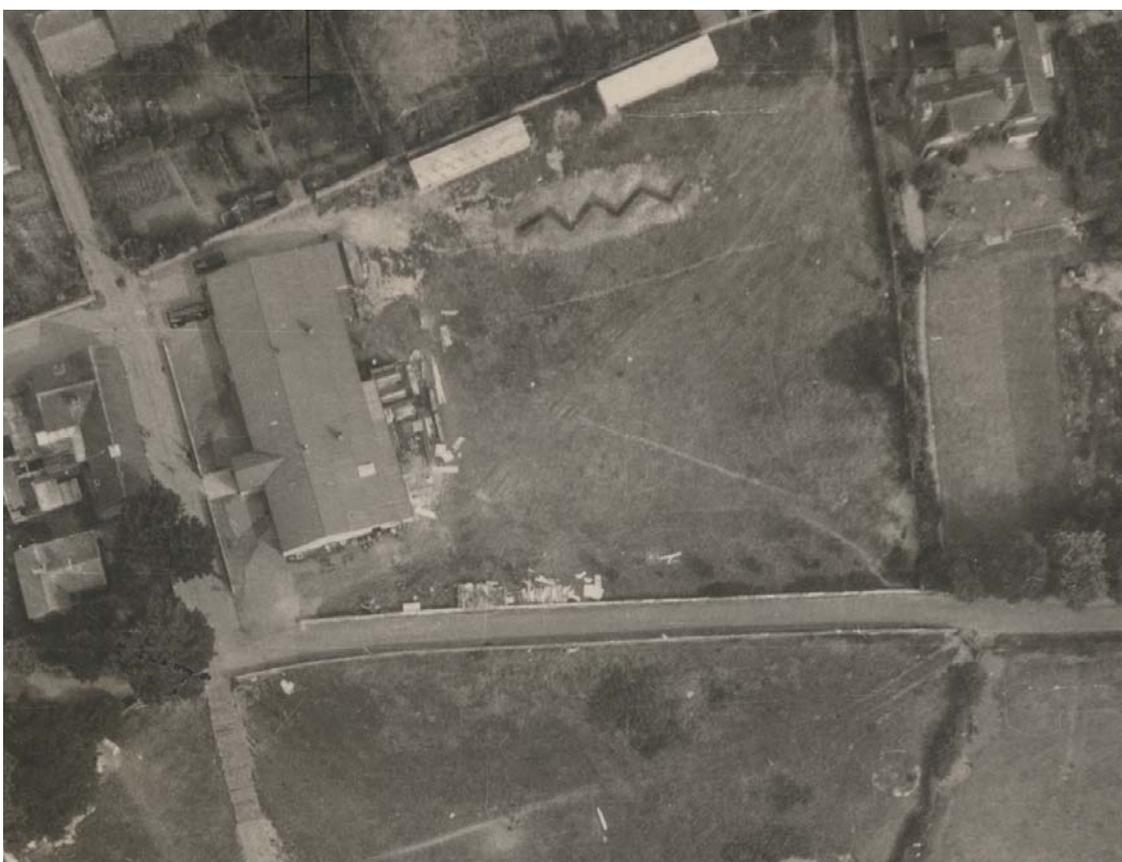
Fig 47: Second World War trenches behind the fire station in Pevensey village visible in an extract of a 1940 RAF vertical photograph. This site was subsequently occupied by a hutted camp RAF/26C/UK/1443 1573 21-AUG-1940 Historic England RAF Photography

Two bell tents recorded on the July 1940 aerial photographs are still in place in August 1940 on either side of the path inside the west gateway. All other insertions and alterations to the castle are obscured from view or within the fabric of the castle walls. Outside the castle walls there is some evidence of wartime preparations including a long zigzag trench, probably an emergency air raid shelter, behind the fire station on the southern side of the main street (Fig 47).

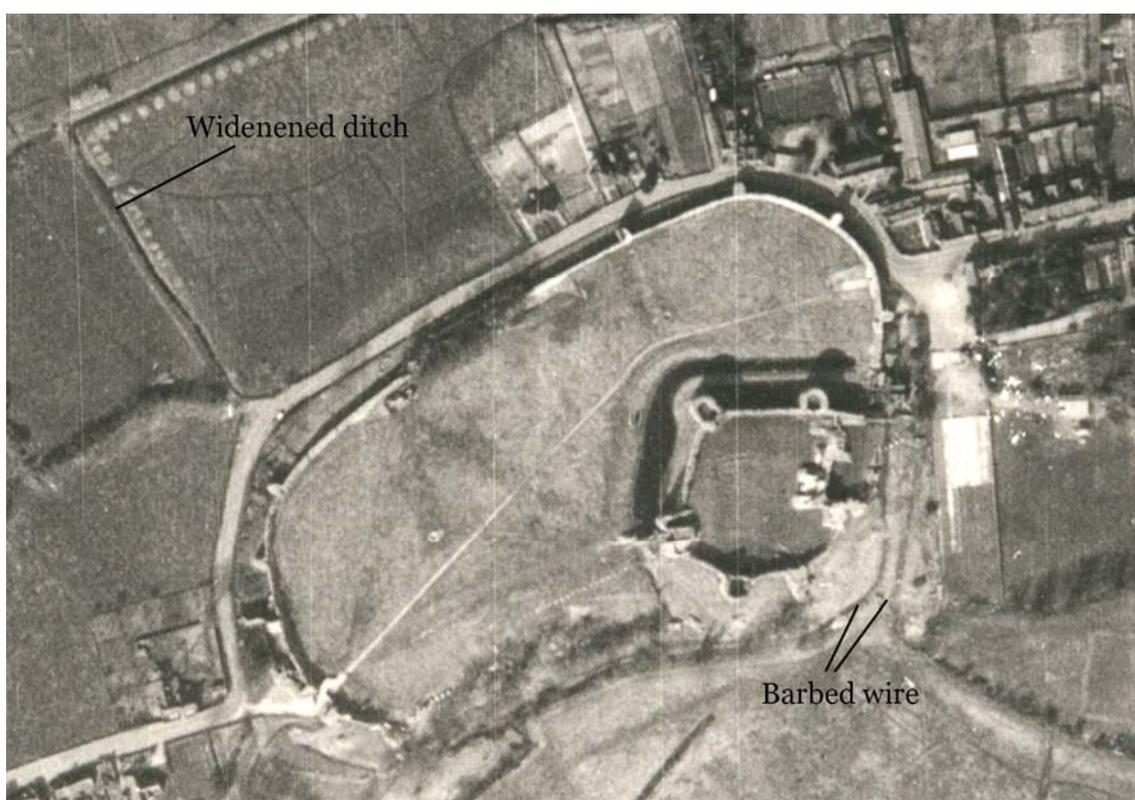
Fig 48: Extract of RAF vertical showing traces of barbed wire entanglements around the south-east corner of the castle and widened ditches to the north, to impede access from low-lying ground. Note the presence of the pond on the outside of the walls RAF/HLA/430/RV 6044 26-MAR-1942 Historic England RAF Photography

As well as the 1940 sortie there was also aerial reconnaissance covering Pevensey by the RAF on 26th March 1942. These were another high-altitude set of verticals in which details were hard to discern (Fig 48). The interior of the castle appears little changed since 1940, apart from the removal or grassing over of the disturbed ground resulting from the fortifications carried out in 1940. The faint course of a number of lines of barbed wire can be seen extending around the south side of the castle from the west gate to just east of the ruined keep, providing further obstructions alongside the castle's ditch. Also of note is the clearing and widening of the drains around a large field to the north of the castle and another on the eastern edge of Pevensey village, possibly to act as anti-tank ditches intended to impede access from the marshes to the road network. Within Pevensey village a small military camp comprised huts extending across three fields east of the church, including the area around the fire station (Fig 49). This camp may have served as supplementary accommodation to that provided within the castle for troops manning the defences. Oblique photographs taken in 1948 by Aerofilms clearly show a mixture of Nissen huts and pitched-roofed huts (see Fig 53 below) The zigzag ditch of the air raid shelter by the fire station appears to have been covered over or filled in and was partly obscured by a large hut or building.

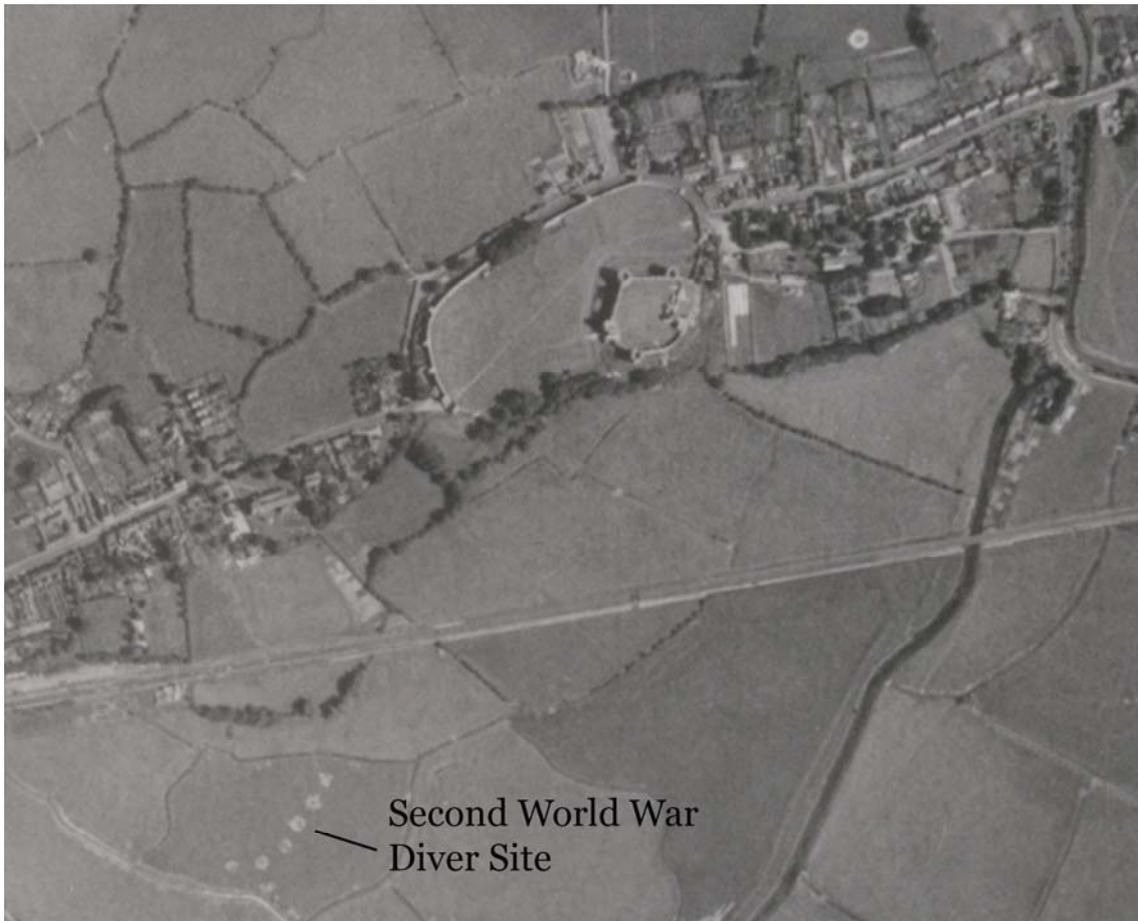
Fig 50: 1945 aerial view of Pevensey showing the traces of a Diver Battery – the location of six mobile anti-aircraft guns installed to counter the German V1 and V2 rocket raids. Extract of RAF/3G/MEW/T5/V 5144 08-JUL-1945 Historic England RAF Photography

Pevensey was photographed by the RAF again in July 1943, but the small scale and poor clarity of the photographs means that little detail of the castle and surrounding area can be discerned. The next set of reconnaissance photographs were taken by the RAF in July 1945 (Fig 50). Again, these are high-altitude vertical photographs which, though being at small-scale, show Pevensey just over two months after the end of the war in Europe. It is not possible to make out much detail, but the hutted camp is still present within Pevensey village. However, it is not possible to tell if the camp is still in use. To the south of the railway line and Westham village at TQ 6418 0426 the traces of a Second World War DIVER Battery (Coastal Gun Belt Diver Battery B13 (NRHE 1477145)) can be seen as an arc or flattened V of six pale sub-circular marks (Fig 50). Each mark indicates the position of a mobile anti-aircraft gun set on a portable Pile platform of steel rails, filled with ballast. Within the arc was the command post which typically left a smaller rectangular mark, most noticeable on the two southern sites (Lowery *et al* 2001, 61-2; see Fig 51).

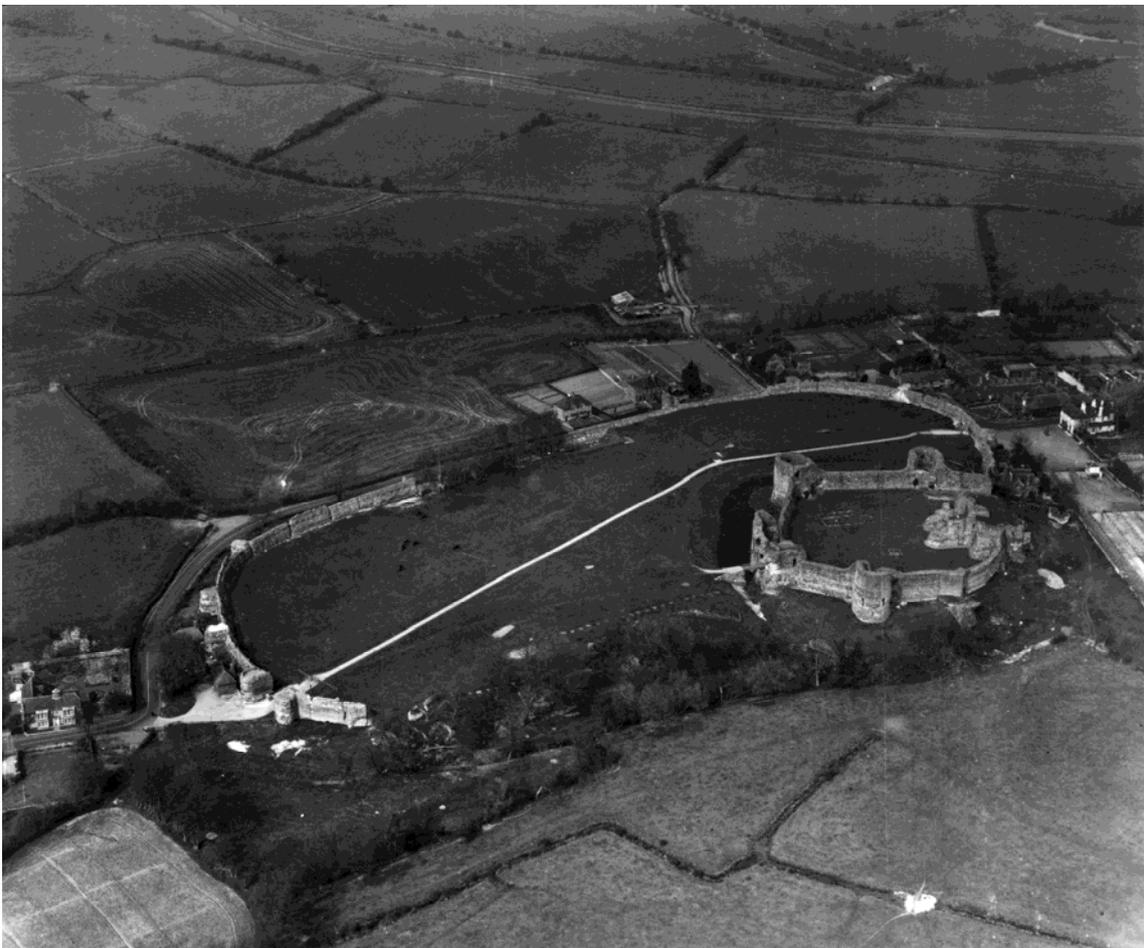
Fig 52: The castle from the south AFL19480413 EAW014353 13-APR-1948 ©Historic England Archive. Aerofilms Collection

The 1945 aerial photographs also recorded the possible gun emplacement or pillbox placed against the wall of the former cattle market to the east of the castle. These were no longer there in 1948 when Aerofilms photographed the site (Fig 52). However, the locations of the anti-tank cubes can still be seen as bald patches in the grass of the outer bailey and there are clear signs of recent removal of defences at the west gate. Also of note is the absence of the pound and cowshed which were present through the war. The 1948 Aerofilms photographs also record the Nissen huts within the military camp still extant to the east of the church (Fig 53). All huts with the exception of the pitched-roof hut had been removed by 1951 (Fig 54).

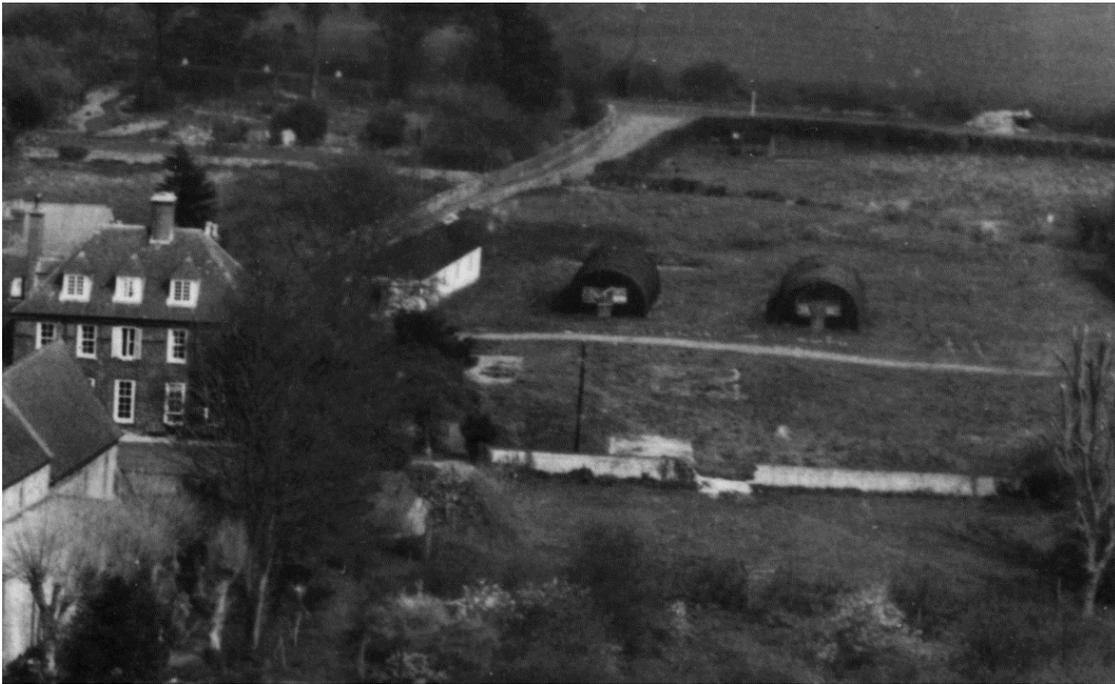
Fig 53: 1948 Aerofilms oblique aerial photograph showing part of the military camp to the east of the church with Nissen huts, a pitched roofed hut and concrete hard-standings of three removed huts in the foreground AFL19480413 EAW014357 13-APR-1948 ©Historic England Archive. Aerofilms Collection

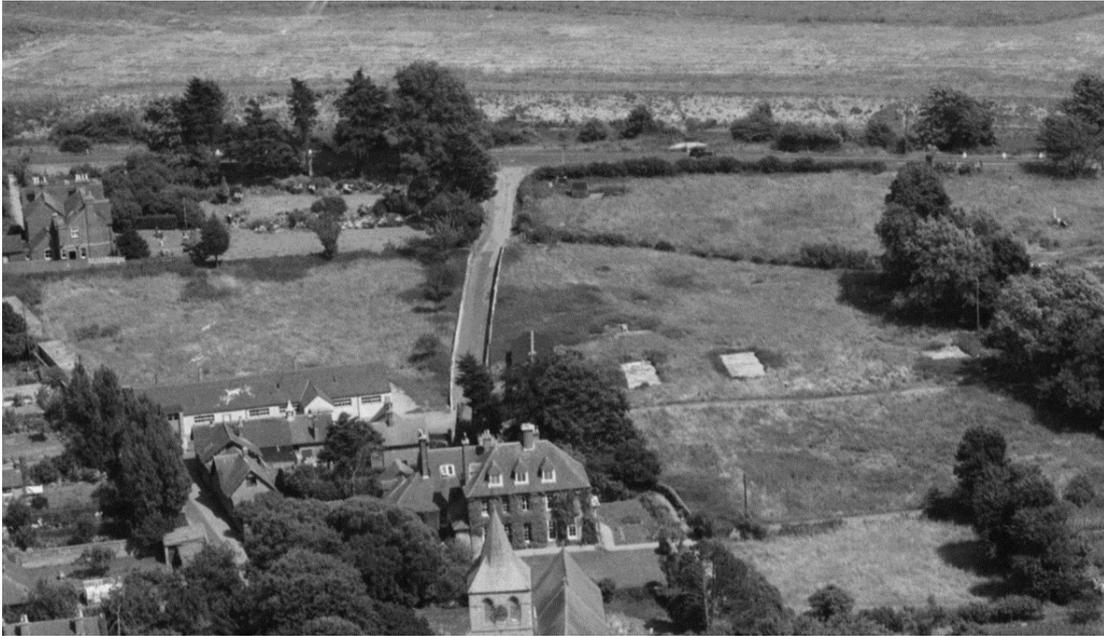
*Fig 54: Aerofilms oblique aerial photograph showing the last surviving building – a pitched roofed hut (roof just visible above the trees in the centred of the photograph) and concrete hard-standings of the military camp to the east of the church
EAW037831 AFL19510717 17-JUL-1951 ©Historic England Archive. Aerofilms Collection*

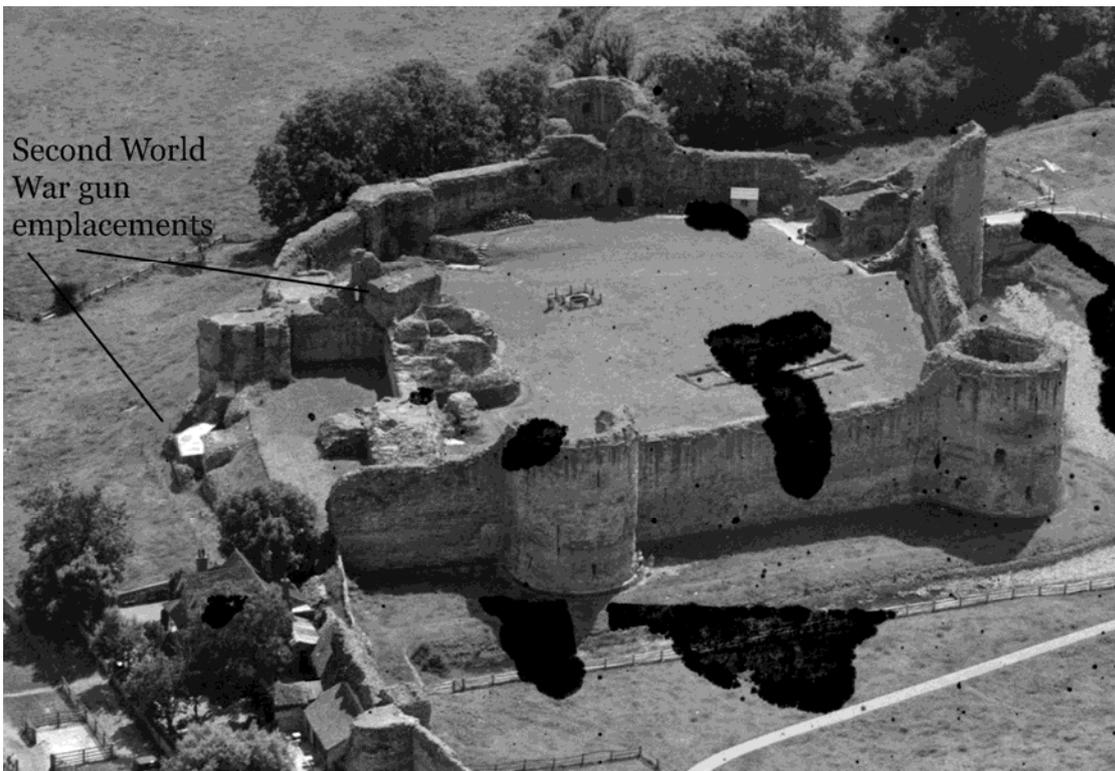
Fig 55: Retained Second World War defences within the keep and fallen masonry visible in 1951. The large black marks are photo blemishes. Extract of Aerofilms vertical photograph ALF19510717 EAW037830 17-JUL-1951 ©Historic England Archive. Aerofilms Collection

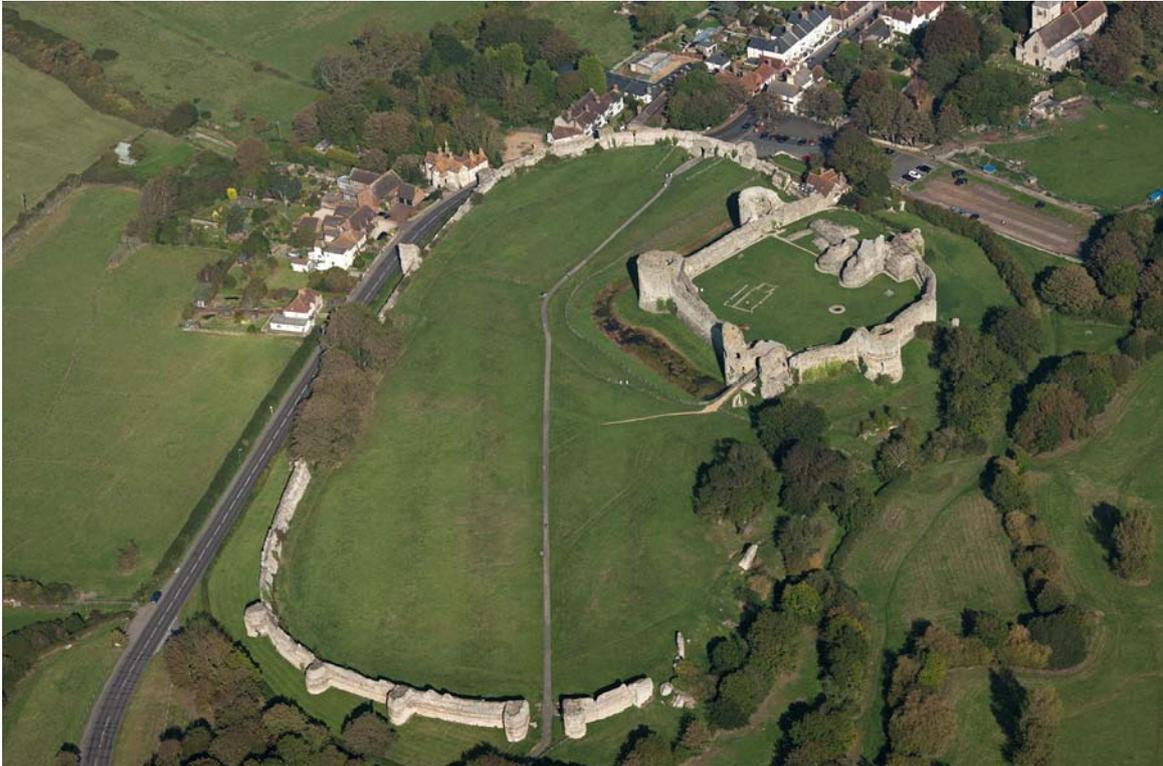
Fig 56: Oblique view of Pevensey Castle from the west, September 2011 HEA 27303/029 29-Sep-2011 ©Historic England

Comparing the early photographs with the more recent images it is clear that a considerable amount of vegetation and trees have encroached on the site (Fig 56). The moat, which was cleaned and bare of vegetation after the major works undertaken in 1936, appeared overgrown and clogged with weed when photographed during Historic England reconnaissance in 2011 and on the most recent Google Earth aerial photographs from 2016. These recent photographs illustrate how overgrown the areas to the east of the castle and keep are. These show vegetation growing out of the tops of walls and ivy on the walls of both the Roman fort and the medieval castle. Much of this has now been cleared.

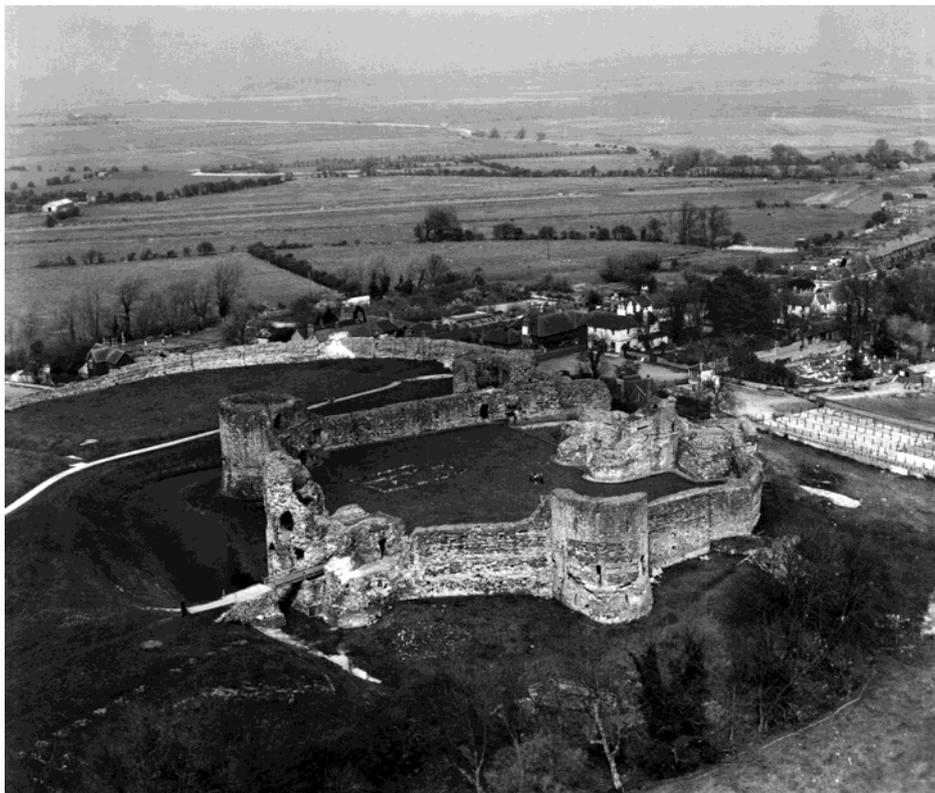
*Fig 68: A line of pale marks in the grass left by the removed Second World War
anti-tank cubes is still visible in the grass (bottom left of image) AFL19480413
EAW014358 13-APR-1948 ©Historic England Archive. Aerofilms Collection*
