Historic England

Farmstead and Landscape Statement

Pevensey Levels

NATIONAL CHARACTER AREA 124

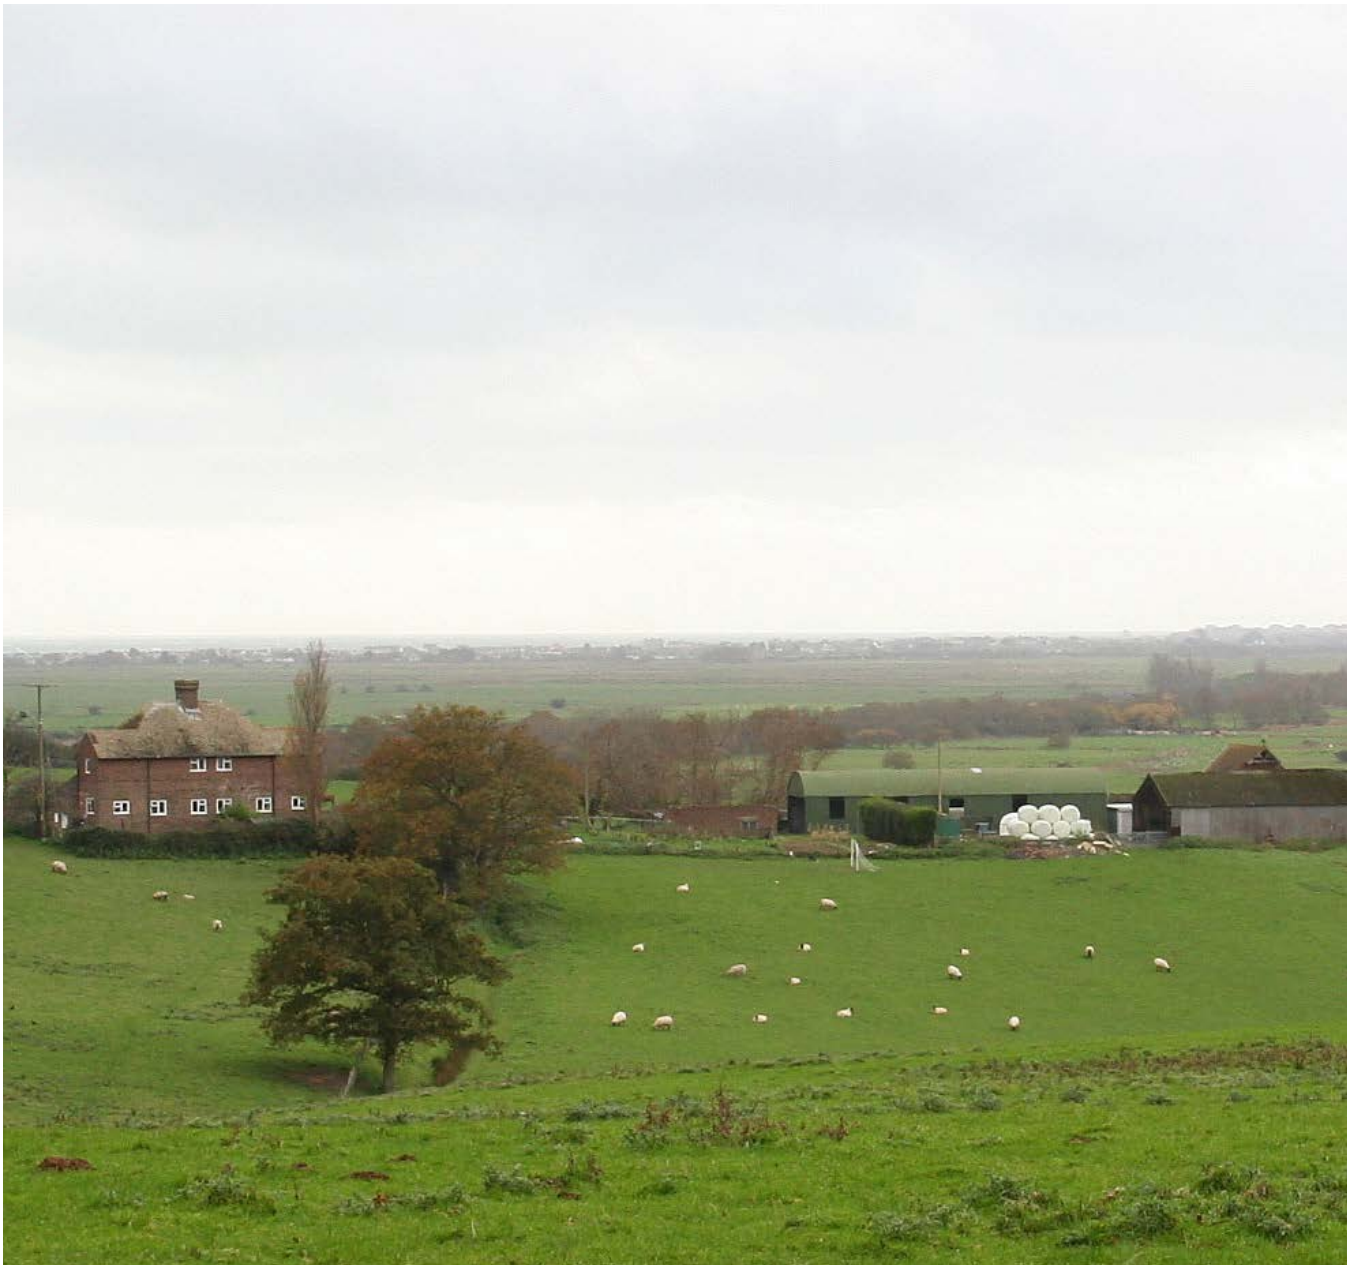
Front cover: A farmstead located on the edge of the reclaimed marshland. Typically, this farmstead is dominated by its large sheds which have largely replaced or obscured its traditional working buildings. Photo © Bob Edwards

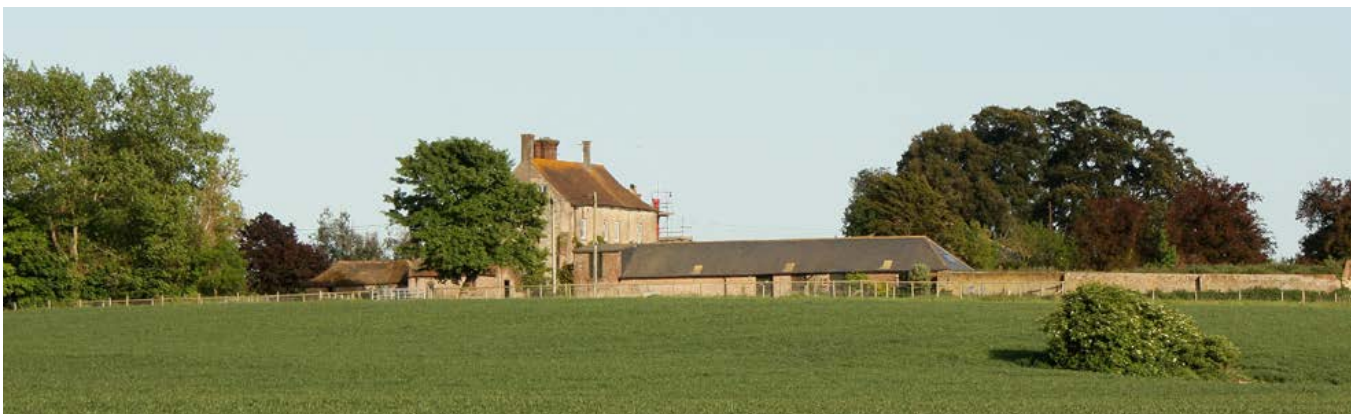
View towards farmstead with a large mid-late 18th century house at Hankham. Photo © Bob Edwards

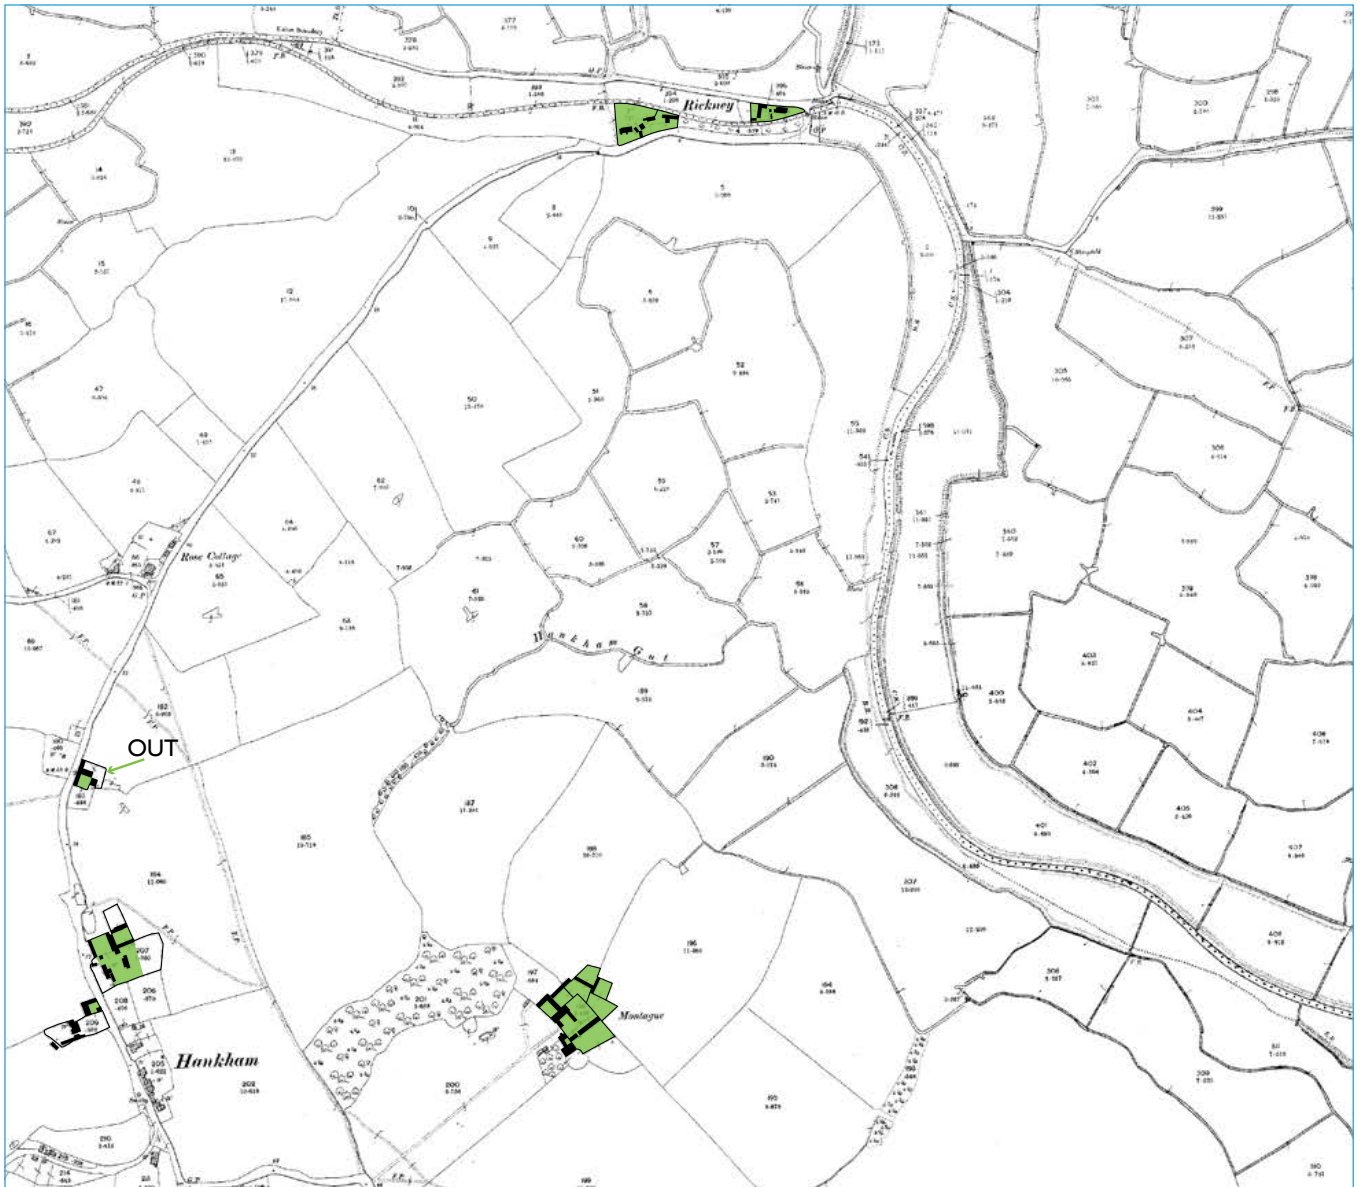
Hankham

Farmstead, showing the buildings in black and the boundaries of the main yards (highlighted in green), working areas and gardens.

The Pevensey Levels Character Area divides into two distinct areas: the flat, reclaimed marshland of the north-eastern part of the area and slightly higher ground to the south-west. This map extract covers the boundary between these two zones. The small, irregular fields of the marshland, largely bounded by drainage ditches, contrast with the larger fields bounded by hedgerows on the higher ground. Farmsteads were concentrated on the higher ground to the south-west and around the edge of the marsh, with few located within the marshes. The larger farms of the area consist of regular multi-yard plans as at Montague, which has a fine group of 18th century buildings, but the majority of farmsteads were of smaller, loose courtyard or dispersed plan types or regular L-plans.

Maps are based on 2nd edition 25" Ordnance Survey maps, which show farmsteads after the last major phase in the building of traditional farmsteads in England. © Crown Copyright [and database rights] 2020. OS 100024900

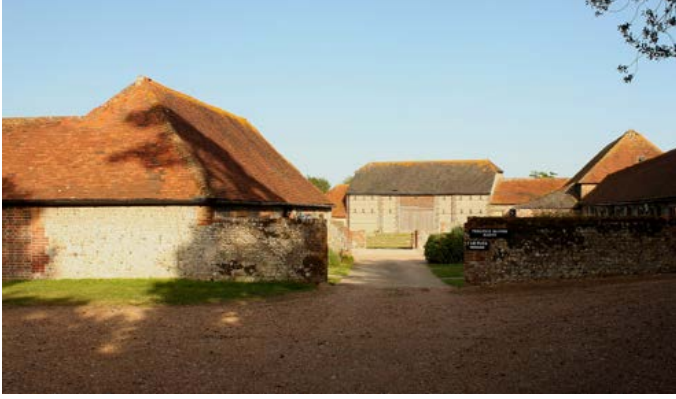
The larger, usually higher-status farmsteads in the area were often of regular multi-yard plan, reflecting the combination of arable farming and stock management. Photo © Bob Edwards

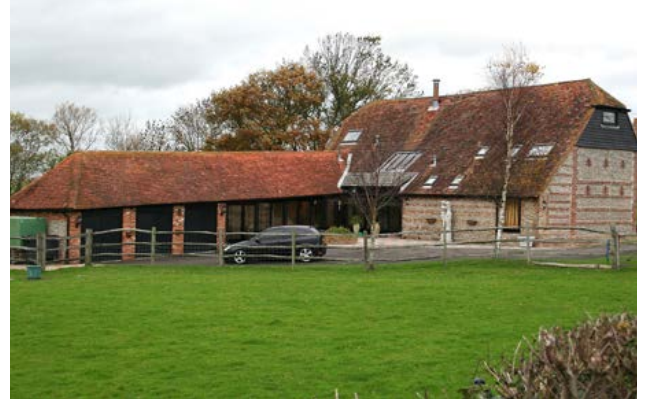
A regular L-plan consisting of a threshing barn with an attached, single-storey range which was probably a shelter shed for cattle. Photo © Bob Edwards

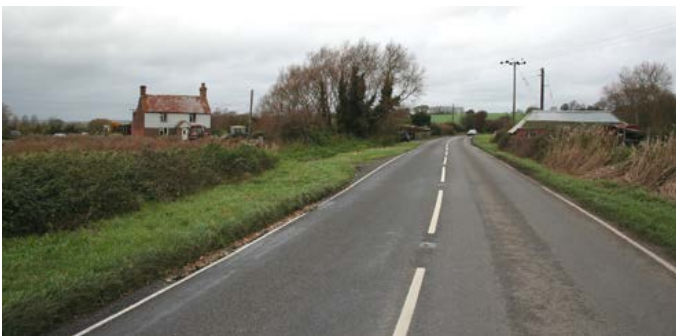
A small, dispersed plan farmstead with its buildings across the road from the farmhouse. Photo © Bob Edwards

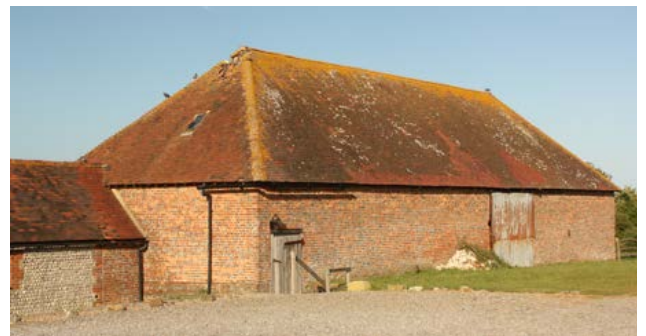
A rare survival of an 18th-century, brick-built barn with a hipped roof. The single door possibly indicates the presence of animal housing in one end. Photo © Bob Edwards

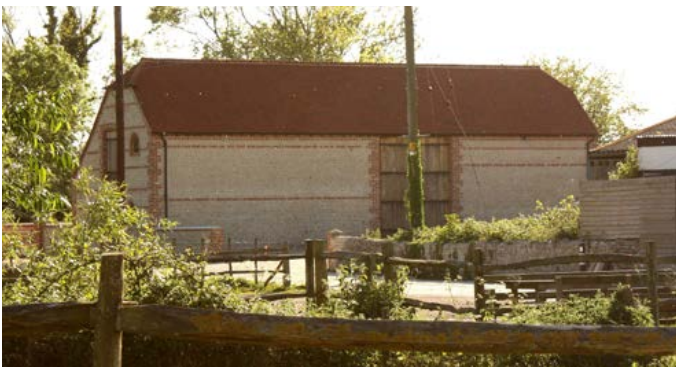
A large threshing barn reflecting the extent of arable on the higher ground to the south-west of the area. Photo © Bob Edwards

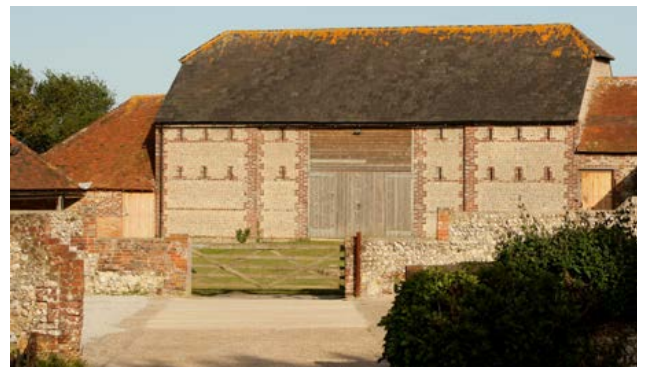
A five-bay, 19th-century barn built of cobble with brick dressings and having a half-hipped slate roof. Photo © Bob Edwards

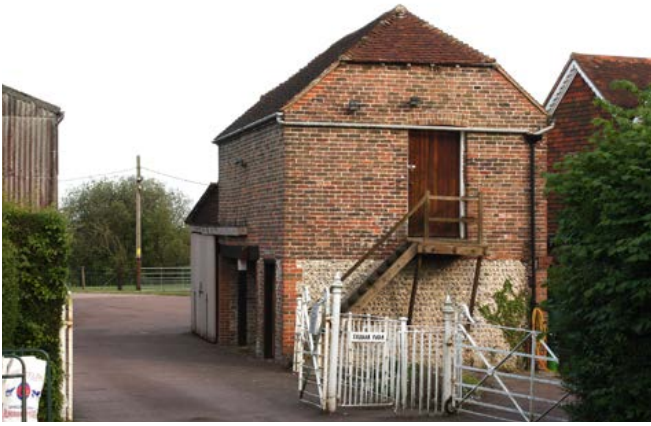
A small stable with a granary above. Photo © Bob Edwards

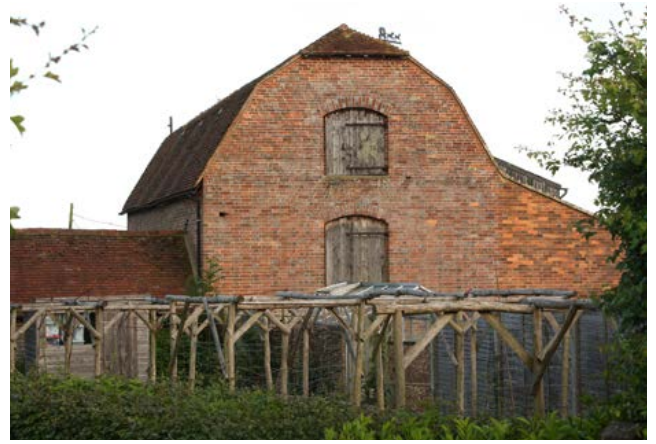
An unusual mansard type roof on this possibly three-storey 19th-century building. Photo © Bob Edwards

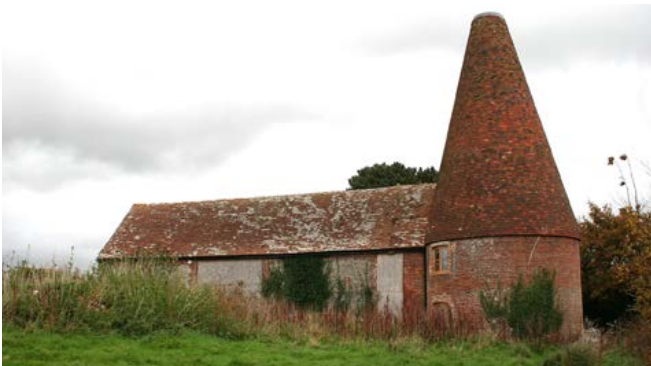
Hops were grown in the area, particularly on the higher ground to the south west, and there are several surviving oast houses. Photo © Bob Edwards

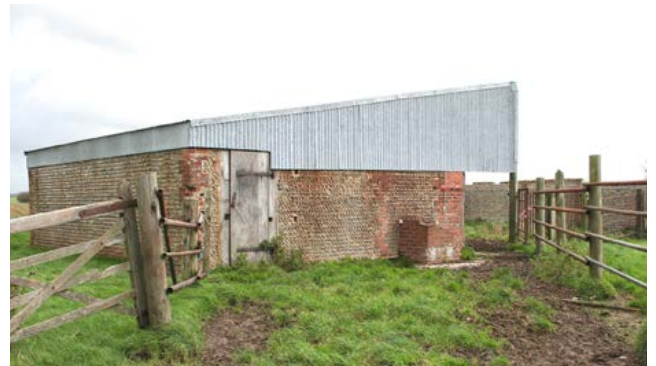
Outfarms and field barns were a common feature of the landscape in both the marshes and on the higher ground. Many have been lost or are ruinous as is the case of this field barn. Photo © Bob Edwards
