Cusgarne Manor Farmhouse
Higher Cusgarne
Gwennap
Cornwall

Tree-ring Analysis of Oak, Elm, and Conifer Timbers

Research Report Series 213-2020

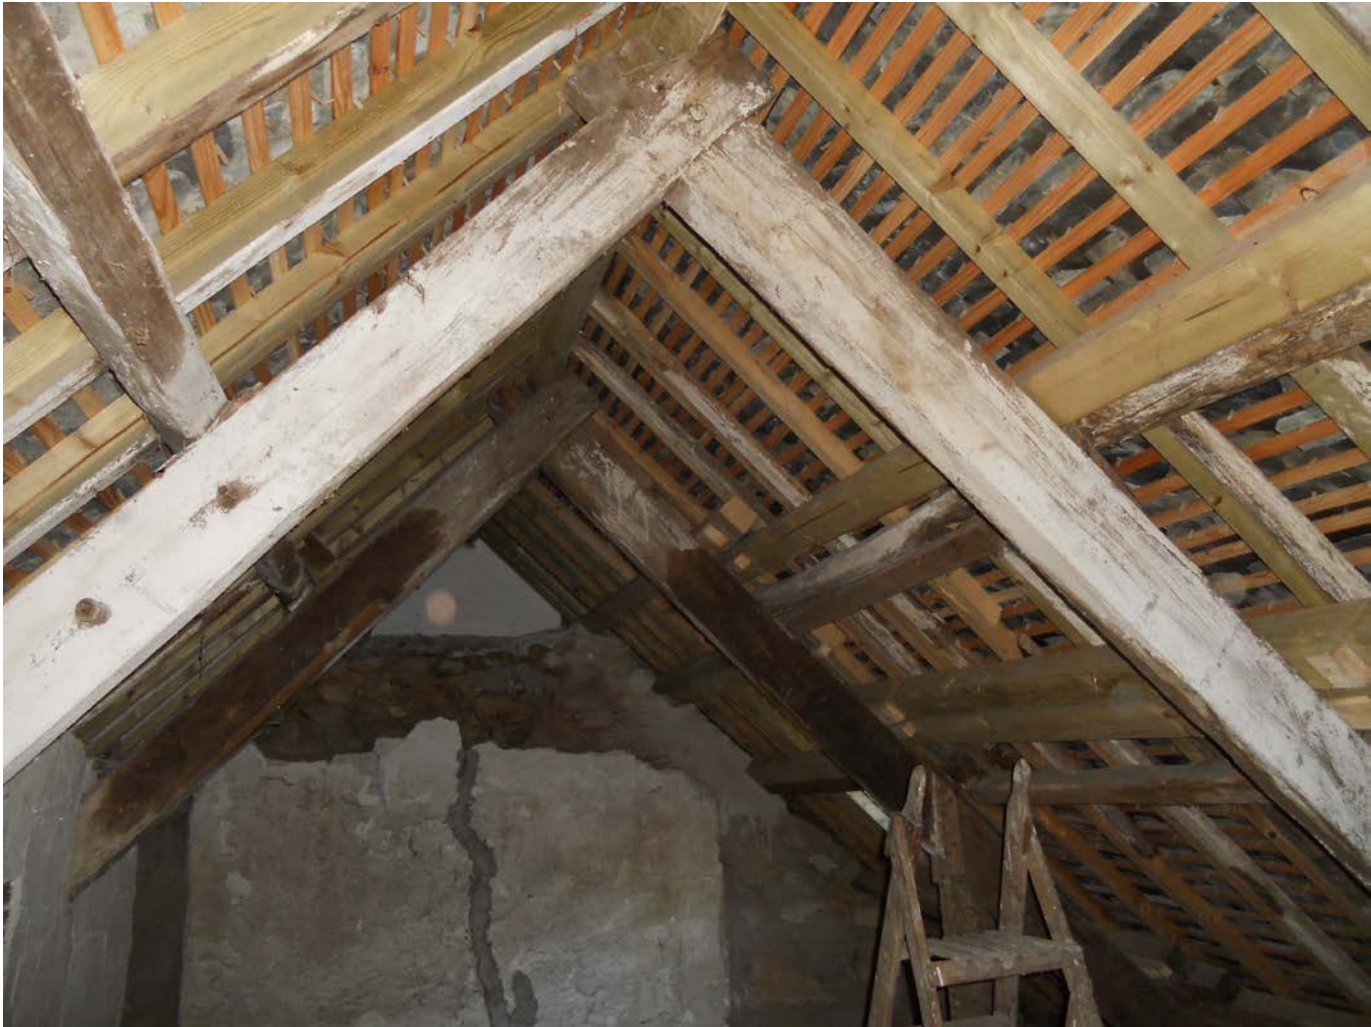
Figure 3: View of the roof, looking west, showing small scantling conifer timbers (photograph Martin Bridge)

Some window lintels of possible seventeenth- and eighteenth-century origin had been extracted and were available *ex situ* for sampling. The roof over the main range is of crude construction, made of coniferous wood, with tiebeam, principal-rafter, and queen-strut construction using timbers of small scantling. It has two tiers of purlins which sit on the principals with no trenching. Many of the joints are nailed, rather than pegged. This is assumed to be a replacement roof.
