The Malt House
Blacker Hall Farmhouse
Wakefield
West Yorkshire

Tree-ring Analysis of Oak Timbers

Research Report Series 206-2020

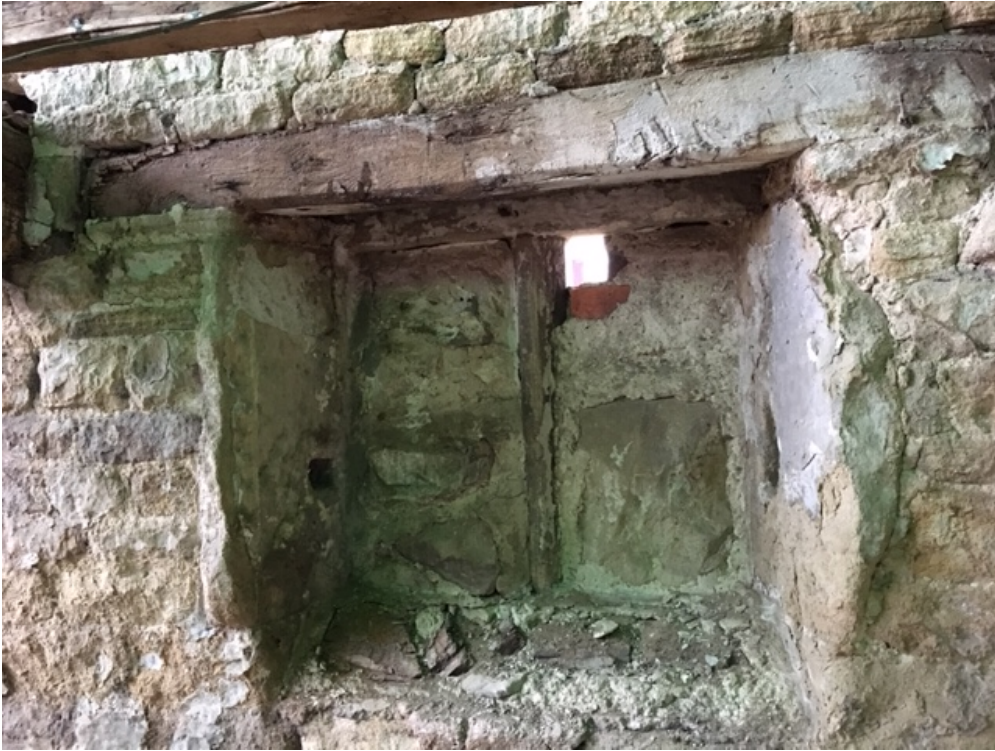
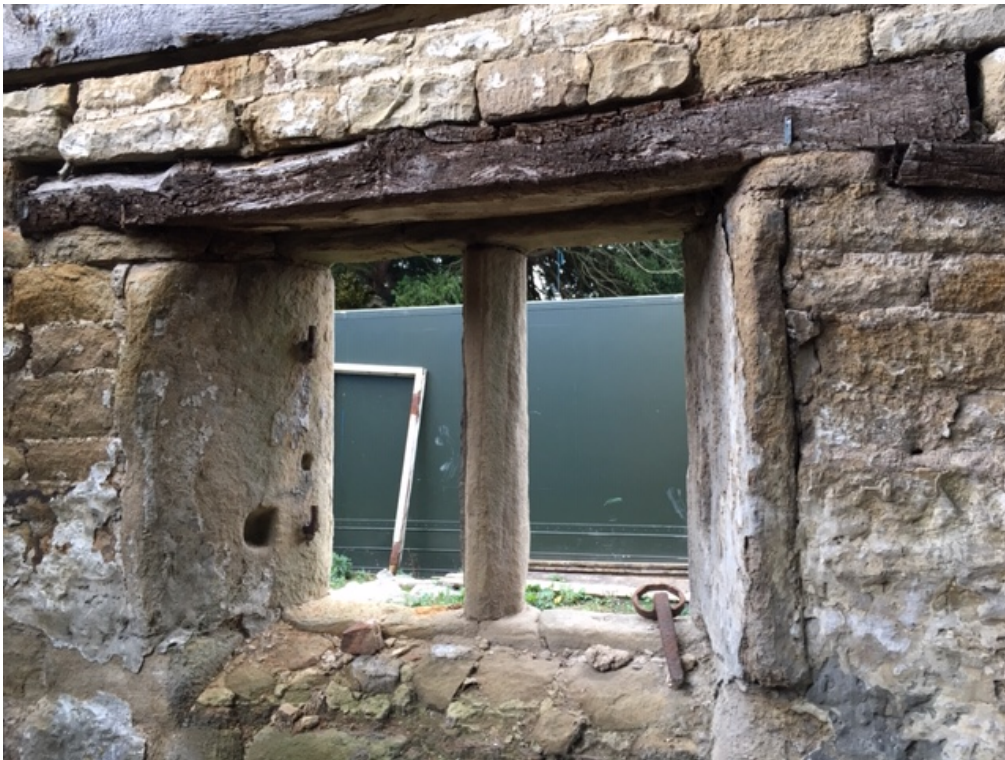
Figure 4a/b: Windows in the east wall (above and below), photograph taken from the west (Alison Arnold)

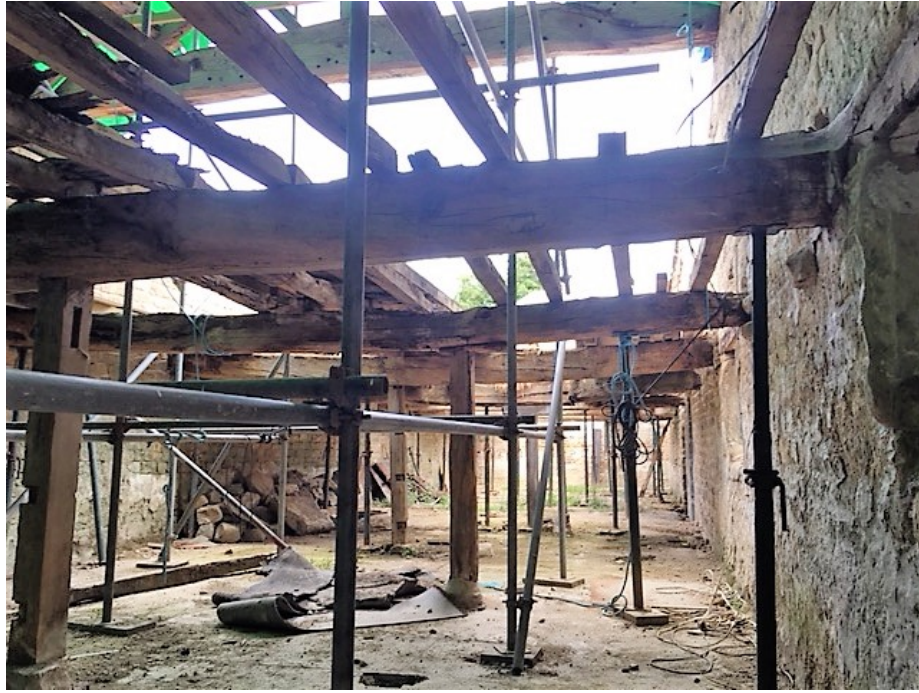
Figure 5: Floor structure, beam 4 in foreground, photograph taken from the south (Alison Arnold)

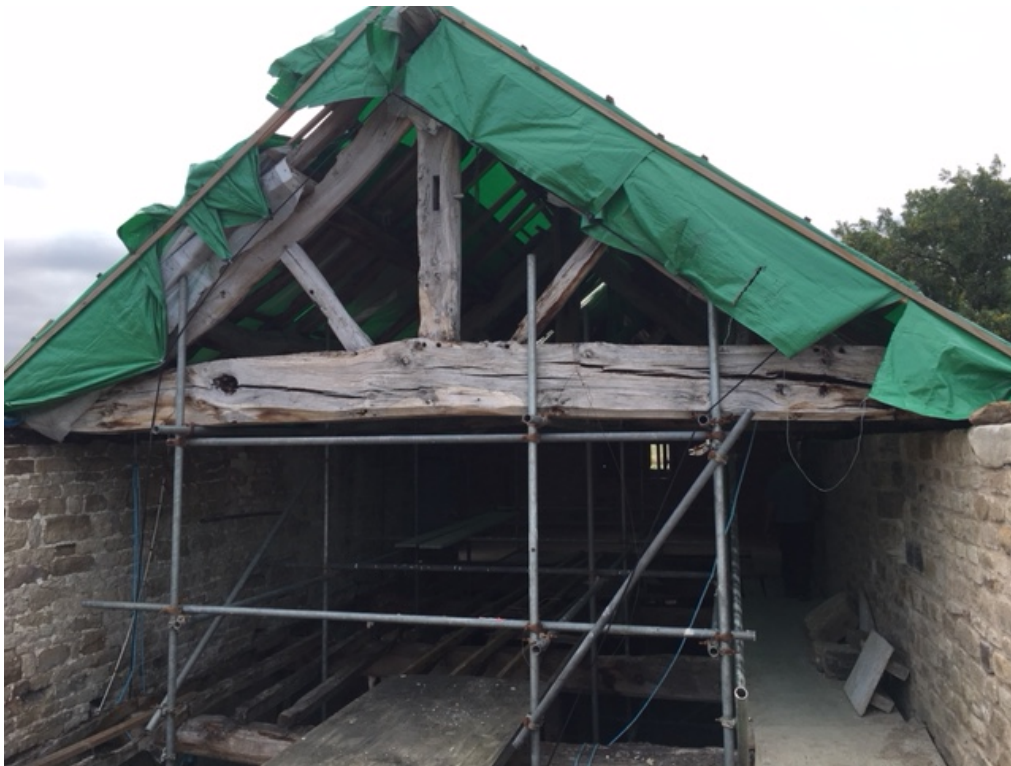
Figure 6: Truss 3 showing principal rafters, single angle struts, and straight braces to a diamond-set ridge. Photograph taken from the north (Alison Arnold)

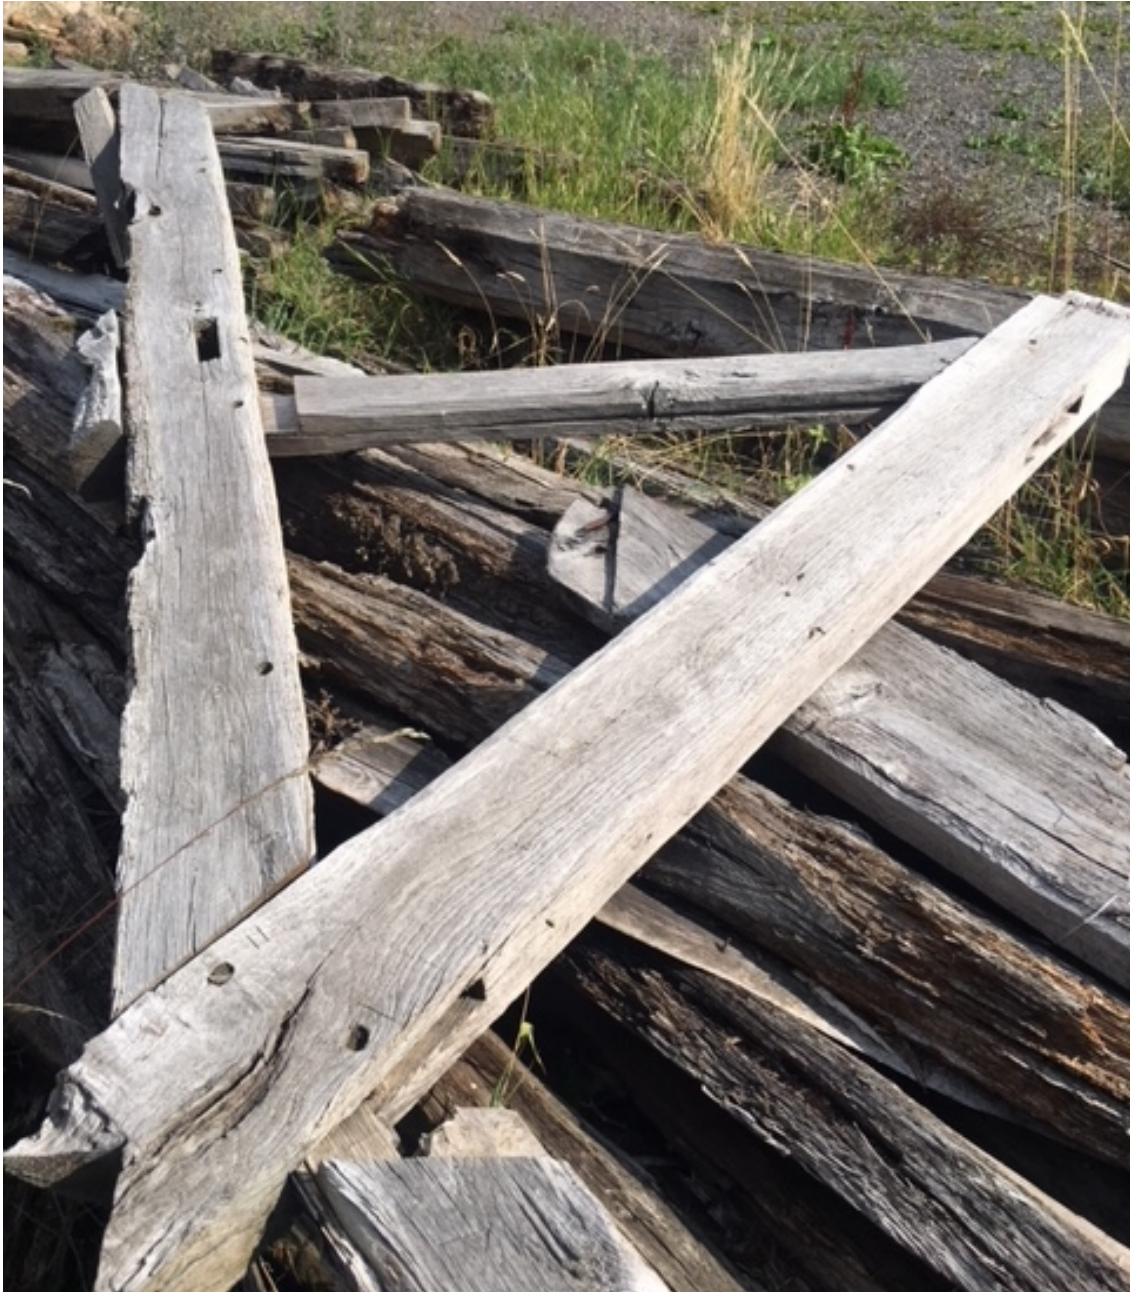
Figure 7: Pile of ex situ timbers, possibly discarded original trusses (Alison Arnold)

The Malt House, an early-mid seventeenth-century Grade II* listed building (LEN 1135604), is located approximately 15 metres south-west of Blacker Hall Farmhouse (Fig 1). The main building is of two storeys and seven bays with a single bay outshut to the south and an attached gabled kiln to the north end (Fig 2). Entry to the ground floor is via a Tudor-arched doorway with chamfered surround (Fig 3), to the north of which are two two-light double-chamfered mullioned windows (Fig 4a/b). Access to the lime-ash first floor is via a flight of stone steps. The floor is supported by a series of heavy main beams and common joists (Fig 5). The surviving roof consists of three king-post and stop-chamfered tiebeams, with principal rafters, single angle struts, and straight braces to a diamond-set ridge (Fig 6). Amongst a pile of timbers outside can be distinguished a further tiebeam, a possible crown post and rafters. It is known that two of the original trusses had been replaced with trusses of (probably) eighteenth-century fish-bone king-post type, and these are thought to also be amongst the *ex situ* timbers (Fig 7).

In addition to the *in situ* timbers dated, two of the salvaged timbers have also been dated; these are now known to have been felled in AD 1675–1700. Although it is not possible to identify the location within the building from which these timbers came, it can be seen from the *intra-site* cross matching that they resemble most closely the other roof samples (Table 3). It is, therefore, likely that they represent primary roof timbers salvaged from the collapsed northern half of the roof. It is unfortunate that the *ex situ* timbers thought to be the potentially eighteenth-century replacement roof trusses were unsuitable for analysis, as this therefore cannot be proven by tree-ring dating.

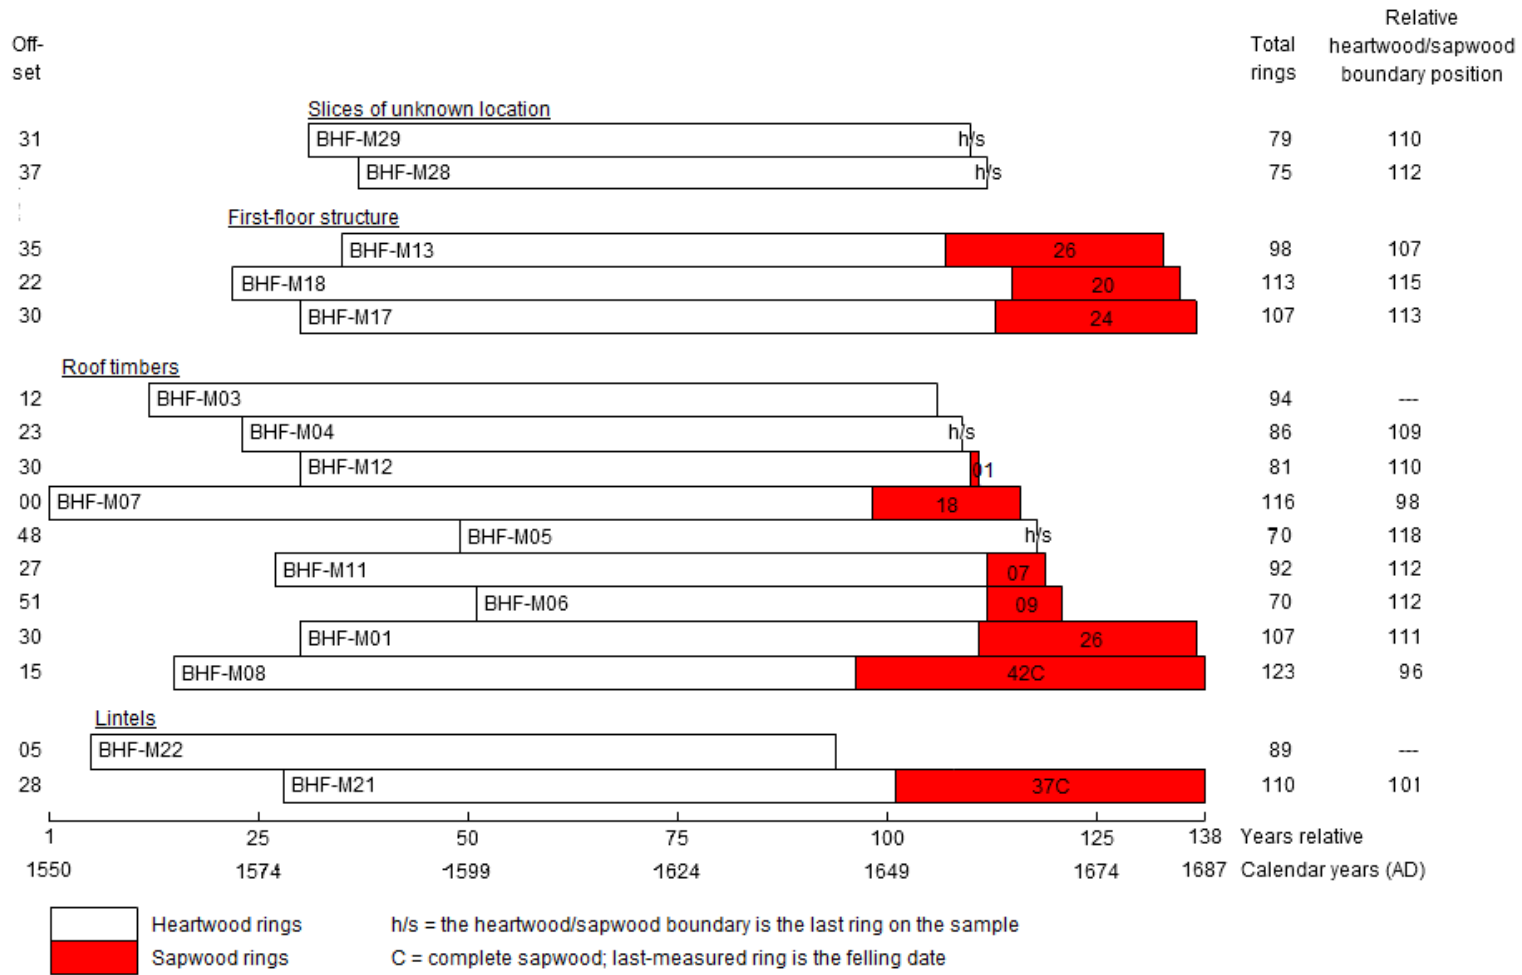
Figure 14: Bar diagram to show the relative position of samples in site sequence BHFMSQ01, sorted by area

Firstly, 16 samples matched each other at a minimum t -value of 4.6 and were combined at the relevant offset positions to form BHFMSQ01, a site sequence of 138 rings (Fig 14). This site sequence was then compared against an extensive series of relevant reference chronologies for oak where it was found to match securely and consistently at a first-ring date of AD 1550 and a last-measured ring date of AD 1687. The evidence for this dating is given in Table 2.

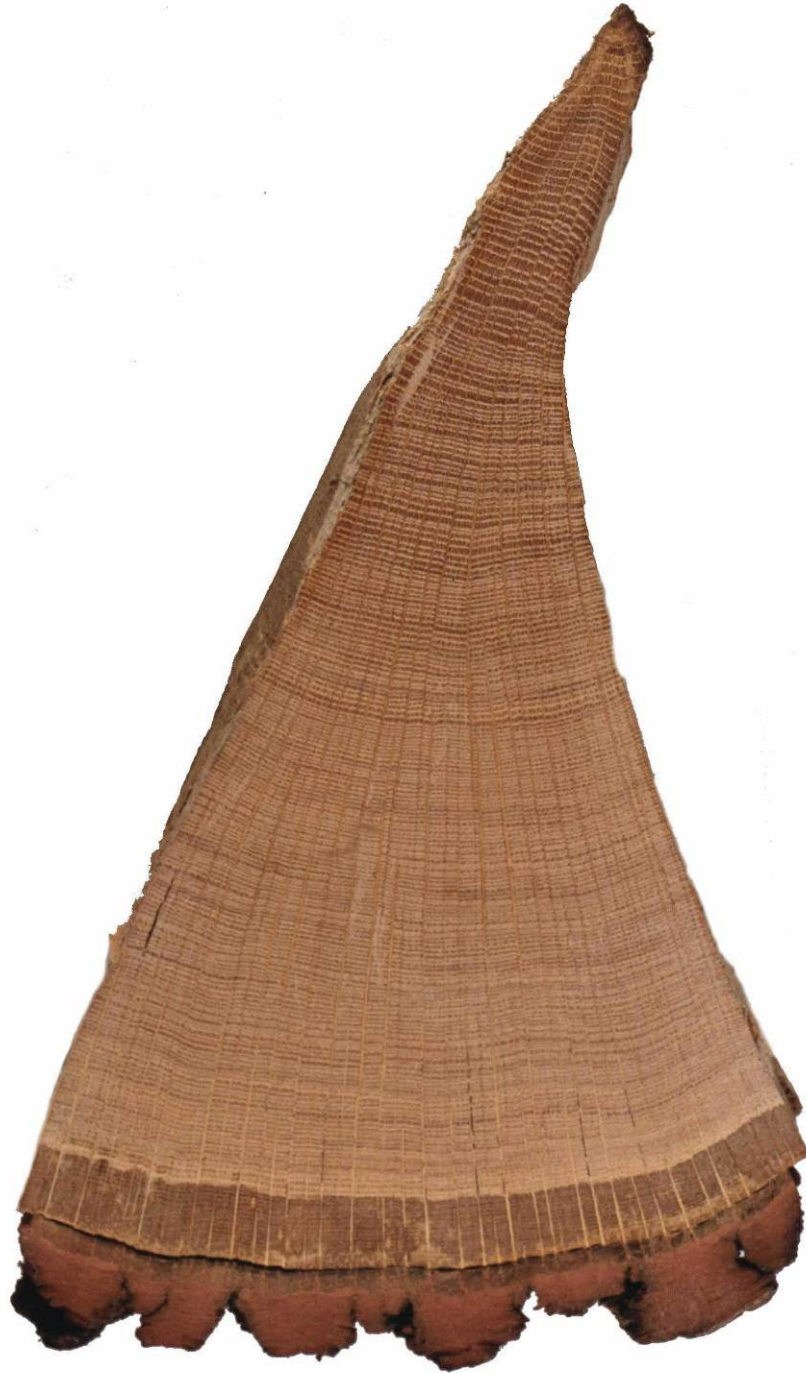
Figure A1: A wedge of oak from a tree felled in 1976. It shows the annual growth rings, one for each year from the innermost ring to the last ring on the outside, just inside the bark. The year of each ring can be determined by counting back from the outside ring, which grew in 1976

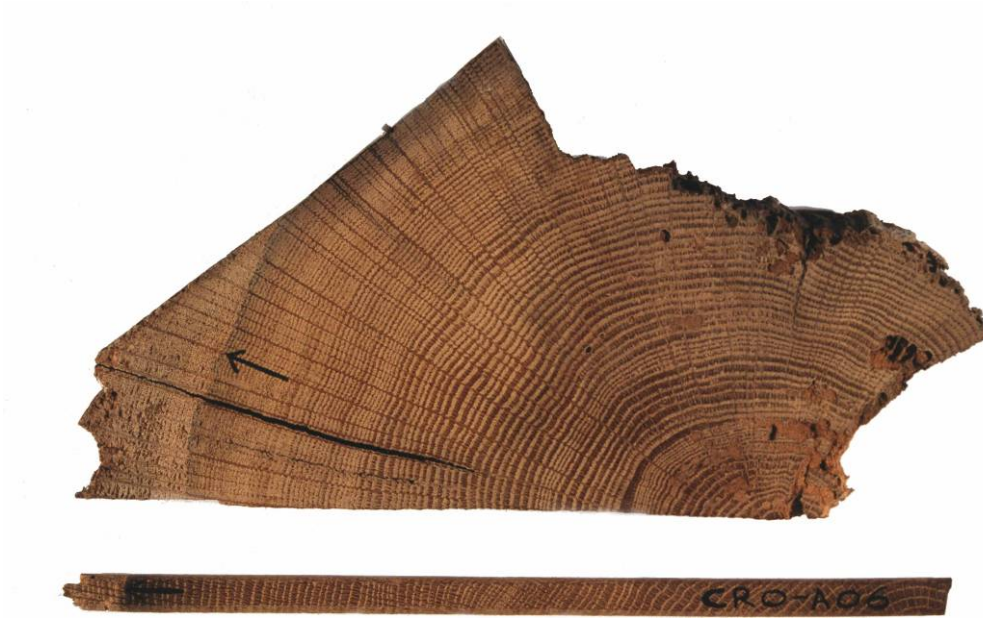
Figure A2: Cross-section of a rafter, showing sapwood rings in the left-hand corner, the arrow points to the heartwood/sapwood boundary (H/S); and a core with sapwood; again the arrow is pointing to the H/S. The core is about the size of a pencil

Quite often some, though not all, of the original outer rings are missing on a timber. The outer rings on an oak, called sapwood rings, are usually lighter than the inner rings, the heartwood, and so are relatively easy to identify. For example, sapwood can be seen in the corner of the rafter and at the outer end of the core in Figure A2, both indicated by arrows. More importantly for dendrochronology, the sapwood is relatively soft and so liable to insect attack and wear and tear. The builder, therefore, may remove some of the sapwood for precisely these reasons. Nevertheless, if at least some of the sapwood rings are left on a sample, we will know that not too many rings have been lost since felling so that the date of the last ring on the sample is only a few years before the date of the original last ring on the tree, and so to the date of felling.

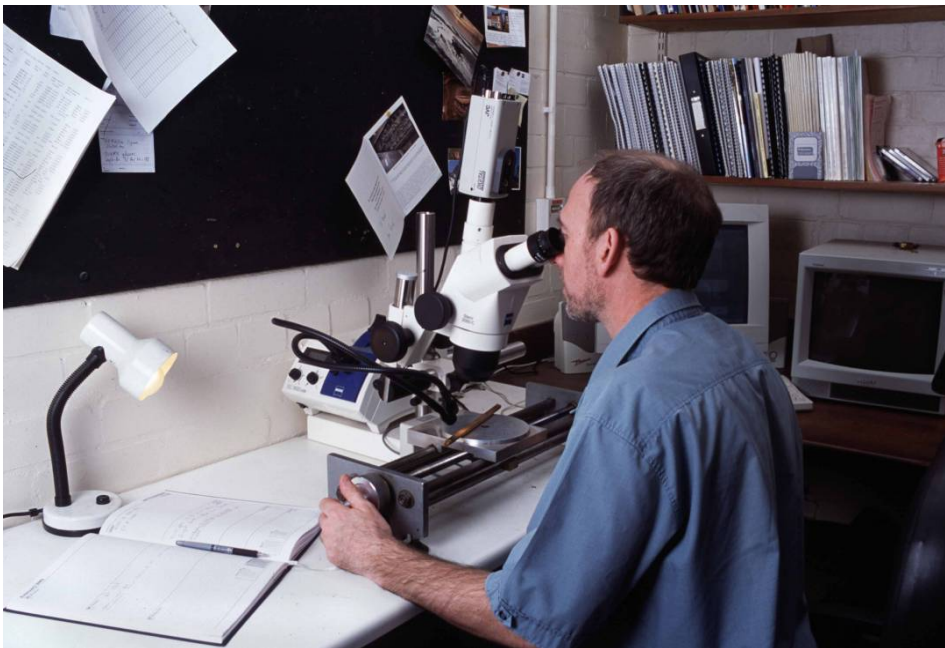
Figure A3: Measuring ring widths under a microscope. The microscope is fixed while the sample is on a moving platform. The total sequence of widths is measured twice to ensure that an error has not been made. This type of apparatus is needed to process a large number of samples on a regular basis

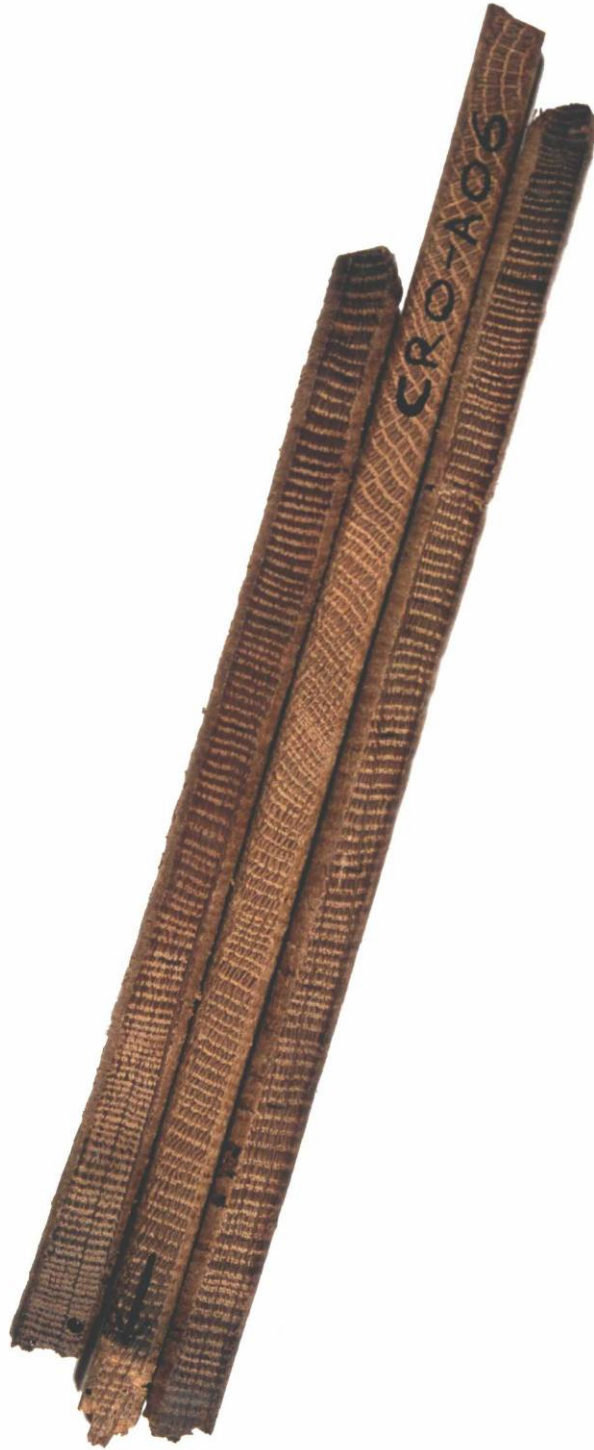
Figure A4: Three cores from timbers in a building. They come from trees growing at the same time. Notice that, although the sequences of widths look similar, they are not identical. This is typical
