Wrest Park, Silsoe, Bedfordshire Bathhouse Grounds Analytical Earthwork Survey

**WREST PARK,
SILSOE,
BEDFORDSHIRE**

**BATHHOUSE GROUNDS
ANALYTICAL EARTHWORK SURVEY**

NGR: TL 089 353

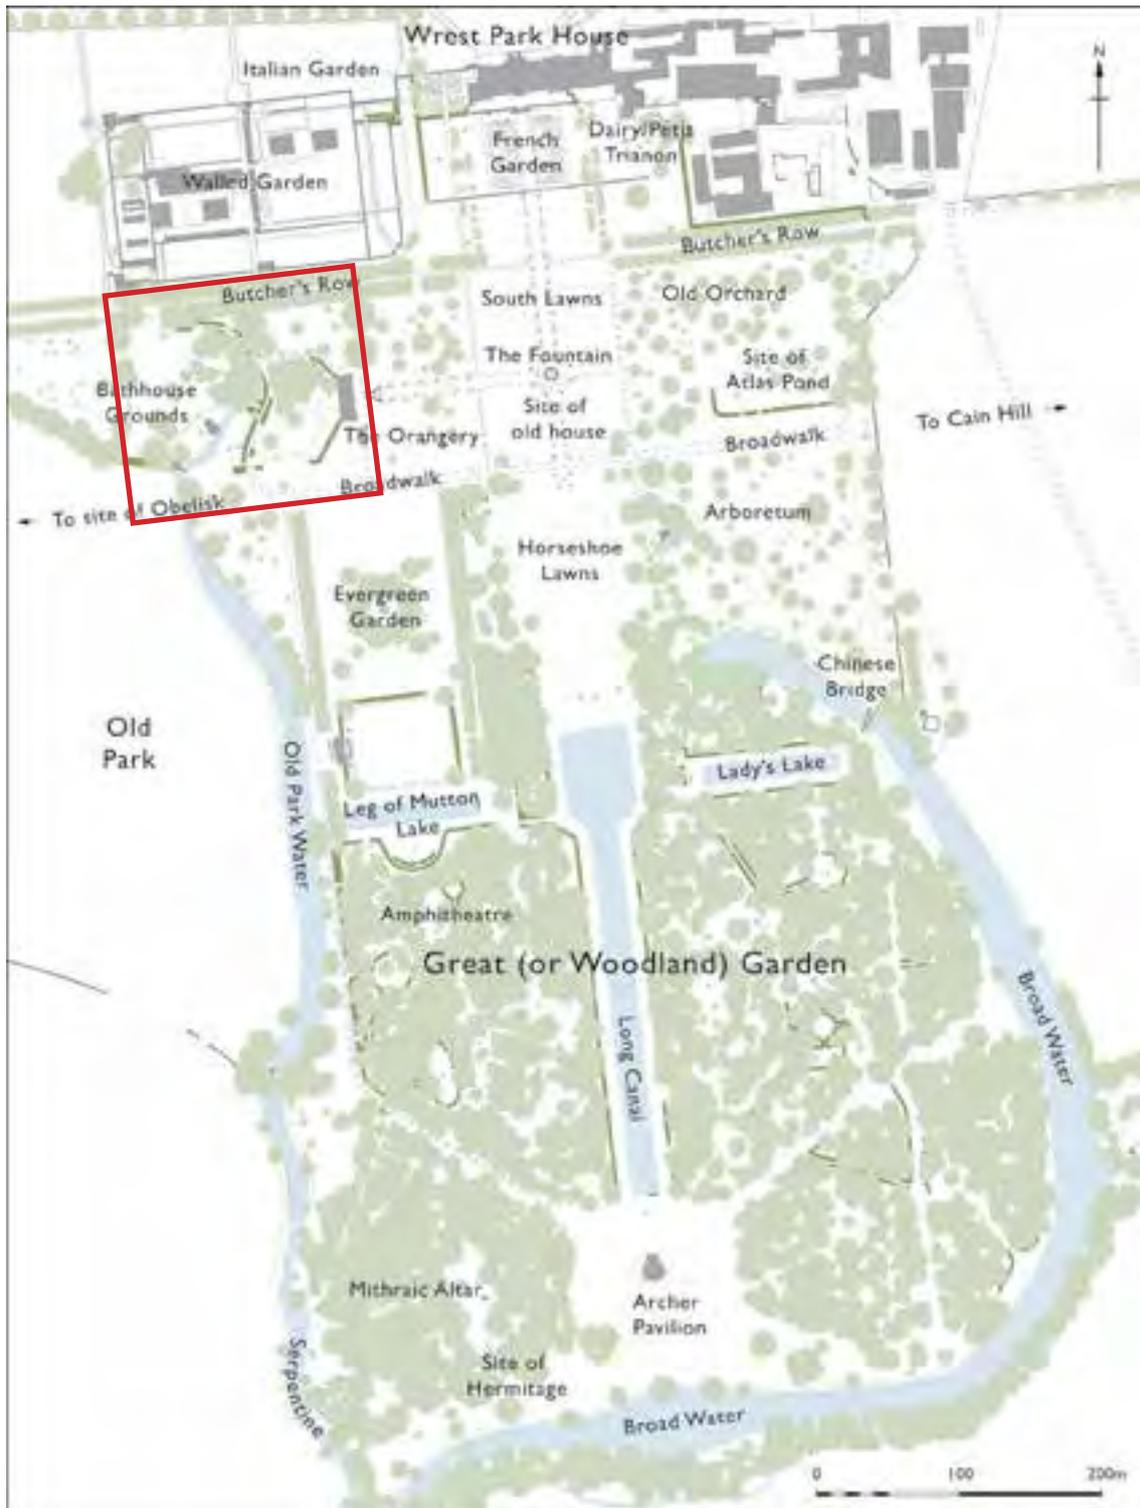
Figure 2 The house and gardens with the location of the survey area in red (Sharon Soutar, based upon a survey by Atkins for English Heritage in 2009, note that some areas have been redeveloped since this date)

The survey area lay to the south of Butcher's Row and north of the line of Broadwalk, and extended west from the Orangery as far as the current limit of the gardens (Figure 2). Its full extent was determined both by the area to be developed and previous survey work already undertaken (see 'Earthwork description' below).

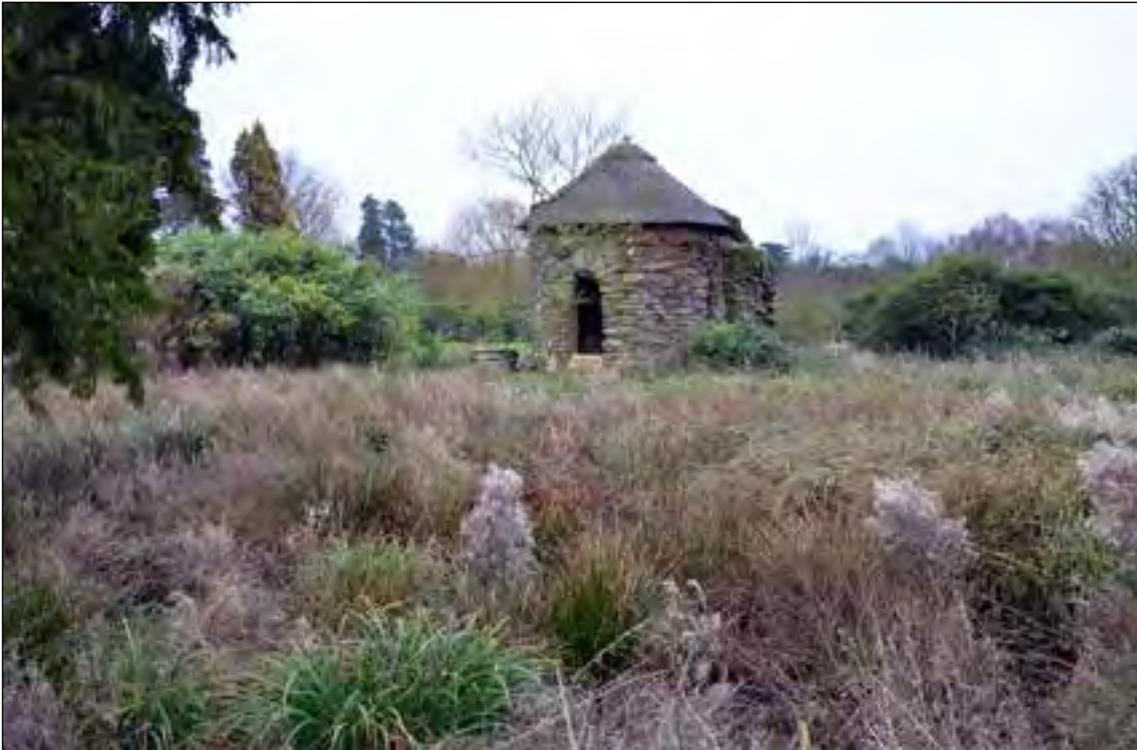
Figure 3 The Bathhouse grounds from the west (Brian Kerr)

A similar area to the west of the Bathhouse was drier and no channels had been dug to drain it (Figure 3). It was also thickly vegetated but some scarps could be picked out. Where these could be resolved into coherent features they were surveyed.

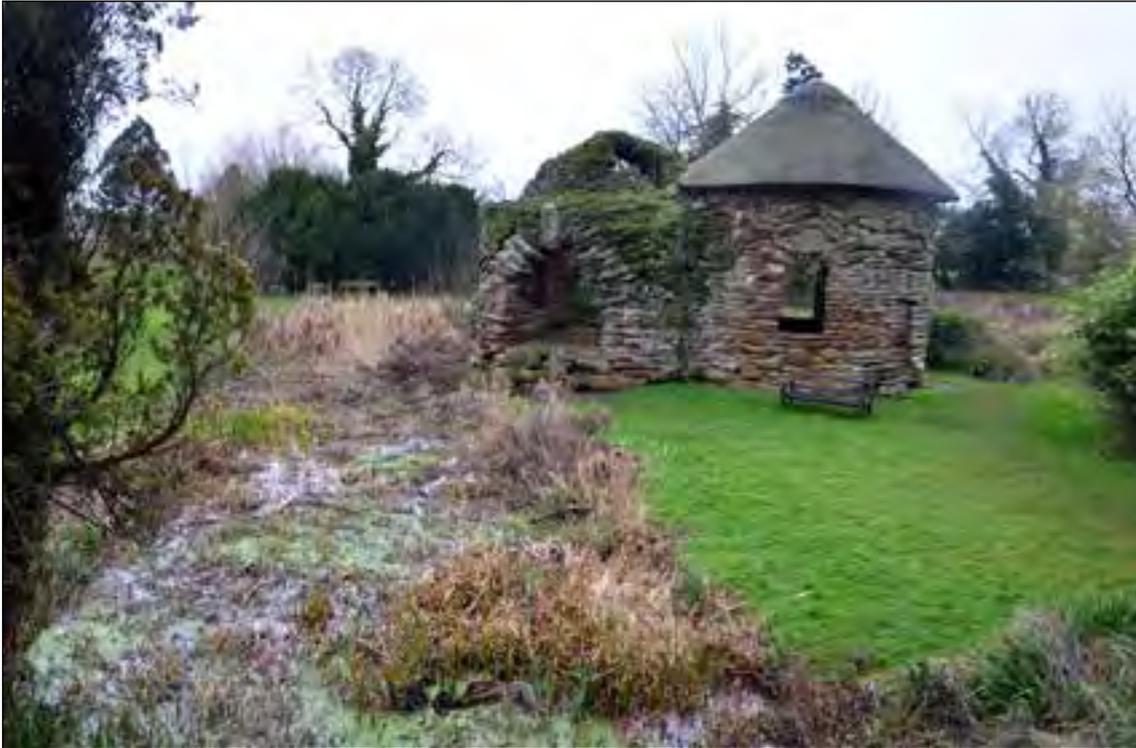
Figure 4 The Bathhouse from the Cascade with the weed choked Bathhouse Water to its left (Brian Kerr)

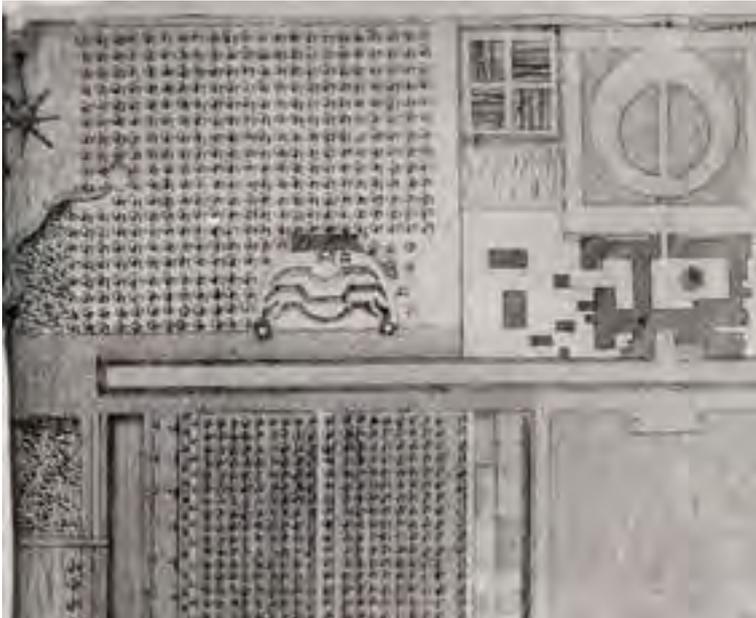
Figure 8 Detail from a monochrome photograph of a rather damaged version of the Rocque map of 1737 (© Historic England Archive, Map Room 99/7)

south end of the Orangery (see Figure 17), and was situated on a mound referred to as 'Green House Hill' on the 1830 map (Figure 11). This mound had the form of a broadly stepped amphitheatre, with wings to east and west (Figure 8), presumably intended to reflect the larger amphitheatre to the south (see Figure 2) which had been built some time earlier. This layout lasted until its demolition and replacement by the Orangery; it was included in 'Views of Wrest 1831' (Figure 14) where it appears largely unchanged (note the clear fall away from Broadwalk visible in the foreground). It seems highly likely that the Orangery terraces [35], at least to the south, made use of the existing earthworks associated with the earlier Greenhouse, so their core, if not much of their outer form, is probably from the 1730s. It is also possible that some at least of the scarps at the west end of the Orangery terraces, which appeared to be the result of erosion by foot traffic, could in fact also be the remnants of parts of the western ends of the upper Greenhouse terraces. The large scarp behind the yew hedge [37] is also highly likely to be a reshaped version of that constructed for the Greenhouse.

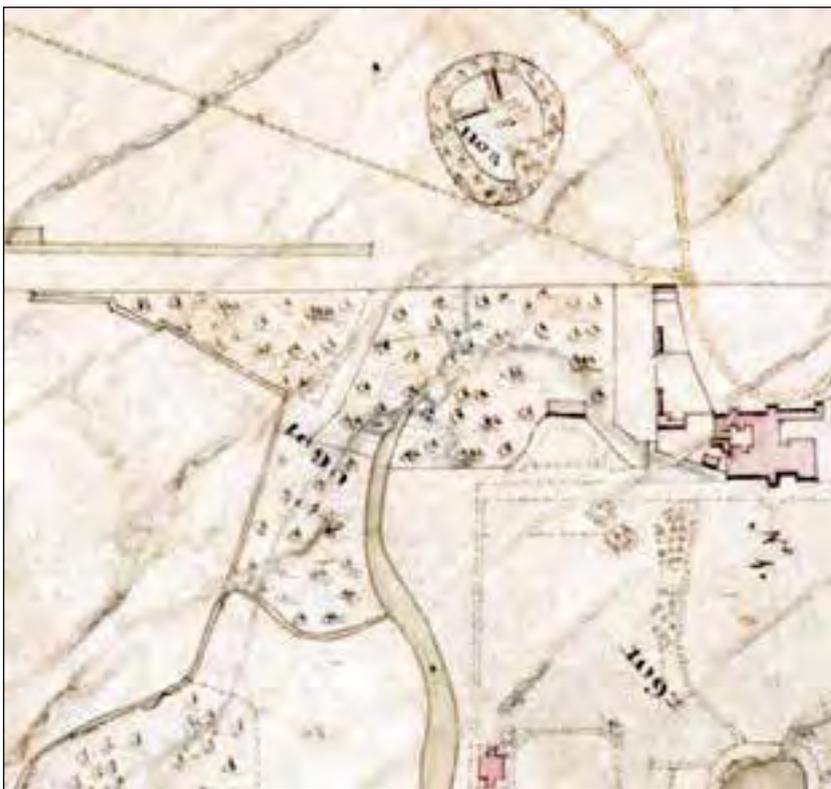
Figure 9 Detail from a 'pre-inclosure' map of about 1800 (BLARS L33/21, Patricia Payne © Historic England DP110957)

paralleling the avenue to the north and another to the east of the Greenhouse (Figure 9). The east/west section of the yew hedge was of considerable antiquity, possibly dating back to 1716 ([12] above). The northern boundary could also be of some age as the avenue that it paralleled appears in sources from about 1704 though it is first shown on the 1800 map (Figure 9). It lay outside the survey area but may have been preserved as a southwards fall noted within the dense vegetation north of the 'S' track. It seems more likely that the eastern and western boundaries were contemporary with the Bathhouse. They first appear on the 1800 map (Figure 9) and there are no obvious earlier or later contexts for their creation. The western boundary was clearly visible ([19] above) and some possible hints of the eastern boundary were recorded during previous survey work on the lawns to the east of the Orangery (Alexander et al 2014).

The Bathhouse originally looked out onto the rusticated column monument, now known as 'Brown's Column' (LUC 1993), which was moved to its current position in the woodland gardens by about 1830, certainly 1831 (based upon the maps shown in Figure 9 and Figure 10 though the areas concerned are not reproduced here, see Alexander et al 2014, Figure 106 and Figure 120, item U; contra LUC 1993). It is unclear where this would have been, though a site to the north-west would have been visible from the door, or one within the south-east quadrant from the windows of the bath itself.

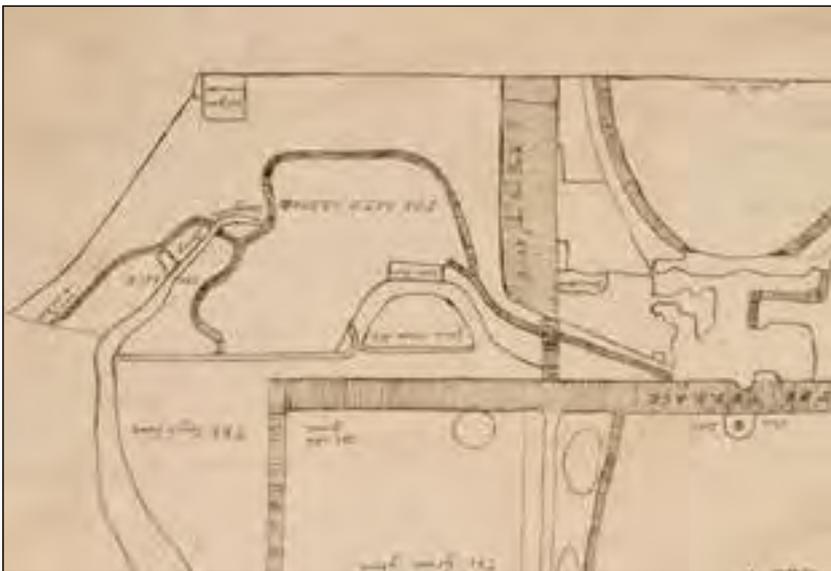
Figure 11 Detail from an undated and anonymous copy of a map of about 1830, inverted so that north is at the top, note the 'chalybeate spring' to the north-east of the bathhouse (BLARS L33/208 Patricia Payne © Historic England DP110948)

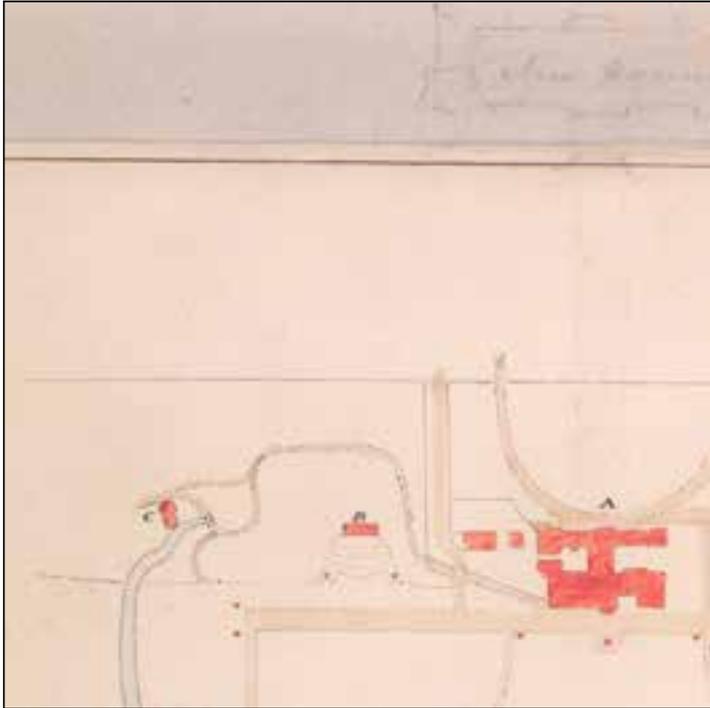
Figure 12 Detail of the map from 'Views of Wrest 1831', A is 'The House' (note the 'New House' pencilled in above), B 'The Greenhouse', C 'The Bath' (Steve Cole © Historic England DP110018, by permission of a descendent of Thomas Earl de Grey)

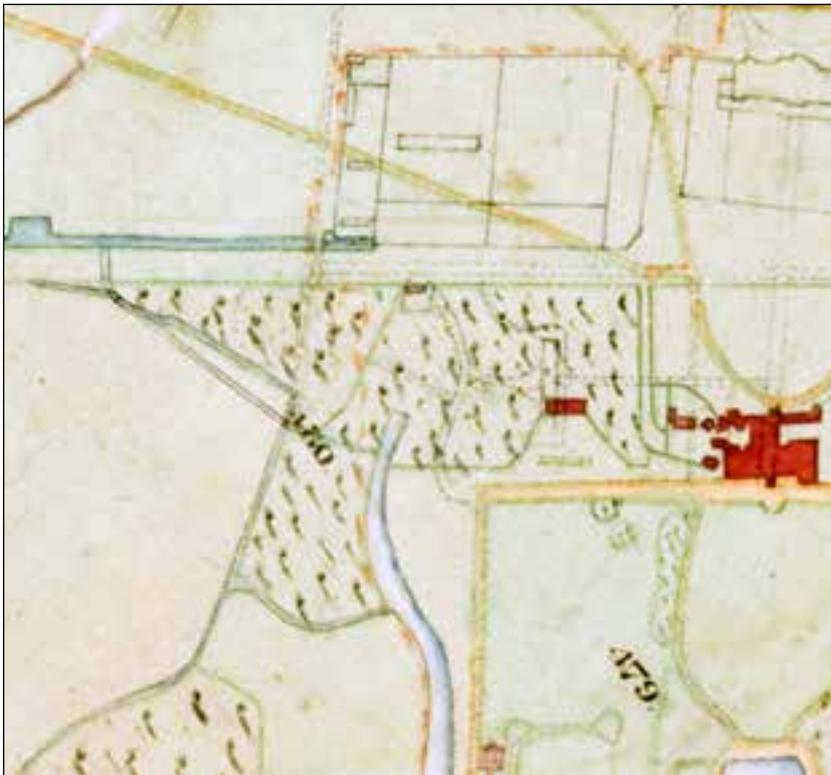
Figure 17 Detail from an 'inclosure' map of about 1809 with additions probably of about 1840 (Patricia Payne © Historic England DP110956)

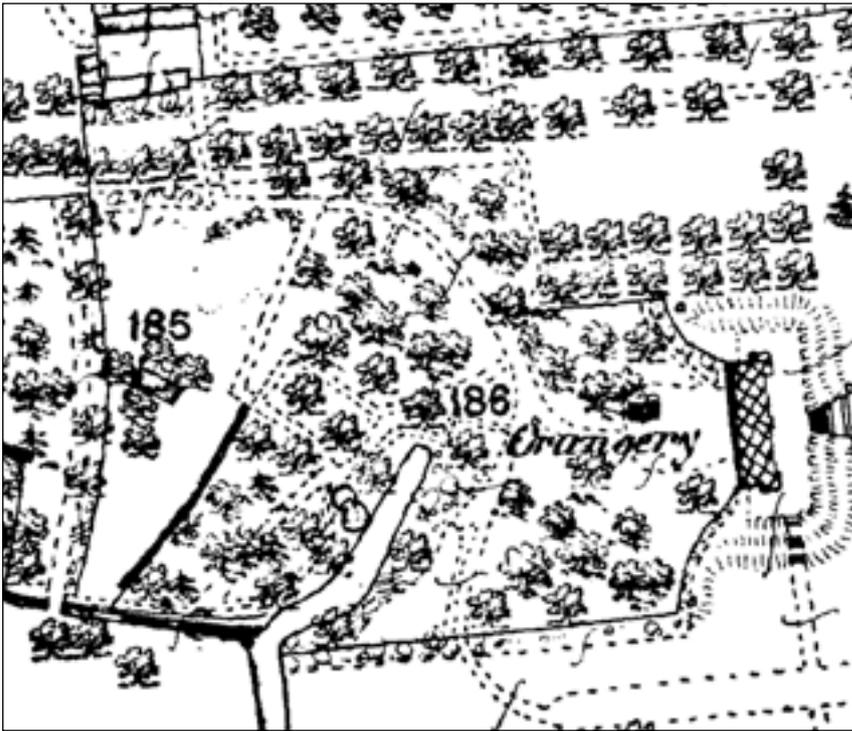
Figure 18 First edition 25" to 1 mile OS map, surveyed 1881, published 1887, taken from the Historic England corporate GIS, NTS. It is planned to restore most of the paths to this layout. (Historic Ordnance Survey mapping: © and database right Crown Copyright and Landmark Information Group Ltd (All rights reserved 2015) Licence numbers 000394 and TP0024)

the west. This was the site of a rectangular building, measuring about 11m by 5m, surrounded by trees shown on the 1881 and 1899 OS maps (Figure 18 and Figure 19). This had been replaced by a smaller building with yards to the north-west (a sty or kennels perhaps), about 6.5m by 5.5m in total, on approximately the site of the eastern end of the earlier building by the 1922 map (Figure 20), and which survived until at least the 1947 map (not reproduced). Both buildings were oriented north-west to south-east rather than east/west as suggested by the earthworks, however the ridges to the south were perhaps more aligned with the mapped buildings, as was a scarp to their south-east and it is possible that the east/west and north/south scarps to their north had been confused by tree boles. Trees are certainly shown growing close to the north-east side of the building on the first edition OS map.

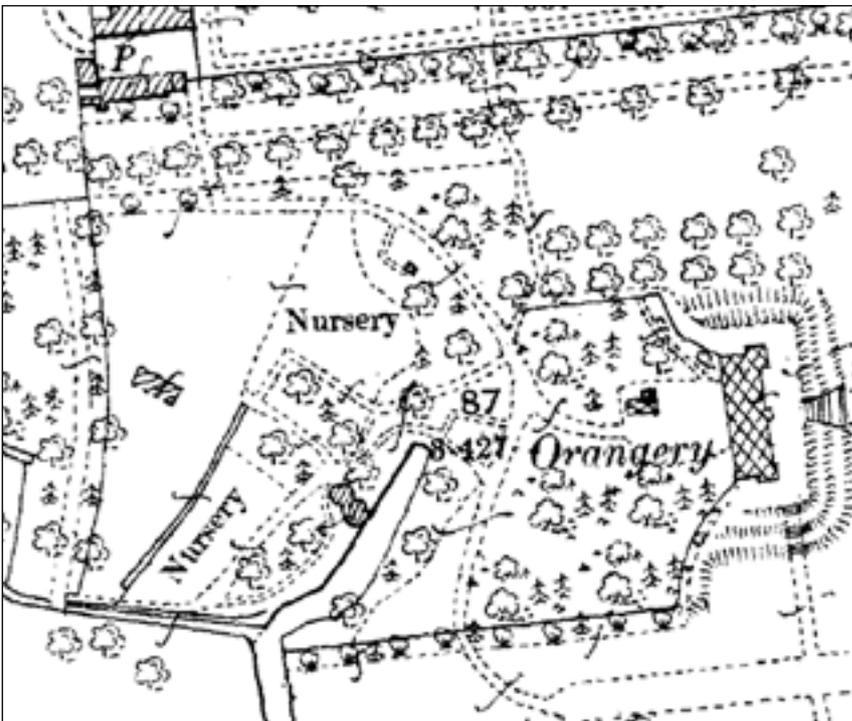
Figure 19 25" to 1 mile OS map, surveyed 1899, published 1902, taken from the Historic England corporate GIS, NTS (Historic Ordnance Survey mapping: © and database right Crown Copyright and Landmark Information Group Ltd (All rights reserved 2015) Licence numbers 000394 and TP0024)

The 1899 OS map (Figure 19) is clearer, showing wooded areas more stylistically, but otherwise most elements remain the same. The greater clarity shows that Bathhouse Water was directly connected to Old Park Water and there are hints that the inlet from the west may have been controlled by a weir, the opposite of the current position. It also shows considerable clearance of trees particularly on the triangular area to the west, and to the north and west of the Bathhouse where the new open areas are both labelled 'Nursery' (that to the north also shows a small building with approaching track).

The point at which the low marshy area to south of the Orangery service yard became waterlogged is unknown. The 1899 (Figure 19) to 1947 maps (not reproduced) show coniferous trees within the heart of this area, perhaps indicative of relatively dry ground, though by the 1975 map (Figure 21) those that remained seem to have been restricted to the north-west corner hinting that the ground was becoming wetter.

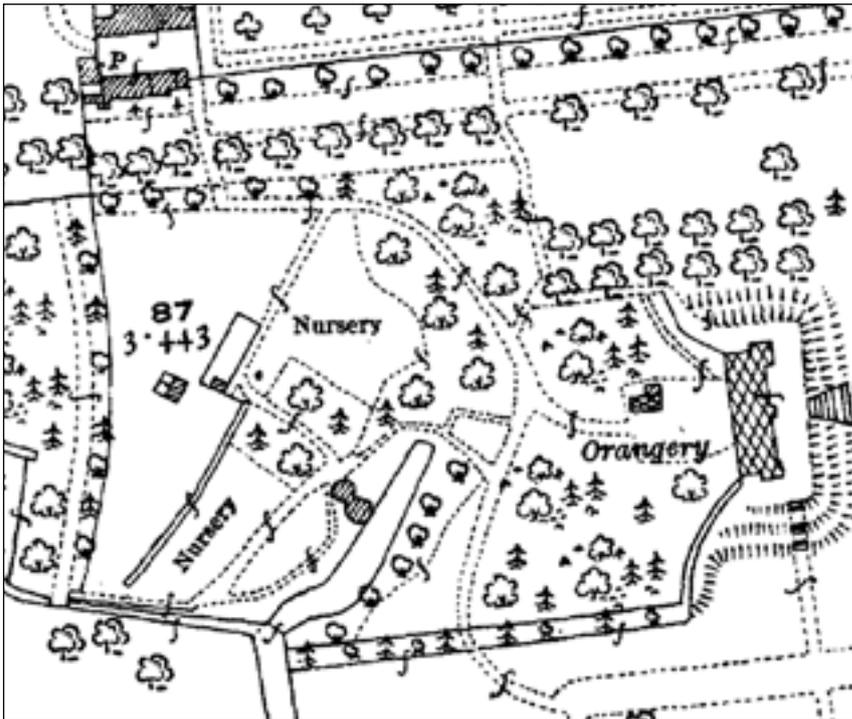
Figure 20 25" to 1 mile OS map, surveyed 1922, published 1925, taken from the Historic England corporate GIS, NTS (Historic Ordnance Survey mapping: © and database right Crown Copyright and Landmark Information Group Ltd (All rights reserved 2015) Licence numbers 000394 and TP0024)

Whilst most of the details remained the same on the 1922 OS map (Figure 20) the building on the lawn to the west had been demolished and replaced with a different building in roughly the same area. To the immediate east of this was an enclosure with another building within it. The 1947 OS map (not reproduced) is largely unchanged from 1922.

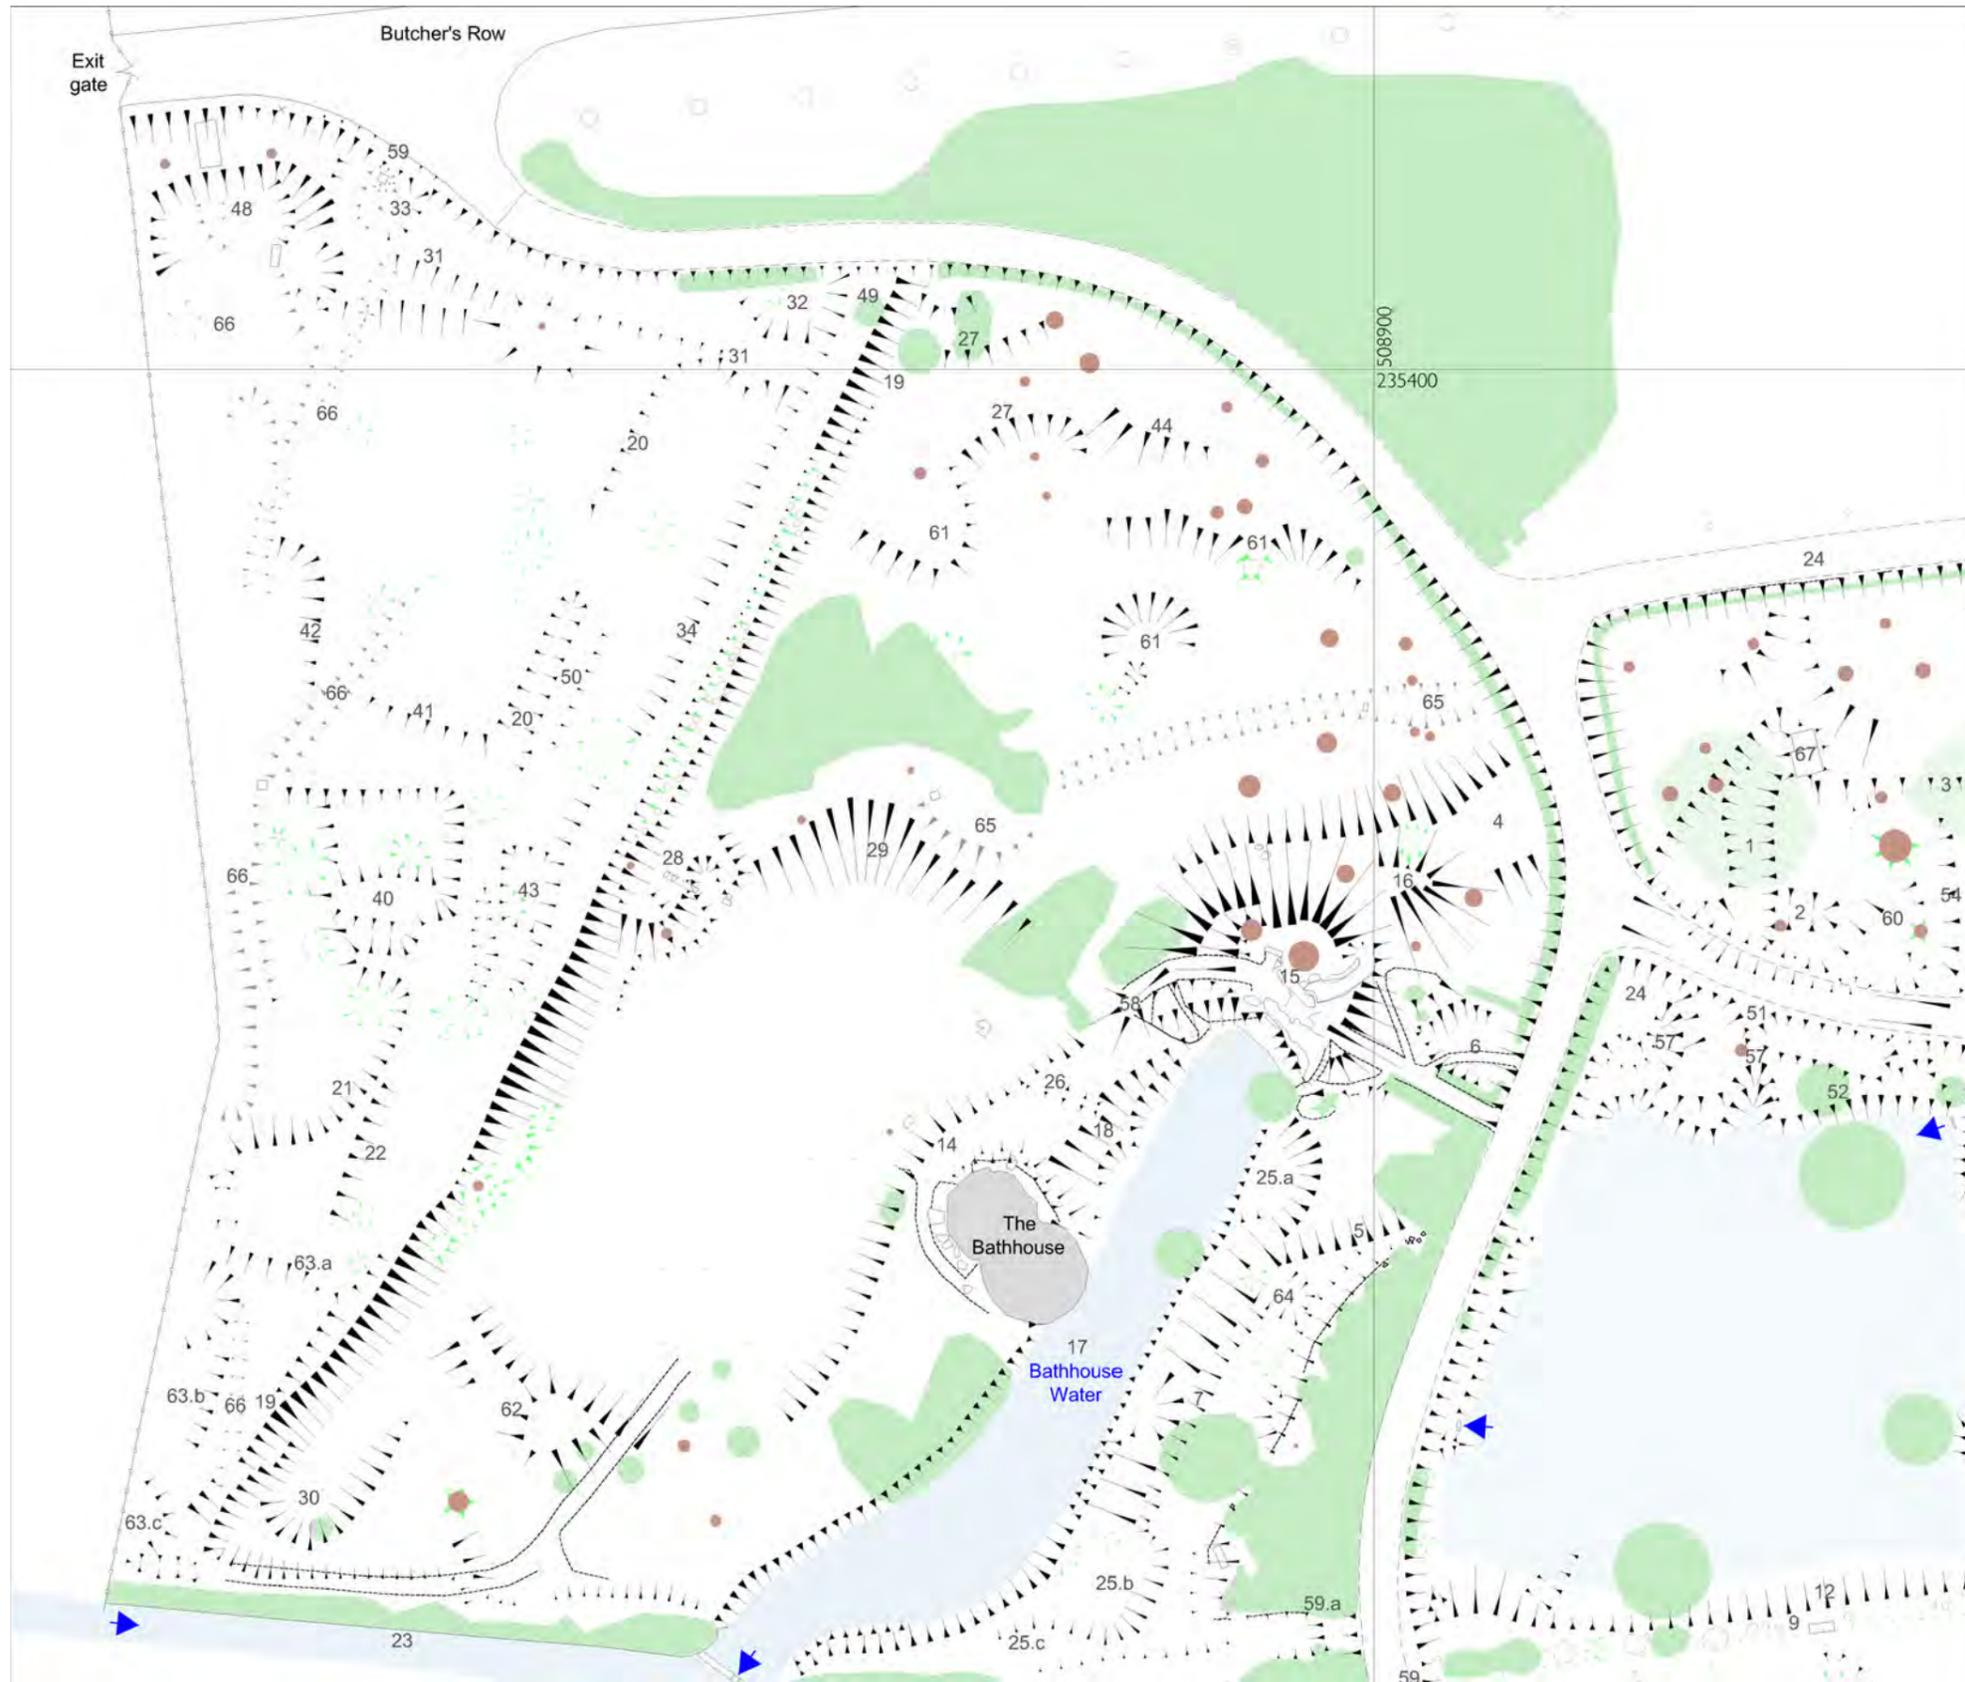
Figure 22 Survey plan (north-west section)
 1:500 at A3, green hachures relate to
 probable vegetation, grey hachures
 to services, greyed out features from
 Atkins 2005

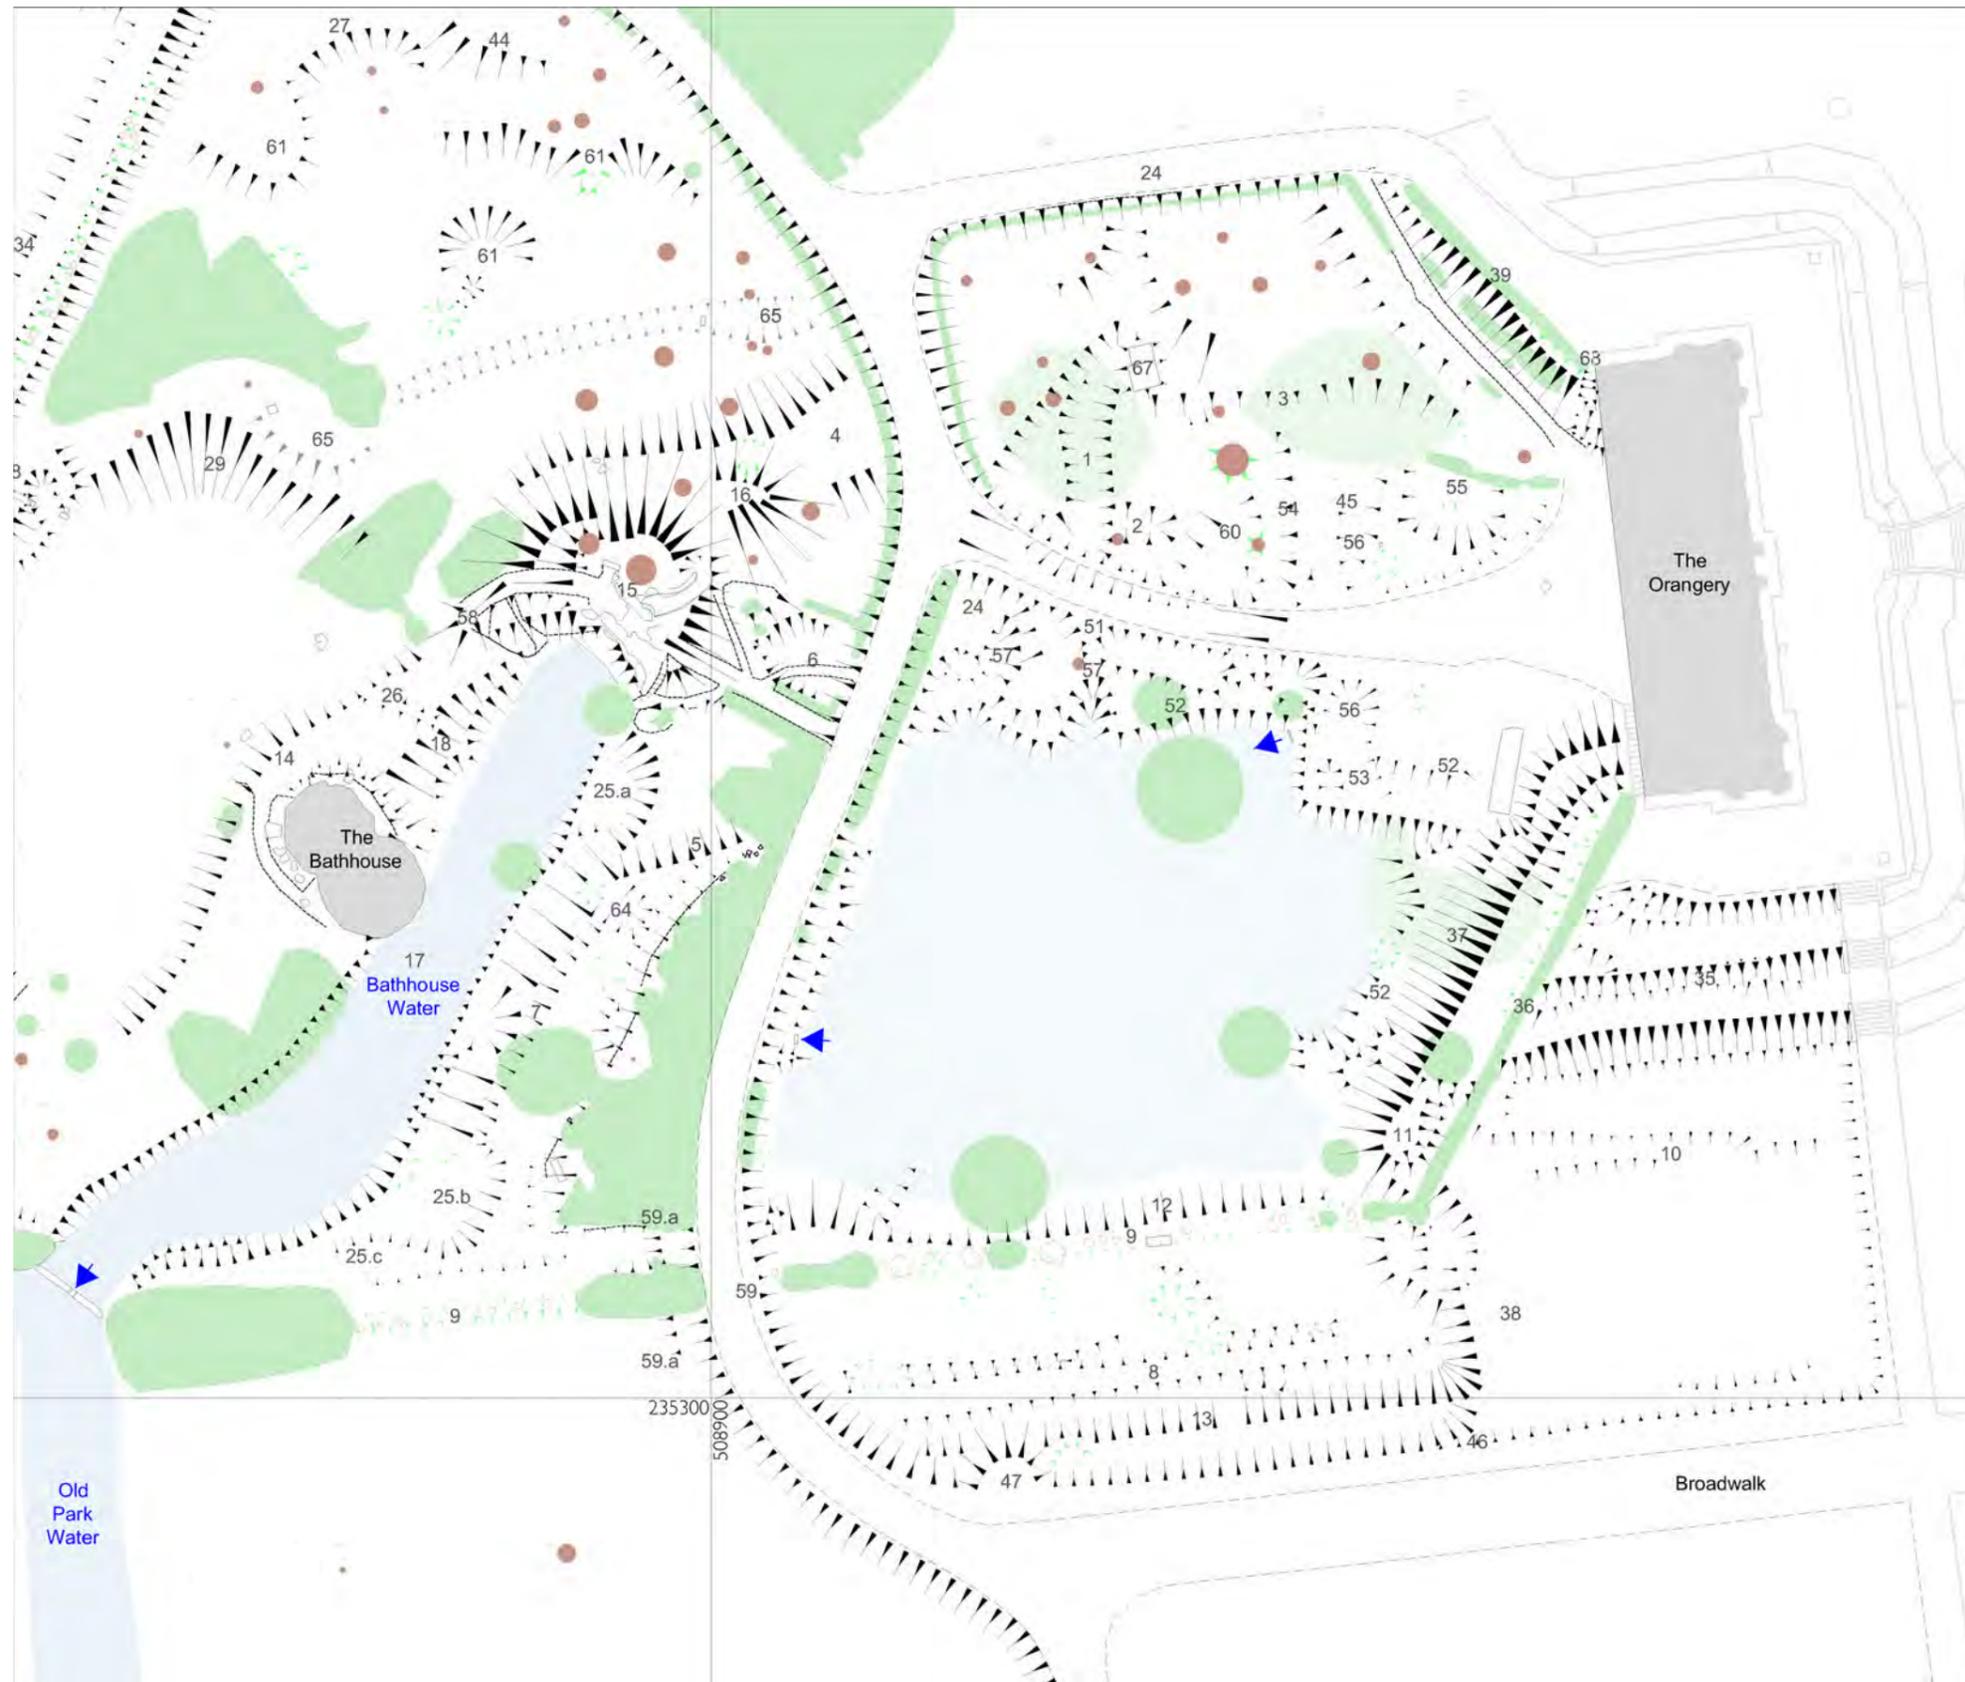
Figure 23 Survey plan (south-east section)
 1:500 at A3, green hachures relate to
 probable vegetation, grey hachures
 to services, greyed out features from
 Atkins 2005
