Hardwick House
Southam Road
Banbury
Cherwell
Oxfordshire

Tree-ring Analysis of Oak Timbers

Research Report Series no. 246-2020

HARDWICK HOUSE
SOUTHAM ROAD
BANBURY
CHERWELL
OXFORDSHIRE

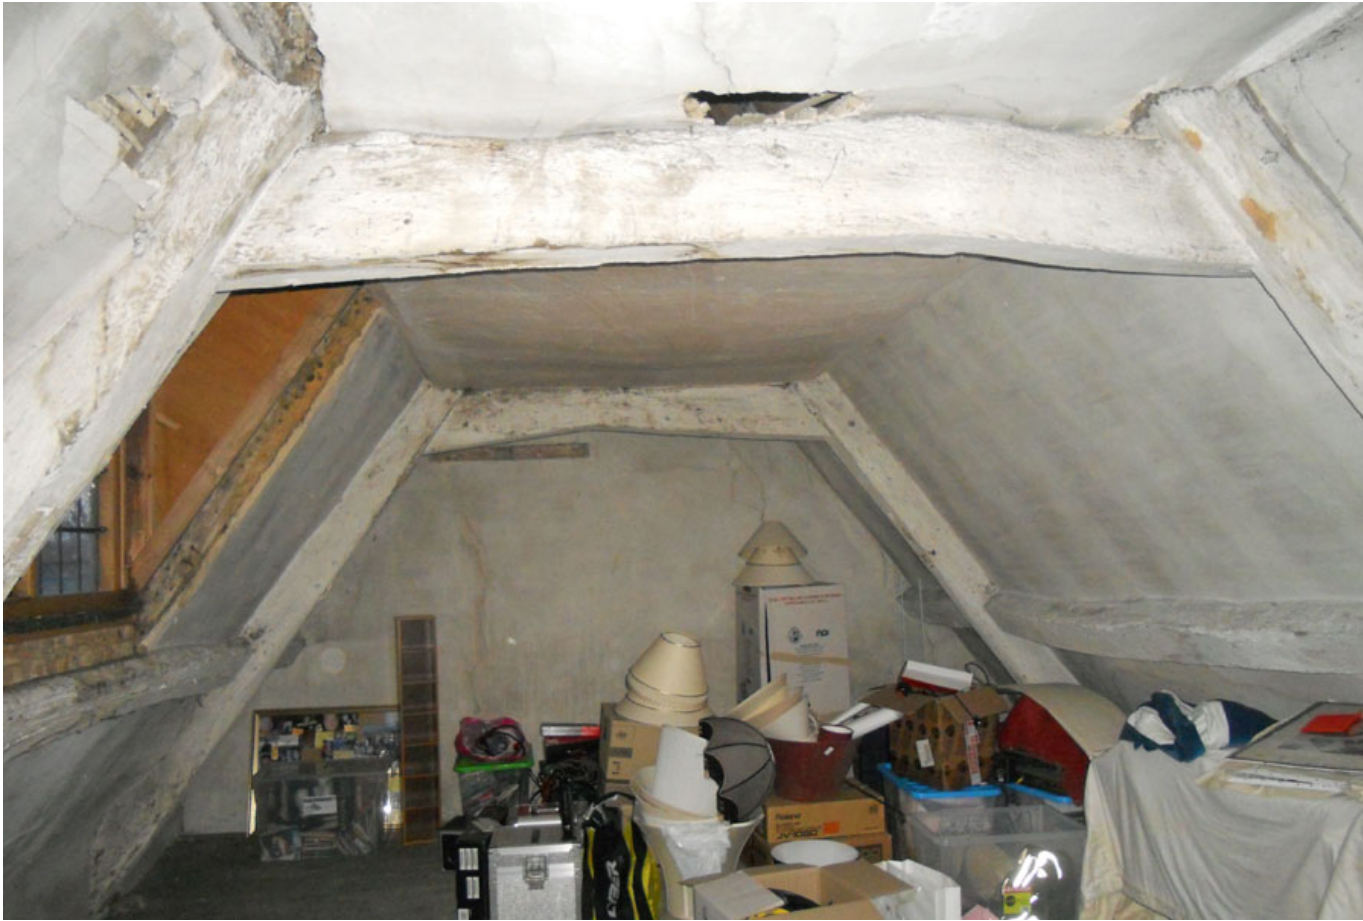
Figure 3: View of the east-range roof, looking south (photograph Martin Bridge)

The east-range roof (Figs 2 and 3) was seen to have had a replacement principal rafter inserted on the west side of the northern truss (truss 1) and this was sampled (hwkb08) in the hope that it might provide the date of this intervention. Nine other timbers were sampled from this roof, including an elm purlin (hwkb10) that was thought possibly to have been inserted at the same time as the new principal rafter. The samples from three of the timbers had additional unmeasured sapwood sections, one (hwkb04) of which was detached but complete to the bark edge. Samples hwkb02 and hwkb04, from two principal rafters of the same truss, matched each other well ($t = 12.8$), and were thought to be from the same tree. A new mean series hwkb0204m was formed and used in subsequent analysis. Samples hwkb09i and hwkb09ii matched with other series and showed that there was no rings missing, and they were subsequently combined to form a single series hwkb09. The series from four cross-matched timbers (Table 2a) were combined to form a single site chronology HWKBeast, which was subsequently dated to the period AD 1184–1343, a selection of the strongest matches being shown in Table 3a. In addition, cross-matching was also identified between the ring series from hwkb03 and hwkb07 ($t = 8.0$ with 54 years of overlap; Fig 4). These were combined (hwkb0307) for further analysis but could not be dated. Two further measured samples from this roof also failed to date.

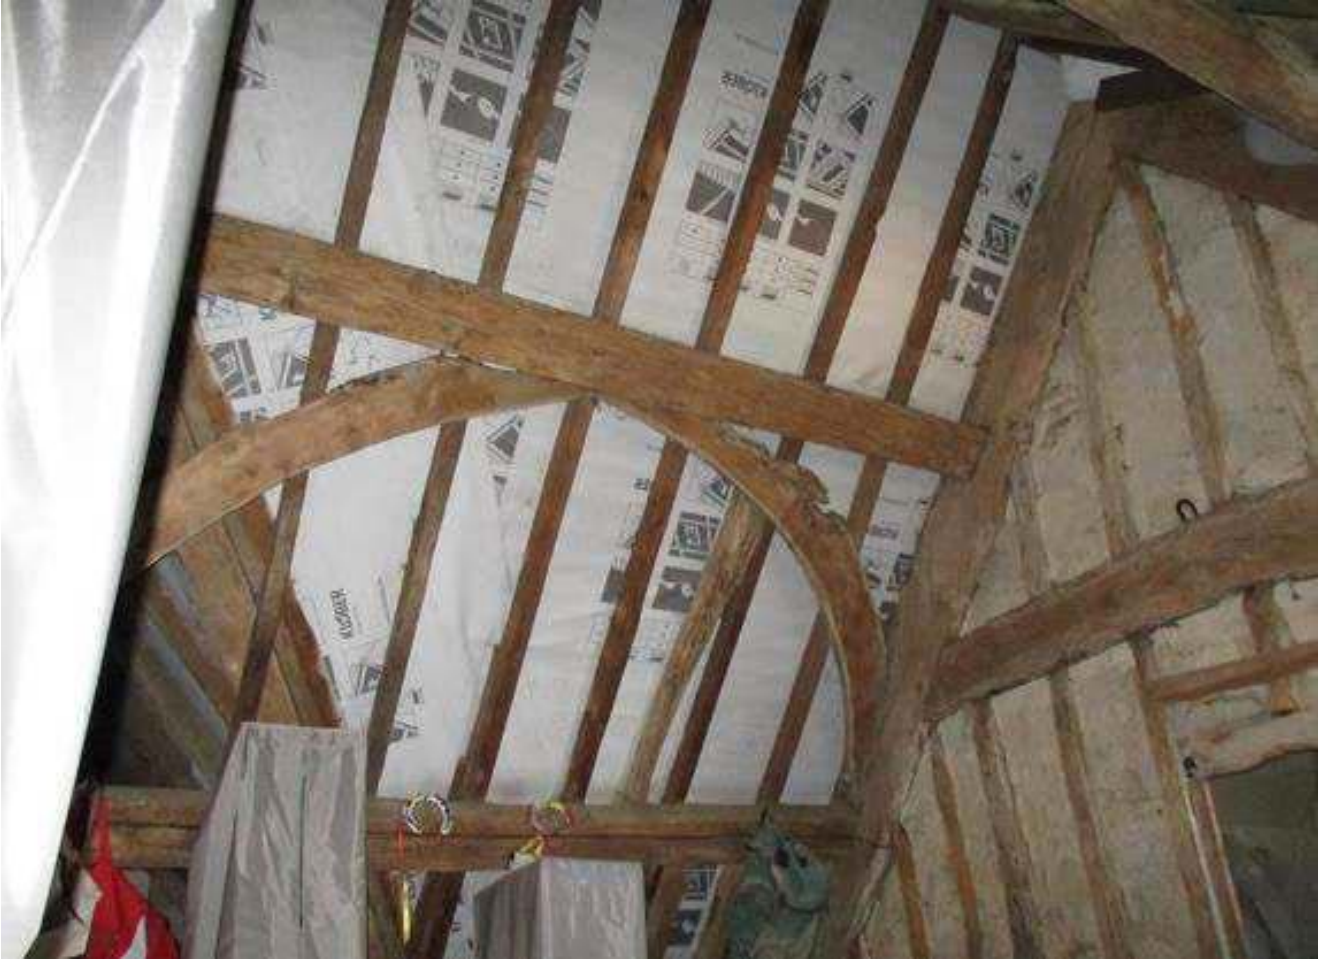
Figure 5: View of truss 3 in the north range, looking south-west (photograph Oxfordshire Buildings Record)

The north-range roof (Fig 5) is dated by just two timbers, with one retaining the heartwood/sapwood boundary, giving a likely felling date range of AD 1477–1509 for both timbers assuming that they are coeval (Fig 10). Documentary research presented by Clark *et al* (2017 unpubl) shows the Cope family acquired the property in AD 1496, and it seems quite likely that major work at the site would have occurred soon after this. The matches for these timbers (Table 3b) are widely spread and, apart from a likely English origin, little more can be said about their geographical origin.

Superficially the west- and north-range roofs look very similar (Figs 5 and 7), with many medieval characteristics such as curved collars, curved windbraces, and scratched assembly marks. Neither shows any sign of sooting, but the timbers of the

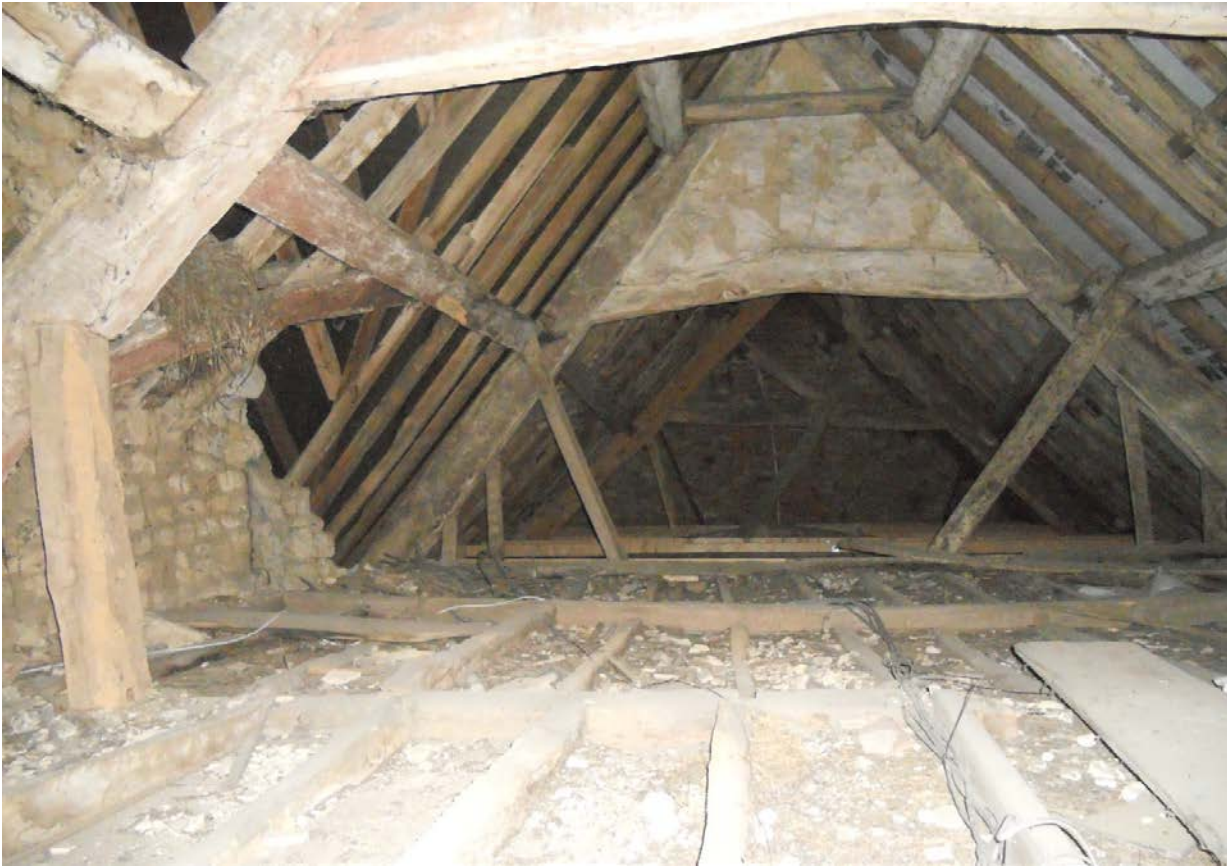
Figure 7: View of the west-range roof, looking south, with the inserted stack to the left (photograph Martin Bridge)

The roof timbers of the west-range roof (Fig 7) were found to be of both oak and elm, although the purlins were all noted as oak. These were sampled as they were relevant to the then on-going Historic England funded project on elm timbers from historic buildings (Bridge 2020). The two samples from the truss 4 collar, hwkb20a and hwkb20b cross-matched ($t = 5.7$ with 36 years of overlap) and were combined to produce a single timber series. Three of the series from elm timbers cross-matched with each other (Table 2b; Fig 8) and were combined into a single site chronology, HWKBelm. This elm site chronology was compared with the oak reference database, as well as the few extant dated elm site chronologies, but could not be dated. The remaining four measured elm timber series and three measured oak series could not be dated by ring-width dendrochronology either.

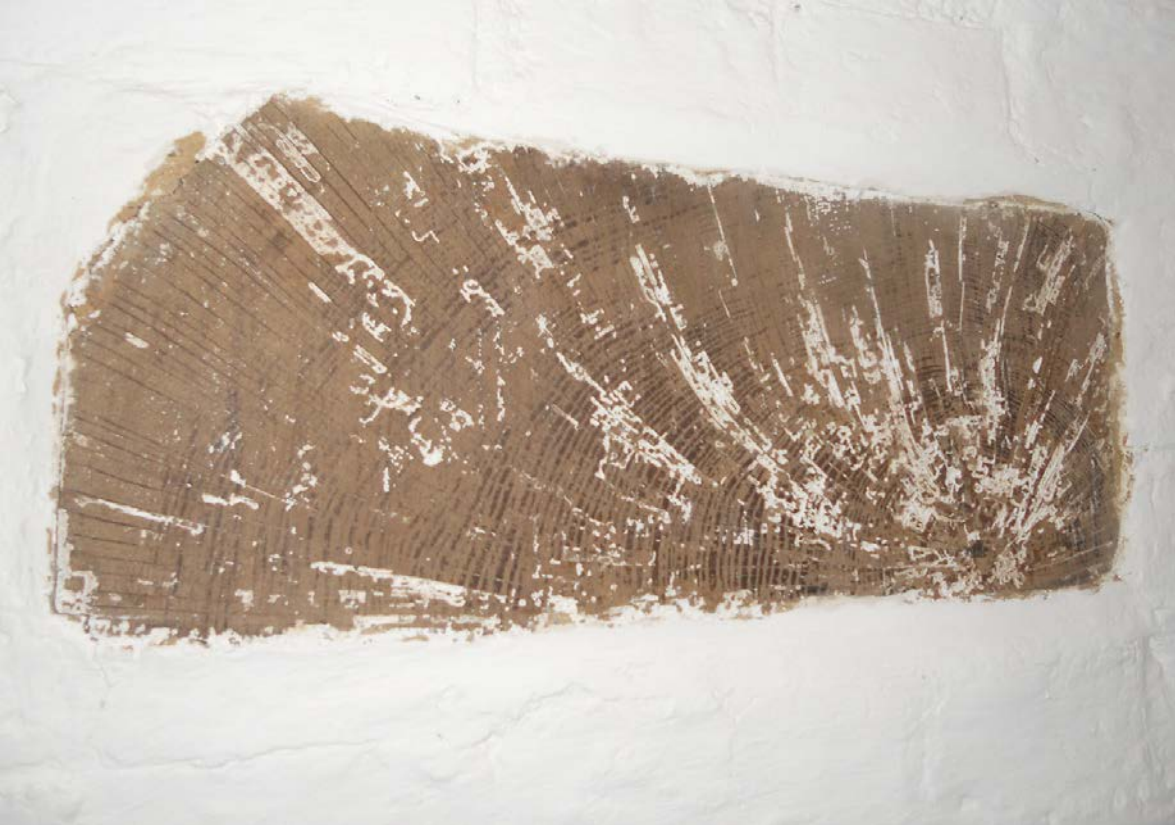
Figure 9: View of the exposed end of the beam in the cellar – hwkb30 (photograph Martin Bridge)

The two samples, hwkb30a and hwkb30b from the beam in the cellar (Fig 9) were known to overlap by only a small number of rings, 30b having been taken to reach the h/s boundary. Series hwkb30a was initially dated and the overlap confirmed by the comparison of hwkb30b to reference chronologies as well, thus they were combined to form a single series, hwkb30, which dated to the period AD 1460–1549. A selection of the strongest matches is shown in Table 3c.

The cellar timber under the north range (Fig 9) gives a likely felling date range of AD 1558–90, although the brick lining suggests construction in the nineteenth century. Although this series matches over a quite wide geographical area (Table 3c), it is likely the timber was of local origin.
